April 23, 2024

RE: Final Compliance Monitoring Summary & NFA Request
4 Corners Cleaners
23886 SE Kent-Kangley Rd.
Maple Valley, WA 98038-6848
AEG Atlas Project # 17-126
VCP ID No. NW3234

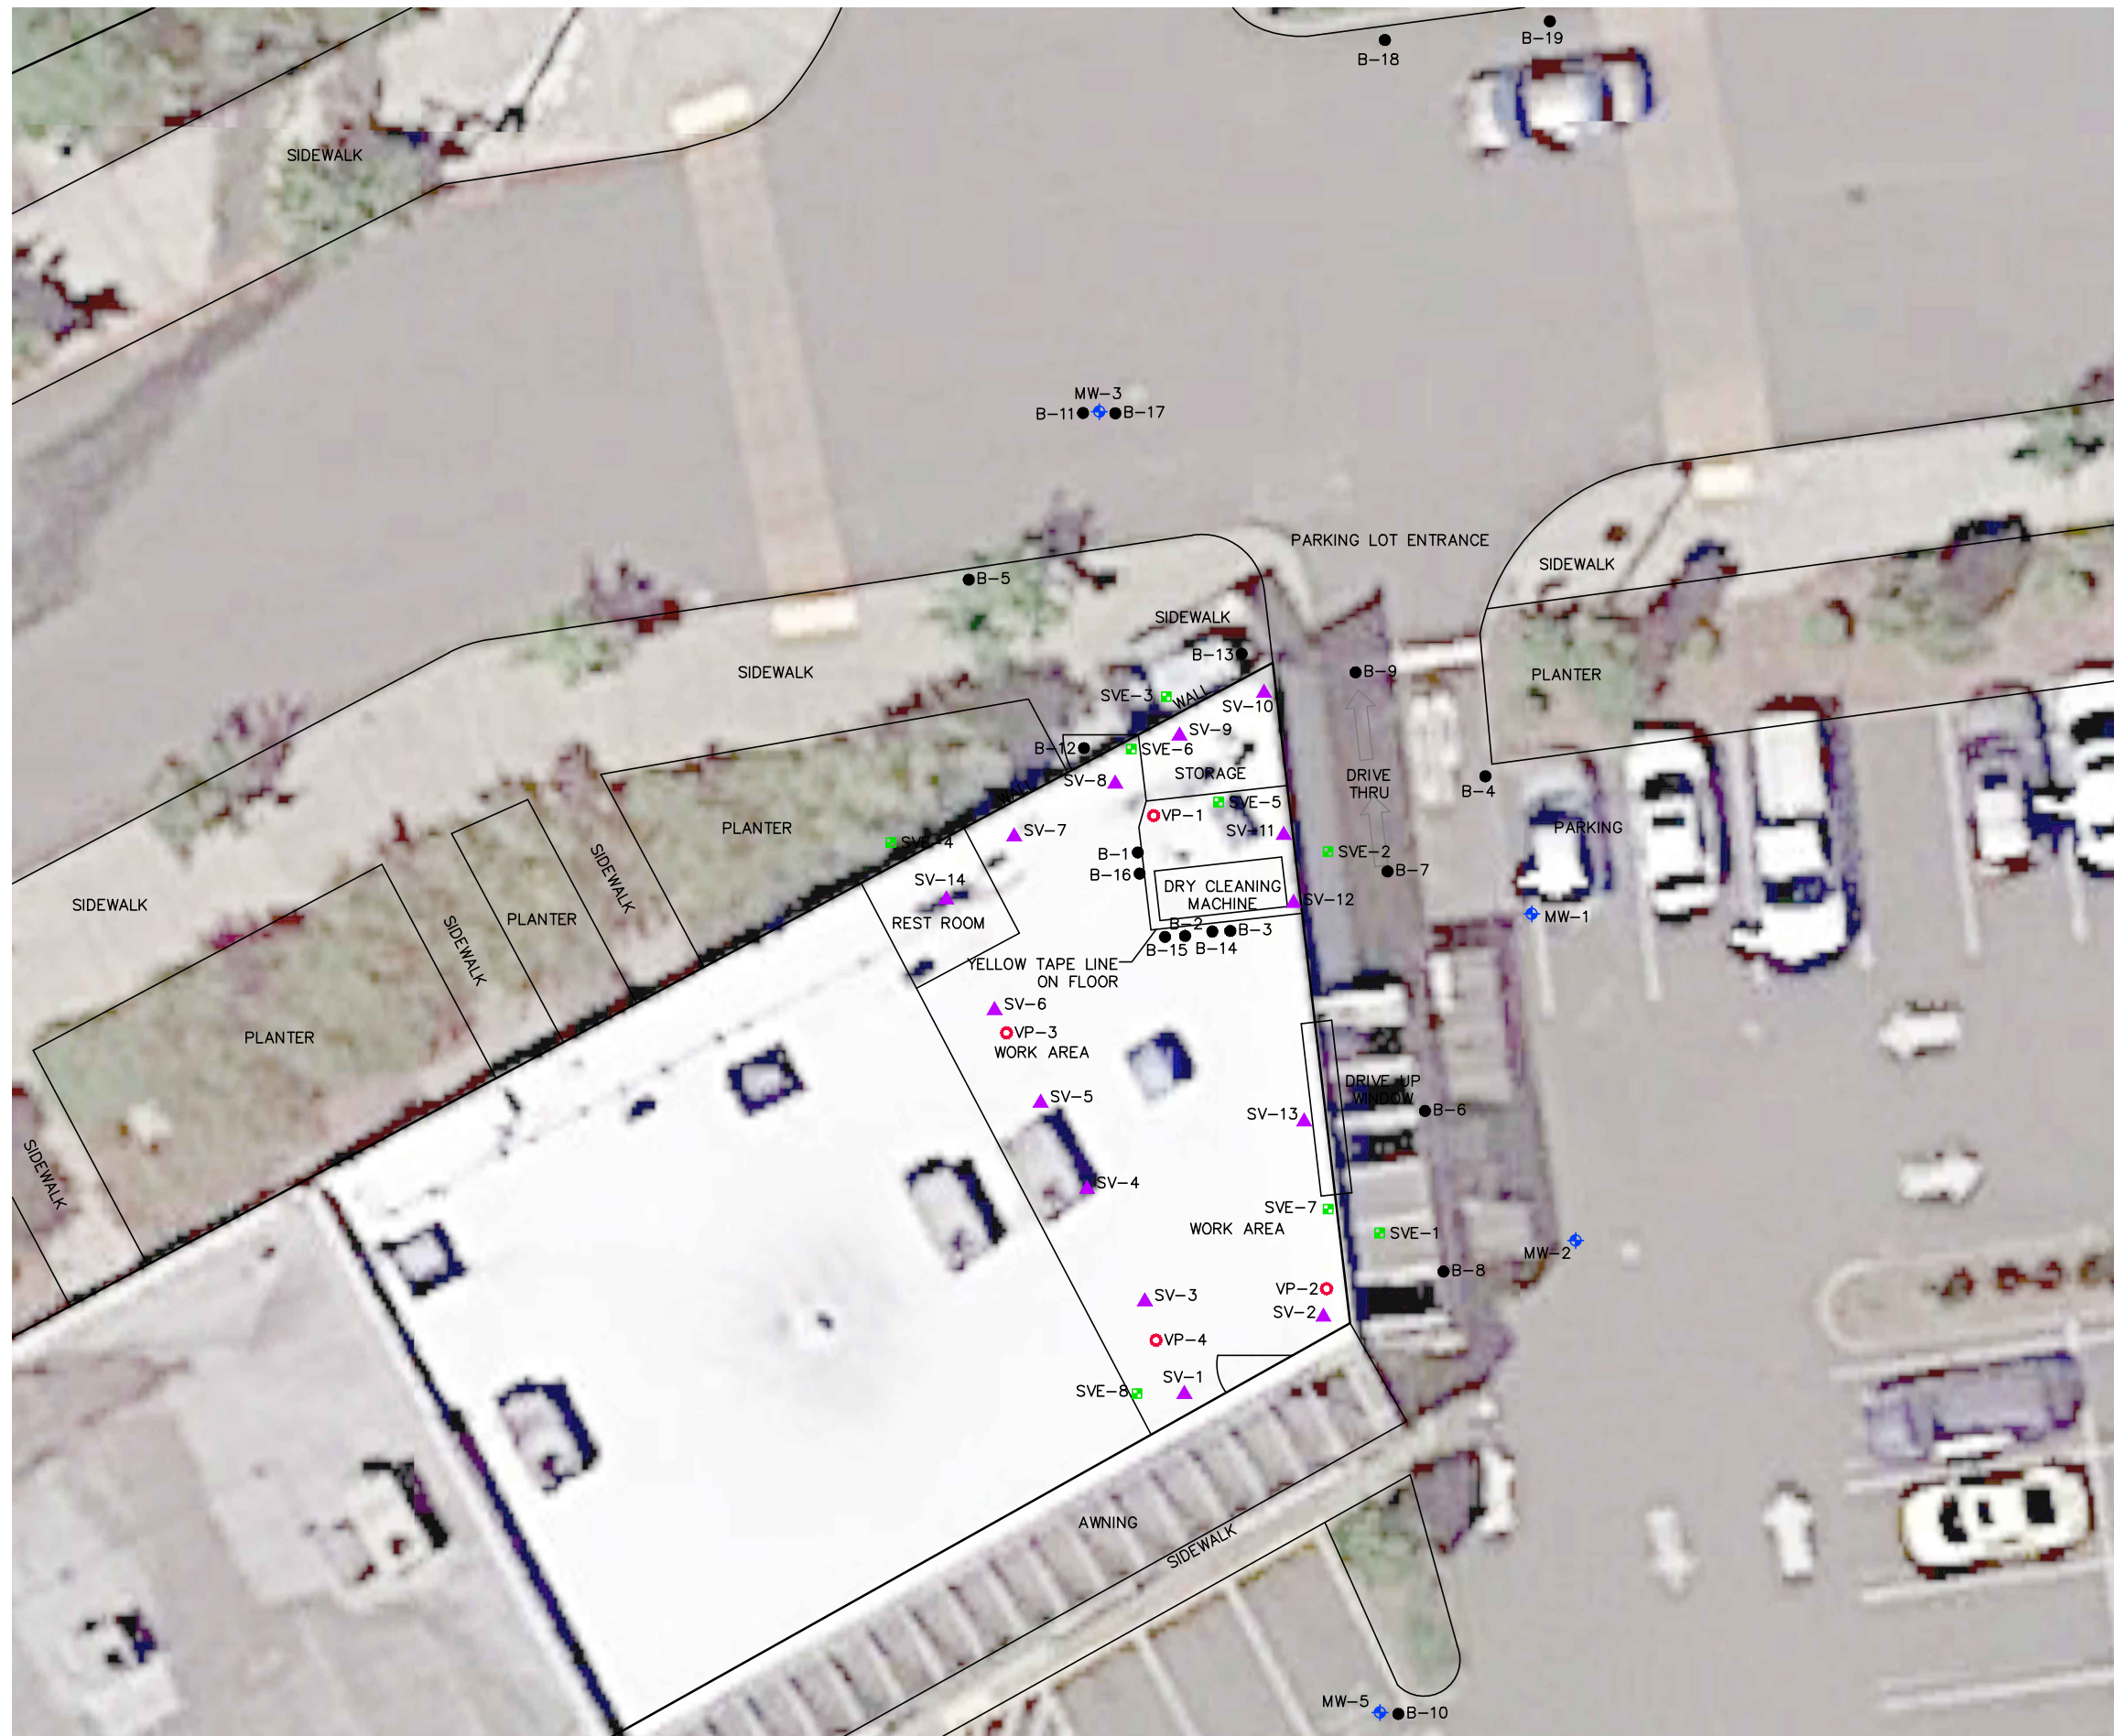
FIGURE 2

The system performance has been monitored by sampling a network of four sub-slab vapor pins installed throughout the inside of the business (VP-1 through VP-4). The analytical results of the past four performance sampling events (May & October 2022, and March & October 2023) indicated that all constituents analyzed for were either non-detect or detected below MTCA Method B screening levels. Analytical results of the sub-slab analytical results are presented in Table 3, *Summary of Sub-Slab Vapor Analytical Results*. Analytical results of the SVE System analytical results are presented in Table 4, *Summary of SVE System Air Analytical Results*. Sample locations are illustrated on Figure 2, *Site Map*.

SITE MAP

AEG Atlas, LLC (AEG) has prepared this report for the purpose of presenting a summary of the confirmation sampling activities at the *4 Corners Cleaners*, located at the above-referenced address in Maple Valley, King County, Washington (Site). A soil vapor extraction (SVE) system was installed on Site in 2019 to remediate soils impacted with tetrachloroethylene (PCE). Confirmation sampling has since been performed for soil, groundwater, and vapor to confirm SVE efforts were successful. Figure 1, *Vicinity Map*, presents the general vicinity of the Site. The Site's current layout and sample locations are illustrated in Figure 2, *Site Map*.

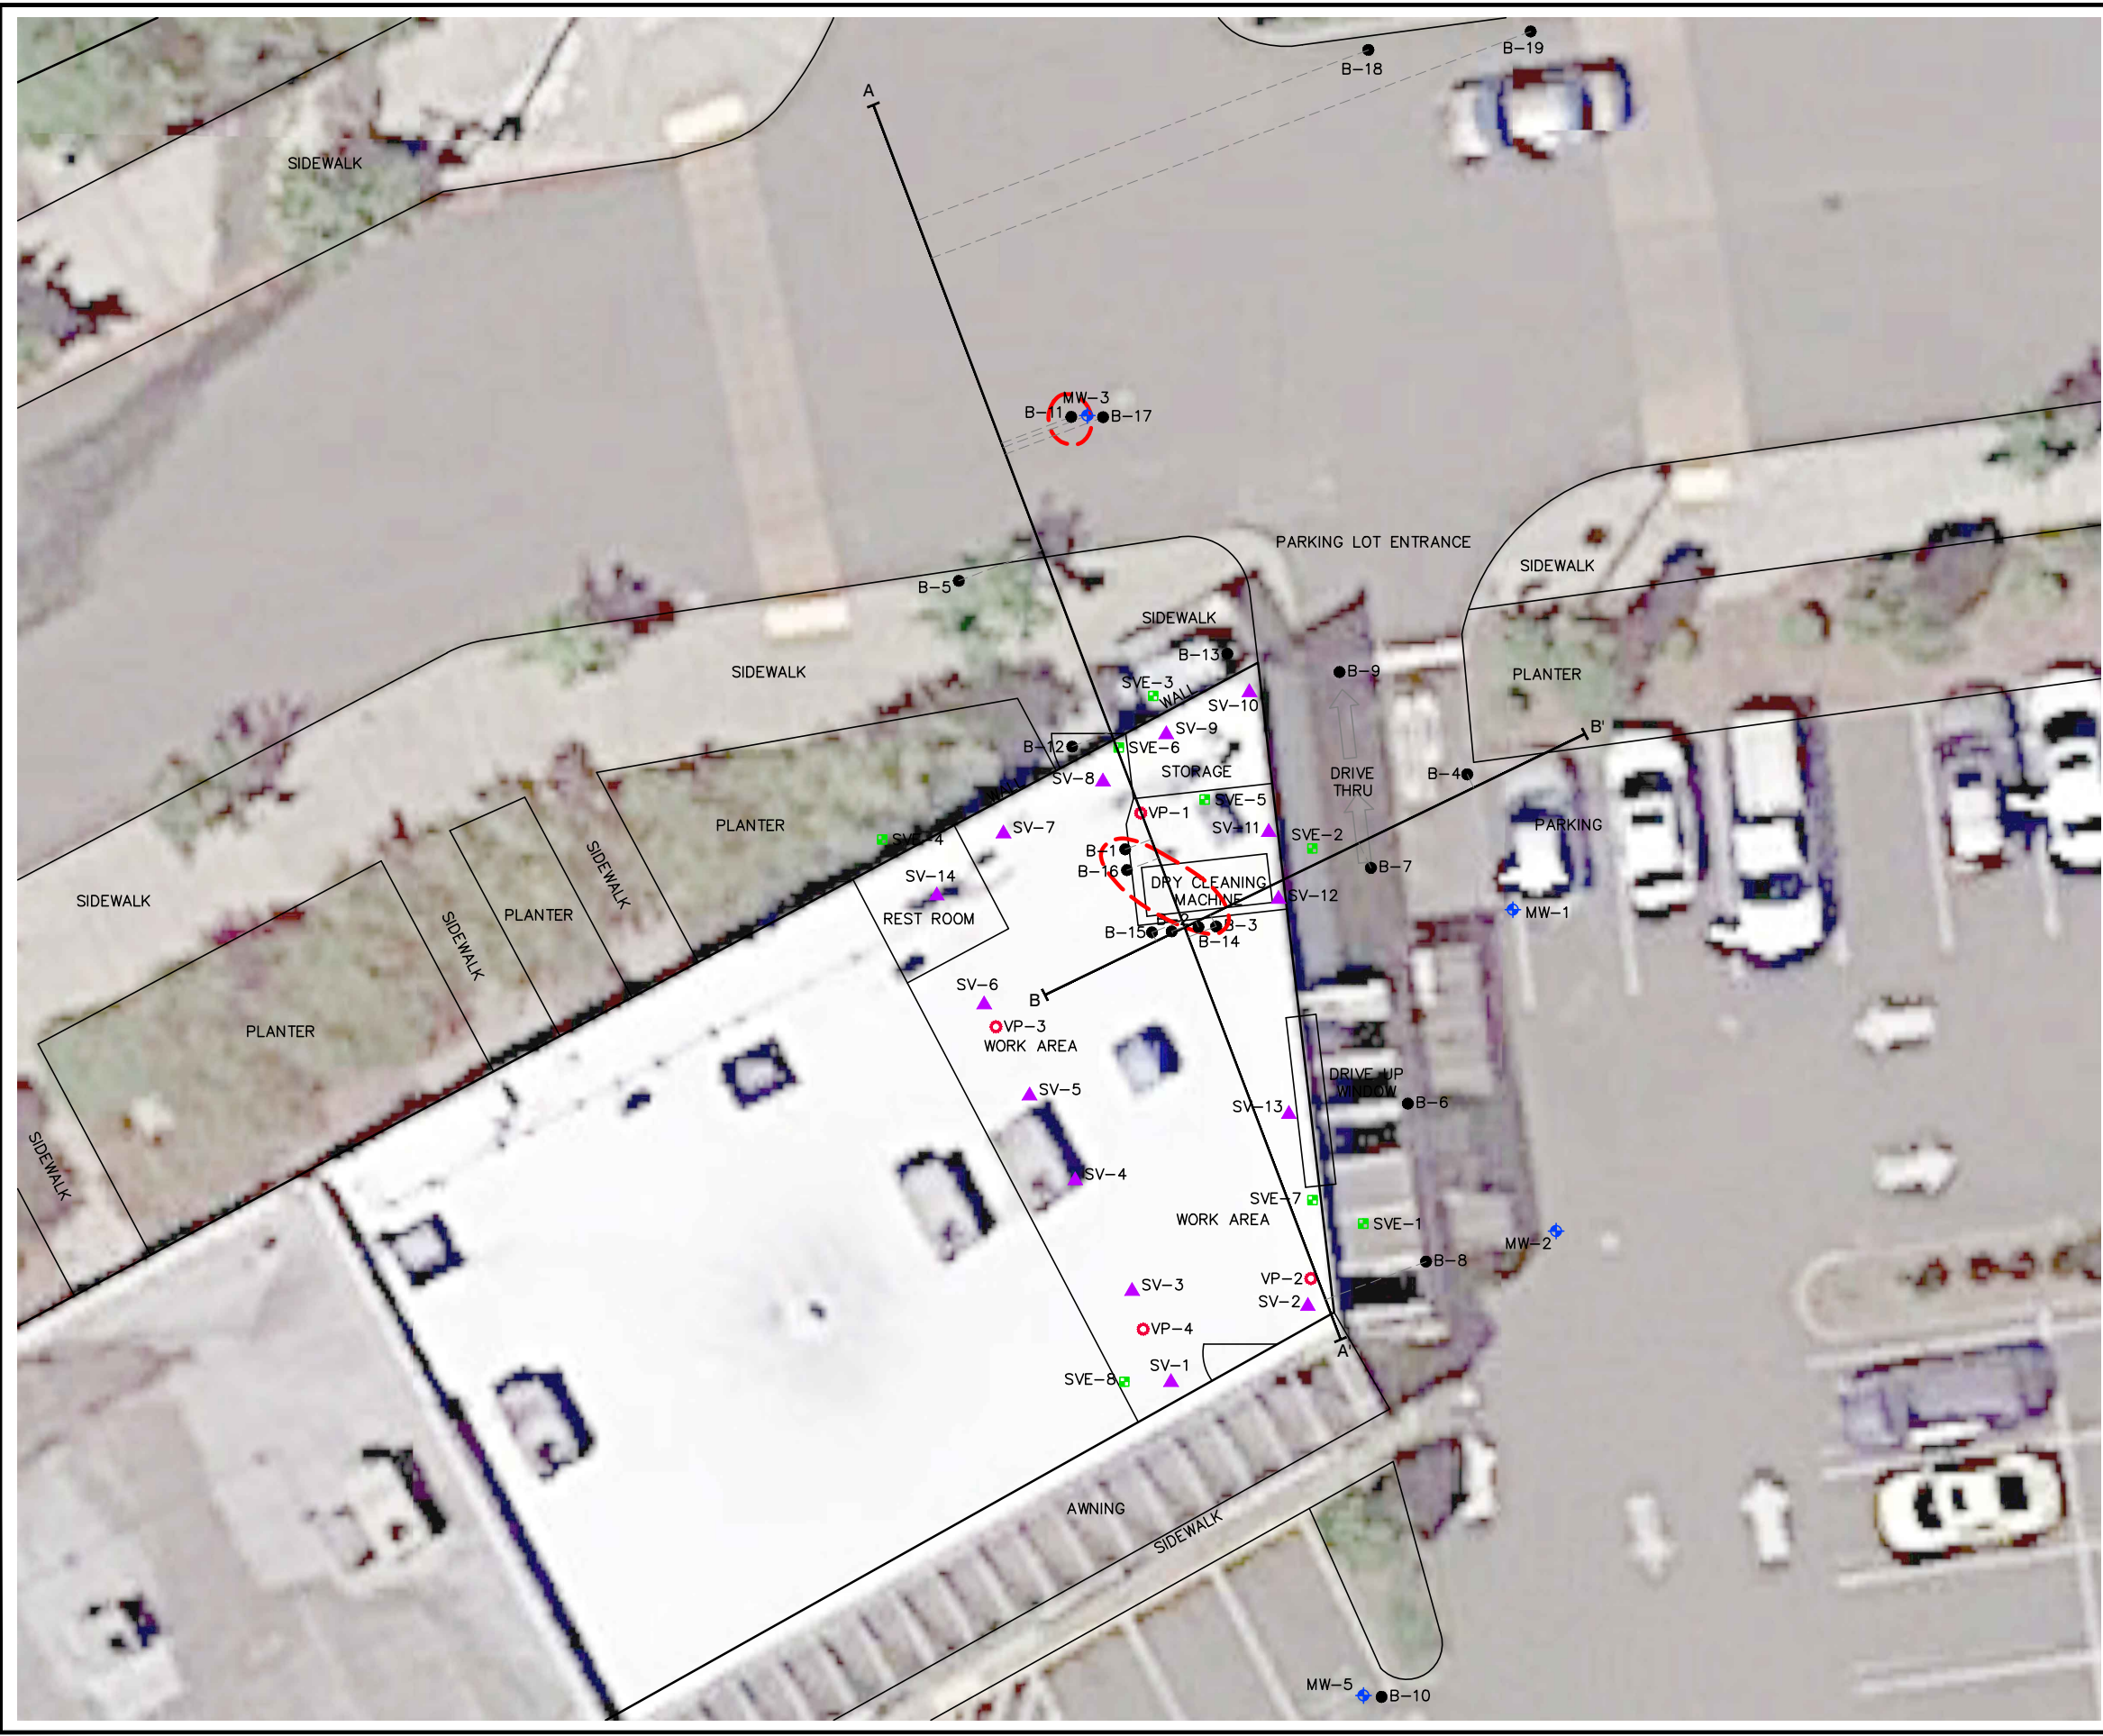
FIGURE 3
CROSS-SECTION INDEX MAP
AND PCE PLUME IN SOIL

A-A' LINE OF LITHOLOGIC CROSS SECTION AND PROJECTION LINE TO BORING/WELL

ESTIMATED EXTENT OF HISTORICAL PCE PLUME IN SOIL

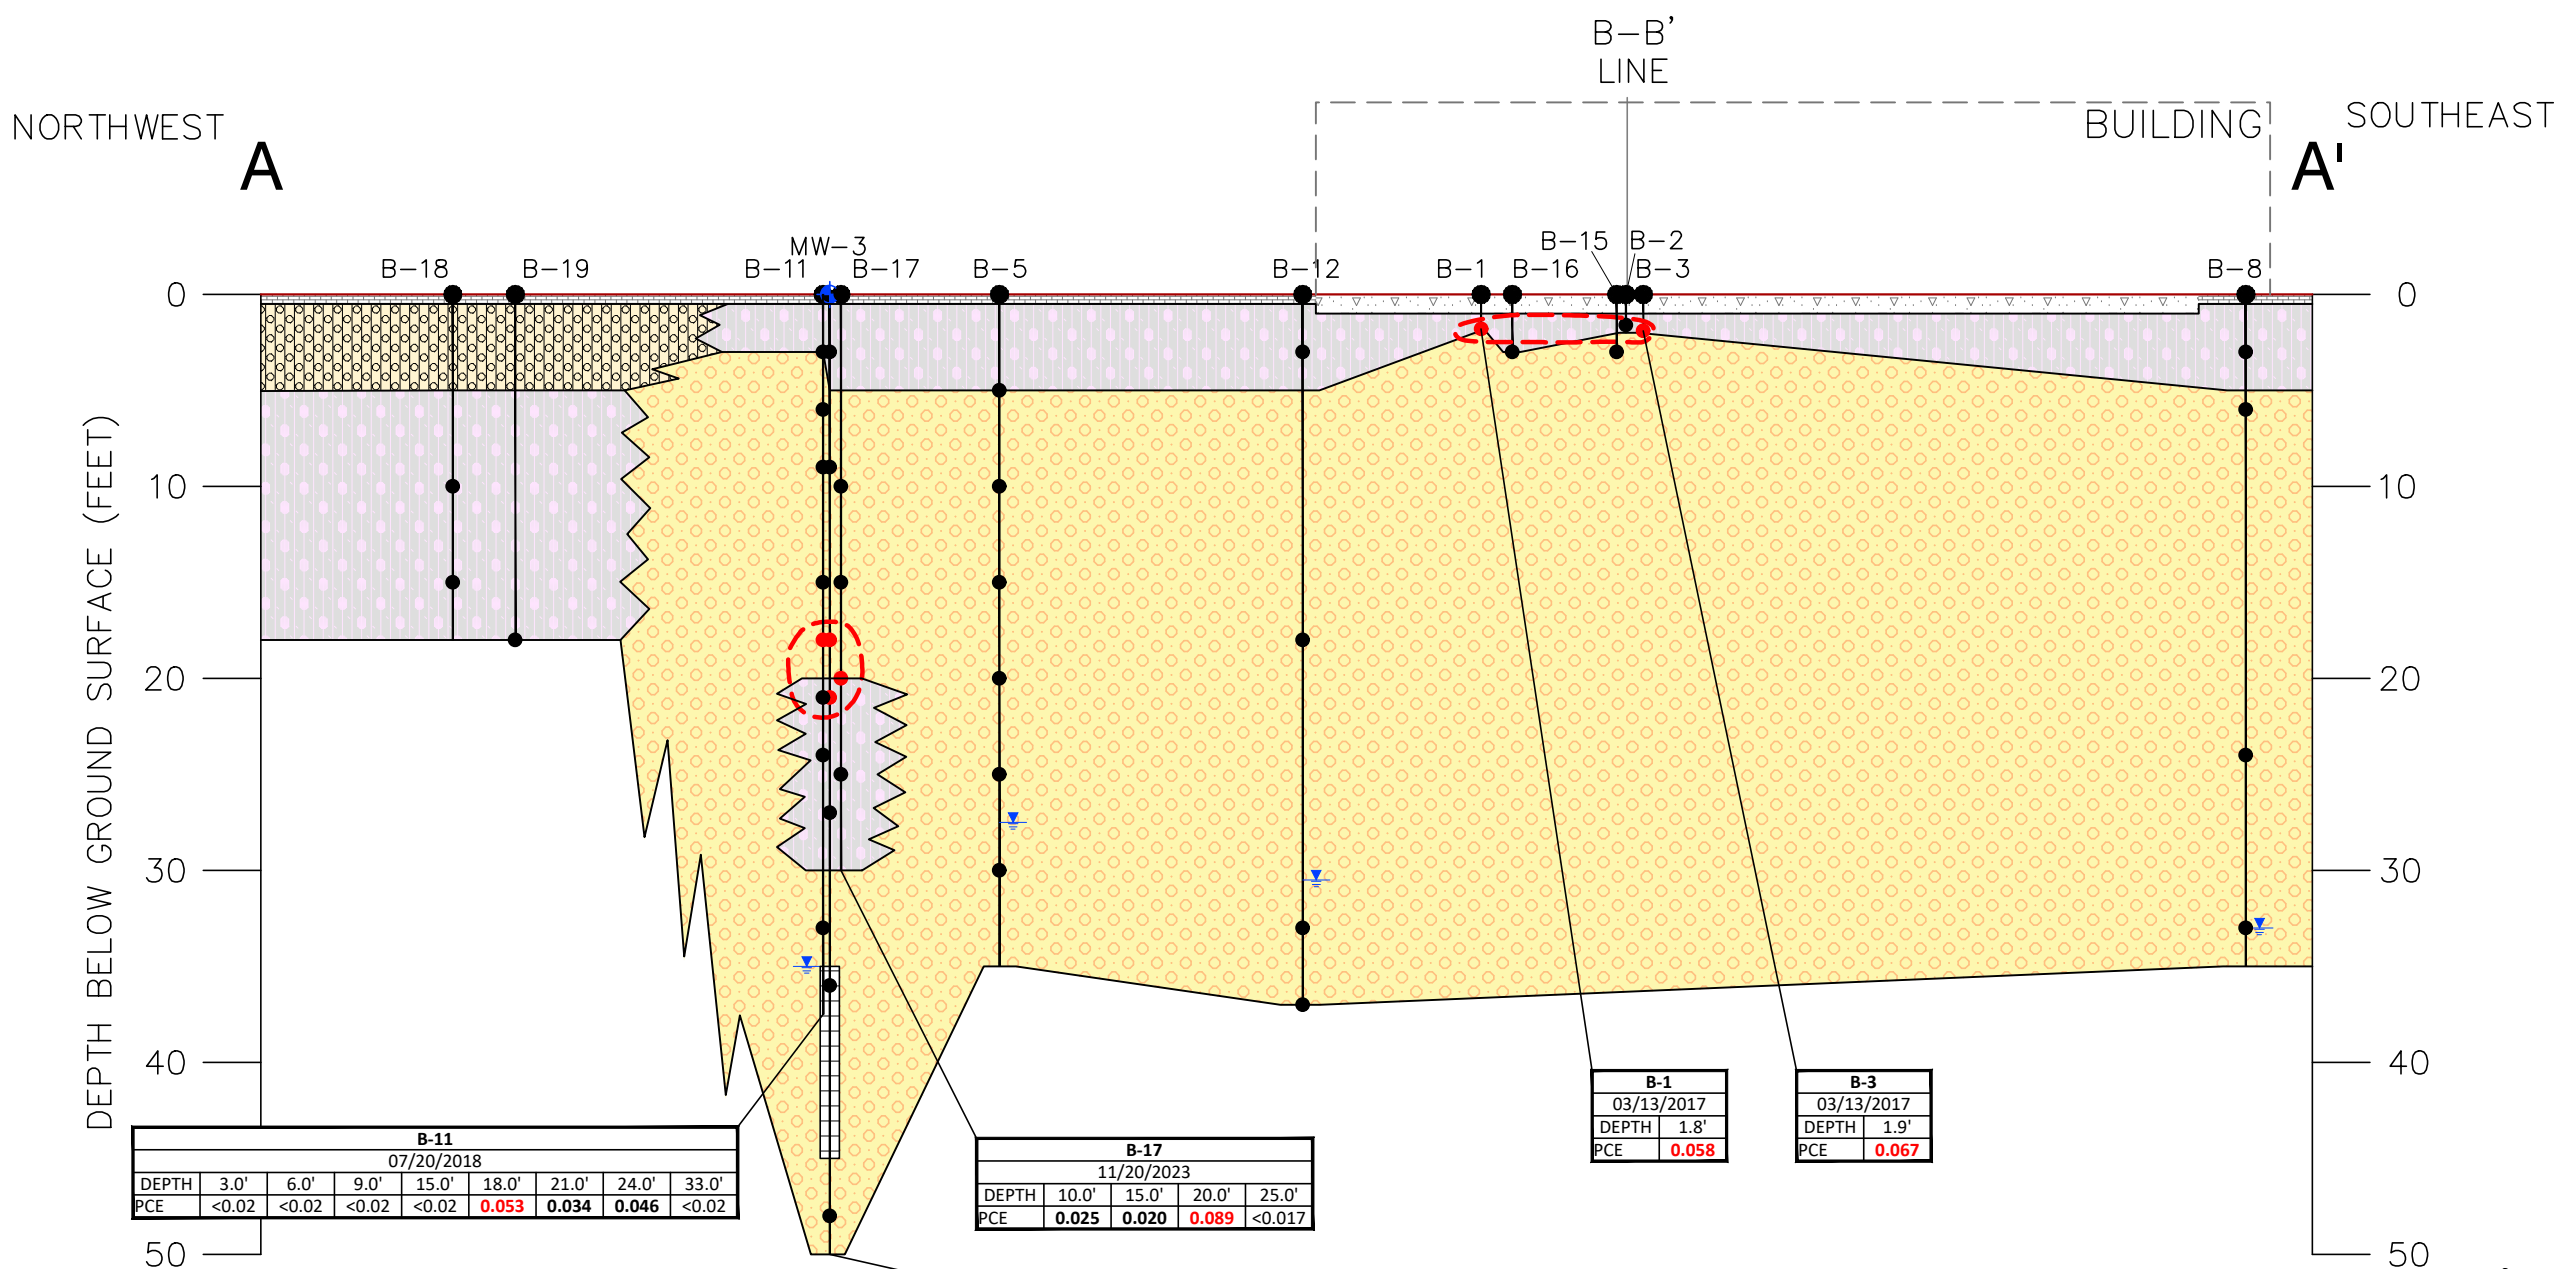
FIGURE 4

CROSS-SECTION A-A'

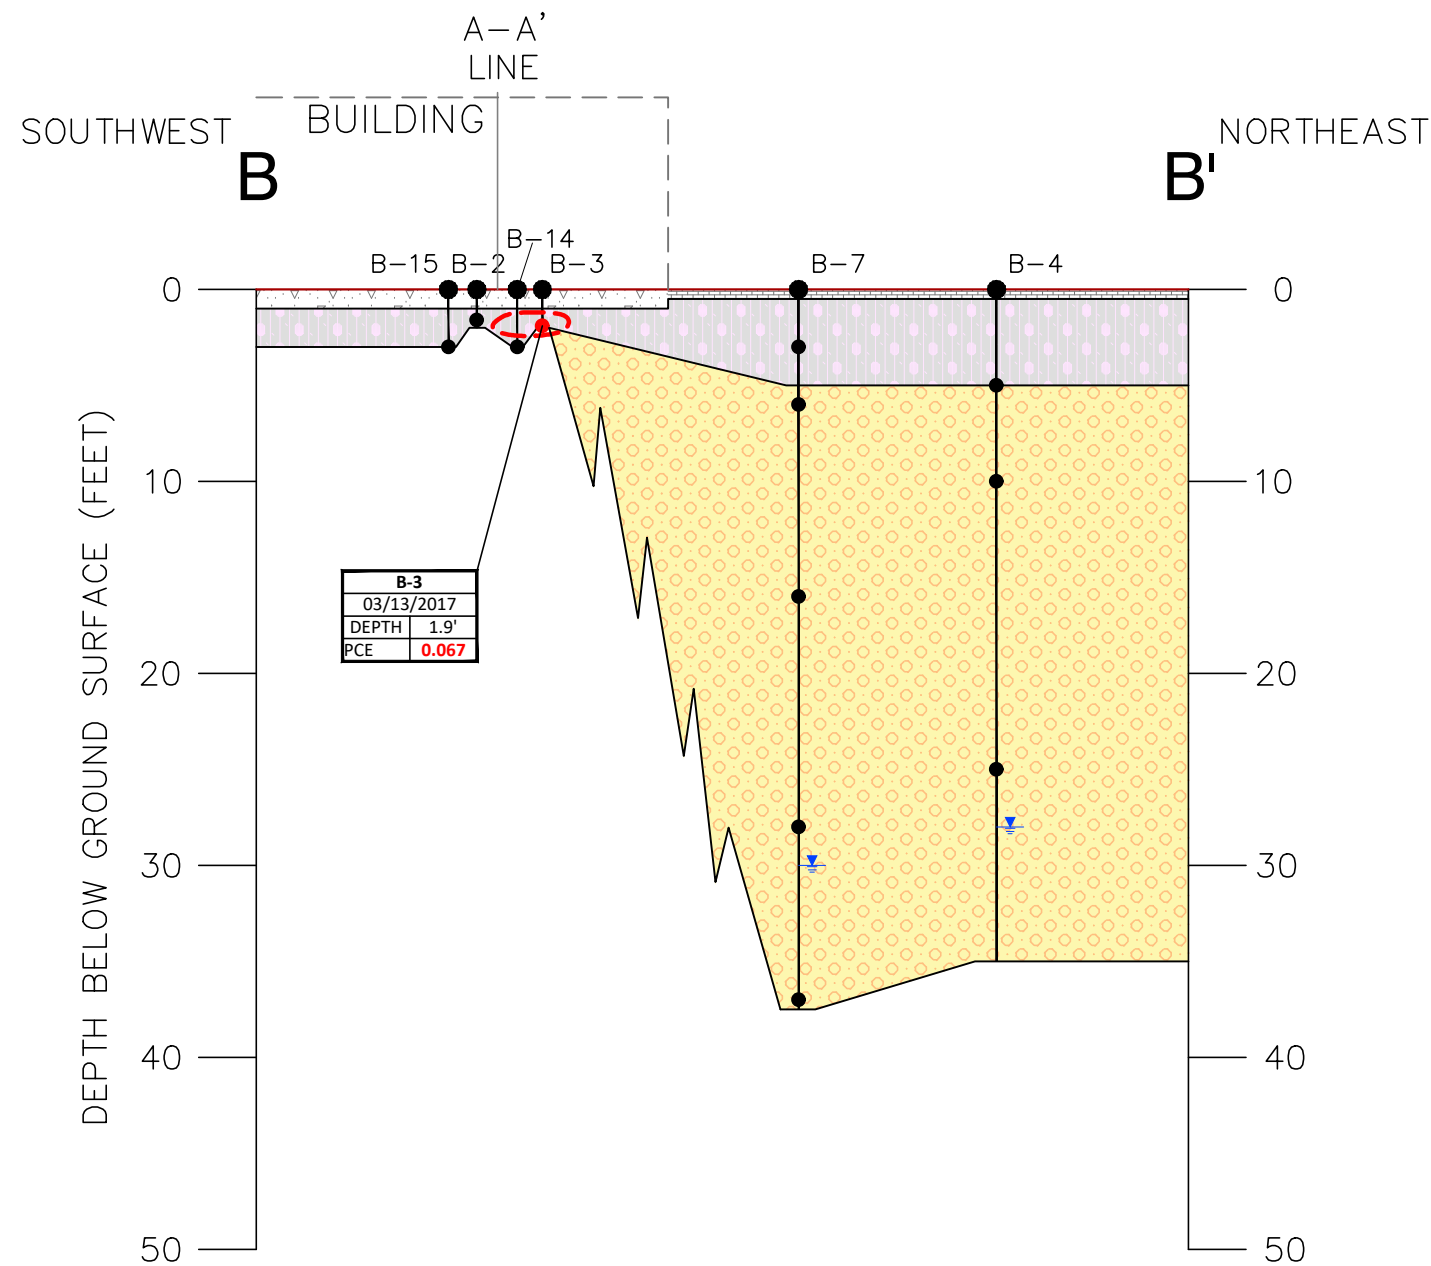
FIGURE 5
CROSS-SECTION B-B'

- B-15
- SOIL BORING
- GROUNDWATER LEVEL AT TIME OF DRILLING
- SCREENED INTERVAL
- SOIL SAMPLE LOCATION (< MTCA CLEANUP LEVELS)
- SOIL SAMPLE LOCATION (> MTCA CLEANUP LEVELS)
- MAXIMUM DEPTH EXPLORED

- SOIL CONTACT
- ASPHALT
- CONCRETE
- SM= SILTY SANDS, SAND-SILT MIXTURES
- SP= POORLY-GRADED SANDS, GRAVELLY SANDS
- GM= SILTY GRAVELS, GRAVEL-SAND-SILT MIXTURES
- ESTIMATED EXTENT OF HISTORICAL PCE PLUME IN SOIL
