TERMINAL 30 2022 ANNUAL SITE PERFORMANCE REPORT – YEAR 3

2022 Annual Terminal 30 Site Performance Report

Port of Seattle
Terminal 30 Site

Project number: 60681370

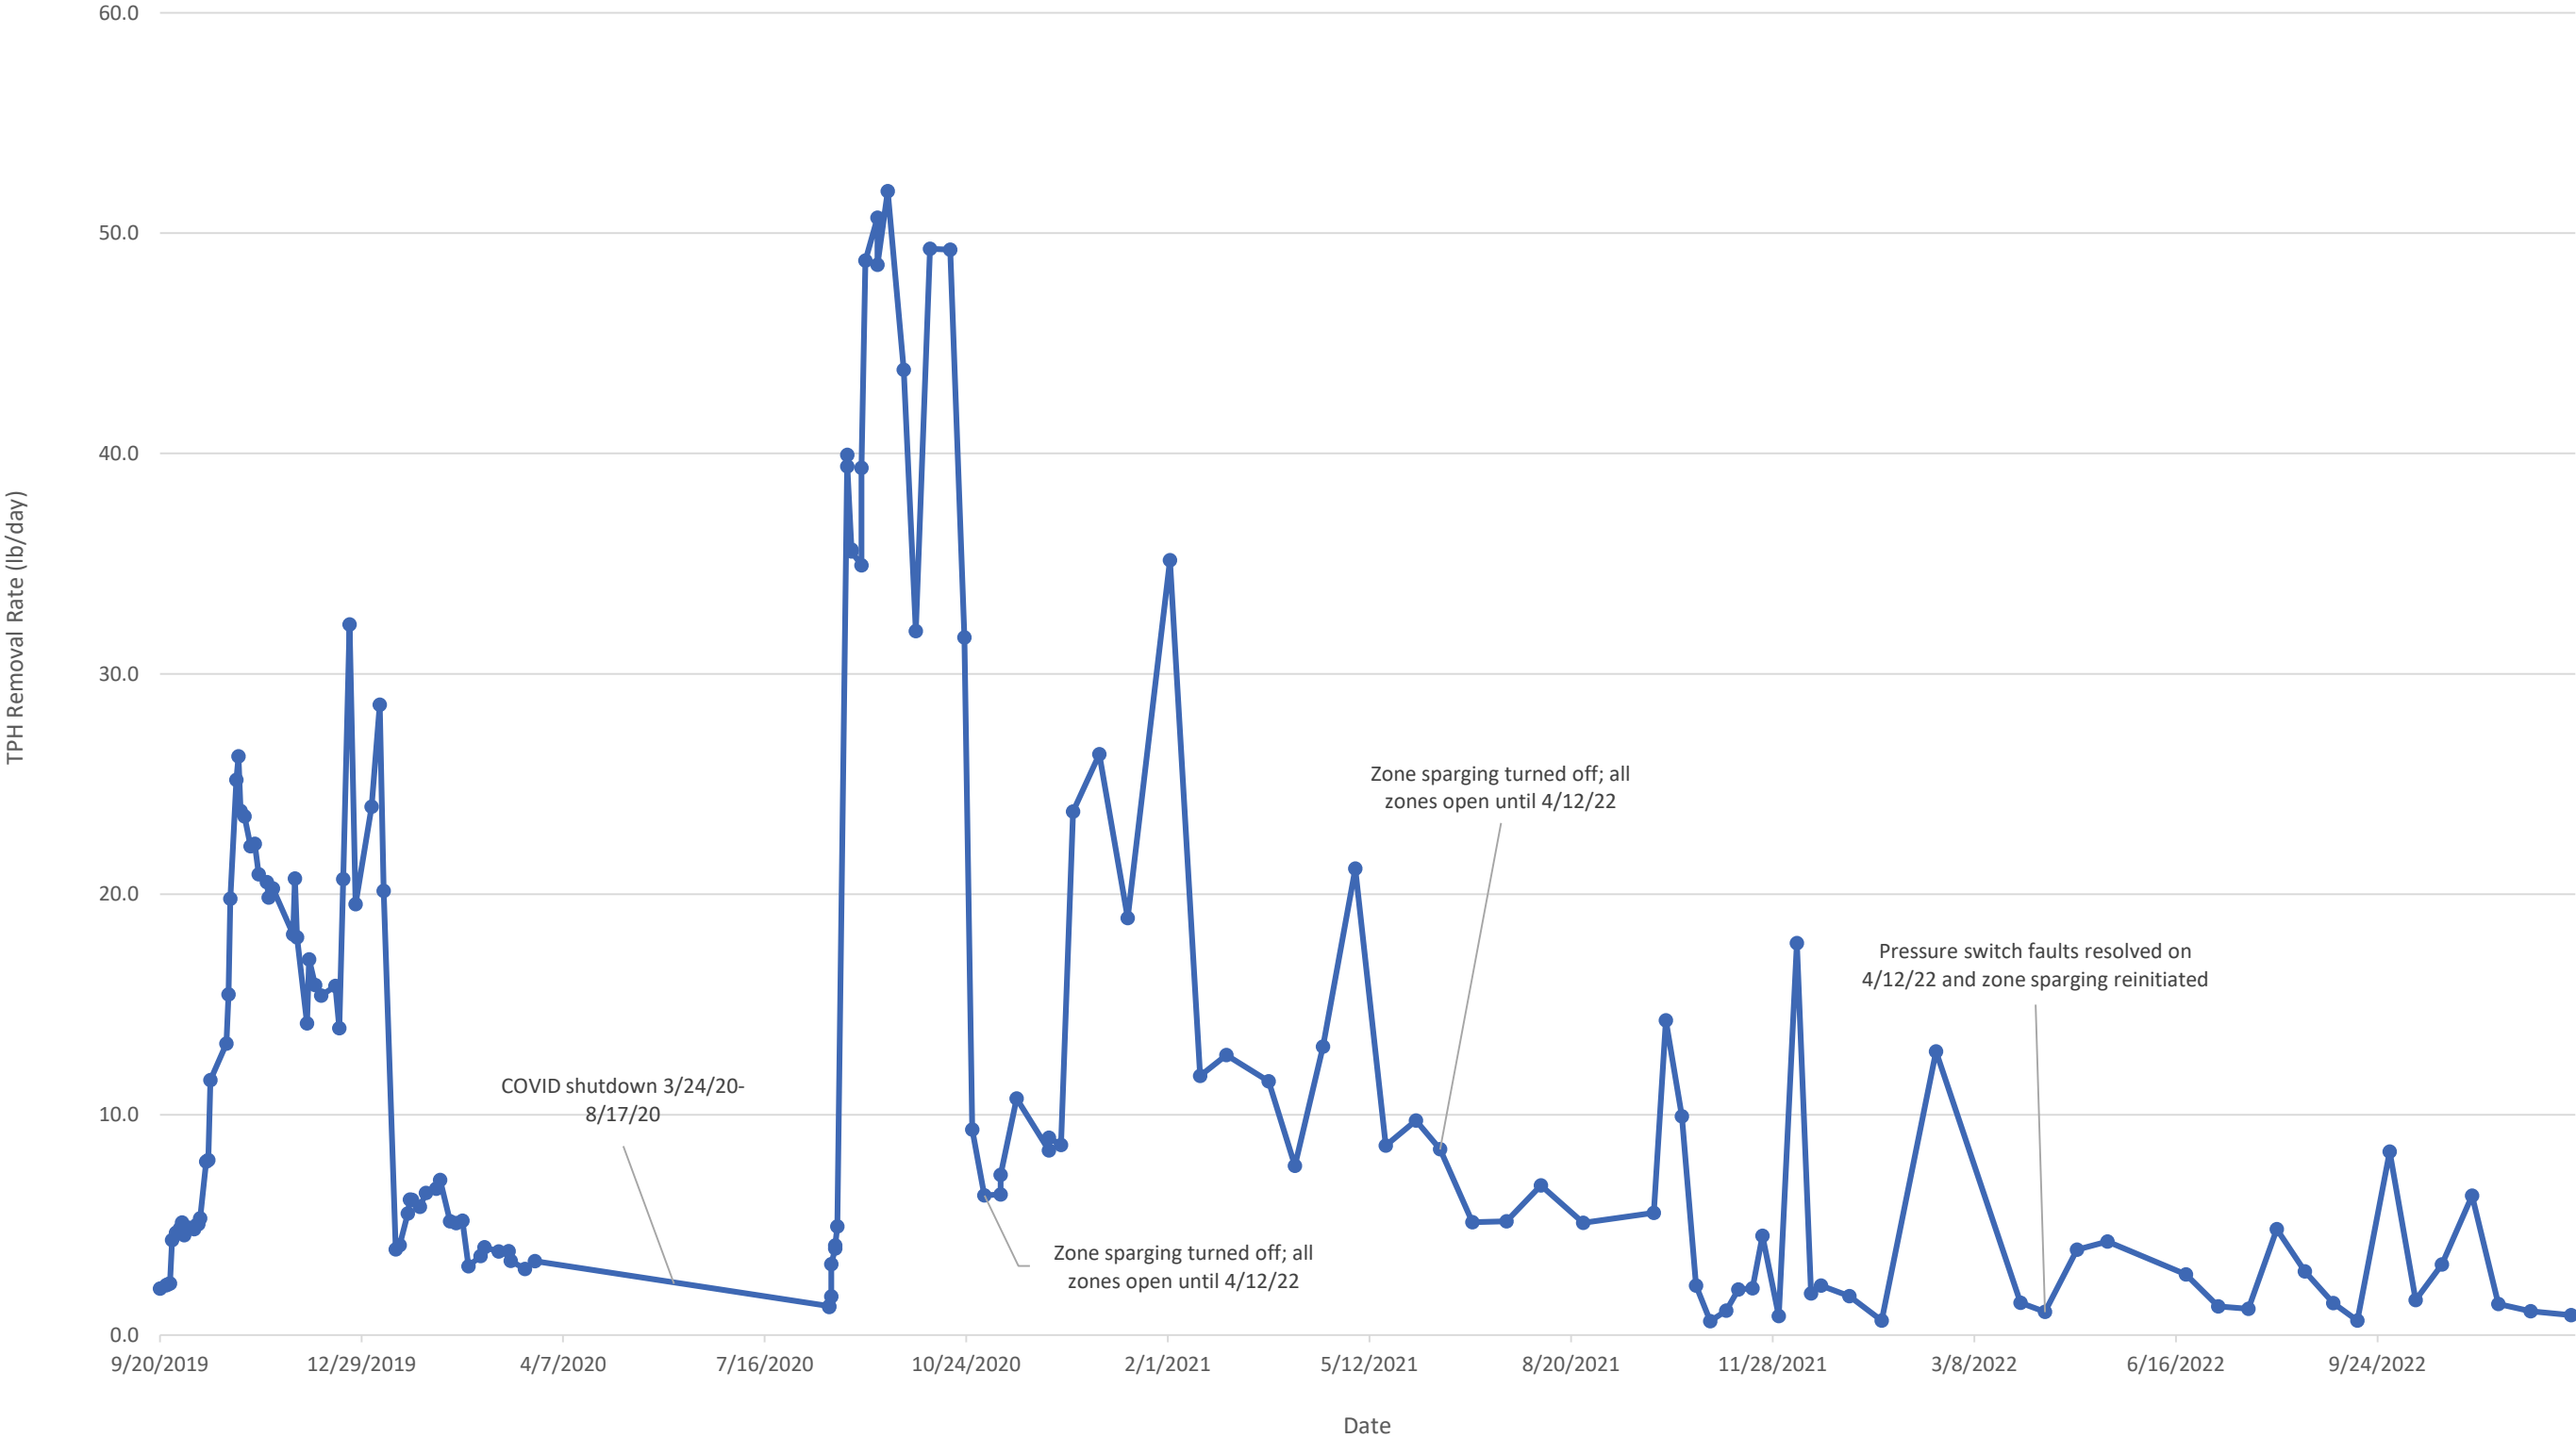
Figure 5 - Period VOC Removal Rates

Notes:
1. Data shown is a combination of PID field data and laboratory-analyzed vapor data.

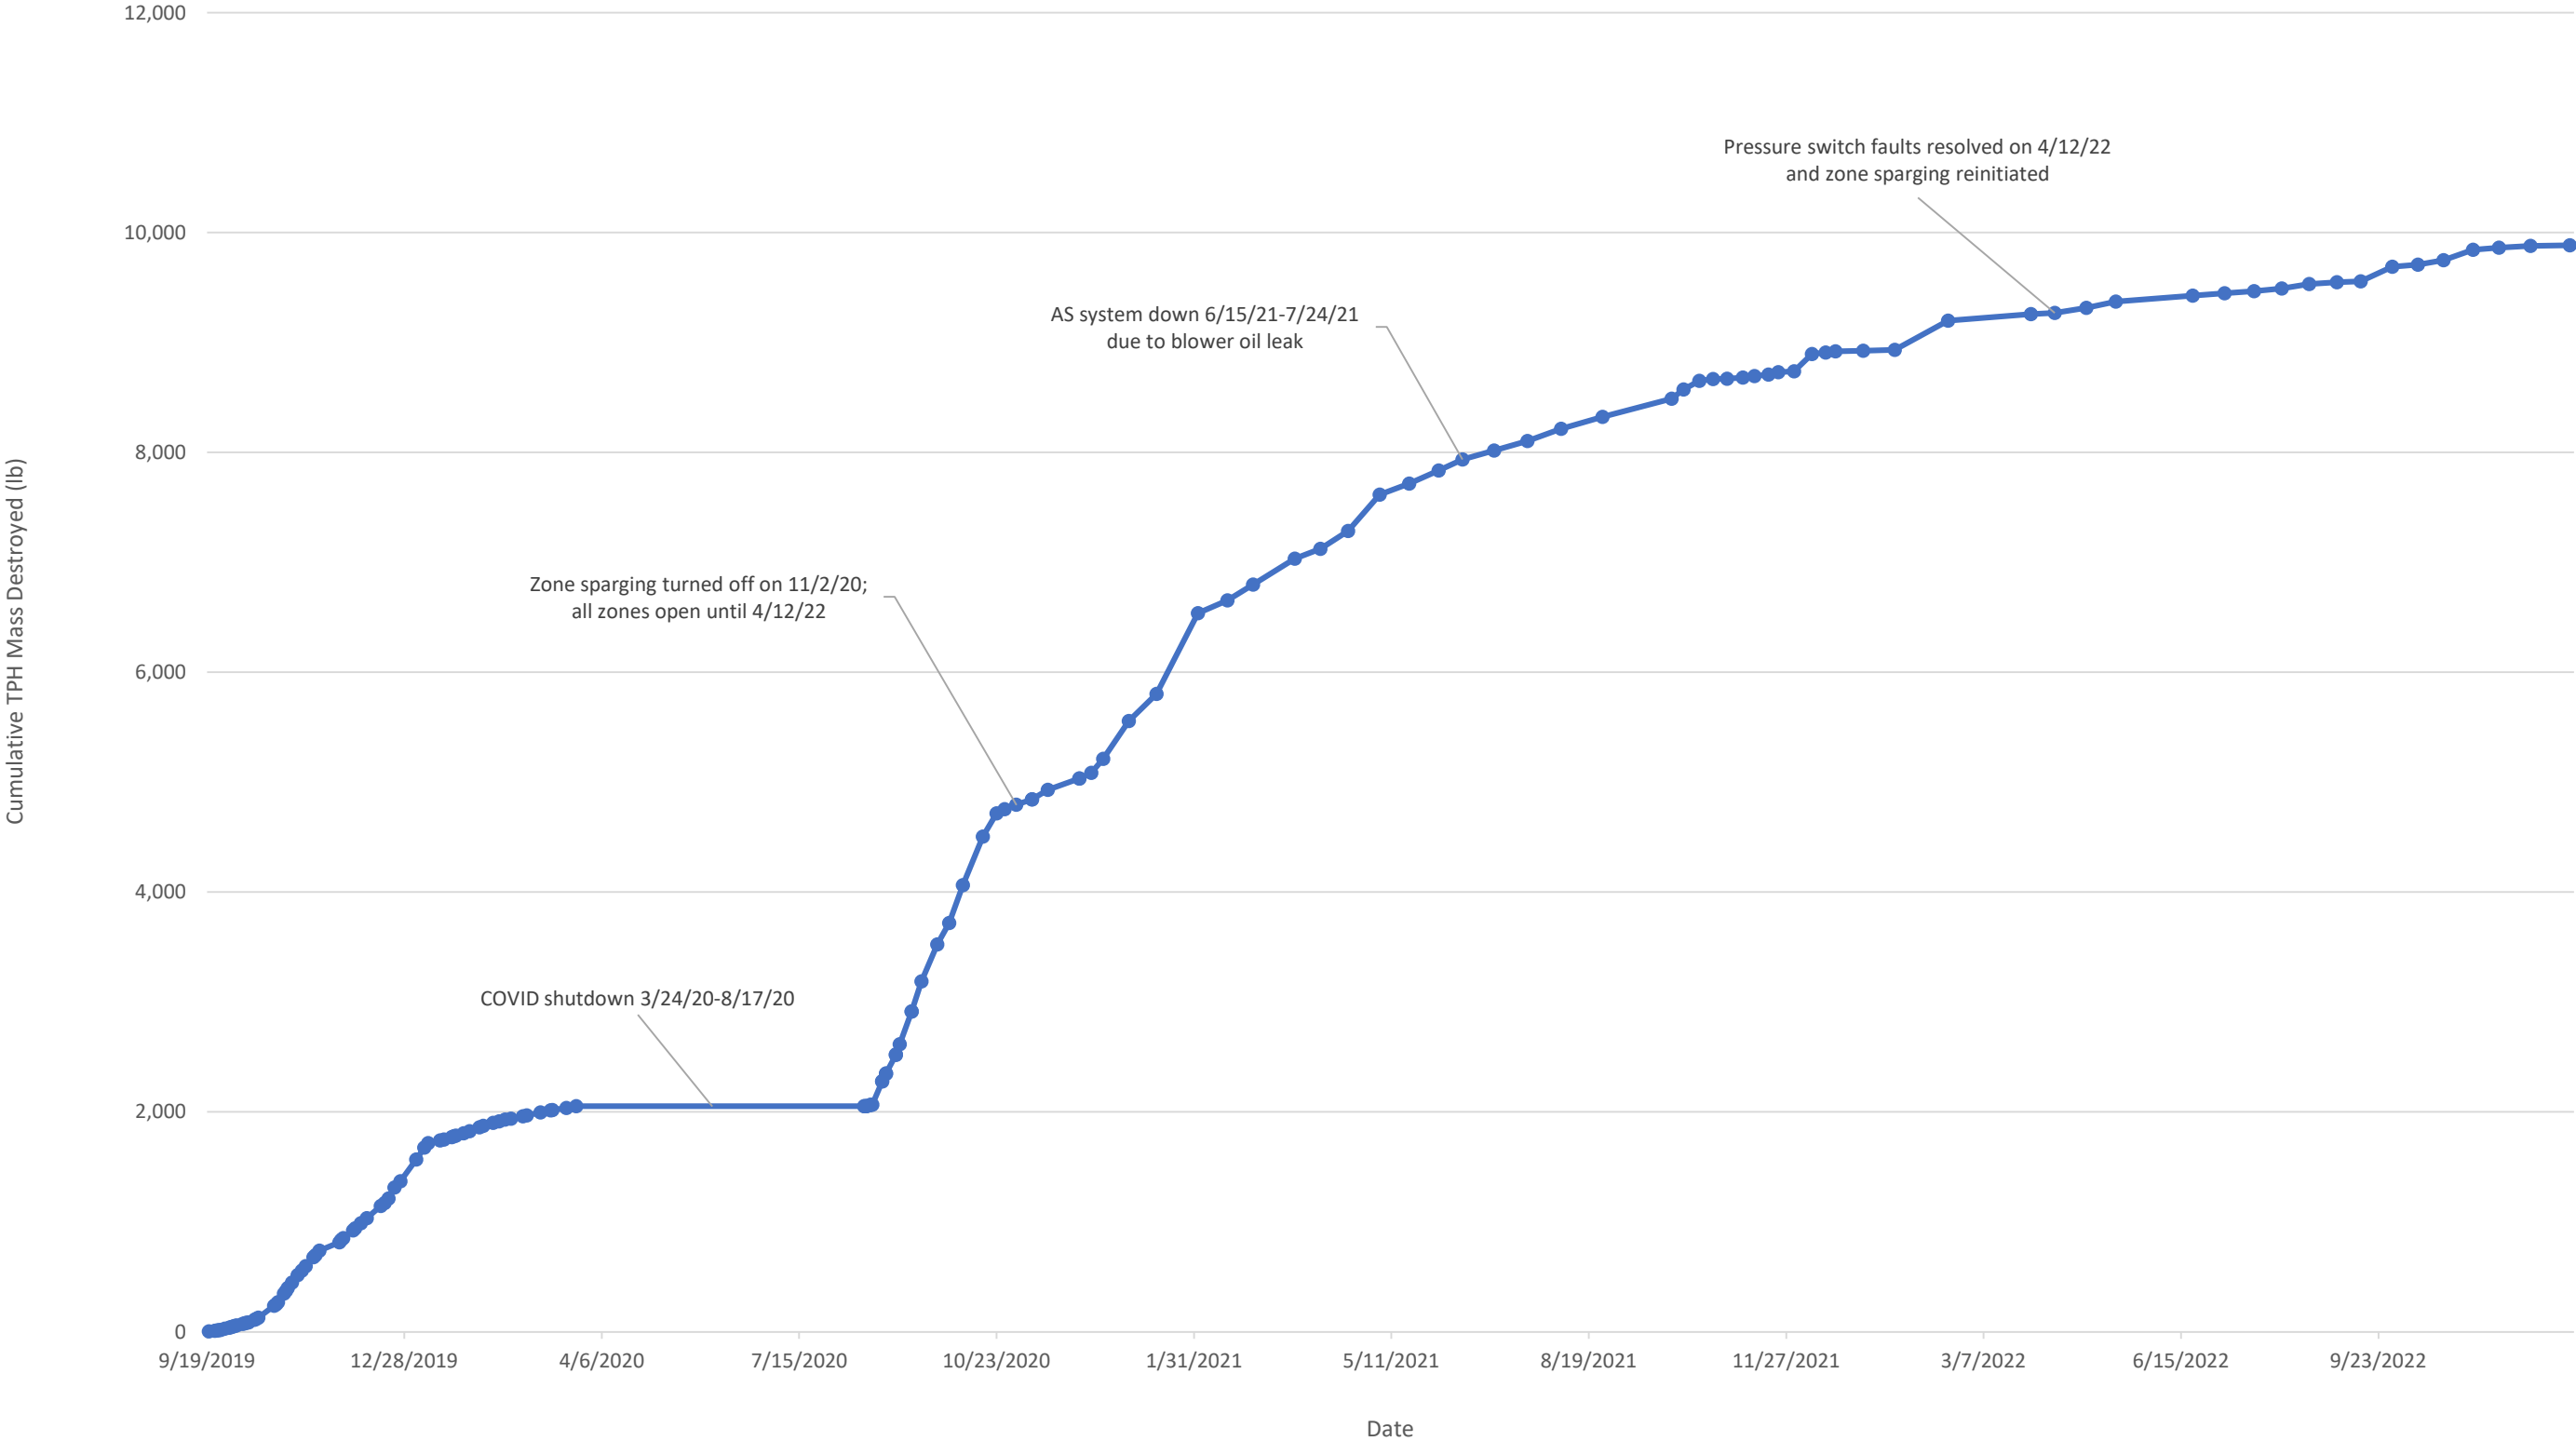
Figure 6 - Cumulative VOC Mass Removal

Notes:
1. Data shown is a combination of PID field data and laboratory-analyzed vapor data.

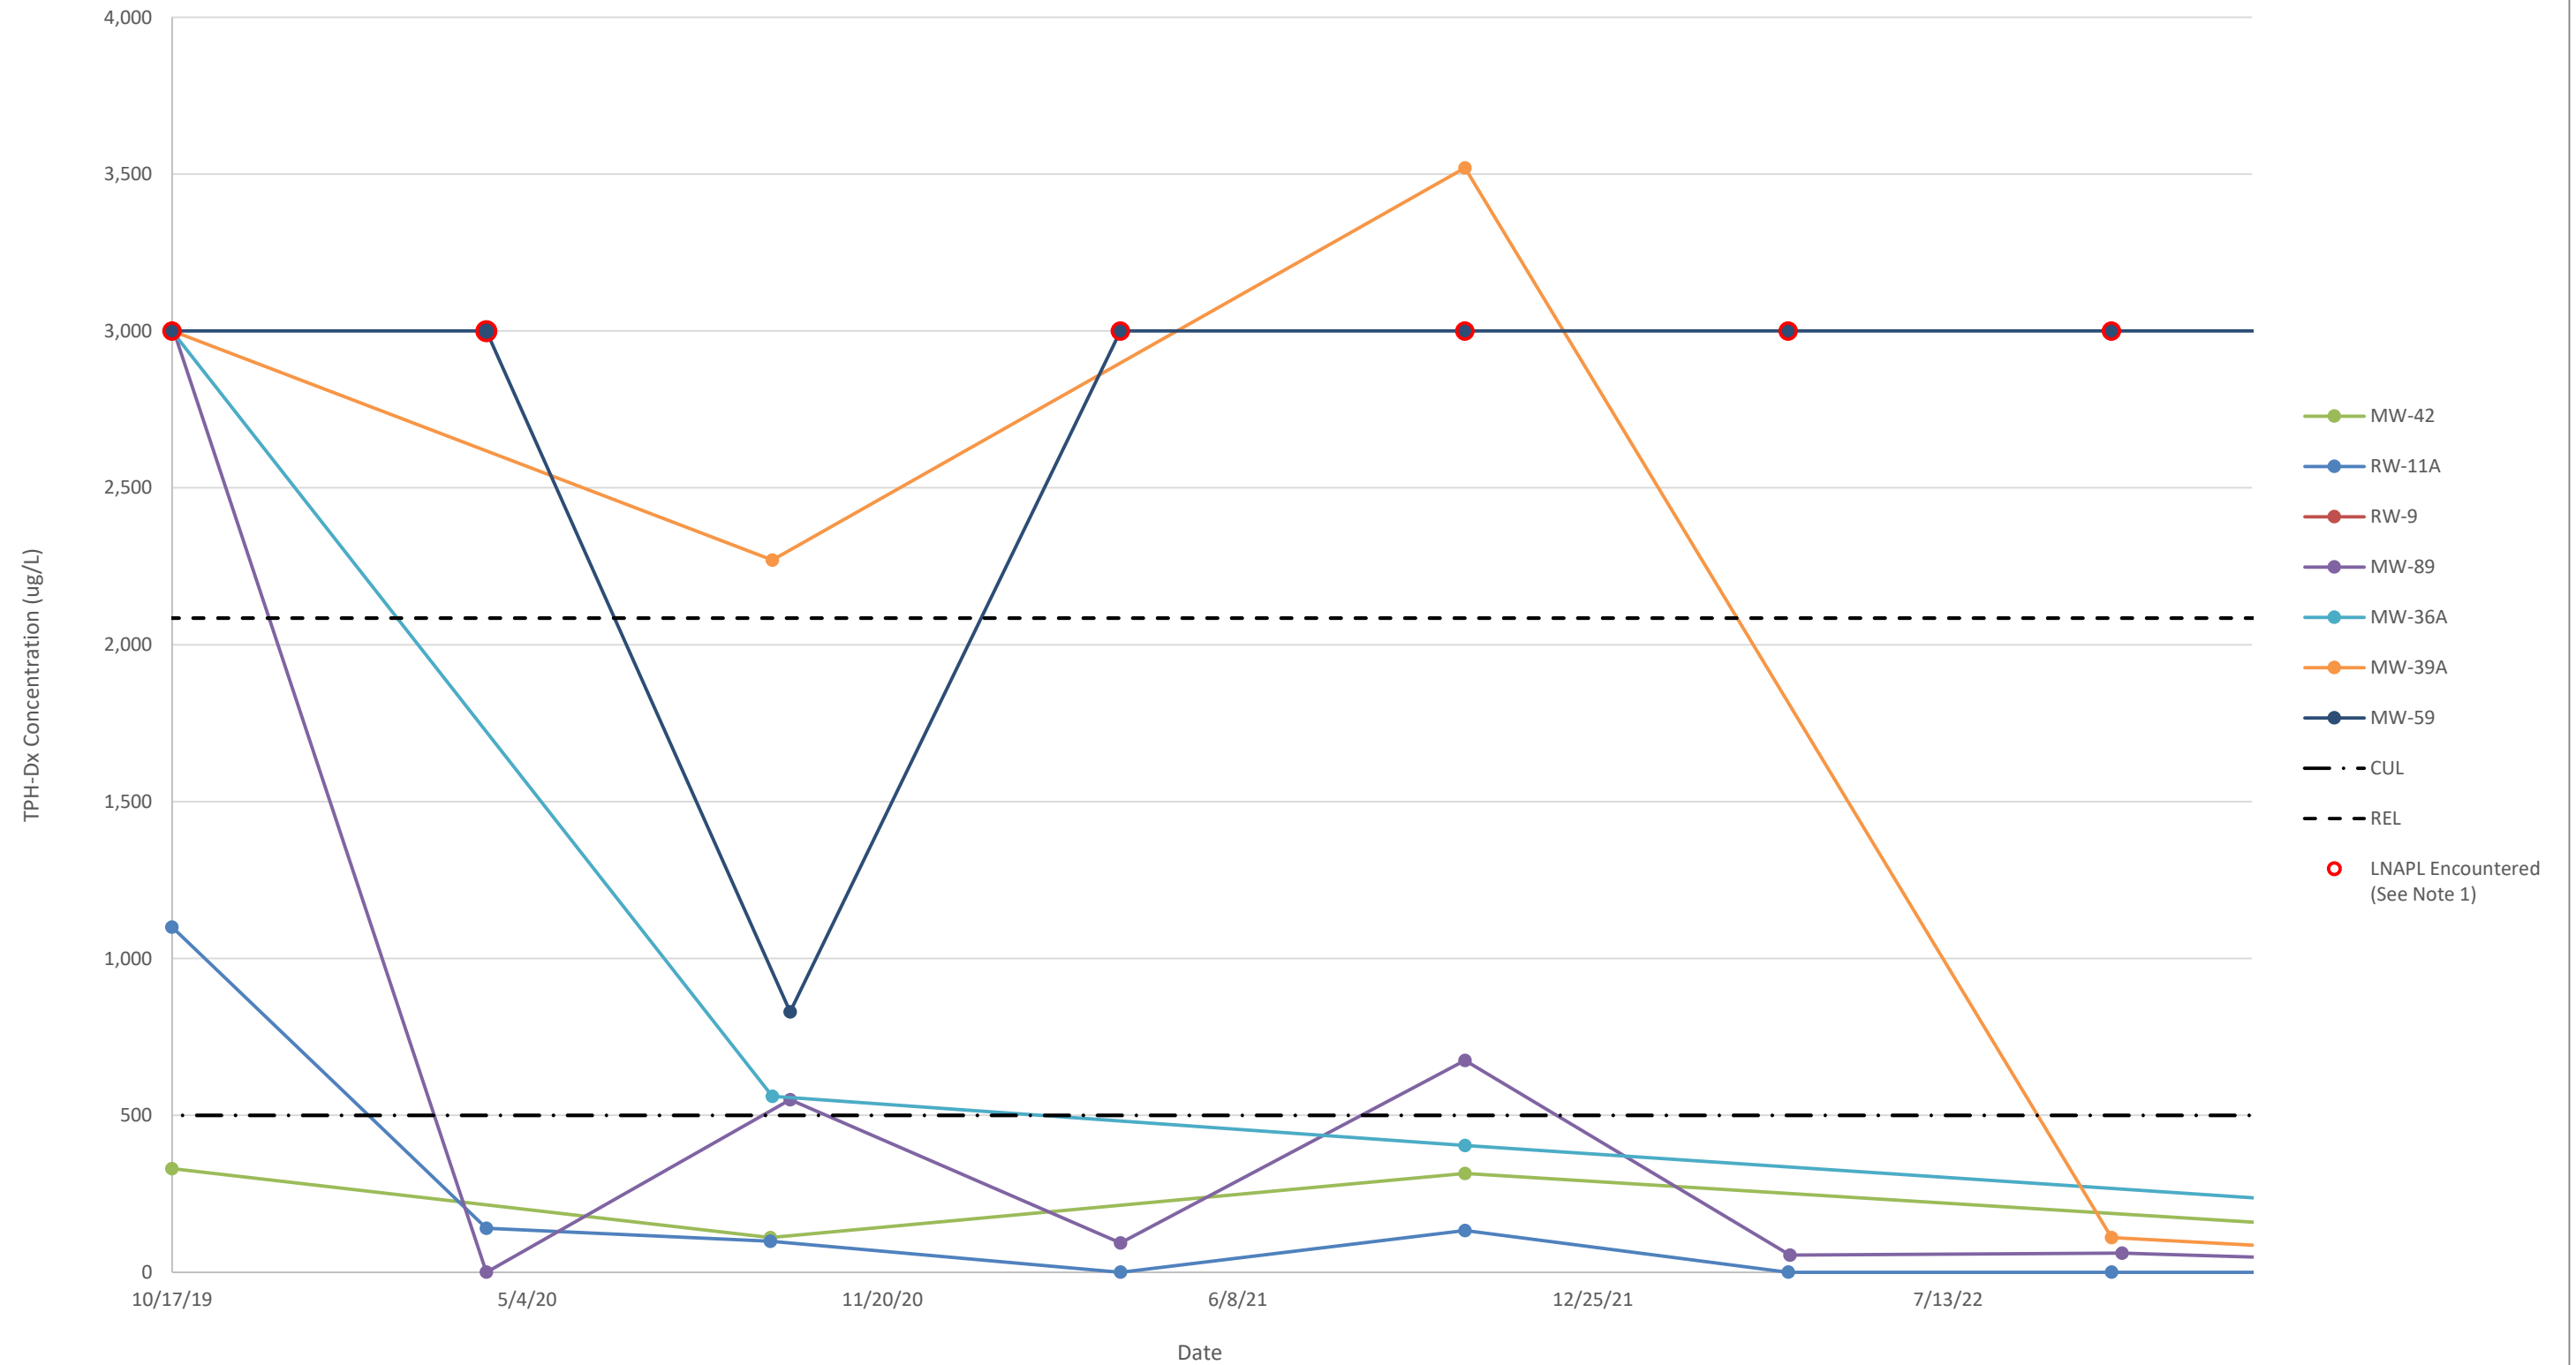
Figure 11 - Performance Monitoring Well TPH-Dx Concentrations

Notes:
 1. Wells with free product present at the time of sampling, or not sampled due to free product measurements within the preceding four quarters, are shown with a TPH concentration of 3,000 µg/L. This value is used only to represent free product and does not reflect actual TPH concentrations.
