Revised Annual Report 2023 Remedial Action Performance and Groundwater Compliance Monitoring

Cenex Harvest States Cooperatives Site
300 Division Street East
Quincy, Washington

Farallon PN: 301-001

December 14, 2023

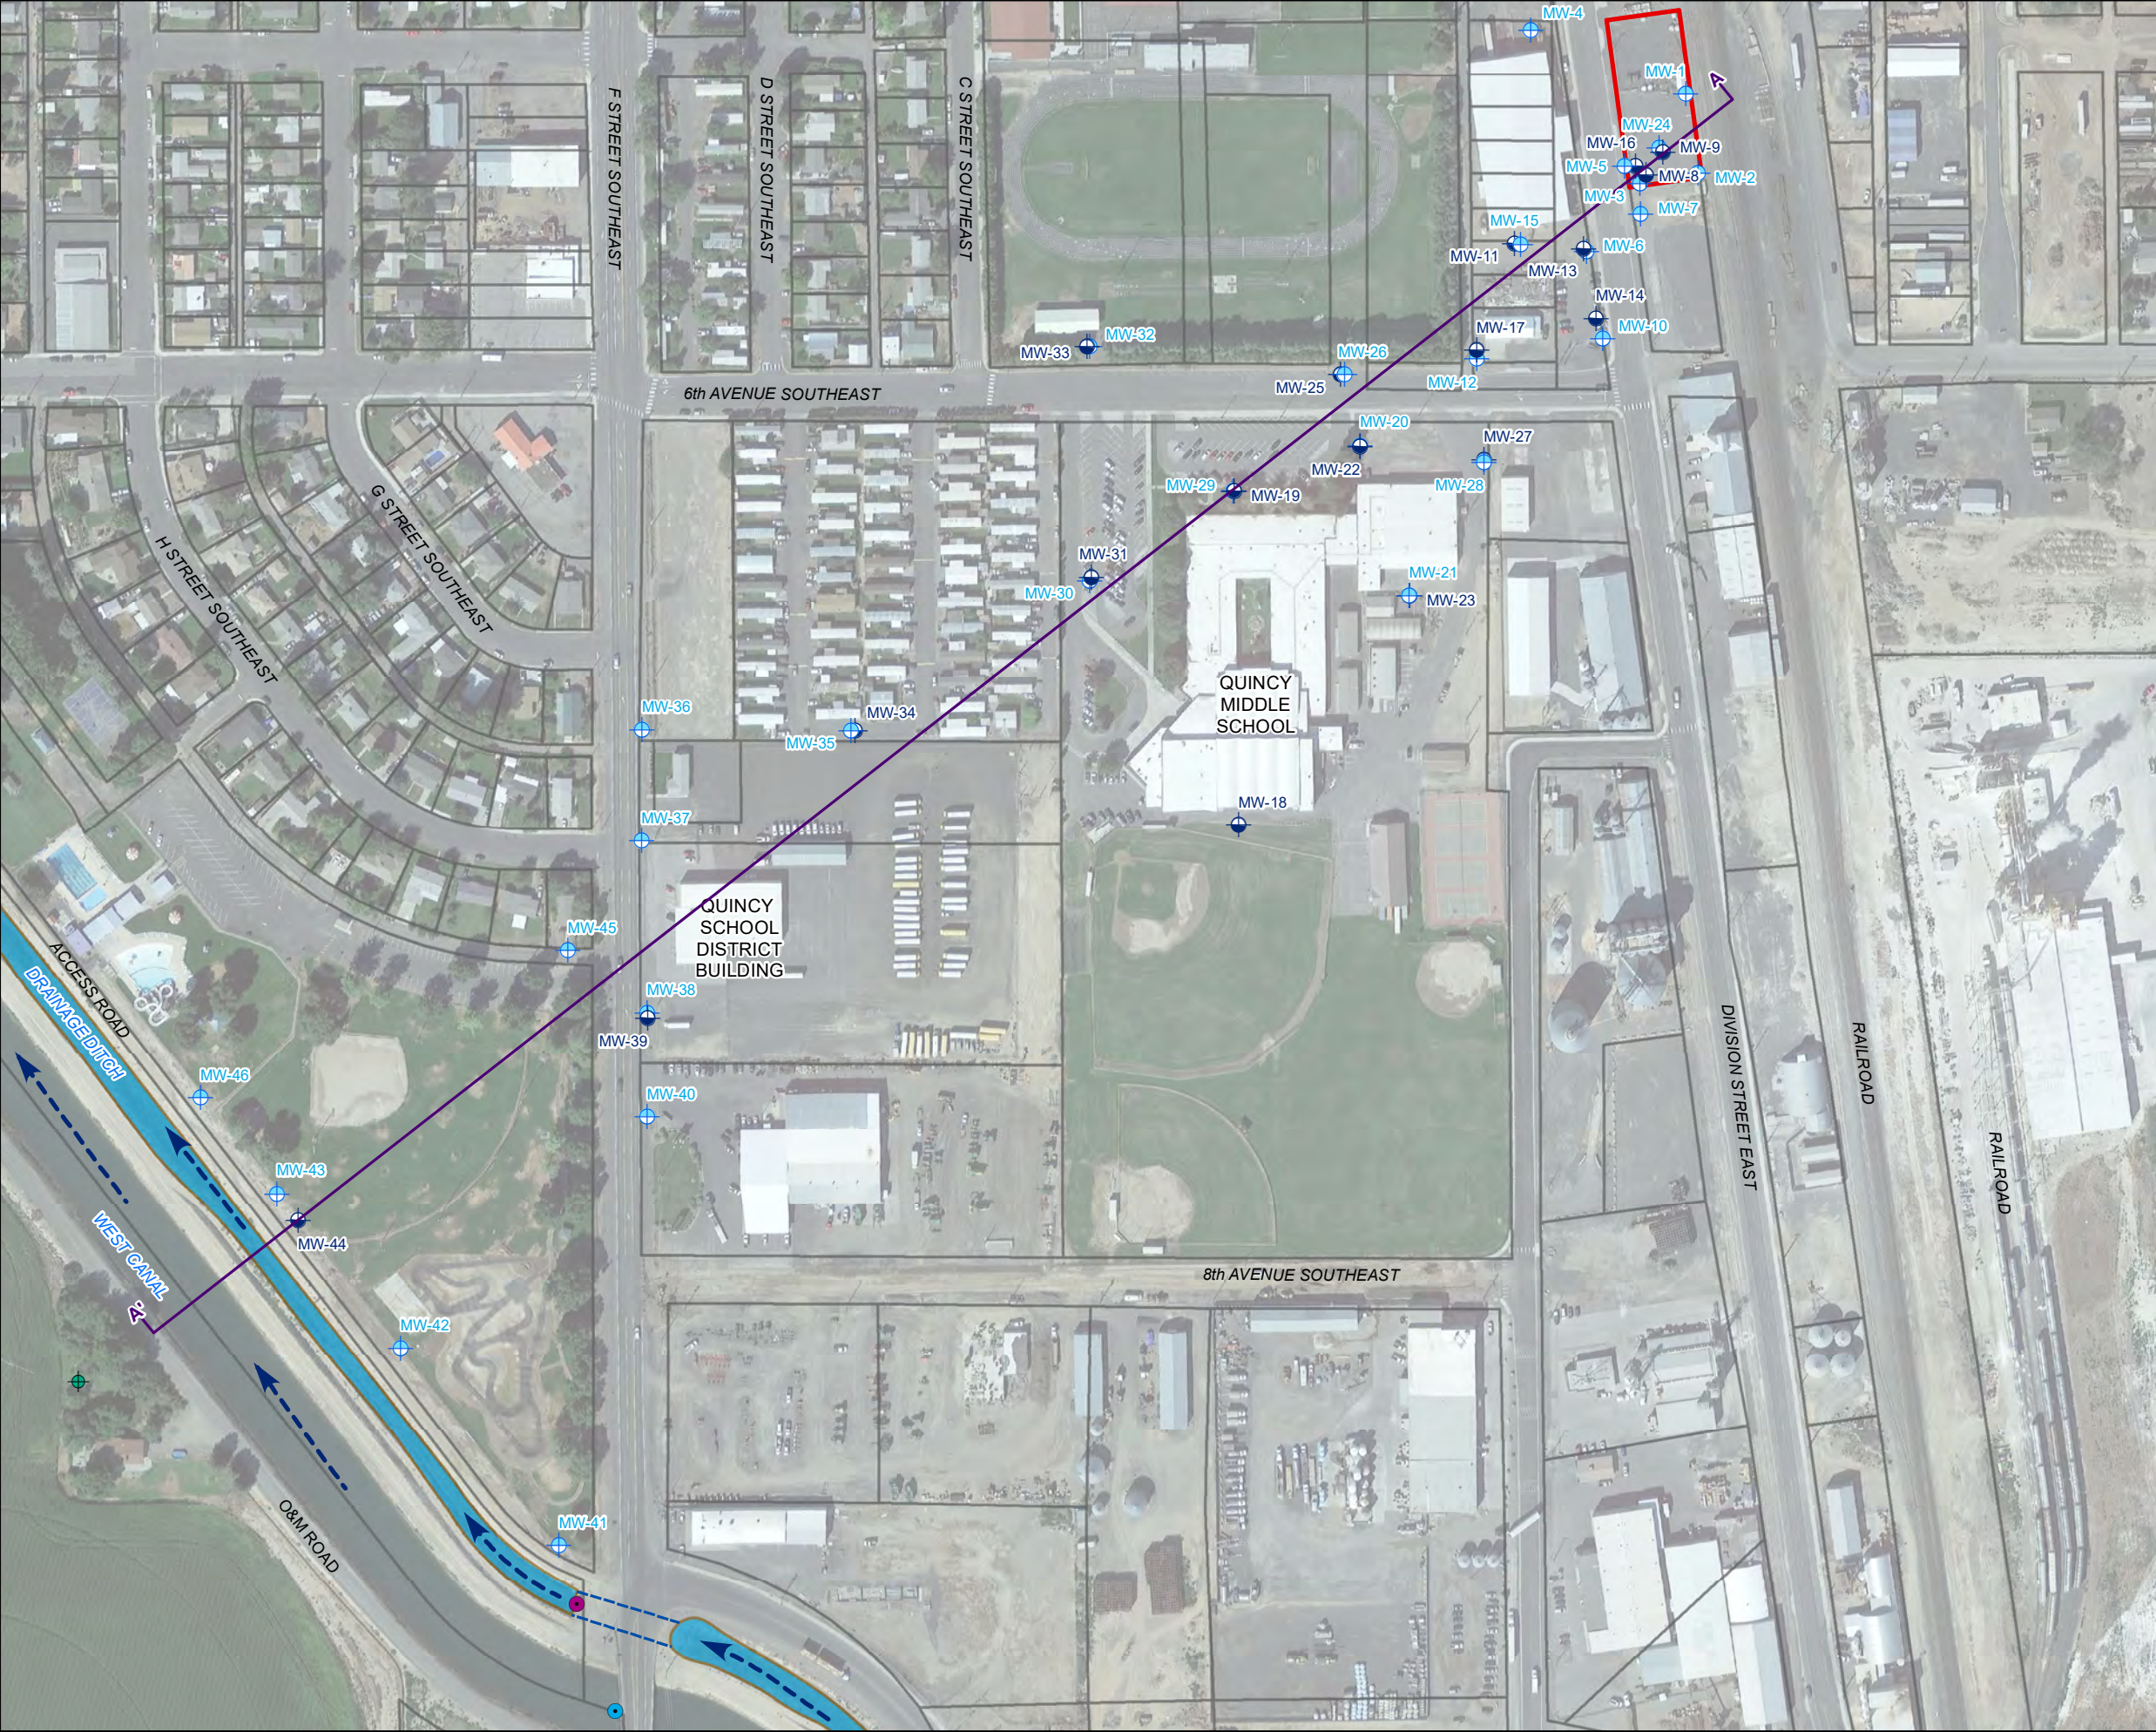
C:\Temp\GIS\301\Mapfiles\011\Figure-02_CHS-PropertyPlan.mxd

- MONITORING WELL (SHALLOW)
- MONITORING WELL (DEEP)
- WEST CANAL SURVEYED MEASURING POINT
- WEST CANAL DRAINAGE DITCH SURVEYED MEASURING POINT
- DOMESTIC WELL
- WEST CANAL/DRAINAGE DITCH FLOW DIRECTION
- WEST CANAL DRAINAGE DITCH CULVERT
- CHS PROPERTY BOUNDARY
- WEST CANAL DRAINAGE DITCH
- LINE OF CROSS-SECTION

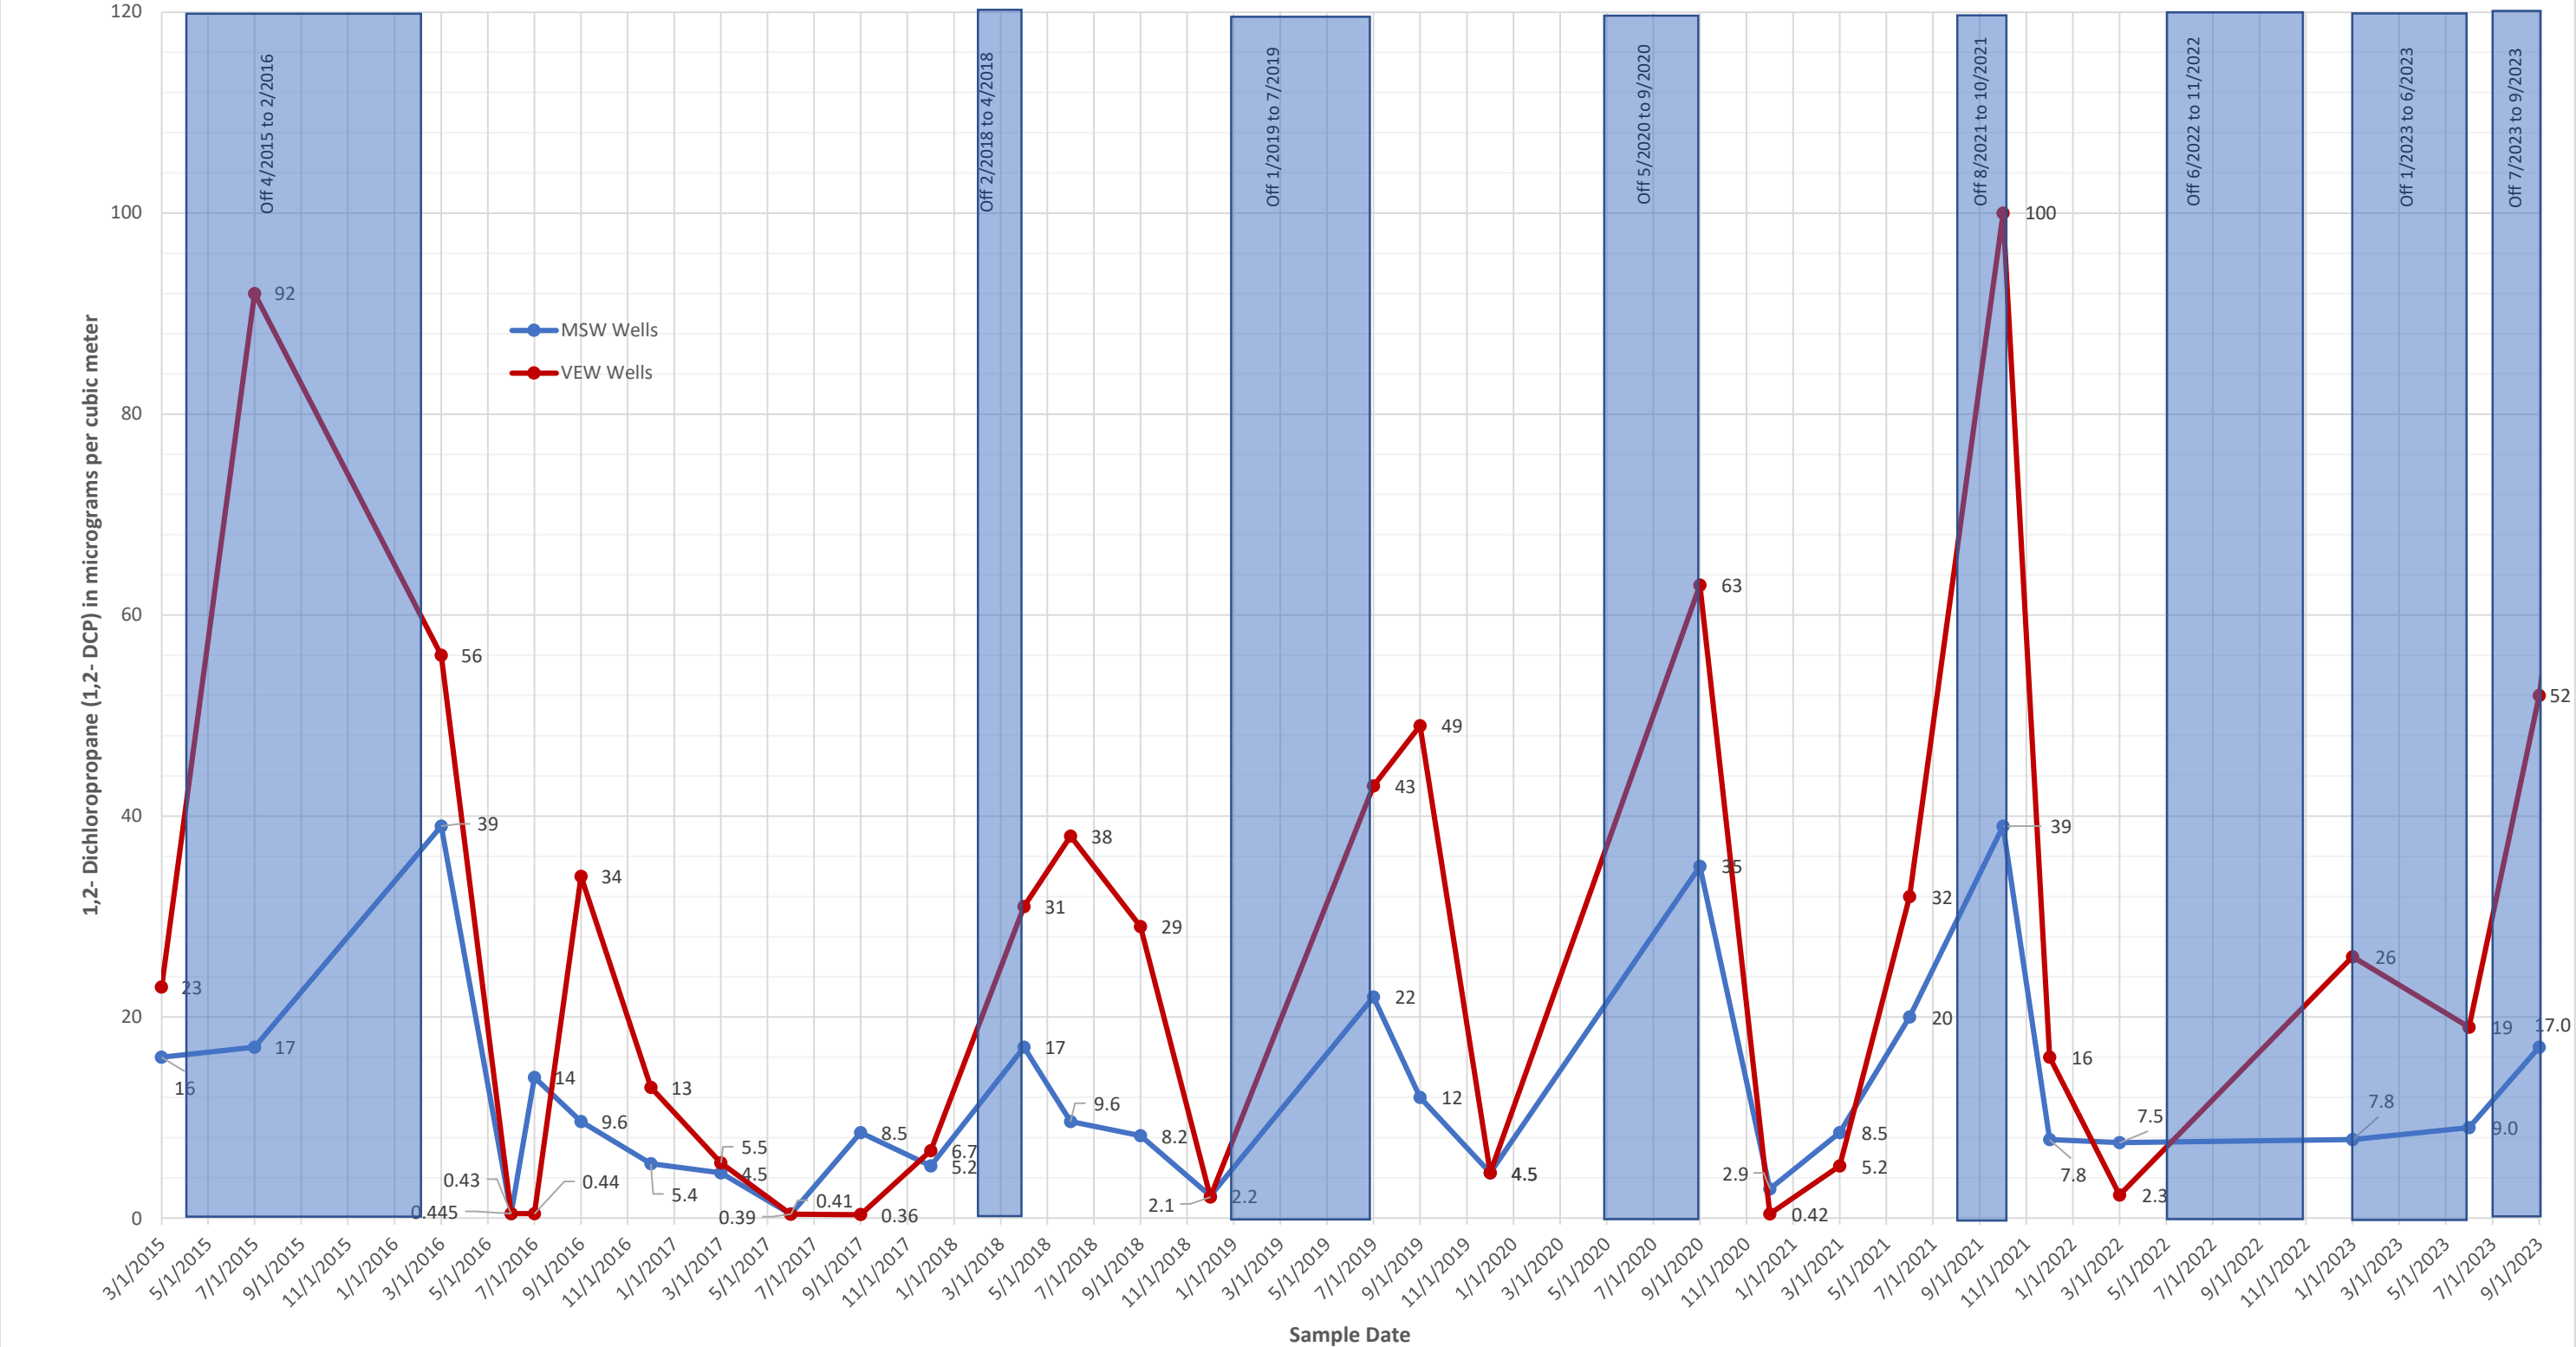
Chart 1
Summary of Laboratory Analytical Results for 1,2-DCP in SVE Influent Air
March 2015 to Septebmer 2023
Cenex Harvest State Cooperatives Site
Quincy, Washington
Farallon PN: 301-001

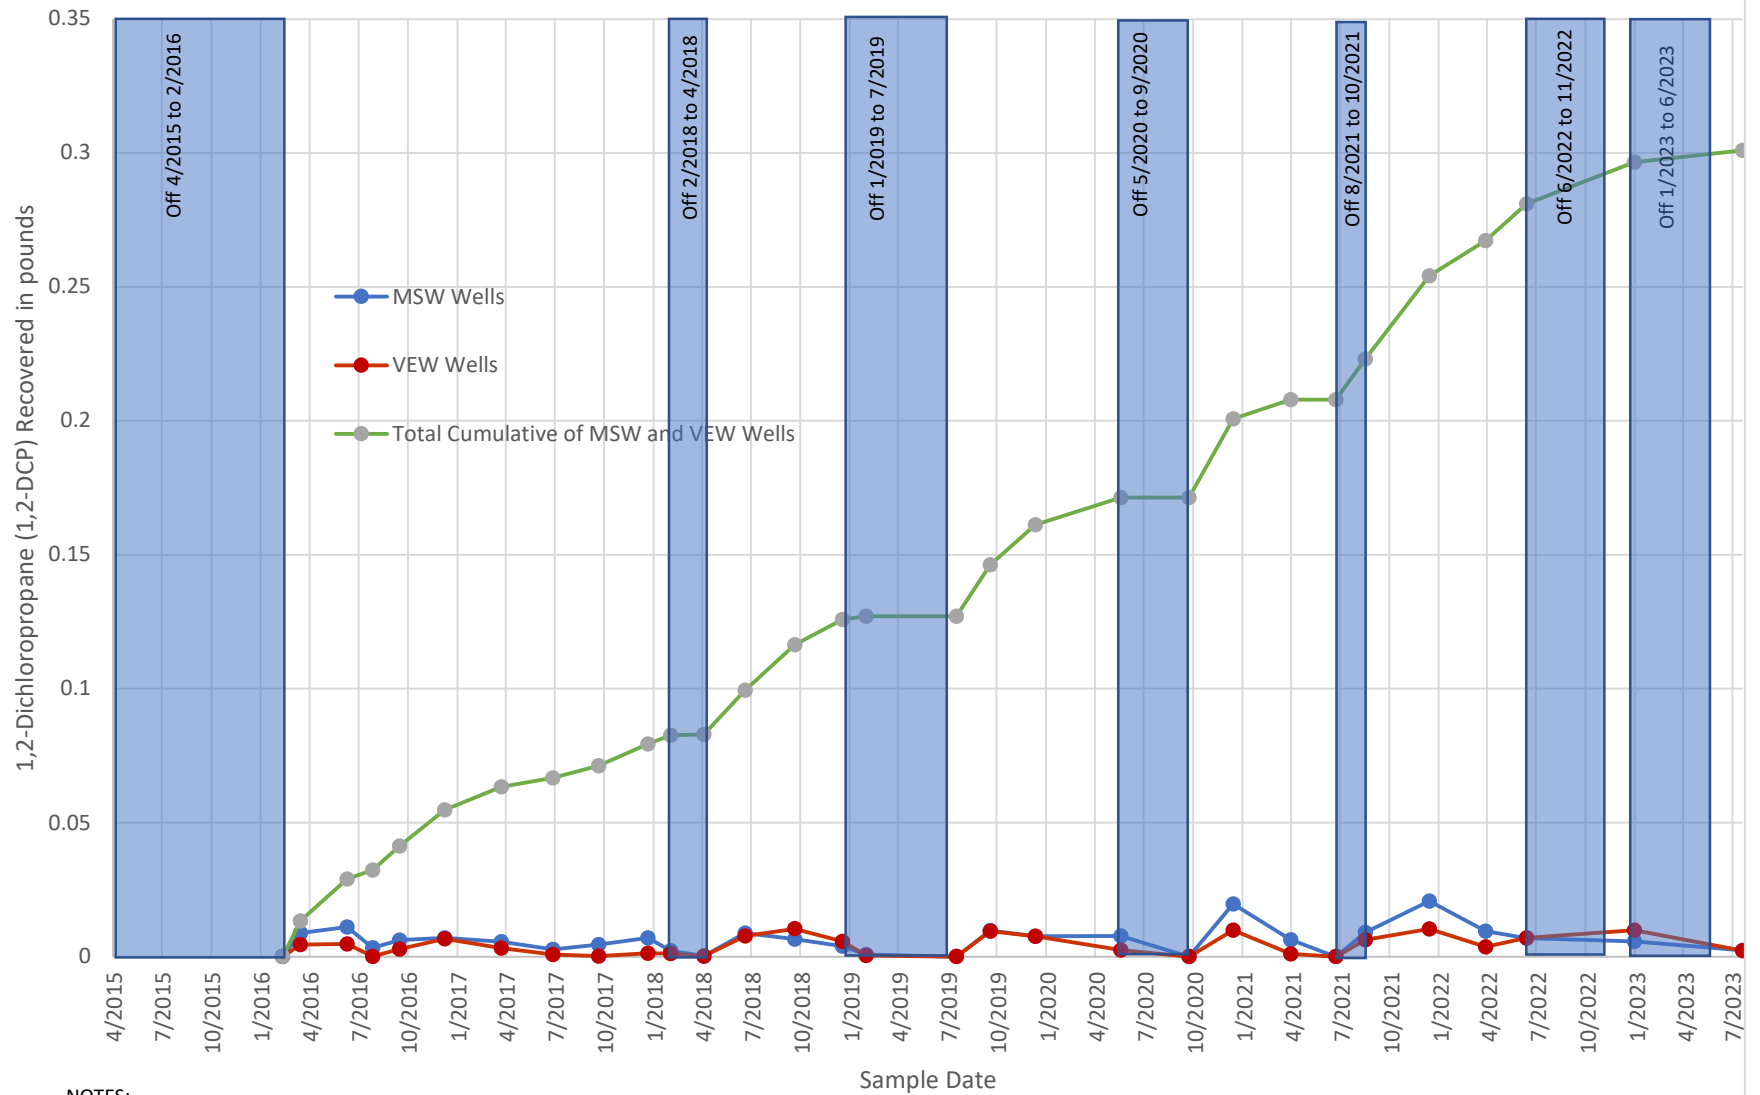
Chart 2
Summary of 1,2-DCP Recovered by MS/SVE System
February 2016 to July 2023
Cenex Harvest States Cooperatives Site
Farallon PN: 301-001

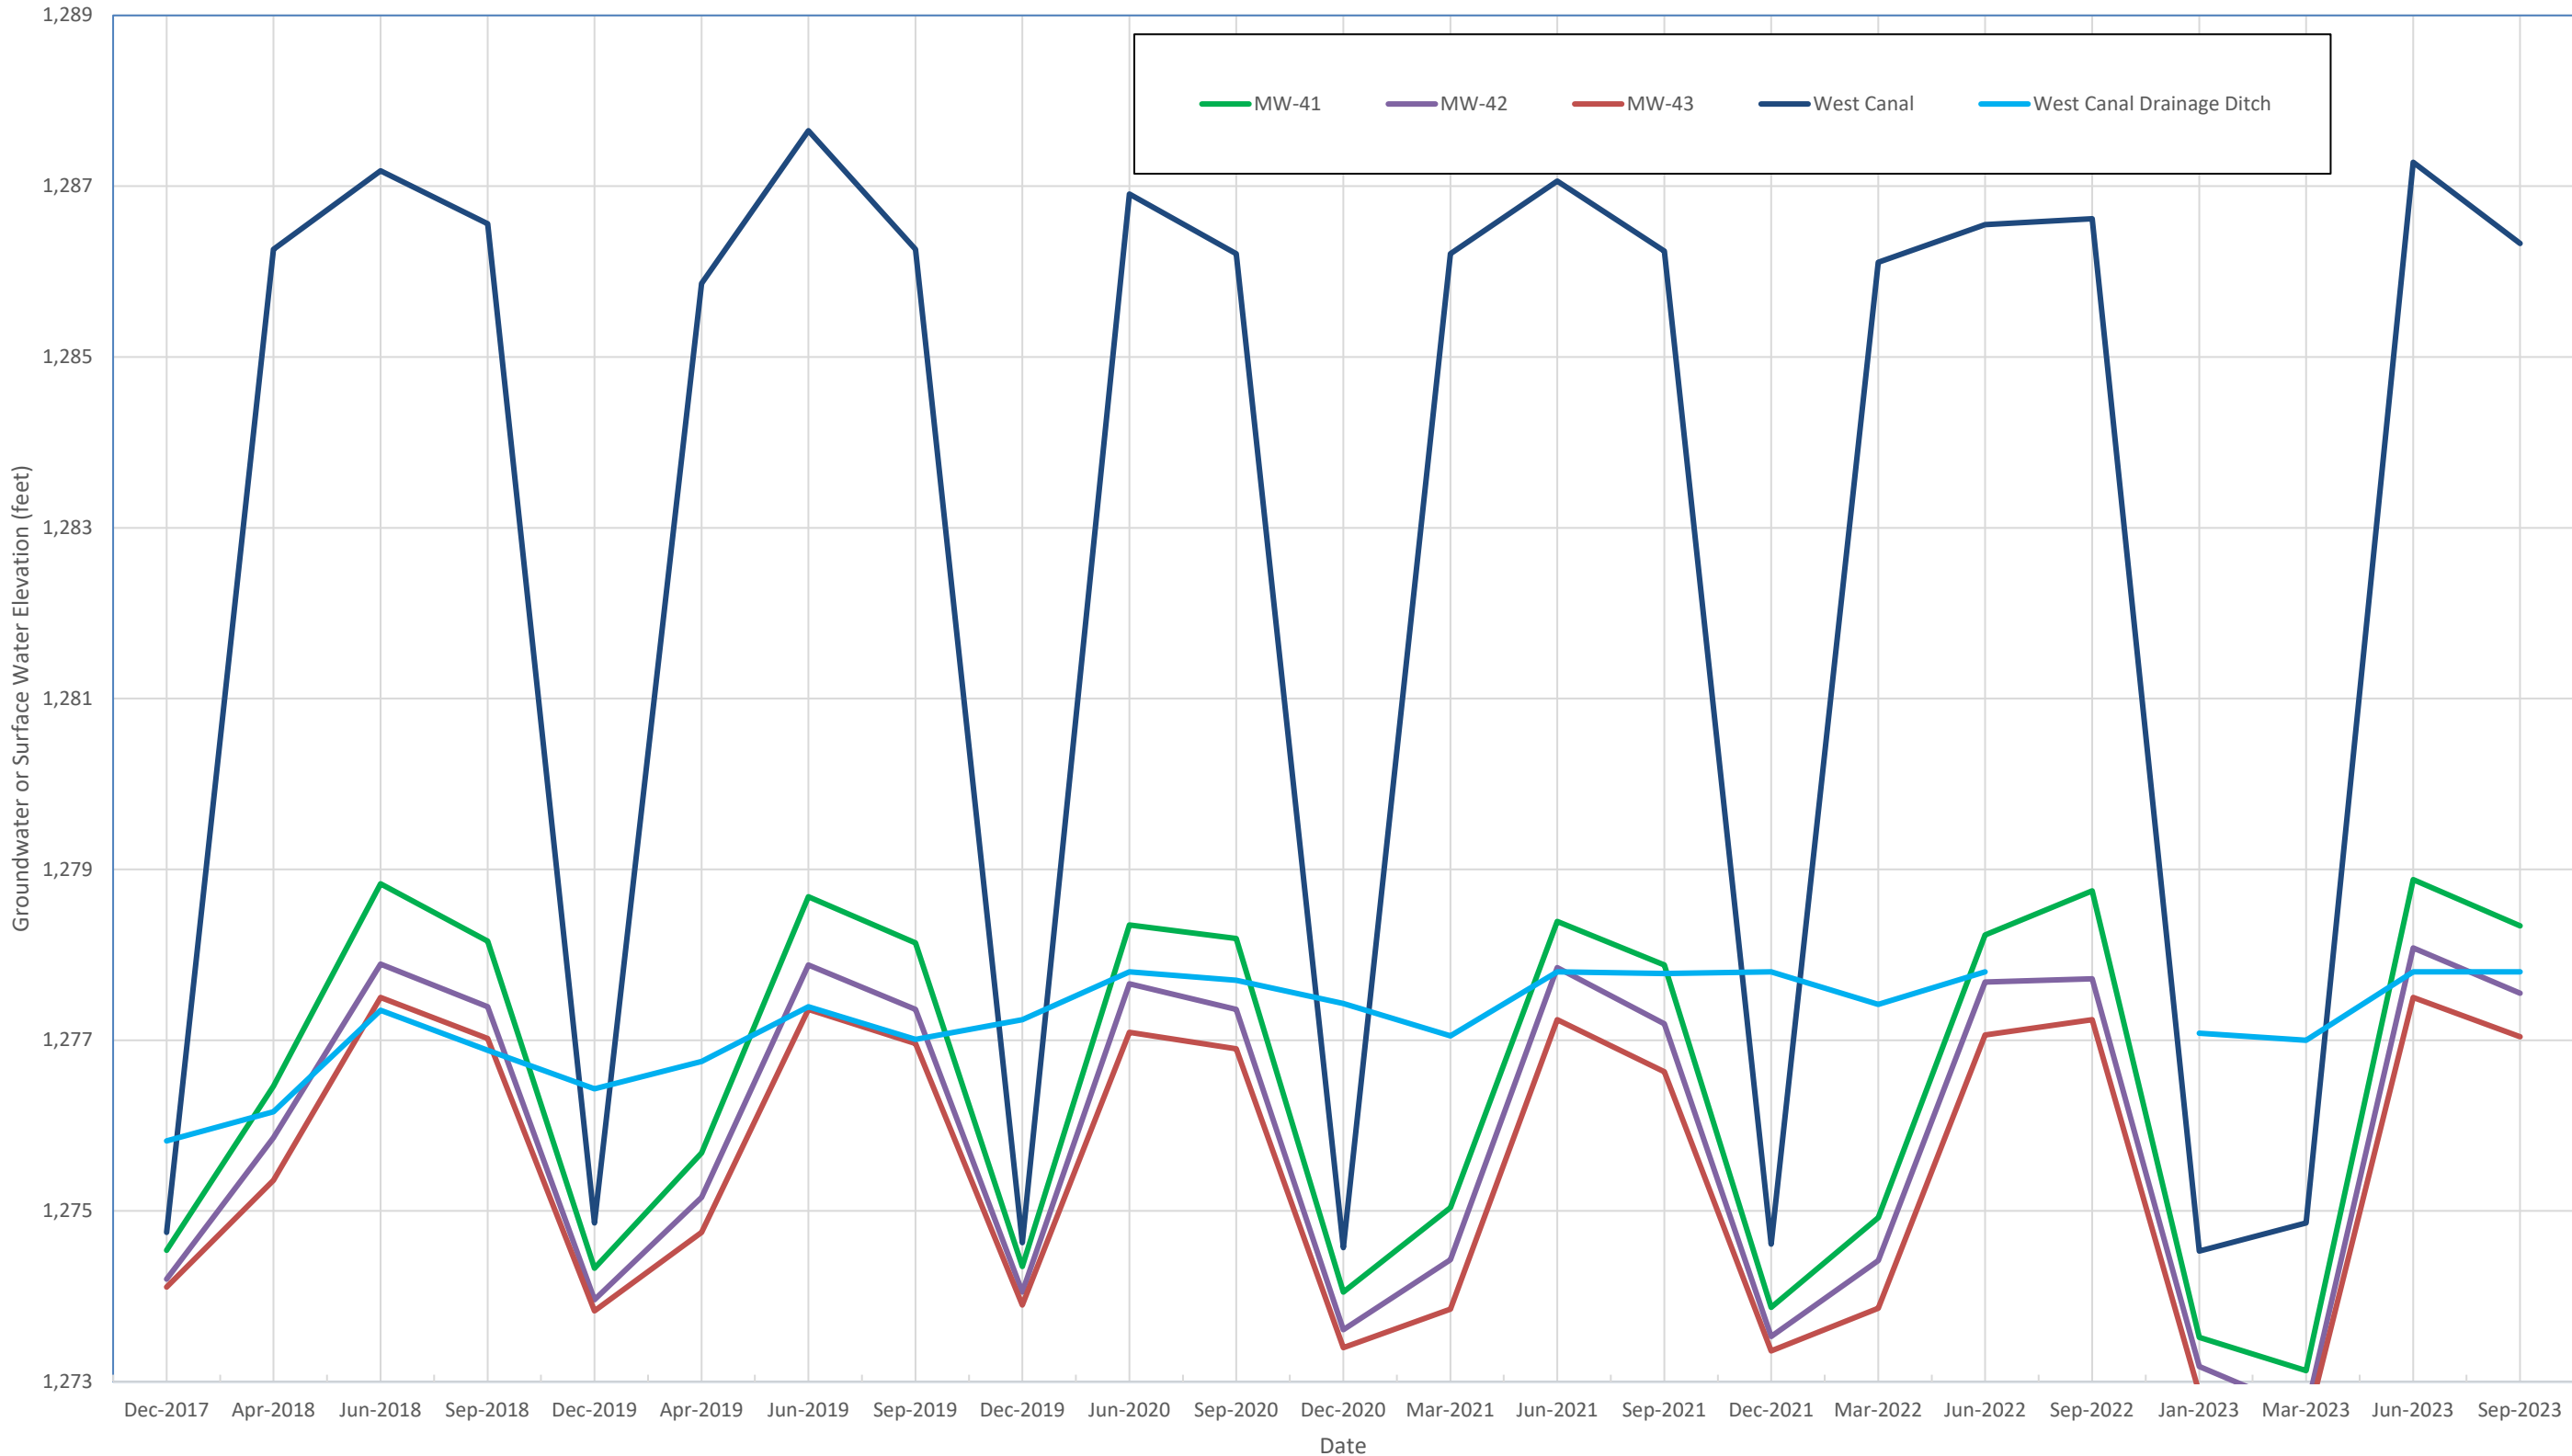
Chart 3
Groundwater and Surface Water Elevations – December 2017 to September 2023
Cenex Harvest States Cooperatives Site
Quincy, Washington
Farallon PN: 301-001

Surface water elevations measured in the West Canal over the past year were the highest during the June 2023 monitoring event and the lowest during the January 2023 monitoring event. The surface water elevation in the West Canal influences the groundwater elevation, gradient, and flow direction in monitoring wells adjacent to the canal. When the surface water elevation in the West Canal is high (June), higher groundwater elevations usually are observed in adjacent monitoring wells; when the surface water elevation in the West Canal

is low (January) lower groundwater elevations are observed. A steeper groundwater gradient generally is observed in monitoring wells adjacent to the West Canal when the surface water elevation in the West Canal is low (Table 5; Chart 3).

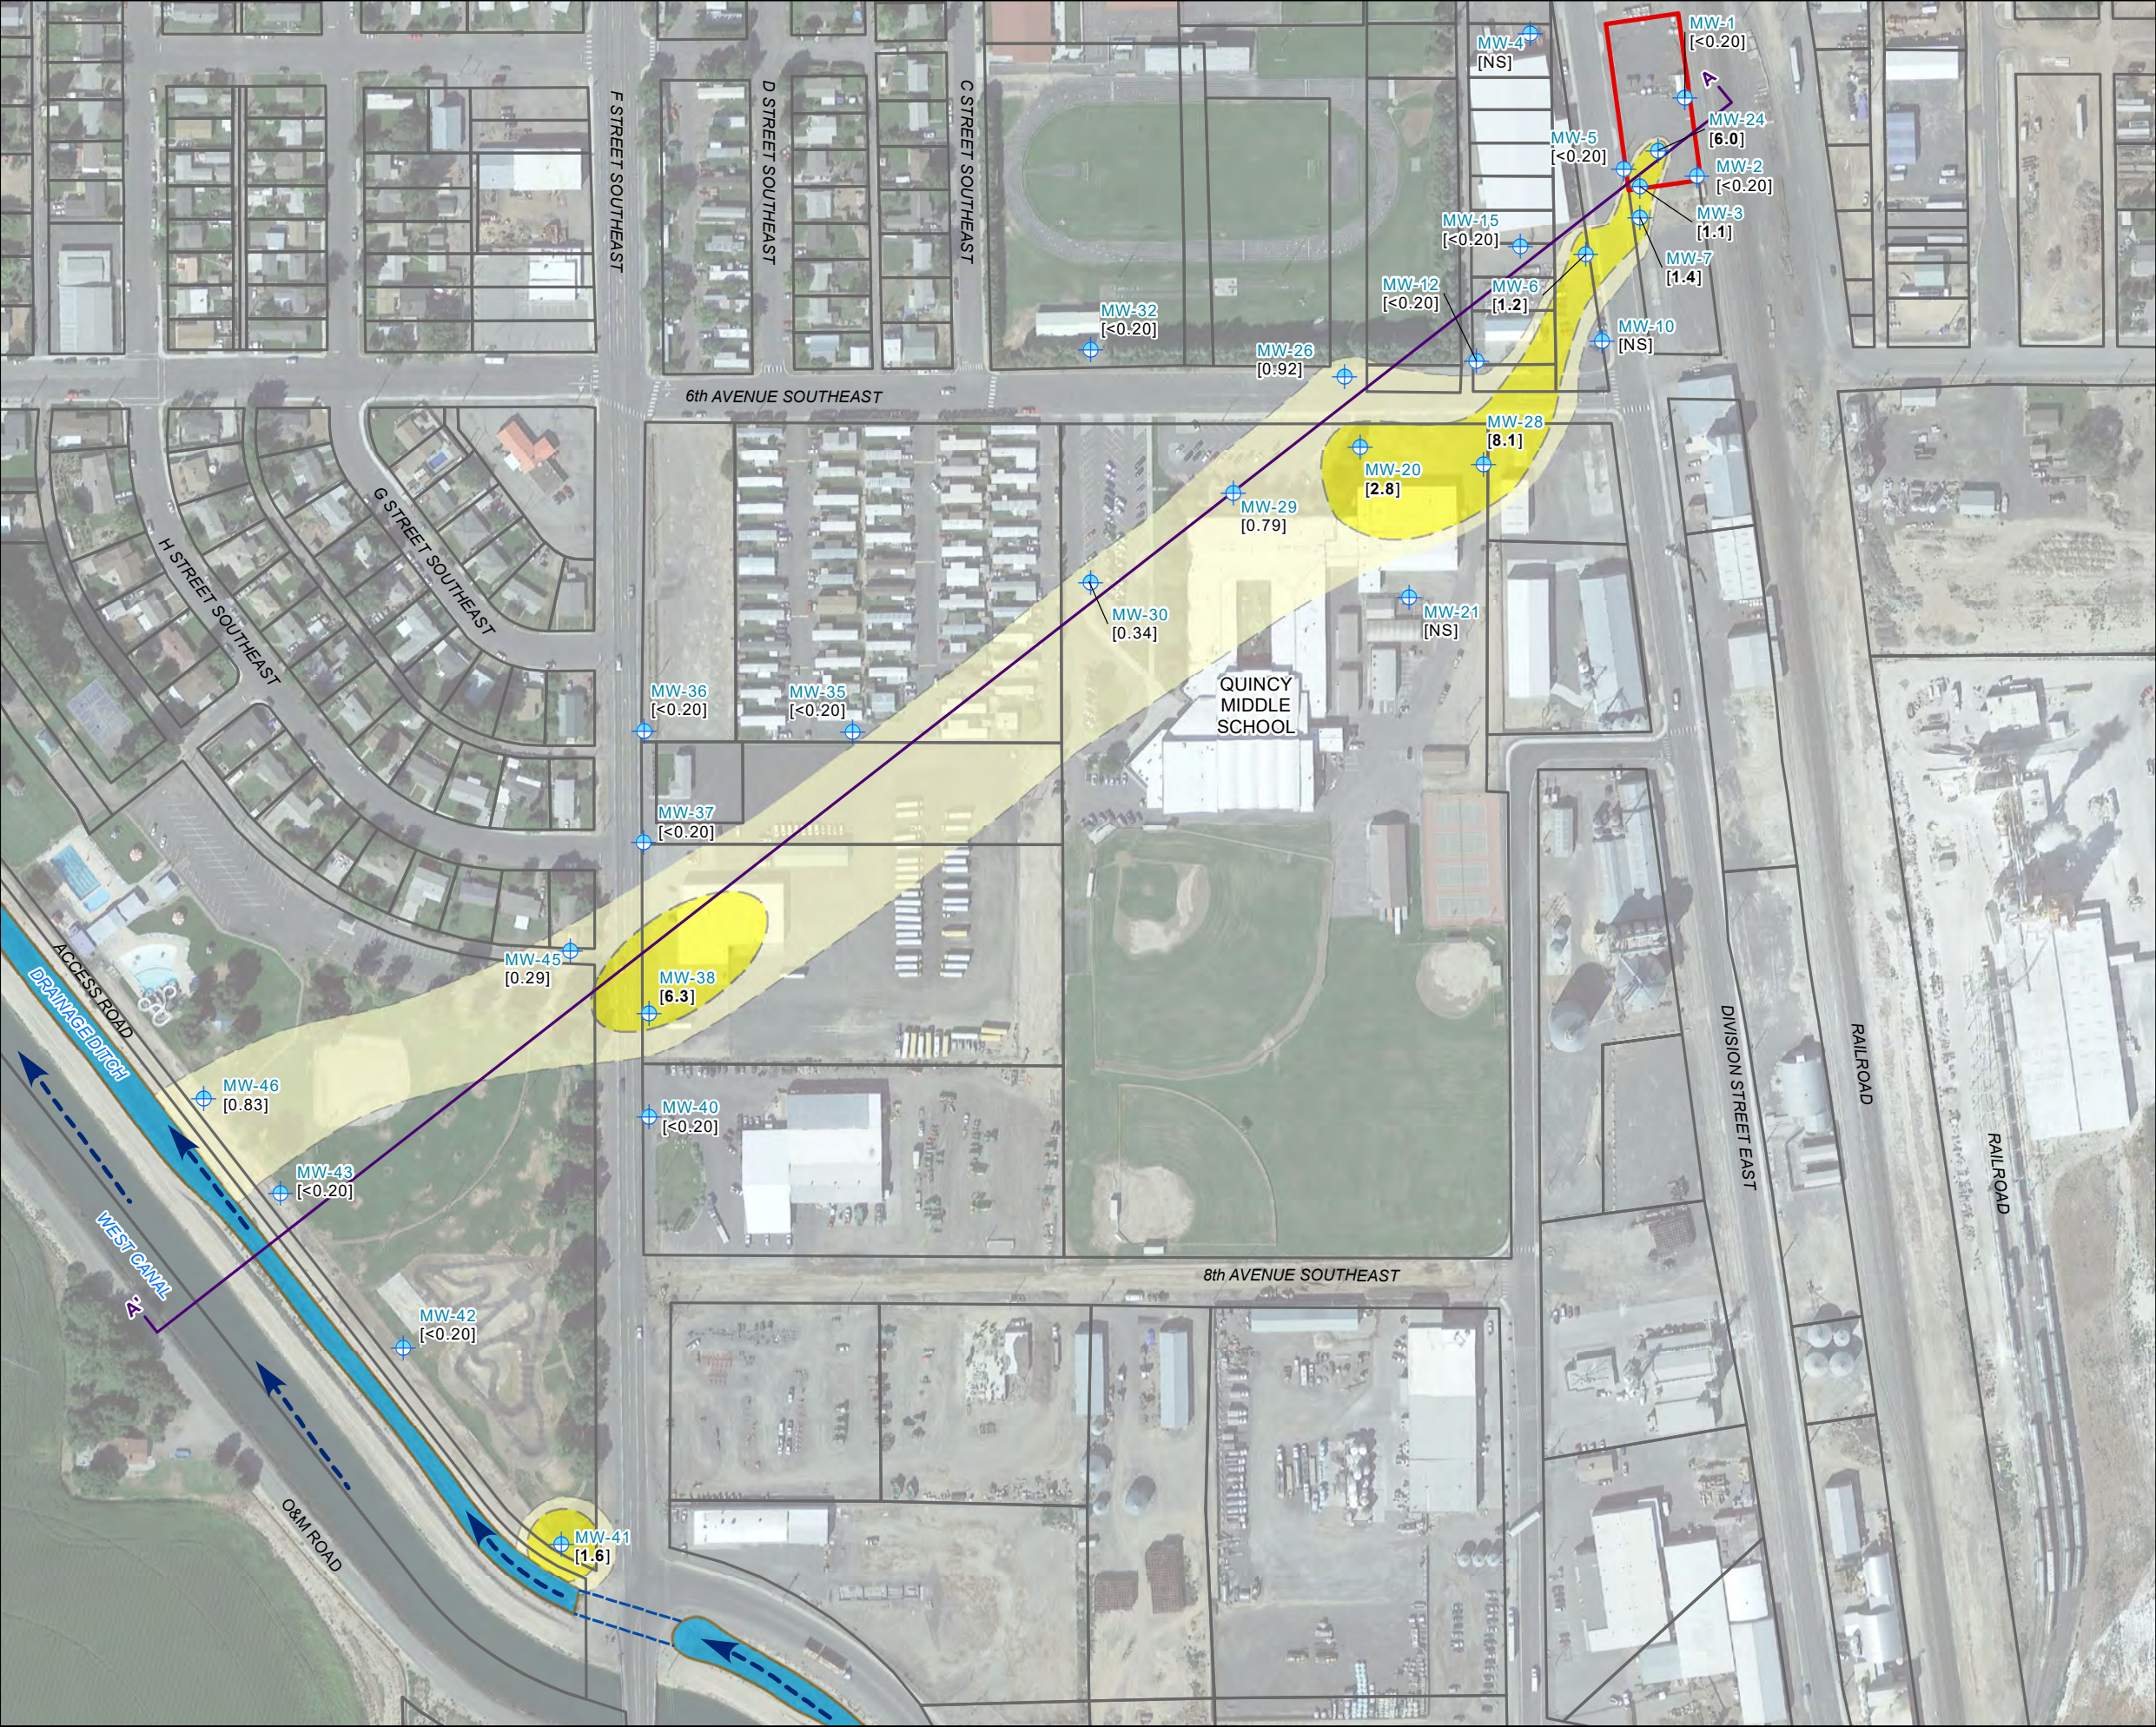
Q:\Projects\301 Cenix\001 Quincy\Mapfiles\011Figure-A1_GW_Elevations_Shallow_2023-09.mxd

- MONITORING WELL (SHALLOW)
- WEST CANAL/DRAINAGE DITCH FLOW DIRECTION
- WEST CANAL DRAINAGE DITCH CULVERT
- CHS PROPERTY BOUNDARY
- WEST CANAL DRAINAGE DITCH
- LINE OF CROSS-SECTION

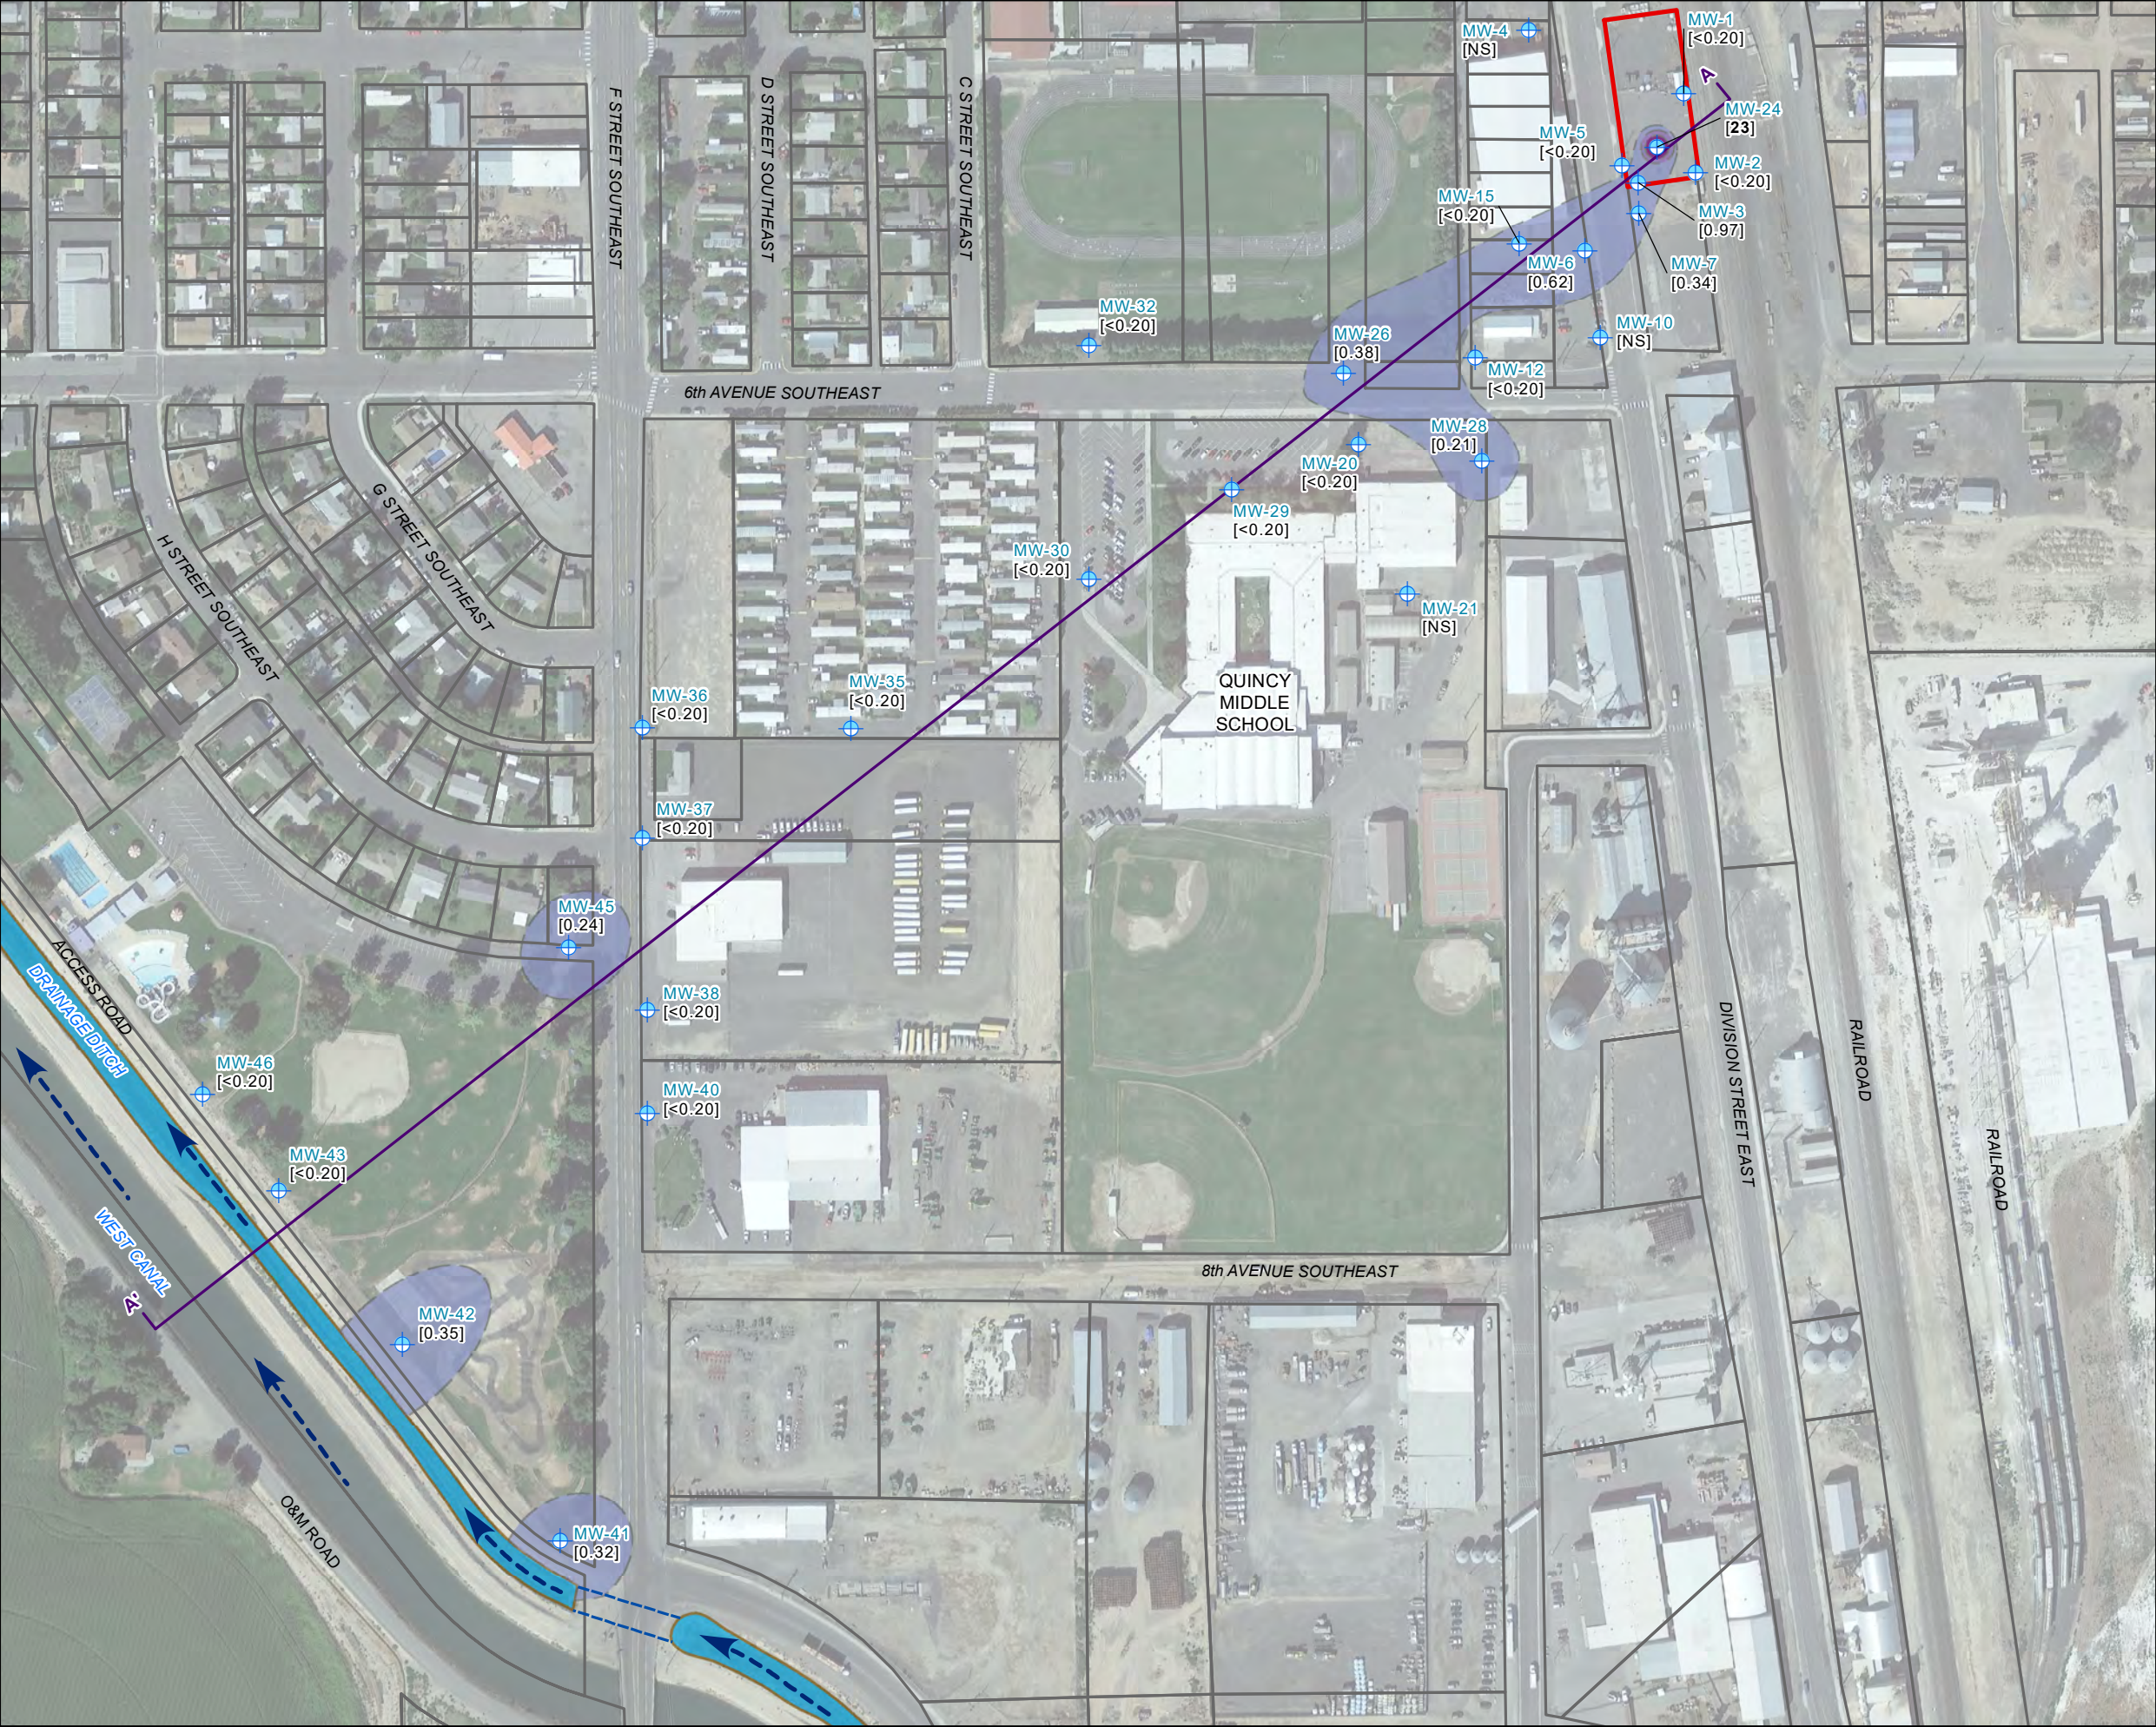
- LEGEND**
- MONITORING WELL (SHALLOW)
 - WEST CANAL/DRAINAGE DITCH FLOW DIRECTION
 - WEST CANAL DRAINAGE DITCH CULVERT
 - CHS PROPERTY BOUNDARY
 - WEST CANAL DRAINAGE DITCH
 - LINE OF CROSS-SECTION
- [0.74] = CONCENTRATIONS OF 1,2,3-TRICHLOROPROPANE (1,2,3-TCP) IN MICROGRAMS PER LITER (µg/l)
- BOLD** = INDICATES SAMPLE OR REPORTING LIMIT EXCEED SITE CLEANUP LEVEL OF 1 µg/l
- < = INDICATES NOT DETECTED AT OR ABOVE REPORTING LIMIT LISTED
- NS = WELL NOT SAMPLED
- ESTIMATED LIMITS OF 1,2,3-TCP ARE DASHED WHERE INFERRED
