Revised Annual Report 2023 Remedial Action Performance and Groundwater Compliance Monitoring

Cenex Harvest States Cooperatives Site
300 Division Street East
Quincy, Washington

Farallon PN: 301-001

December 14, 2023

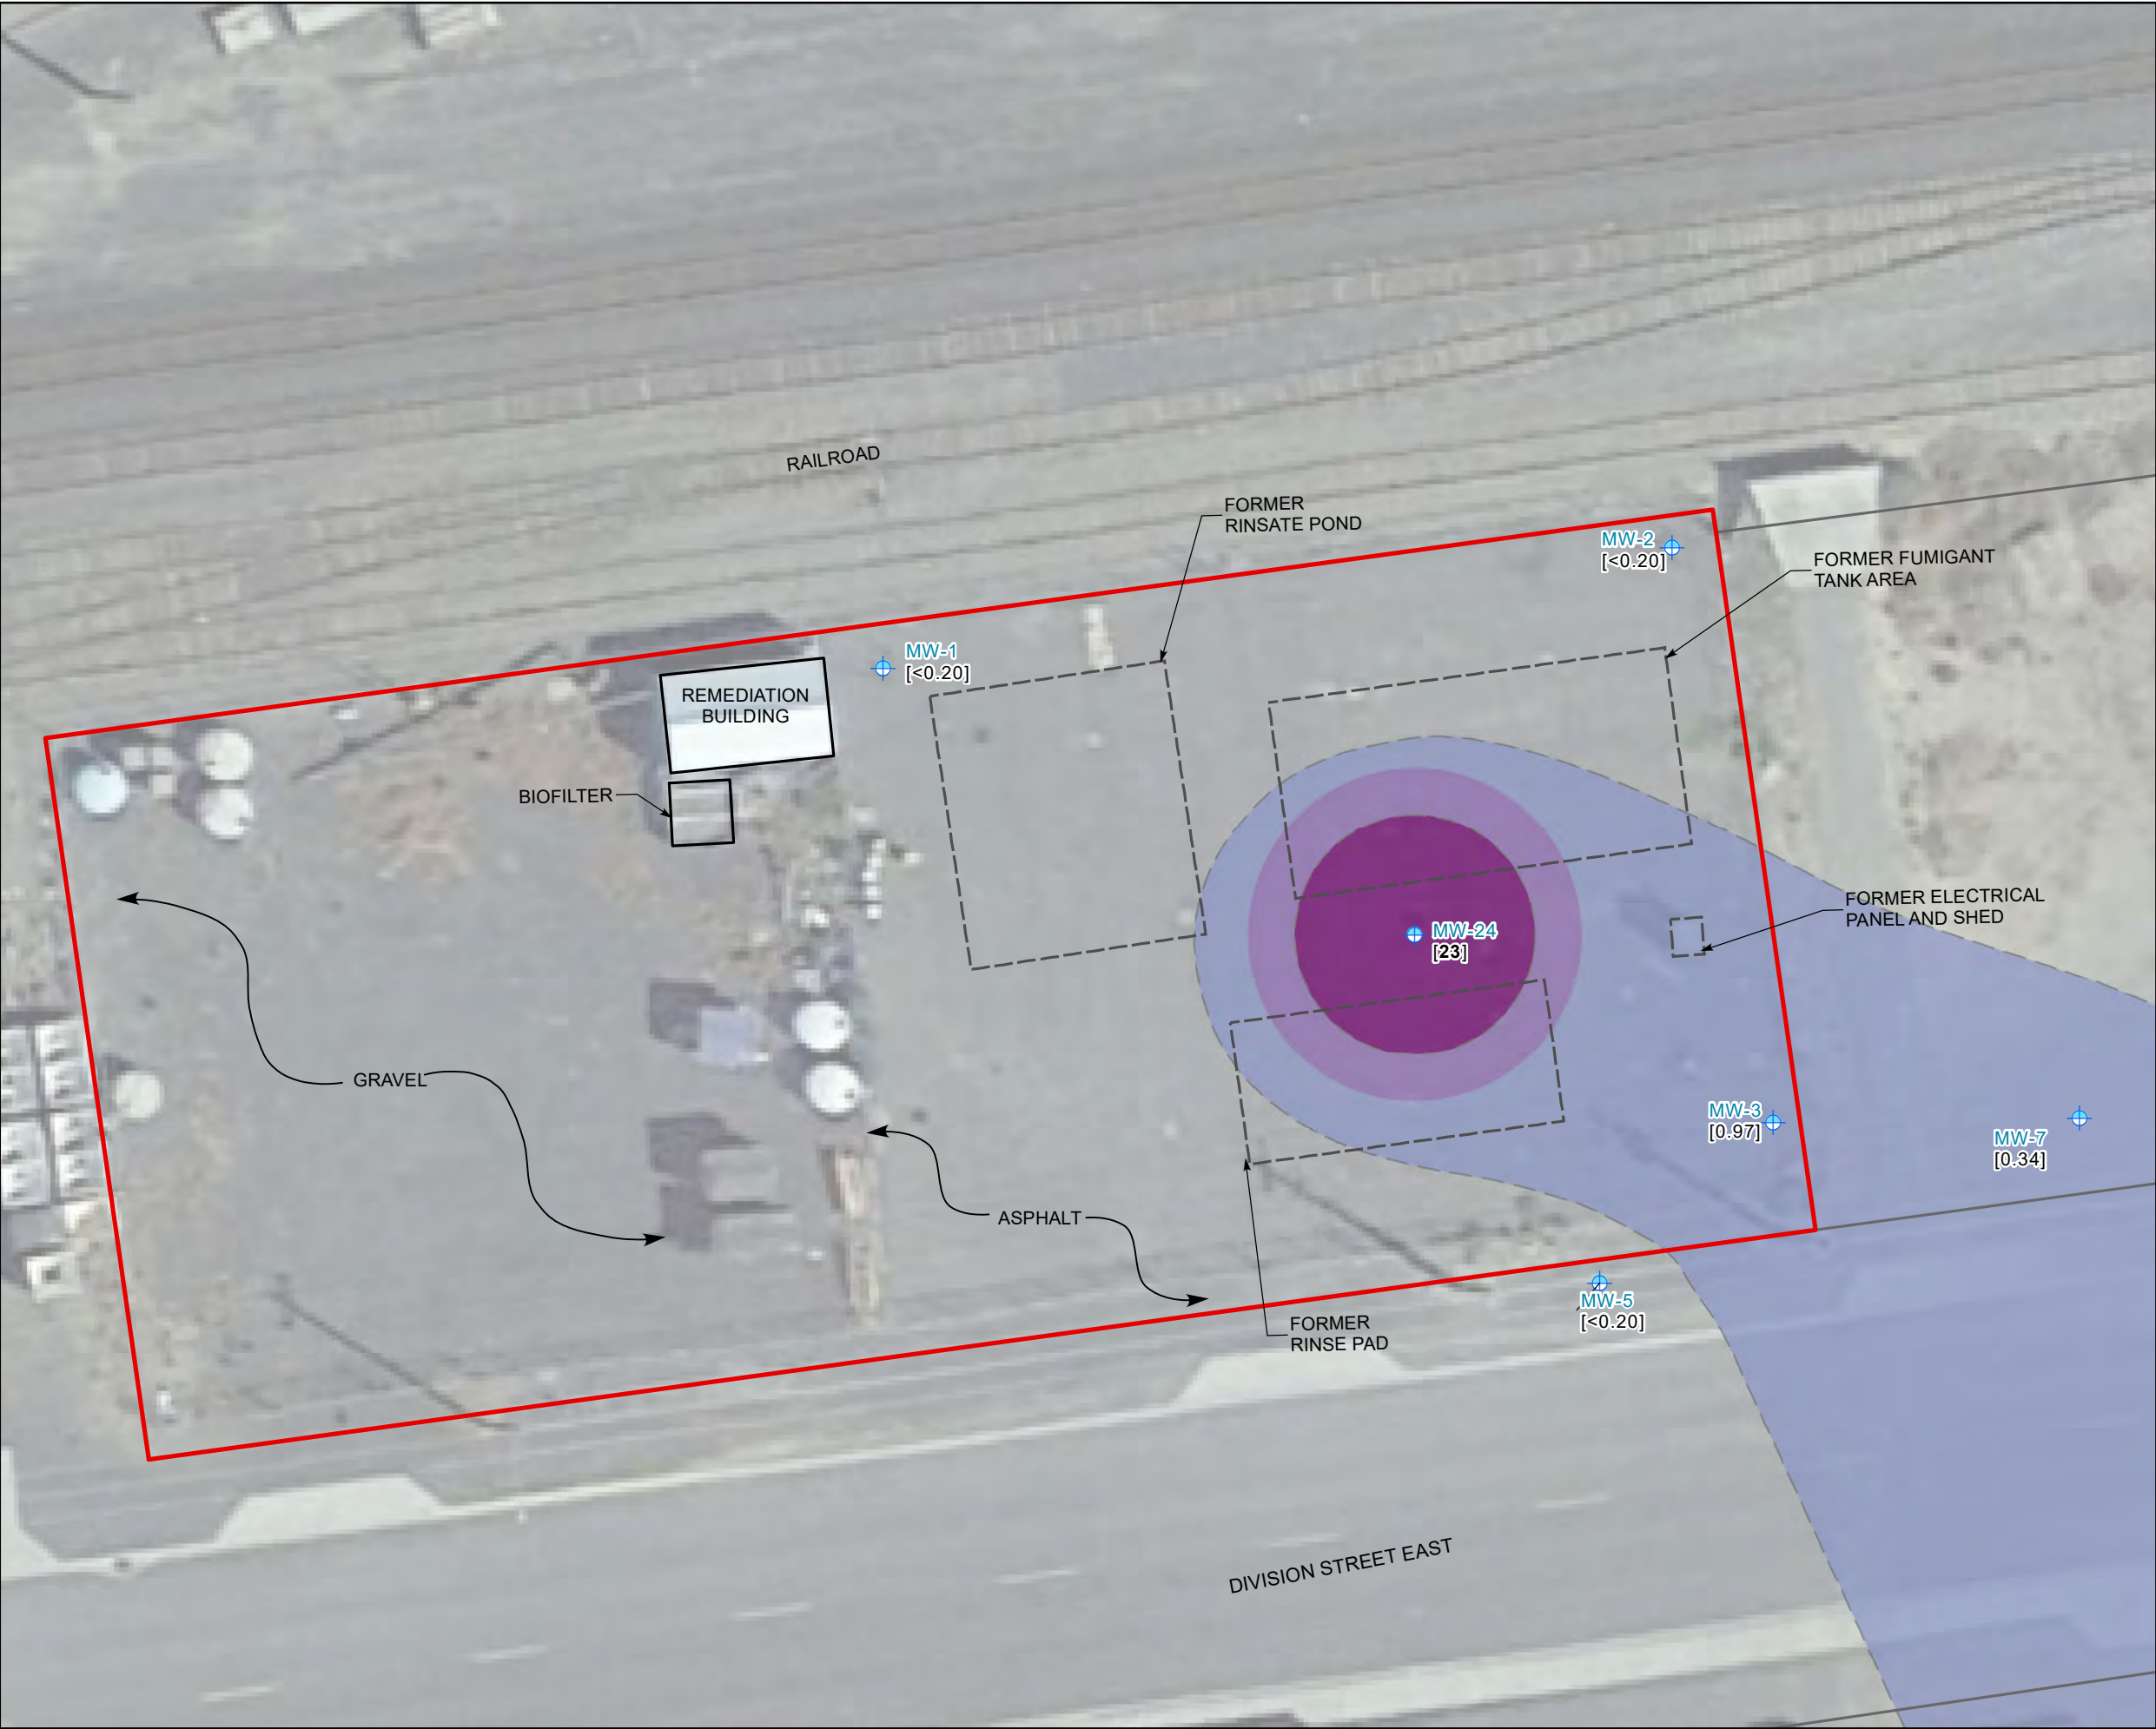
Q:\Projects\301_Cenex\001_Quincy\Mapfiles\011\Figure-A4_GW-Property-Shallow_DCP_2023-08.mxd

MONITORING WELL (SHALLOW)

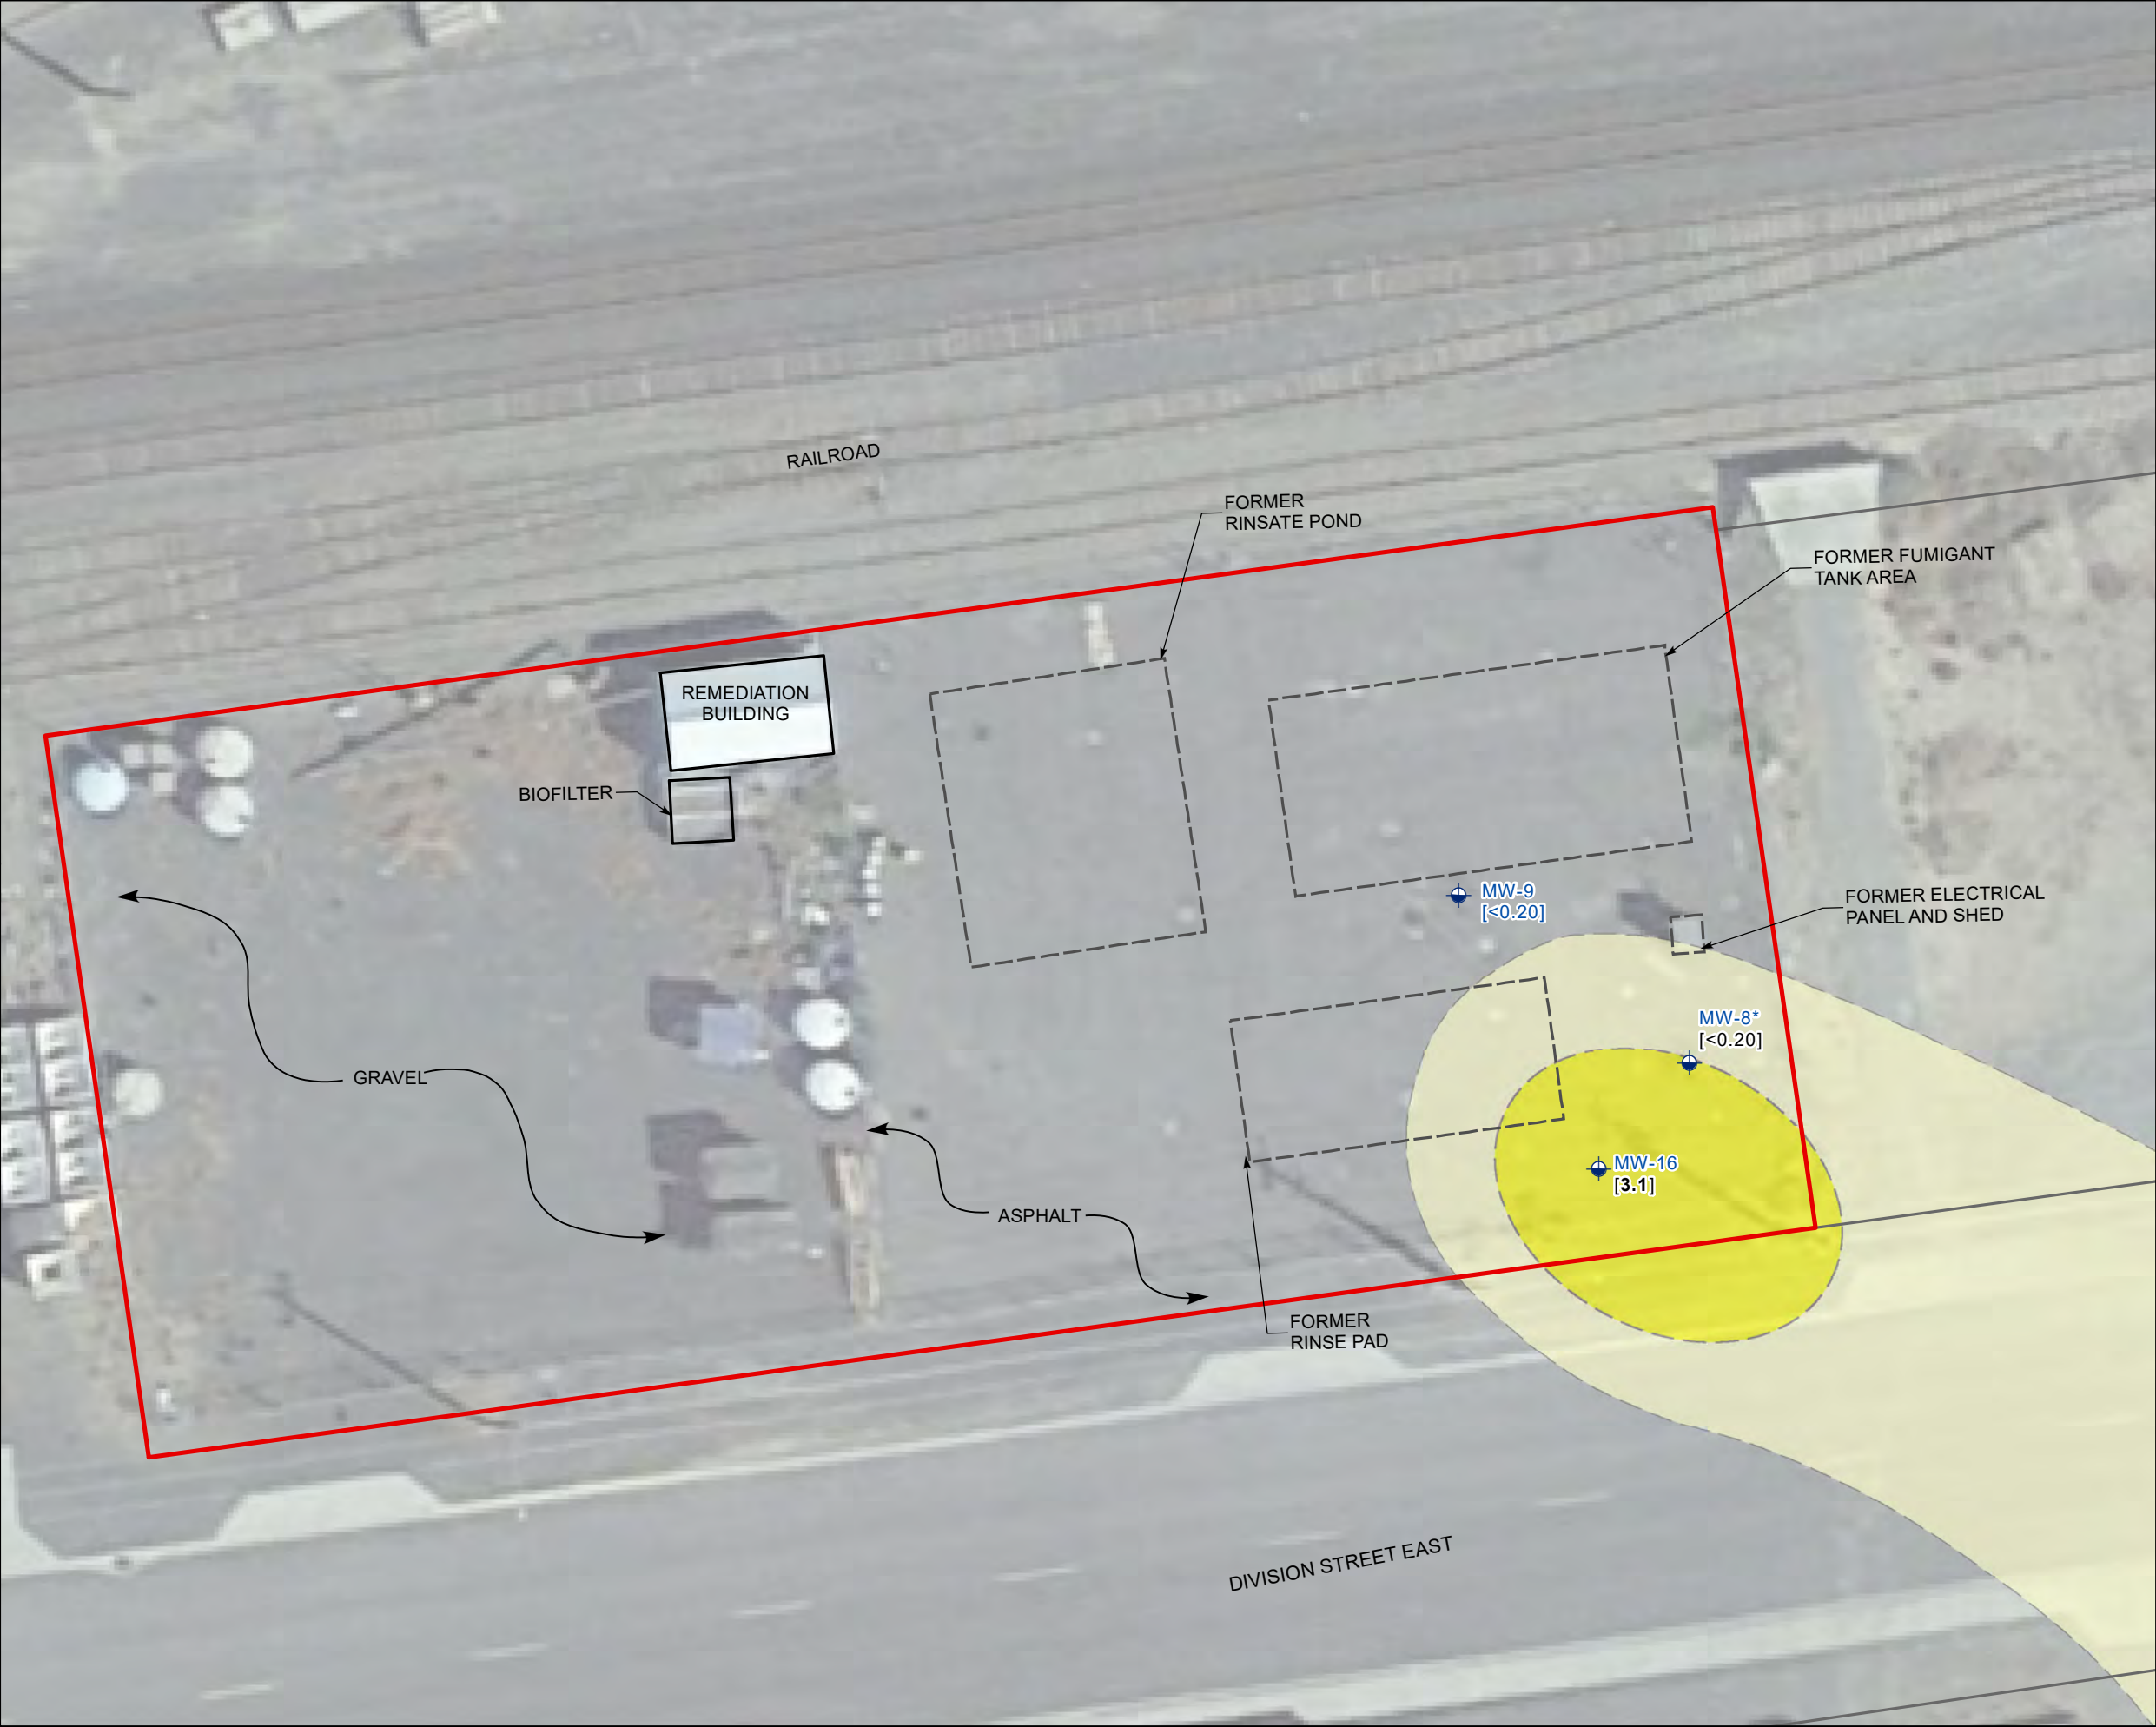
- LEGEND**
- MONITORING WELL (DEEP)
 - CURRENT SITE FEATURE
 - FORMER SITE FEATURE
 - CHS PROPERTY BOUNDARY
- [3.1]** = CONCENTRATIONS OF 1,2-DICHLOROPROPANE (1,2-DCP) IN MICROGRAMS PER LITER (µg/l)
- * = MONITORING WELL MW-8 NOT USED FOR CONSTRUCTION OF ISOCONCENTRATION CONTOURS
- BOLD** = INDICATES SAMPLE OR REPORTING LIMIT EXCEED SITE CLEANUP LEVEL OF 1 µg/l
- < = INDICATES NOT DETECTED AT OR ABOVE REPORTING LIMIT LISTED
- — — ESTIMATED LIMITS OF 1,2-DCP ARE DASHED WHERE INFERRED

1,2-DCP CONCENTRATION IN µg/l

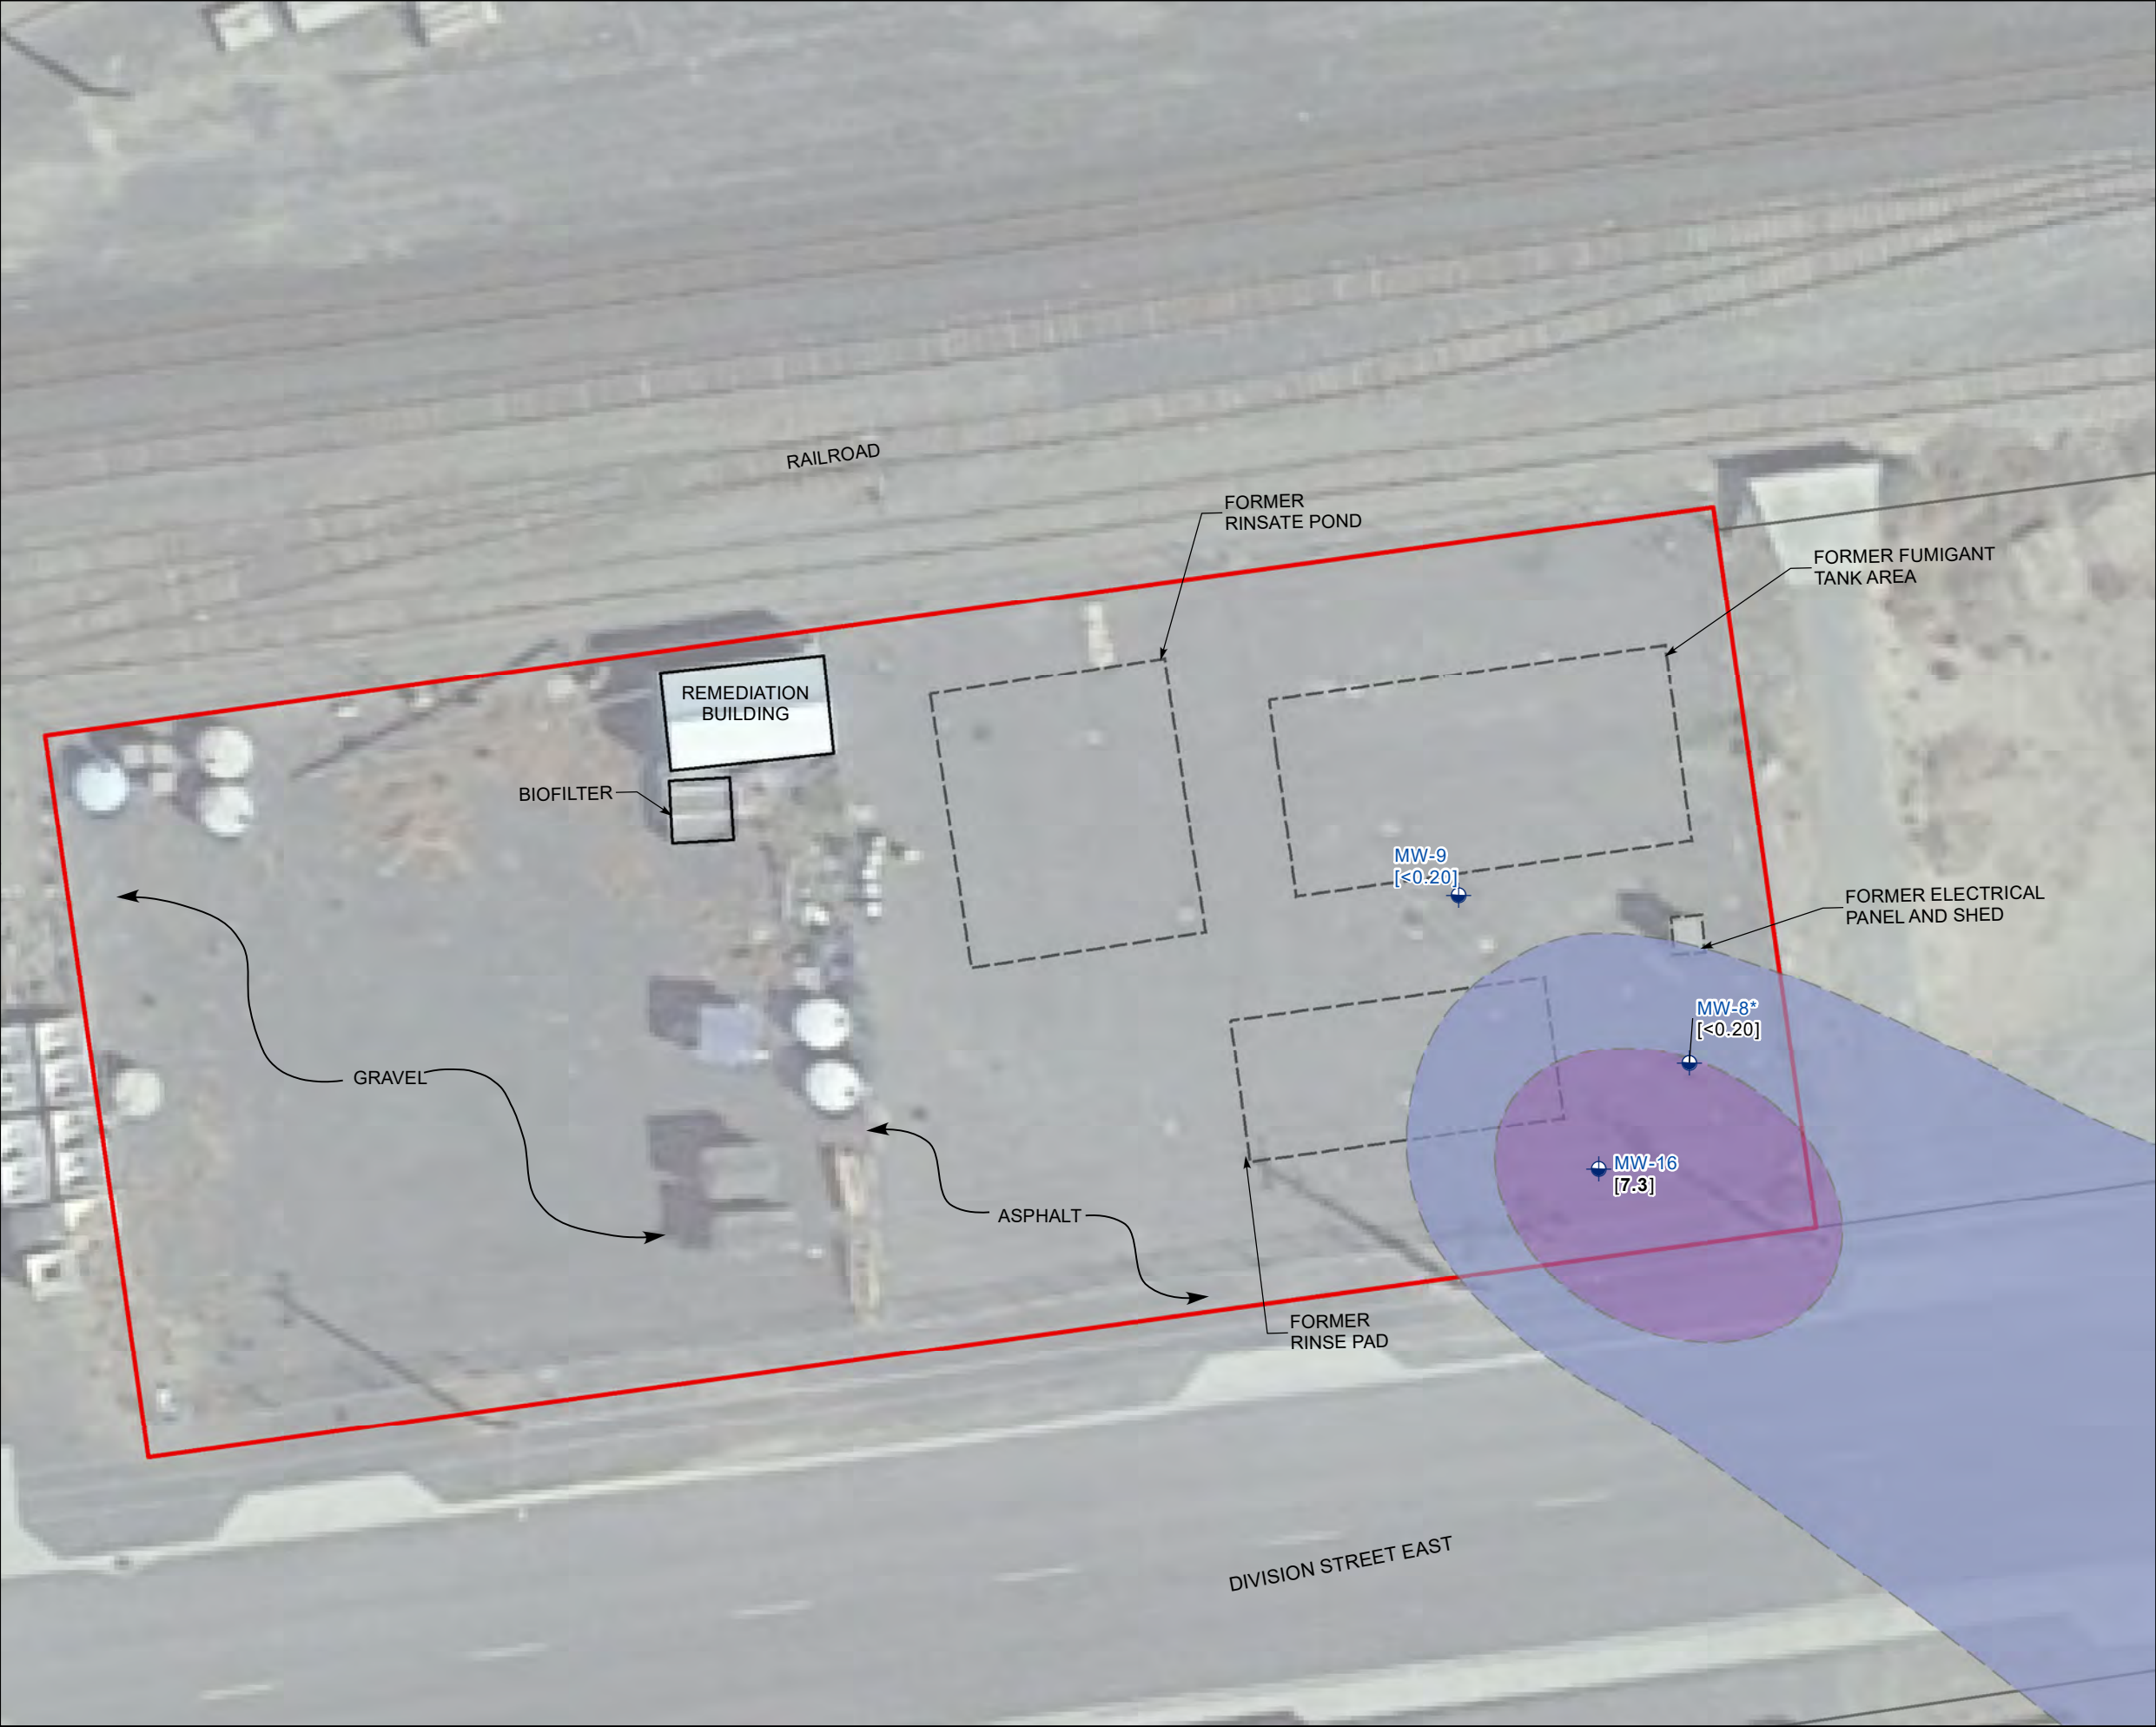
D:\Projects\301 Cenix\001 Quincy\Mapfiles\011\Figure-A8_GW-Property-Deep_DCP_2023-08.mxd

- MONITORING WELL (DEEP)
- CURRENT SITE FEATURE
- FORMER SITE FEATURE
- CHS PROPERTY BOUNDARY

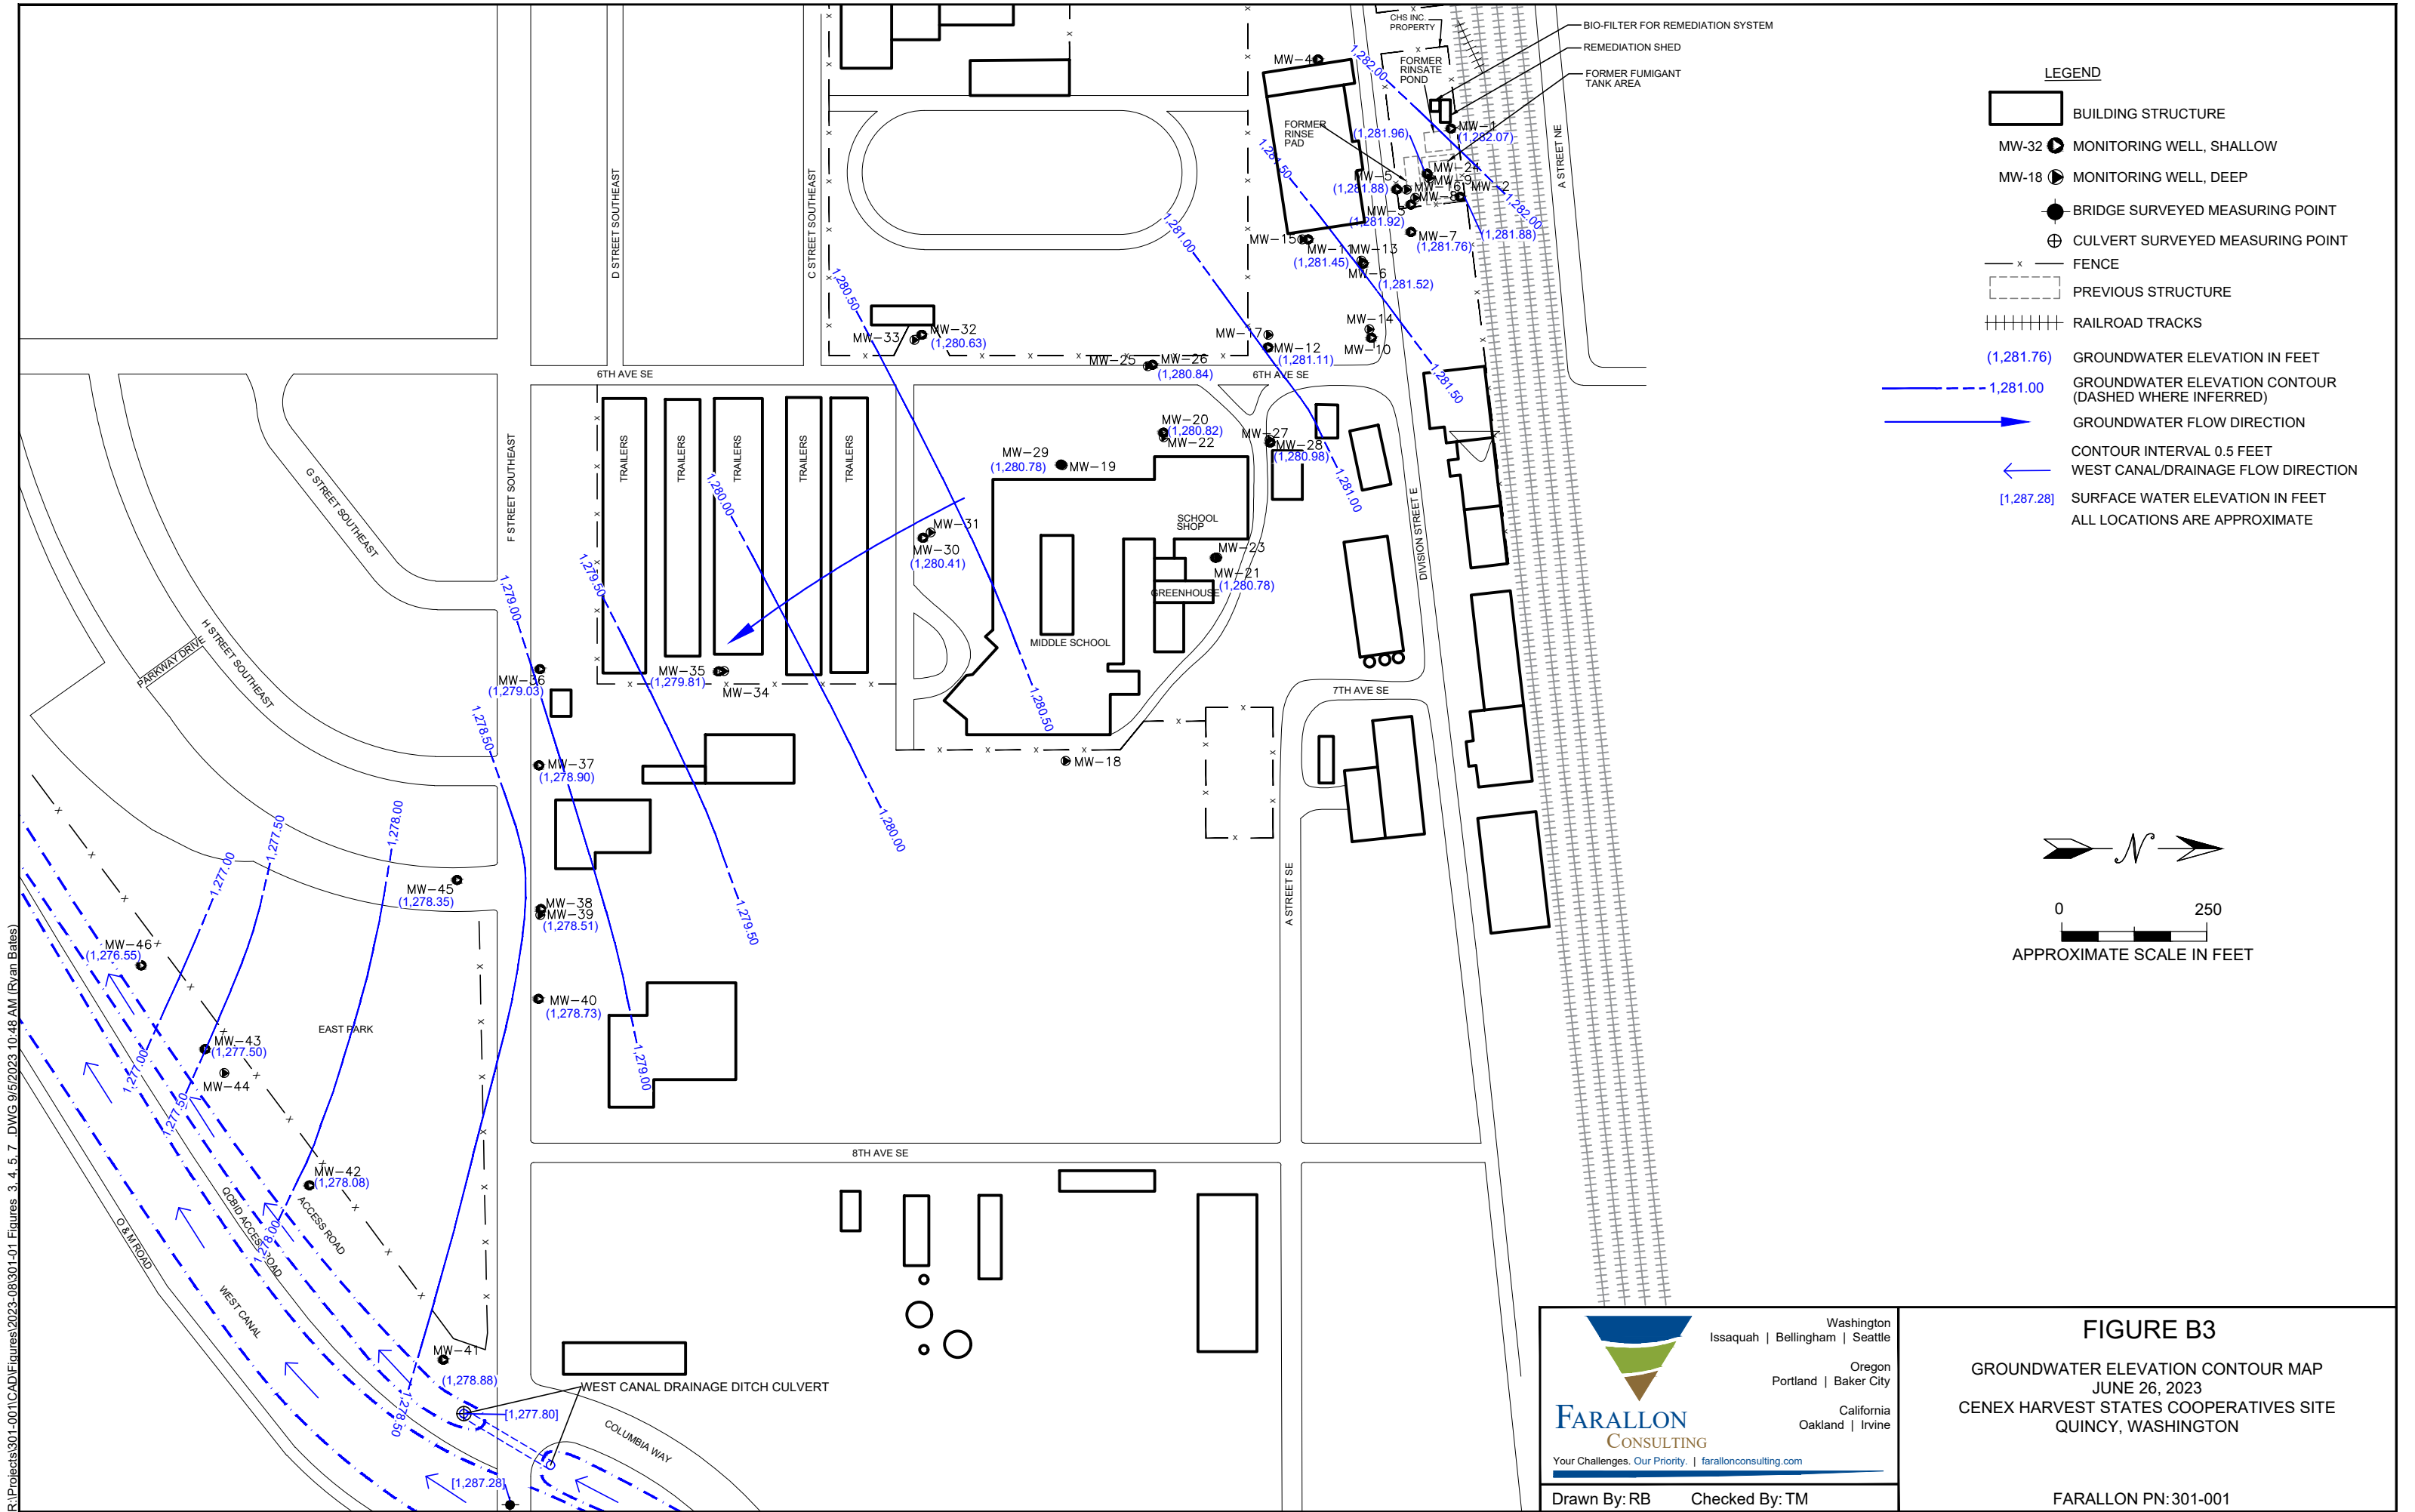
FIGURE B3
GROUNDWATER ELEVATION CONTOUR MAP
JUNE 26, 2023
CENEX HARVEST STATES COOPERATIVES SITE
QUINCY, WASHINGTON

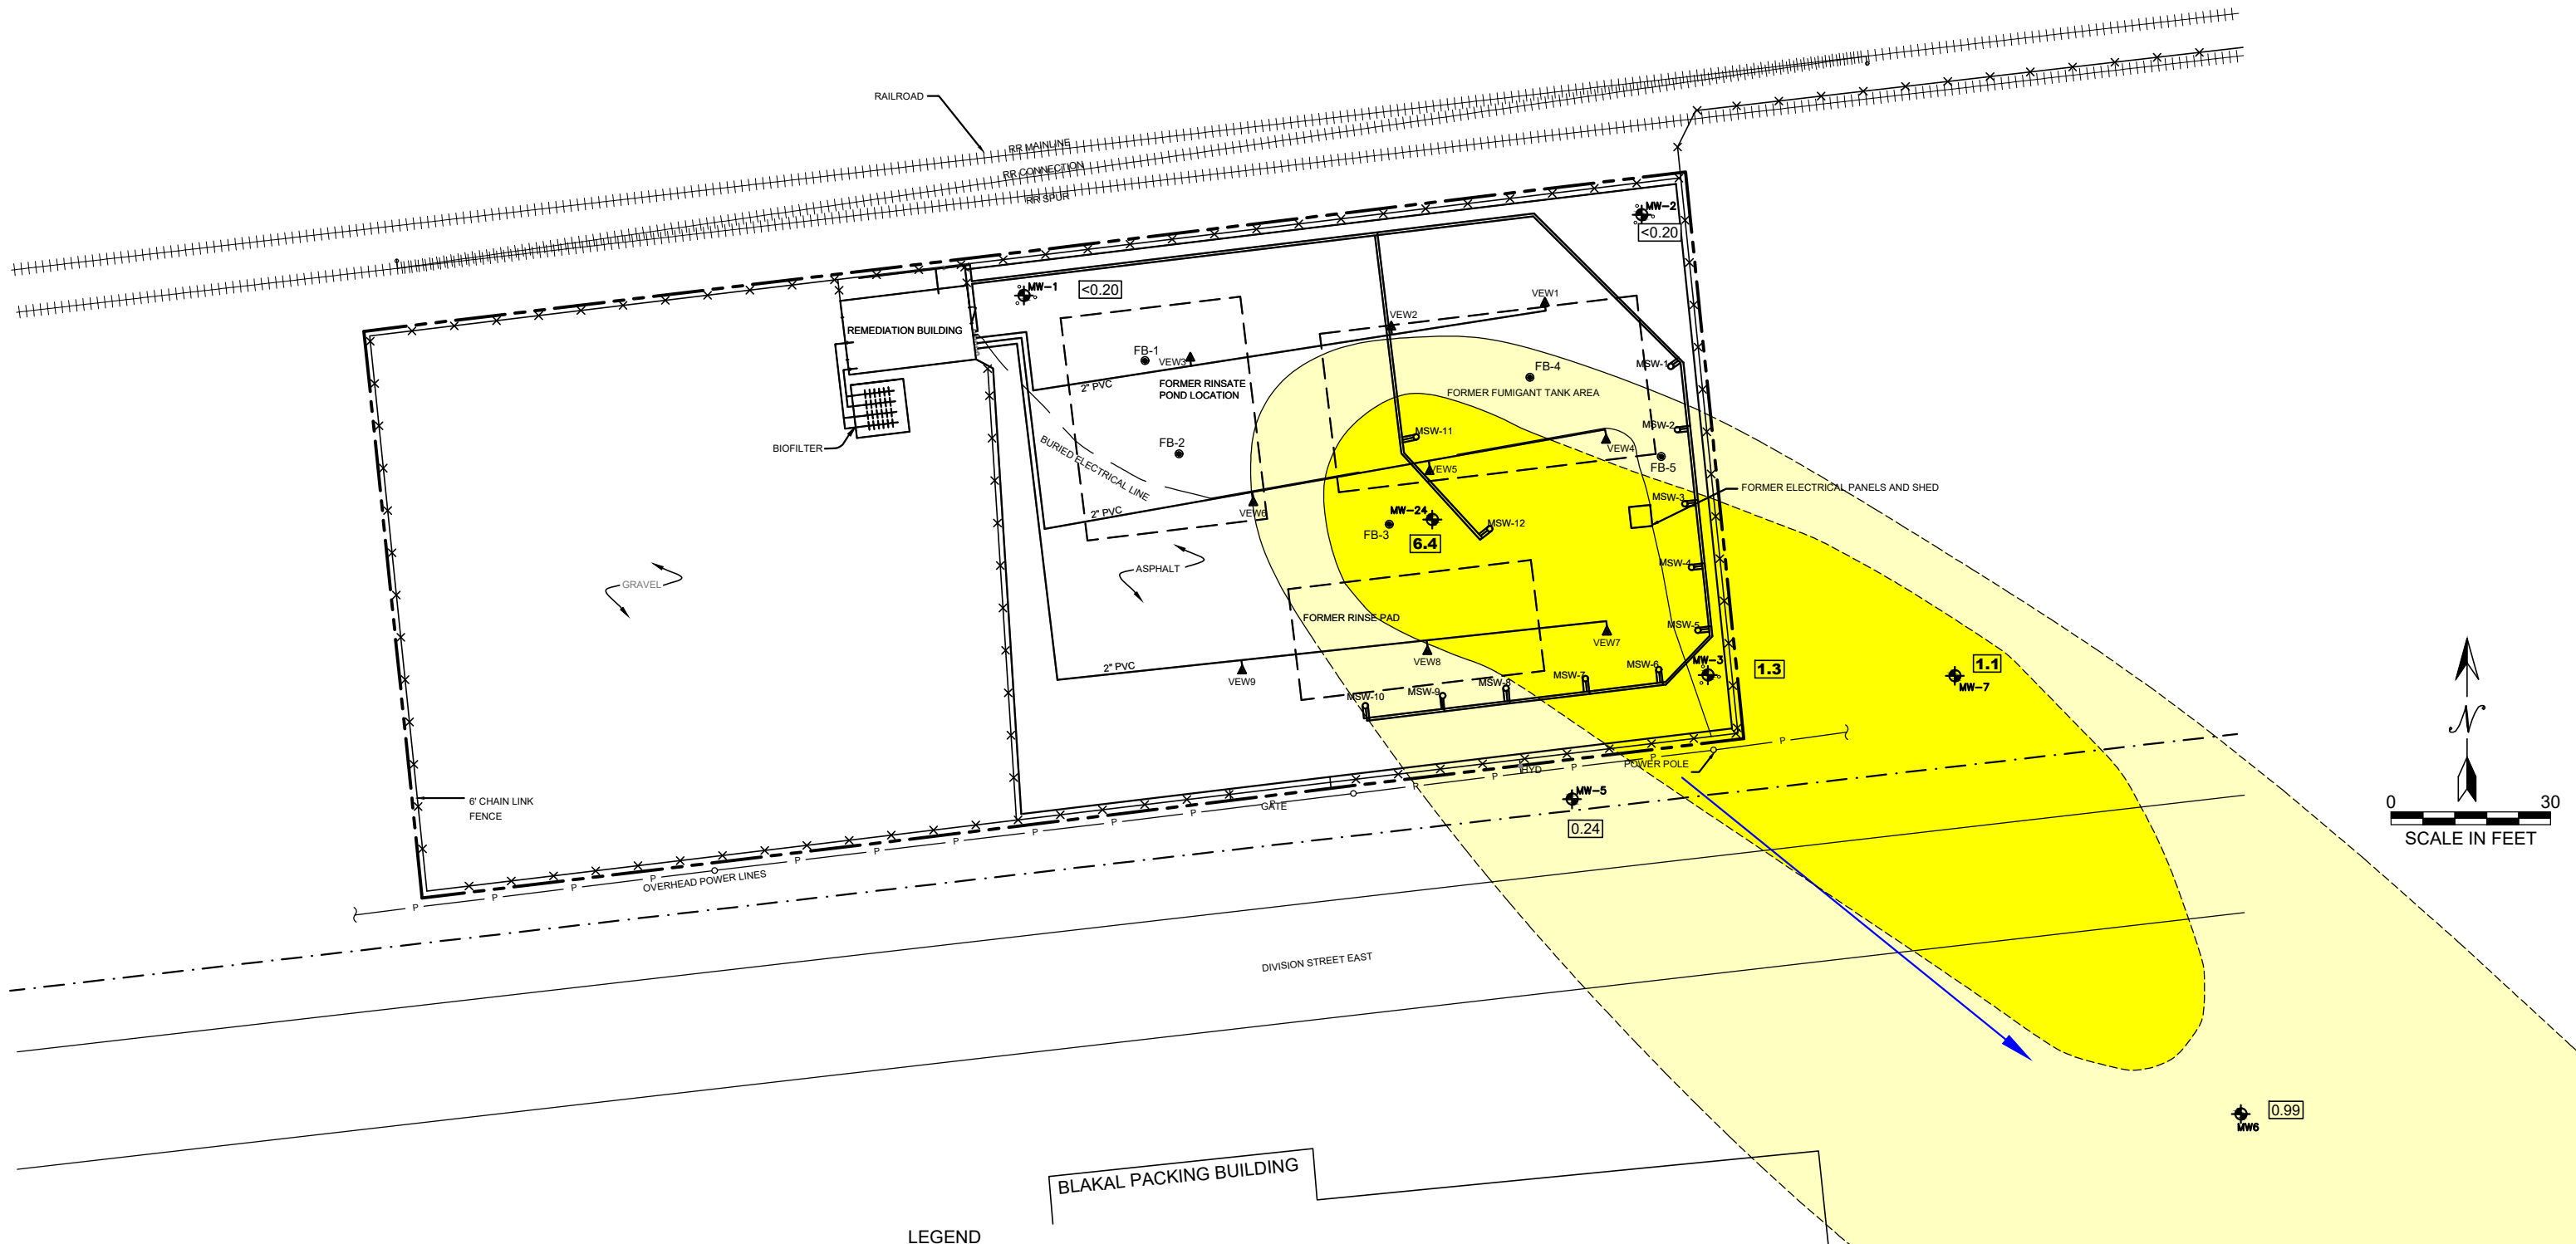
FIGURE C8
ISOCONCENTRATION CONTOURS AND GROUNDWATER
ANALYTICAL RESULTS FOR 1,2-DCP IN SHALLOW
MONITORING WELLS IN SOURCE AREA - JUNE 2023
GENEX HARVEST STATES COOPERATIVES SITE
QUINCY, WASHINGTON
FARALLON PN:301-001

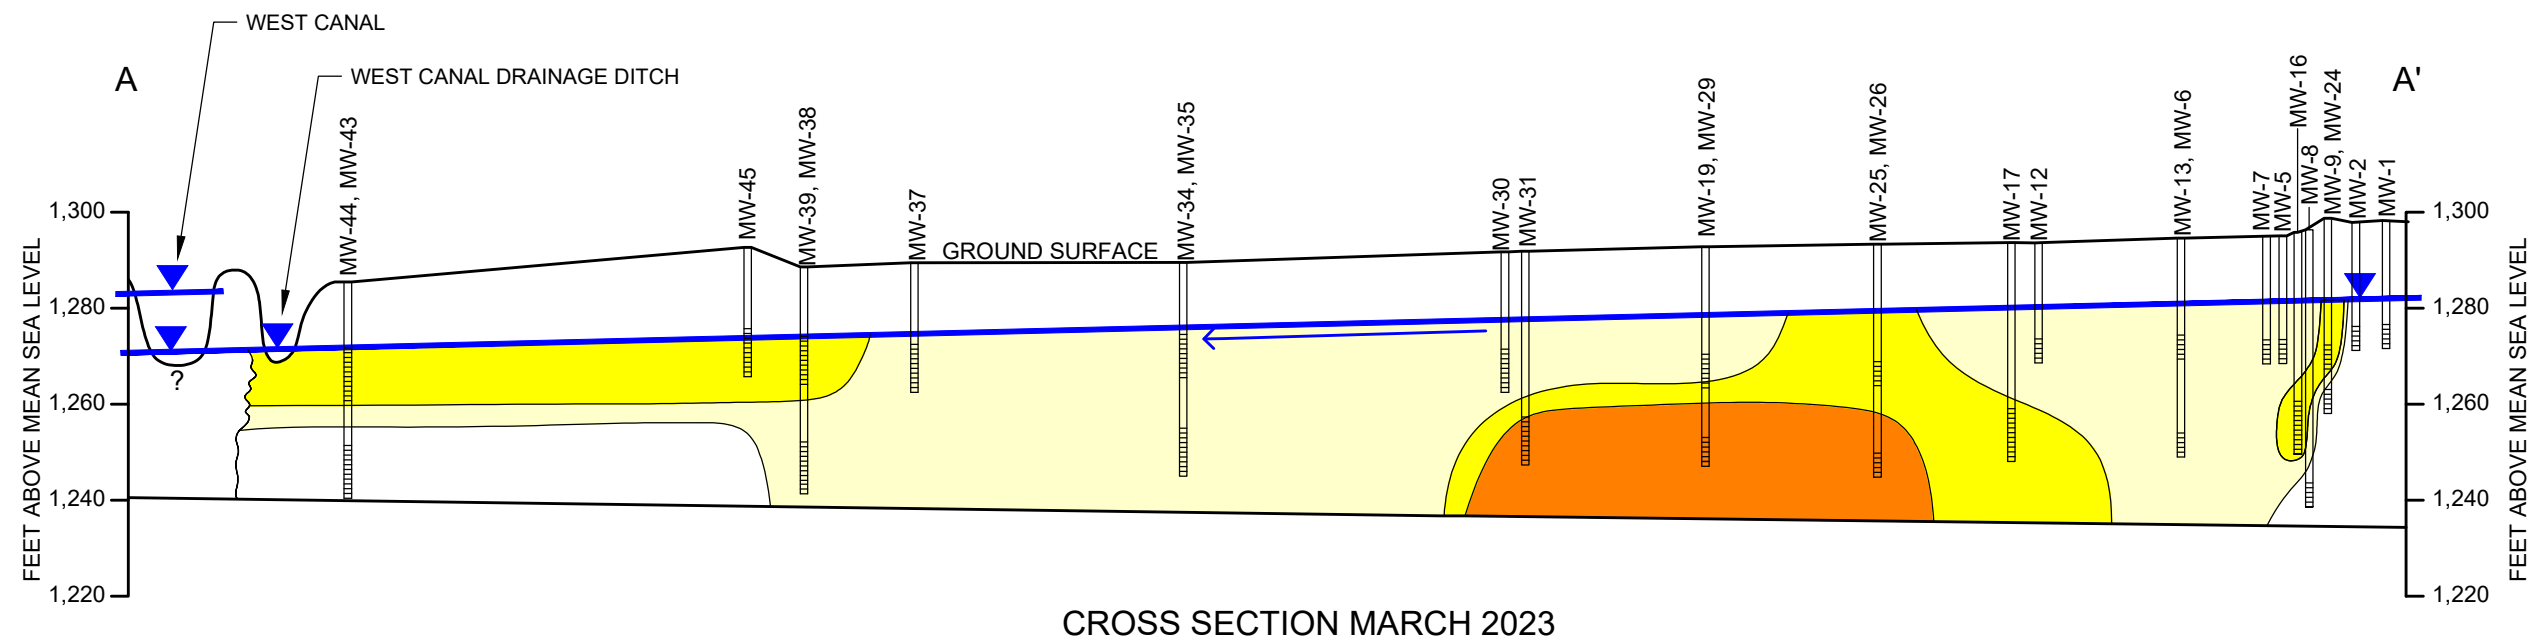
FIGURE D2
CROSS SECTION OF 1,2-DCP
GROUNDWATER PLUME
MARCH 2023
CENEX HARVEST STATES COOPERATIVES SITE
QUINCY, WASHINGTON
FARALLON PN:301-001
