Revised Annual Report 2023 Remedial Action Performance and Groundwater Compliance Monitoring

Cenex Harvest States Cooperatives Site
300 Division Street East
Quincy, Washington

Farallon PN: 301-001

December 14, 2023

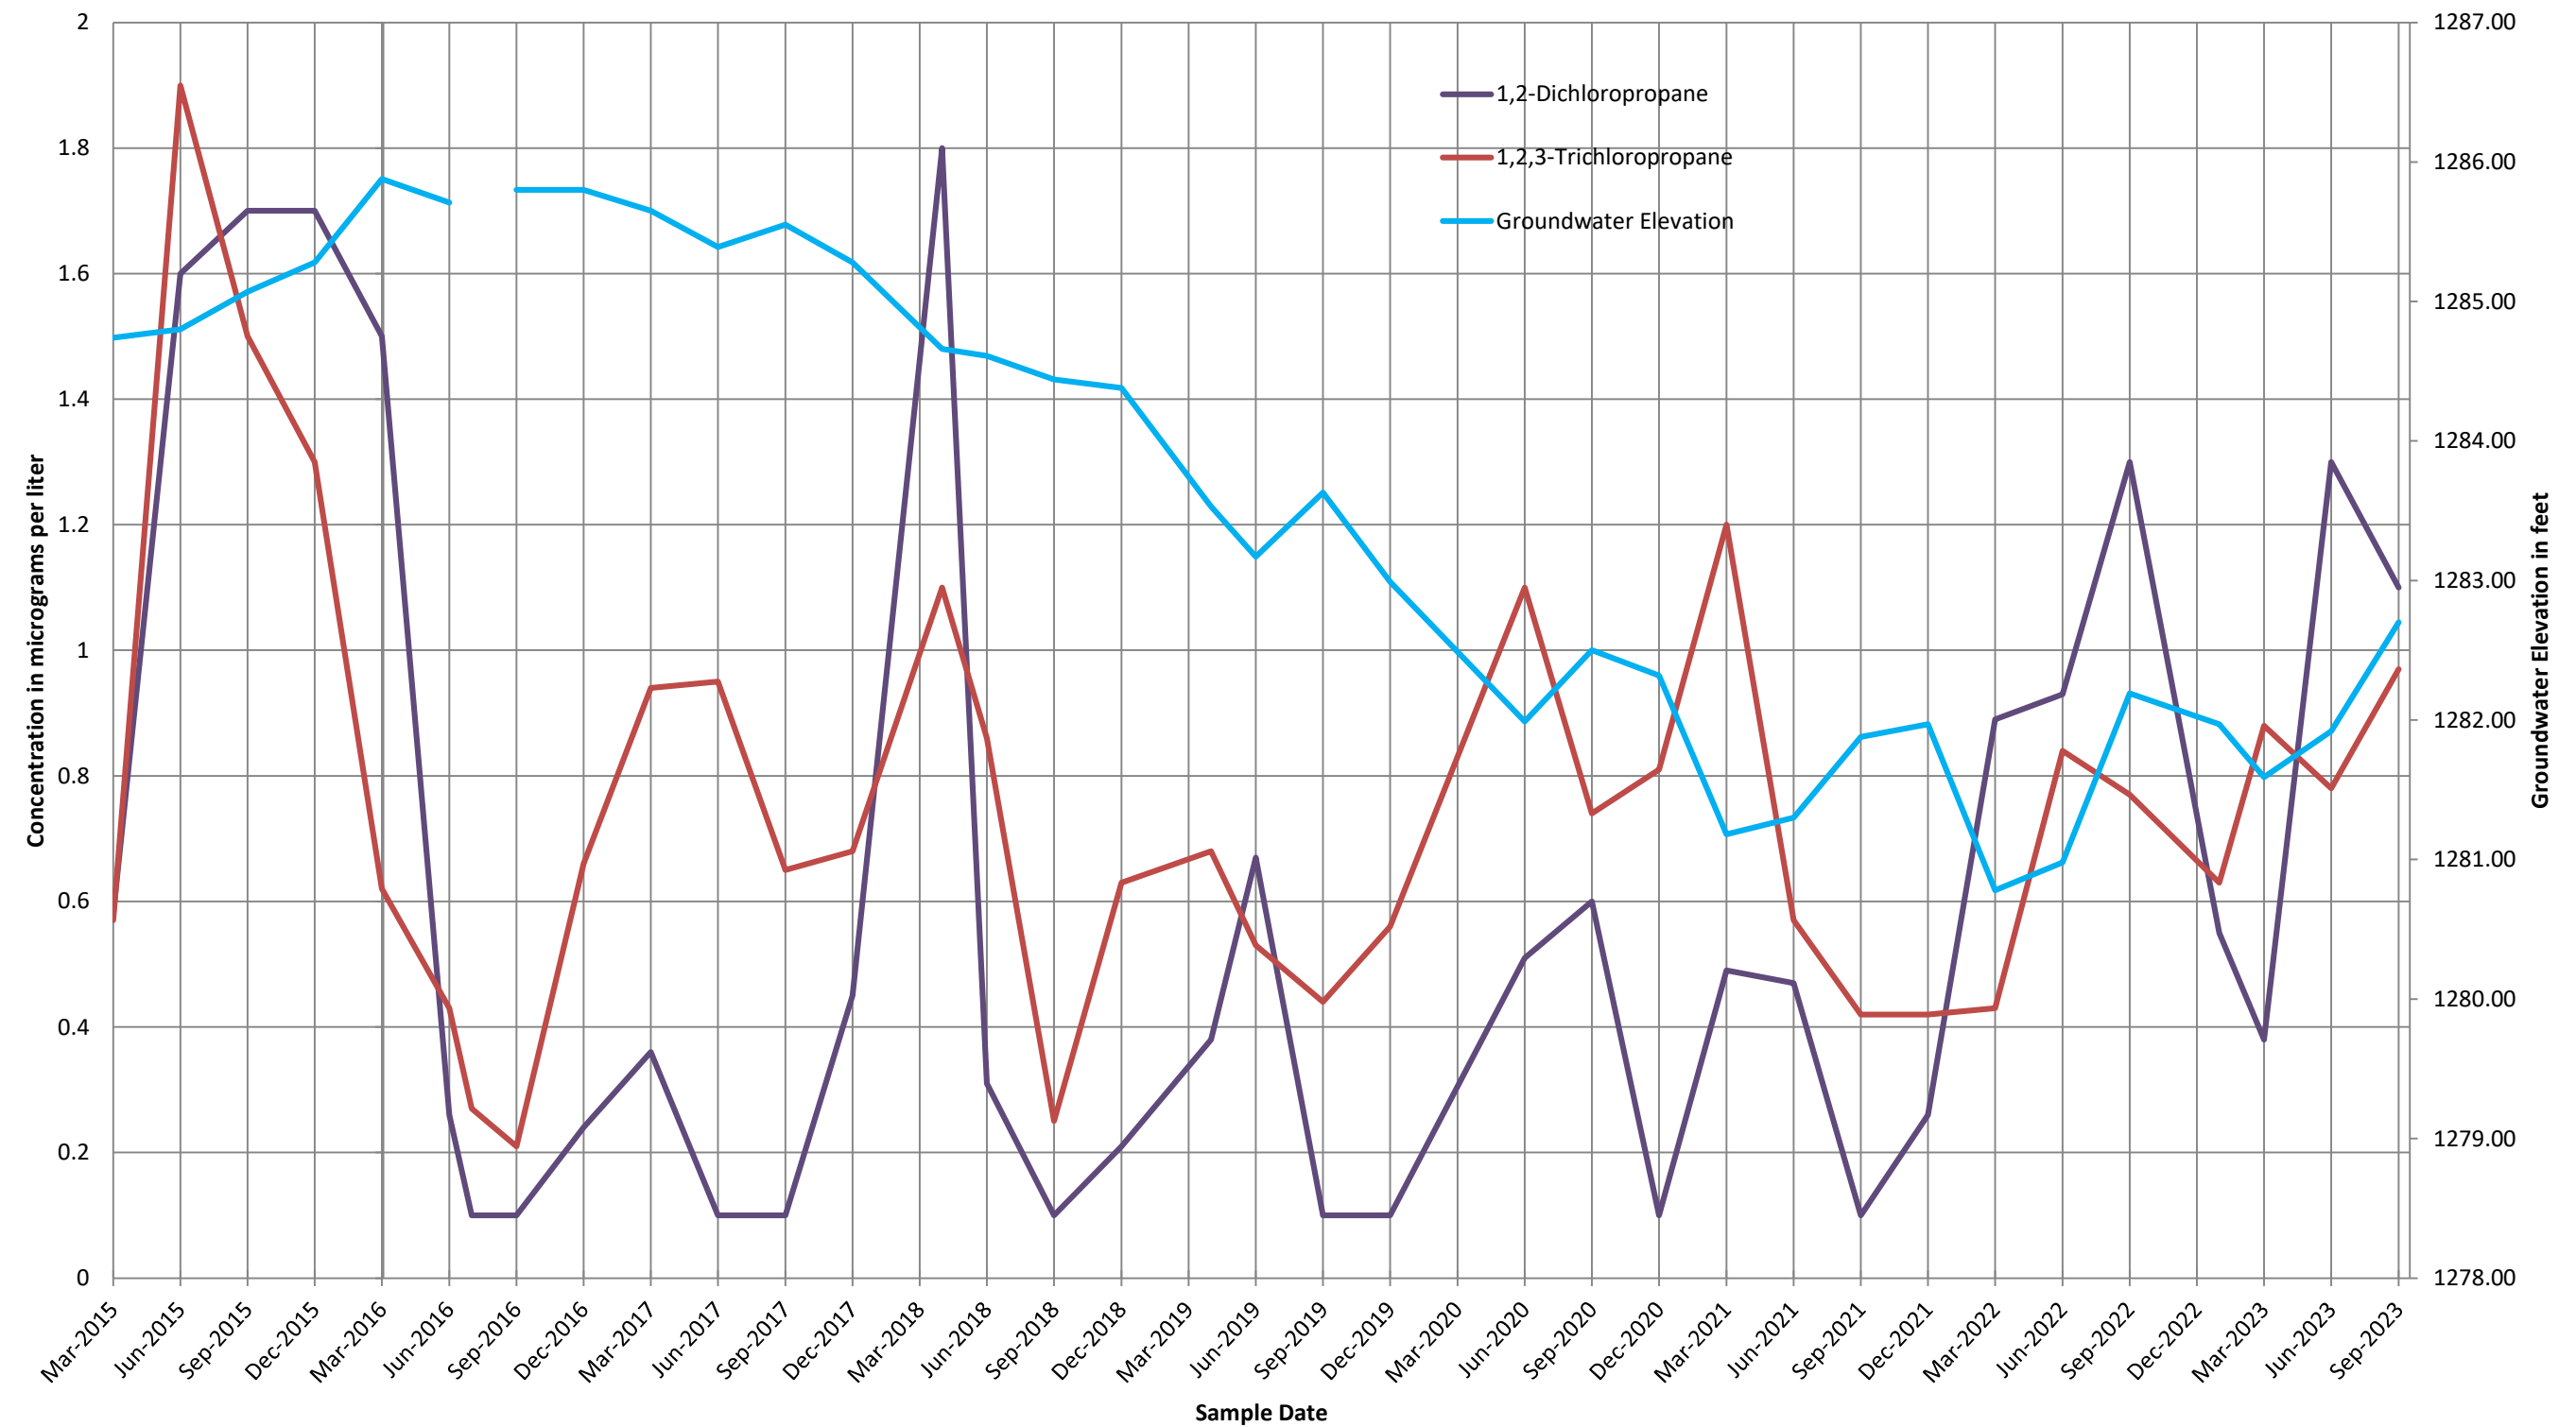
Chart E1
Monitoring Well MW-3 (shallow) Groundwater Analytical Results 2015 to 2023
Cenex Harvest States Cooperatives Site
Quincy, Washington
Farallon PN: 301-001

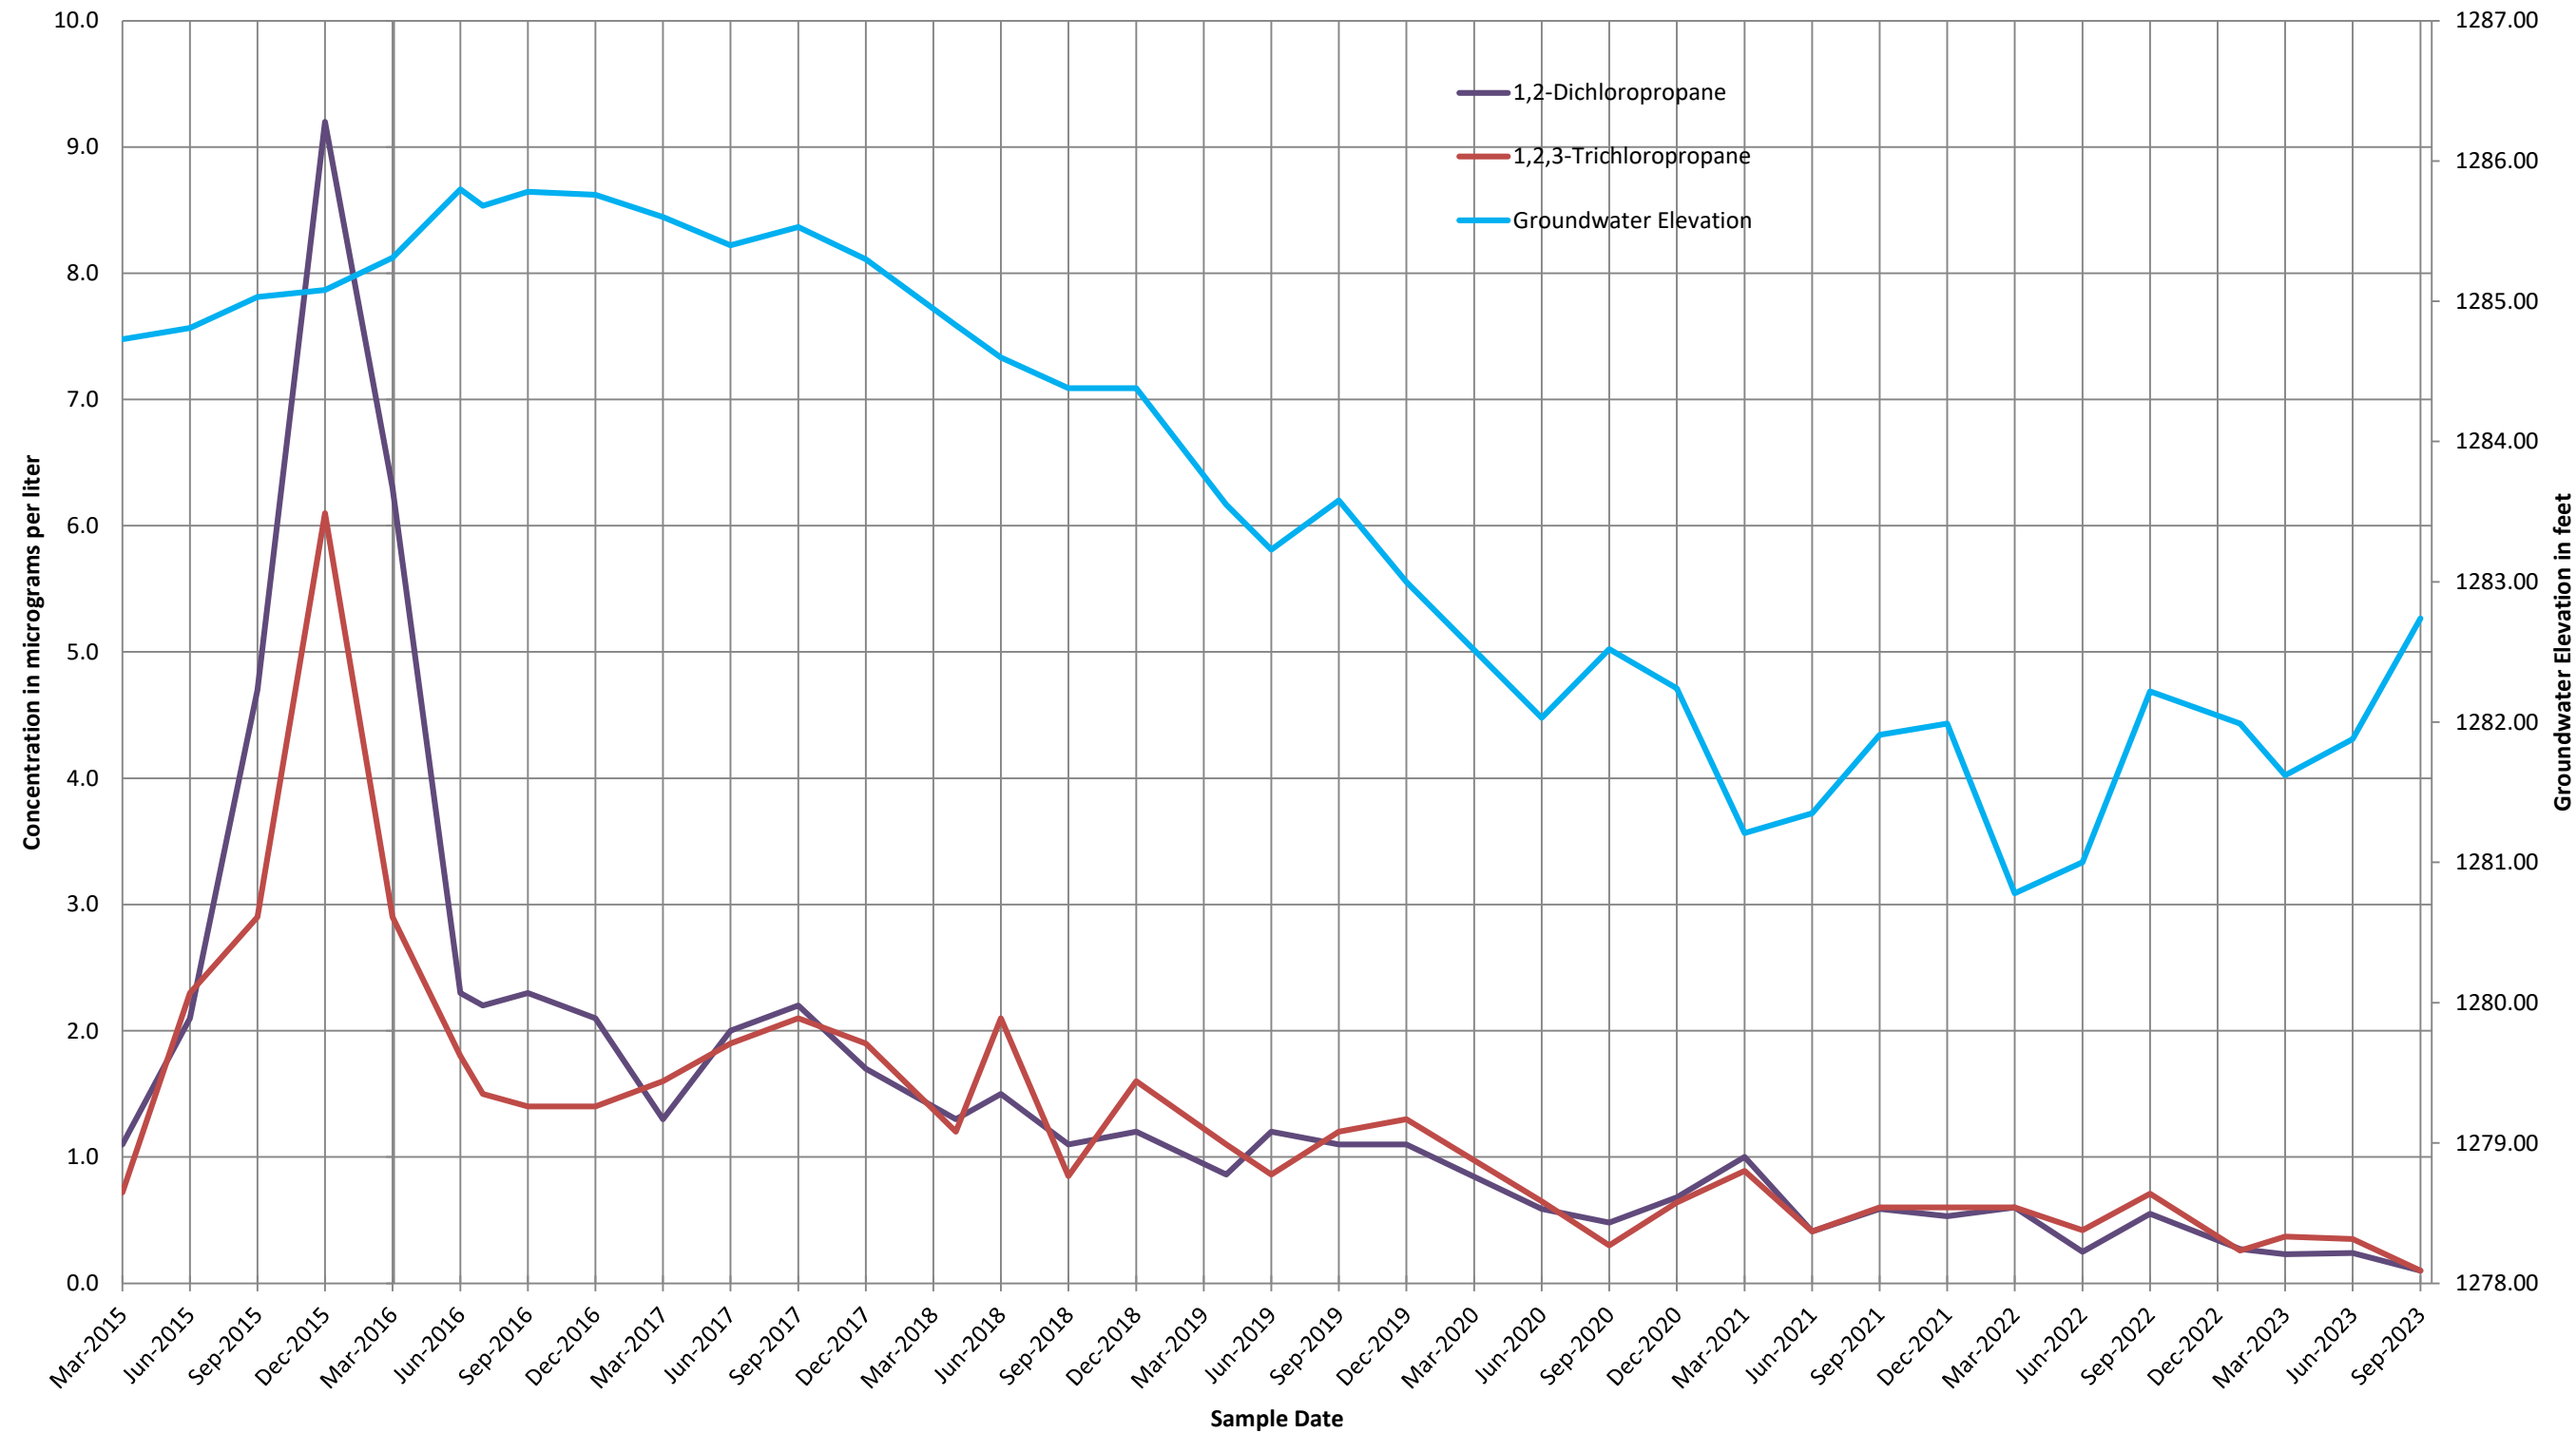
Chart E2
Monitoring Well MW-5 (shallow) Groundwater Analytical Results 2015 to 2023
Cenex Harvest States Cooperatives Site
Quincy, Washington
Farallon PN: 301-001

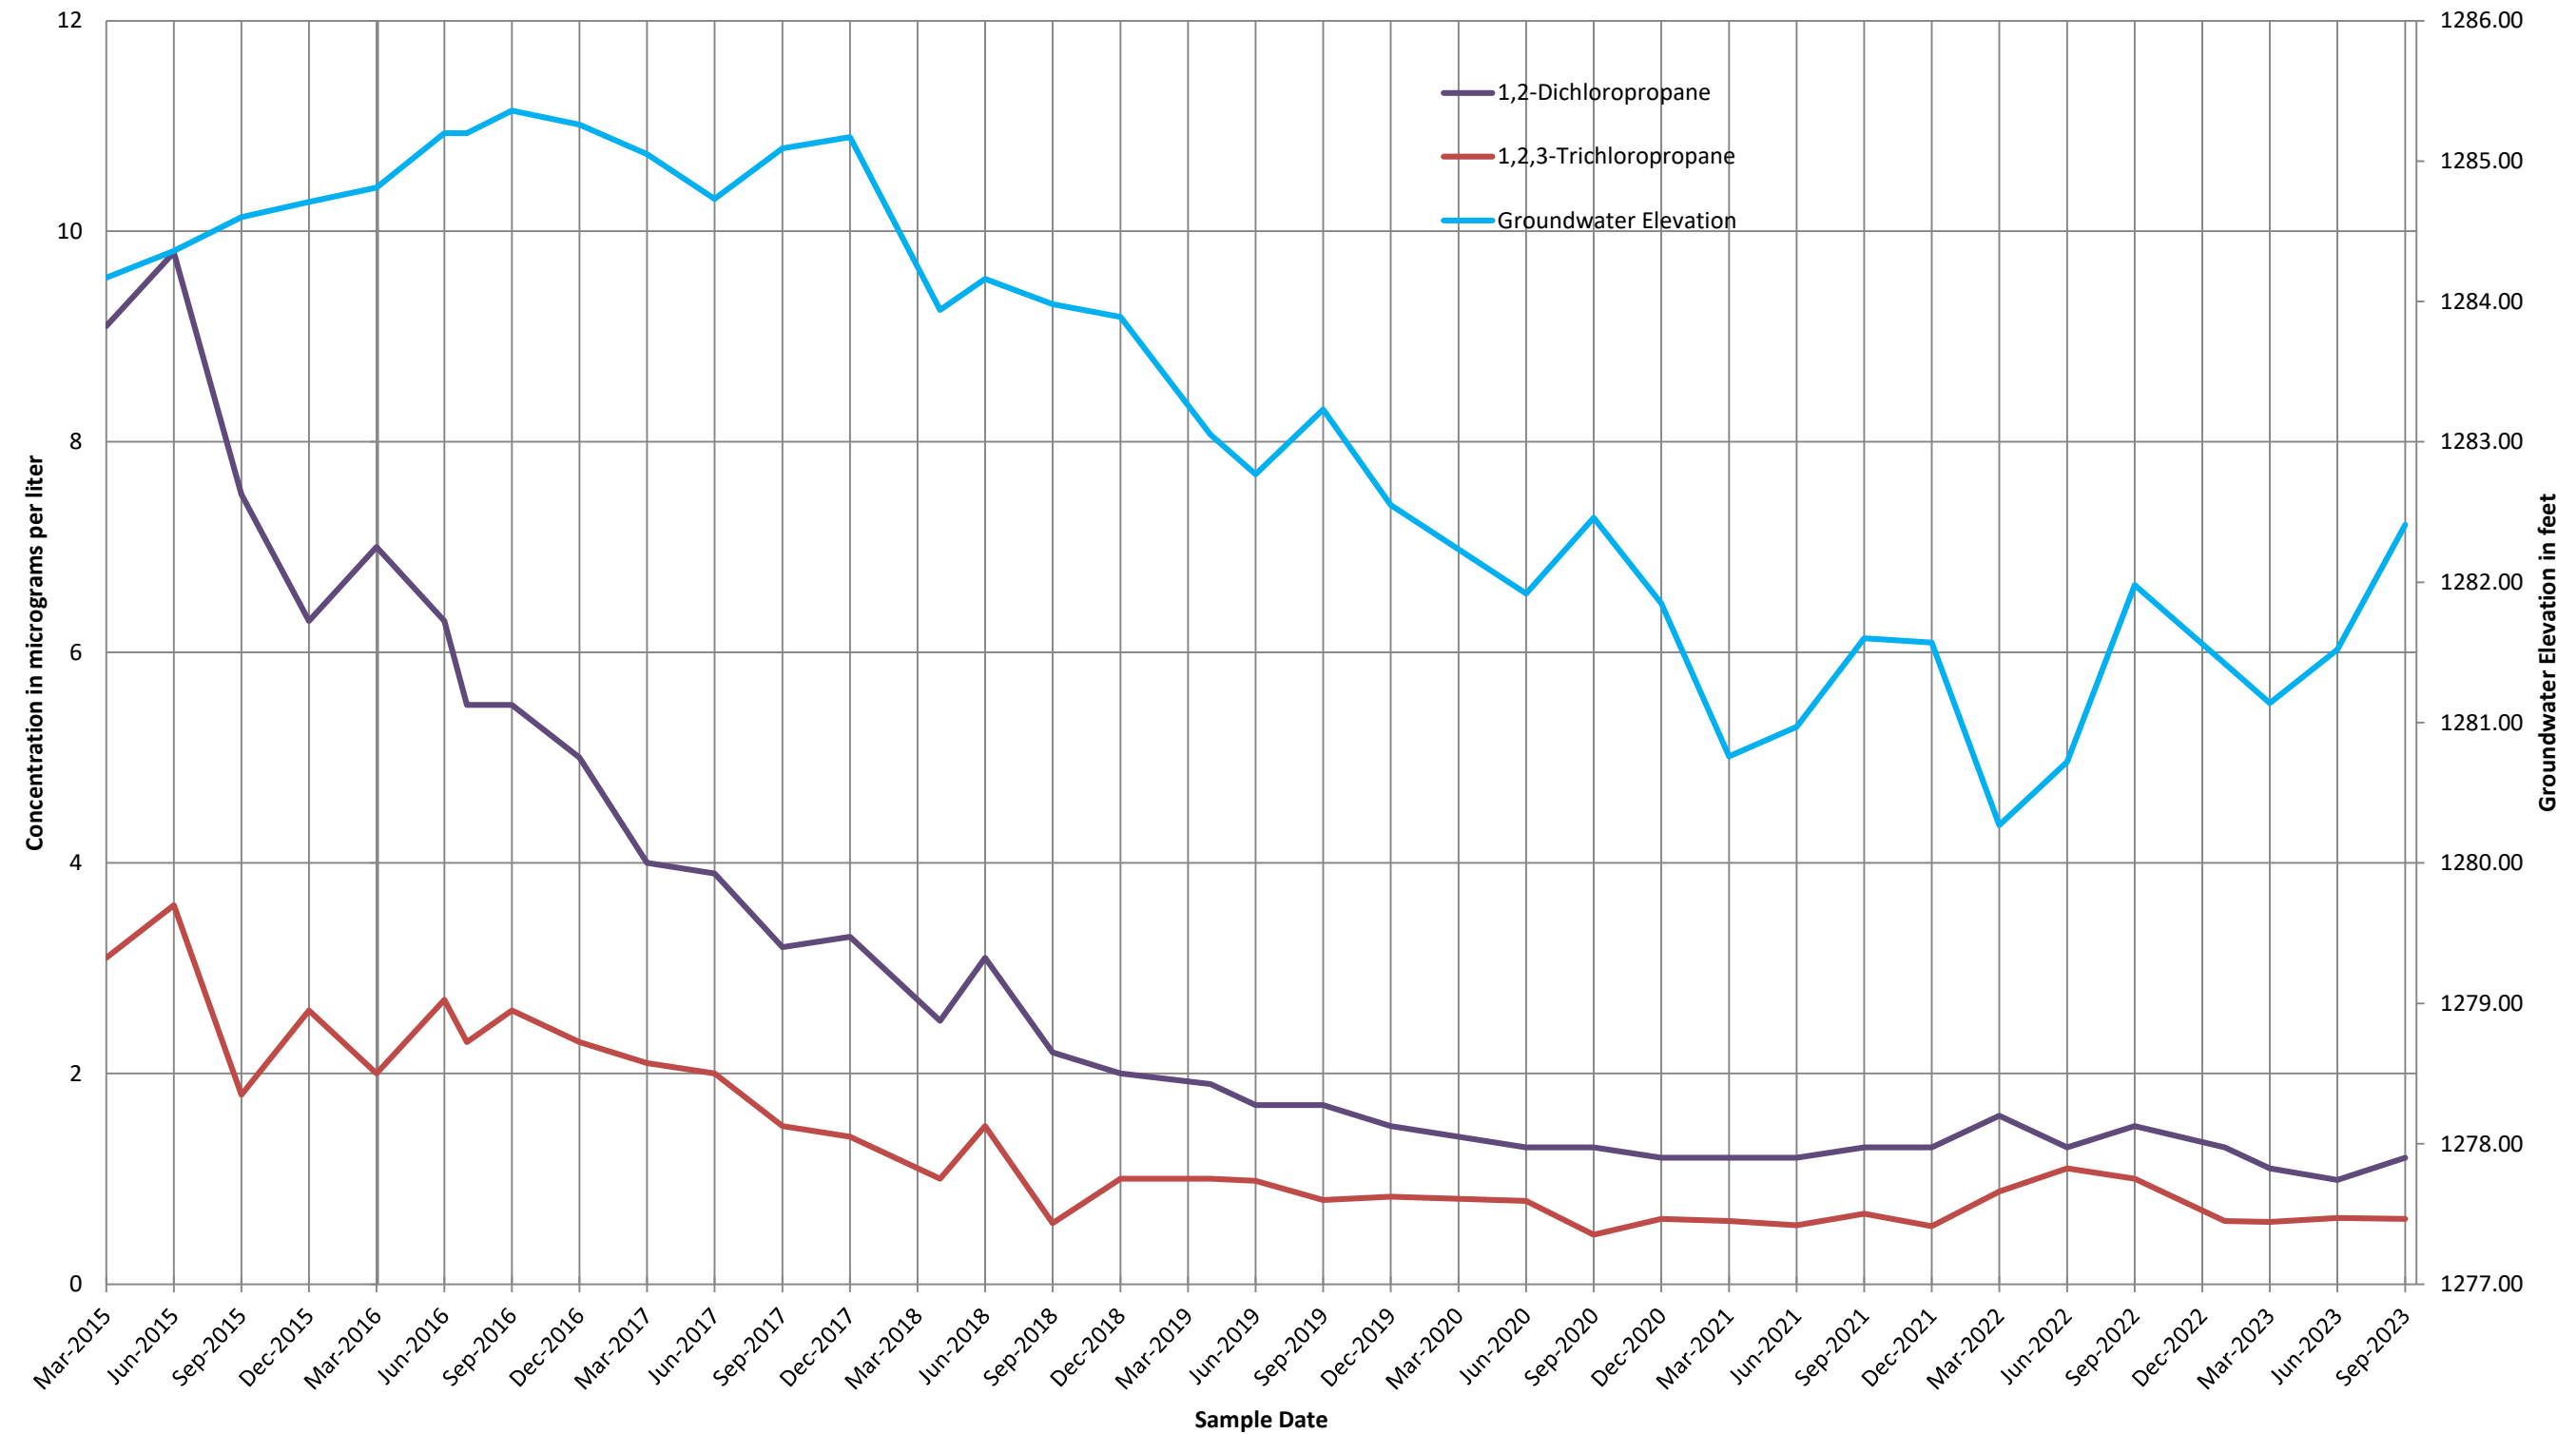
Chart E3
Monitoring Well MW-6 (shallow) Groundwater Analytical Results 2015 to 2023
Cenex Harvest States Cooperatives Site
Quincy, Washington
Farallon PN: 301-001

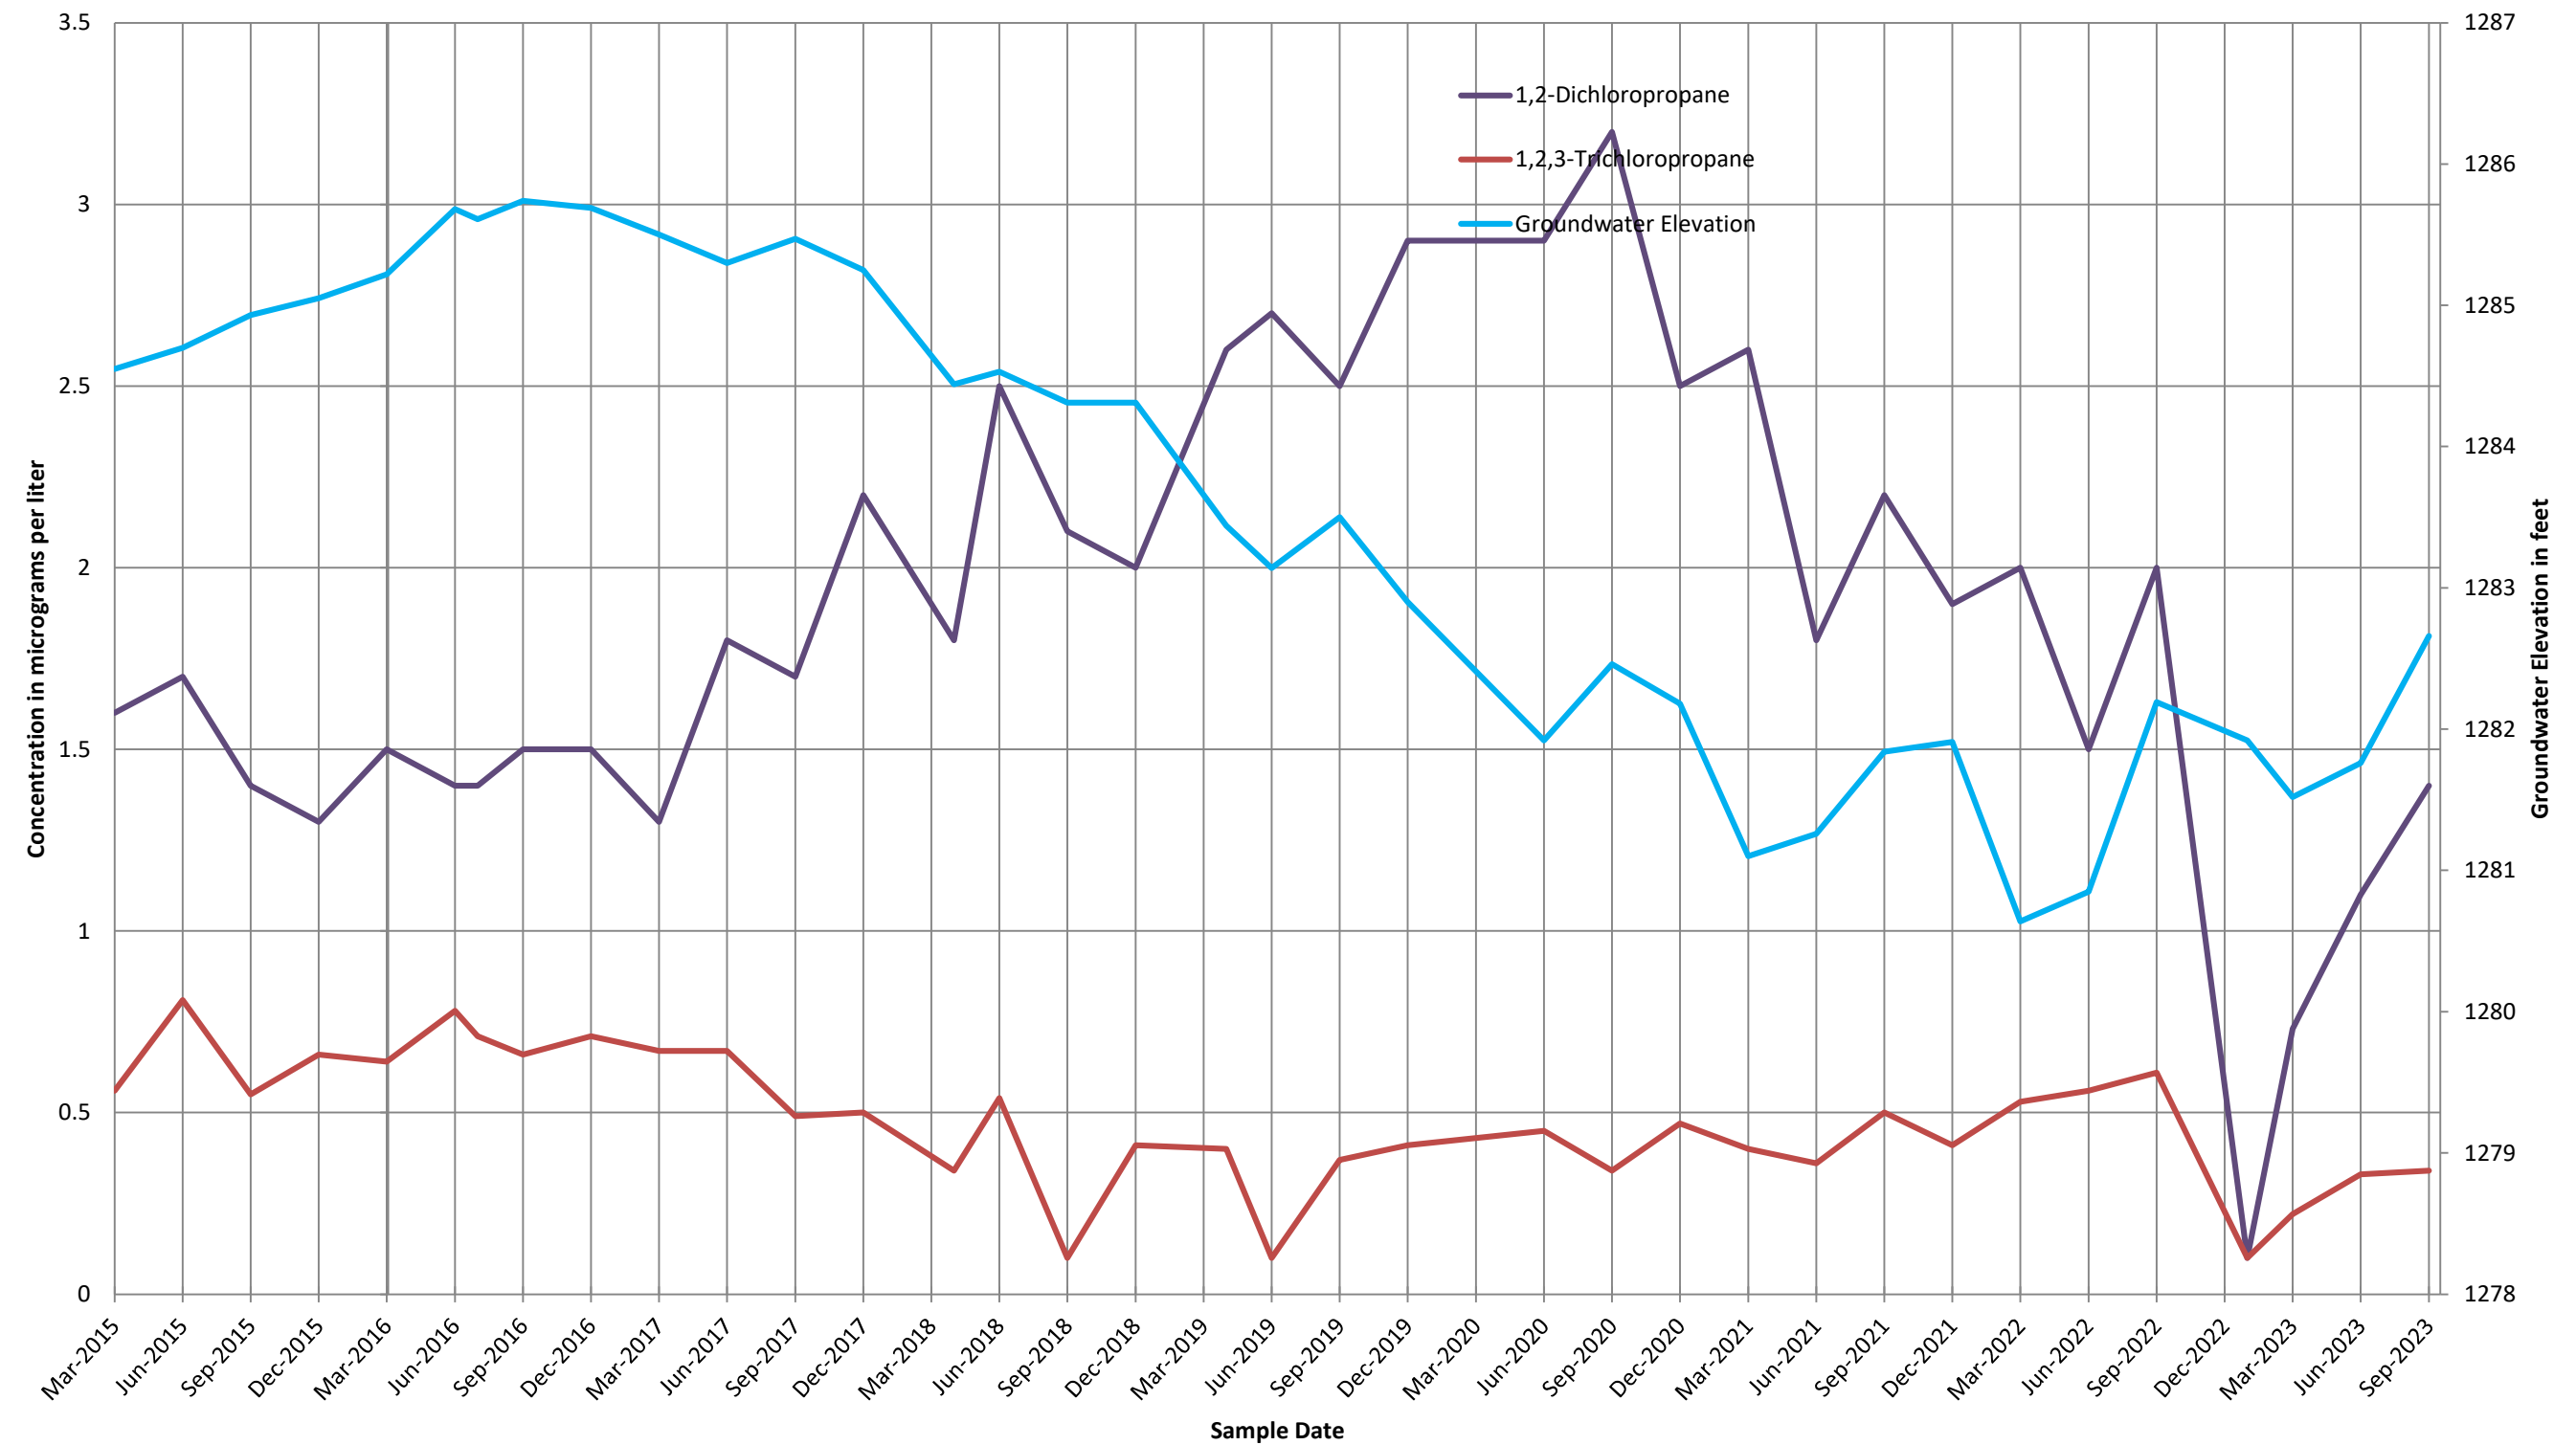
Chart E4
Monitoring Well MW-7 (shallow) Groundwater Analytical Results 2015 to 2023
Cenex Harvest States Cooperatives Site
Quincy, Washington
Farallon PN: 301-001

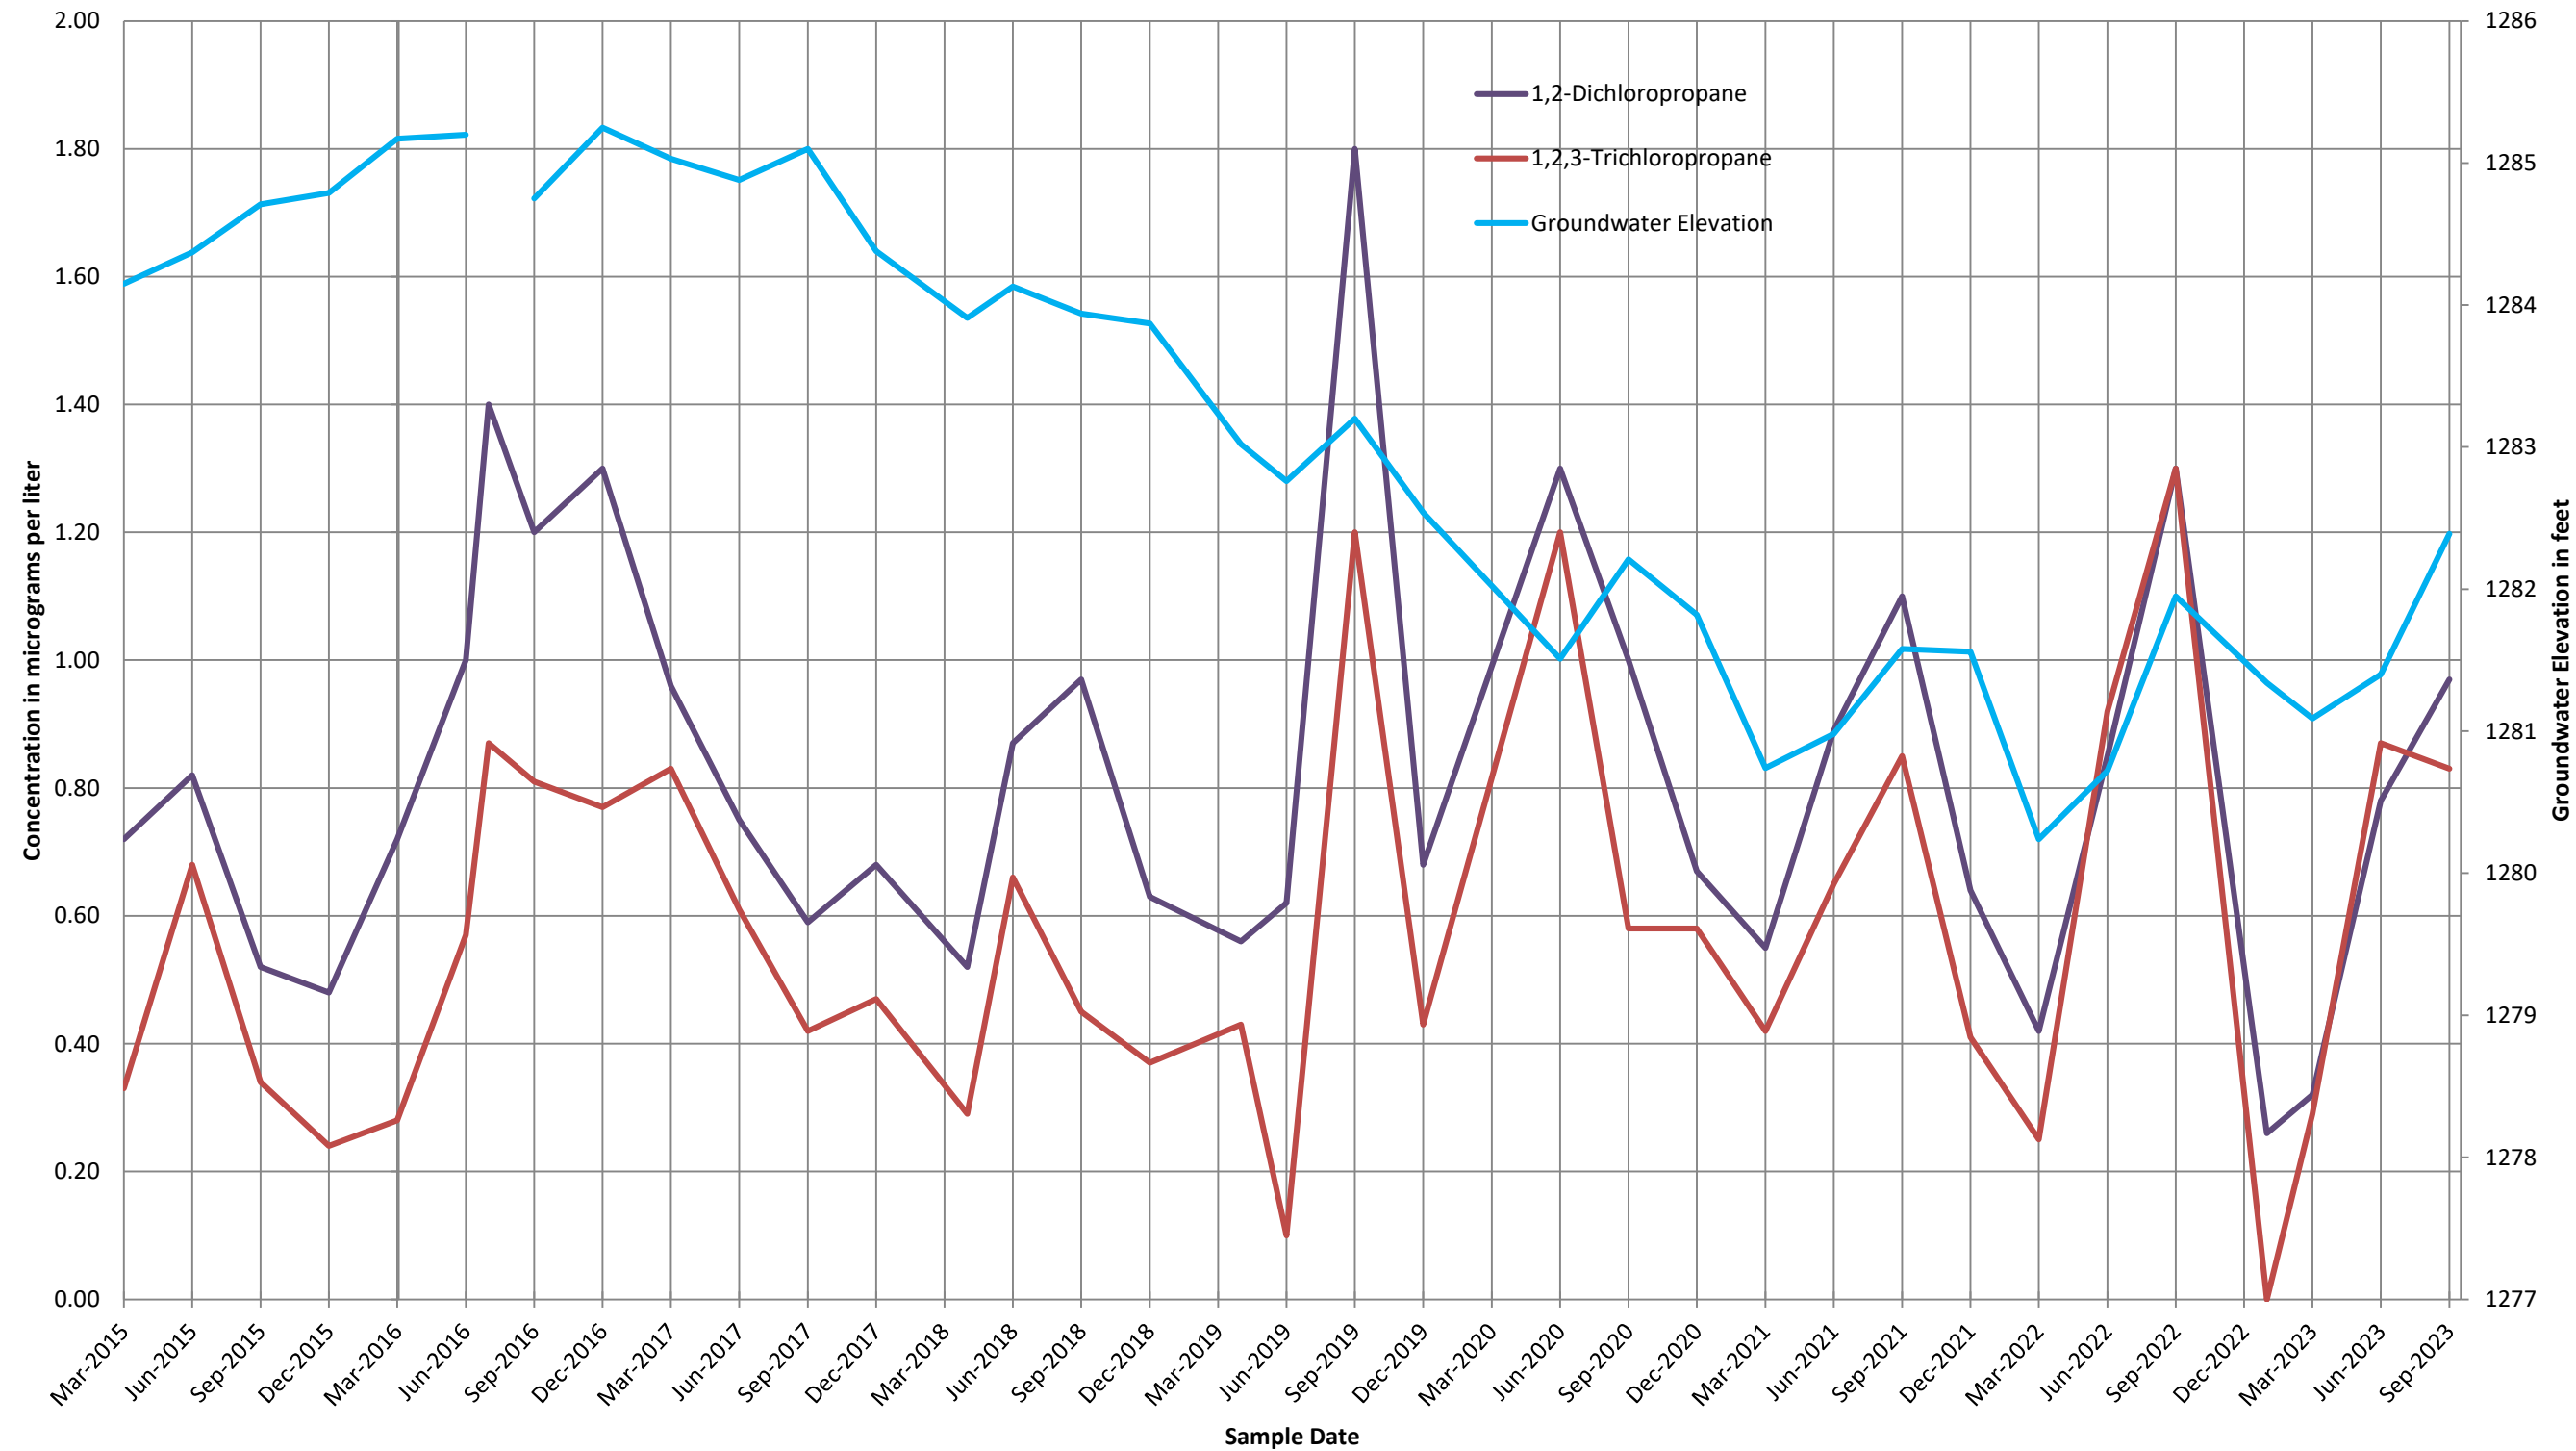
Chart E5
Monitoring Well MW-13 (deep) Groundwater Analytical Results 2015 to 2023
Cenex Harvest States Cooperatives Site
Quincy, Washington
Farallon PN: 301-001

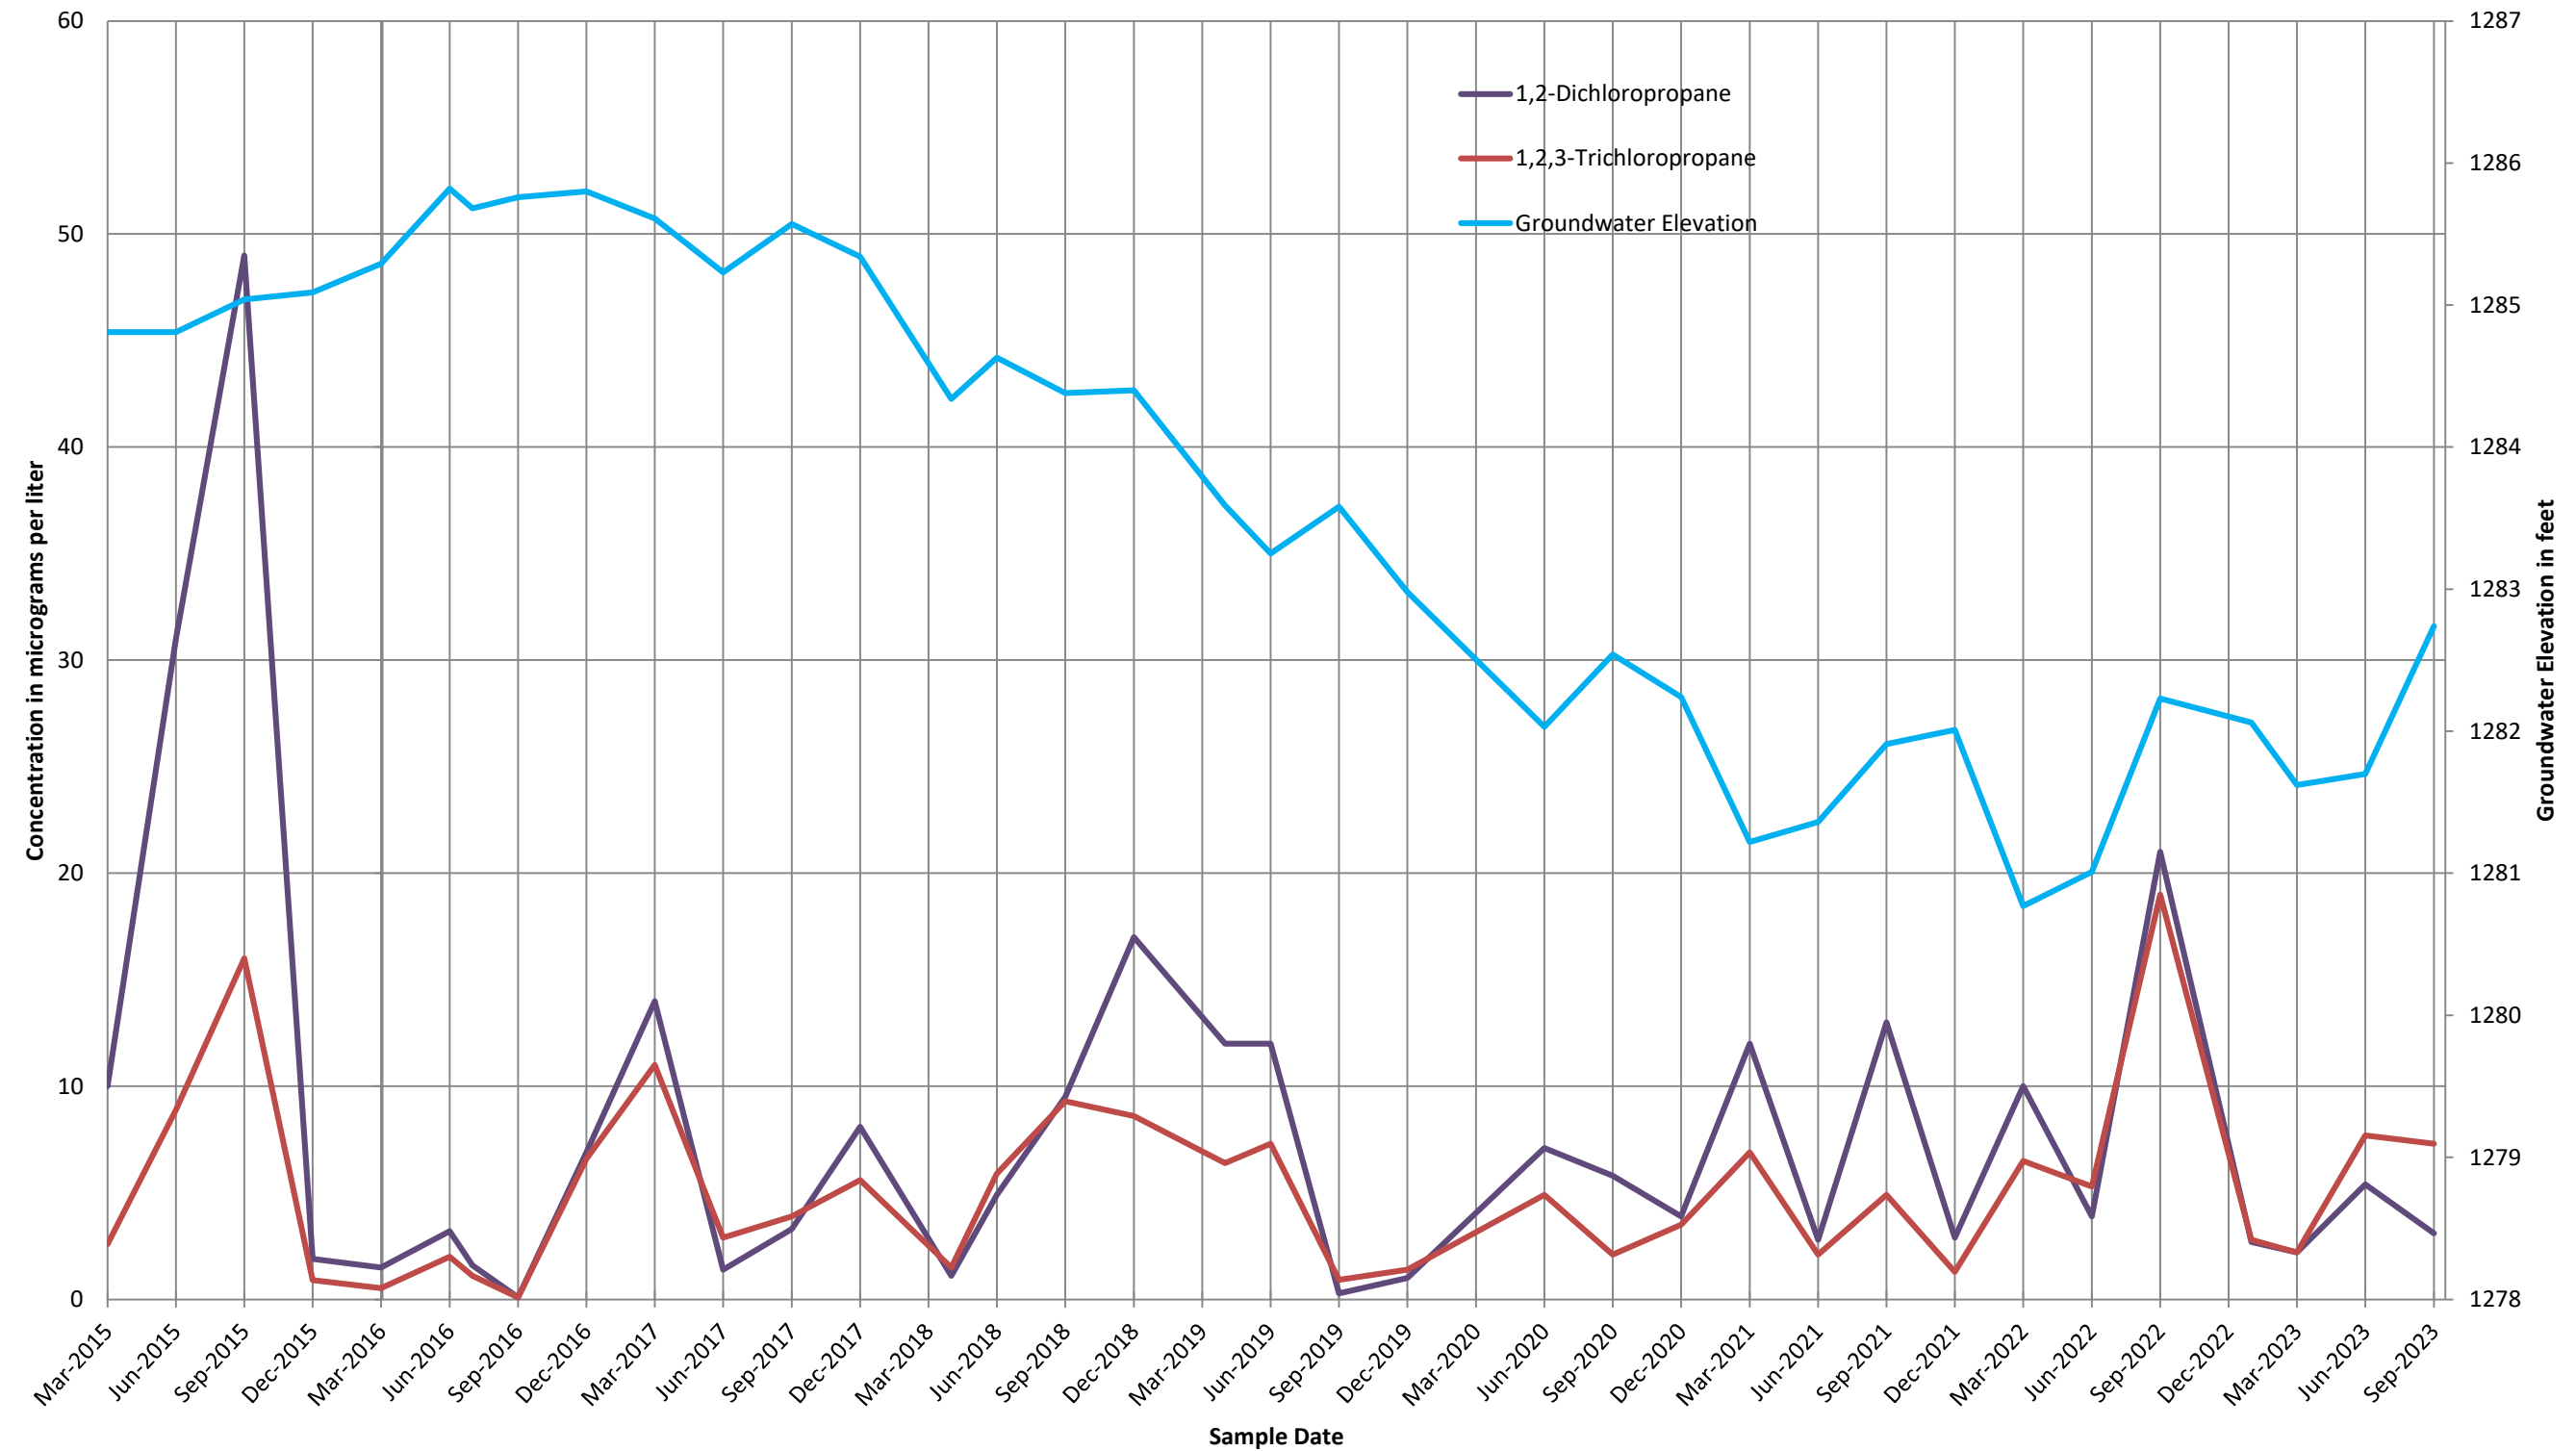
Chart E6
Monitoring Well MW-16 (deep) Groundwater Analytical Results 2015 to 2023
Cenex Harvest States Cooperatives Site
Quincy, Washington
Farallon PN: 301-001
