Revised Annual Report 2023 Remedial Action Performance and Groundwater Compliance Monitoring

Cenex Harvest States Cooperatives Site
300 Division Street East
Quincy, Washington

Farallon PN: 301-001

December 14, 2023

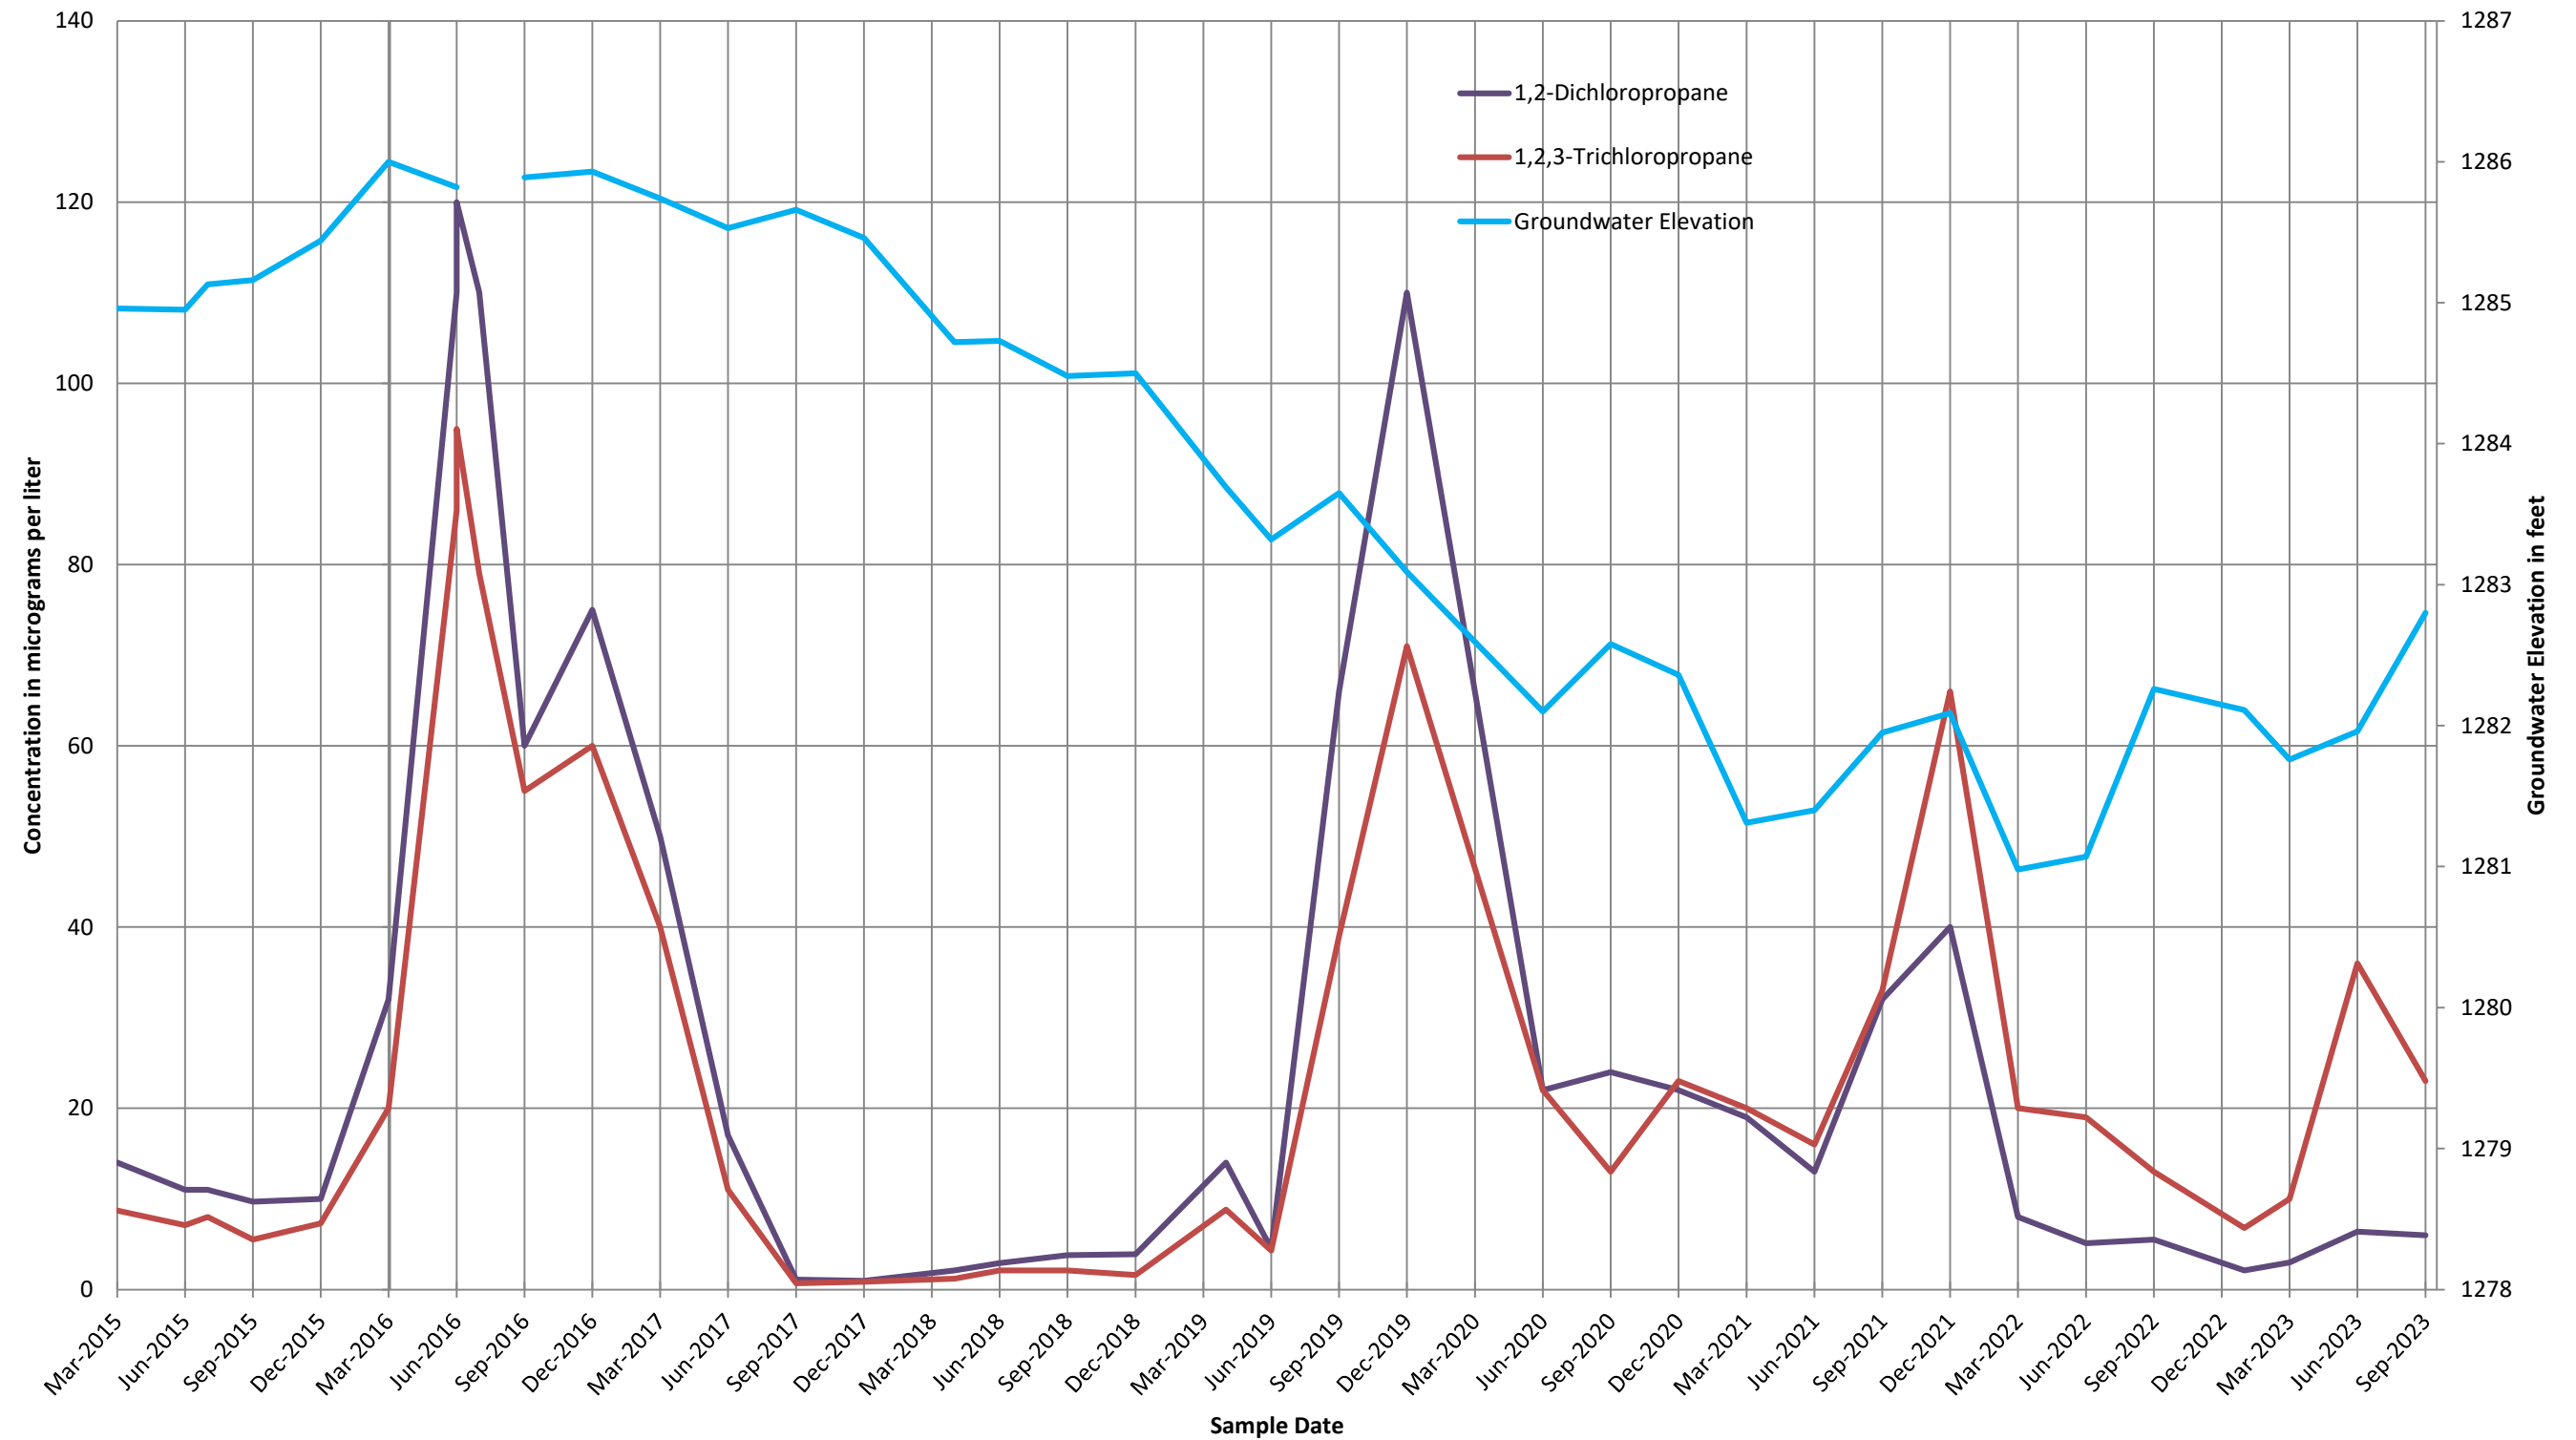
Chart E7
Monitoring Well MW-24 (shallow) Groundwater Analytical Results 2015 to 2023
Cenex Harvest States Cooperatives Site
Quincy, Washington
Farallon PN: 301-001
