2023 Operations, Maintenance, and Monitoring Annual Report South Park Landfill

**Seattle
Public
Utilities**

March 2024

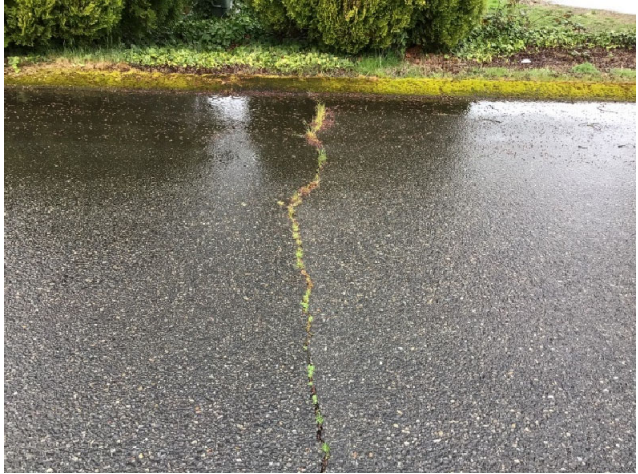
SRDS	Description	December 2022 Inspection		April 2023 Inspection				Photographs
		Conditions Observed and Recommended Action	Action Taken	Condition Status	Conditions Observed and Recommended Action	Timeline for Repair and/or Reinspection	Recommended Action Assignment	
AC-10	Minor pavement cracking with grass growing in the cracks	Follow-up inspection	No actions taken or required	No significant changes observed	Follow-up reinspection	6 months	Site Coordinator

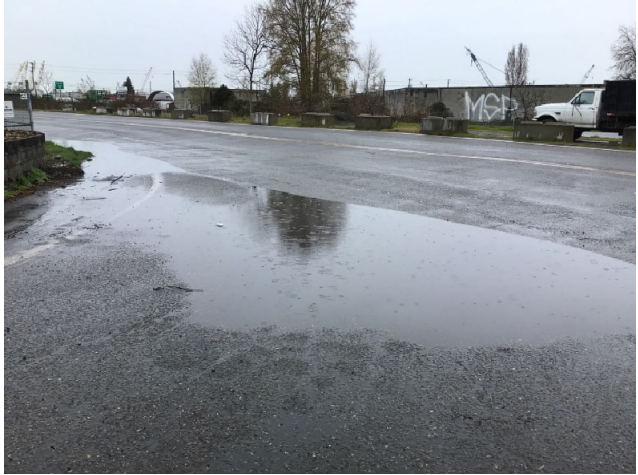
AC-11	Minor cracking with asphalt degrading and ponding	Follow-up inspection	No actions taken or required	No significant changes observed	Ponding in the area. Follow-up reinspection	6 months	Site Coordinator

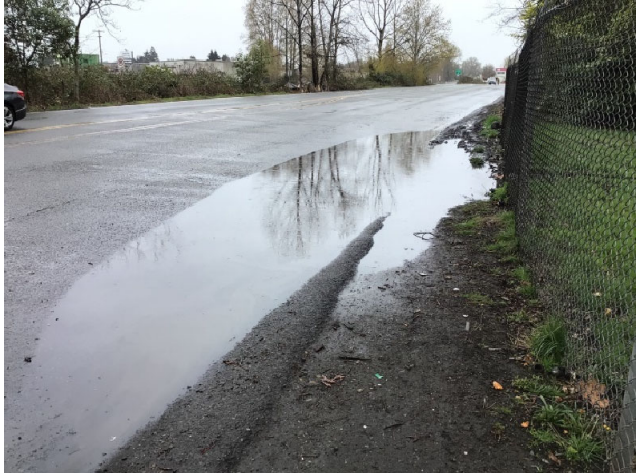
SRDS	Description	December 2022 Inspection		April 2023 Inspection				Photographs
		Conditions Observed and Recommended Action	Action Taken	Condition Status	Conditions Observed and Recommended Action	Timeline for Repair and/or Reinspection	Recommended Action Assignment	
AC-17	Ponding	Follow-up inspection	No actions taken or required	No significant changes observed	Follow-up reinspection	6 months	Site Coordinator

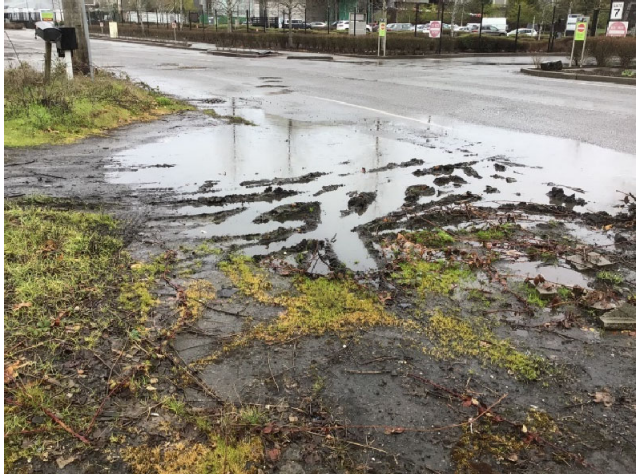
AC-18	Ponding	Follow-up inspection	No actions taken or required	No significant changes observed	Follow-up reinspection	6 months	Site Coordinator

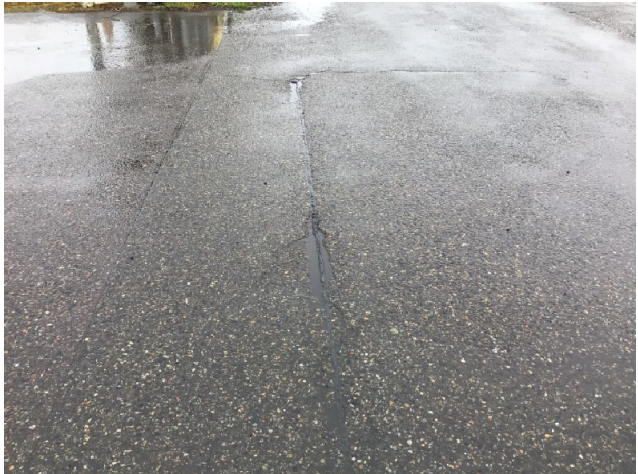
AC-19	Minor cracks in asphalt with ponding			New location	Follow up reinspection	6 months	Site Coordinator

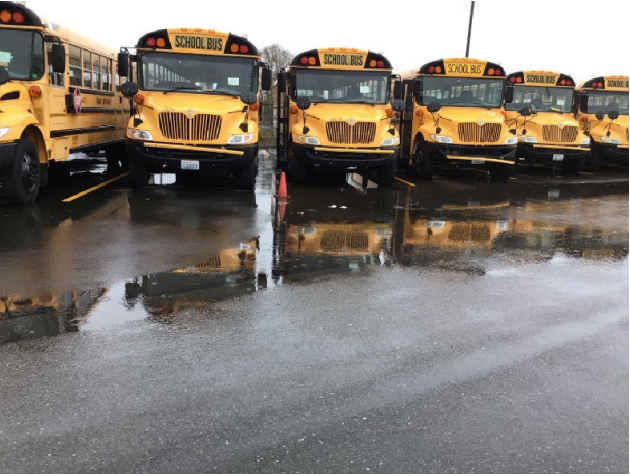
Center Point (SPPD) Location	Description	December 2022 Inspection		April 2023 Inspection				Photographs
		Conditions Observed and Recommended Action	Action Taken	Condition Status	Conditions Observed and Recommended Action	Timeline for Repair and/or Reinspection	Recommended Action Assignment	
Asphalt Concrete								
AC-1	Ponding	Follow-up inspection	No actions taken or required	No significant changes observed	Follow-up reinspection	6 months	Site Coordinator

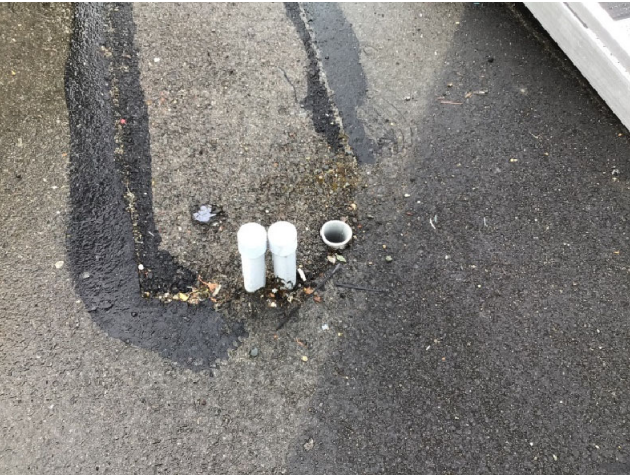
AC-3	New buildings, potential cap penetrations.	<p>There is one hole from where the previous building was that needs to have the seal fixed. An uncapped pipe protruding from the asphalt needs to be capped or filled and sealed.</p> <p>Property owner should request Occupancy Permit from tenant which would include drawings for the new buildings.</p>	Holes have been sealed. Pipe is still not capped. No maintenance form was submitted.	Some improvement	Previous recommended action regarding open pipe remains.	60 days	CenterPoint

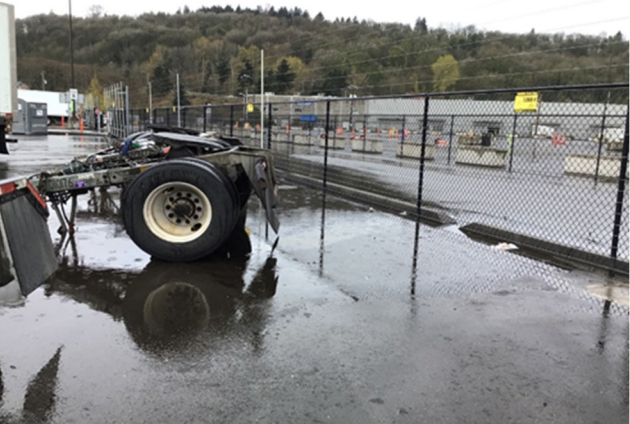
AC-10	Ponding	Follow-up inspection	No actions taken or required	No significant changes observed	Follow-up reinspection	6 months	Site Coordinator

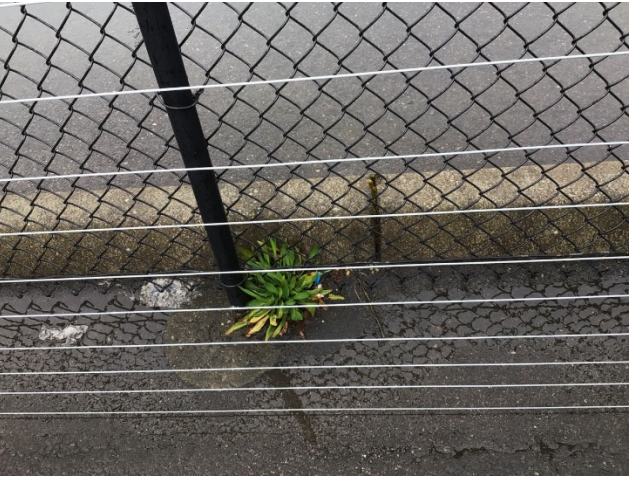
Center Point (SPPD) Location	Description	December 2022 Inspection		April 2023 Inspection				
		Conditions Observed and Recommended Action	Action Taken	Condition Status	Conditions Observed and Recommended Action	Timeline for Repair and/or Reinspection	Recommended Action Assignment	Photographs
AC-19	Holes near fence allowing growth of grasses			New location	Remove plants and seal cap penetrations.	No later than end of calendar year	CenterPoint

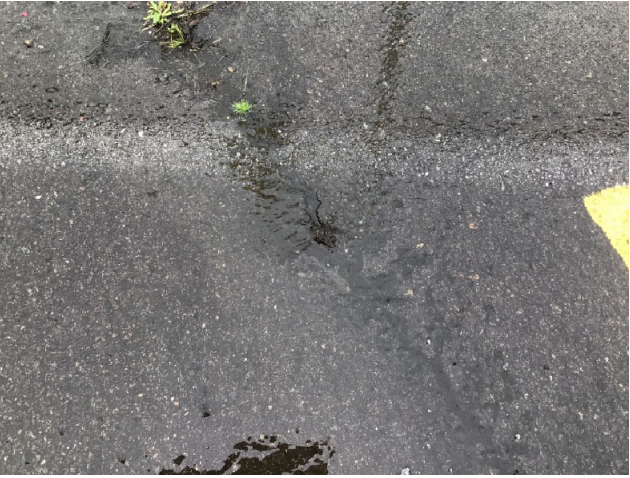
AC-20	Minor cracks and failed patch			New location	Follow-up reinspection	6 months	Site Coordinator

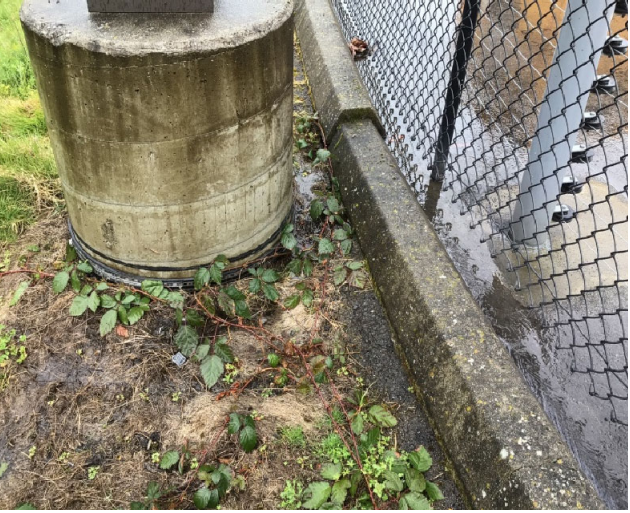
Center Point (SPPD) Location	Description	December 2022 Inspection		April 2023 Inspection				
		Conditions Observed and Recommended Action	Action Taken	Condition Status	Conditions Observed and Recommended Action	Timeline for Repair and/or Reinspection	Recommended Action Assignment	Photographs
G-4	Loss of grass cover along with blackberry shrubs growth in the area	April 2022 recommendations remain. Blackberry shrubs have been introduced to the area since the April 2022 inspection. Remove blackberries before the roots spread and become invasive, may need to re-seed the grass.	Action Not Yet Completed	Worse	Loss of grass around the concrete post exposing the soil and growth of blackberry shrubs around the region. Remove the blackberry shrubs before the roots spread and re-seed the grass.	No later than end of calendar year	CenterPoint

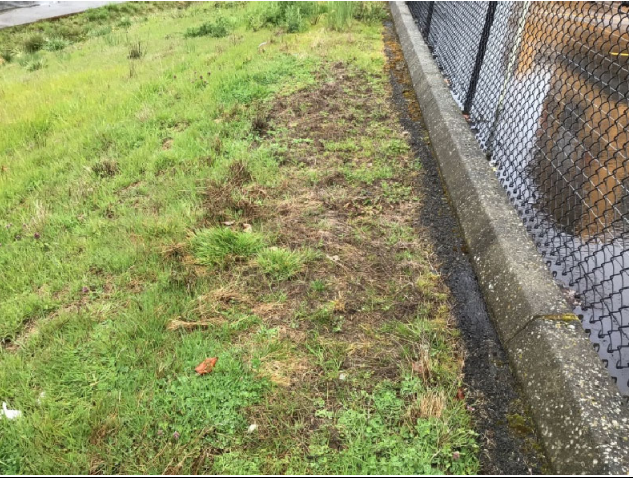
Center Point (SPPD) Location	Description	December 2022 Inspection		April 2023 Inspection				Photographs
		Conditions Observed and Recommended Action	Action Taken	Condition Status	Conditions Observed and Recommended Action	Timeline for Repair and/or Reinspection	Recommended Action Assignment	
G-5	New grass cover over previously exposed geomembrane	See Location G-4 2022 recommendations.	Action Not Yet Completed	Improved	Follow-up reinspection	6 months	Site Coordinator

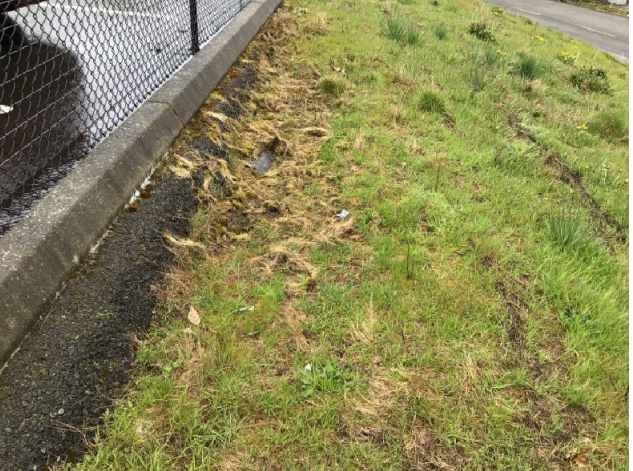
G-6	Geomembrane exposed in one area	See Location G-4 2022 recommendations.	Action Not Yet Completed	Some Improvement	Improved vegetation. Exposed geomembrane remains in one area. Add soil to exposed geomembrane and re-seed grasses	60 days	CenterPoint will work in coordination with Site Coordinator to establish a solution

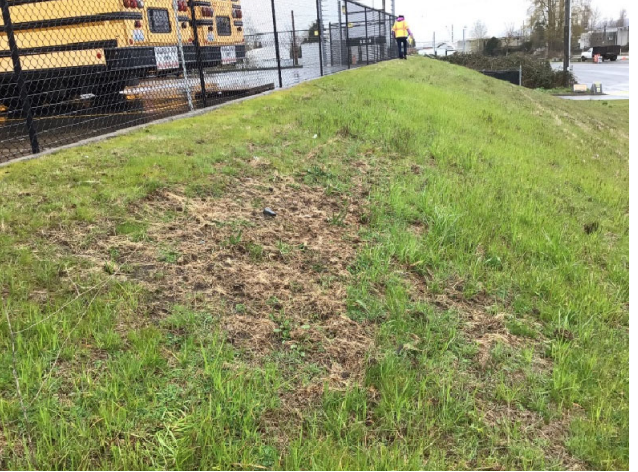
G-12	Poor vegetative cover			New location	Areas of exposed soil. Grass should be re-seeded.	No later than end of calendar year	CenterPoint

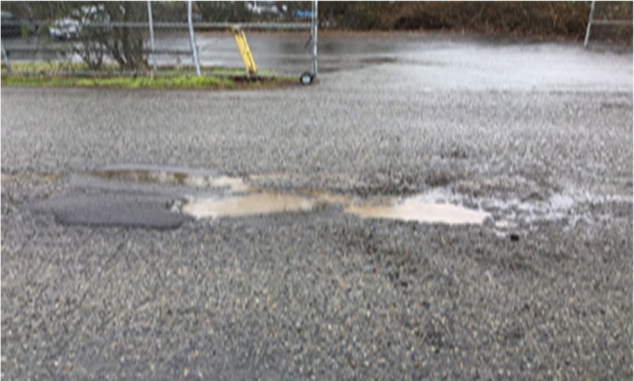
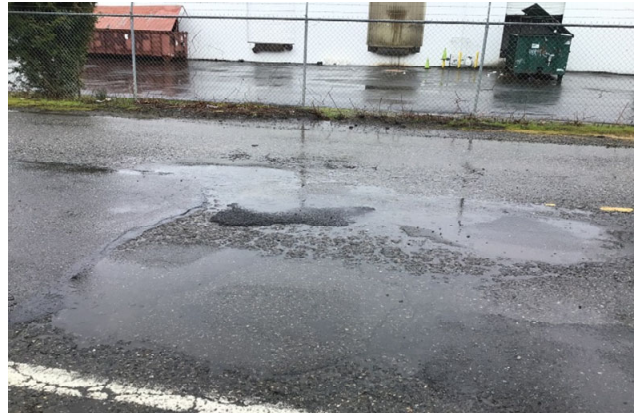
ROW Location	Description	December 2022 Inspection		April 2023 Inspection				Photographs
		Conditions Observed and Recommended Action	Action Taken	Condition Status	Conditions Observed and Recommended Action	Timeline for Repair and/or Reinspection	Recommended Action Assignment	
Asphalt Concrete								
AC-1	Cracks and pavement repair	Roadway is in poor condition, there are large open cracks and ruts in the asphalt pavement. SDOT previously repaired a portion of this location but did not cover the entire area. Recommend coordination with SDOT.	No action taken	Worse	Cracks got worse with ponding. Repair/repatching should be coordinated with SDOT	60 days	SPU to coordinate with SDOT

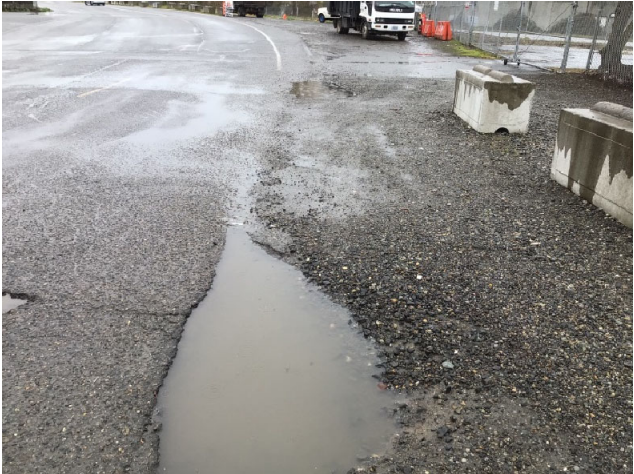
AC-3	Asphalt cracking and potholes alongside of street	Pothole appears to be getting worse and should be patched to prevent further erosion.	No action taken	No Significant Change Observed	Previous recommendations remain.	No later than end of calendar year	SPU to coordinate with SDOT

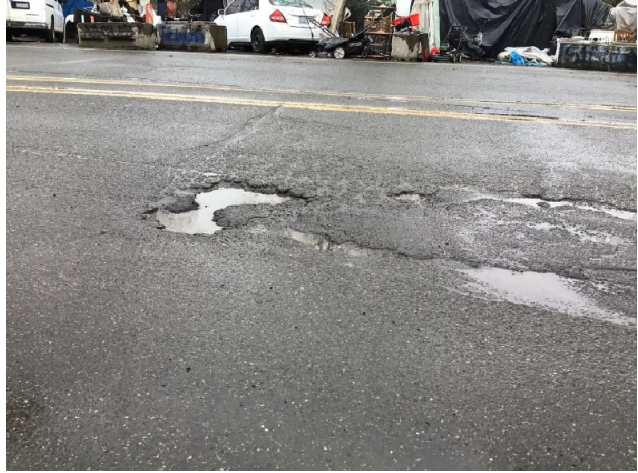
ROW Location	Description	December 2022 Inspection		April 2023 Inspection				Photographs
		Conditions Observed and Recommended Action	Action Taken	Condition Status	Conditions Observed and Recommended Action	Timeline for Repair and/or Reinspection	Recommended Action Assignment	
AC-4	Potholes in the middle of roadway			New location	Repatch work should be arranged with SDOT	No later than end of calendar year	SPU to coordinate with SDOT

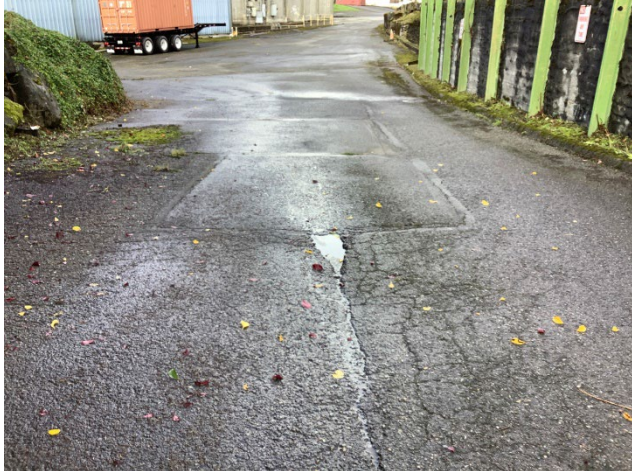
SRDS	Description	April 2023 Inspection		October 2023 Inspection				Photographs
		Conditions Observed and Recommended Action	Action Taken	Condition Status	Conditions Observed and Recommended Action	Timeline for Repair and/or Reinspection	Recommended Action Assignment	
Asphalt Concrete								
AC-13	Minor pavement cracking and deep rutting with water accumulation	Observed much deeper rutting, to where soil may be exposed. The open crack should be patched.	No action taken	No significant changes observed	The open hole should be patched.	No later than end of calendar year	SRDS

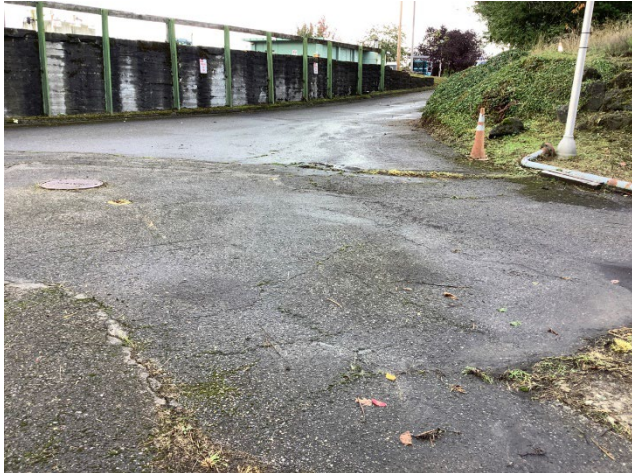
AC-14	Minor pavement cracks with exposed moss	The spalling has continued to degrade the cap to the point where soil may be exposed. This area should be patched.	No action taken	No significant changes observed	Vegetation growing between asphalt cracks. This area should be patched.	No later than end of calendar year	SRDS

In February 2024, cracks were repaired at locations SRDS AC-13, AC-14, and AC-20 with hot mix asphalt and sealant. The Site Coordinator observed the repairs and determined the repair activities were complete.

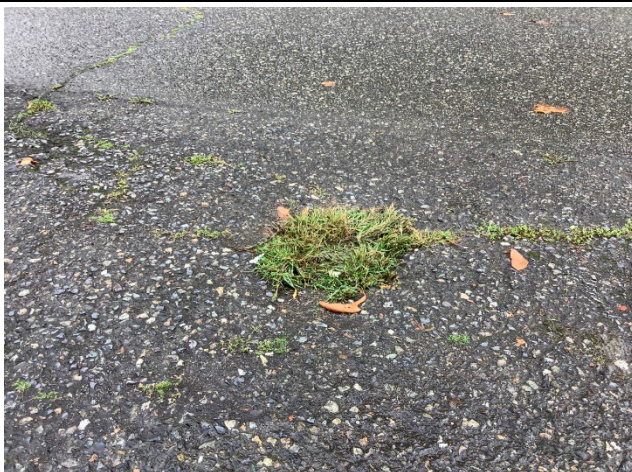
AC-20	Open rut with grass growth	Open hole with stagnated water	No actions taken	Worse	Sediment and grass in the previously seen hole. This hole needs to be patched	No later than end of calendar year	SRDS

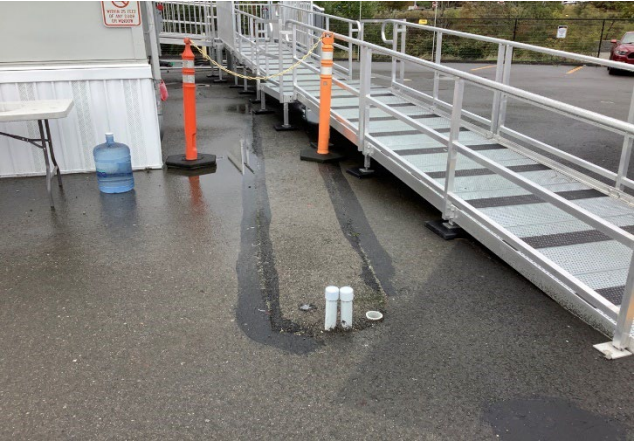
Center Point (SPPD) Location	Description	April 2023 Inspection		October 2023 Inspection				Photographs
		Conditions Observed and Recommended Action	Action Taken	Condition Status	Conditions Observed and Recommended Action	Timeline for Repair and/or Reinspection	Recommended Action Assignment	
Asphalt Concrete								
AC-3	Uncapped pipe	An uncapped pipe protruding from the asphalt needs to be capped or filled and sealed.	Pipe is still not capped.	No significant changes observed	Previous recommended action regarding open pipe remains.	60 days	CenterPoint

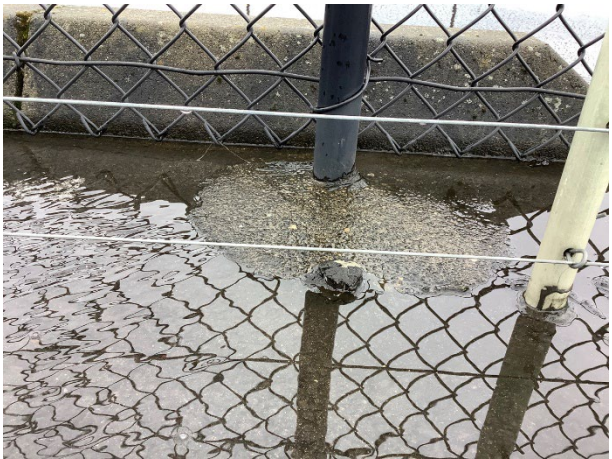
AC-6	Gaps and holes in electric fence post holes and ponding	Seal the remaining gaps in the interface between the posts of the new electric fence and the asphalt There are still some electric fence posts that have not been completely sealed, especially around the back of the pipe where it would be hard to reach. There are also some holes that were drilled next to the installed post. All posts and holes need to have complete seals.	Action Not Yet Completed	No visible improvement	Ponding. Previous recommended repairs remain.	No later than end of calendar year	CenterPoint

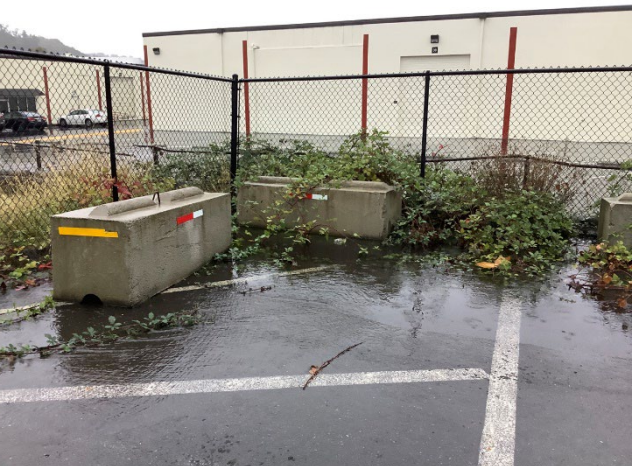
AC-13	Blackberry shrubs growth and stagnated water behind the concrete blocks	Remove blackberry shrubs and clear pathways to allow proper water flow into the storm drains. Follow up inspection	No Actions Taken	Worse	Blackberries continue to grow. Sediment blocking flow from the swale causing up to 4" of ponding water. Previous recommended repairs remain.	No later than end of calendar year	CenterPoint

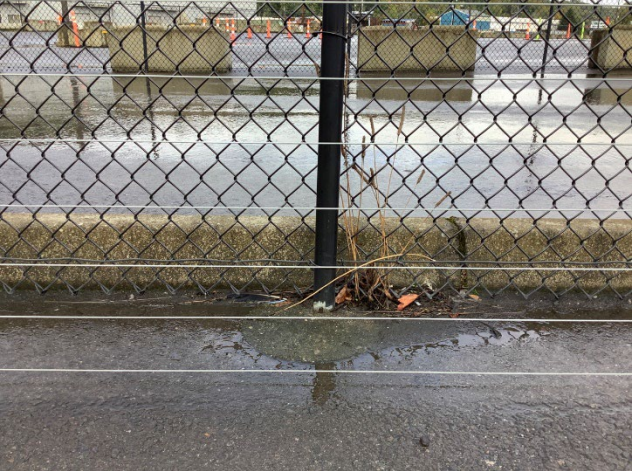
Center Point (SPPD) Location	Description	April 2023 Inspection		October 2023 Inspection				Photographs
		Conditions Observed and Recommended Action	Action Taken	Condition Status	Conditions Observed and Recommended Action	Timeline for Repair and/or Reinspection	Recommended Action Assignment	
AC-19	Pavement cracks near to fences	Remove plants and seal cap penetrations	No actions taken or required	No significant changes observed	Plants look dead but the crack is not sealed. Previous recommended repairs remain.	No later than end of calendar year	CenterPoint

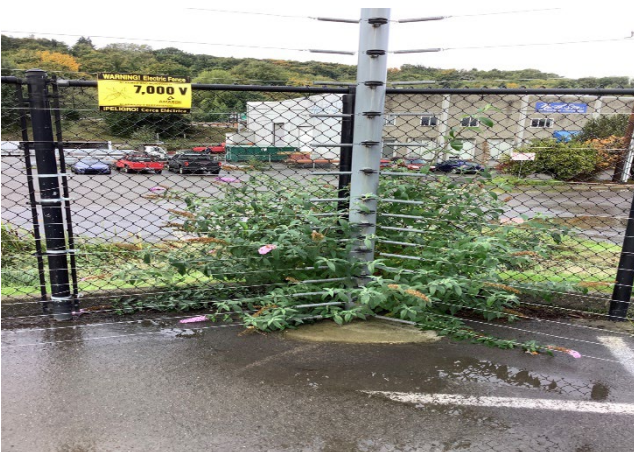
AC-21	Holes near fence allowing growth of invasive plants & ponding presence	Remove plants and seal cap penetrations.	No actions taken or required	Worse	Invasive plants continue to grow in hole near fence with ponding Previous recommendations remain	No later than end of calendar year	CenterPoint

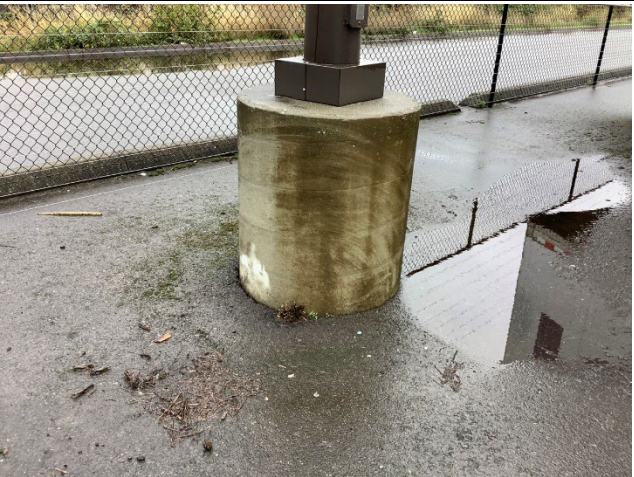
AC-22	Unsealed pavement after plant removal	Remove plants and seal cap penetrations.	Actions Taken	Improved	Part of the plant has been removed but the pavement has not been sealed	No later than end of calendar year	CenterPoint

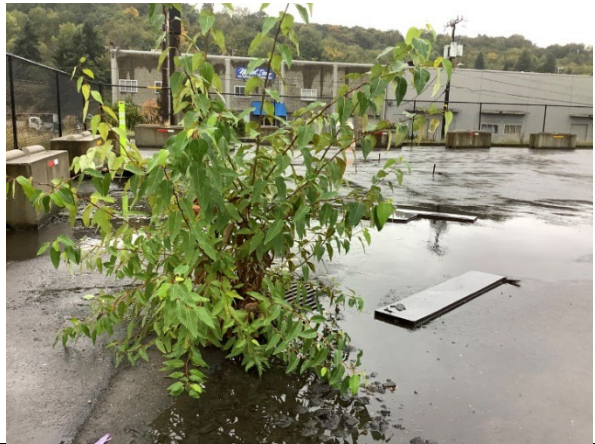
Center Point (SPPD) Location	Description	April 2023 Inspection		October 2023 Inspection				Photographs
		Conditions Observed and Recommended Action	Action Taken	Condition Status	Conditions Observed and Recommended Action	Timeline for Repair and/or Reinspection	Recommended Action Assignment	
AC-23	Invasive plant growth			New location	6ft tall plant next to the storm drain. Remove the plants and seal the cap penetration.	No later than end of calendar year	CenterPoint

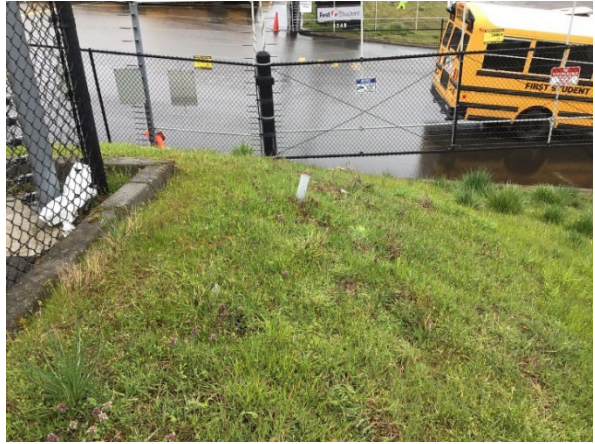
Low-Permeability Geomembrane								
G-1	An open pipe present	Need investigation of this open pipe and action should be taken to cap it, if it does not have any purpose.	Action Not Yet Completed	No significant changes observed	Previous recommendations remain	No later than end of calendar year	CenterPoint

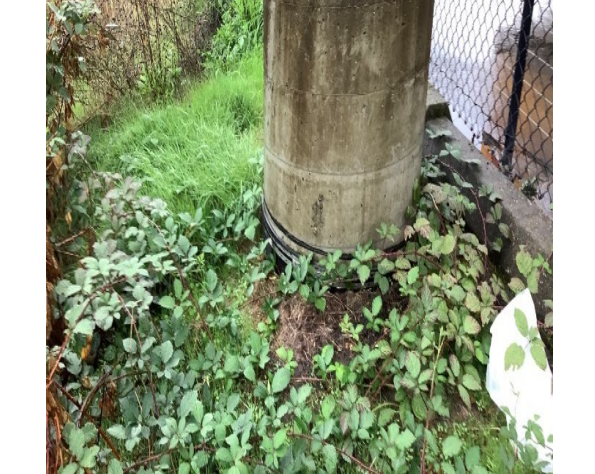
G-4	Blackberry shrubs growth in the area	Loss of grass around the concrete post exposing the soil and growth of blackberry shrubs around the region. Remove the blackberry shrubs before the roots spread and re-seed the grass.	Action Not Yet Completed	Worse	Improved growth of grass and growth of blackberry shrubs around the region. Previous recommendations remain	No later than end of calendar year	CenterPoint

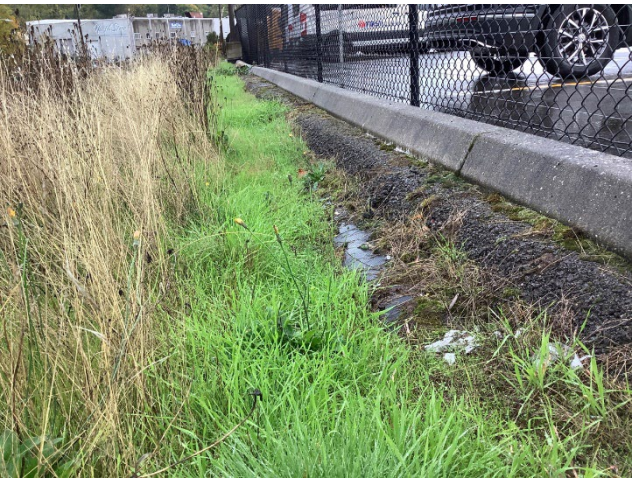
Center Point (SPPD) Location	Description	April 2023 Inspection		October 2023 Inspection				Photographs
		Conditions Observed and Recommended Action	Action Taken	Condition Status	Conditions Observed and Recommended Action	Timeline for Repair and/or Reinspection	Recommended Action Assignment	
G-6	Geomembrane exposed in this area	Improved vegetation. Exposed geomembrane remains in one area. Locations with exposed geomembrane are of the highest concern due to the potential compromise of the landfill cap. The configuration of the geomembrane and cover at the interface of the parking area does not appear to be in accordance with Figure 5 of the Interim Action Work Plan (IAWP). The geomembrane appears to be directly below the asphalt with no drainage layer or surfacing layer in between. Along with Site Coordinator, prepare a plan to reestablish cover over the geomembrane. Most likely, the area should be exposed, and the geomembrane tested for damage before repairs are made. The crest of slope should then be provided cover to the maximum extent possible considering the existing asphalt and curb configuration	Action Not Yet Completed	No significant changes observed	Geomembrane still exposed. Previous recommendations from 2023 remain.	60 days	CenterPoint will work in coordination with Site Coordinator to establish a solution

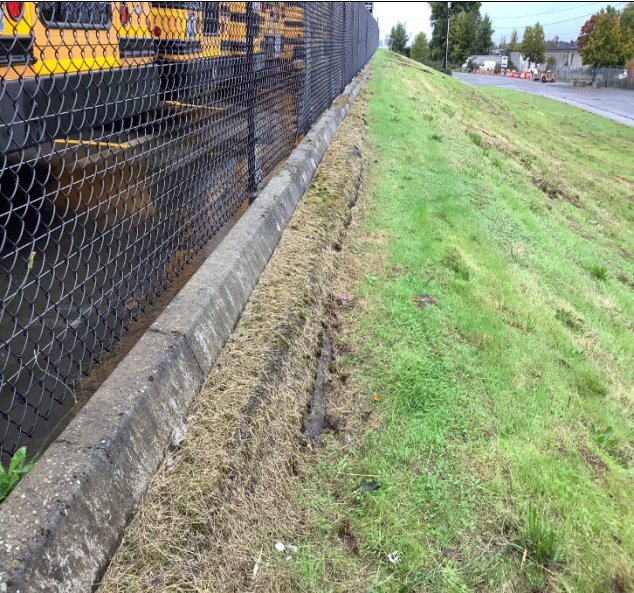
G-7	Exposed and damaged geomembrane at the parking area interface	The geomembrane remains exposed at G7. Locations with exposed geomembrane are of the highest concern due to the potential compromise of the landfill cap. The configuration of the geomembrane and cover at the interface of the parking area does not appear to be in accordance with Figure 5 of the Interim Action Work Plan (IAWP). The geomembrane appears to be directly below the asphalt with no drainage layer or surfacing layer in between. Along with Site Coordinator, prepare a plan to reestablish cover over the geomembrane. Most likely, the area should be exposed, and the geomembrane tested for damage before repairs are made. The crest of slope should then be provided cover to the maximum extent possible considering the existing asphalt and curb configuration	Action Not Yet Completed	Worse	Geomembrane still exposed. Previous recommendations from 2023 remain.	60 days	CenterPoint will work in coordination with Site Coordinator to establish a solution

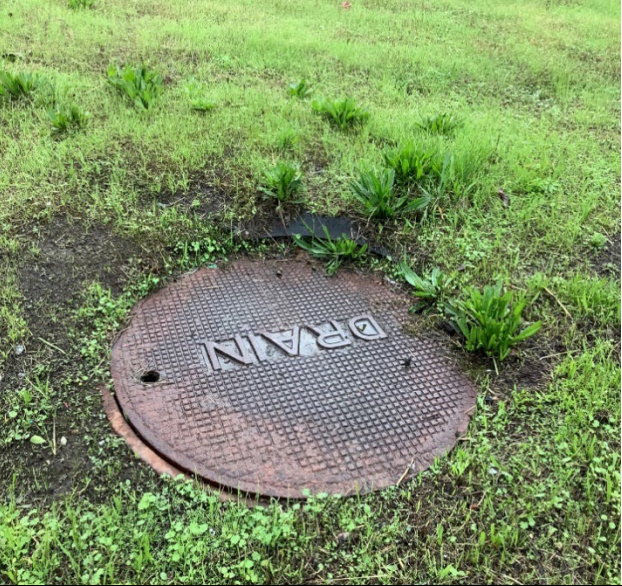
Center Point (SPPD) Location	Description	April 2023 Inspection		October 2023 Inspection				Photographs
		Conditions Observed and Recommended Action	Action Taken	Condition Status	Conditions Observed and Recommended Action	Timeline for Repair and/or Reinspection	Recommended Action Assignment	
G-8	Exposed geomembrane around utility access hole	Work with Site Coordinator to prepare a plan to re-establish cover over the geomembrane. The geomembrane should be carefully exposed so as to not damage the geomembrane and inspected to determine if it is excess material or part of the cover. Make repairs as necessary and install adequate cover soil in accordance with the IAWP.	No documentation of actions taken	No significant changes observed	Previous recommendations from 2023 remain	60 days	CenterPoint will work in coordination with Site Coordinator to establish a solution

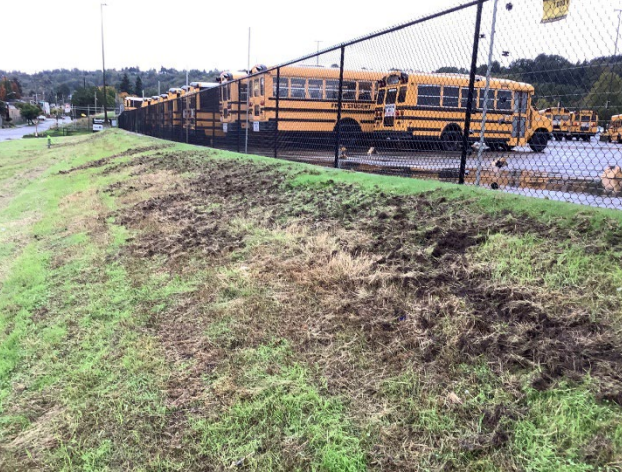
G-12	Poor vegetative cover	Areas of exposed soil. Grass should be re seeded. Follow-up inspection	No documentation of actions taken.	Changed	Dirt appears to be tilled and the area may have been seeded. No maintenance report received. Submit maintenance report if the tilling was intentional otherwise repair vegetation.	No later than end of calendar year	CenterPoint

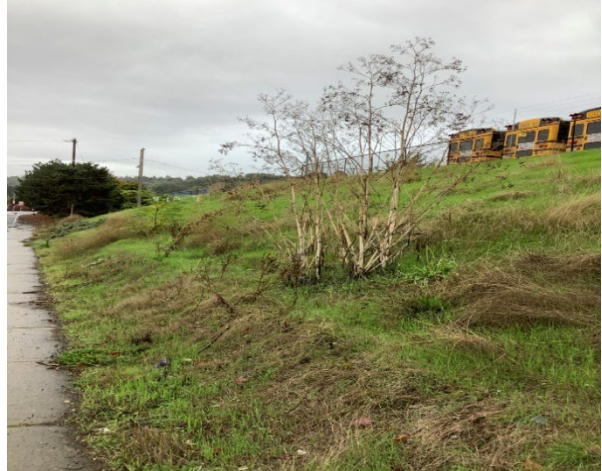
Center Point (SPPD) Location	Description	April 2023 Inspection		October 2023 Inspection				Photographs
		Conditions Observed and Recommended Action	Action Taken	Condition Status	Conditions Observed and Recommended Action	Timeline for Repair and/or Reinspection	Recommended Action Assignment	
G-14	Invasive Plants			New location	Invasive large plant growth. Remove the large plant due to risk of roots compromising the cover system.	No later than end of calendar year	CenterPoint

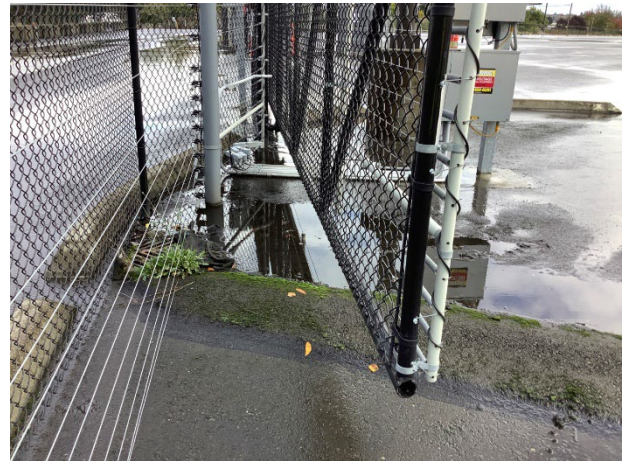
SW-4	Catch basin clogged			New location	Catch basin inlet obstructed with sediment buildup and plant growth. Remove the obstruction and vegetation.	60 days	CenterPoint will work in coordination with Site Coordinator to establish a solution

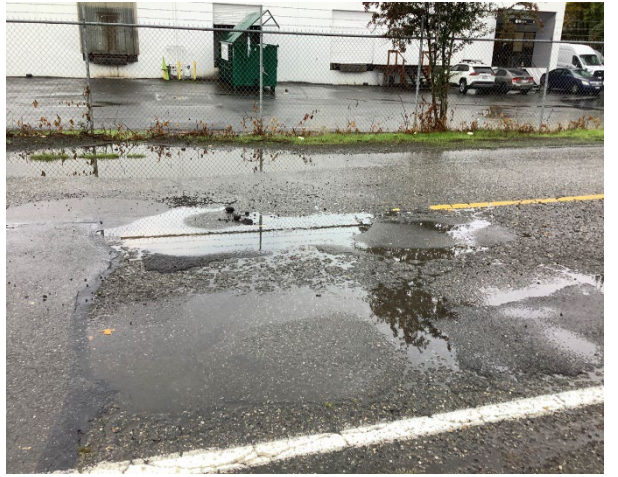
AC-2	Asphalt open cracking	Cracks got bigger with ponding. Repatching should be coordinated with SDOT	No action taken	Worse	Cracks got extended. Previous recommendation remains	60 days	SPU to coordinate with SDOT

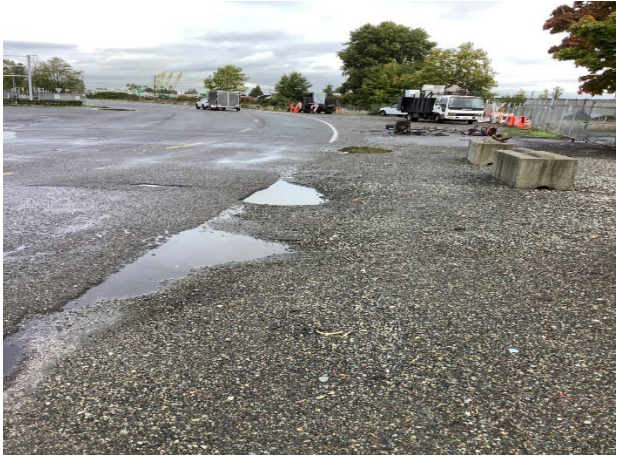
AC-4	Potholes in the middle of roadway	Repatch work should be arranged with SDOT	No action taken	Worse	The pothole got bigger and ponding inside. Repatching should be done coordinating with SDOT	60 days	SPU to coordinate with SDOT

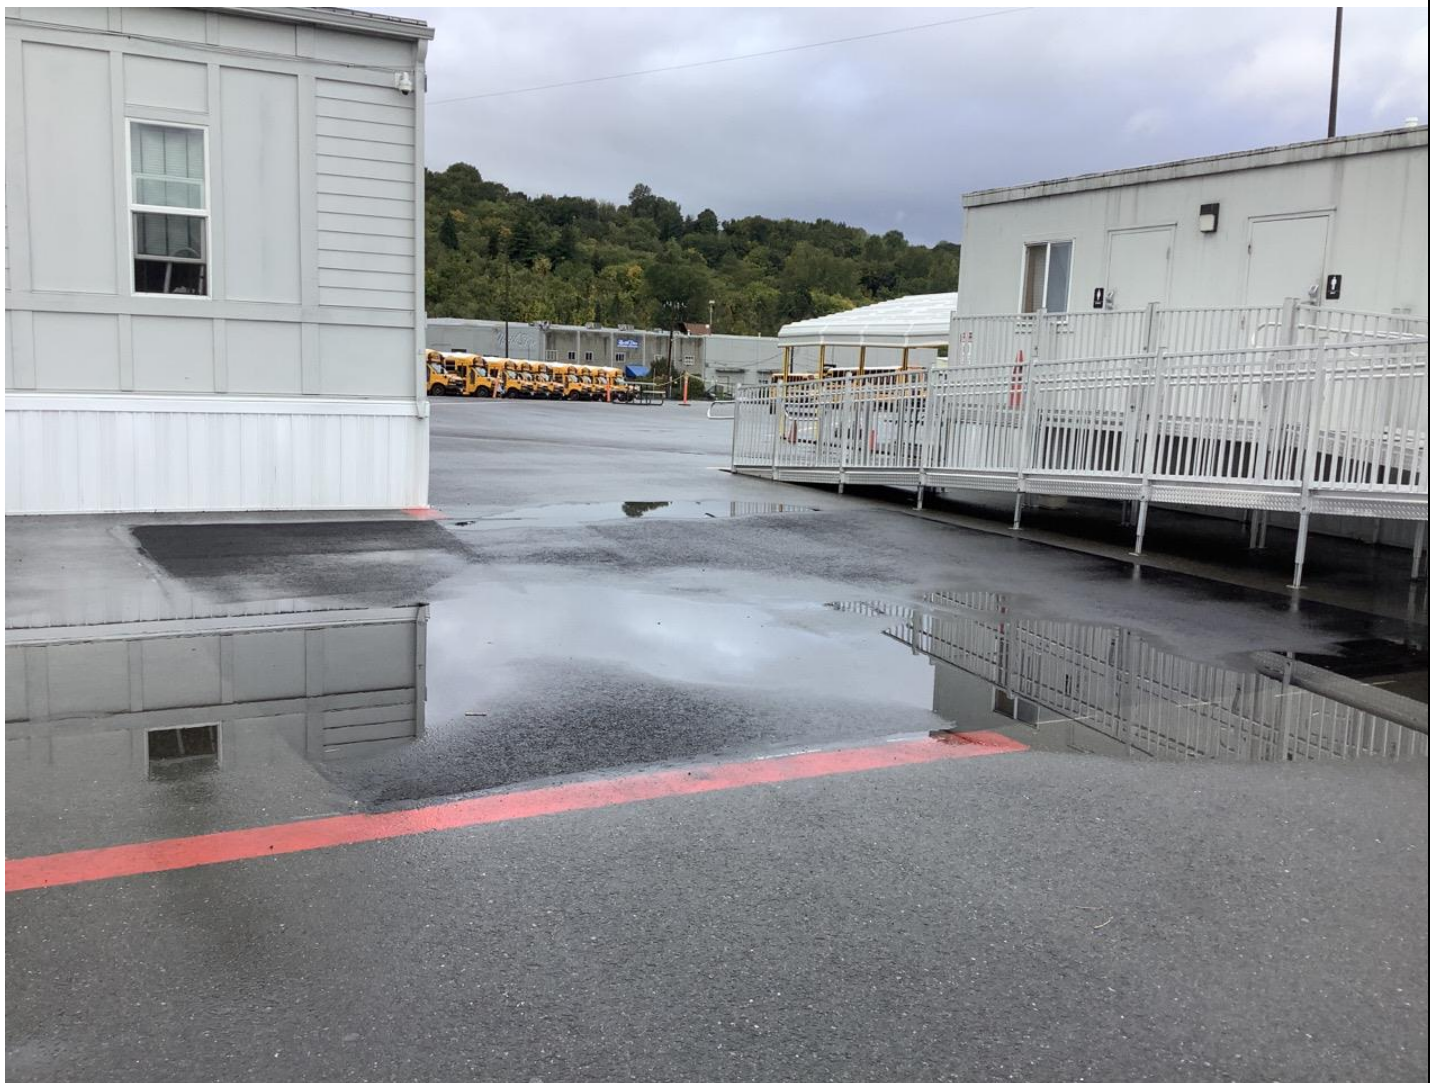
Location (1)

Pavement patches were inspected from the maintenance form CenterPoint Submitted. Patches have low points causing ponding, especially at (1) and (8) as seen in the pictures below. We were not able to locate (7). No further modifications recommended at this time but we will continue to monitor the area for increased ponding. An additional patch was noted that was not included in the submitted maintenance report (last picture).

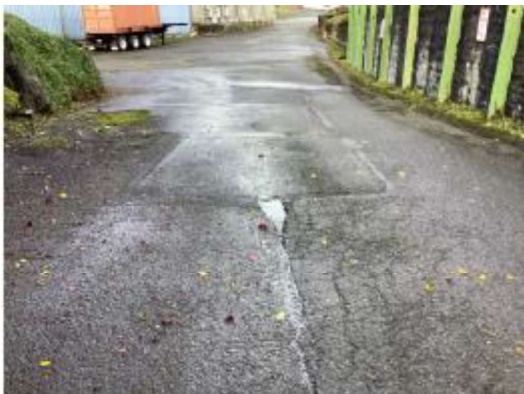
Before

Reason for Maintenance:
Crack Open

Describe Maintenance Location (attach sketch and photos):
AC-13

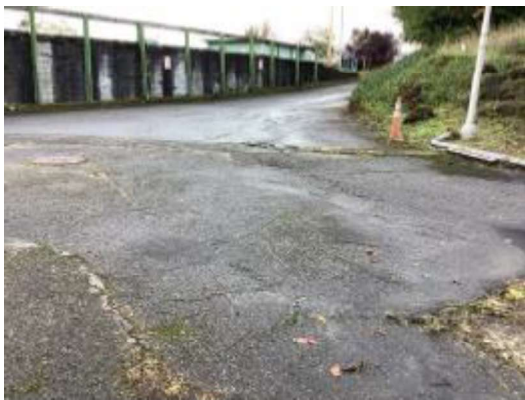
Before

Reason for Maintenance:
Crack open

Describe Maintenance Location (attach sketch and photos):
AC-14

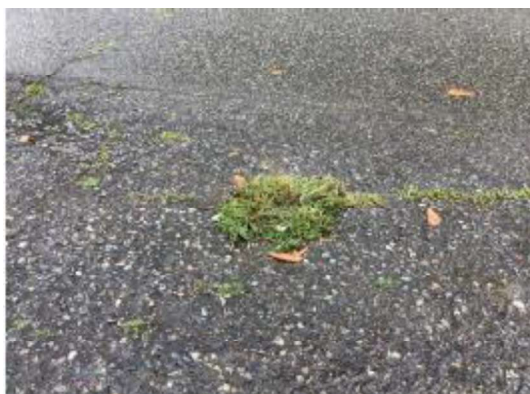
Before

Reason for Maintenance:
Crack open

Describe Maintenance Location (attach sketch and photos):
AC-20

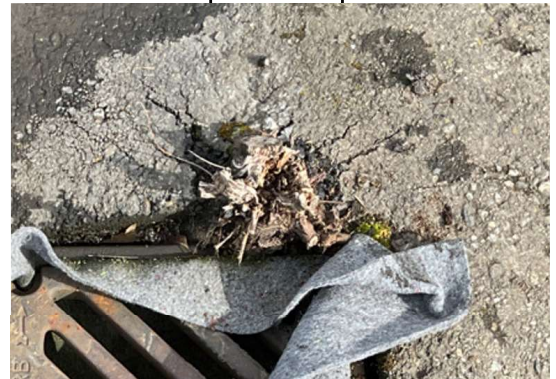
SW-3 - Catch basin still has obstructions though less than during previous inspection

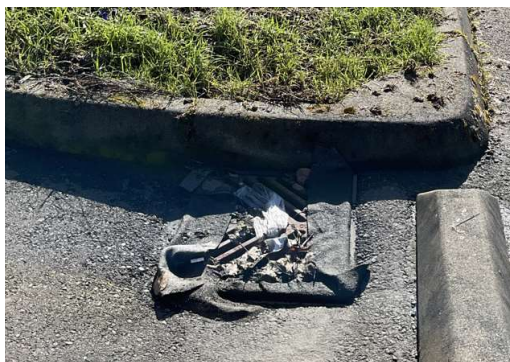
SW-4 - Catch basin has been cleaned of obstructions

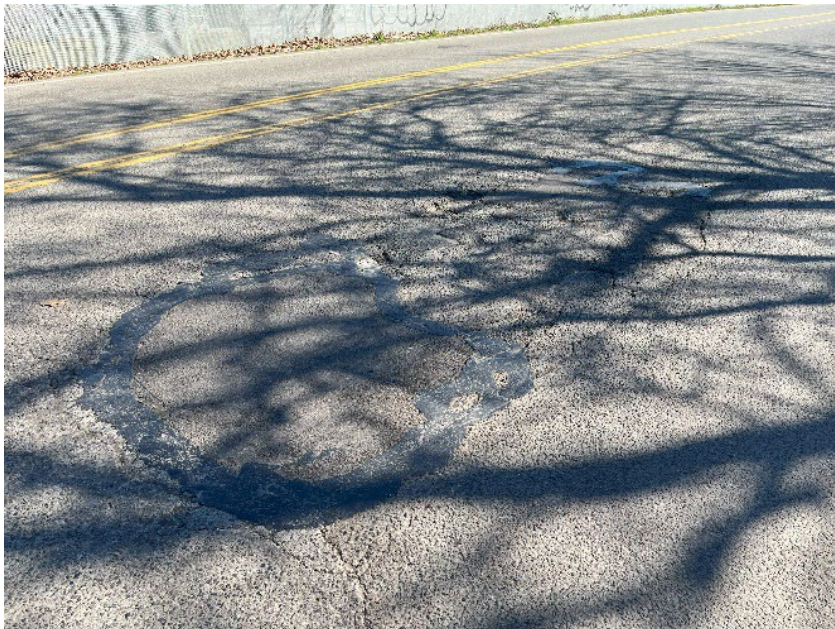
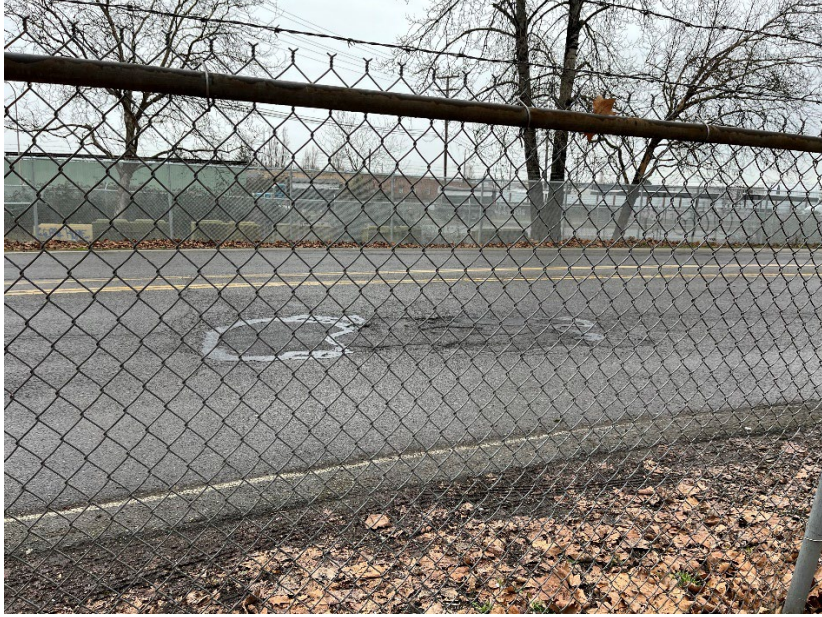
ROW AC-4. Complete. Large and smaller potholes patched with asphalt.
