Re: DTG Yakima – Agreed Order No. DE 21624 – Monthly Progress Letter – April

Re: Monthly Data Assessment Report DTG Yakima Landfill Fire Incident – April 2024

Monthly Monitoring Data Review

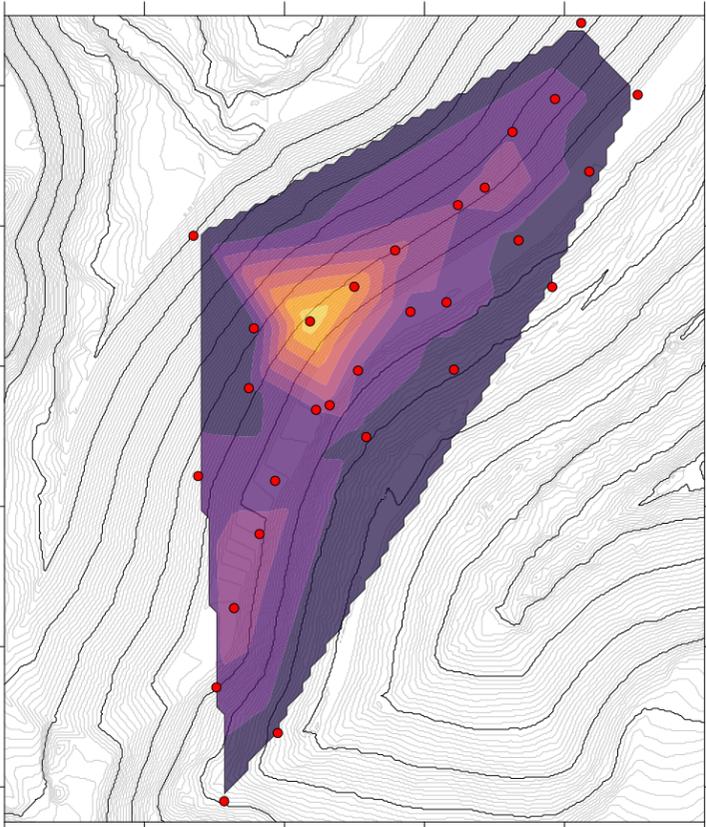
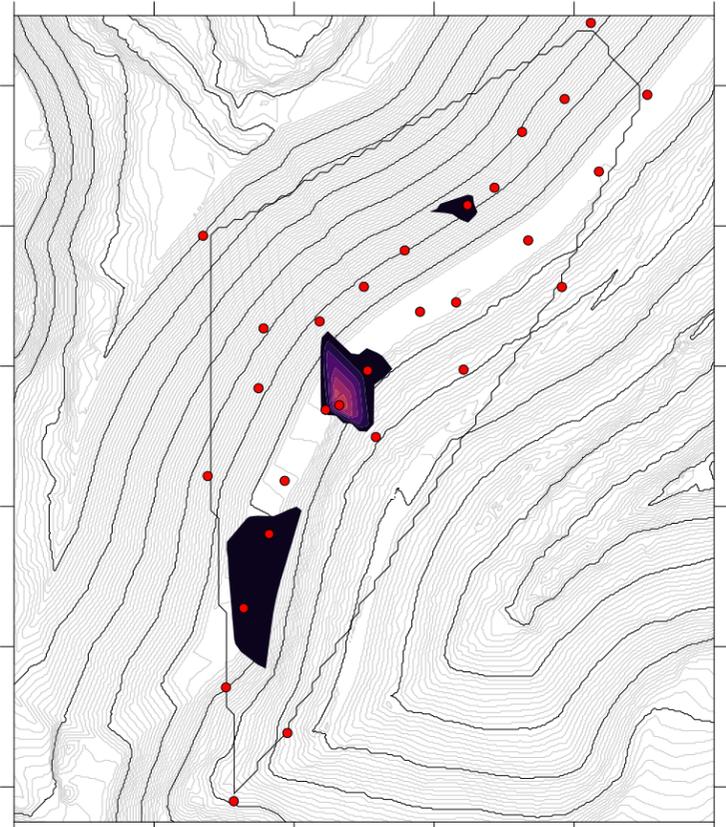
April 26, 2024
Last Monitoring Event

Plotting of the temperature and CO data in plan view clearly shows that the area affected by fire has markedly decreased over time. Based on the available data, LFCI believes that a small smolder continues to be active in close proximity to GP-3, and that the rate of combustion of the smolder is steadily decreasing.

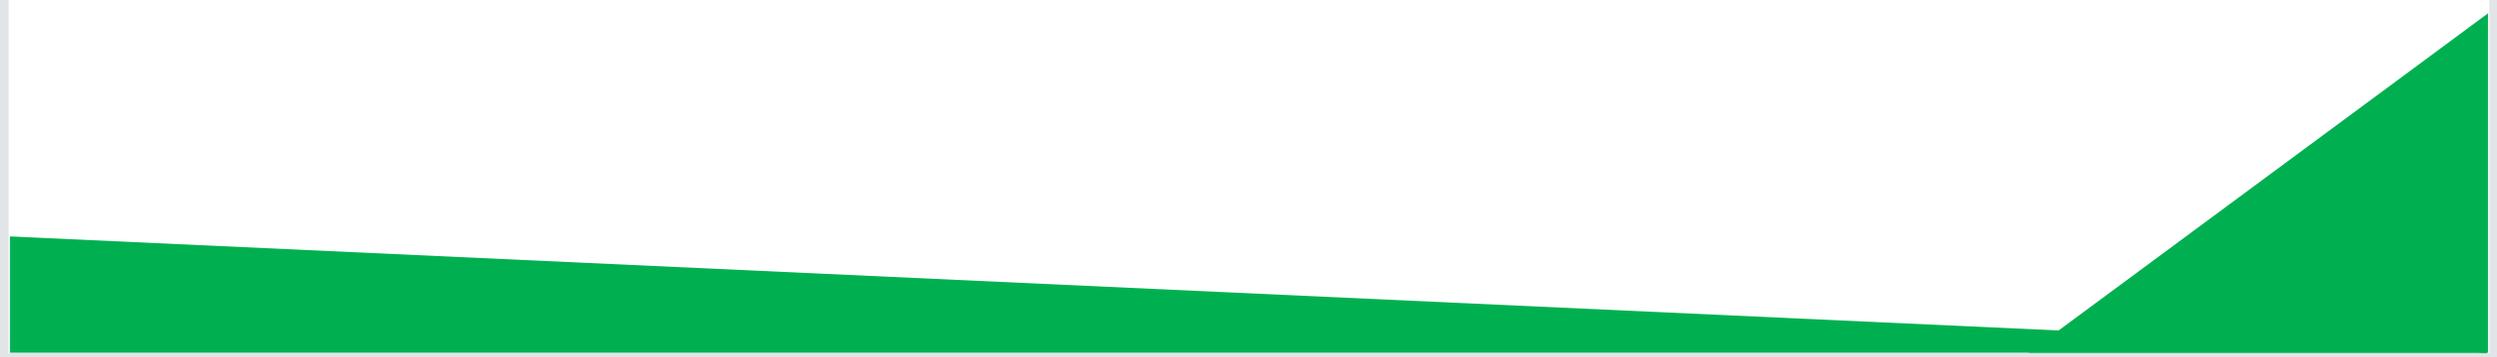
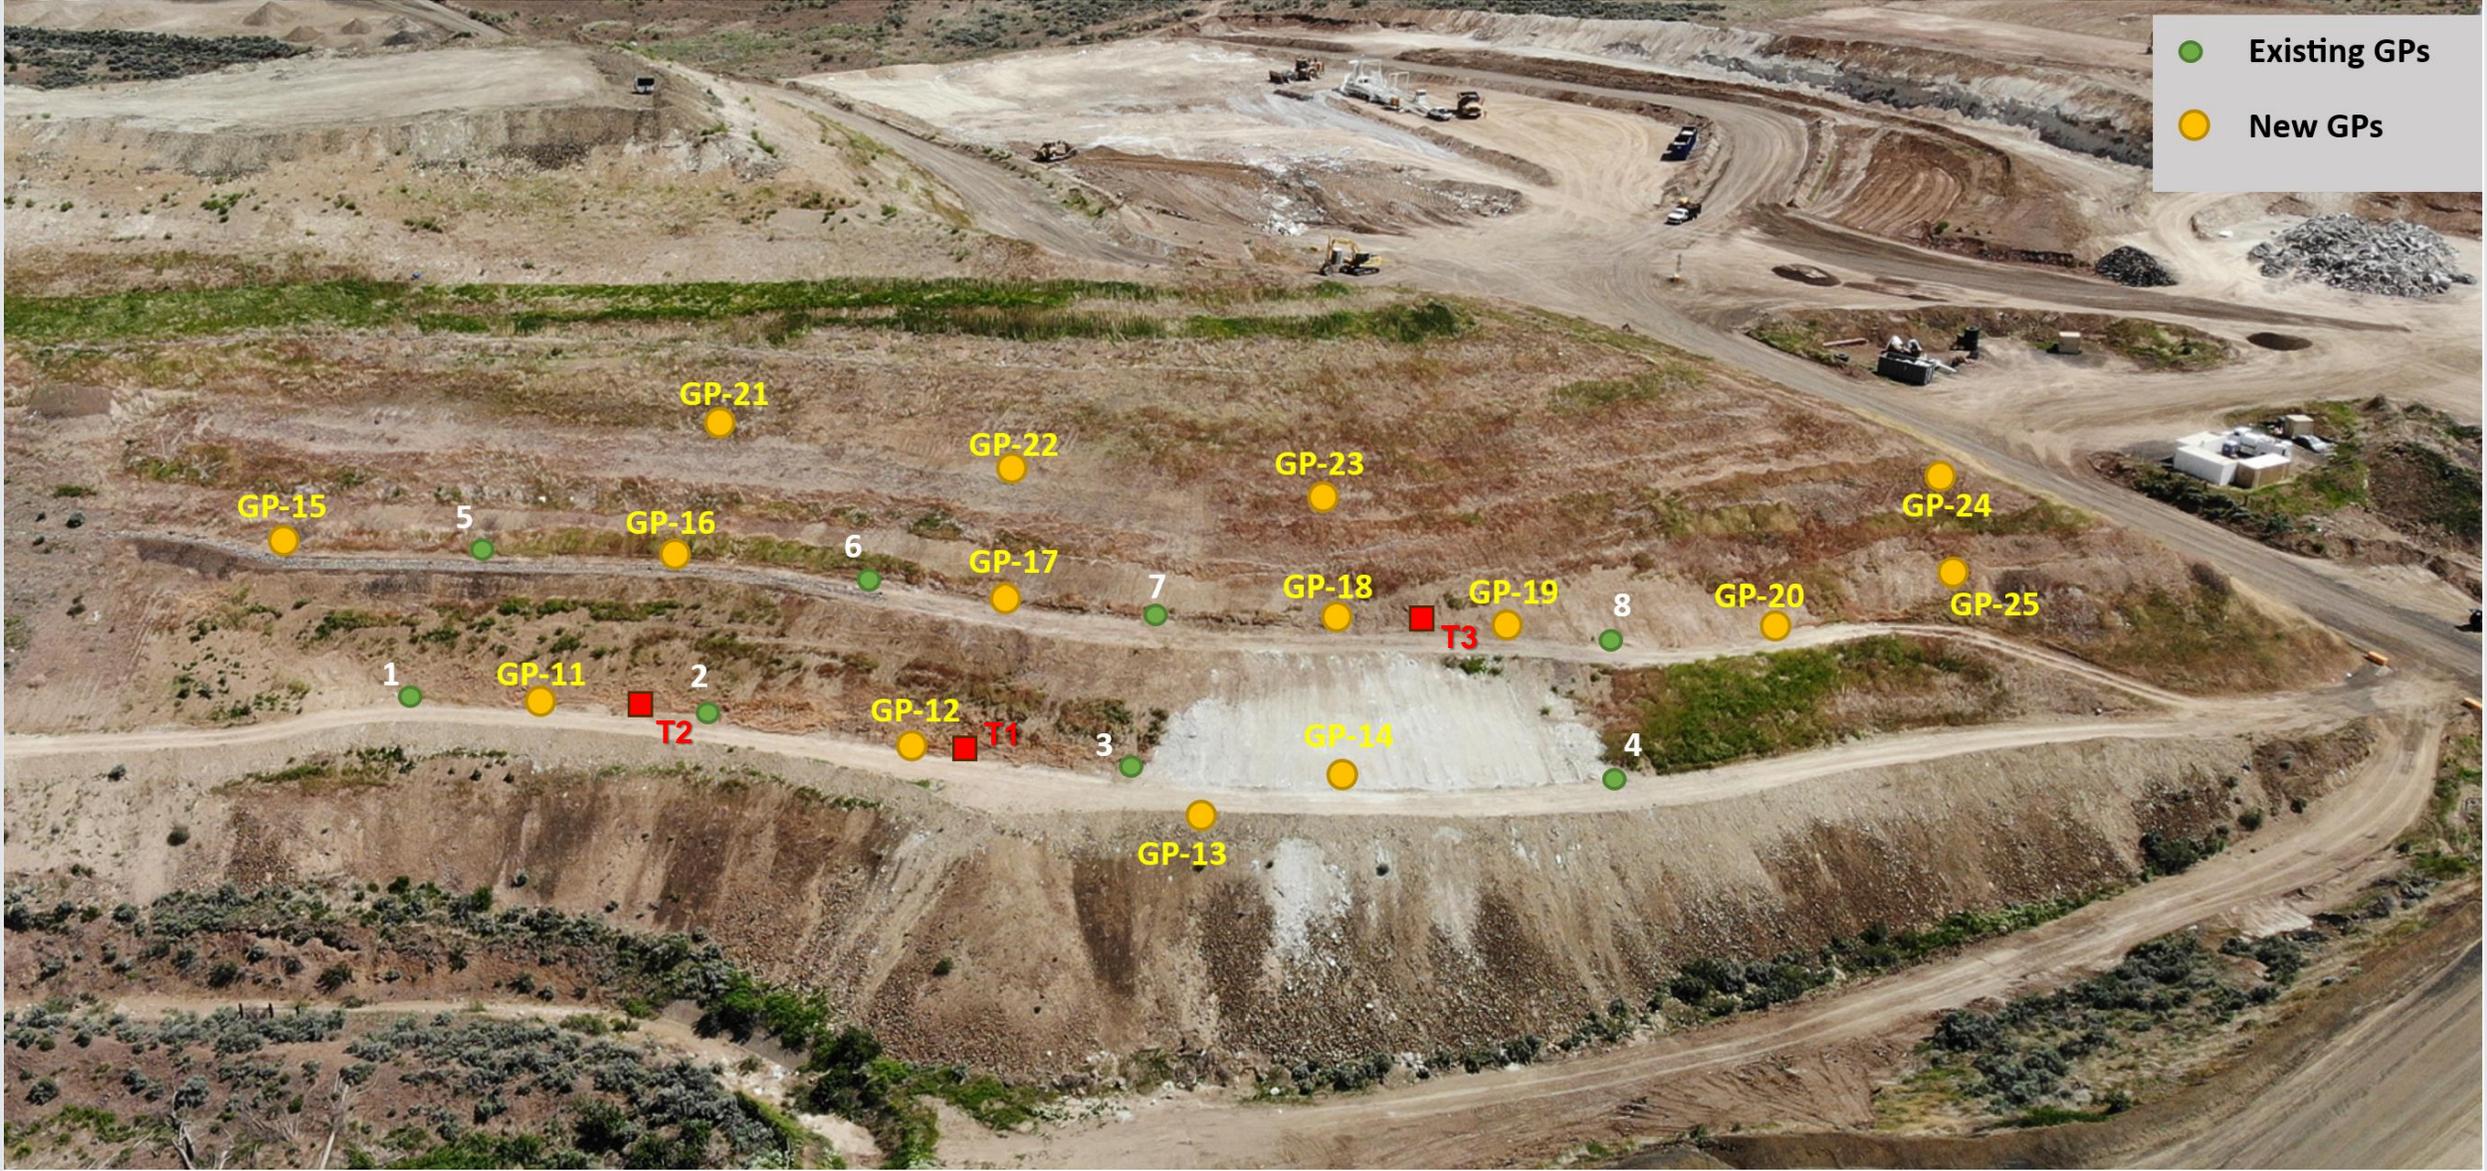
Thermistor Temperature Data

Overall Interpretation

GP-15
5
GP-16
6
GP-21
GP-22
GP-23
GP-17
7
GP-18
GP-19
8
GP-20
GP-24
GP-25
1
GP-11
2
T2
GP-12
T1
3
GP-13
GP-14
4

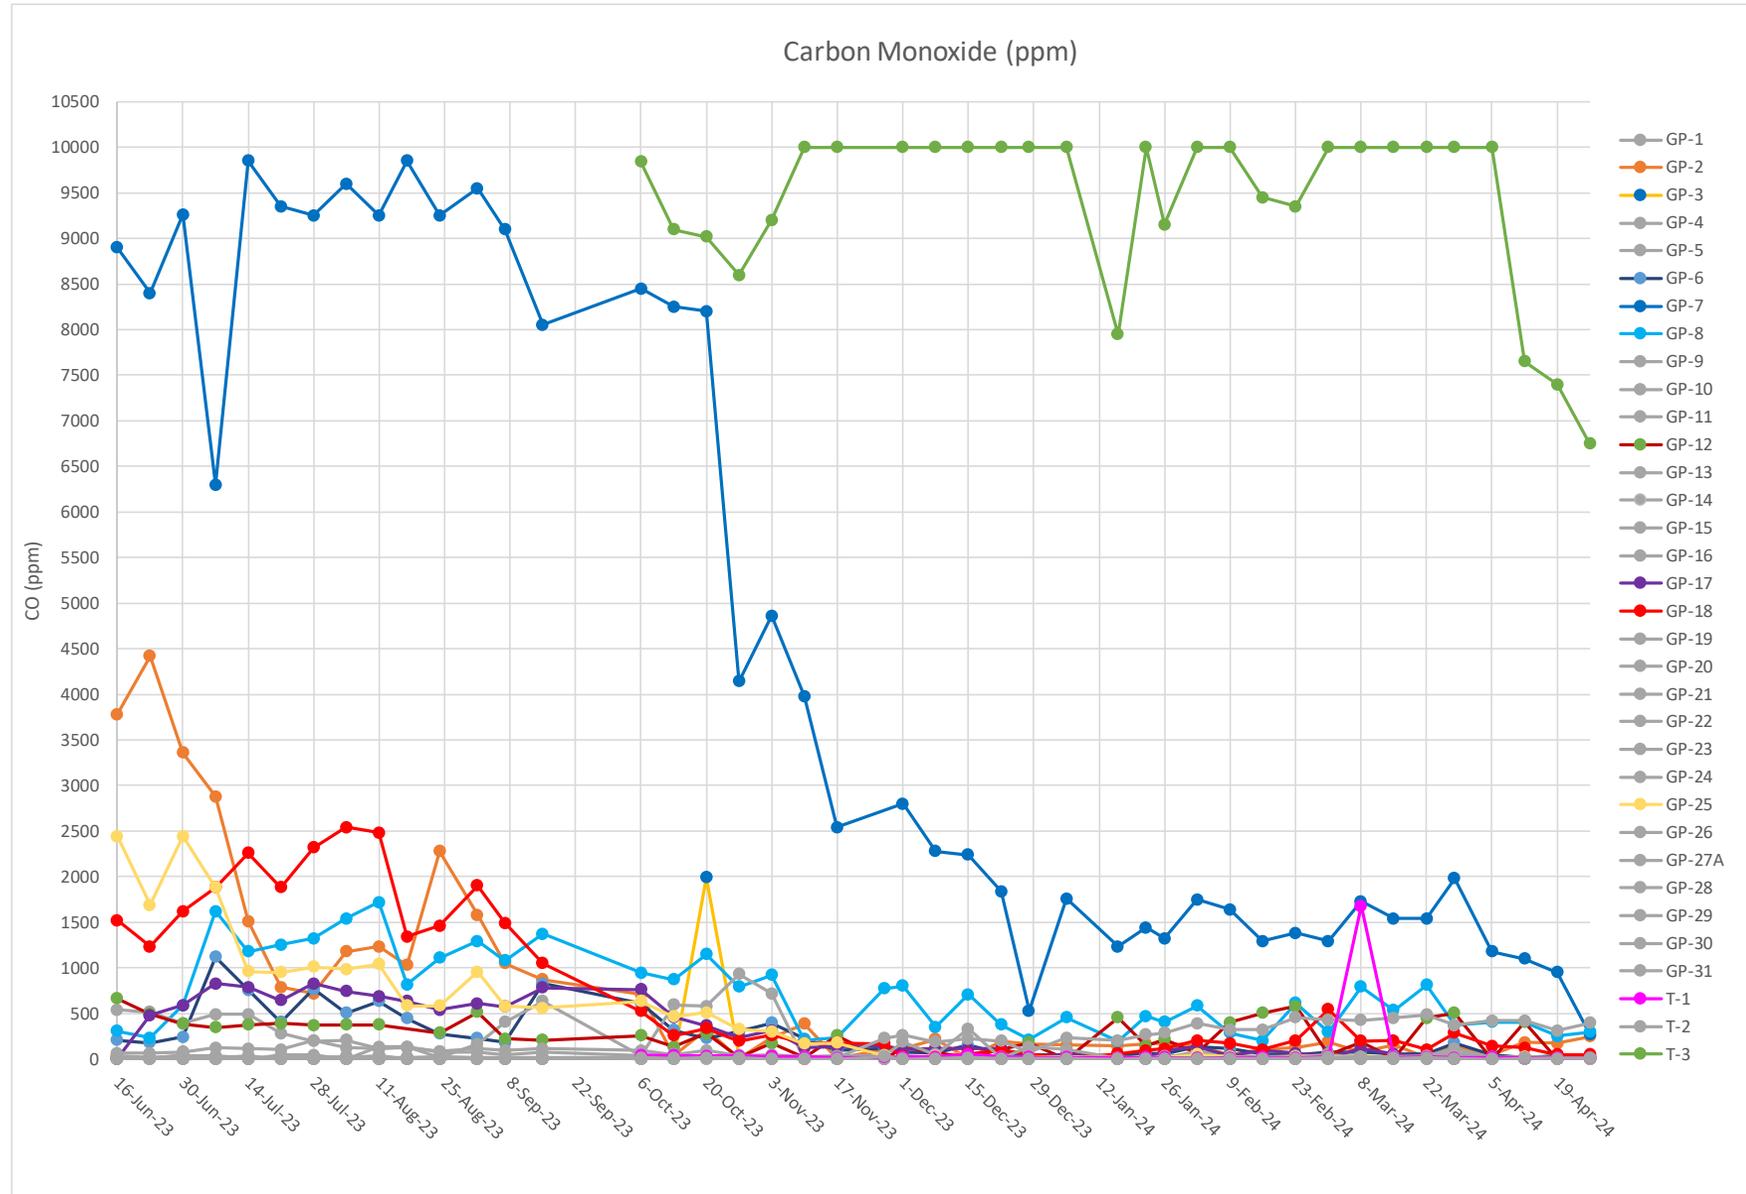
Carbon Monoxide

T-3 has decreased significantly over the last month.

GP-7 has also decreased significantly, to under 500ppm.

In LFCI experience, CO has been best indicator of suppression at other landfill sites. CO levels in GP-7 and T-3 have dropped significantly in past month.

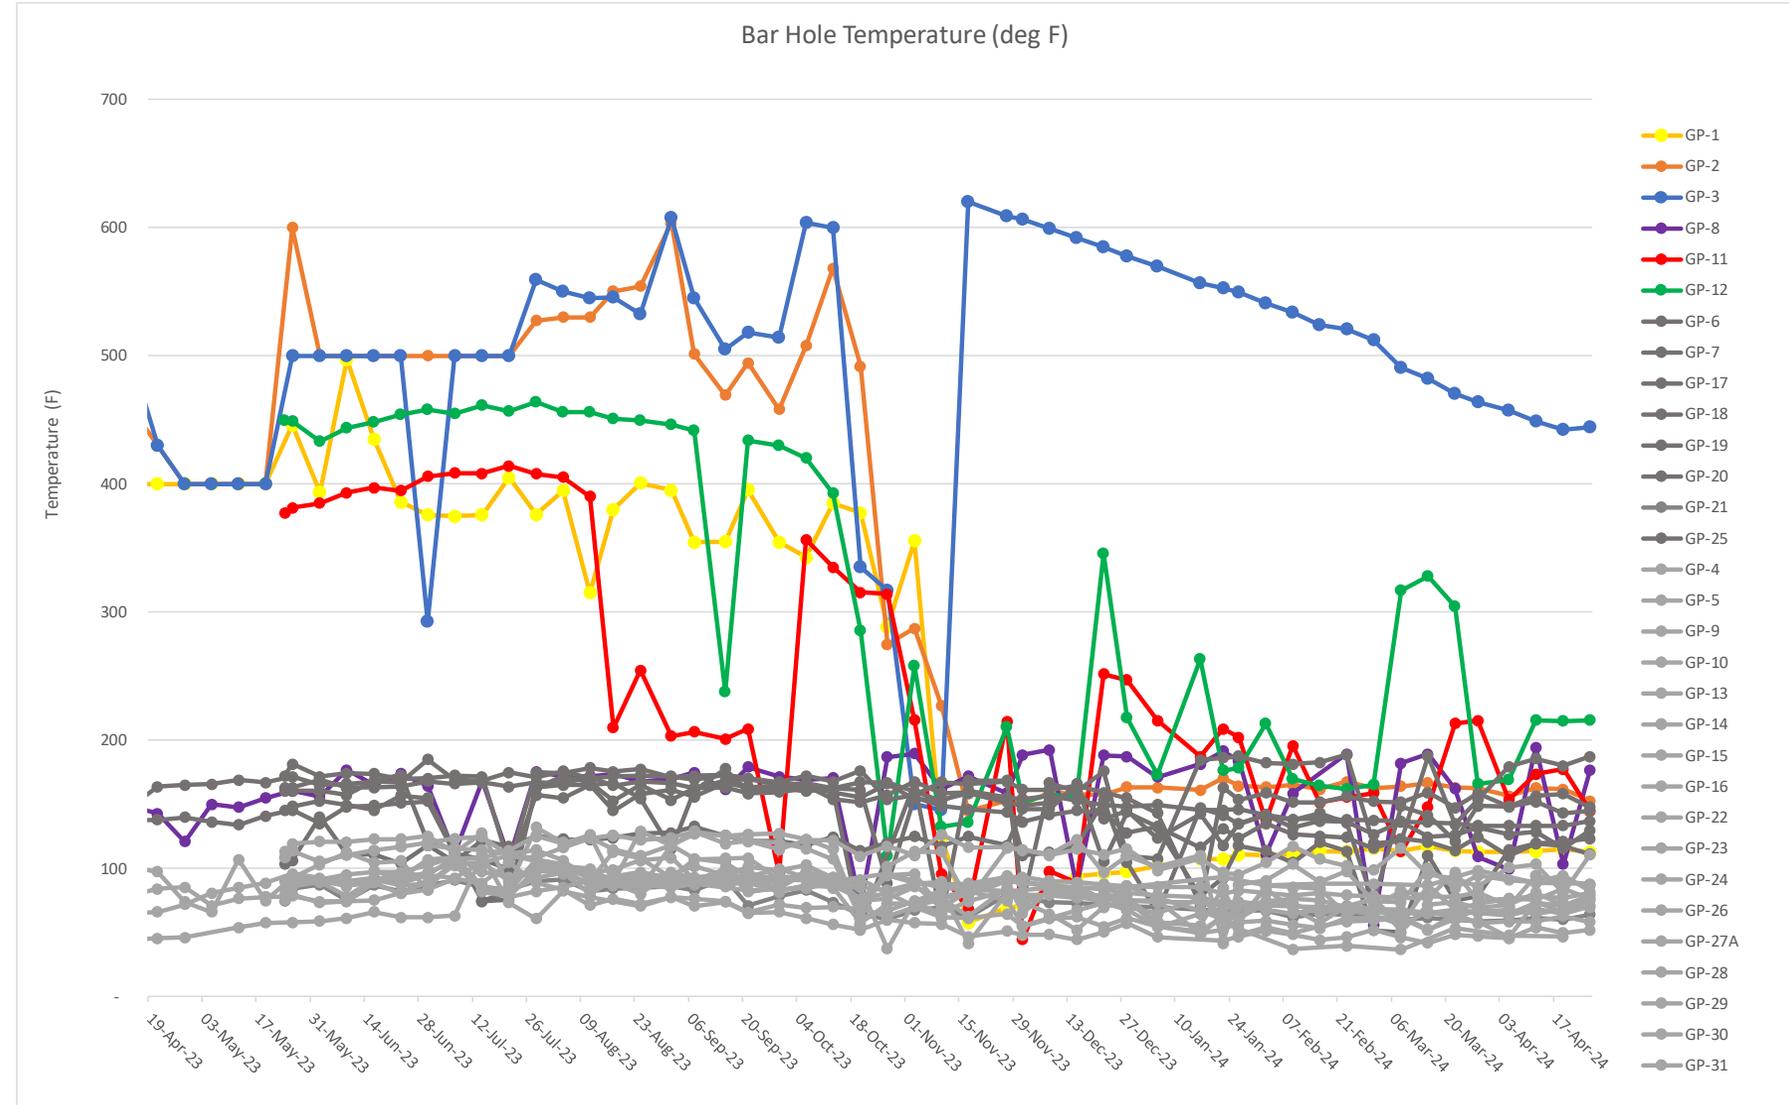
Temperature (F)

Temperature has continued to decrease in GP-3, with a slight uptick in last weeks monitoring event.

This matches with higher temperatures in T-1 at 30' below ground, currently around 350F.

All other wells have remained low, with some variability possibly caused by atmospheric pressure swings.

Temperature has dropped significantly all around, especially in GP-3.

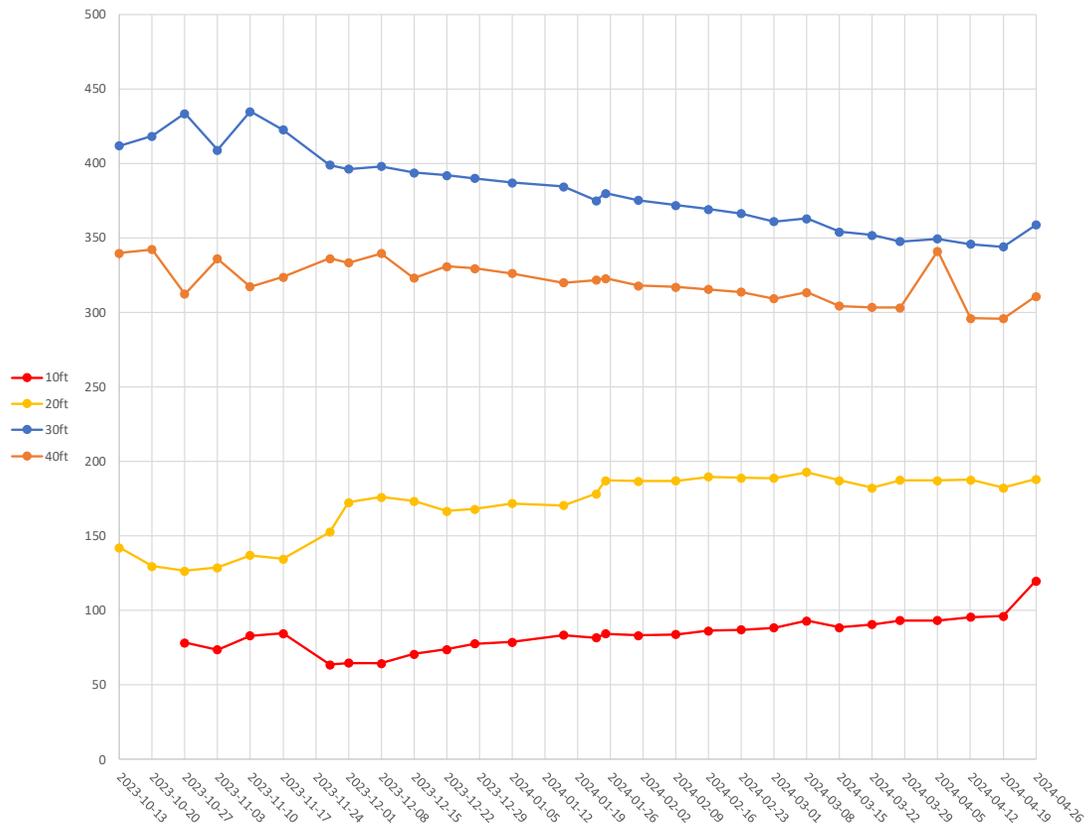
Thermistor 1

Thermistor temperatures mostly stable. Slight uptick in temperatures in T-1 this week, but overall stable/decreasing trend continues.

Will keep a close eye on T-1 to ensure no major changes.

Slight uptick in temperatures in T-1 and GP-3 this week.

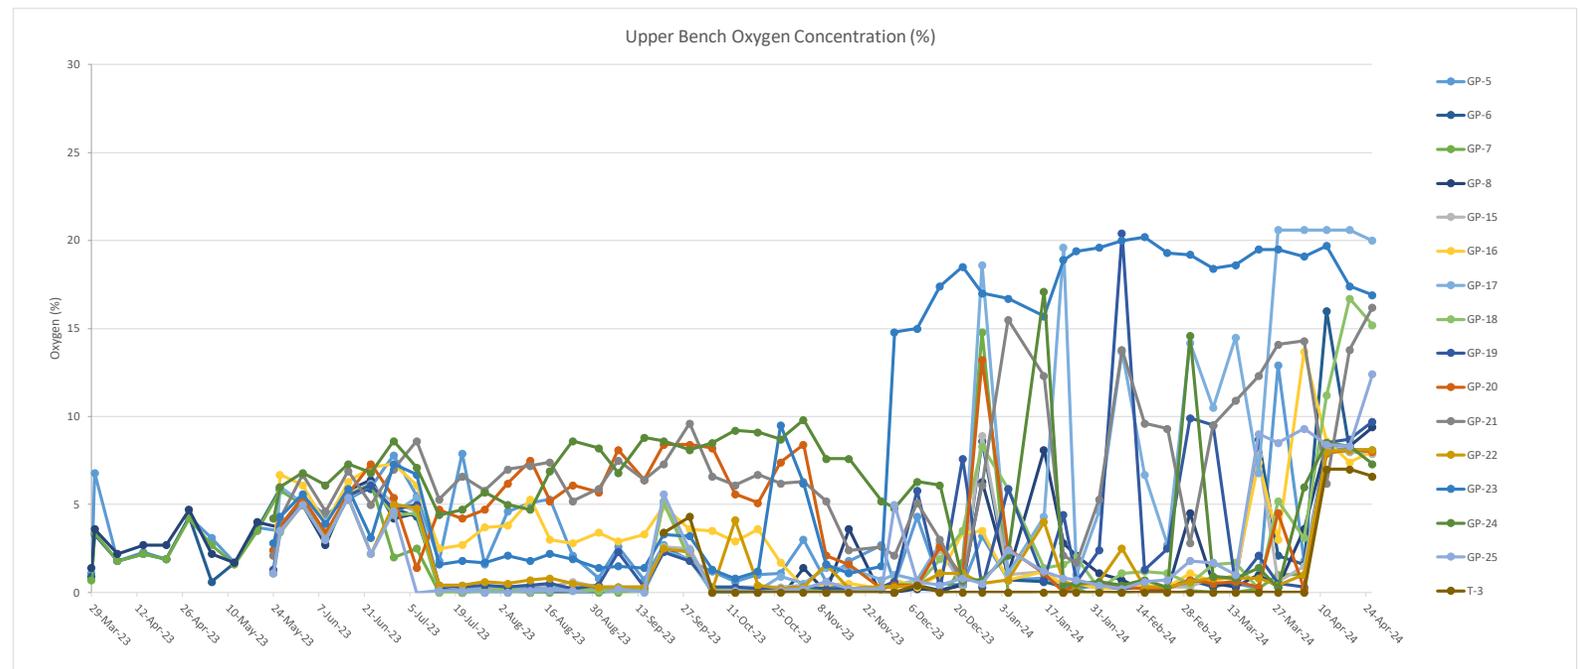
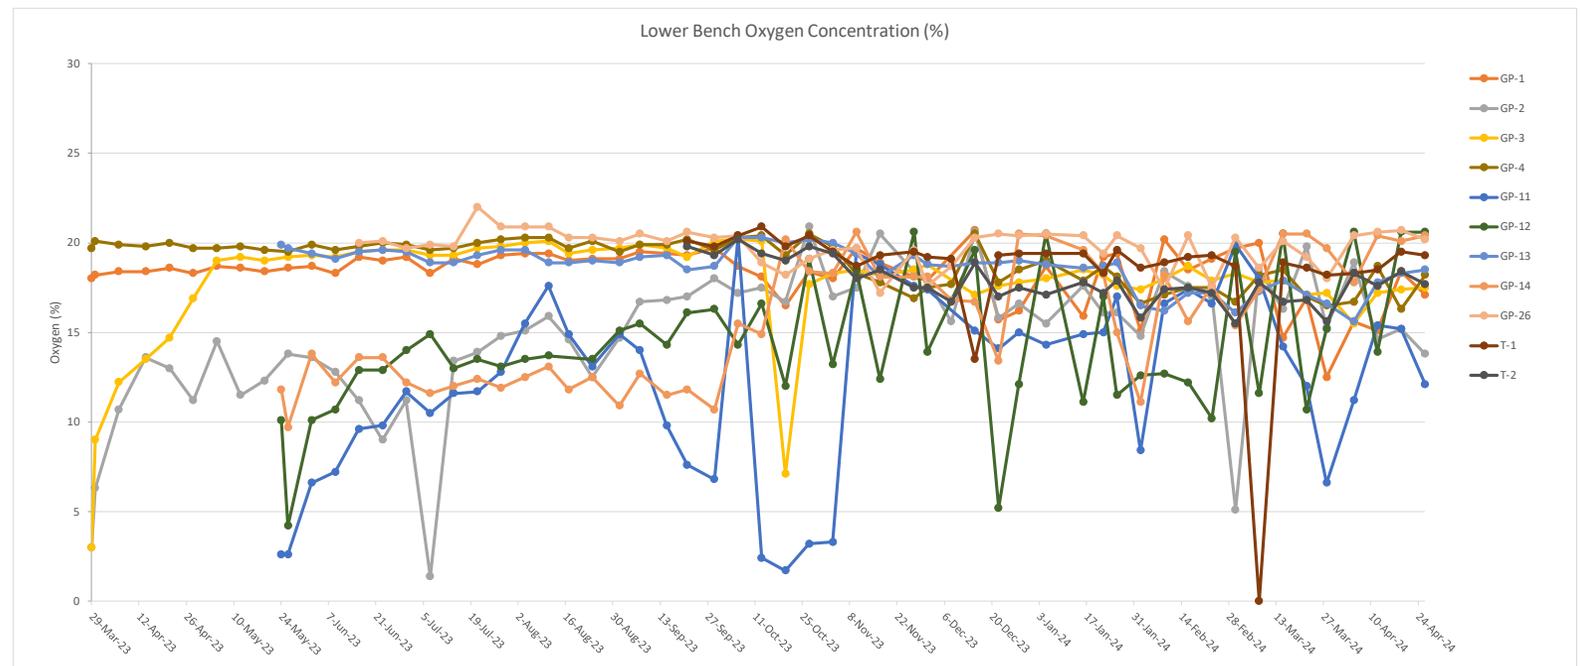
Both areas of landfill (upper and lower bench) are reading high oxygen in past two weeks. This may be due to the fire not consuming any more of the oxygen.

Oldest portion of Landfill is probably relatively inert and biologically inactive, producing very little methane. As a result, pore space is full of atmospheric air.

Some GPs likely susceptible to swings in pressure – LFCI believes this is causing the spikes.

High O₂ below lower bench road continues, has expanded to extent of monitoring - this is likely due to large atmospheric pressure swings and pervious waste mass allowing entry of ambient air.

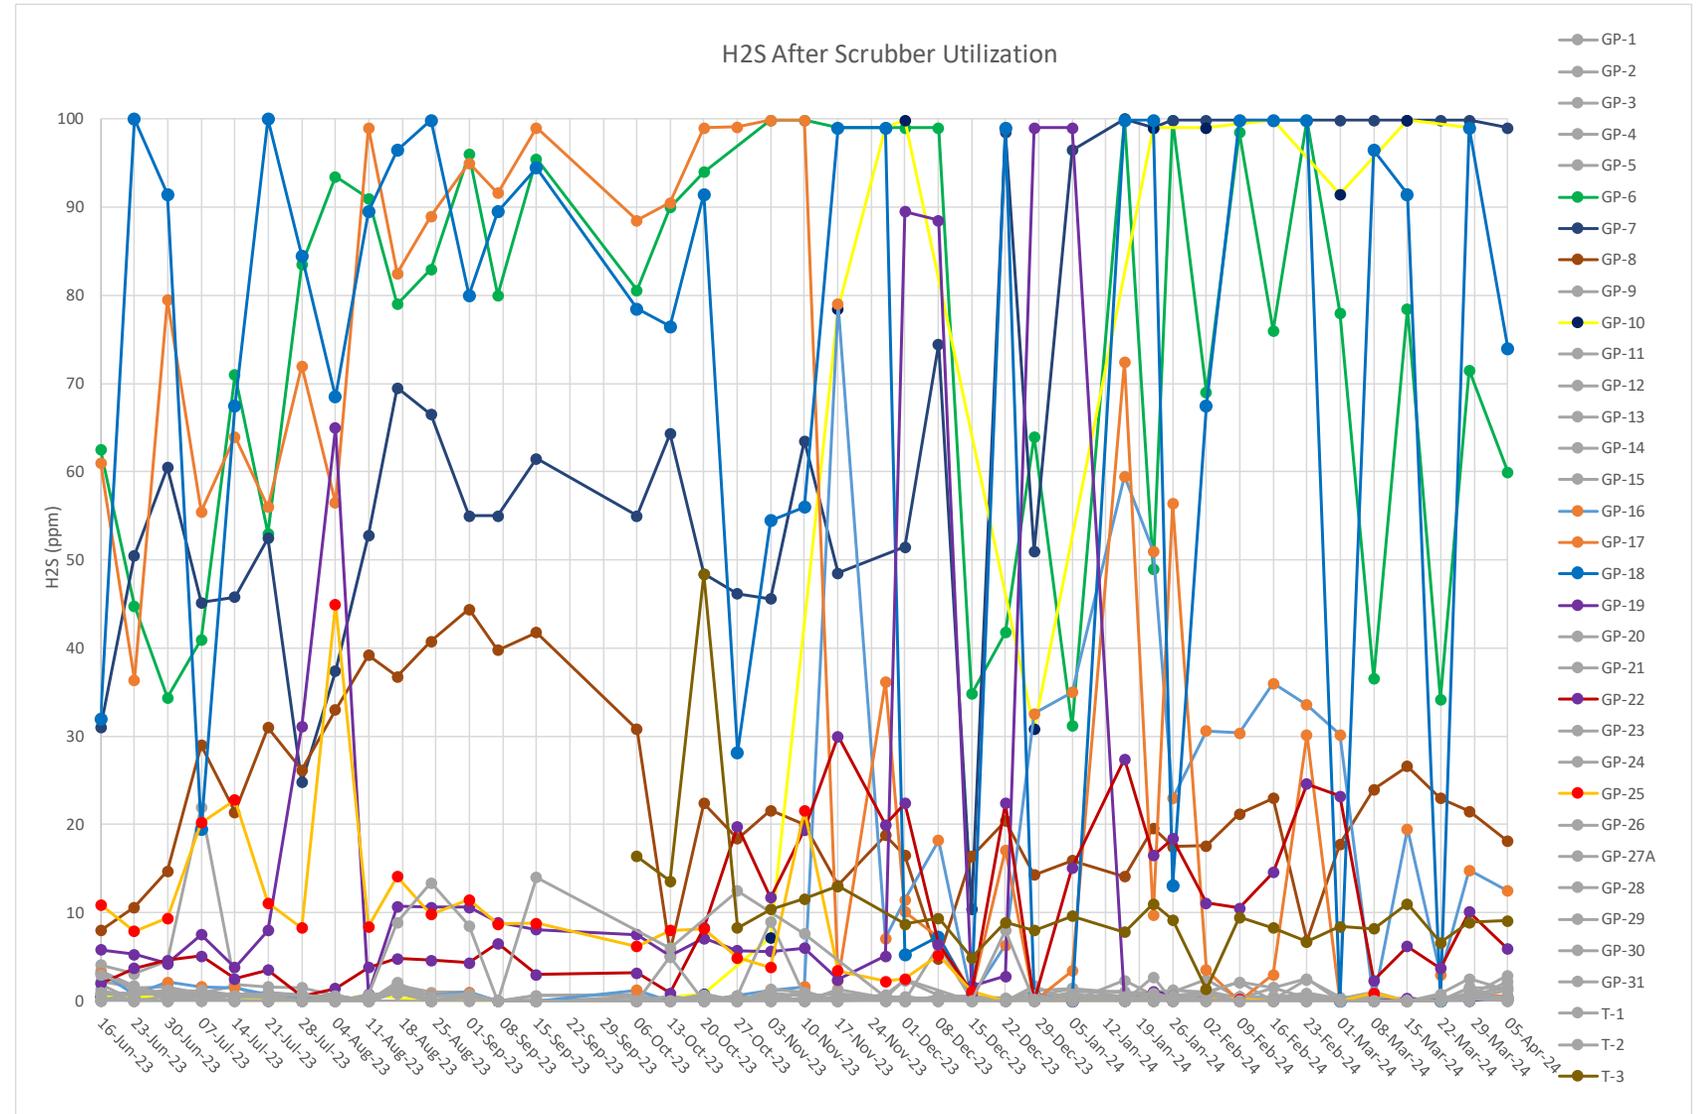
H₂S data continues to be noisy, likely affected by atmospheric pressure fluctuation.

Of note, GP-7 has remained high for past few months, and T-3 has remained stable around 10ppm.

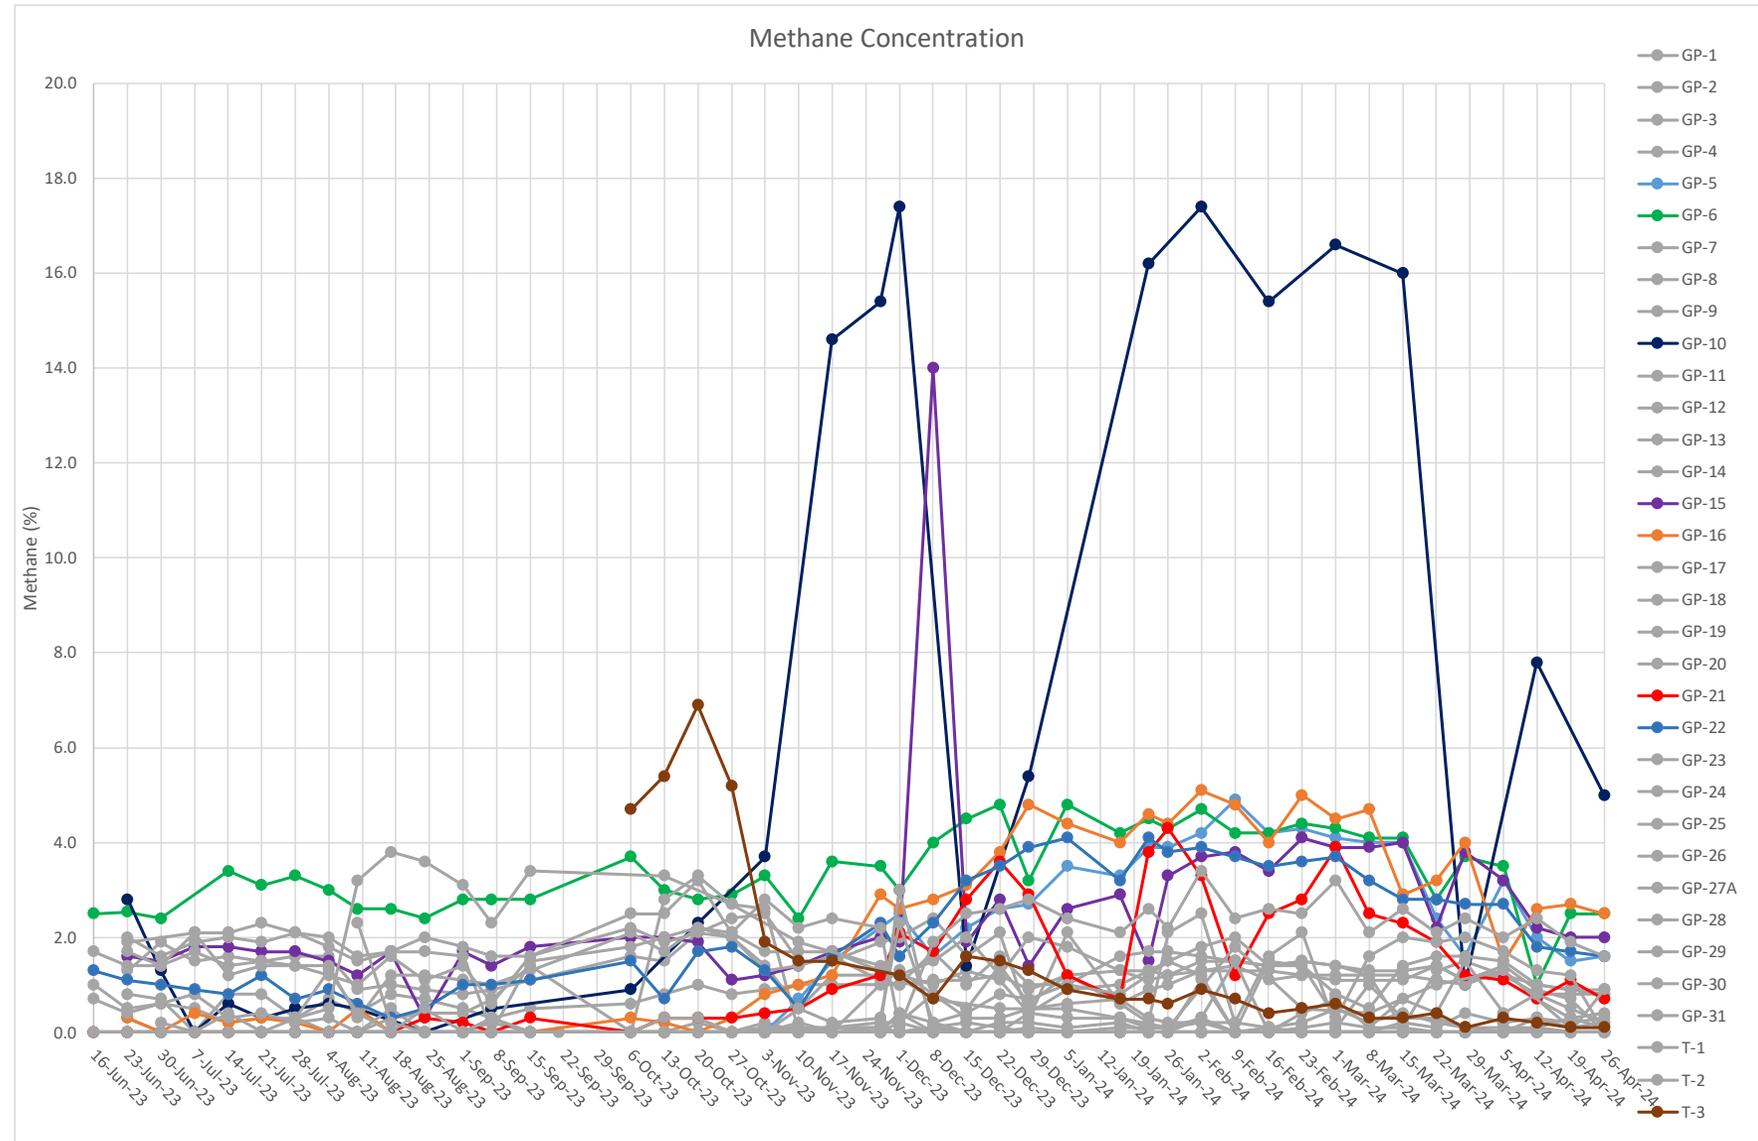
CH₄ (%)

GP-10 has dropped significantly since last month.

South upper bench area slightly elevated, at around 2-4%.

Methane has increased slightly, then decreased since early March as a result of very large atmospheric pressure swings. Now CH₄ is down below 3% in all wells except GP-10.

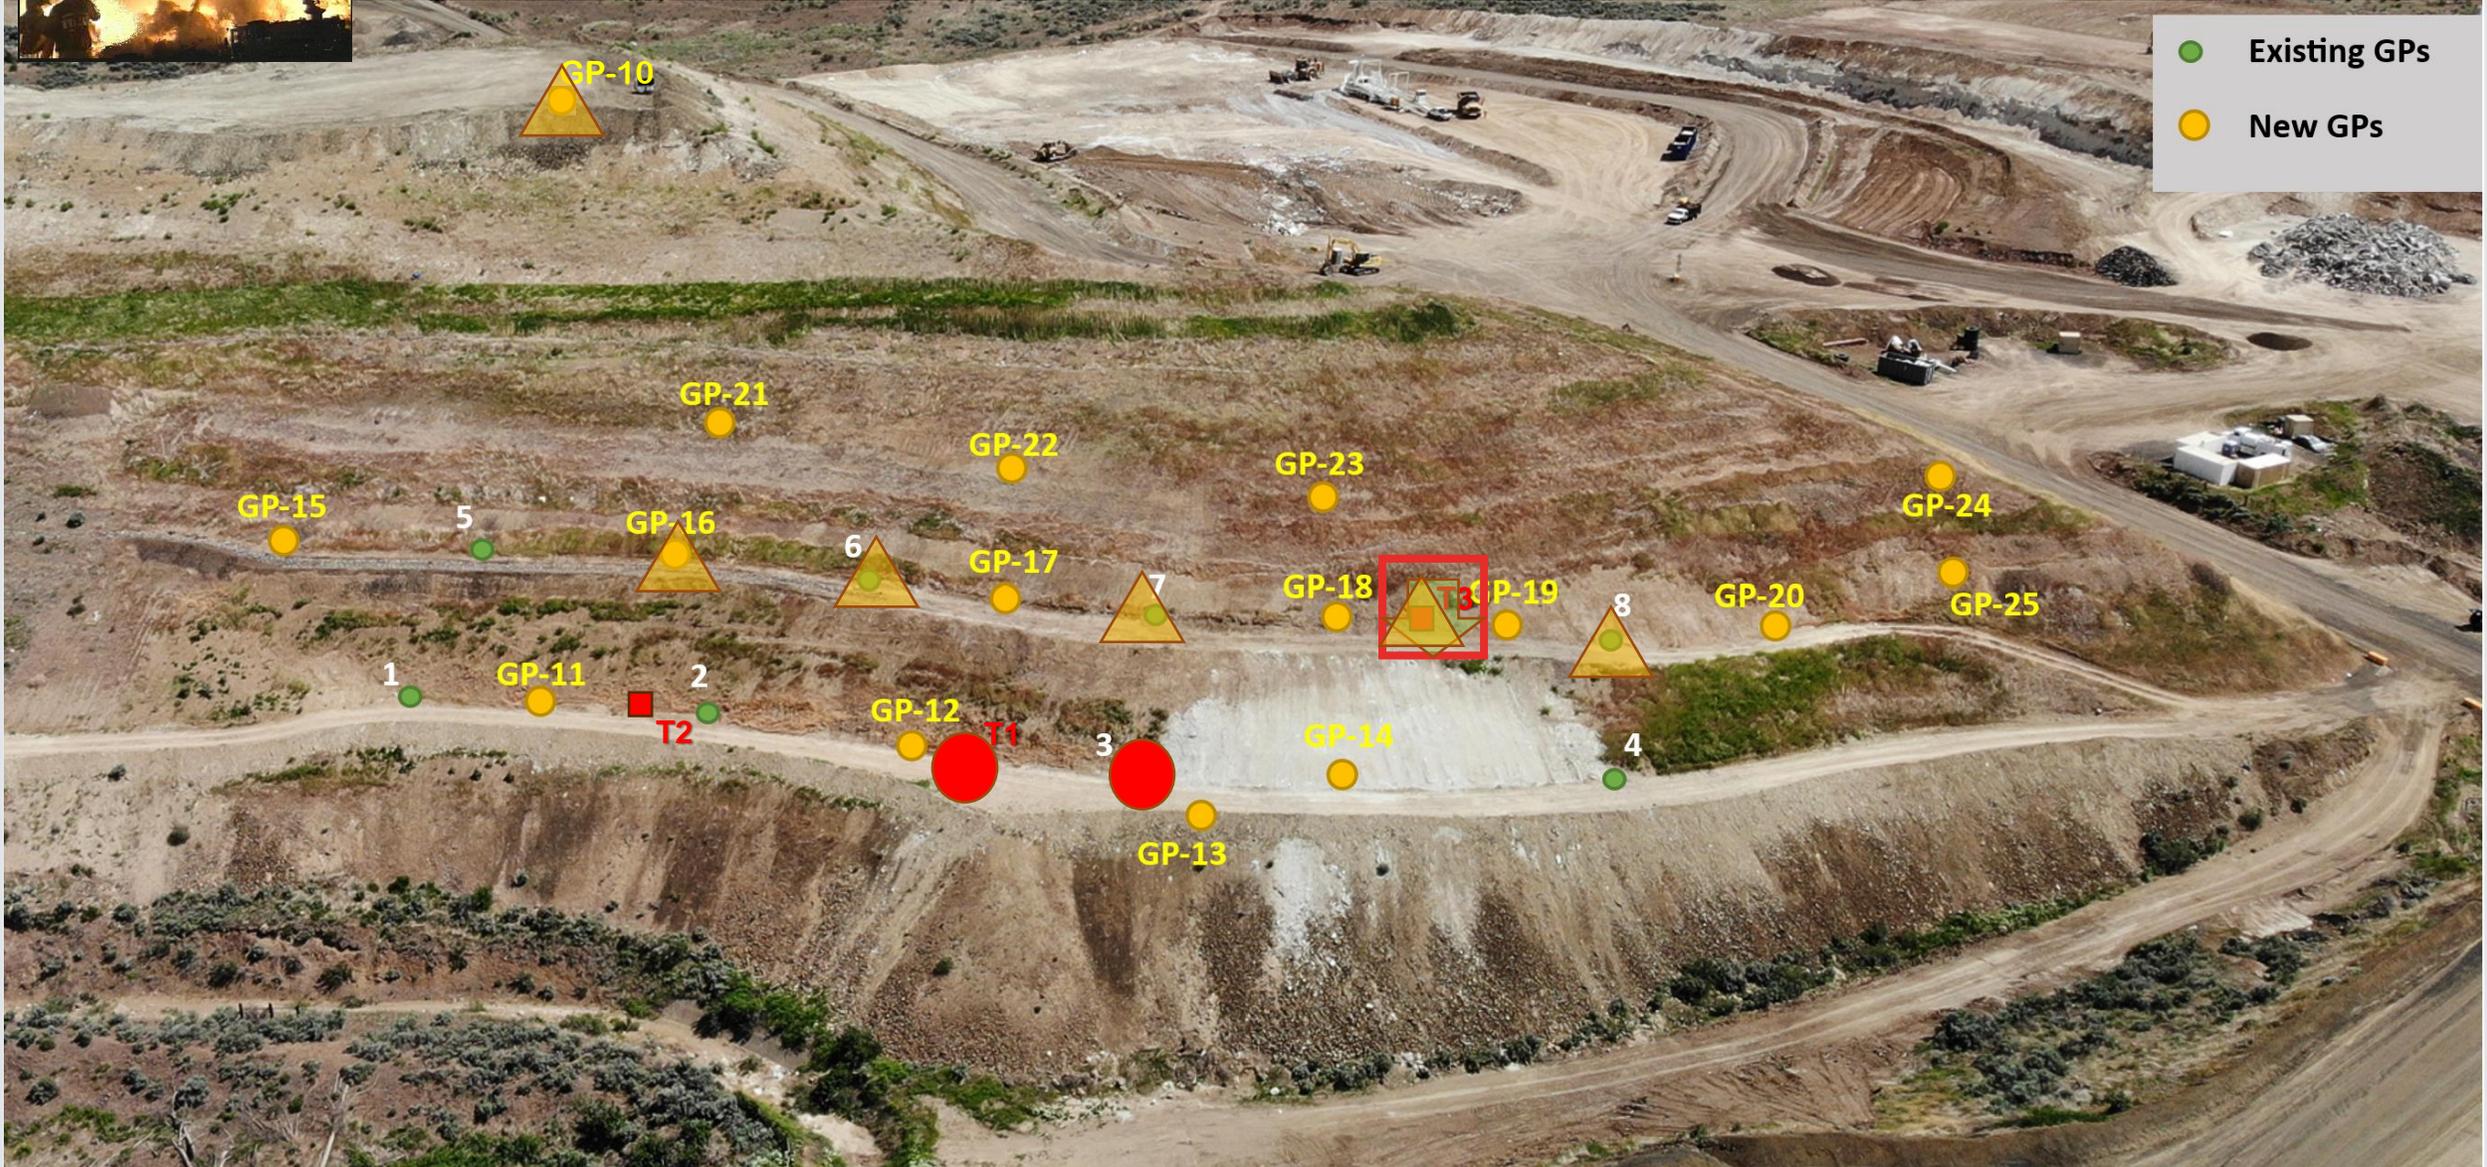
Fire Path

▼ High VOC

● Existing GPs
● New GPs

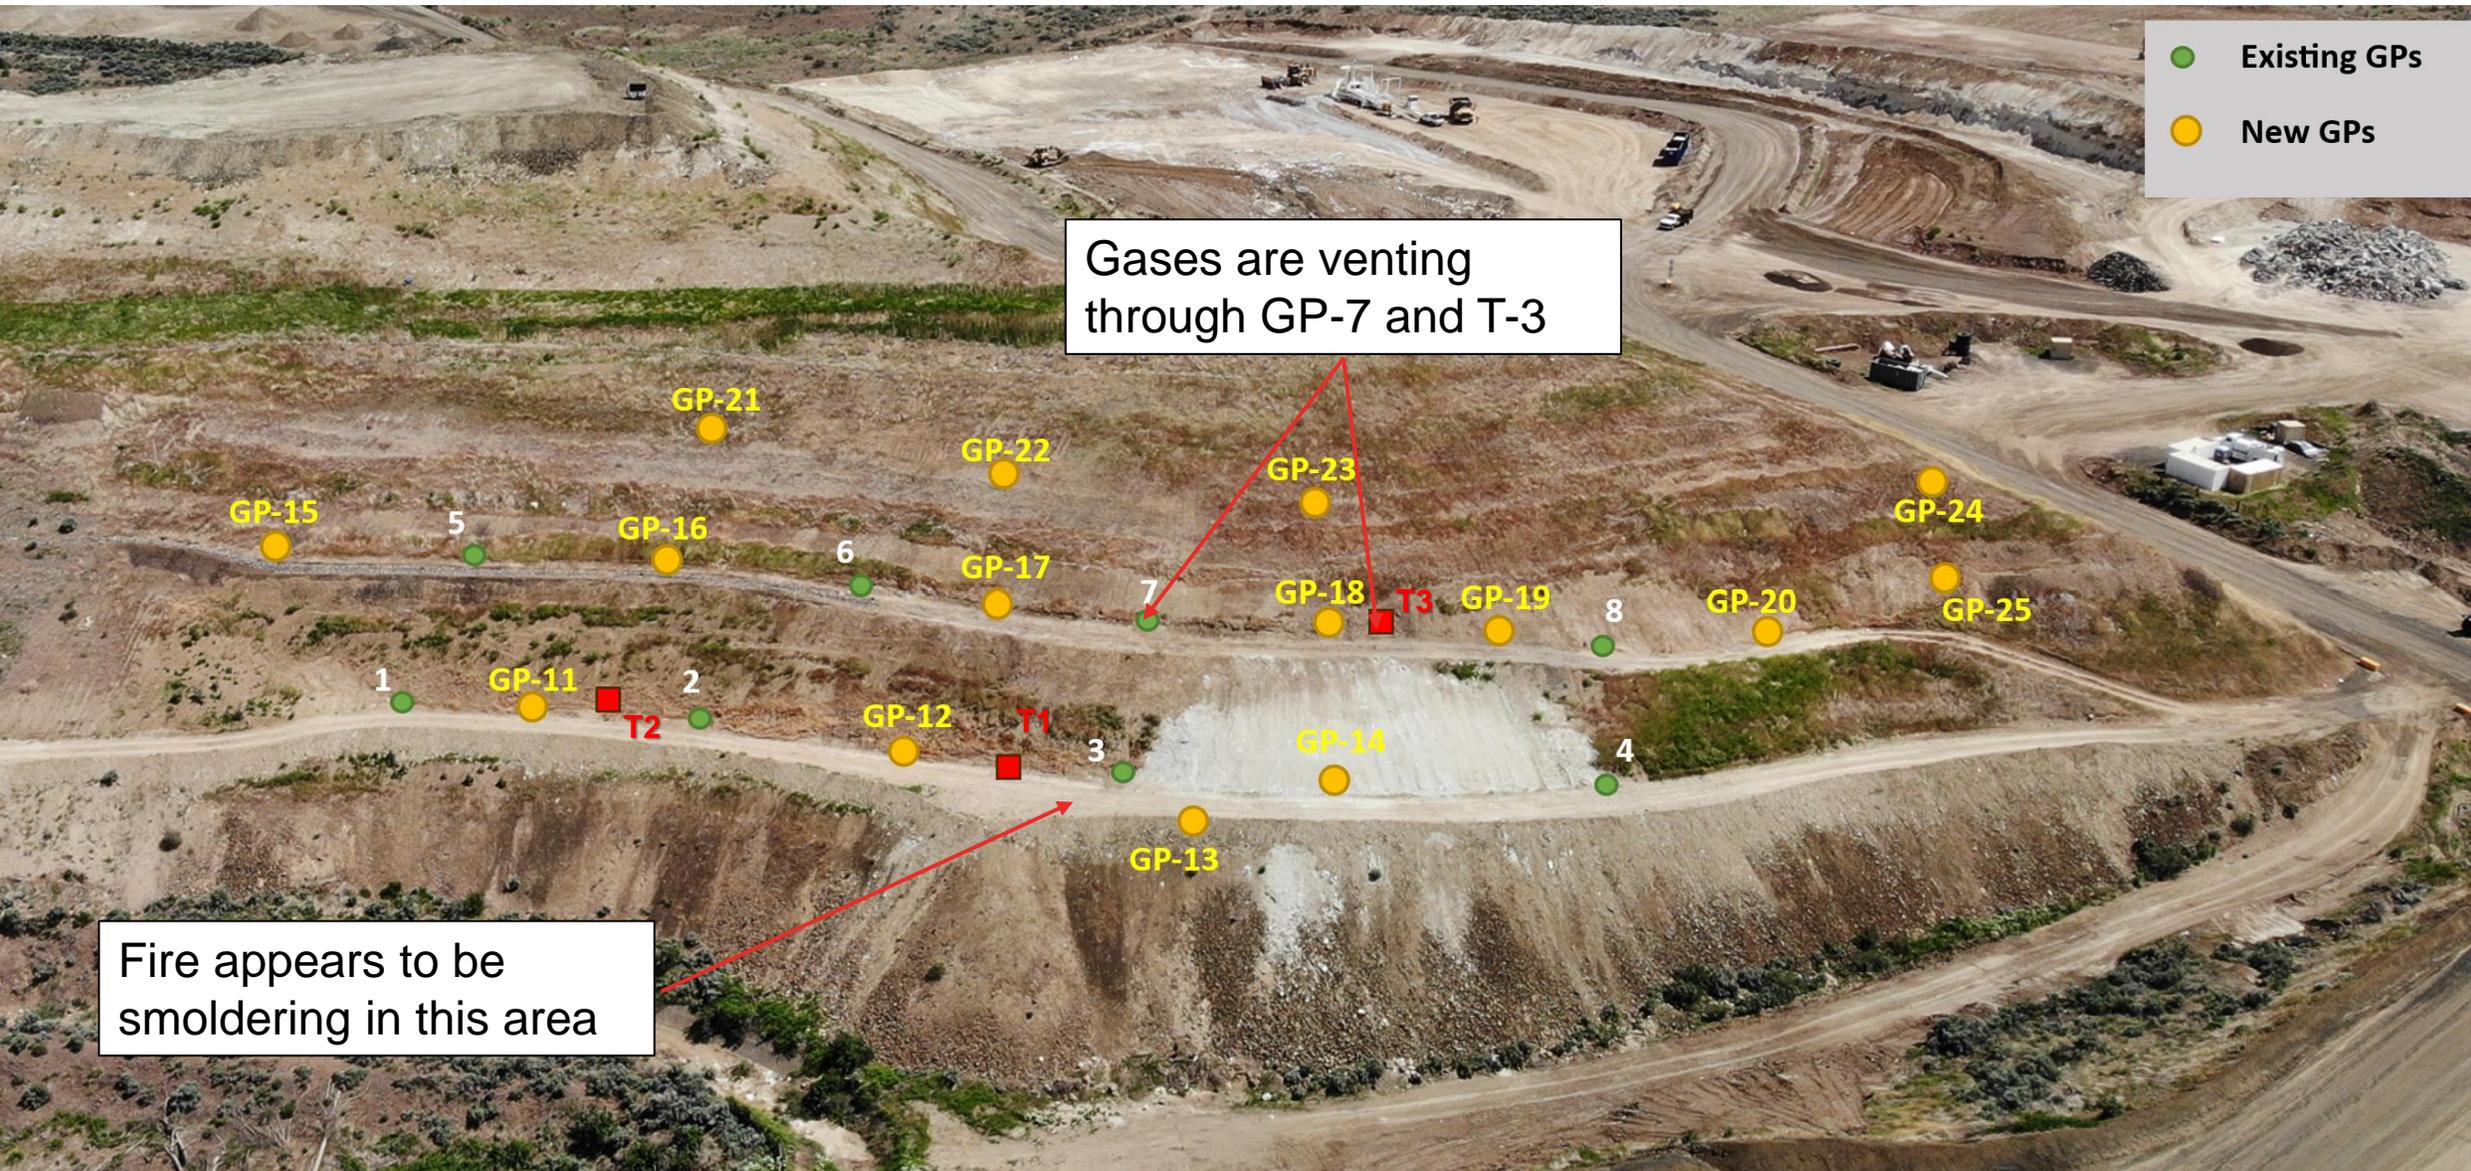
Overall, it appears that the waste is smoldering underneath GP-3 and T-1 (elevated temperature) and a 'chimney' effect is occurring, causing higher CO and VOC's in T-3 and GP-7.
