Re: DTG Yakima – Agreed Order No. DE 21624 – Monthly Progress Letter – April

Re: Monthly Data Assessment Report DTG Yakima Landfill Fire Incident – April 2024

Monthly Monitoring Data Review

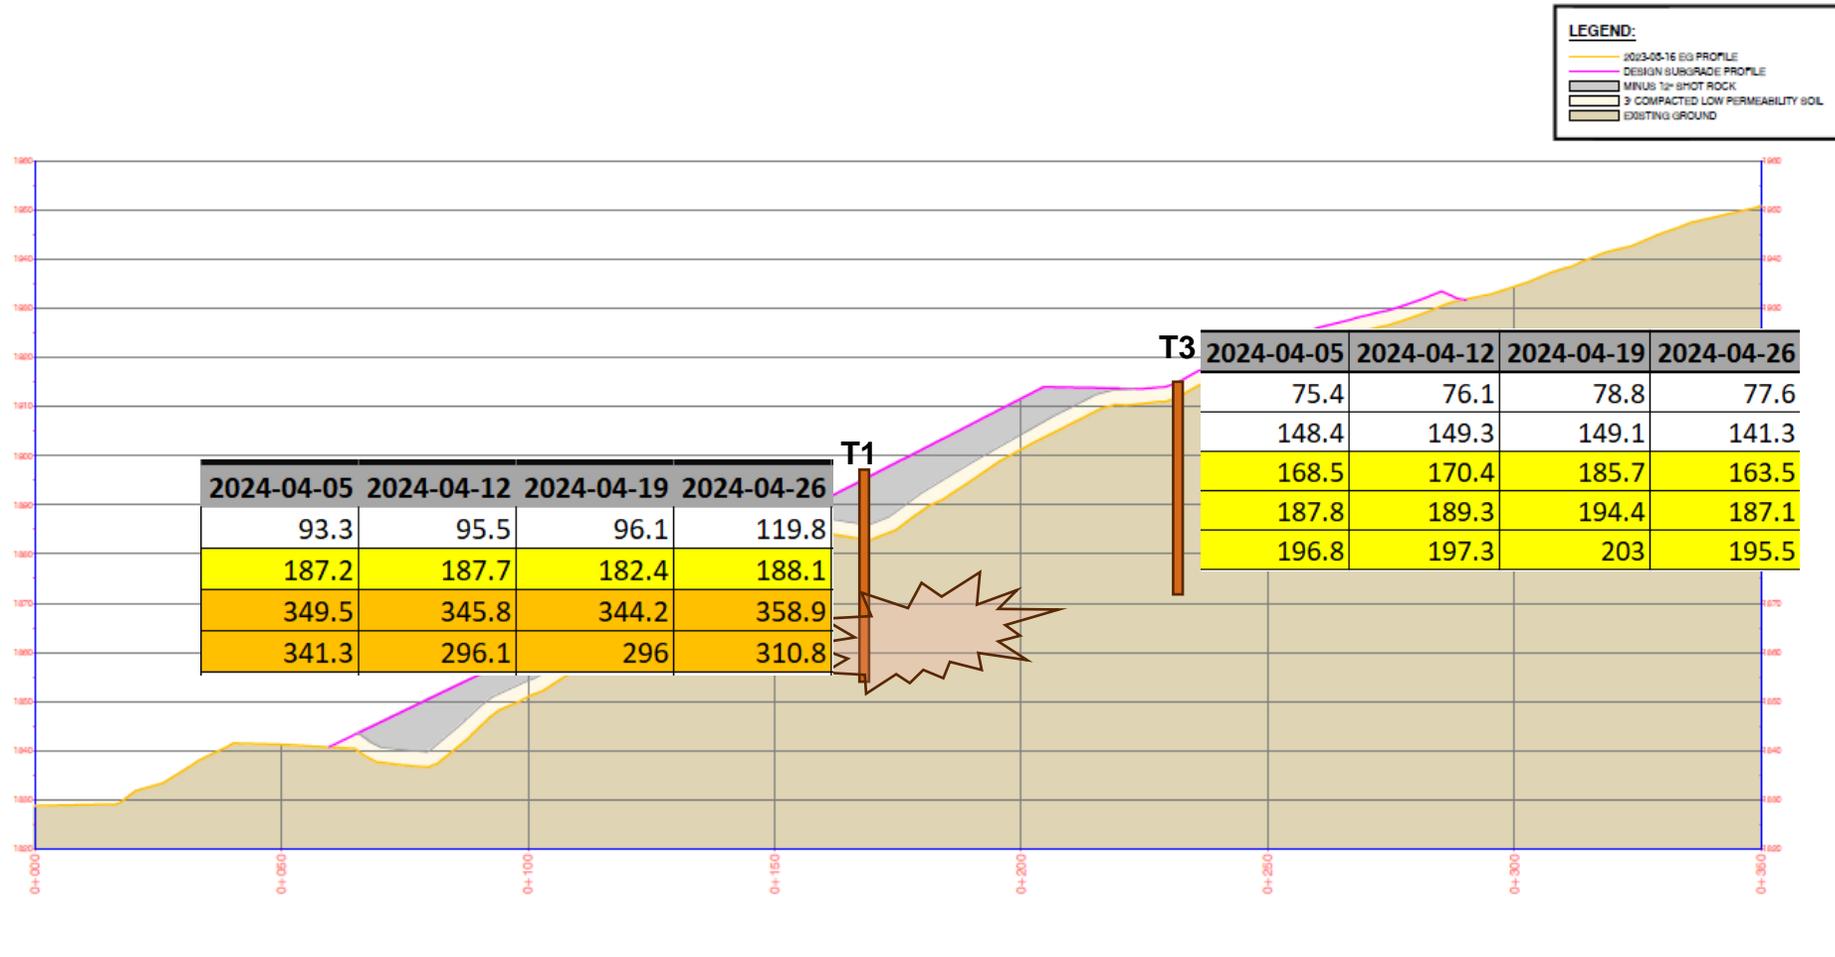
SECTION B - B'
 H - 1" = 25'
 V - 1" = 25'

2024-04-05	2024-04-12	2024-04-19	2024-04-26
	93.3	95.5	96.1	119.8
	187.2	187.7	182.4	188.1
	349.5	345.8	344.2	358.9
	341.3	296.1	296	310.8

2024-04-05	2024-04-12	2024-04-19	2024-04-26
	75.4	76.1	78.8	77.6
	148.4	149.3	149.1	141.3
	168.5	170.4	185.7	163.5
	187.8	189.3	194.4	187.1
	196.8	197.3	203	195.5
