APPENDIX M (continued)
Field Report – Geotechnical

Field Report

Project:
Kite Hill Soil Cover Project

Location:
Gasworks Park, Seattle, WA

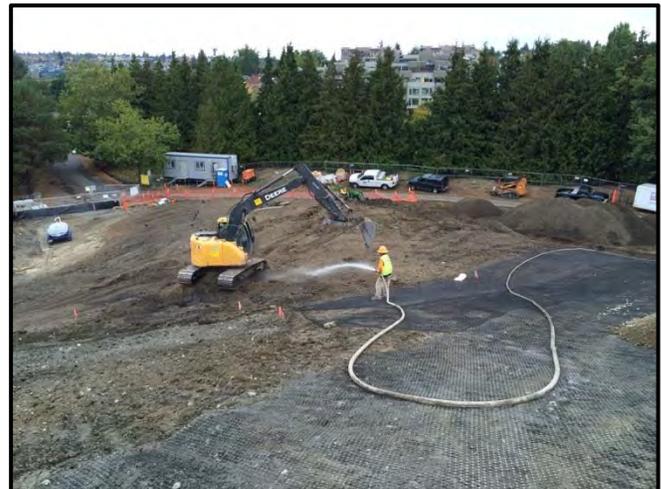
We observed the contractor performing some fine grading (shallow cuts and fills) on the north side and in the northwest quadrant of Kite Hill utilizing a Deere 135 D track mounted excavator. The graded area was moisture conditioned and track compacted by the excavator prior to the placement of the geo-grid (see attached site plan).

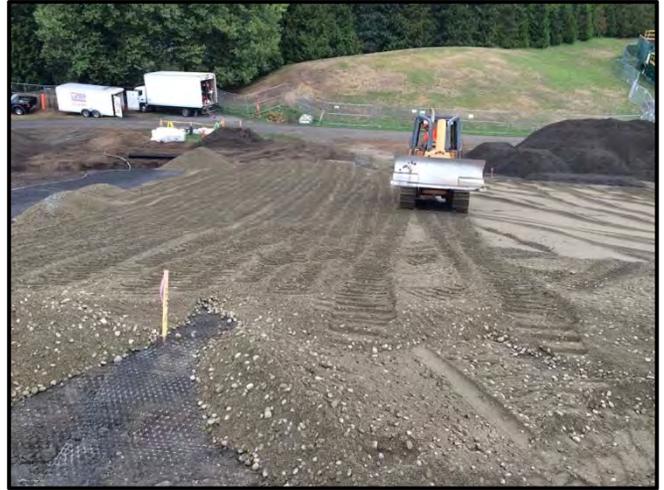
We also observed the contractor place an approximately 6-inch lift of City of Seattle Type 17 bank run gravel (City of Seattle Specification 9-03.12(2)B) over a portion of the geo-grid placed today (see attached site plan). The contractor was moisture conditioning the material utilizing a fire hose. The Type 17 placed today and over the last two days was compacted utilizing an Ingersoll Rand steel drum vibratory roller. After rolling, the contractor track compacted the Type 17 with a minimum of two passes with a Case 650HLT dozer. After the Type 17 was compacted, the contractor began placing an approximately 12-inch lift of topsoil over it (see attached site plan). The topsoil was being dozed into place with a Case 650HLT dozer, and was being track compacted at the same time.

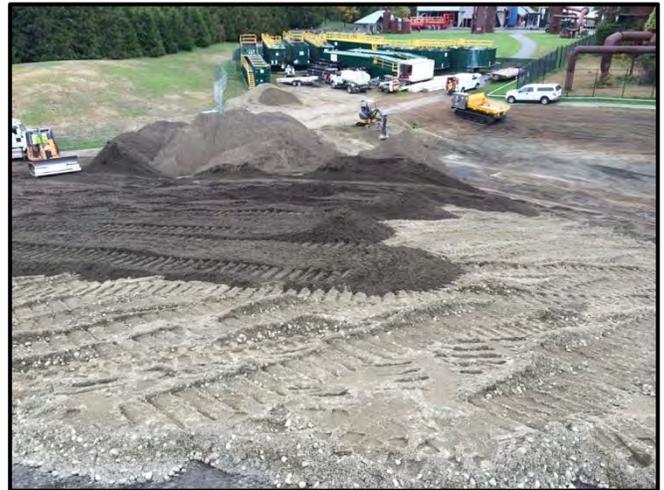
At this time temporary erosion and sedimentation control efforts include silt fencing, temporary interceptor swales, check dams, quarry spalls installed along the edge of the asphalt pavement trucking route, temporary sediment ponds and an array of 10- 20,000 gallon Baker Tanks for runoff storage during storm events (see attached site plan). These efforts were observed to be functioning as intended so that soil was not observed to be leaving the site.

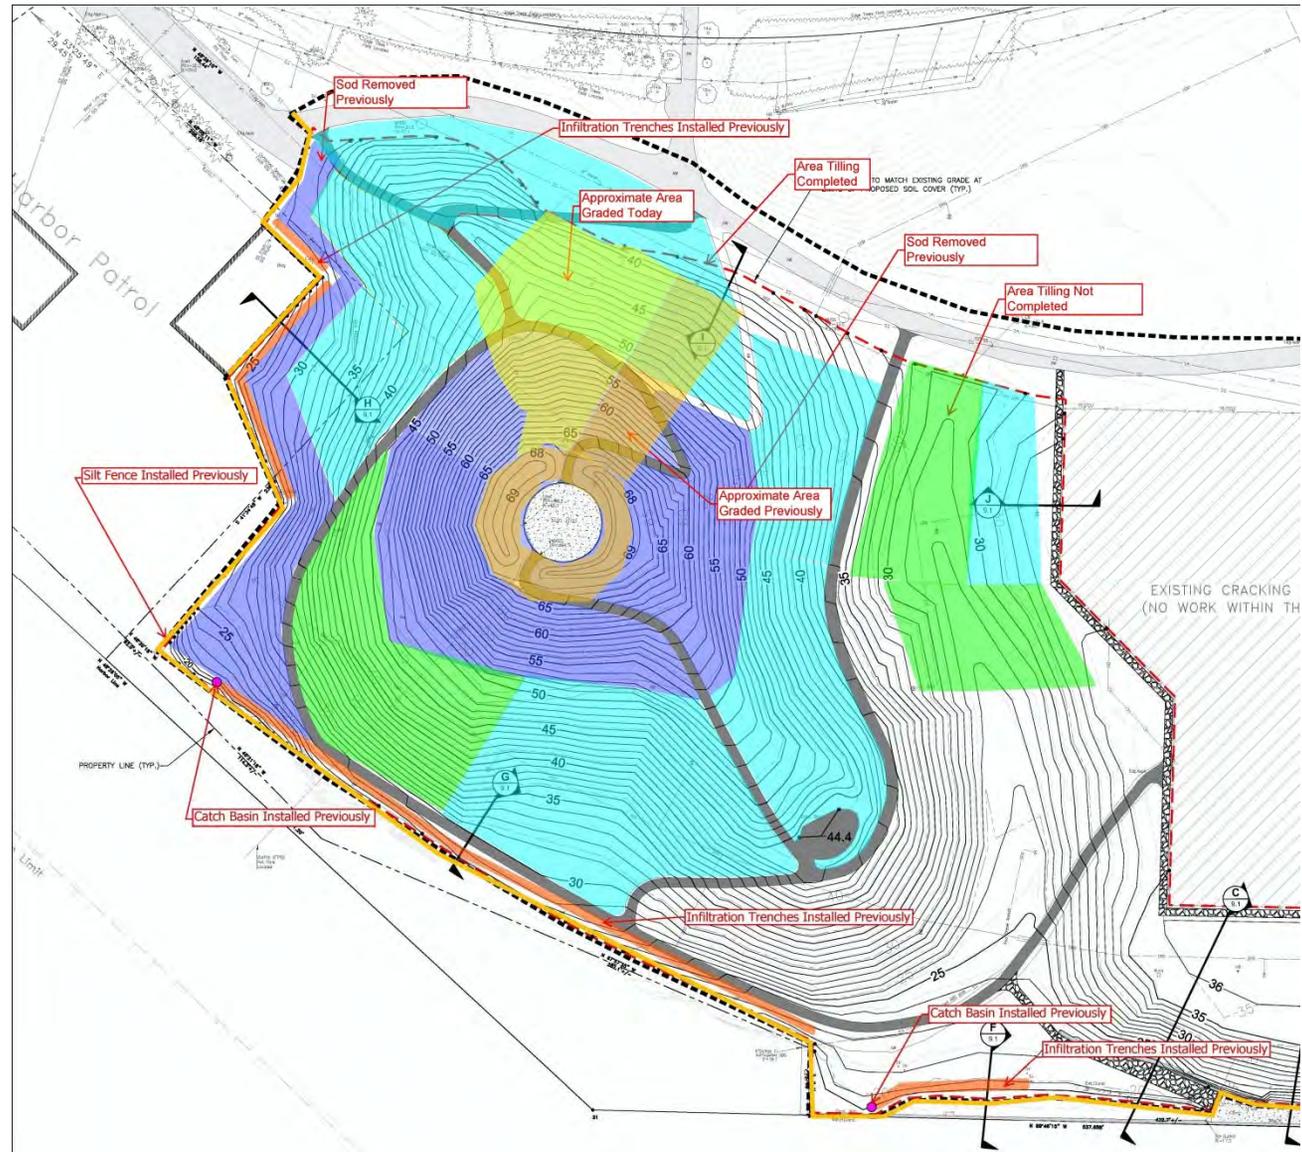
Site Plan of Earthwork

We observed the contractor place geo-grid (Tensar TX130S) on the prepared subgrade on the north and in the northwest quadrant of Kite Hill (see attached site plan). The subgrade was evaluated prior to placing the geo-grid to ensure that the subgrade was compacted properly and was free of pumping soil conditions and observed to be firm. We evaluated the subgrade by means of probing with a 1/2-inch diameter steel probe rod. Probe depths were generally in the range of 2- to 3-inches.

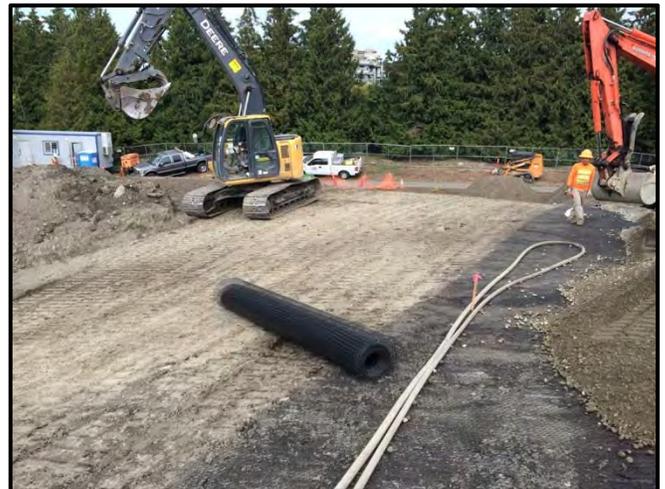
We observed the contractor performing some fine grading (shallow cuts and fills) in the northwest quadrant of Kite Hill utilizing a Deere 135 D track mounted excavator. The graded area was moisture conditioned and track compacted by the excavator prior to the placement of the geo-grid (see attached site plan).

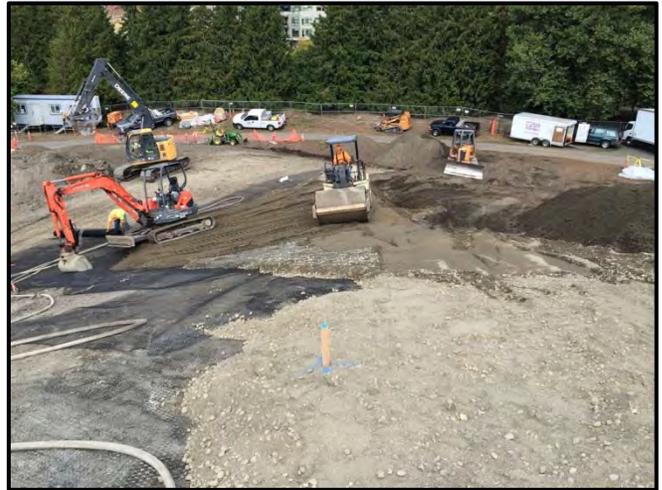
We also observed the contractor place an approximately 6-inch lift of City of Seattle Type 17 bank run gravel (City of Seattle Specification 9-03.12(2)B) over a portion of the geo-grid placed today (see attached site plan). The contractor was moisture conditioning the material utilizing a fire hose. The Type 17 was compacted utilizing an Ingersoll Rand steel drum vibratory roller. After rolling, the contractor track compacted the Type 17 with a minimum of two passes with a Case 650HLT dozer. After the Type 17 was compacted, the contractor began placing an approximately 12-inch lift of topsoil over it (see attached site plan). The topsoil was being dozed into place with a Case 650HLT dozer, and was being track compacted at the same time.

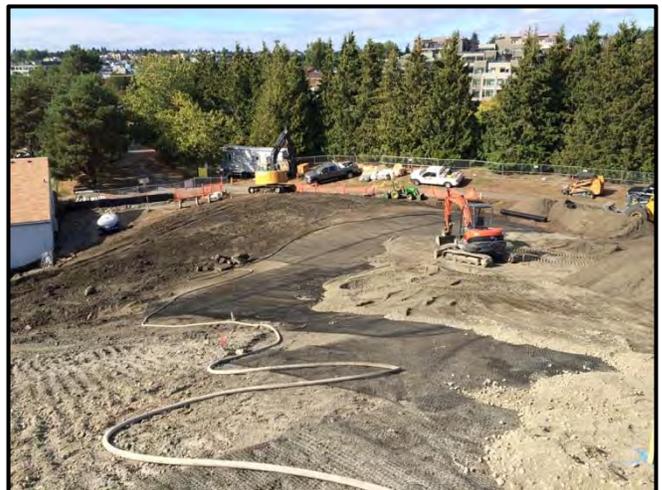
At this time temporary erosion and sedimentation control efforts include silt fencing, temporary interceptor swales, check dams, quarry spalls installed along the edge of the asphalt pavement trucking route, temporary sediment ponds and an array of 10- 20,000 gallon Baker Tanks for runoff storage during storm events (see attached site plan). These efforts were observed to be functioning as intended so that soil was not observed to be leaving the site.

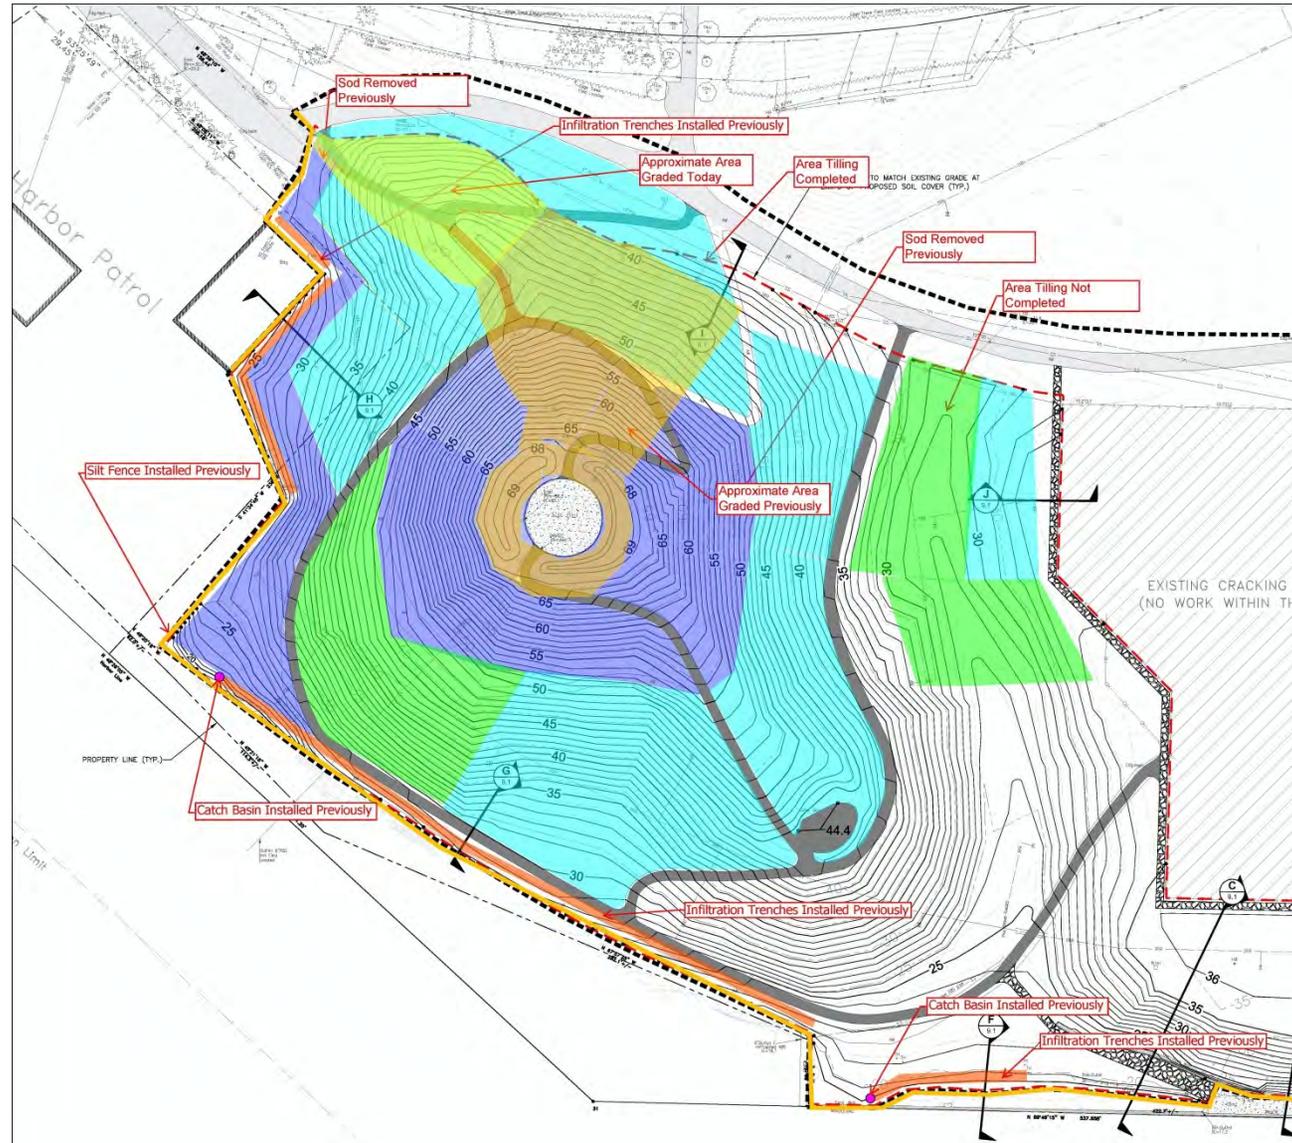
Site Plan of Earthwork

We observed the contractor place geo-grid (Tensar TX130S) on the prepared subgrade in the northwest quadrant of Kite Hill (see attached site plan). The subgrade was evaluated prior to placing the geo-grid to ensure that the subgrade was compacted properly, was free of pumping soil conditions and was observed to be firm. We evaluated the subgrade by means of probing with a ½-inch diameter steel probe rod. Probe depths were generally in the range of 2- to 3-inches.

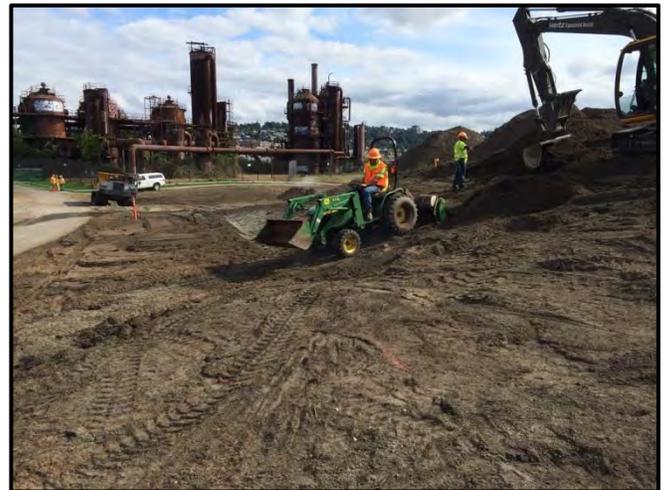
We observed the contractor tilling near the northwest quadrant of Kite Hill where stockpiled materials were previously stored (see attached site plan). The contractor utilized a John Deere tractor with a rear mounted tiller to break up and mix the sod and roots. The tilled area was deemed acceptable after the material was clear of sod clumps and large organics. The area was evaluated by means of probing with a 1/2-inch diameter steel probe rod. Probe depths were generally in the range of 8- to 10-inches. The contractor was also removing debris (brick, concrete, asphalt, metal) larger than 4 inches in diameter from the tilled area.

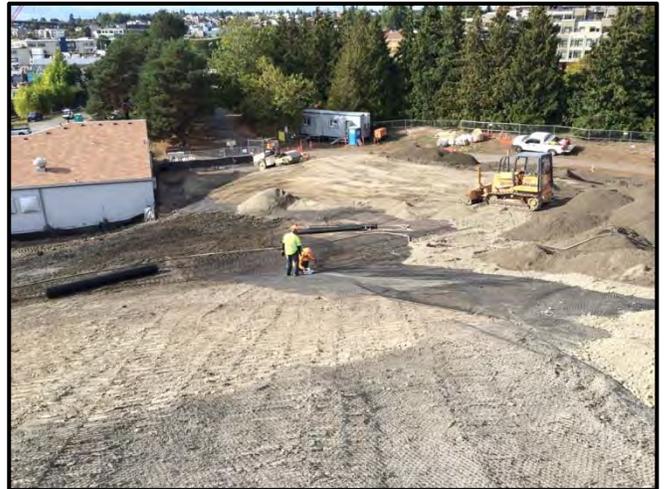
We observed the contractor place geo-grid (Tensar TX130S) on the prepared subgrade in the northwest quadrant of Kite Hill (see attached site plan). The subgrade was evaluated prior to placing the geo-grid to ensure that the subgrade was compacted properly, was free of pumping soil conditions and was observed to be firm. We evaluated the subgrade by means of probing with a ½-inch diameter steel probe rod. Probe depths were generally in the range of 2- to 3-inches.

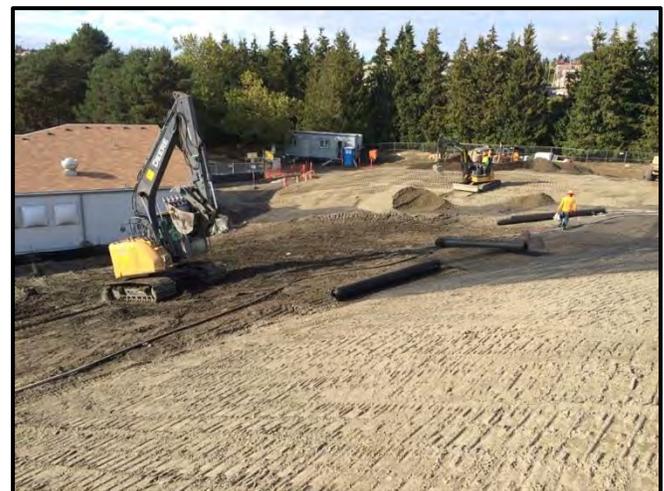
At this time temporary erosion and sedimentation control efforts include silt fencing, temporary interceptor swales, check dams, quarry spalls installed along the edge of the asphalt pavement trucking route, temporary sediment ponds and an array of 10- 20,000 gallon Baker Tanks for runoff storage during storm events (see attached site plan). These efforts were observed to be functioning as intended so that soil was not observed to be leaving the site.

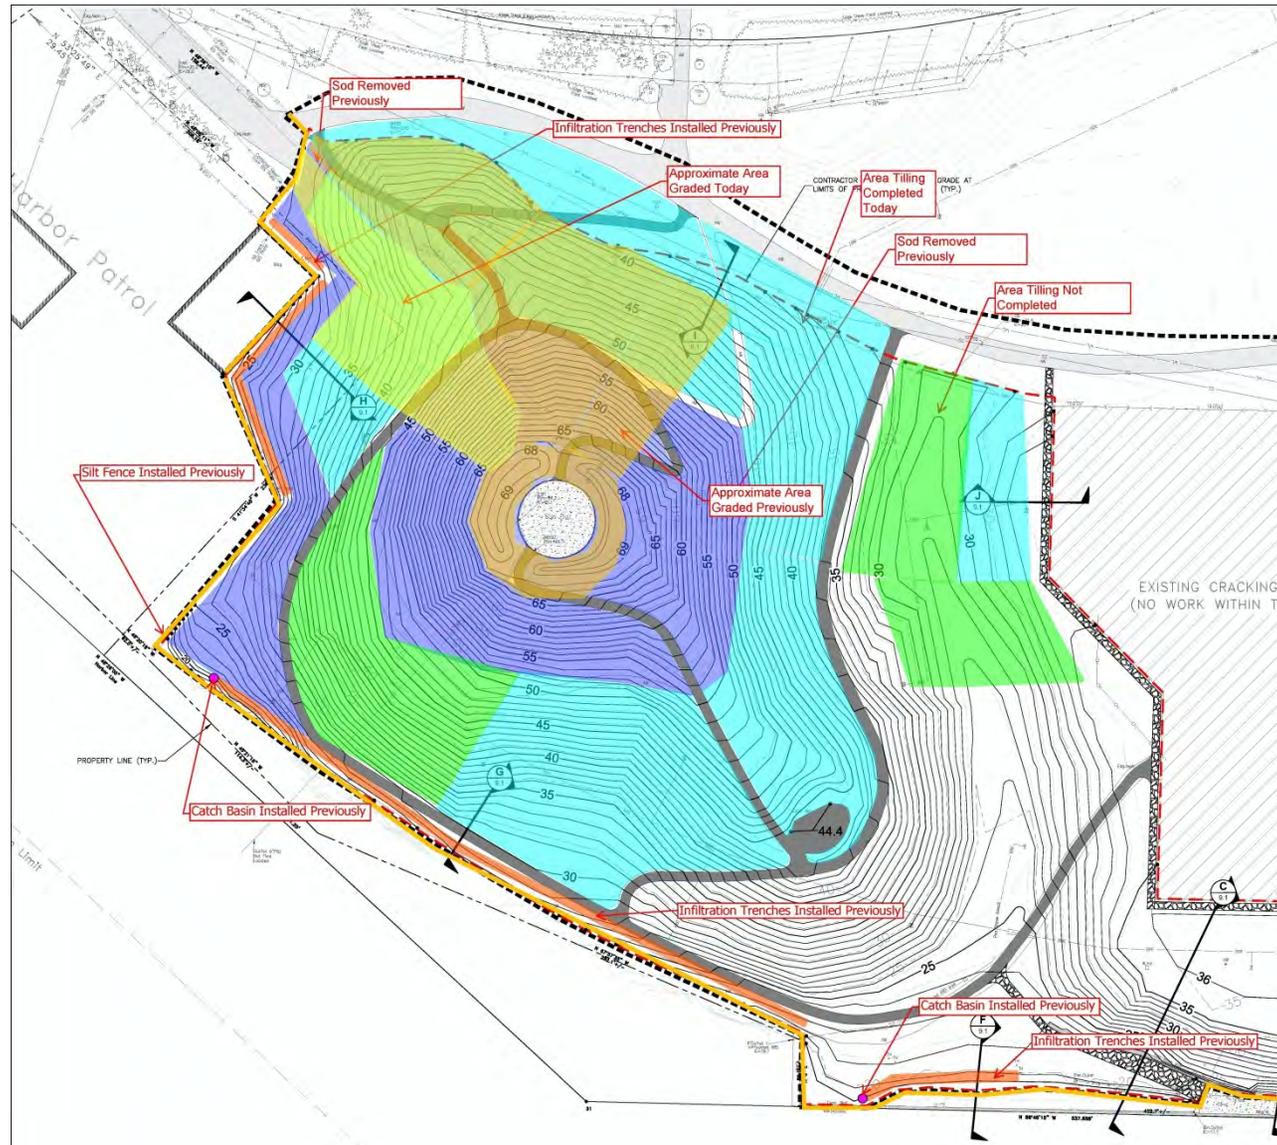
Site Plan of Earthwork

We observed the contractor performing some fine grading (shallow cuts and fills) in the northwest quadrant of Kite Hill utilizing a Deere 135 D track mounted excavator. The graded area was moisture conditioned and track compacted by the excavator prior to the placement of the geo-grid (see attached site plan).

We also observed the contractor place an approximately 6-inch lift of City of Seattle Type 17 bank run gravel (City of Seattle Specification 9-03.12(2)B) over a portion of the geo-grid placed today (see attached site plan). The contractor was moisture conditioning the material utilizing a fire hose. The Type 17 was compacted utilizing an Ingersoll Rand steel drum vibratory roller. After rolling, the contractor track compacted the Type 17 with a minimum of two passes with a Case 650HLT dozer. After the Type 17 was compacted, the contractor began placing an approximately 12-inch lift of topsoil over it (see attached site plan). The topsoil was being dozed into place with a Case 650HLT dozer, and was being track compacted at the same time.

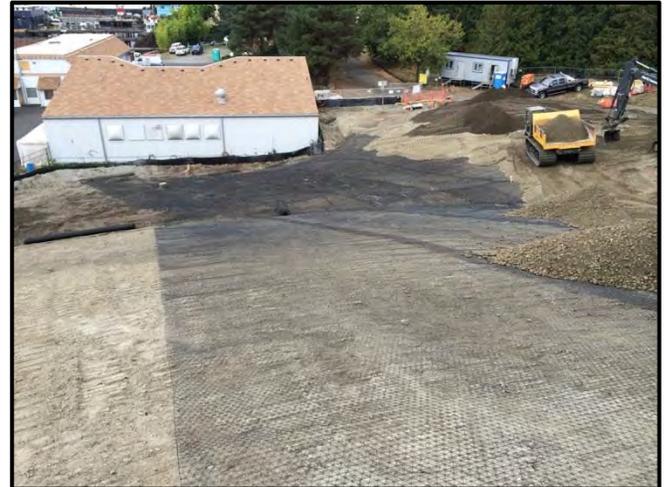
We observed the contractor performing some fine grading (shallow cuts and fills) on the west side of Kite Hill utilizing a Deere 135 D track mounted excavator. The graded area was moisture conditioned and track compacted by the excavator prior to the placement of the geo-grid (see attached site plan).

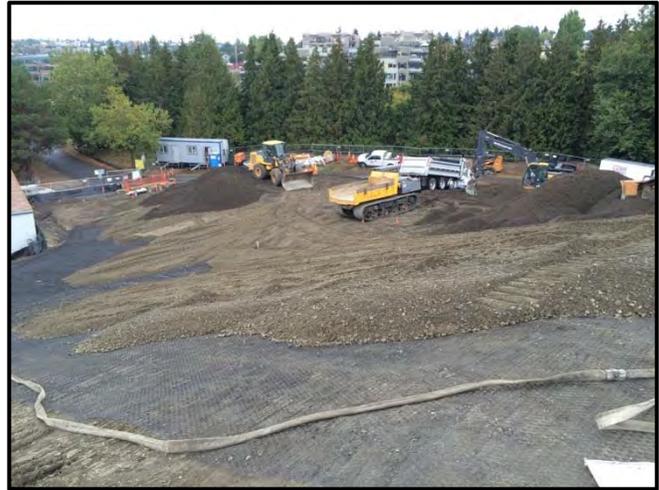
We also observed the contractor place an approximately 6-inch lift of City of Seattle Type 17 bank run gravel (City of Seattle Specification 9-03.12(2)B) over a portion of the geo-grid placed today (see attached site plan). The contractor was moisture conditioning the material utilizing a fire hose. The Type 17 was compacted utilizing an Ingersoll Rand steel drum vibratory roller. After rolling, the contractor track compacted the Type 17 with a minimum of two passes with a Case 650HLT dozer. After the Type 17 was compacted, the contractor began placing an approximately 12-inch lift of topsoil over it (see attached site plan). The topsoil was being dozed into place with a Case 650HLT dozer, and was being track compacted at the same time.

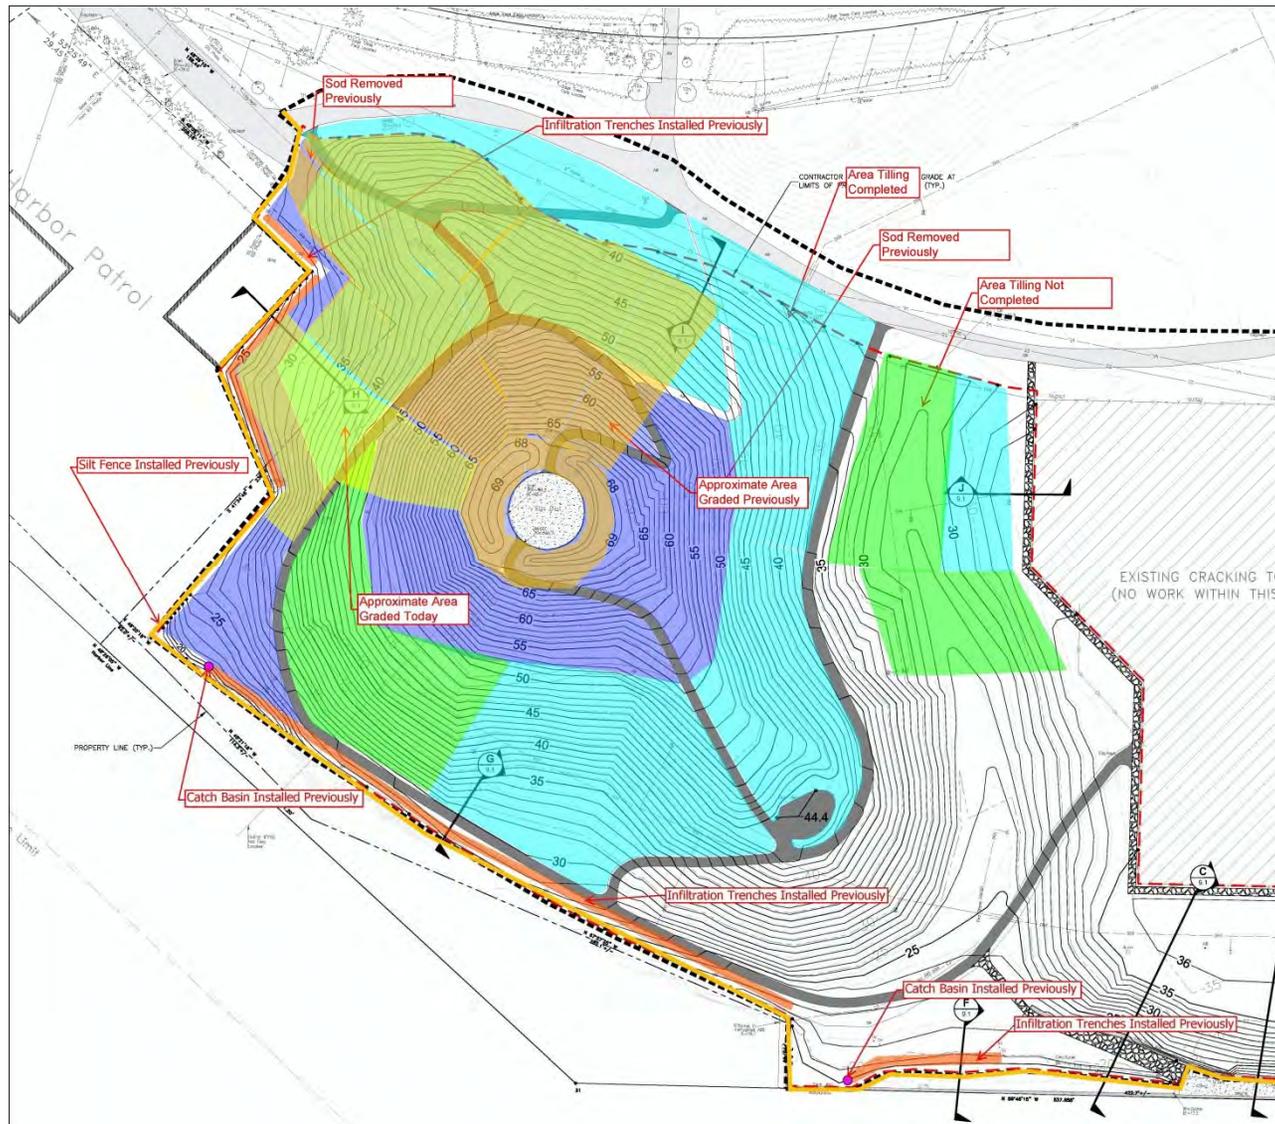
Site Plan of Earthwork

We observed the contractor place geo-grid (Tensar TX130S) on the prepared subgrade on the west side of Kite Hill (see attached site plan). The subgrade was evaluated prior to placing the geo-grid to ensure that the subgrade was compacted properly, was free of pumping soil conditions and was observed to be firm. We evaluated the subgrade by means of probing with a 1/2-inch diameter steel probe rod. Probe depths were generally in the range of 2- to 3-inches.

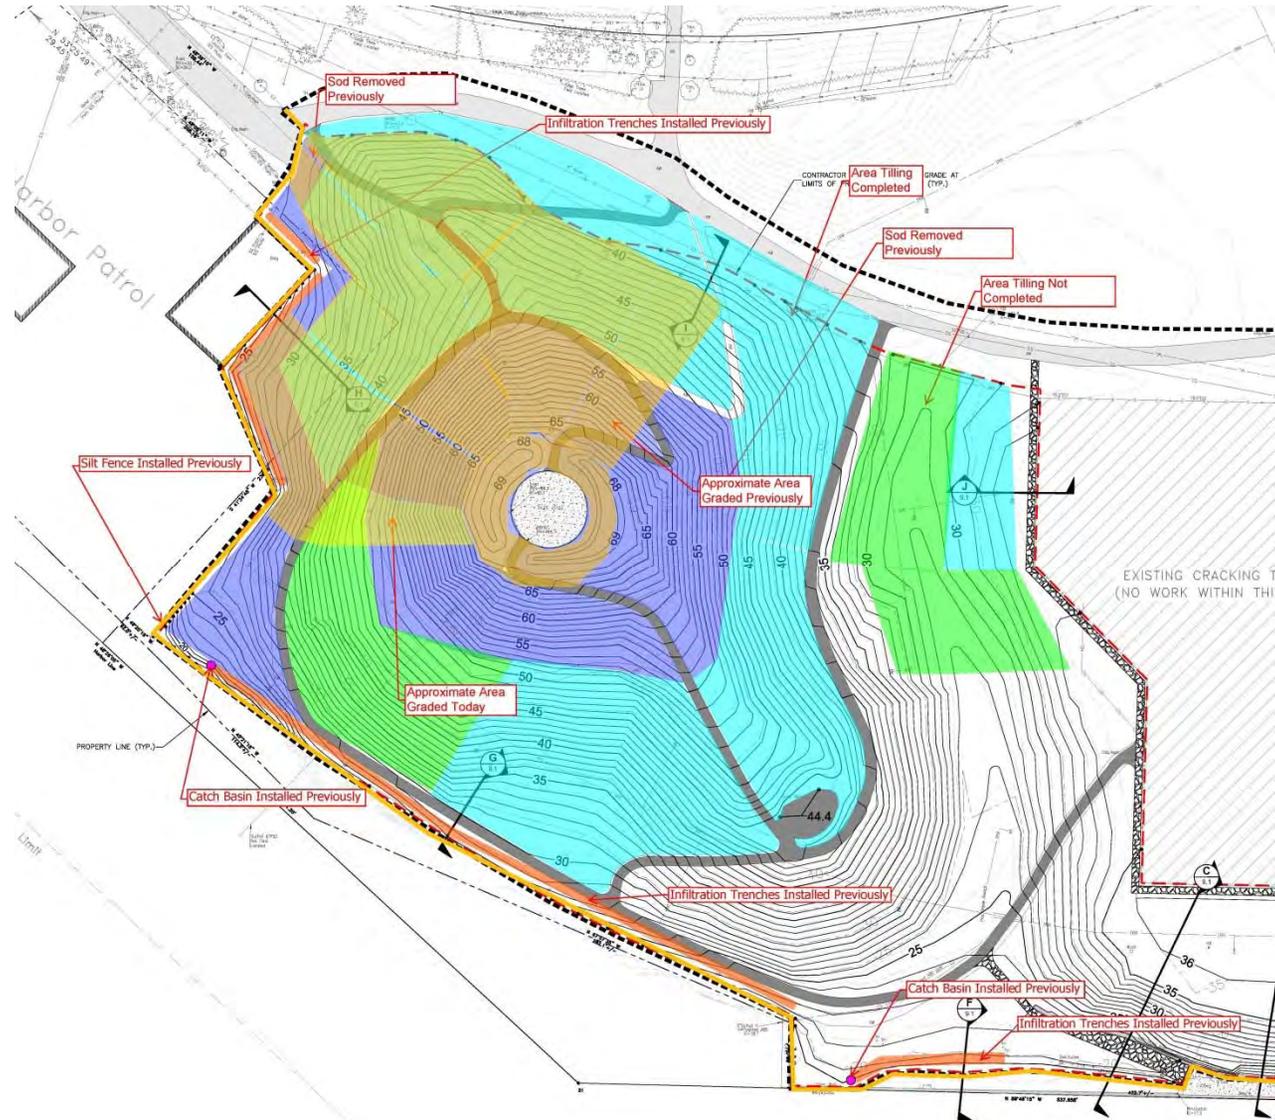
Site Plan of Earthwork

We observed the contractor performing some fine grading (shallow cuts and fills) in the northwest quadrant of Kite Hill utilizing a Deere 135 D track mounted excavator. The graded area was not track compacted as the subgrade was too wet. No geo-grid was placed in the area yet (see attached site plan).

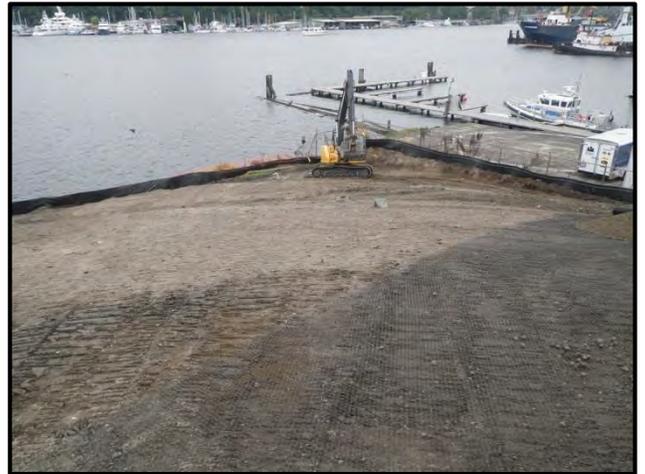
We observed the contractor performing some fine grading (shallow cuts and fills) in the southwest quadrant of Kite Hill utilizing a Deere 135 D track mounted excavator. The graded area was track compacted by the excavator prior to the placement of the geo-grid (see attached site plan).

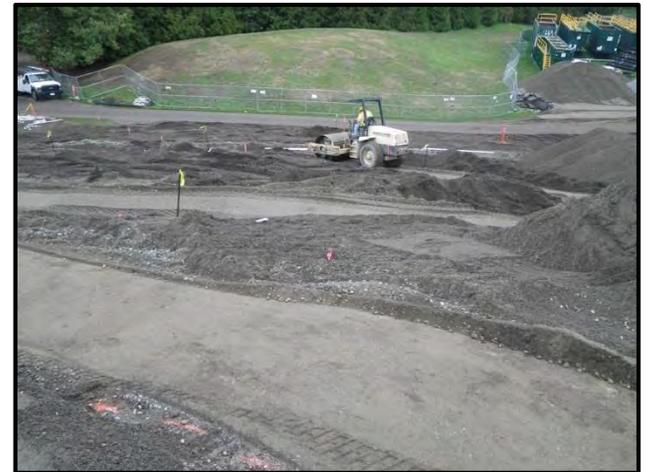
We also observed the contractor preparing the subgrades for the paved pedestrian paths on the north side of Kite Hill. The contractor placed approximately 6-inches of Type 17 along the path alignment and compacted it with an Ingersoll Rand steel drum vibratory roller. After the Type 17 was compacted, we observed the contractor begin placing 5/8-inch minus crushed rock base course over it.

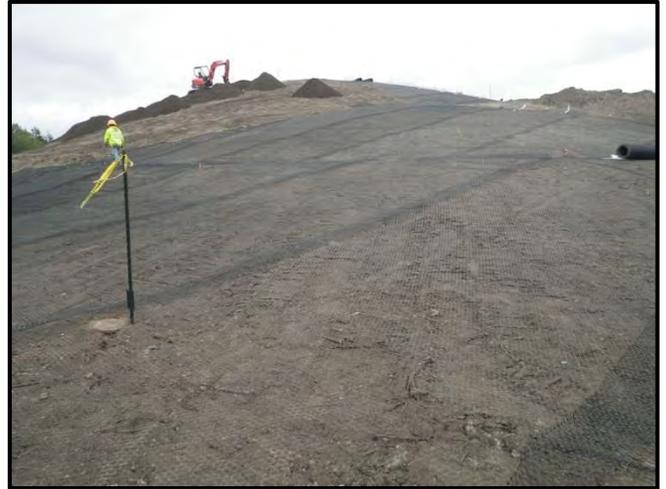
We observed the contractor place geo-grid (Tensar TX130S) on the prepared subgrade in the southwest quadrant of Kite Hill (see attached site plan). The subgrade was evaluated prior to placing the geo-grid to ensure that the subgrade was compacted properly, was free of pumping soil conditions and was observed to be firm. We evaluated the subgrade by means of probing with a ½-inch diameter steel probe rod. Probe depths were generally in the range of 2 to 3 inches. In those areas that were not tilled where grading is progressing, the contractor stripped the sod and stockpiled it on site for later removal.

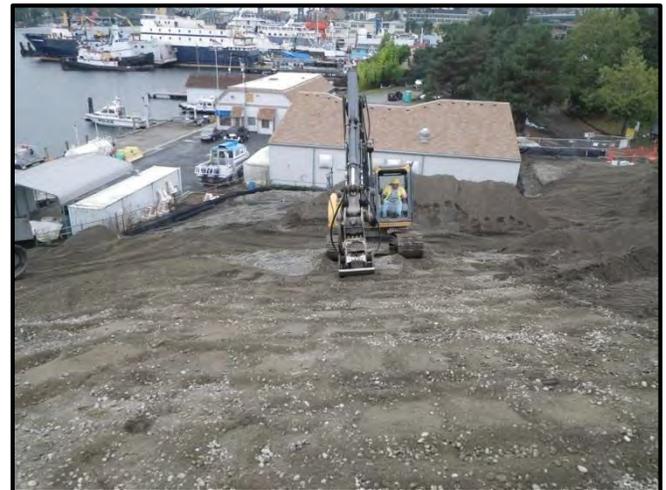
We also observed the contractor place an approximately 6-inch thick lift of City of Seattle Type 17 bank run gravel (City of Seattle Specification 9-03.12(2)B) over a portion of the geo-grid placed today (see attached site plan). The Type 17 was compacted utilizing a hoepac attached to a Deere 135 D track mounted excavator. After compacting, the contractor track compacted the Type 17 with a minimum of two passes with a Case 650HLT dozer. After the Type 17 was compacted, the contractor began placing an approximately 12-inch thick lift of topsoil over it (see attached site plan). The topsoil was being dozed into place with a Case 650HLT dozer, and was being track compacted at the same time.

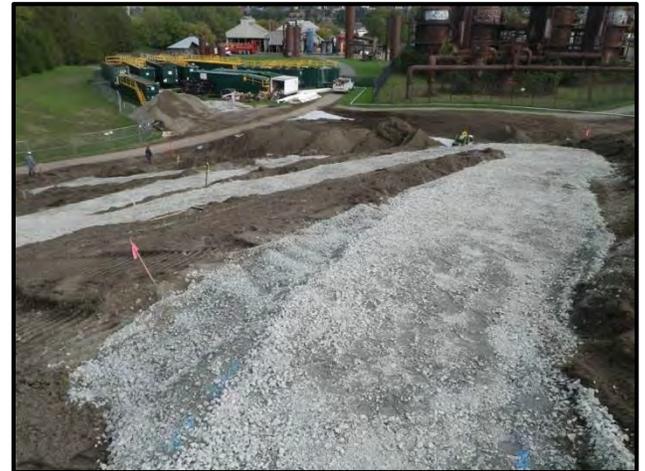
We also observed the contractor preparing the subgrades for the paved pedestrian paths on the north side of Kite Hill. The contractor placed approximately 6-inches of Type 17 at the path alignment and compacted it with an Ingersoll Rand steel drum vibratory roller. After the Type 17 was compacted, we observed the contractor begin placing 5/8-inch minus crushed rock base course over it.

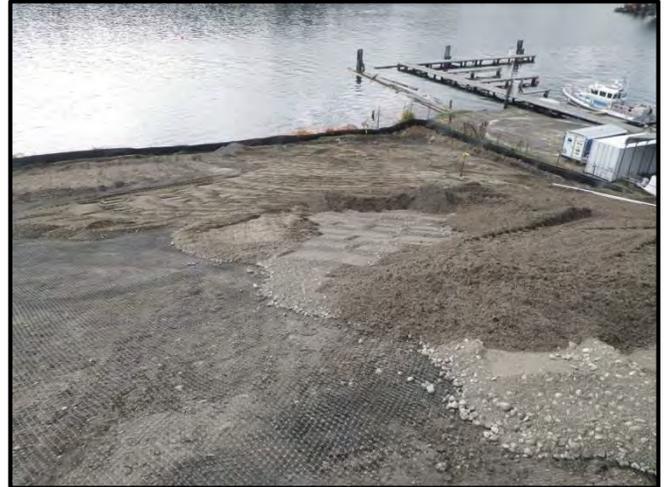
We observed the contractor place an approximately 6-inch lift of City of Seattle Type 17 bank run gravel (City of Seattle Specification 9-03.12(2)B) over a portion of the geo-grid placed yesterday (see attached site plan). The Type 17 was compacted utilizing a hoepac attached to a Deere 135 D track mounted excavator. After the Type 17 was compacted, the contractor began placing an approximately 12-inch lift of topsoil over it (see attached site plan). The topsoil was being dozed into place with a Case 650HLT dozer, and was being track compacted at the same time.

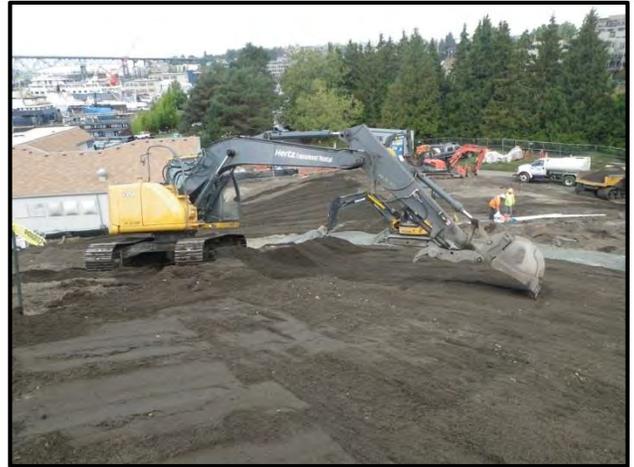
We observed the contractor performing some fine grading of the topsoil on the north and west sides of Kite Hill utilizing a Deere 135 D track mounted excavator. The graded area was track compacted and/or tamped with the excavator bucket, and was being raked smooth by hand (see attached site plan).

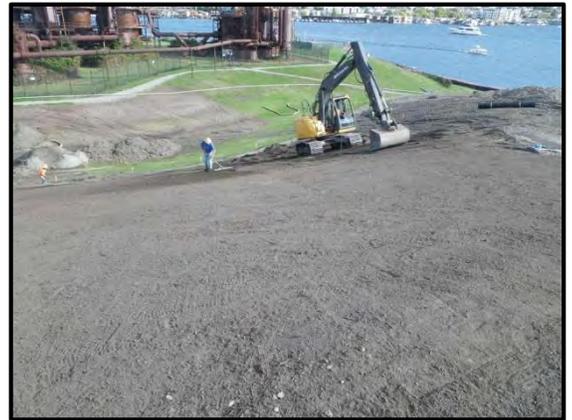
We observed the contractor performing some fine grading of the topsoil on the north, west and east sides of Kite Hill utilizing a Deere 135 D track mounted excavator. The graded area was track compacted and/or tamped with the excavator bucket, and was being raked smooth by hand (see attached site plan).

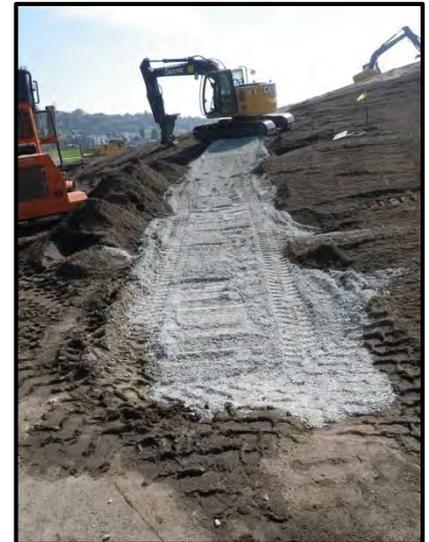
We also observed the contractor preparing the subgrades for the paved pedestrian paths on the north side of Kite Hill. The contractor placed approximately 6-inches of Type 17 at the path alignment and compacted it with an Ingersoll Rand steel drum vibratory roller. After the Type 17 was compacted, we observed the contractor begin placing 5/8-inch minus crushed rock base course over it.

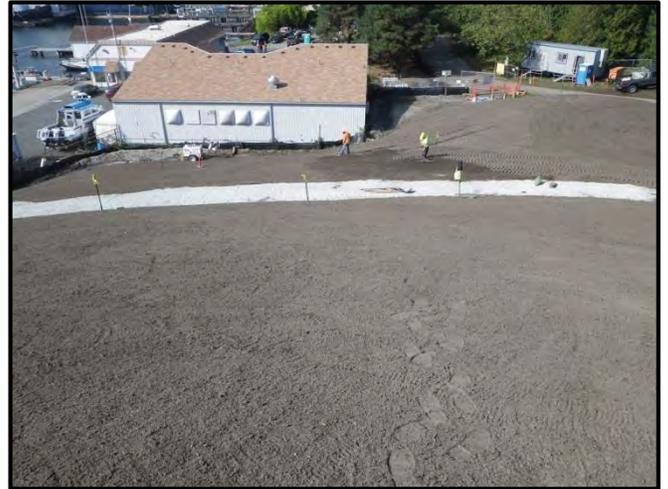
We observed the contractor perform finish grading of the 12-inch lift of topsoil in preparation for hydroseeding later this week (see attached site plan). The topsoil was being dozed into place with a Case 650HLT dozer and fine graded with a Deere 135 D track mounted excavator.

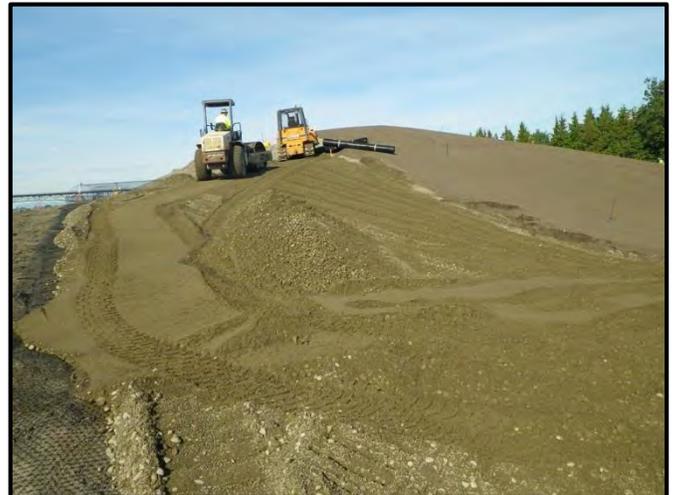
We observed the contractor performing some fine grading (shallow cuts and fills) on the south side of Kite Hill utilizing a Deere 135 D track mounted excavator. The graded area was track compacted by the excavator prior to the placement of the geo-grid (see attached site plan).

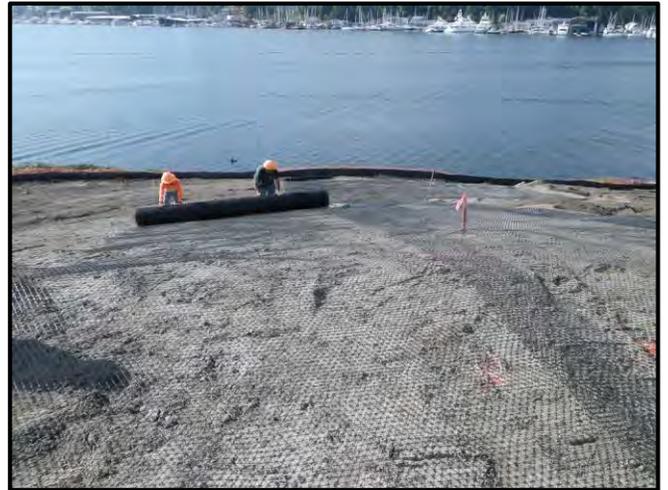
We also observed the contractor place an approximately 6-inch lift of City of Seattle Type 17 bank run gravel (City of Seattle Specification 9-03.12(2)B) over a portion of the geo-grid placed today (see attached site plan). The Type 17 was compacted utilizing an Ingersoll Rand steel drum vibratory roller. After compacting, the contractor track compacted the Type 17 with a minimum of two passes with a Case 650HLT dozer. After the Type 17 was compacted, the contractor began placing an approximately 12-inch lift of topsoil over it (see attached site plan). The topsoil was being dozed into place with a Case 650HLT dozer, and was being track compacted at the same time.

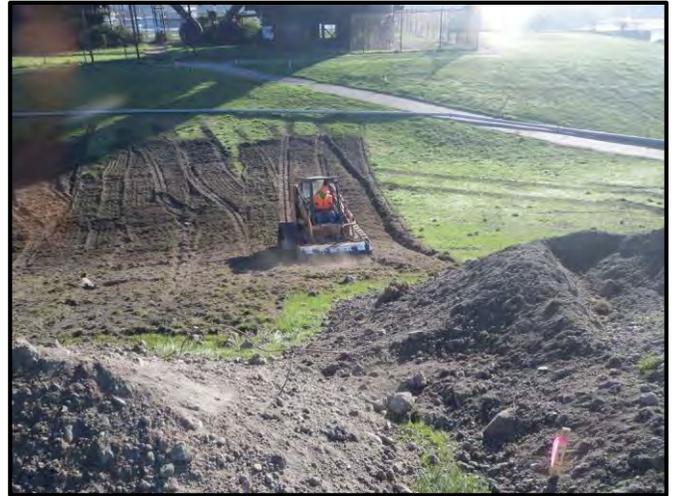
We observed the contractor tilling in an area south, and east of Kite Hill in the swale area (see attached site plan). The contractor utilized a Case 450C skid steer with a front mounted Bobcat tiller to break up and mix the sod and roots. The tilled area was deemed acceptable after the material was clear of sod clumps and large organics. We evaluated the area by means of probing with a ½-inch diameter steel probe rod. Probe depths were generally in the range of 8- to 10- inches. The contractor was also removing debris (brick, concrete, asphalt, metal) larger than 4 inches in diameter from the tilled area.

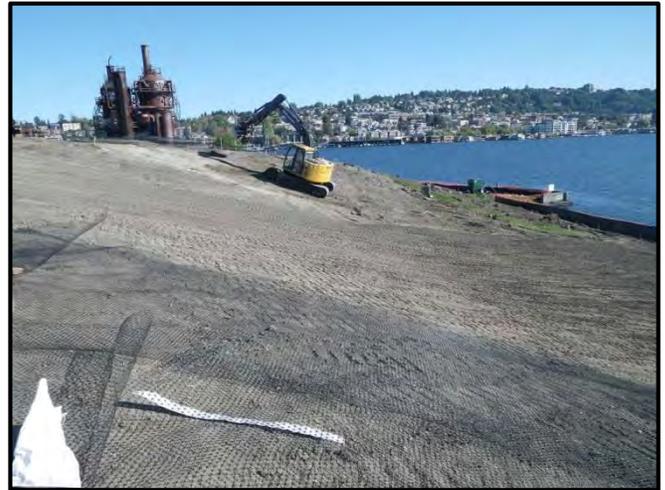
We observed the contractor place geo-grid (Tensar TX130S) on the prepared subgrade on the south side of Kite Hill (see attached site plan). The subgrade was evaluated prior to placing the geo-grid to ensure that the subgrade was compacted properly, was free of pumping soil conditions and was observed to be firm. We evaluated the subgrade by means of probing with a ½-inch diameter steel probe rod. Probe depths were generally in the range of 2- to 3-inches.

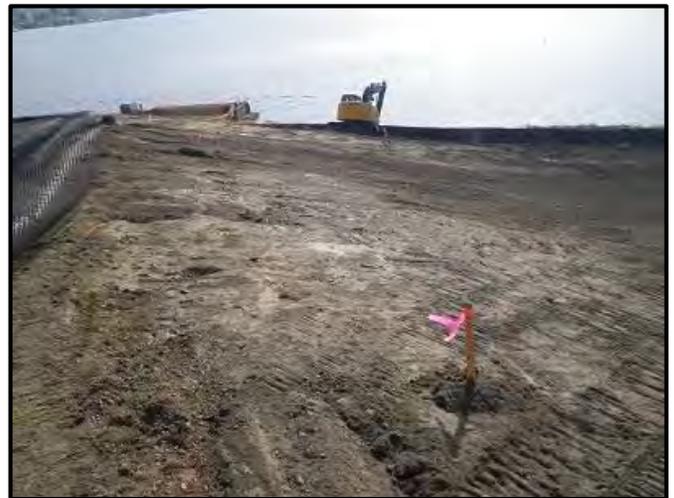
We observed the contractor performing some fine grading (shallow cuts and fills) on the south side of Kite Hill utilizing a Deere 135 D track mounted excavator. The graded area was track compacted by the excavator prior to the placement of the geo-grid (see attached site plan).

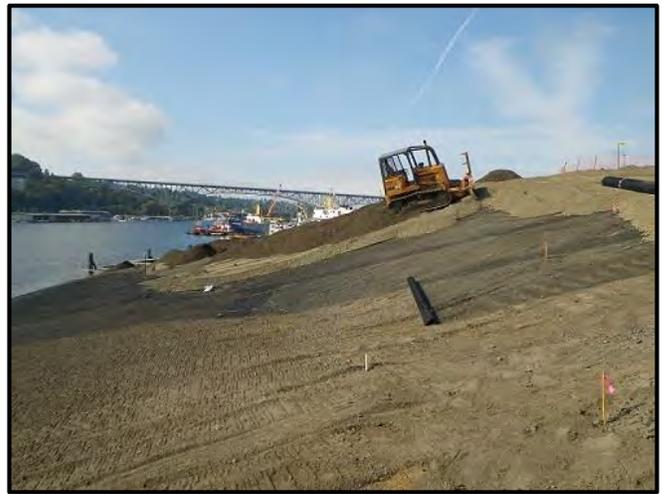
We also observed the contractor place an approximately 6-inch lift of City of Seattle Type 17 bank run gravel (City of Seattle Specification 9-03.12(2)B) over a portion of the geo-grid placed today (see attached site plan). The Type 17 was compacted utilizing an Ingersoll Rand steel drum vibratory roller. After compacting, the contractor track compacted the Type 17 with a minimum of two passes with a Case 650HLT dozer. After the Type 17 was compacted, the contractor began placing an approximately 12-inch lift of topsoil over it (see attached site plan). The topsoil was being dozed into place with a Case 650HLT dozer, and was being track compacted at the same time.

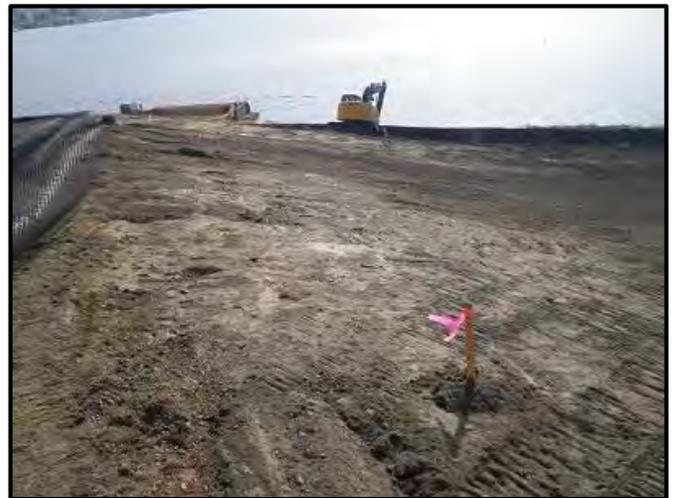
We observed the contractor performing some fine grading (shallow cuts and fills) in the southeast quadrant of Kite Hill utilizing a Deere 135 D track mounted excavator. The graded area was track compacted by the excavator prior to the placement of the geo-grid (see attached site plan).

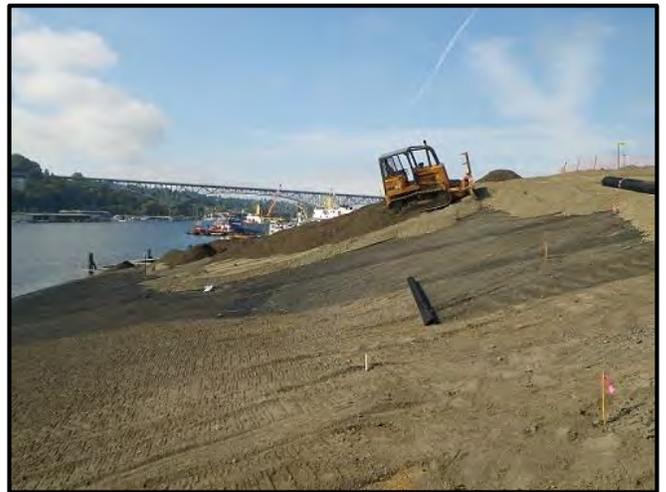
We observed the contractor perform finish grading of the 12-inch lift of topsoil in the southwest quadrant of Kite Hill in preparation for hydroseeding next week (see attached site plan). The topsoil was being fine graded with a Deere 135 D track mounted excavator.

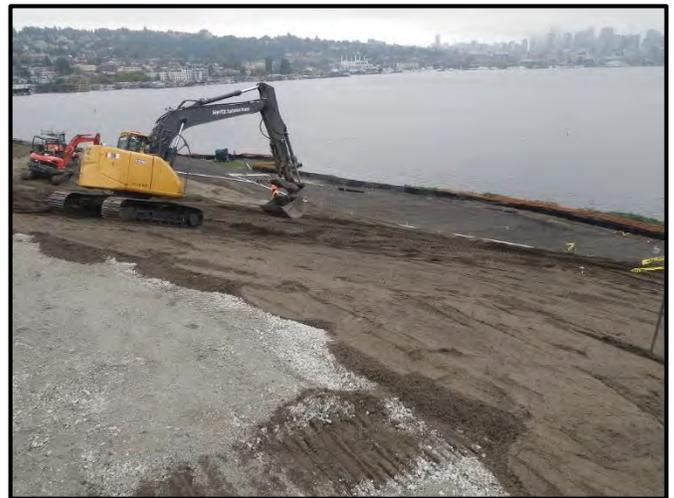
We observed the contractor performing some fine grading (shallow cuts and fills) in the southeast quadrant of Kite Hill utilizing a Deere 135 D track mounted excavator. The graded area was track compacted by the excavator prior to the placement of the geo-grid (see attached site plan).

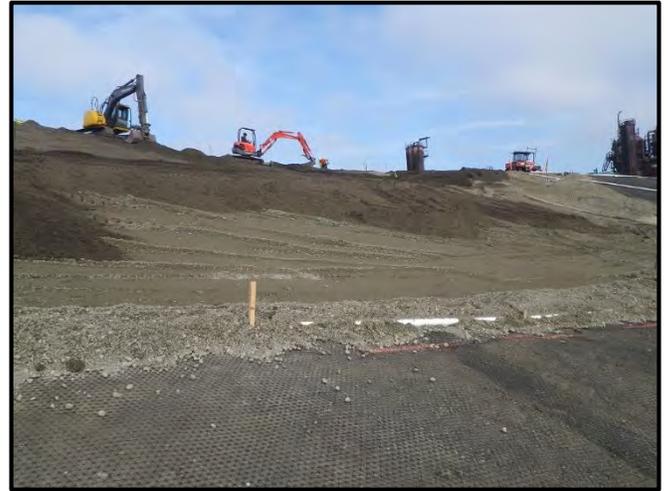
We observed the contractor place geo-grid (Tensar TX130S) on the prepared subgrade on the south side of Kite Hill (see attached site plan). The subgrade was evaluated prior to placing the geo-grid to ensure that the subgrade was compacted properly, was free of pumping soil conditions and was observed to be firm. We evaluated the subgrade by means of probing with a ½-inch diameter steel probe rod. Probe depths were generally in the range of 2- to 3-inches.

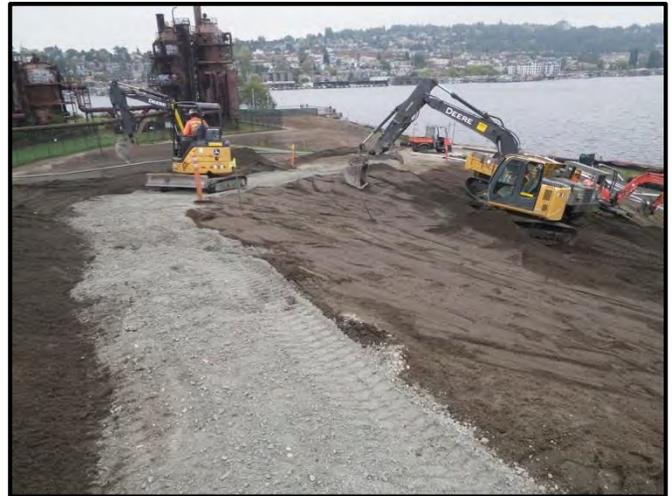
We observed the contractor performing some fine grading (shallow cuts and fills) in the southeast quadrant of Kite Hill utilizing a Deere 135 D track mounted excavator. The graded area was track compacted by the excavator prior to the placement of the geo-grid (see attached site plan).

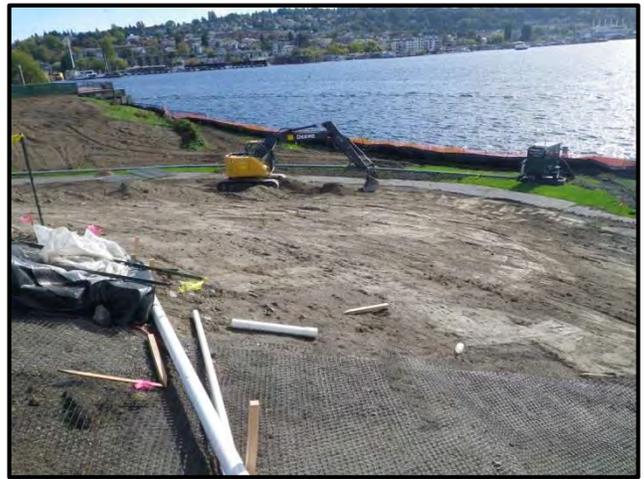
We observed the contractor performing some fine grading (shallow cuts and fills) in the southeast quadrant of Kite Hill utilizing a Deere 135 D track mounted excavator. The graded area was track compacted by the excavator prior to the placement of the geo-grid (see attached site plan).
