APPENDIX M (continued)
Field Report – Geotechnical

Field Report

Project:
Kite Hill Soil Cover Project

Location:
Gasworks Park, Seattle, WA

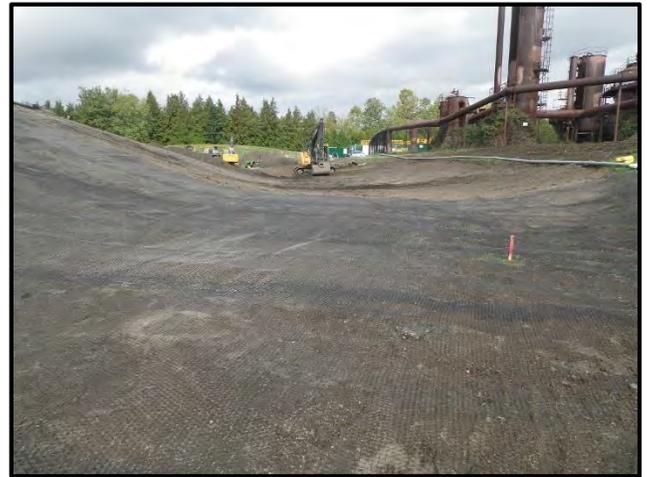
We observed the contractor performing some fine grading (shallow cuts and fills) in the southeast quadrant of Kite Hill and in the south end of the swale area east of Kite Hill utilizing a Deere 135 D track mounted excavator. The graded area was track compacted by the excavator prior to the placement of the geo-grid (see attached site plan).

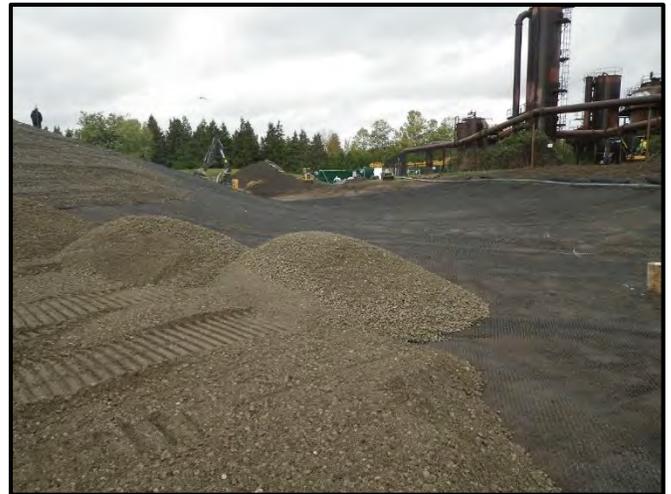
We observed the contractor performing some fine grading (shallow cuts and fills) in the swale area east of Kite Hill utilizing a Deere 135 D track mounted excavator. The graded area was track compacted by the excavator prior to the placement of the geo-grid (see attached site plan).

We also observed the contractor stripping the vegetation from the steep slope north of the existing block wall just south of the Cracking Towers (see attached site plan).

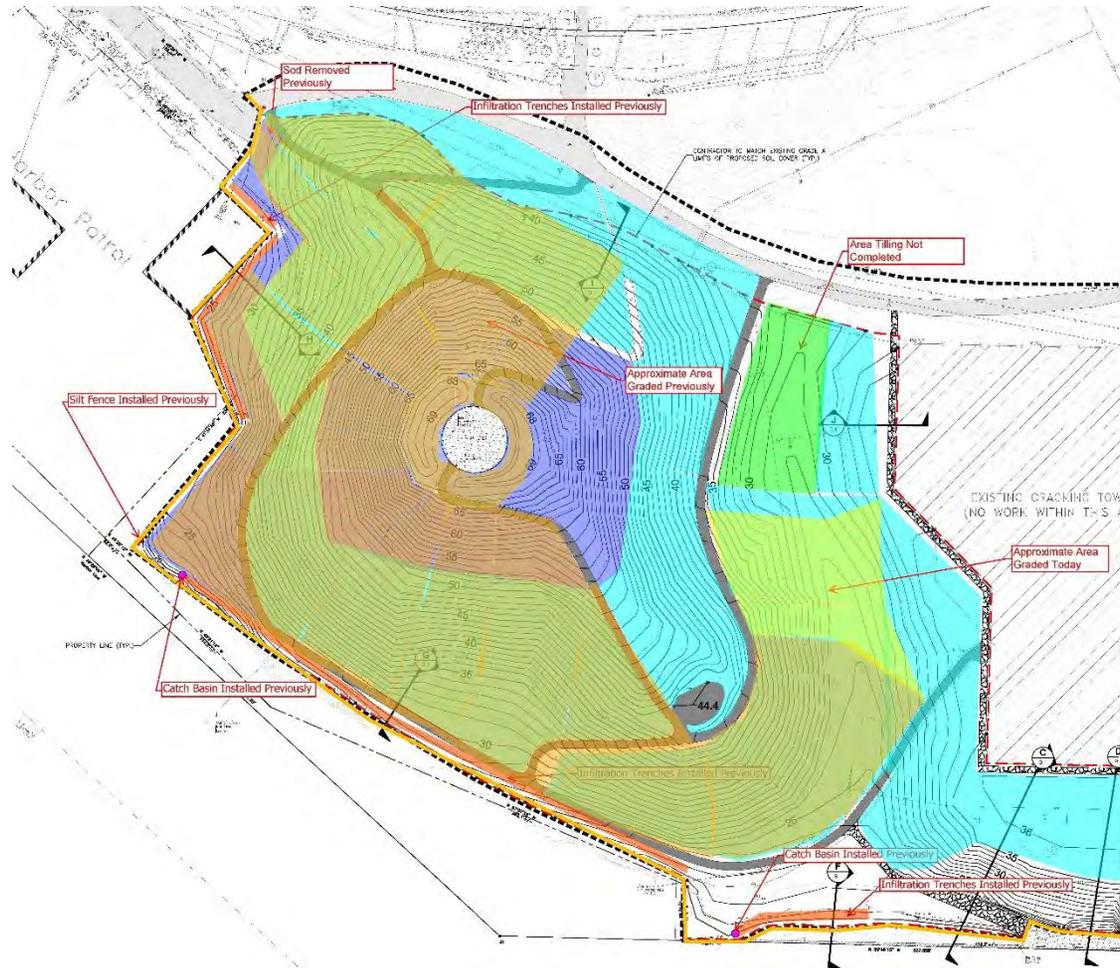
Site Plan of Geo-gird/Type 17 Placement

We observed the contractor place geo-grid (Tensar TX130S) on the prepared subgrade in the swale area east of Kite Hill (see attached site plan). The subgrade was evaluated prior to placing the geo-grid to ensure that the subgrade was compacted properly, was free of pumping soil conditions and was observed to be firm. We evaluated the subgrade by means of probing with a 1/2-inch diameter steel probe rod. Probe depths were generally in the range of 2- to 3-inches.

We also observed the contractor place an approximately 6-inch lift of City of Seattle Type 17 bank run gravel (City of Seattle Specification 9-03.12(2)B) over a portion of the geo-grid placed previously in the southeast quadrant of Kite Hill (see attached site plan).

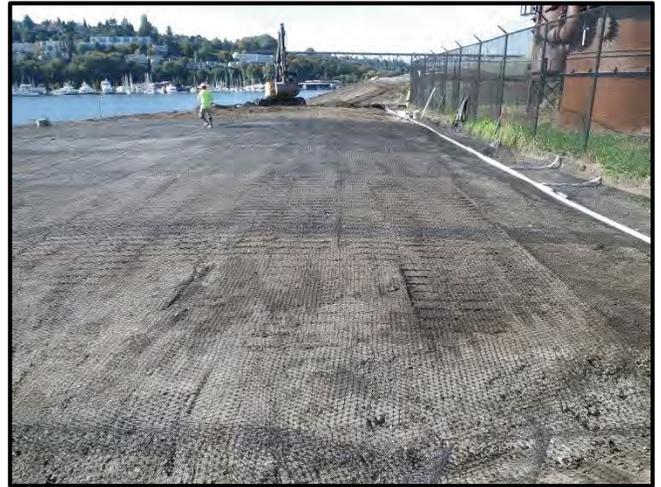
We also observed the contractor place an approximately 6-inch lift of City of Seattle Type 17 bank run gravel (City of Seattle Specification 9-03.12(2)B) over a portion of the geo-grid placed previously in the southeast quadrant and in the swale east of Kite Hill (see attached site plan). After the Type 17 was compacted, the contractor began placing an approximately 12-inch lift of topsoil over it (see attached site plan). The topsoil was being dozed into place with a Case 650HLT dozer, and was being track compacted at the same time.

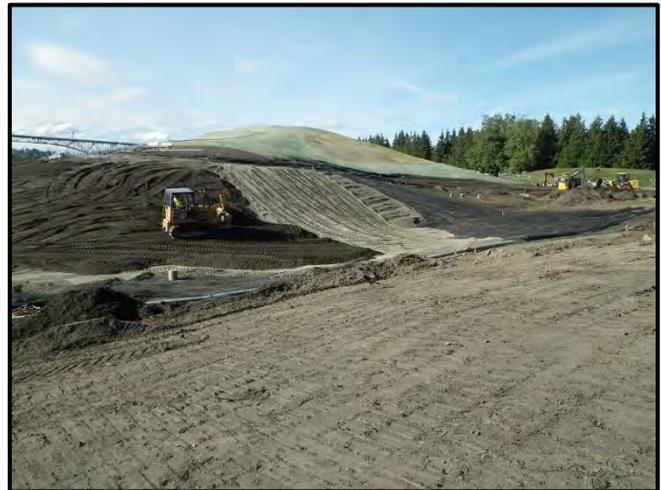
We observed the contractor continue installing the new irrigation system in the area east of Kite Hill just south of the Cracking Towers.

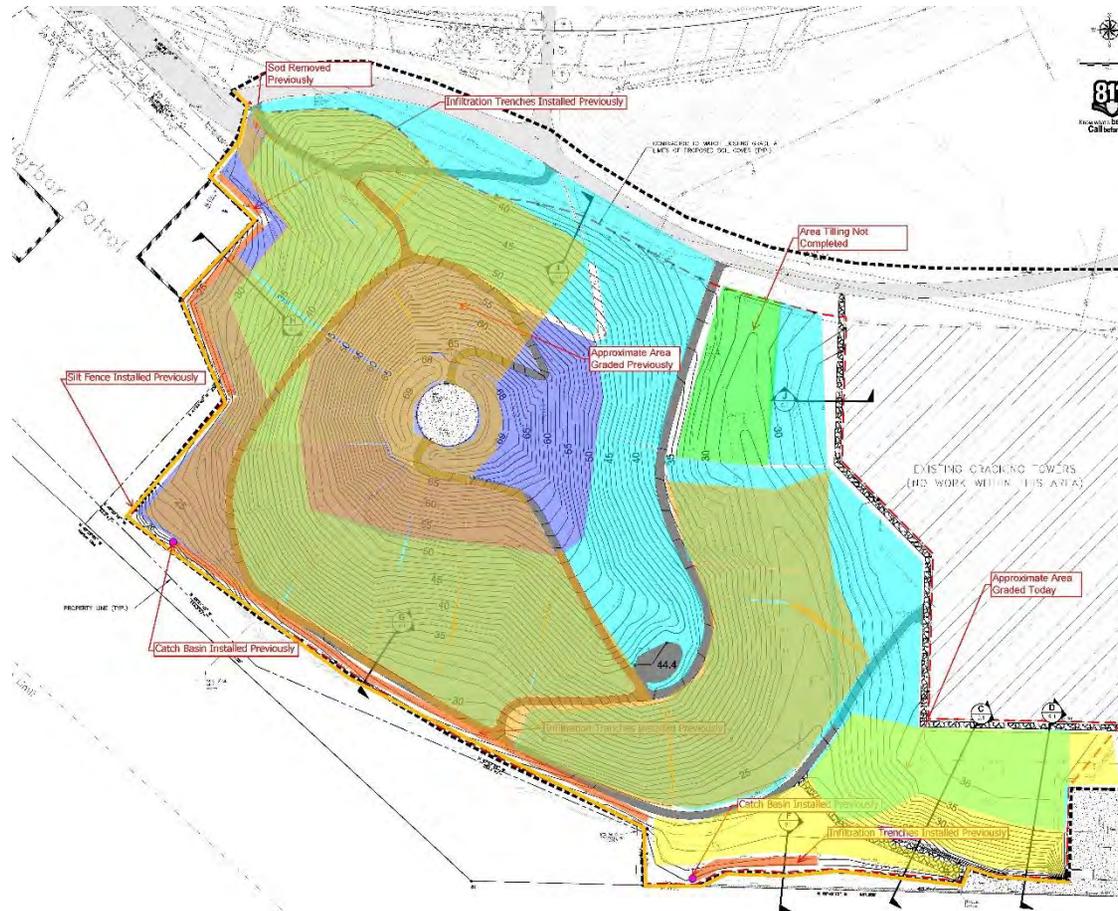
Site Plan of Earthwork

We observed the contractor performing some fine grading (shallow cuts and fills) in the area south of the Cracking Towers utilizing a Deere 135 D track mounted excavator. The graded area was track compacted by the excavator prior to the placement of the geo-grid (see attached site plan).

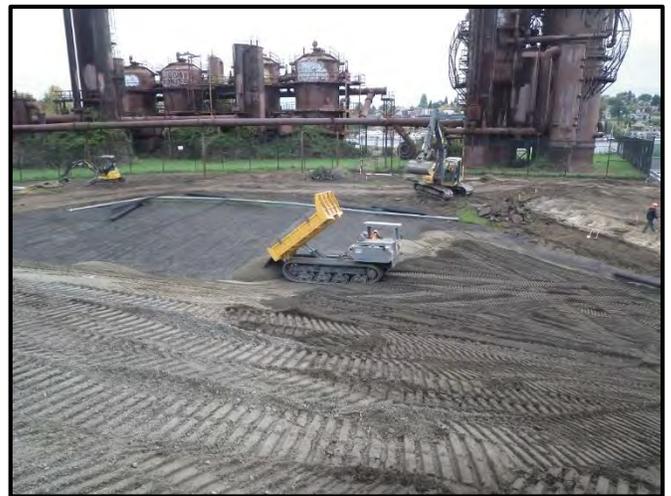
We observed the contractor performing some fine grading (shallow cuts and fills) in the swale area east of the Kite Hill utilizing a Deere 135 D track mounted excavator. The graded area was track compacted by the excavator prior to the placement of the geo-grid (see attached site plan).

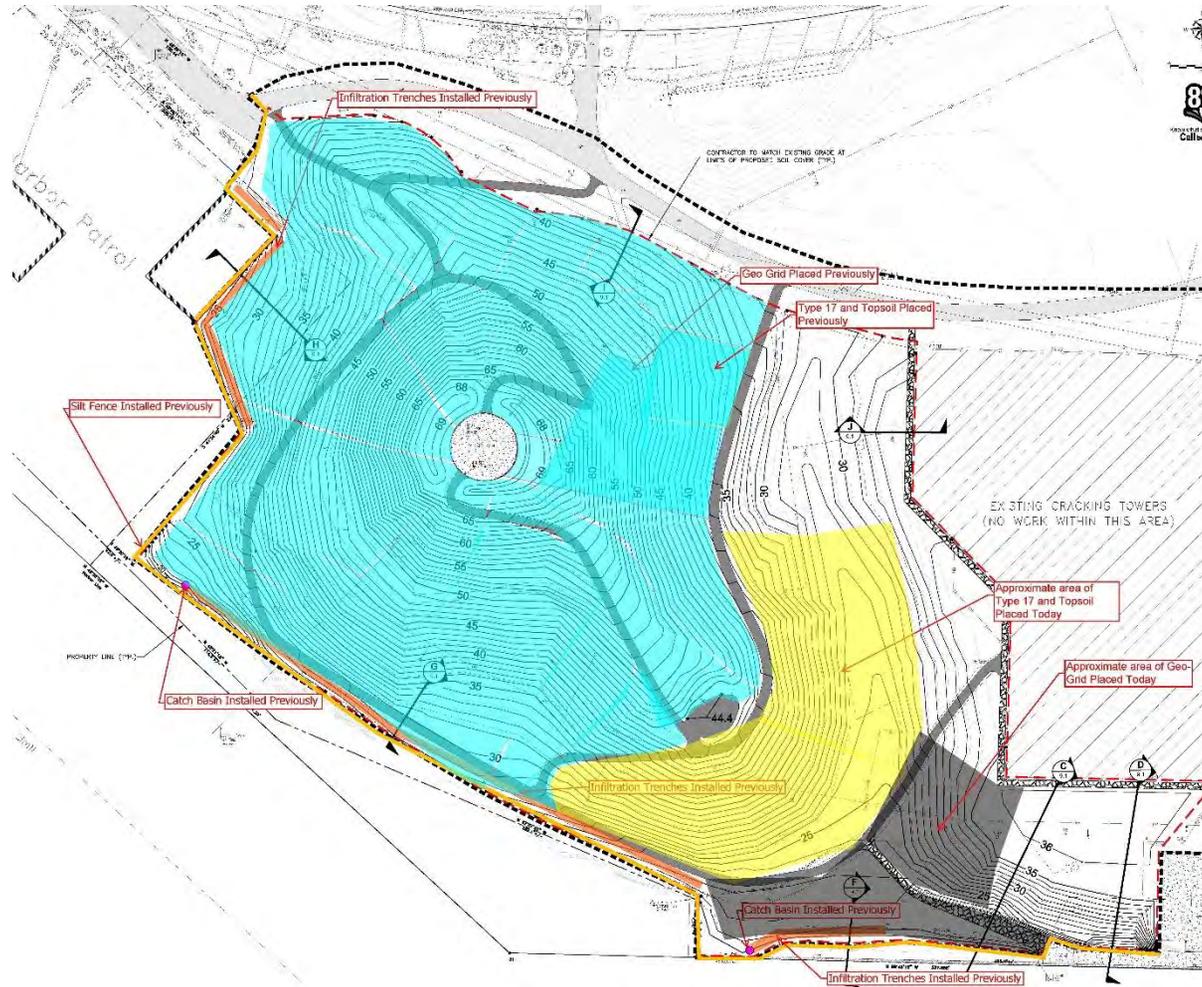
Site Plan of Geo-gird/Type 17 Placement

We observed the contractor place geo-grid (Tensar TX130S) on the prepared subgrade in the swale area east of Kite Hill (see attached site plan). The subgrade was evaluated prior to placing the geo-grid to ensure that the subgrade was compacted properly, was free of pumping soil conditions and was observed to be firm. We evaluated the subgrade by means of probing with a 1/2-inch diameter steel probe rod. Probe depths were generally in the range of 2- to 3-inches.

We also observed the contractor place an approximately 6-inch lift of City of Seattle Type 17 bank run gravel (City of Seattle Specification 9-03.12(2)B) over a portion of the geo-grid placed previously in the swale east of Kite Hill (see attached site plan). After the Type 17 was compacted, the contractor began placing an approximately 12-inch lift of topsoil over it (see attached site plan). The topsoil was being dozed into place with a Case 650HLT dozer, and was being track compacted at the same time.

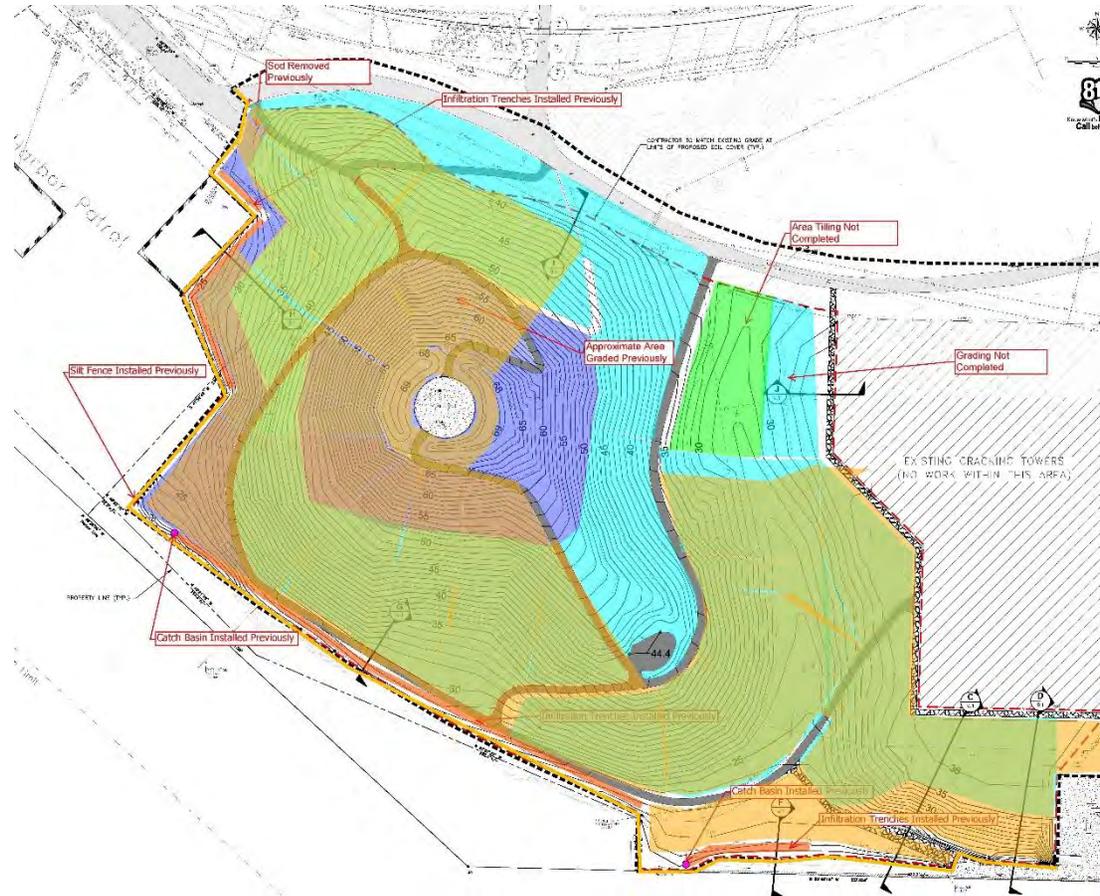
Site Plan of Earthwork

We observed the contractor fine grading the path subgrade from the top of Kite Hill down the southeast quadrant to the bench area. The contractor was spreading 1 ¼-inch minus crushed rock base material in thin lifts and compacting it with a vibratory plate compactor.

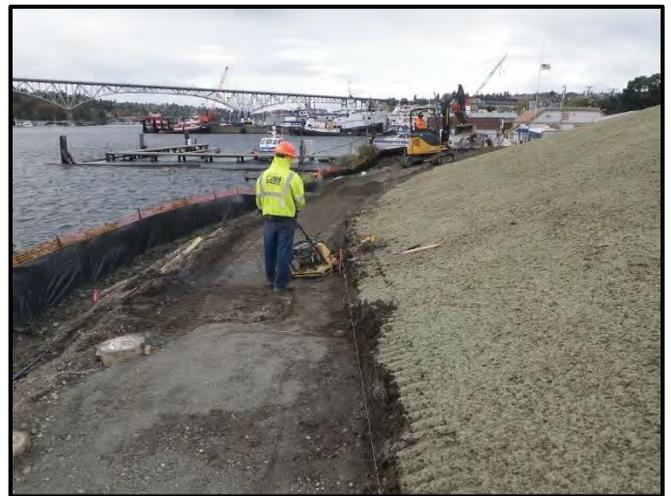
We observed the contractor fine grading the path subgrade on the south side of Kite Hill near the lake shore. The contractor was spreading 1 ¼-inch minus crushed rock base material in thin lifts and compacting it with a vibratory plate compactor.

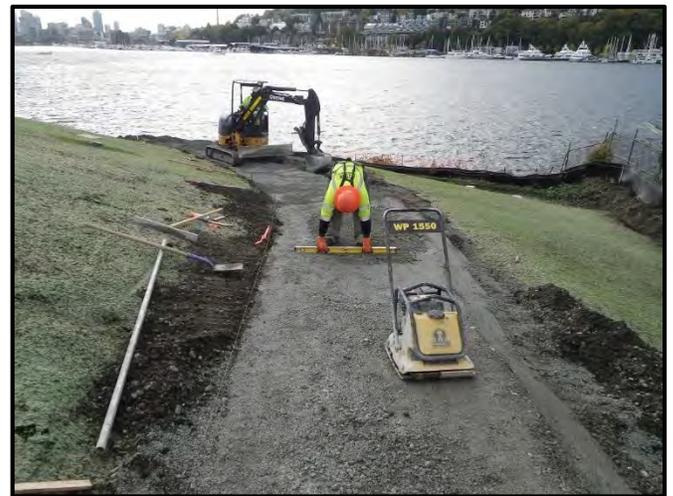
We observed the contractor fine grading the path subgrade in the southwest quadrant of Kite Hill. The contractor was spreading 1 ¼-inch minus crushed rock base material in thin lifts and compacting it with a vibratory plate compactor.

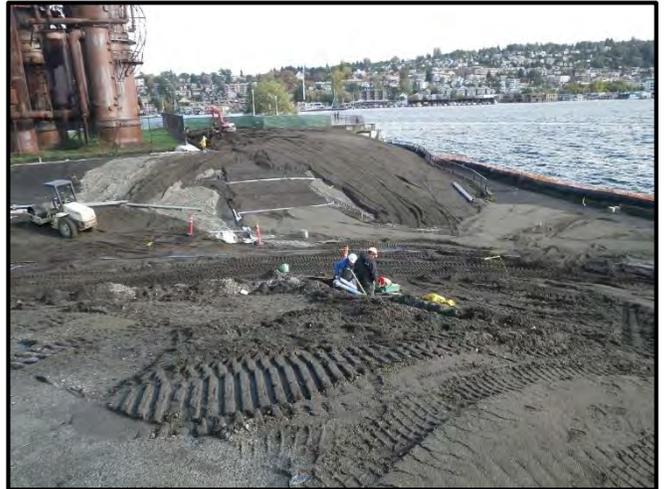
We also observed the contractor pumping stormwater runoff from yesterday's storm out of the swale area and into the Baker Tanks utilizing a 2-inch portable pump. The volume pumped appeared to be in the range of 25,000 to 30,000 gallons.

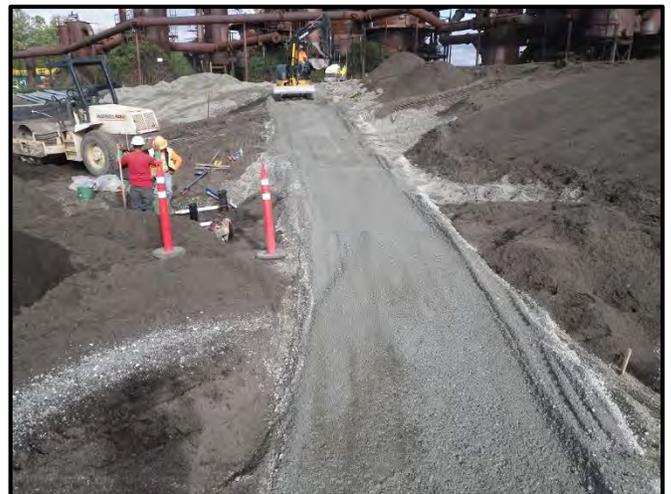
We observed the contractor fine grading the path subgrade on the south and west sides of the Cracking Tower. The contractor was spreading 1 ¼-inch minus and/or 5/8-inch minus crushed rock base material in thin lifts and compacting it with a vibratory plate compactor and/or a Wacker RD12 dual drum articulated mini compactor.

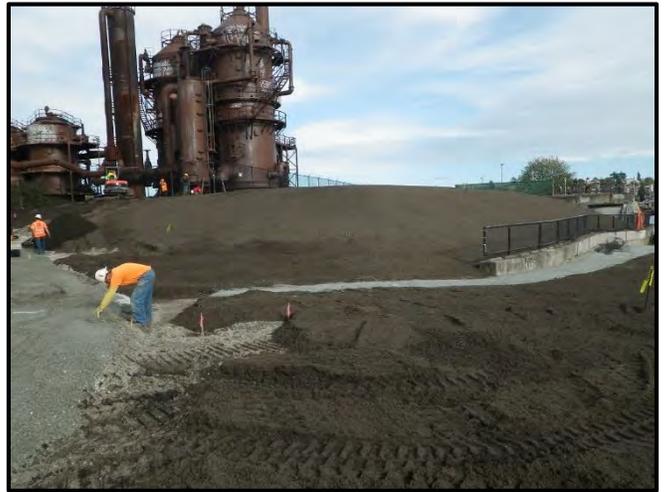
We also observed the contractor place an approximately 6-inch lift of City of Seattle Type 17 bank run gravel (City of Seattle Specification 9-03.12(2)B) material in the swale area east of Kite Hill (see attached site plan). The material was being dozed into place with a Case 650HLT dozer, and was compacted with an Ingersoll Rand steel drum vibratory roller. After compacting, the contractor track compacted the Type 17 with a minimum of two passes with a Case 650HLT dozer. After the Type 17 was compacted, the contractor began placing an approximately 12-inch lift of topsoil over it (see attached site plan). The topsoil was being dozed into place with a Case 650HLT dozer, and was being track compacted at the same time.

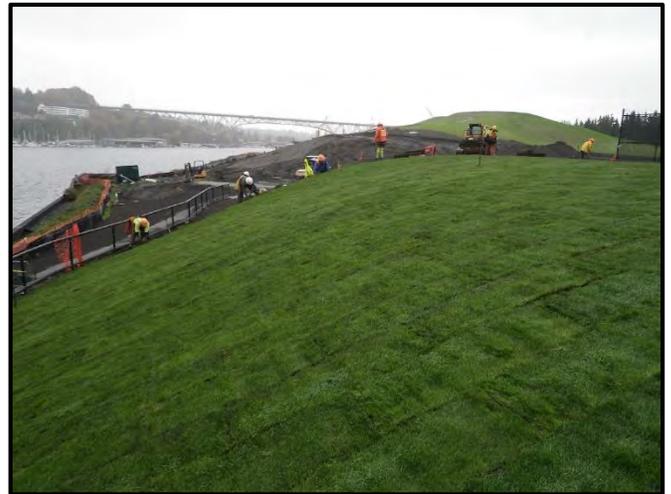
The contractor focused their efforts on installing approximately 10,000 sq. ft. of sod lawn on the south side of the Cracking Towers.

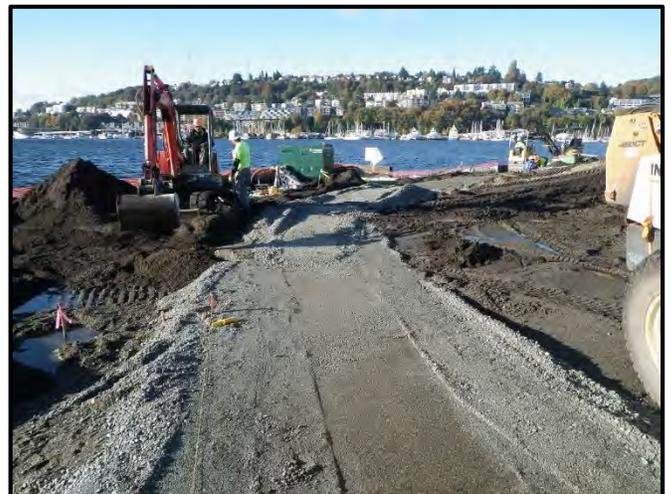
We observed the contractor fine grading the path subgrade on the west side of the Cracking Tower. The contractor was spreading 1¼-inch minus crushed rock base material in thin lifts and compacting it with a vibratory plate compactor and/or a Wacker RD12 dual drum articulated mini compactor.

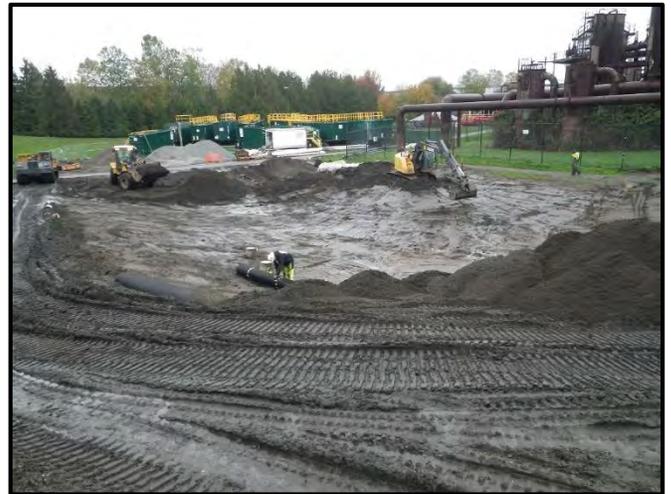
We observed the contractor performing some fine grading (shallow cuts and fills) in the swale area east of Kite Hill utilizing a Deere 135 D track mounted excavator. The graded area was track compacted by the excavator prior to the placement of the geo-grid (see attached site plan).

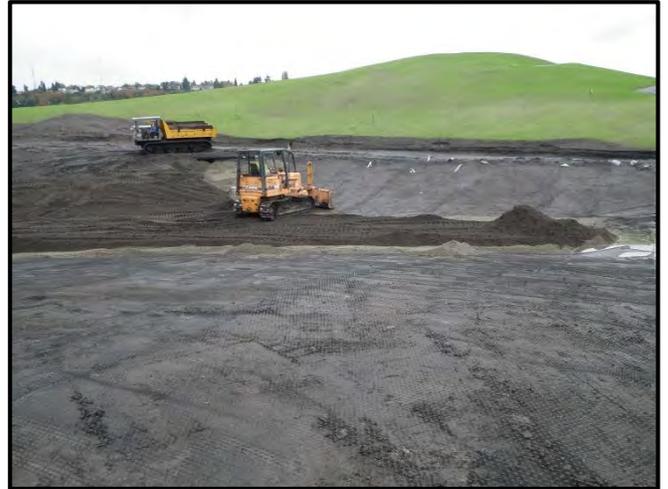
We also observed the contractor place an approximately 6-inch lift of City of Seattle Type 17 bank run gravel (City of Seattle Specification 9-03.12(2)B) material in the swale area east of Kite Hill (see attached site plan). The material was being dozed into place with a Case 650HLT dozer, and was compacted with an Ingersoll Rand steel drum vibratory roller. After compacting, the contractor track compacted the Type 17 with a minimum of two passes with a Case 650HLT dozer. After the Type 17 was compacted, the contractor began placing an approximately 12-inch lift of topsoil over it (see attached site plan). The topsoil was being dozed into place with a Case 650HLT dozer, and was being track compacted at the same time.

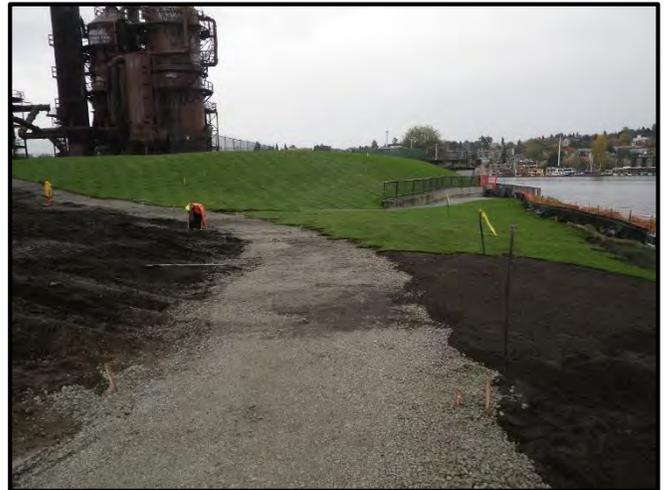
Kite Hill remained stable during excavation activities; there was no seepage along the face of the slope, no sloughing or raveling of the site soils and no tension cracks were observed along the crest of the slope. No evidence of instability of the existing slope was observed during our site visit today.

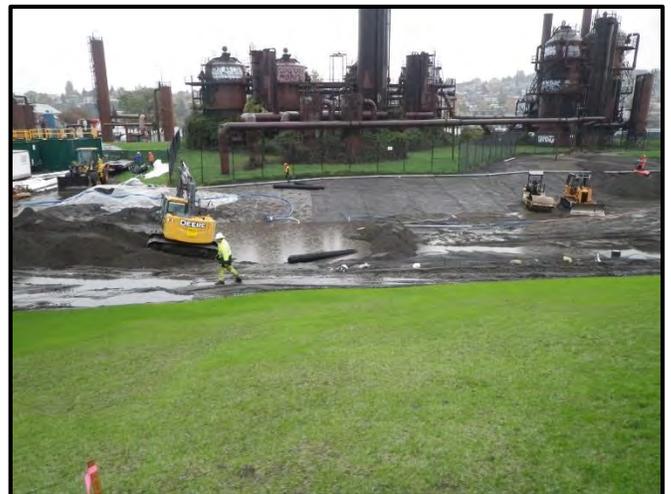
Kite Hill remained stable during excavation activities; there was no seepage along the face of the slope, no sloughing or raveling of the site soils and no tension cracks were observed along the crest of the slope. No evidence of instability of the existing slope was observed during our site visit today.

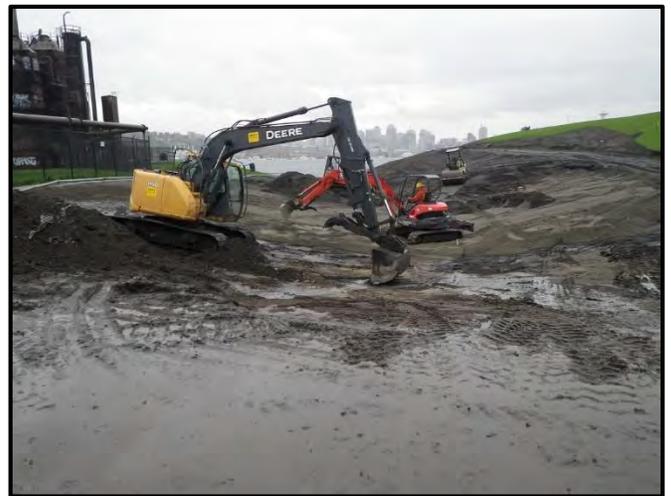
We observed the contractor performing some fine grading (shallow cuts and fills) in the swale area east of the Kite Hill utilizing a Deere 135 D track mounted excavator. The graded area was track compacted by the excavator prior to the placement of the geo-grid (see attached site plan).

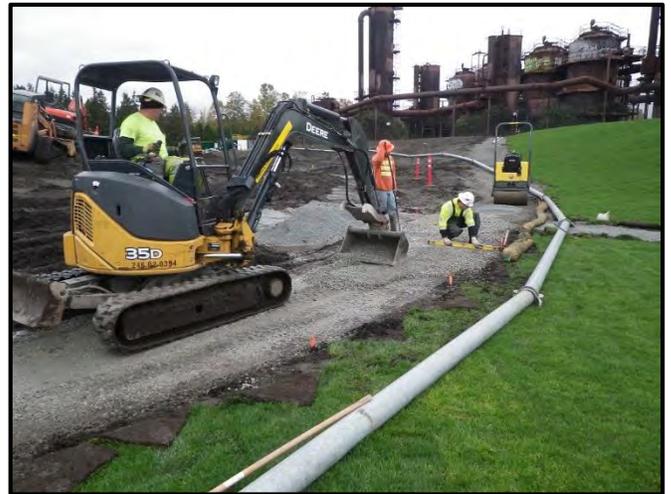
We observed the contractor performing some fine grading (shallow cuts) in the path alignment east of the Kite Hill utilizing a Deere 135 D track mounted excavator. The graded area was track compacted by the excavator prior to the placement of the geo-grid (see attached site plan).

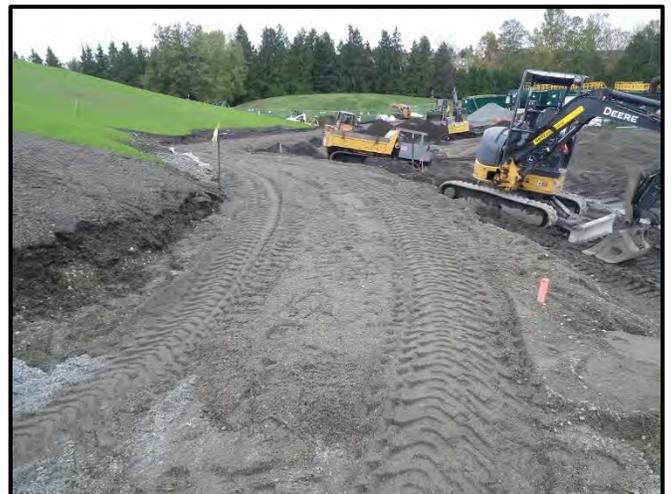
We observed the contractor grading the path subgrade on the east side of Kite Hill (see attached site plan). The contractor placed an approximately 6-inch lift of City of Seattle Type 17 bank run gravel (City of Seattle Specification 9-03.12(2)B). The material was being dozed into place with a Case 650HLT dozer, and was compacted with an Ingersoll Rand steel drum vibratory roller. The contractor was spreading 5/8-inch and/or 1 1/4-inch minus crushed rock base material in thin lifts over the Type 17 and compacting it with a vibratory plate compactor and/or a Wacker RD12 dual drum articulated mini compactor.

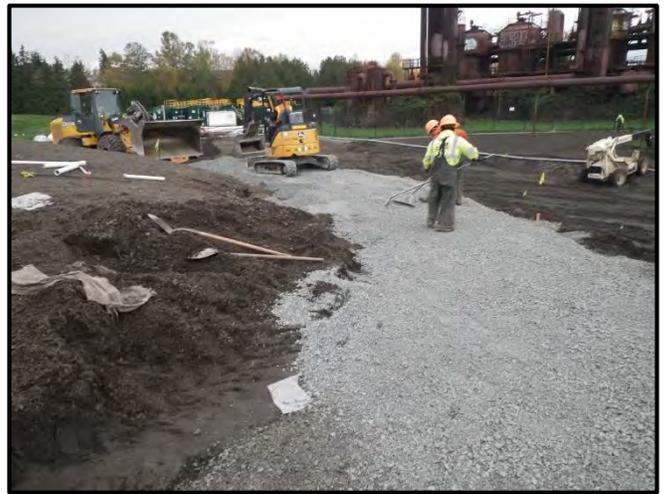
We also observed the contractor placing an approximately 6-inch lift of City of Seattle Type 17 bank run gravel (City of Seattle Specification 9-03.12(2)B) material in the path alignment east of Kite Hill (see attached site plan). The material was being dozed into place with a Case 650HLT dozer, and was compacted with an Ingersoll Rand steel drum vibratory roller.

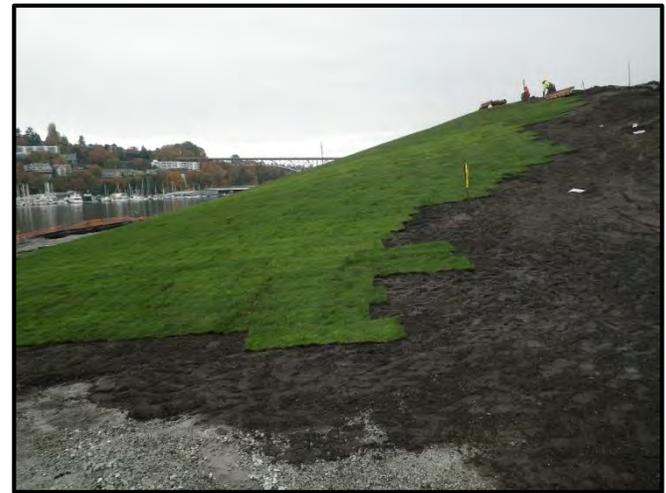
Kite Hill remained stable during excavation activities; there was no seepage along the face of the slope, no sloughing or raveling of the site soils and no tension cracks were observed along the crest of the slope. No evidence of instability of the existing slope was observed during our site visit today.

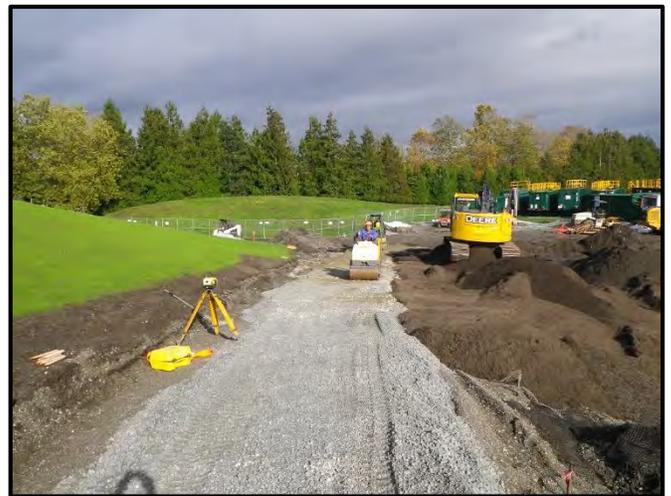
We observed the contractor grading the path subgrade on the east side and the lower north side of Kite Hill (see attached site plan). The contractor was spreading 5/8-inch and/or 1 1/4-inch minus crushed rock base material in thin lifts over the Type 17 and compacting it with a vibratory plate compactor and/or a Wacker RD12 dual drum articulated mini compactor.

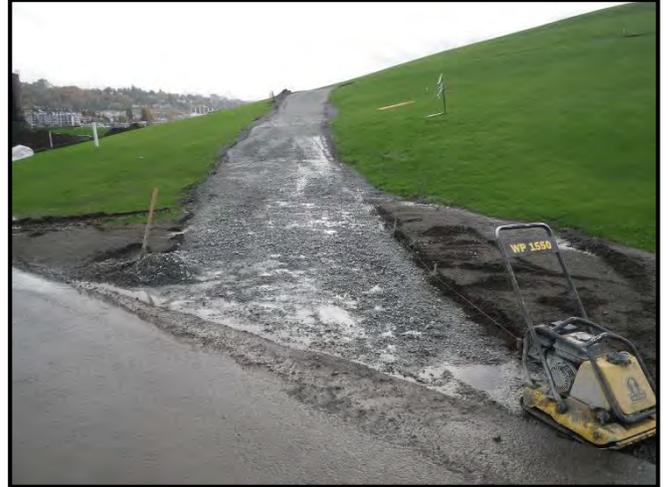
We also observed the contractor pumping stormwater runoff from the swale area and into the Baker Tanks utilizing a 6-inch portable pump.

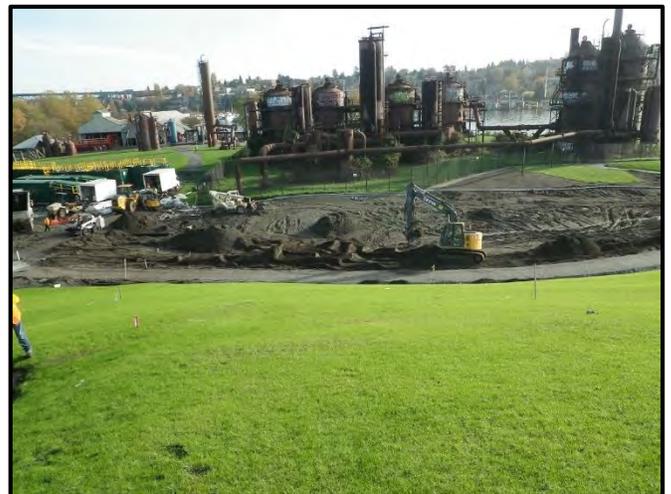
We observed the contractor grading the path subgrade on the east side and the lower north side of Kite Hill (see attached site plan). The contractor was spreading 5/8-inch and/or 1¼-inch minus crushed rock base material in thin lifts over the Type 17 and compacting it with a vibratory plate compactor and/or a Wacker RD12 dual drum articulated mini compactor.

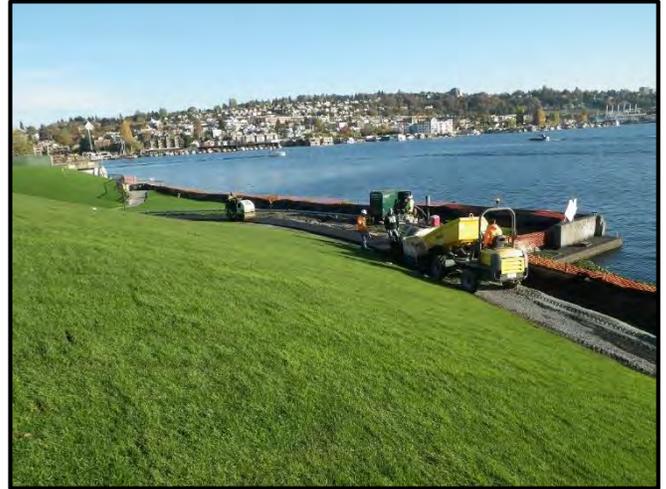
At this time temporary erosion and sedimentation control efforts include silt fencing, temporary interceptor swales, check dams, quarry spalls installed along the edge of the asphalt pavement trucking route, temporary sediment ponds and an array of 10 - 20,000 gallon Baker Tanks for runoff storage during storm events (see attached site plan). We also observed the contractor using a street sweeper to clean the paved on- and off-site haul route several times throughout the day. These efforts were observed to be functioning as intended so that soil was not observed to be leaving the site.

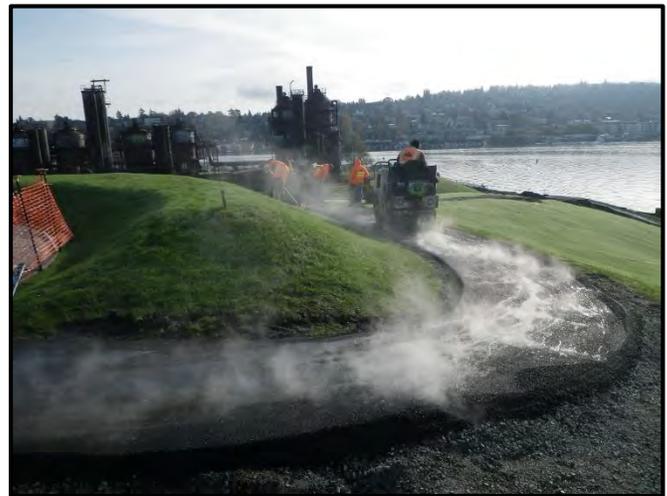
We observed that Northwest Paving was on site today to finish the path paving started yesterday. Hot mix asphalt was being delivered from the solo delivery truck to the Ingersoll Rand 450P paving machine in two Wacker Neuson 3001s articulated buggies. The pavement was placed over the prepared subgrade in either 2- or 3-inch thicknesses, and either 5- or 6-feet wide depending on location. The asphalt was being compacted with both a vibratory plate compactor and an Ingersoll Rand DD-14 dual drum vibratory roller. The remainder of the paving was completed today.

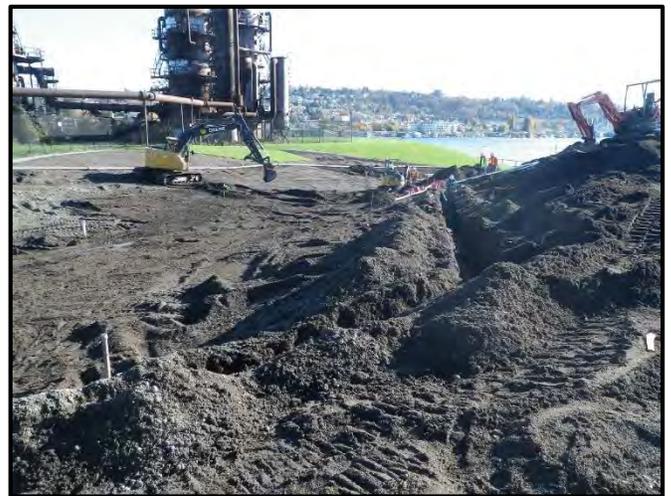
Earthwork performed today was limited to excavating trenches for the irrigation system.

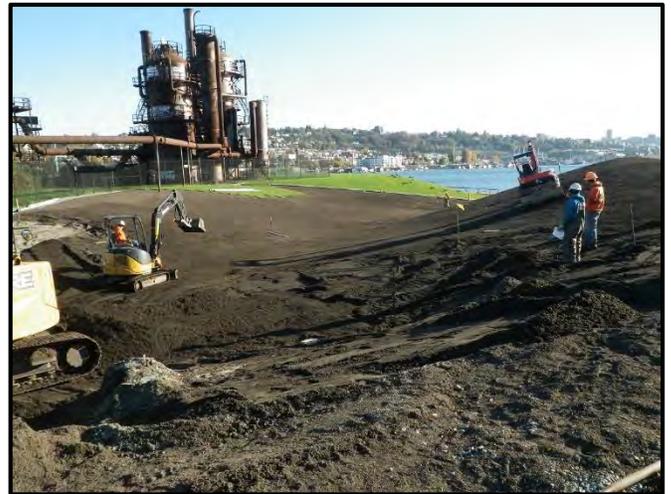
Earthwork performed today was limited to excavating trenches for the irrigation system.

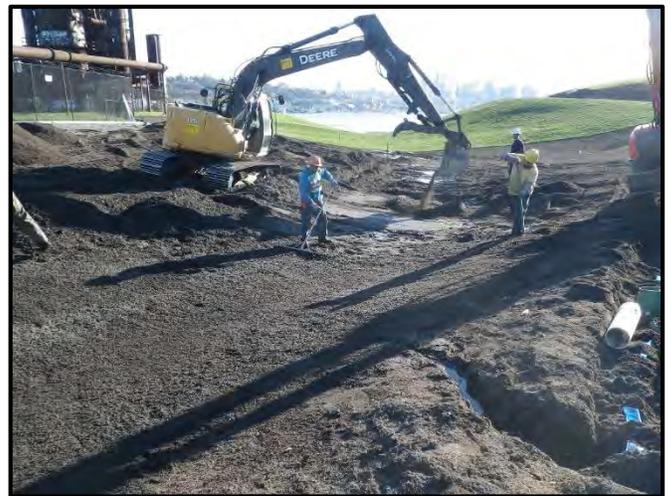
We observed the contractor performing some fine grading of the topsoil in the swale area east of Kite Hill utilizing a Deere 135 D track mounted excavator. The graded area was track compacted and/or tamped with the excavator bucket, and was being raked smooth by hand (see attached site plan).

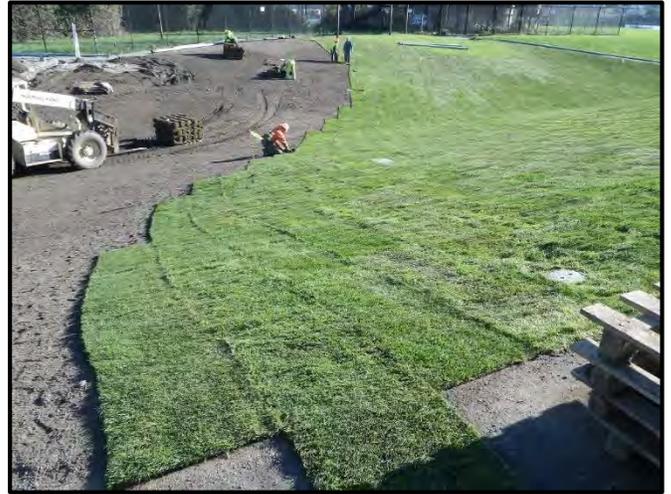
At this time temporary erosion and sedimentation control efforts include silt fencing, temporary interceptor swales, check dams, quarry spalls installed along the edge of the asphalt pavement trucking route, temporary sediment ponds and an array of 10- 20,000 gallon Baker Tanks for runoff storage during storm events (see attached site plan). We also observed the contractor using a street sweeper to clean the paved on- and off-site haul route several times throughout the day. These efforts were observed to be functioning as intended so that soil was not observed to be leaving the site.

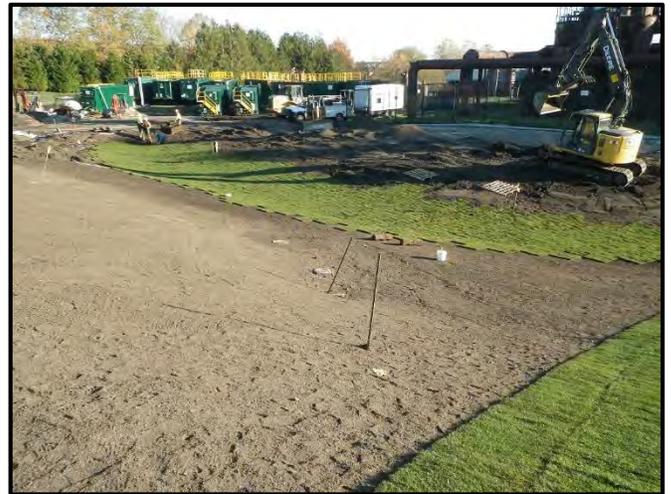
We observed the contractor performing some fine grading of the topsoil in the swale area east of Kite Hill utilizing a Deere 135 D track mounted excavator. The graded area was track compacted and/or tamped with the excavator bucket, and was being raked smooth by hand (see attached site plan).

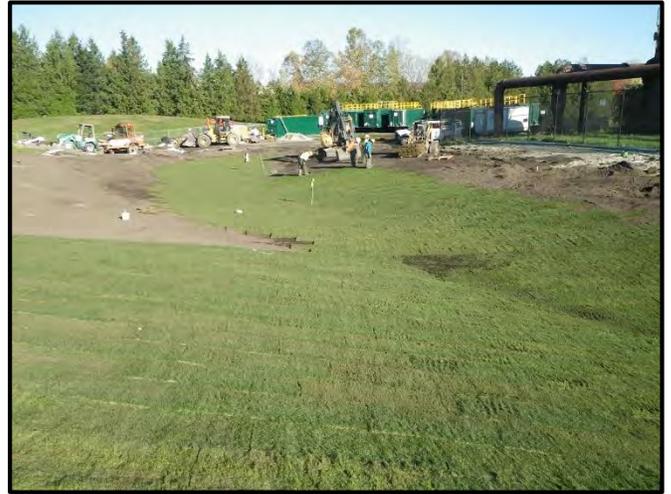
At this time temporary erosion and sedimentation control efforts include silt fencing, temporary interceptor swales, check dams, quarry spalls installed along the edge of the asphalt pavement trucking route, temporary sediment ponds and an array of 6- 20,000 gallon Baker Tanks for runoff storage during storm events (see attached site plan). We also observed the contractor using a street sweeper to clean the paved on- and off-site haul route several times throughout the day. These efforts were observed to be functioning as intended so that soil was not observed to be leaving the site.

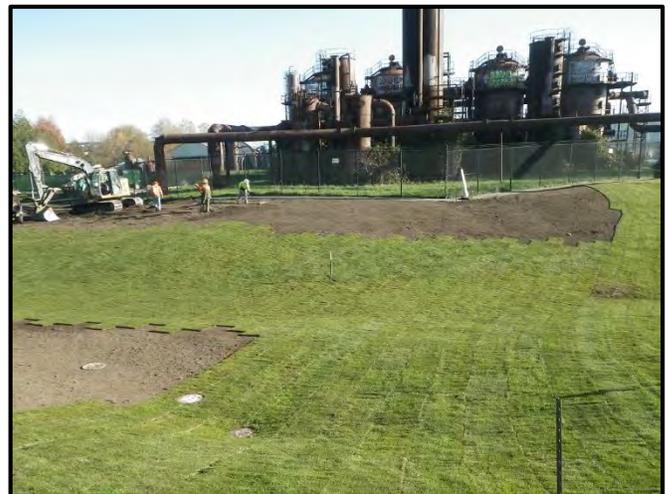
We observed the contractor performing some fine grading of the topsoil in north end of the swale area east of Kite Hill utilizing a Deere 135 D track mounted excavator. The graded area was track compacted and/or tamped with the excavator bucket, and was being raked smooth by hand (see attached site plan).

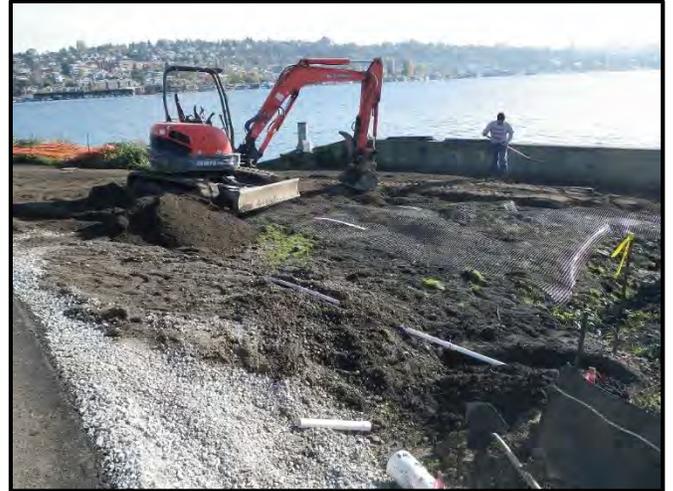
At this time temporary erosion and sedimentation control efforts include silt fencing, temporary interceptor swales, check dams, quarry spalls installed along the edge of the asphalt pavement trucking route, temporary sediment ponds and an array of 6- 20,000 gallon Baker Tanks for runoff storage during storm events (see attached site plan). We also observed the contractor using a street sweeper to clean the paved on- and off-site haul route several times throughout the day. These efforts were observed to be functioning as intended so that soil was not observed to be leaving the site.

The contractor has begun removing the perimeter silt fence at the south side of the site in sections as required to finish grade the topsoil, and install sod.

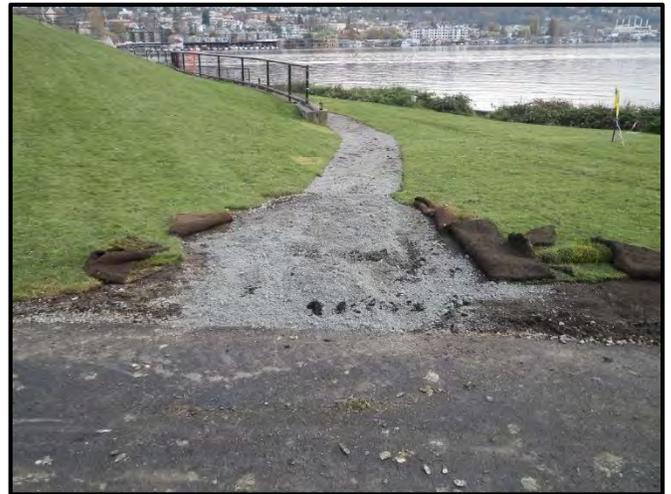
We observed the contractor placing loose crushed rock base course in the path areas west of the Cracking Towers (see site plan). The material will be graded and compacted later this week.

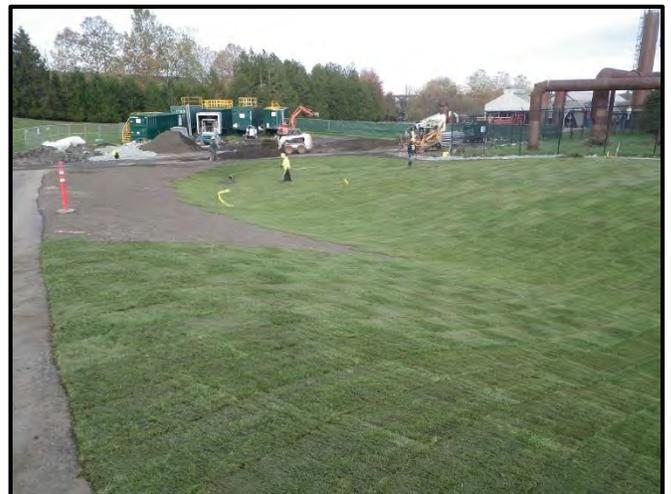
We observed the contractor install approximately 10,000 sq. ft. of sod in the swale area east of Kite Hill (see attached site plan).

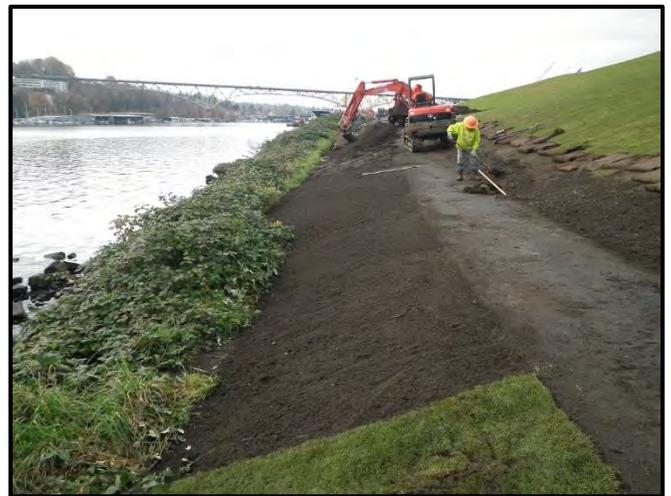
We observed the contractor place an approximately 12-inch lift of topsoil over the previously installed geo-grid along the south perimeter of the site adjacent to the lakeshore (see attached site plan). The topsoil was being placed with a track mounted mini excavator, and was being tamped into place with the excavator bucket. After the topsoil was finish graded, it was raked smooth by hand in preparation for sod installation next week.

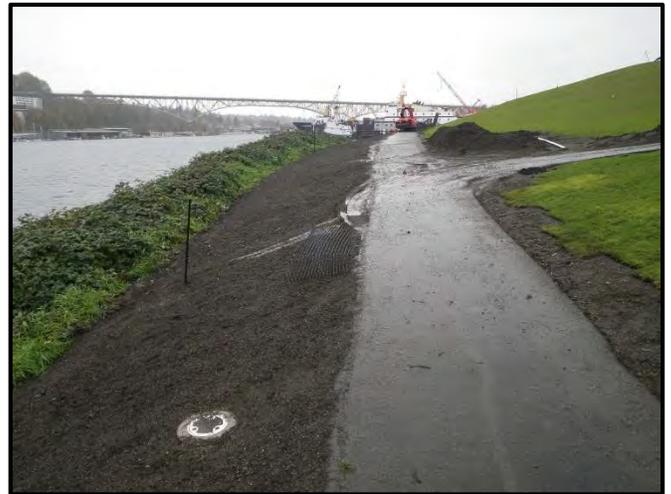
We observed the contractor place an approximately 12-inch lift of topsoil over the previously installed geo-grid along the south perimeter of the site adjacent to the lakeshore (see attached site plan). The topsoil was being placed with a track mounted mini excavator, and was being tamped into place with the excavator bucket. After the topsoil was finish graded, it was raked smooth by hand in preparation for sod installation next week.

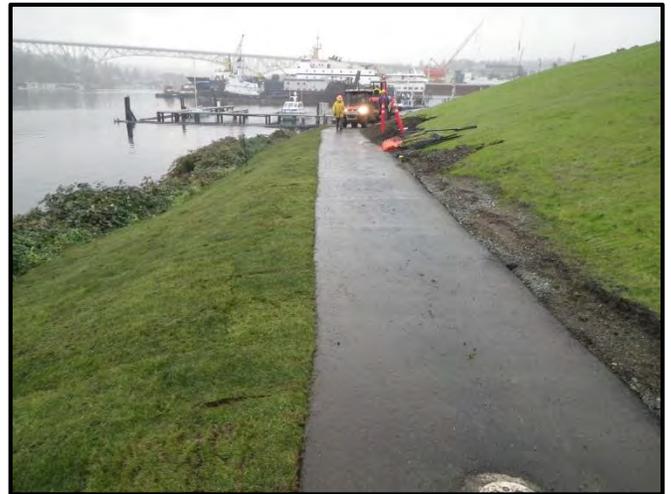
We observed the contractor place an approximately 12-inch lift of topsoil over the previously installed geo-grid along the south perimeter of the site adjacent to the lakeshore (see attached site plan). The topsoil was being placed with a track mounted mini excavator, and was being tamped into place with the excavator bucket. After the topsoil was finish graded, it was raked smooth by hand in preparation for sod installation next week.

We also observed the contractor install approximately 3,500 sq. ft. of sod in this same area.

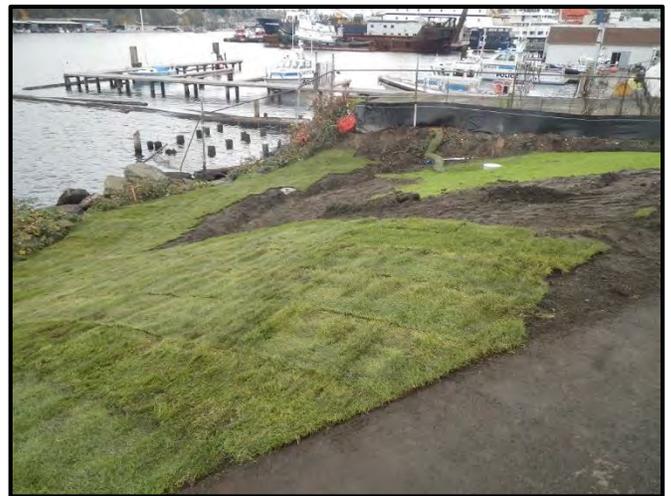
We observed the contractor place an approximately 12-inch lift of topsoil over the previously installed geo-grid in the southwest corner of the site adjacent to the lakeshore (see attached site plan). The topsoil was being placed with a track mounted mini excavator, and was being tamped into place with the excavator bucket. After the topsoil was finish graded, it was raked smooth by hand in preparation for sod installation next week.

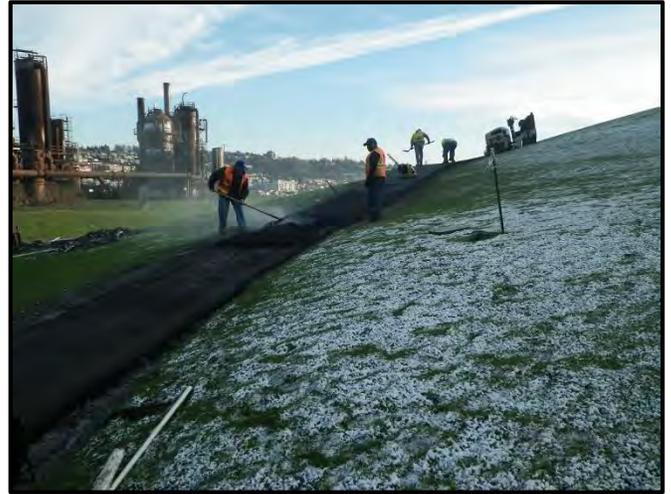
At this time temporary erosion and sedimentation control efforts include silt fencing, temporary interceptor swales, check dams, quarry spalls installed along the edge of the asphalt pavement trucking route, temporary sediment ponds and an array of 2- 20,000 gallon Baker Tanks for runoff storage during storm events. We also observed the contractor using a street sweeper to clean the paved on- and off-site haul route several times throughout the day. These efforts were observed to be functioning as intended so that soil was not observed to be leaving the site.

The contractor was removing the perimeter silt fence at the west side of the site in sections as required to finish grade the topsoil, and install sod.
