APPENDIX M (continued)
Field Report – Geotechnical

Field Report

Project:
Kite Hill Soil Cover Project

Location:
Gasworks Park, Seattle, WA

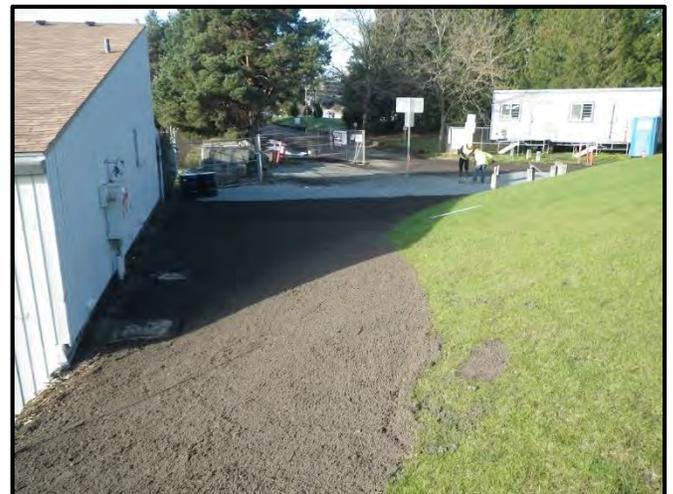
We observed the contractor place an approximately 12-inch lift of topsoil over the previously installed geo-grid at the west perimeter of the site as well as along the path edges on the west side of Kite Hill (see attached site plan). The topsoil was being placed with a track mounted mini excavator, and was being tamped into place with the excavator bucket. After the topsoil was finish graded, it was raked smooth by hand in preparation for sod installation.

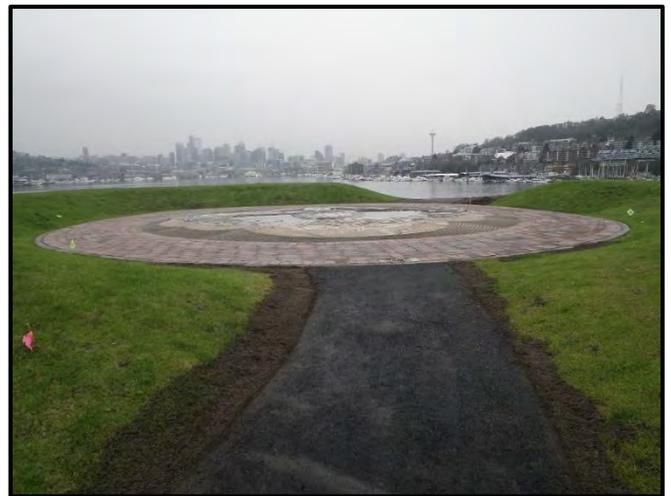
We observed the contractor place an approximately 6- to 12-inch lift of topsoil along the path edges on the north, south, and west sides of Kite Hill (see attached site plan). The topsoil was being placed with a track mounted mini excavator, and was being tamped into place with the excavator bucket. After the topsoil was finish graded, it was raked smooth by hand in preparation for sod installation next Monday.

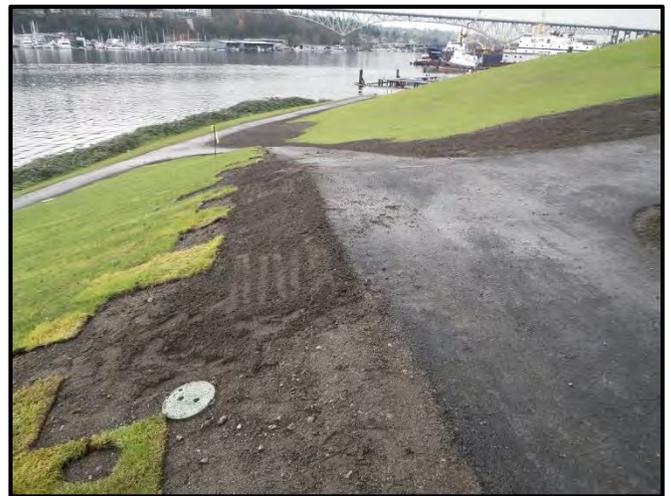
We observed the contractor place an approximately 6- to 12-inch lift of topsoil along the path edges on the north, south, and east sides of Kite Hill (see attached site plan). The topsoil was being placed with a track mounted mini excavator, and was being tamped into place with the excavator bucket. After the topsoil was finish graded, it was raked smooth by hand in preparation for sod installation next Monday.

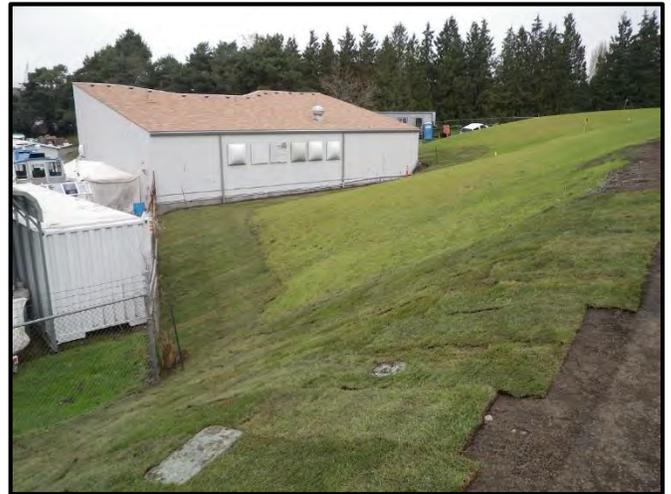
Kite Hill remained stable during excavation activities; there was no seepage along the face of the slope, no sloughing or raveling of the site soils and no tension cracks were observed along the crest of the slope. No evidence of instability of the existing slope was observed during our site visit today.

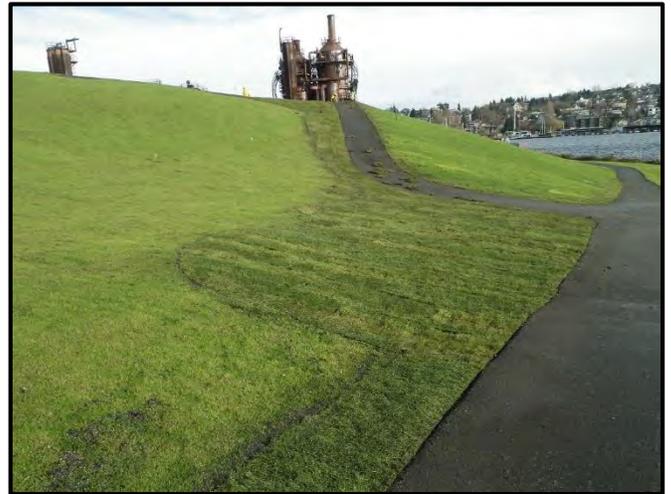
We observed the contractor install approximately 6,600 sq. ft. of sod along the path edges on the south half of Kite Hill (see attached site plan).

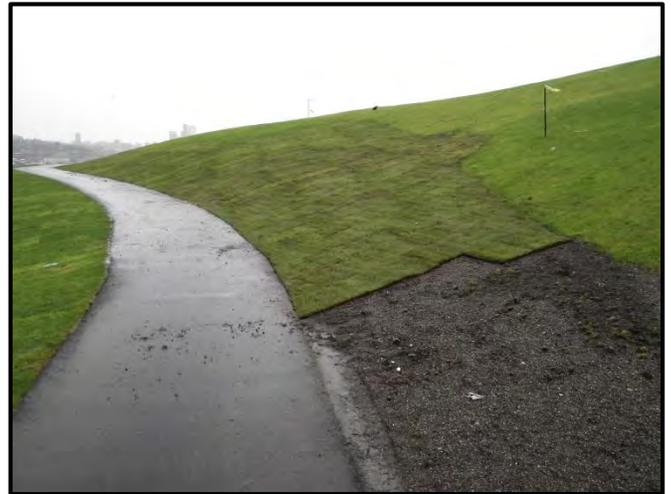
We observed the contractor install approximately 600 sq. ft. of sod along the path edges on the south half of Kite Hill (see attached site plan).

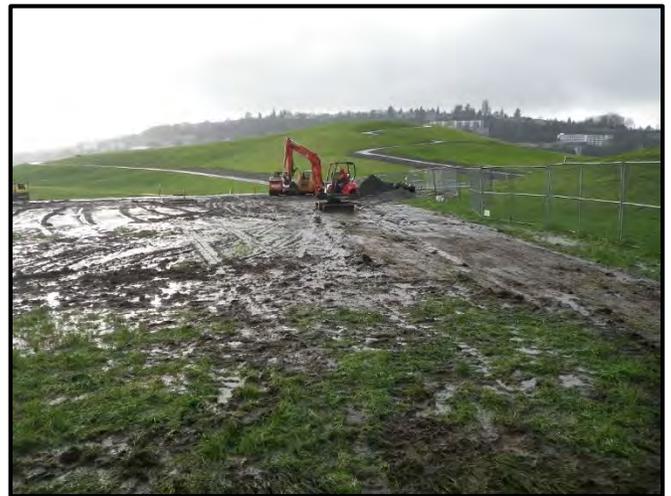
Kite Hill remained stable during construction activities; there was one very small area of groundwater seepage observed on the west slope between the path and the northeast corner of the Harbor Patrol Building (approximately a 5 sq. ft. area). No sloughing or raveling of the site soils and no tension cracks were observed, however the topsoil in that area is saturated and very soft. We will continue to monitor this location to determine if remedial action is required at a later date. No evidence of instability of the existing slope was observed during our site visit today.

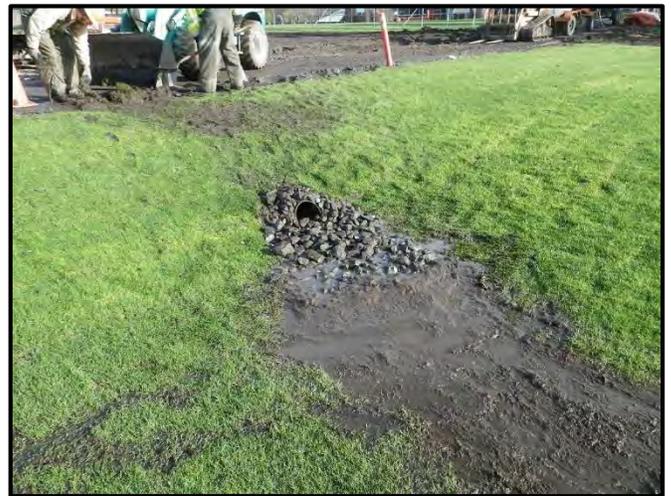
We observed the contractor placing 2- to 4-inch quarry spalls at the end of the storm drain that discharges to the swale east of Kite Hill.

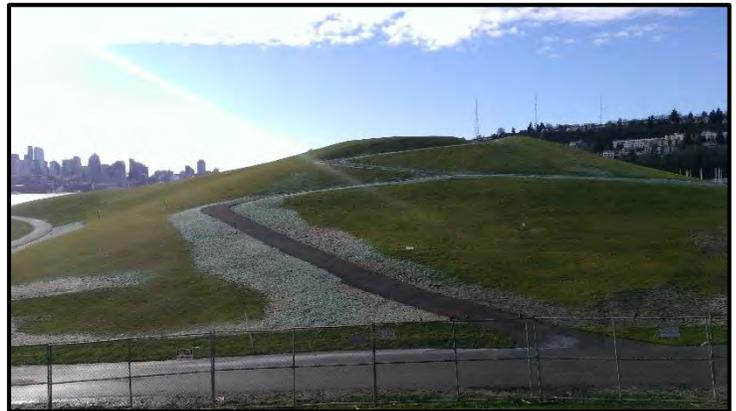
The slopes and areas of Kite Hill that were recently regarded were observed to be stable during our site visit today with no sloughing, raveling, tension cracks or other instability of site soils observed on the slopes. The sod was observed to be saturated and very soft in many areas, which is to be expected. We will continue to make periodic site visit to observe the site conditions during the wet winter months (as required by the grading extension) to determine if remedial action is required at a later date.

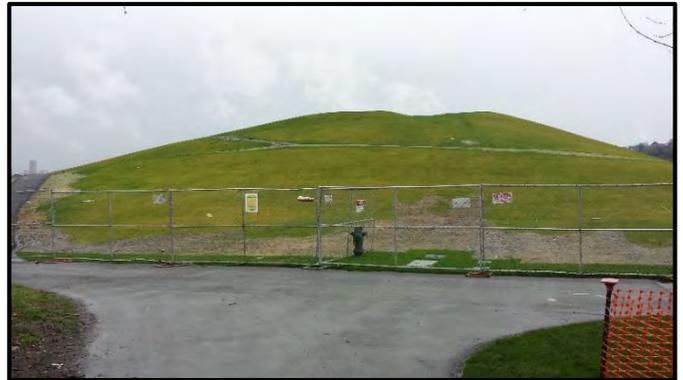
Photo 1 - View of Kite Hill from north

The slopes and areas of Kite Hill that were regraded were observed to be stable during our site visit today with no sloughing, raveling, tension cracks or other instability of site soils observed on the slopes. The sod/grass areas were observed to be saturated and very soft in many areas, which is to be expected.

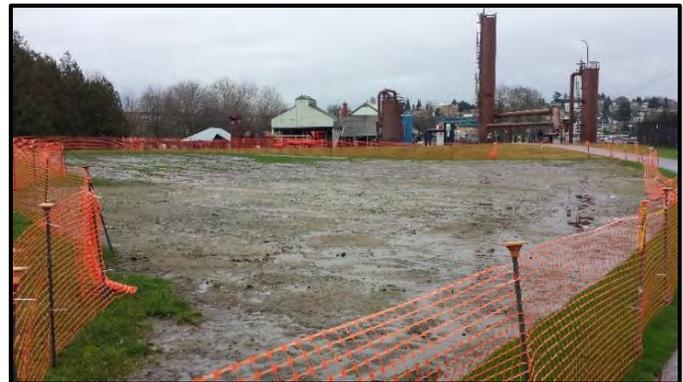
Photo 2 - Former staging Area

The area located in the northeast corner of the site used as a staging area during construction activities (see Photo 2) was observed to consist of a mixture of soil, sod and hydroseed. Runoff water from this area was observed to flow down slope along the swale located along the east side of Kite Hill (see Photo 3). The water approached the lake near the southeast corner of the site. A straw waddle was observed at the end of this runoff water and no sediment was observed in the flow.

1. Inspect the filter fabric sock in the CB at the former staging area and replace it if necessary (discharges to east swale area).
2. Install a straw wattle barrier around the CB discussed above.
3. Install additional straw wattles along the east drainage swale to further slow the stormwater velocities to reduce the risk of erosion. The wattles should be spaced approximately 25 feet on center and staked firmly into the sod. In addition we recommend that the areas of loose sod (see Photo 4) be repaired using geotextile anchoring staples to hold in place.

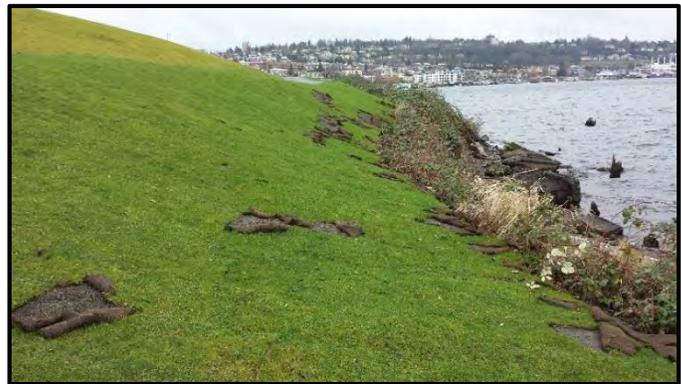
Photo 4 - Areas of loose sod on south side of Kite Hill

Loose areas of sod were observed along the edges of the south side of Kite Hill. We recommend that the edges of the sod be repaired as discussed below so that the sod will take root in the topsoil.

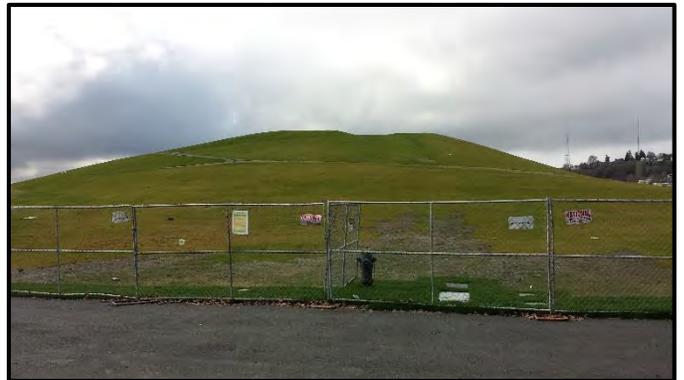
Photo 1 - View of Kite Hill from north

The slopes and areas of Kite Hill that were regraded were observed to be stable during our site visit today with no sloughing, raveling, tension cracks or other instability of site soils observed on the slopes. The sod/grass areas were observed to be saturated and very soft in many areas, which is to be expected.

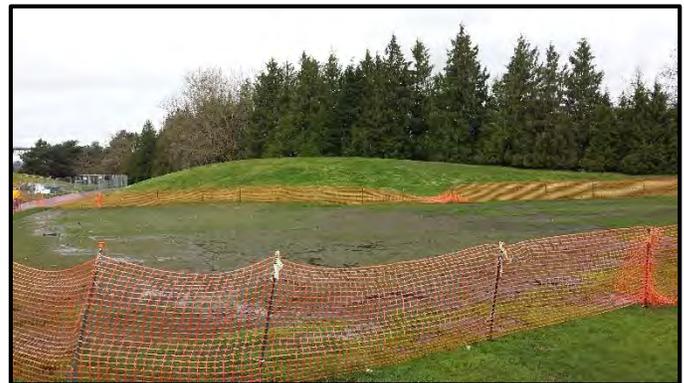
Photo 2 - Former staging Area

The area located in the northeast corner of the site used as a staging area during construction activities (see Photo 2) was observed to consist of a mixture of soil, sod and hydroseed. Runoff water from this area was observed to flow down slope along the swale located along the east side of Kite Hill (see Photos 3 and 4). The water approached the lake near the southeast corner of the site. Straw wattles were observed at the end of this runoff water and no sediment was observed in the flow.

1. Inspect the filter fabric sock in the CB at the former staging area and replace it if necessary (discharges to east swale area).
2. Install a straw wattle barrier around the CB discussed above.
3. Install additional straw wattles along the east drainage swale to further slow the stormwater velocities to reduce the risk of erosion. The wattles should be spaced approximately 25 feet on center and staked firmly into the sod. In addition we recommend that the areas of loose sod (see Photo 5) be repaired using geotextile anchoring staples to hold in place.

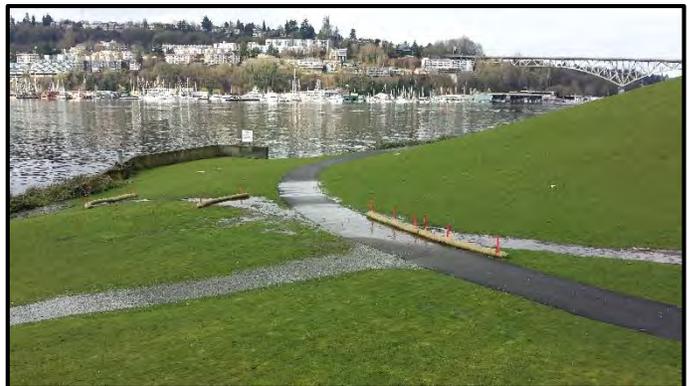
Photo 4- Straw wattles in lower swale

Additional straw wattles were observed to be installed per our recommendations in FR-76 dated February 2, 2015.

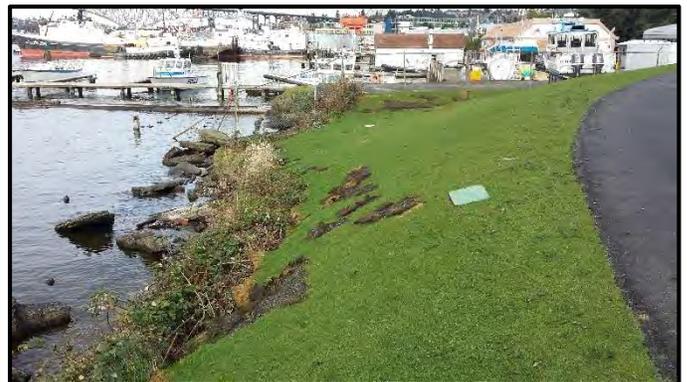
Photo 5 - Areas of loose sod on south side of Kite Hill

Loose areas of sod were observed along the edges of the south side of Kite Hill. We previously observed that this was due to geese foraging in the area. We recommend that the edges of the sod be repaired as discussed below so that the sod will take root in the topsoil.

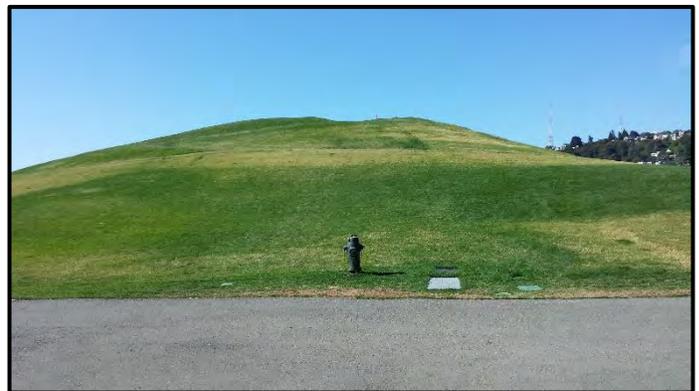
Photo 1 - View of Kite Hill from north

At this time permanent erosion and sedimentation control measures consisting of sod and hydroseed have been placed throughout the site and vegetation is well established (see Photos 1 and 2), with the exception of a small area of quarry spalls located along the area of low swale to the east side of kite hill. The vegetation has been in place for months and the Kite Hill area was reopened to the public by about July 1, 2015.

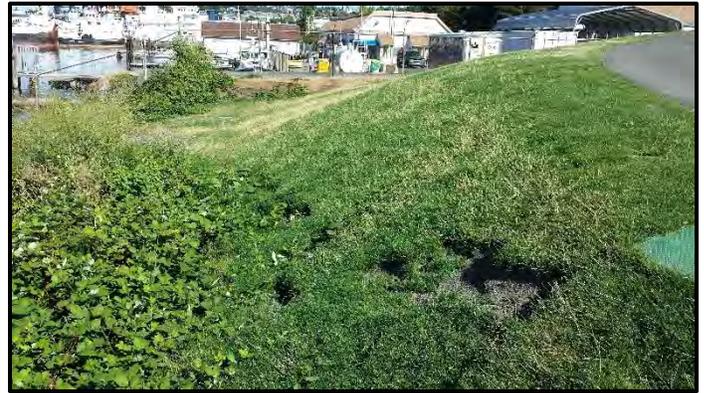
Photo 3 - Loose sod along south side of Kite Hill

Small areas of loose sod were observed along the edges of the south side of Kite Hill (see Photo 3). We previously observed that this was due to geese foraging in the area. We recommend that the edges of the sod be repaired as discussed below so that the sod will take root in the topsoil.

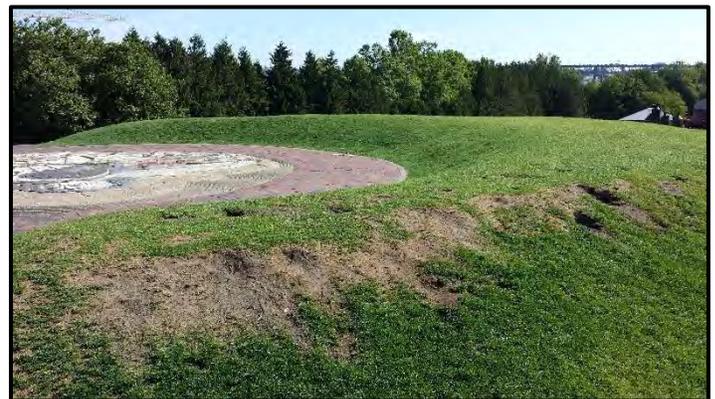
Photo 4 - Diggings along top of Kite Hill

We also observed an area along the “sun dial” at the top of the slope where digging (children? or dogs?) has been occurring (see Photo 4). This area should be regraded and planted to establish grass cover.
