20 April 2021

Subject: Cap Integrity Monitoring
BNSF Railway Company, Hillyard Dross Cap
Spokane, Washington
KJ 2196114*00

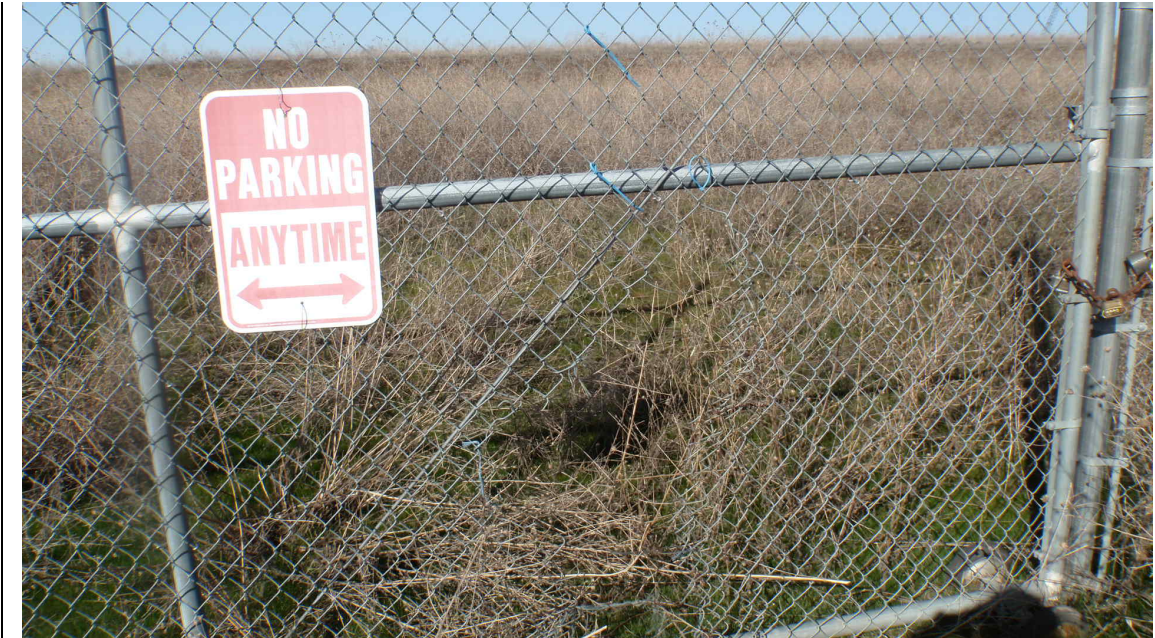
Photo #1: Hole in fence enclosing the dross cap.

- A hole had been cut in the fence surrounding the dross cap; repairs will be performed.
- Monitoring wells were observed to be in good condition.
- One monitoring well (MW-4) is in the work area of an ongoing Washington State Department of Transportation (WSDOT) project and will be converted to a traffic-rated flush mounted monument by WSDOT in the future.

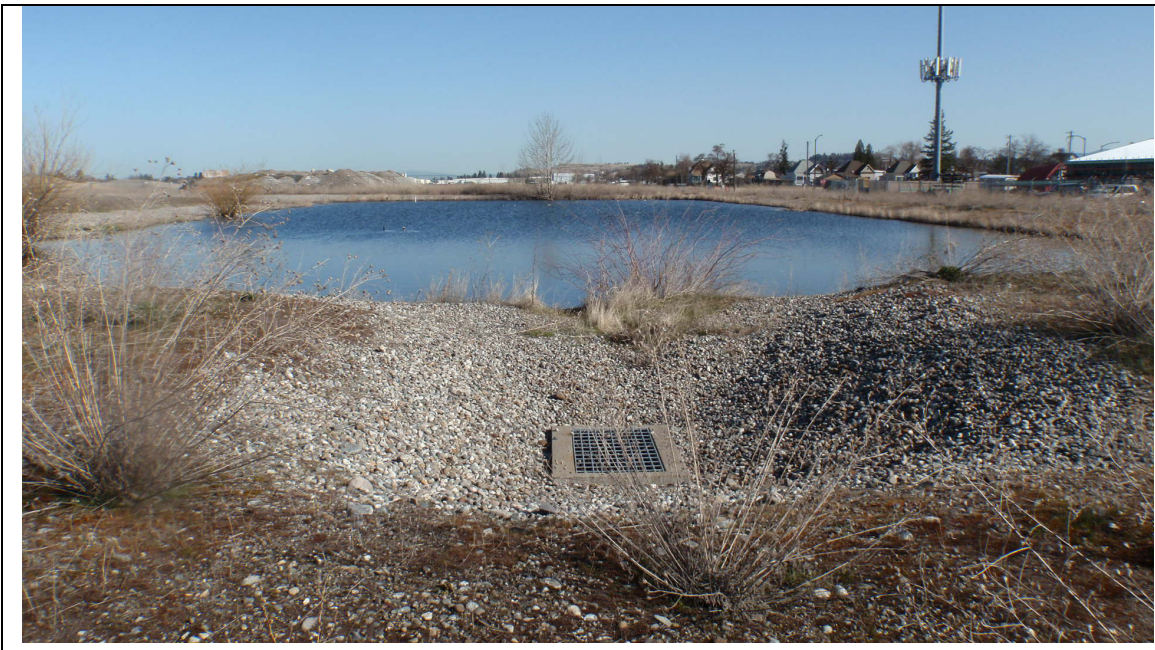
The evaporation pond that collects Site stormwater is located directly northeast of the dross encapsulation cell. Water level elevations measured in the pond are referenced to the North American Vertical Datum of 1988. Post-construction evaporation pond water level elevations are presented in Attachment A. The evaporation pond was not observed to be discharging to the overflow sump and drywell during April 2021.

Photo #2: Stormwater retention pond and overflow sump.

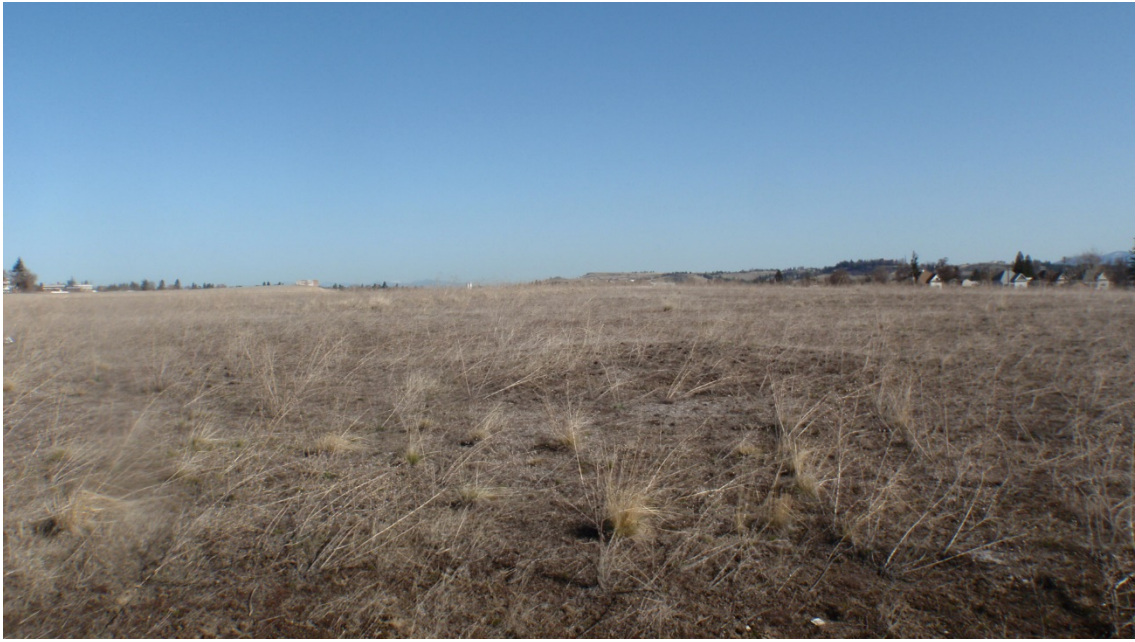
No erosion or settlement of the dross cap was observed during 2021. Grasses and forbs were abundant on and surrounding the dross encapsulation cell during the growing season and were dormant during dry months, as is normal.

Photo #3: Dross cap area.

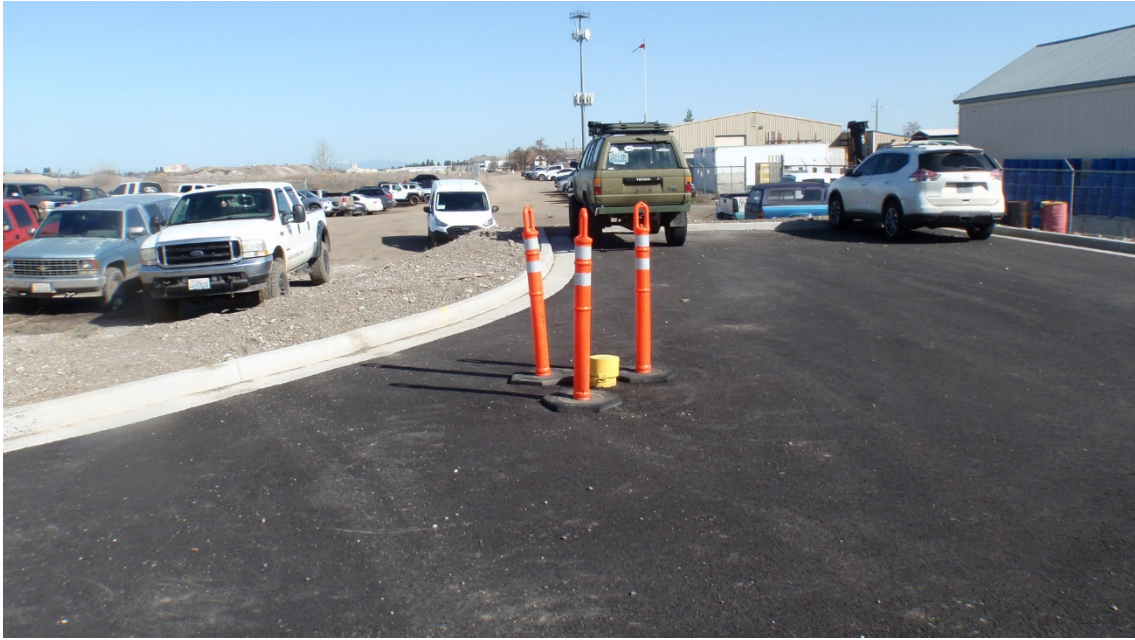
Photo #4: Monitoring well MW-4; to be converted to a traffic-rated flush mount.
