ENVIRONMENTAL SITE ASSESSMENT And Site Closure Report

C & L AUTO REPAIR

2901 17th Avenue South Seattle, Washington 98144 ORION Project Number 2010437 (Task 1)

Re: Environmental Site Assessment – In-Place Tank Closure C & L Auto Repair 2901 17th Avenue South Seattle, Washington 98144 ORION Project Number 2010437 (Task 1)

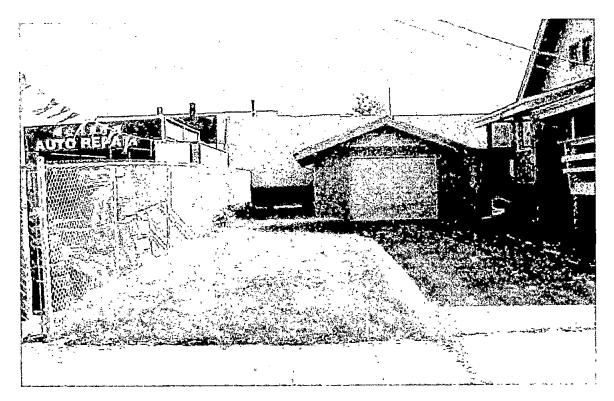
Photograph of C&L Auto Repair (left) and the adjacent property where petroleum hydrocarbon contaminants were found along the property boundary.

The waste oil tank identified at the site has been properly closed in-place using prescribed methods recommended by federal, state and local regulations. It appears that petroleum contamination still exist at the site, and may be migrating to an adjacent property.

Based upon the findings of this assessment, a Phase II subsurface investigation is recommended at this site.

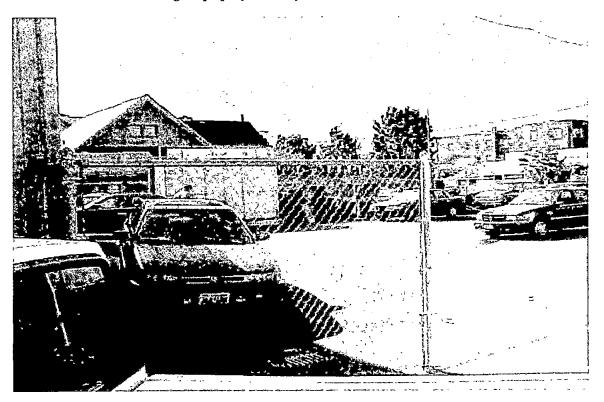
Photograph of the C&L Auto Repair shop facing west, depicting the parking lot and residential properties in the background.
