Title of Report: Burrows Island Light Station Remediation Project, Skagit County, Washington

TECHNICAL MEMORANDUM

Burrows Island Light Station Remediation Project, Skagit County, Washington

December 11, 2023

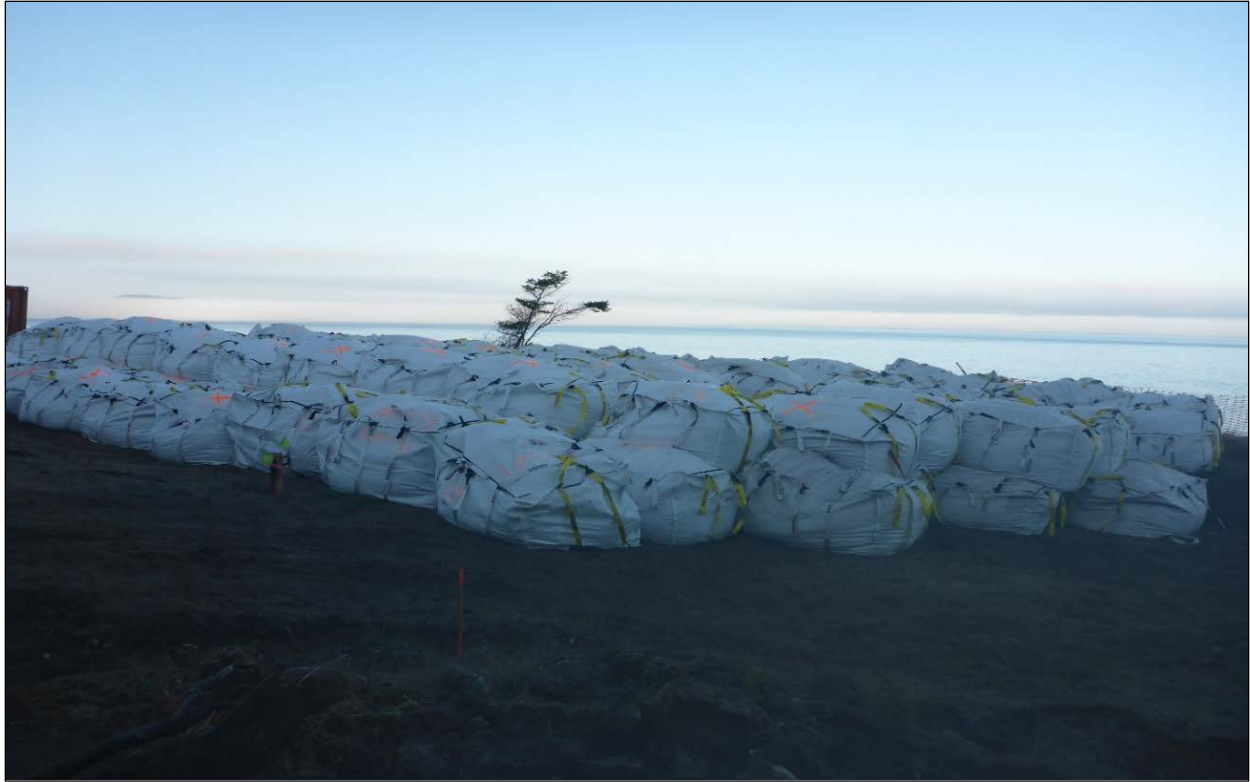
The excavation procedures consisted of methodically excavating the contaminated soils and placing them directly into PacTec LiftPac zipper-top hazardous waste bags (Figure 4). The primary bag size used had a capacity to hold 3.5 cubic yards of material. A smaller 1 cubic yard bag was used in hard-to-reach places or to collect contaminated debris. A bag was placed into a metal-framed box to hold the spoils in place. When full of spoils, the bags were closed and lifted to a stockpile area and later barged out from the island for proper disposal. Each bag received a tracking number. With this procedure, monitors only inspected the surface of excavated areas for the presence of cultural materials and features. As the excavations were completed for each area, Arcadis personnel collected multiple soil samples to verify if contaminants in the soil were removed to accepted levels and that no more excavation was needed at that location (Figure 5). A small crew from Walker Specialty Construction (WSC) was also present on the island working on the removal of Asbestos Containing Material (ACM) roof tiles from the duplex building, although this work did not involve ground-disturbance and was not archaeologically monitored.

Figure 4. Bags (3.5 cubic yards) used to collect contaminated soils.

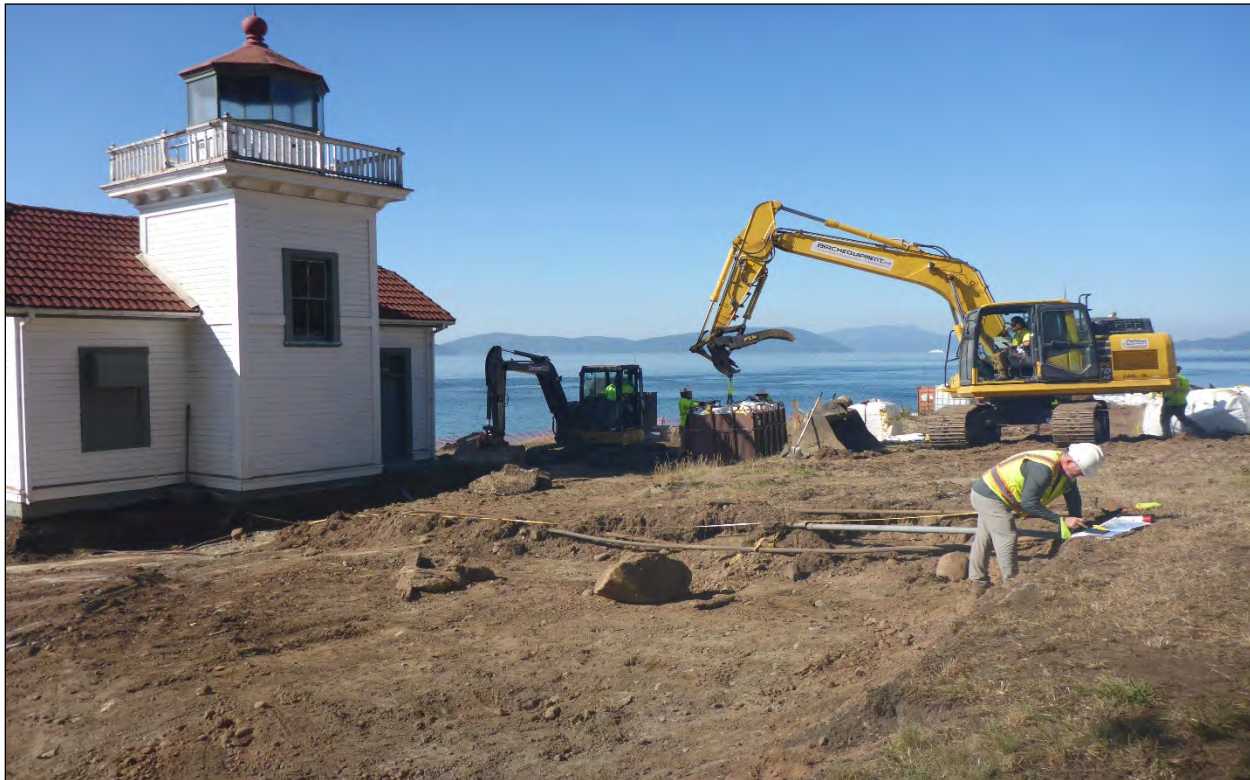
Figure 5. Arcadis personnel collecting soil samples for testing. View northwest.

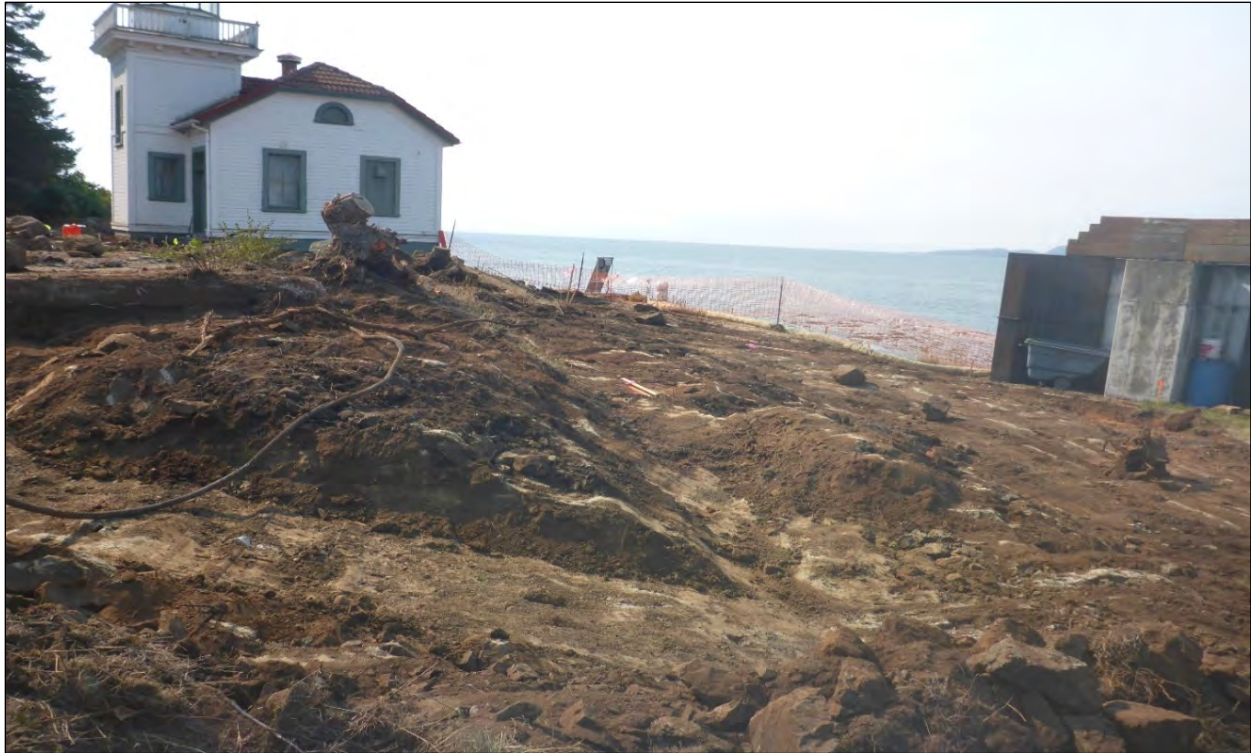
Areas A, B, C, and D were small adjacent areas with irregular shapes. Work in these areas was all conducted during Session 2. The existing Acoustic Reflector was within Area A and the concrete foundation for the former Oil-Paint Storage building was within Area D (Figure 6). Sediment observed in those four areas generally consisted of brown to yellowish-brown silt fill mixed with glacial gravelly sand and serpentinite residuum bedrock material. Tree stumps and large roots were present in these Areas.

Figure 6. Overview of excavated Areas A, B, C, and D. The Acoustic Reflector is on the right and the former Oil Paint Storage Building foundation on the left. View to the southwest.

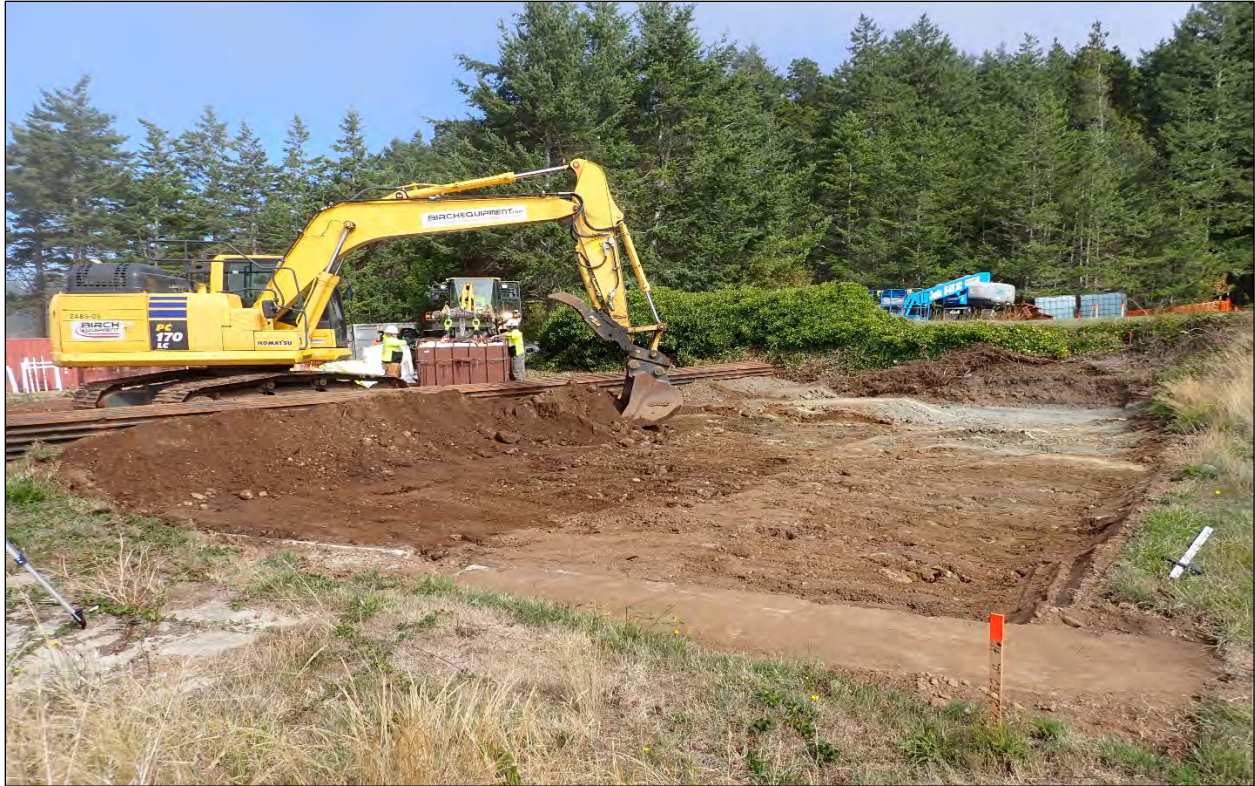
Excavation in Area E was conducted during Session 1 and started at the helicopter landing pad. The corrugated steel helicopter pad was removed and sediments excavated to a depth of 1 foot below ground surface (ft. bgs). Sediment observed consisted of gray and dark reddish-brown gravelly coarse sandy silt that was poorly sorted and contained few small to medium roots. The deposit consisted of reworked, redeposited glacial till used as fill (Figure 6).

Figure 6. Overview Area E (helicopter pad) showing excavated sediment. View to the east.

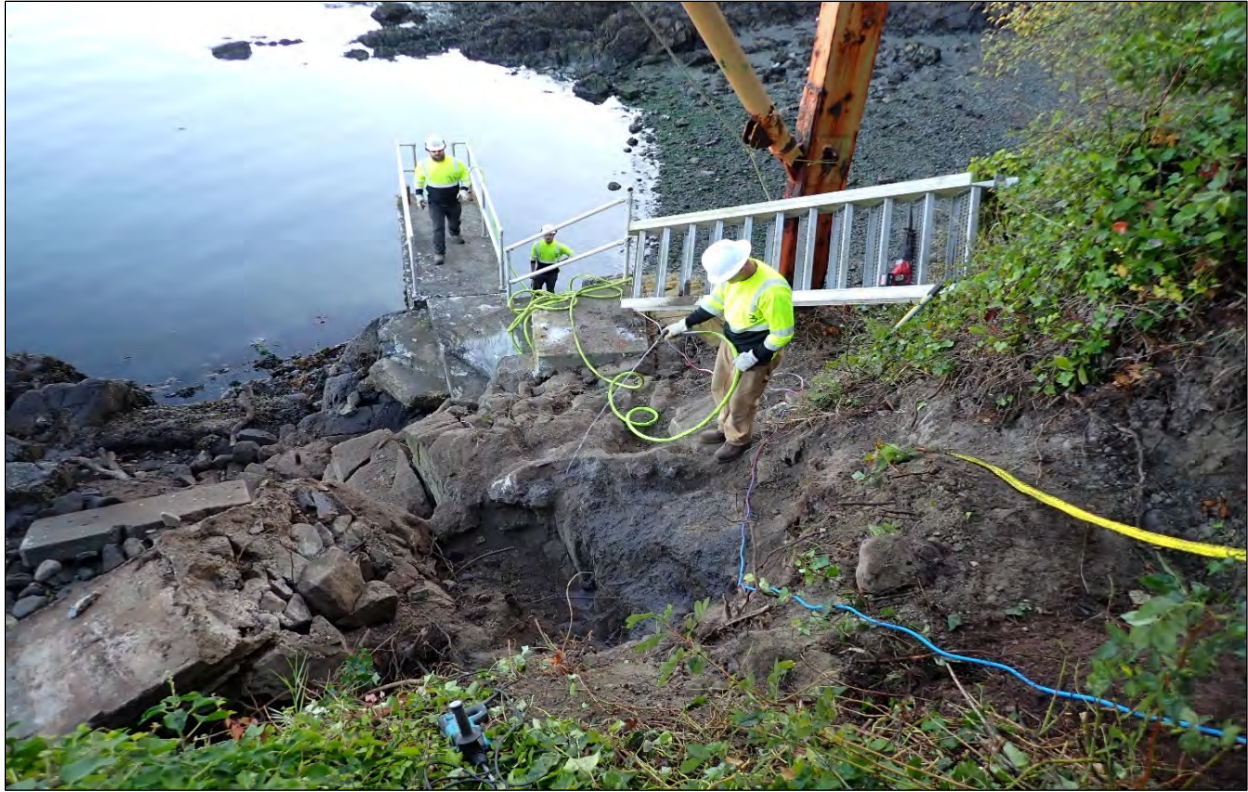
To repair and rebuild the light station access staircase, the Brice crew hand-excavated about $\frac{1}{2}$ -cubic yard of glacial material from the hillside, hosed off the bedrock, and drilled holes into the rocks within the staircase footprint (Figure 7). Grayish-brown fine sandy silt colluvial glacial till debris was observed under a thick English-ivy mat.

Figure 7. Hosing off the bedrock and exposing for drilling at the staircase. View to the north.

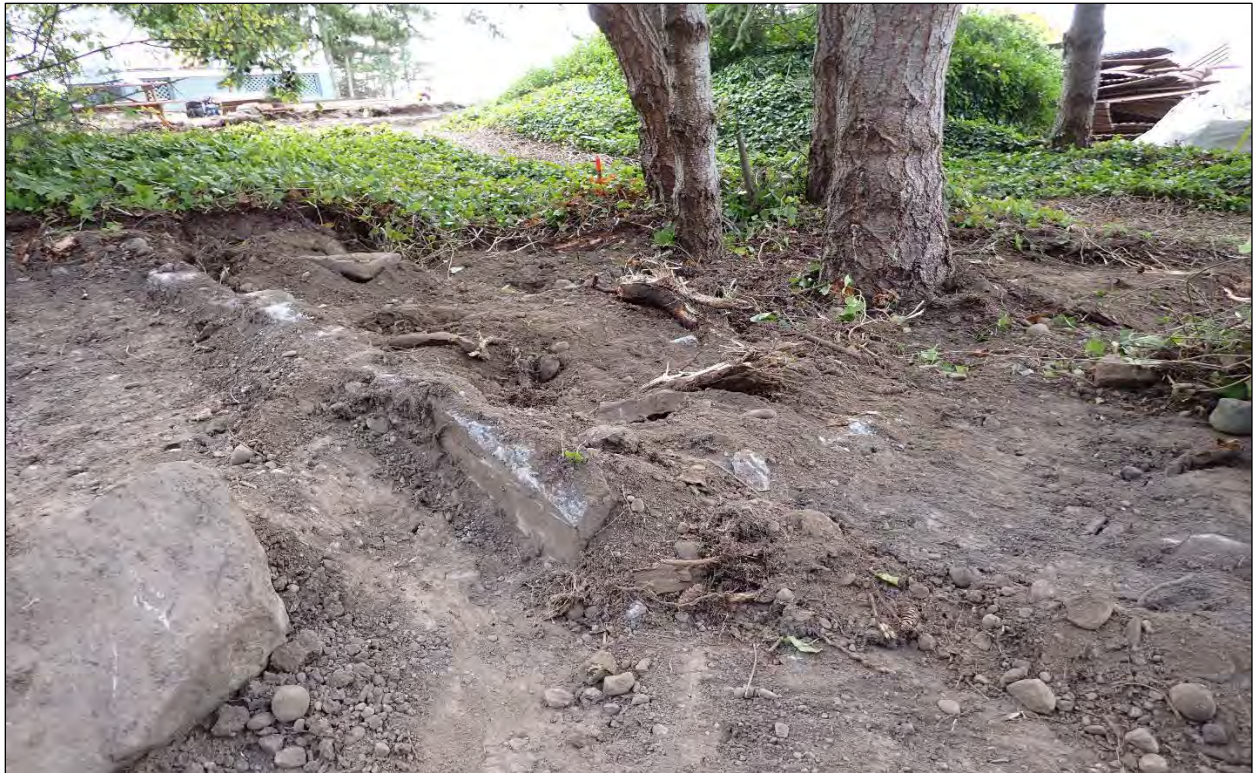
Area F was located on the northeast edge of the former OIC Quarters, no longer extant. The ground surface was covered by ivy and a few deciduous trees and vines which made excavation difficult. The target depth of excavation was ½-foot but ended up slightly deeper in few spots because of tree roots. Remnants of the former OIC concrete wall foundation were exposed but not removed during excavations conducted during Session 3 (Figure 8). The sediment consisted of redeposited glacial till, a gray-brown and reddish-brown silty gravelly sand with common to many subrounded pebbles and boulders.

Figure 8. Remnants of the former OIC concrete wall foundation exposed during excavation of Area F. View to the southwest.

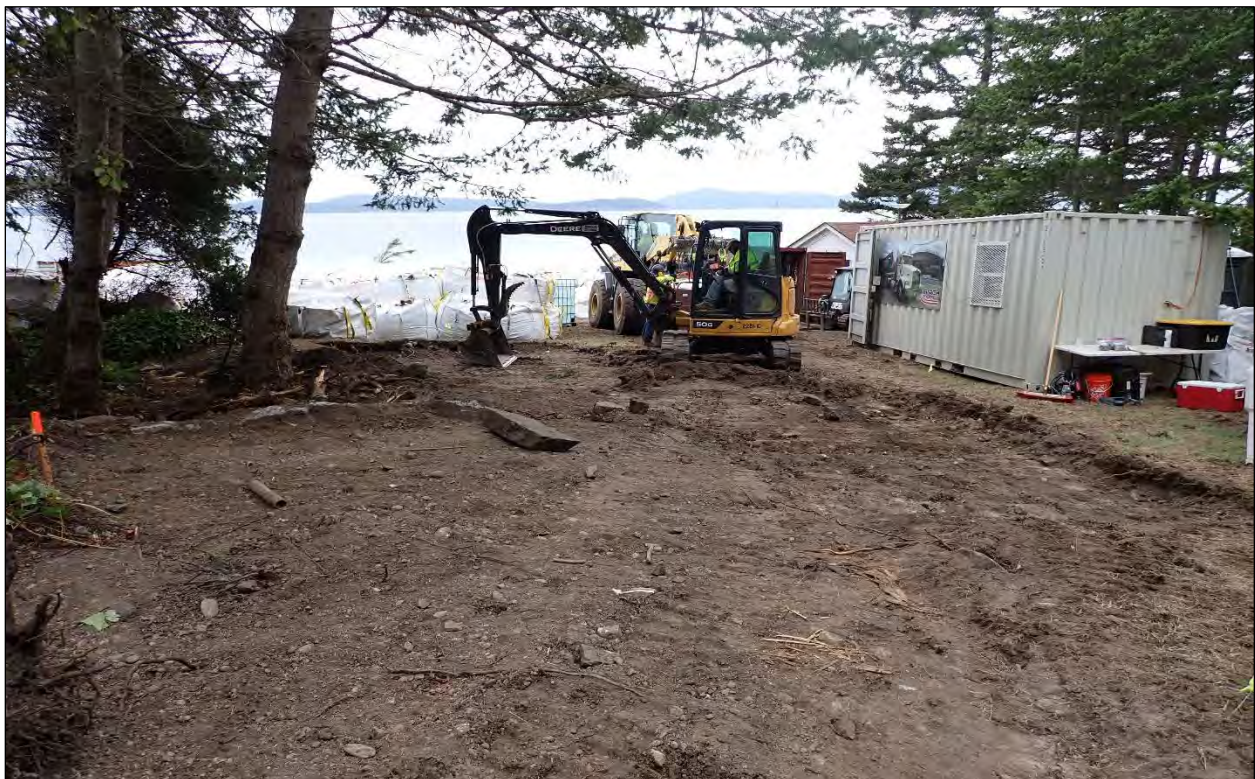
An additional three small areas were also excavated around Area F to remove approximately 200 sq feet. of sediments during Session 4 (Figure 9). Bioturbated gray silty gravelly sand was observed at the base of the excavation. No significant cultural materials were found during Session 4.

Figure 9. Overview of excavation along the northeast side of Area F. View to the northwest.

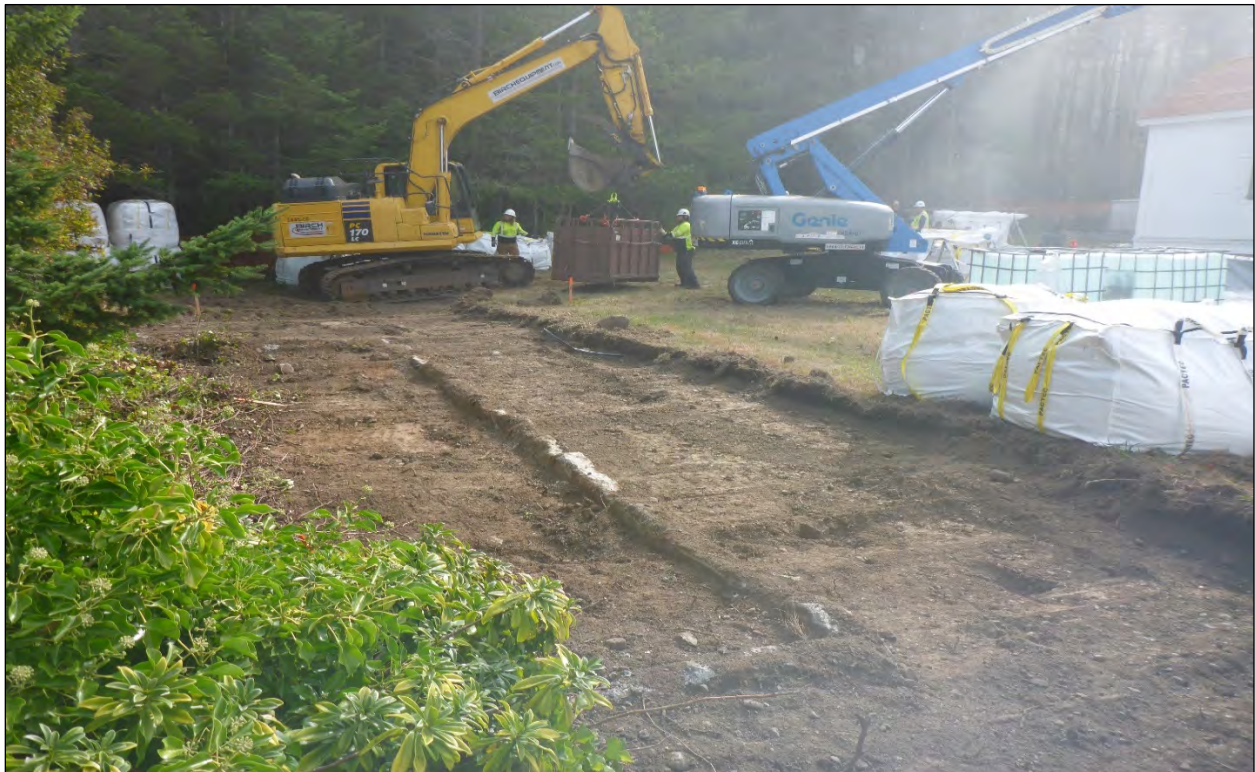
Area G is located on the south side of the former OIC Quarters. The target depth of excavation was ½-foot. The excavation, conducted during Session 2, exposed remnants of the concrete foundation. The wall remnants were 6 inches wide and built by poured-in-place concrete method. The monitor noticed two types of fills. The outside edge of the former building contained slightly compacted gray silty pebbly gravelly fine sand on the exterior and yellowish-gray fine sandy silty, less gravelly and rich in fine root debris in the interior of the foundation (Figure 10). Fragments of modern PVC pipes were observed within the fill. The foundation was left in place.

Figure 10. Area G excavation exposing concrete wall foundation from the former Officer-in-Charge Quarters. View to the southeast.

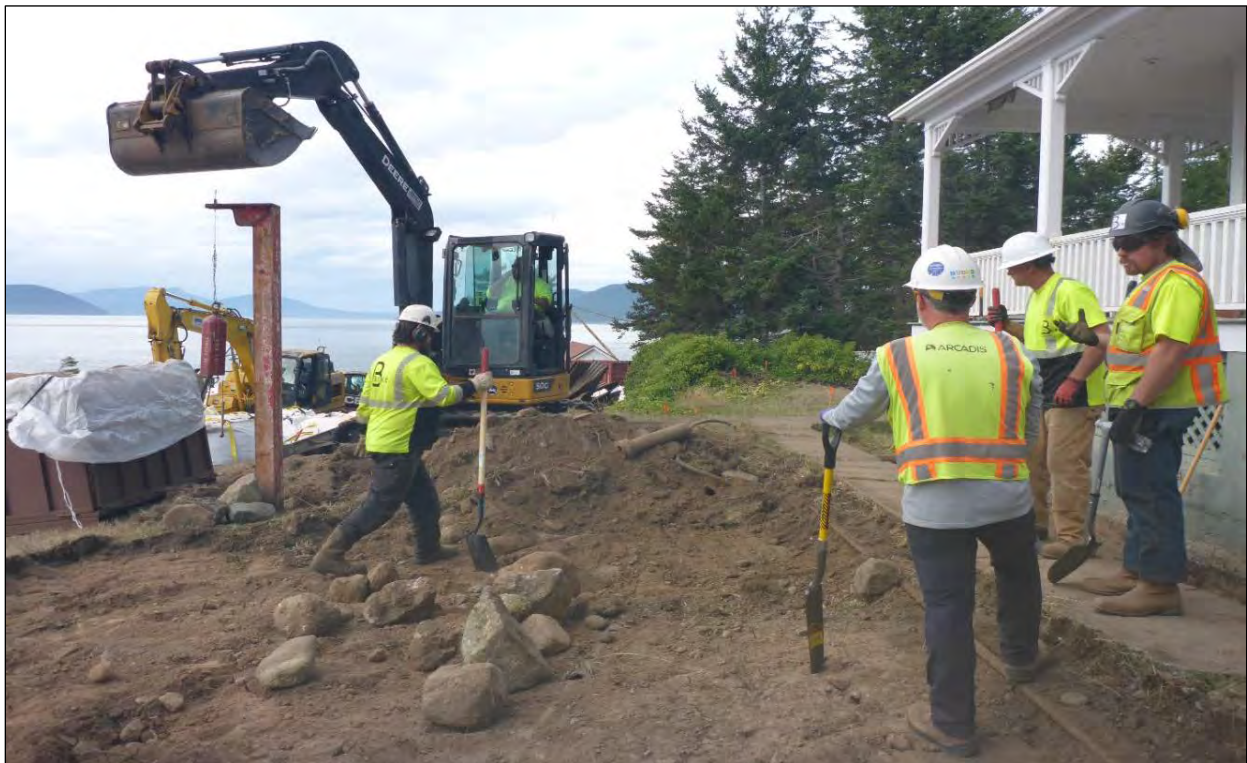
Area H surrounds the Duplex and was excavated to ½-foot. Excavations around the sidewalks were conducted by hand to minimize damage to the sidewalks, water tank foundations present near the Duplex, and the Duplex foundation during Sessions 2 and 3. The sediment observed consisted of yellowish-brown and gray pebbly gravelly very fine to fine sandy silt reworked glacial till with occasional presence of small-medium erratic boulders, mostly granitic material. Shallow 4-inch-diameter terracotta and 1 ½-inch-diameter metal pipelines (including a fuel line) were observed, as were a modern cable line (Figure 11). A backyard chiminea was observed on the south side of Area H at about 40 feet from the building. It was built with rocks, brick

Figure 11. Northwest corner excavation of the Duplex showing exposed utility lines. View to the north.

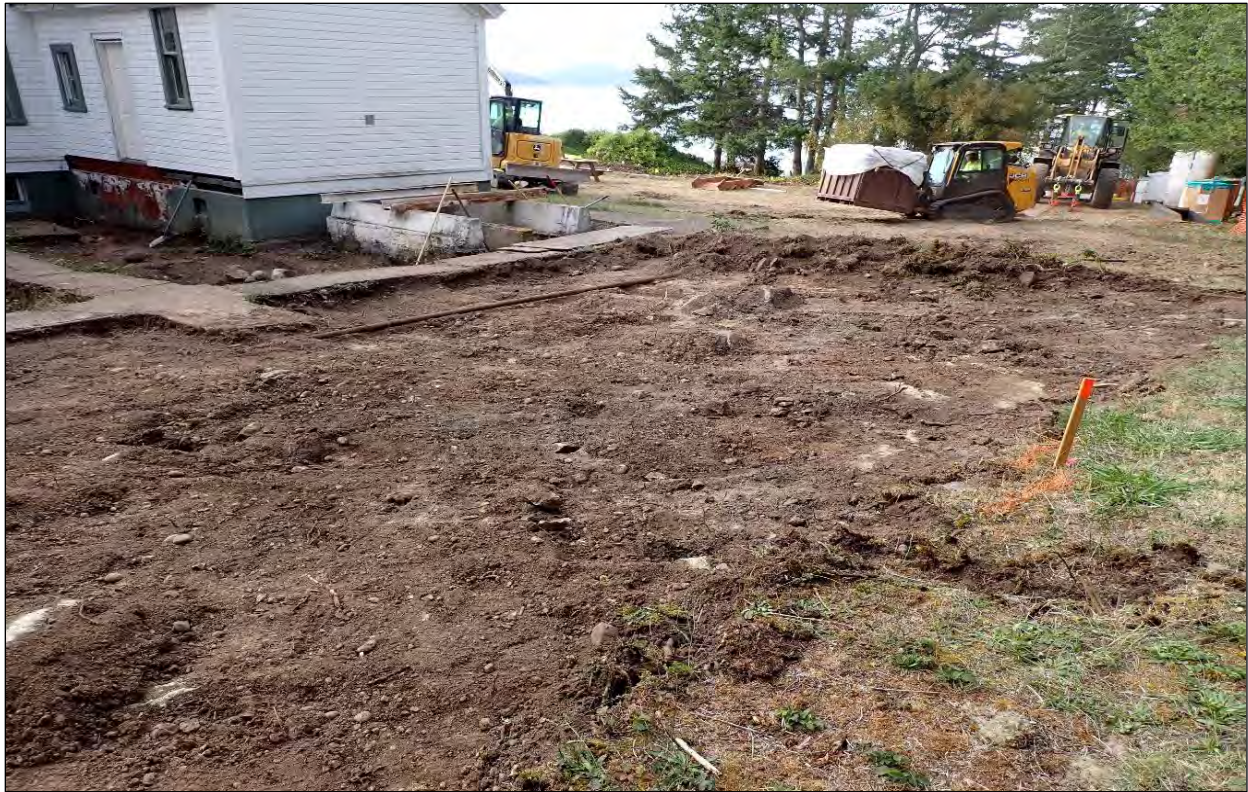
Excavation on the north side of Area H, conducted during Session 3, exposed more fuel and 4-inch-diameter terracotta pipelines, brick, concrete chunks, and ceramic and window glass fragments in the spoils (Figure 12). Sediments consisted of gray-brown and reddish-brown silty gravelly sand with many subrounded pebbles to small boulders interpreted to be reworked and redeposited glacial till over bedrock. A fragment of an aqua glass vessel was observed within the spoils of Area H during Session 3 (Figure 13).

Figure 12. Excavation of the northeast end of Area H showing exposed old fuel line. View to the northwest.

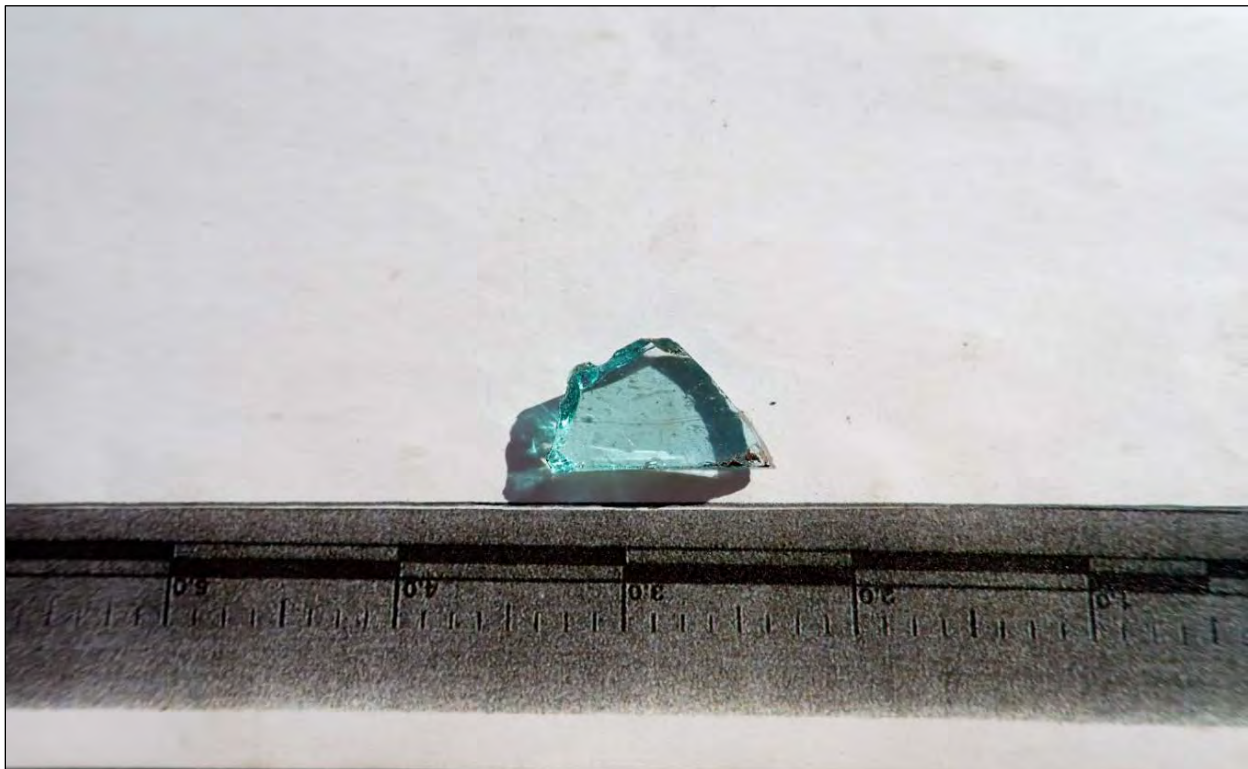
Figure 13. One aqua glass fragment was observed in spoils from Area H excavation.

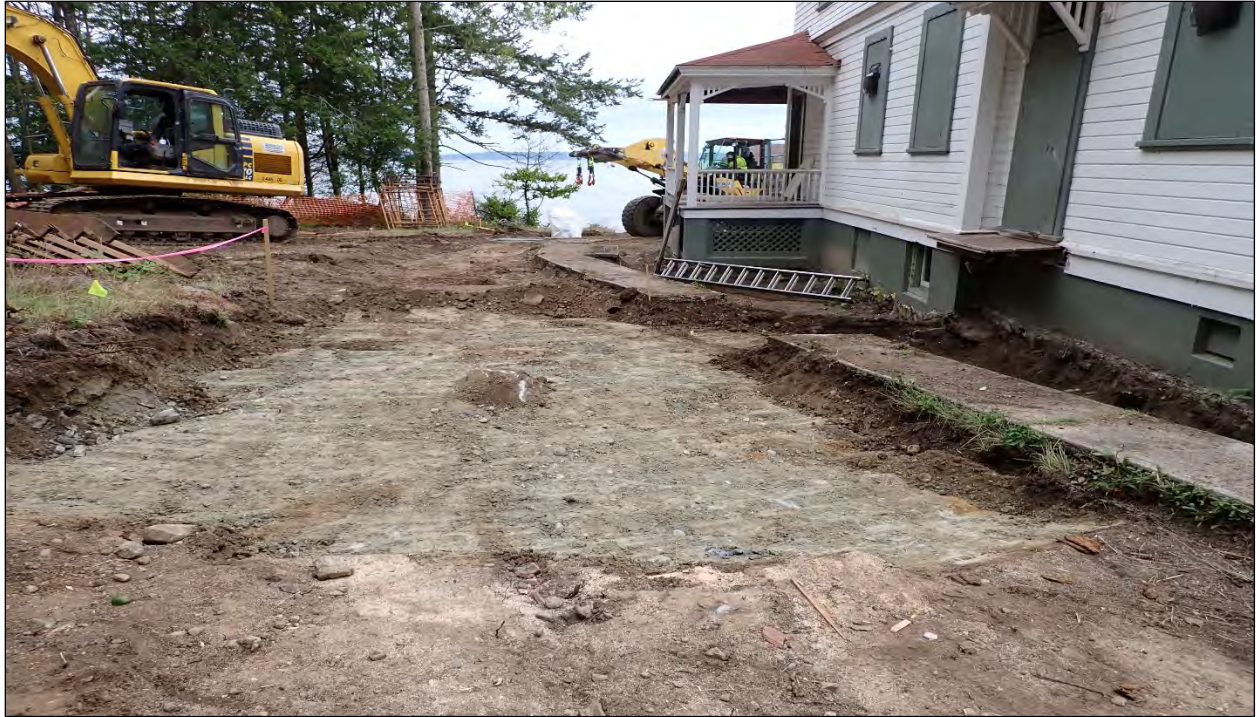
During Session 4, ultimately, 1 foot of sediments were removed from the south and east sides of Area H from an area 540 sq ft. (Figure 14), exposing gray silty gravelly sand glacial till. Concrete chunks and metal pipes were observed throughout the area. A wire fence was removed. Excavations in Area H reached glacial till (Figure 15). Sediments closest to the Duplex were hand excavated to preserve the existing sidewalks, as were those in between the water tank supports on the east side of the Duplex (Figures 16 and 17).

Figure 14. South side of Area H with final excavation. View to the west.

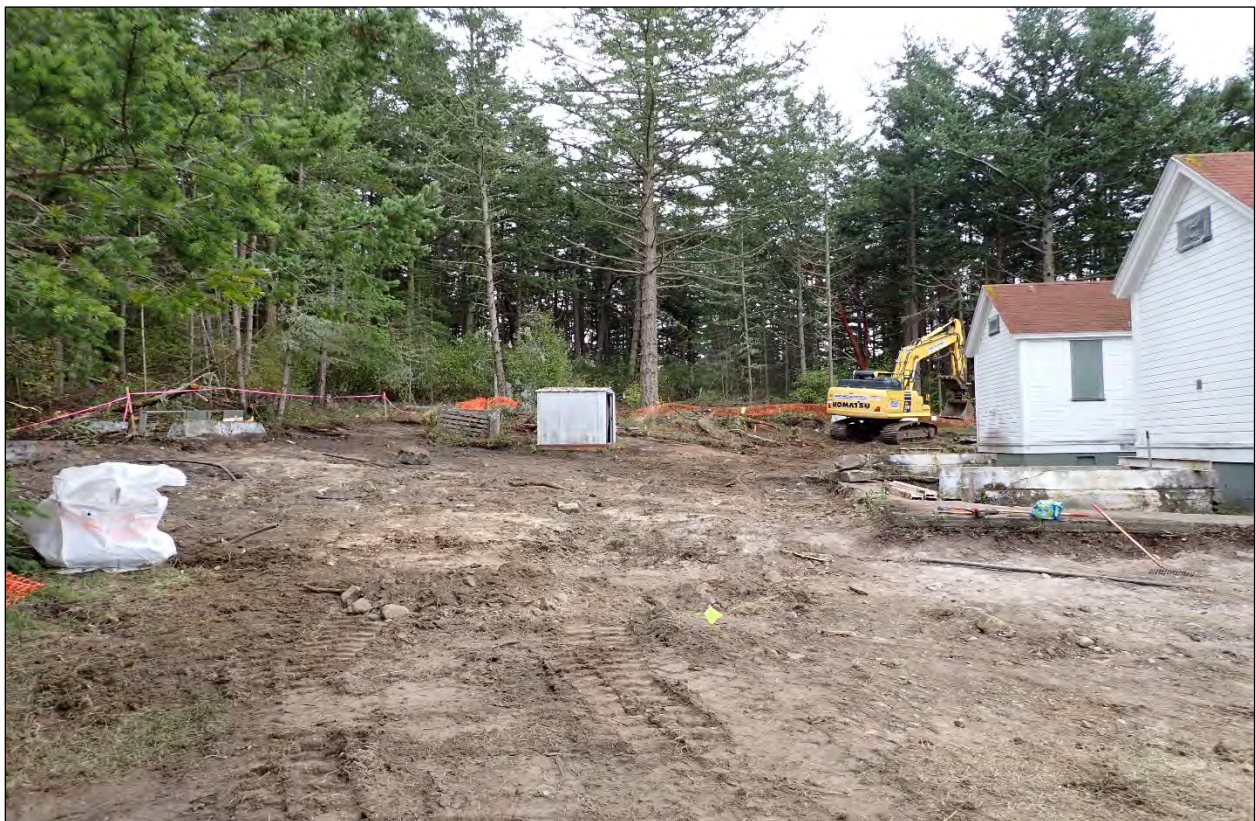
Figure 15. Excavated segment between the Duplex (right) (Area H) and Area L (concrete foundation on the left is the former firehouse pump building foundation). View to the south.

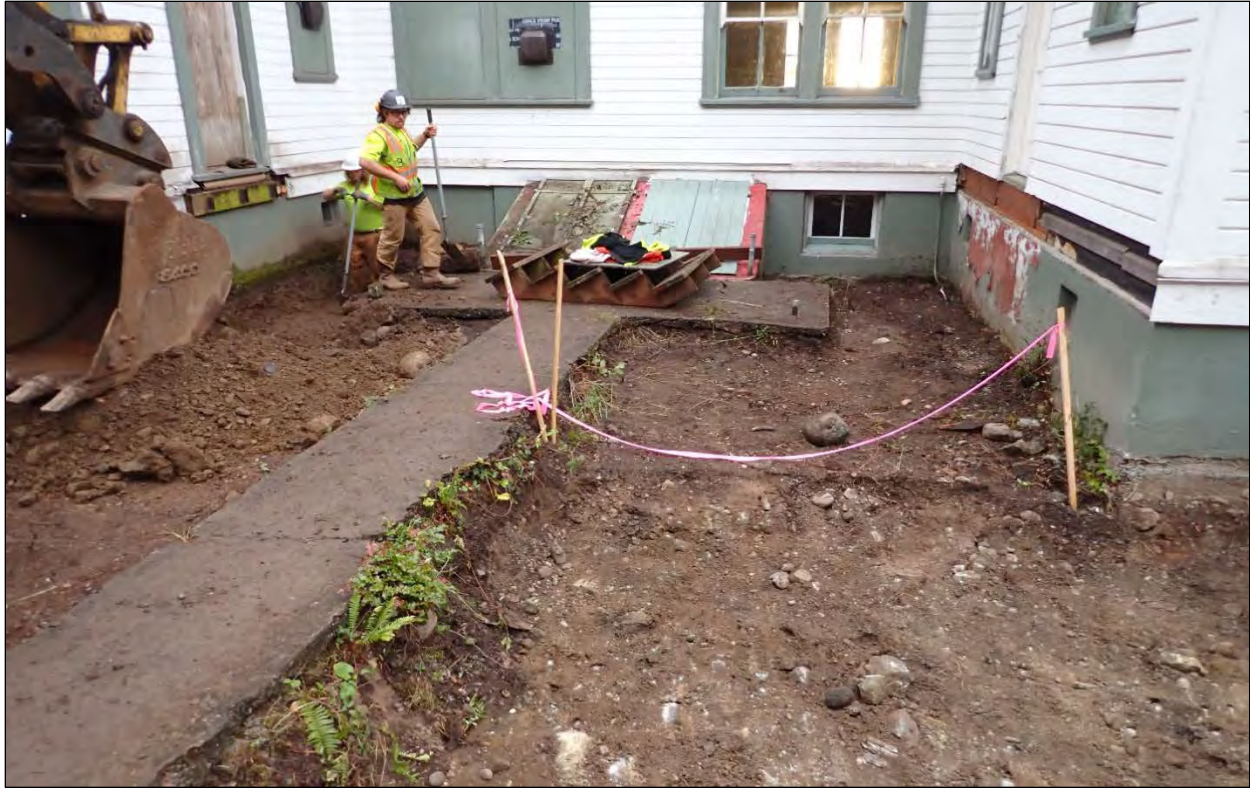
Figure 16. Overview of hand excavation on the east side of the Duplex by the cellar. View to the west.

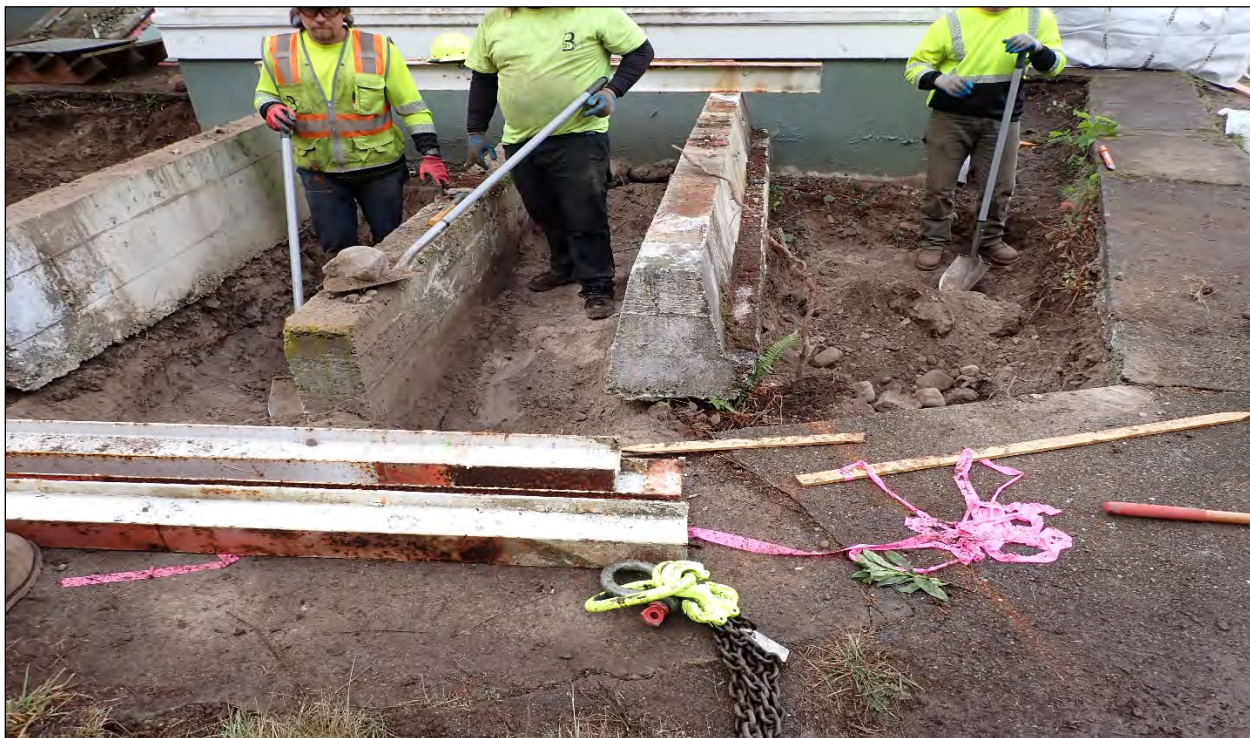
Figure 17. Hand-excavation in between water tank concrete support on the northeast corner of Duplex. View to the west.

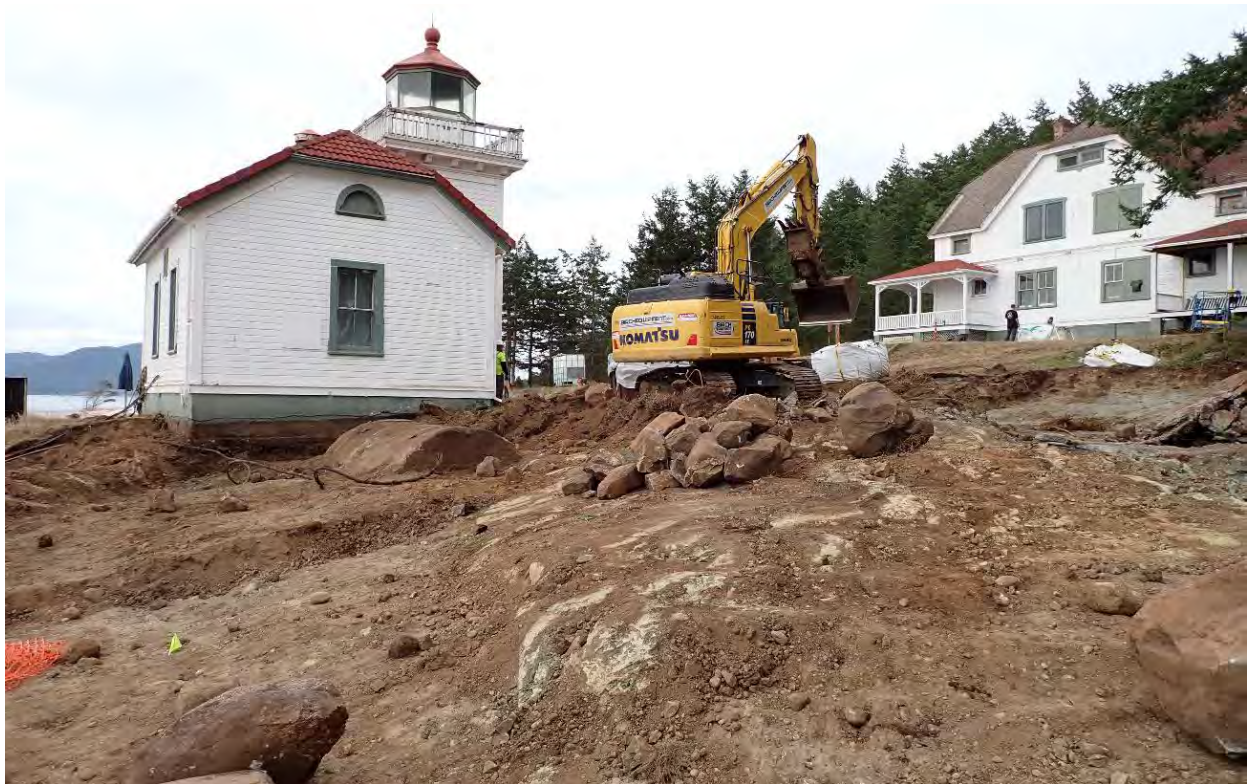
In Area J, 2 feet of sediments were removed. An abandoned concrete cistern tank partially buried into the bedrock on the south side of the Lighthouse was left in place (Figure 18). Removed sediments consisted of grayish-brown silty gravelly sand reworked glacial till mixed with modern debris over remnants of gray gravelly sand. In the eastern half of Area J, two layers of concrete and concrete poured over chain-link fencing was observed directly on bedrock; it was connected to the concrete and fencing identified in Area K.

Figure 18. Overview of Area J showing shallow sediments and bedrock. Cistern is visible in middle left of photo. View to the northeast.

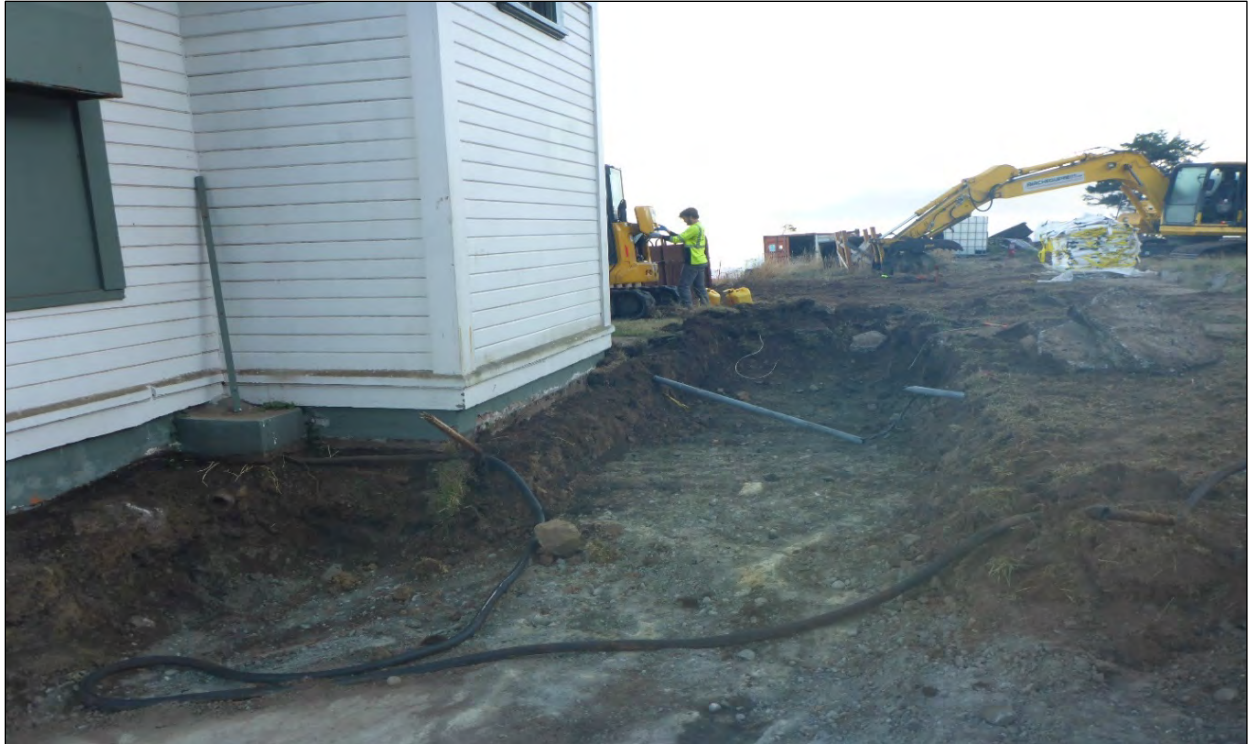
In Areas I and J, excavations around the perimeter of the Lighthouse and excavations along the walls of the building were completed primarily by hand to avoid compromising the building's integrity. Buried terracotta and metal utility lines and wire cables were exposed and removed. The sediment consisted of brown fine sandy silt with common pebbly fill gravels deposited on top of the bedrock (Figure 19). A loose single layer of red mud bricks was observed under the sod in some portions of the east and north side of the Lighthouse. The bricks were laid flat along the edge of the building foundation. A copper metal plate attached to a lead wire was excavated on the northwest corner of the building and may have been a grounding mechanism.

Figure 19. Overview east side of Lighthouse, Area I, that shows excavated 2 feet of fill over bedrock. View to the north.

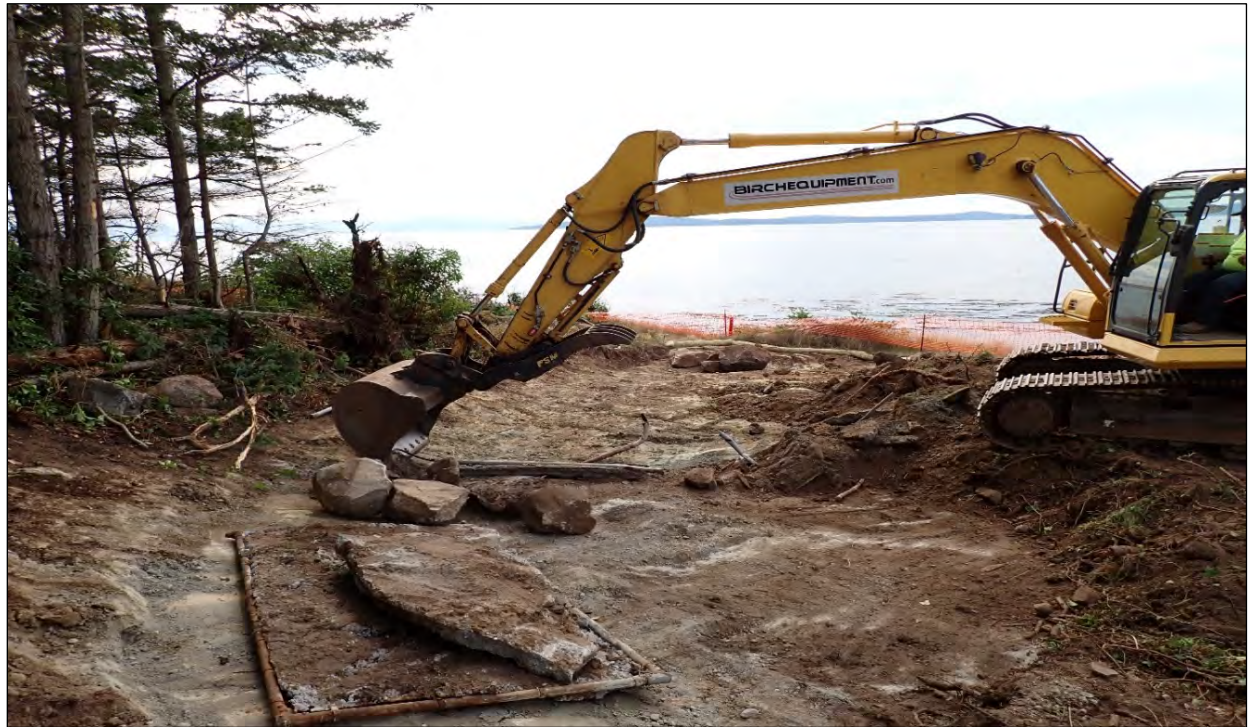
During Session 3, contaminated sediments in Area K were removed from three hotspots: one large hotspot along the southern border of Area K was excavated to 2 ft. bgs; a smaller hotspot on the west edge of Area K by the cliff that was dug to about 3 ft. bgs to the top of the serpentinite bedrock; and a third hotspot consisting of concrete covering a high concentration of PCBs at the former transformer location in the southeastern portion of Area K (Figure 21). The sediment from the hotspots was removed to bedrock and contained metal scraps, metal pipe, chain-link fence fragments, and concrete chunks. Our initial interpretation of Area K containing intact sediments during Session 1 monitoring, was revised following this work to remove sediments from hotspots during Session 3.

Figure 20. Overview of Area K east-half. Operator removing concrete/fence slab. View to the southwest.

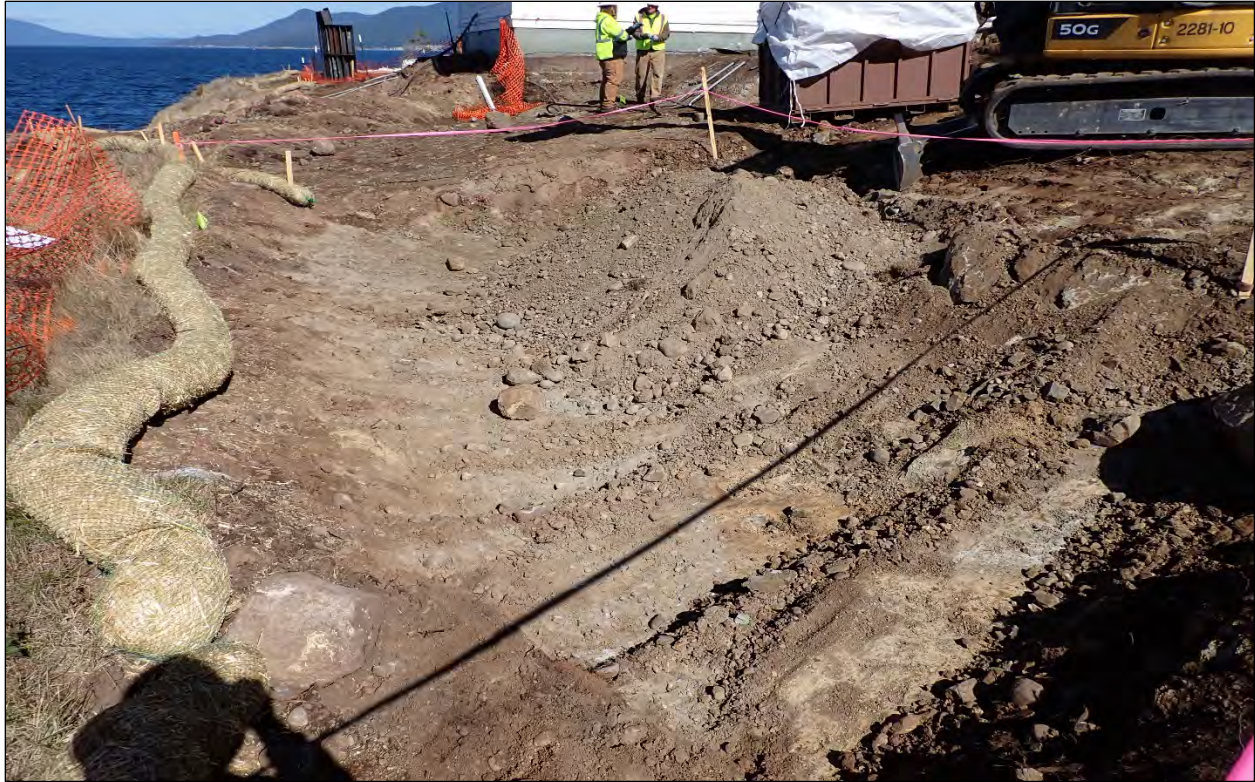
Figure 21. Excavated hotspot on the west side of Area K by the cliff. View to the north.

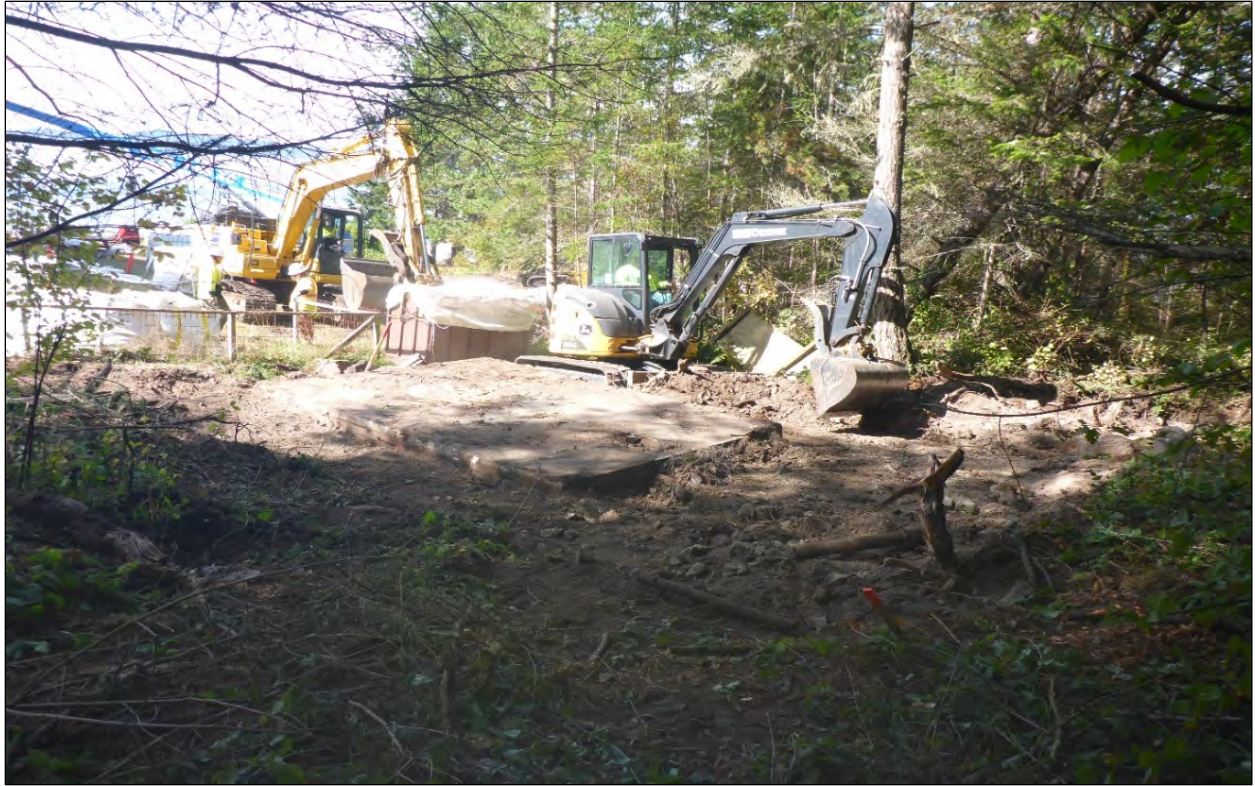
Area L, monitored during Session 2, was located on the east side of the Light Station complex at the edge of the wooded area where the former Firehouse Pump building once stood. The concrete foundation slab was still extant (Figure 22). One foot of fill material was removed from the perimeter of the foundation. Numerous metal pipelines around the foundation were exposed and removed. Sediments were a loose light gray gravelly fine to medium sandy silt, ashy texture mixed with natural forest-burned soil under the forest duff and appeared to be a colluvium and reworked glacial till deposit.

Figure 22. Overview of excavation in Area L. View to the northwest.
