Title of Report: Burrows Island Light Station Remediation Project, Skagit County, Washington

TECHNICAL MEMORANDUM

Burrows Island Light Station Remediation Project, Skagit County, Washington

December 11, 2023

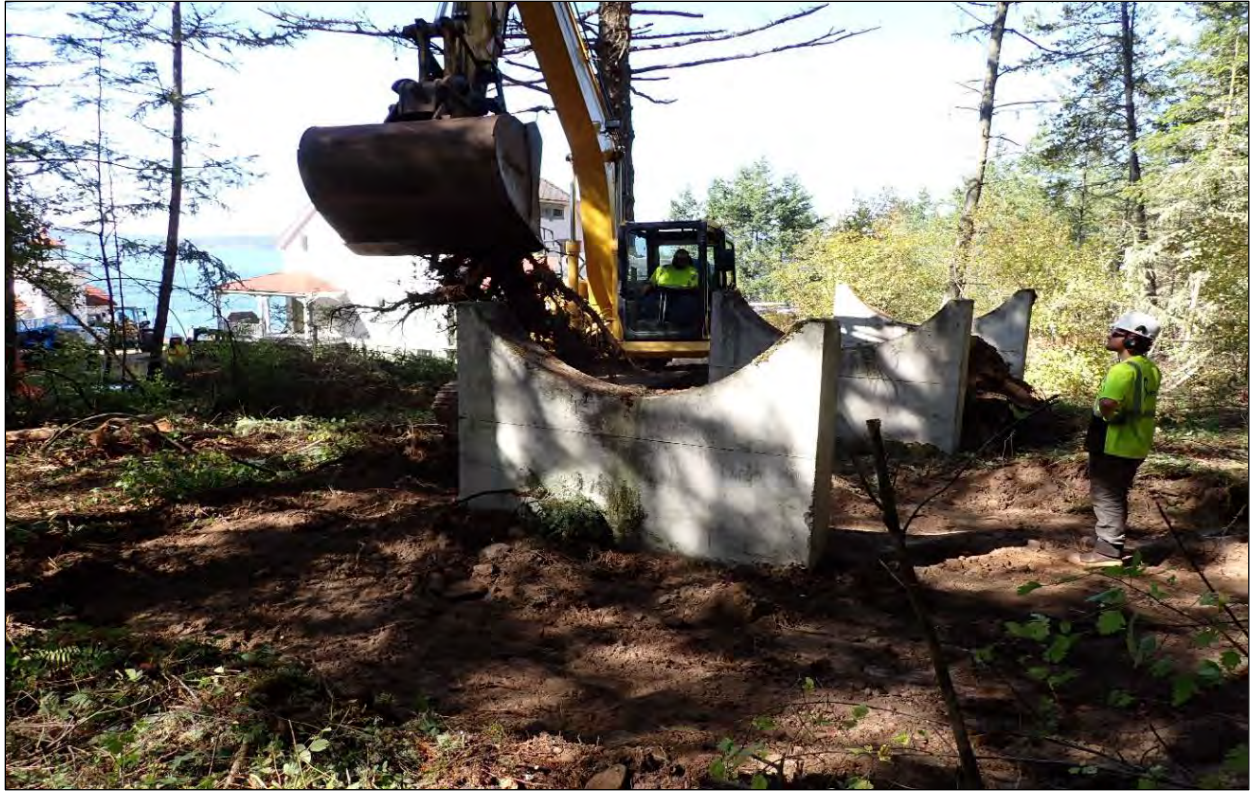
Area M was monitored during Session 1 and surrounded a concrete oil tank foundation located at the edge of the wooded area on the southeast side of the light station complex (Figure 23). One-half foot of sediments surrounding the concrete support foundation were removed. Sediments observed were yellowish coarse sand mixed with brown silty medium sand and many rounded and angular gravels that were bioturbated by roots. Deposits seemed to be a mixture of reworked glacial till in serpentinite residuum.

Figure 23. Overview of Area M excavation in progress. View to the northwest.

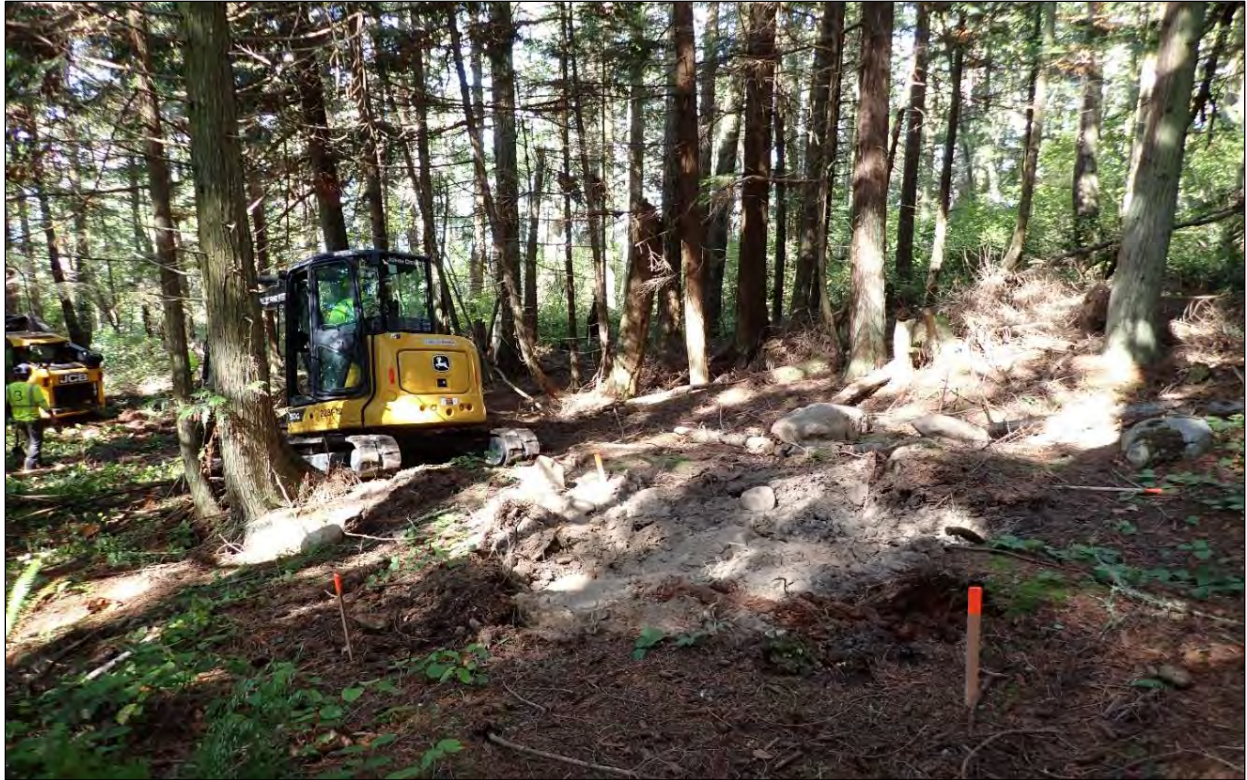
Area N was monitored during Session 1 and was located on the far east end of the Light Station near three former water tank platforms in a densely forested area. The target depth excavation for Area N was ½-ft. bgs. Sediment observed was heavily bioturbated by many roots and consisted of gray silty gravelly medium sand with an ashy texture and a few subrounded small boulders (Figure 24).

Figure 24. Overview of Area N completed excavation. View to the northwest.

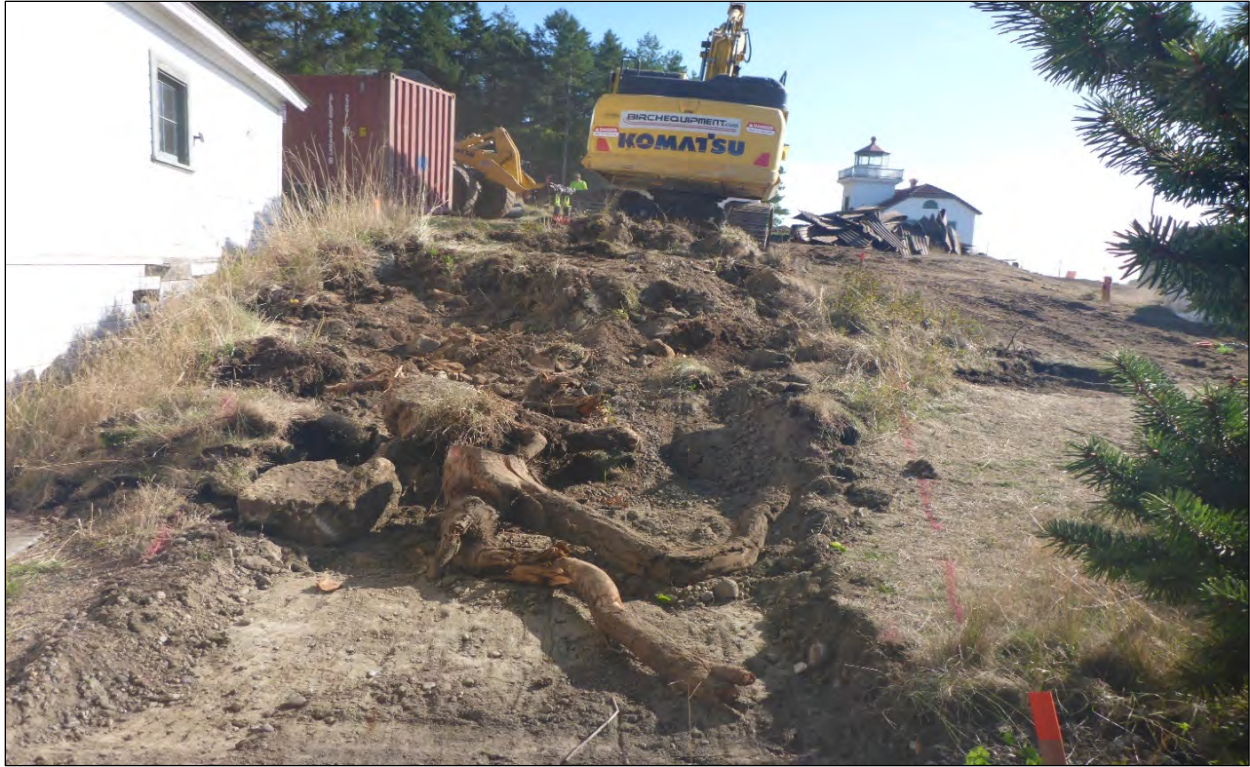
Area O was monitored during Session 2 and was located on the west side of the Boathouse and the northwestern part of the complex, where ½-foot of sediment was excavated. Soil accumulation over the bedrock was minimal and consisted of mostly sandy gravel fill from the Boathouse construction mixed with glacial till and residuum serpentinite under a thin sod mat. The presence of large boulders and large roots made it difficult for Brice to scrape the excavated surface (Figure 25).

Figure 25. Overview of excavated Area O adjacent to Boathouse. View to the south.

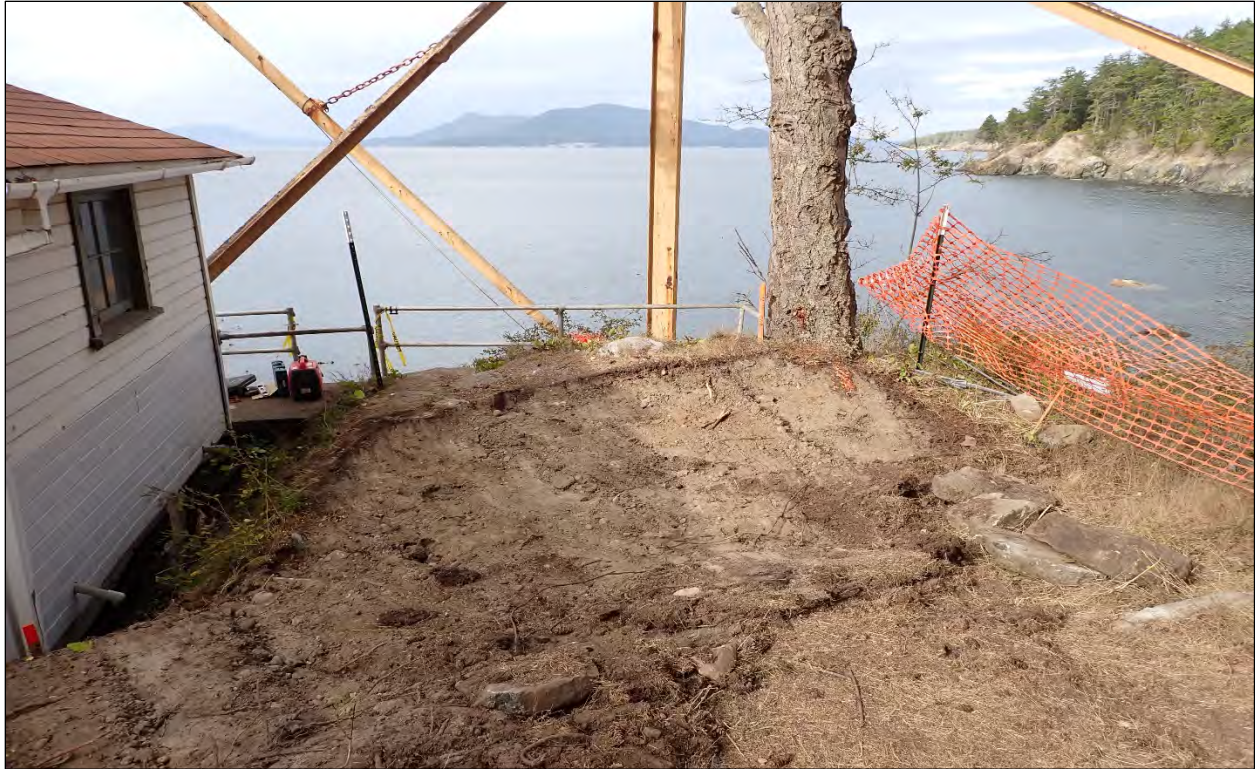
Area P was monitored during Session 3 and located on the northeast side of the Boathouse. The Area P footprint was 80 square feet (sq ft.) with a target depth of $\frac{1}{2}$ -ft. bgs and contained gray and grayish-brown silty gravelly sand redeposited glacial till on top of bedrock (Figure 26).

Figure 26. Overview of excavated Area P. View to the north.

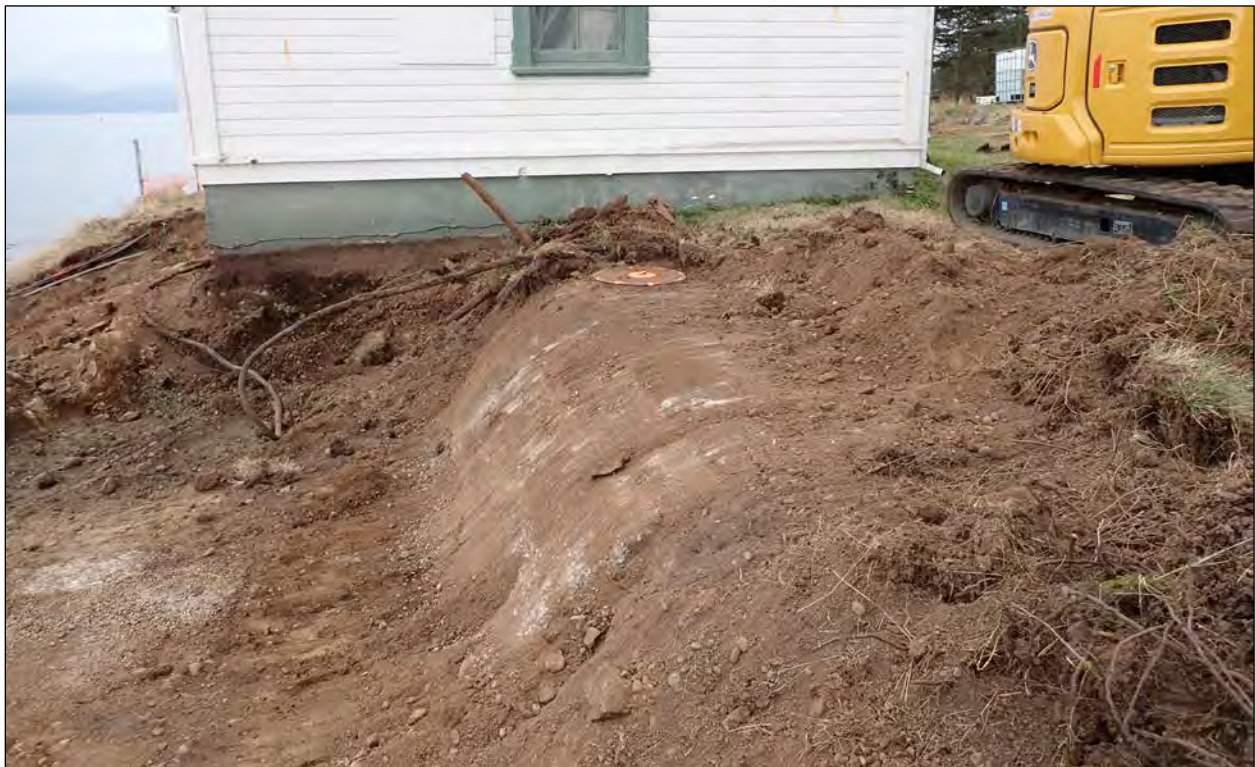
The remnant concrete cistern was exposed during the excavated monitoring conducted within Area J on the south side of the lighthouse. It is located approximately 2 feet south of the lighthouse's south wall and was completely buried prior to the excavation. The cistern was installed as part of improvements made to the lighthouse sometime between 1906 and 1972 (McKoon-Hennick 2010). The cistern is semi-cylindrical shaped and 12 feet long with a radius measuring 4 feet and a flat base measuring 8 feet in width. A round opening is present at the north end of the cistern that was covered with a metal cap measuring approximately 1 feet in diameter at the time of investigation. The cap was removed to inspect the contents of the cistern, which was partially filled with a dark viscous liquid (interpreted to be stagnant water) that obscured the view of the base of the cistern's interior.

Figure 27. Overview of concrete cistern at site 21-86-1. View to the north.

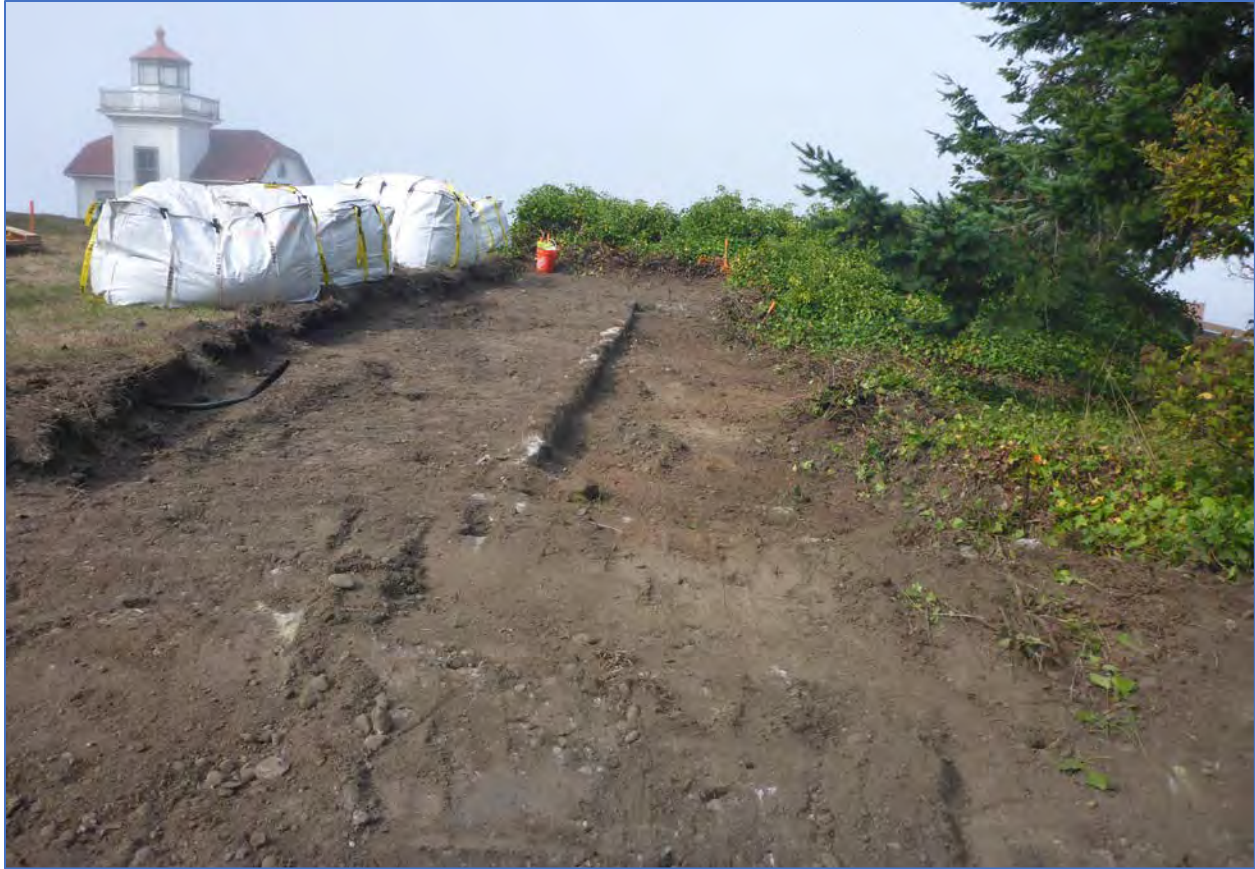
The OIC single-family house's remnant concrete foundation is located in Areas F and G, approximately 15-meter (50 feet) north of the Duplex. The foundation's north and south walls were exposed, but not removed, during the removal of contaminated soils in Areas F and G (Figure 28).

The OIC house was constructed north of the Duplex in the 1950s after the USCG began administering the Light Station in 1939 (Neblett and Williamson 1977). After the house was demolished in the 1971, the foundation walls were left in place, with the slab removed and some debris from the building left within the original footprint. Photographs of the island from 1978 and 1981 show the remaining foundation largely untouched (Figure 29). By the time of the archaeological monitoring in 2023, the foundation was covered by ivy and a shallow layer of sediment, with bushes and trees growing within and around it. The northern portion of the foundation was exposed during the remediation excavation work in Area F, and the southern end was exposed during the remediation work in Area G. The exposed portions of the concrete foundation wall measured 6 inches thick. Based on the dimensions of the exposed northern and southern ends of the foundation, it measured approximately 30 feet from east to west by 40 feet from north to south. A small concrete pad, possibly a doorstep, was attached to the exterior of the northwest corner of the foundation. Monitored excavations at the building footprint extended to a depth of approximately 6 inches below the ground surface. No historic artifacts were found associated with the foundation.

Figure 28. Overview of south edge of OIC foundation at site 21-86-1. View to the west.

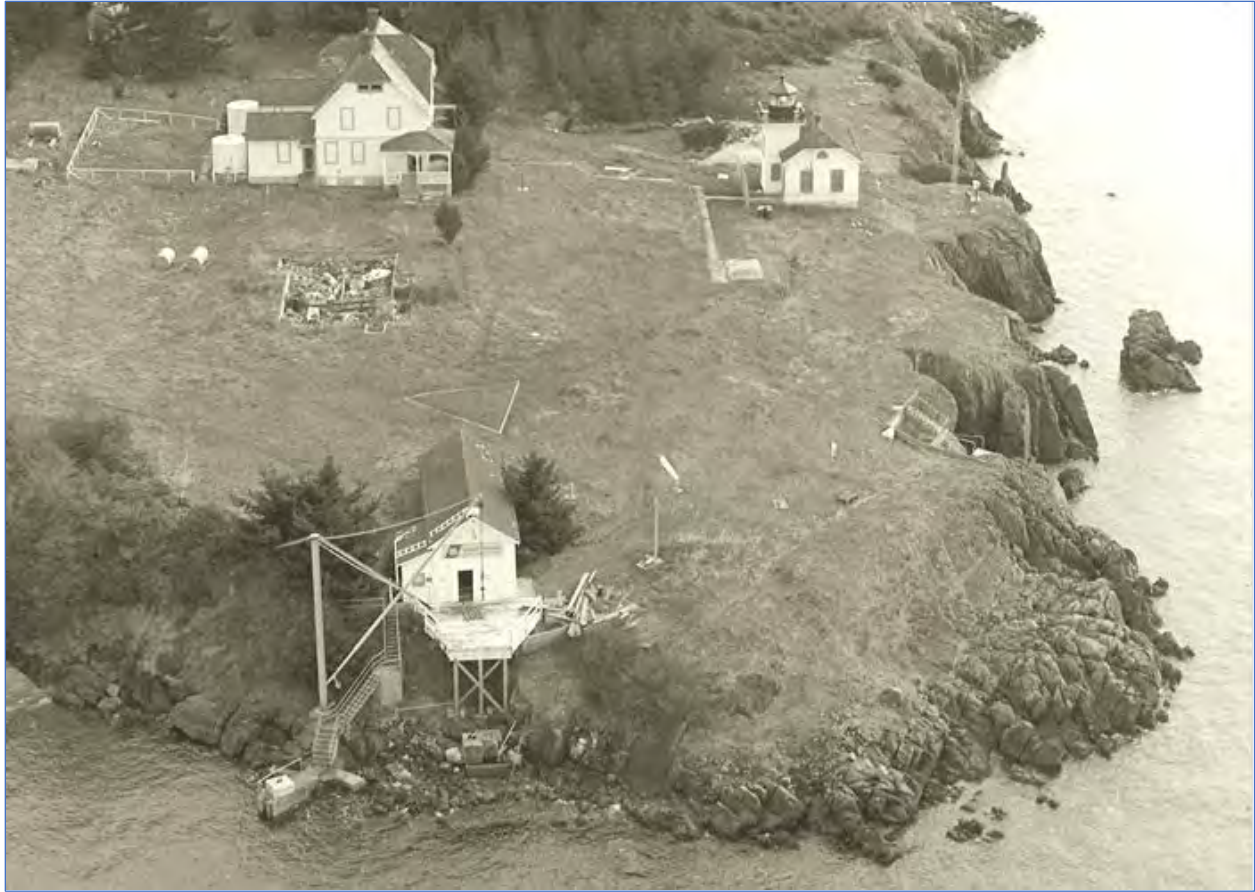
Figure 29. 1981 air photo depicting the Burrows Island Light Station with the OIC foundation at center-left of photo, north of the Duplex (photo from U.S. Coast Guard Museum, Seattle, Washington). View to the south.

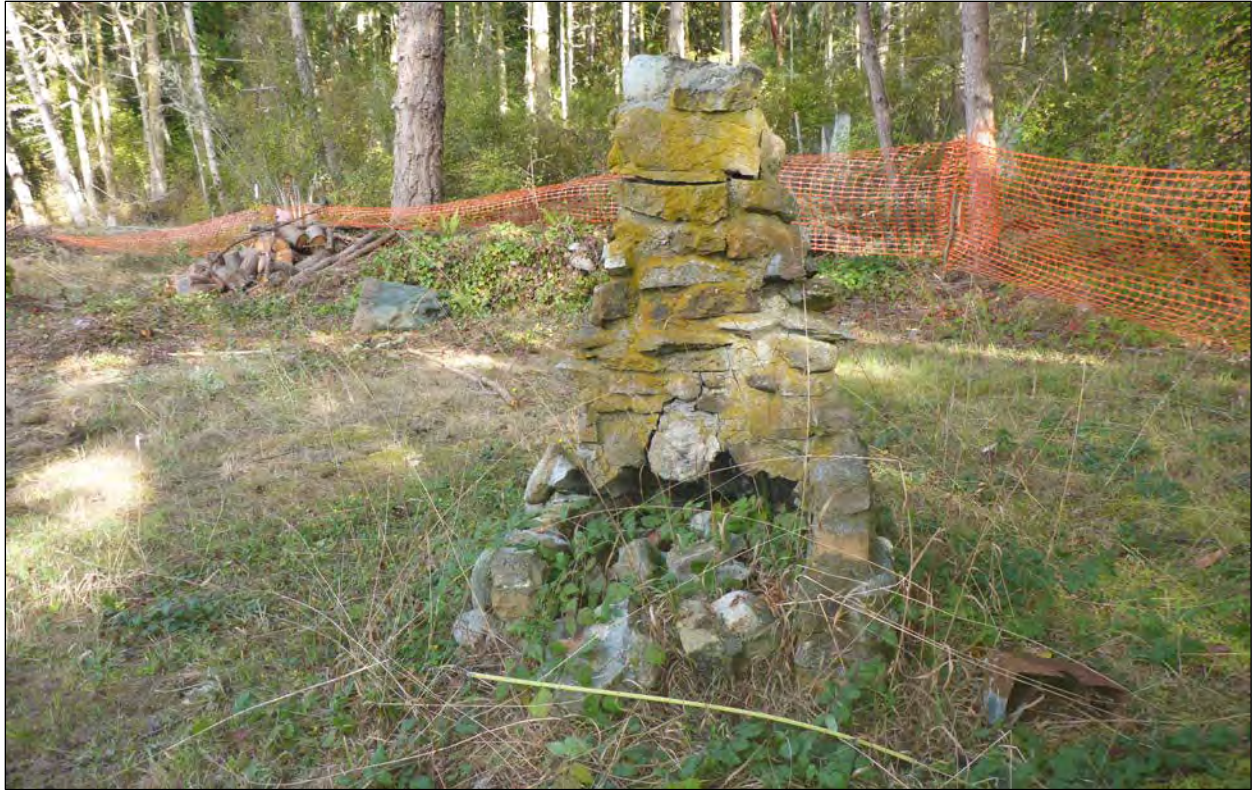
The chiminea is located approximately 18 meters (60 feet) south of the Duplex in a small clearing near the northern edge of the forest. The chiminea structure is built with bricks and large mismatched stones (both angular and rounded) that are held together with a concrete mortar (Figure 30). The age of the structure is unknown, although it likely was built at some point during the period when the Duplex was used as the Keeper's Quarters between 1906 and 1972, after which time it was no longer used as a residence (McKoon-Hennick 2010). The chiminea structure consists of a tall, narrow conical-shaped chimney with a shallow open pit at the base. The entire structure covers a surface area measuring 35 inches from east to west and 41 inches from north to south. The pit occupies the western portion of the overall structure. It measures 41 inches (north to south) by 18 inches (east to west) and is approximately 13 inches tall. The sides and opening of the pit are in disrepair, with collapsed stones and bricks within and around it. It appears as though the pit was previously nearly completely enclosed with an opening facing west, away from the chimney. The chimney measures 41 inches (north to south) by 17 inches (east to west) at its base and is 55 inches high. The top of the chimney is roughly circular-shaped and approximately 15 inches in diameter. The interior of the chimney is 6 inches in diameter and consists of smoothed mortar.

Figure 30. Chiminea at 21-86-1. View to the east.

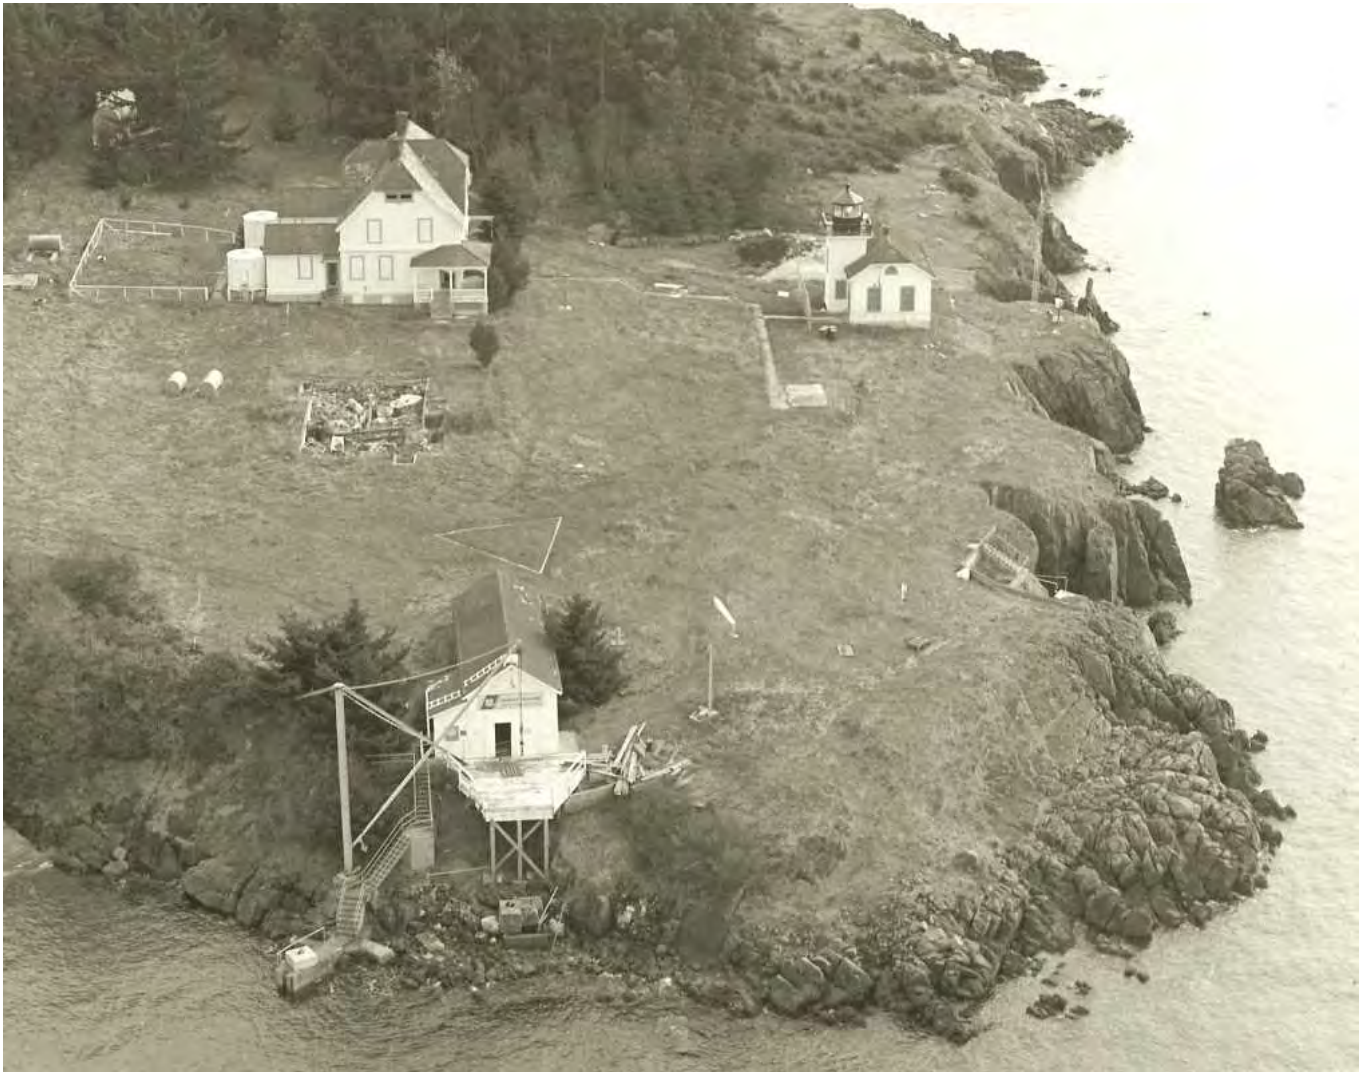
Photo ID	748553
Title	March 19, 1981 Air Photo.jpg
Year Taken	1981
Is Circa?	<input type="checkbox"/>
Notes	March 19, 1981 air photo showing site location.
Type	image/jpeg
Photo View	Plan
Source	U.S. Coast Guard Museum, Seattle, Washington
Copyright	<input type="checkbox"/>

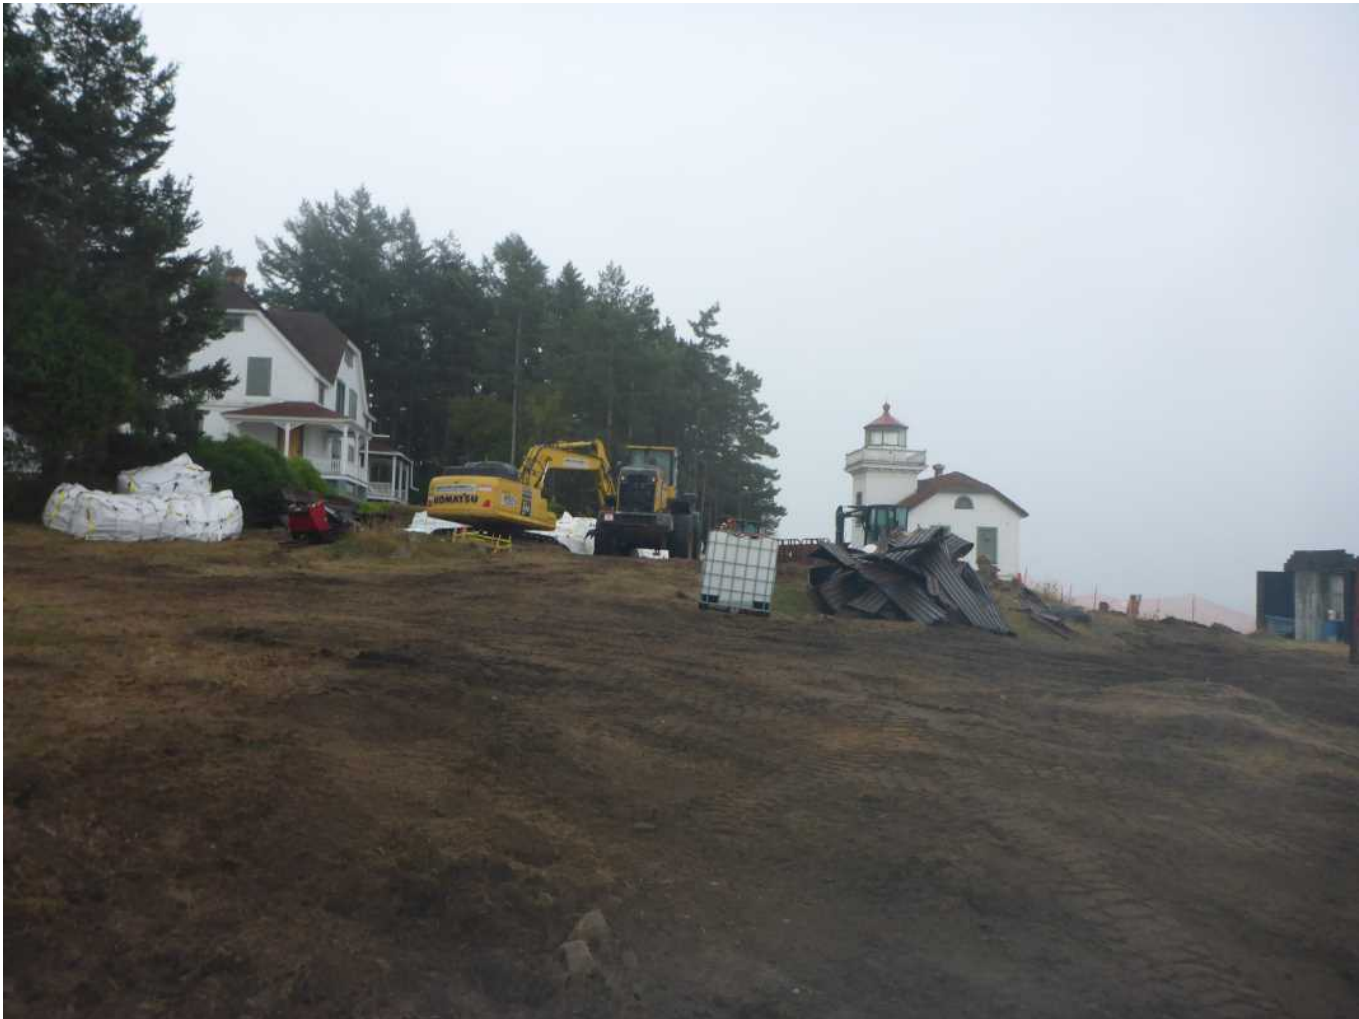
Photo ID	748552
Title	Overview 3.JPG
Year Taken	2023
Is Circa?	<input type="checkbox"/>
Notes	Site overview photo.
Type	image/jpeg
Photo View	South
Source	Photo taken by WillametteCRA, Ltd.
Copyright	<input type="checkbox"/>

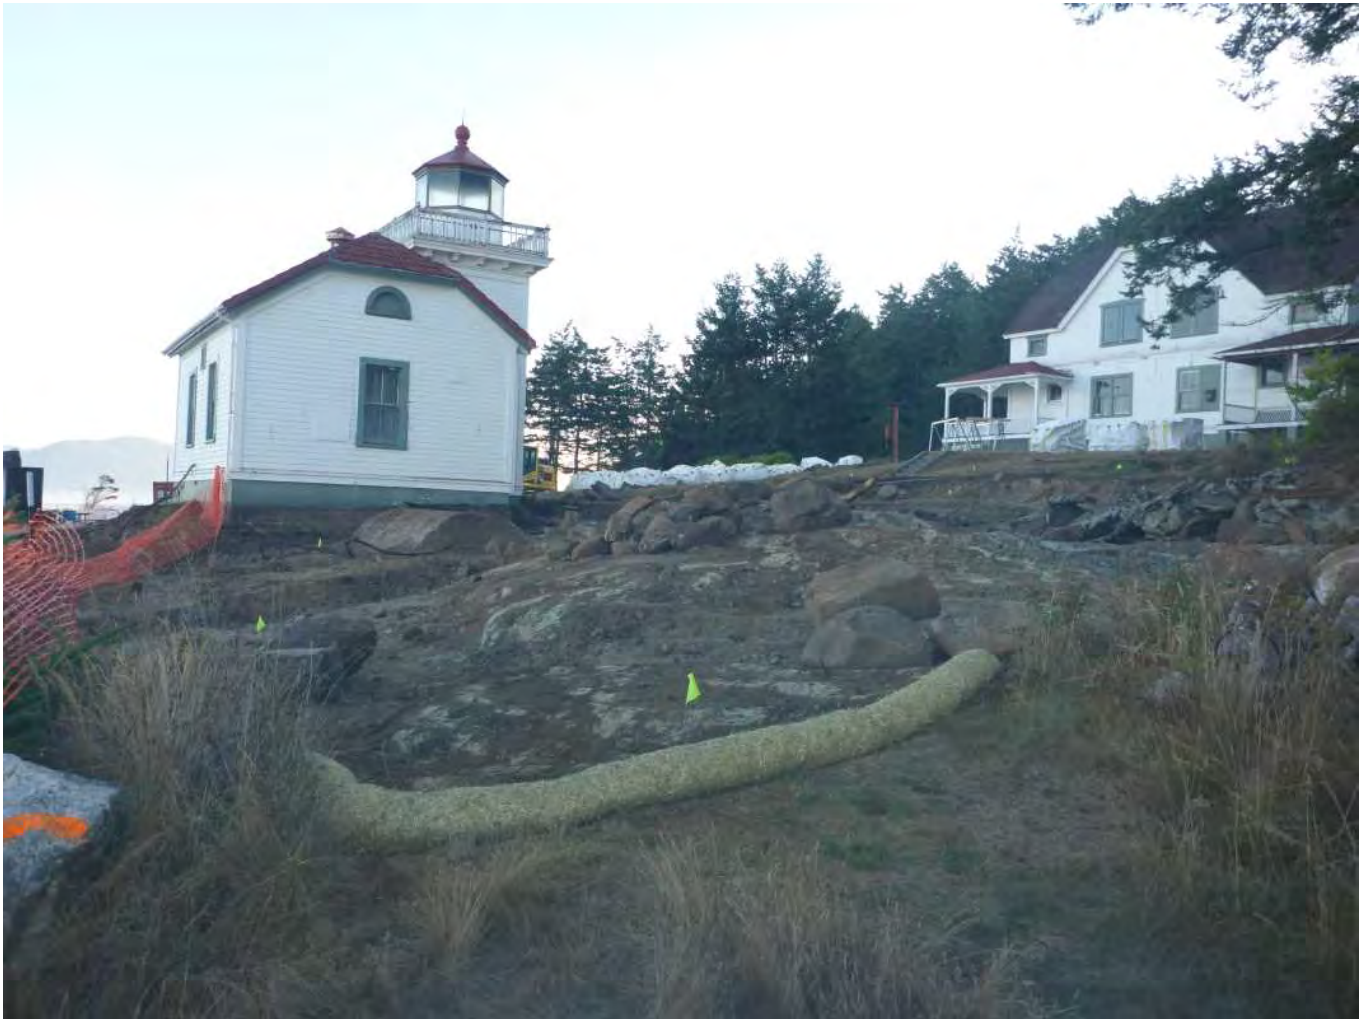
Photo ID	748551
Title	Overview 2.JPG
Year Taken	2023
Is Circa?	<input type="checkbox"/>
Notes	Site overview photo with cistern at center left near the lighthouse.
Type	image/jpeg
Photo View	Northeast
Source	Photo taken by WillametteCRA, Ltd.
Copyright	<input type="checkbox"/>

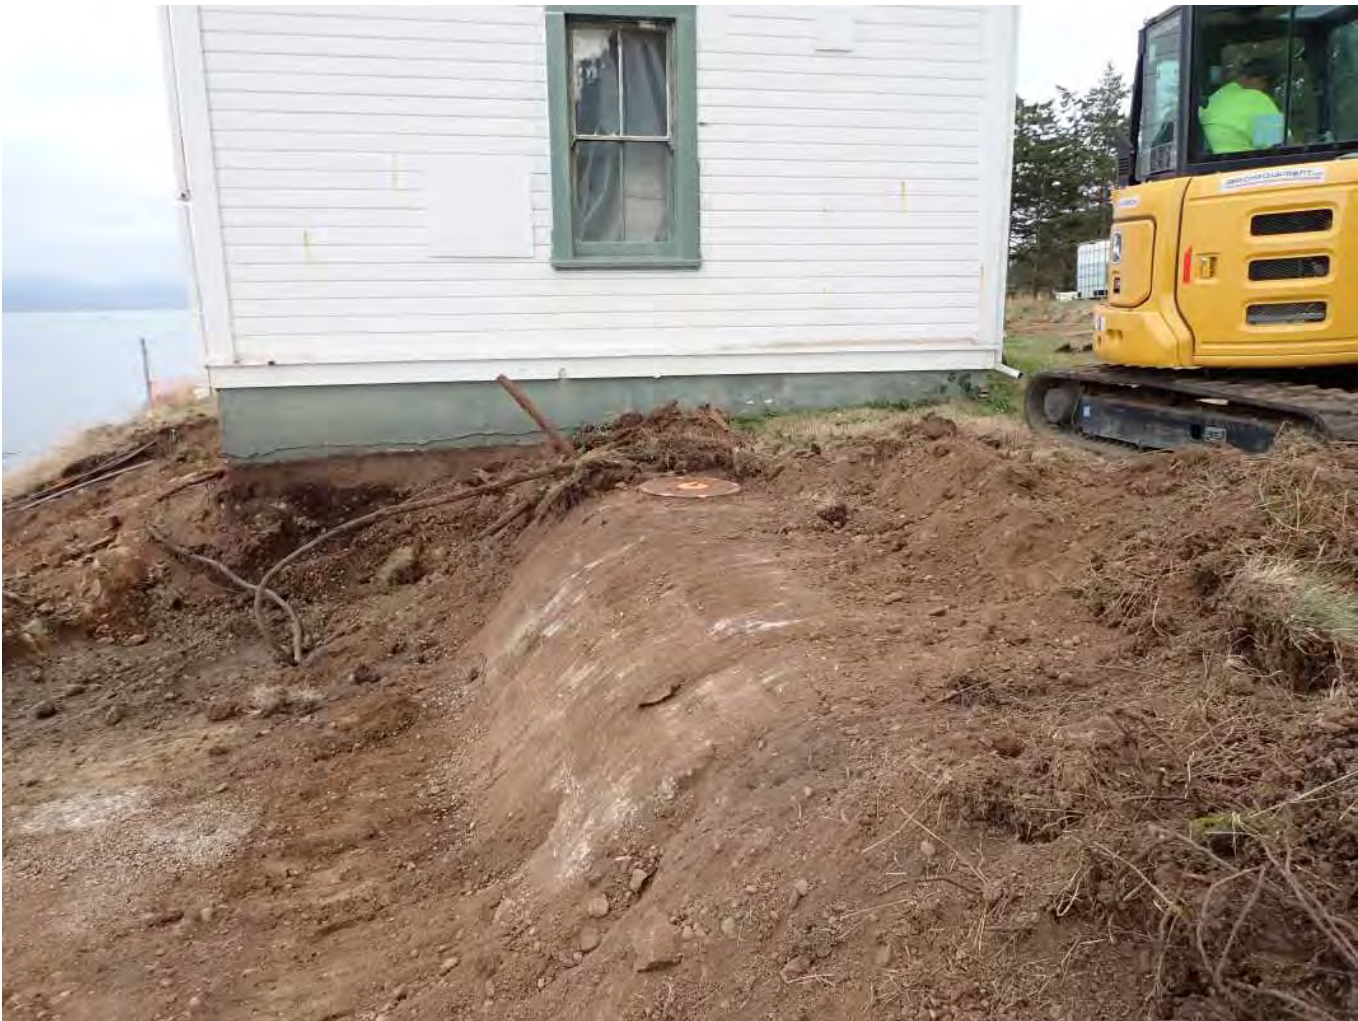
Photo ID 748549
Title Cistern View 2.JPG
Year Taken 2023
Is Circa? ☐
Notes Cistern on the south side of the lighthouse.
Type image/jpeg
Photo View North
Source Photo taken by WillametteCRA, Ltd.
Copyright ☐

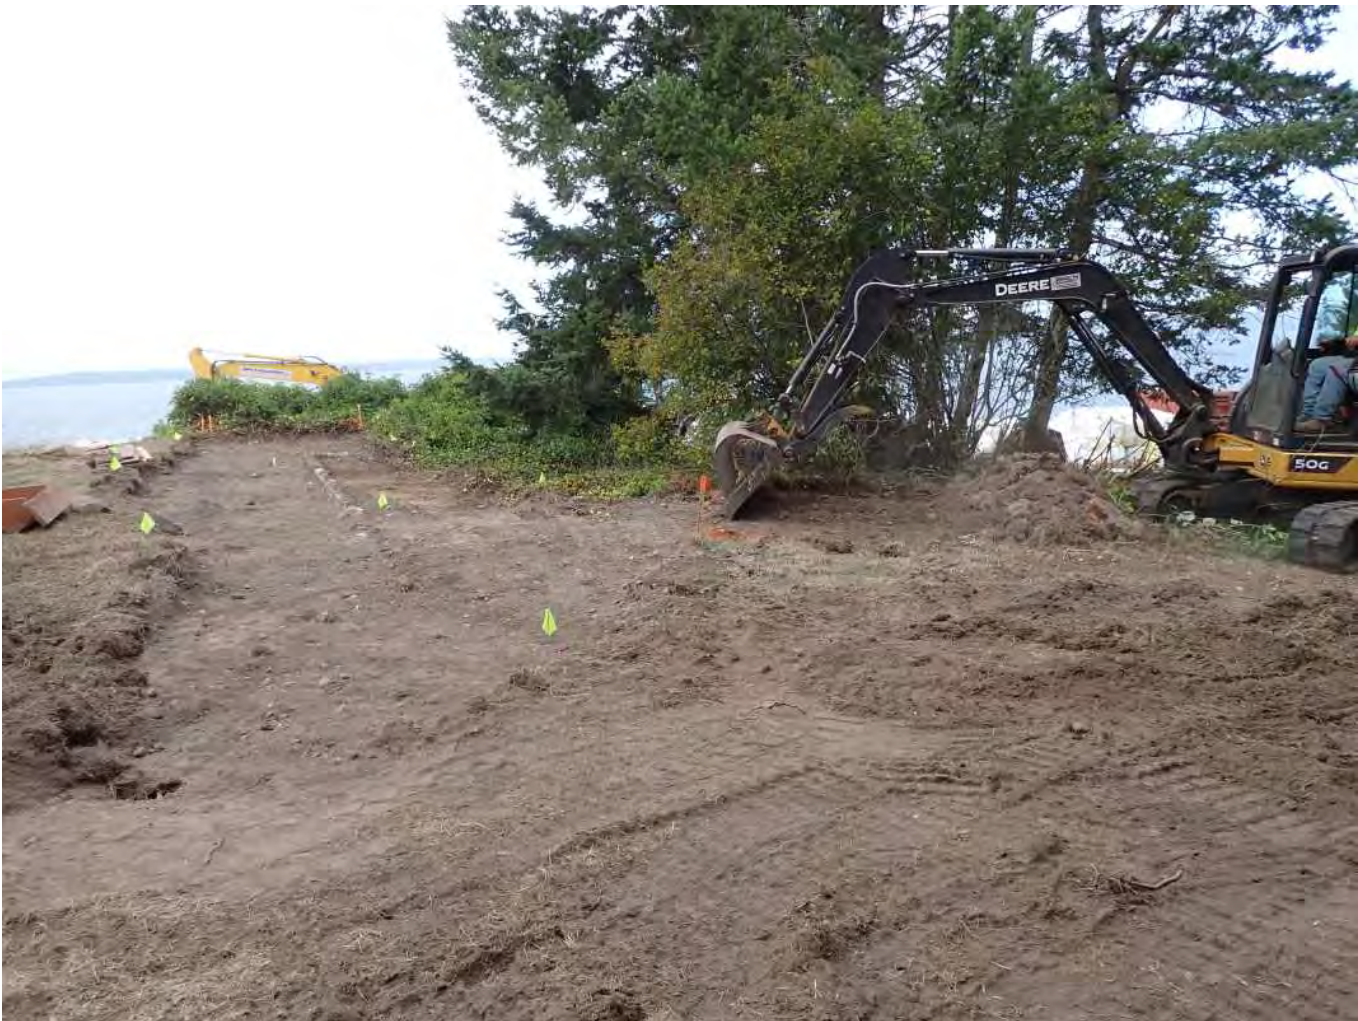
Photo ID 748548

Title OIC Foundation Overview.JPG

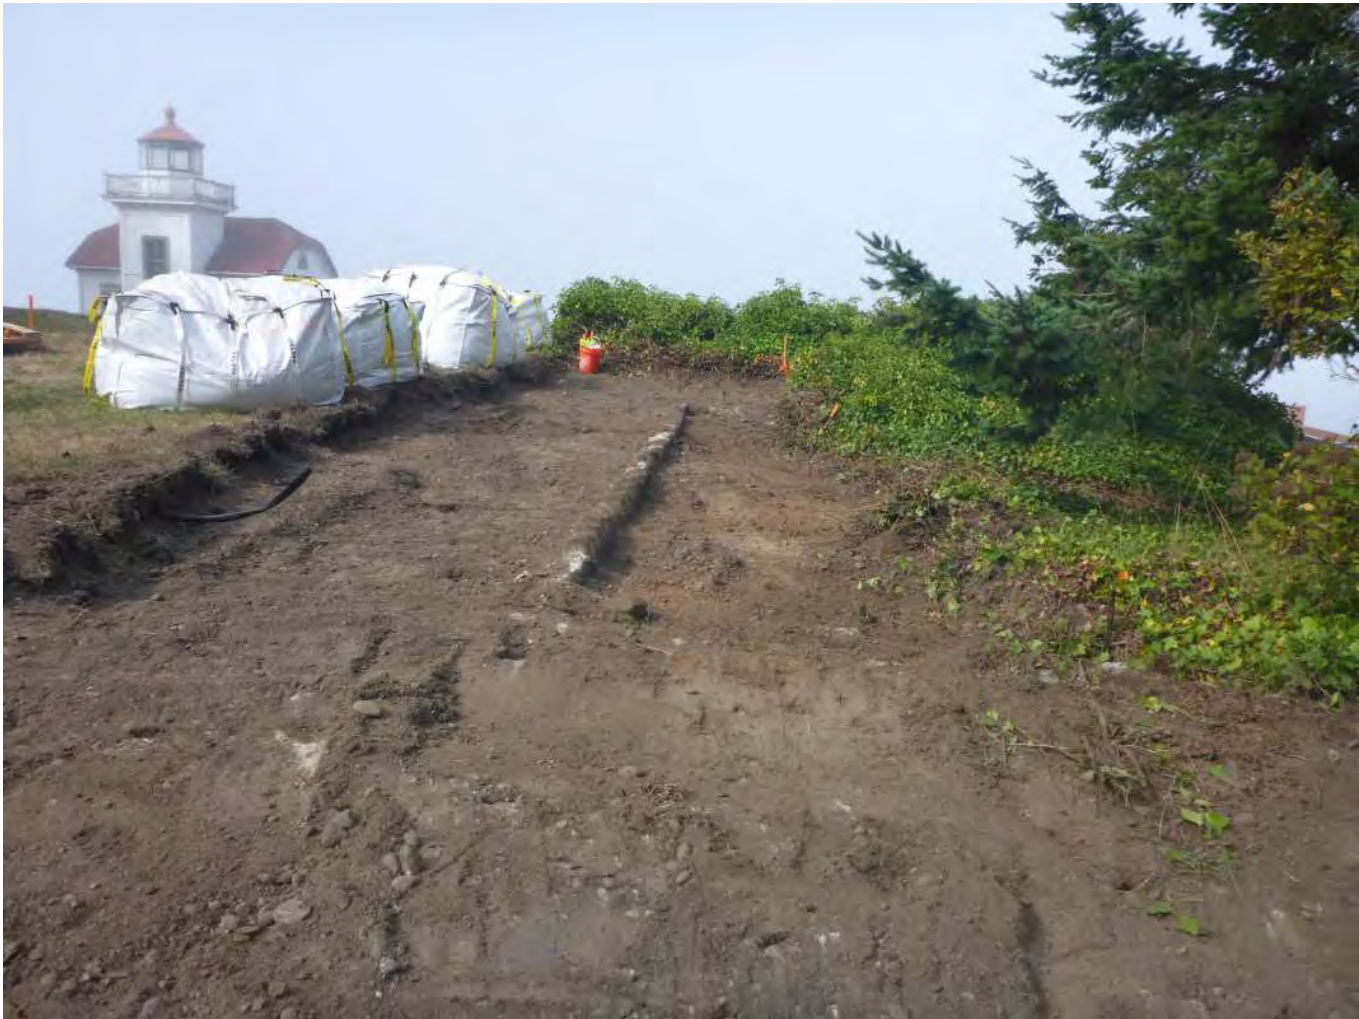
Photo ID 748547
Title OIC Foundation (south).JPG
Year Taken 2023
Is Circa? ☐
Notes South wall of OIC house foundation.
Type image/jpeg
Photo View West
Source Photo taken by WillametteCRA, Ltd.
Copyright ☐

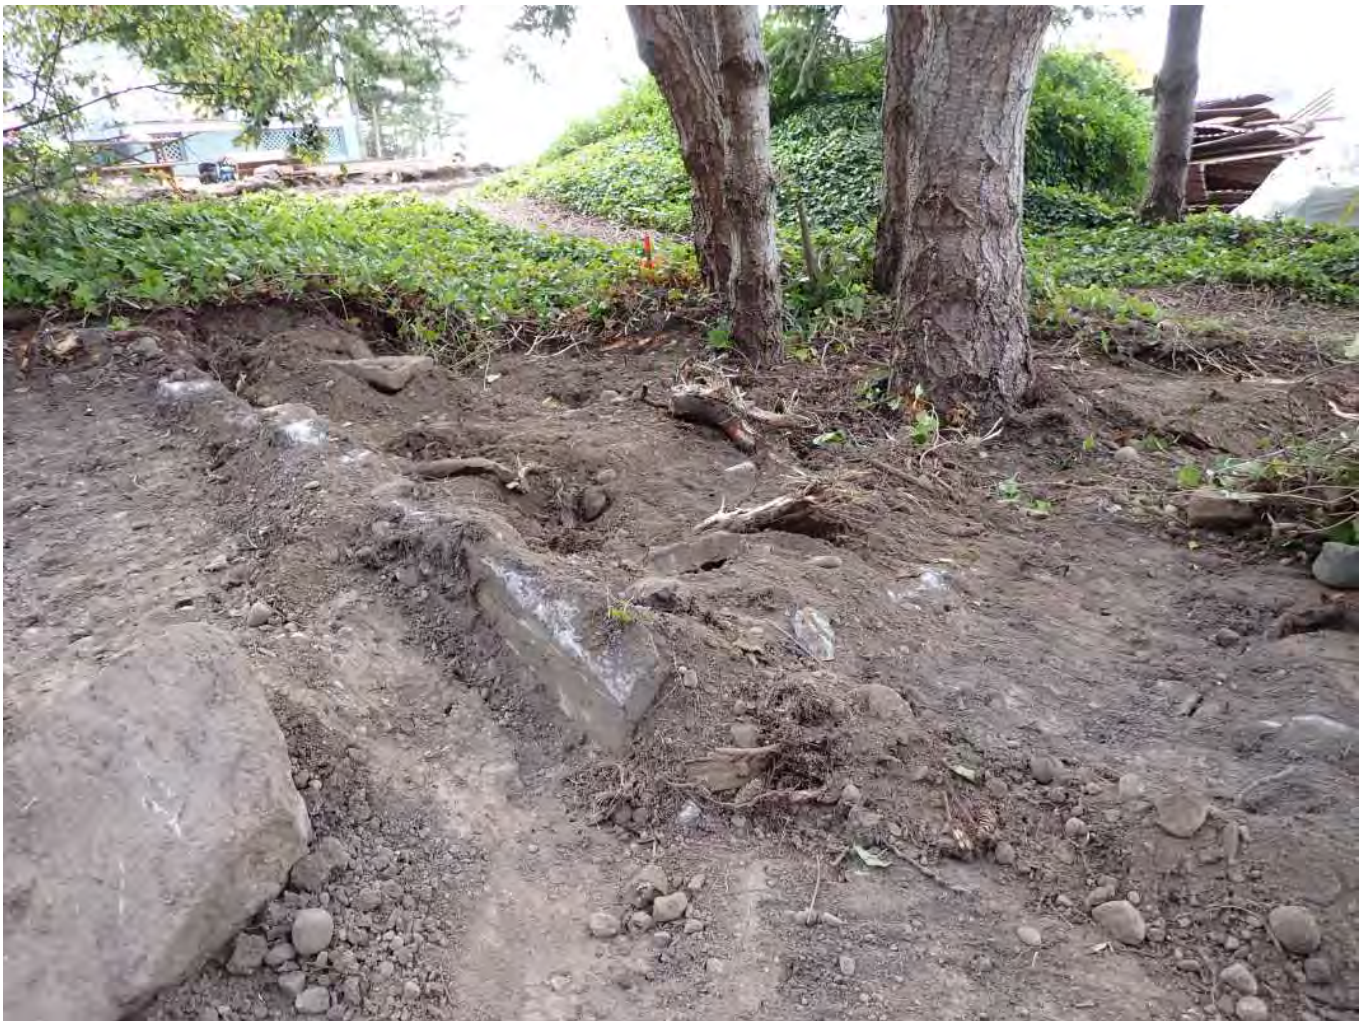
Photo ID	748546
Title	OIC Foundation (north).JPG
Year Taken	2023
Is Circa?	<input type="checkbox"/>
Notes	North wall of OIC house foundation.
Type	image/jpeg
Photo View	Southwest
Source	Photo taken by WillametteCRA, Ltd.
Copyright	<input type="checkbox"/>

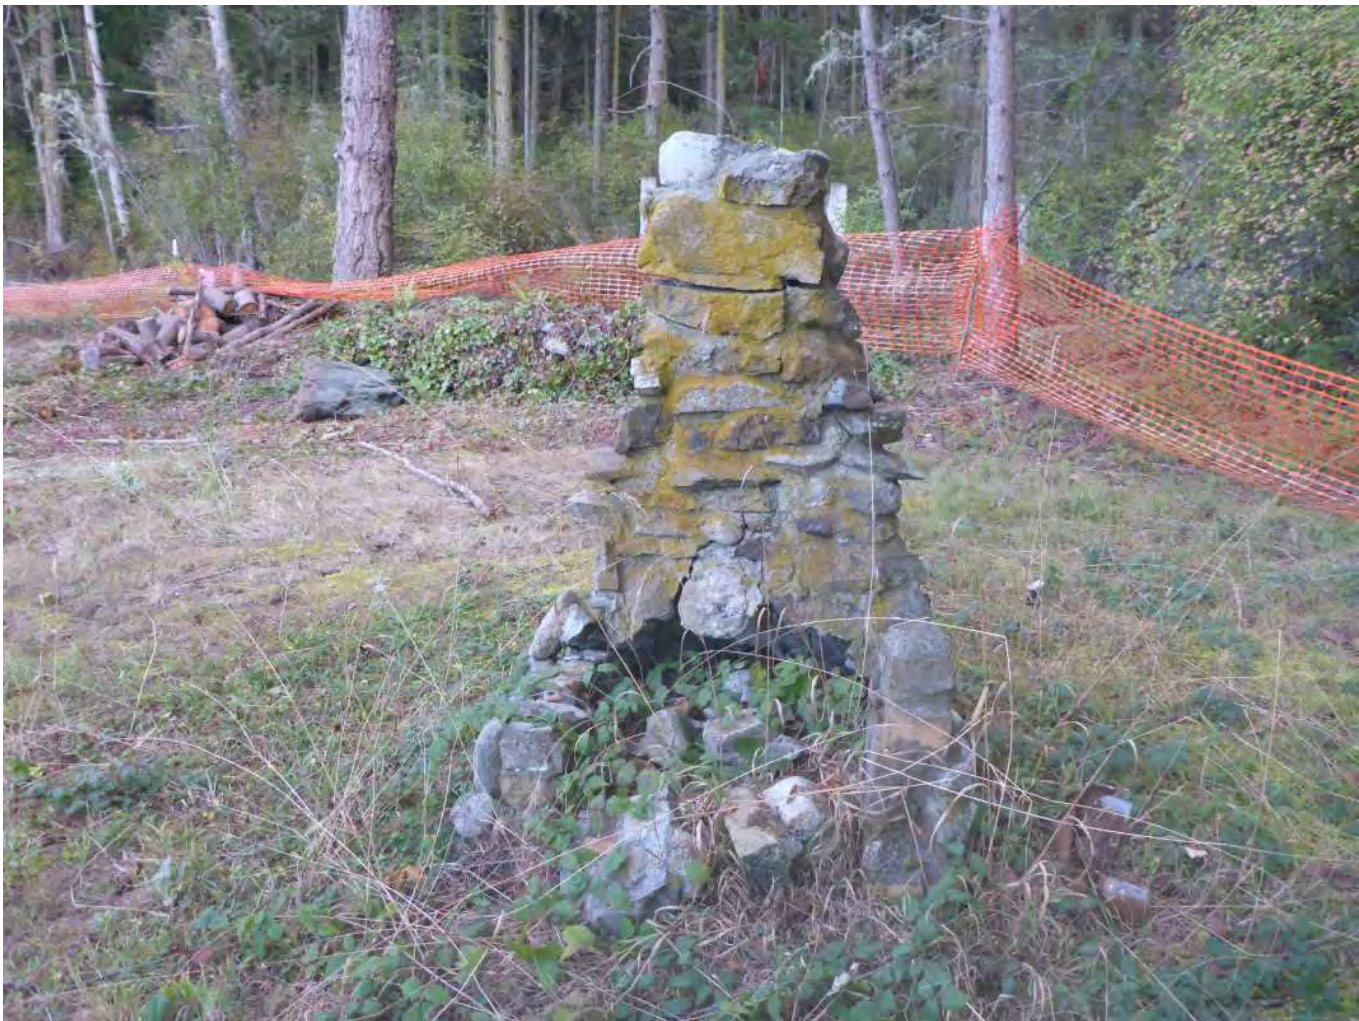
Photo ID	748545
Title	Chiminea.JPG
Year Taken	2023
Is Circa?	<input type="checkbox"/>
Notes	View of west side of chiminea.
Type	image/jpeg
Photo View	East
Source	Photo taken by WillametteCRA, Ltd.
Copyright	<input type="checkbox"/>

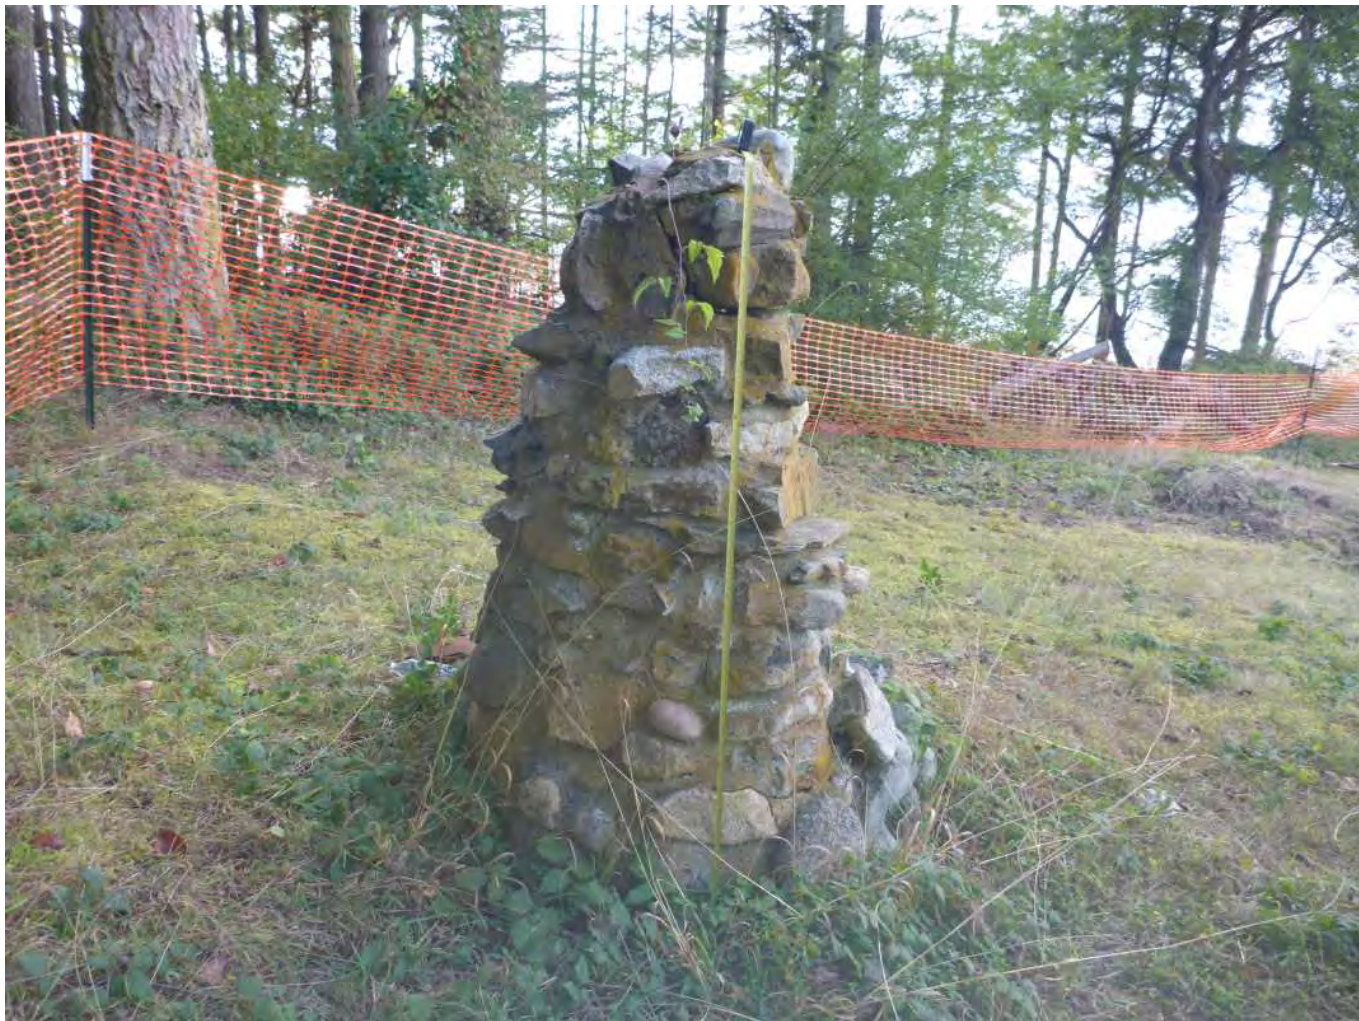
Photo ID	748544
Title	Chiminea Back Side.JPG
Year Taken	2023
Is Circa?	<input type="checkbox"/>
Notes	View of back side of chiminea.
Type	image/jpeg
Photo View	Southwest
Source	Photo taken by WillametteCRA, Ltd.
Copyright	<input type="checkbox"/>
