Title of Report: Burrows Island Light Station Remediation Project, Skagit County, Washington

TECHNICAL MEMORANDUM

Burrows Island Light Station Remediation Project, Skagit County, Washington

December 11, 2023

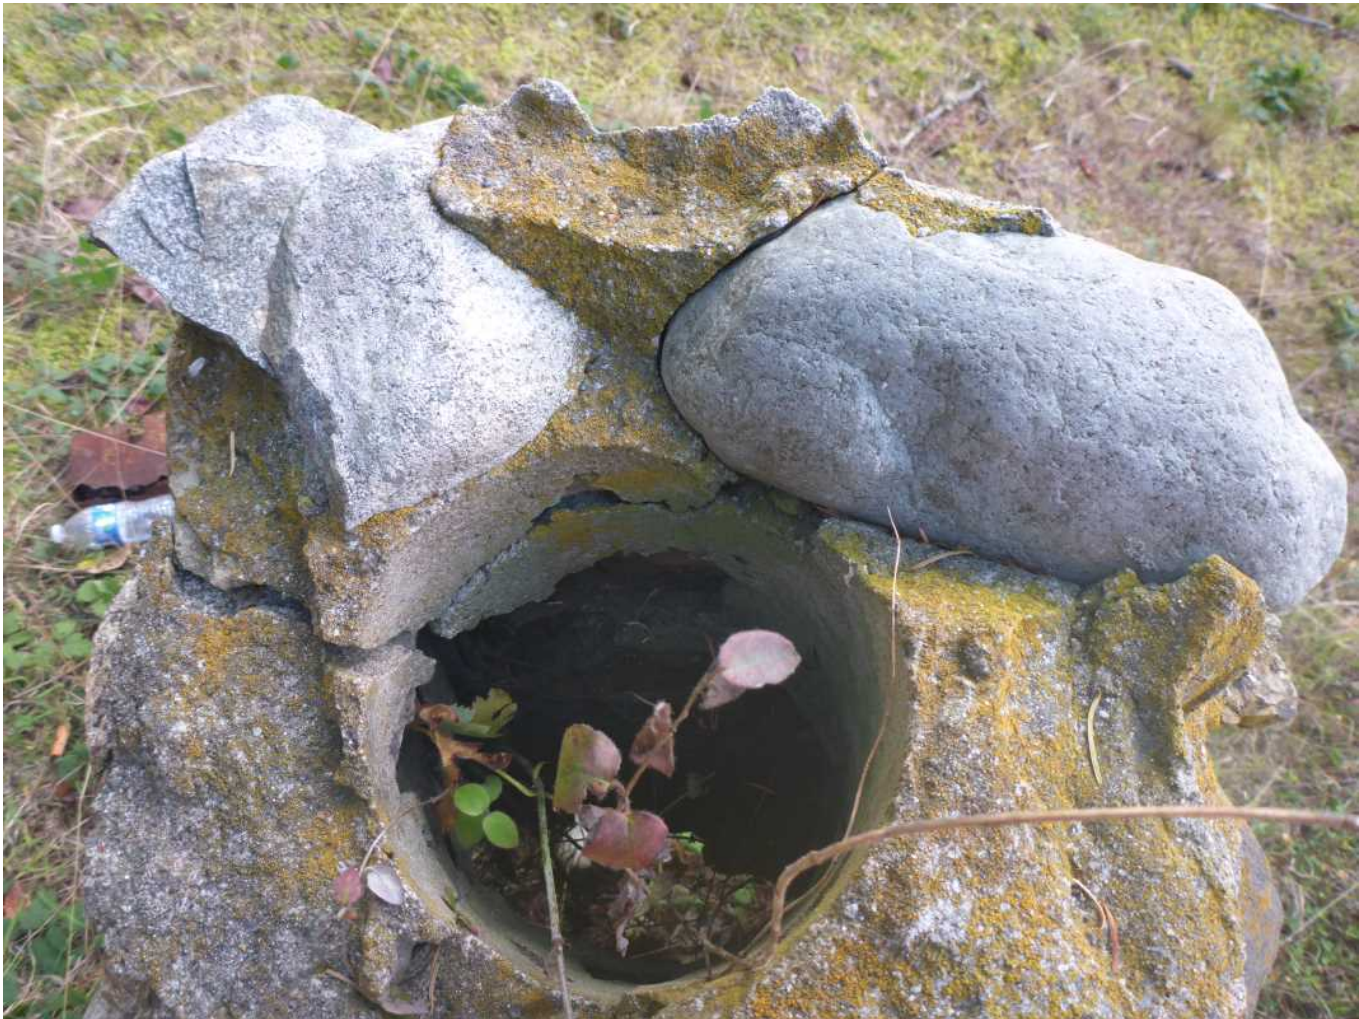
Photo ID	748543
Title	Chiminea Top.JPG
Year Taken	2023
Is Circa?	<input type="checkbox"/>
Notes	View of top of chiminea.
Type	image/jpeg
Photo View	Plan
Source	Photo taken by WillametteCRA, Ltd.
Copyright	<input type="checkbox"/>

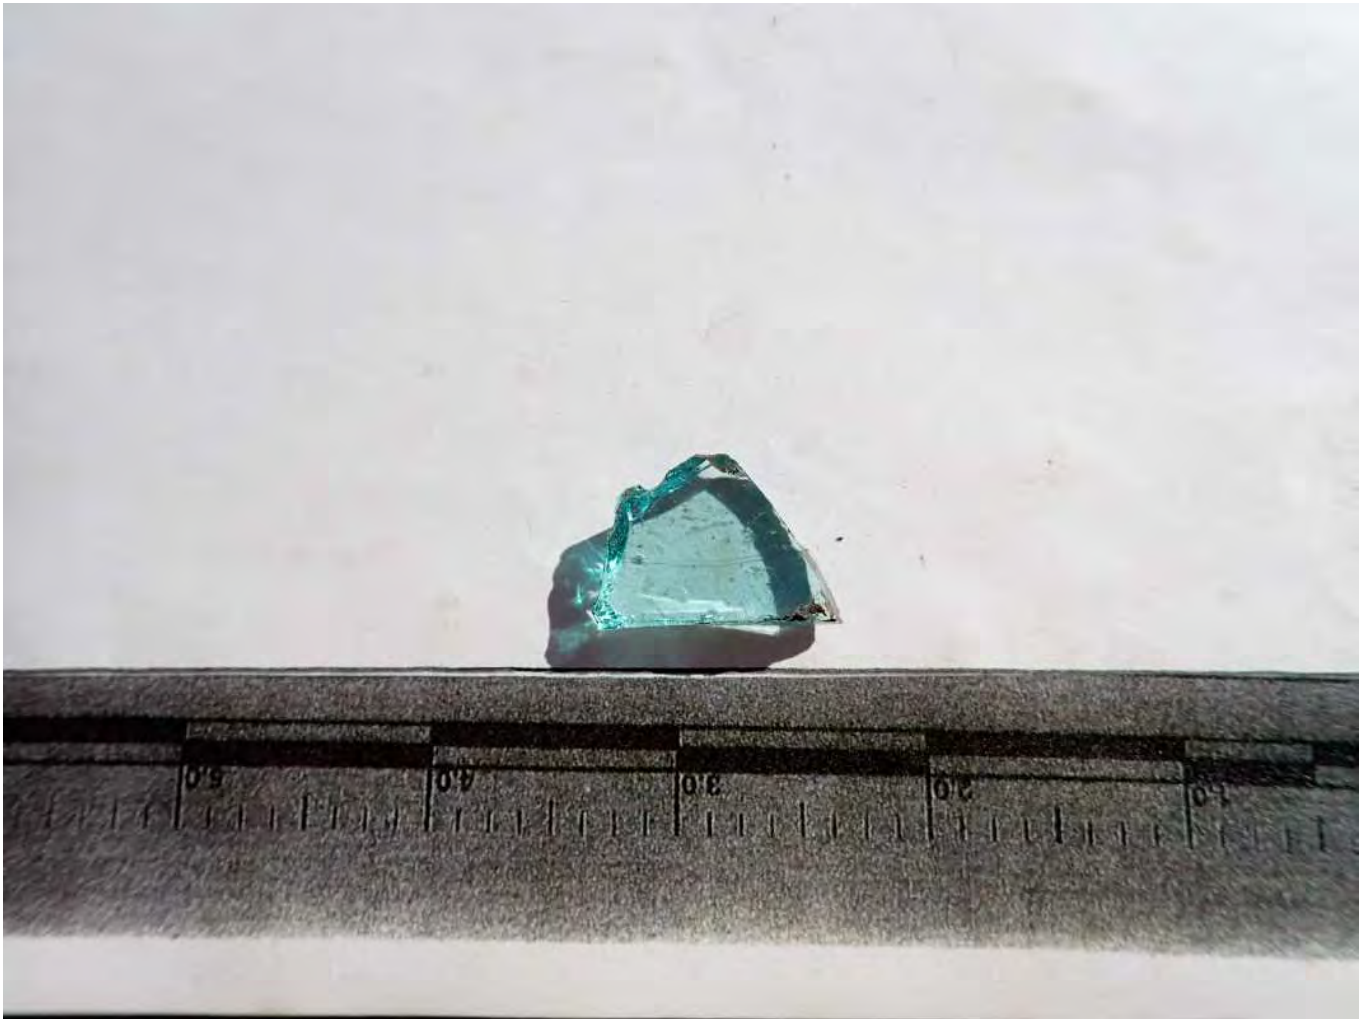
Photo ID	748542
Title	Aqua Glass.JPG
Year Taken	2023
Is Circa?	<input type="checkbox"/>
Notes	Aqua glass fragment.
Type	image/jpeg
Photo View	Plan
Source	Photo taken by WillametteCRA, Ltd.
Copyright	<input type="checkbox"/>
