# **DRAFT FINAL REMEDIAL INVESTIGATION AND FOCUSED FEASIBILITY STUDY REPORT**

Burrows Island Light Station  
Skagit County, Washington

Prepared by:  
Arcadis U.S., Inc.  
2300 Clayton Road  
Suite 400  
Concord  
California 94520  
Tel 925 274 1100  
Fax 925 726 0121

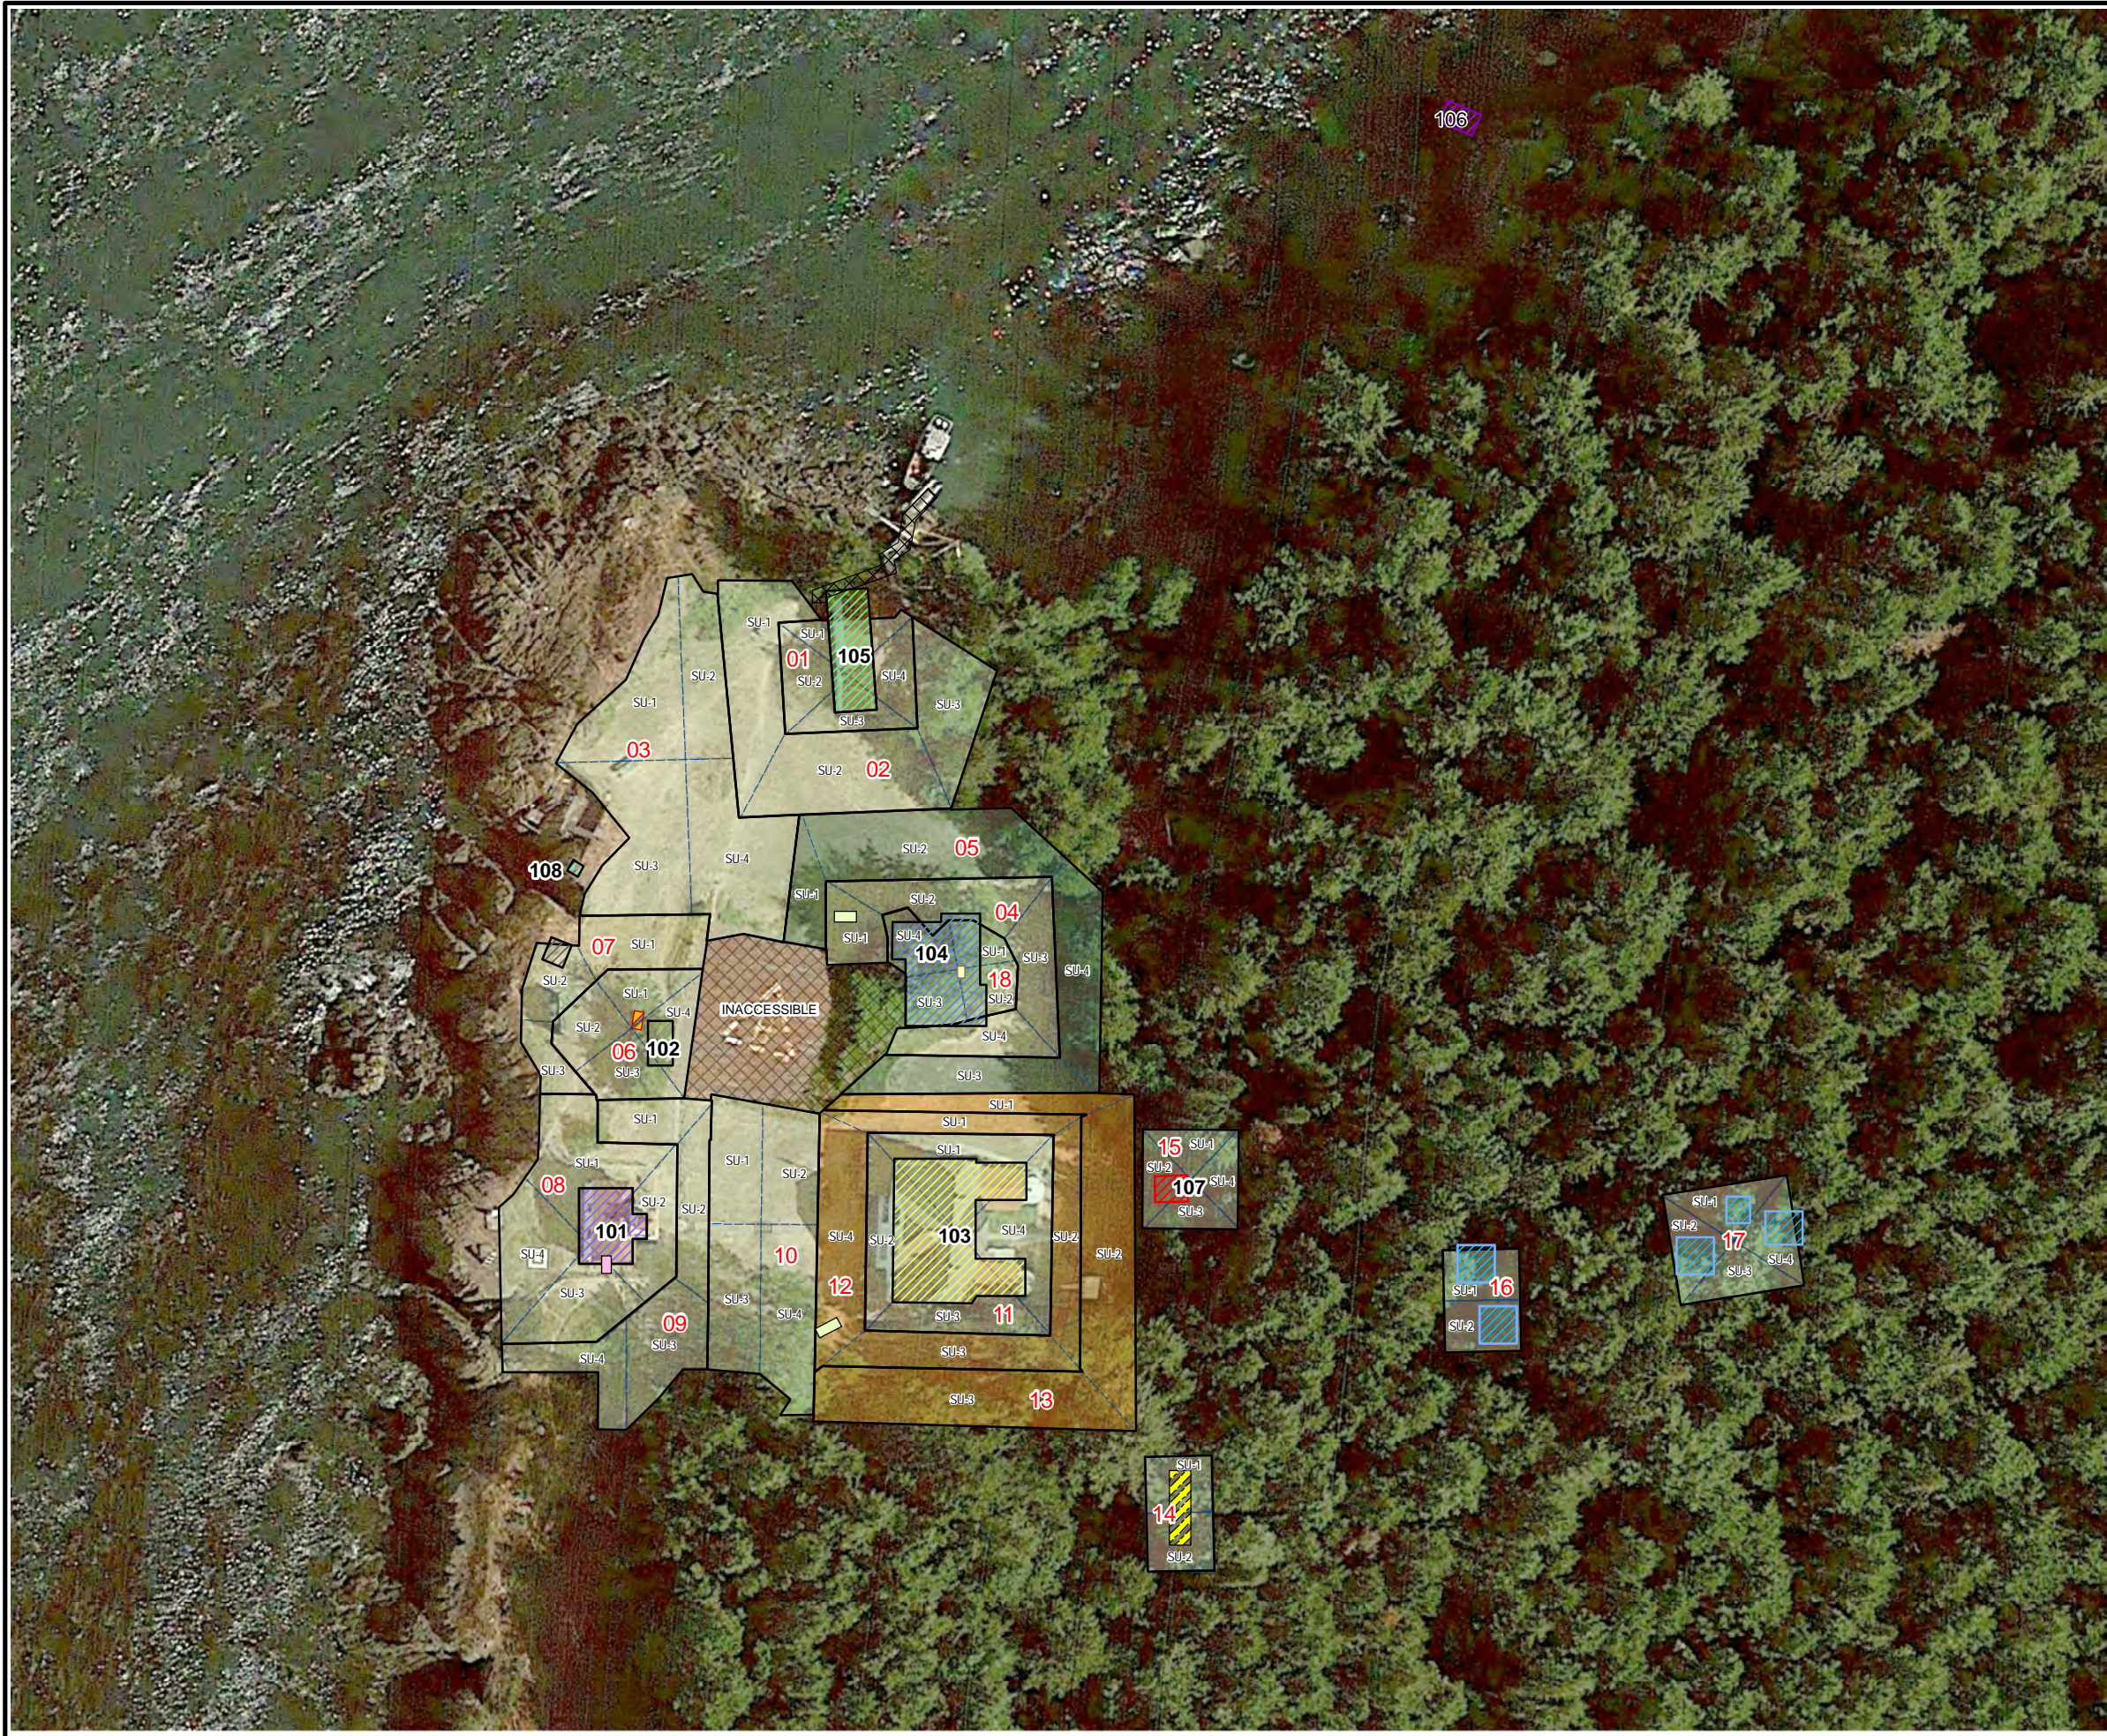
**Locations of Decision Units  
and Subunits**

As described in the QAPP and SAP (Arcadis 2018), the site was divided into 18 decision units (DUs) based on the results of the XRF screening event conducted in November 2018 (Appendix A). Each DU was selected to represent a location where soil conditions were consistent based on proximity to structures and were subdivided into 30 equally sized areas with a sample location placed at the center of each area. Where possible, soil samples were collected using a hand auger from each of the 30 locations within the DU. An equal volume of soil was taken from each increment and combined to form an incremental composite sample.

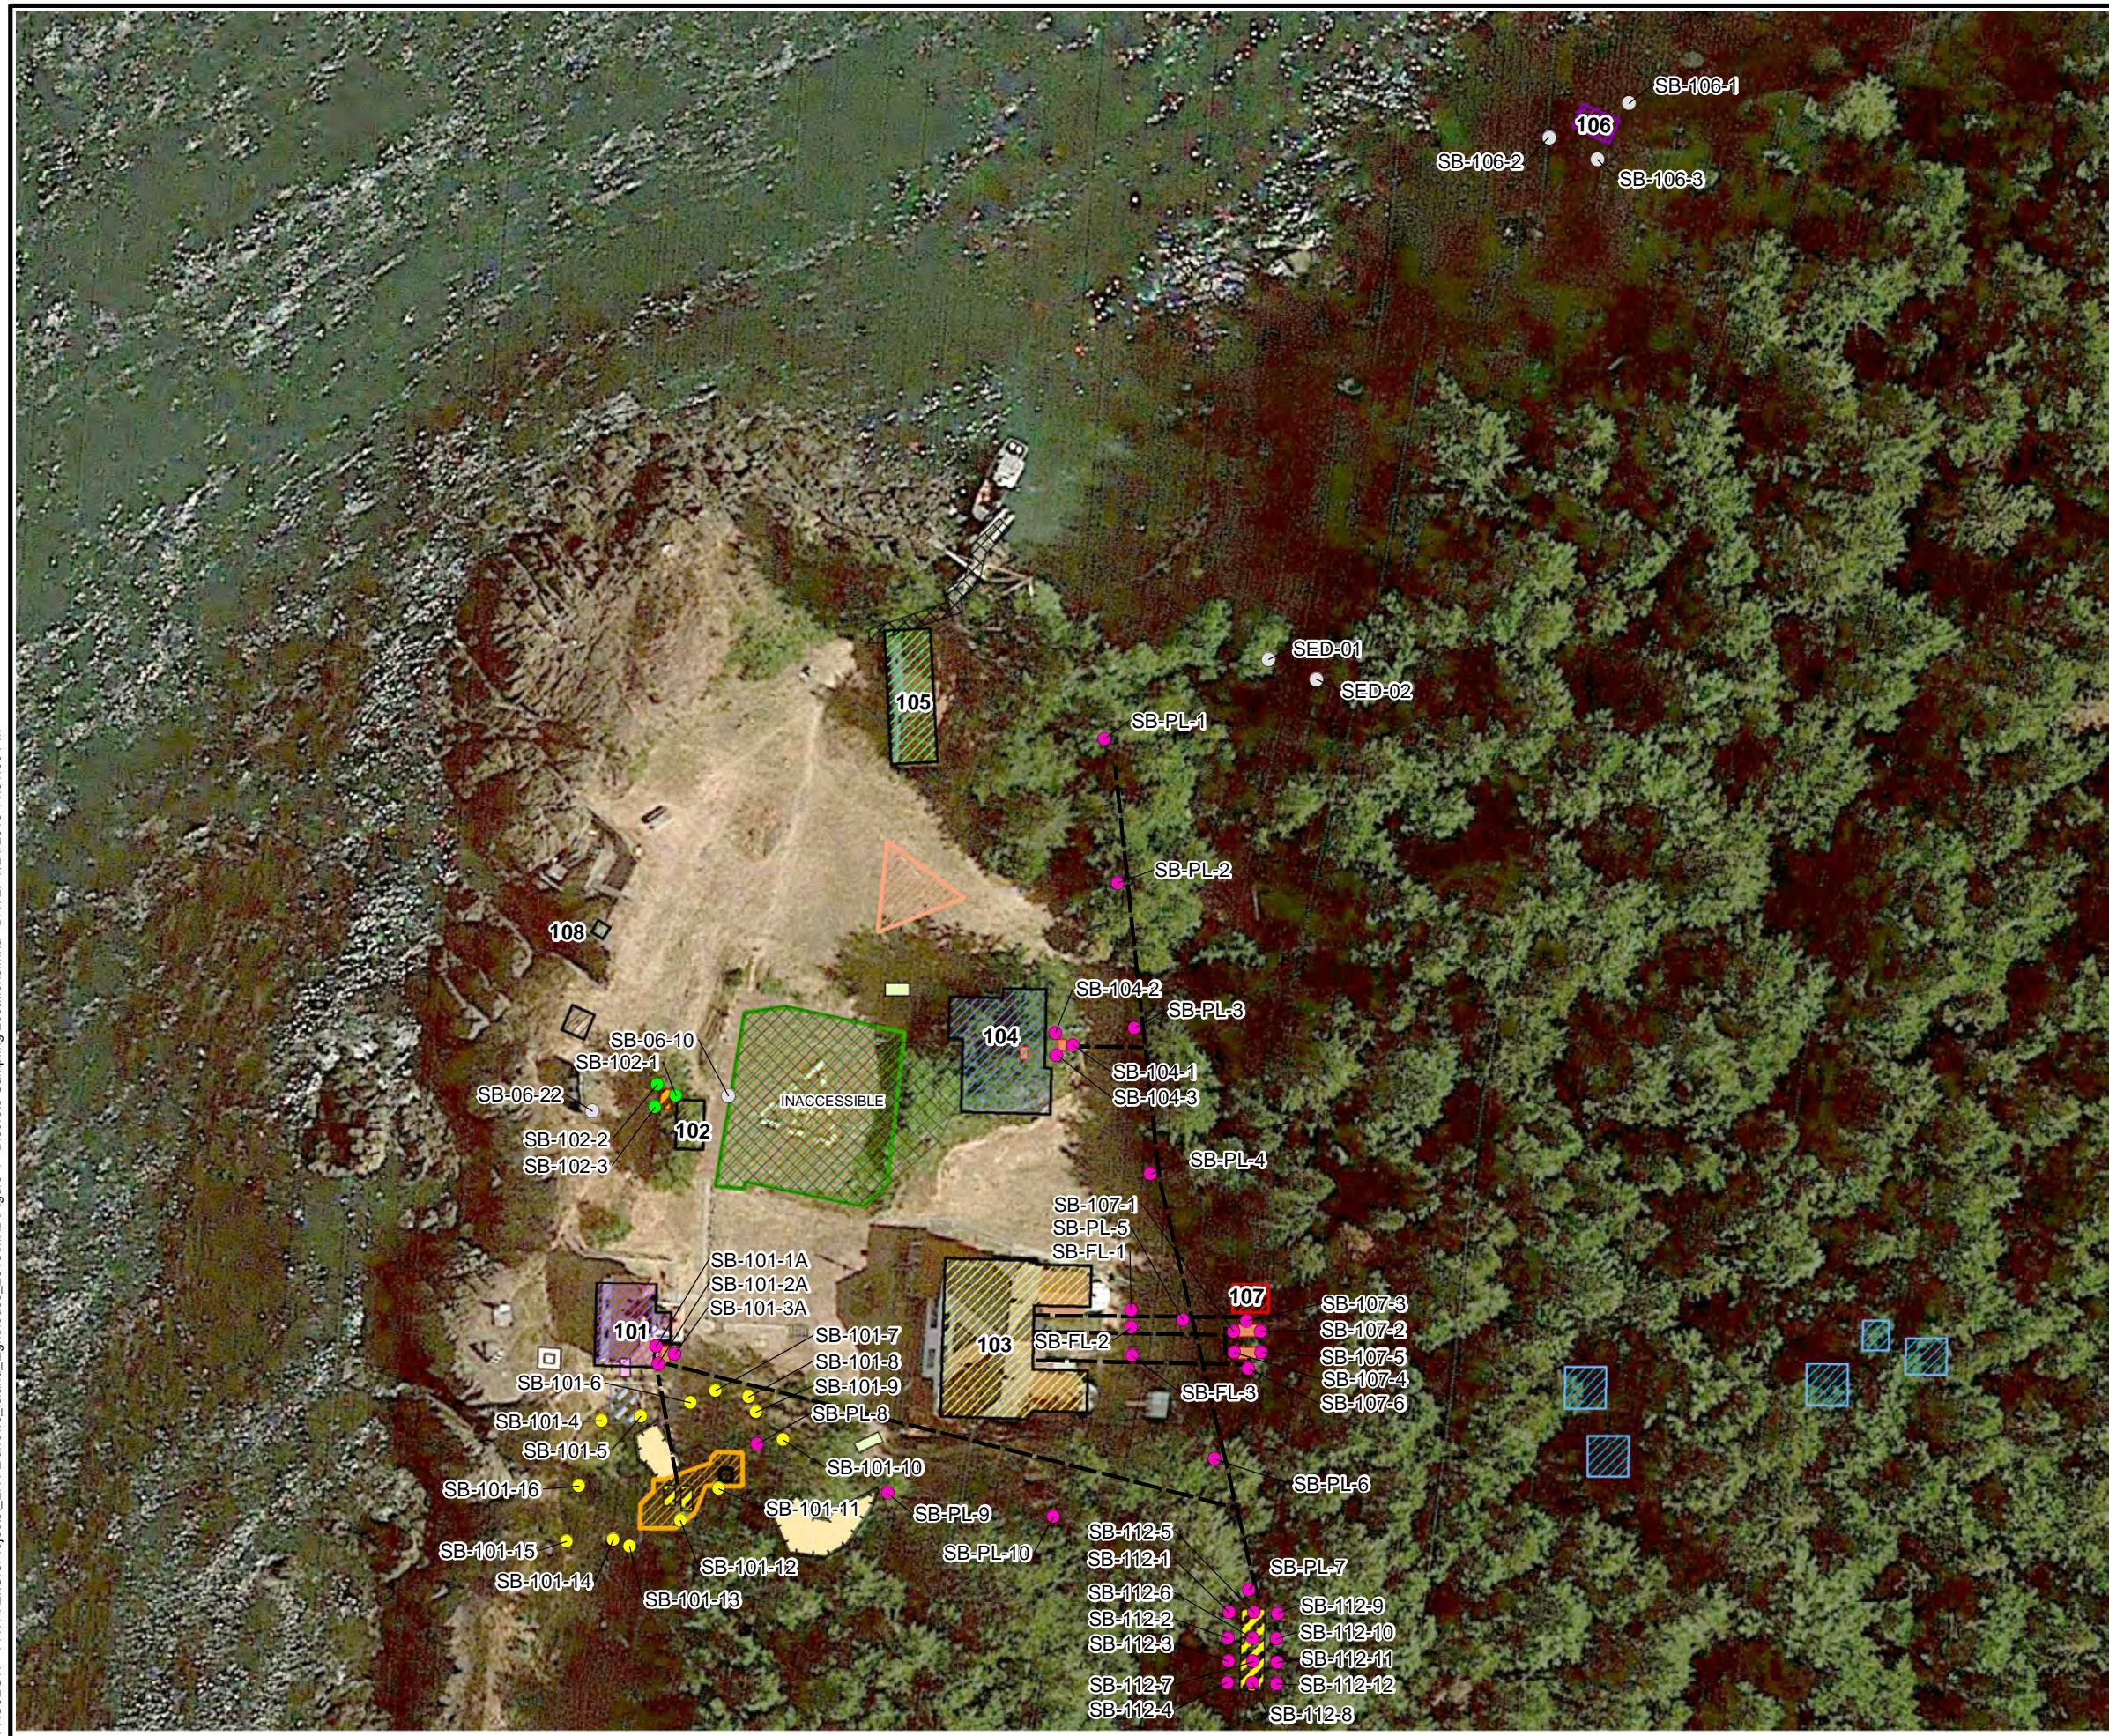
Discrete Sample Locations

Samples were collected from three locations around each of the known former ASTs and UST from the surface (0 to 0.5 foot bgs) and the deepest interval that could be collected before encountering refusal. Based on historical documentation, the UST associated with the OIC Quarters was removed and over-excavated to a depth of 5 feet bgs. One of the sample locations was collected within the backfill material, based on field observations of soil conditions. Due to the larger footprint of the 10,000-gallon AST, samples were collected from 12 locations. Samples were collected from 14 locations along the former petroleum piping in accordance with Ecology guidance (Ecology 1991). Where the pipeline was visible, samples were collected from soil immediately below the pipeline. If the pipeline was not identified, samples were collected at the maximum depth that could be obtained prior to refusal. Based on historical documentation, the primary fuels handled and stored at the site were diesel and fuel oil. Samples were analyzed for DRO and HO. Samples collected near the former gasoline storage tank associated with the Oil and Paint Storage Building were also analyzed for gasoline range organics. Samples were field screened using a photo ionization detector (PID) and submitted for analysis as outlined in the QAPP and SAP (Arcadis 2018).

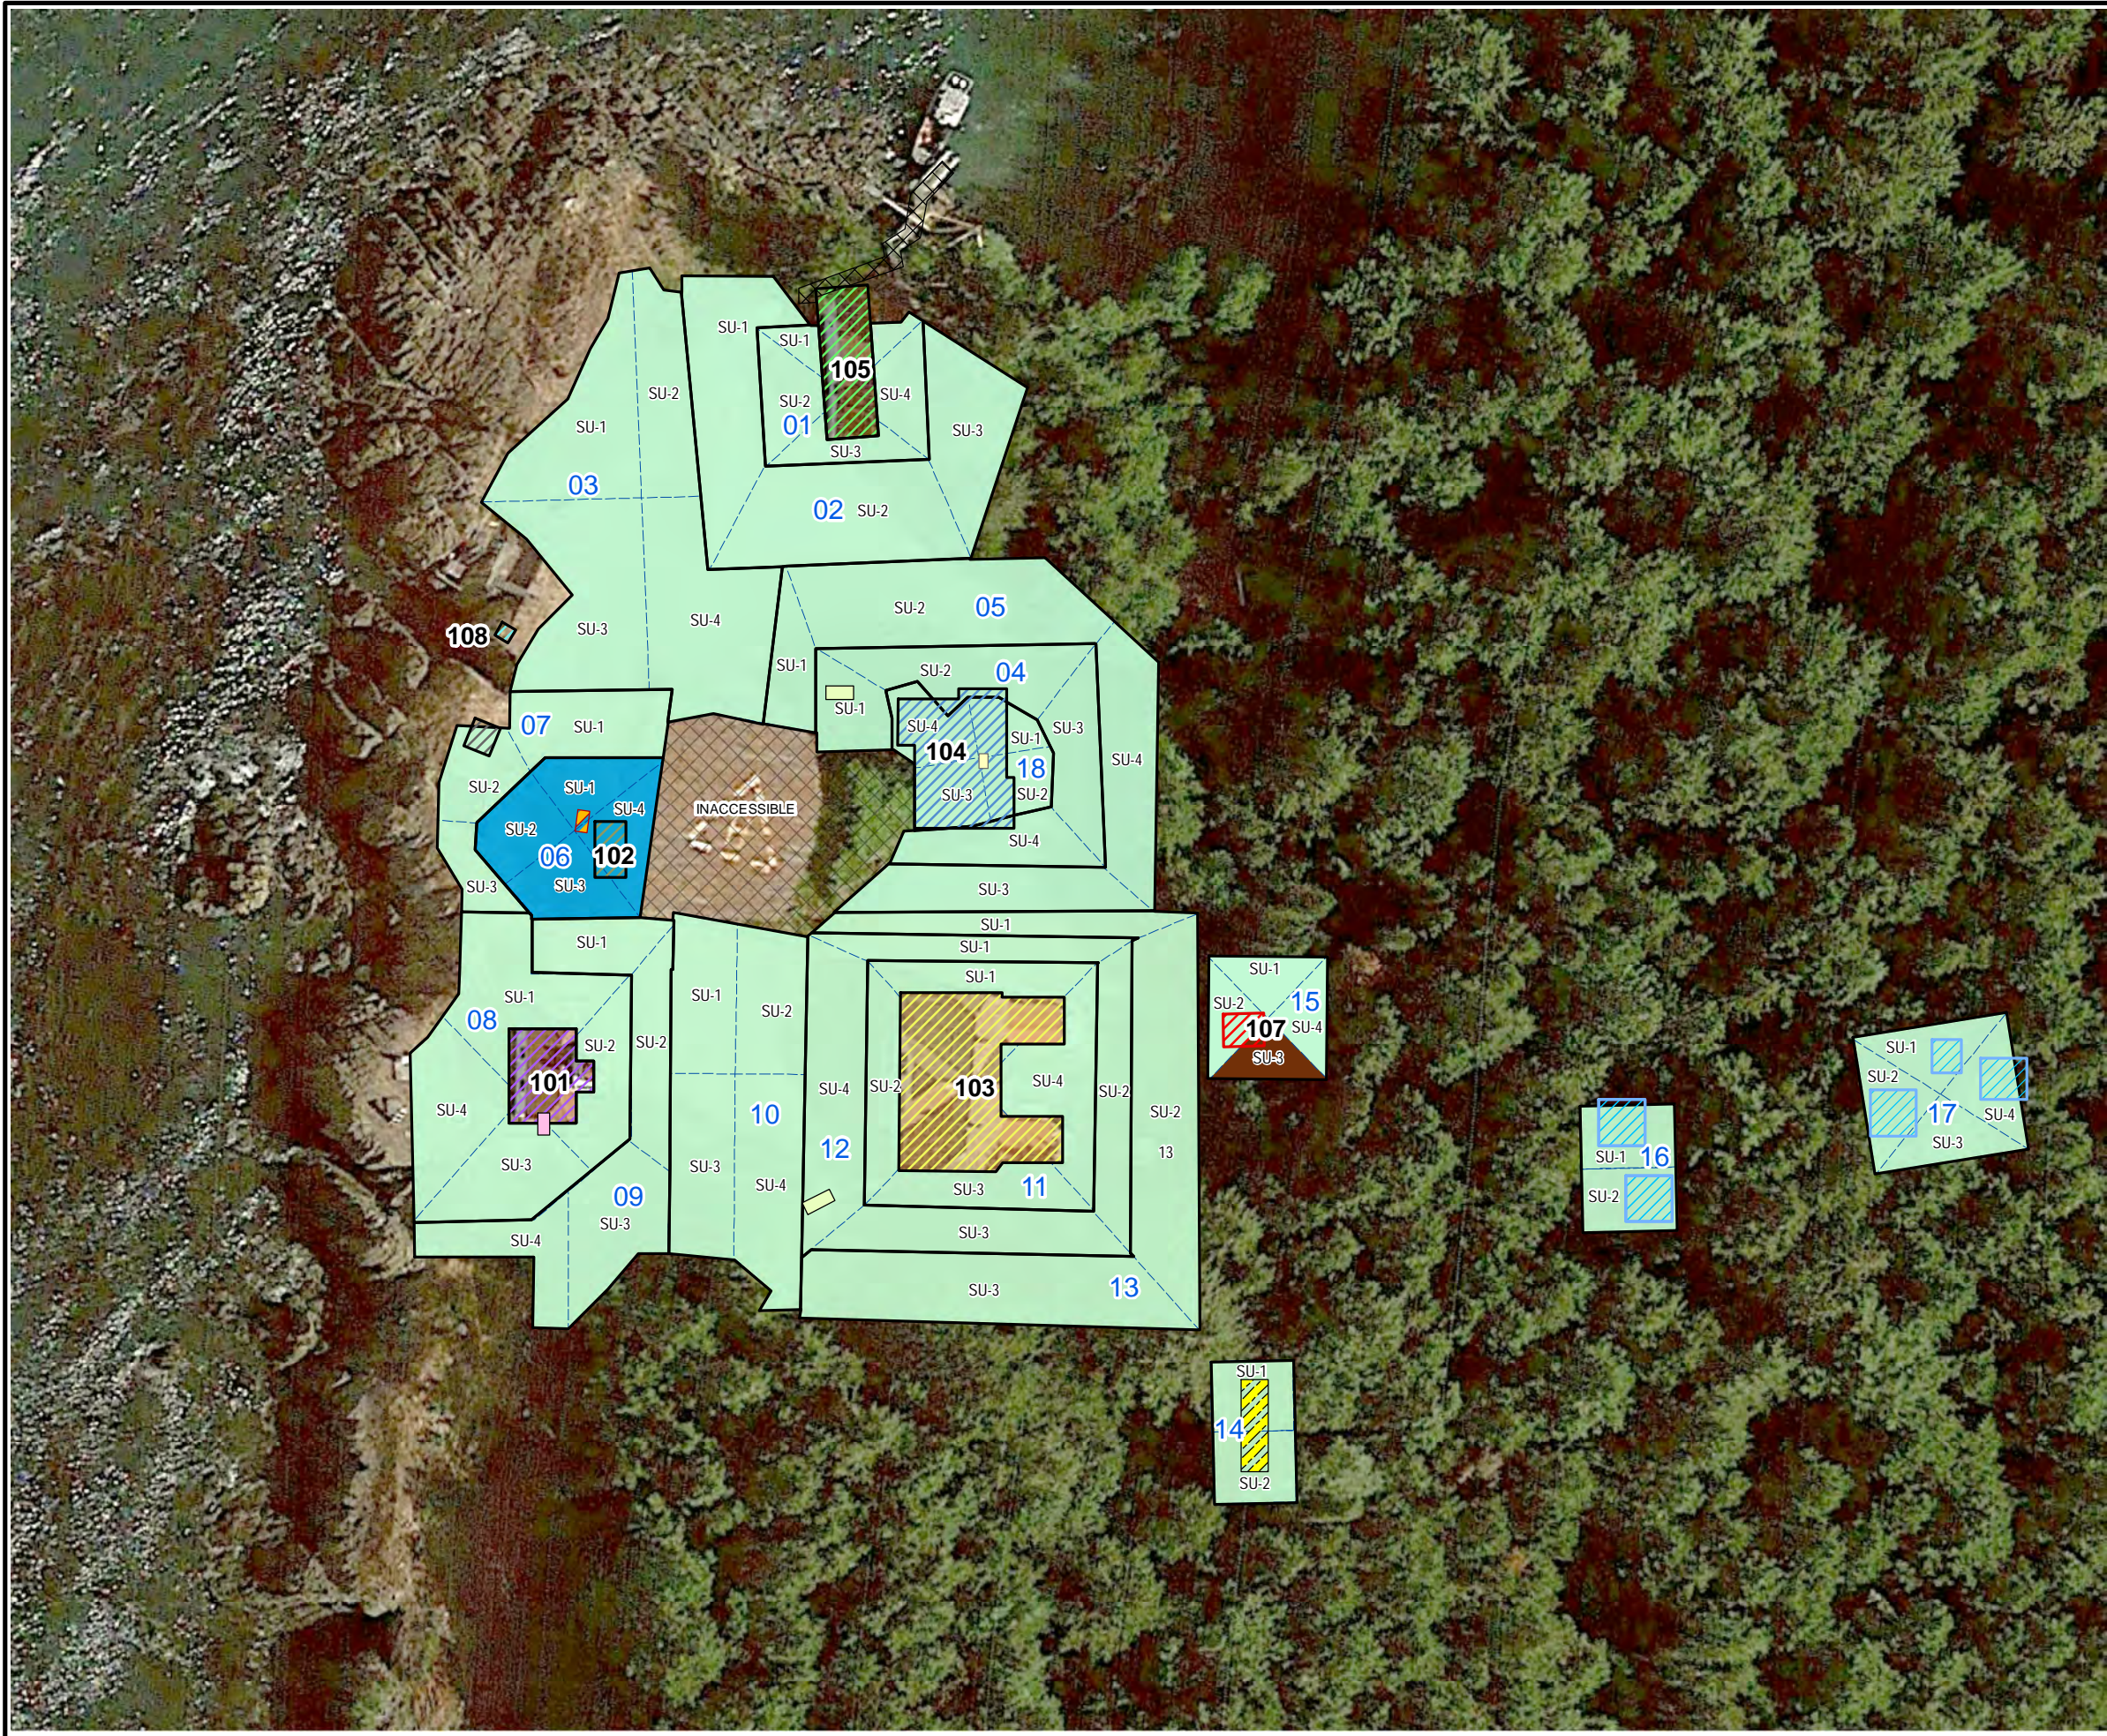
**ISM Total Lead Analytical Results:**  
**0 to 0.5 foot**

The former water tanks located east of the Duplex were included in DU-16 and DU-17. Lead concentrations in the ISM samples from 0 to 0.5 foot and 0.5 to 1 foot bgs were less than 100 mg/kg in both DUs. Increment locations were relocated as noted in Section 2.3.2. Analytical results for ISM and SU samples are summarized in Tables 3 and 4 and shown on Figures 5 through 8.

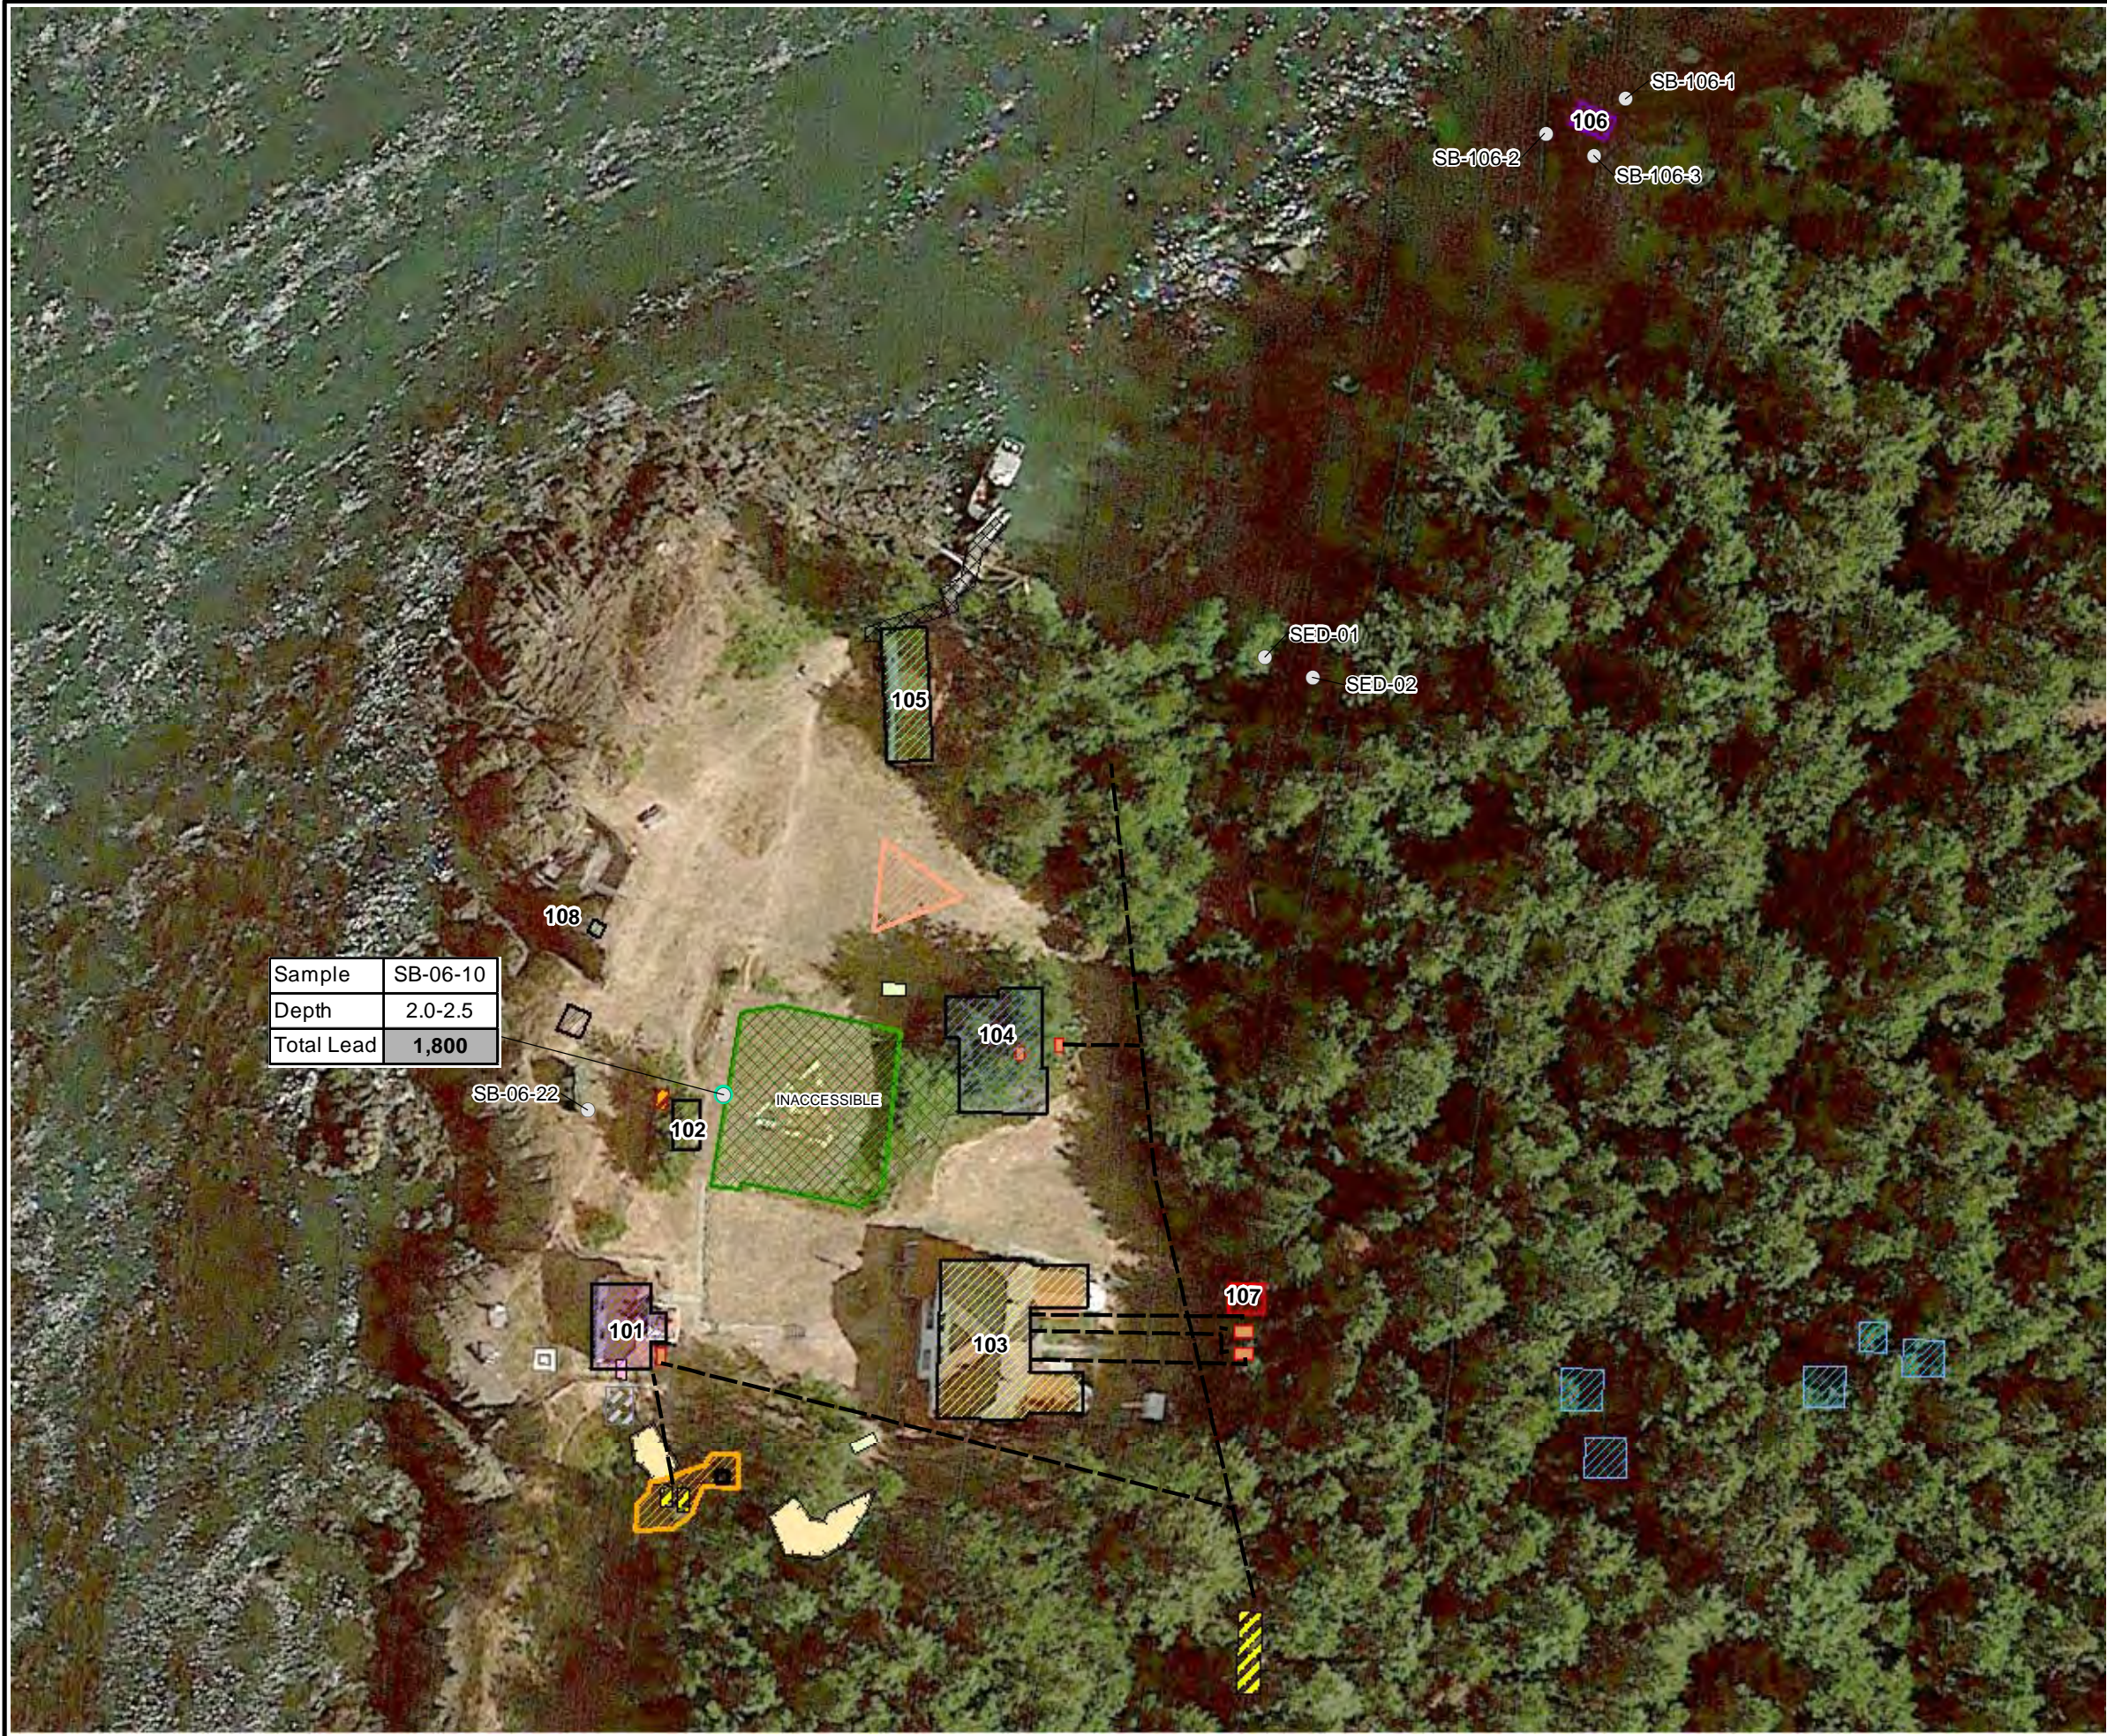
Discrete Sample Results - Total Lead

Sample	SB-06-10
Depth	2.0-2.5
Total Lead	1,800

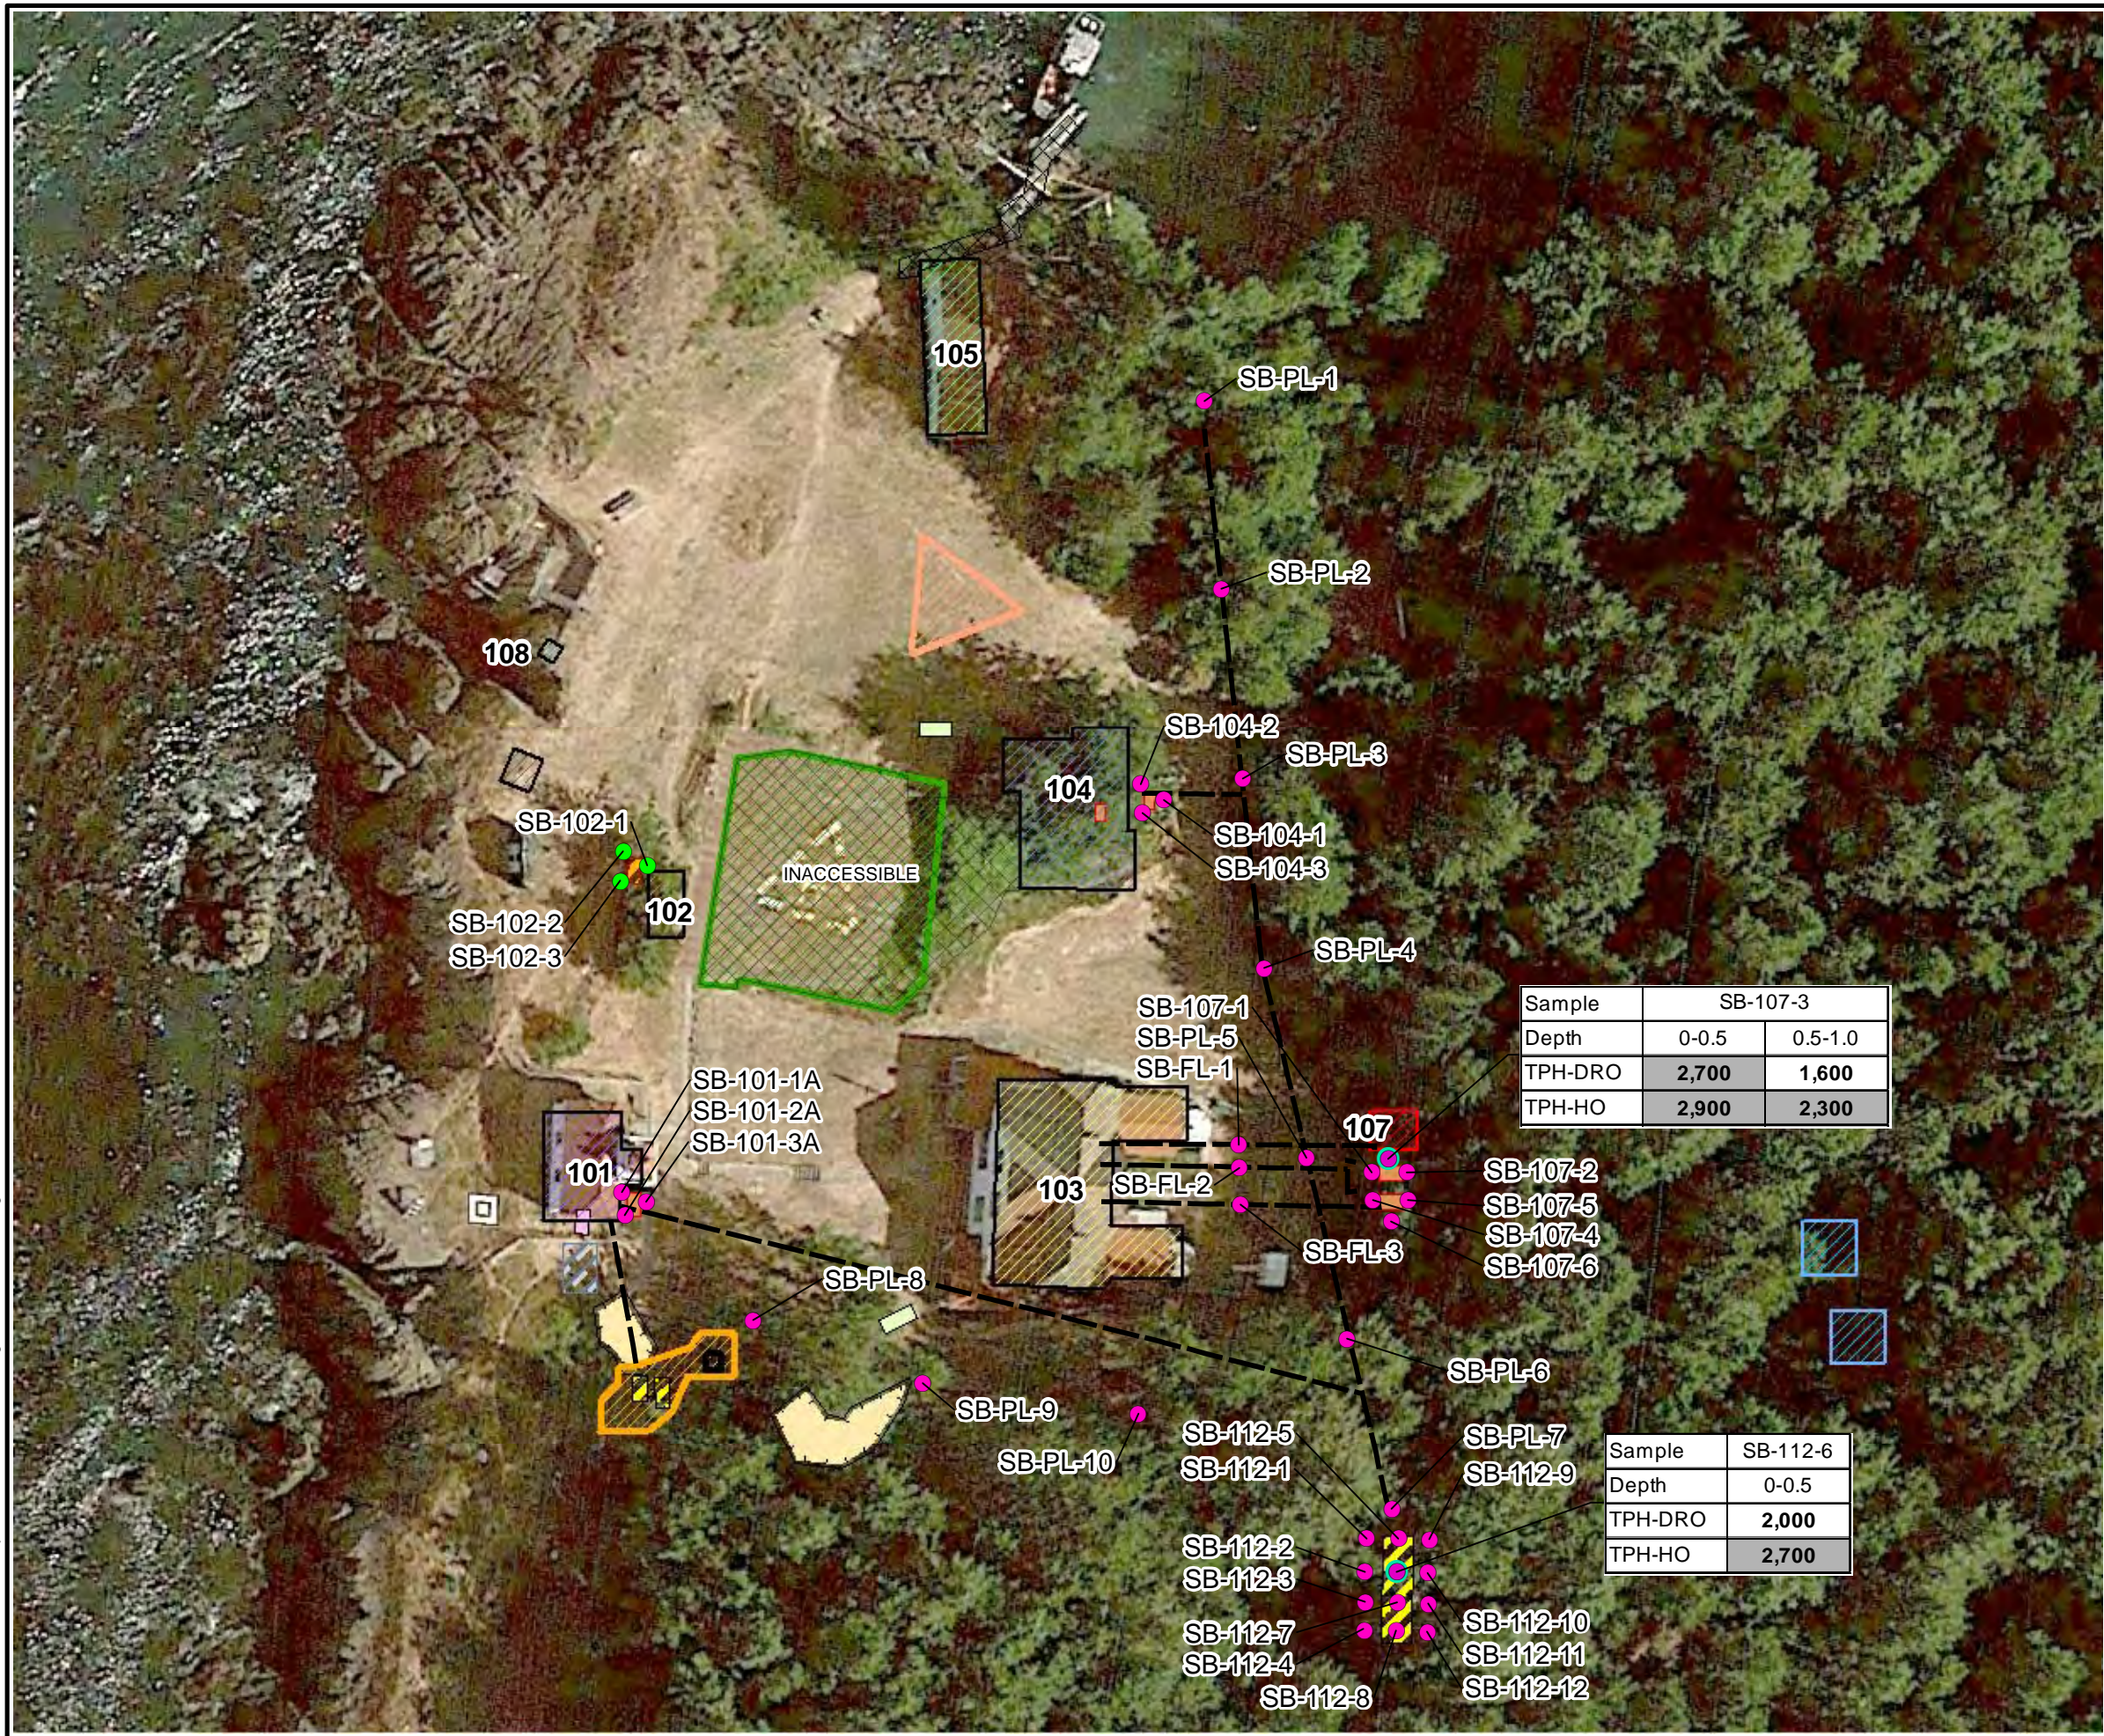
Discrete Sampling Results -  
Petroleum Hydrocarbons

Heavy-end petroleum contaminants from fuel oil, diesel, or PCB-containing transformer oil are expected to adhere to soil particles and have relatively low mobility in soil. Petroleum hydrocarbons are readily degraded by naturally occurring microorganisms in the environment and typically diminish over time through biodegradation and volatilization. PCBs are persistent in the environment and do not significantly degrade through time. Primary transport mechanisms for hydrocarbons and PCBs include erosion of shallow impacted soil by wind or water. Analytical data from the 2019 RI indicate that these constituents are present near the anticipated source areas and migration away from these areas has been limited.
