# **DRAFT FINAL REMEDIAL INVESTIGATION AND FOCUSED FEASIBILITY STUDY REPORT**

Burrows Island Light Station  
Skagit County, Washington

Prepared by:  
Arcadis U.S., Inc.  
2300 Clayton Road  
Suite 400  
Concord  
California 94520  
Tel 925 274 1100  
Fax 925 726 0121

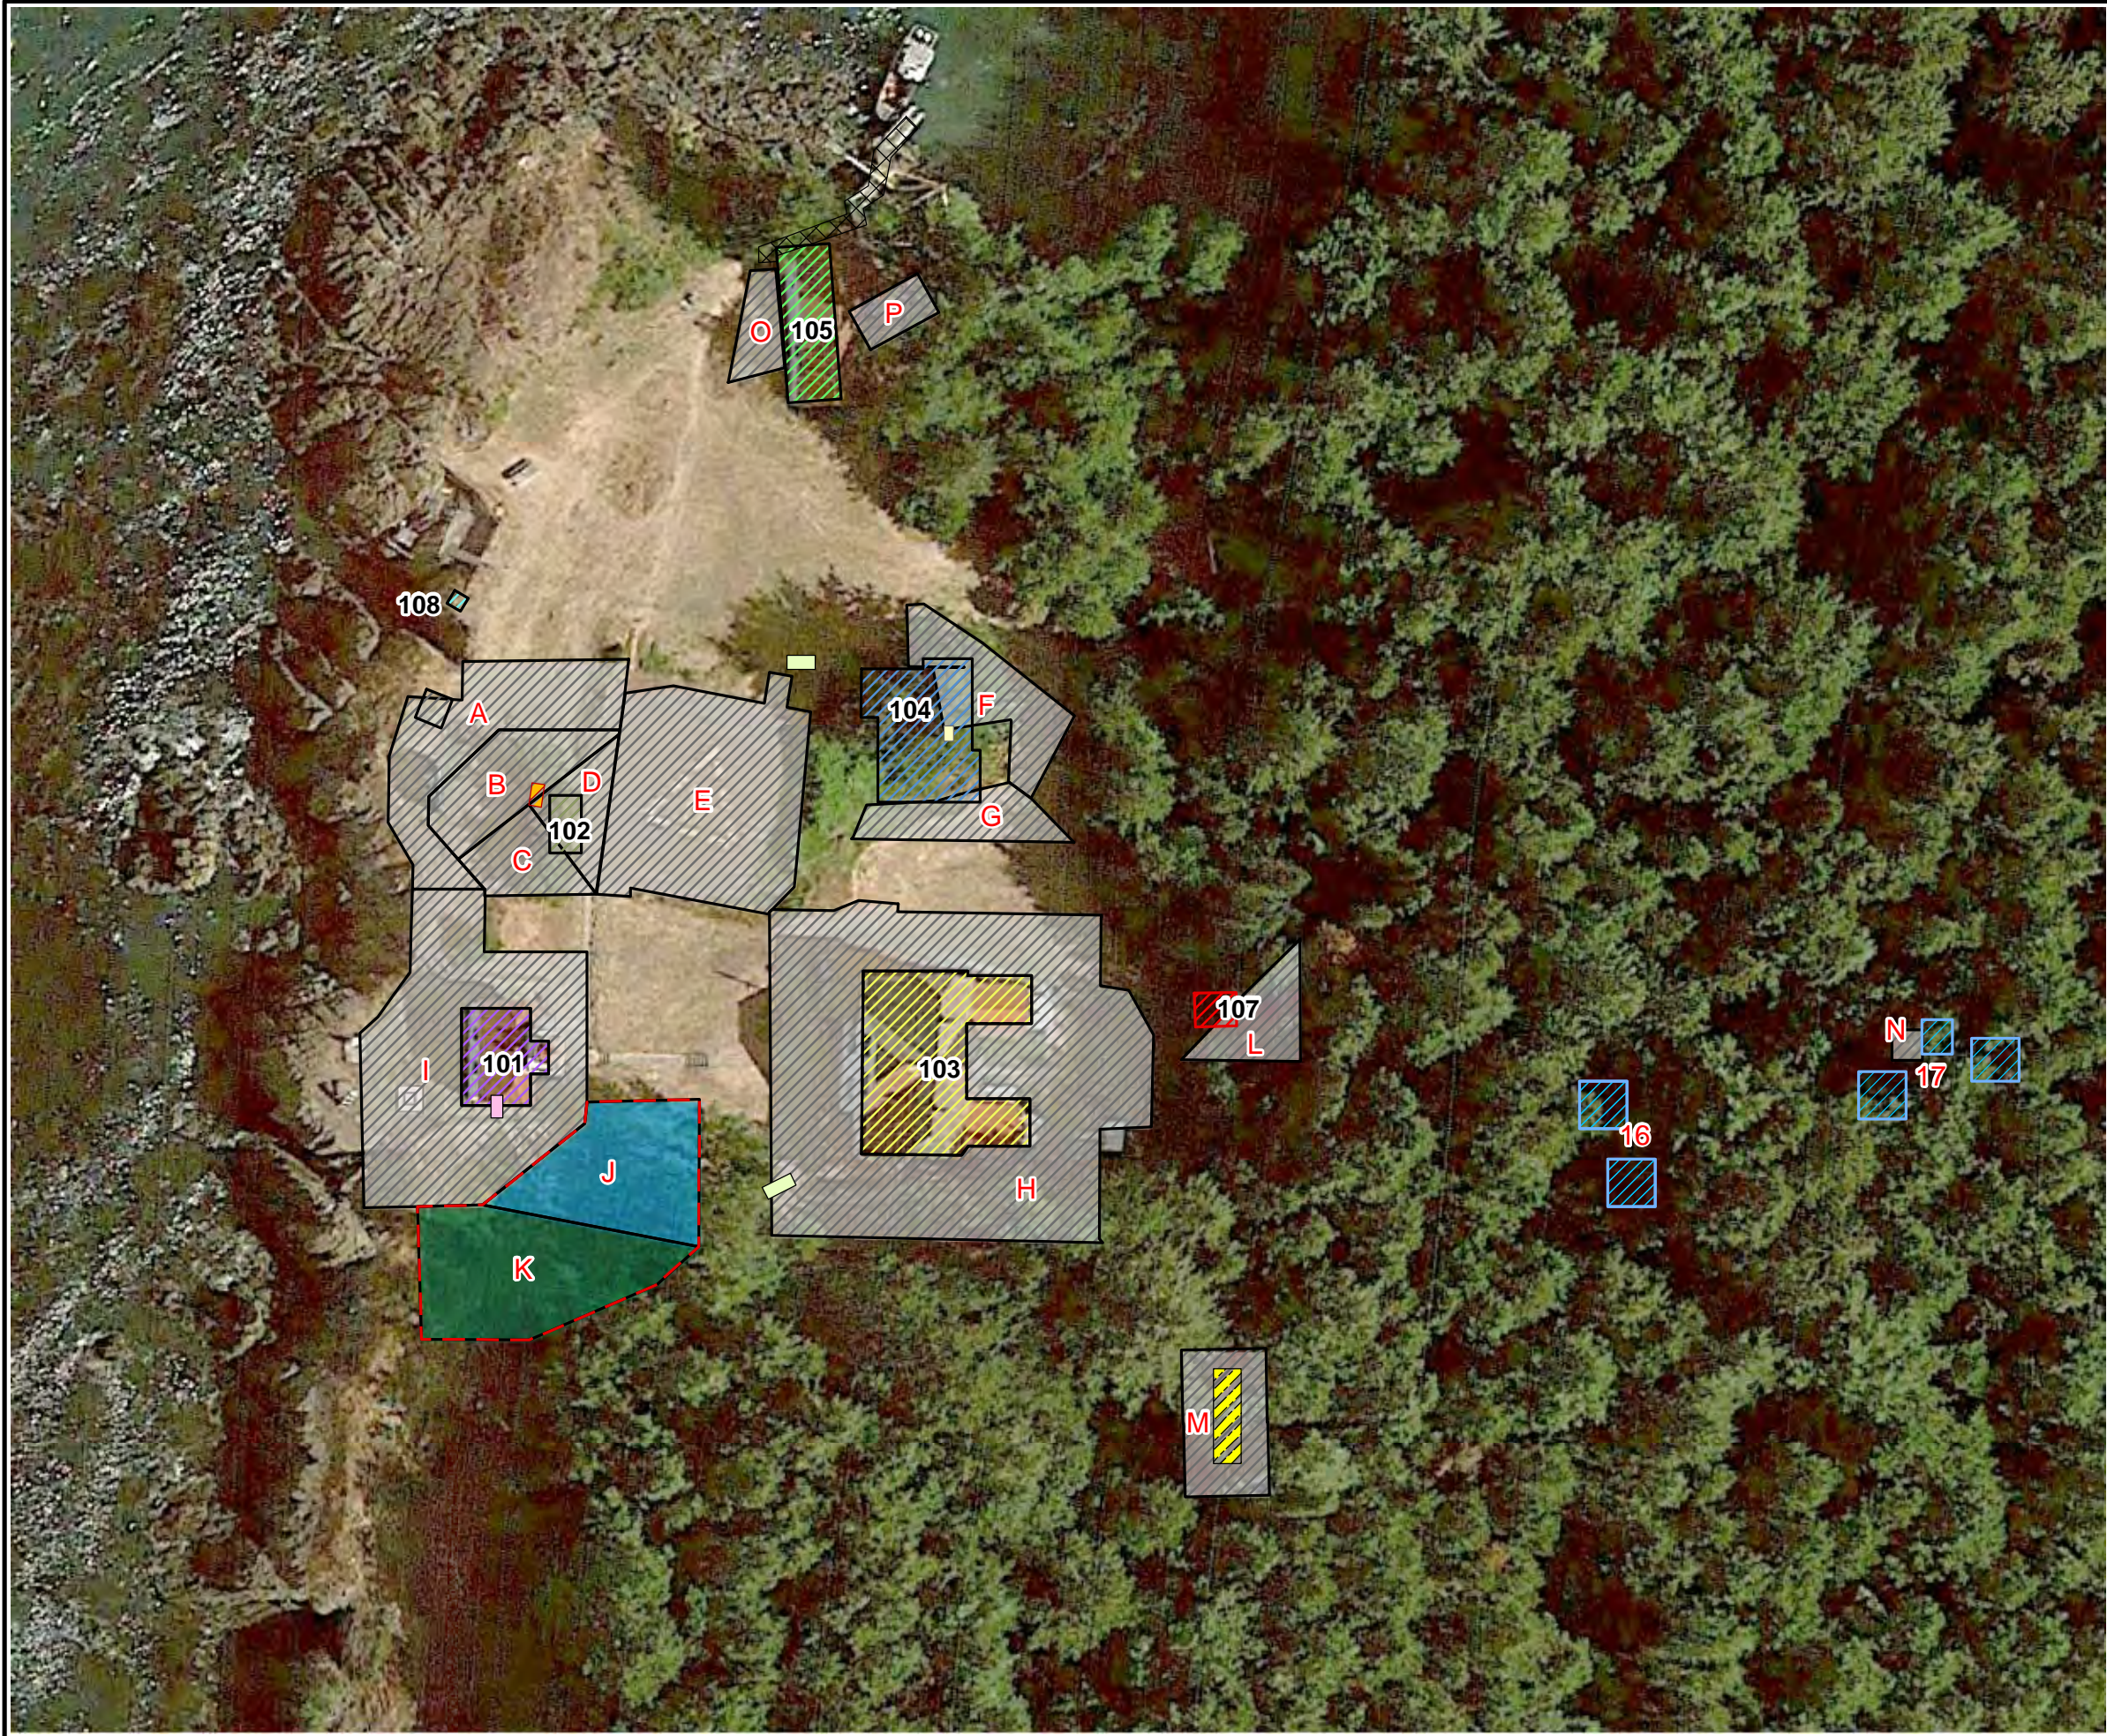
Alternative 2 - Excavation and Capping

- Excavation Areas
- Capped Areas
- Polychlorinated Biphenyl Area
- Structures
  - Lighthouse
  - Oil and Paint Storage Building
  - Duplex
  - Officer In Charge Quarters
  - Boathouse
  - Firehouse Pump Building
  - Saltwater Flushing Pumphouse
  - Water Tanks/Platforms
  - Elevated 10,000-Gallon Fuel Oil Tank
  - Septic Tank
  - 675-Gallon Fuel Oil Tank
  - Fuel Oil Tank
  - Gasoline Storage Tank
  - Landing/Dock
- Excavation Depth (feet bgs)
  - 2.0 feet
  - 3.0 feet

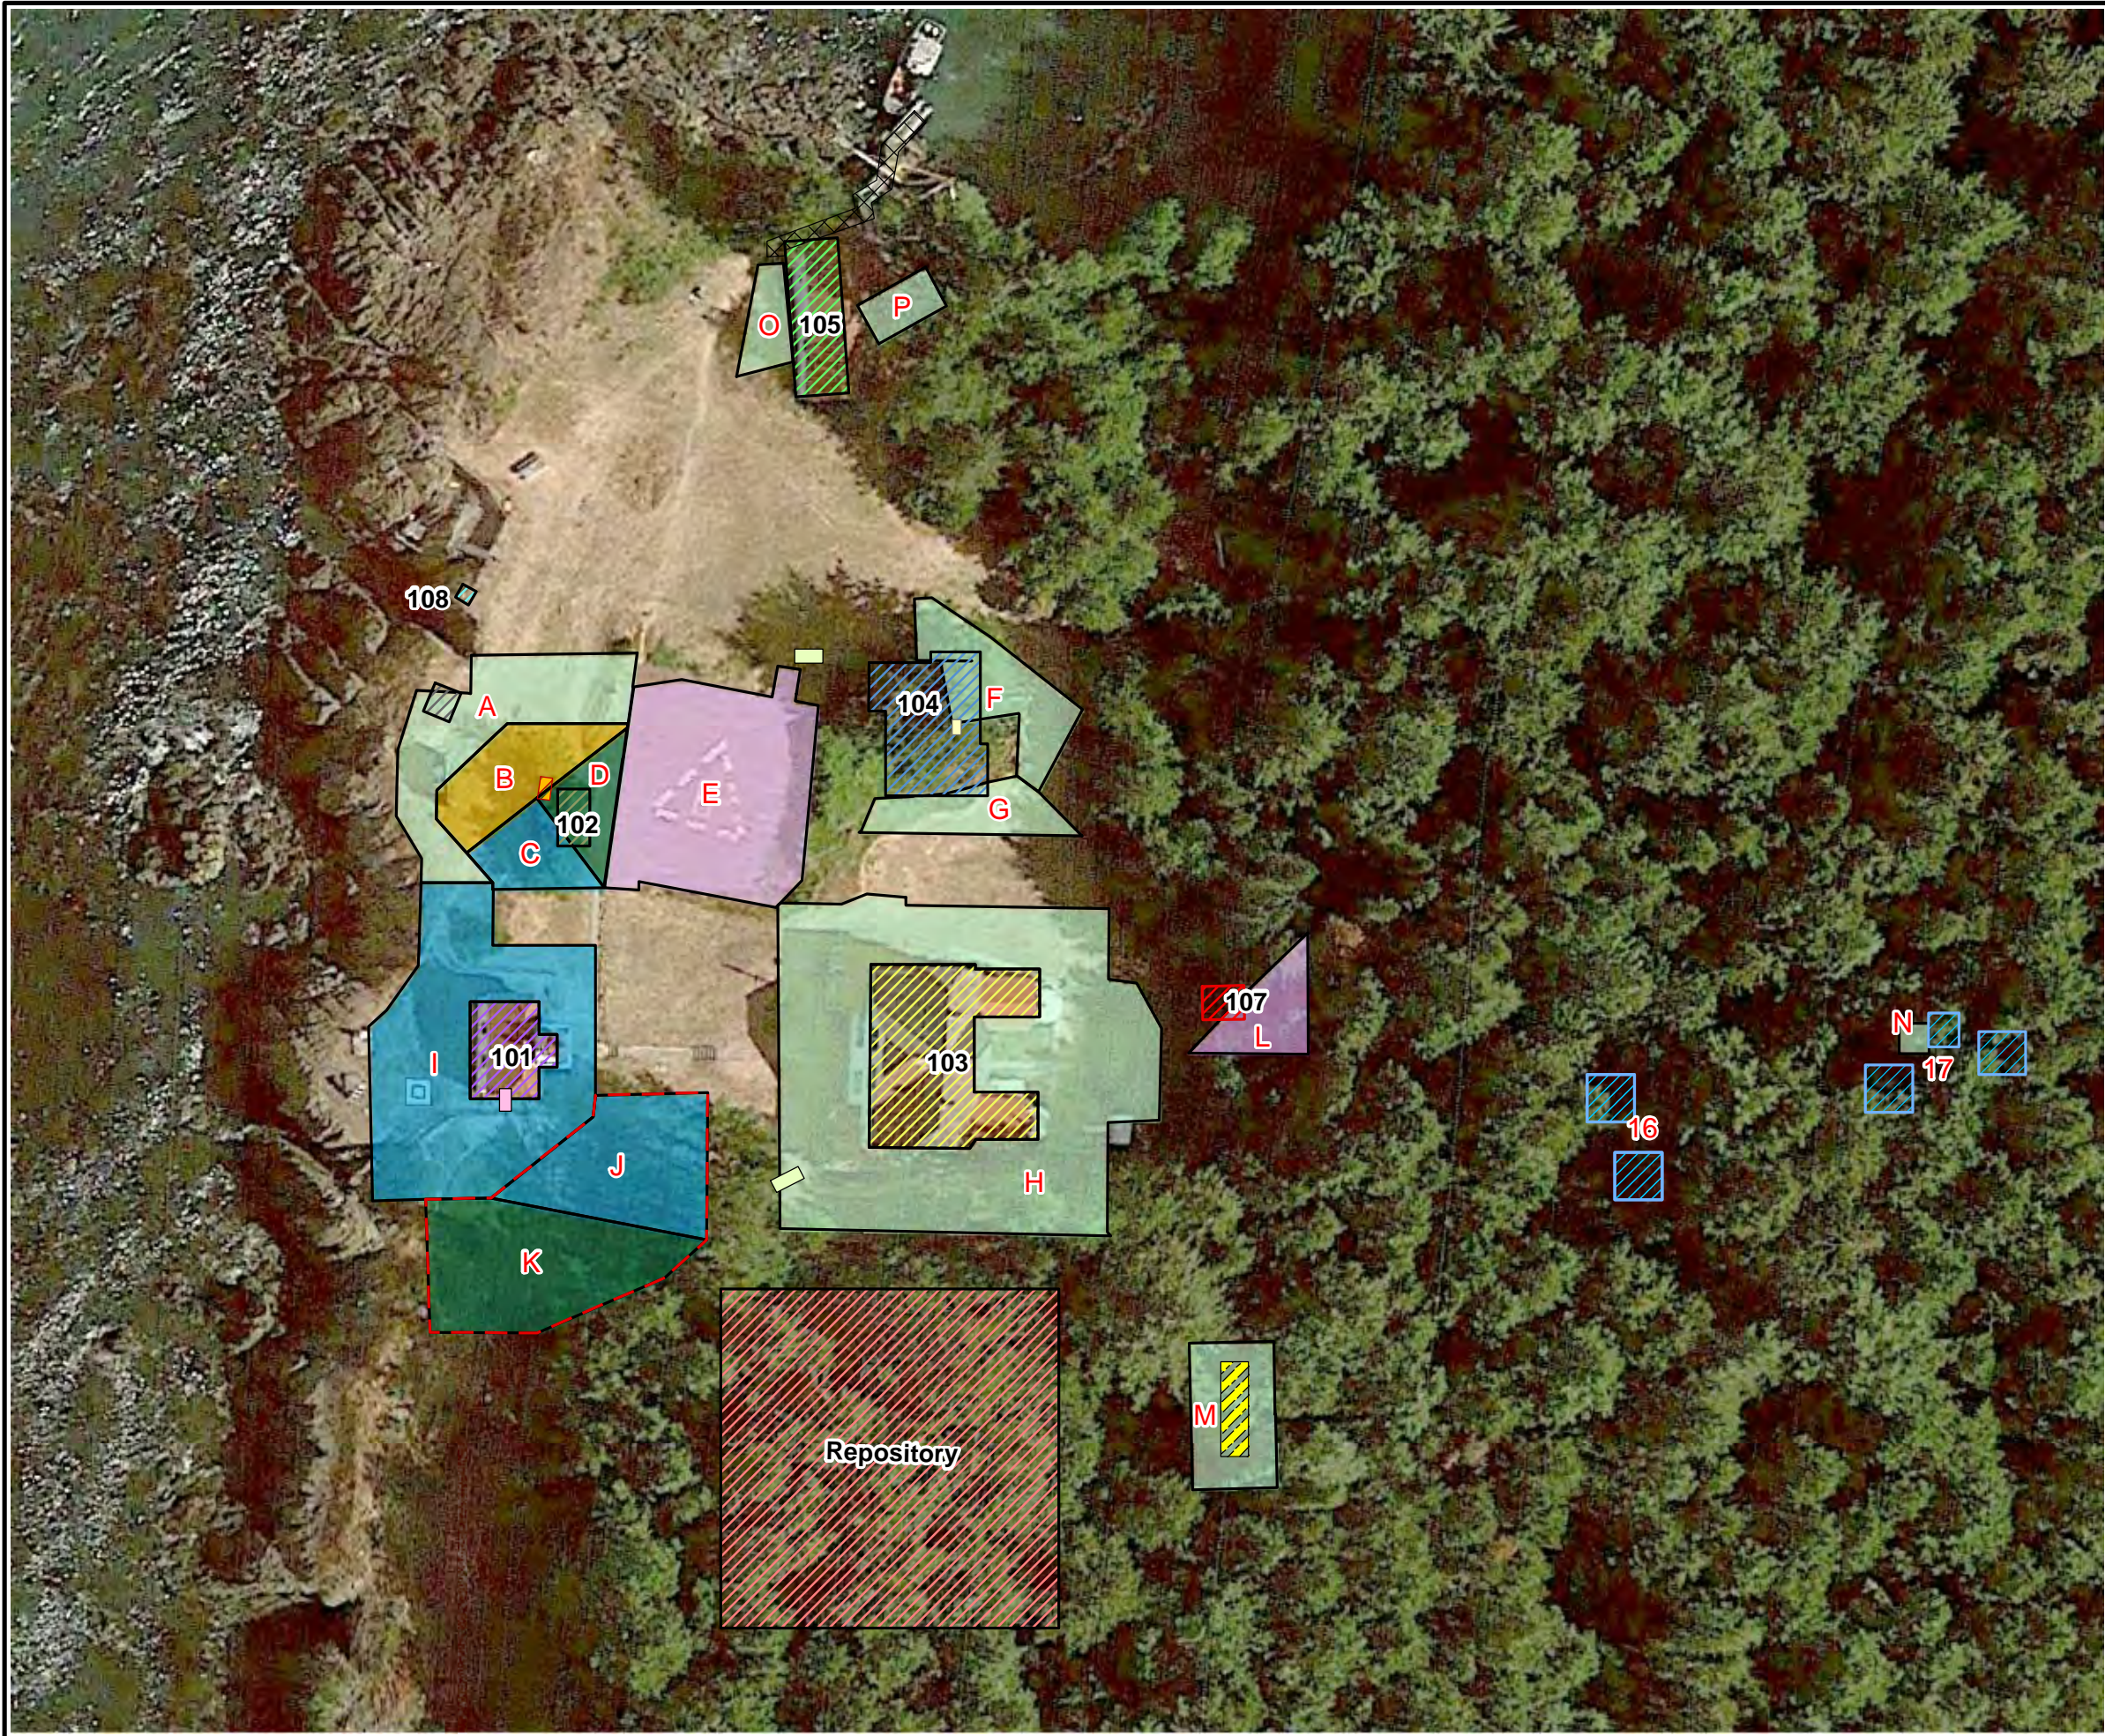
Alternative 3 - Excavation and Onsite Repository

- Excavation Areas
- Polychlorinated Biphenyl Area
- Structures
  - Lighthouse
  - Oil and Paint Storage Building
  - Duplex
  - Officer In Charge Quarters
  - Boathouse
  - Firehouse Pump Building
  - Saltwater Flushing Pumphouse
  - Repository
  - Water Tanks/Platforms
  - Elevated 10,000-Gallon Fuel Oil Tank
  - Septic Tank
  - 675-Gallon Fuel Oil Tank
  - Fuel Oil Tank
  - Gasoline Storage Tank
  - Landing/Dock

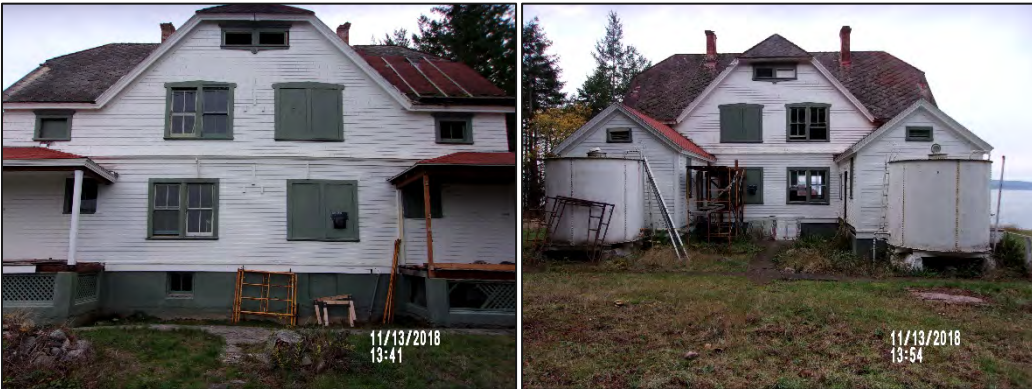
<b>125 total</b> 121, 0.0-0.5 feet 4, 0.5-1.0 feet	1,352 ± 23	ND, <11	21	5	<ul style="list-style-type: none"><li>• Visible paint chipping and sloughing in areas on trim and from porches. Also very weathered in drip lines.</li><li>• Removal area within parts of the sidewalks adjacent to building.</li><li>• Fence around the east side of building is chipping and in poor condition.</li></ul>

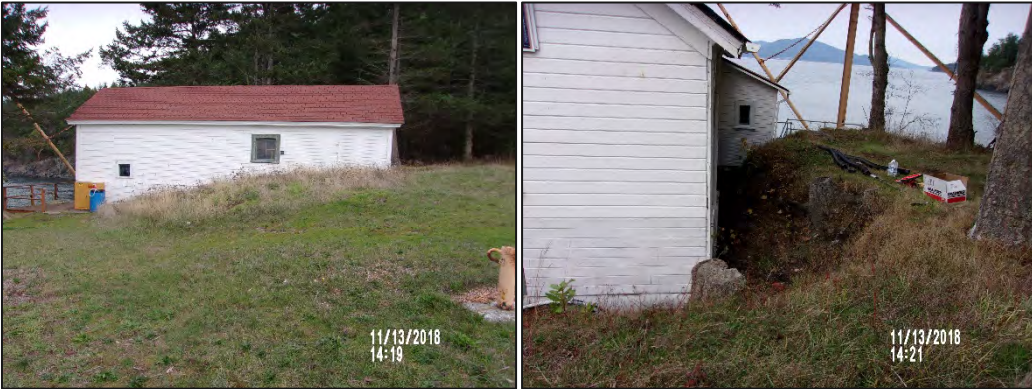
<b>62 total</b> 59, 0.0-0.5 feet 3, 0.5-1.0 feet	448 ± 9	ND, <12	2	6	<ul style="list-style-type: none"><li>Apparent excavation and replacement of siding along east, south and west sides.</li><li>North side inaccessible for sampling due to slope and rocks.</li><li>Some building materials with paint encountered east of the building</li></ul>

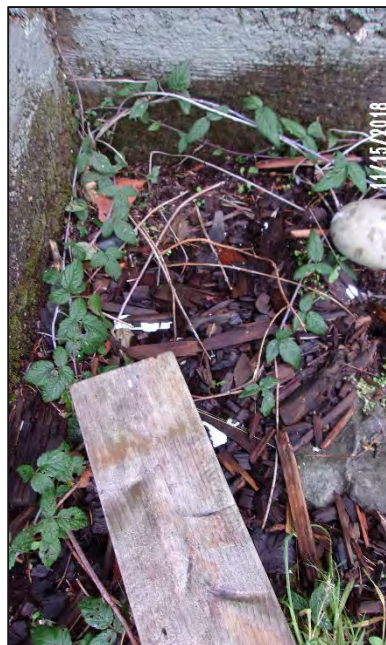
**Photo: 12**

**Description:**  
Paint deterioration visible  
on drip lines and trim on  
north side of Duplex

**Location:**  
Duplex (103)

### **6.2.2 Repair of Building Encapsulation**

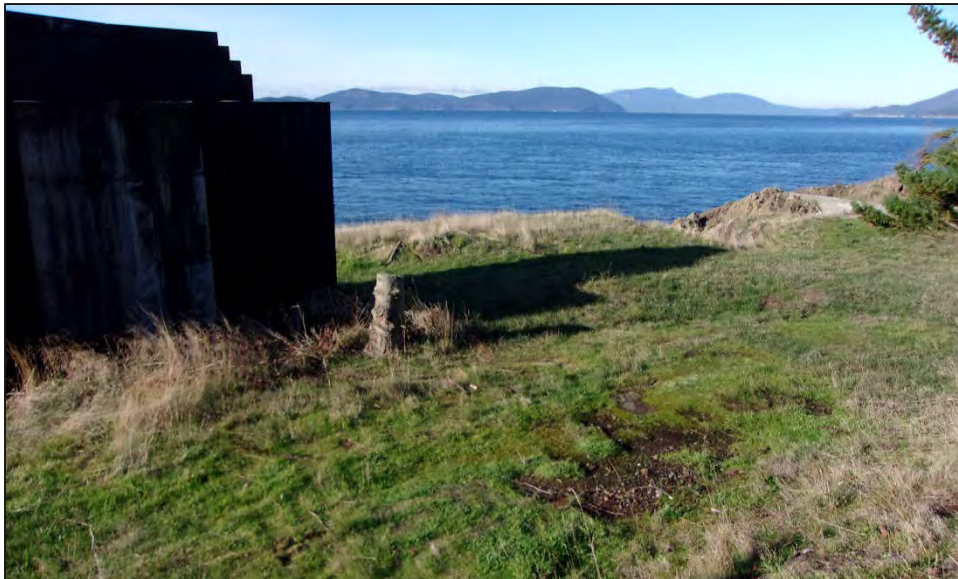
**Photo: 28**

**Description:**  
Concrete foundation from  
Former Oil & Paint Storage  
Building west of helicopter  
pad

**Location:**  
Former Oil & Paint Storage  
Building (102)

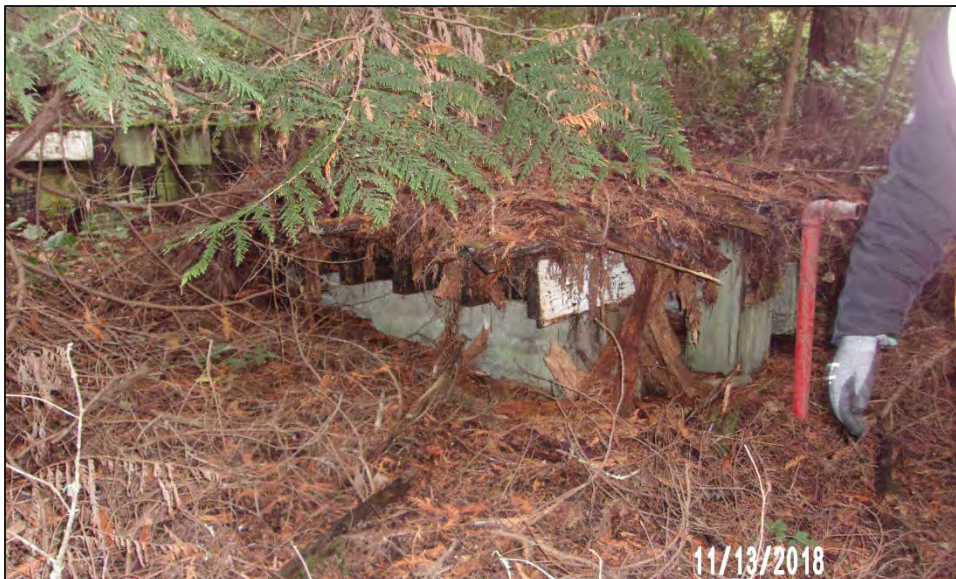
**Photo: 36**

**Description:**  
Salt water pumphouse on  
concrete foundation

**Location:**  
Salt Water Flushing  
Pumphouse (108)

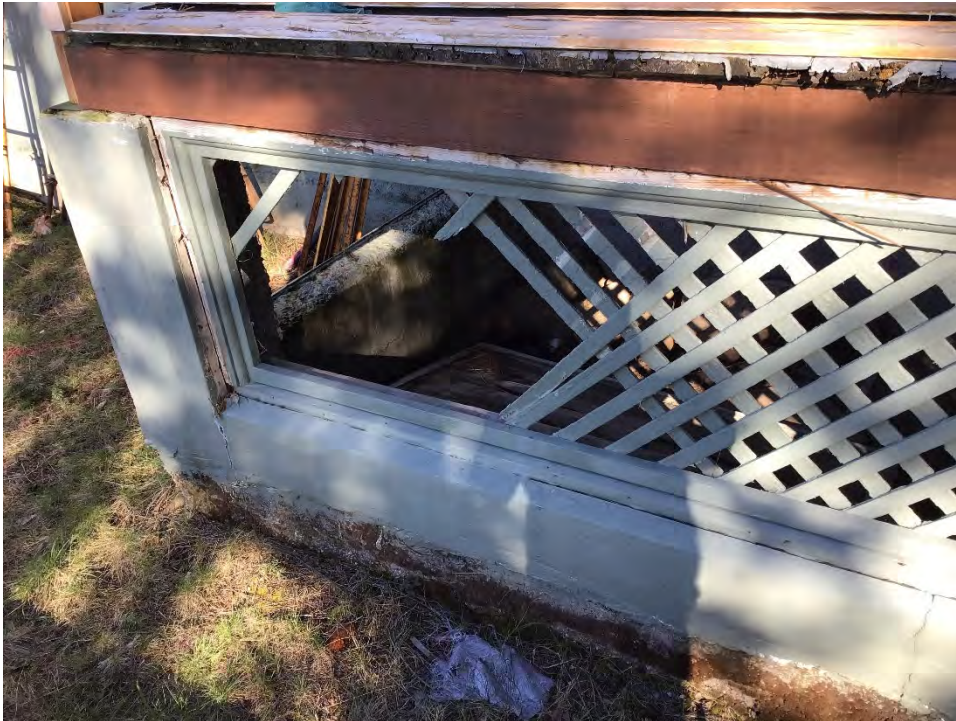
**Photograph: 1**

**Description:**  
Damaged lattice on  
porch – W side of  
Duplex
