Underground Storage Tank Closure Report

USACE Wildlife Mitigation
Operations/Maintenance Facility
Chief Joseph Dam
Bridgeport, Washington
Facility Site ID: 22348824
UST Site No.: 6690

Prepared for:
United States Corps of Engineers
Seattle District

November 6, 2014

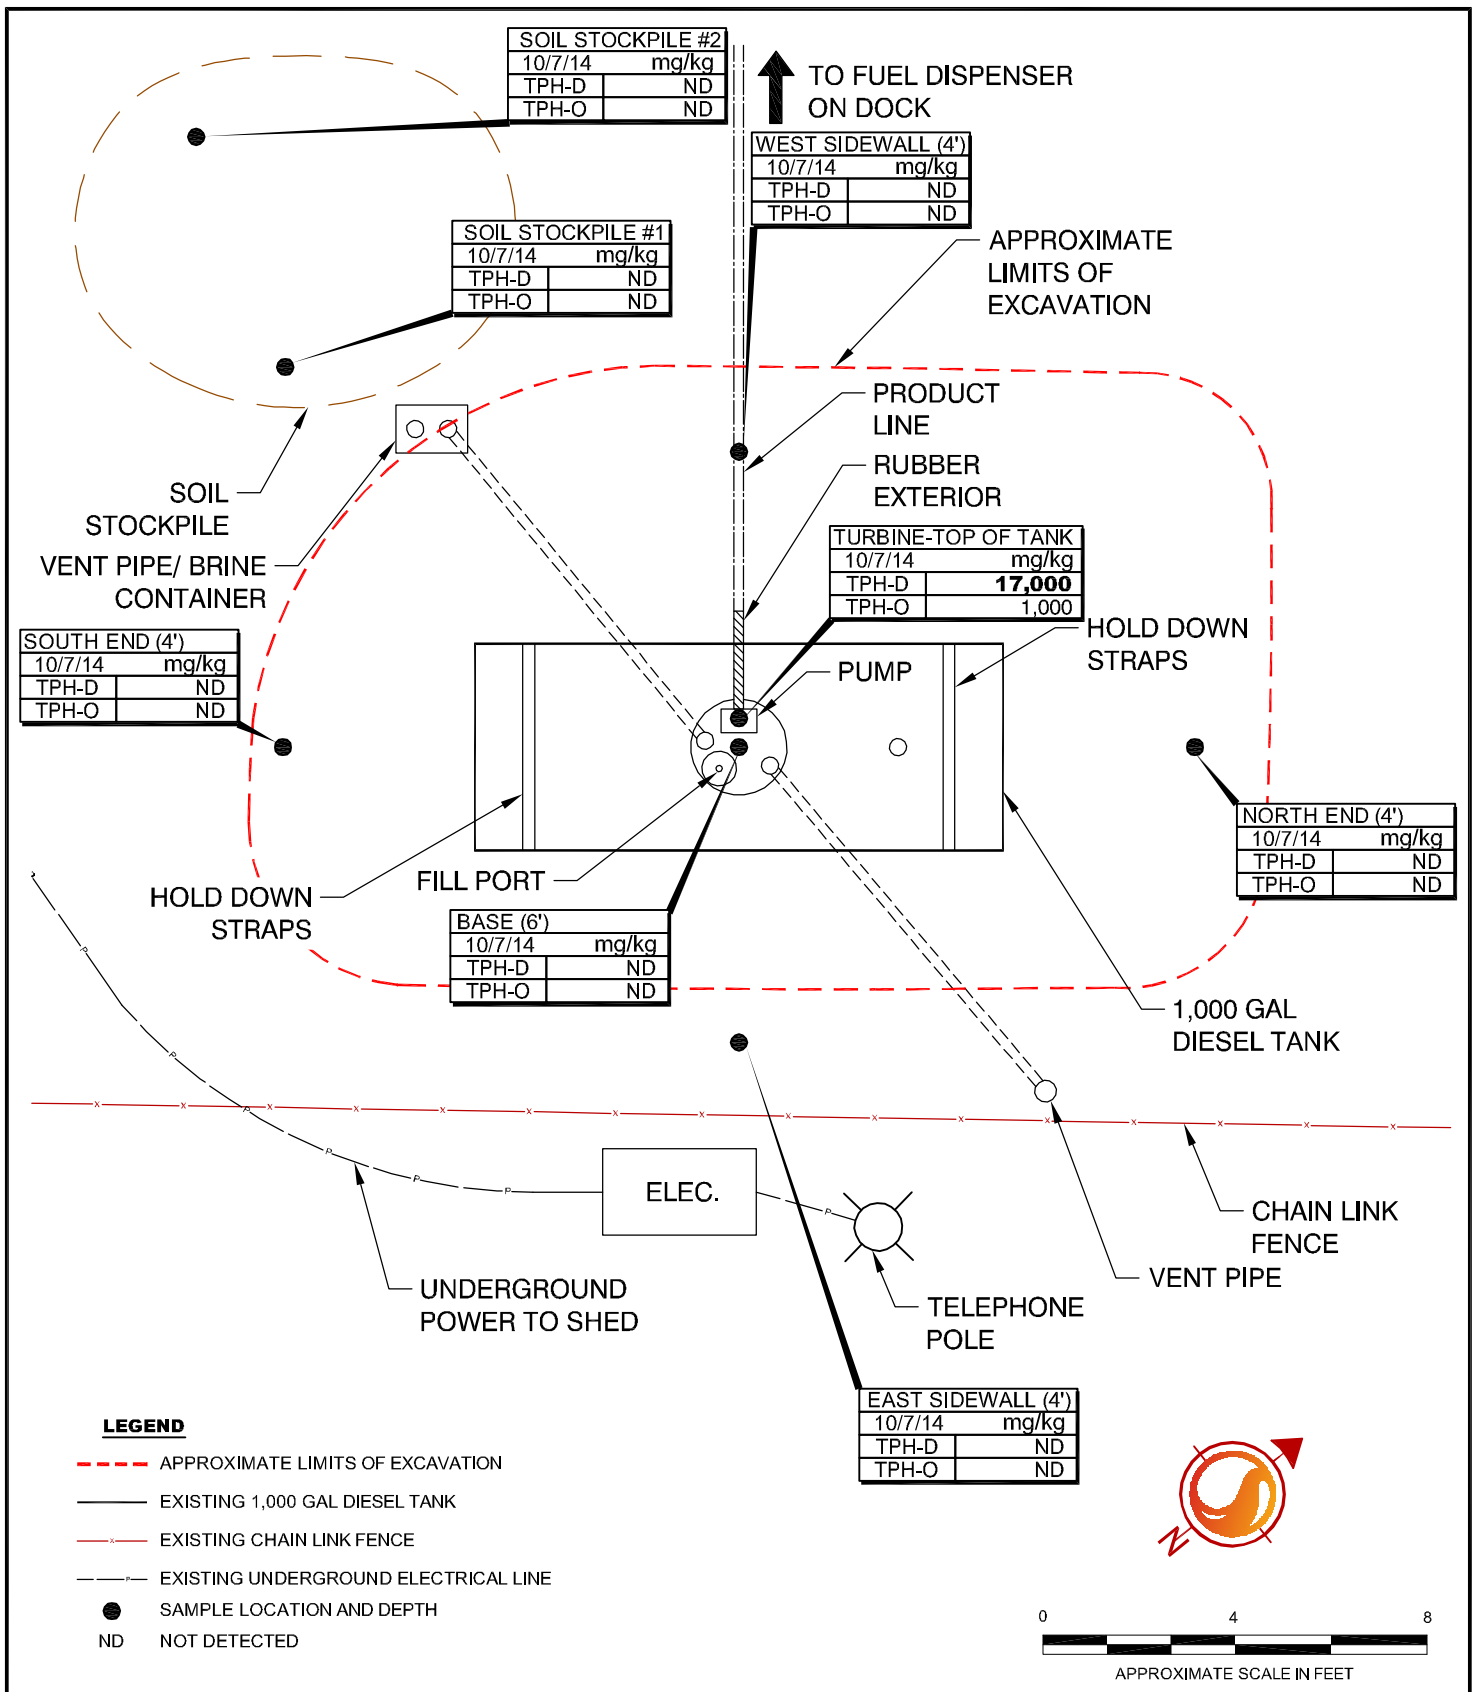
The UST was staged on plastic sheeting beside the excavation for inspection. The fiberglass UST measured 11 feet long by 4.5 inches in diameter. The UST appeared to be in good condition with the exception of a small puncture at the north end of the UST caused by Sabyr's backhoe bucket during removal activities. Approximately 1-2 gallons of blue/green brine solution was released from the puncture before it could be plugged with an absorbent pad. The brine solution filled the interstitial space and was used in the tank monitoring system. There was a concrete hold down pad with tank straps at a depth of approximately 7-feet bgs. The vent line extended to the vent pipe located approximately 7 feet east of the UST. Another pipe extended to the west to the tank monitoring system and brine reservoir. No groundwater was encountered in the UST excavation (**Figure 3**).

None of the soil samples collected from the sidewalls or ends of the UST had detectable concentrations of diesel or oil-range TPH. The Base (6') sample had a diesel-range concentration of 1,500 milligrams per kilogram (mg/Kg) and an oil-range concentration of 99 mg/Kg. Both concentrations are below the Model Toxics Control Act (MTCA) Method A Cleanup Level (CUL) of 2,000 mg/Kg.

There were no detectable concentrations of BTEX compounds in the Base (6') sample. Naphthalene was detected at a concentration of 19 µg/Kg, benzo[a]anthracene was detected at a concentration of 17 µg/Kg, 1-Methylnaphthalene was detected at a concentration of 42 µg/Kg and 2-Methylnaphthalene was detected at a concentration of 56 µg/Kg. All concentrations were below the Method A Cleanup Level for Naphthalene in soil of 5 mg/kg. Analytical results from the UST closure activities are summarized in **Table 1A and 1B**. TPH-Dx results are presented on **Figure 3**.
