First Periodic Review Holly Street Landfill

600 W Holly St, Bellingham, Whatcom County, WA
Facility Site ID: 2925, Cleanup Site ID: 253

Washington State Department of Ecology
Shoreline, Washington

May 2024

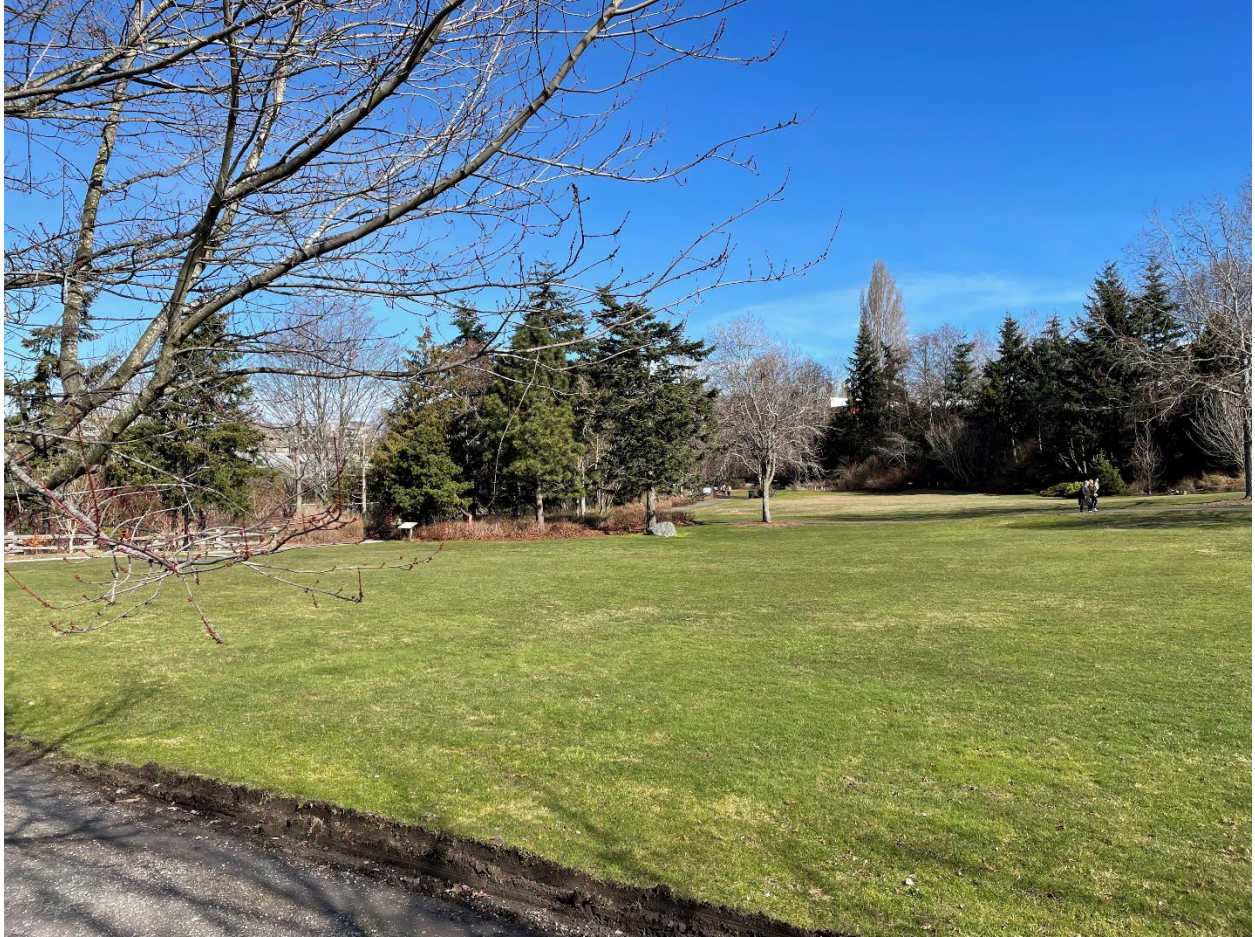
Photo 1: Looking north at Maritime Heritage Park open space with trails (former Holly Street Landfill southern lobe).

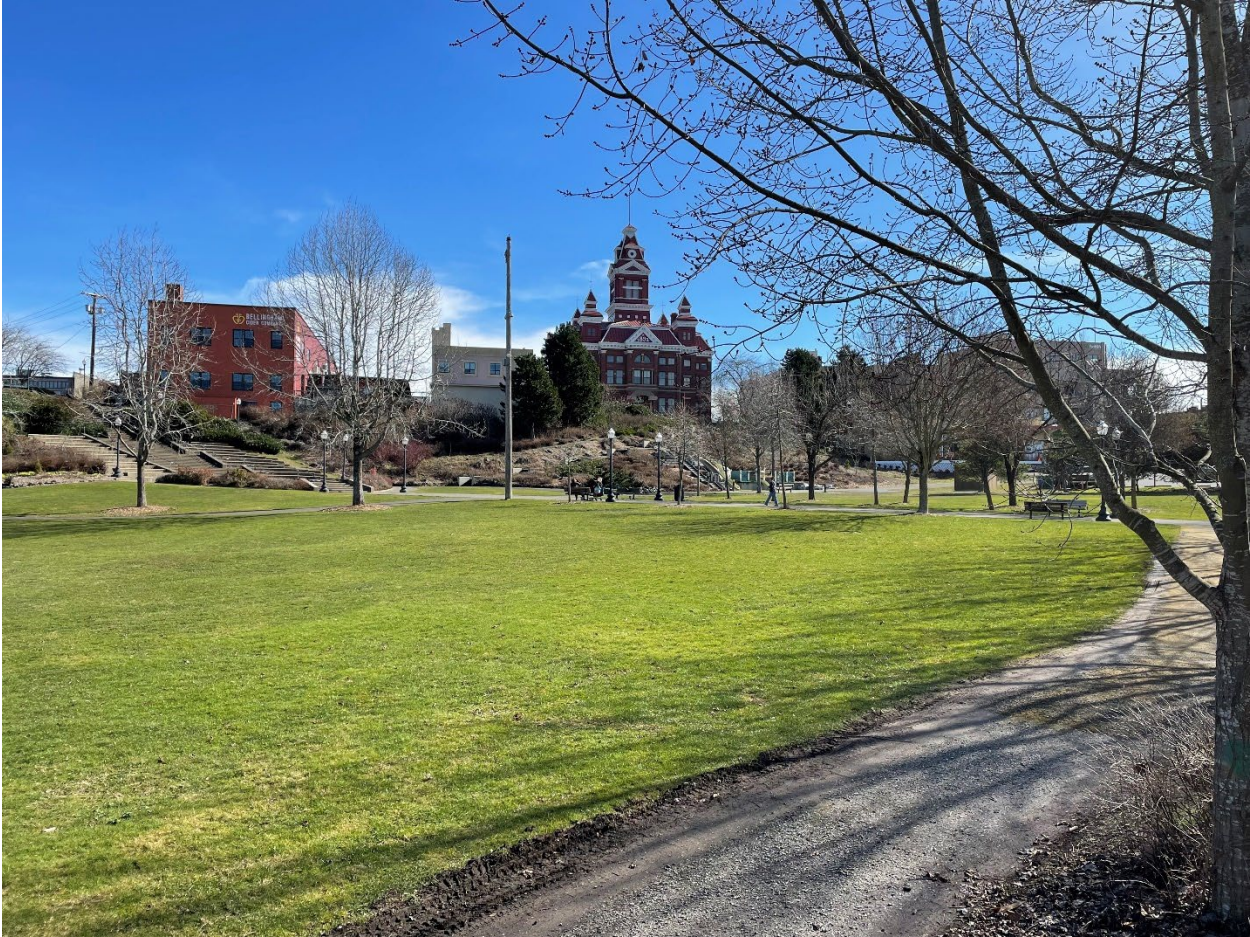
Photo 3: Looking northeast along the nature trail and habitat restoration along the southeast bank of Whatcom Creek.

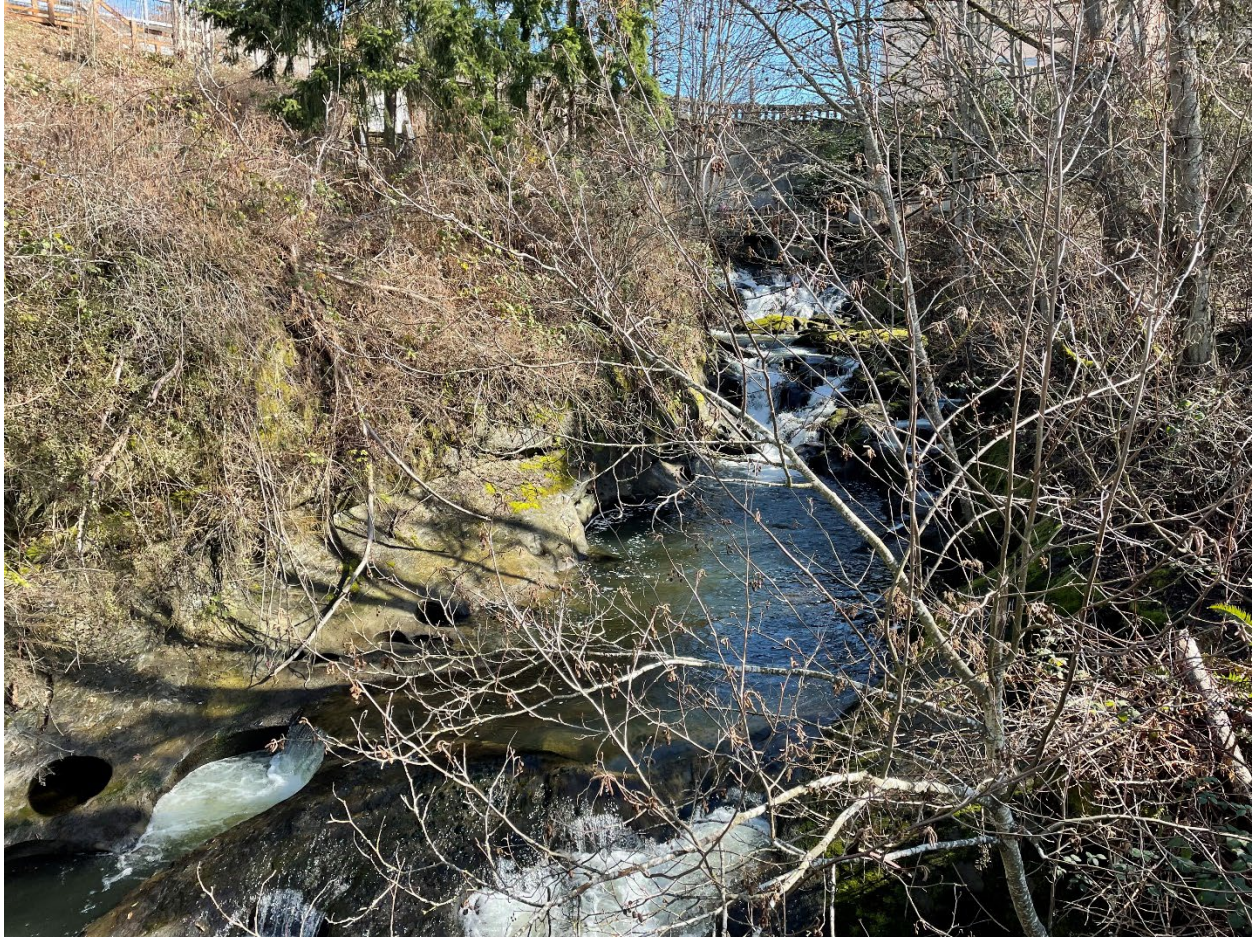
Photo 5: Looking southwest at upper Maritime Heritage Park and Whatcom Creek channel northeast bank and former Holly Street Landfill northern lobe.

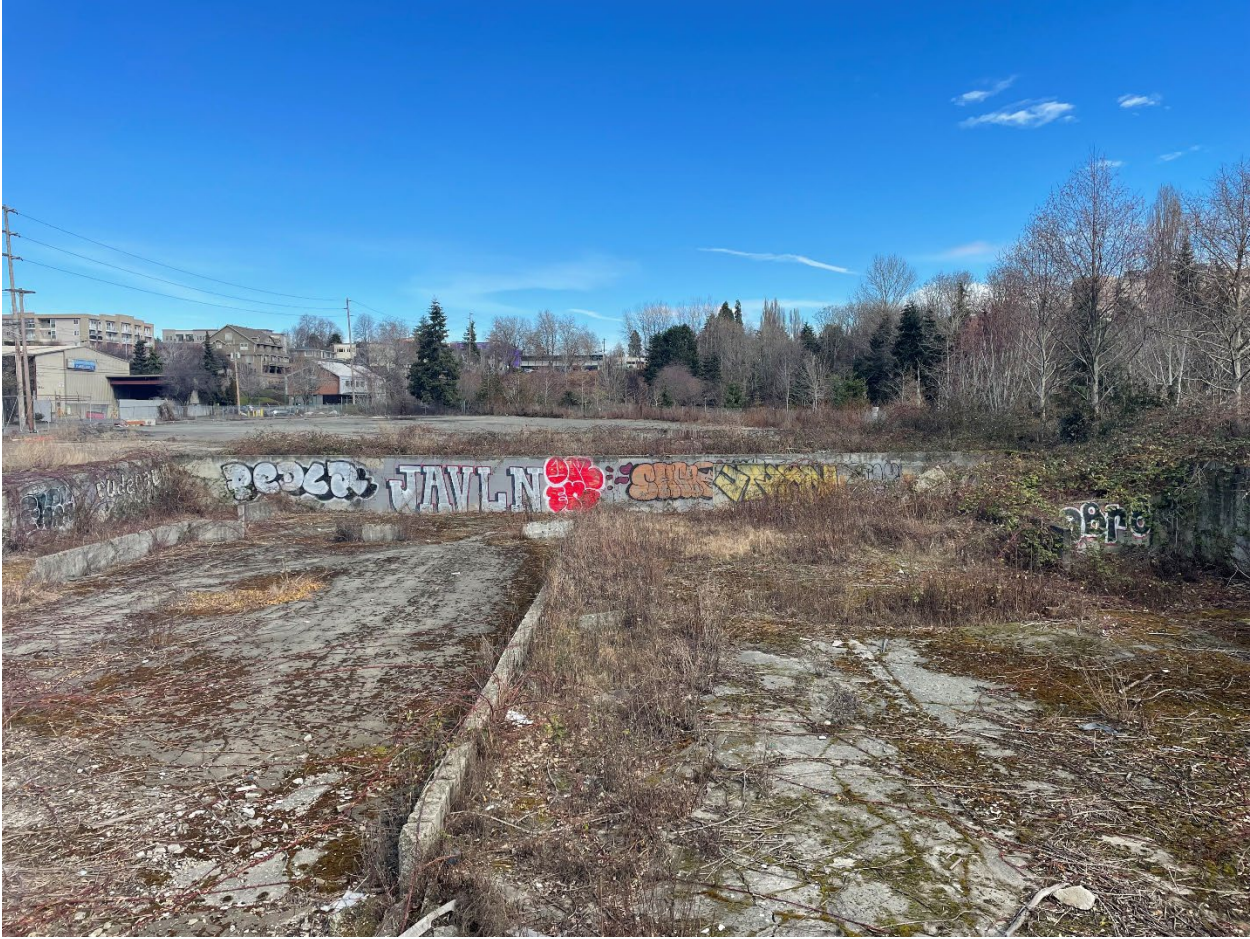
Photo 9: Looking northeast at urban development along C Street in the north lobe of the Holly Street Landfill in the Brownfield Project area.

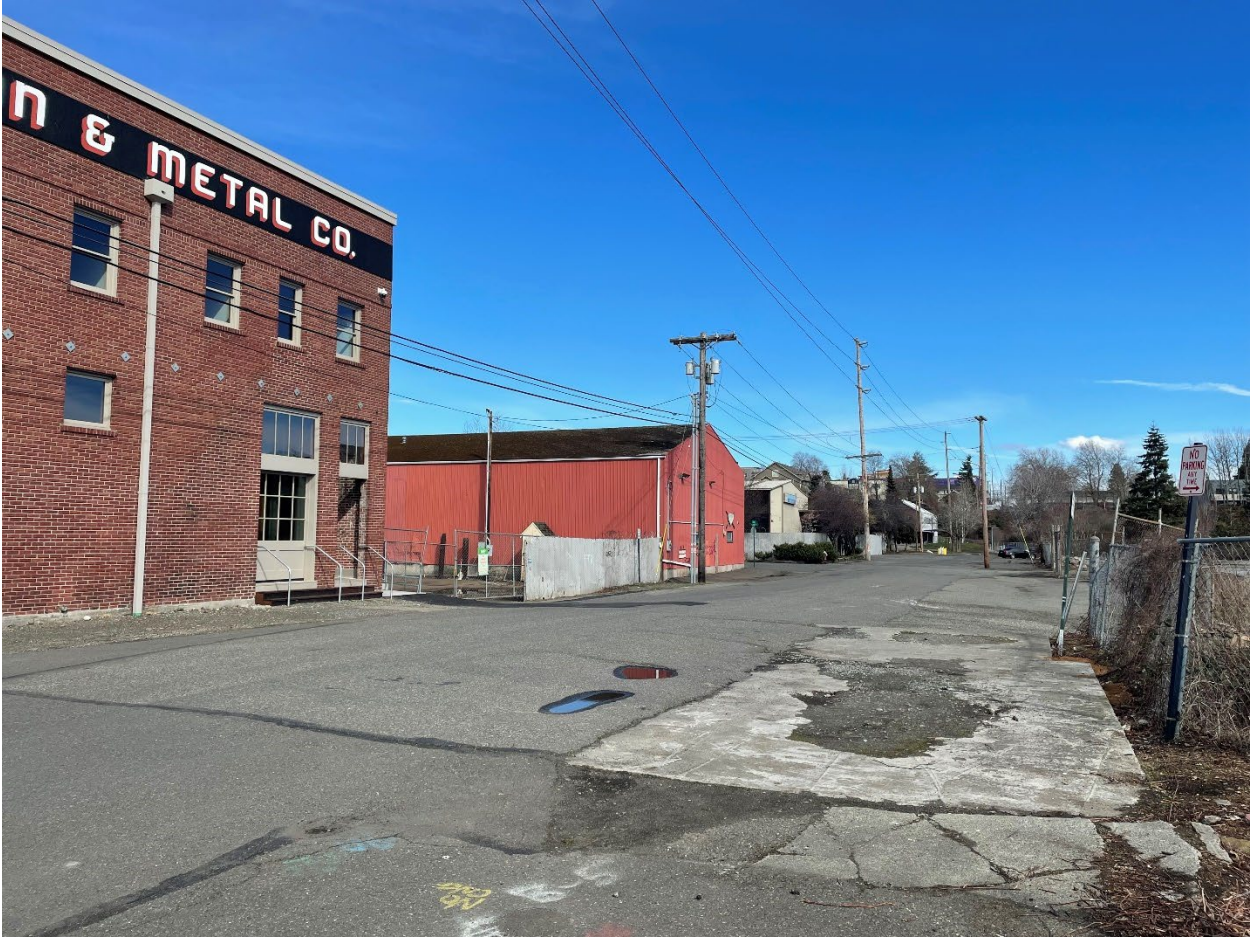
Photo 10: Looking north at the approximate intersection of Holly Street and E Street where the former Holly Street Landfill northern lobe boundary terminates.
