HETI Project No. 200-150

Subject: February 2024 Quarterly Groundwater Monitoring Report, RH Smith Distributing Co. Inc., I-90,  
Exit 136, M.P. 137.5, Vantage, Washington  
Cleanup Site Identification #15108

Quarterly Groundwater Sampling Report  
RH Smith, I-90 Exit 136, M.P. 137.5, Vantage, Washington

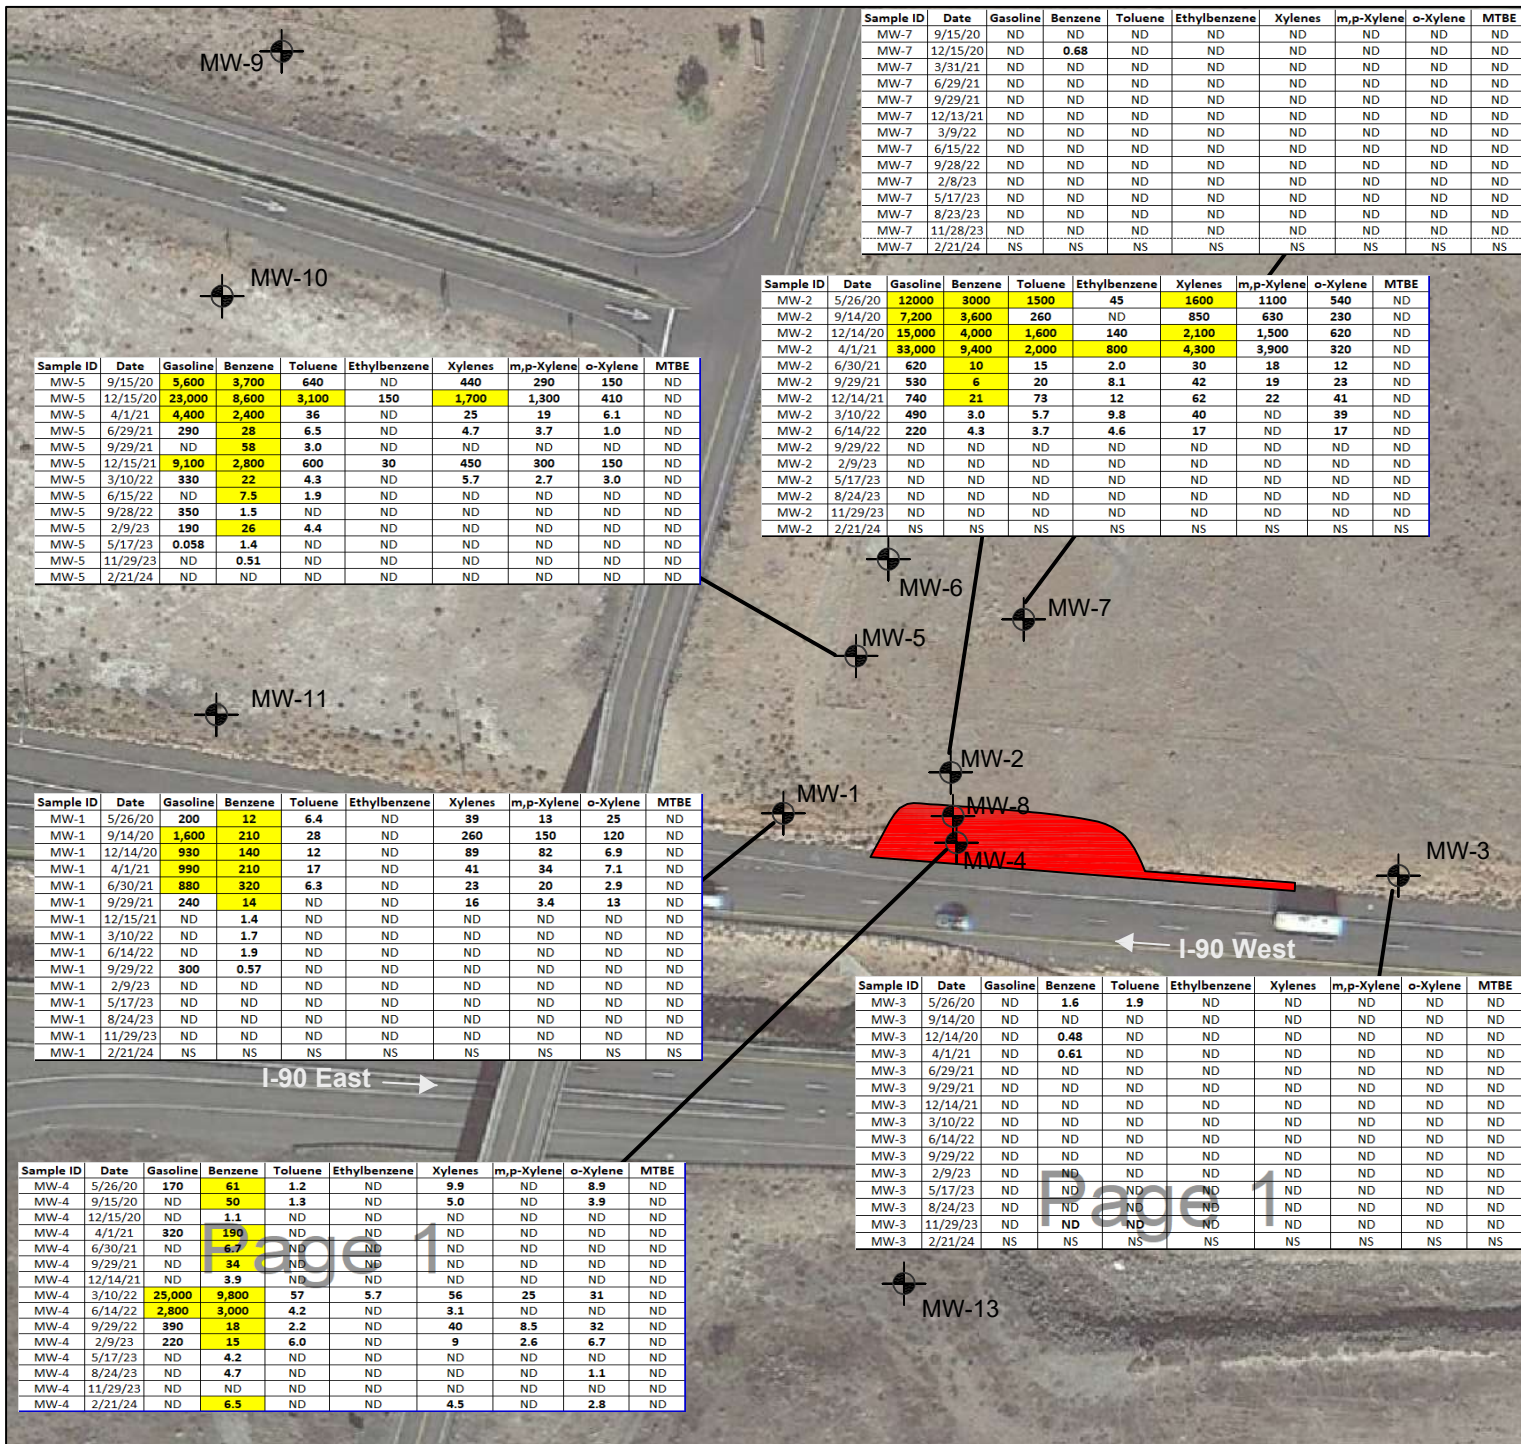
## Figure 4A Groundwater Analytical Results

Analytical results were compared to the State of Washington DOE Model Toxics Cleanup Act (MTCA) Method A Cleanup Standards. Only groundwater sample MW-4 was found to contain an analyte above the MTCA Standard (benzene at 6.5 µg/L, slightly exceeding the standard of 5.0 µg/L). None of the other submitted groundwater samples were found to exceed the respective MTCA Standards for the chosen analytical suite.

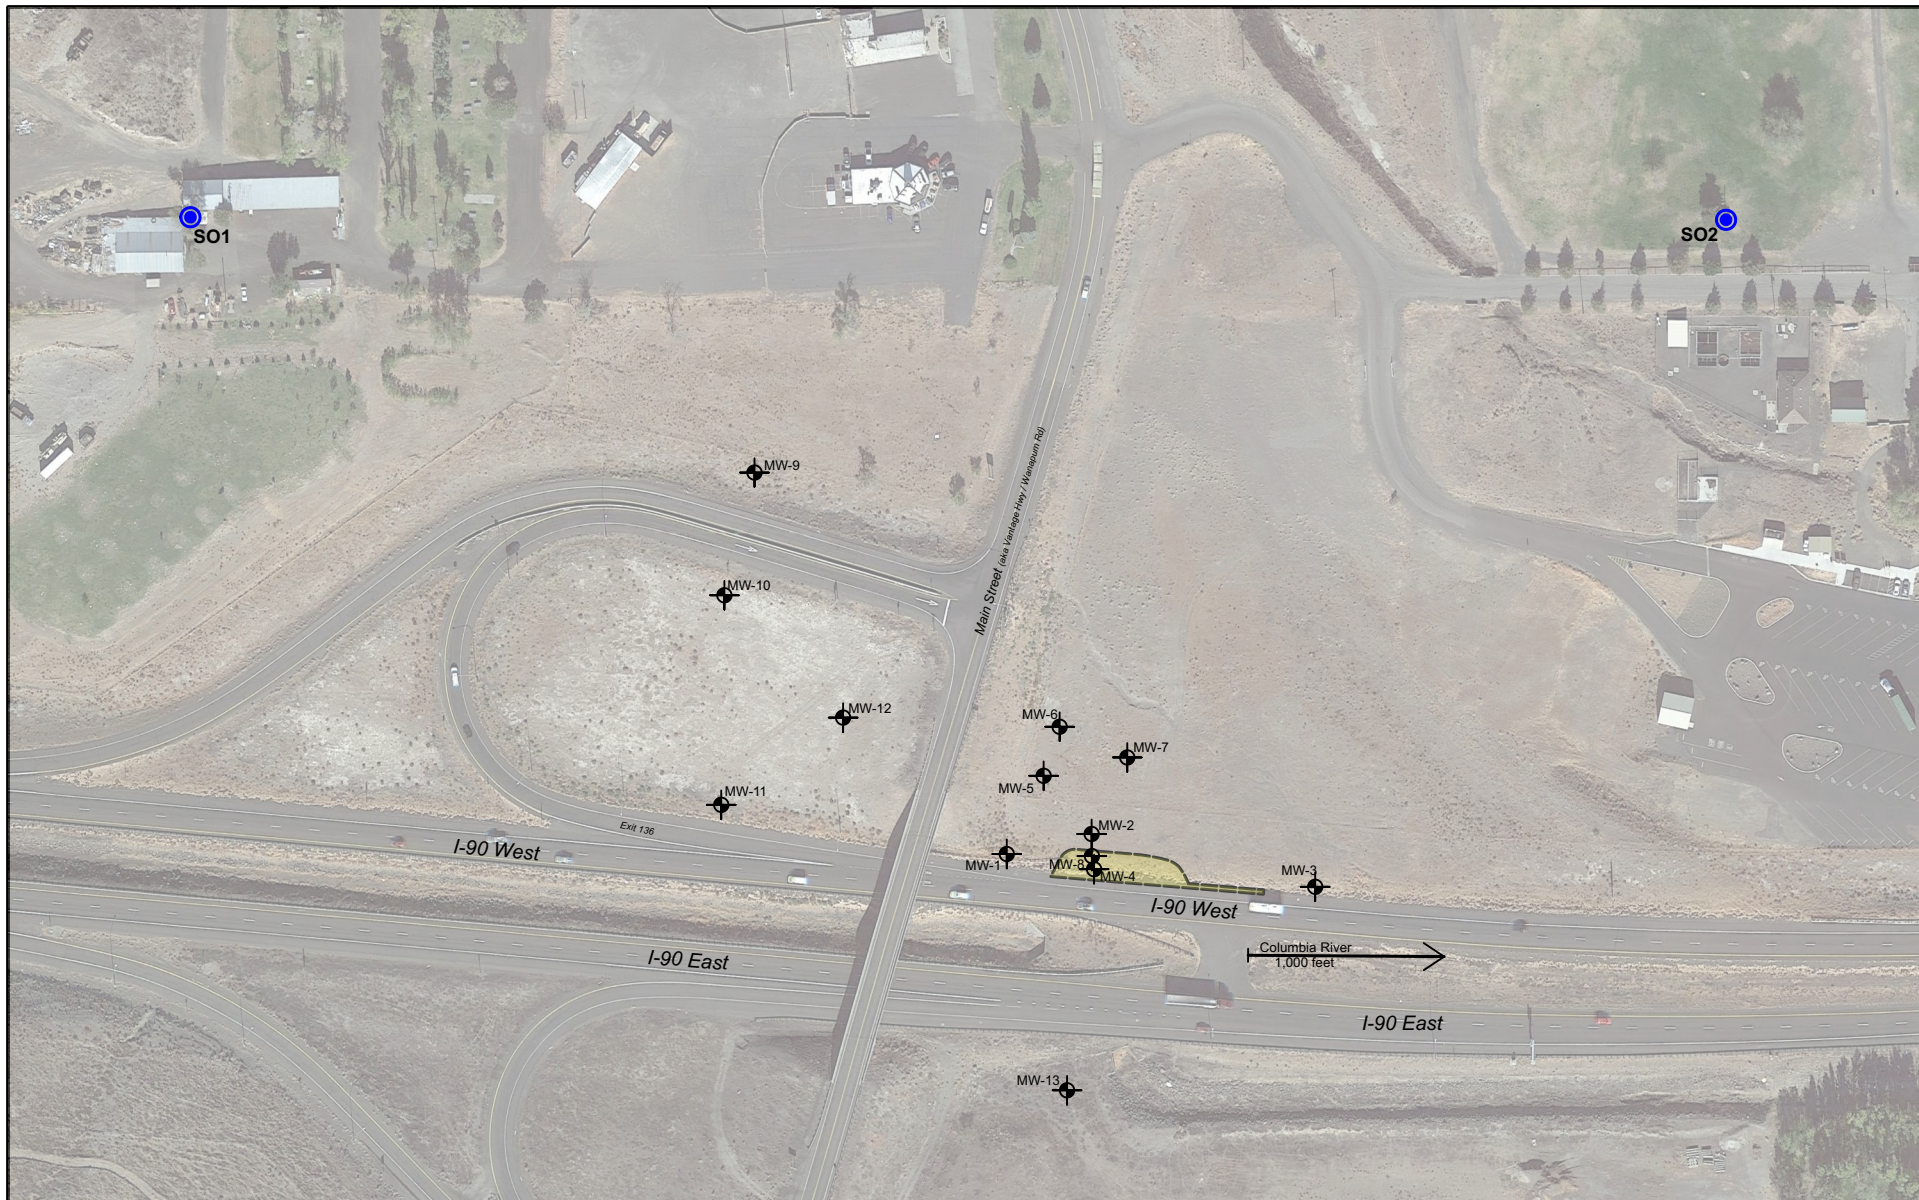
Figure 10  
Monitoring Well and  
Production Well Locations

HETI has identified two deep, bedrock water supply wells, designated SO1 and SO2, which supply certain end-users in Vantage, a census-designated place with a population of 74 as of the 2010 census. These wells are graphically depicted in relation to the spill location and groundwater monitoring wells MW-1 through MW-13 on [Figure 10](#).

Production Well SO1 is located approximately 1,040 feet northwest of the spill location. This well was installed in 1960 to a total depth of 275 feet bgs. The well log, as provided by the driller, describes an interflow zone from 230 feet to 270 feet bgs.

Production Well SO2 is located approximately 900 feet northeast of the spill location. This well was installed in 1968 to a total depth of 440 feet bgs. The well log, as produced by the driller, states that water was encountered at 200 feet bgs.
