GOLDER
MEMBER OF WSP

DAILY FIELD REPORT # 91

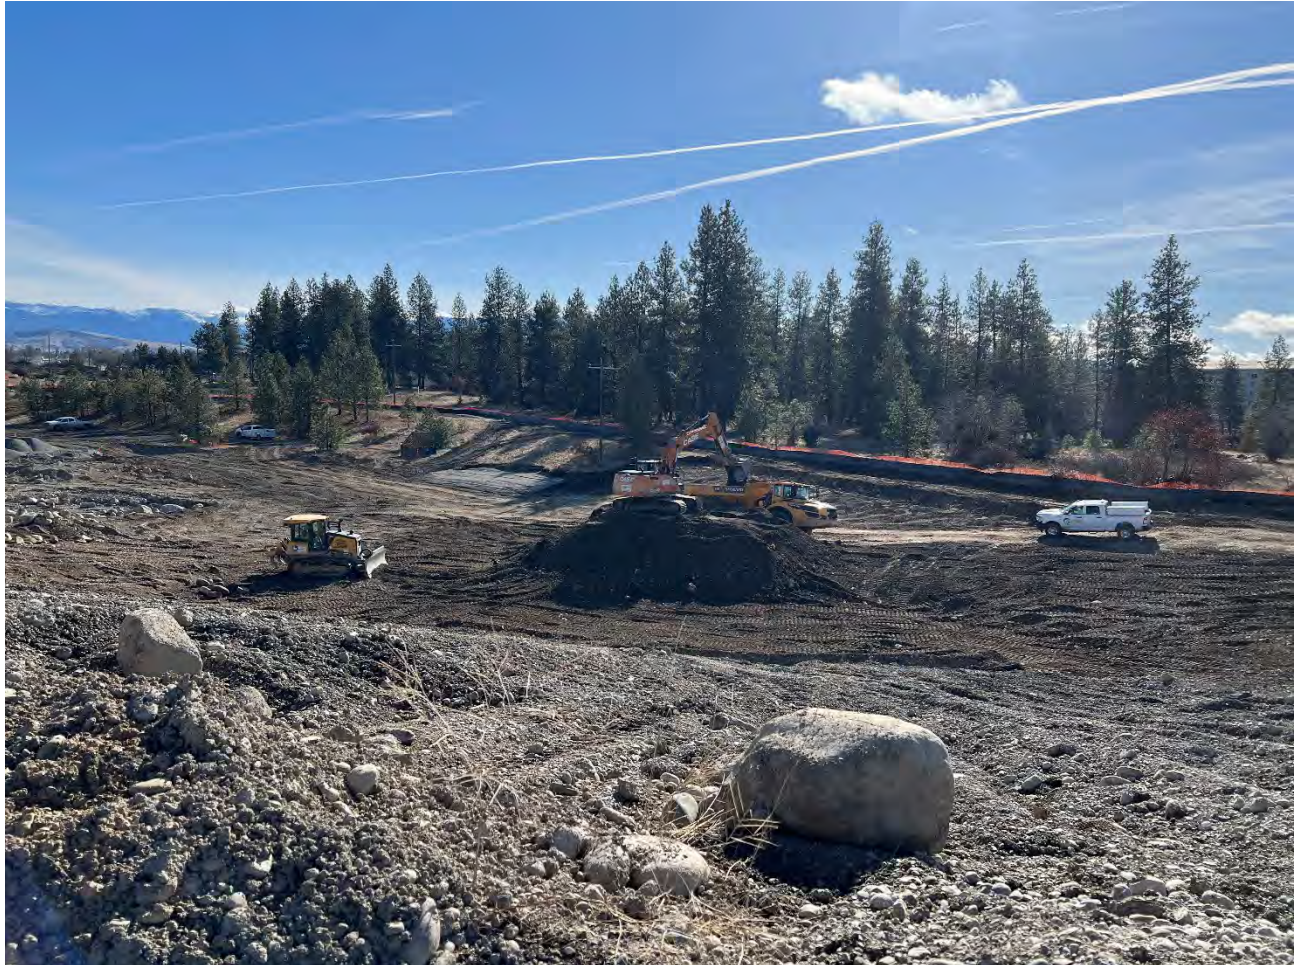
Photograph 1: Loading and transporting of excavated material from WSDOT to UPRR cap area.

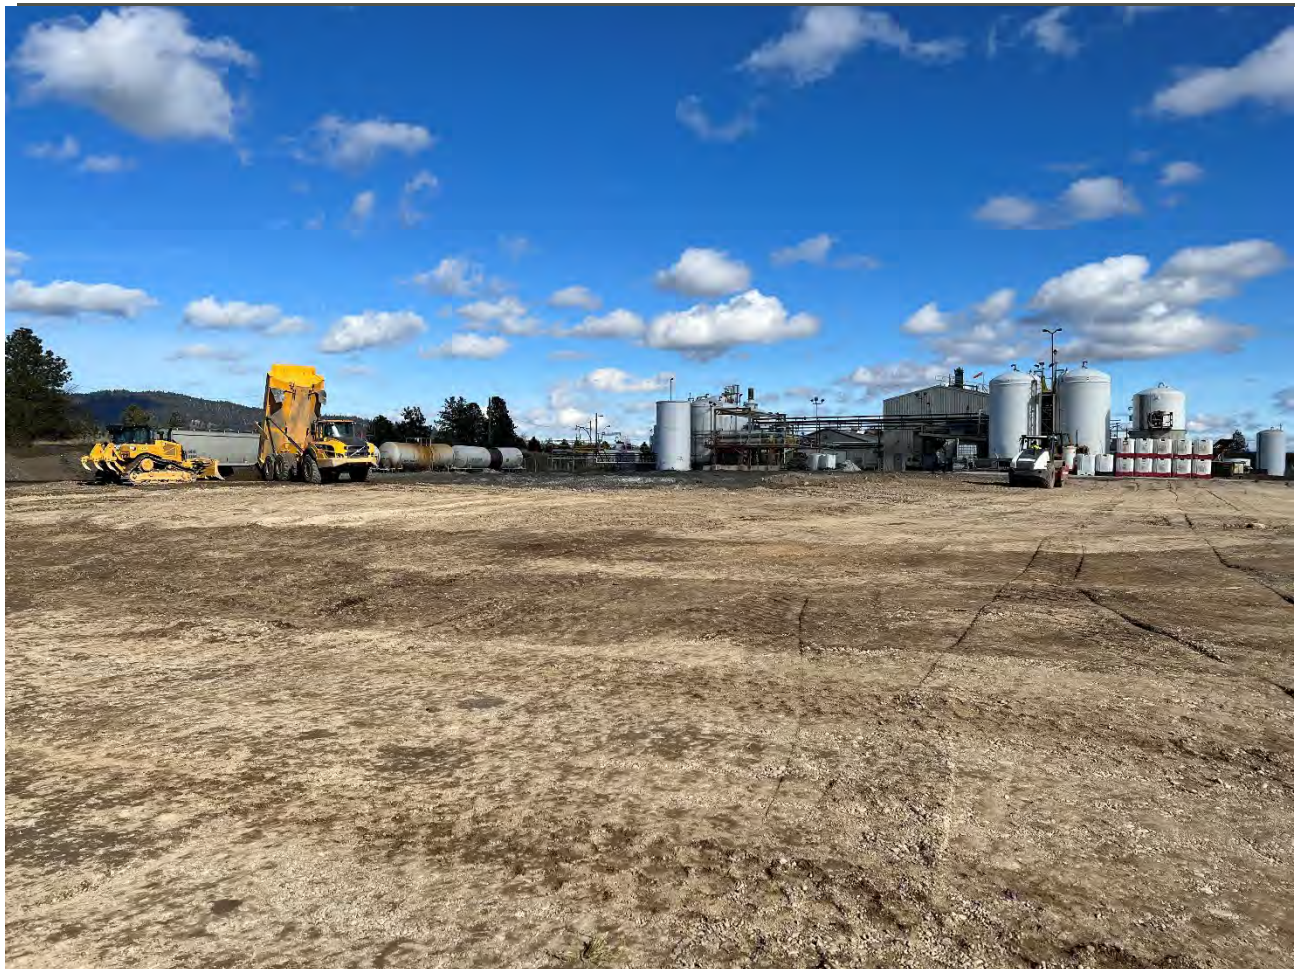
Photograph 2: Placing, spreading in 1-ft loose lifts, and compacting on the UPRR cap area.

- The CAT D6 bulldozer was used to spread excavated material from WSDOT and Pentzer into 1-ft loose lifts on UPRR cap area. The DYNAPAC CA2500D roller was used to compact 1-ft loose lifts into subgrade. See Photograph 2.

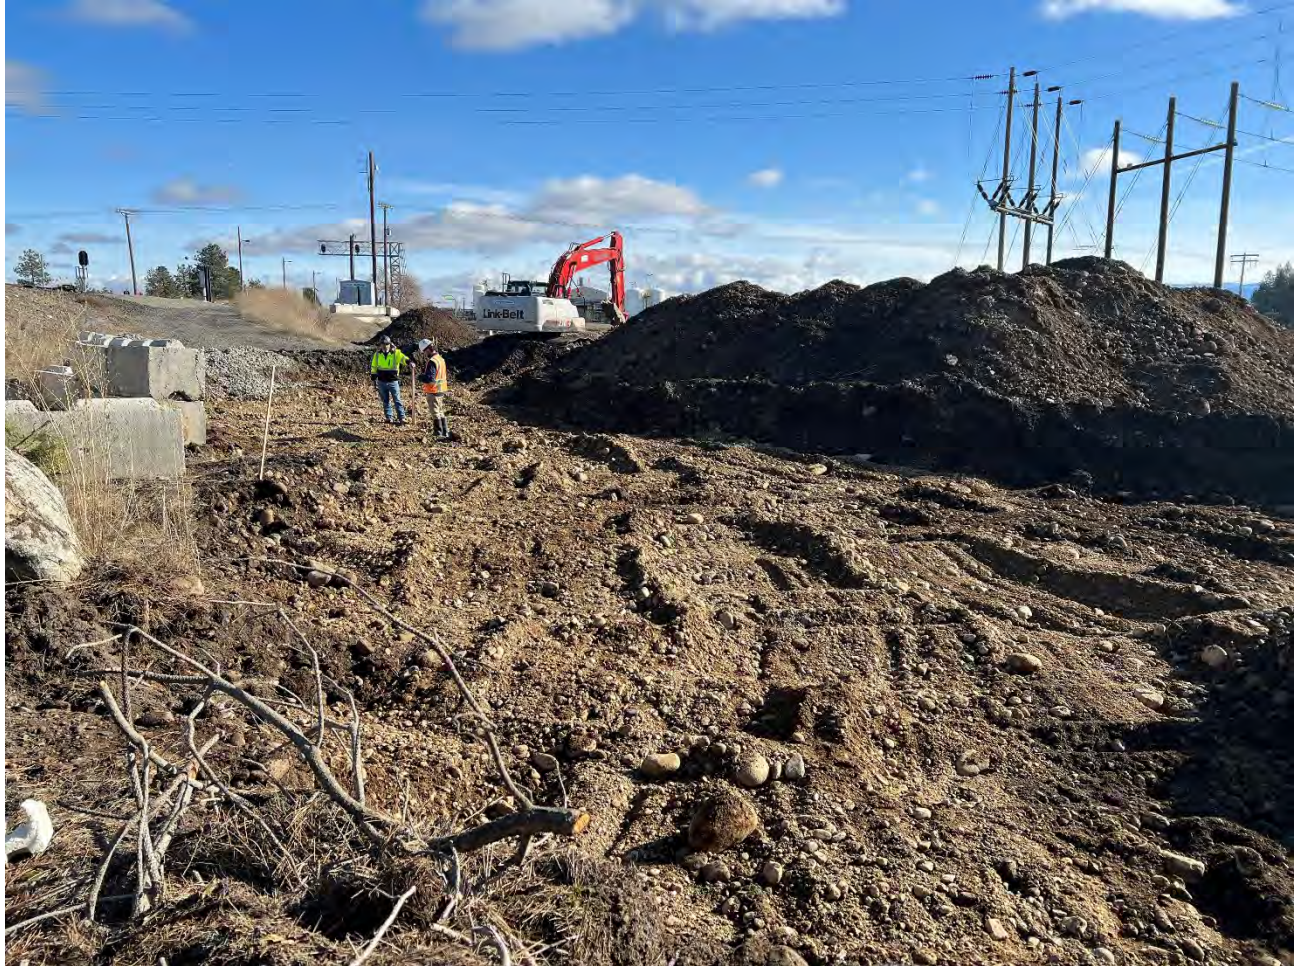
Photograph 3: Excavation to 2-ft bgs on the north edge of Pentzer property. View looking east.

- The LinkBelt 210x4 trackhoe continued to excavate a portion of the 2-ft area on the Pentzer property near Excavation One. The excavated materials were stockpiled near Excavation 1 to be hauled to the UPRR former dross stockpile area using the off-road haul truck. See Photograph 3.

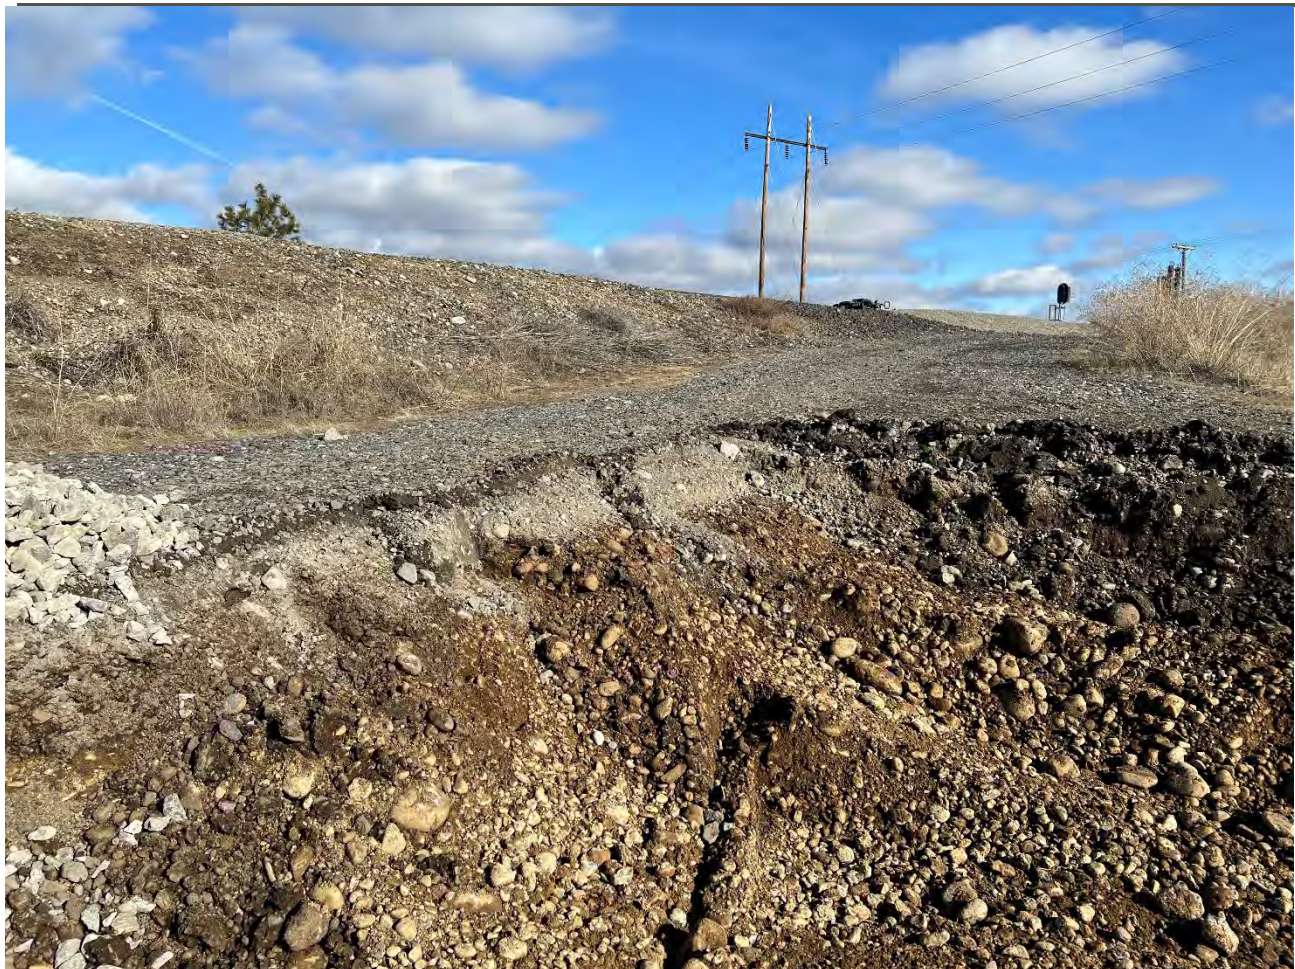
- Additional dross was encountered on the north edge of the Pentzer property outside of the estimated dross impacted area. Visual dross was removed up to 25-ft railroad buffer and/or to ecology blocks (to be moved to continue excavation to 25-ft railroad buffer). See Photograph 4.

Photograph 4: Additional dross observed outside of estimated dross impacted area on the north edge of the Pentzer property. View looking northeast.

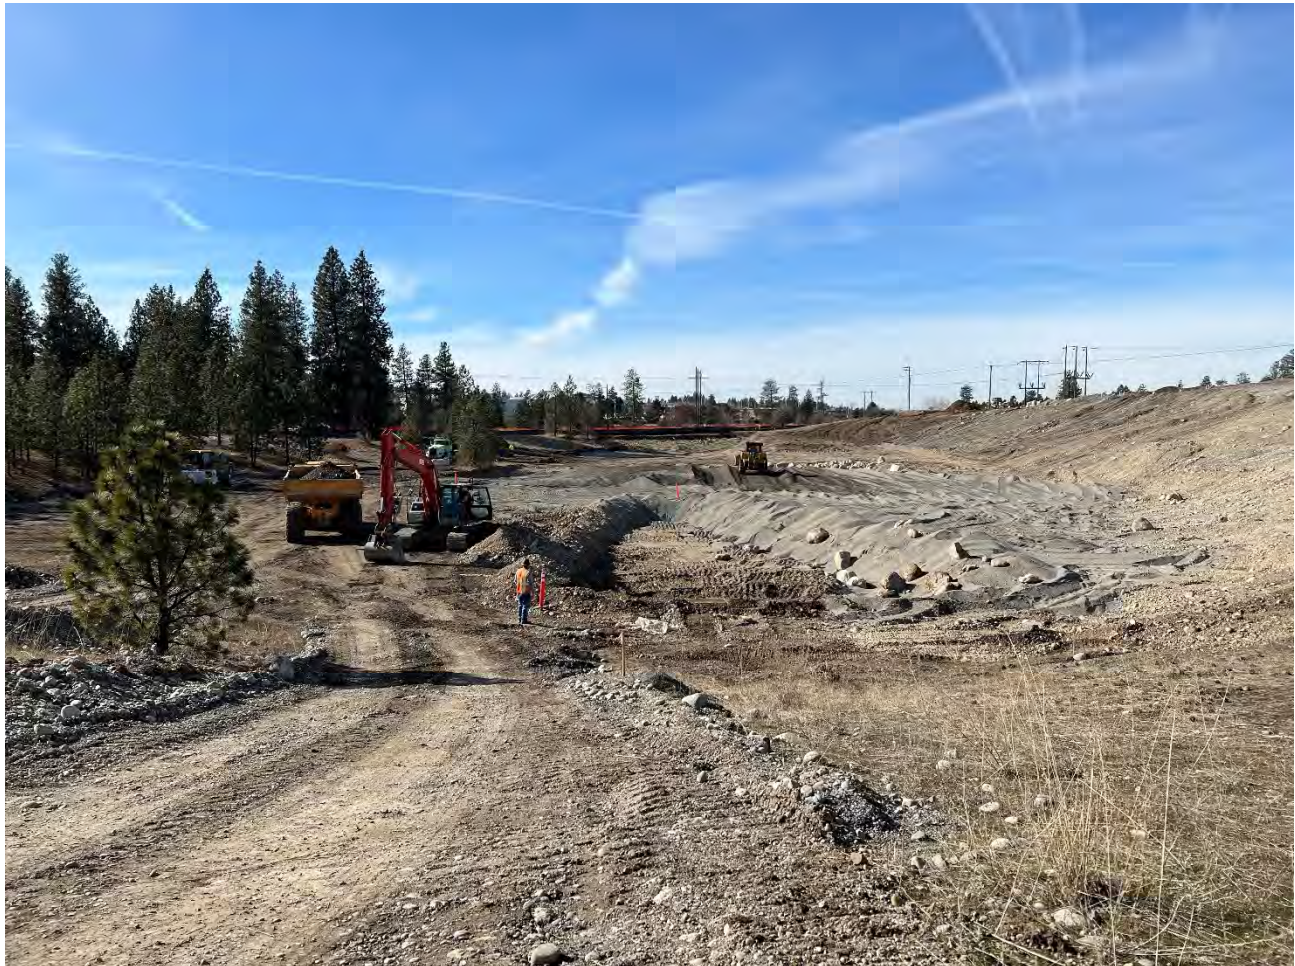
Photograph 1: Excavation of SE corner of the WSDOT property to depth of 2ft below ground surface. View looking west.

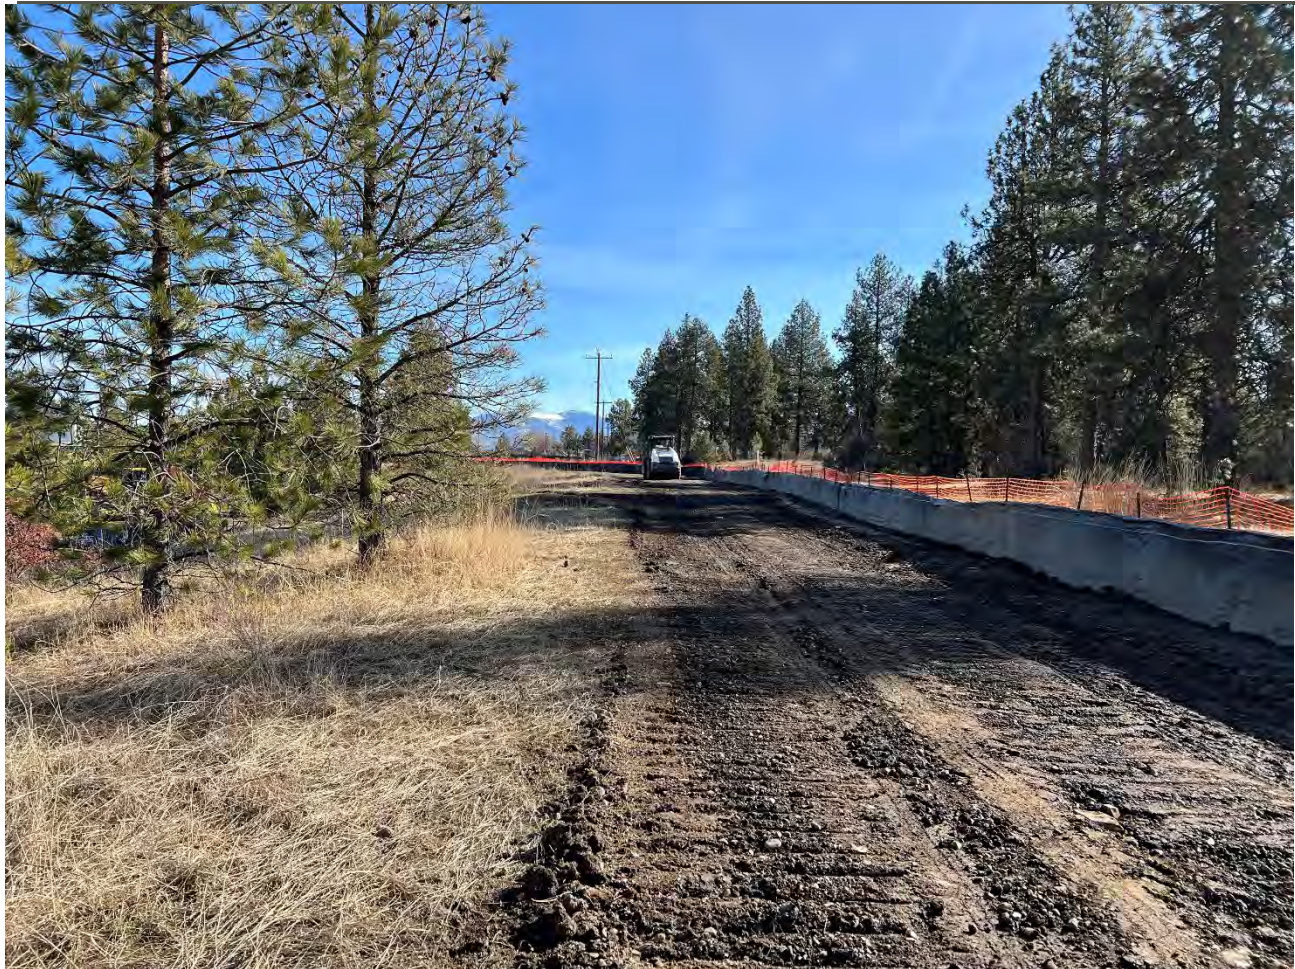
Photograph 2: Cleaning up, placing clean imported backfill, and rolling access road in SE corner of project area. View looking east.

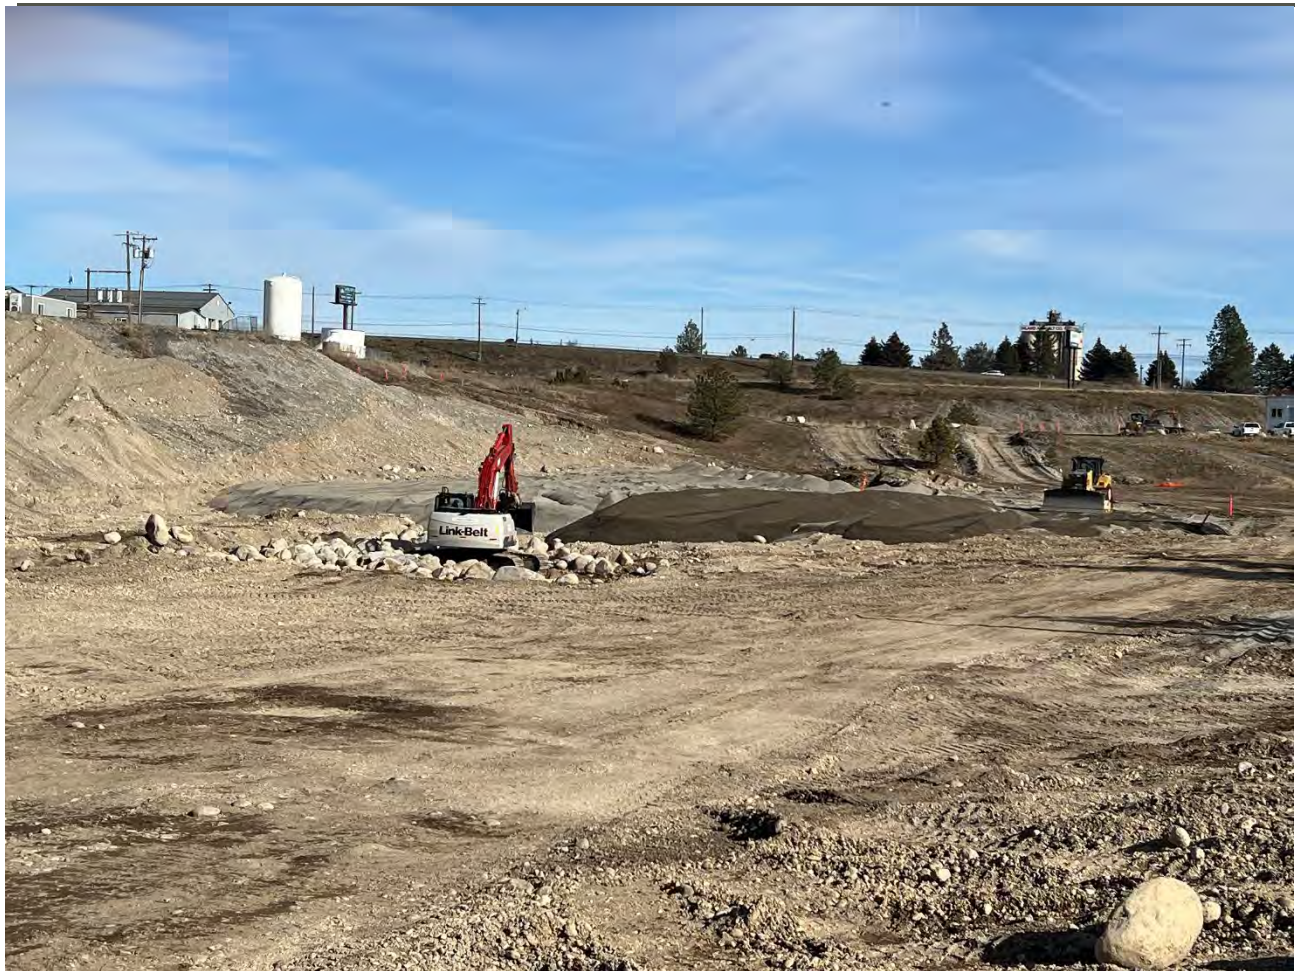
Photograph 3: Placing clean imported backfill in excavation 6. View looking east.

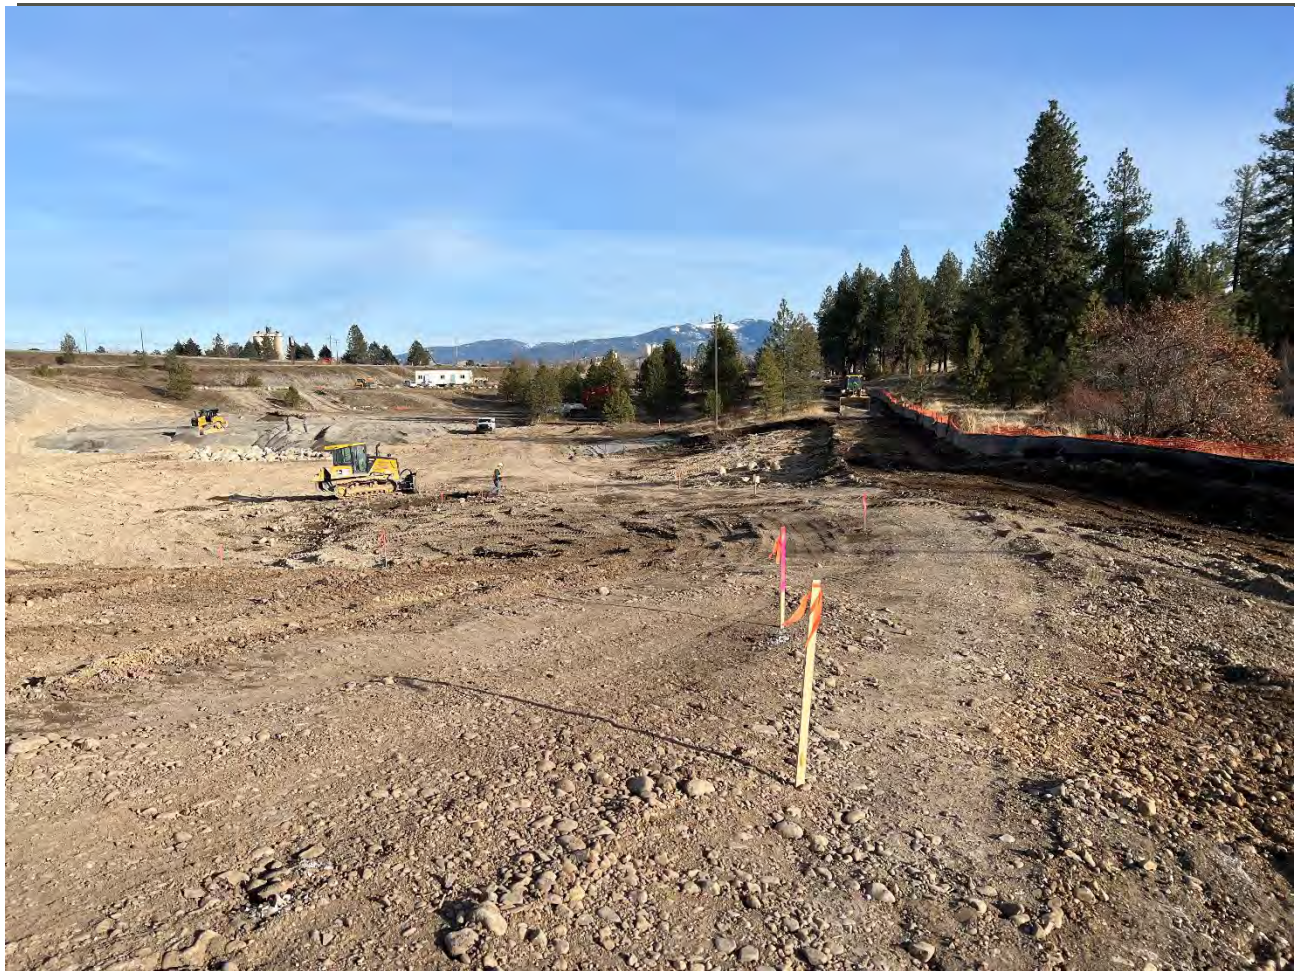
Photograph 4: Staking from surveyors for 4-ft and 6-ft depth excavation extents in excavation 3 and 4. View looking east.

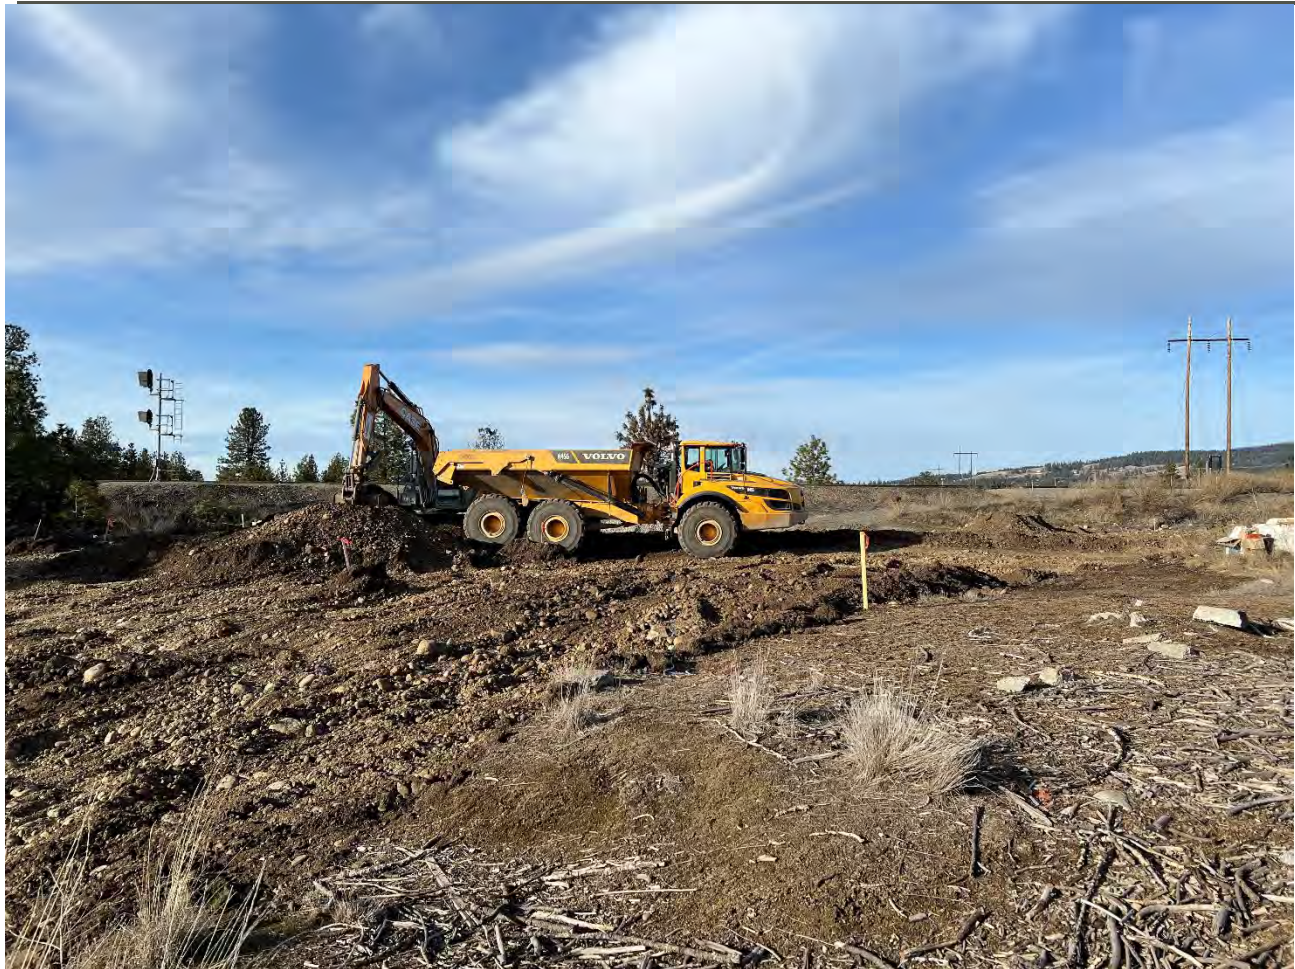
Photograph 5: Loading and transporting excavated material from Pentzer to the UPRR cap area for placement in ecological cap subgrade. View looking north.

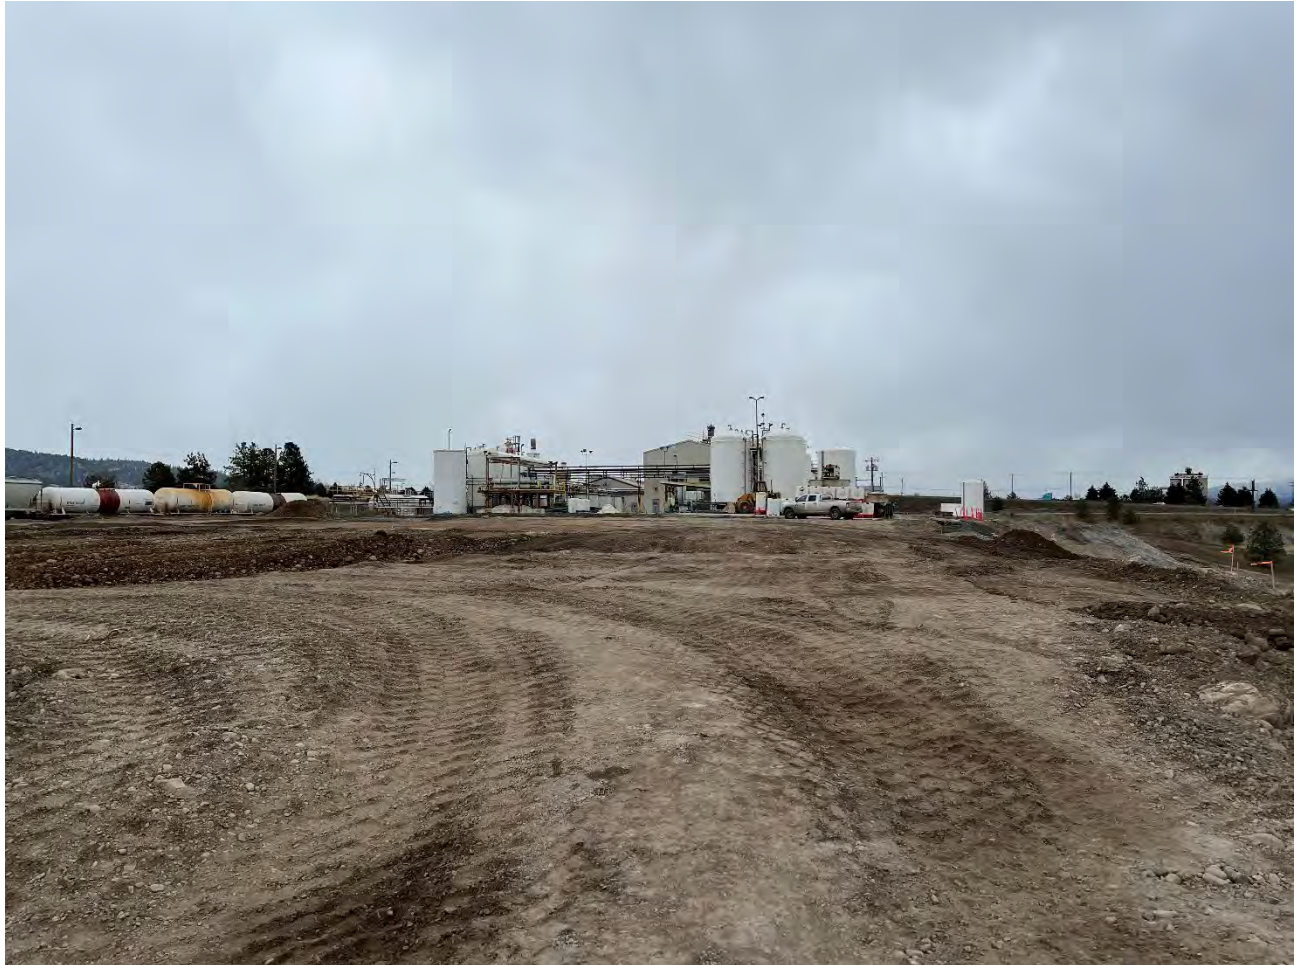
Photograph 1: UPRR property with excavated material from WSDOT and Pentzer properties placed into 1-ft loose lifts and compacted with roller. SW corner of cap area; view looking east.

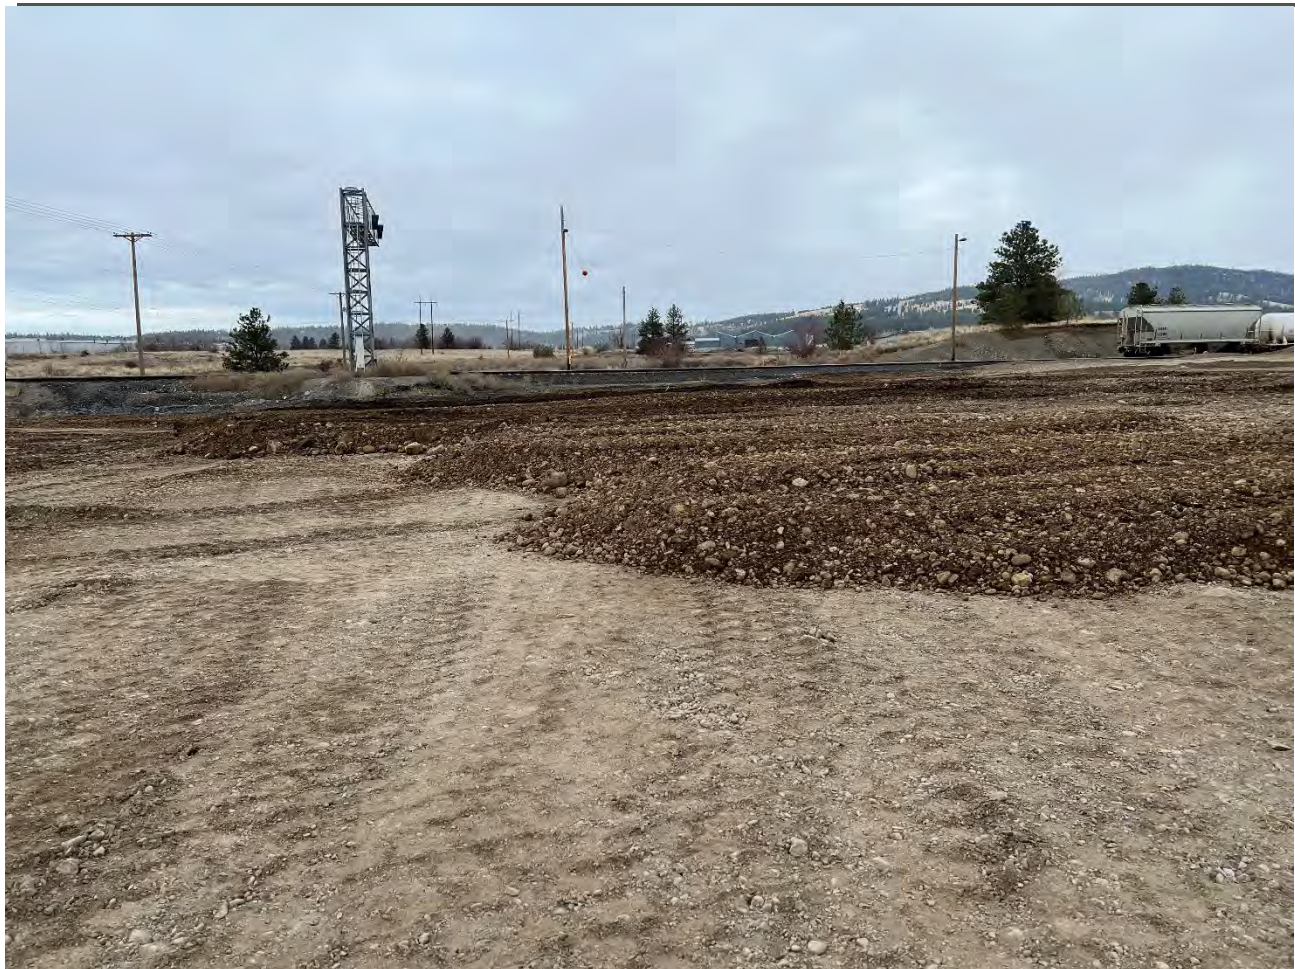
Photograph 2: UPRR property with excavated material from WSDOT and Pentzer properties placed into 1-ft loose lifts (before compacted with roller).

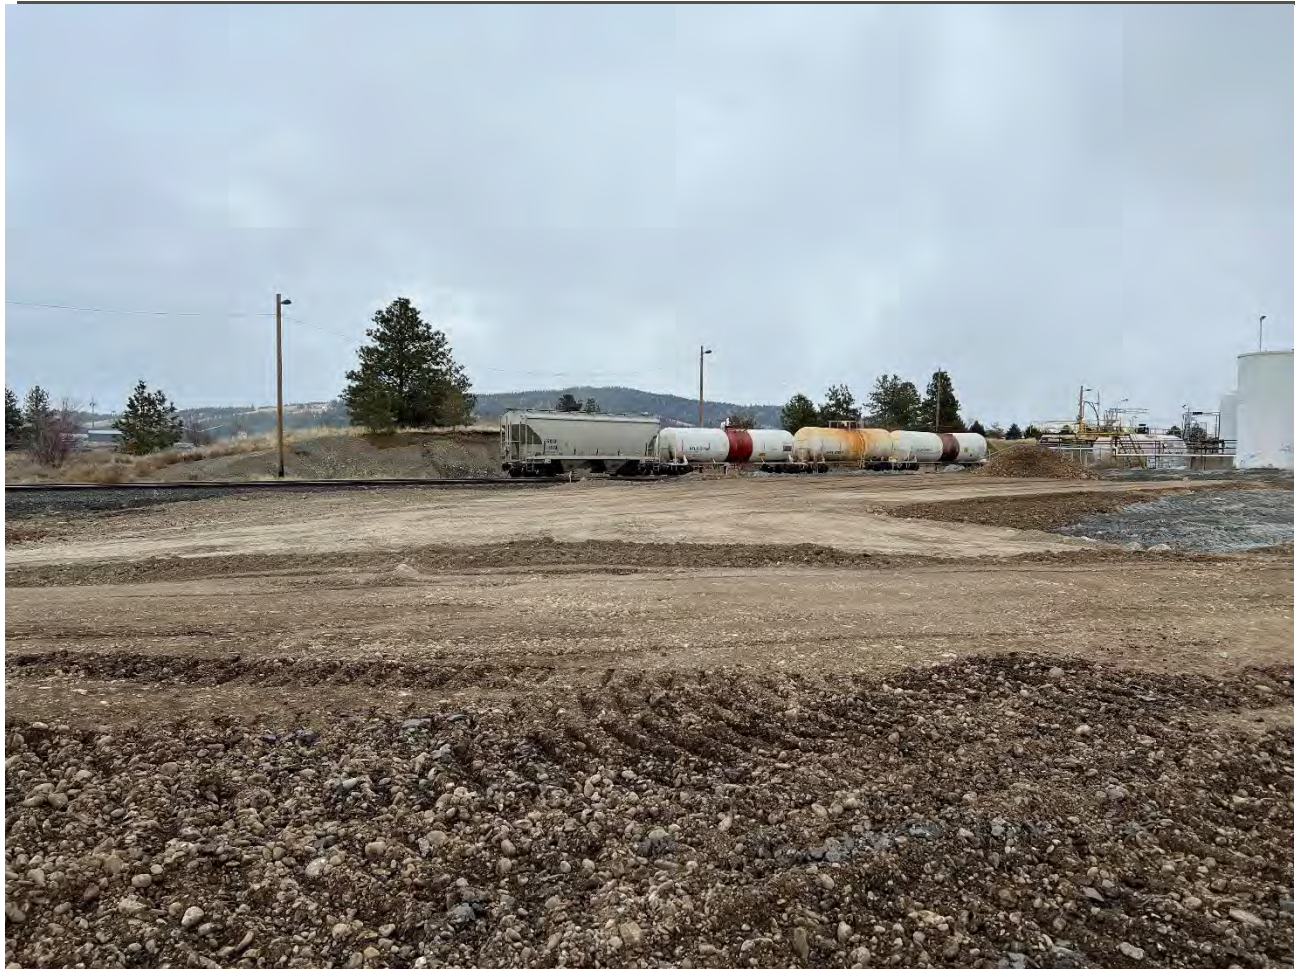
Photograph 3: UPRR property with excavated material from WSDOT and Pentzer properties placed into 1-ft loose lifts and compacted with roller. NE corner of cap area; view looking north.

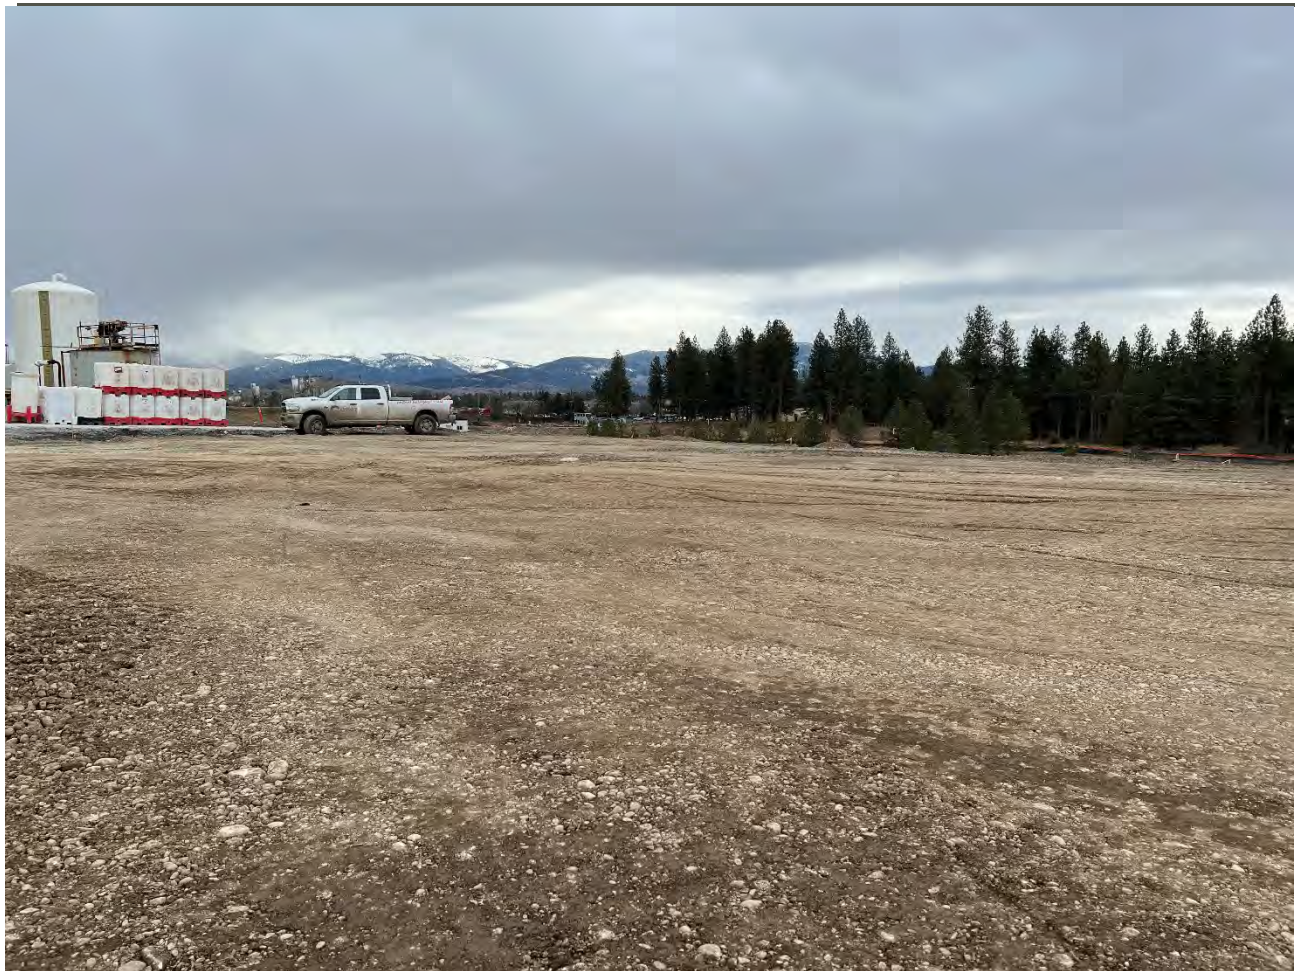
Photograph 4: UPRR property with excavated material from WSDOT and Pentzer properties placed into 1-ft loose lifts and compacted with roller. SE corner of cap area; view looking east.

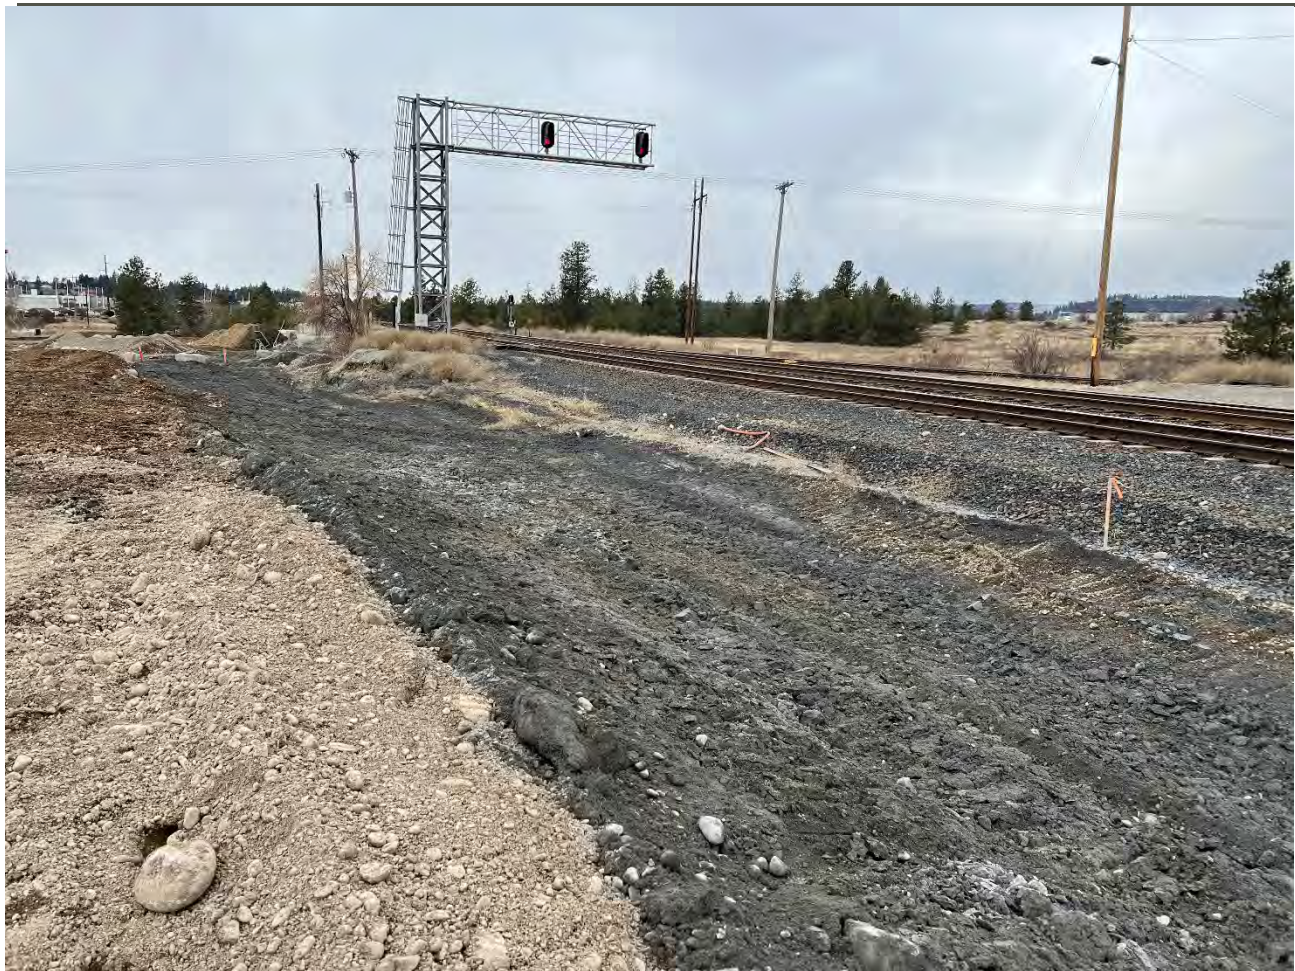
Photograph 5: Railroad ditch subgrade being prepped and graded to drain to west.

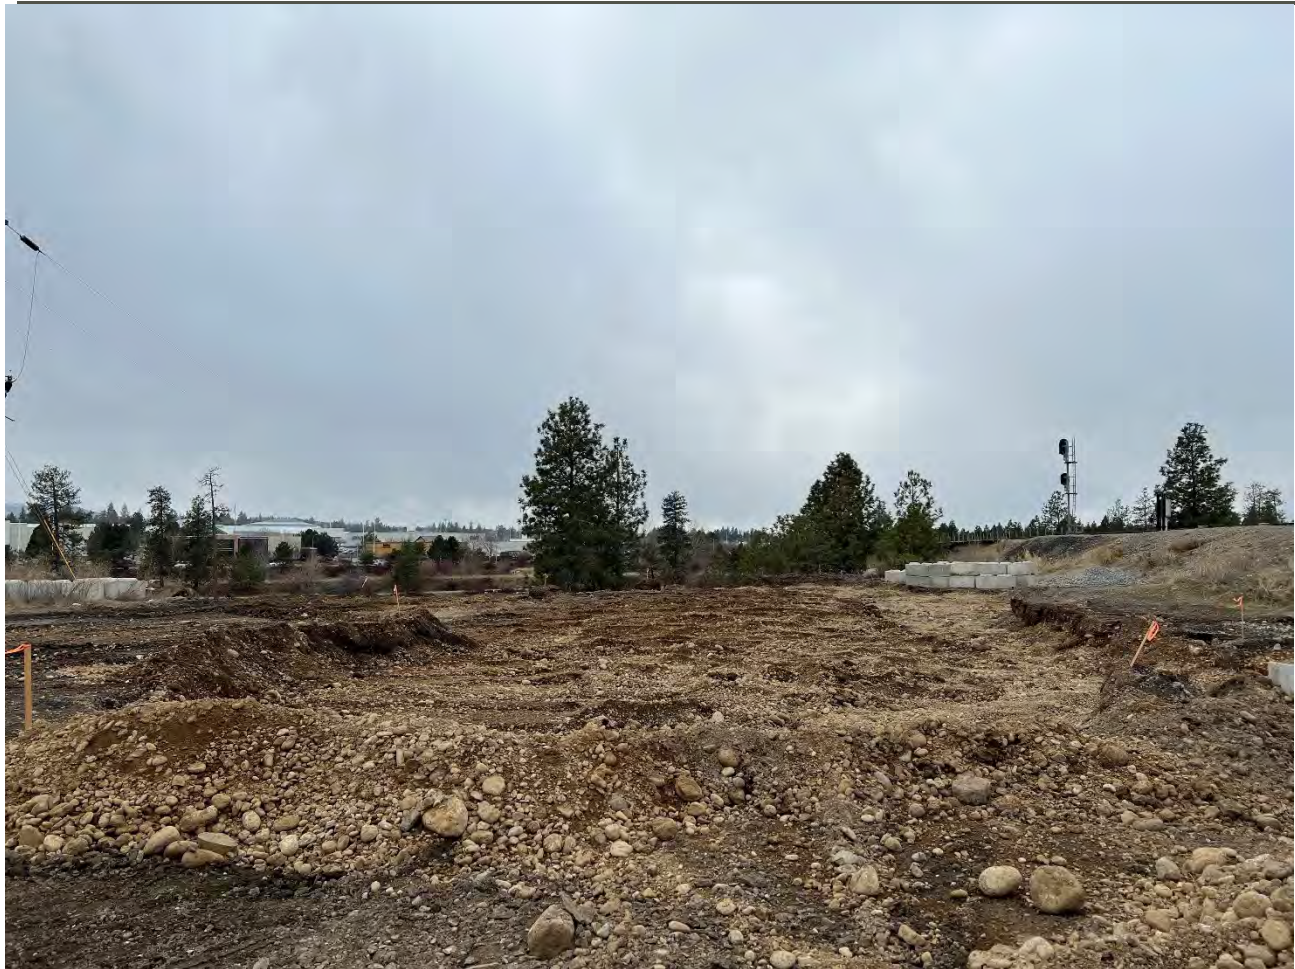
Photograph 6: Excavation 1 on Pentzer property with 2-ft depth of material excavated. View looking west.

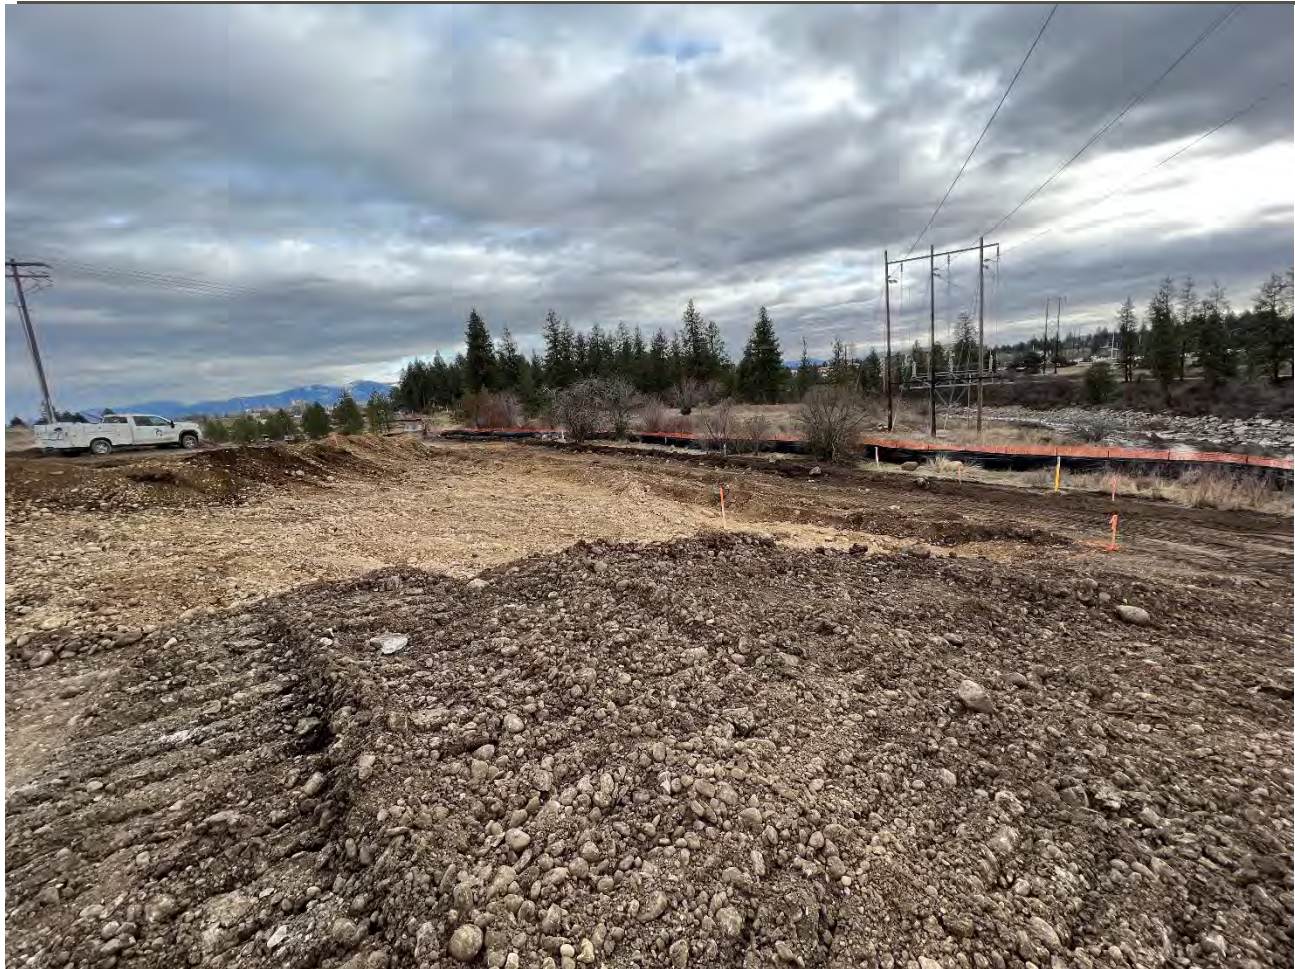
Photograph 7: Excavation 2 on Pentzer property with 4-ft depth of material excavated. View looking east.

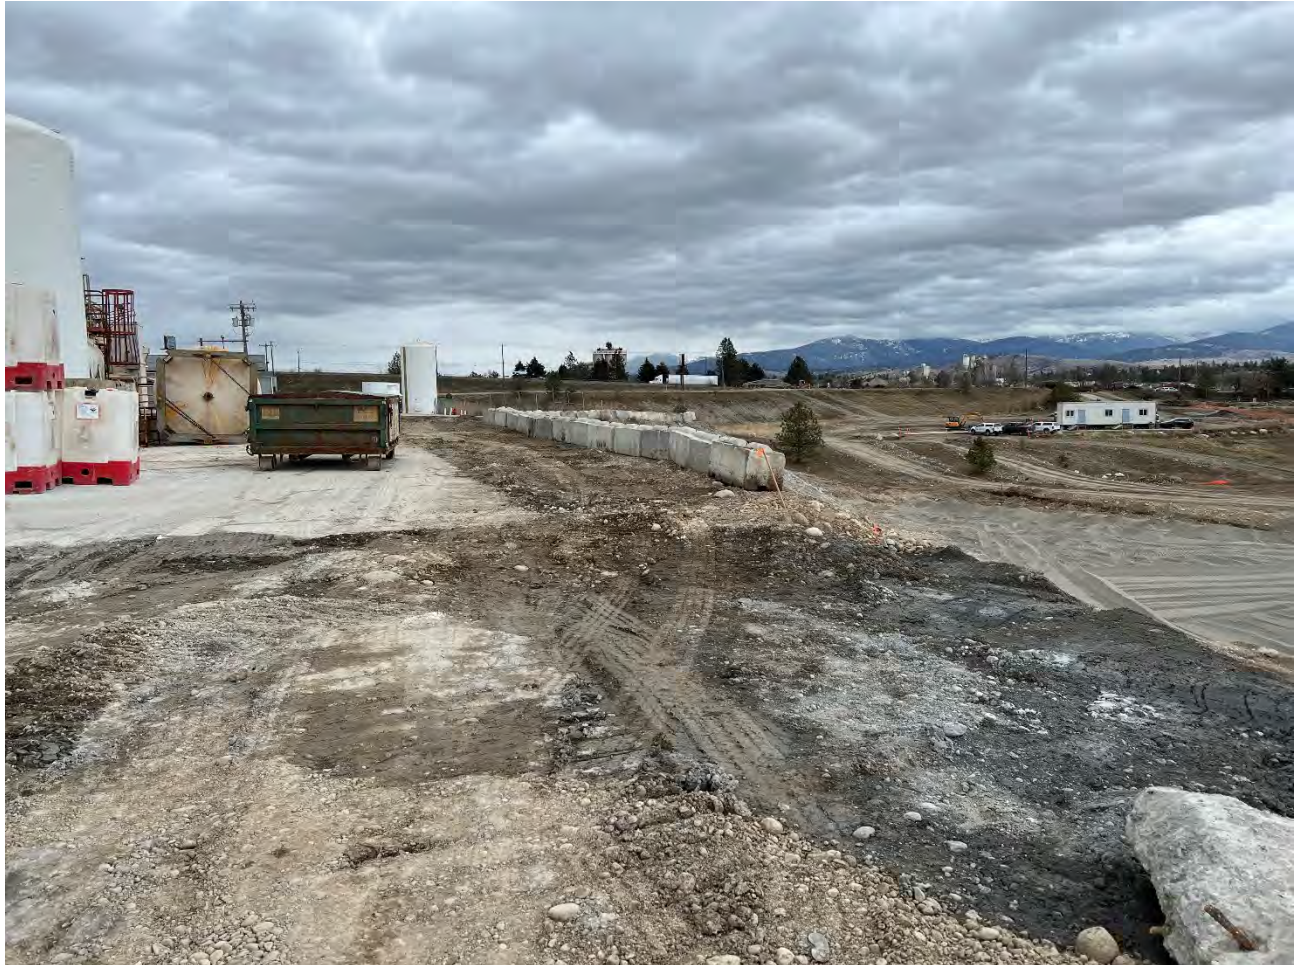
Photograph 1: Ecology blocks from various locations around site placed on west edge of Kemira facility. View looking east.
