GOLDER
MEMBER OF WSP

DAILY FIELD REPORT # 91

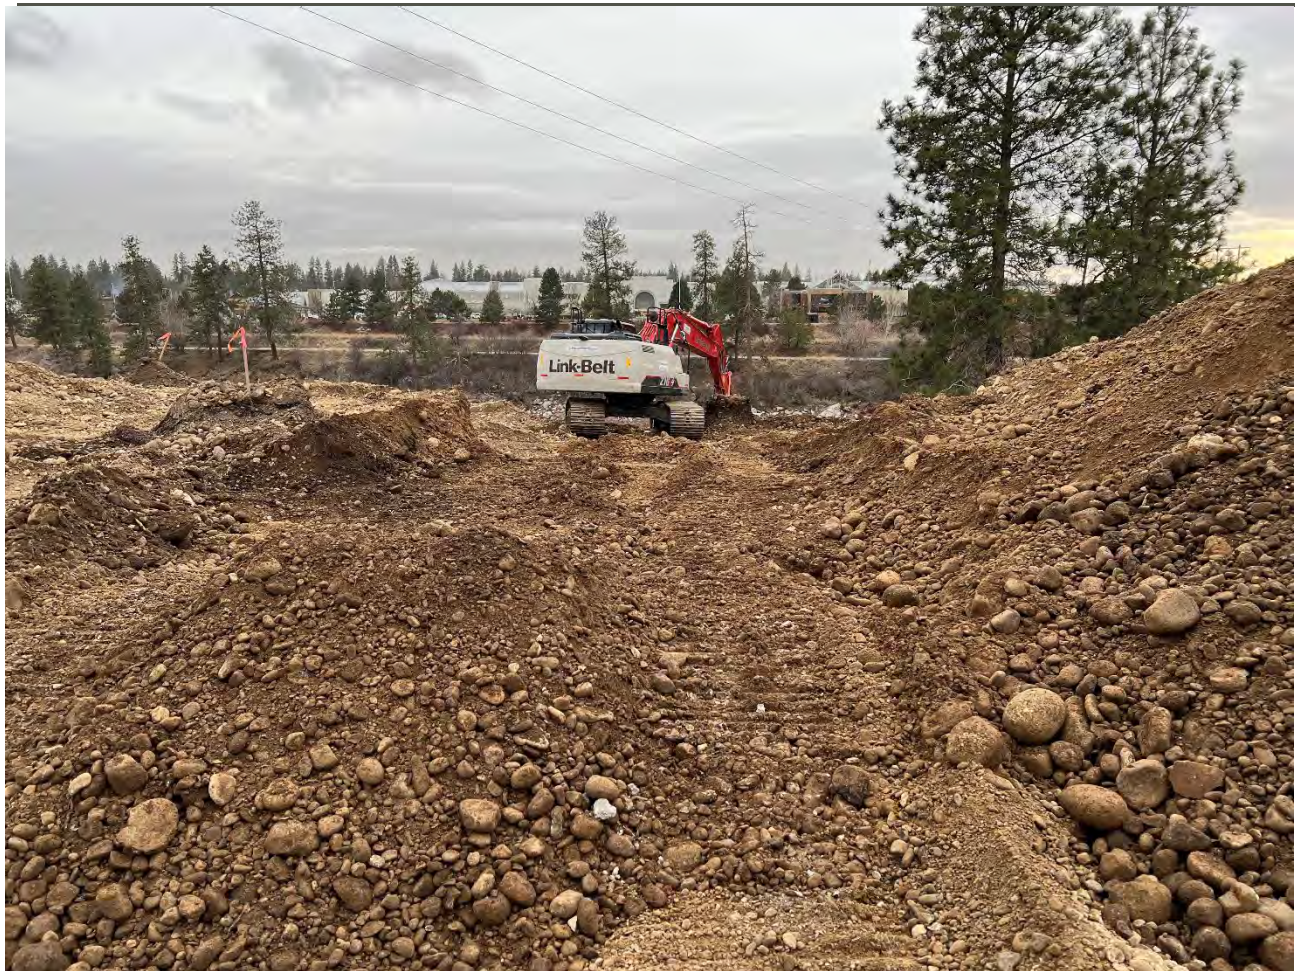
Photograph 2: Link-Belt 210x4 excavating excavation 1 on the Pentzer property to a 4ft depth. View looking west.

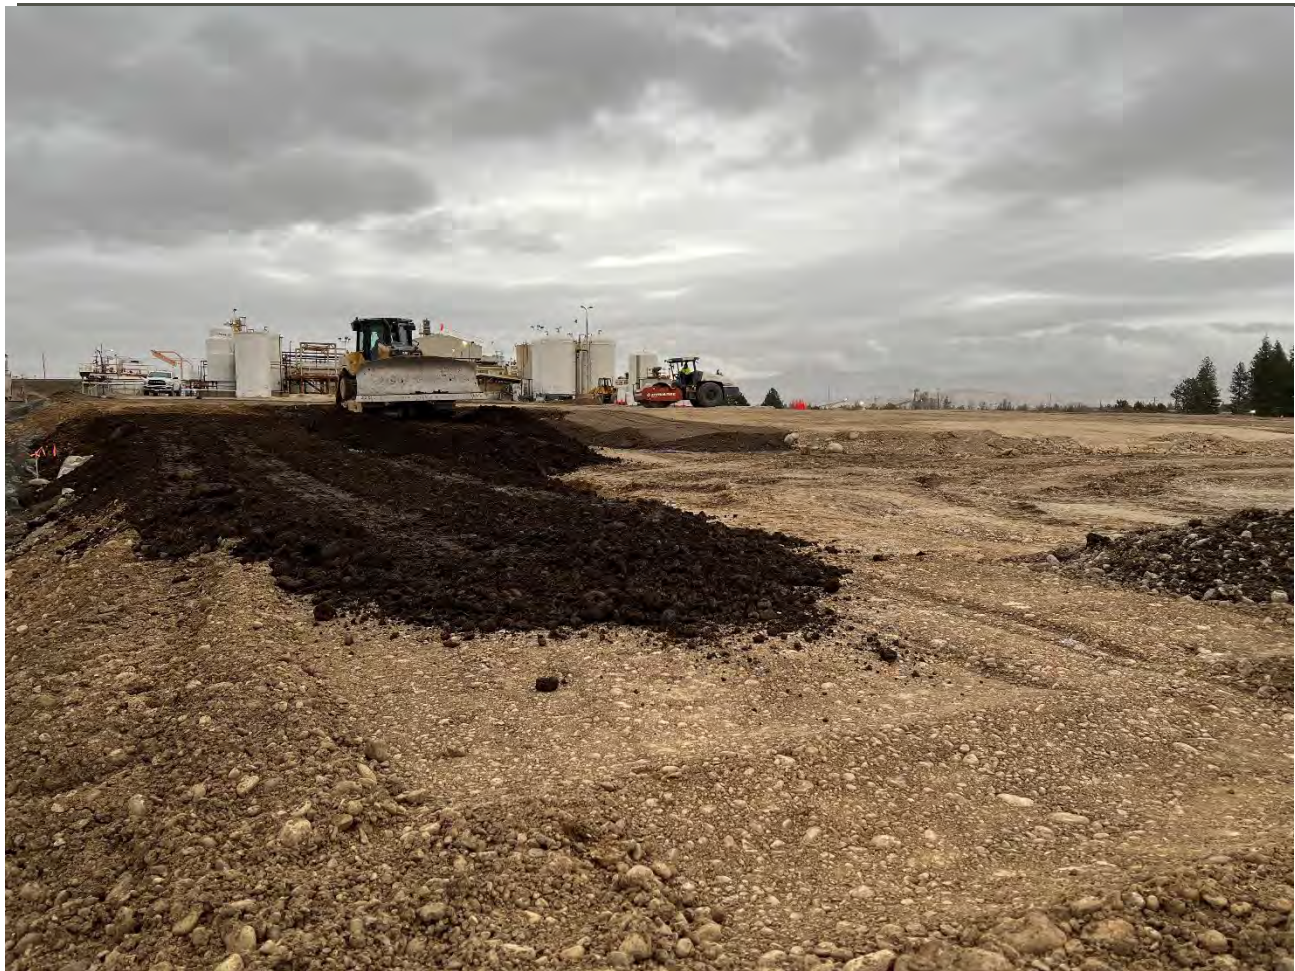
Photograph 3: Topsoil and subgrade interfacing material excavated from Pentzer being spread on to the UPRR ecological cap area.

- An interfacing layer of topsoil and subgrade material was being excavated out on Pentzer property. Golder recommended mixing topsoil material with other soil during or before placement.
- Golder observed boulders (>2 ft in diameter) being placed in the ecological cap subgrade. GrayMar said that some boulders (~2-4 ft in diameter, less than the trackhoe bucket width) were hauled to the UPRR ecological cap. Golder and GrayMar agreed that boulders already up on the UPRR cap area could be buried; making sure material is packed tightly around them. Moving forward, larger boulders encountered while excavating will be kept in place.

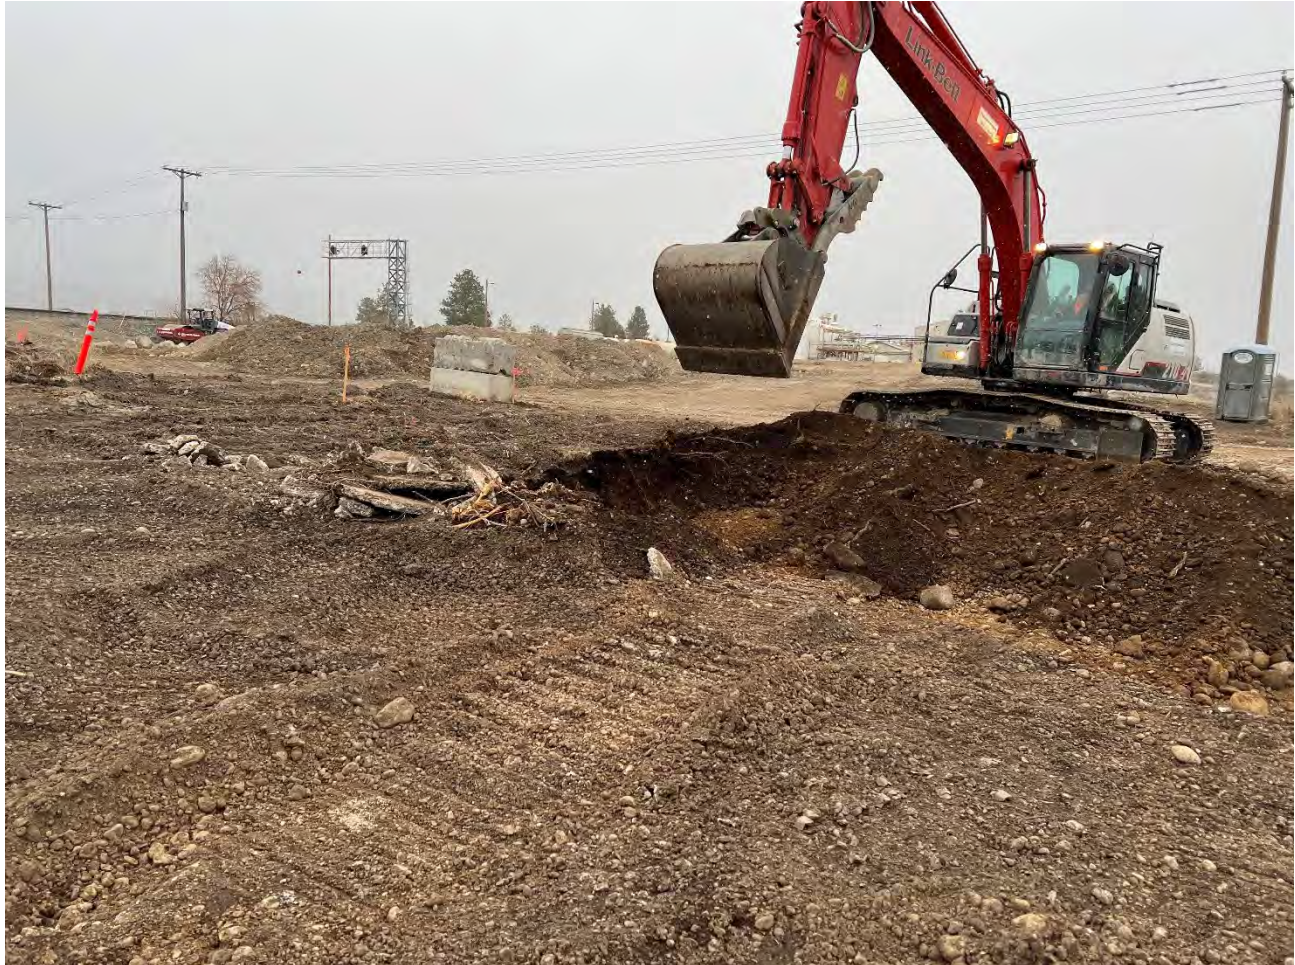
Photograph 1: Interfacing layer of topsoil and subgrade material being excavated out on Pentzer property

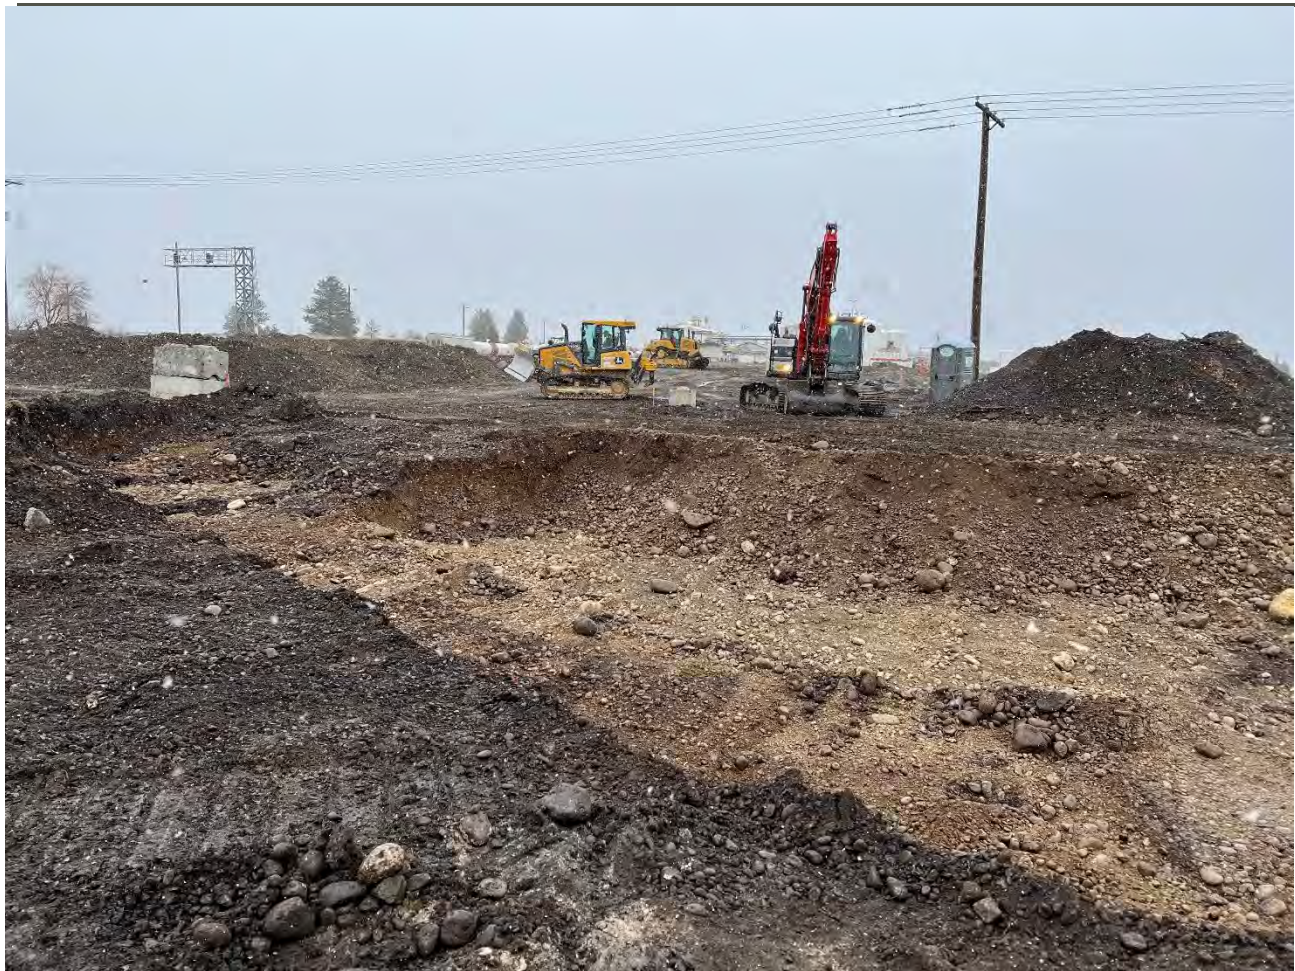
Photograph 2: Excavation 2 excavated down to 2ft, 4ft, and 6ft depths.

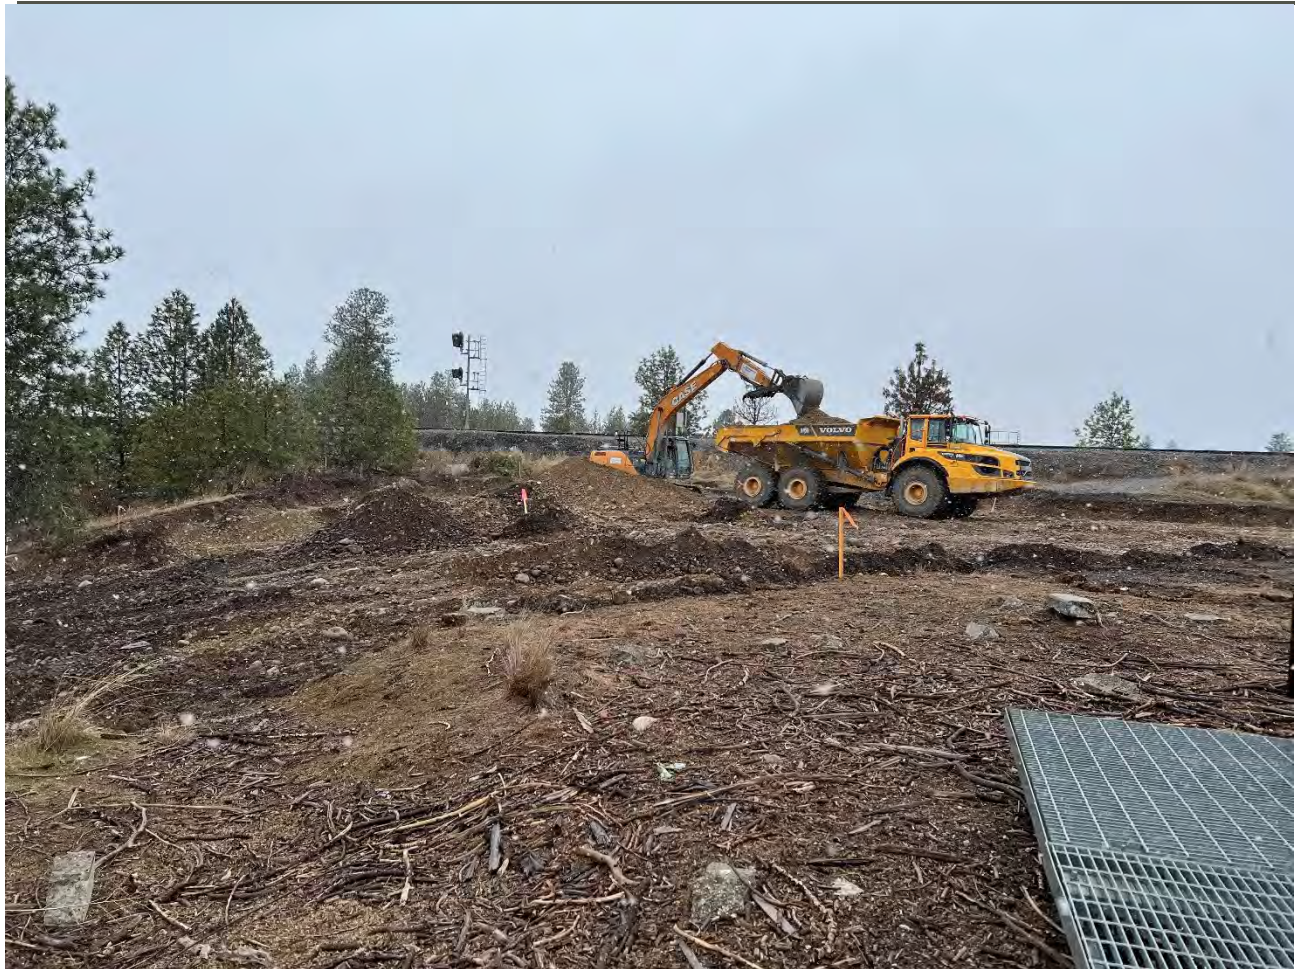
Photograph 3: Excavating, loading, and hauling of material from excavation 1 to UPRR cap area.

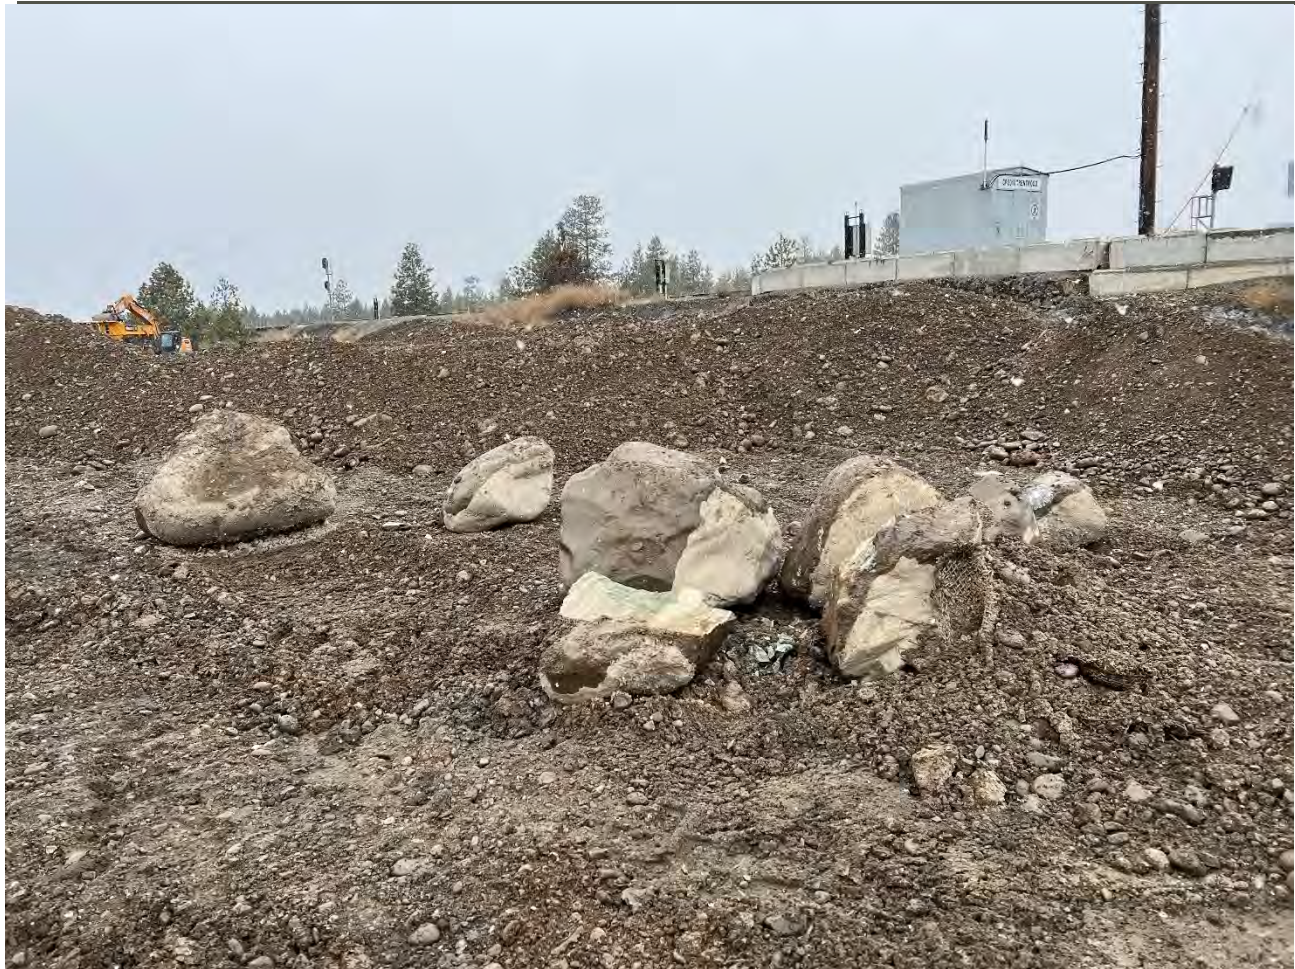
Photograph 4: Boulders stockpiled on UPRR property from WSDOT excavations. To be placed under cap.

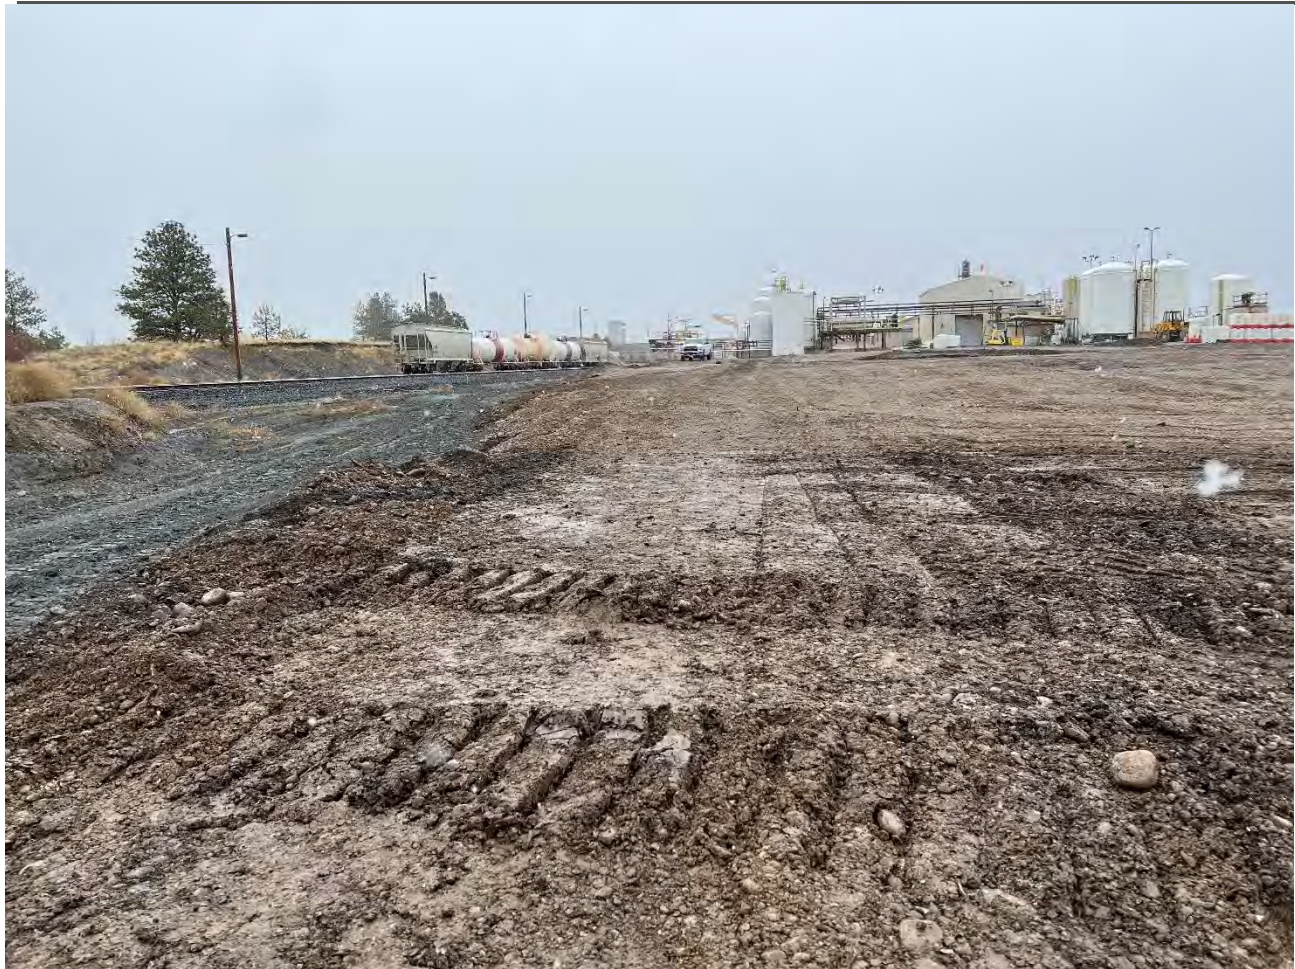
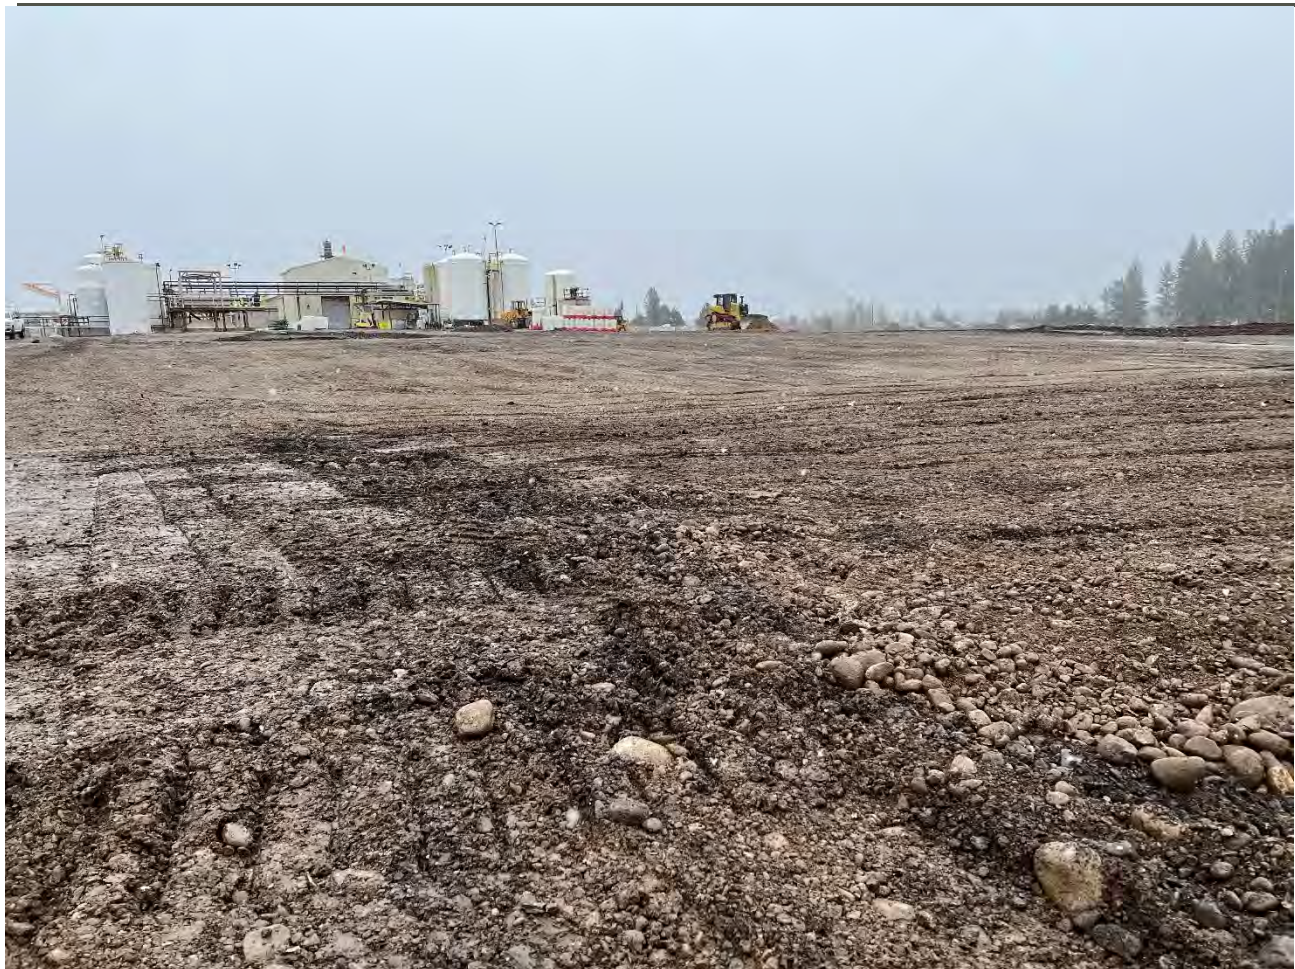
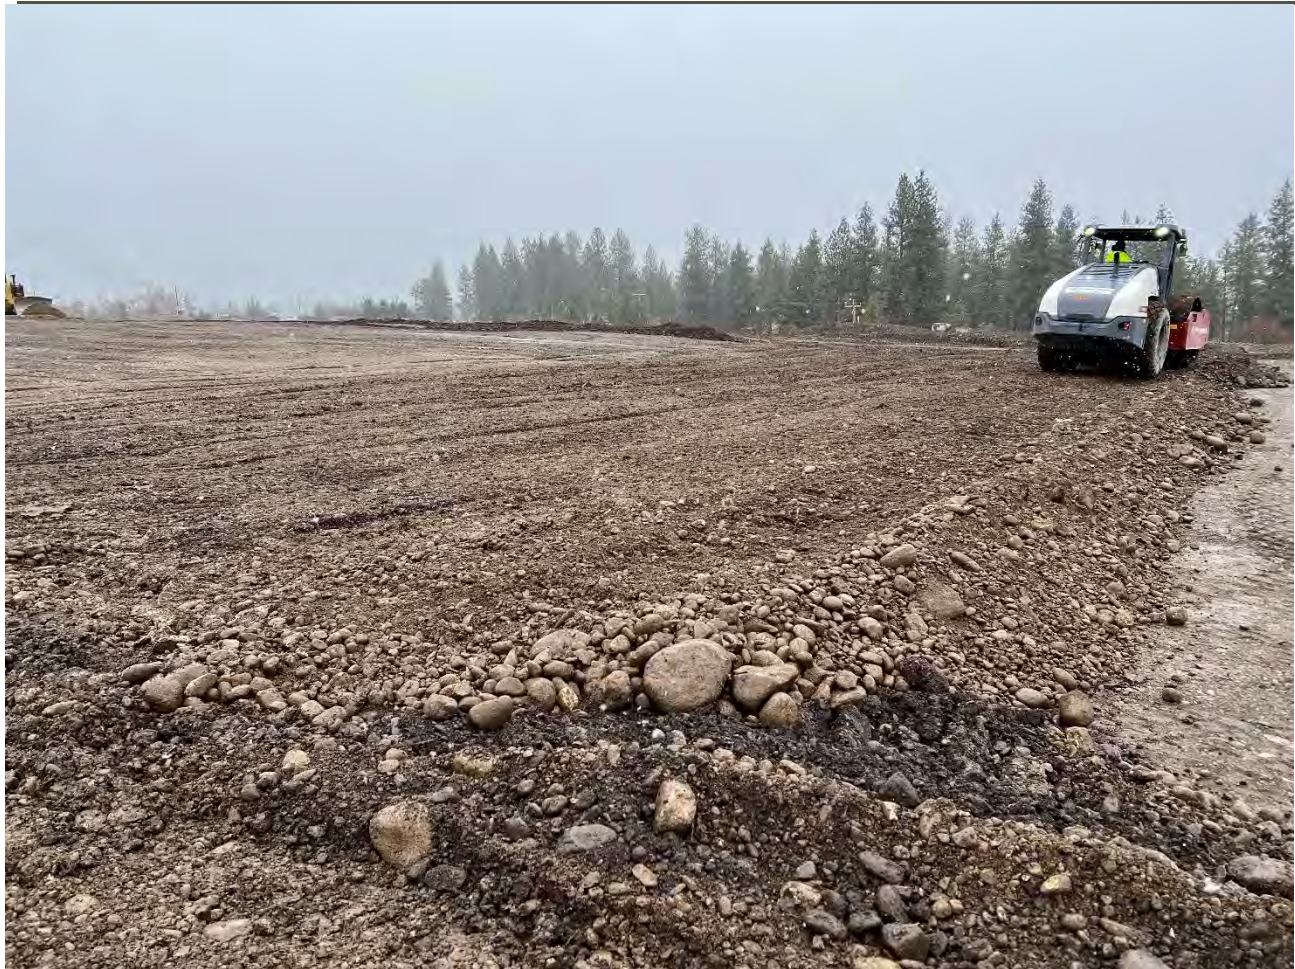
Photograph 5: UPRR cap area subgrade being placed in lifts are rolled for compaction.

Photograph 6: UPRR cap area subgrade being placed in lifts are rolled for compaction.

Photograph 7: UPRR cap area subgrade being placed in lifts are rolled for compaction.

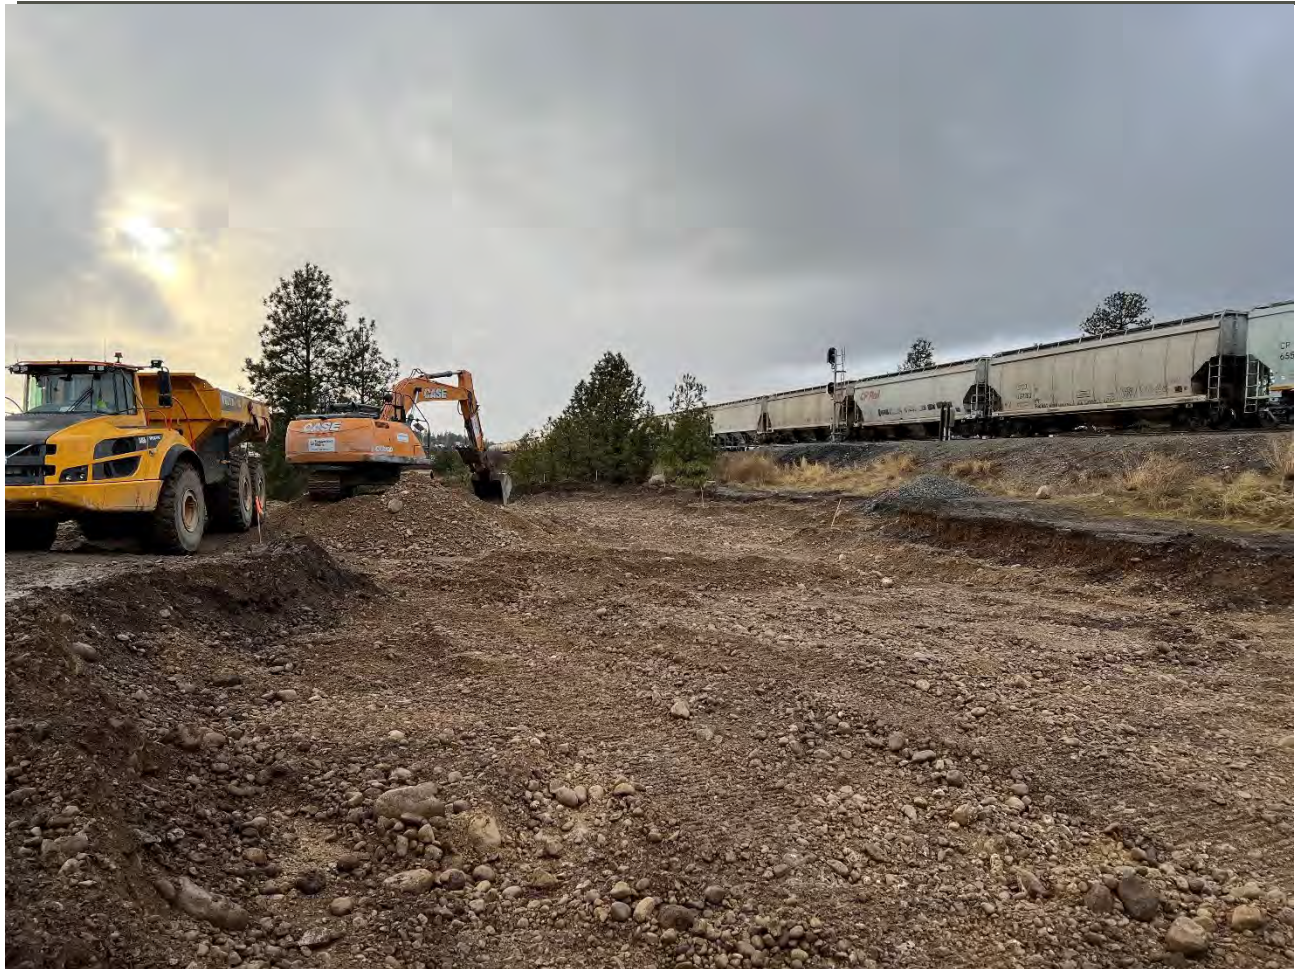
Photograph 8: Excavation 1 on Pentzer property being excavated to 4ft depth.

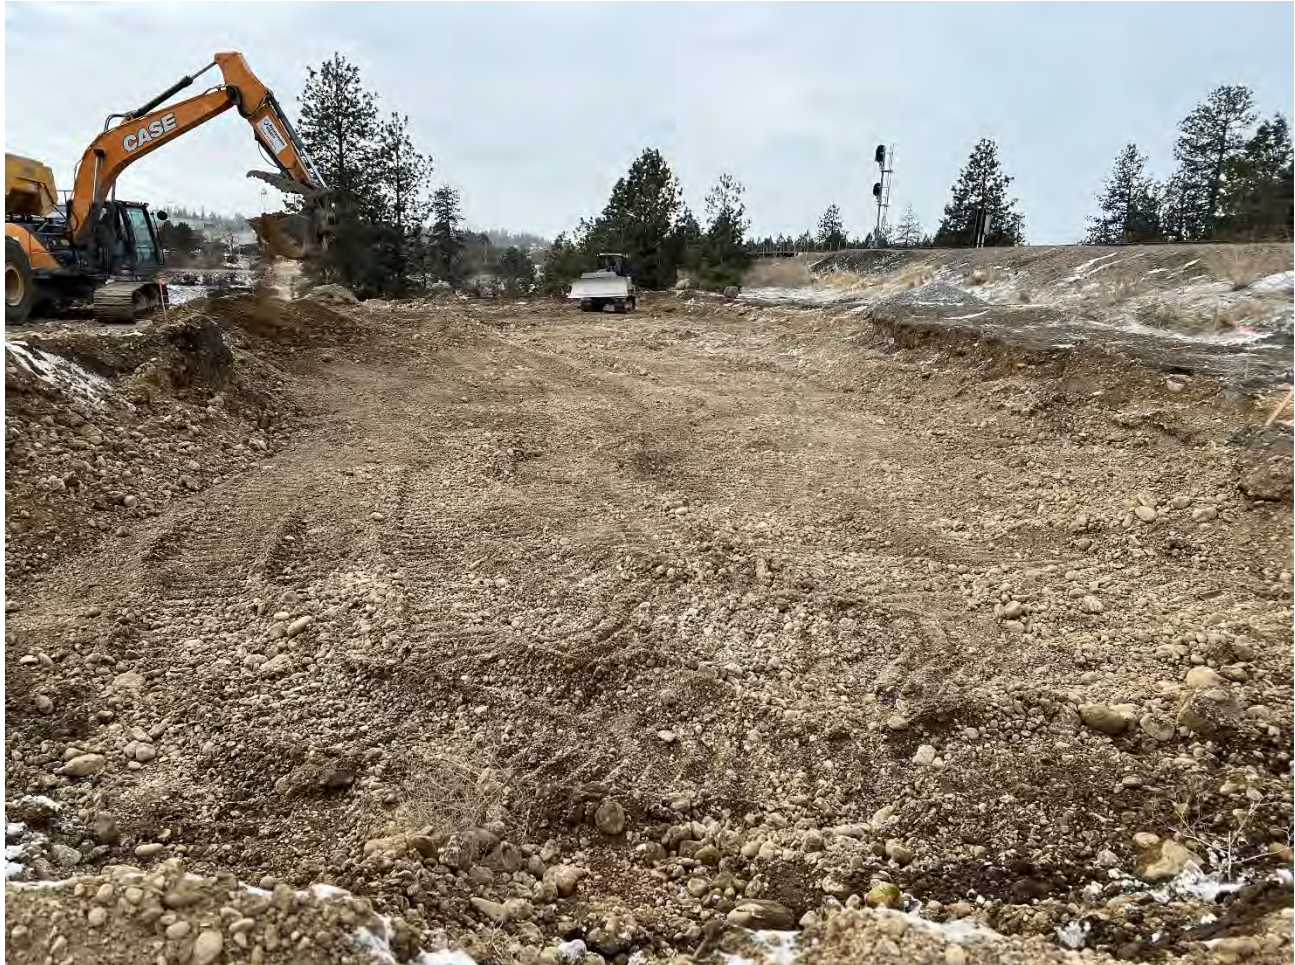
Photograph 1: Excavating and cleaning up of excavation 1.

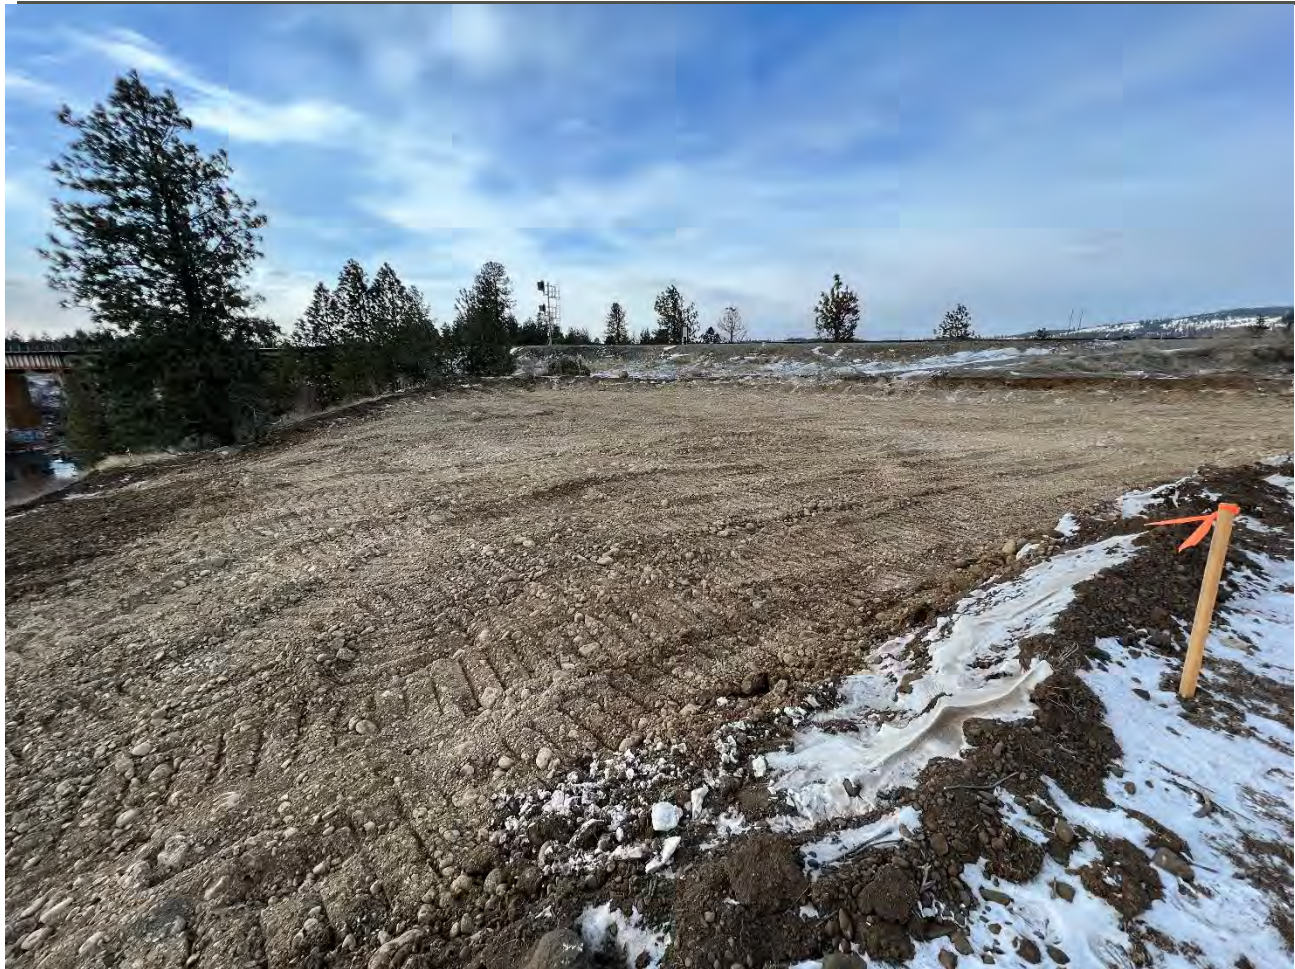
Photograph 2: Excavation 1 ready for sampling after being excavated and cleaned up.

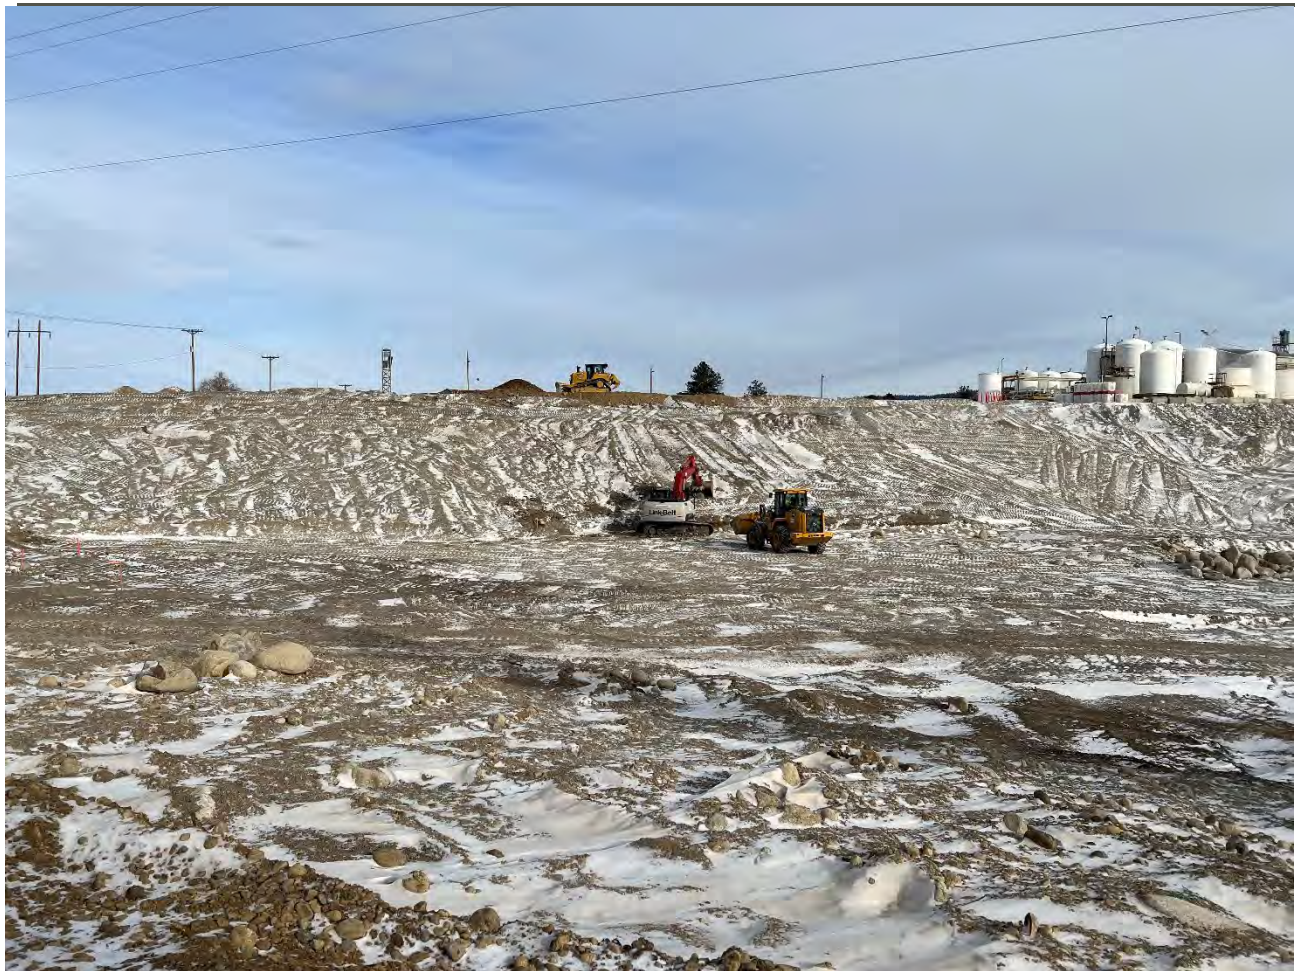
Photograph 3: GrayMar placing and spreading boulders in excavation 6.

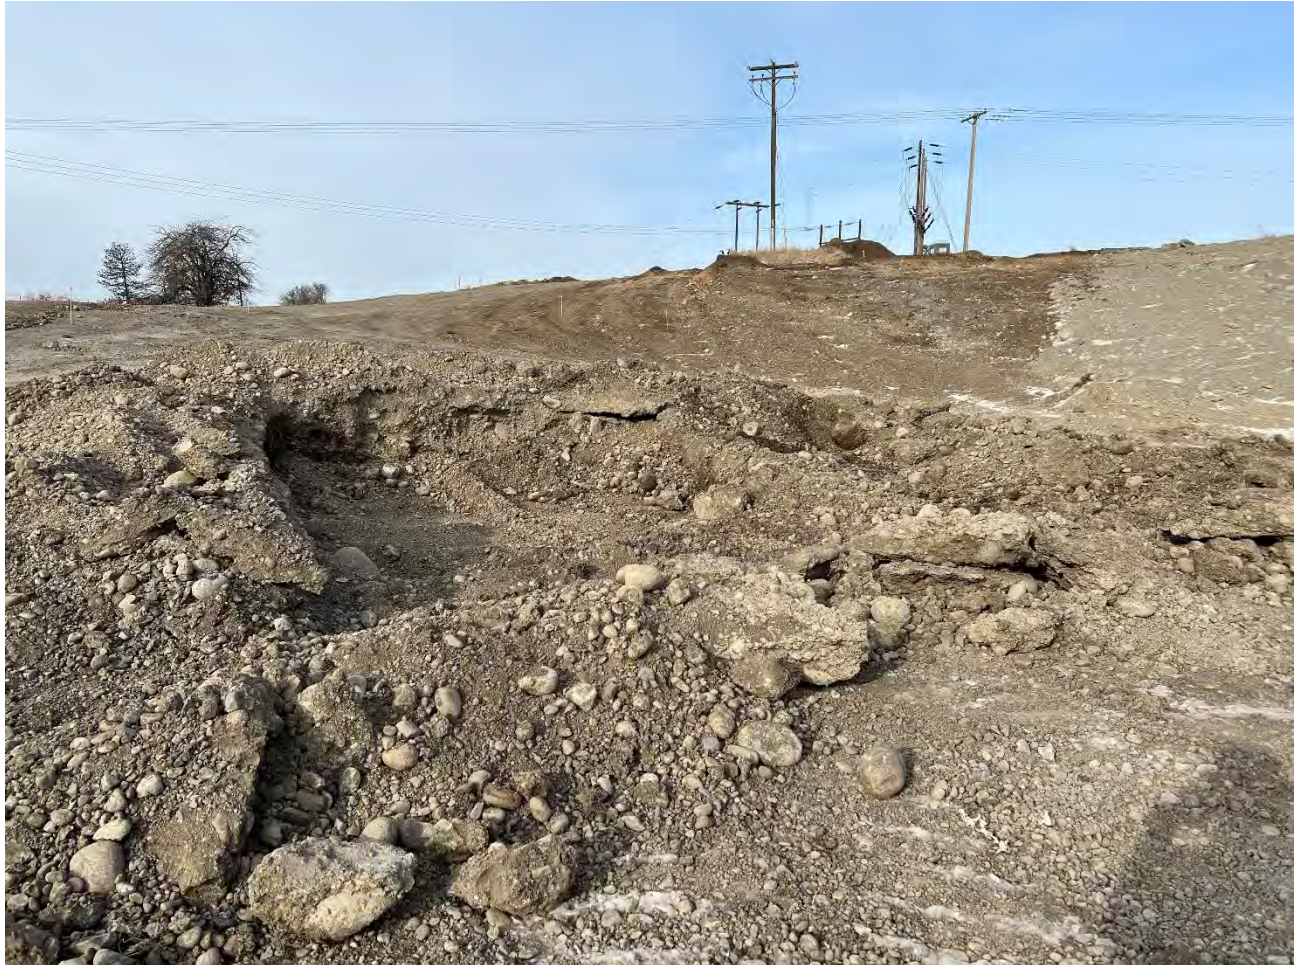
Photograph 1: Excavation 4 with safety berms around edge of excavation.

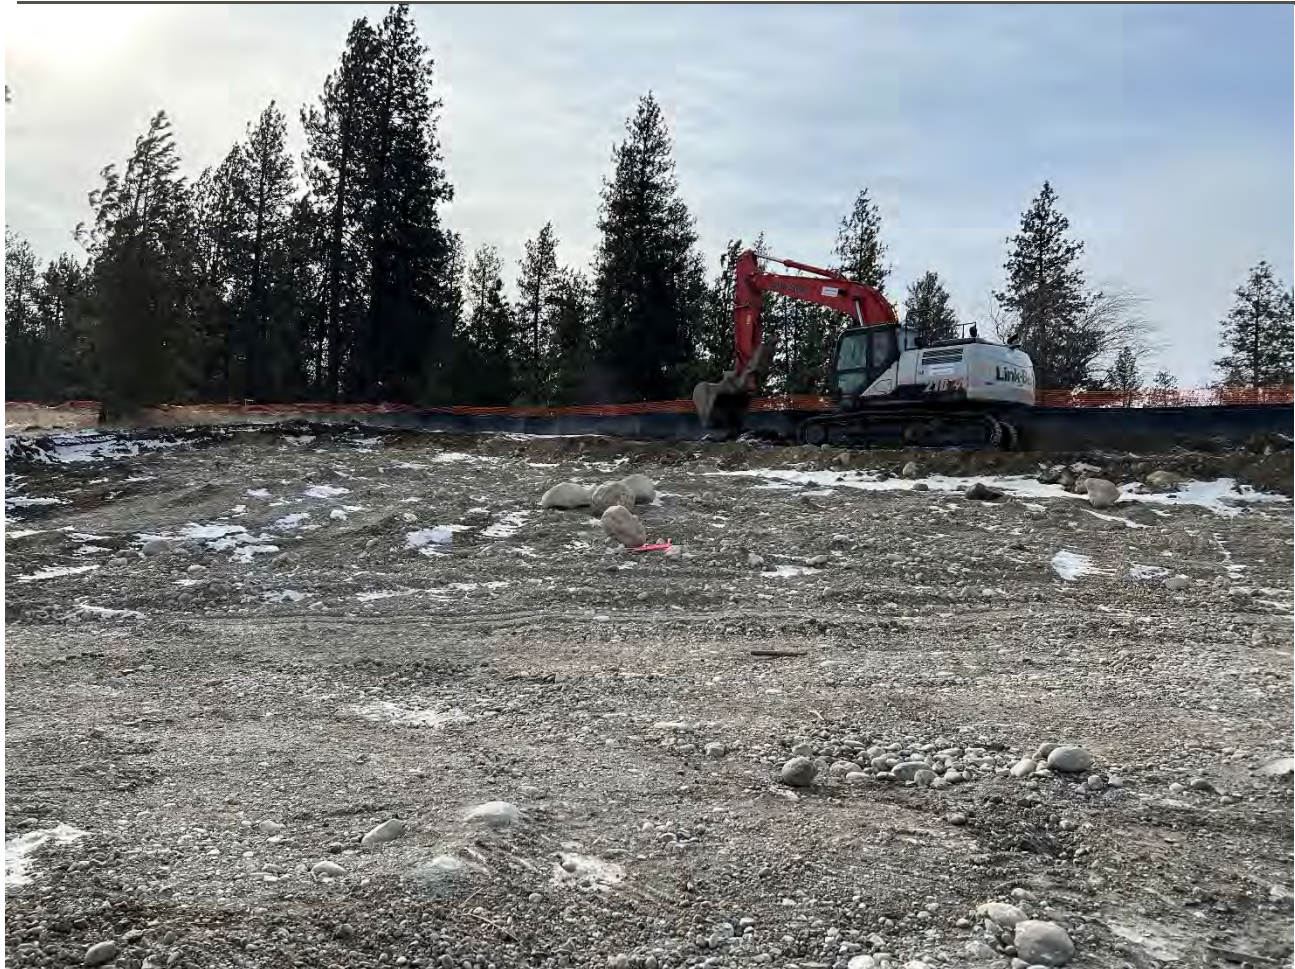
Photograph 2: Excavator removing material from edge of road that was pushed up against silt fence when doing the 2-ft excavations on WSDOT property.

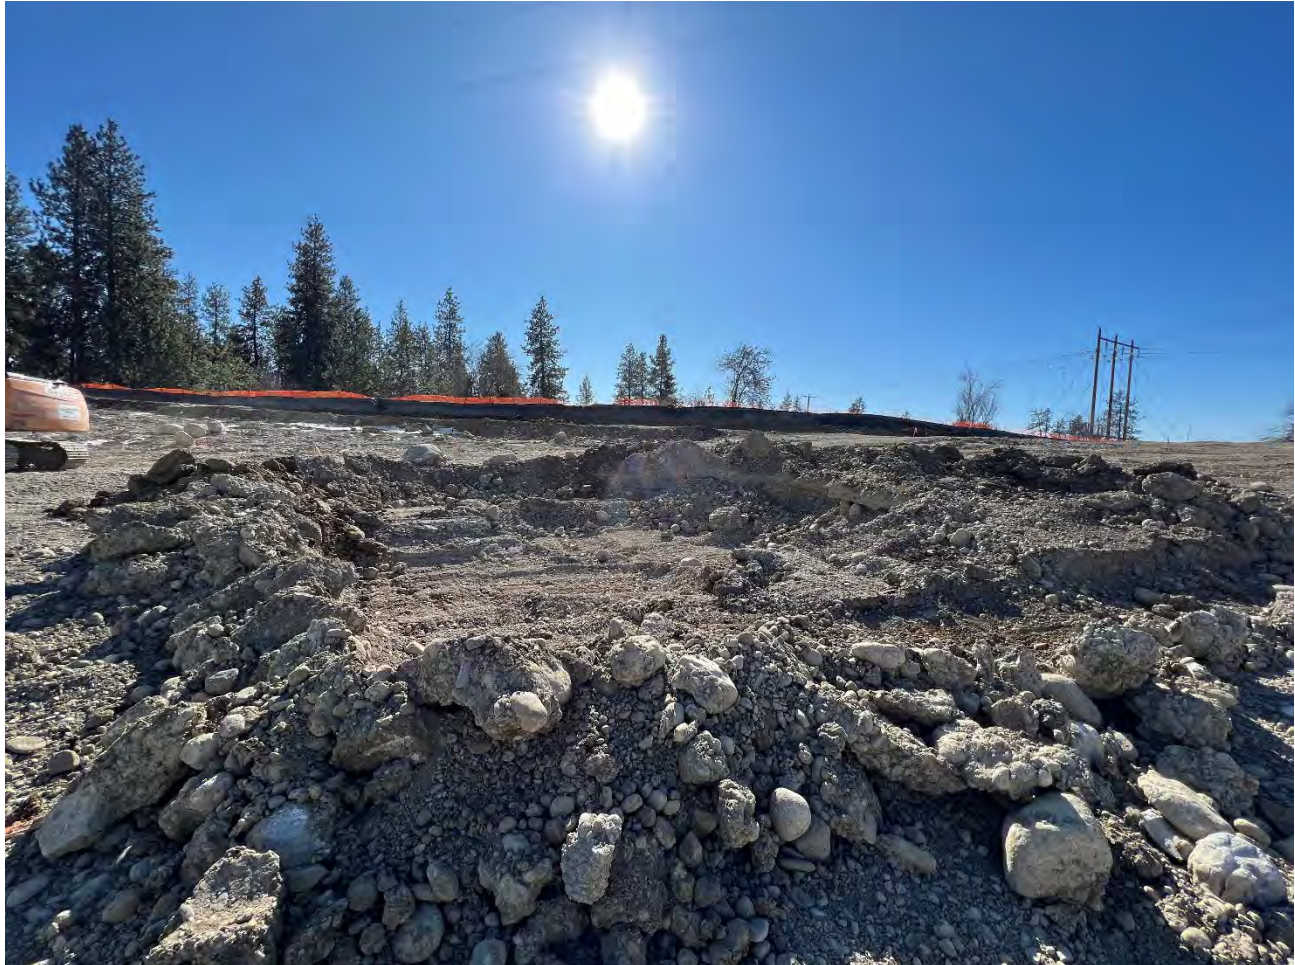
Photograph 1: Excavation 4 with safety berms around edge of excavation.

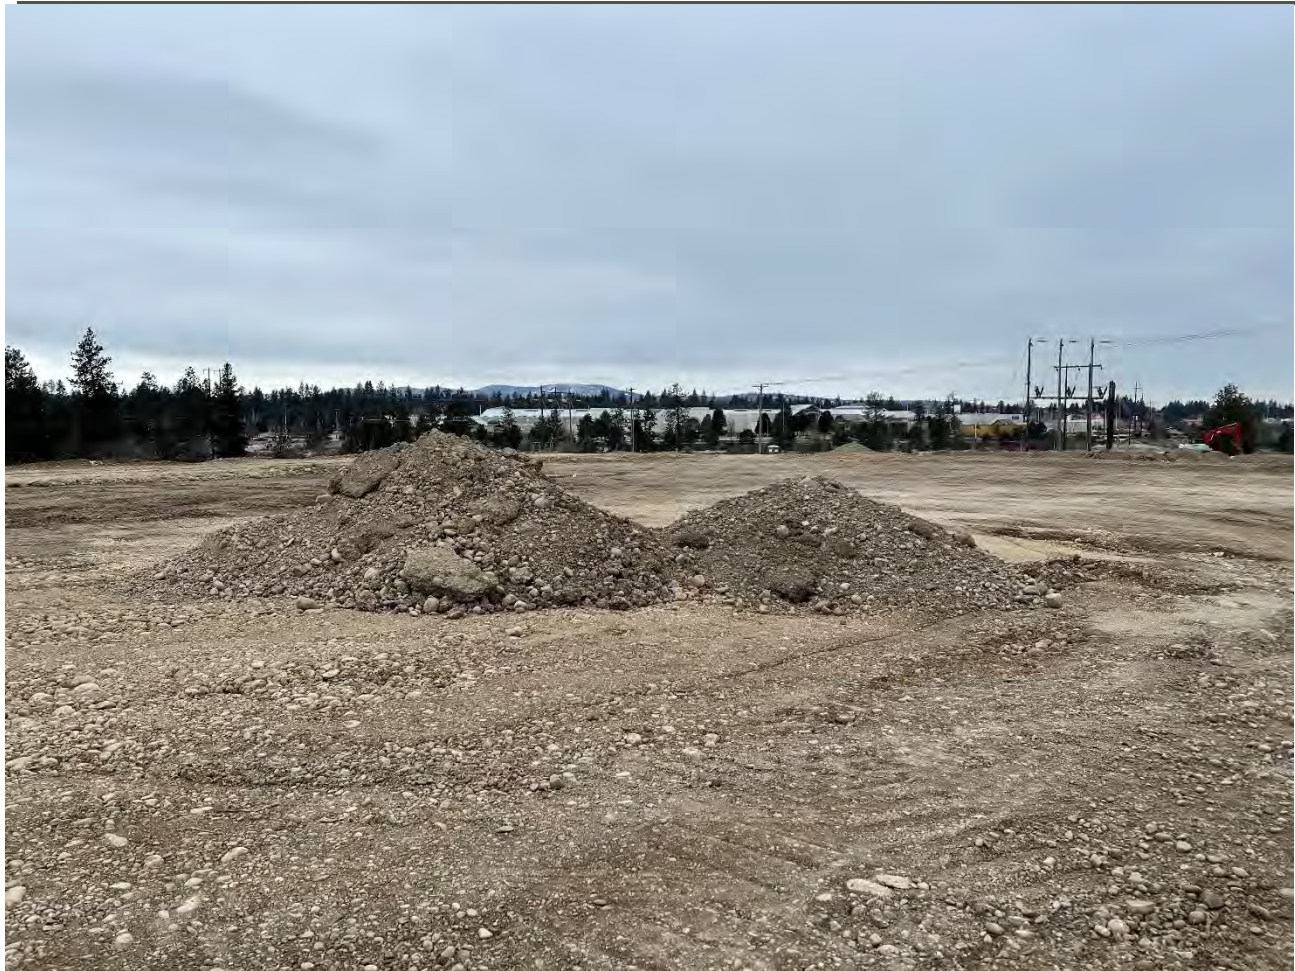
Photograph 2: Ecological cap subgrade being prepped with excavated material stockpiled to spread into another 1ft loose lift.

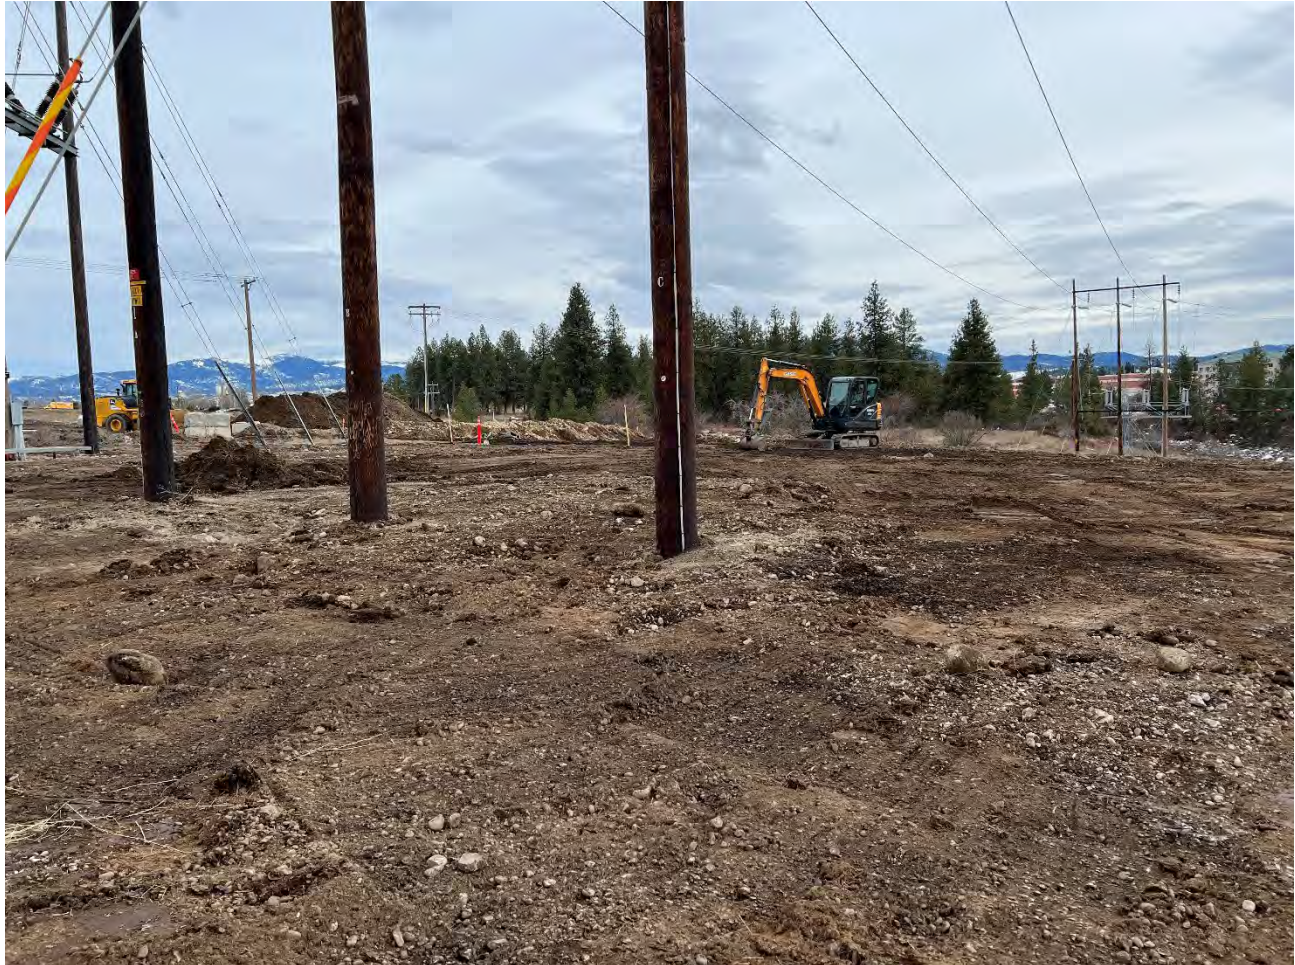
Photograph 1: Pentzer property with topsoil and vegetation removed around BPA utilities.
