GOLDER
MEMBER OF WSP

DAILY FIELD REPORT # 91

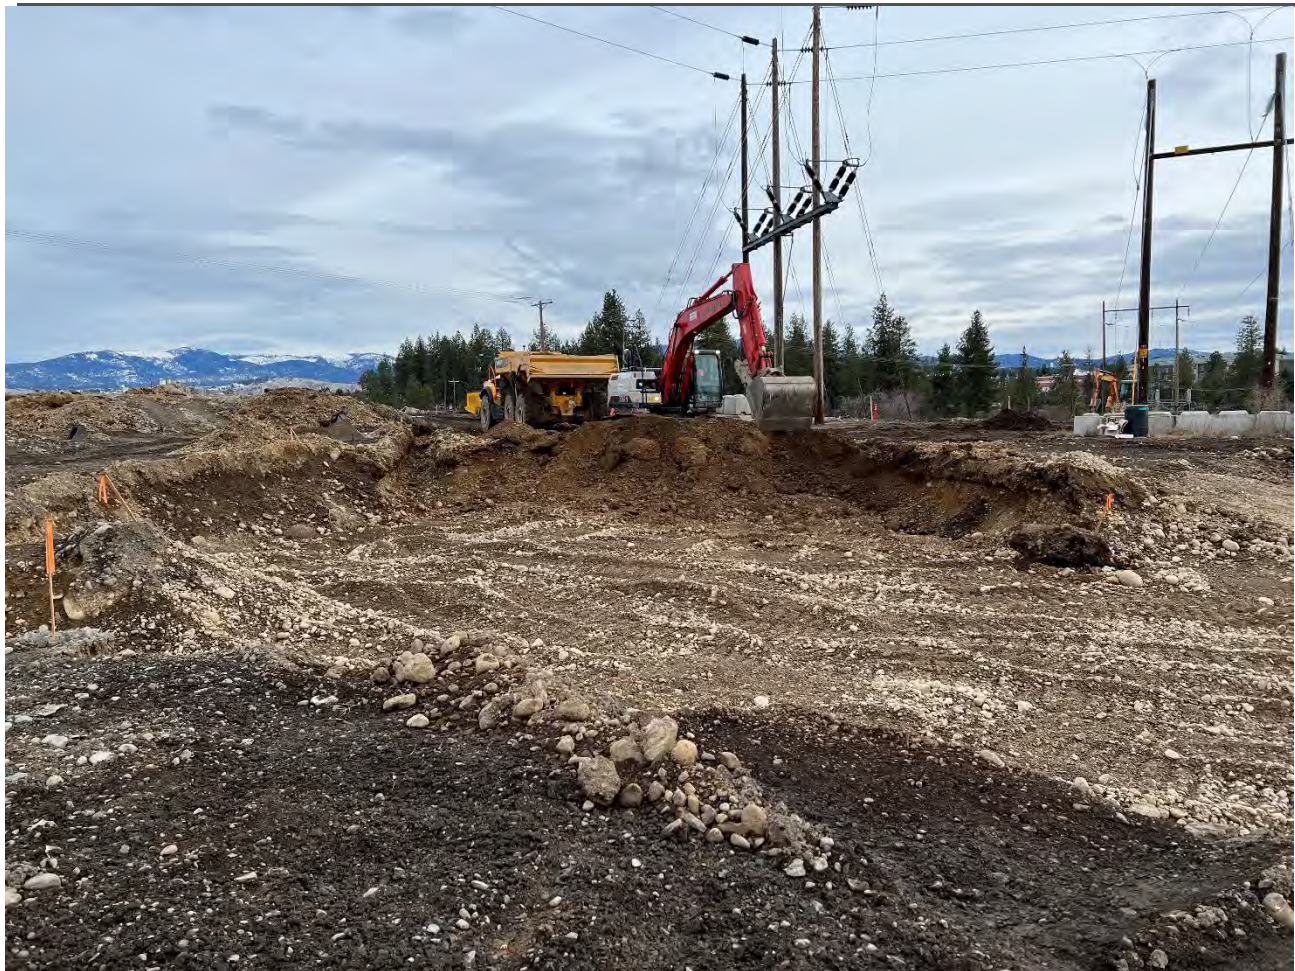
Photograph 2: Excavation 2 on Pentzer property to depth of 4ft.

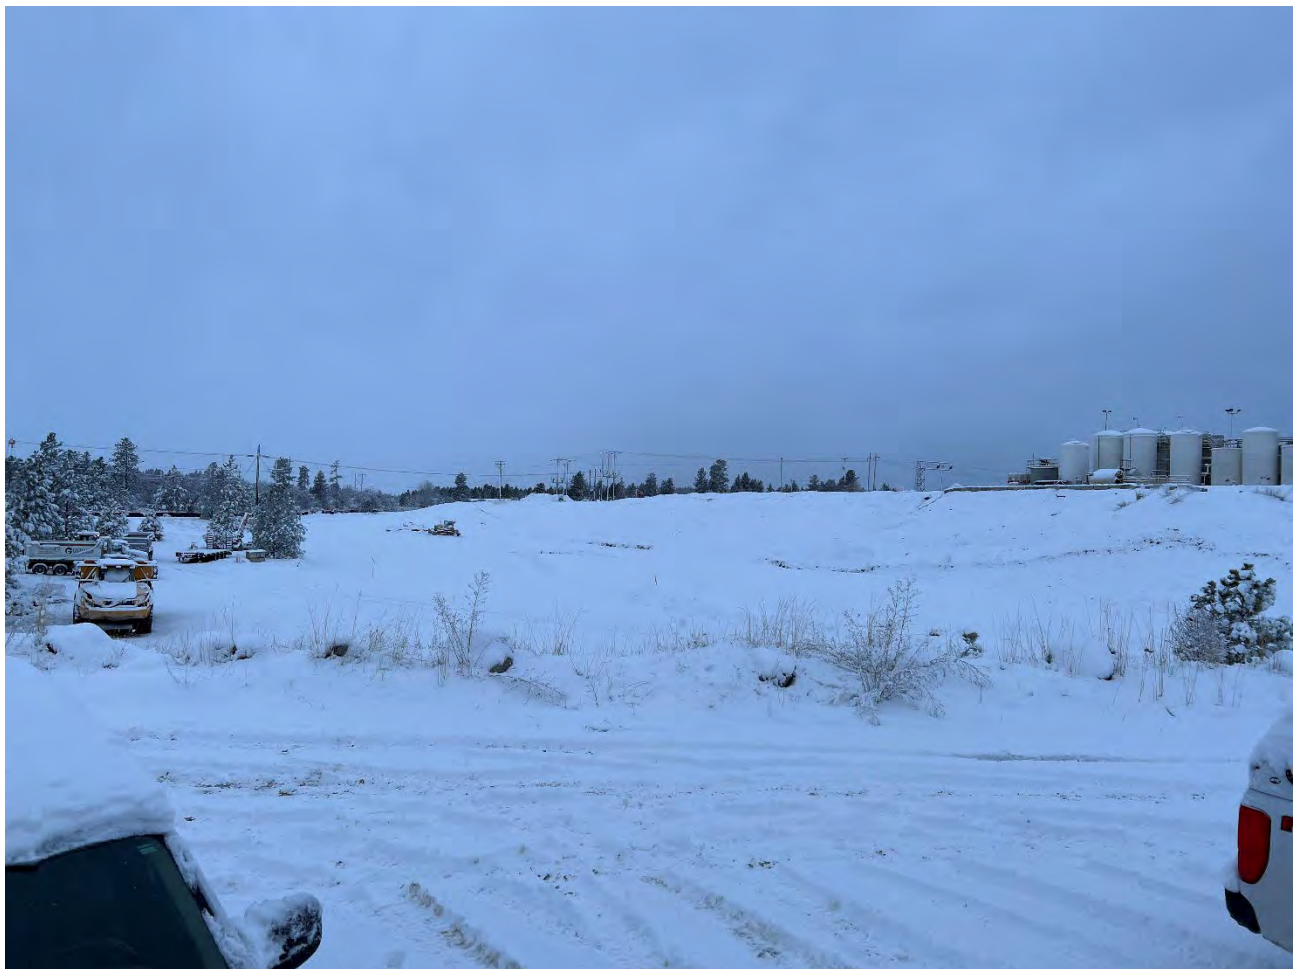
Photograph 1: Snow covering site.

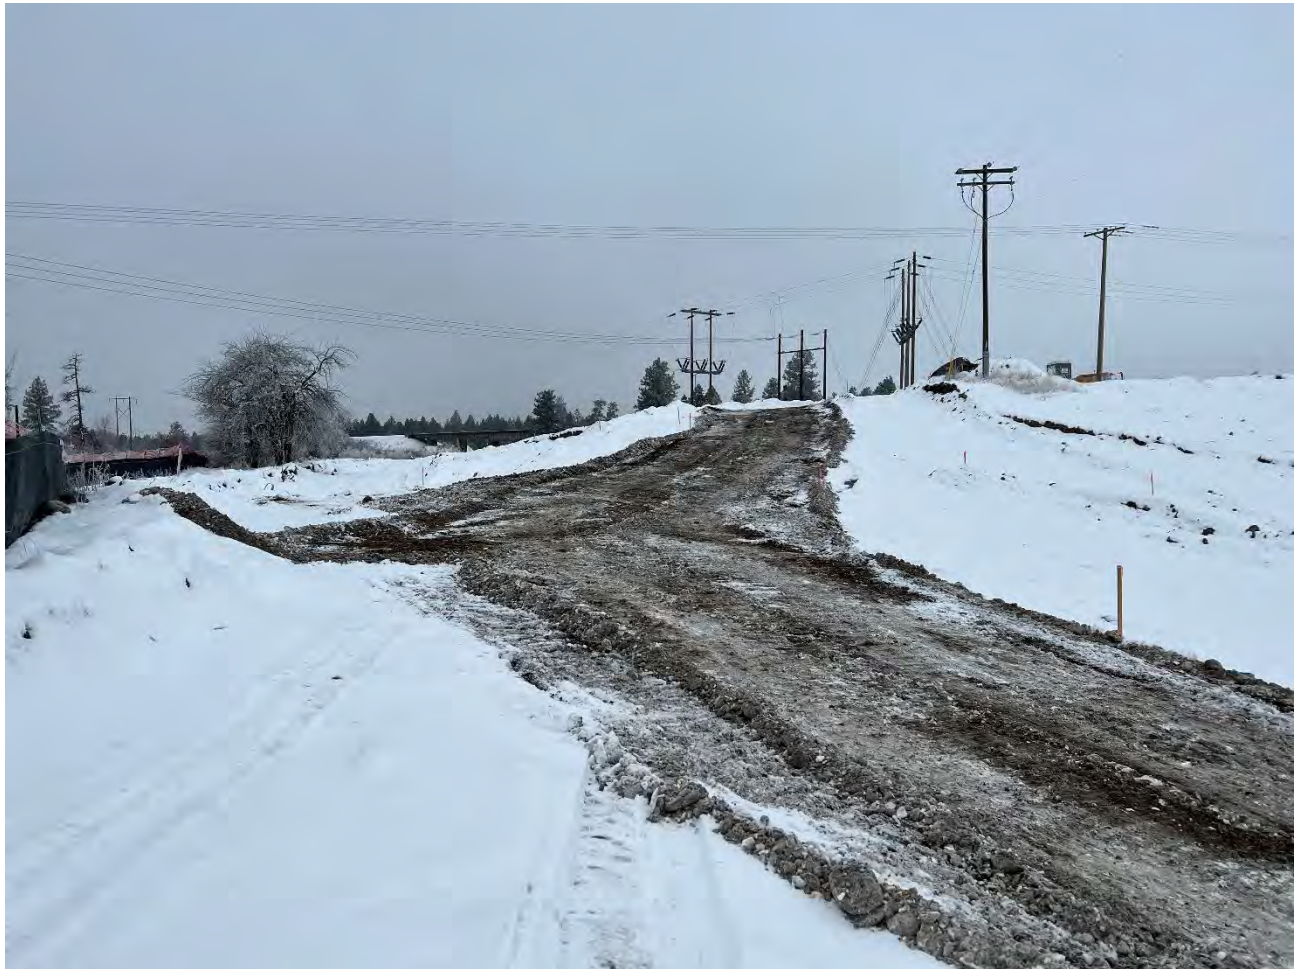
Photograph 1: Cleared access roads from snow and ice for safe travel.

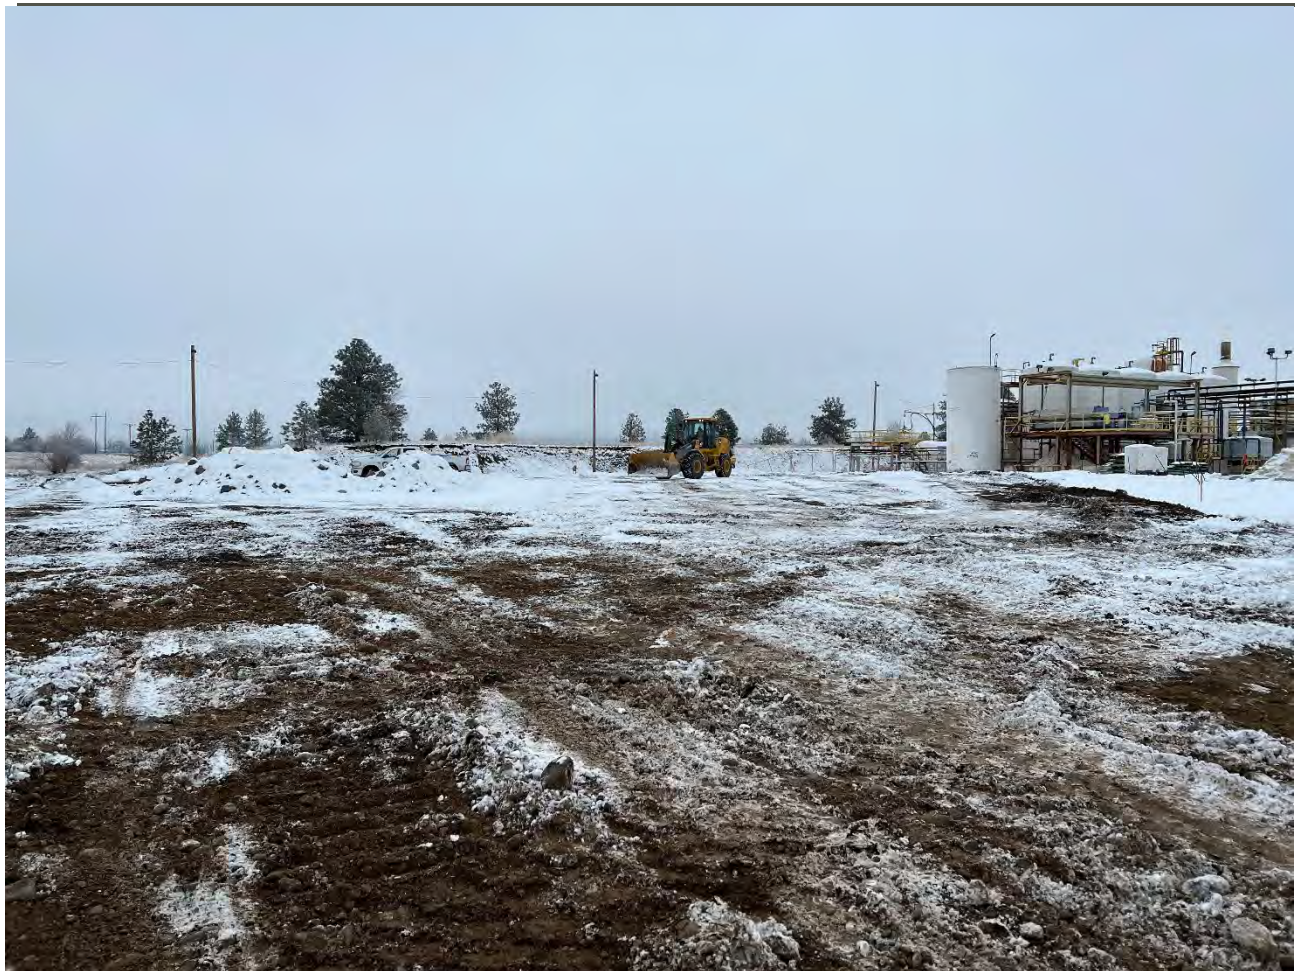
Photograph 2: Clearing ecological cap area of snow and ice.

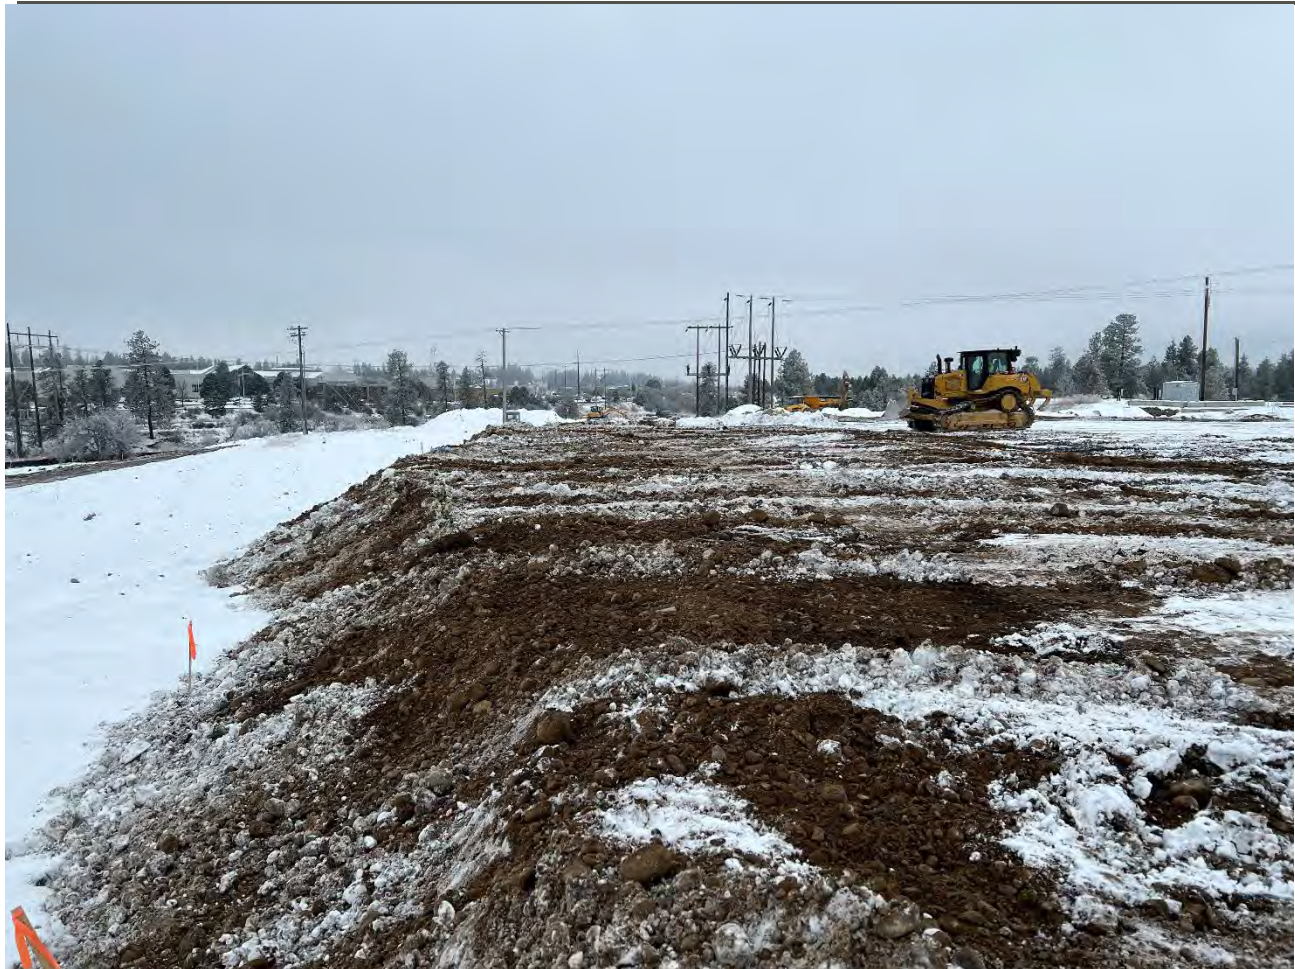
Photograph 3: Placement of excavated material from Pentzer on cap area at crest of slope. To be spread and compacted once snow melts.

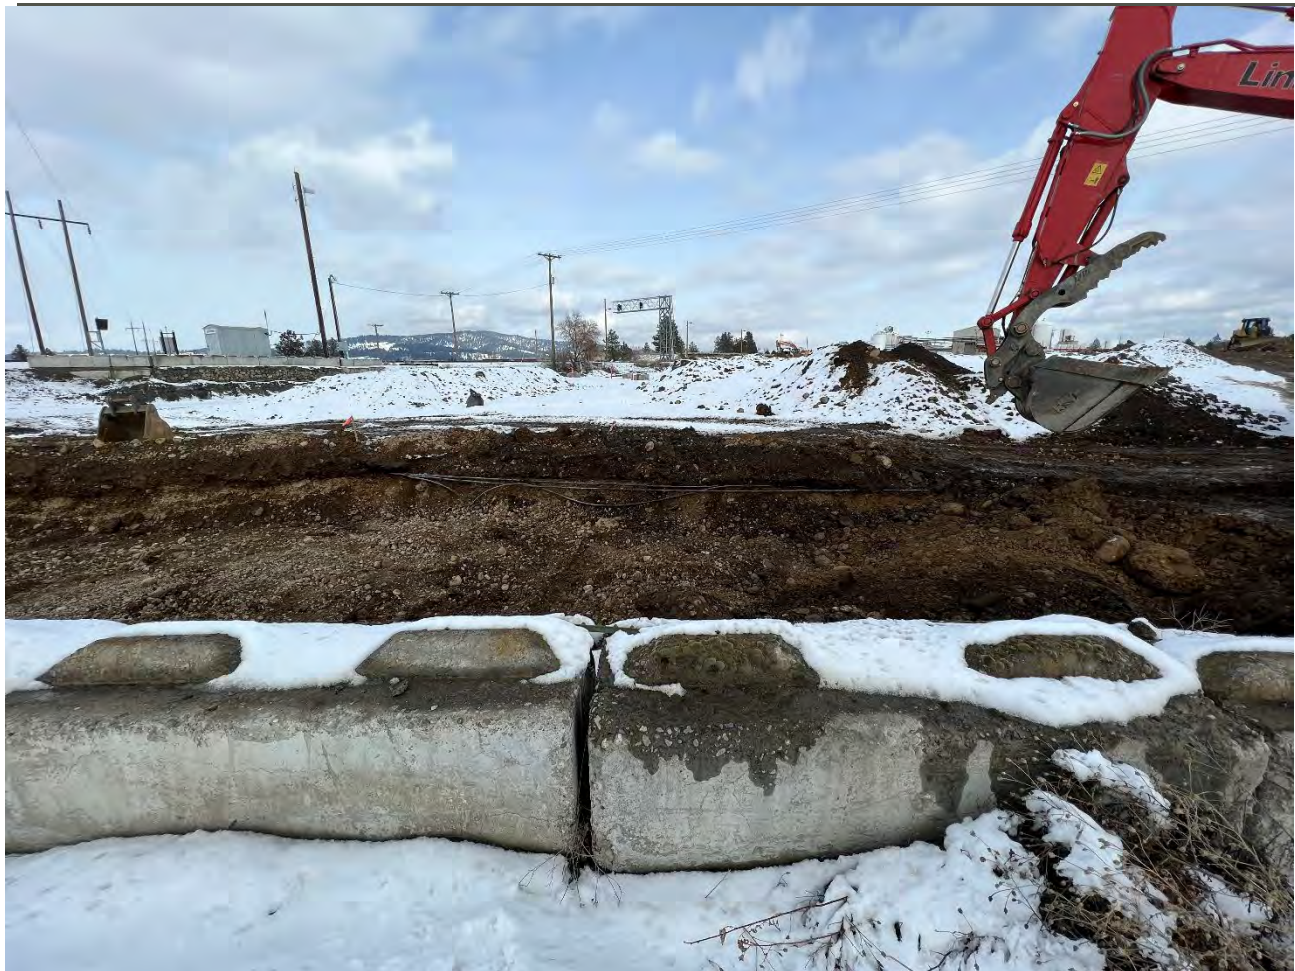
- During excavation of excavation 2 to a depth of 4-ft, GrayMar uncovered a buried underground utility line. GrayMar continued to dig/uncover 15-20-ft of the buried line before stopping work around the line. Golder recommended GrayMar stop work in this area and call Avista to let them know what happened so that they can decide what they wanted to do. GrayMar called Avista who sent a dispatcher to look at the uncovered line. GrayMar said they would stop work in this area until they got further direction from Avista.

Photograph 4. Exposed utility line that GrayMar uncovered.

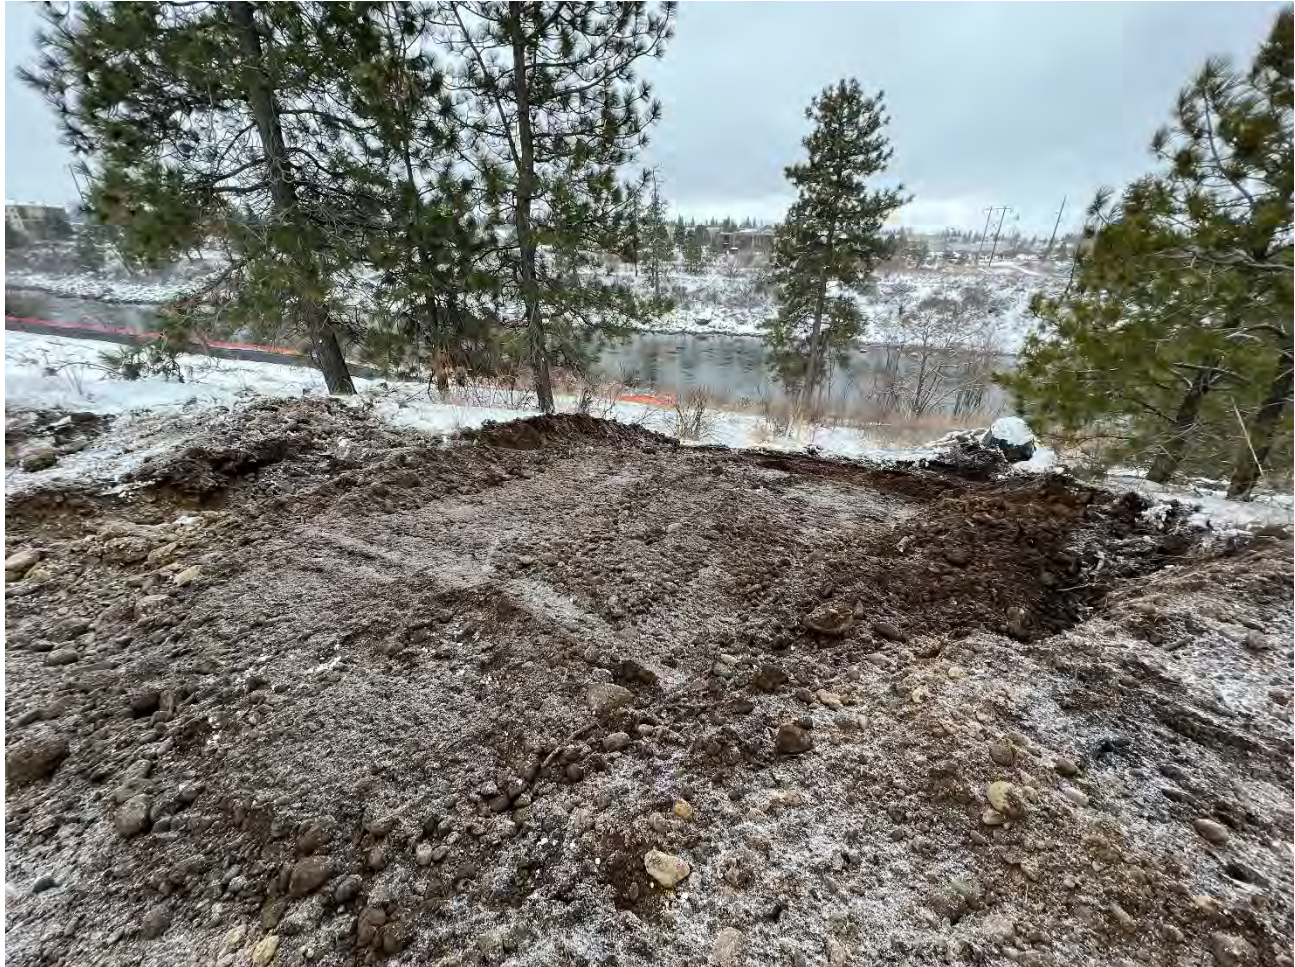
Photograph 1: Excavation of the NW corner of the Pentzer property to a depth of 2-ft.

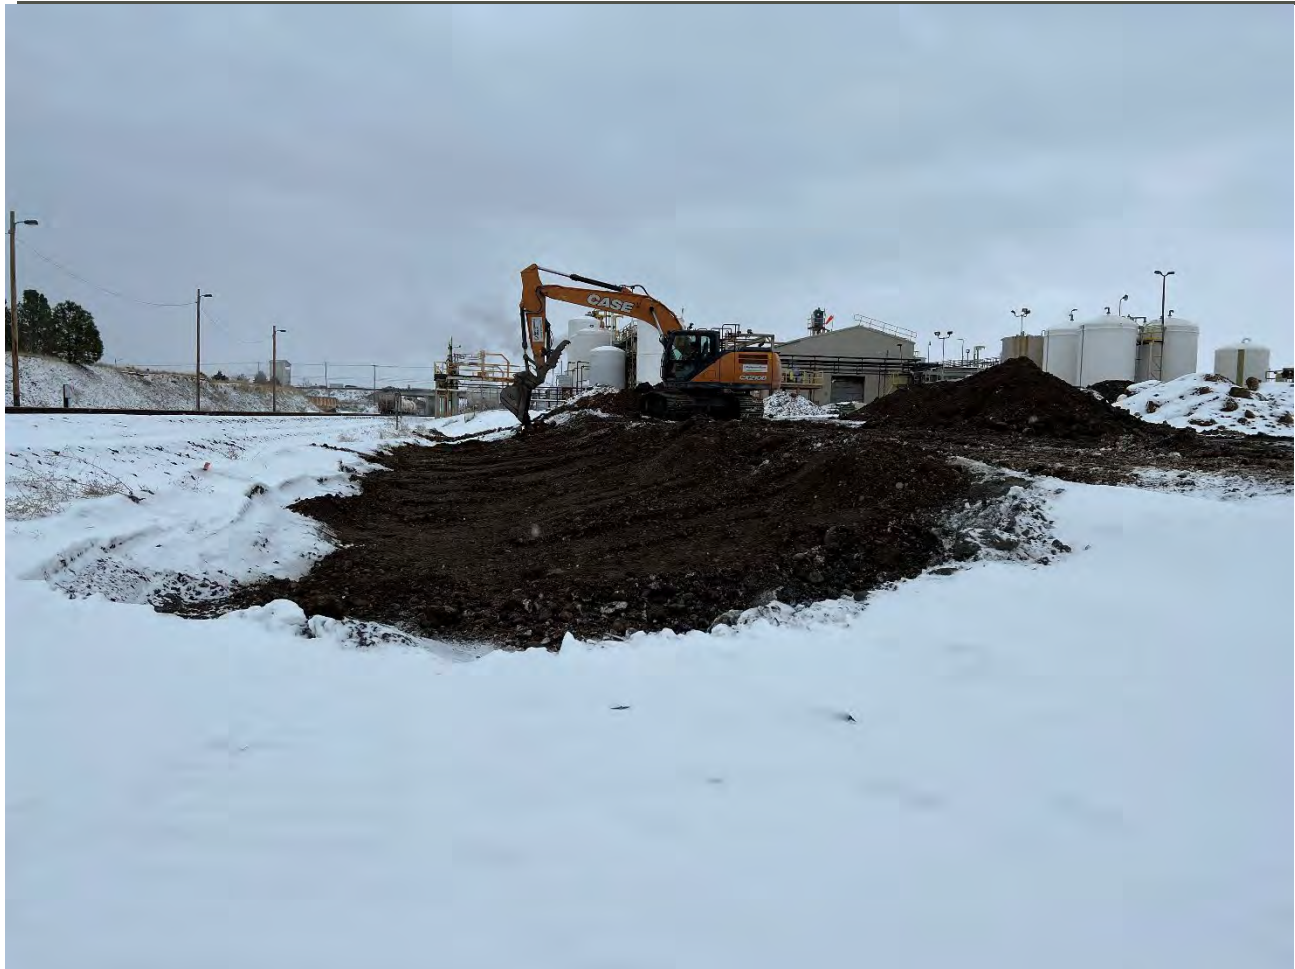
Photograph 2: Excavation of dross in the railroad ditch area on the UPRR property.

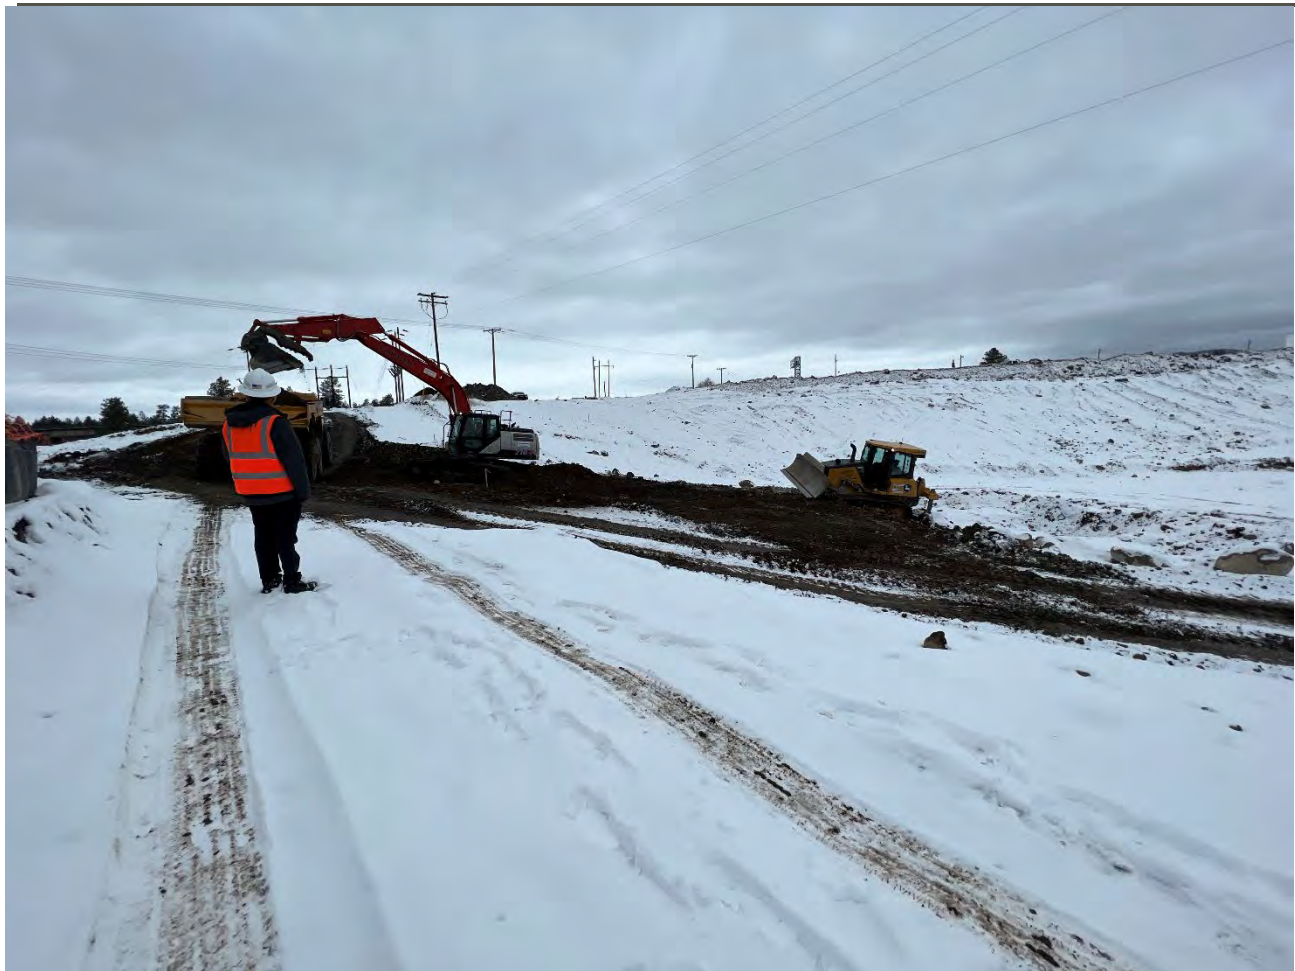
Photograph 3: Excavation of excavations 3 and 4 on WSDOT property and loading of the Volvo A45G Off-Road Haul Truck to haul material to the UPRR cap area.

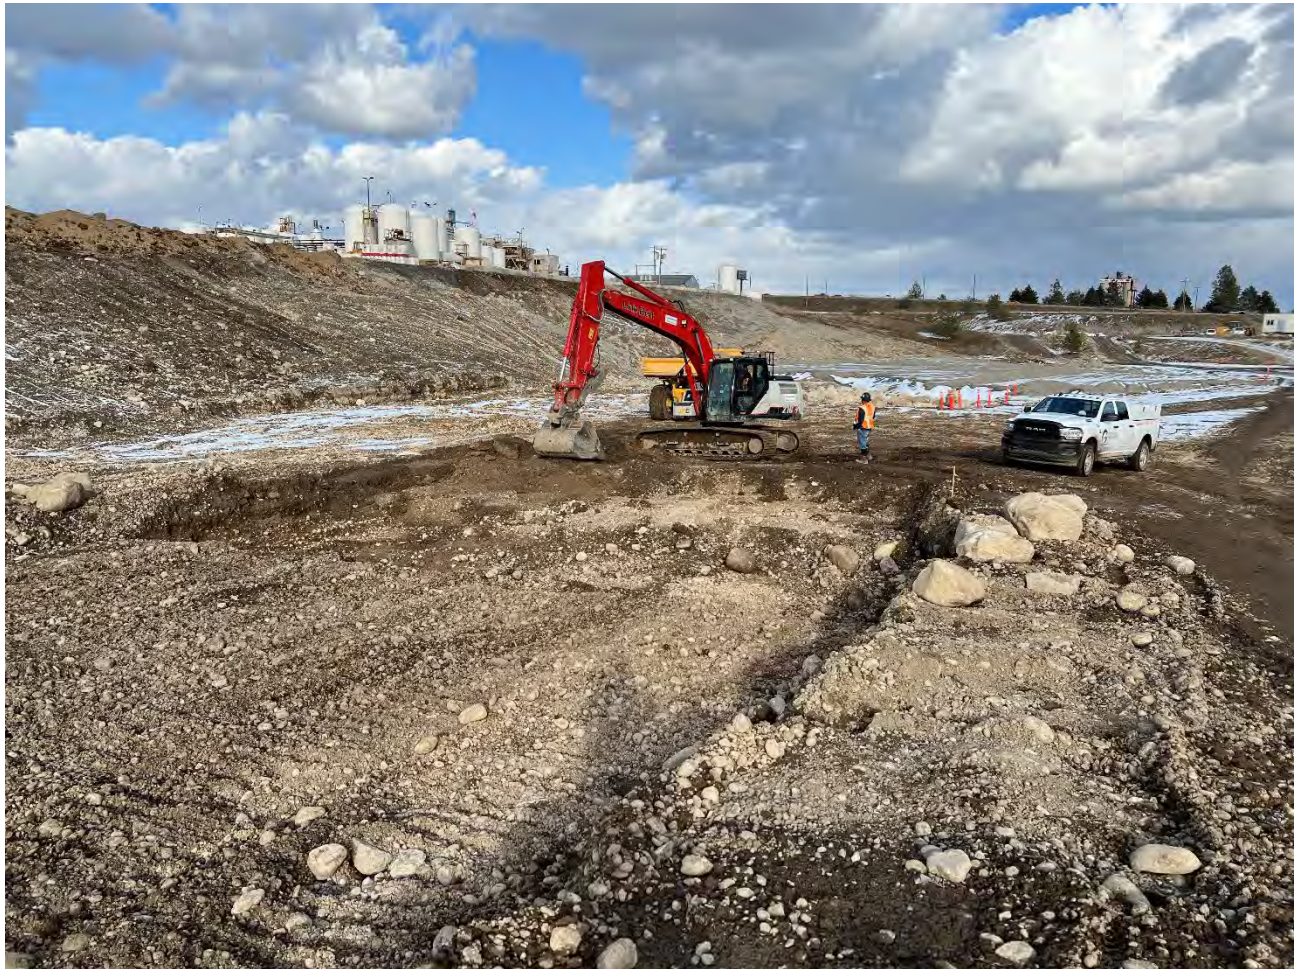
Photograph 1: Excavation 4 being excavated and the excavator removing additional dross visible to the east of excavation 4. View looking east.

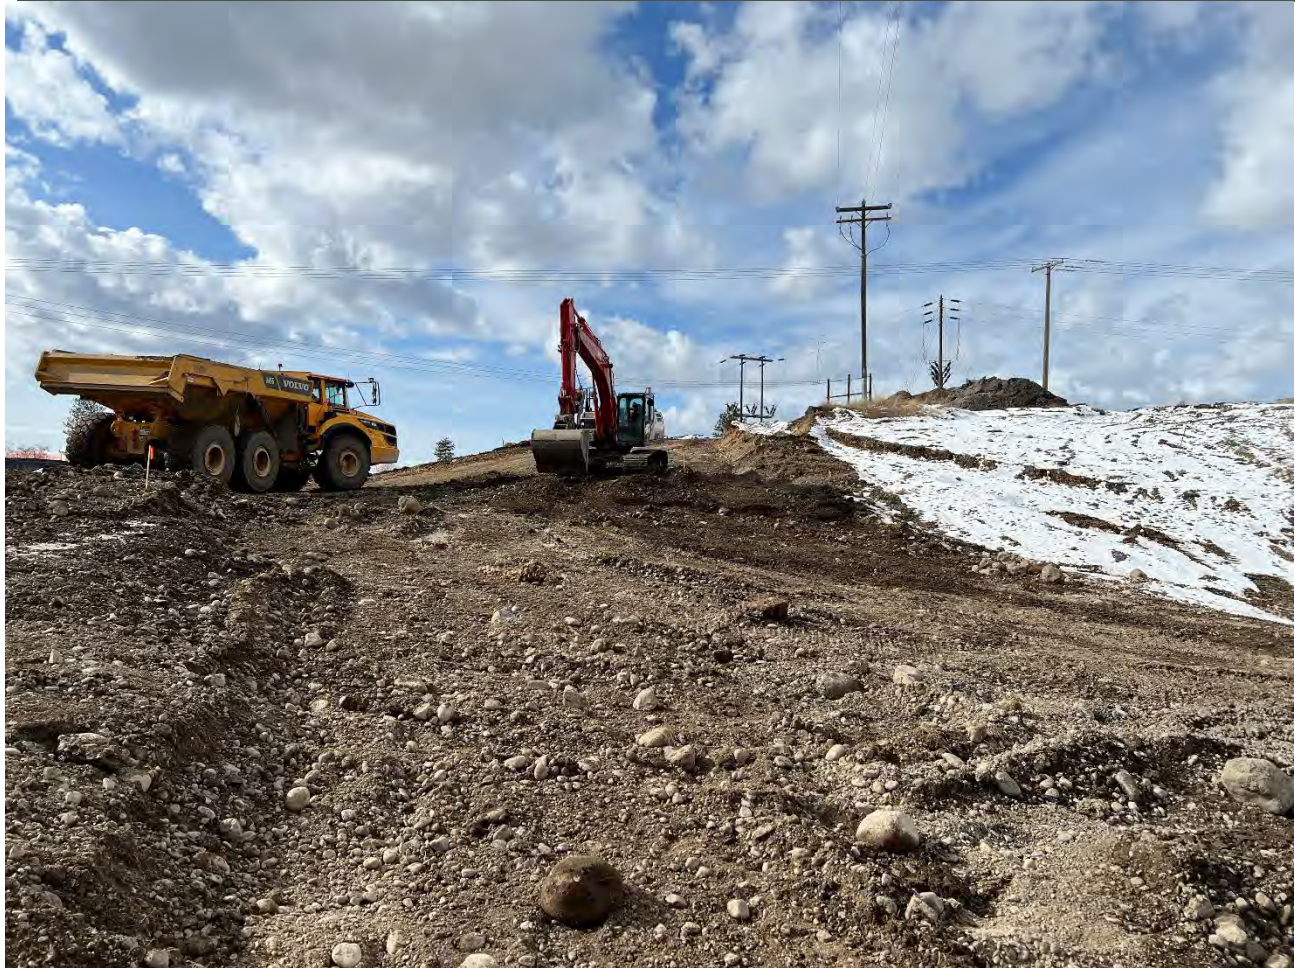
Photograph 2: Excavation 3 being excavated, and material being loaded into the off road haul truck to be hauled to the UPRR cap area. View looking west.

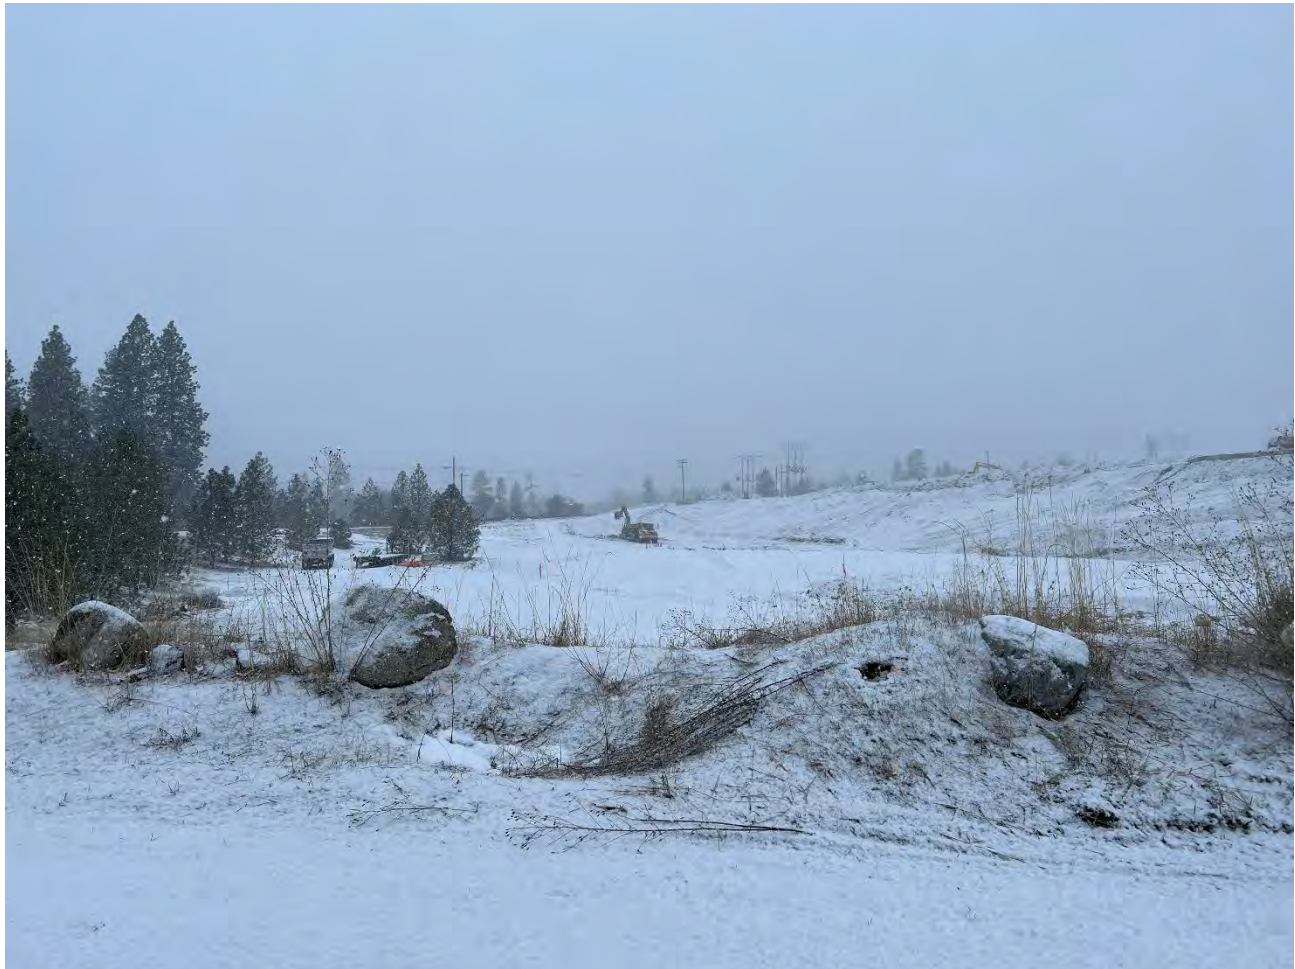
Photograph 1: Snowy conditions on site.

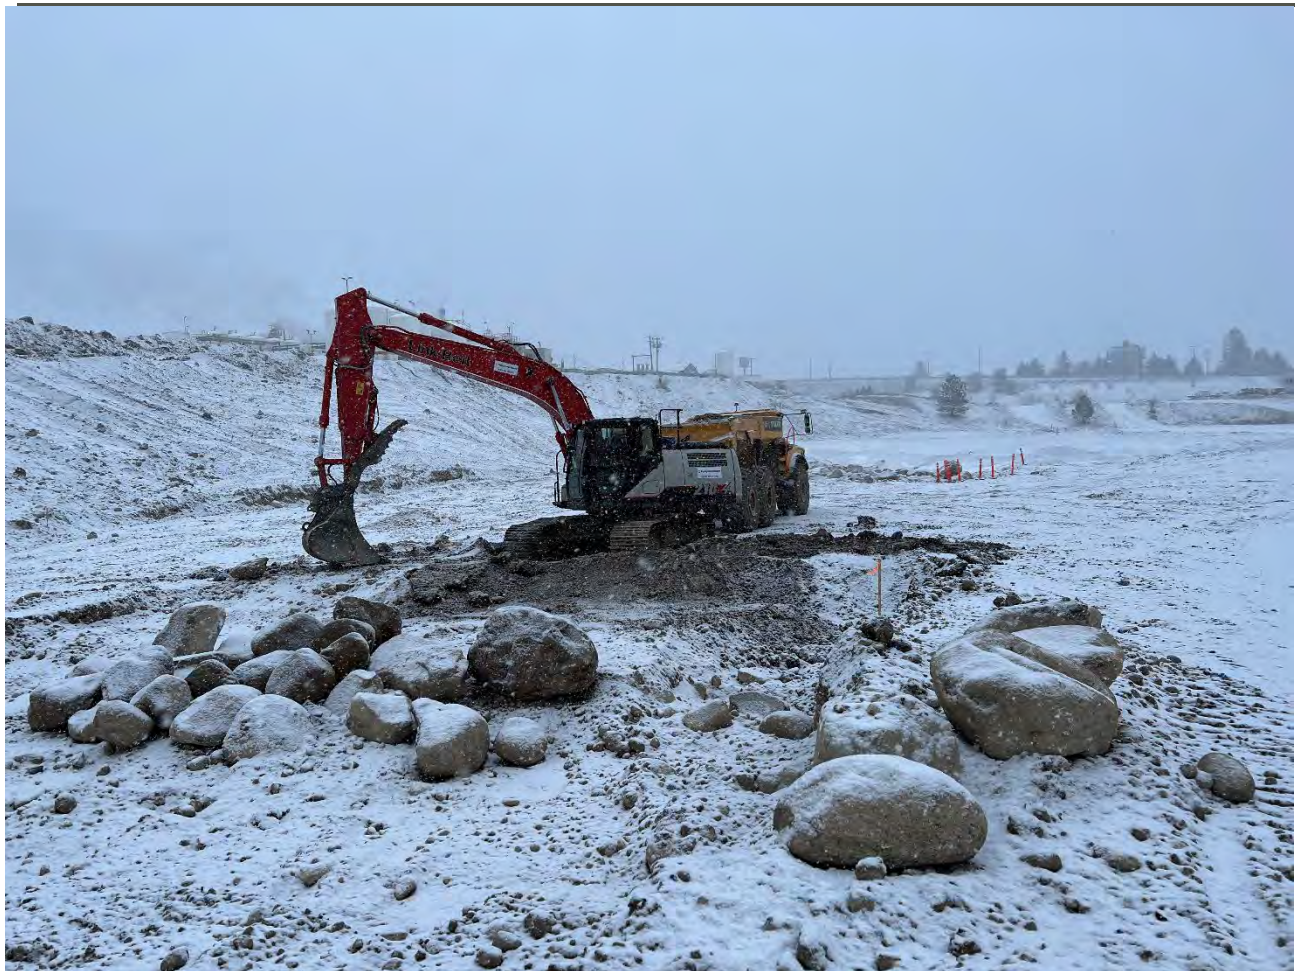
Photograph 2: Removal of additional dross observed on the east wall of excavation 4.

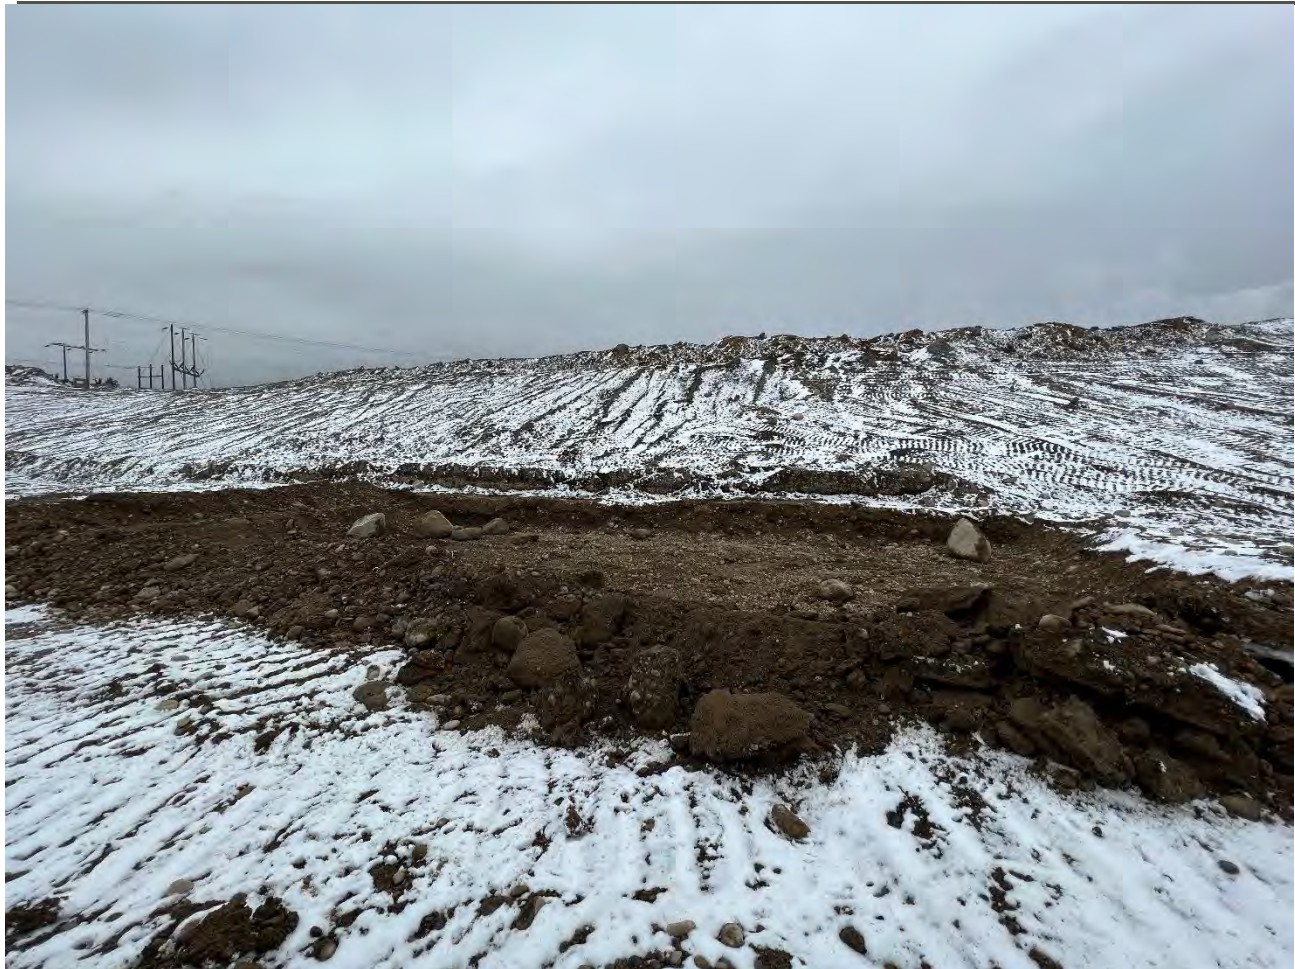
Photograph 3: W1-05 and W1-06 excavated an additional 2-ft for a total depth of 6-ft.

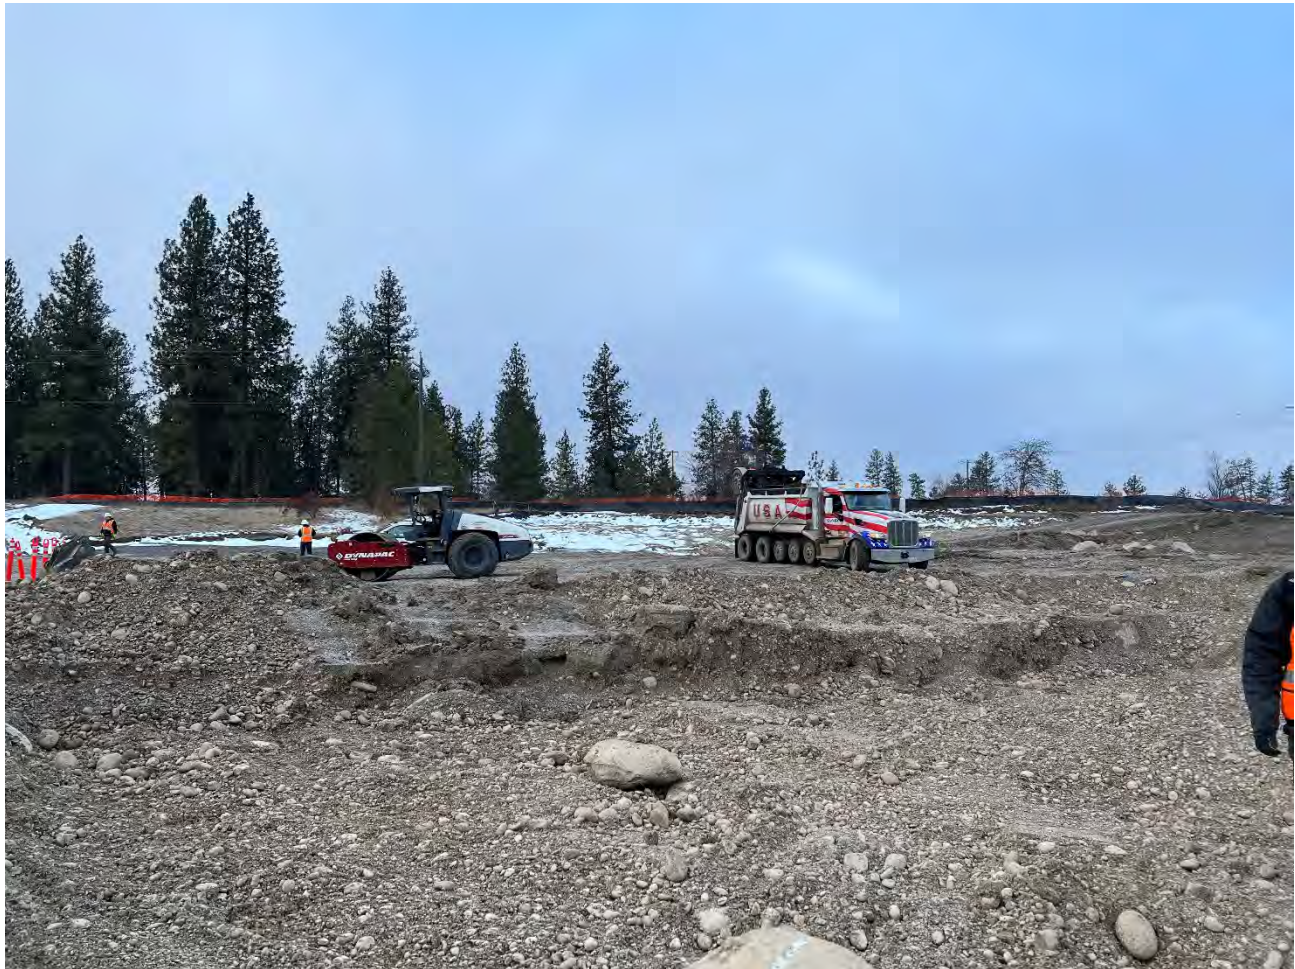
Photograph 1: Haul trucks beginning to place backfill material in SW corner of the WSDOT property.

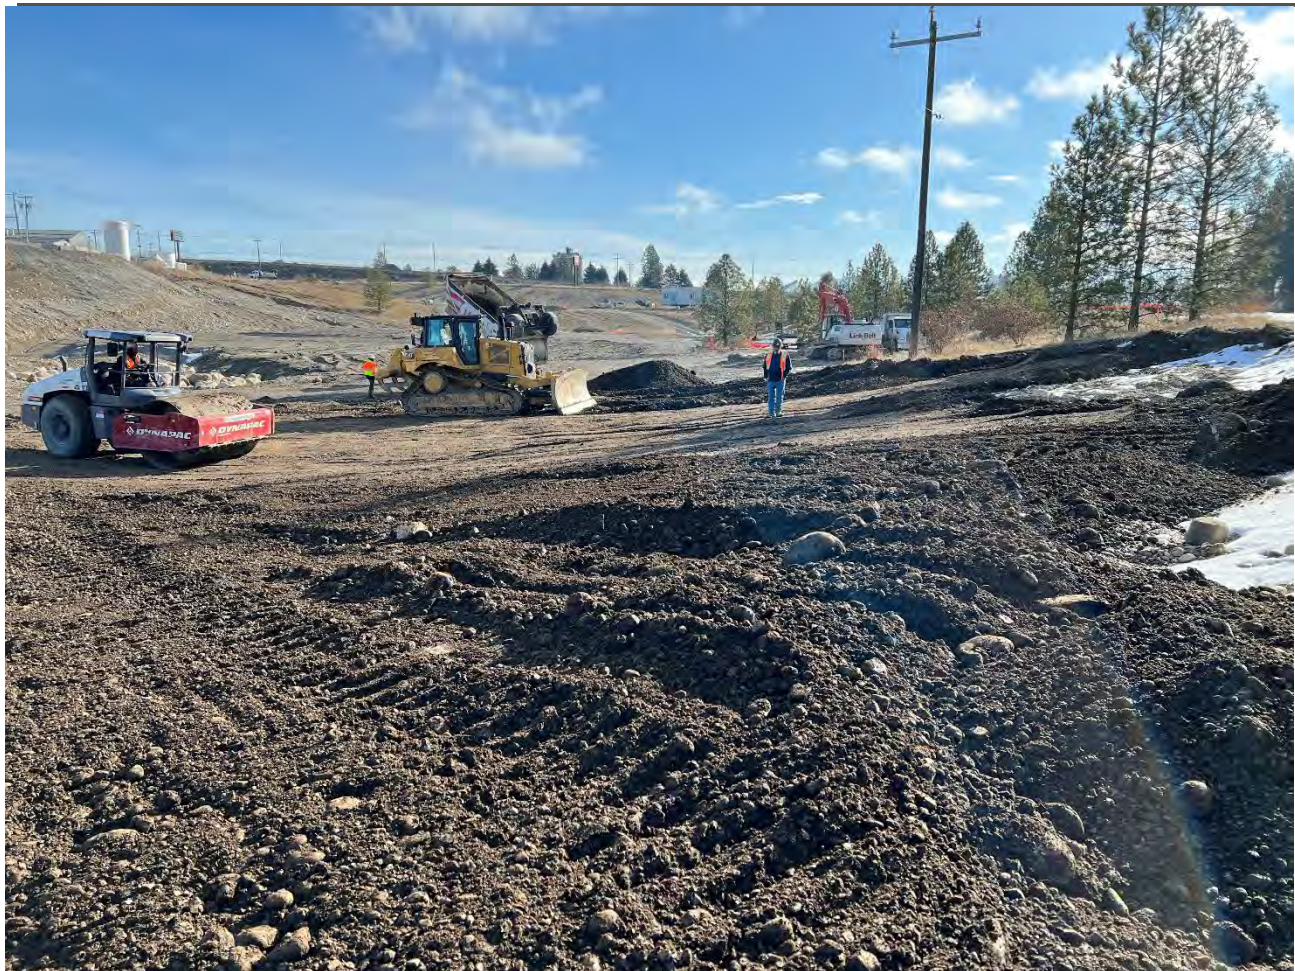
Photograph 2: Placing backfill material in 1-ft loose lifts and compacting it with the roller.

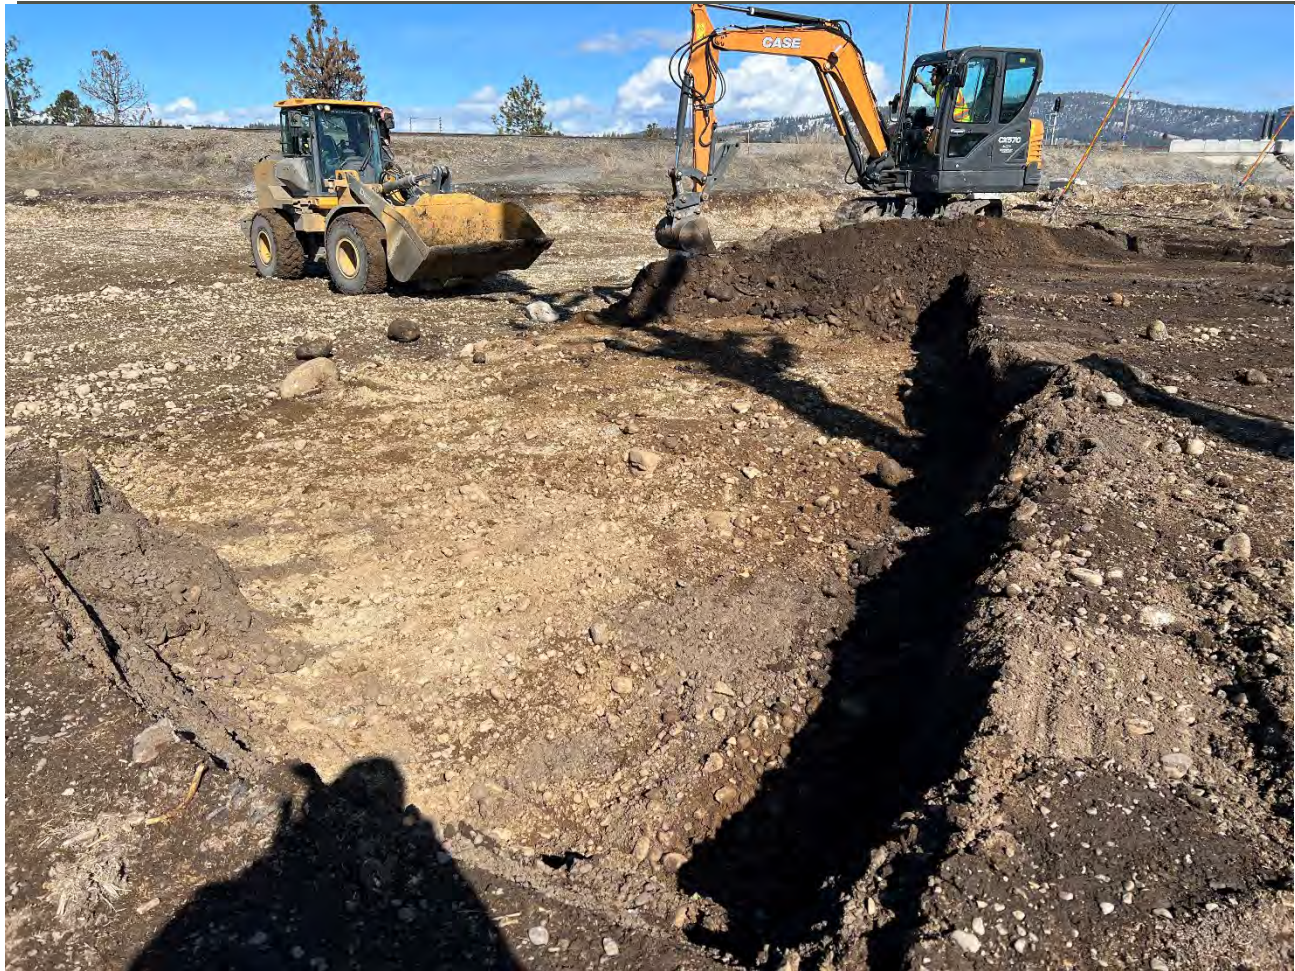
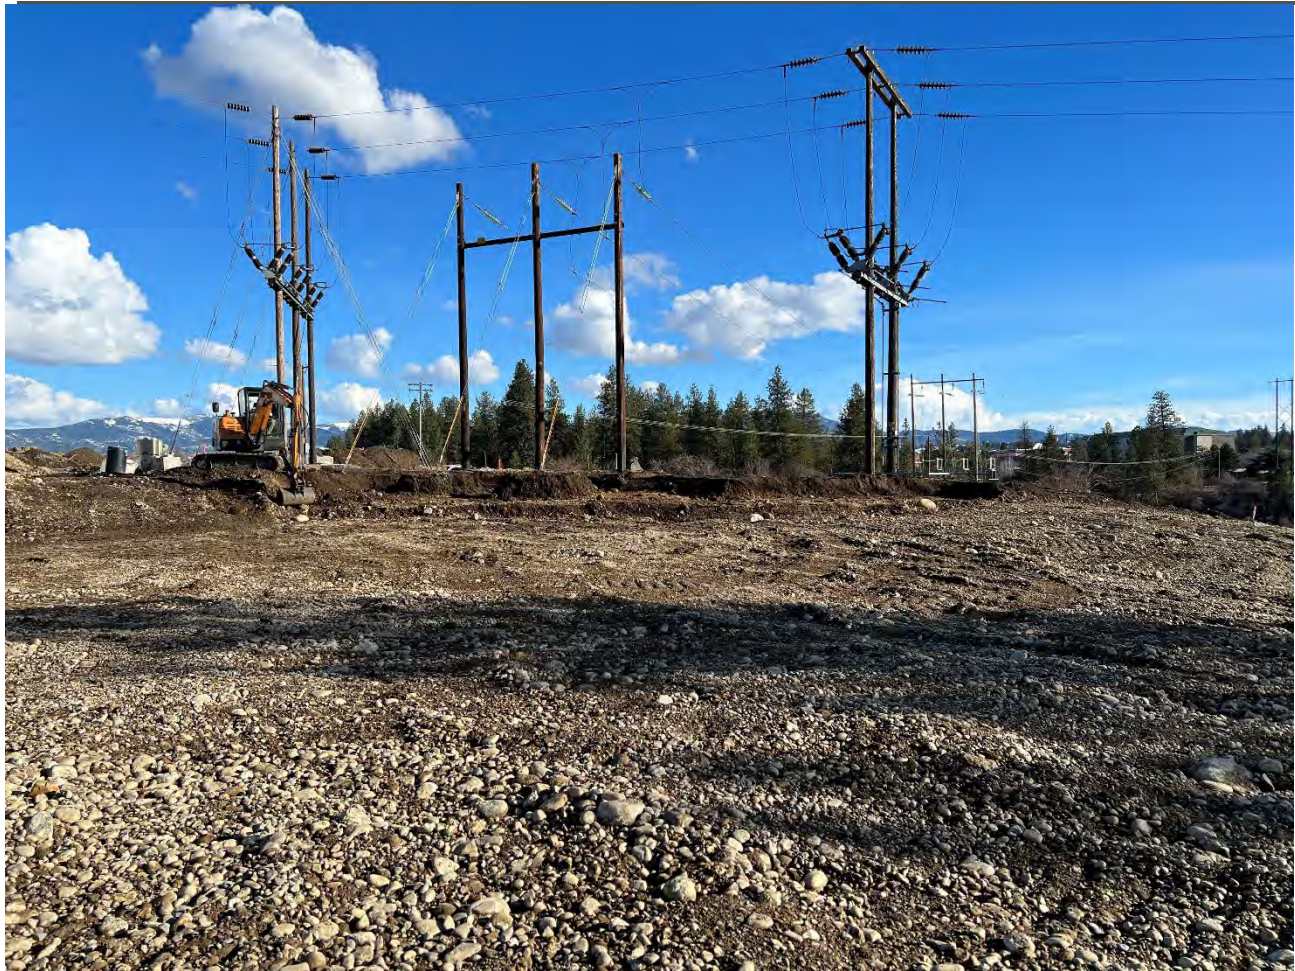
Photograph 3: Excavating around BPA infrastructure to a depth of 2-ft.

Photograph 4: Excavating around BPA infrastructure to a depth of 2-ft.
