GOLDER
MEMBER OF WSP

DAILY FIELD REPORT # 91

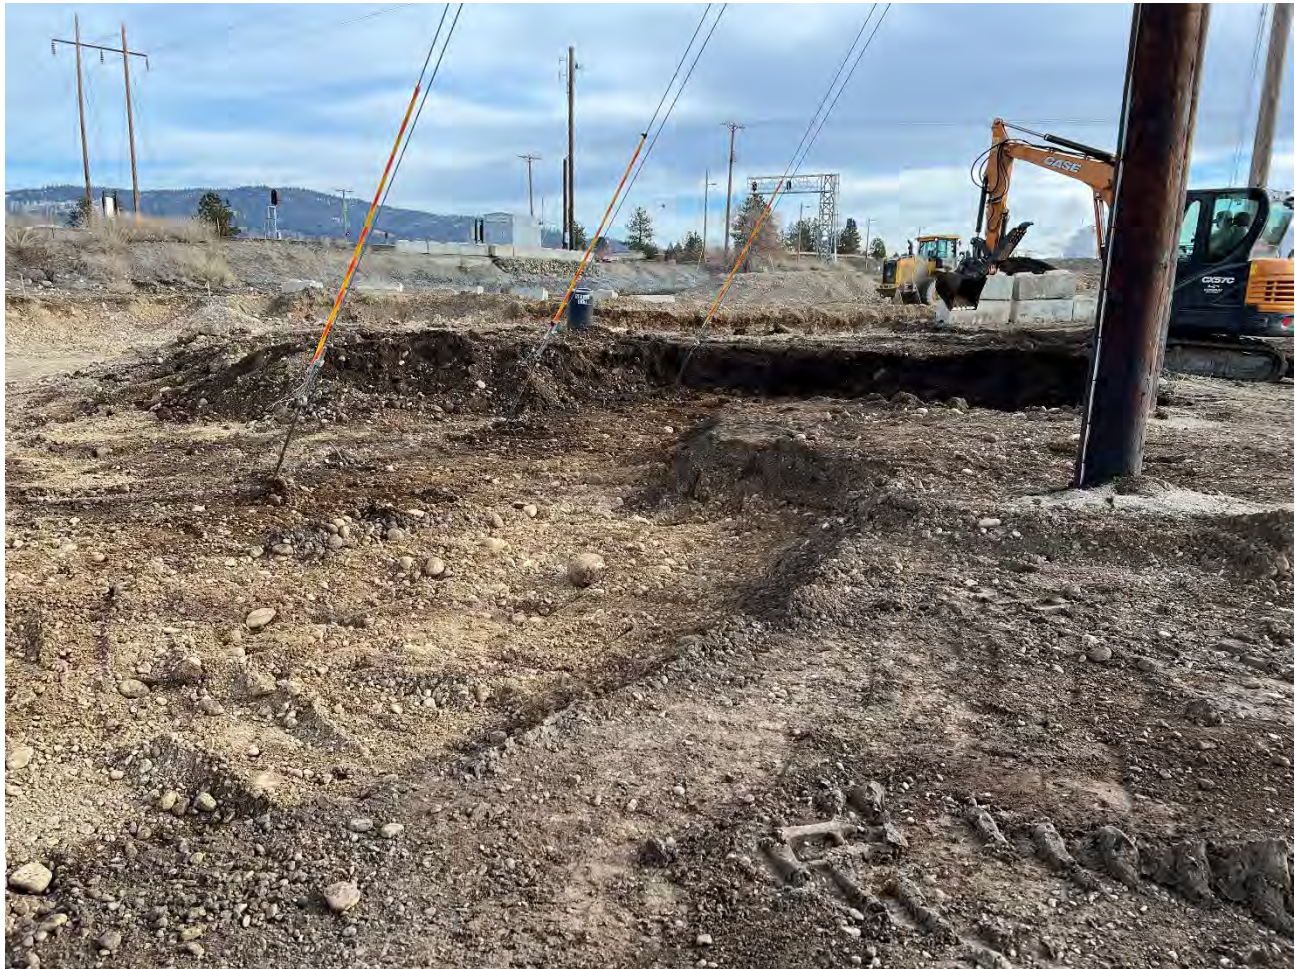
Photograph 1: Excavation around BPA infrastructure on the Pentzer property to a depth of 2-ft. Excavation slightly more than 2-ft around guywires.

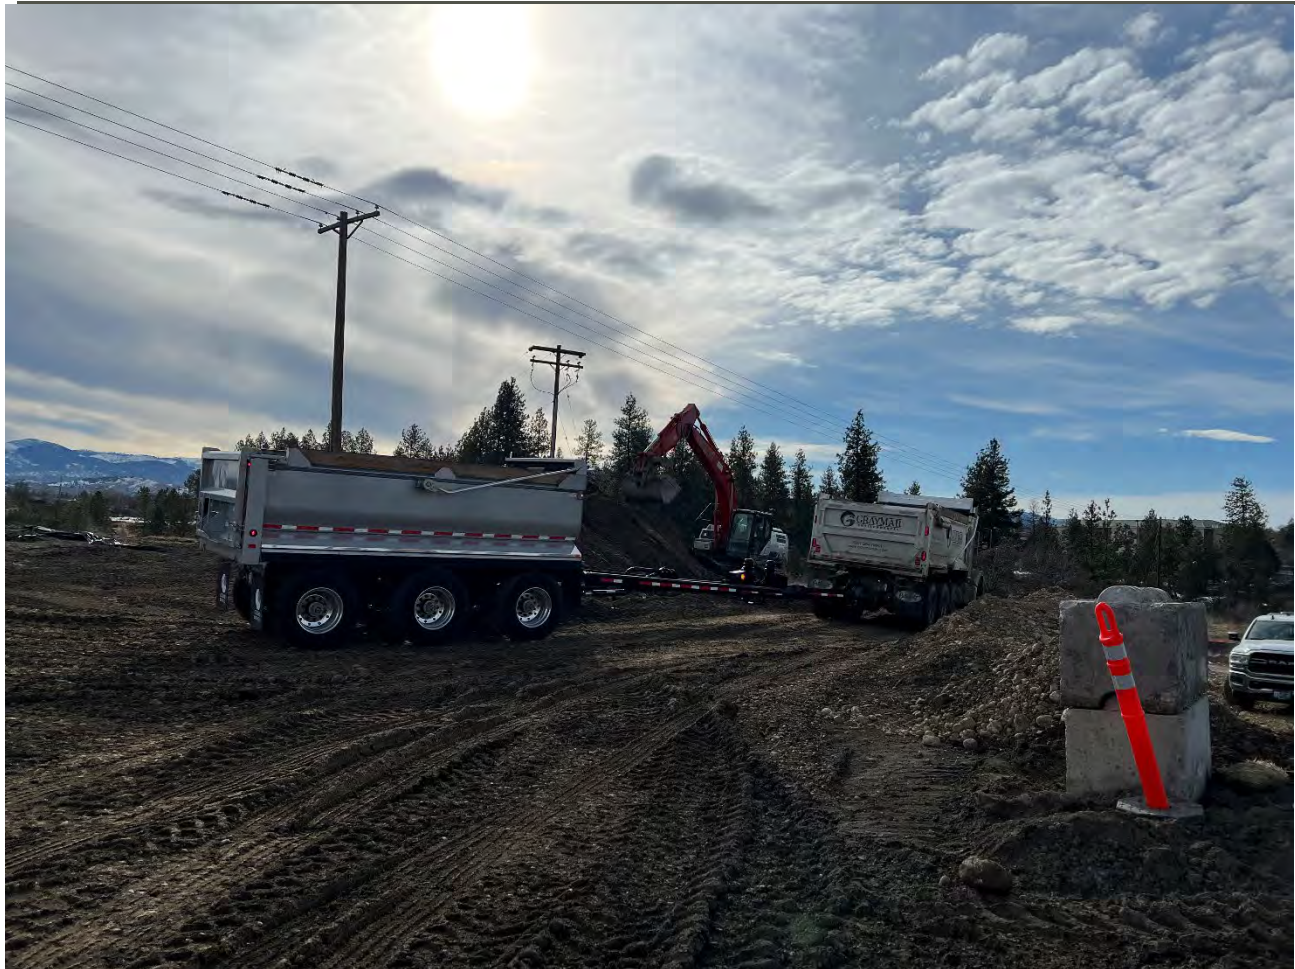
Photograph 2: GrayMar hauling topsoil, vegetation, and excess cross stockpile offsite.

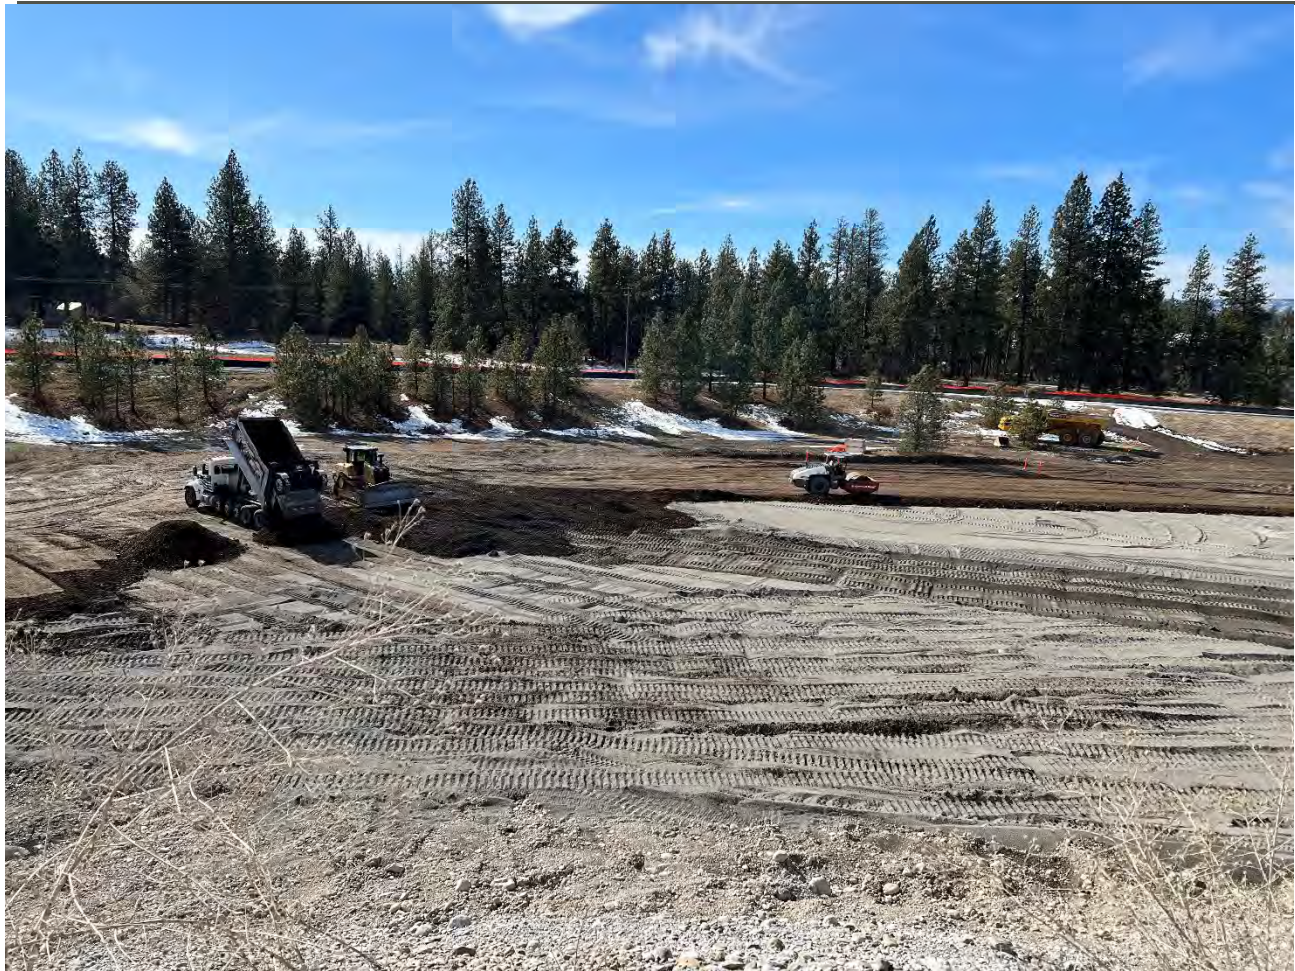
Photograph 3: Placing, spreading, and rolling backfill on WSDOT property.

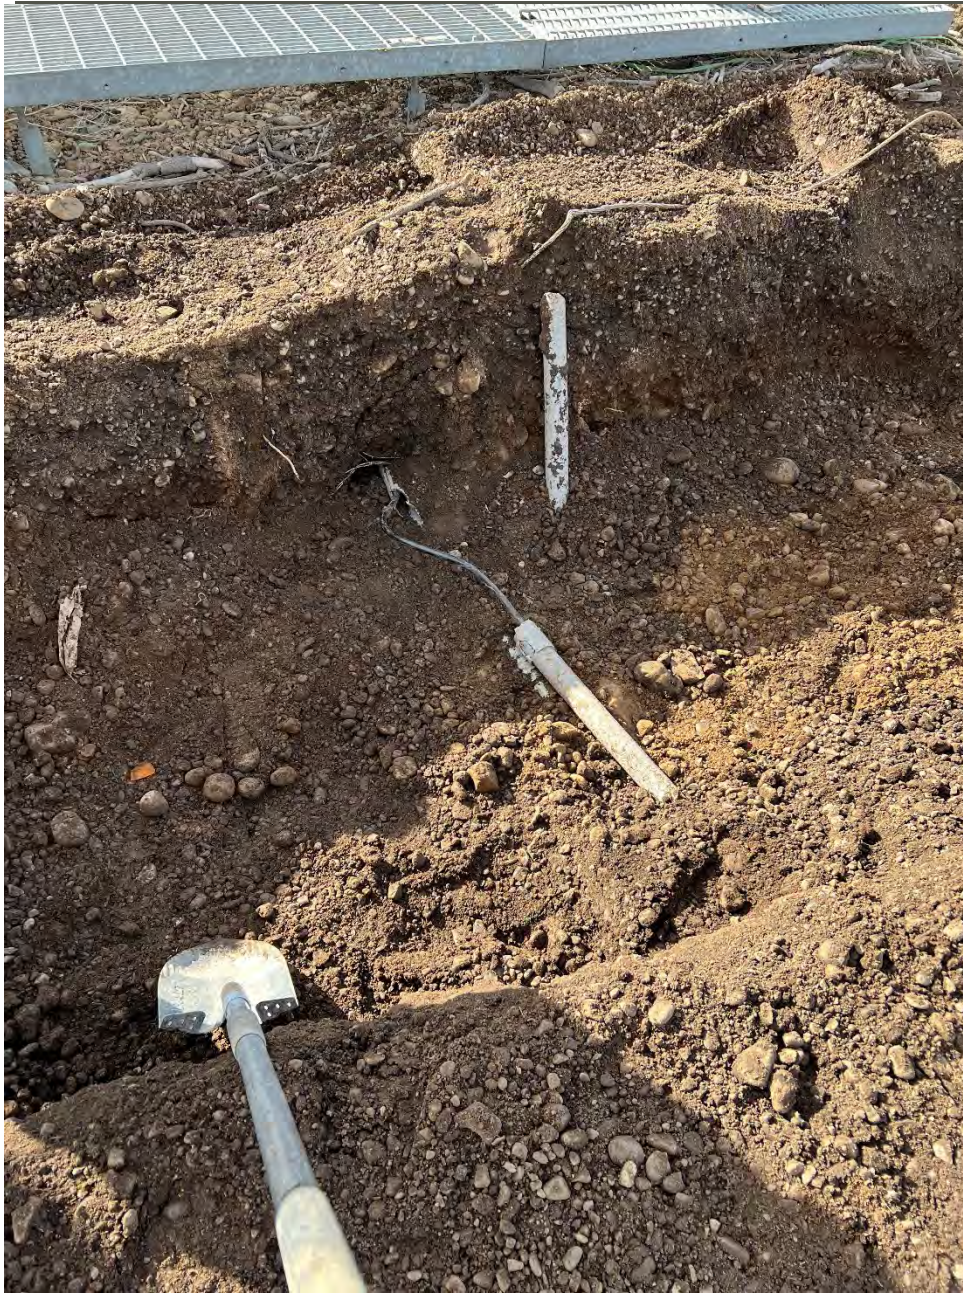
- GrayMar uncovered BPA's grounding wires and broke one of the conduits while excavating. See Photograph 4. A wire was also pulled out of the prongs it was connected to on the power pole when this happened. GrayMar stopped excavating after this happened so that BPA personnel on site could inspect the infrastructure. BPA reconnected the wire to the prongs on the power pole and inspected their underground infrastructure. BPA reported they saw no damage other than the broken conduit and no safety hazards were imminent. BPA requested GrayMar leave the wire and broken conduit exposed while they decide what they want to do with it. BPA also requested GrayMar take extra precautions around the grounding infrastructure now that they know the location and depth of the wires and conduit (i.e., use hand tools around the buried wires and conduits).

Photograph 4: Exposed BPA grounding infrastructure with the wire conduit broken.

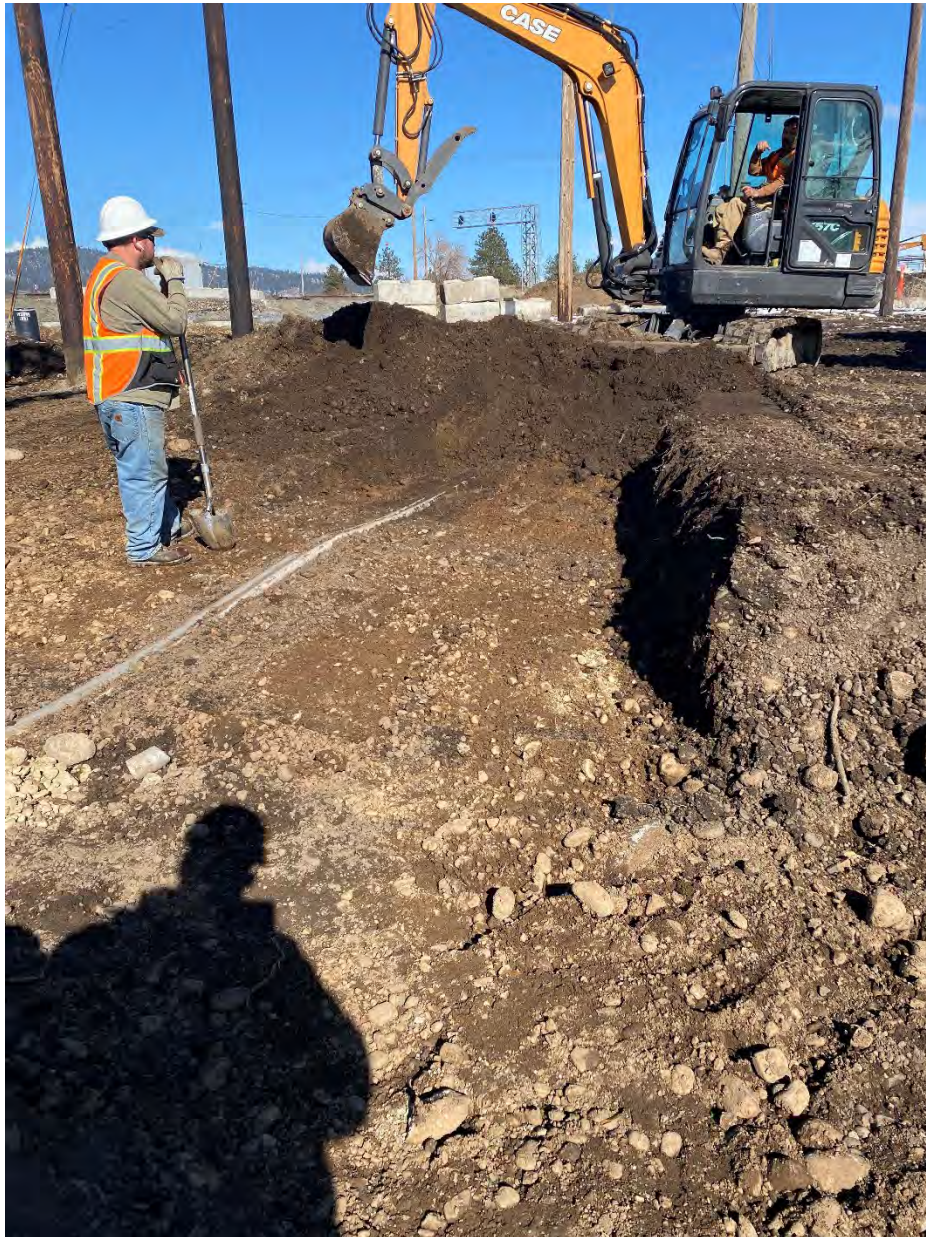
Photograph 1: Excavation around BPA infrastructure on the Pentzer property to a depth of 2-ft. Hand digging around ground wire conduit.

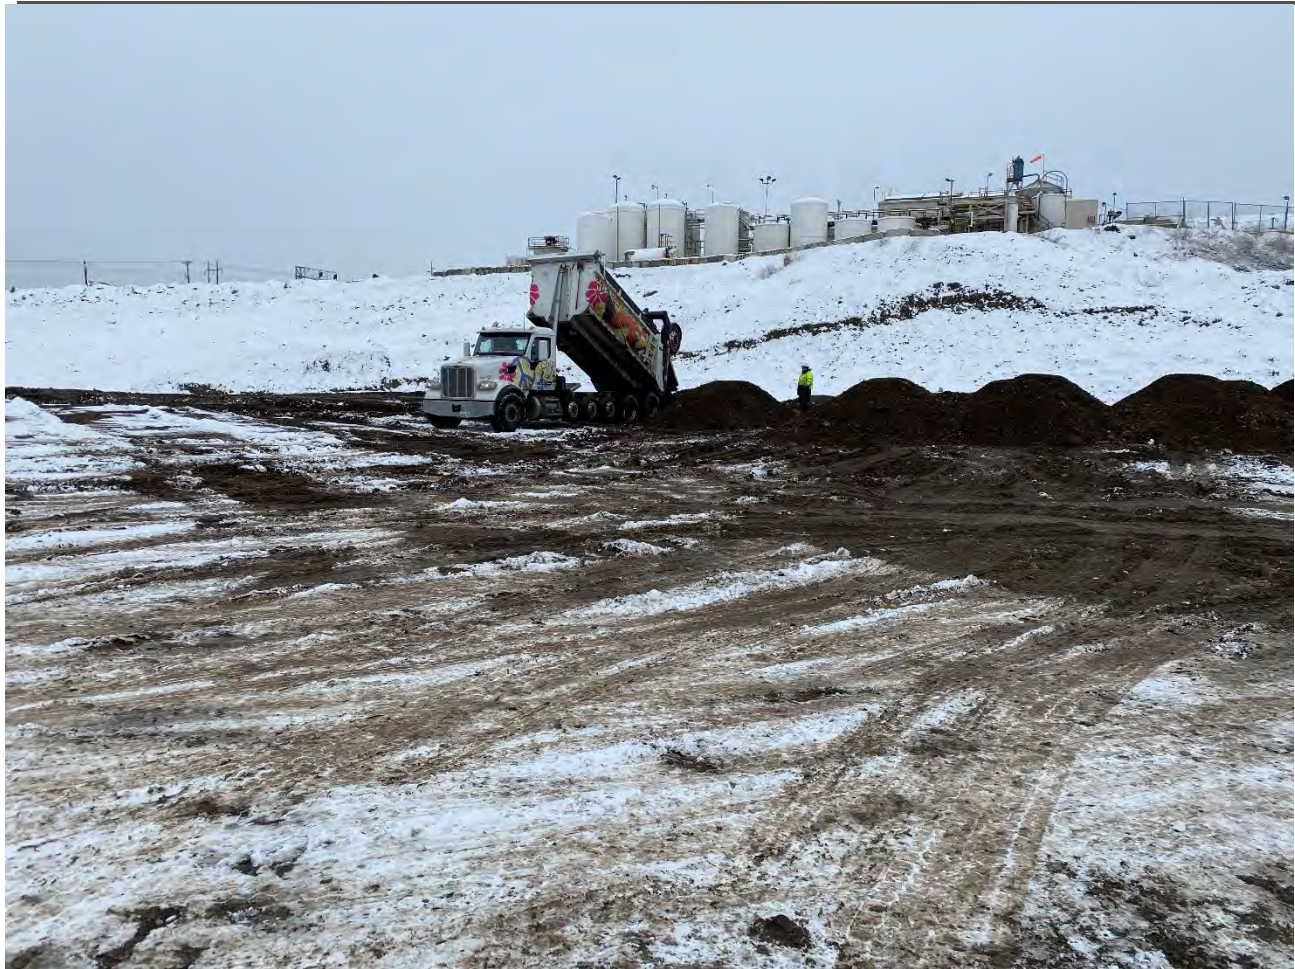
Photograph 2: Importing #5 backfill onto WSDOT Property in the morning

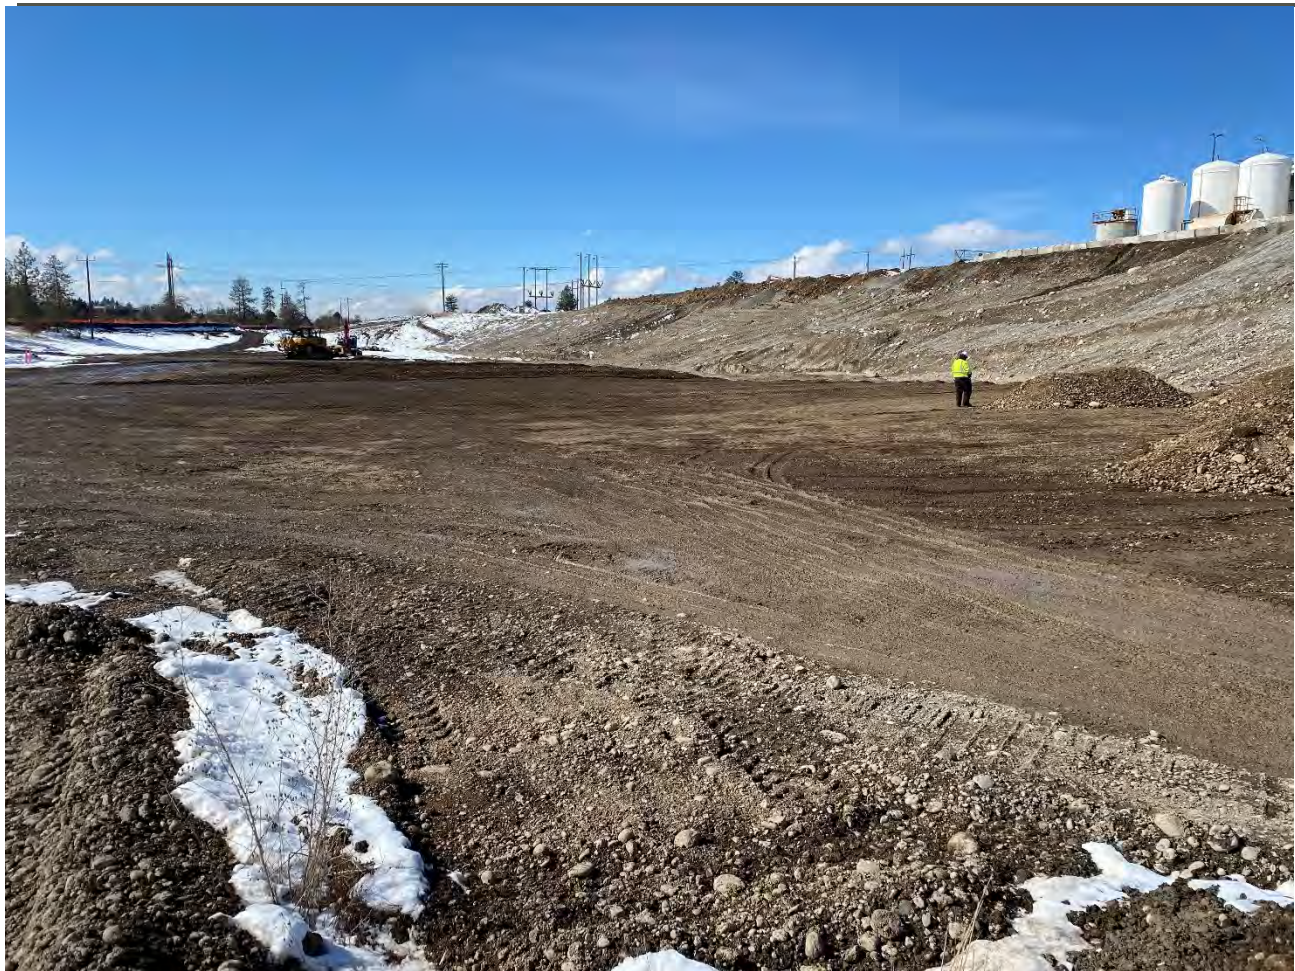
Photograph 3: Compacted backfill on WSDOT property in the afternoon.

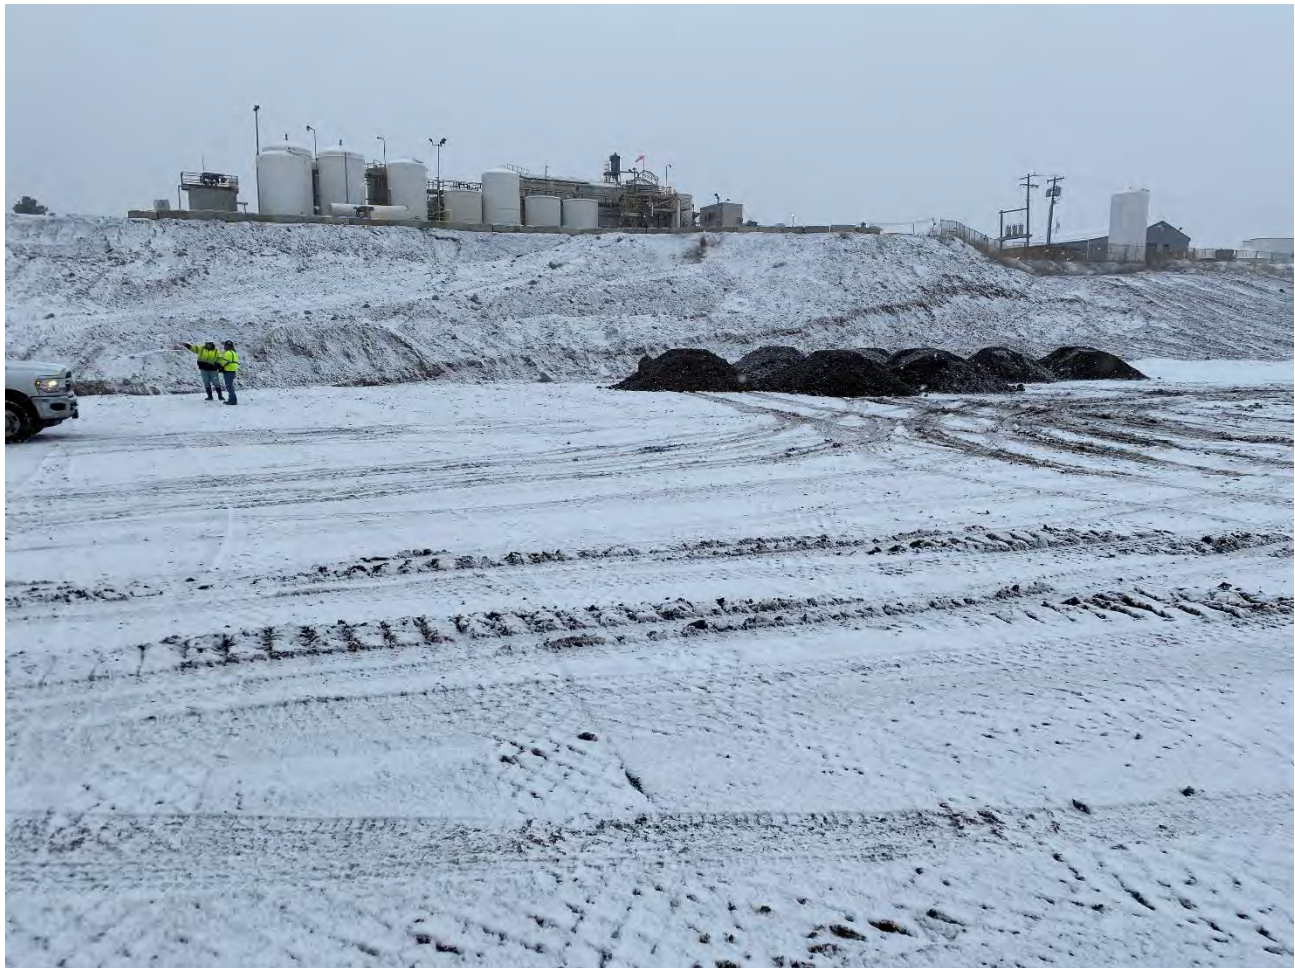
Photograph 1: Placement of backfill #5 on WSDOT.

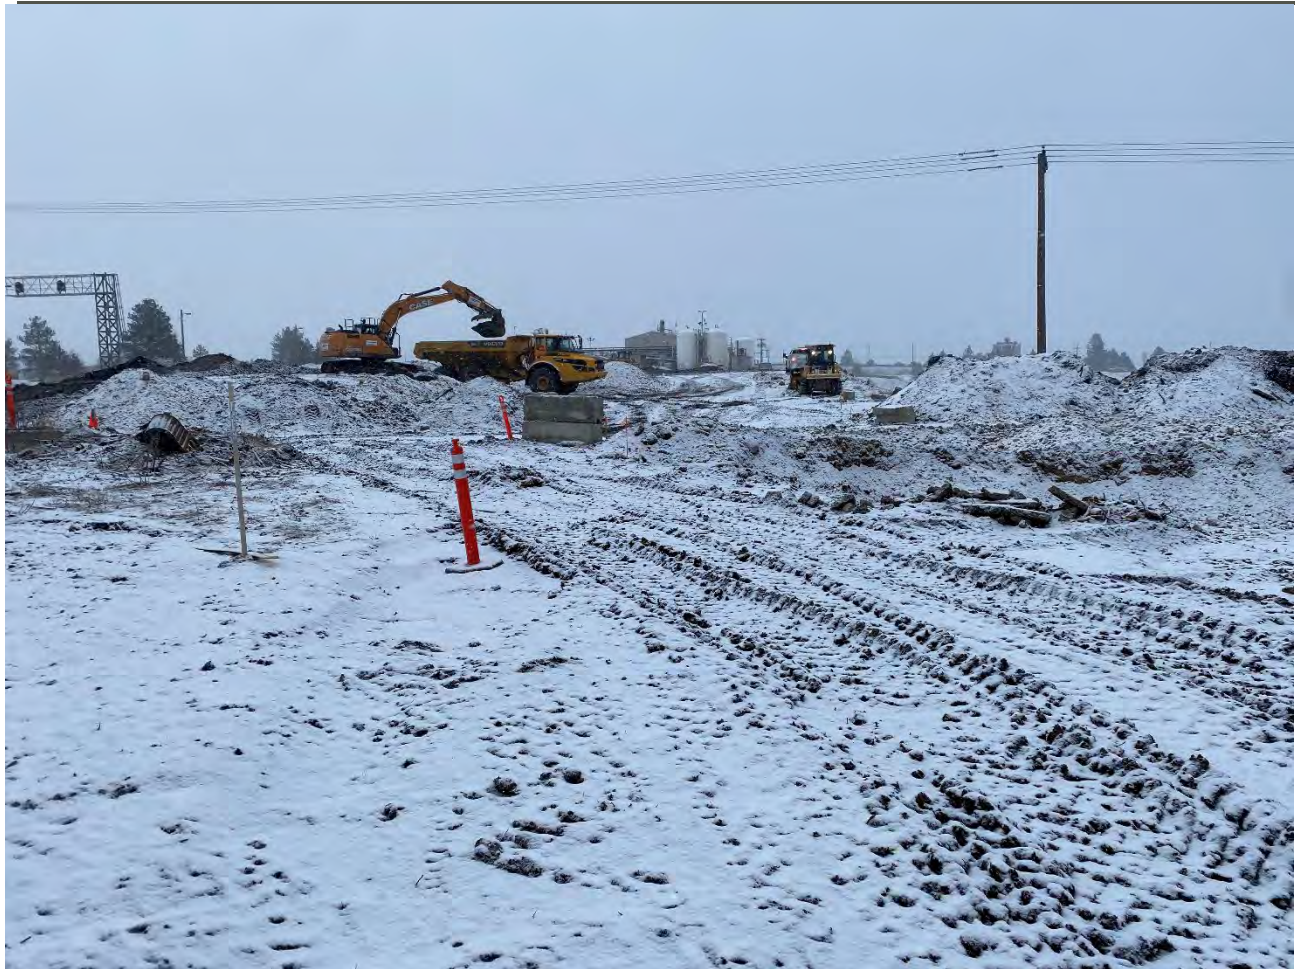
Photograph 2: Building subgrade in upper UPRR cap area.

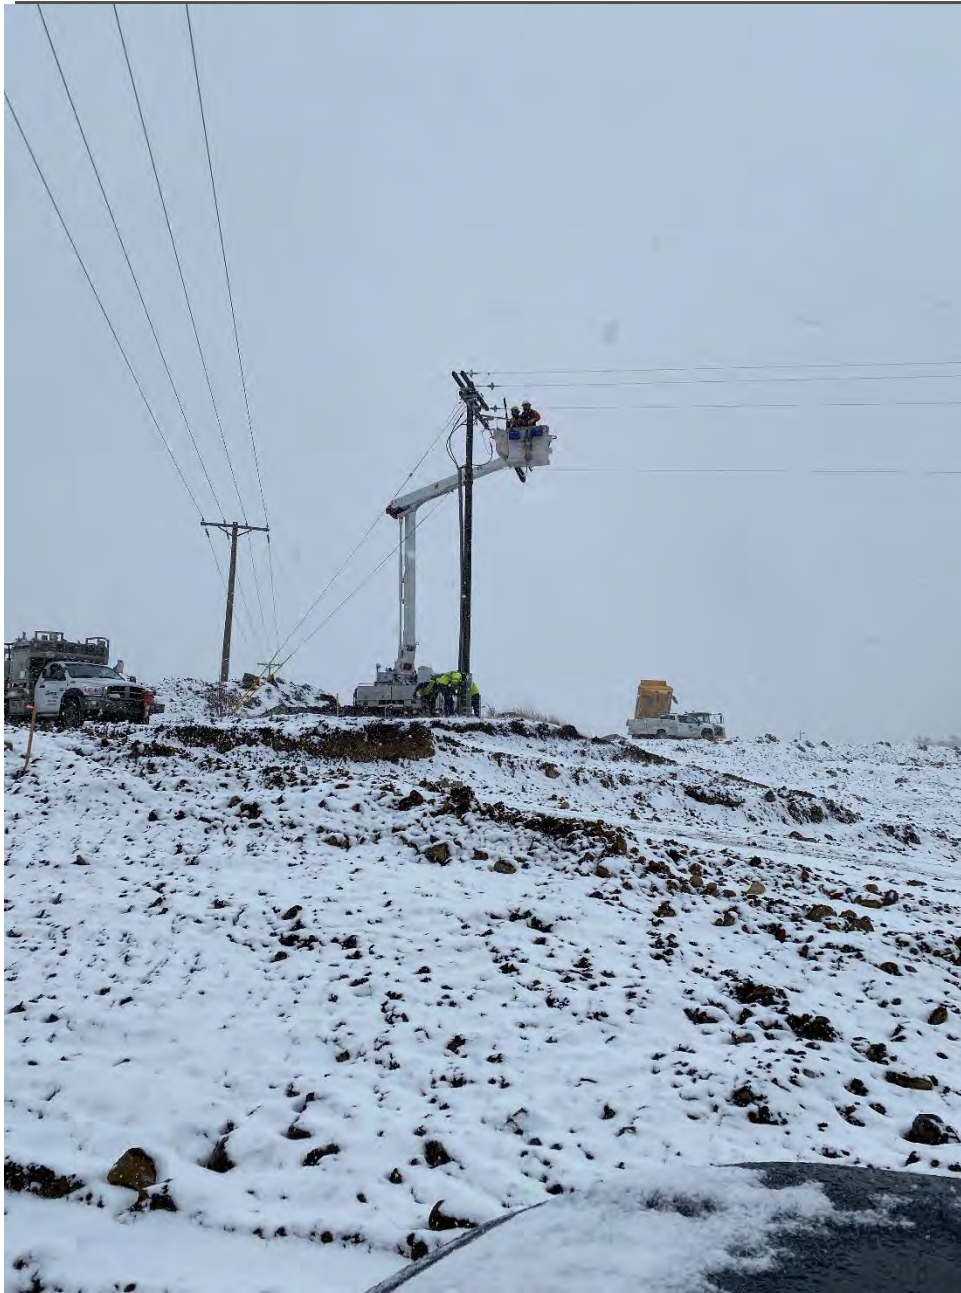
Photograph 3: Avista cutting/removing abandoned lines from utility pole.

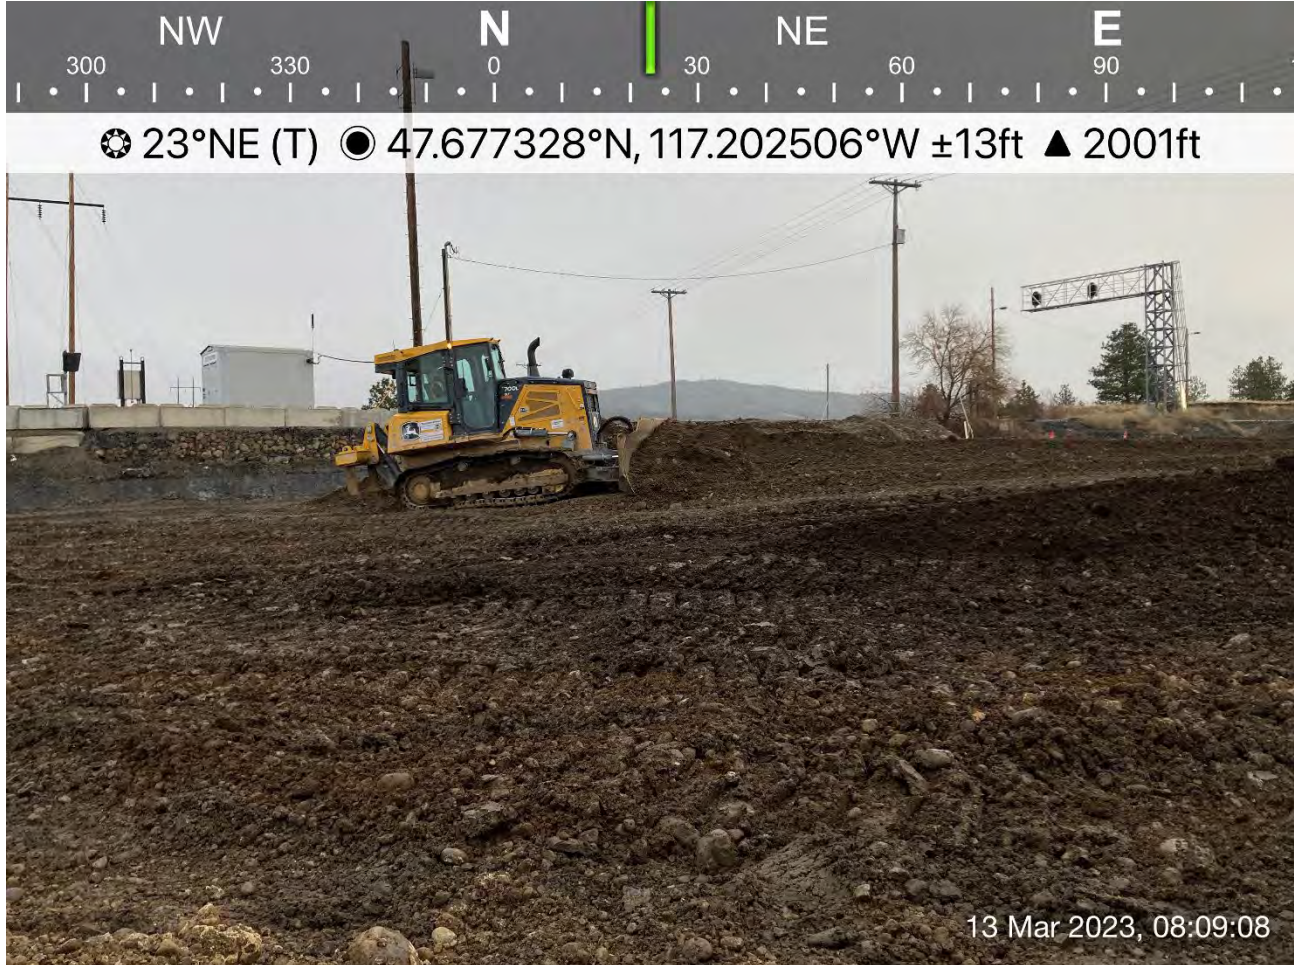
Photograph 1: John Deere 700L dozer utilized to transfer stockpiled excavated materials from the Pentzer property to the UPRR cap area to be placed under the cap.

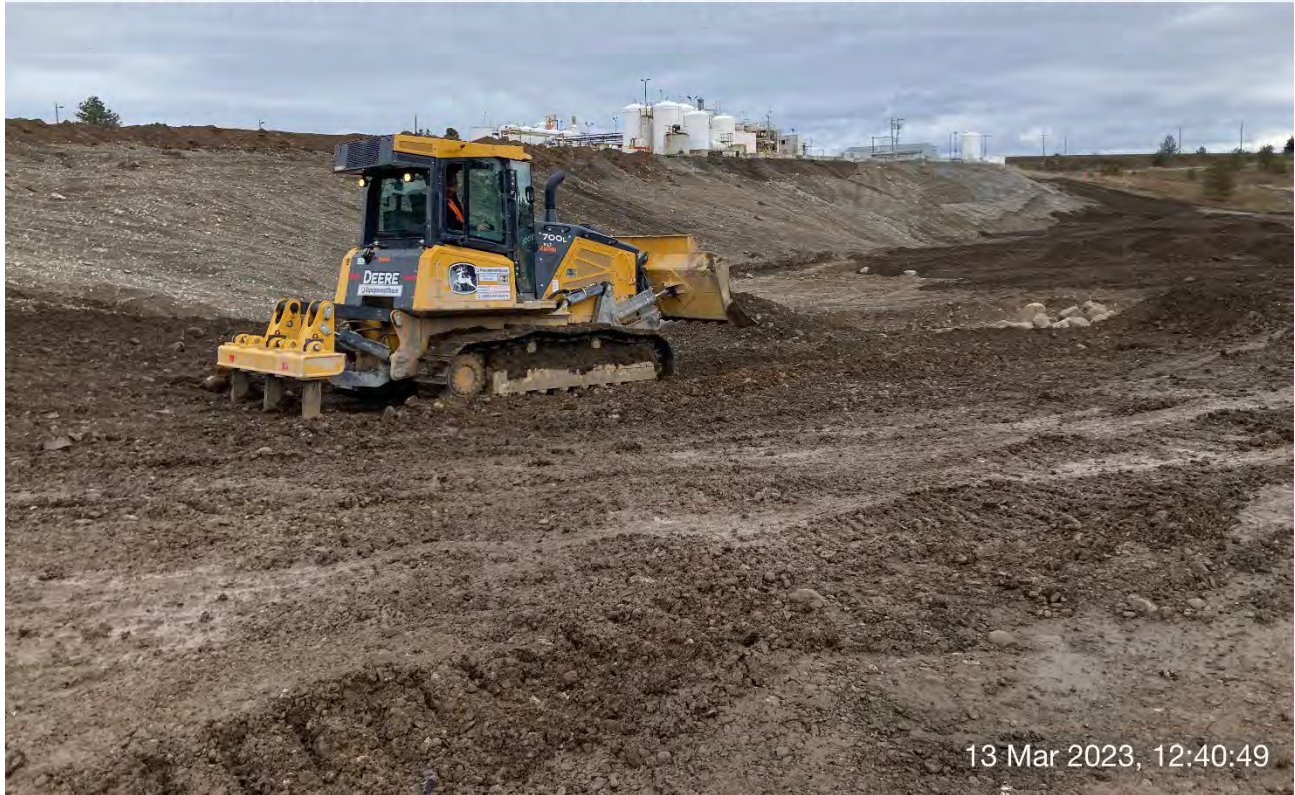
Photograph 2: GrayMar utilizing the John Deere 700L dozer to expand the southern portion of Excavation 3 & 4.

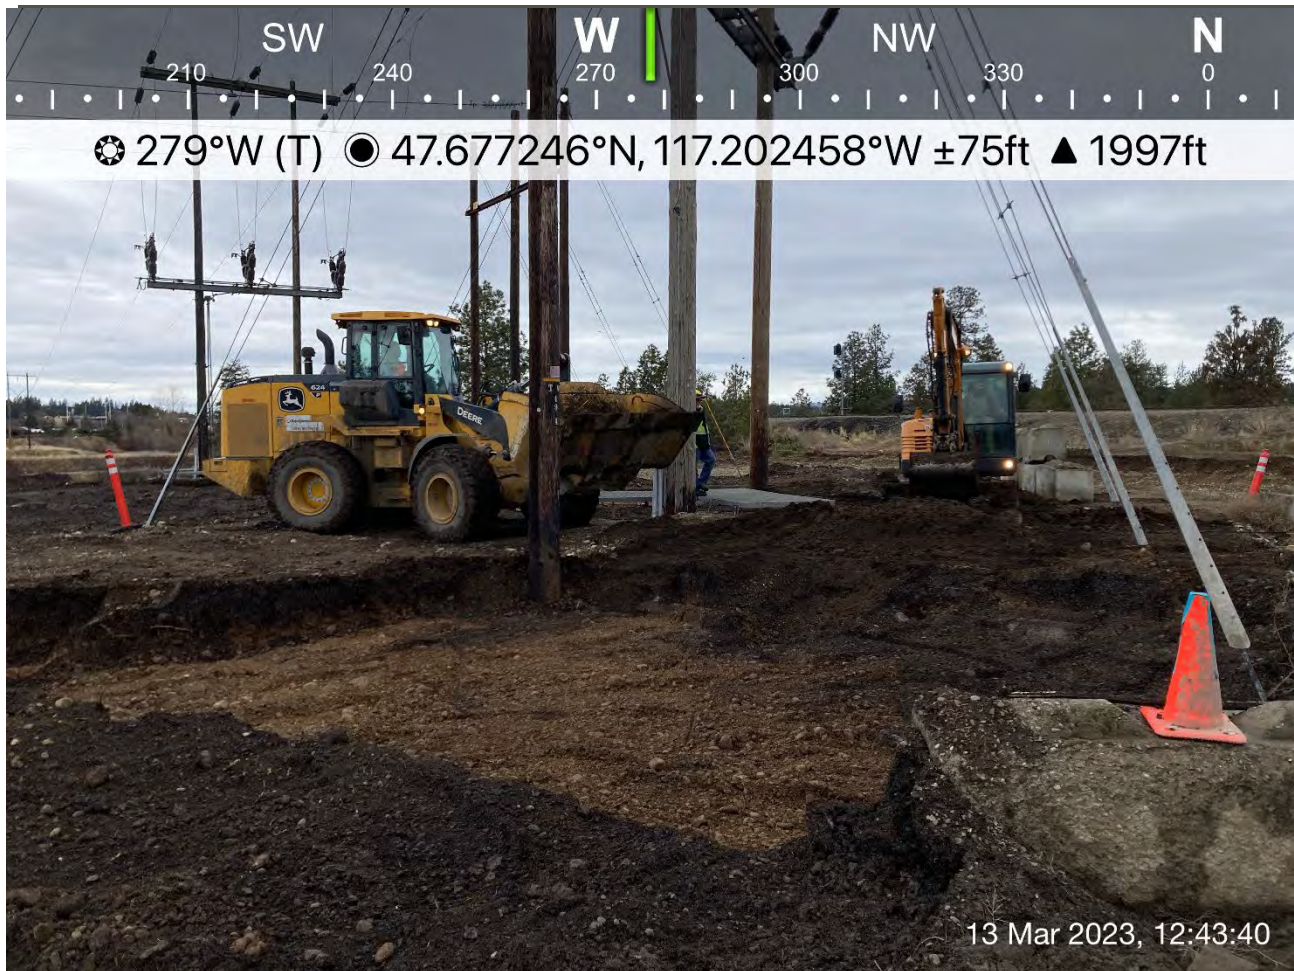
Photograph 3: Excavation around BPA infrastructure on the Pentzer property to a depth of 2-ft.

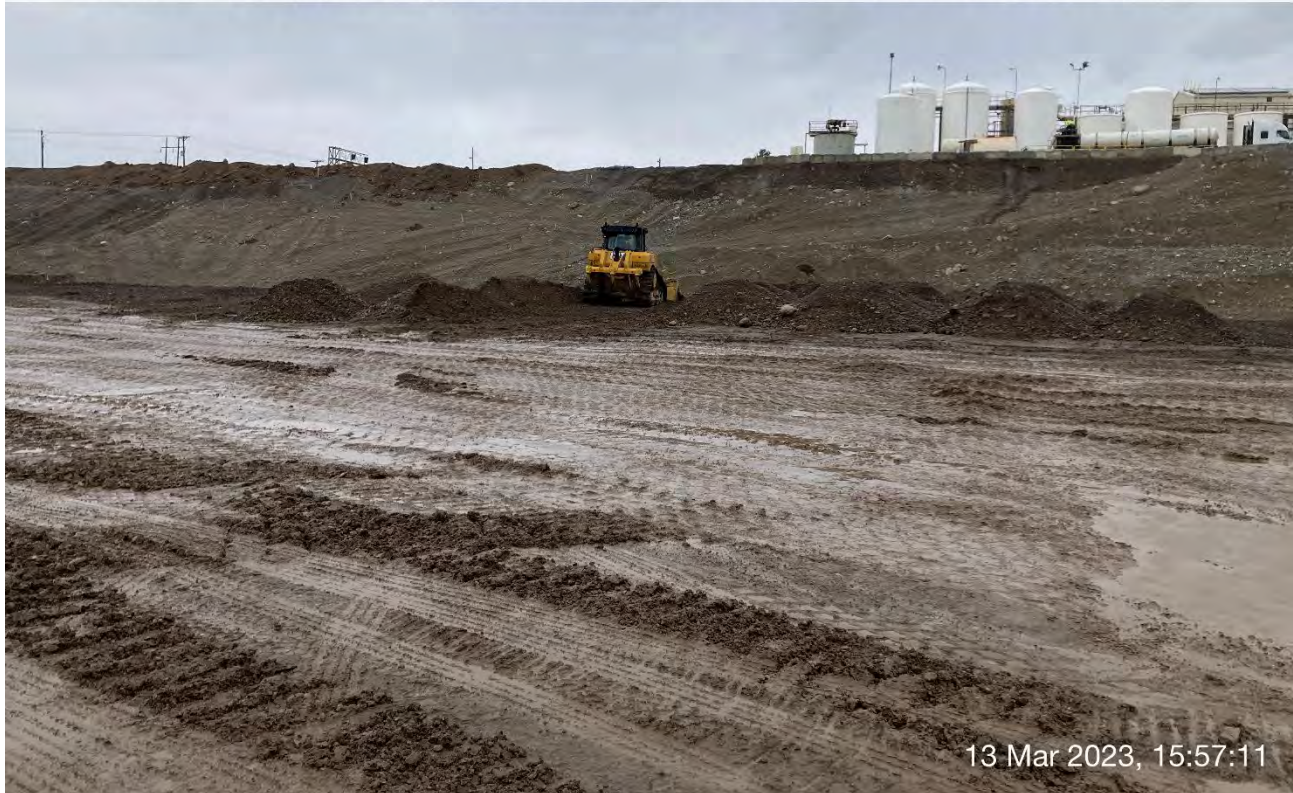
Photograph 4: CAT Dozer used to spread backfill materials on the WSDOT property.

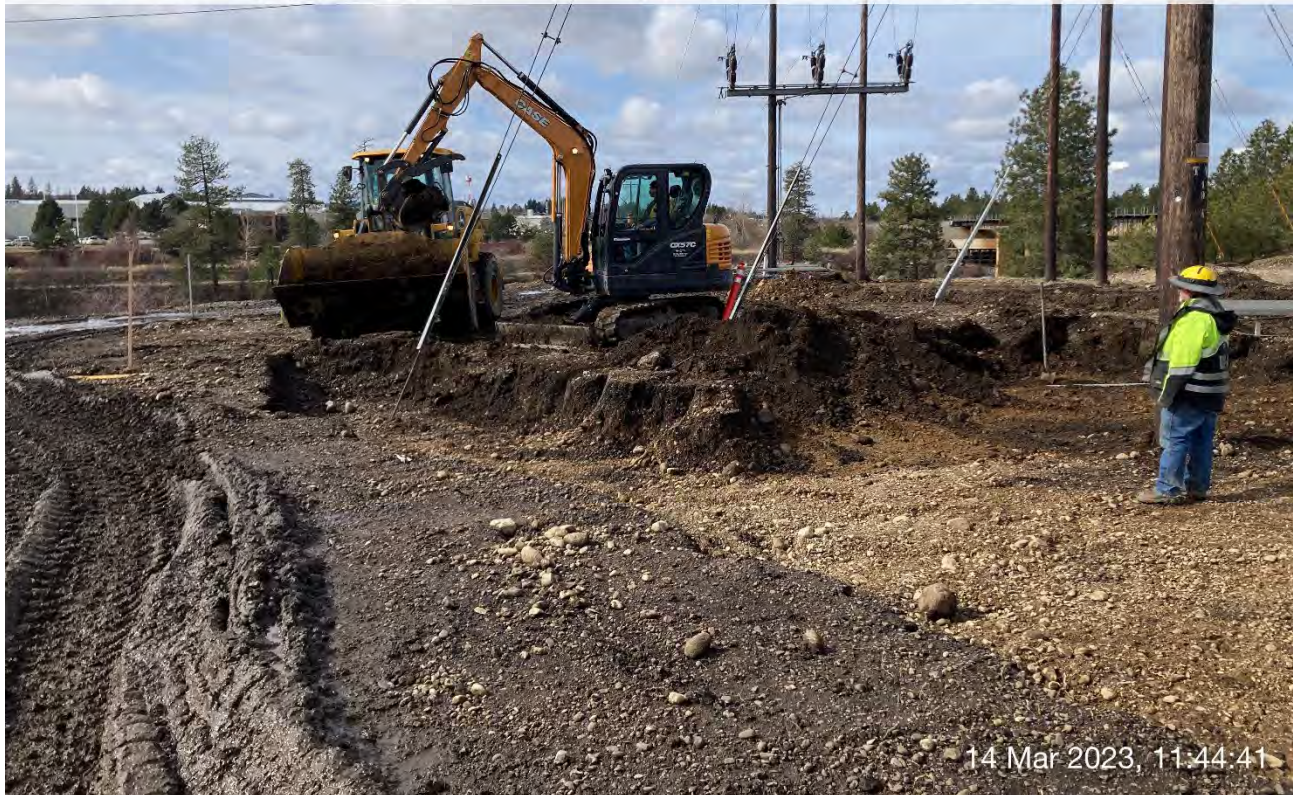
Photograph 2: CAS CX57C mini excavator excavating area under BPA lines to a depth of 2 feet. The John Deere 624 loader was utilized to transfer the excavated materials to the UPRR cap area.

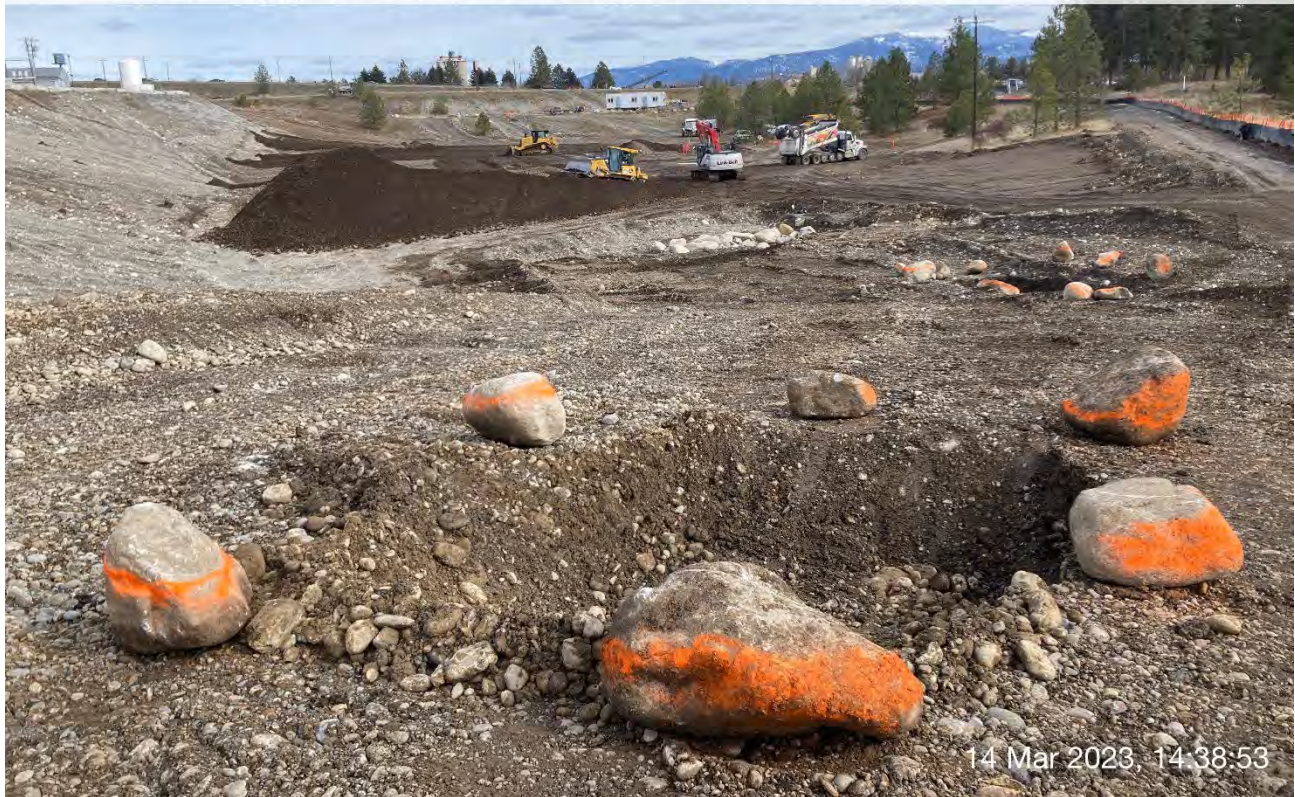
Photograph 3: Areas of visual dross in Excavation 3 and Excavation 4 after excavation and protective boulder placement.

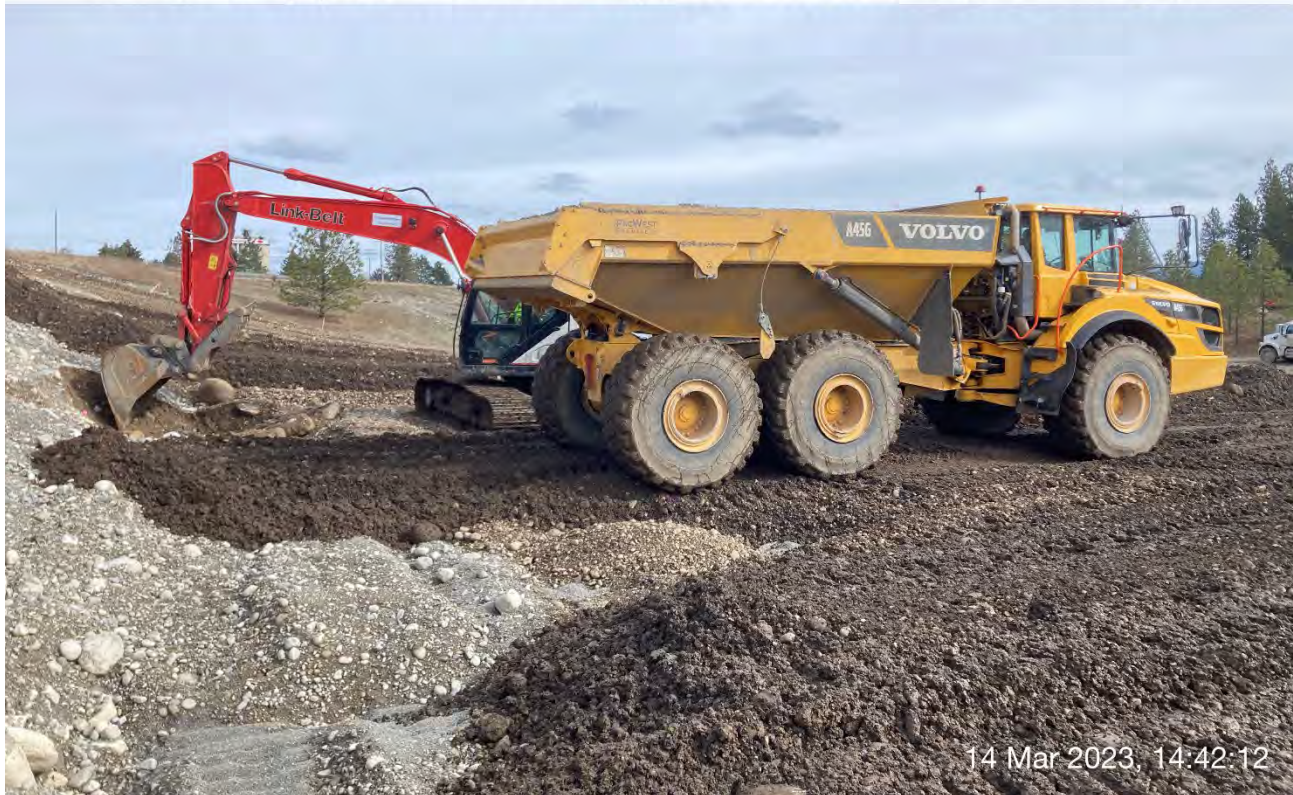
Photograph 4: Excavation of small area in WSDPT property sampling quadrant W1-11 from 4 to 6 feet in depth.

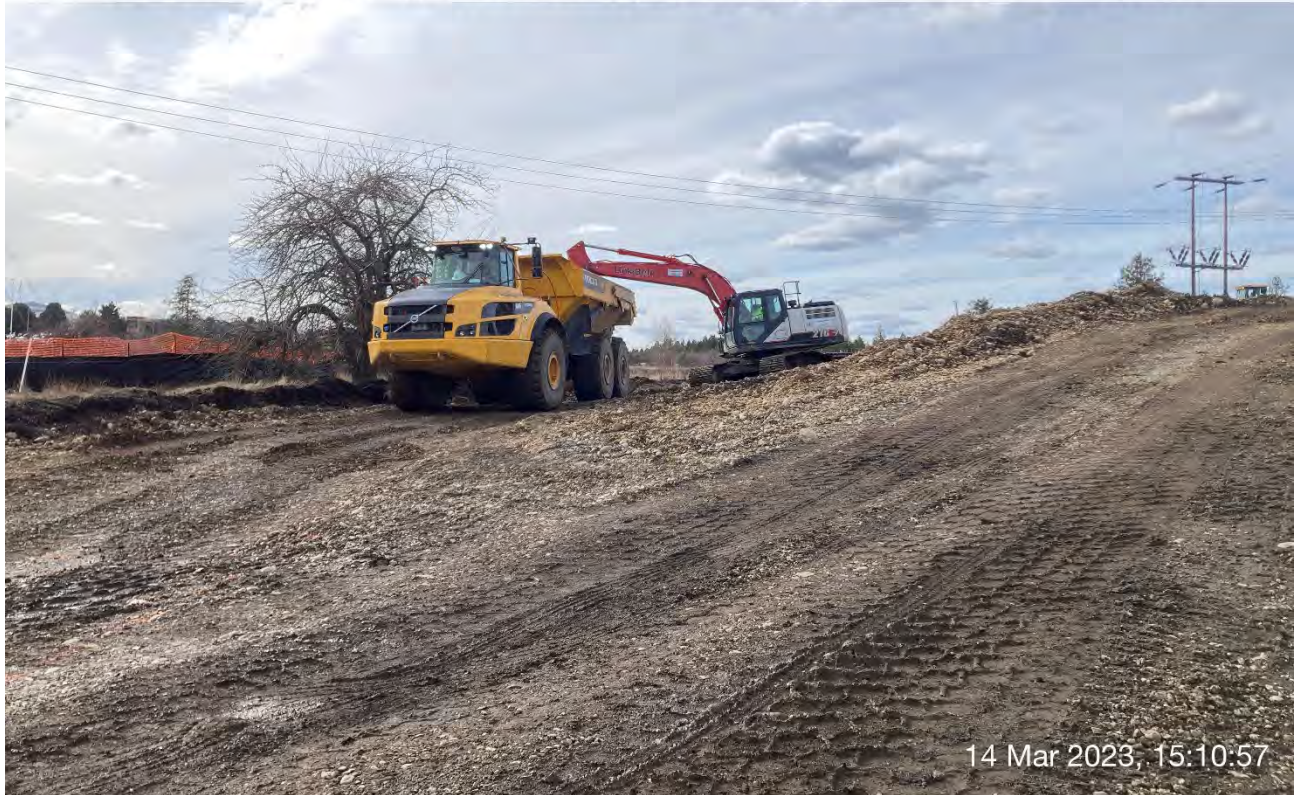
Photograph 5: Excavation of small area in Pentzer property sampling quadrant P1-45 from 2 to 4 feet in depth.

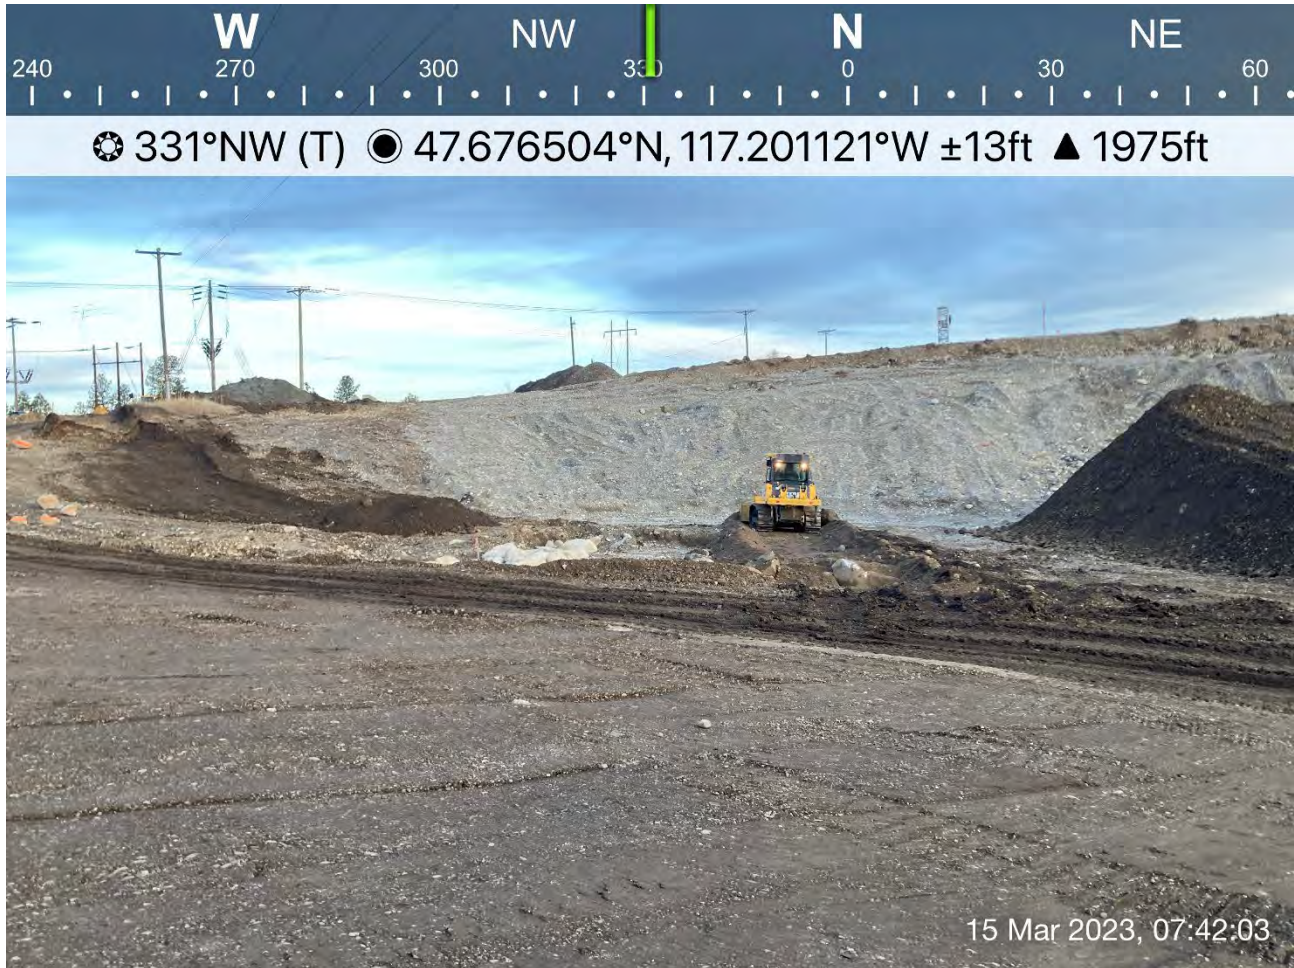
Photograph 1: John Deere 700L dozer expanding the east wall of Excavation 4 due to laboratory analysis results exceeding CULs.
