GOLDER
MEMBER OF WSP

DAILY FIELD REPORT # 91

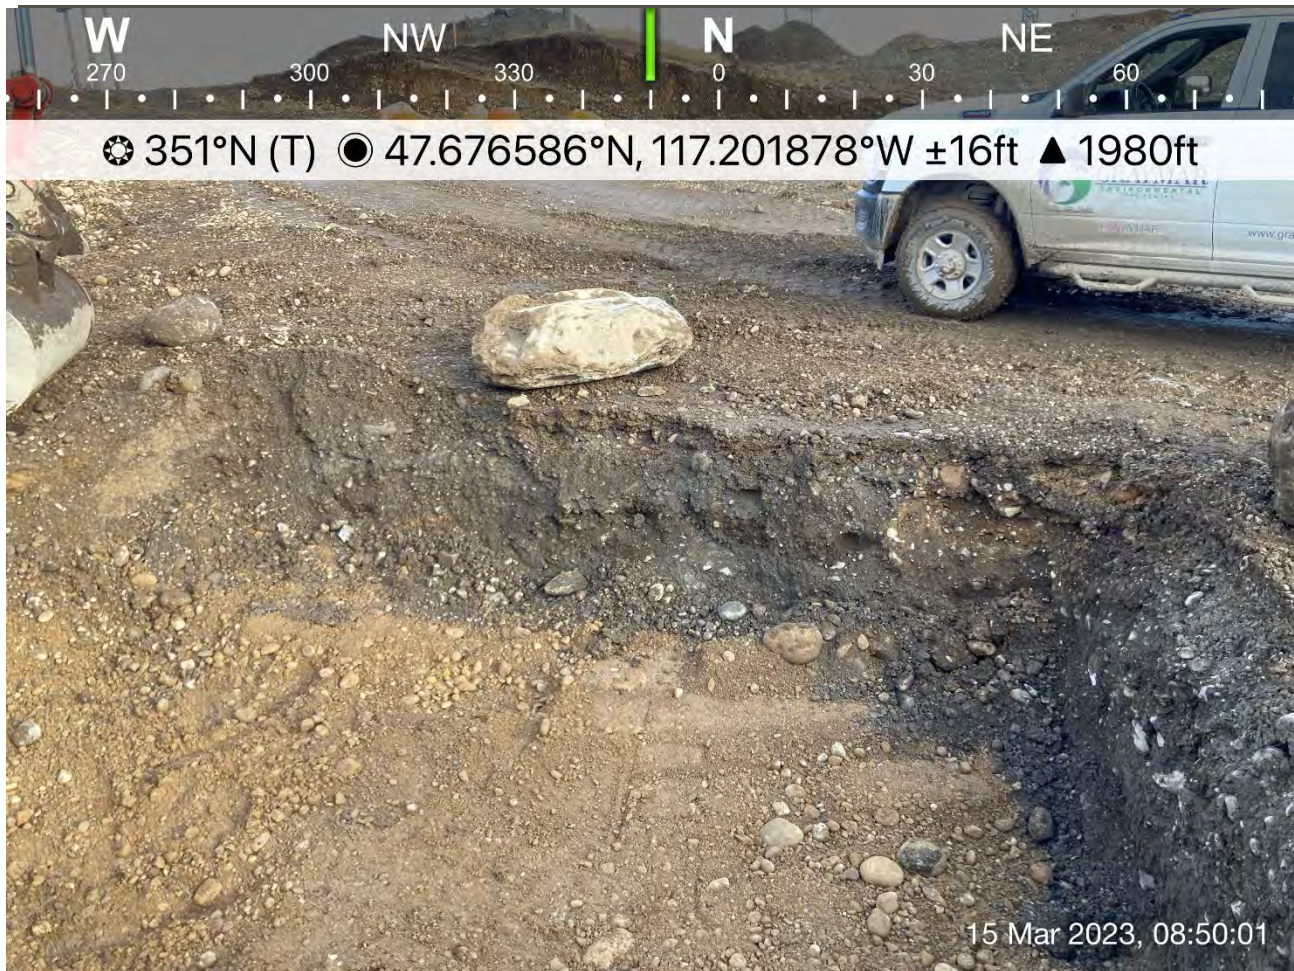
Photograph 2: Dross material found in the north and east sidewalls of the expansion of Excavation 3. Note the proximity of the excavation expansion to the main haul road as seen by the pick-up truck.

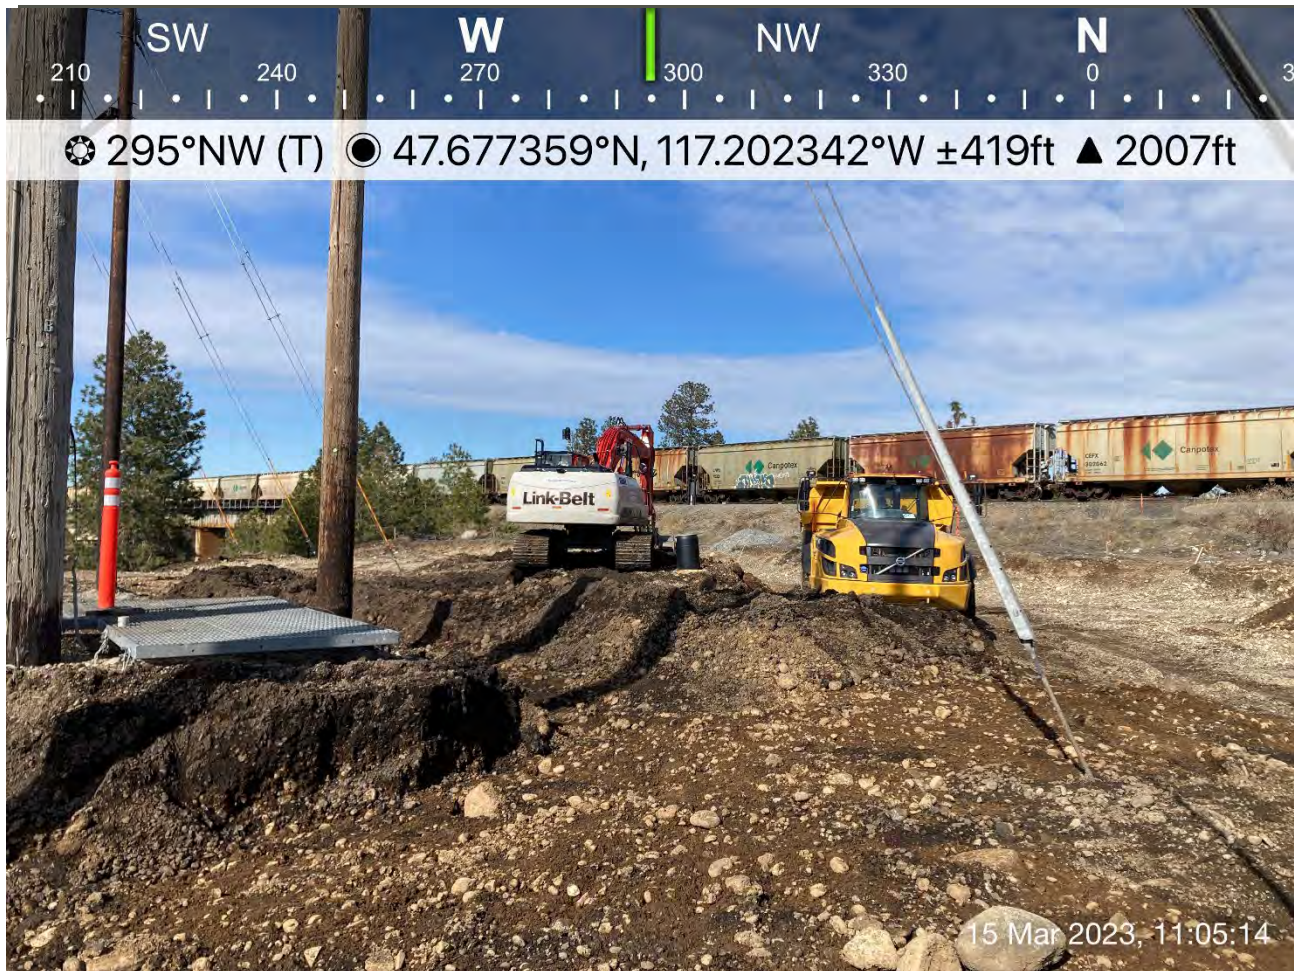
Photograph 3: Excavation of Pentzer property with LinkBelt trackhoe. Excavated materials were transferred to the UPRR cap area by the off-road haul truck.

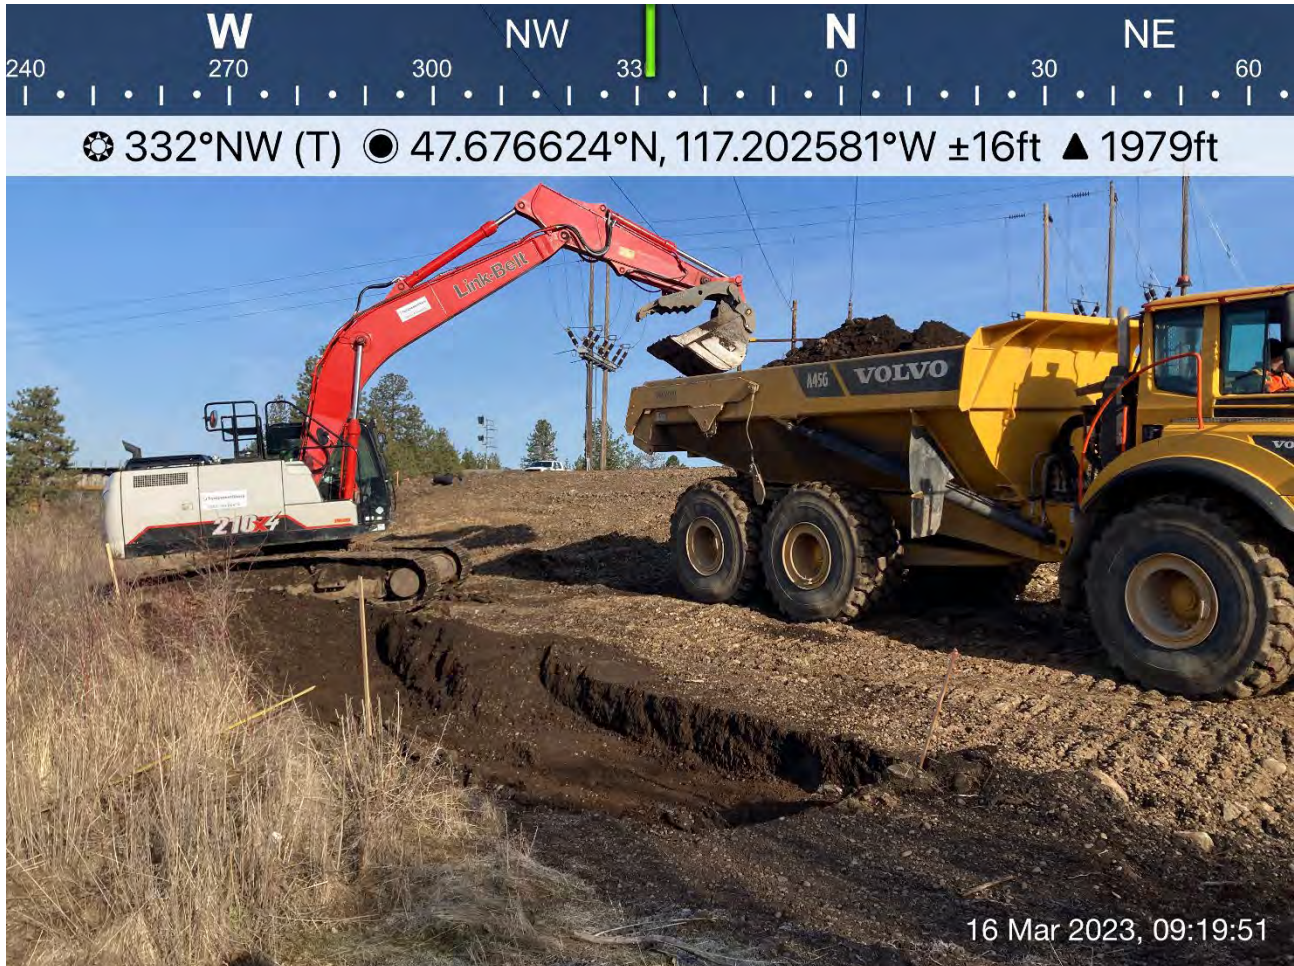
Photograph 1: LinkBelt trackhoe excavating the southern lobe of the 2-foot excavation area that falls onto Washington State Parks and Recreation property. The off-road haul truck transferred the excavated materials to the UPRR cap area for future placement and compaction.

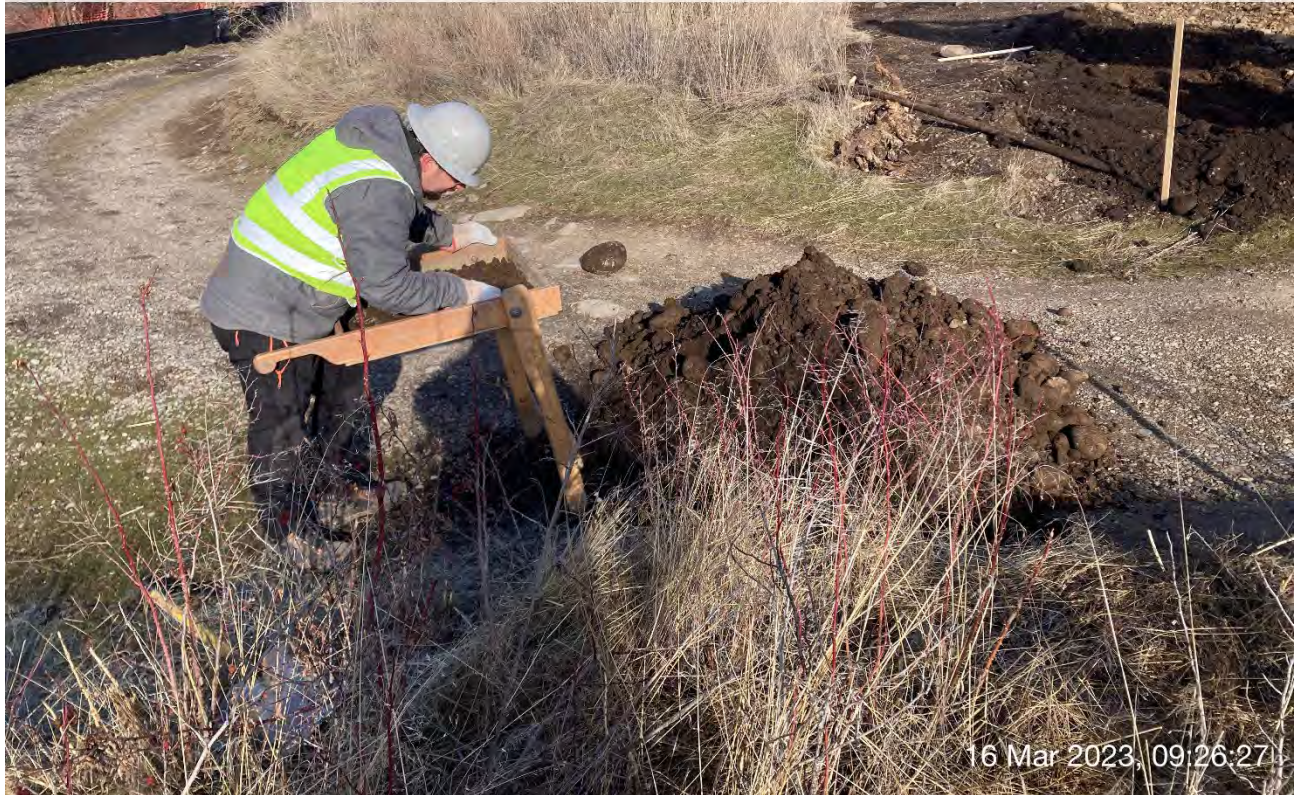
Photograph 2: J. Fitzpatrick of PAI using a screen to analyze soil removed from the southern lobe of the 2-foot excavation area that falls onto Washington State Parks and Recreation property.

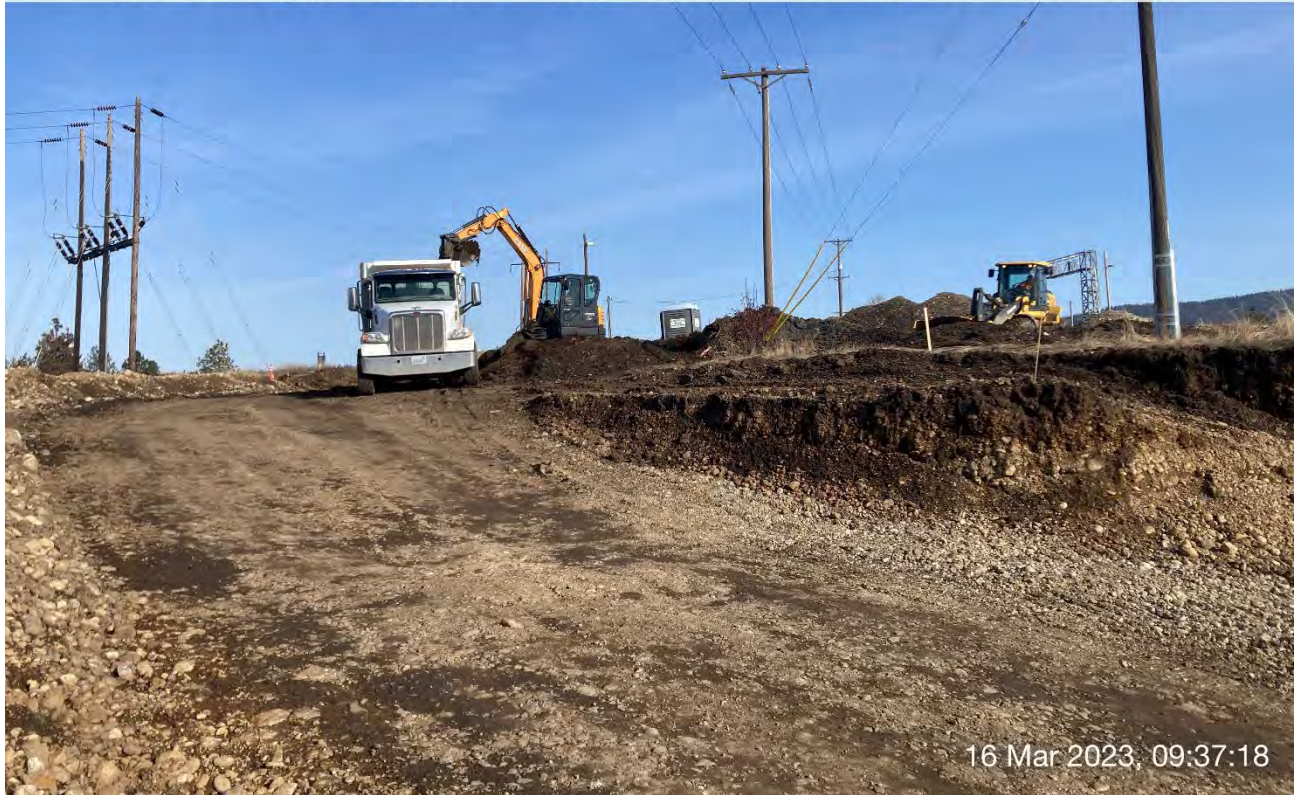
Photograph 3: Mini Excavator used to load the GrayMar haul truck with vegetative materials to be loaded out and disposed off site.

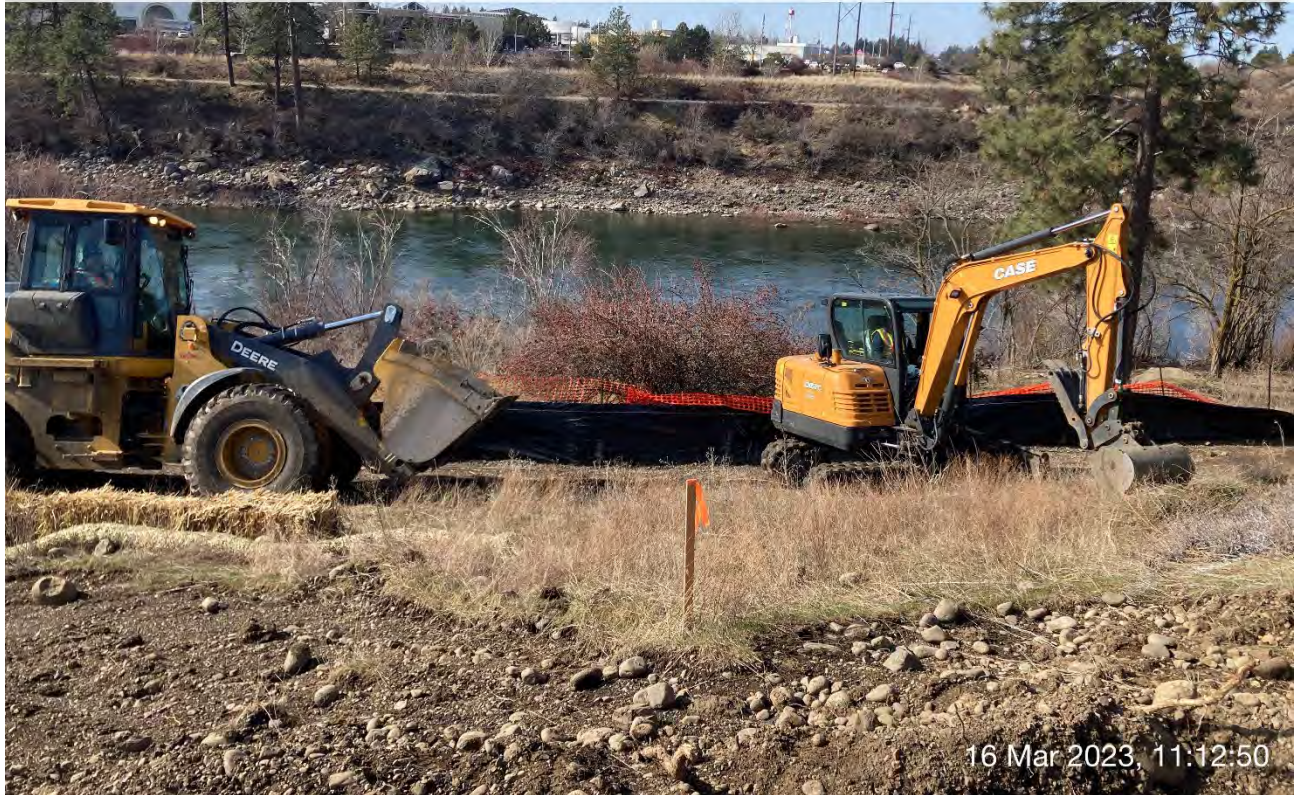
Photograph 4: Mini Excavator excavating the northern lobe of the 2-foot excavation area that falls onto Washington State Parks and Recreation property. The front-end loader transferred the excavated materials to the UPRR cap area for future placement and compaction.

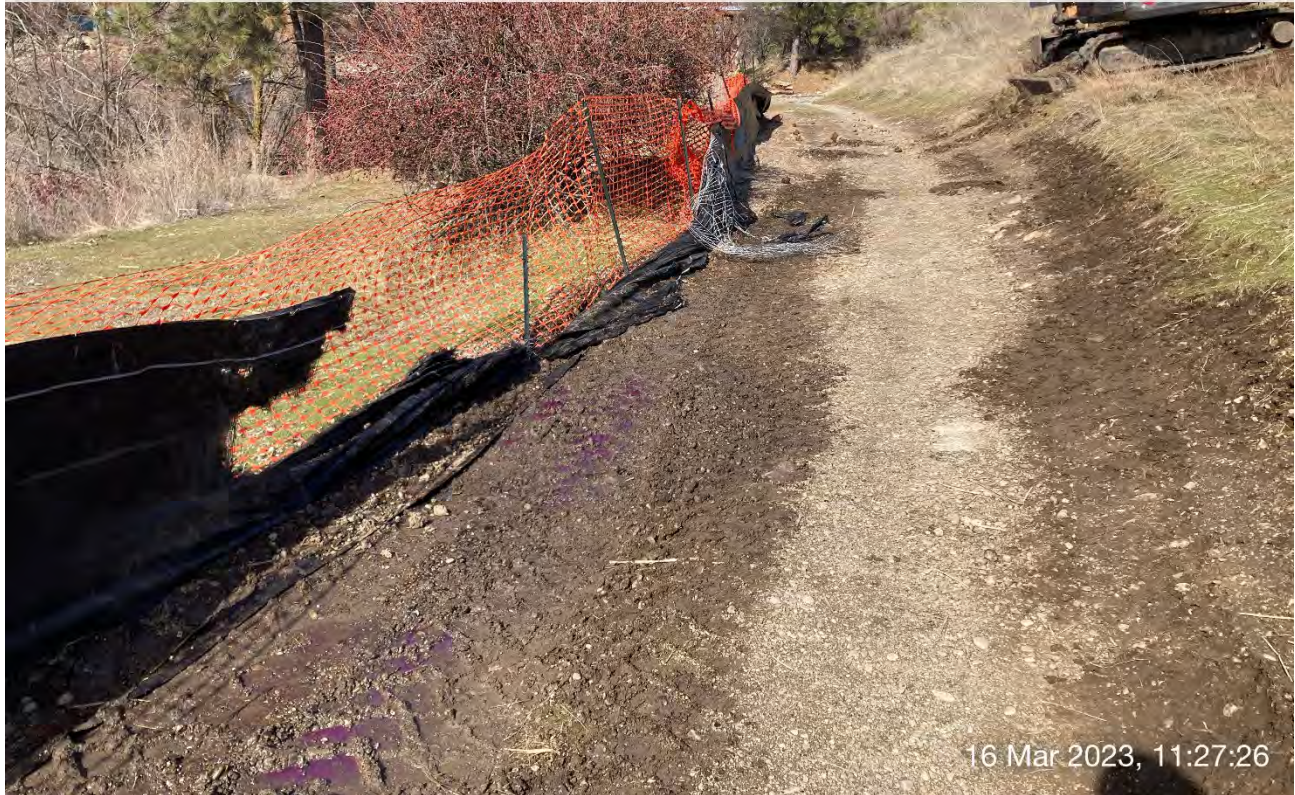
- While attempting to excavate a portion of the Parks and Recreation property with a steep grade, an improperly installed fuel cap on the front-end loader leaked approximately 1 to 2 gallons of diesel fuel on the access road along the western portion of the site. The faulty piece of equipment immediately vacated the area, and the faulty fuel cap was reinstalled correctly. The diesel that spilled pooled in 2 locations. Oil dry and absorbent pads were deployed in the affected areas, and the impacted soils were excavated down to a depth of approximately 1 foot. The excavated soils were drummed for future off-site disposal, and the remaining portion of the road where diesel possibly dripped from the machine was scraped with the blade of the mini excavator.

Photograph 5: Diesel fuel spilled by in incorrectly installed fuel cap on the front-end loader on the railroad access road west of the site.

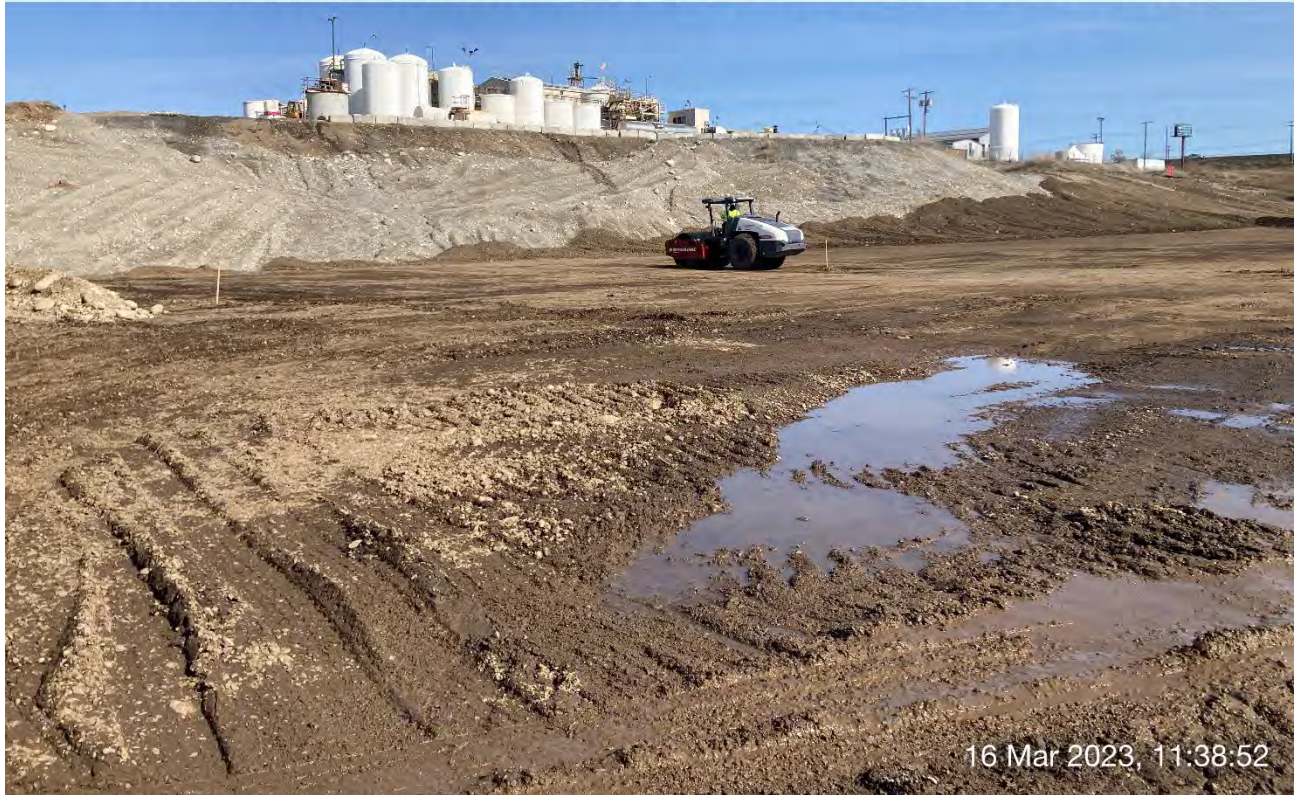
Photograph 6: DYNAPAC CA2500D Roller utilized to compact backfill on WSDOT property.

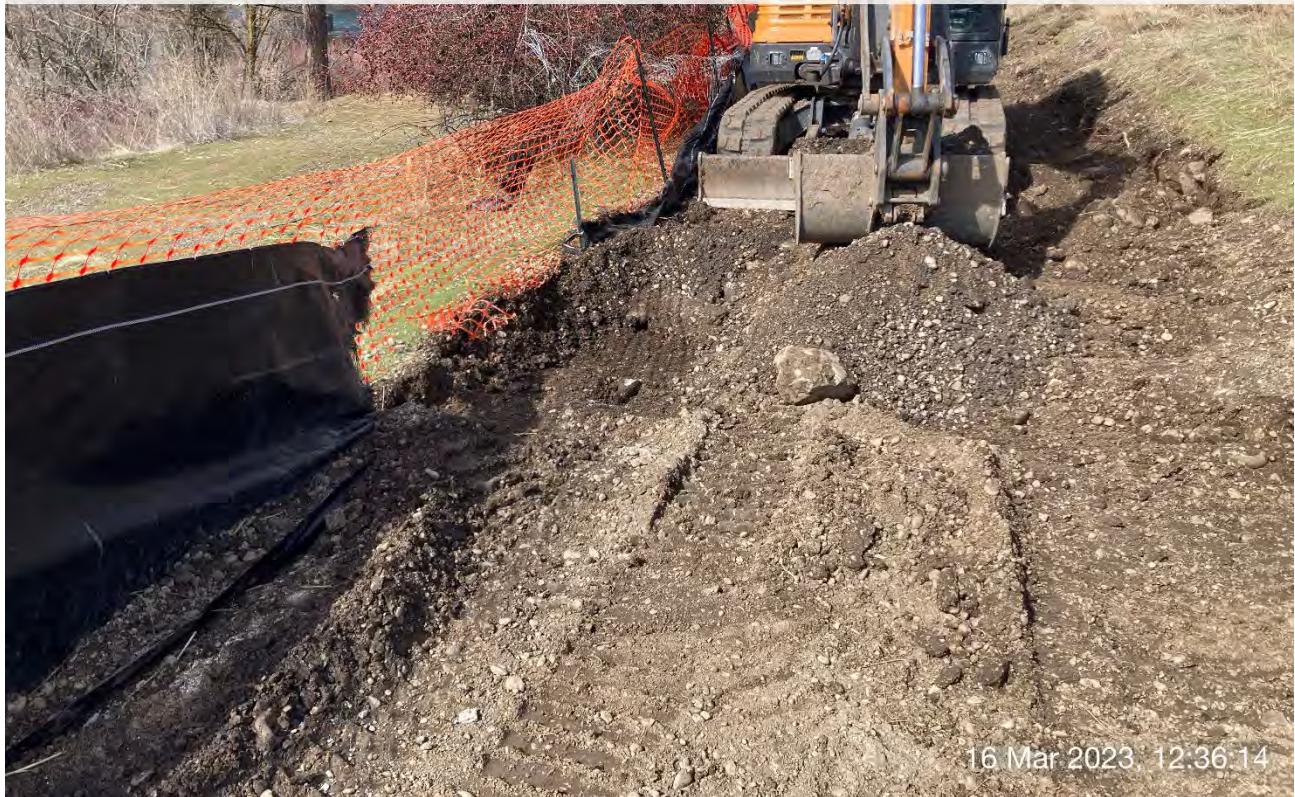
Photograph 7: Mini Excavator used to excavate the diesel-impacted soil. The excavated soil was drummed and staged for future off-site disposal.

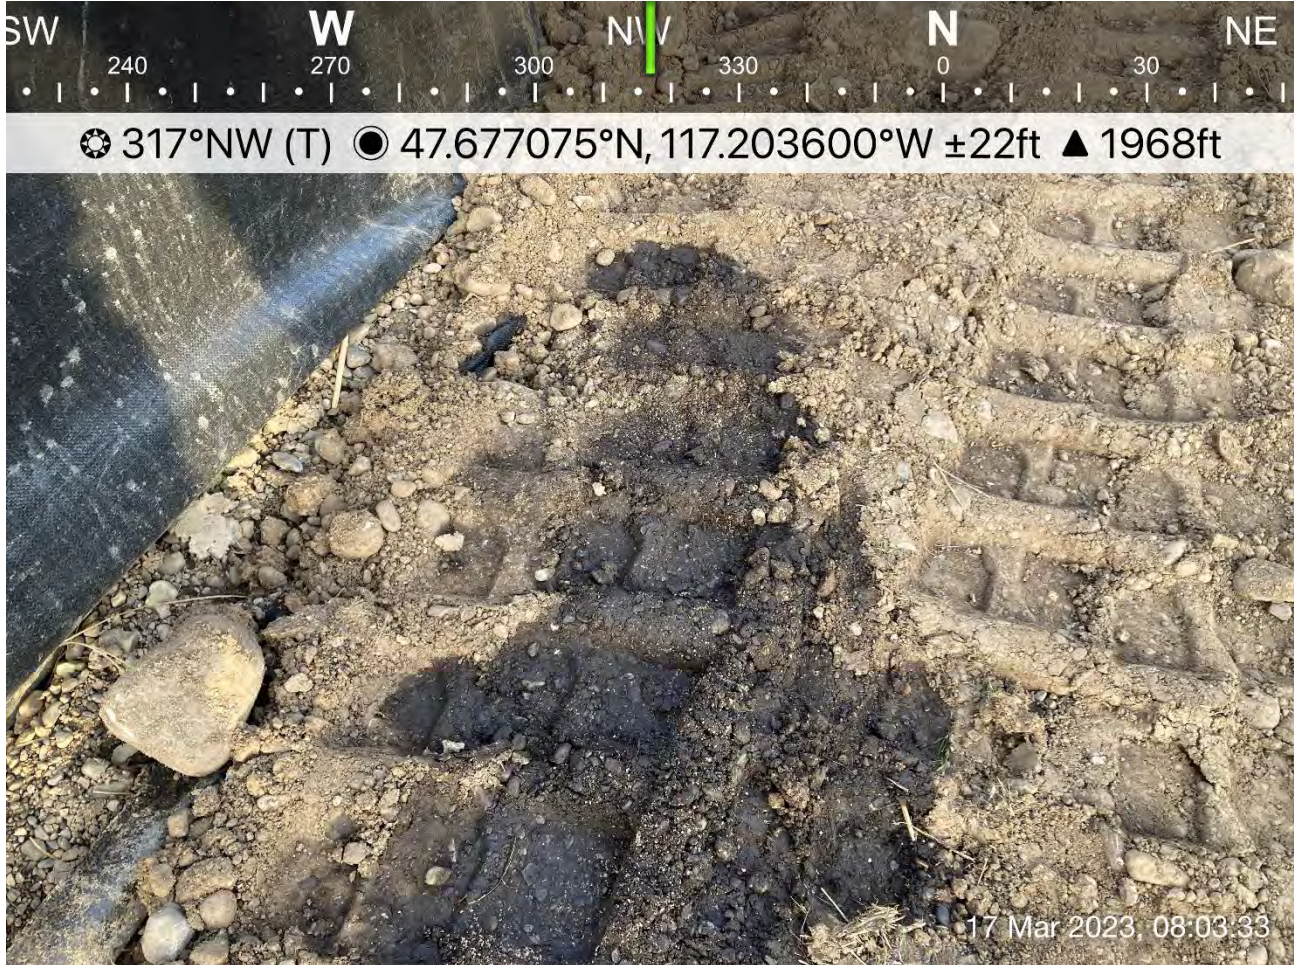
Photograph 1: Small patch of diesel impacted soil on the railroad access road that was missed from yesterday's, 03/16/23, diesel spill. The mini excavator and hand tools were utilized to excavate and remove the impacted soil. The soil was drummed and staged for future off-site disposal.

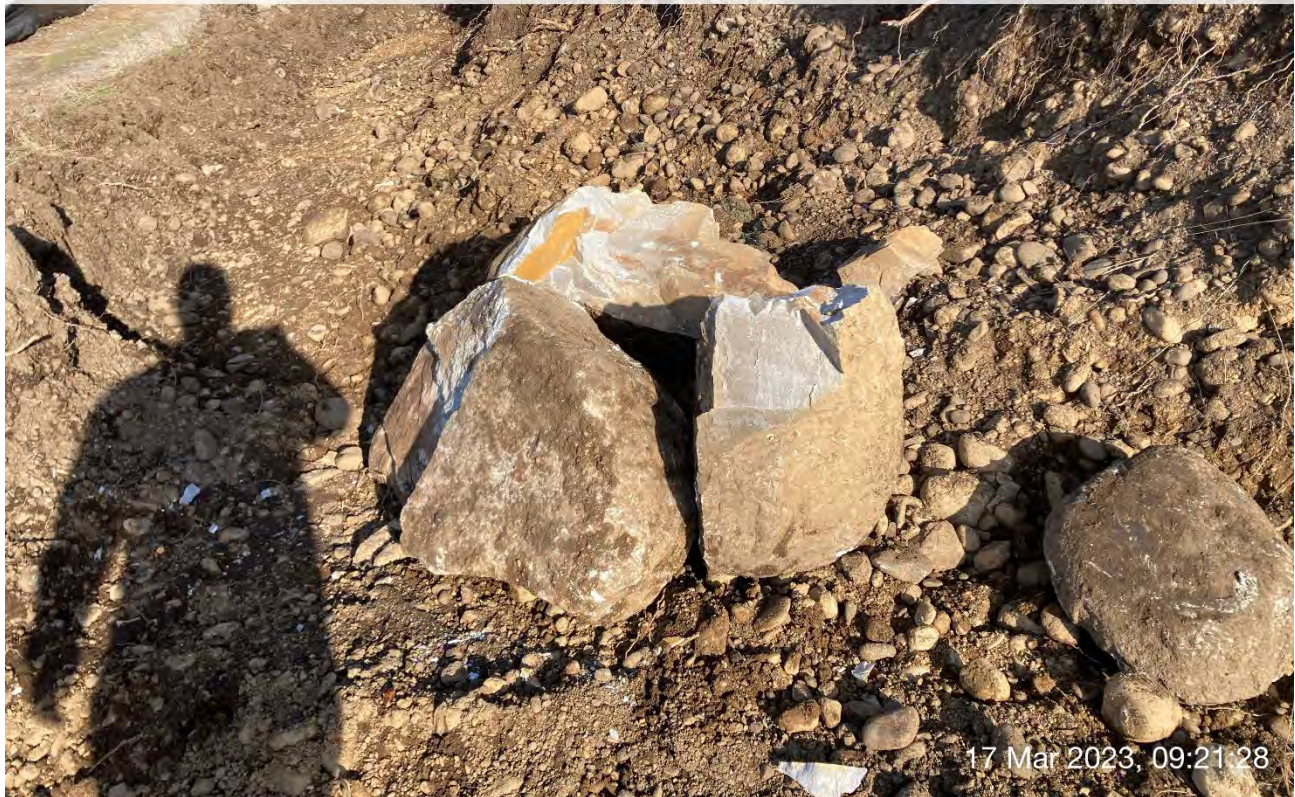
Photograph 2: Broken boulder that caused rock fragments to be sent airborne. A wider berth around the LinkBelt trackhoe was provided after this potential safety hazard occurred.

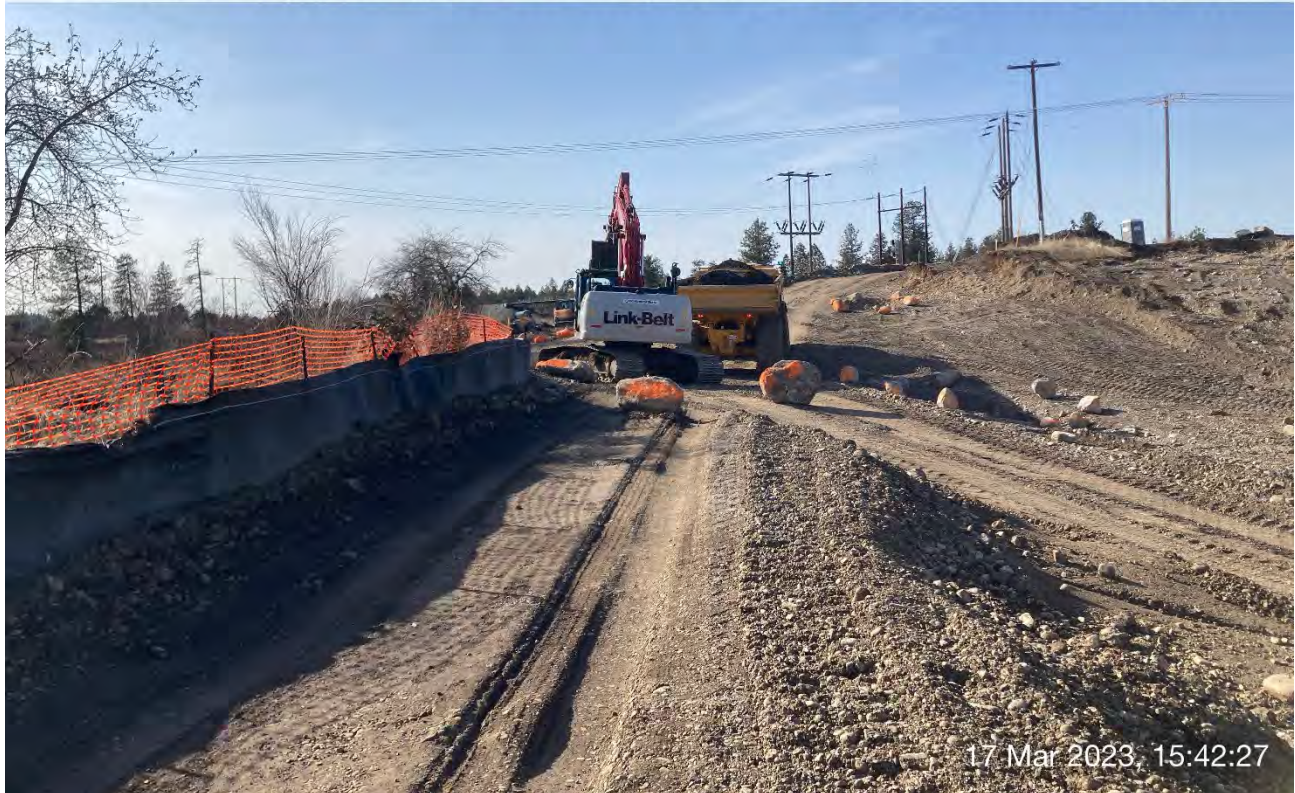
Photograph 3: LinkBelt trackhoe and off-road haul truck expanding the southwest corner of Excavation 3 into the previous haul road. Note: Large boulders painted safety orange were placed in the former haul road and around the excavation itself to prevent entrance to the excavation.

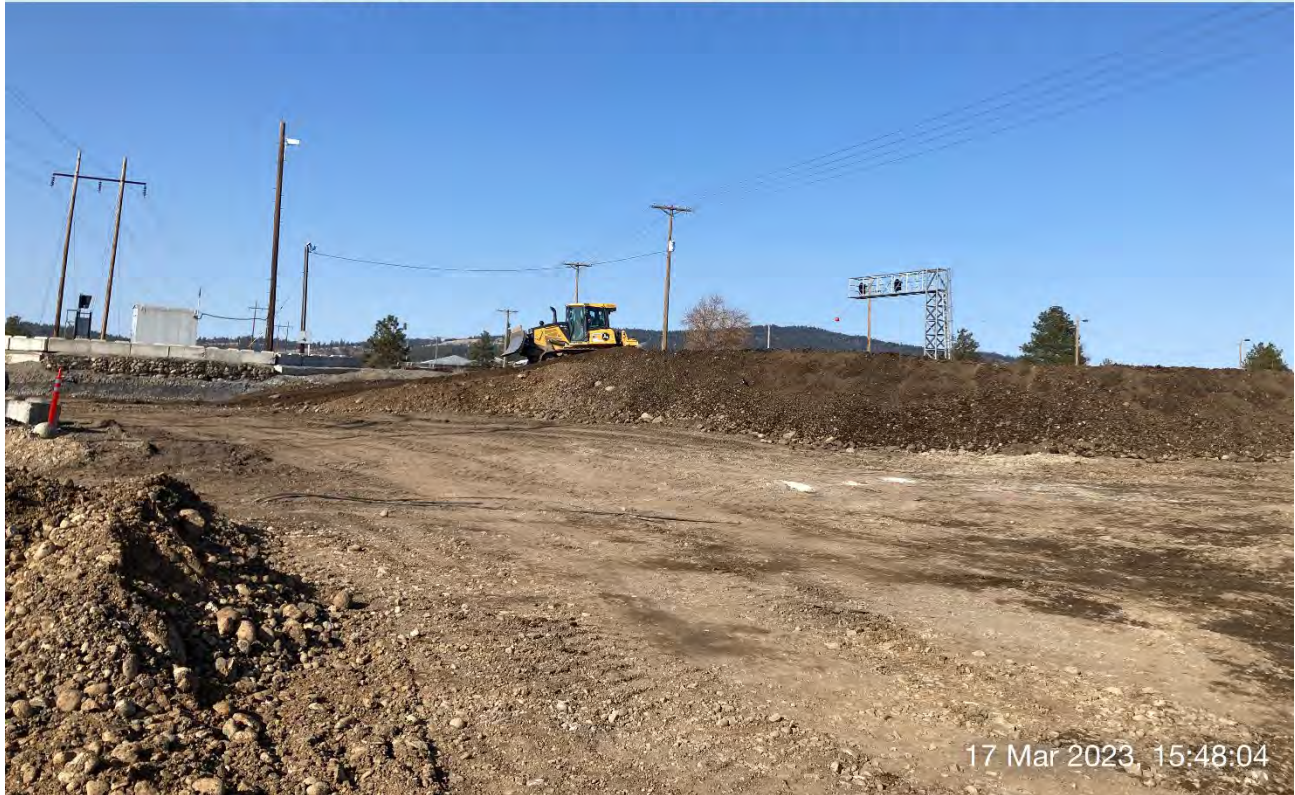
Photograph 4: John Deere 700L dozer mixing excavated materials along the Pentzer property and UPRR cap area boundary.

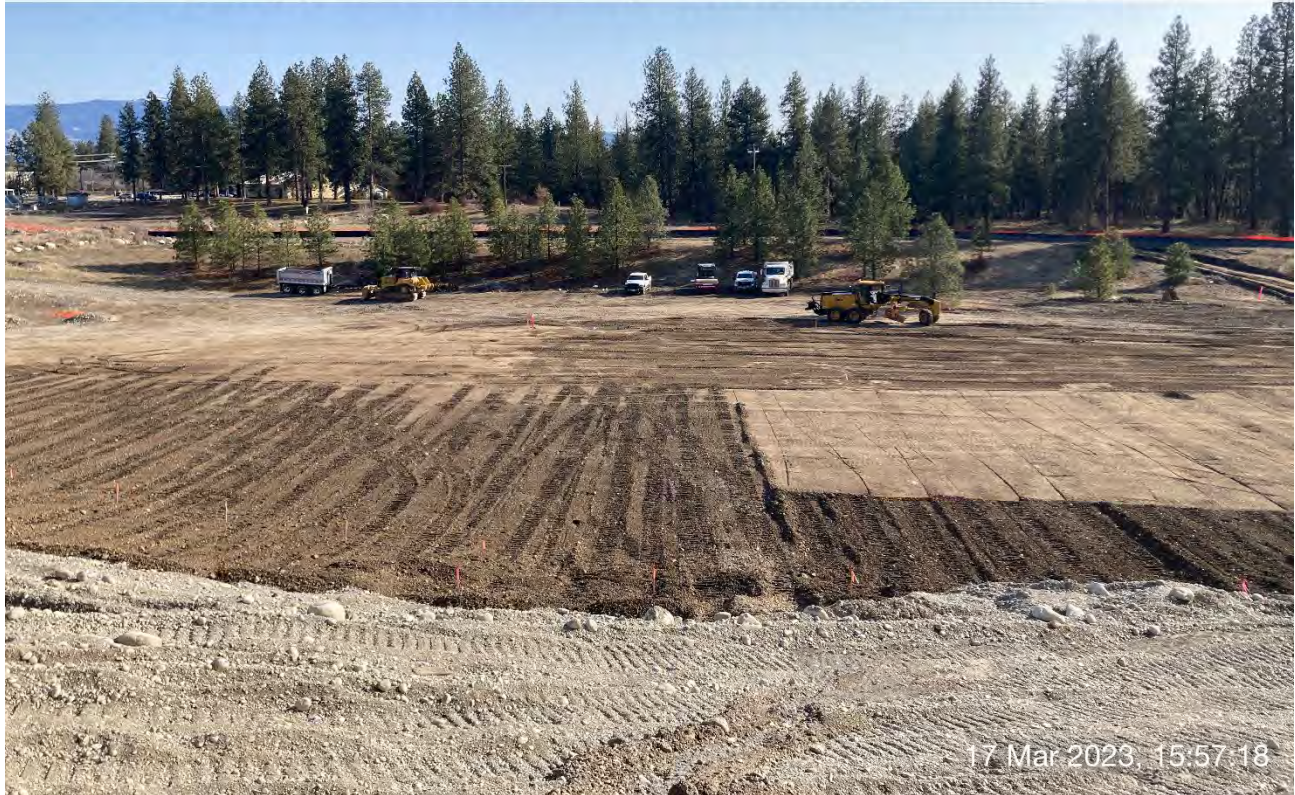
Photograph 5: SANY SMG 200 C-8 Motor Grader utilized to grade the southern and eastern portions of the WSDOT property that has already been backfilled.

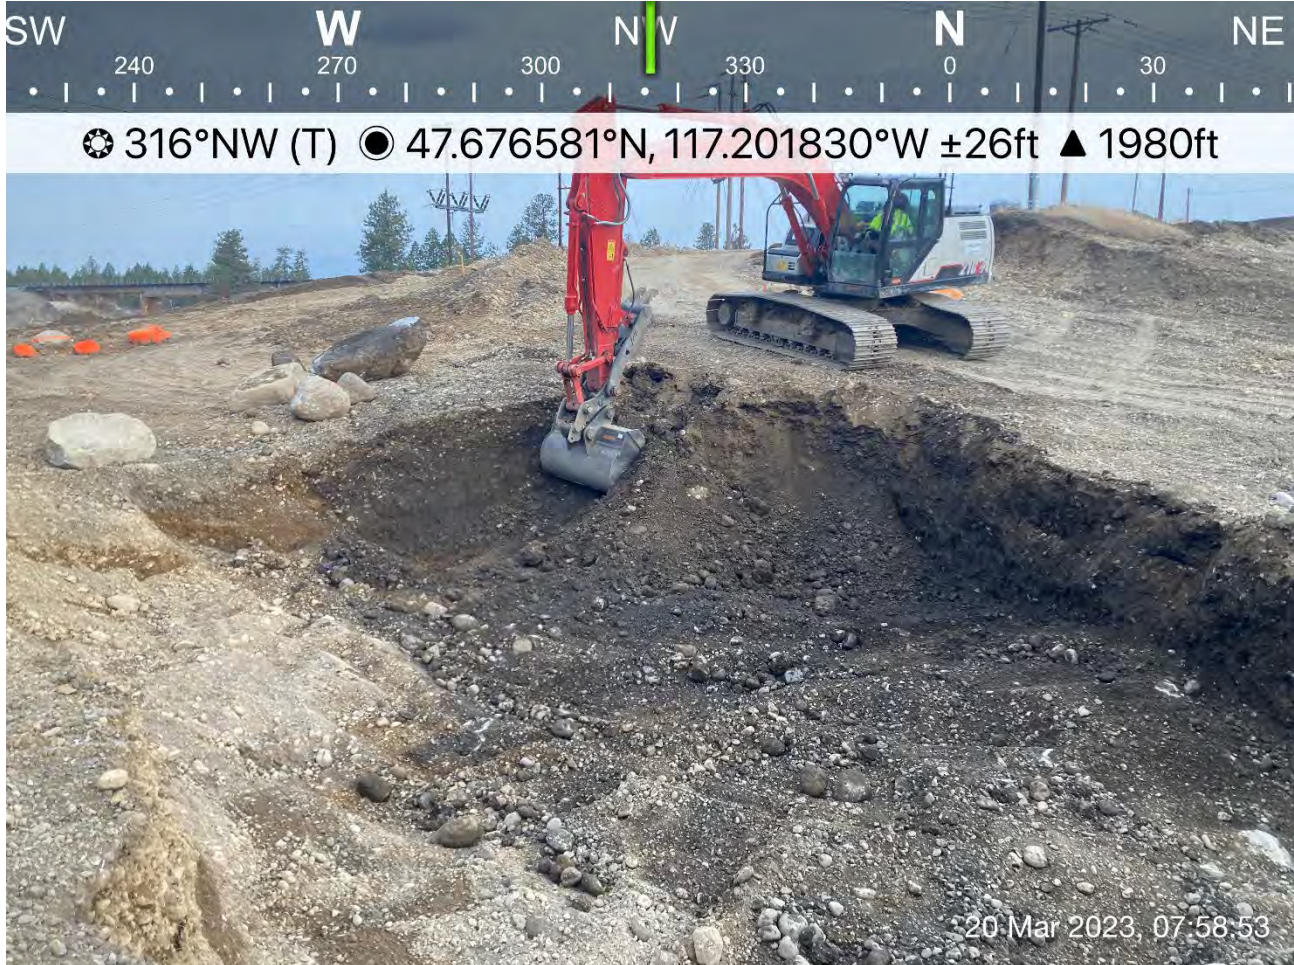
Photograph 1: LinkBelt trackhoe expanding the northwestern corner of the Excavation 3 expansion into the previous haul road.

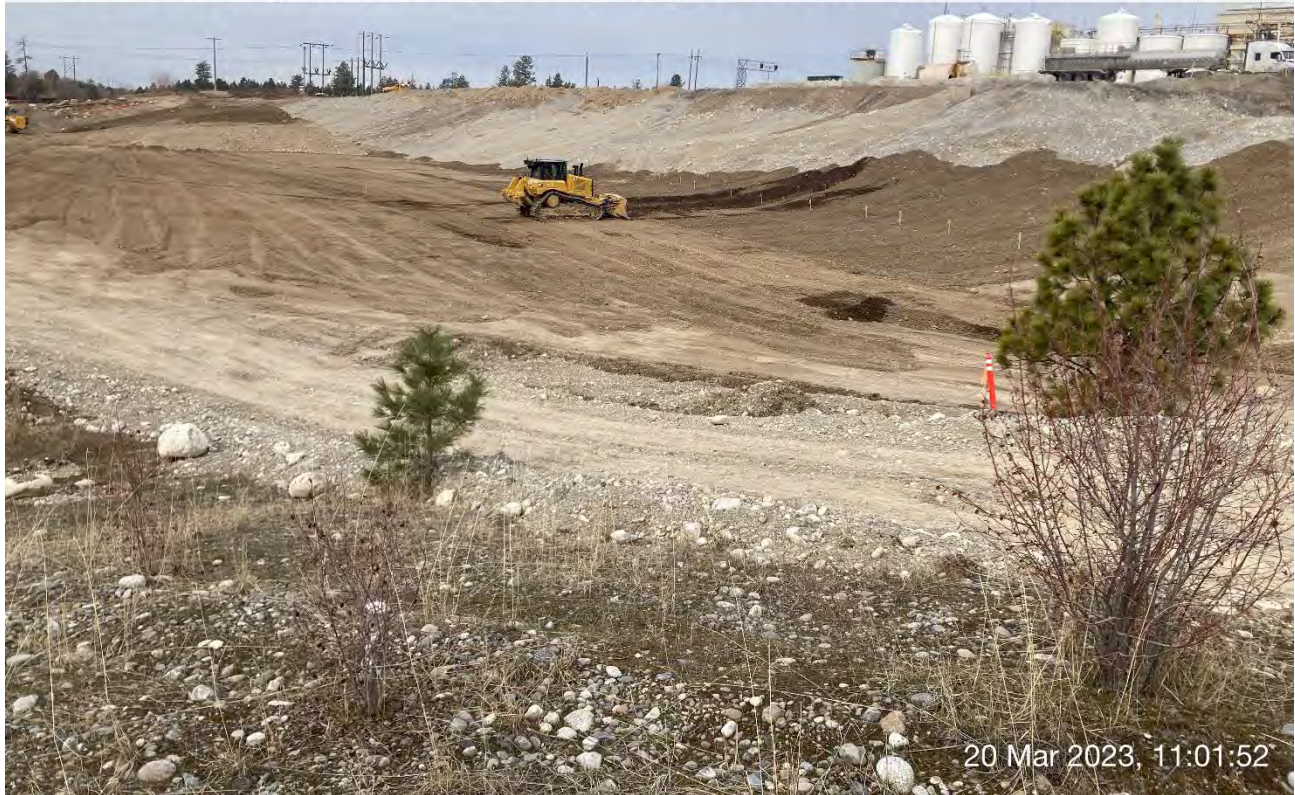
Photograph 2: CAT D6 dozer grading the areas of the WSDOT property that have already been backfilled.

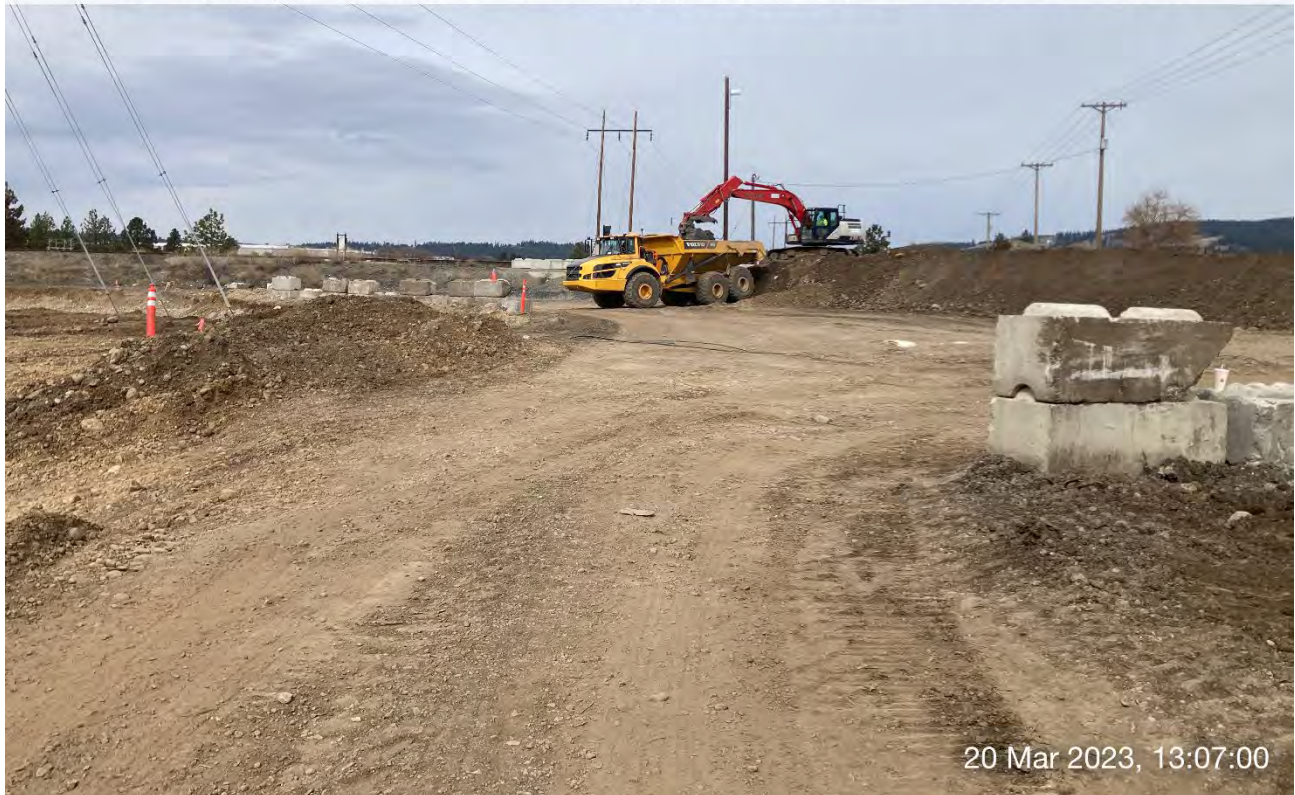
Photograph 3: Transfer of stockpiled excavated materials located on the Pentzer property to the UPRR cap area using the LinkBelt trackhoe and the off-road haul truck.

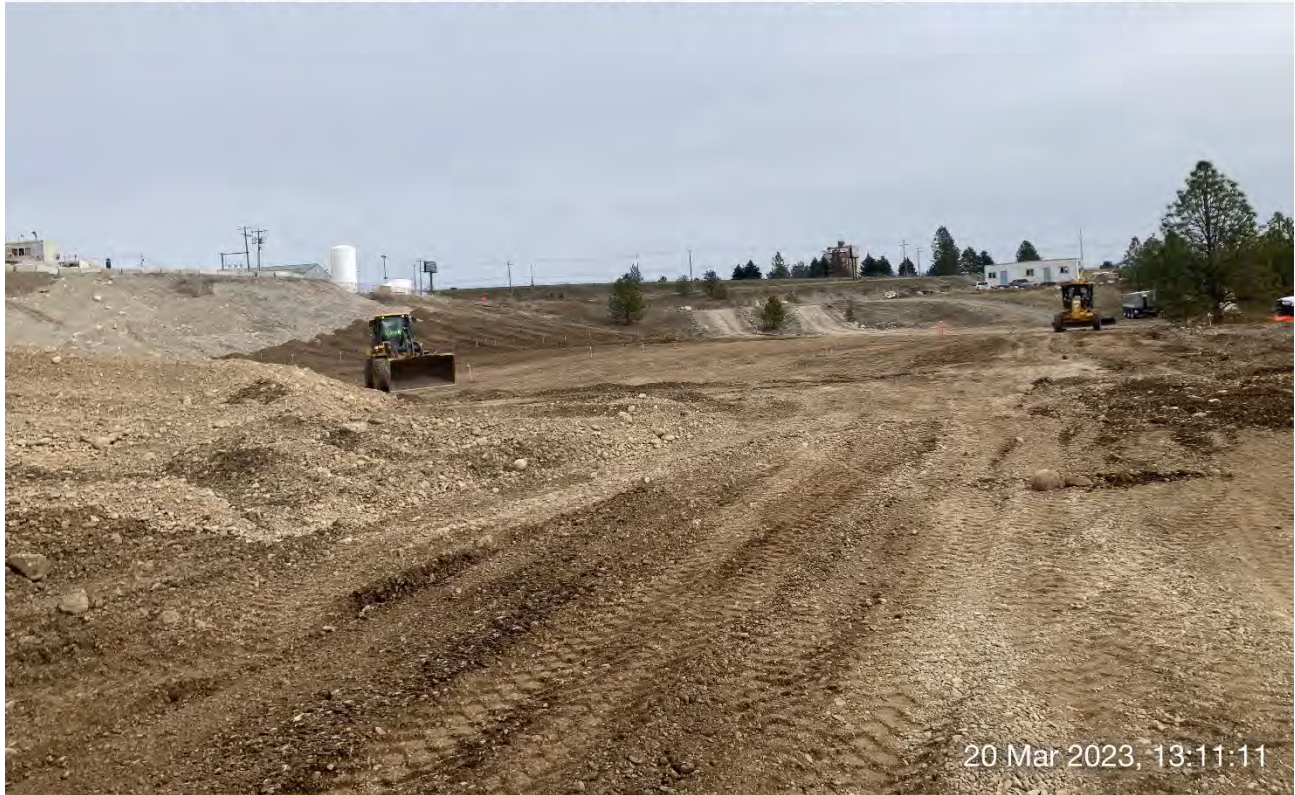
Photograph4: Grading of backfilled portions of the WSDOT property using the front-end loader and the SANY SMG 200 C-8 Motor Grader.

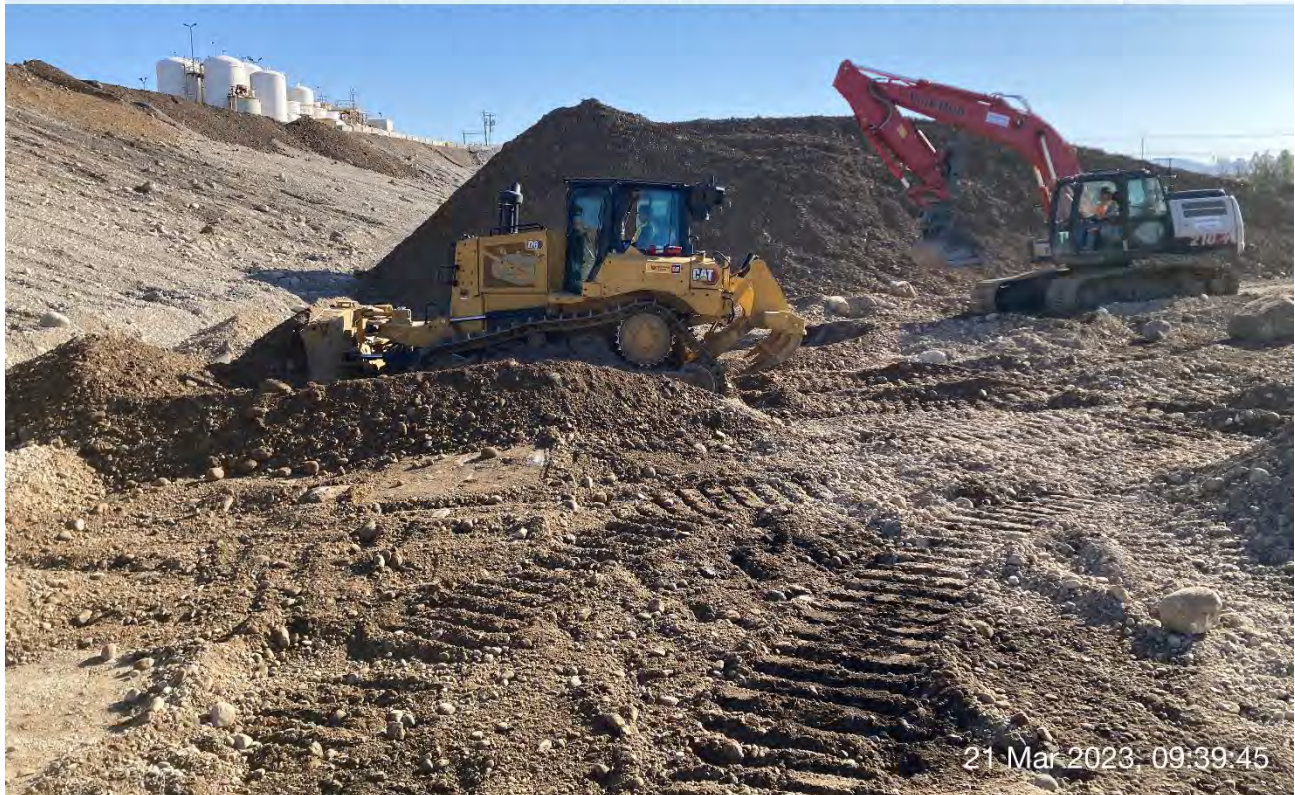
Photograph 3: CAT D6 dozer and the LinkBelt trackhoe expanding the north sidewalls of Excavation 3 and Excavation 4. The displaced materials were pushed northward onto the UPRR slope.

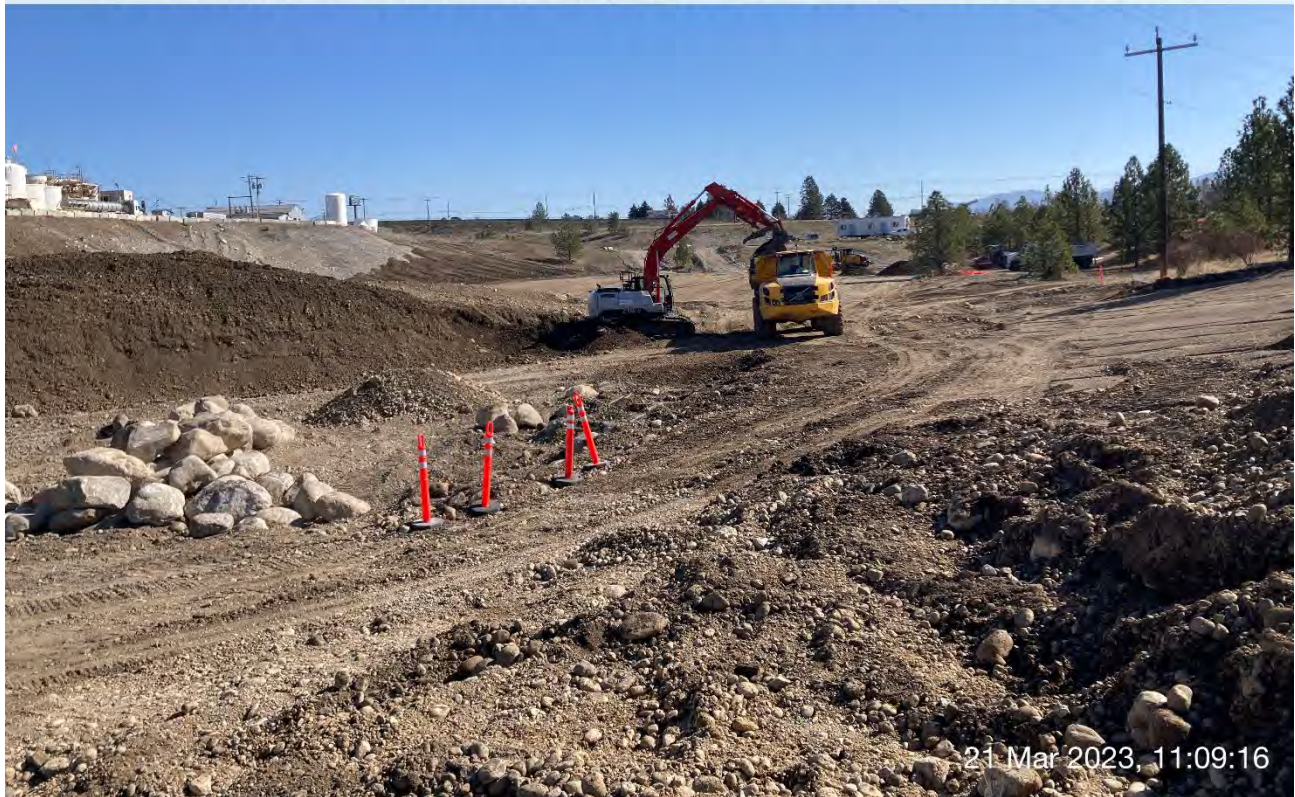
Photograph 4: Transfer of stockpiled backfill materials located east of Excavation 4 on the WSDOT property to Excavation 1 on the Pentzer property using the LinkBelt trackhoe and the off-road haul truck.
