GOLDER
MEMBER OF WSP

DAILY FIELD REPORT # 91

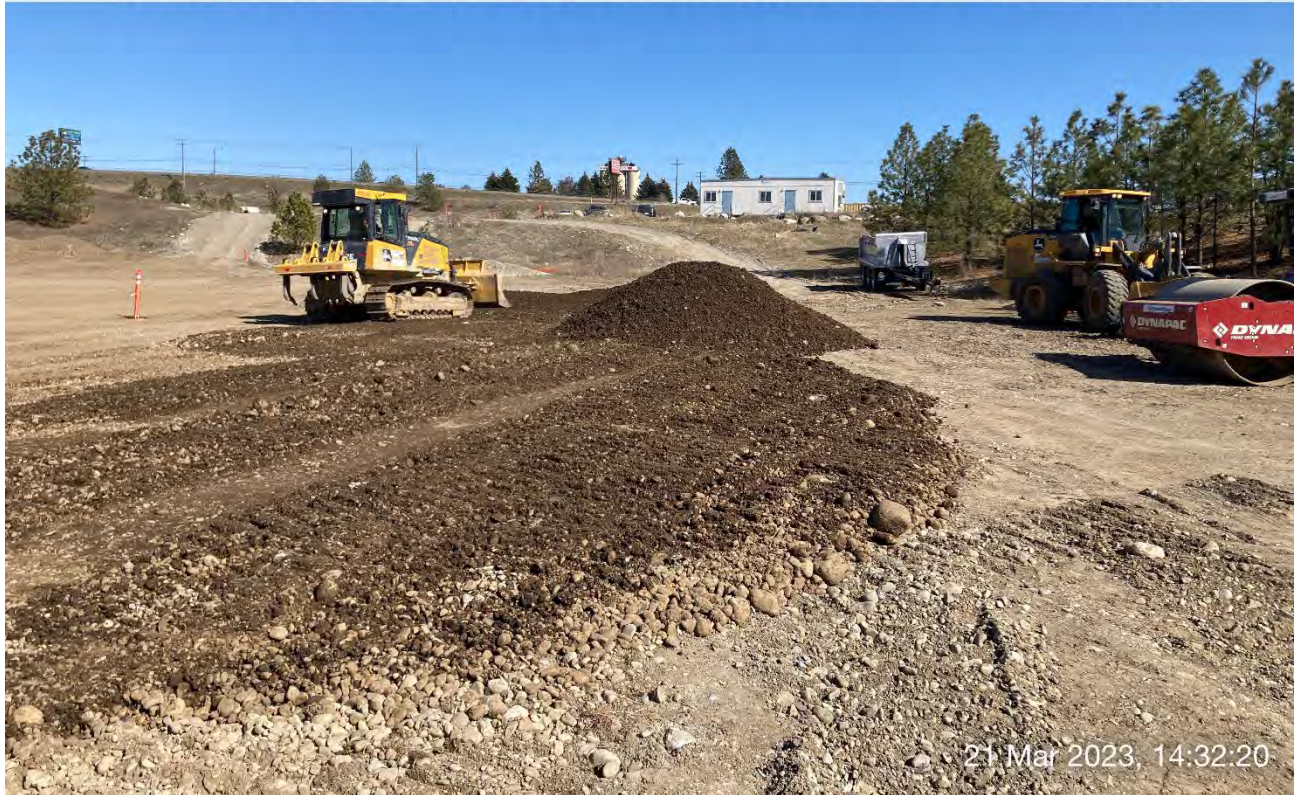
Photograph 5: Grading backfill dumped in an area of the WSDOT property that was not excavated. Four off-road haul truck loads were dumped and spread in this area.

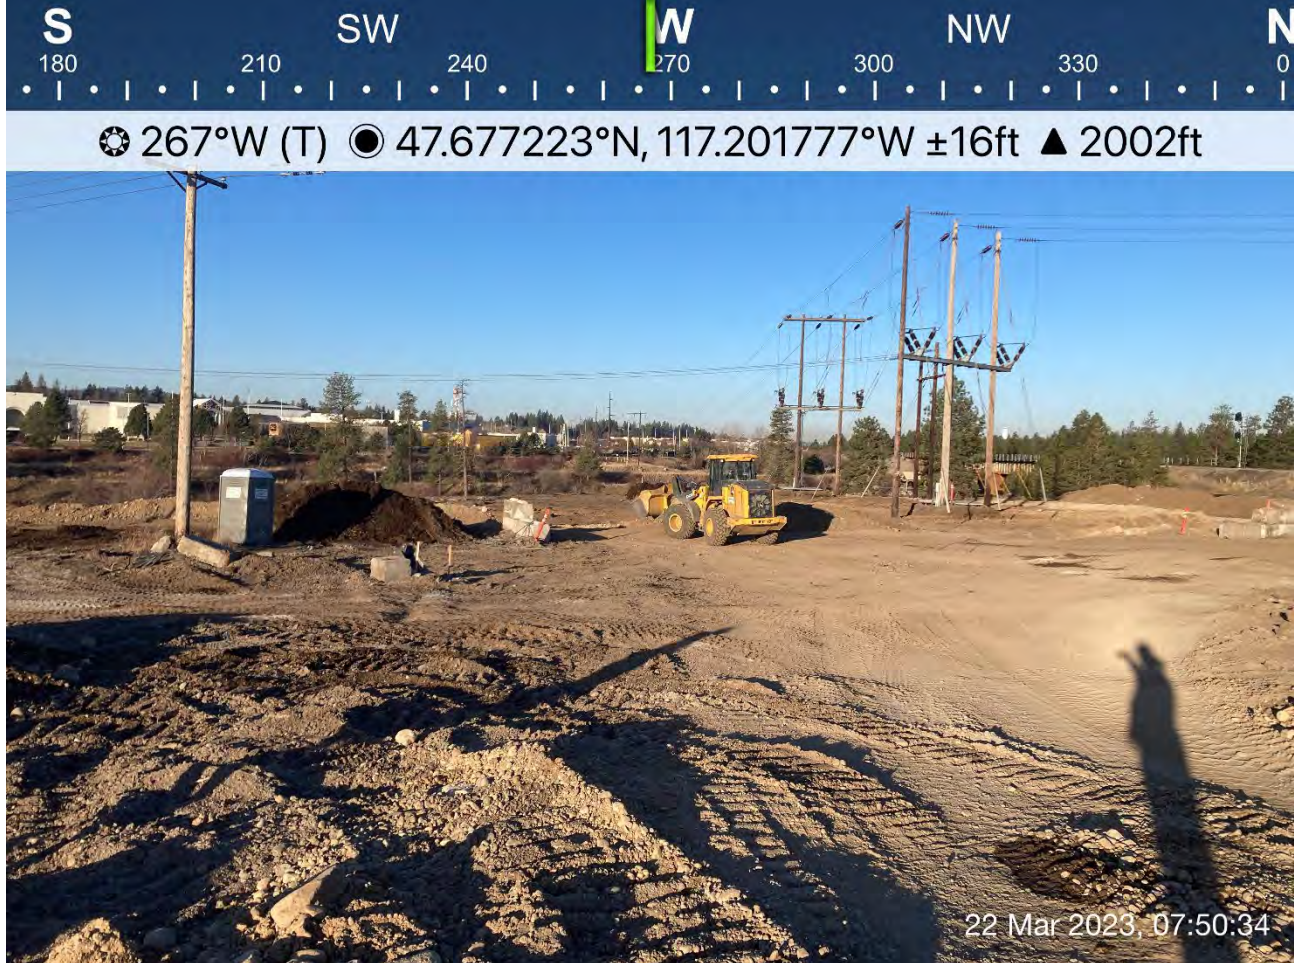
Photograph 1: Front-end loader transferring vegetative materials stockpiled near Excavation 2 to an area in the northeast portion of the Pentzer property.

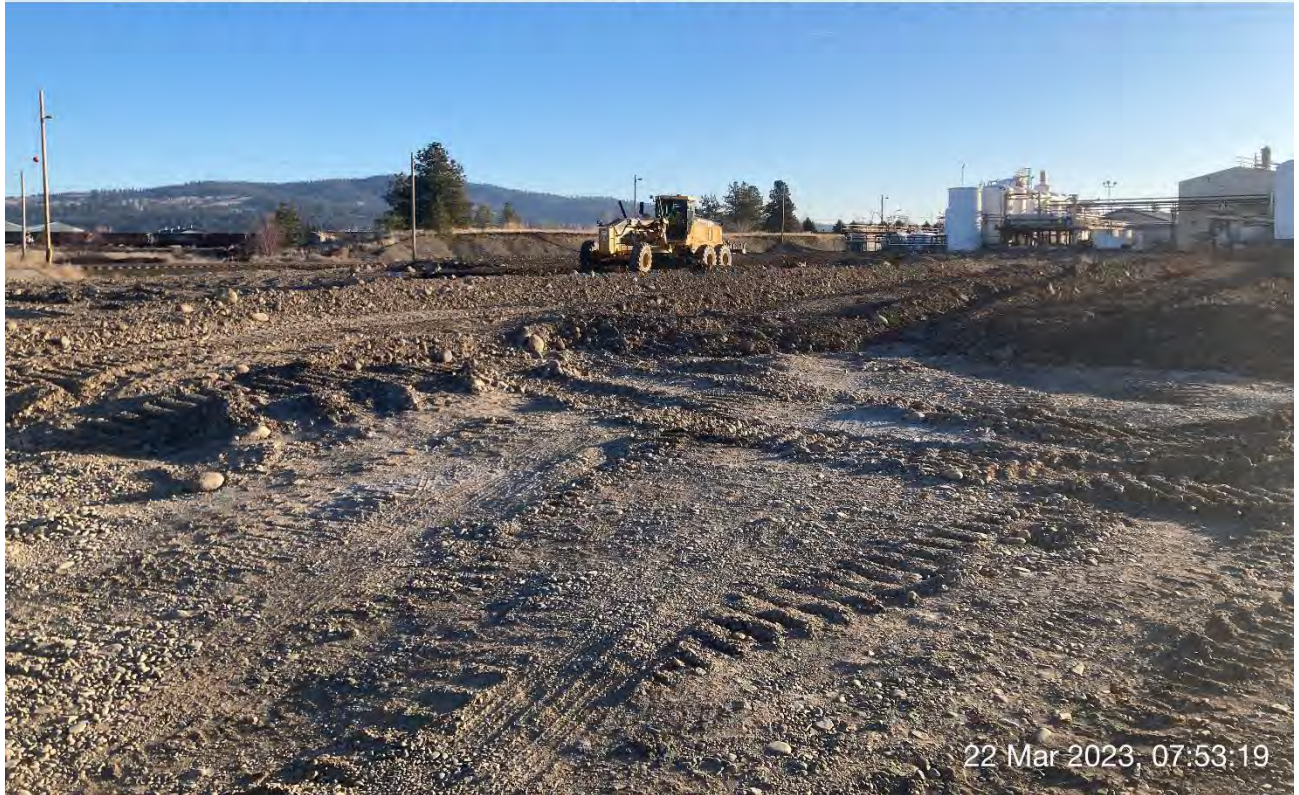
Photograph 2: SANY SMG 200 C-8 Motor Grader grading excavated materials in the UPRR cap area.

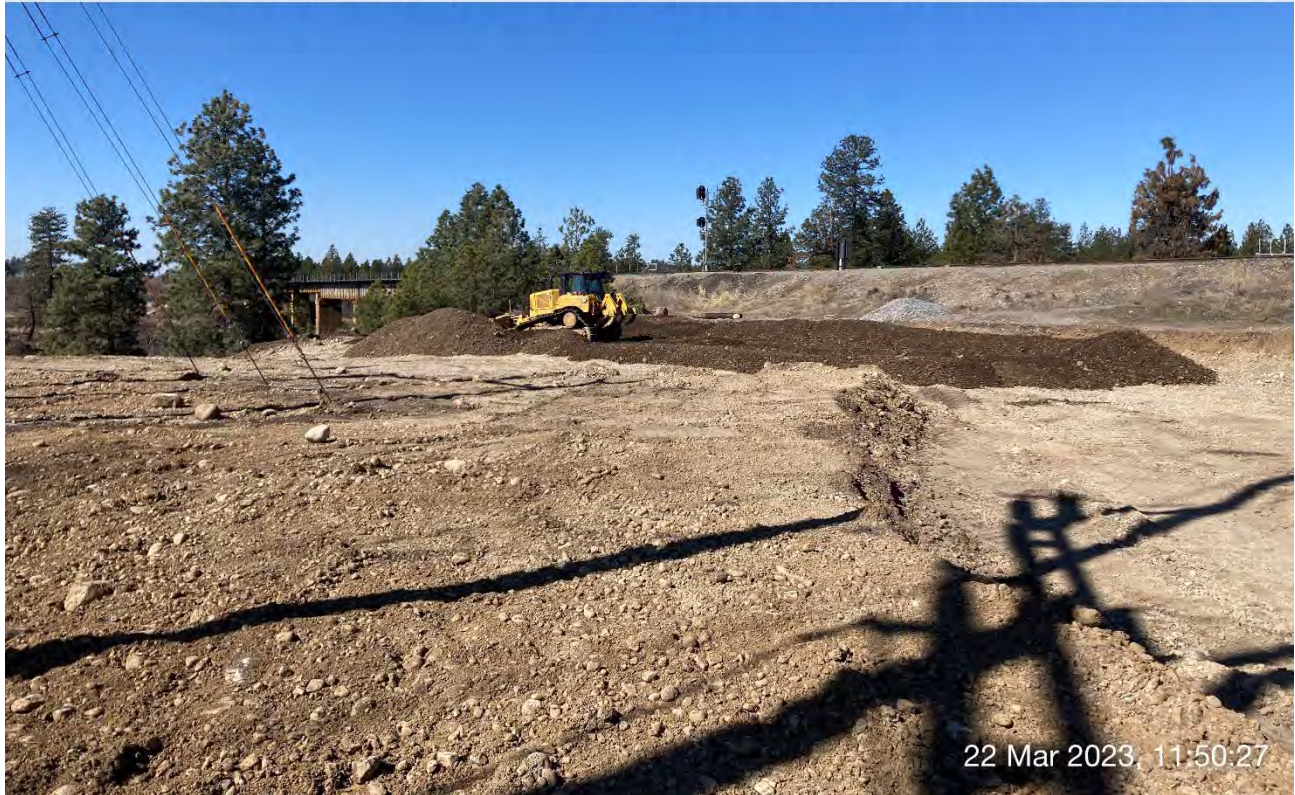
Photograph 4: CAT D6 dozer spreading and grading backfill dumped in Excavation 1 on the Pentzer property.

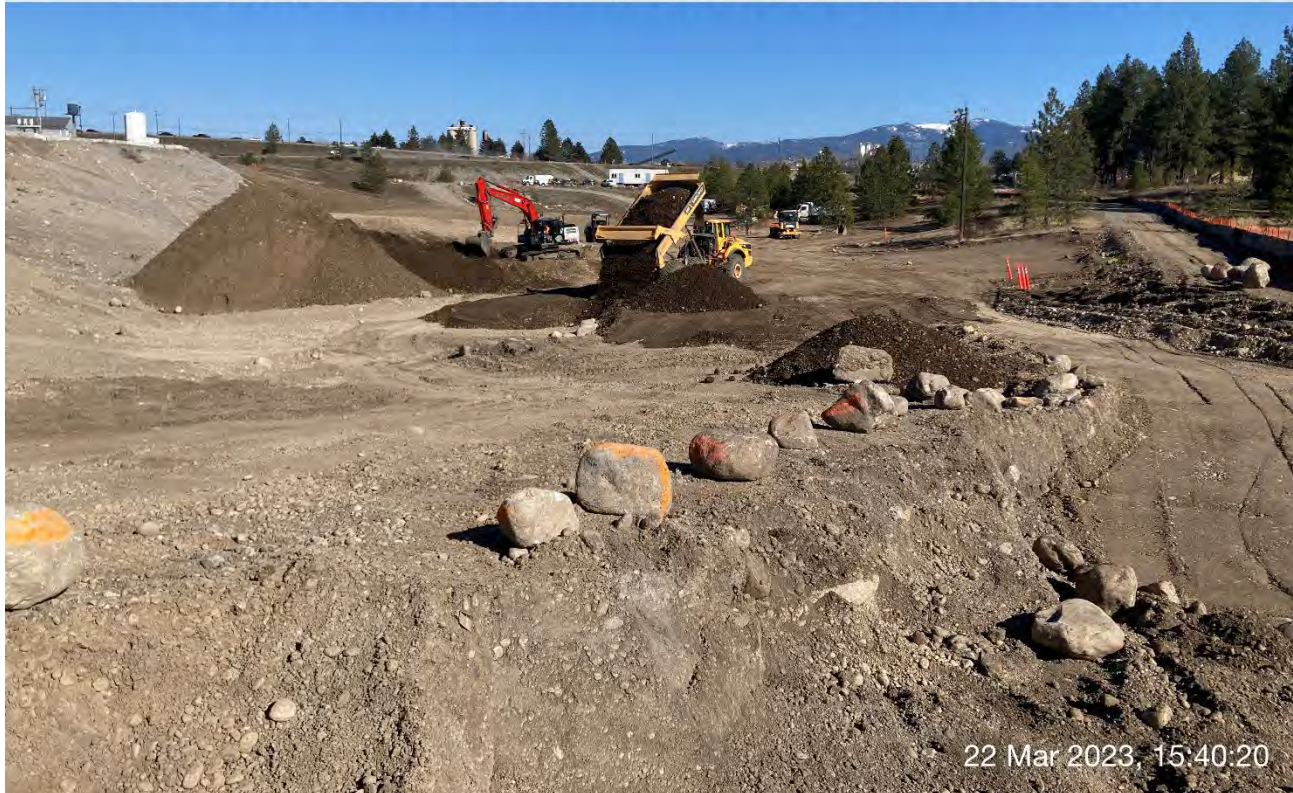
Photograph 5: LinkBelt Trackhoe and the off-road haul truck transferring backfill from the stockpile to Excavation 4.

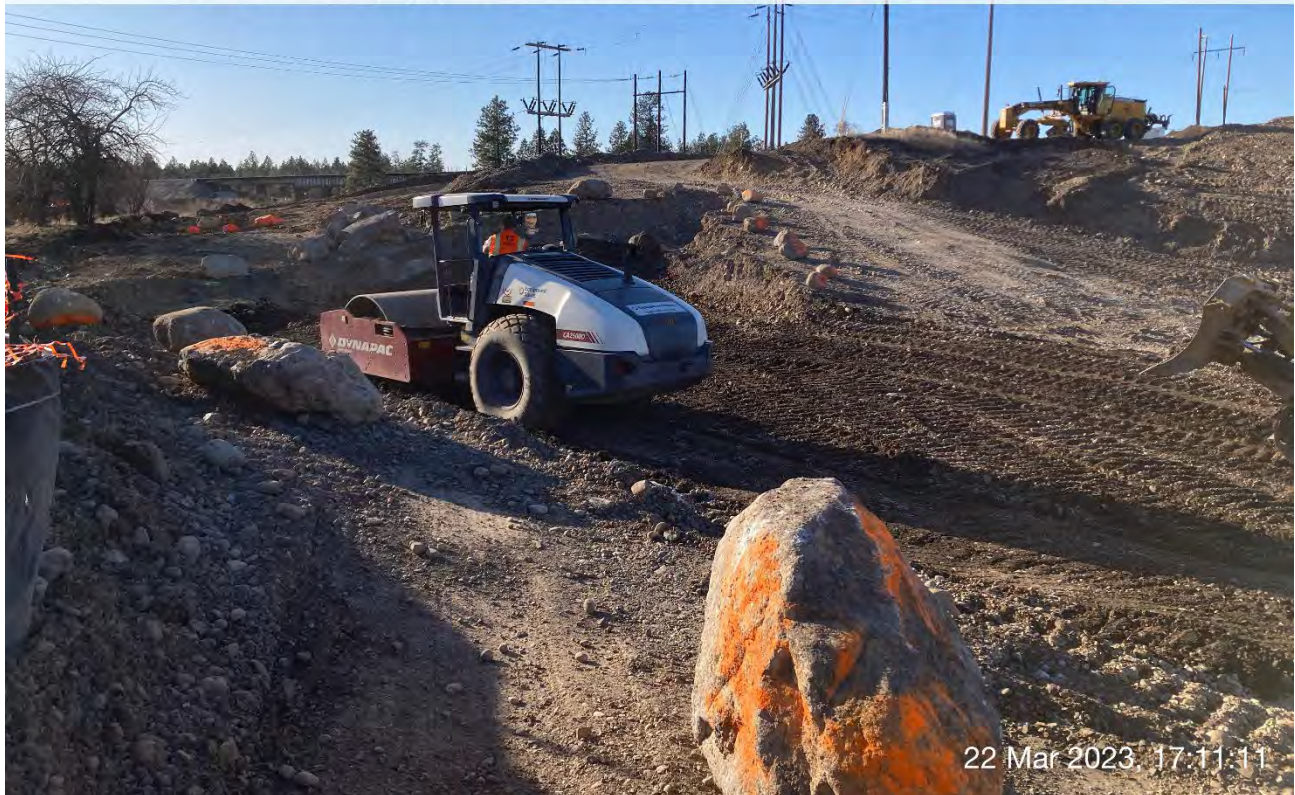
Photograph 6: DYNAPAC CA2500D roller compacting backfill material within Excavation 3 on the WSDOT property.

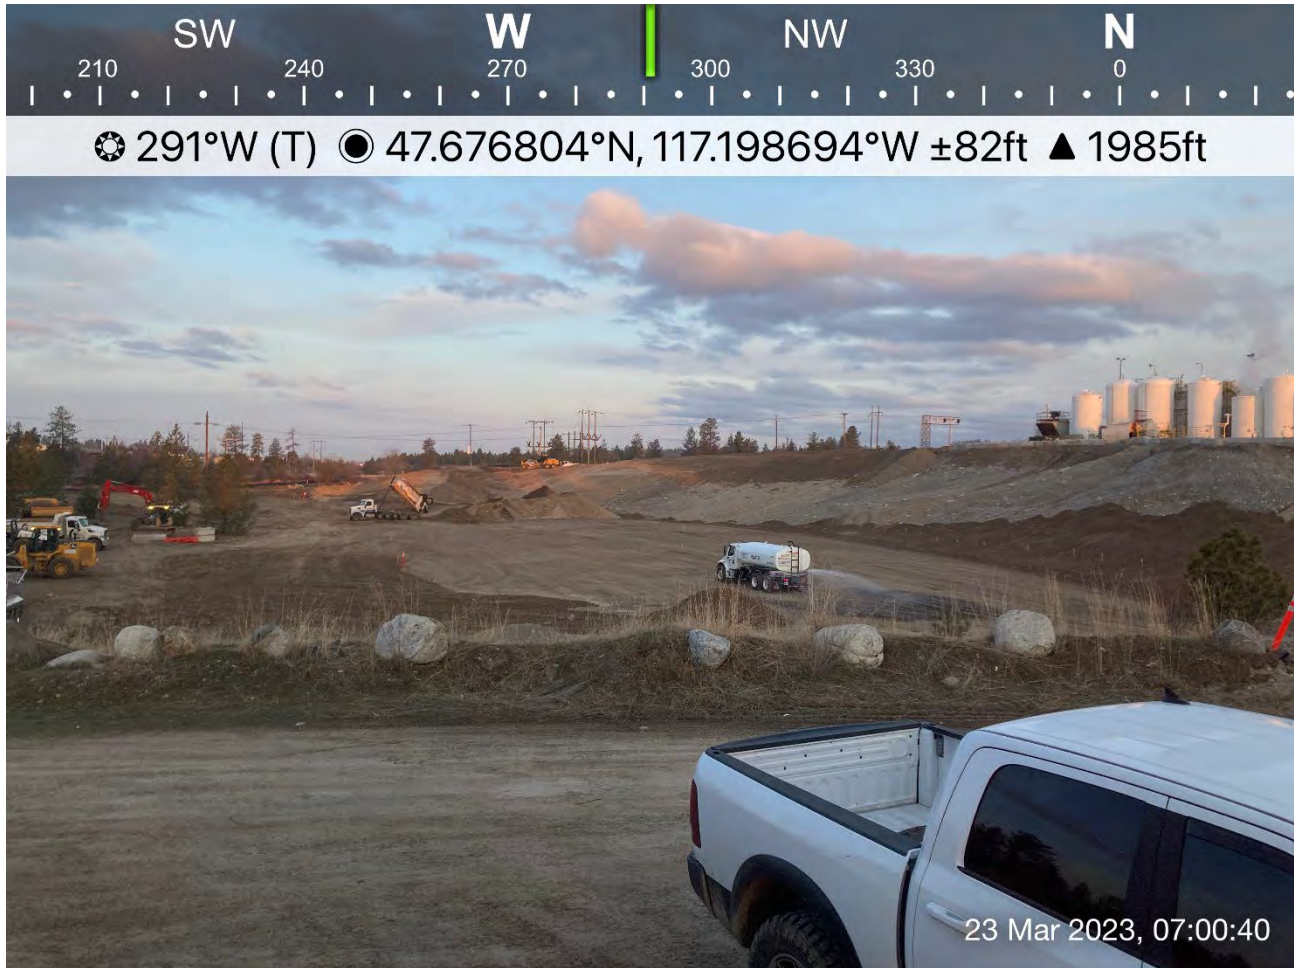
Photograph 1: Water truck spraying haul route used by backfill haul trucks for dust suppression due to dry site conditions.

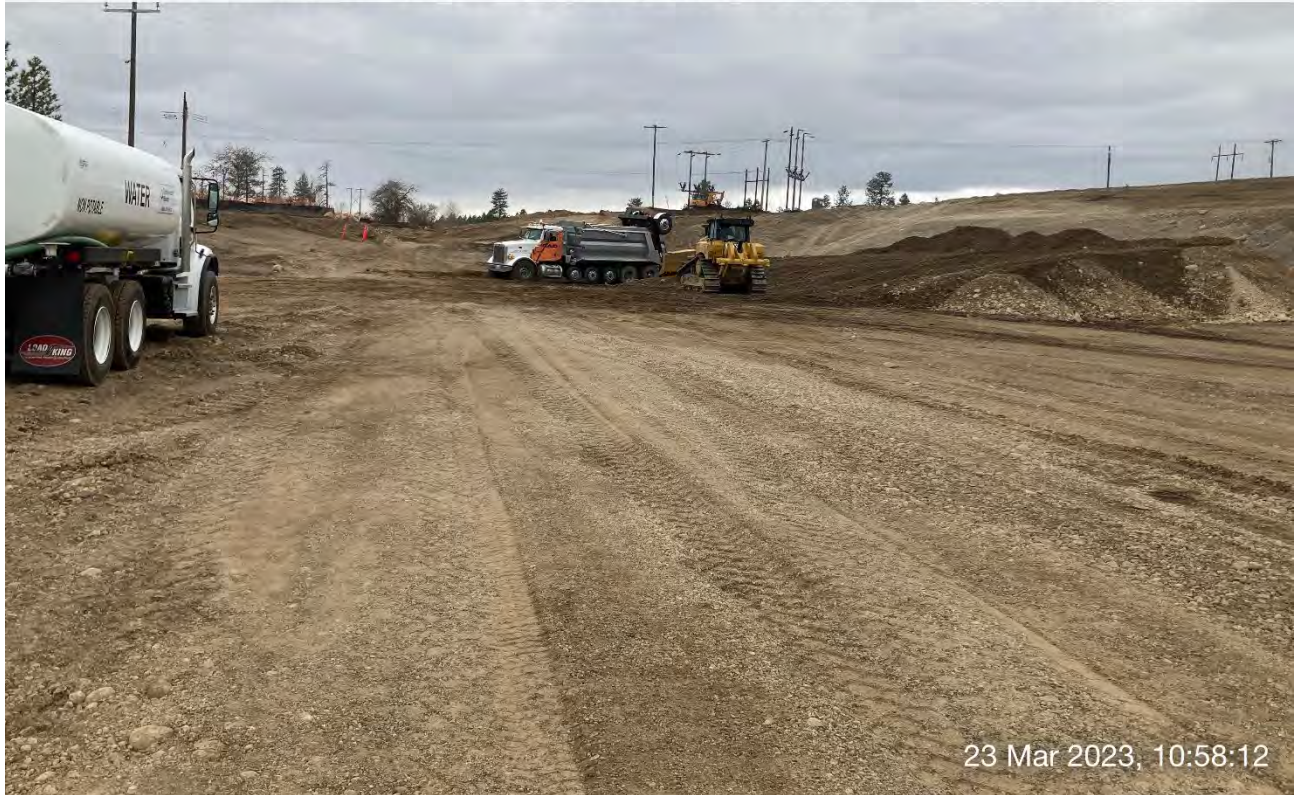
Photograph 2: CAT D6 dozer uses to push backfill material delivered to site.

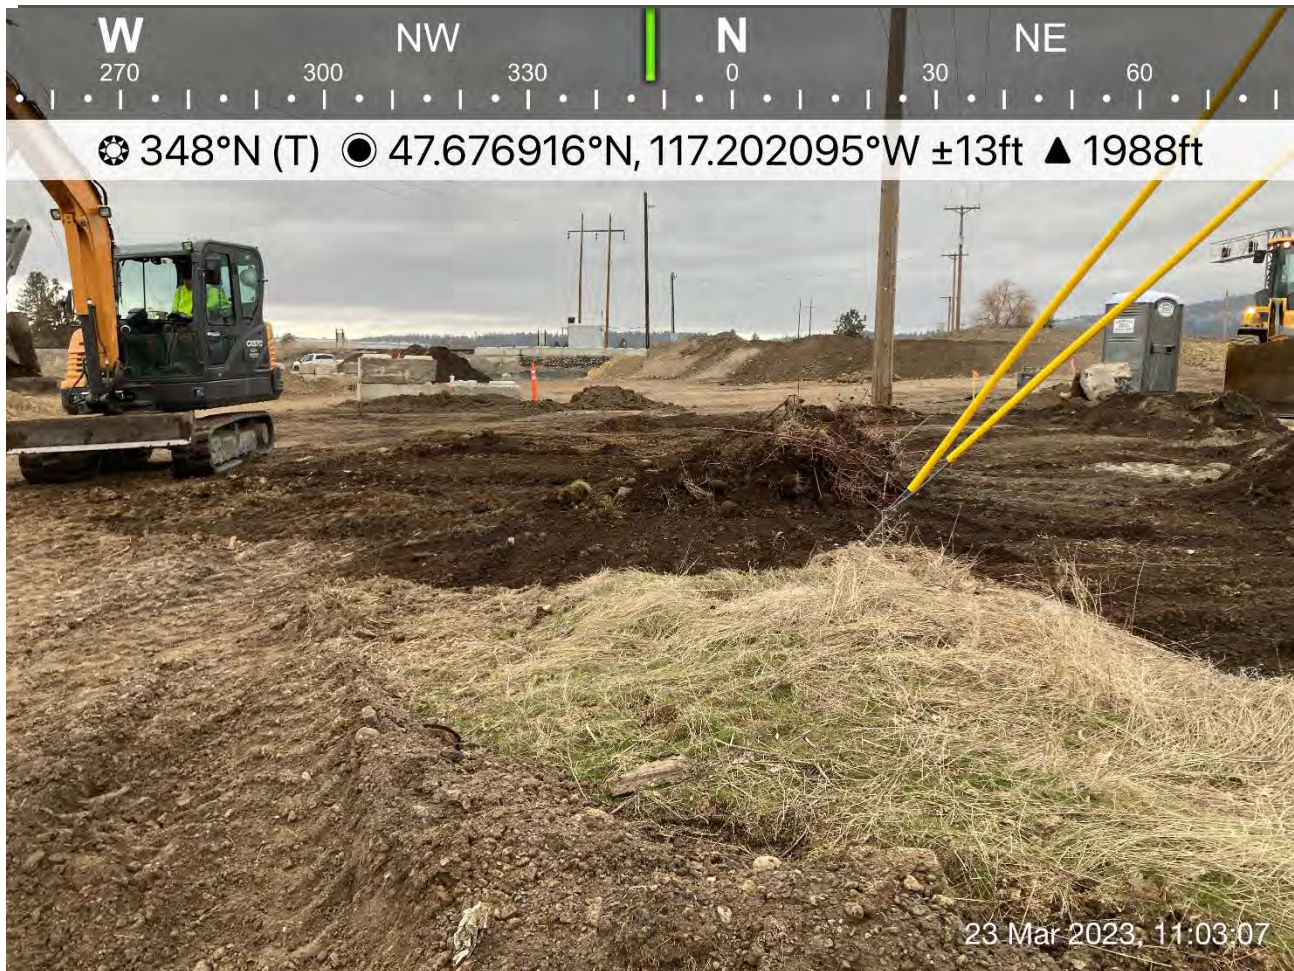
Photograph 3: Mini excavator used to clear the vegetation around the Inland and Avista power poles located near and within the eastern portion of Excavation 2.

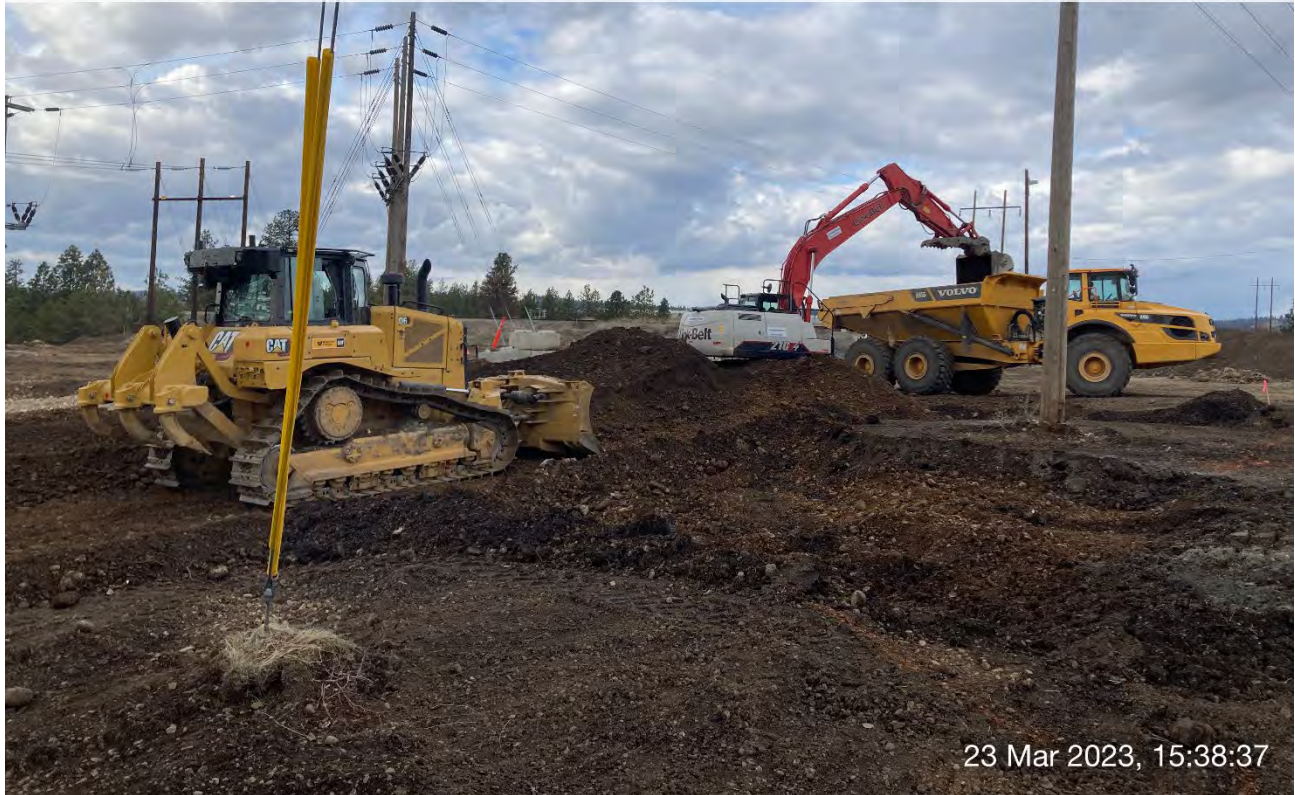
Photograph 4: CAT D6 dozer, LinkBelt trackhoe, and off-road haul truck used to begin excavation of eastern portion of Excavation 2.

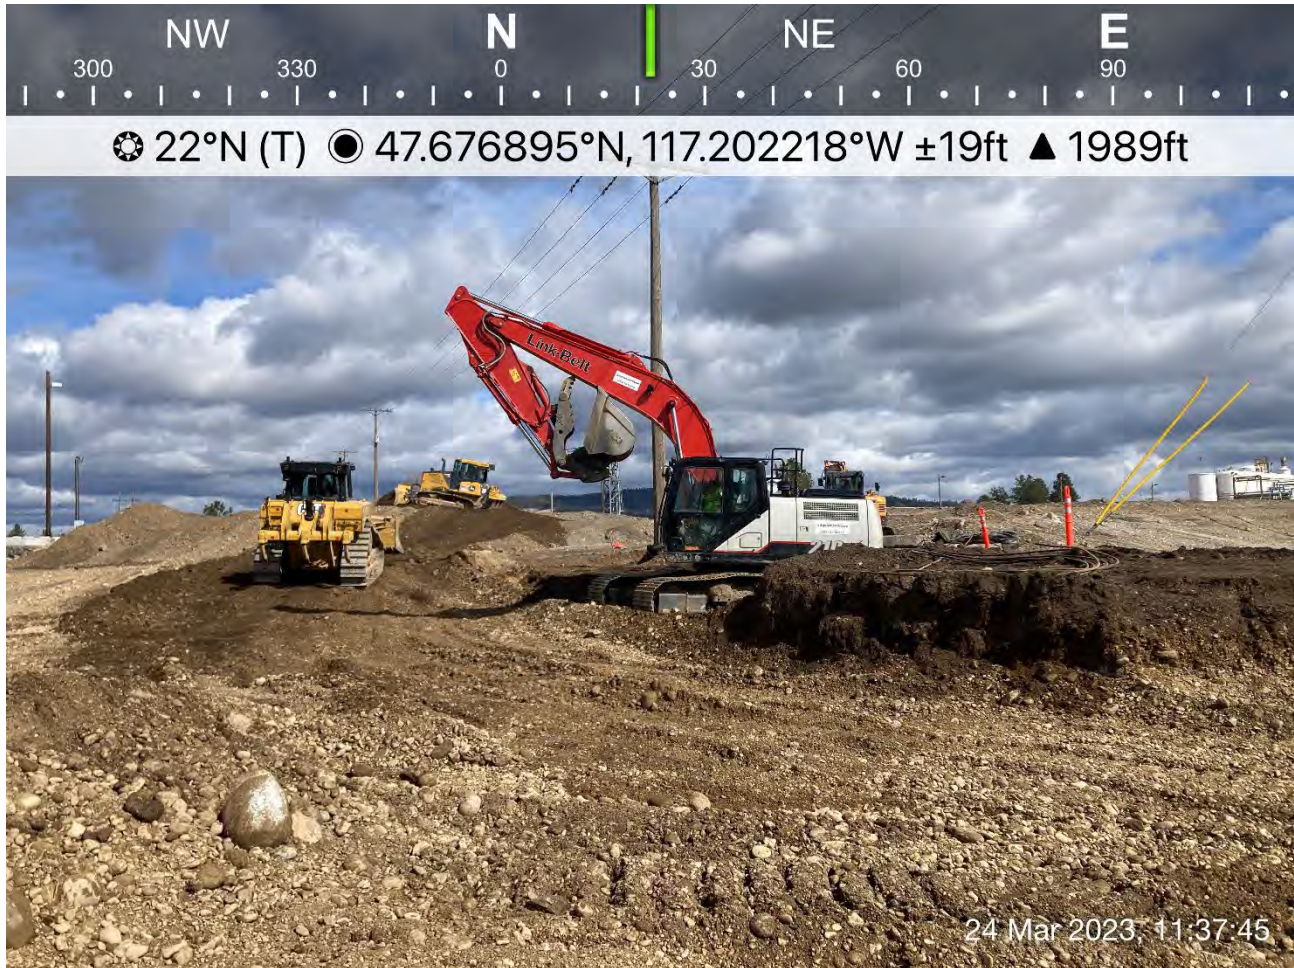
Photograph 1: LinkBelt trackhoe, CAT D6 dozer, and John Deere 700L dozer utilized to excavate the remaining portion of Excavation 2.

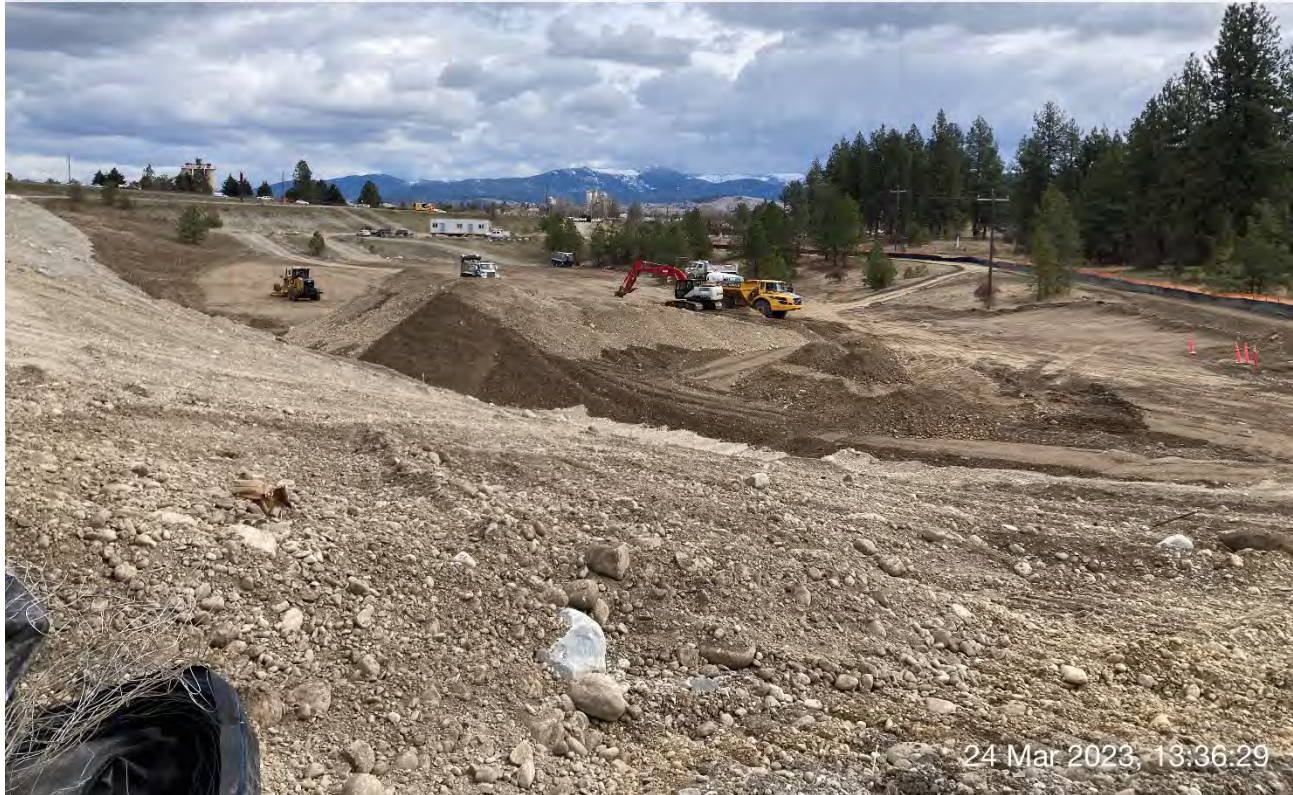
Photograph 2: On-road haul truck delivering backfill material to site, and LinkBelt trackhoe loading Off-road haul truck with backfill material for placement on Excavation 3 and Excavation 4 areas of the WSDOT property.

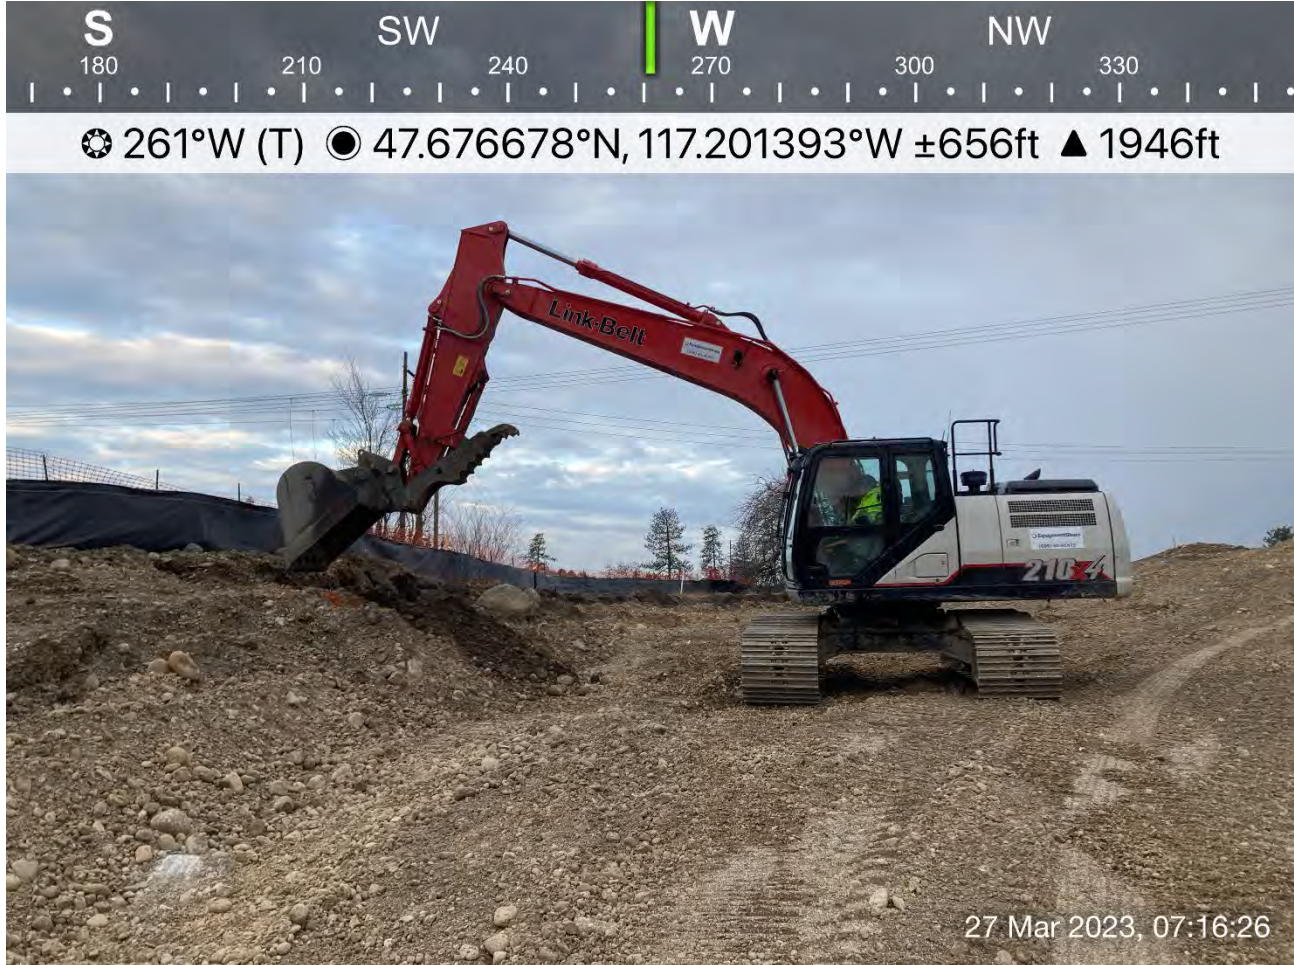
Photograph 1: LinkBelt trackhoe excavating a portion of the southern sidewall of Excavation 3 where laboratory analysis indicated that a sample did not meet CULs.

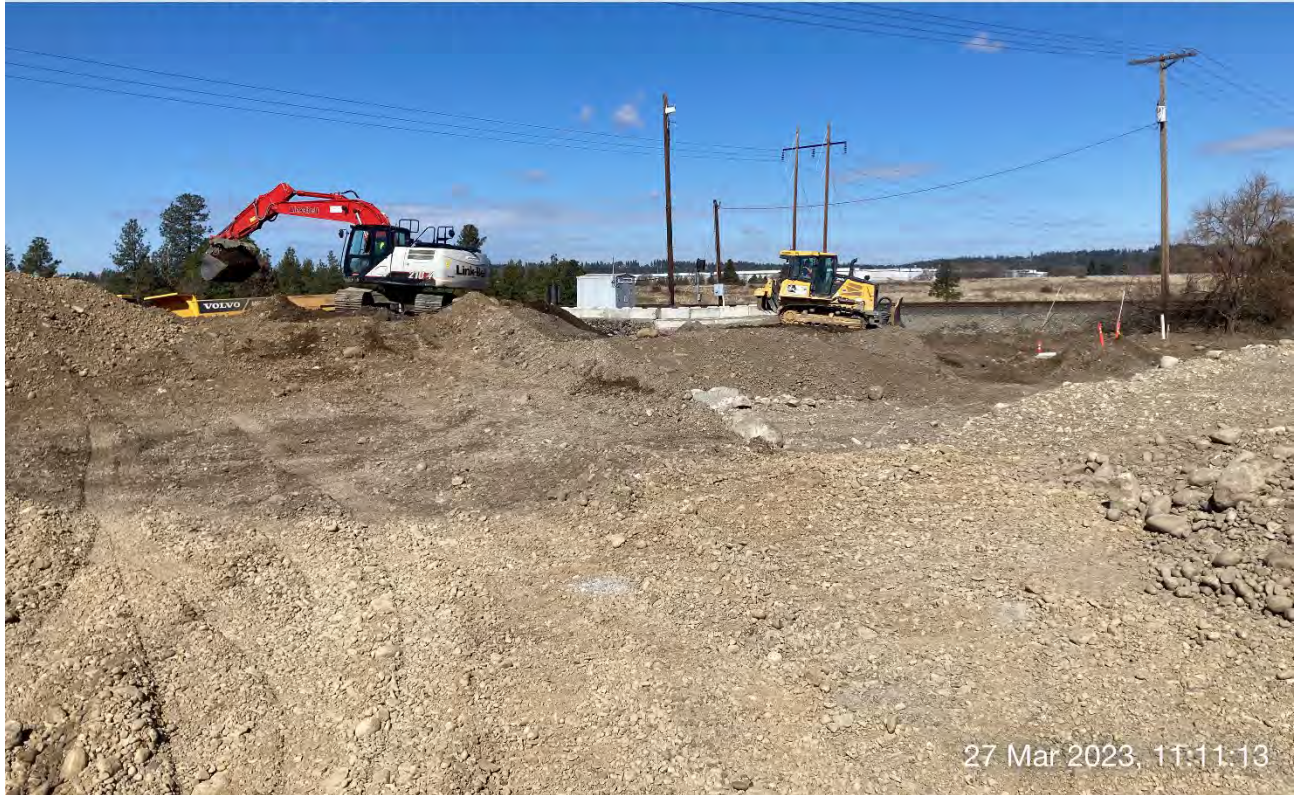
Photograph 2: LinkBelt trackhoe loading the off-road haul truck with excavated materials to be dumped on the UPRR slope. The John Deere 700L dozer pushed excavated material toward the LinkBelt trackhoe to aid in the transfer efforts.

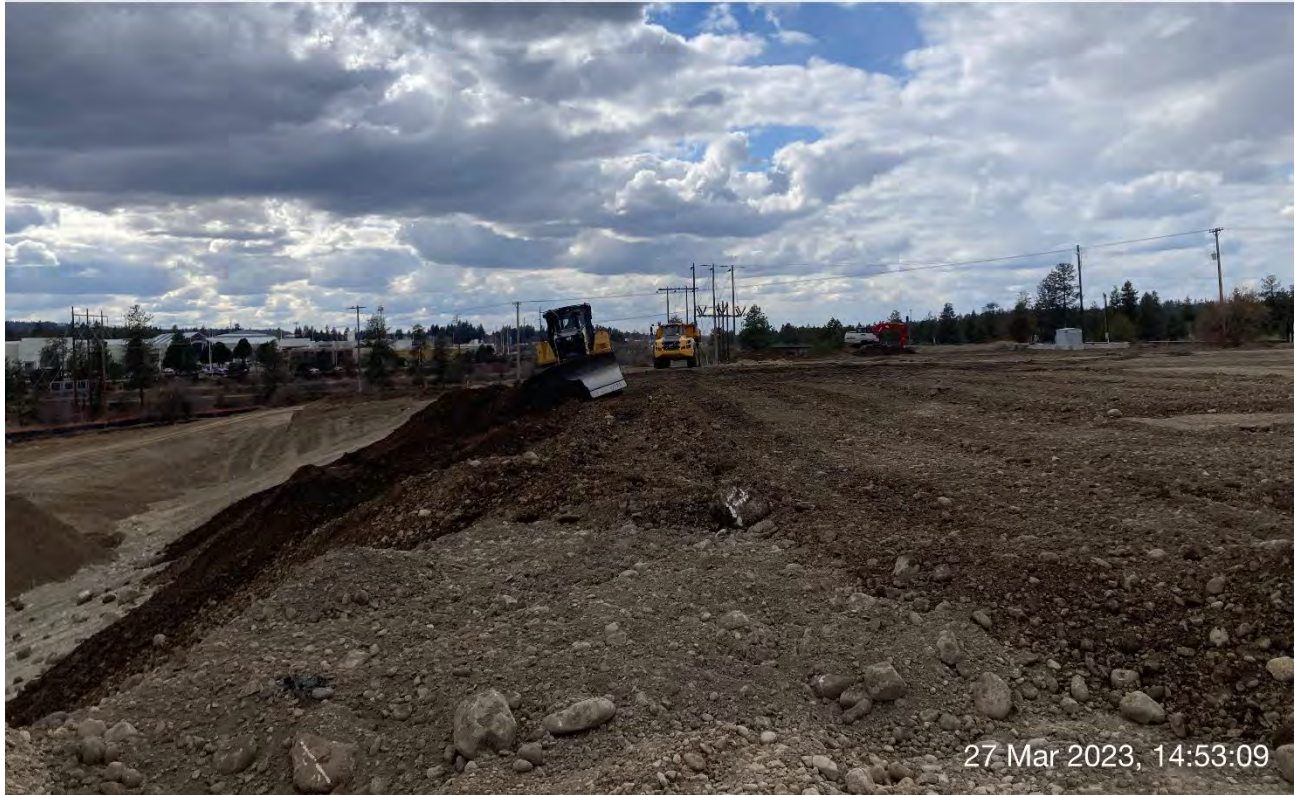
Photograph 3: CAT D6 dozer grading excavated materials dumped on the UPRR slope.

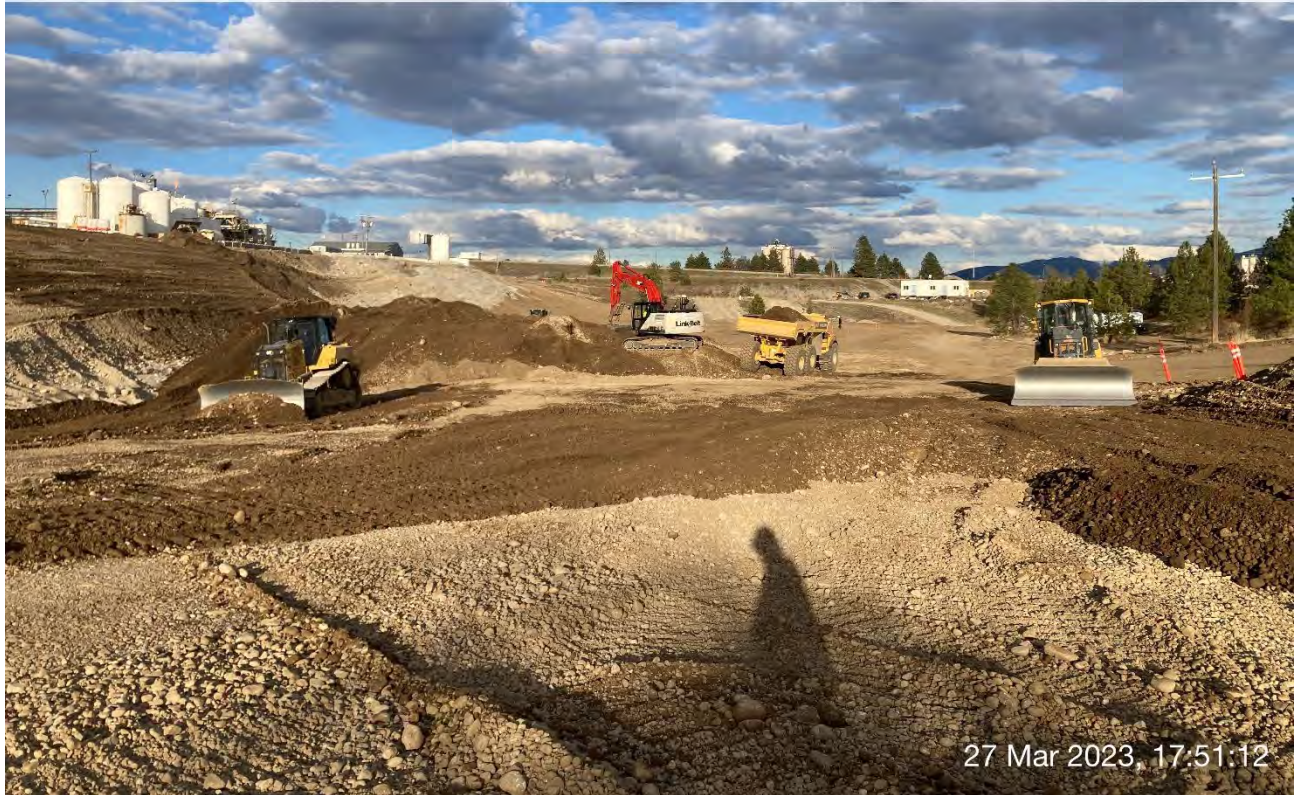
Photograph 4: LinkBelt trackhoe and off-road haul truck transferring stockpiled backfill materials to Excavation 3 and Excavation 4. CAT D6 dozer and John Deere 700L dozer spreading backfill materials in Excavation 4.

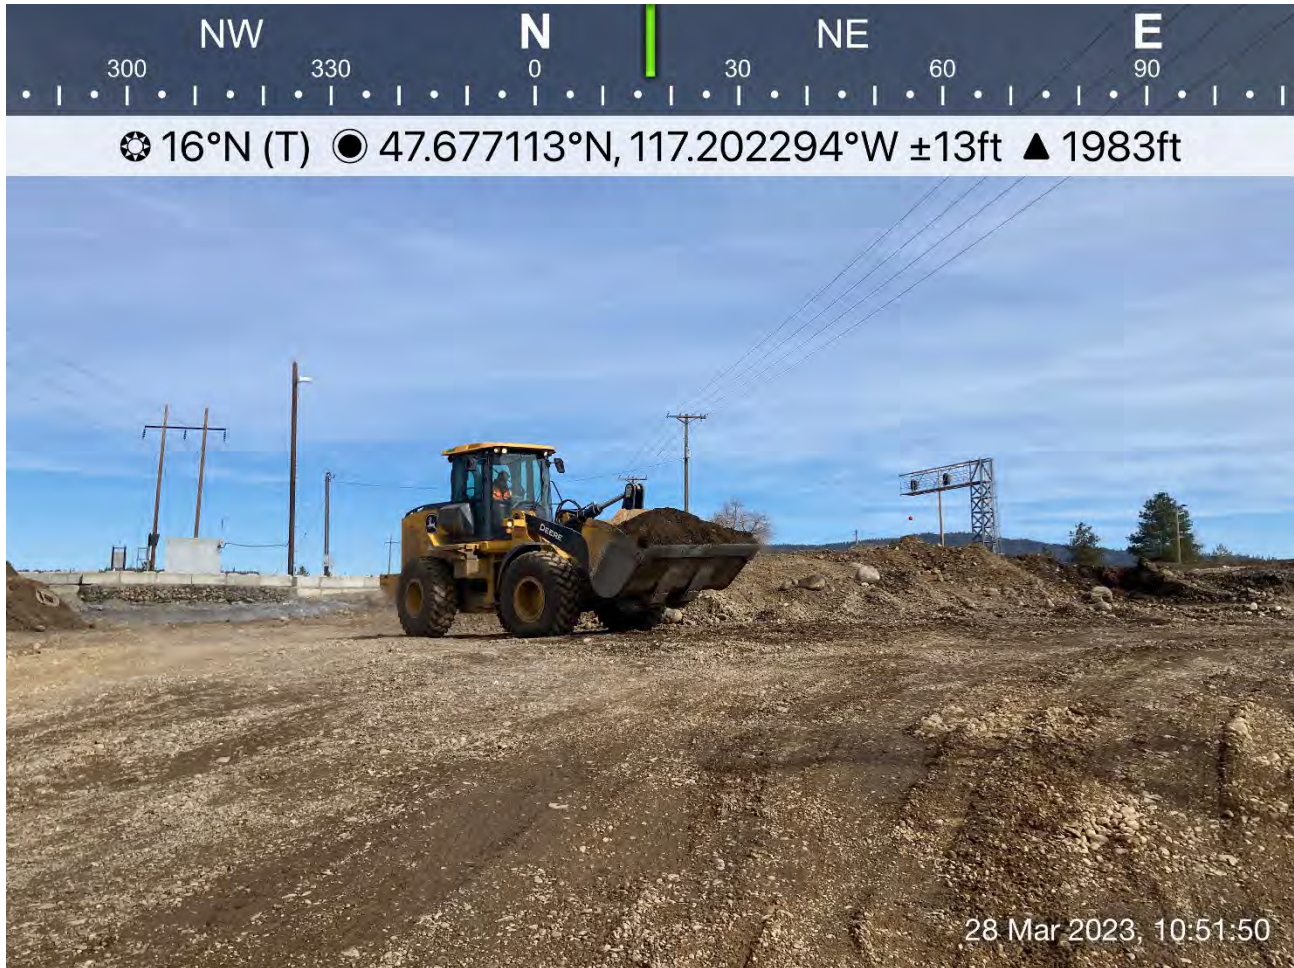
Photograph 1: Front-end loader transferring excavated materials from the stockpile located on the Pentzer property to the UPRR cap area.

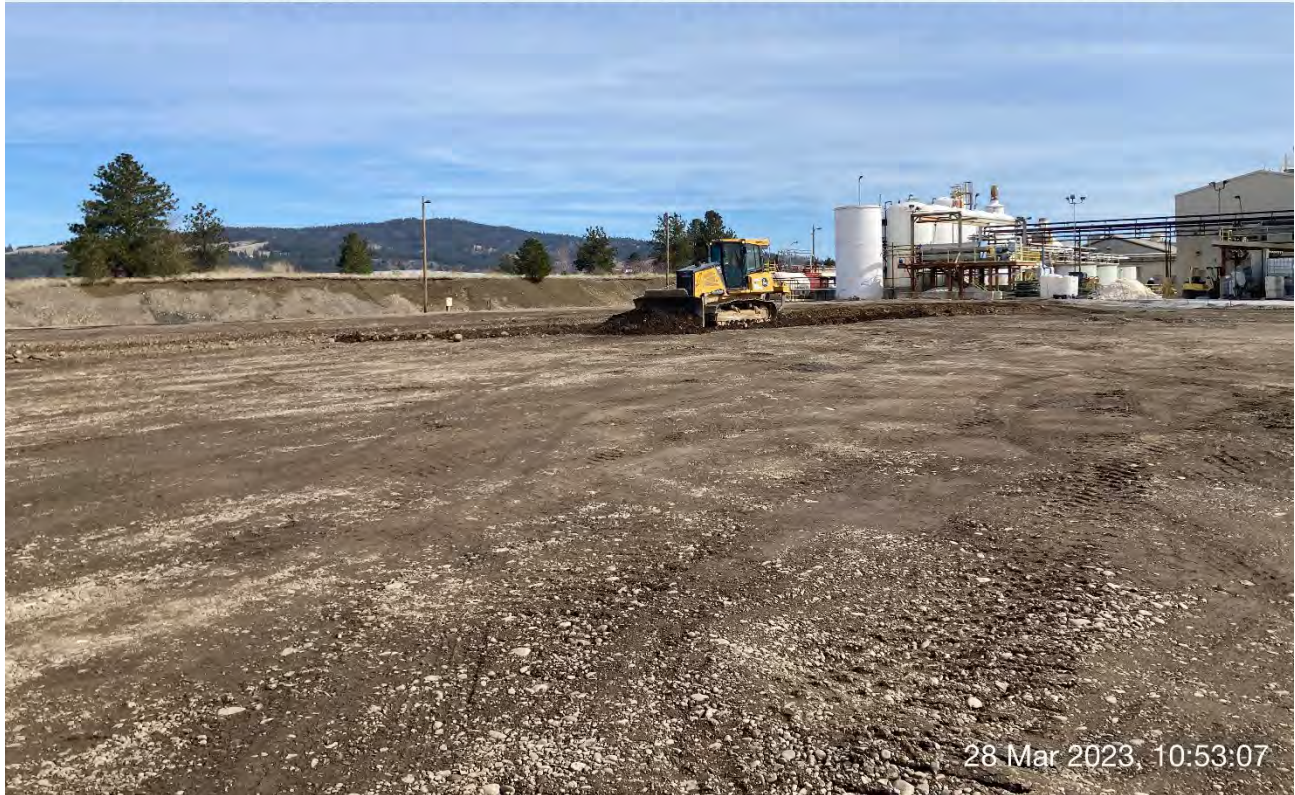
Photograph 2: John Deere 700L dozer spreading excavated materials on top of the UPRR cap area to fill in areas below grade.

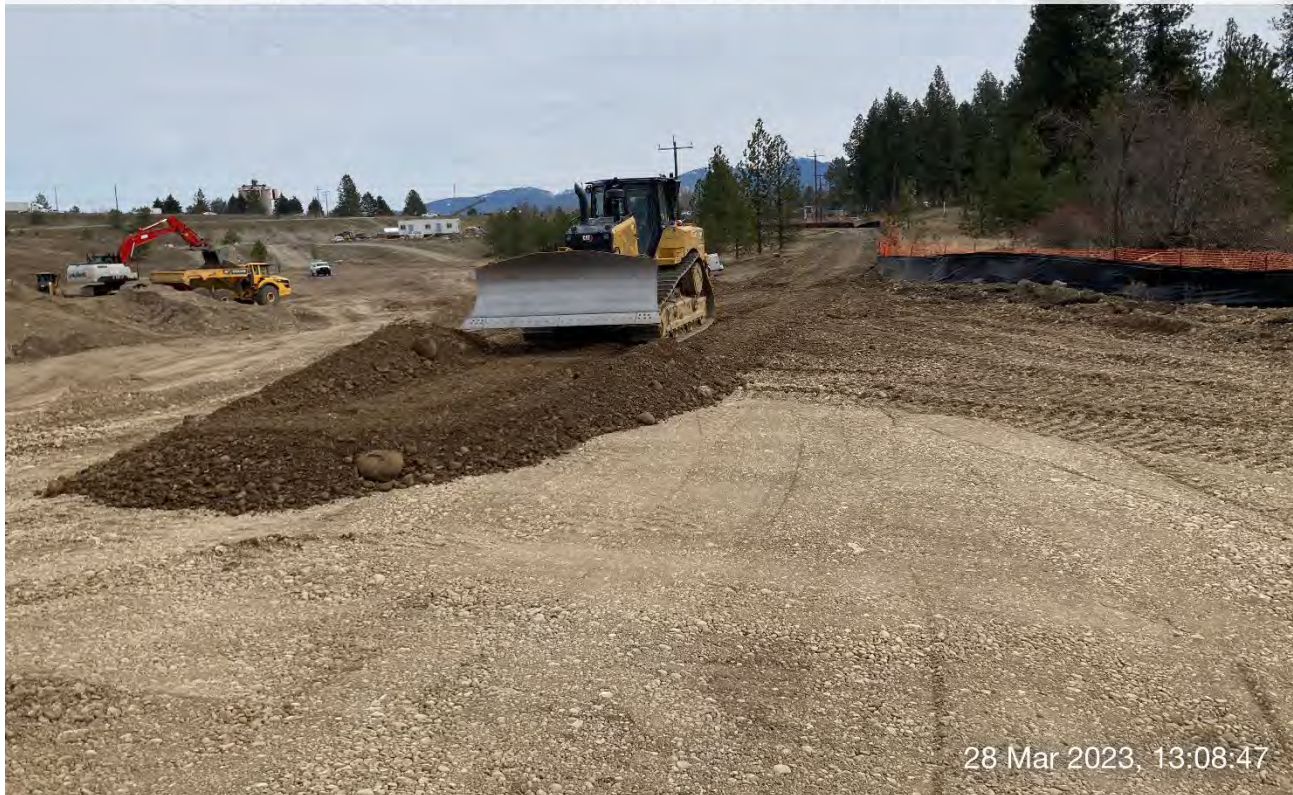
Photograph 3: CAT D6 dozer spreading backfill materials dumped near the property boundary of WSDOT and Pentzer.

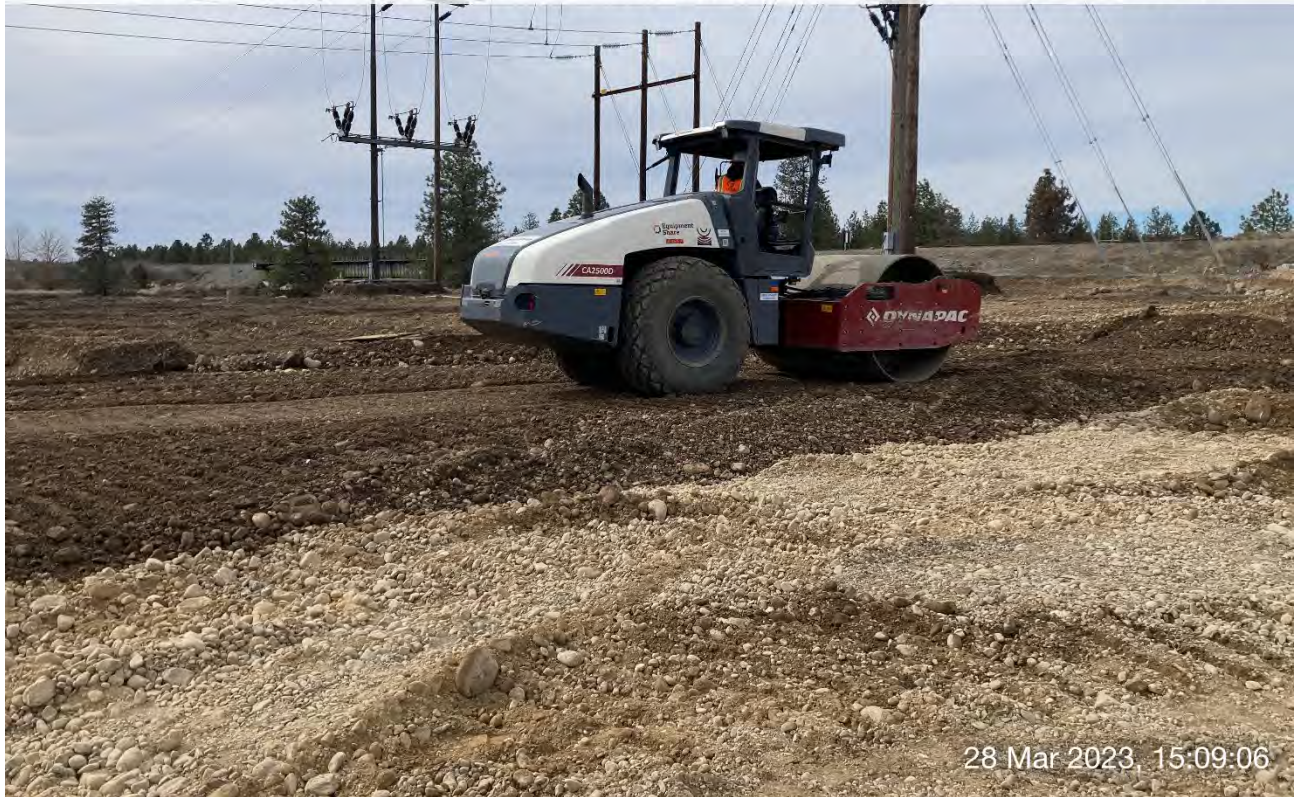
Photograph 4: DYNAPAC CA2500D roller compacting backfill materials placed in the western portion of Excavation 2 on the Pentzer property.
