GOLDER
MEMBER OF WSP

DAILY FIELD REPORT # 91

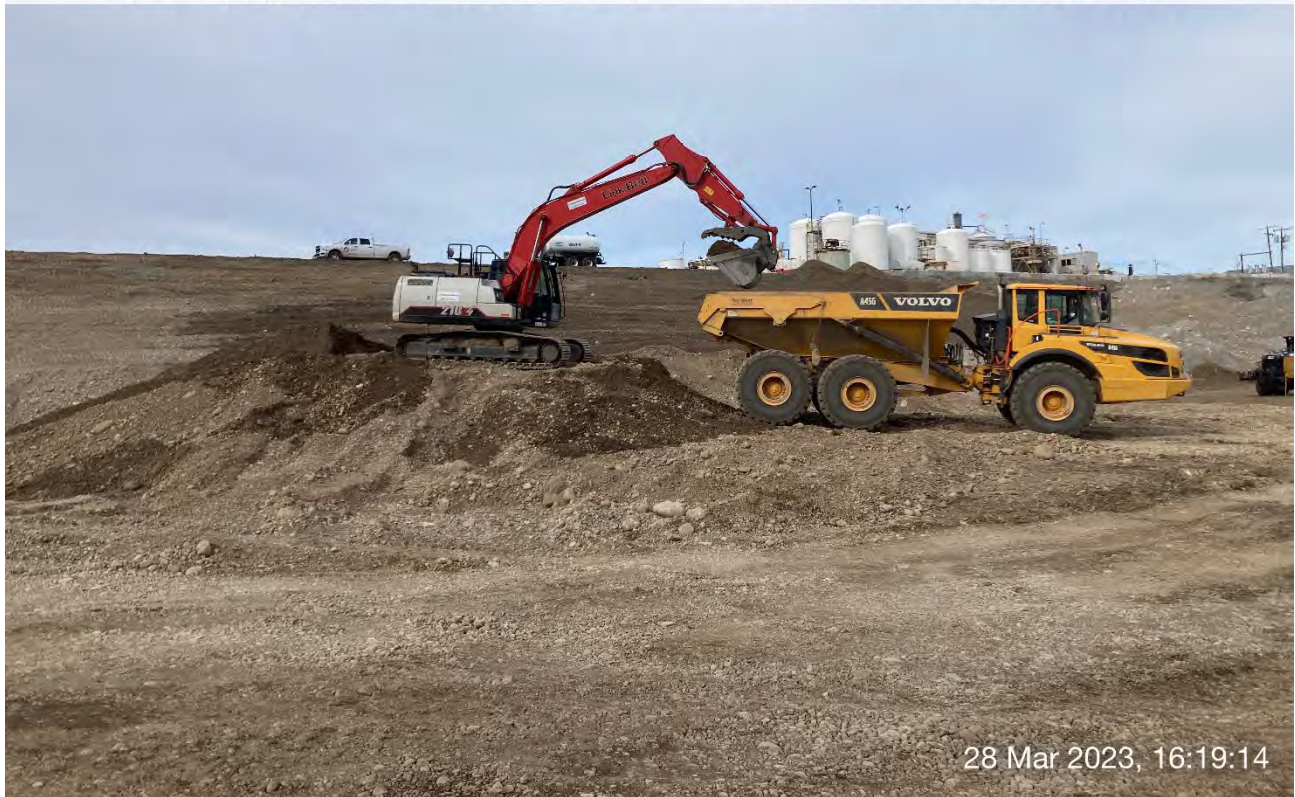
Photograph 5: LinkBelt trackhoe loading backfill materials from the backfill material stockpile located east of Excavation 4 on the WSDOT property into the off-road haul truck for transport.

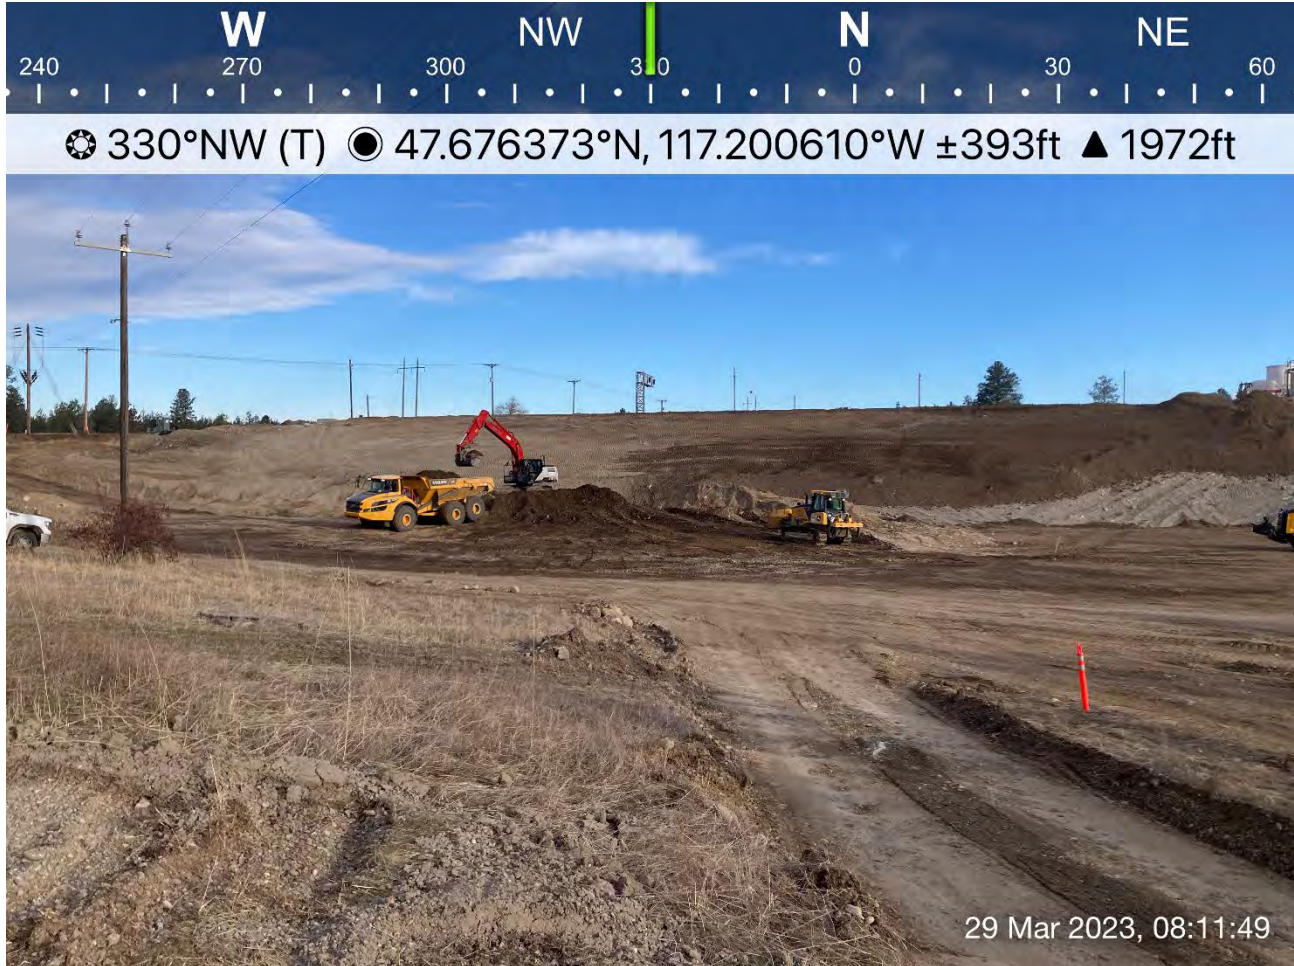
Photograph 1: Front-end loader transferring excavated materials from the stockpile located on the Pentzer property to the UPRR cap area.

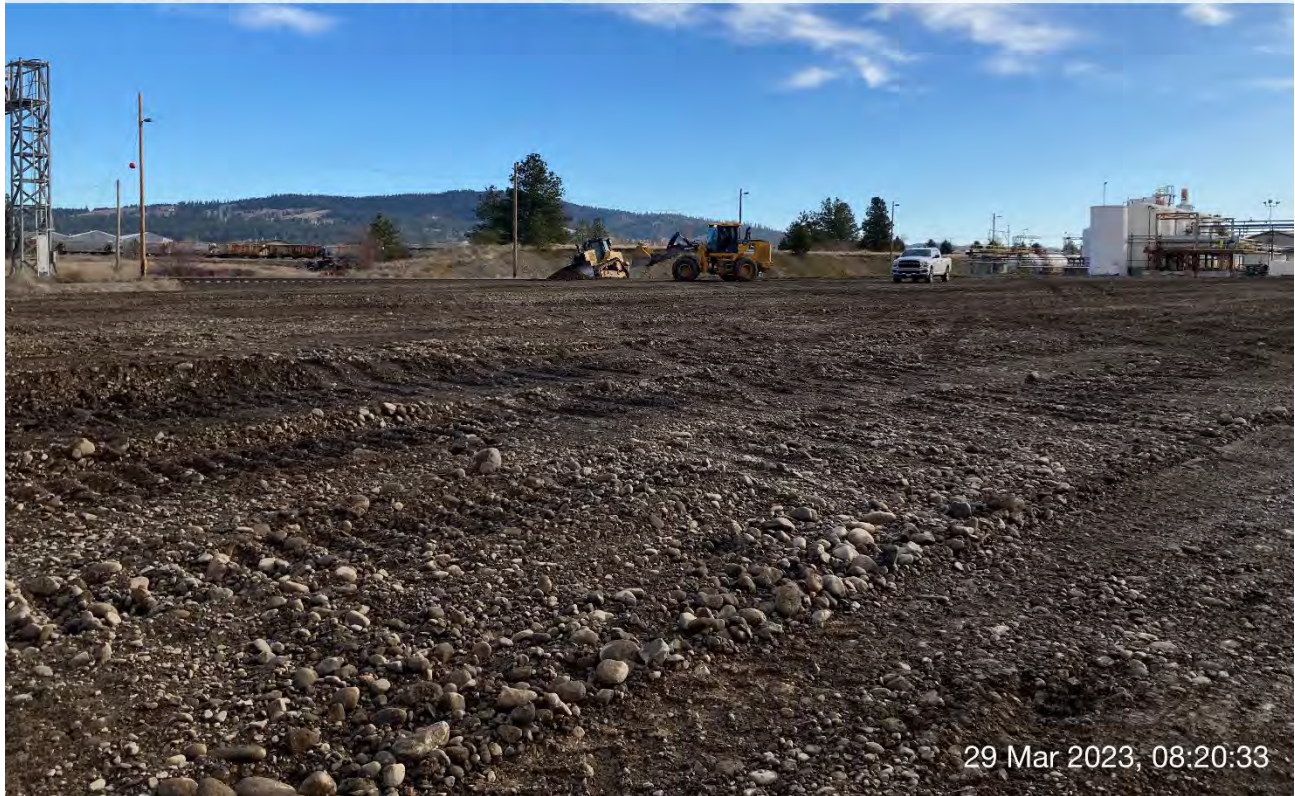
Photograph 2: CAT D6 dozer grading the railroad ditch north of the UPRR cap area. The front-end loader provided excavated materials from the stockpile located on the Pentzer property to fill in areas of the railroad ditch.

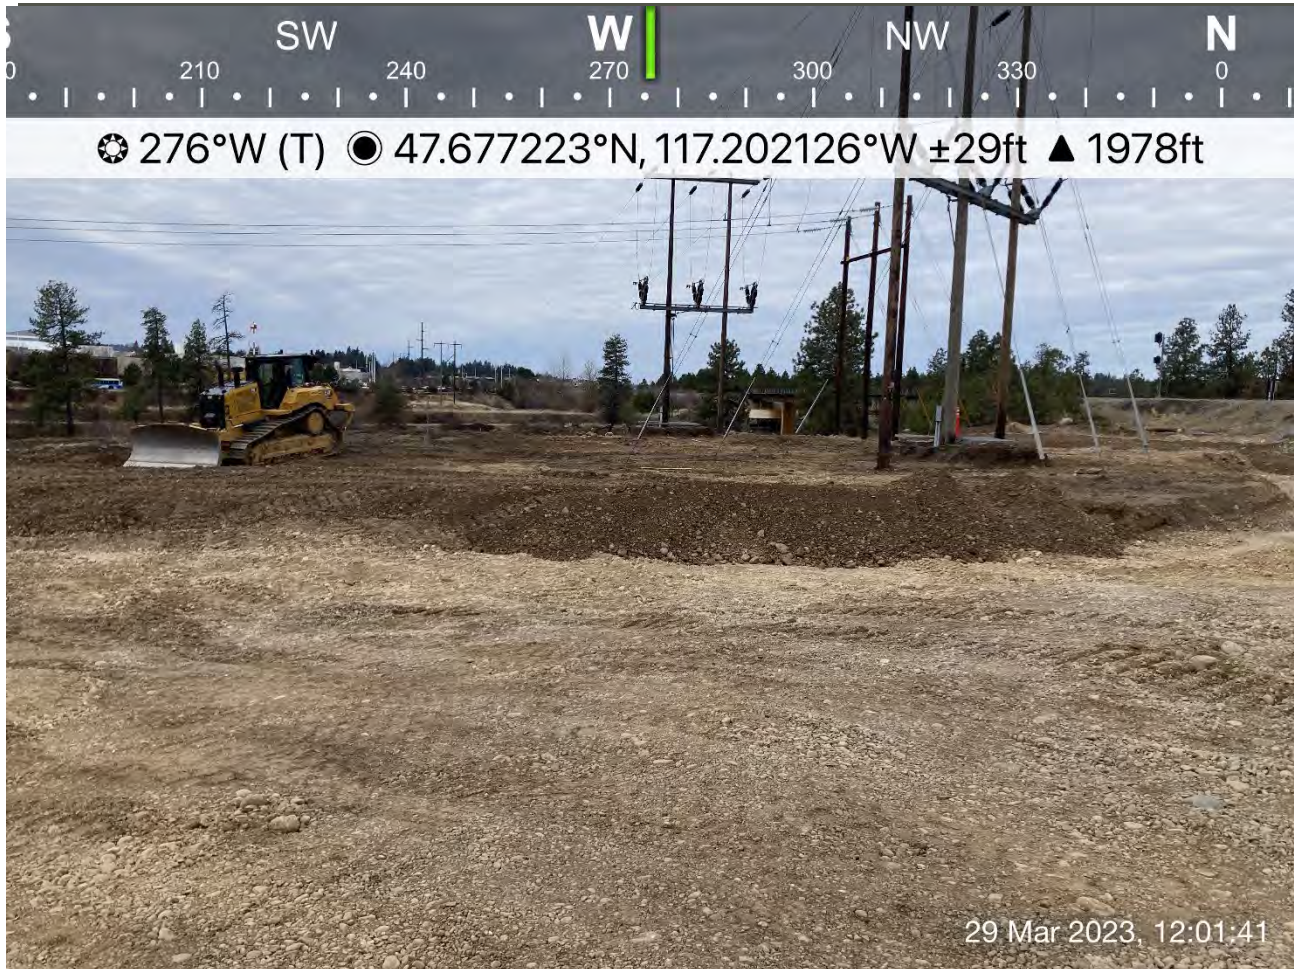
Photograph 3: CAT D6 dozer spreading backfill materials on the Pentzer property near the western portion of Excavation 2.

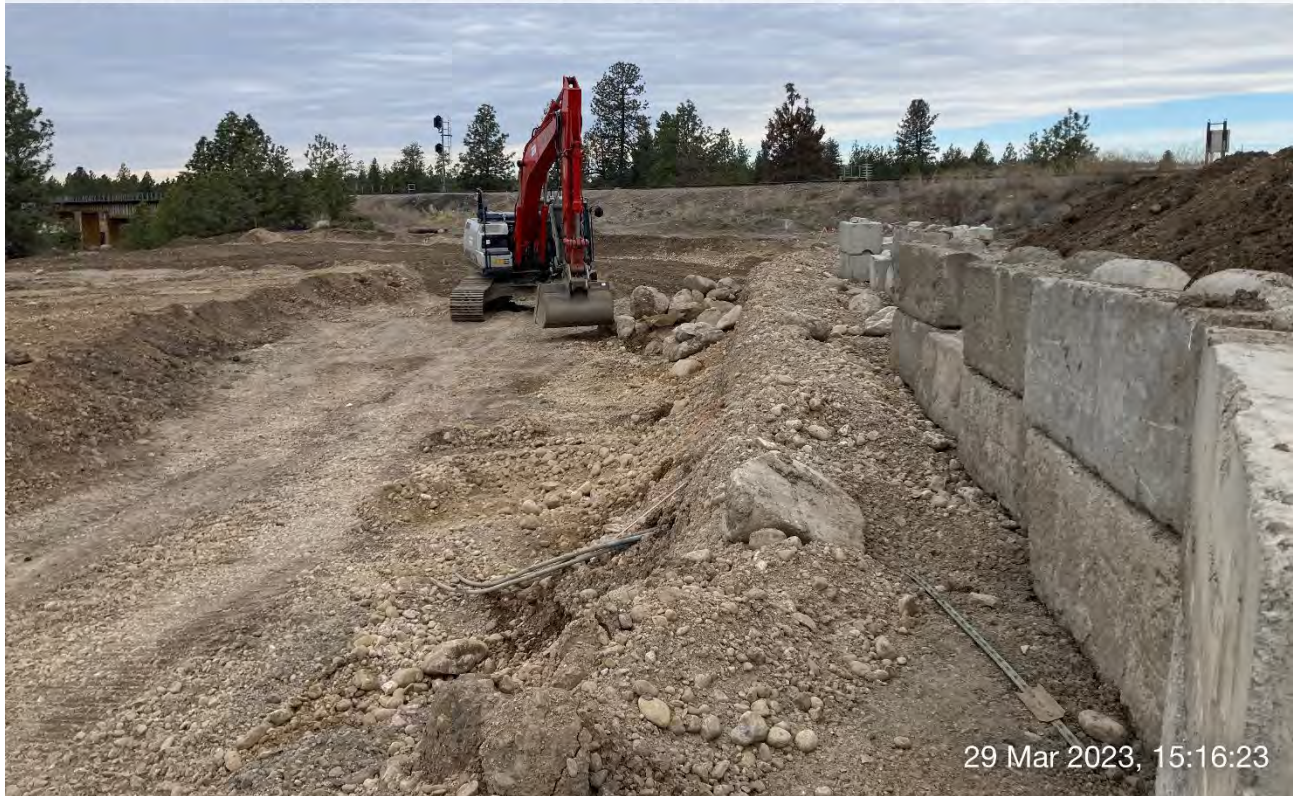
Photograph 4: LinkBelt trackhoe removing boulders from area needed to be excavated in the northeast portion of Excavation 2.

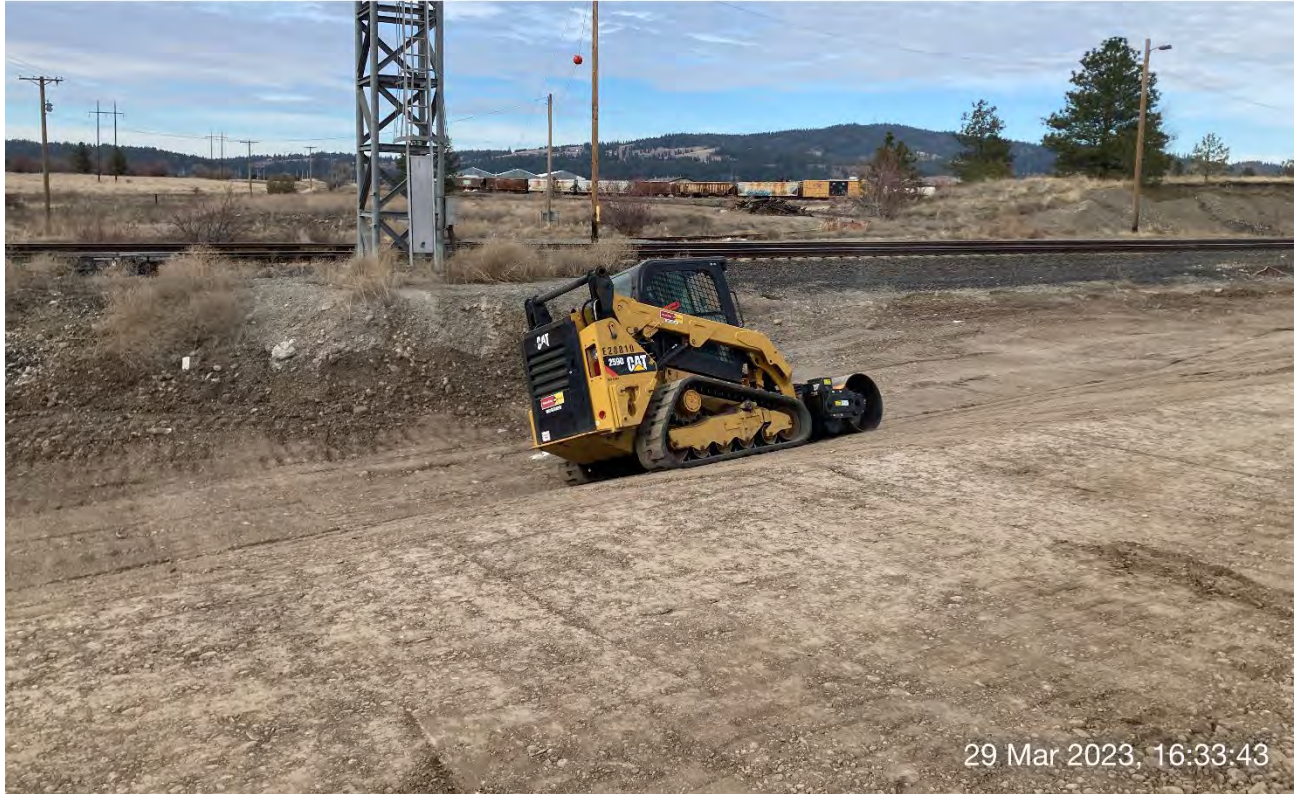
Photograph 5: CAT 259D compacting the graded portions of the railroad ditch north of the UPRR cap area with the compactor attachment.

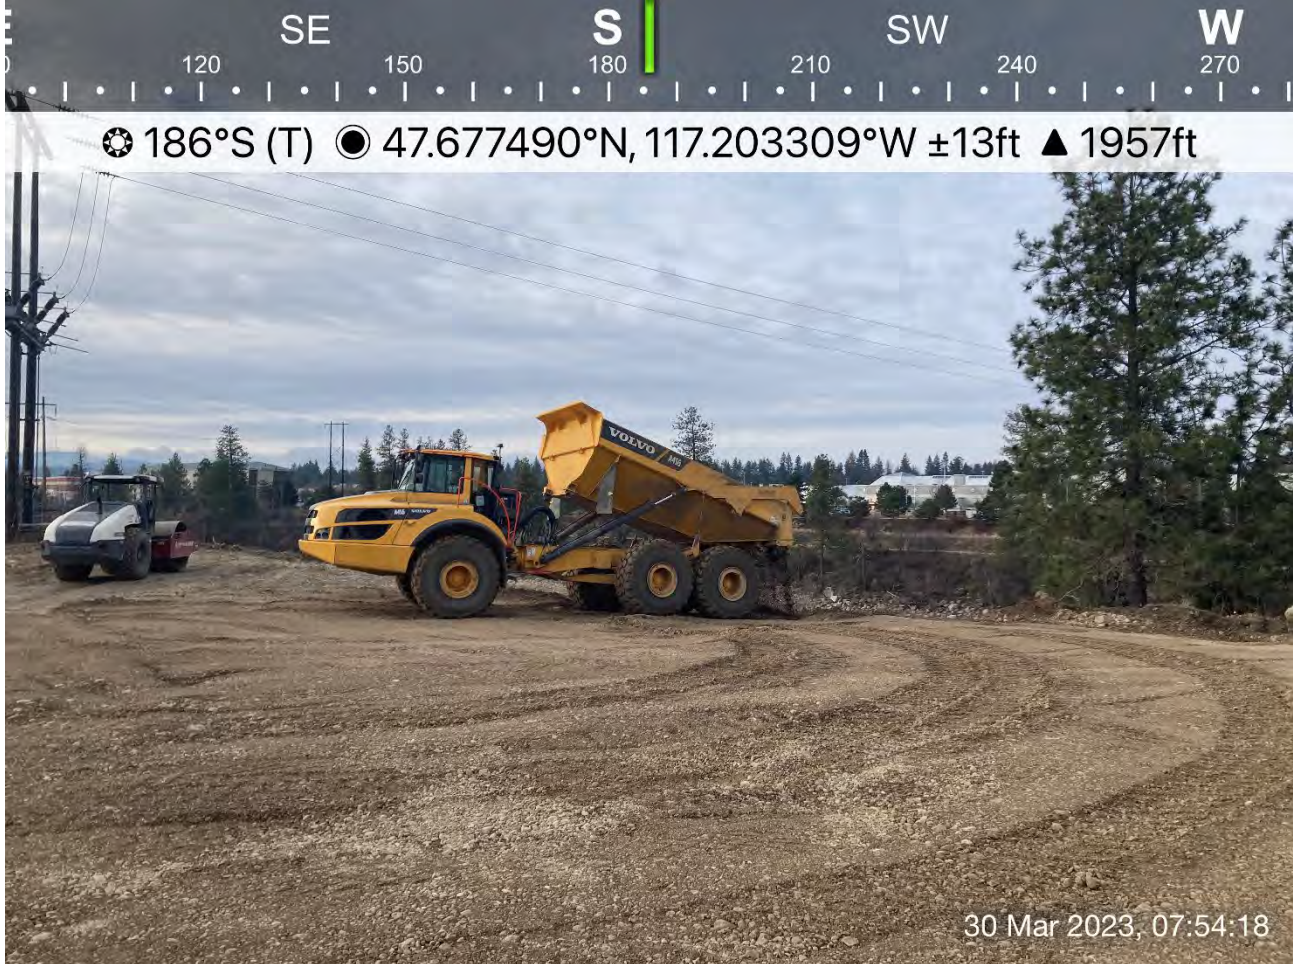
Photograph 1: Off-road haul truck dumping backfill materials graded out of the WSDOT property into Excavation 1 of the Pentzer property.

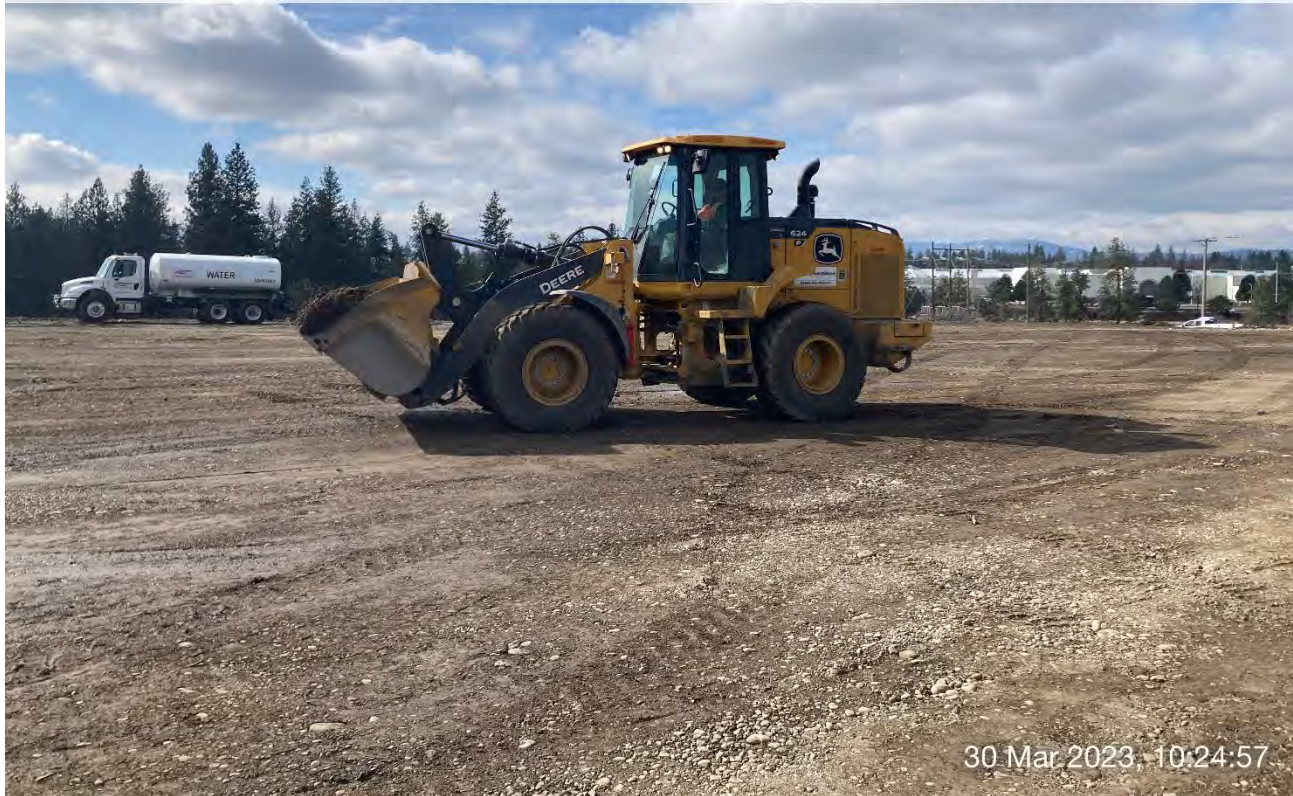
Photograph 2: Front-end loader filling in low areas of the UPRR cap area with excavated materials.

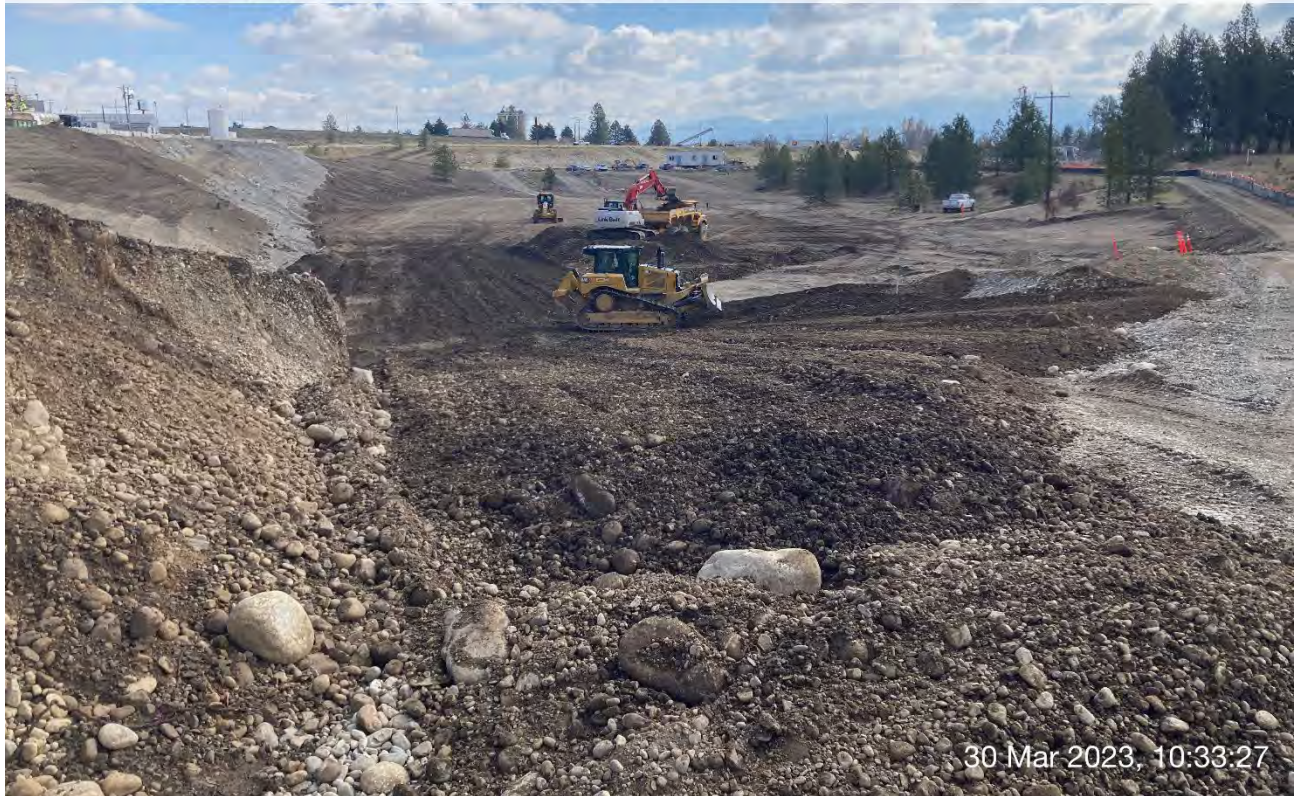
Photograph 3: CAT D6 dozer grading backfill materials on the WSDOT property, LinkBelt trackhoe and off-road haul truck transferring excess backfill material to the Pentzer property.

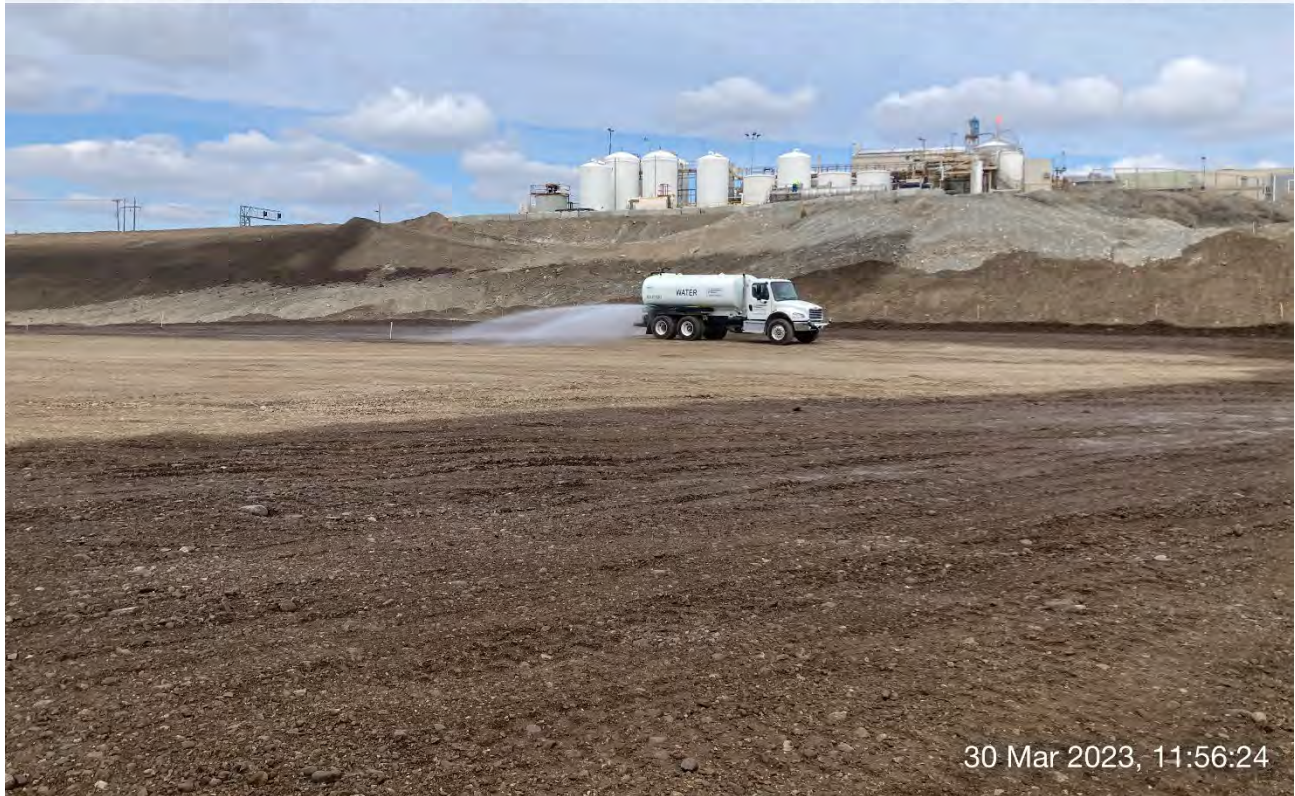
Photograph 4: Water truck spraying water on the WSDOT property.

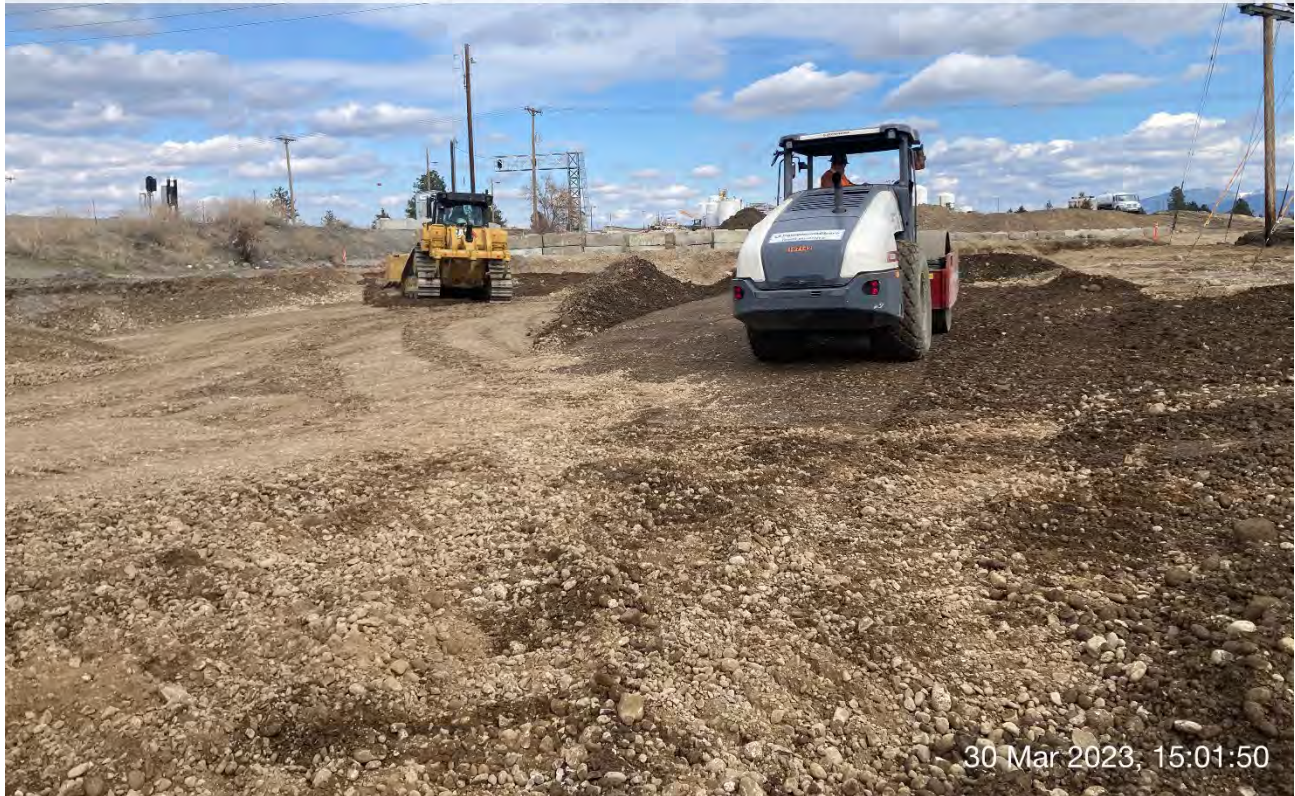
Photograph 5: CAT D6 dozer spreading backfill material in Excavation 1 on the Pentzer property. DYNAPAC CA2500D roller compacting materials already spread within the same location.

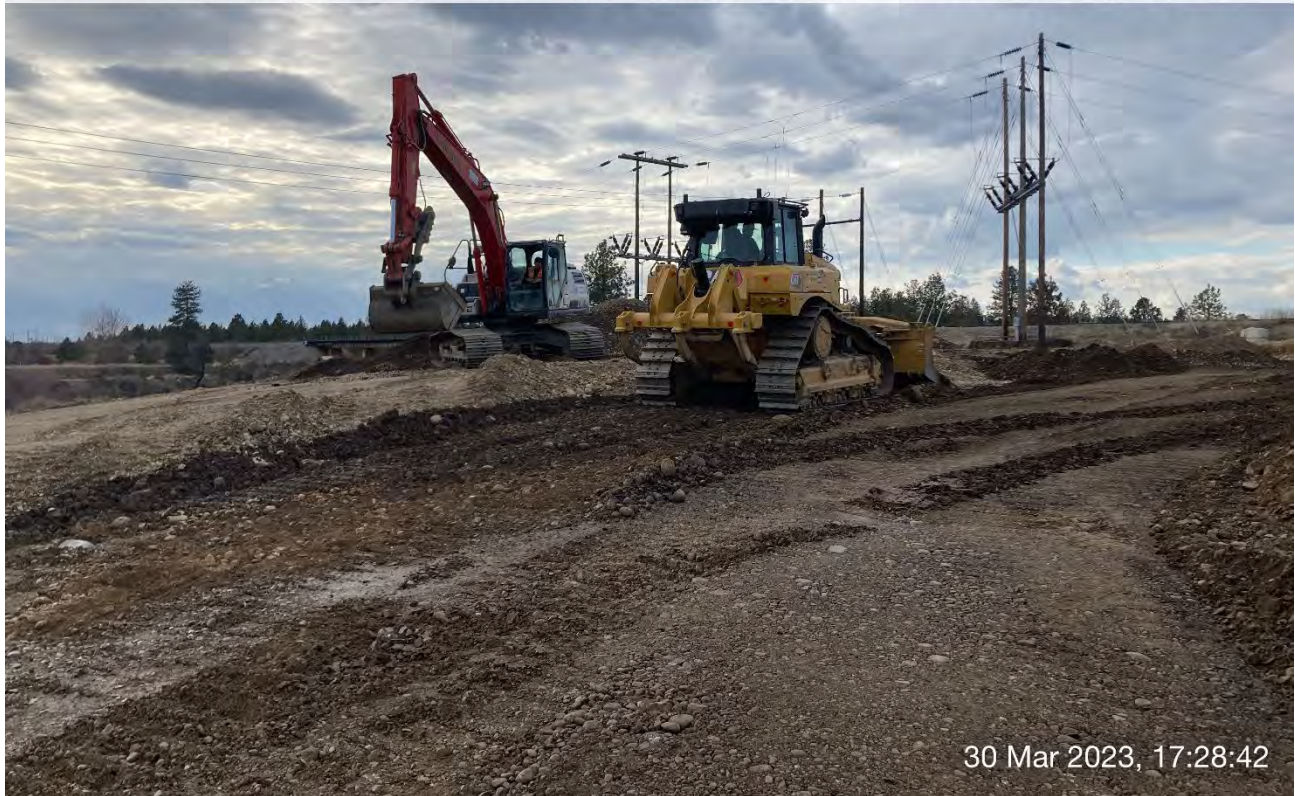
Photograph 6: LinkBelt trackhoe and CAT D6 dozer placing and spreading backfill materials on the Pentzer property near Excavation 2.

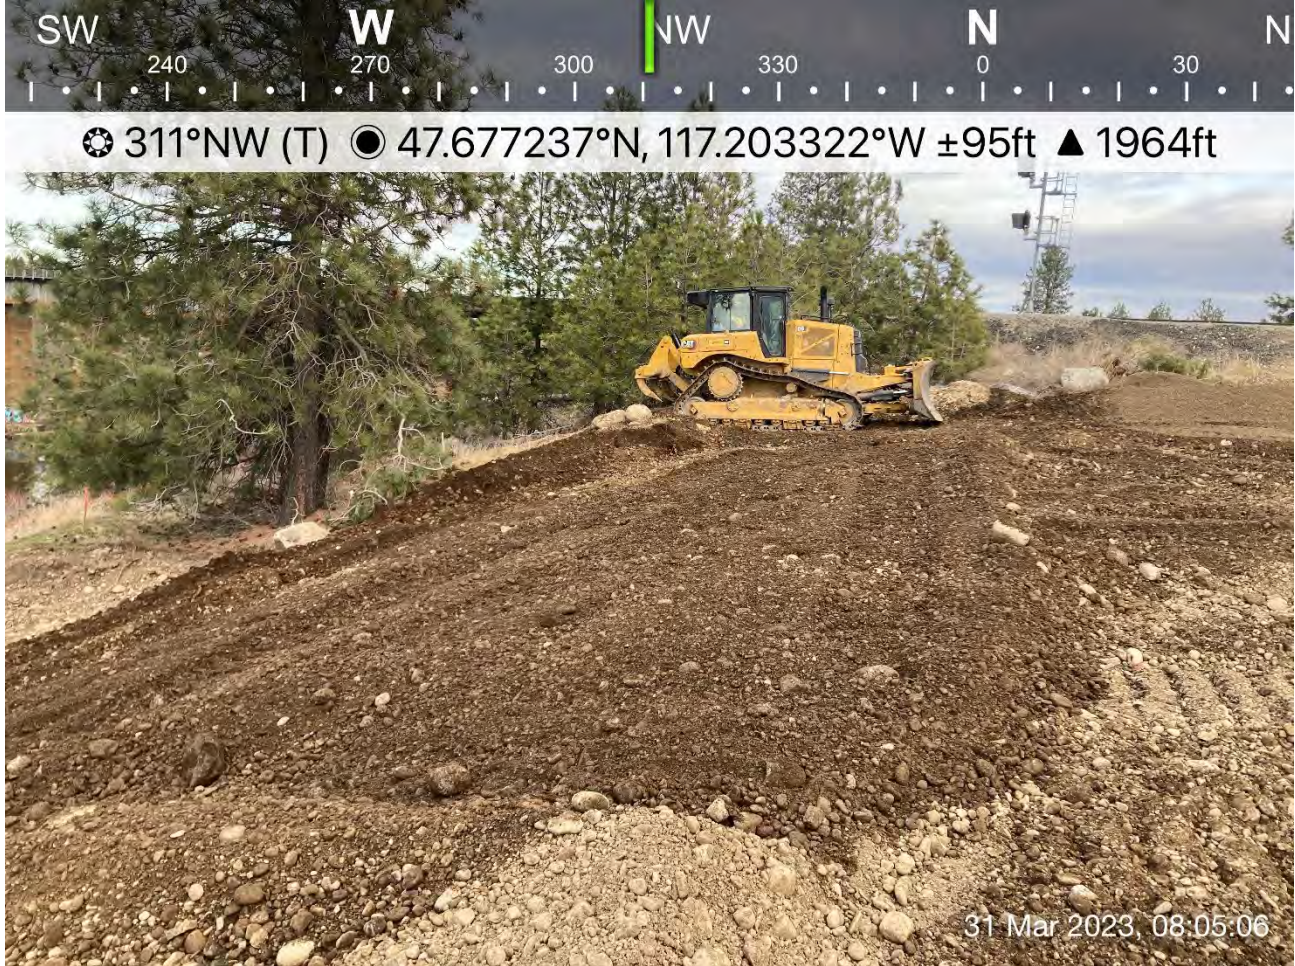
Photograph 1: CAT D6 dozer spreading backfill on the Pentzer property.

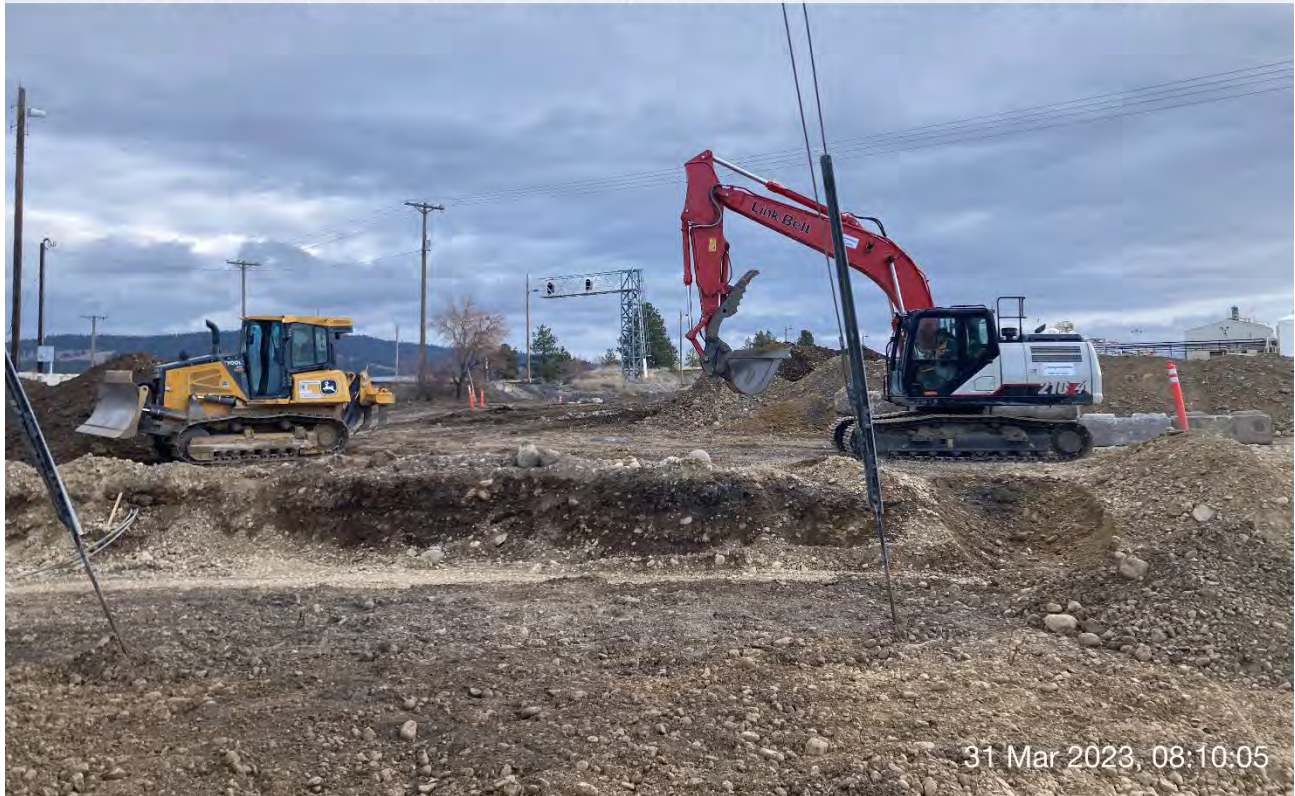
Photograph 2: LinkBelt trackhoe expanding area of Excavation 2 where laboratory analysis results indicated that multiple parameters exceeded two times CULs for one or more COCs.

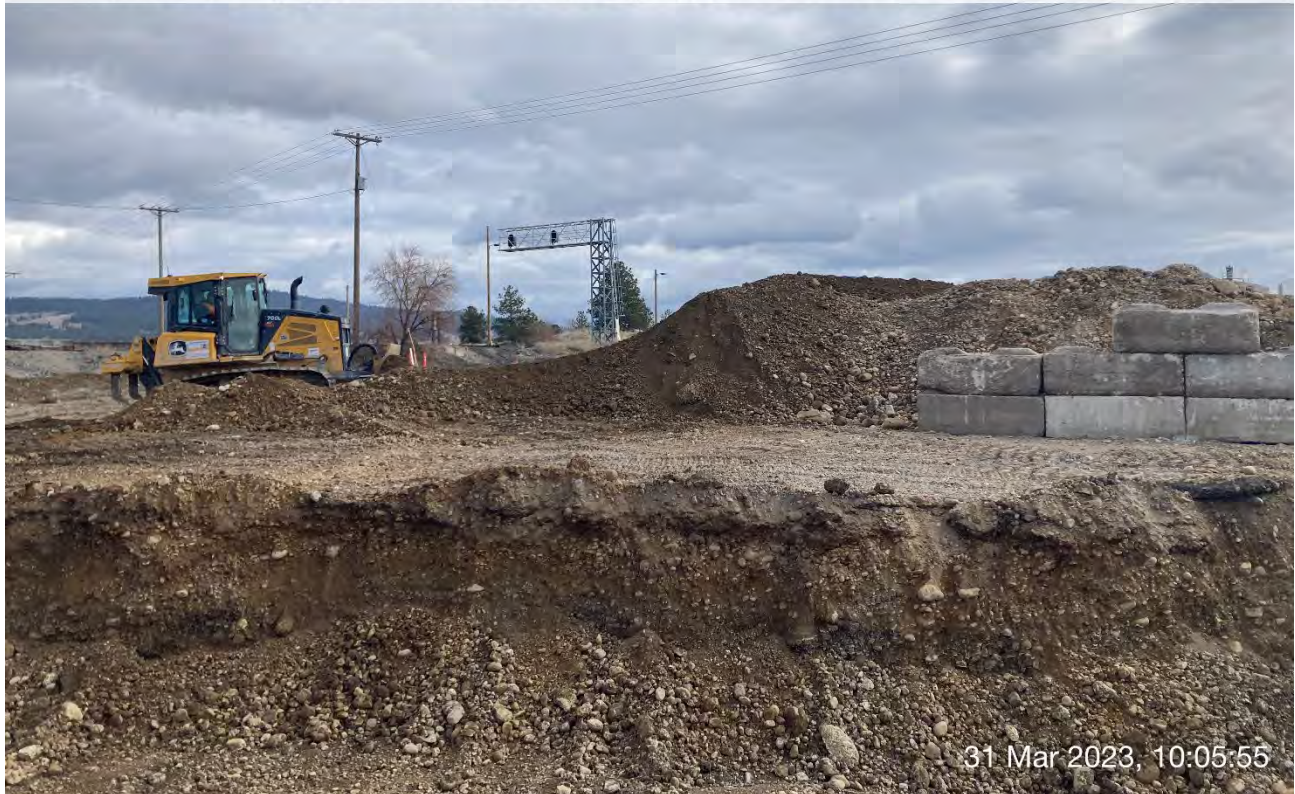
Photograph 3: John Deere 700L dozer pushing excavated materials from the expansion of Excavation 2 into the existing stockpile of excavated materials on the eastern portion of the Pentzer property.

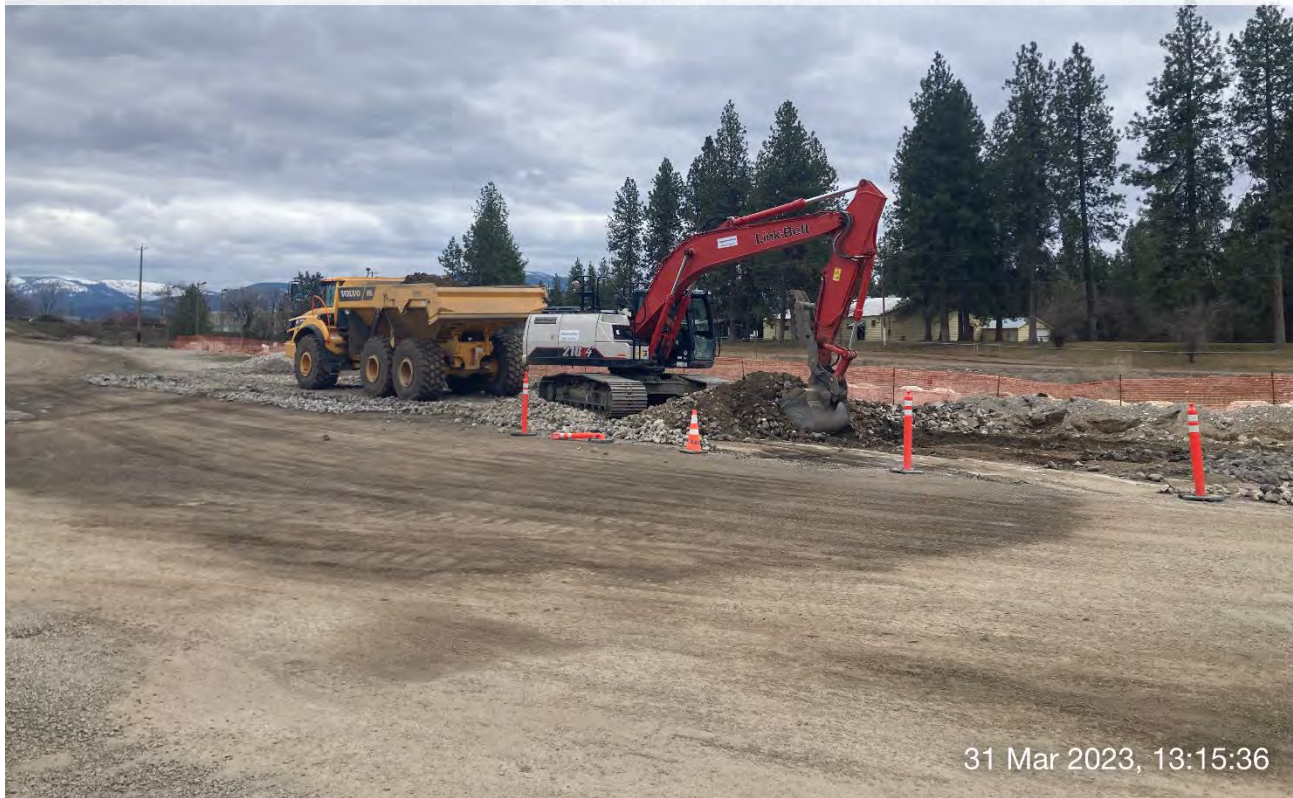
Photograph 4: LinkBelt trackhoe loading rip-rap material from the track-out pad into the off-road haul truck.

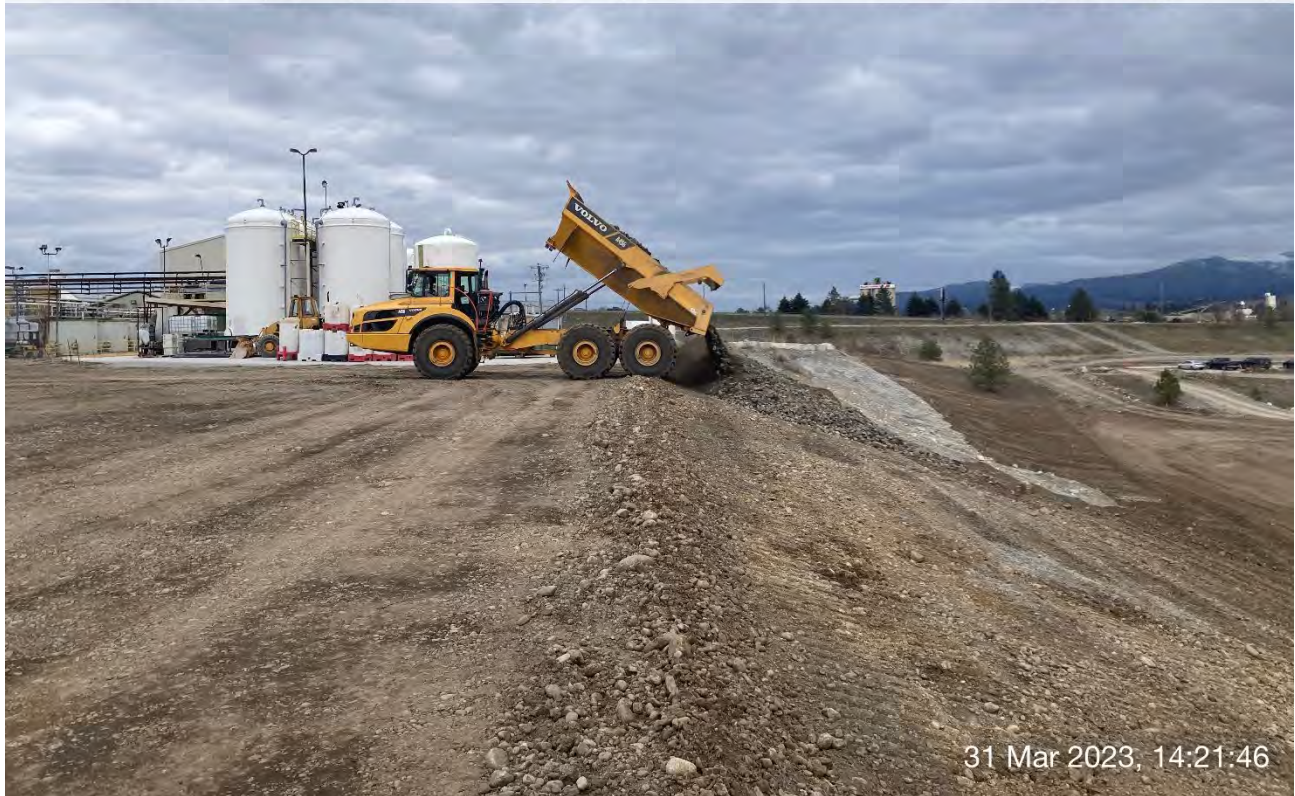
Photograph 5: Off-road haul truck dumping rip-rap material removed from the trackout pad onto the UPRR slope.

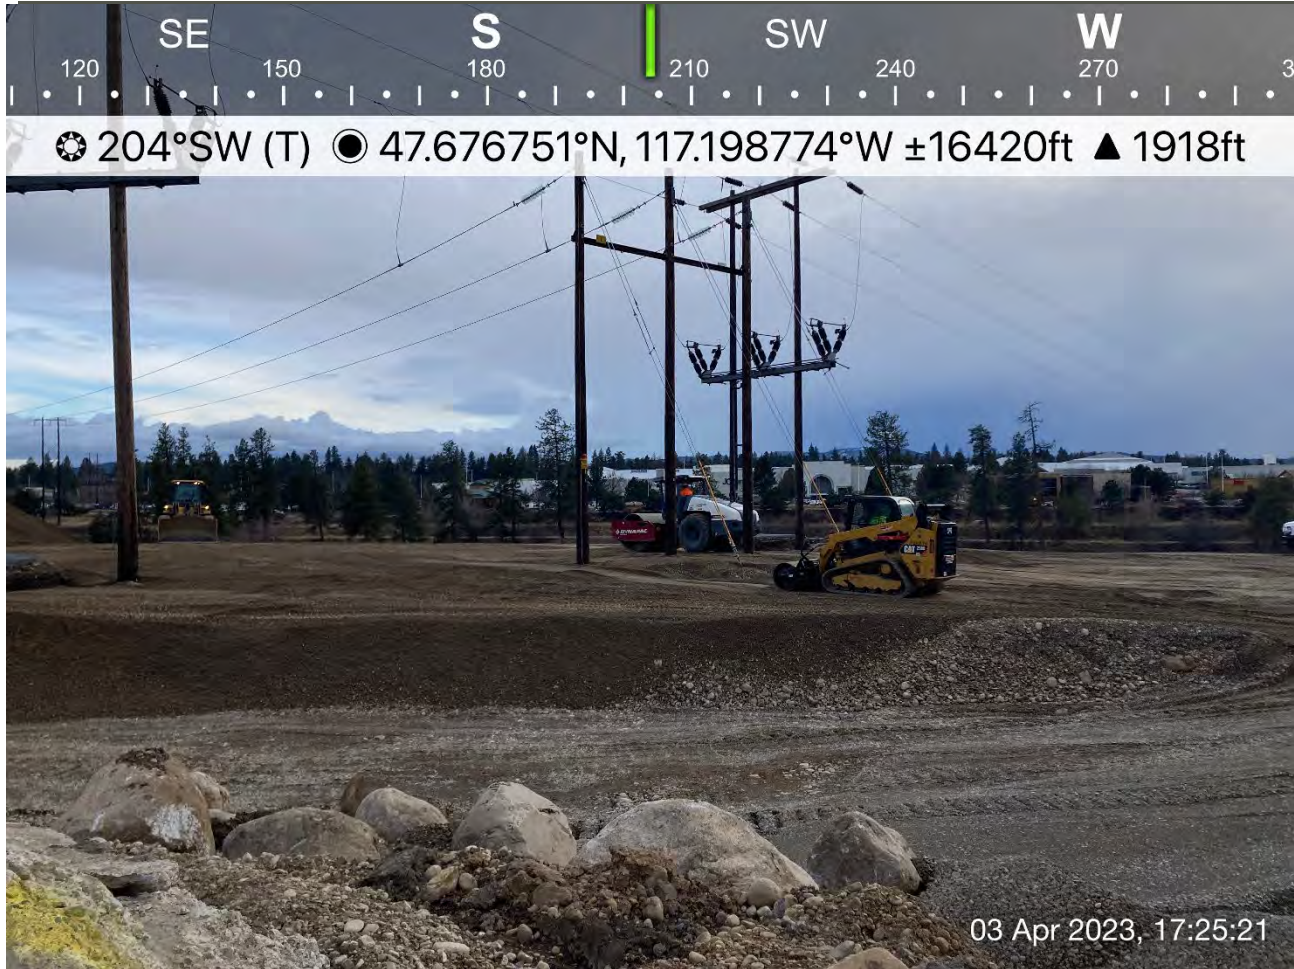
Photograph 5: Compacting backfill in the area of Excavations 1 and 2 and 2-foot excavation on Pentzer property.
