REMEDIATION INVESTIGATION SUMMARY / **CLEANUP ACTION PLAN**

**1871 Ross Avenue
Everett, WA 98201**

May 22, 2024

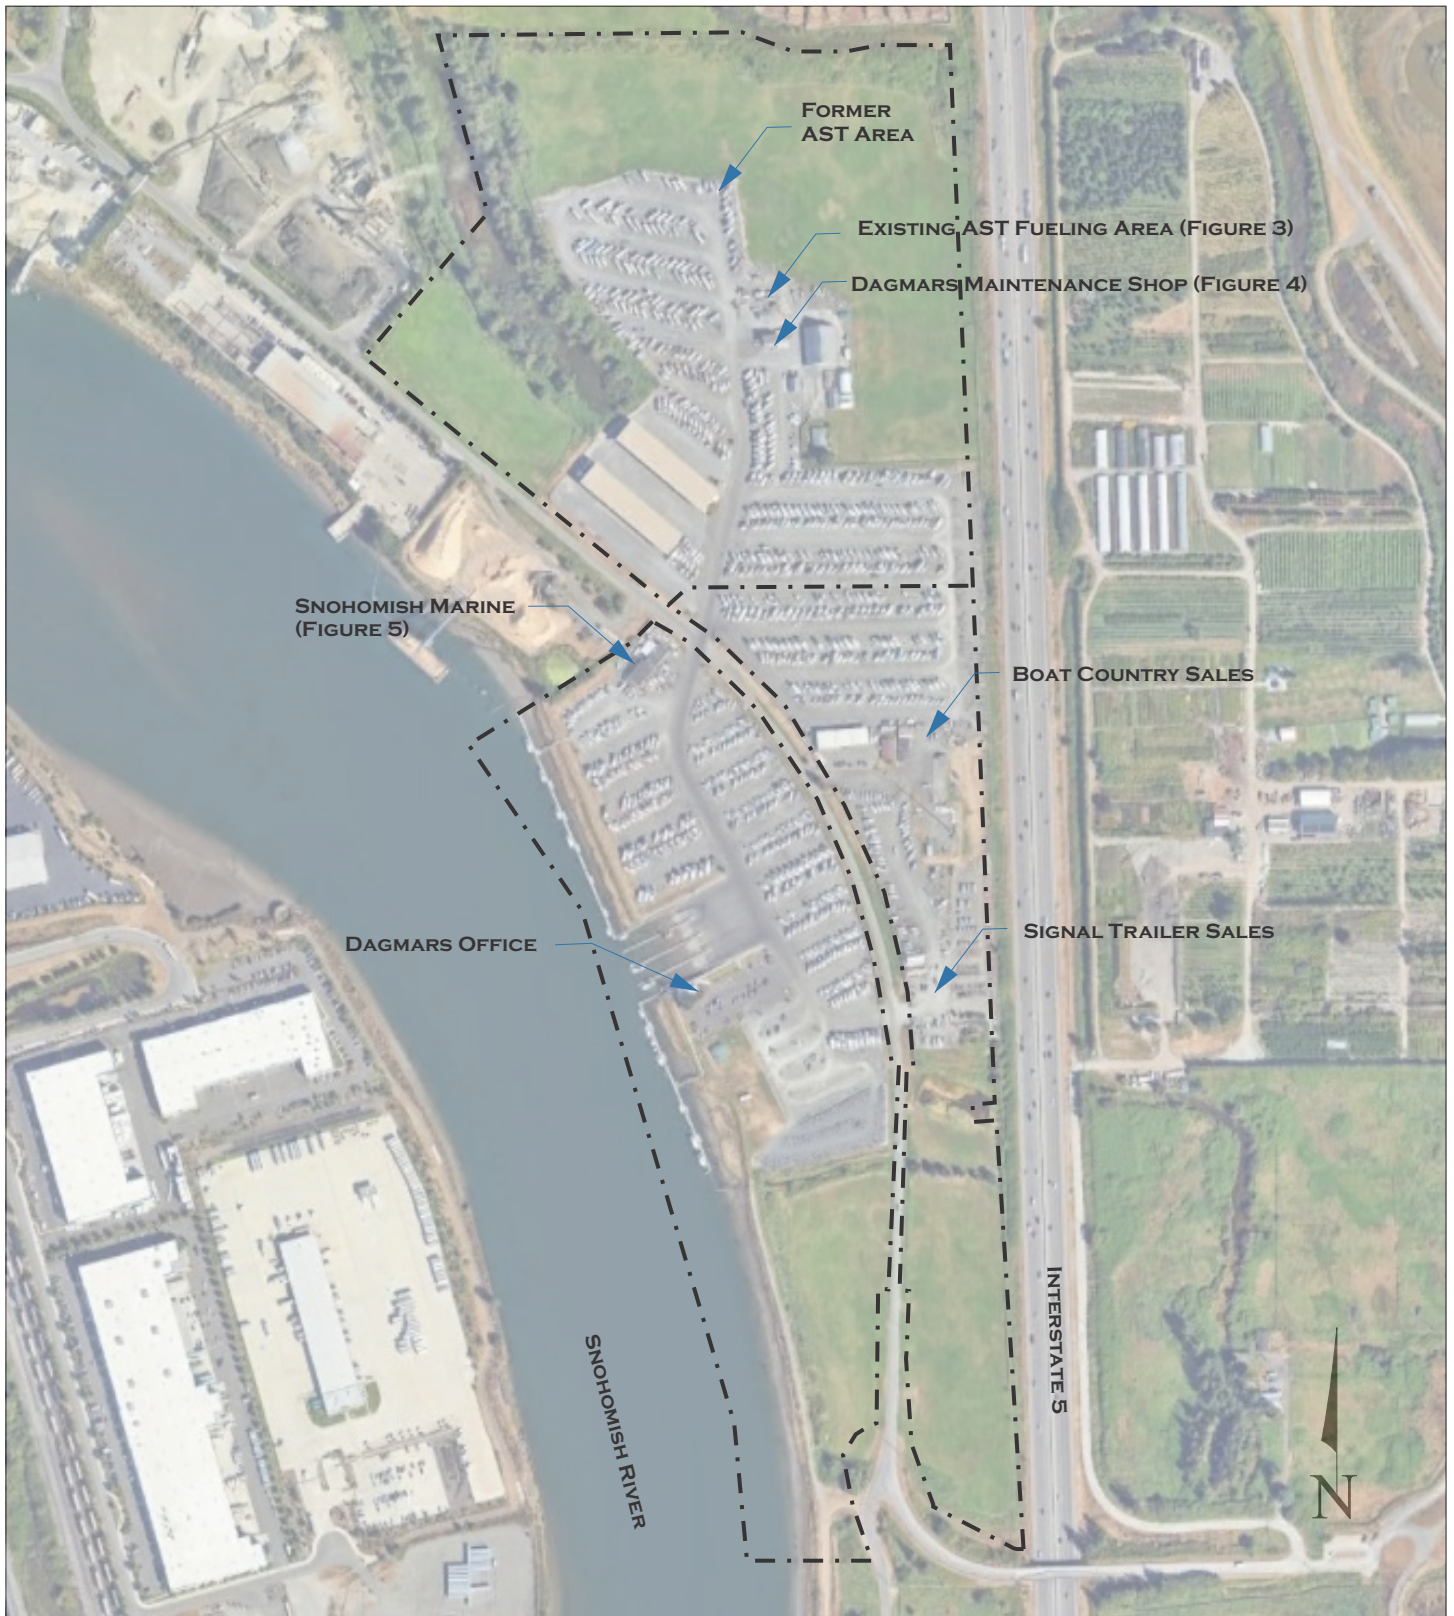
<p>DIXON ENVIRONMENTAL SERVICES</p>	<p>LEGEND</p> <p>--- PROPERTY BOUNDARY</p>	<p>SITE PLAN</p>	
		<p>PROJECT ADDRESS:</p> <p>1871 ROSS AVENUE EVERETT, WA 98201</p>	<p>PAGE:</p> <p>2 OF 5</p>

The current Property layout, allocated tenant areas, and structures are depicted on Figure 2.

The Property consists of a two Snohomish County Tax Parcels (#29050900300100 and 29050900200900), 81.58 acres in size, addressed at 1871 Ross Avenue in Everett, Washington (Figures 1 and 2).

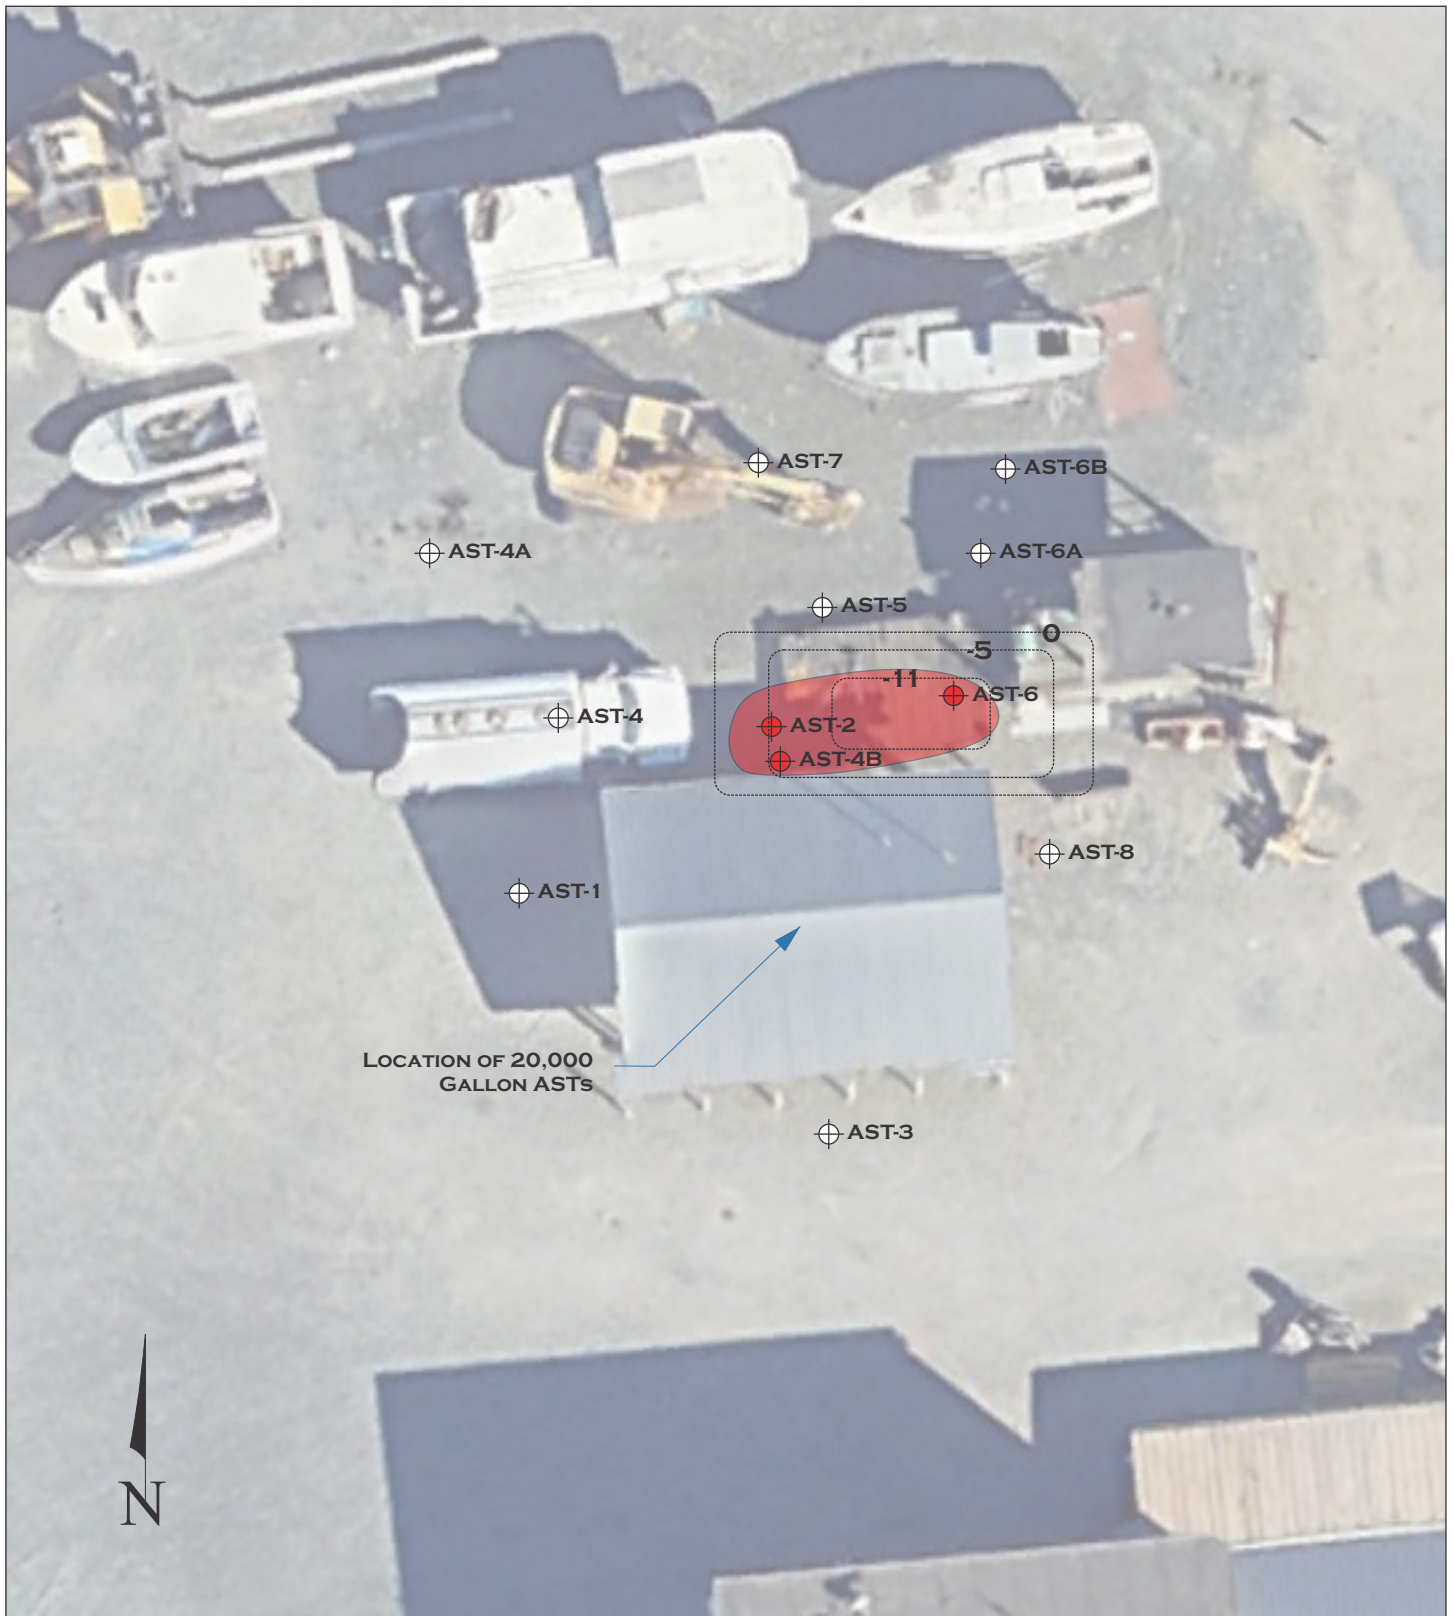
3 OF 5

Conceptual depictions of each remedial excavation area are presented on Figures 3 through 5; however, the full extents of excavation will be dependent on field conditions.

- ⊕ SOIL BORING
- APPROXIMATE AREA OF PETROLEUM CONTAMINATED SOIL

- A surface release of GRPH was identified to the north of the existing ASTs, extending to a depth of approximately 5 feet bgs.
- The presence of the former AST on the north side of the Property does not appear to have resulted in a significant release to the environment.

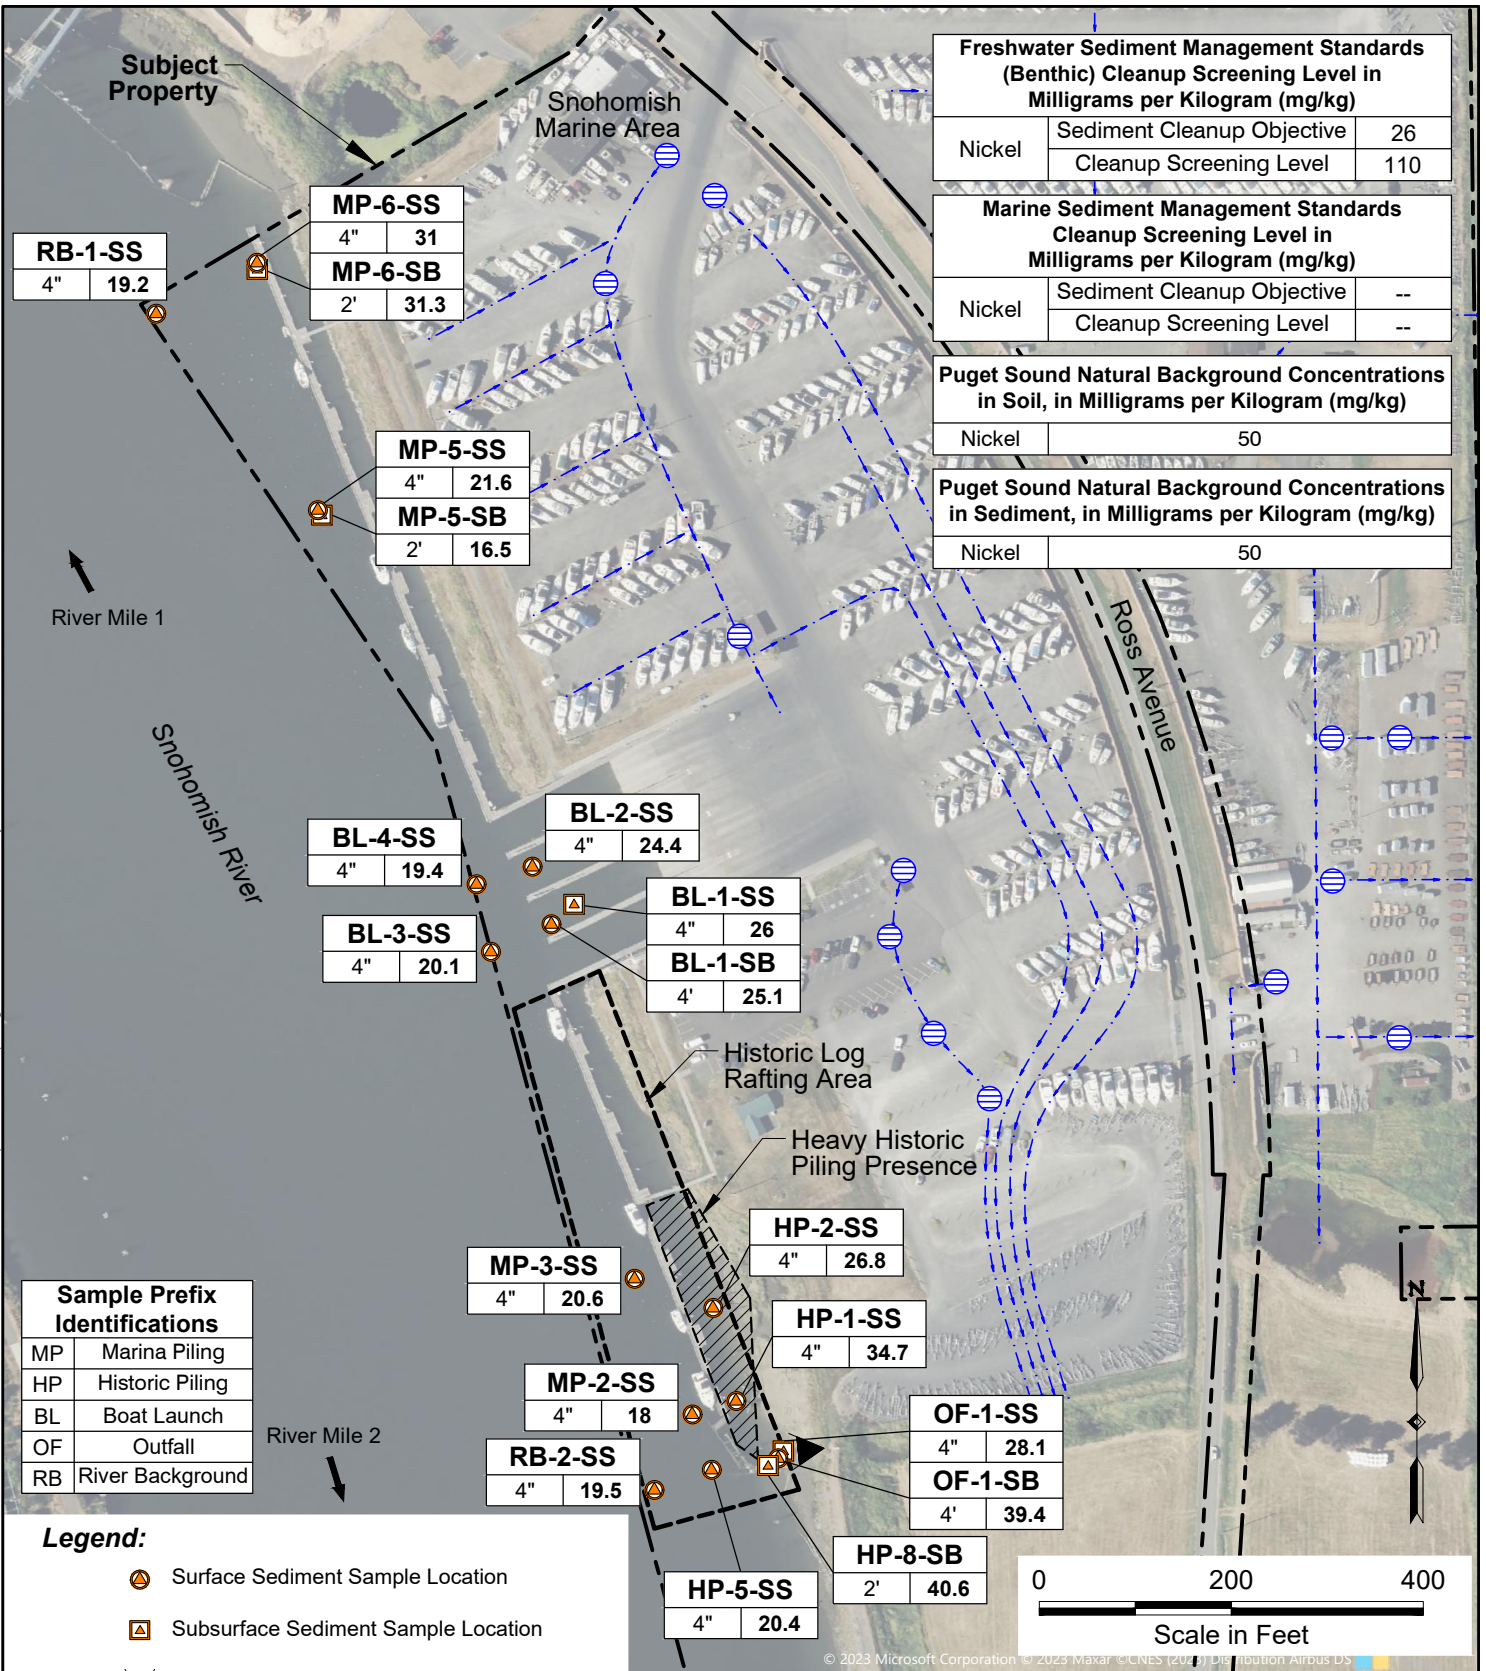
Figure
4

Sediment Sampling Results - Nickel (North)
