**Quarterly Groundwater Compliance Monitoring  
Fourth Quarter 2022**

Ultra Custom Cleaners  
2222 NW Bucklin Hill Road  
Silverdale, Washington

CSID 14334  
FSID 18955

**File No. 22828-001-05**

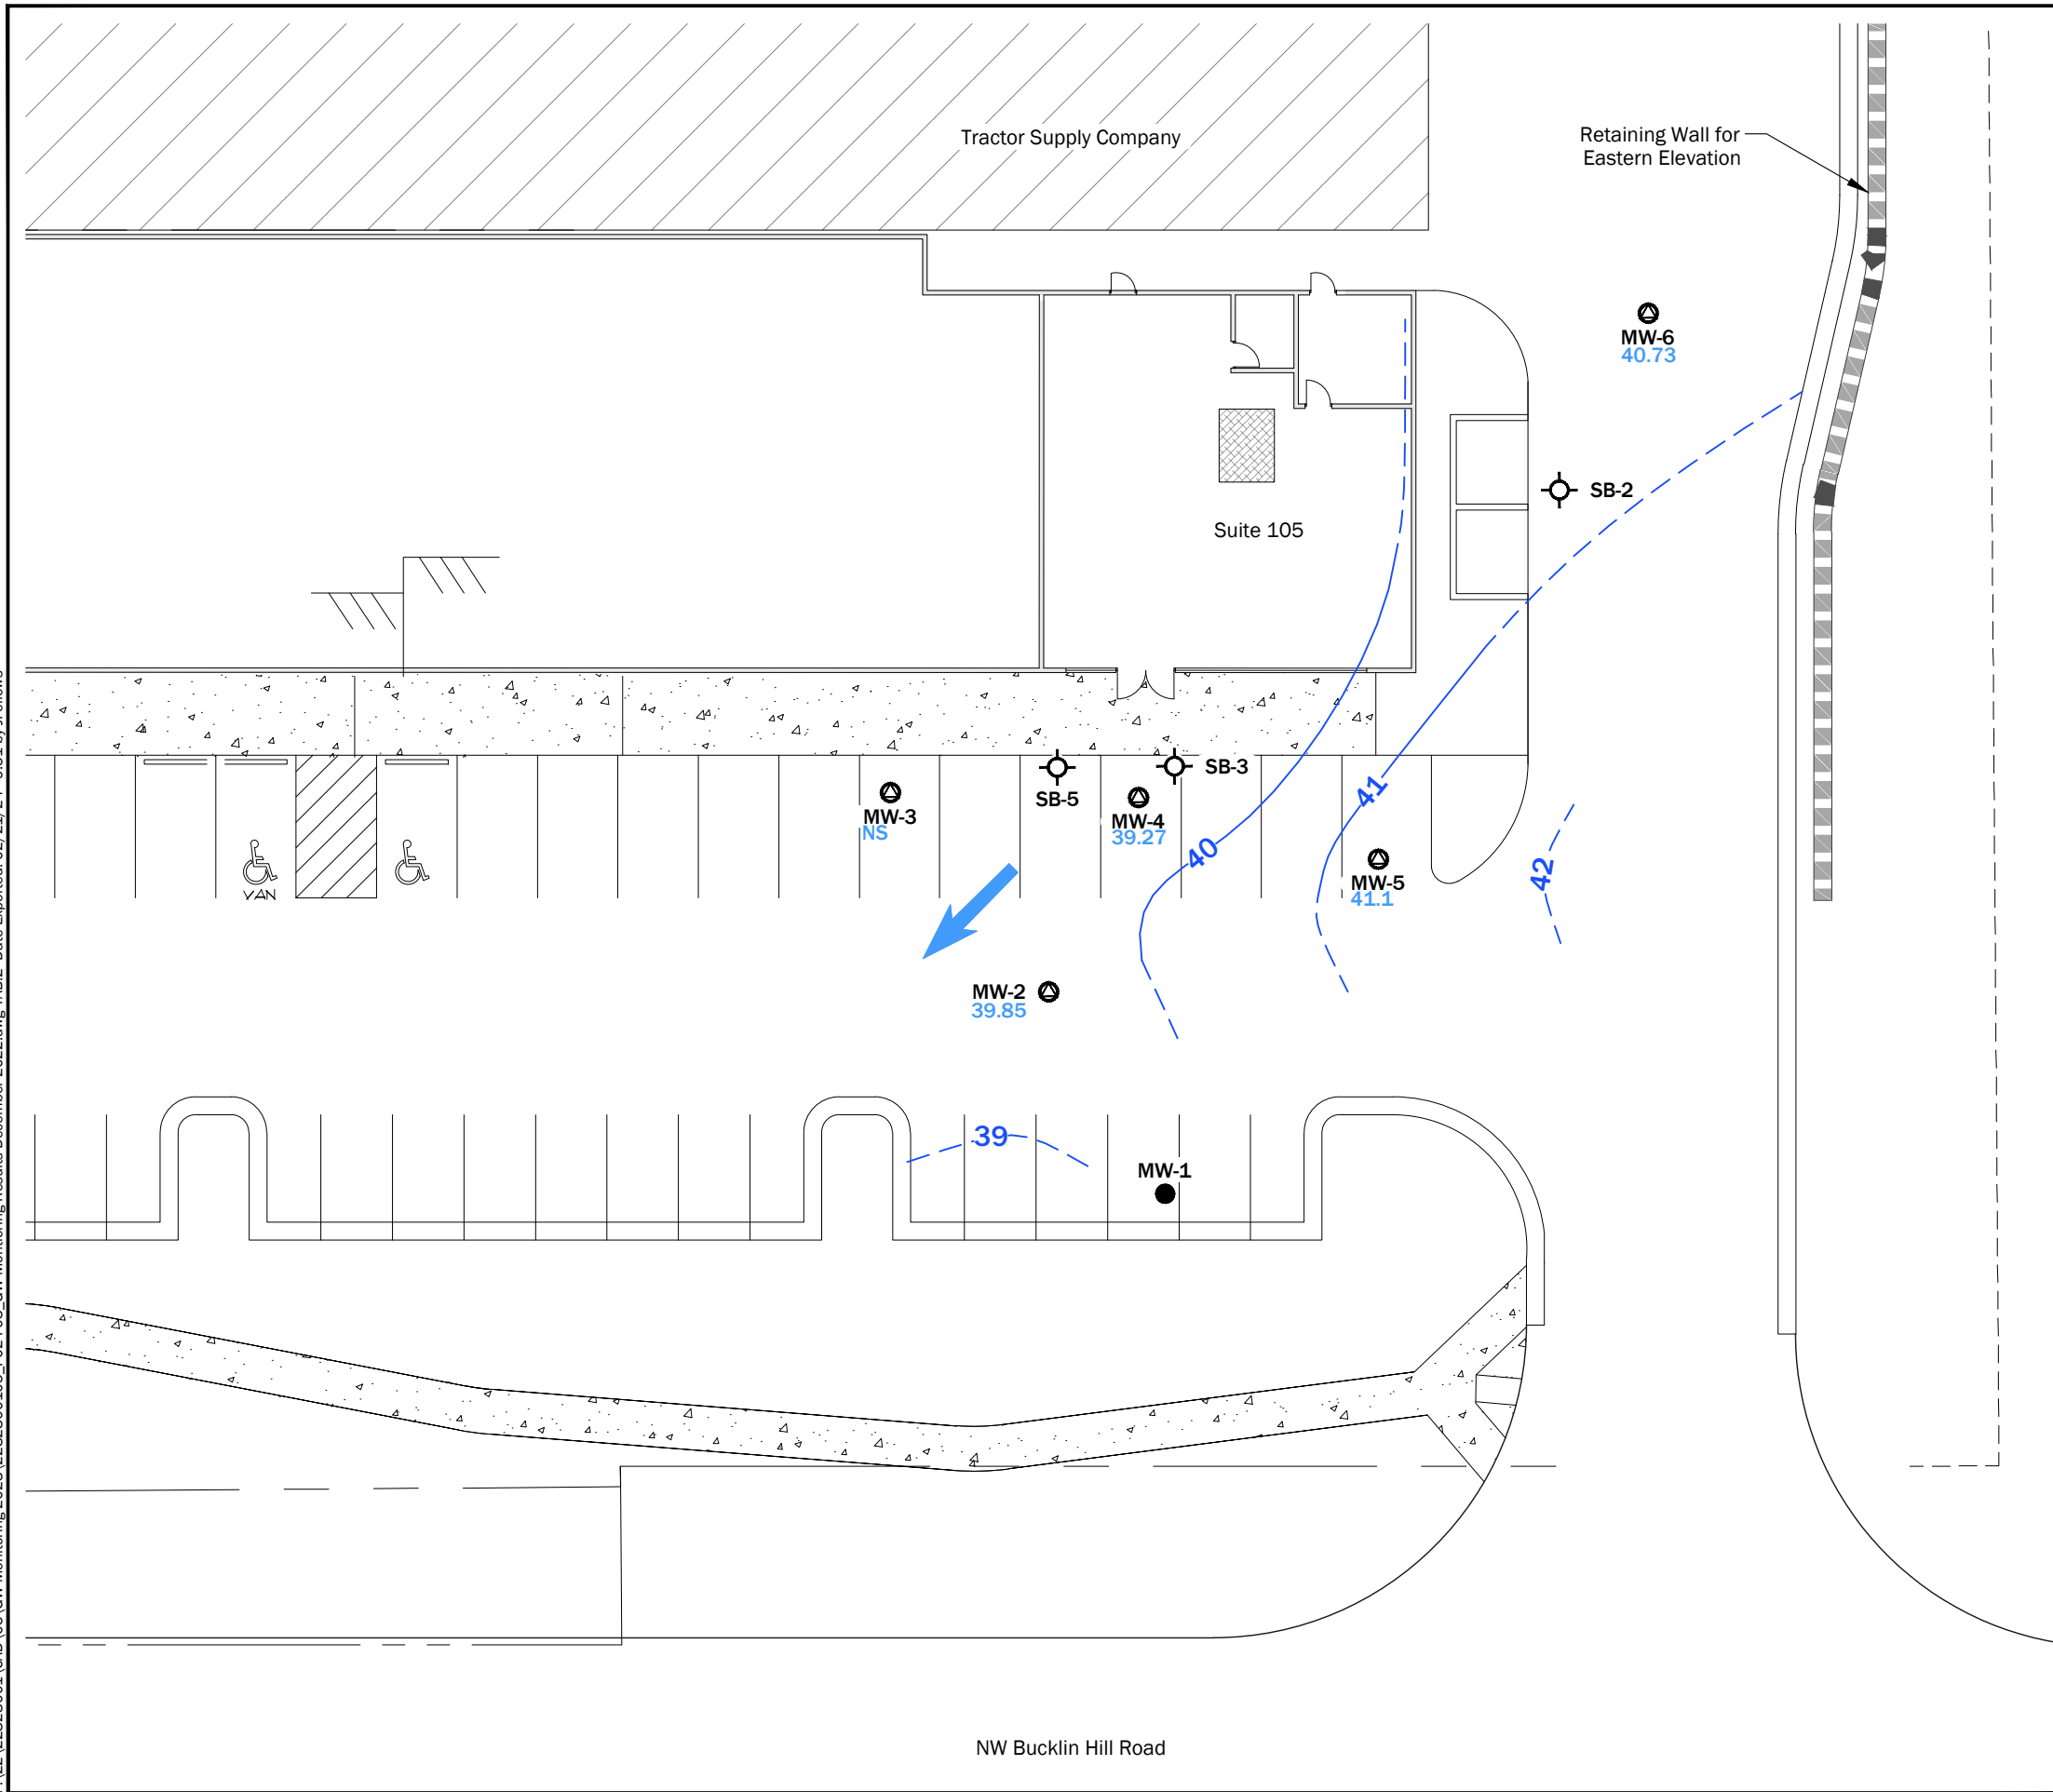
<b>Groundwater Contour Map December 2022</b>	
Ultra Custom Cleaners 2222 NW Bucklin Hill Road Silverdale, Washington	
	<b>Figure 2</b>

Depths to groundwater were measured on December 12, 2022. Depths to groundwater ranged between 5.37 feet below ground surface (bgs) (MW-6) and 7.62 feet bgs (MW-4); MW-1 produced groundwater under artesian pressure. Groundwater elevations ranged from 39.27 feet (MW-4) to 41.10 feet (MW-5) (North American Vertical Datum of 1988 [NAVD88]) and reflect seasonal changes. The groundwater flow direction was generally toward the southwest with a prominent influx coming from the abutment to the east. Depths to groundwater and groundwater elevations are summarized in Table 1. The groundwater elevations and groundwater elevation contours are shown in Figure 2.

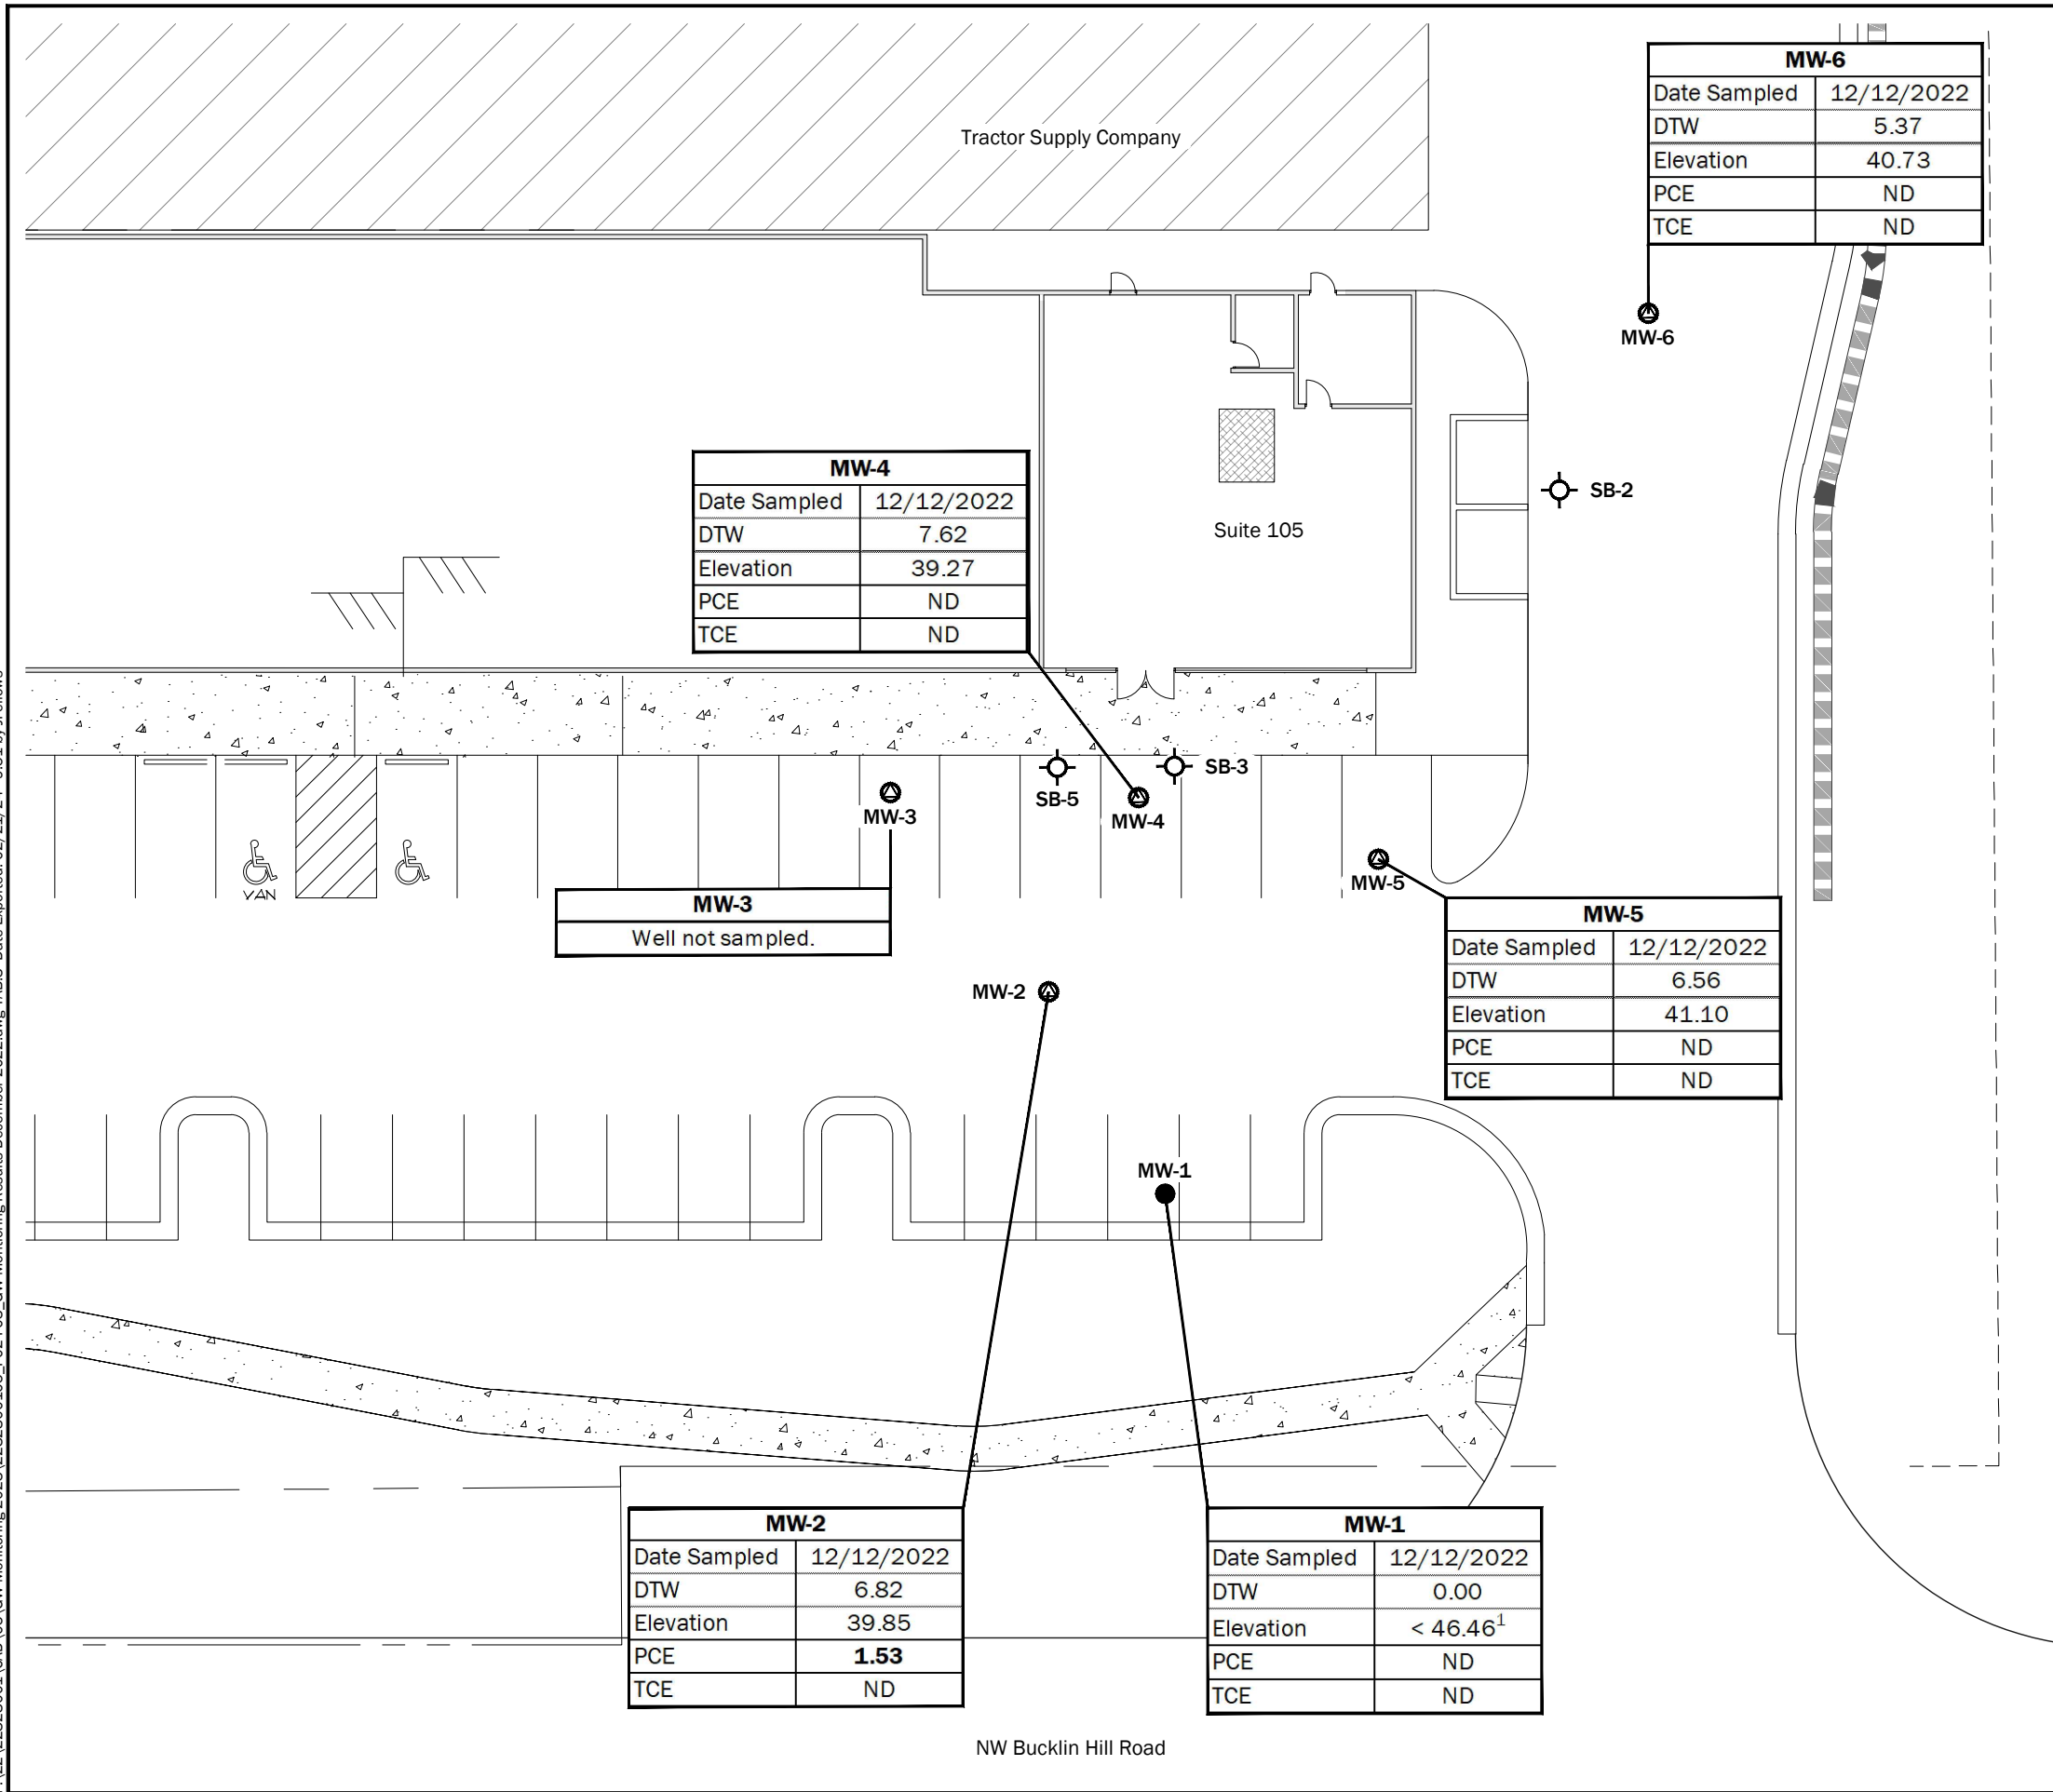
<b>Groundwater Analytical Results December 2022</b>	
Ultra Custom Cleaners 2222 NW Bucklin Hill Road Silverdale, Washington	
	<b>Figure 3</b>

PCE was detected at a concentration less than the MTCA Method A cleanup level (5 micrograms per liter [ $\mu\text{g/L}$ ]) at MW-2 (1.53  $\mu\text{g/L}$ ). PCE was not detected at a concentration greater than the laboratory reporting limit at MW-4, MW-5 or MW-6, nor in the deeper aquifer well MW-1. There were no detections of TCE, cis-1,2-DCE, trans-1,2-DCE and vinyl chloride greater than the laboratory reporting limit for MW-1 through MW-6. These analytical results are depicted on Figure 3.
