Completion Report—AOC 1

Northern State Multi Service Center
Sedro-Woolley, Washington

Agreed Order No. DE 16309
Cleanup Site ID: 10048

June 18, 2024

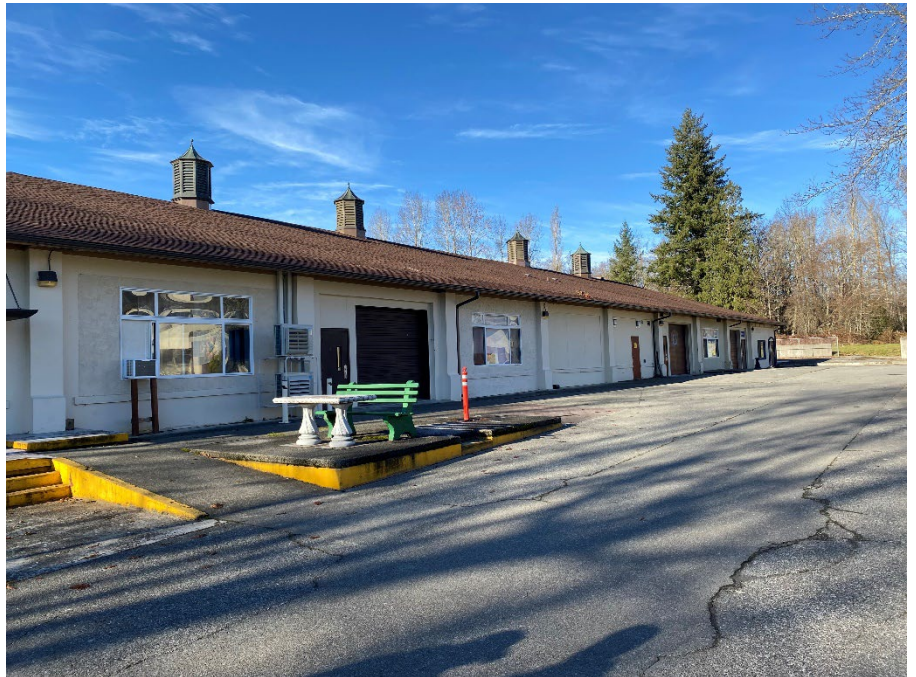
Roof cupolas on the east side of the former laundry building, looking northwest. Piping associated with the sub-slab depressurization system is connected to roof cupolas for ventilation to ambient air.

Vent riser pipes were routed to penetrate through the roof into existing decorative cupolas on the building. Vent riser penetrations in the roof were a minimum of 10 feet away from or 3 feet above any windows, doors, or air intakes and extend through the vent flashing a minimum of 6 inches into the cupolas above the roof.

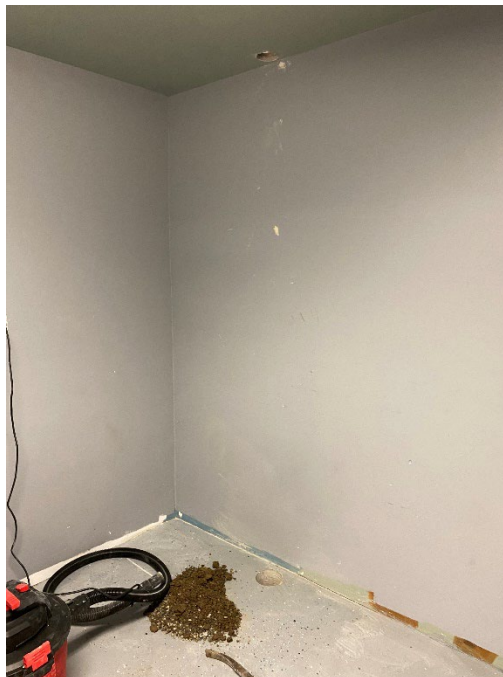
Photo No. 2.

Drilling through the slab and ceiling drywall for vent installation in the workshop area (location VENT04).

For each proposed vent location, a concrete core was removed for pipe installation. Concrete cores were no larger than one half inch greater in diameter than the diameter of the vent pipe. To increase contact with soil gas below the slab, a small hole approximately 6 to 18 inches in radius was created by removing the subgrade material from below the slab prior to the installation of the vent pipes. Sub-grade material generally consisted of gravel to gravelly sand with some fines. Any material removed from below the slab with measurable fines was temporarily drummed on the Site, labeled, and will be sampled for characterization and appropriate disposal.

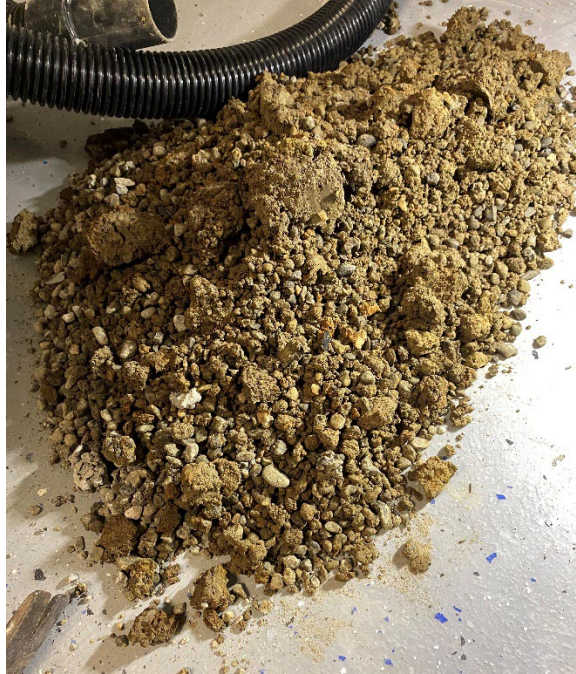
Material removed from
beneath the concrete
slab.

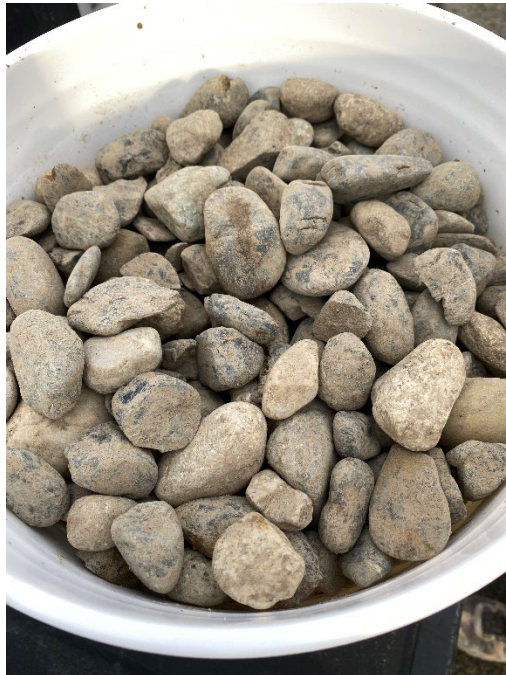
Photo No. 4.

Material used to backfill
the hole beneath the
slab.

The void spaces below the slab were filled with ¾-inch or greater clean gravel (lacking fines). Vent pipes were placed through the slab so that the end rested on the gravel backfill. The gap between the core hole through the concrete slab and the vent pipe was sealed with hydraulic cement, in accordance with the design.

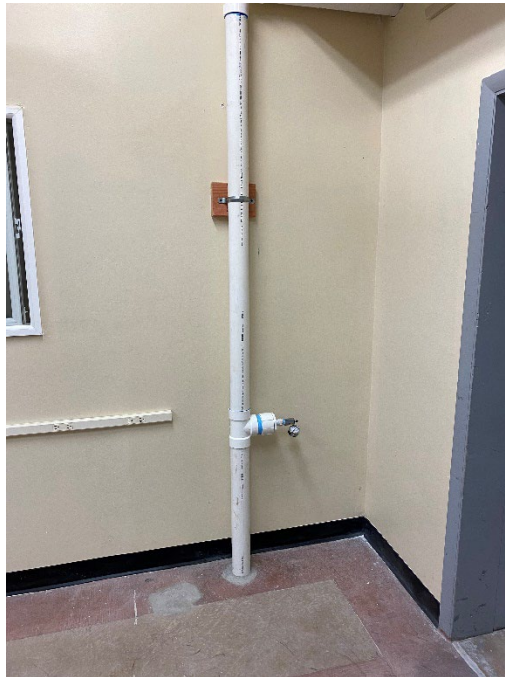
Installed vent in the open room in the north portion of the building (location VENT05).

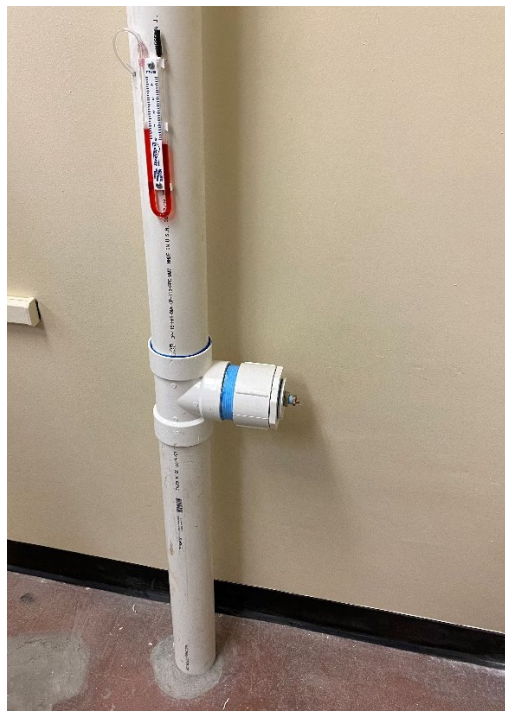
Photo No. 6.

U-tube manometer and sample port installed at location VENT05.

Vent pipes were constructed of 3-inch schedule 40 PVC. The pipe was field routed to the cupolas in as linear a manner as possible, and secured with wall brackets and ceiling hangers. A U-tube manometer was installed at eye level on each vent pipe for ease of access.

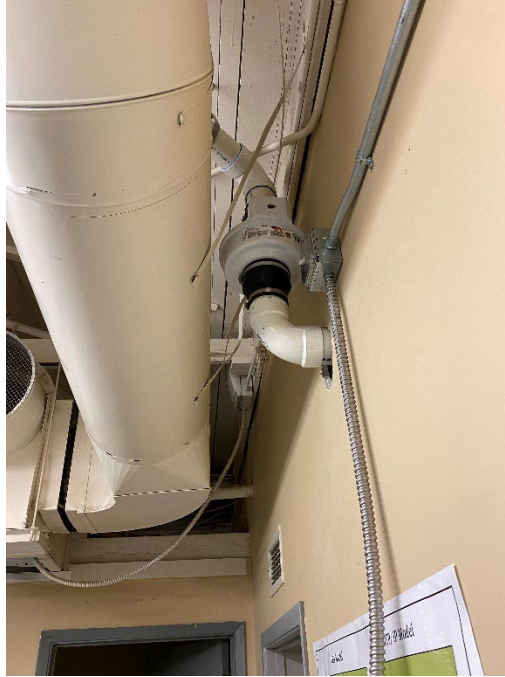
Fan connected to vent
at location VENTO5.

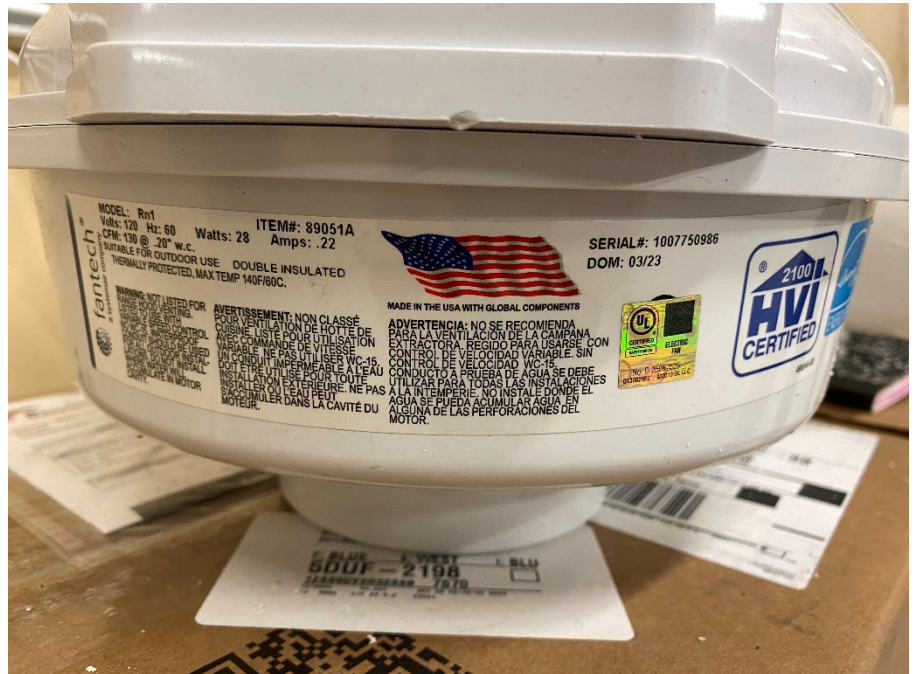
Photo No. 8.

Fantech Rn1 fans used
in the sub-slab
depressurization
system.

As recommended in the design, 4-inch FanTech Rn1 Series Round Inline Exhaust fans were installed at each vent riser. The fans were connected into existing circuits in the building by a licensed electrician. The FanTech Rn1 Series fans were selected due to their ability to resist overheating while operating under low pressure and low flow conditions that are expected below a building slab.

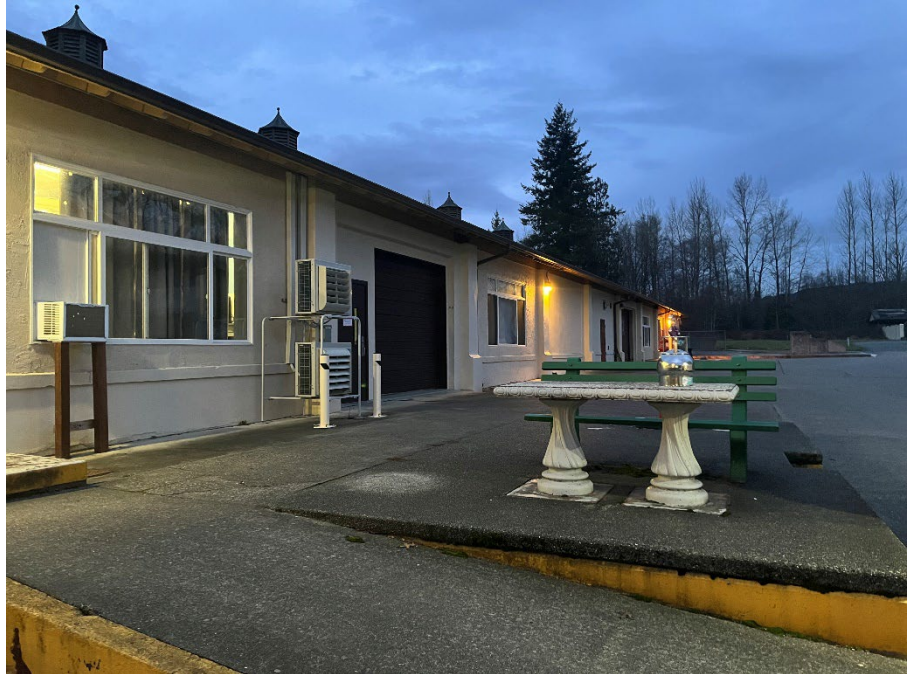
Outdoor air sample
OUTAIRO2 on the east
side of the building,
collected on February
14, 2024.

The outdoor air sample was positioned outside and upwind of the building to capture potential ambient volatile organic compound (VOC) sources for the 8-hour indoor air sample collection period. Field staff deployed the sampler in a location that was free of discernible ambient sources of VOCs. Atmospheric data (including wind speed and direction) from the nearest weather station was used to position the sample upwind of the building. Wind was forecasted to blow from the east on February 14, 2024; therefore, the ambient air sample was positioned east of the building (see Figure 1-2). The reported wind direction at the end of the day was from the northeast.

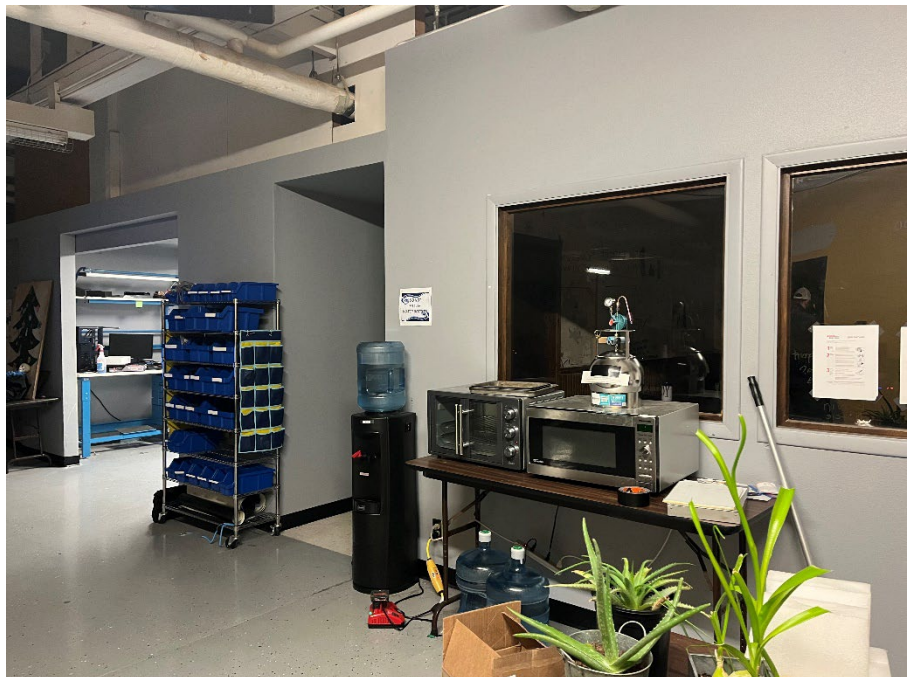
Photo No. 10.

Indoor air sample
INAIRO2 in the central
portion of the building,
collected on February
14, 2024.

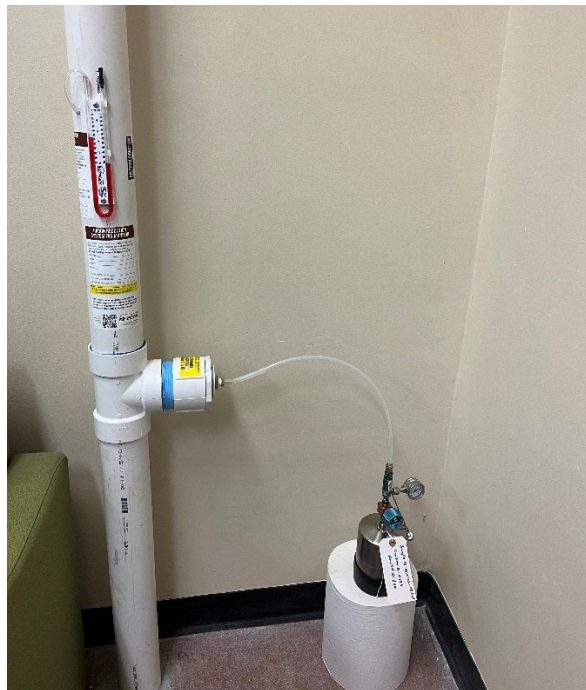
Photo No. 12.

Vent sampling at
VENT05 on February 16,
2024.

On February 16, 2024, MFA collected five air emissions samples (VENT01-021624 through VENT05-021624) from vent risers associated with the SSDS. Air samples were collected using 1-liter
