# Soil Removal Action Completion Report

**Burrows Island Light Station**  
**Skagit County, Washington**

May 2024

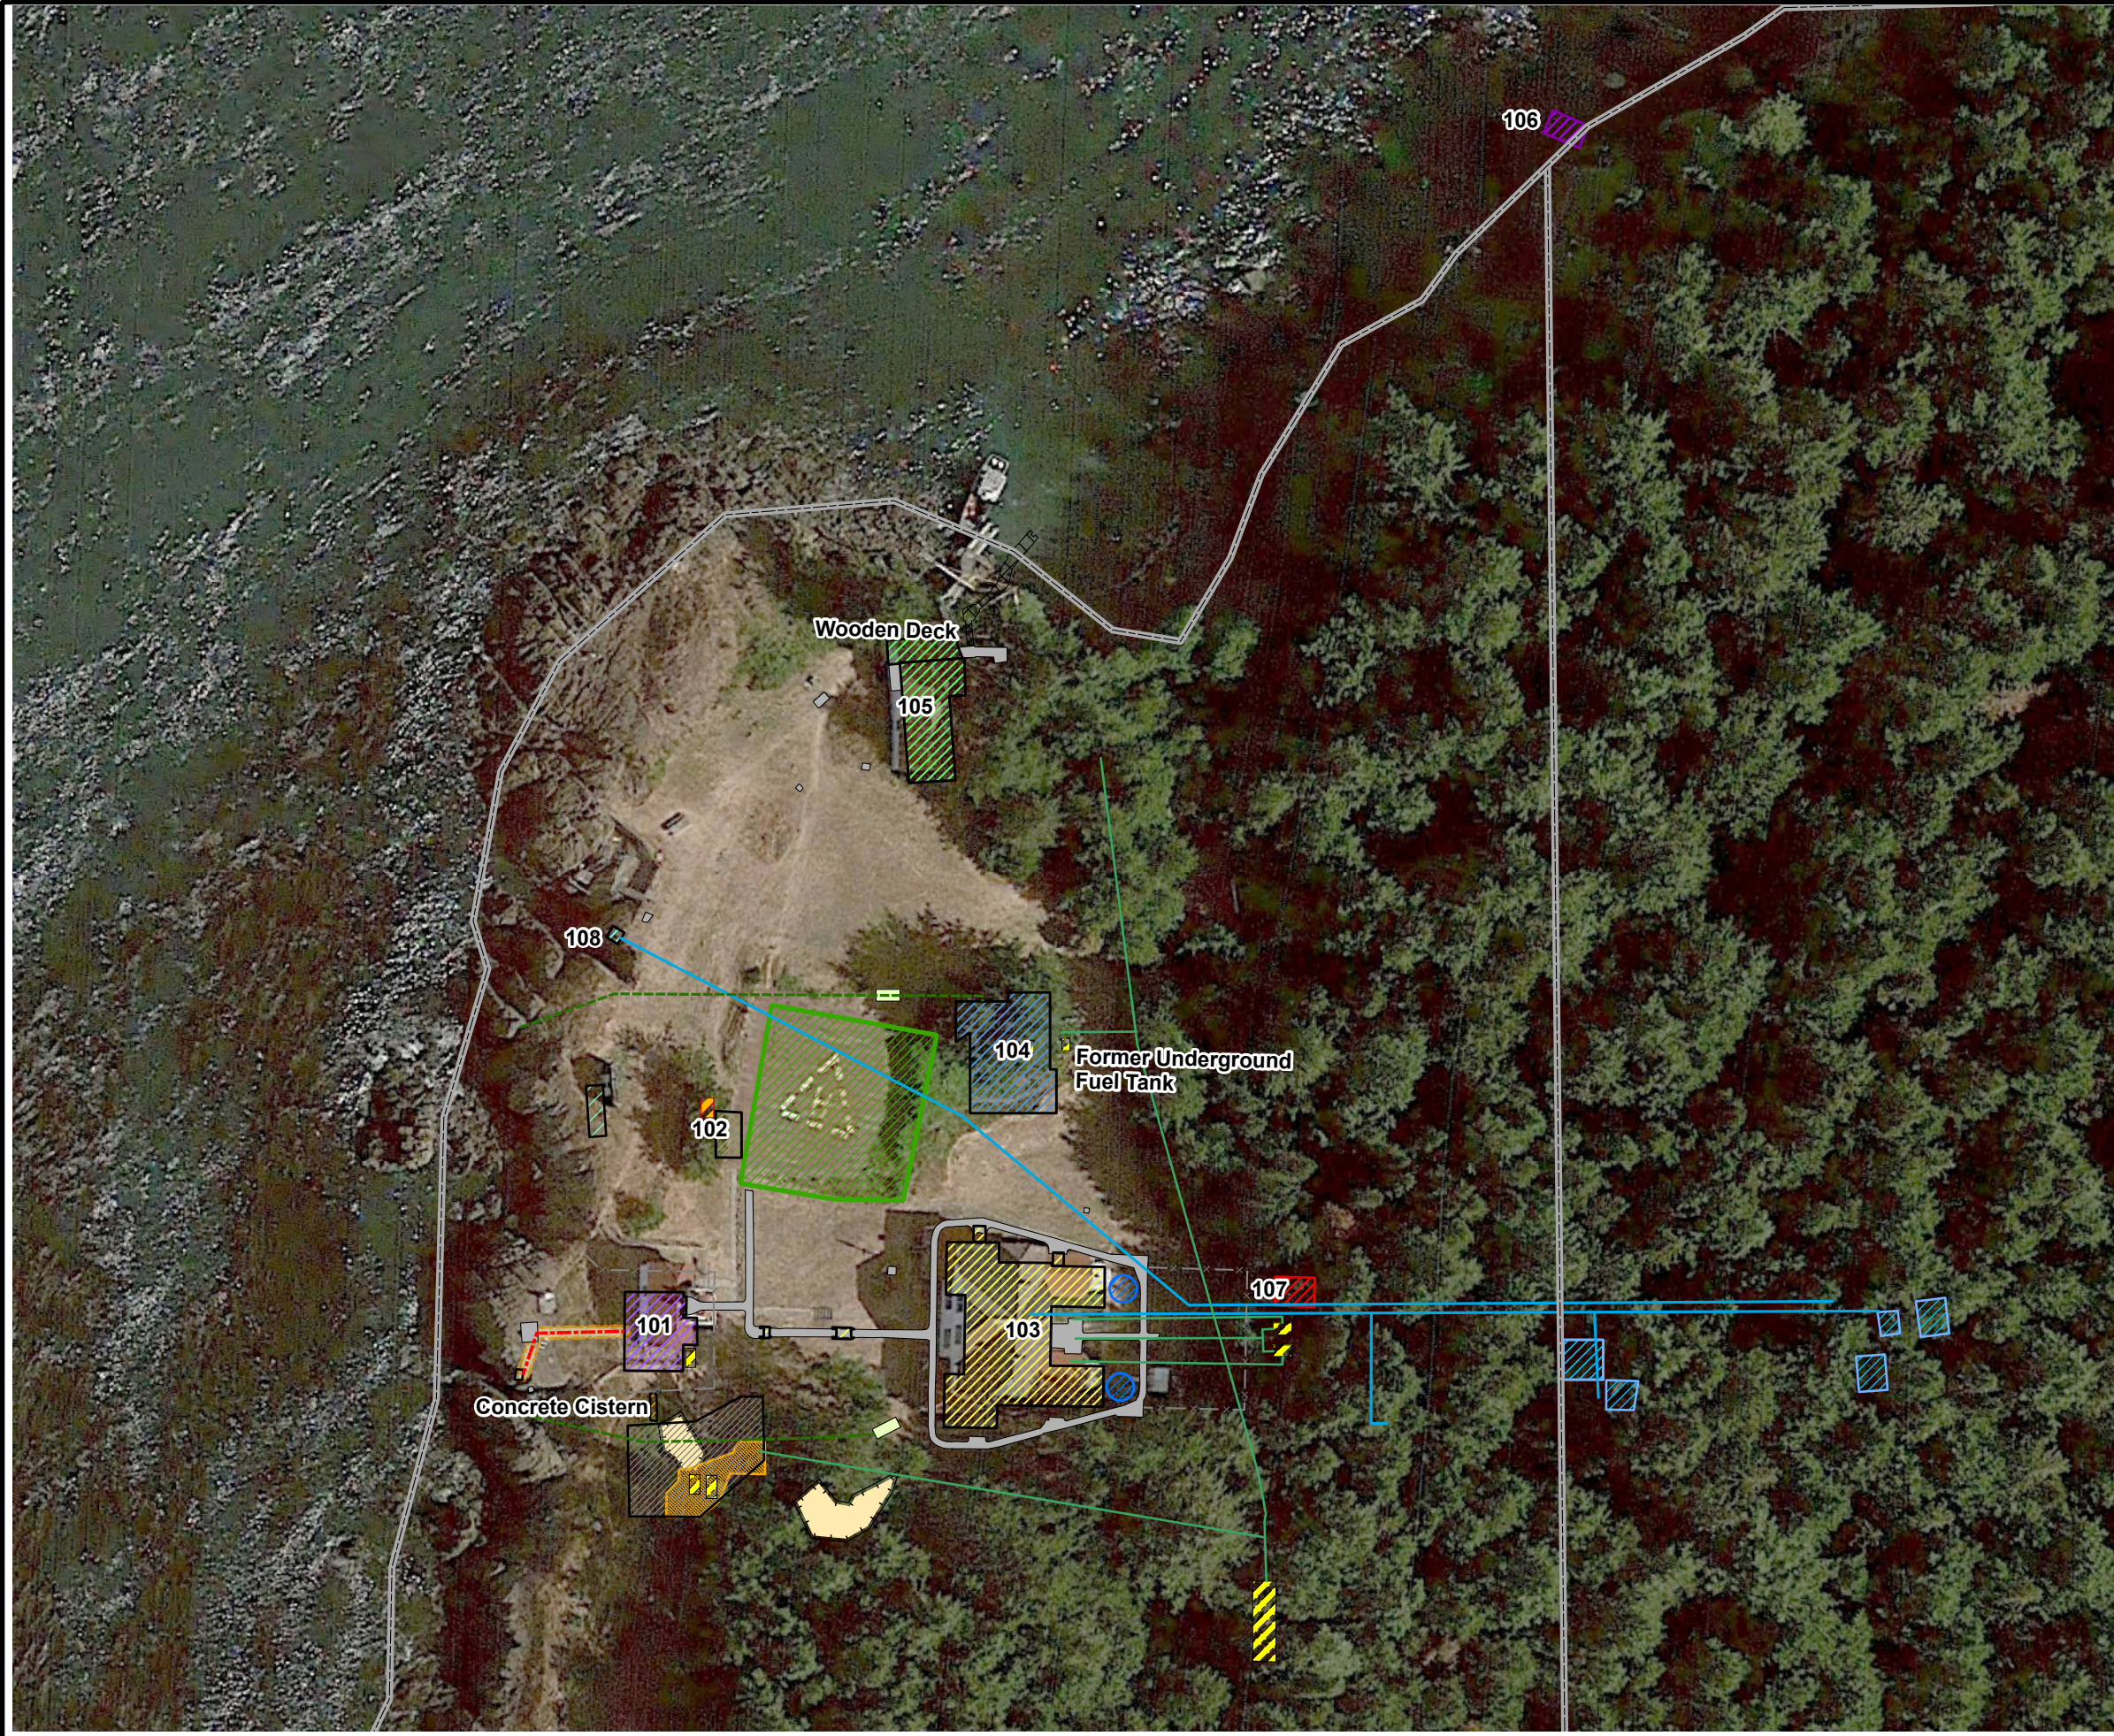
FIGURE  
2

The locations of current and historical structures are shown on Figure 2.

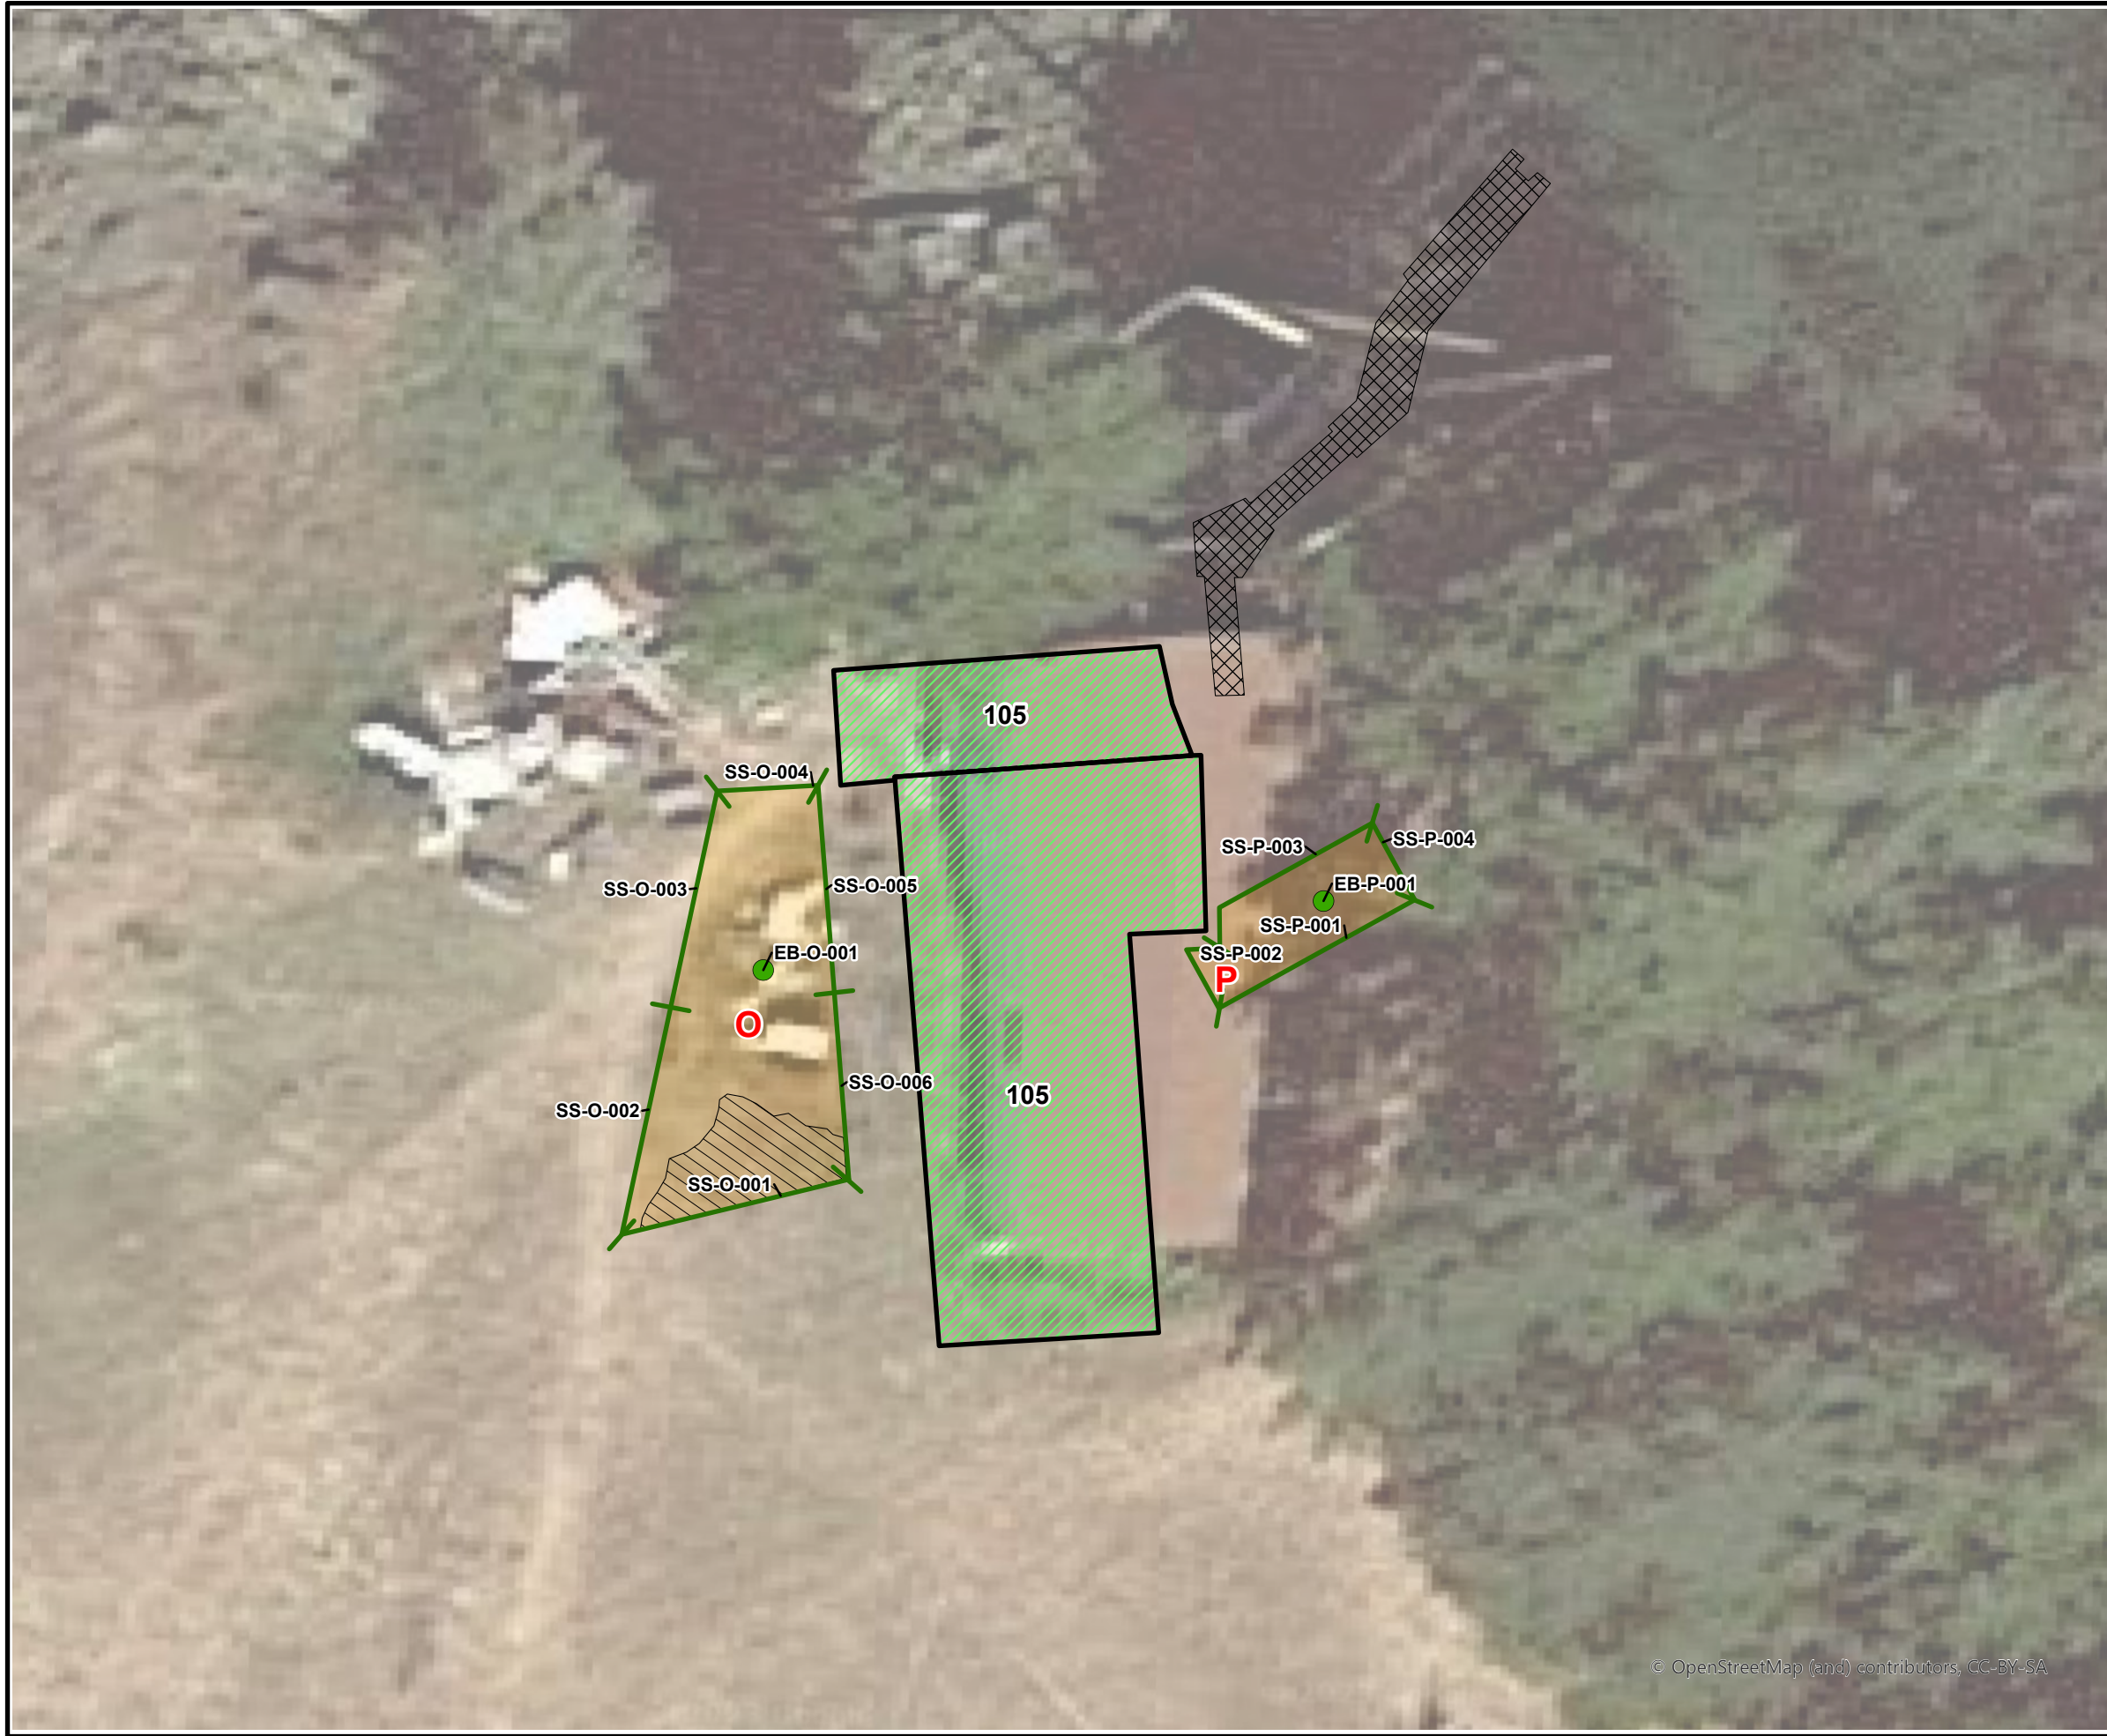
**4**

Confirmation soil sample locations were based on field conditions and are shown on Figures 4 through 11. Samples were collected in each excavation area as soil removal was completed and submitted to the laboratory on an ongoing basis. Analytical results were compared to MTCA Method A CULs to determine if CULs had been achieved. For samples with COC concentrations greater than the MTCA Method A CULs, the excavation area was expanded, and additional soil was removed. Sidewalls were expanded laterally at the same depth as the initial excavation. Additional excavation for bottom samples was performed in 1-foot increments within the area where the confirmation sample was collected. After additional excavation, confirmation samples were collected again. Based on confirmation sample results, additional excavation was conducted in Areas F, H, J, and K, as summarized below in Table 3. All areas where COC concentrations in confirmation samples exceeded the CULs were excavated.
