***Final
Construction Completion Report
Phase I
Upland Interim Remedial Action
Custom Plywood Site
Anacortes, Washington***

***Prepared by Hart Crowser
under Direction and Contract with
the Washington State Department of
Ecology under Agreement with
GBH Investments, LLC***

***October 22, 2012
17800-04***

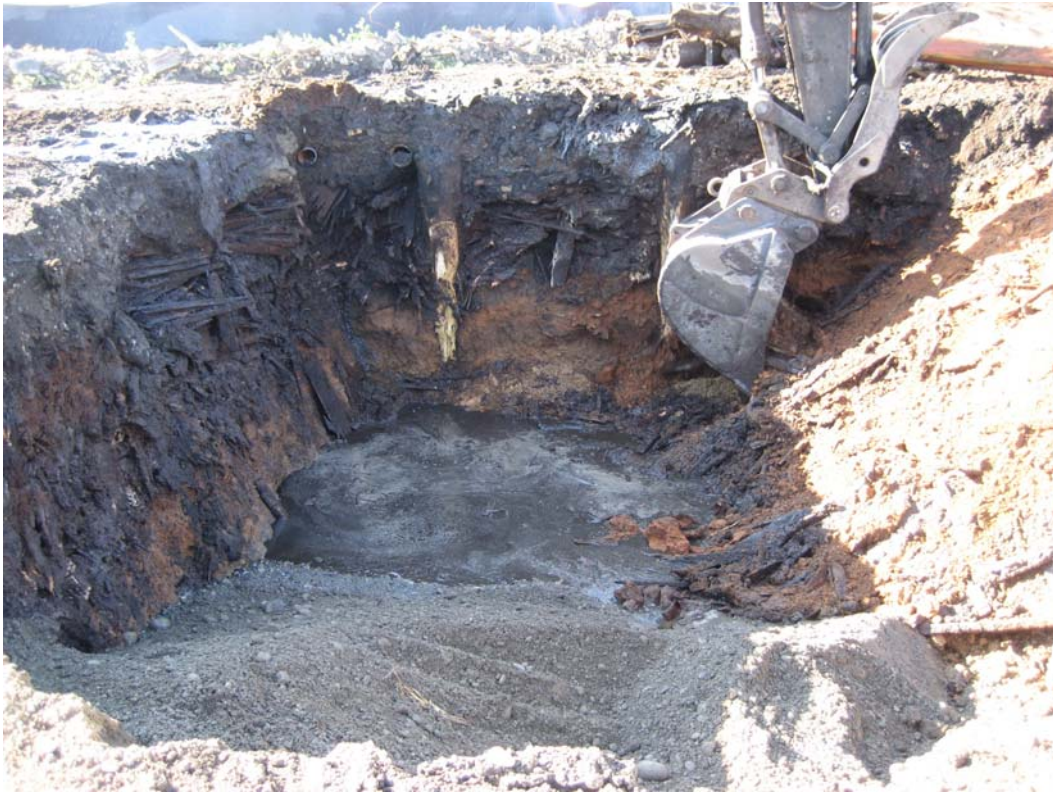
Photograph 1 – Example of stratigraphy observed during excavation (GMX-S24 excavation area September 6, 2011).

The localized stratigraphy varied for each excavation; however, the upper and lower fill units described in the EDR were apparent. In the southern portion of the Site, an upper fill unit generally less than 3 feet thick and consisting of sandy and gravelly soil, was encountered overlaying a lower fill unit consisting of fine-grained wood (e.g., sawdust) and scattered larger woody debris. In the northern portion of the Site, a relatively thicker upper fill unit was observed, which generally contained silty sand and gravel, brick fragments, and buried building debris, as described in the EDR.

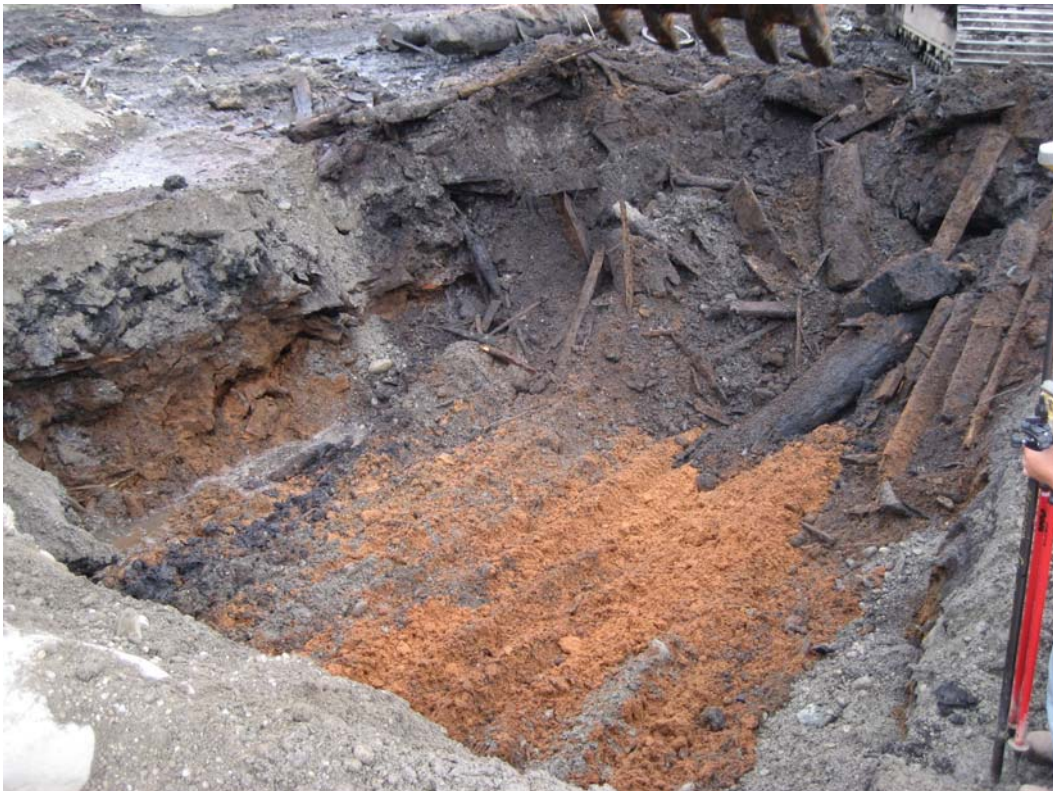
Photograph 2 – Lower fill unit consisting of fine-grained sawdust exposed in floor of excavation (GMX-S49 excavation area, September 14, 2011).

The wood waste encountered throughout the Site generally consisted of a mixture of sawdust (degraded as well as relatively fresh at greater depths), a range of small to large woody debris, dimensional lumber and logs, and entire wood piles. Hydrogen sulfide gas was detected at deeper excavation depths, primarily where sawdust was present. Other debris that was encountered generally consisted of building material remnants, such as brick and concrete ranging in size from gravel to abandoned footings.

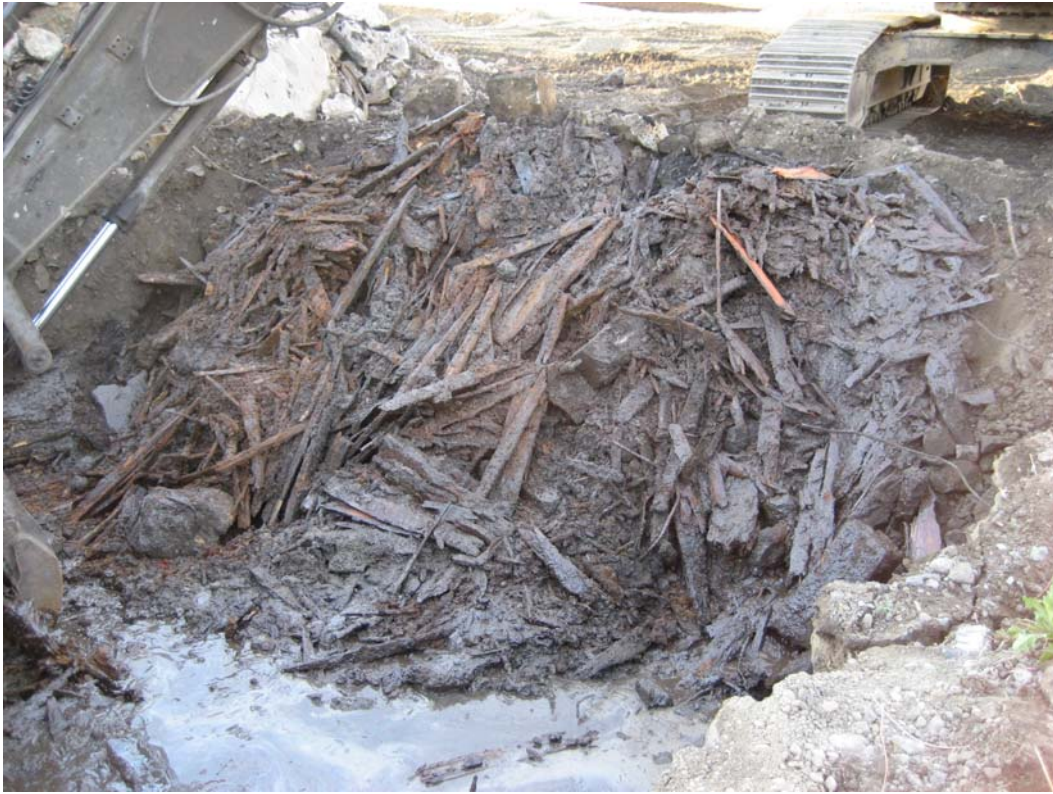
Photograph 3 – Example of woody debris encountered during excavation (GMX-S44 excavation area, September 23, 2011).

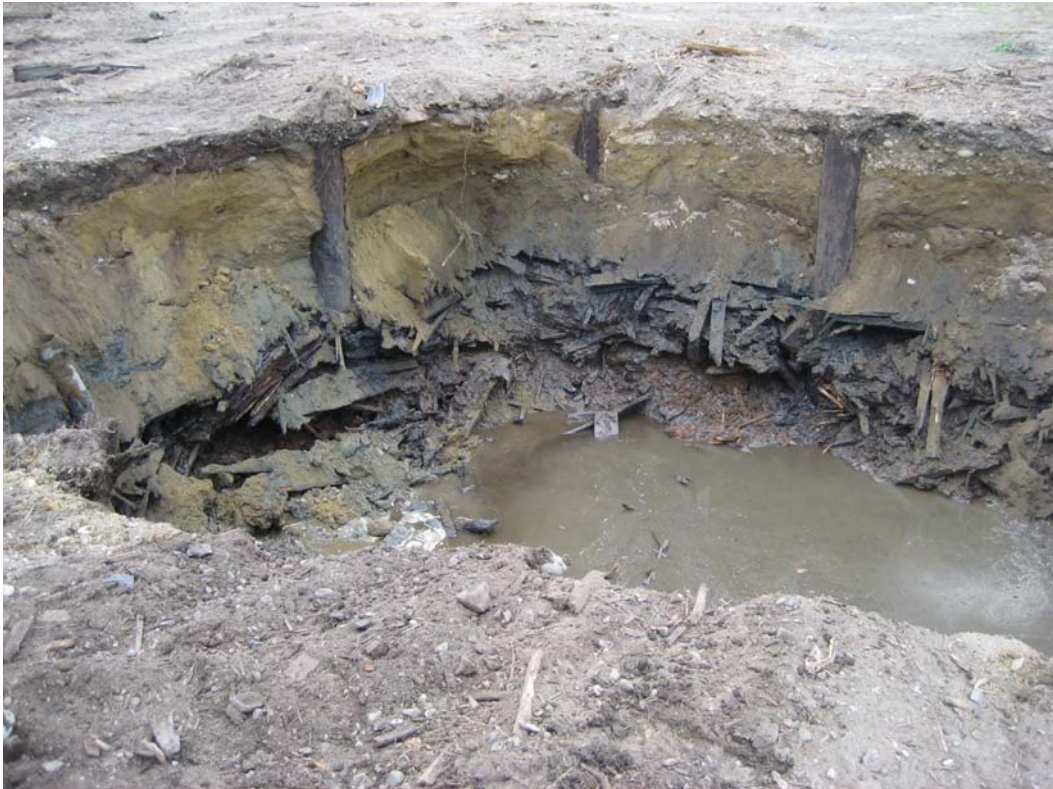
Photograph 4 – Example of soil and wood waste stratigraphy. Note upright pilings in excavation walls (GMX-S41 excavation area, September 15, 2011).

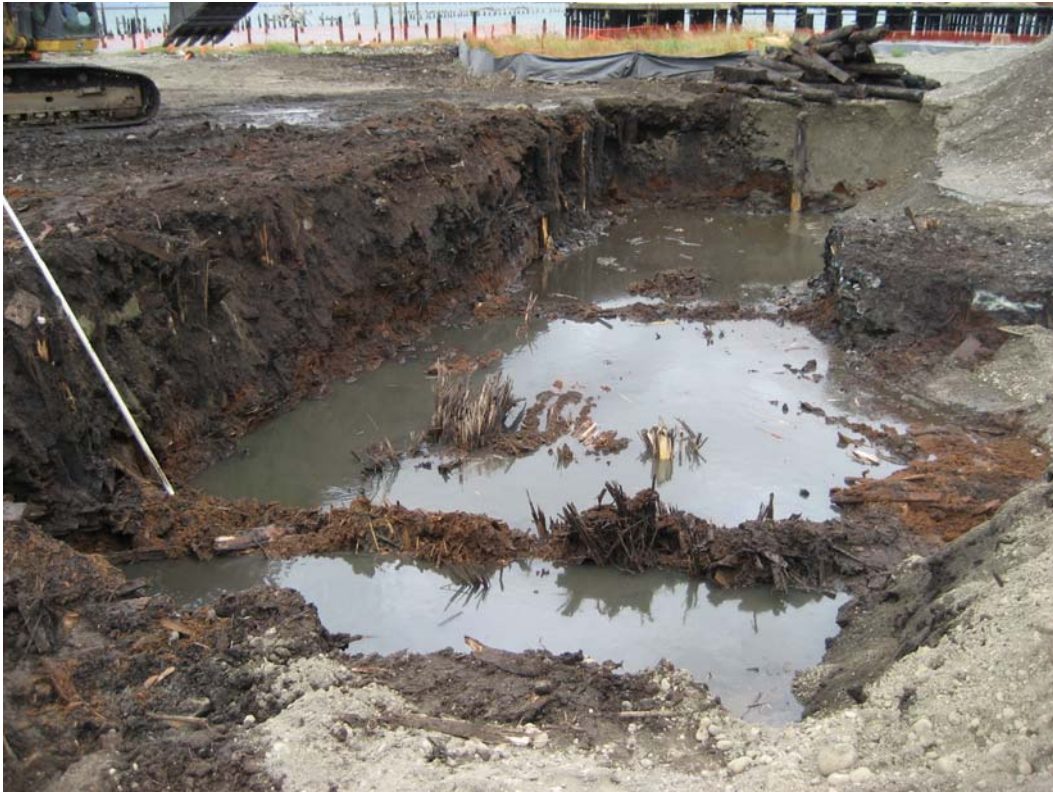
Photograph 5 – Ponded groundwater in excavation. Note splintered remnants of removed pilings in excavation floor (D12X, GMX-S9, and D24 cell H excavation areas, October 3, 2011).

Shallow groundwater was encountered in all of the excavation areas. Because such hydrogeologic conditions were expected, work plans included provisions for managing water encountered during excavation and for excavating in wet conditions. Where the infiltration rate of groundwater into an excavation was great enough to cause ponding, excavation continued in the wet in a manner similar to dredging. In excavation areas where significant ponding occurred, the ponded groundwater was allowed to overflow the excavation footprint during backfilling and infiltrate in nearby contaminated, but as yet unexcavated, areas. As space for infiltration of ponded groundwater became limited toward the end of the excavation work, ponded groundwater was removed from some of the remaining excavation areas by vacuum truck.

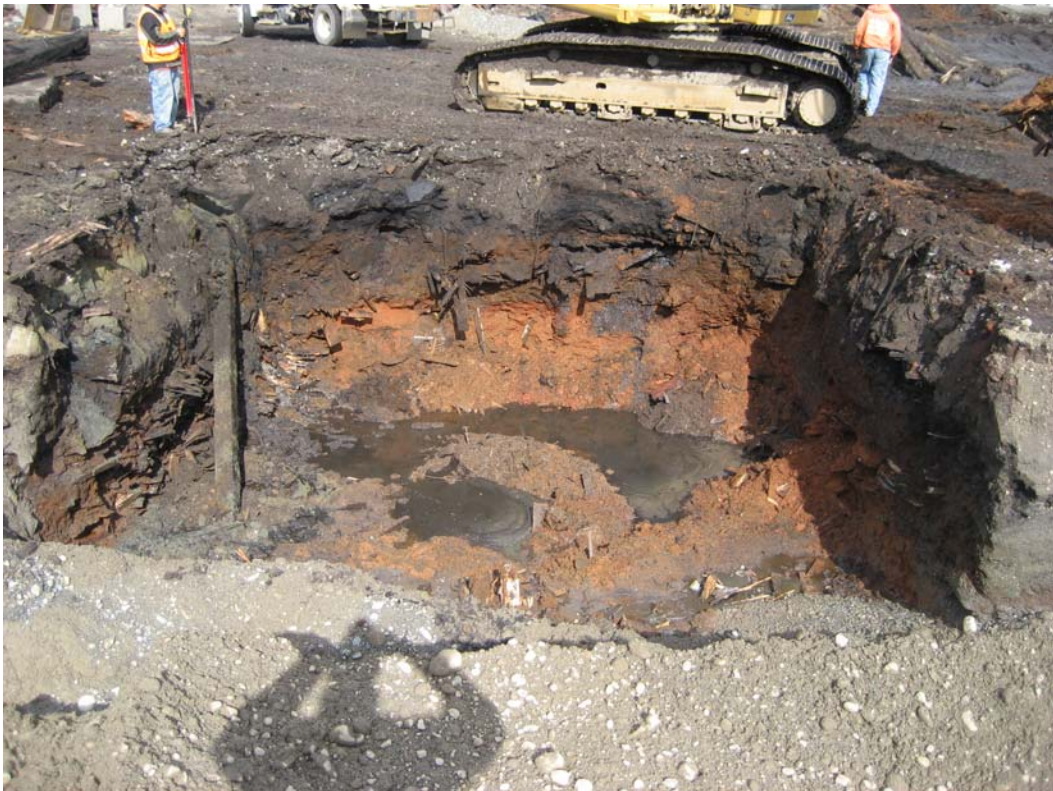
Photograph 6 – Example of stratigraphy observed during excavation (GMX-S47 excavation area, October 10, 2011).

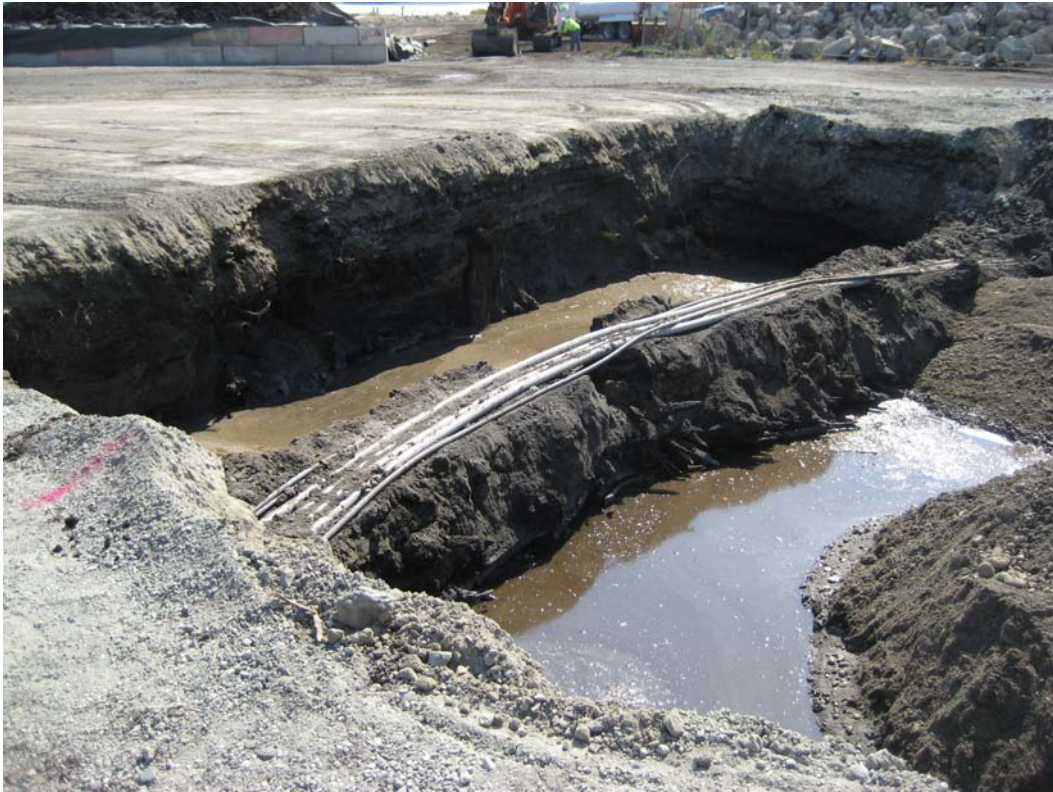
Photograph 7 – Extent of excavation limited by electrical conduit (GMX-MW-03 excavation area, September 8, 2011).

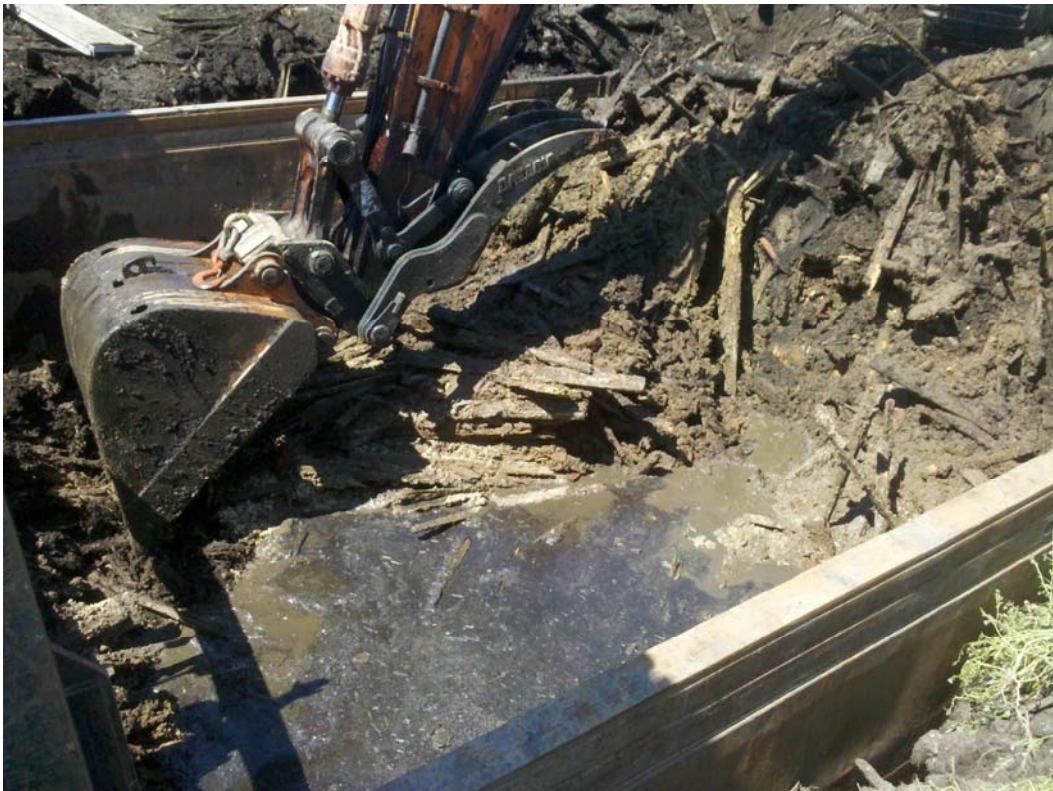
Photograph 8 – Slide rail shoring system used to excavate in saturated conditions along OHW line (August 1, 2011).

In the shoreline protection zone and wetland mitigation complex, a portable slide rail shoring system was used by the contractor to facilitate excavation in saturated conditions without violating the OHW line (see Appendix A, Photographs 8 through 13). This linear shoring system was installed while excavating by sliding vertical steel panels into rails on evenly spaced upright posts along the excavation boundary. Two parallel panel walls were constructed, which were joined by horizontal struts attached to the posts, forming a bay within which excavation could continue without wall collapse. As excavation progressed downward, the panels and posts were incrementally pushed down to the desired depth to continue to support the excavation walls. After the desired excavation depth was attained and backfilling commenced, the slide rail panels were incrementally pulled upwards until the excavation was filled and support of the walls was no longer needed. The use of the slide rail system was a submitted and approved alternate to the specified sheet pile retaining wall.

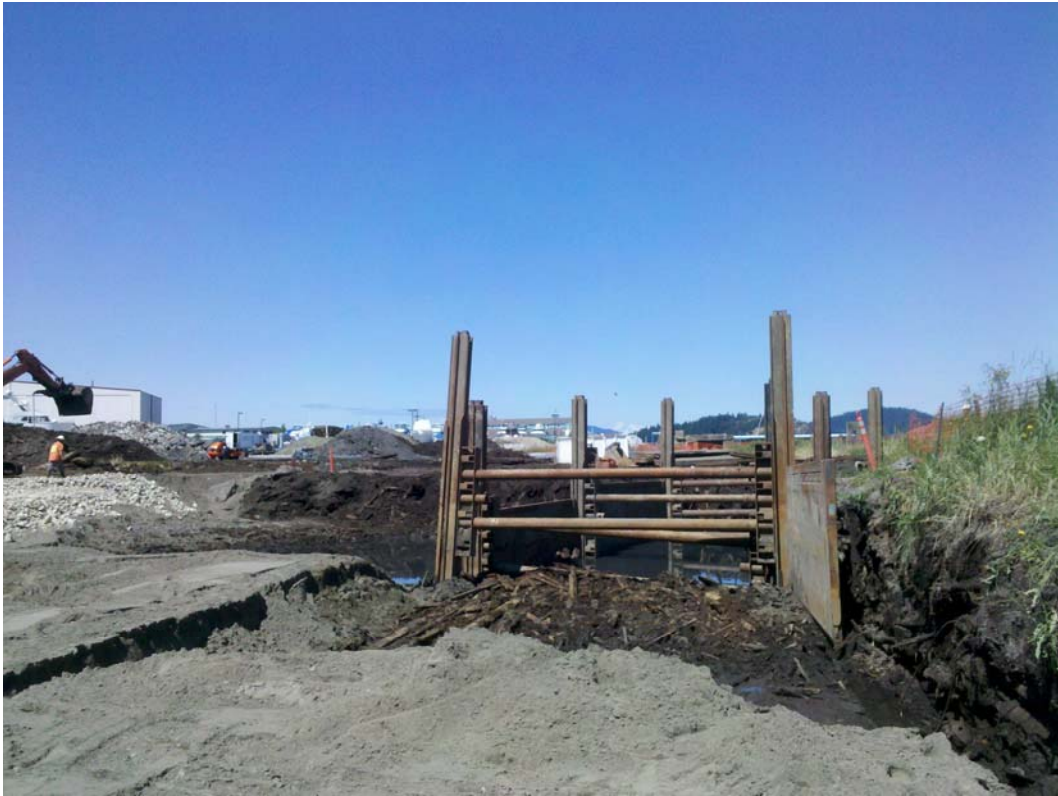
Photograph 9 – Slide rail shoring system. Orange fence marks the OHW line (August 3, 2011).

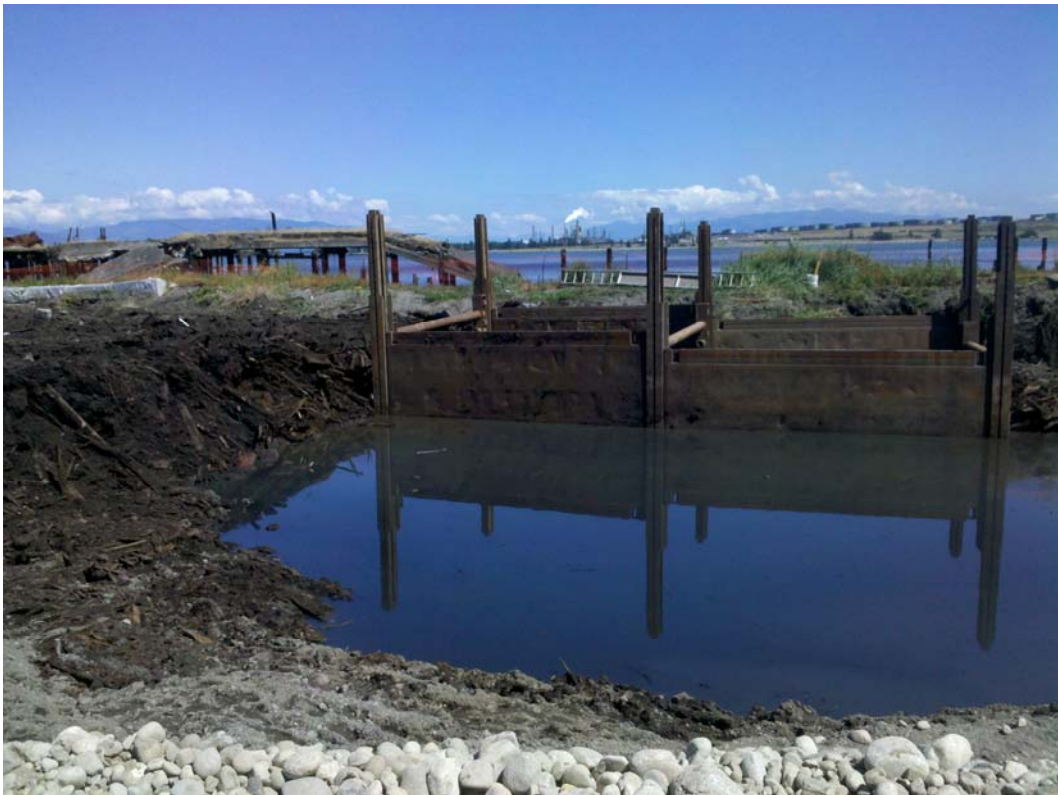
Photograph 10 – Slide rail shoring system (August 3, 2011).

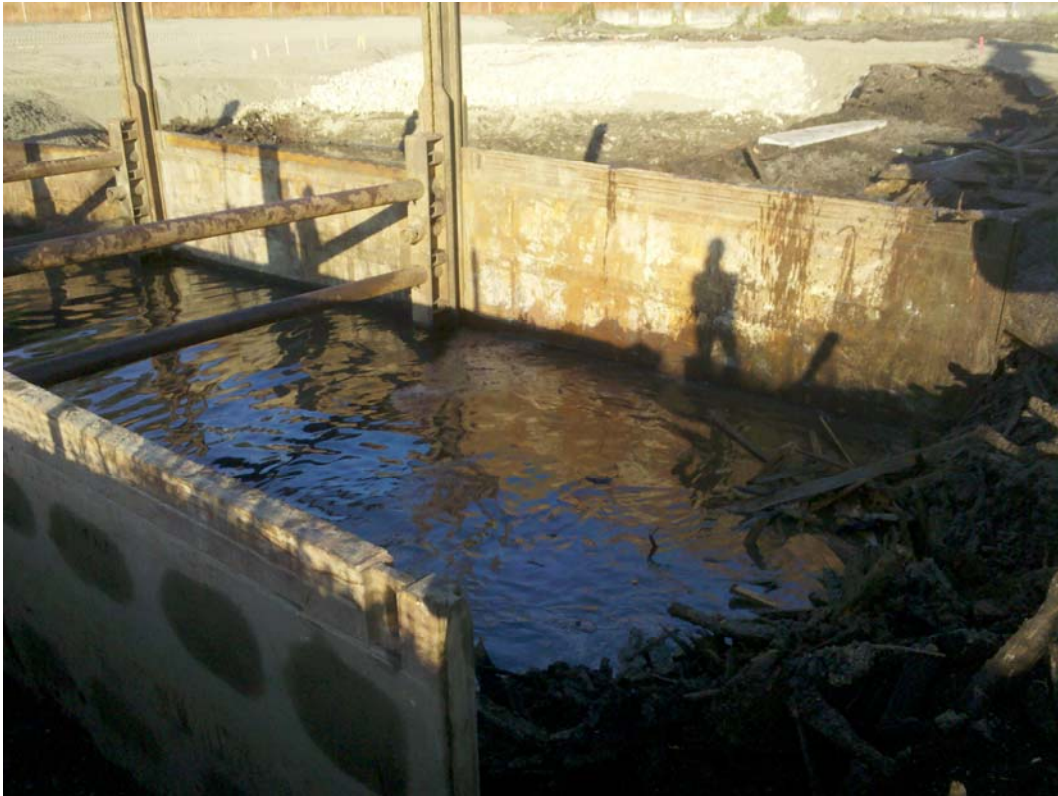
Photograph 11 – Slide rail shoring system (August 4, 2011).

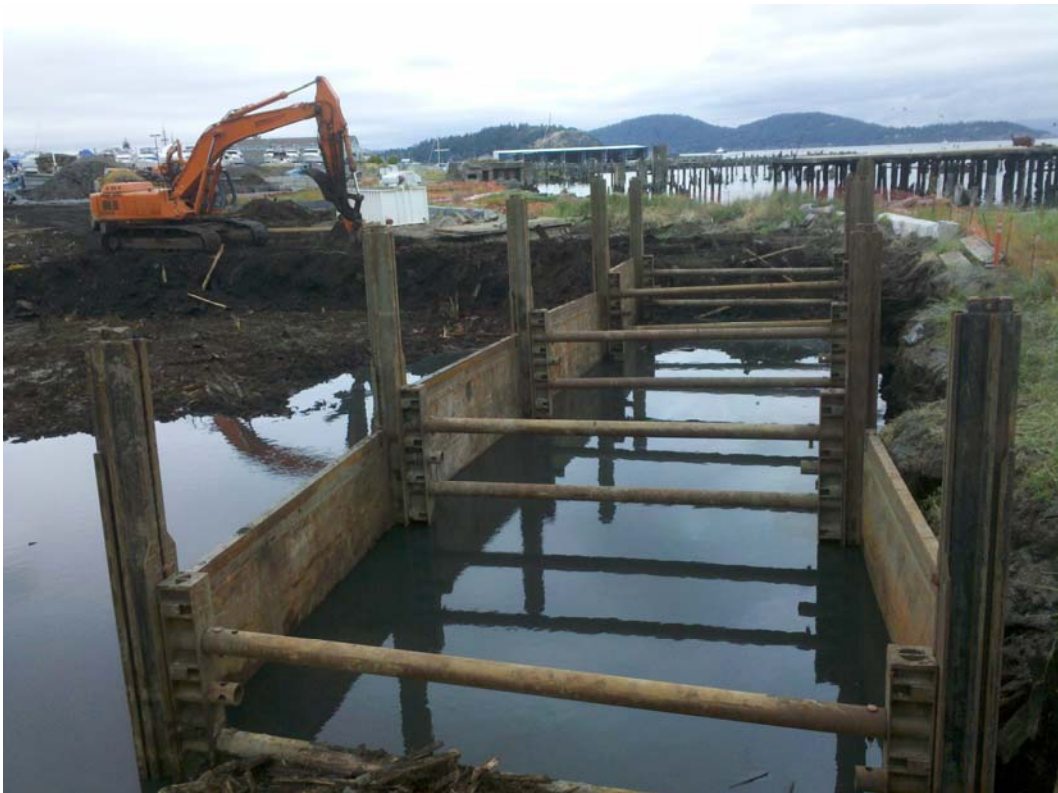
Photograph 12 – Slide rail shoring system. Orange fence marks the OHW line (August 5, 2011).

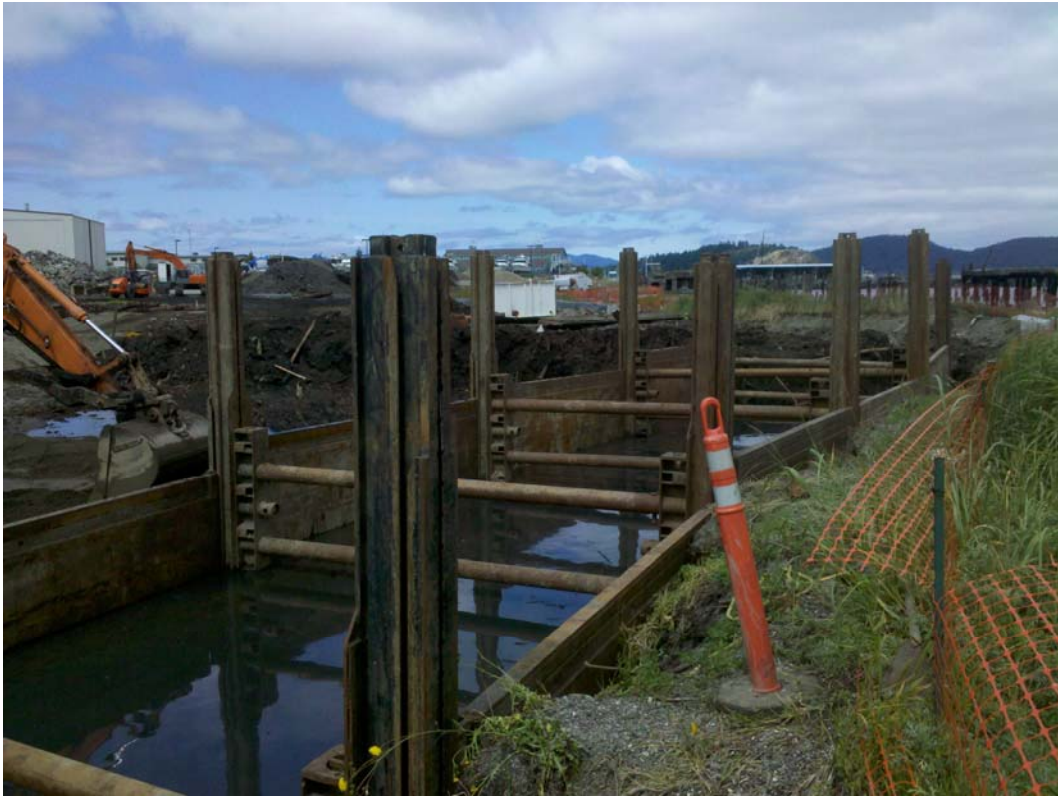
Photograph 13 – Slide rail shoring system. Orange fence marks the OHW line (August 5, 2011).

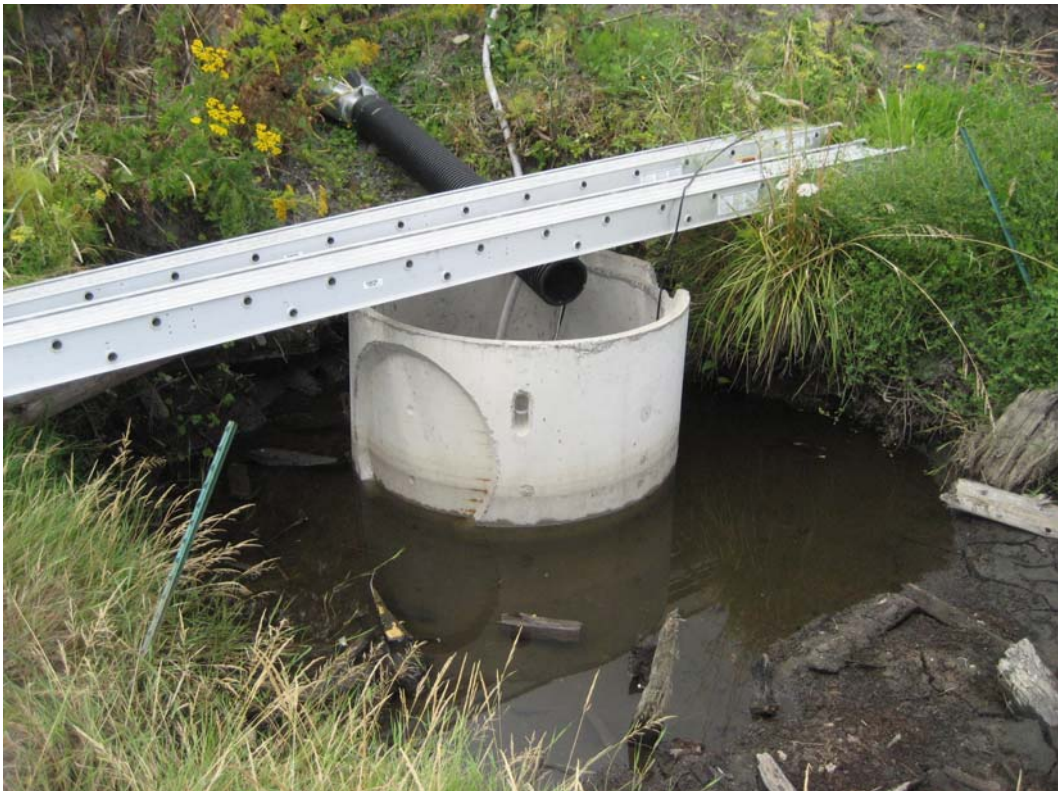
Photograph 14 – Temporary sump and stormwater rerouting system installed at City of Anacortes outfall discharge (August 30, 2011).

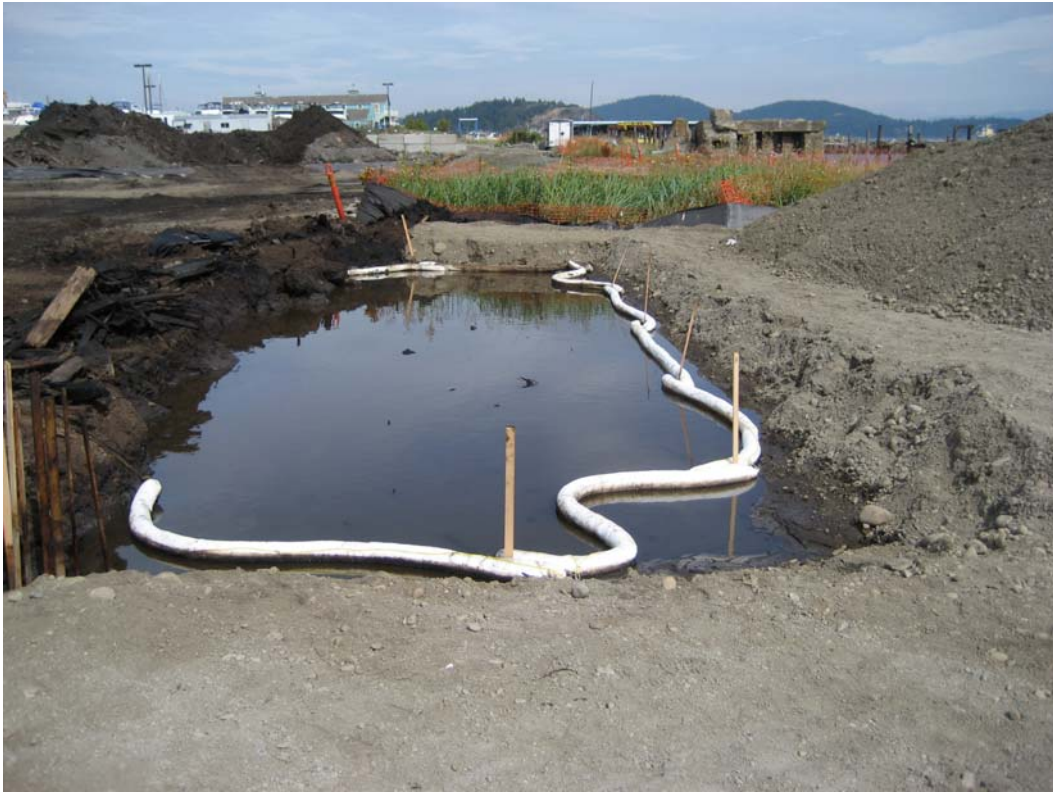
Photograph 15 – Absorbent booms deployed on ponded groundwater south of Wetland E (September 1, 2011).

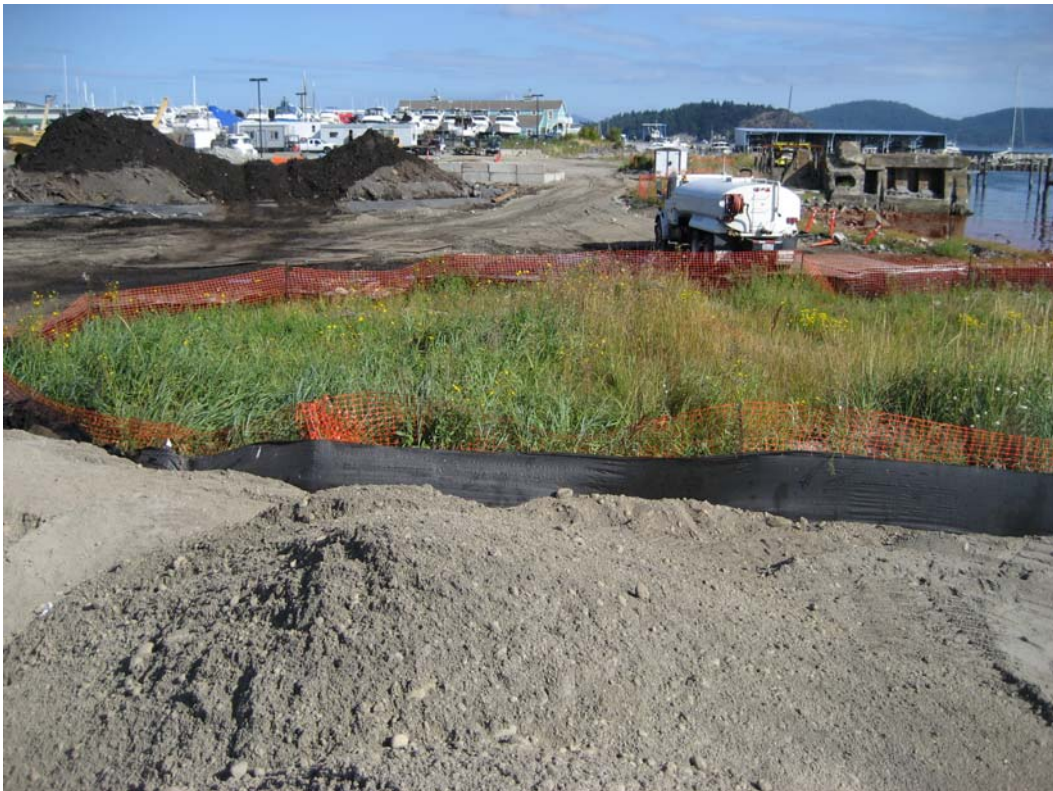
Photograph 16 – Silt fence and high-visibility barrier installed along Wetland E boundary (September 2, 2011).

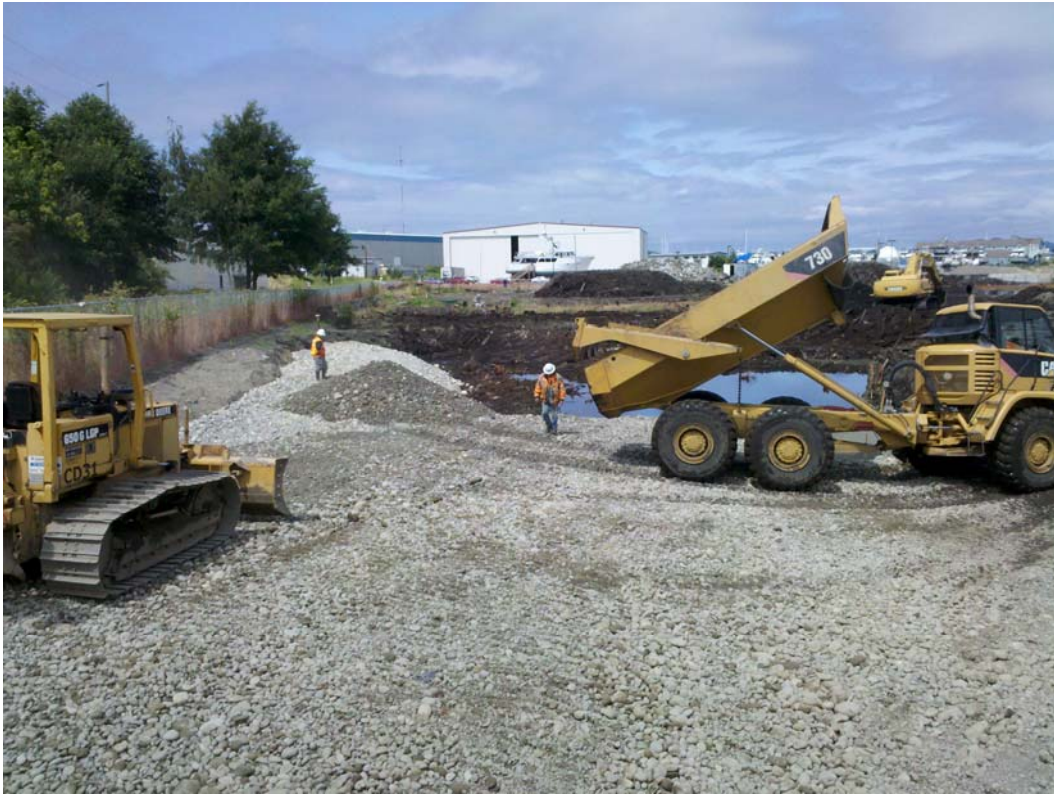
Photograph 17 – Installation of shoreline protection layer in wetland mitigation and buffer areas (July 26, 2011).

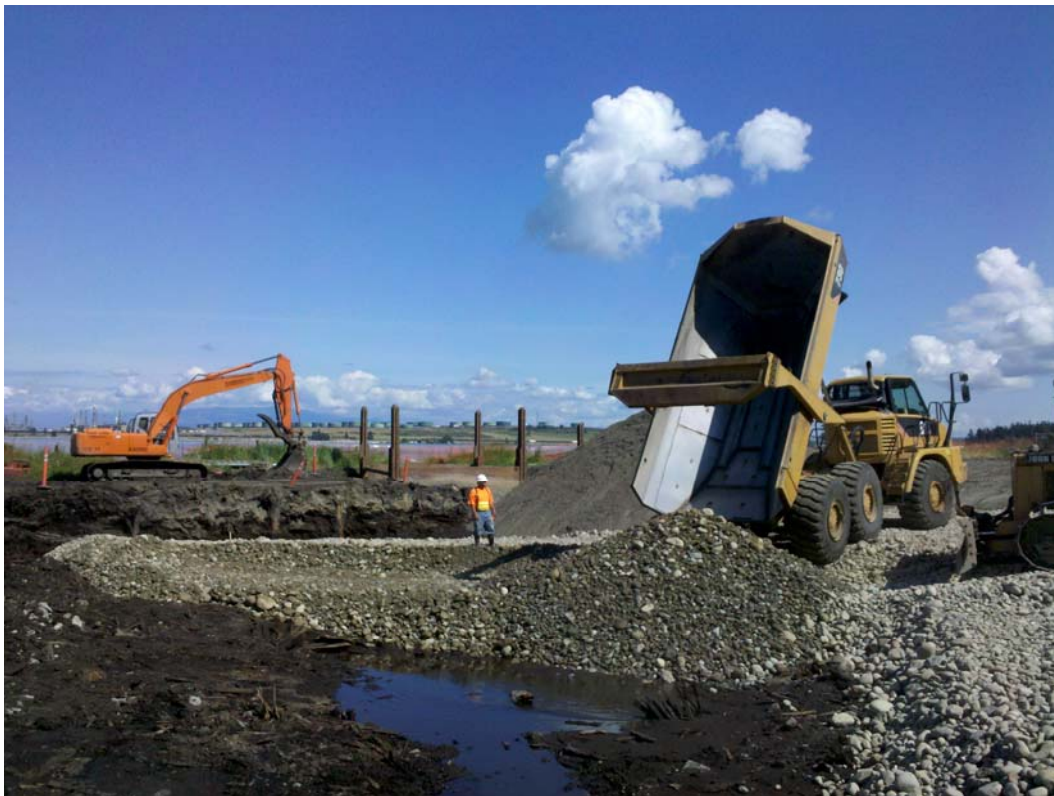
Photograph 18 – Placement of shoreline protection layer material (July 27, 2011).

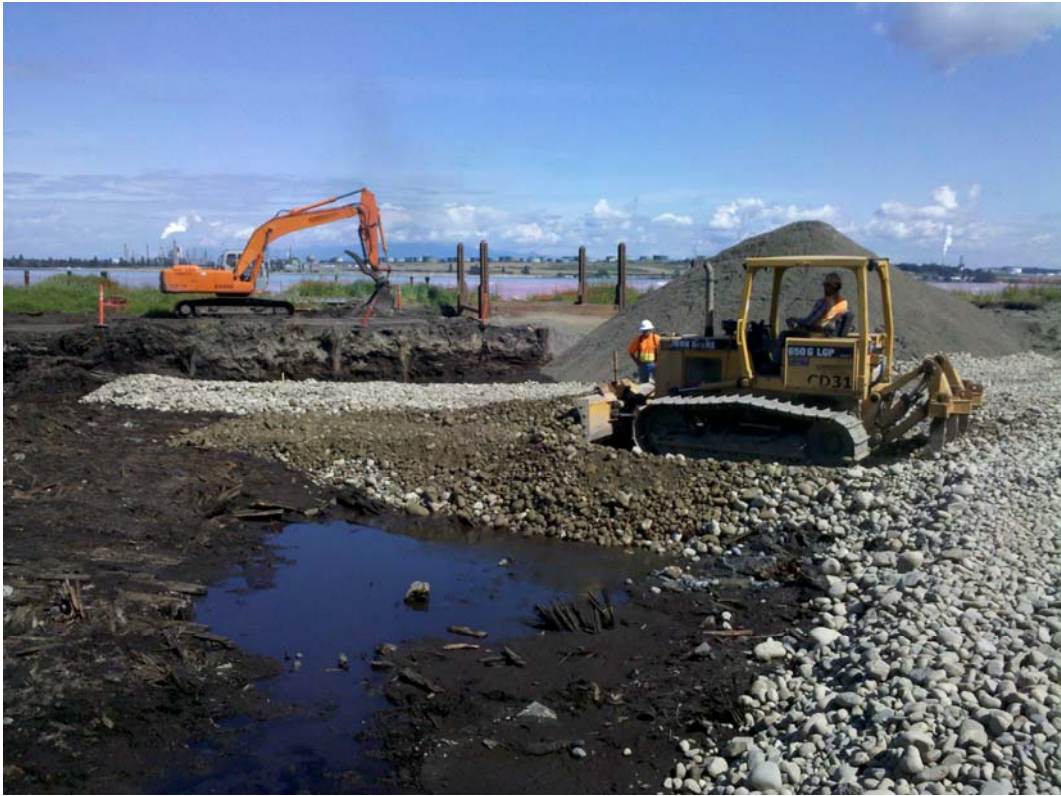
Photograph 19 – Installation of shoreline protection layer in excavated wetland mitigation and buffer areas. Note imported beach sand stockpiled in background (July 27, 2011).

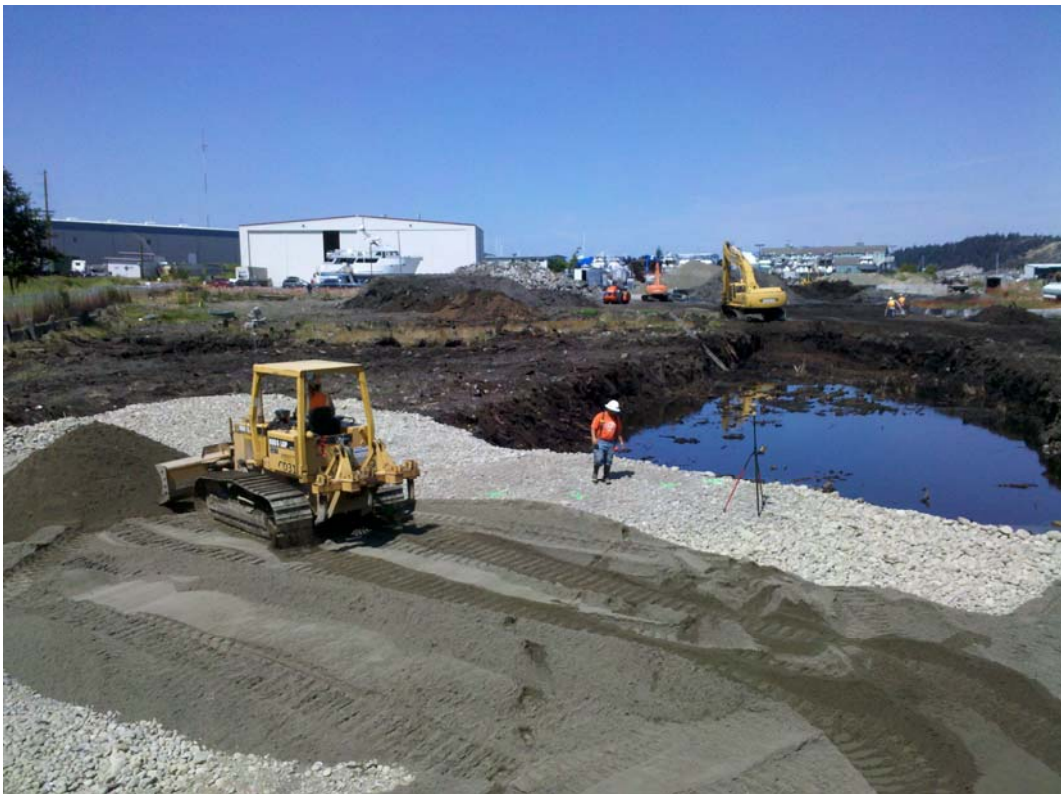
Photograph 20 – Placement of imported beach sand over shoreline protection layer in wetland mitigation area (July 28, 2011).

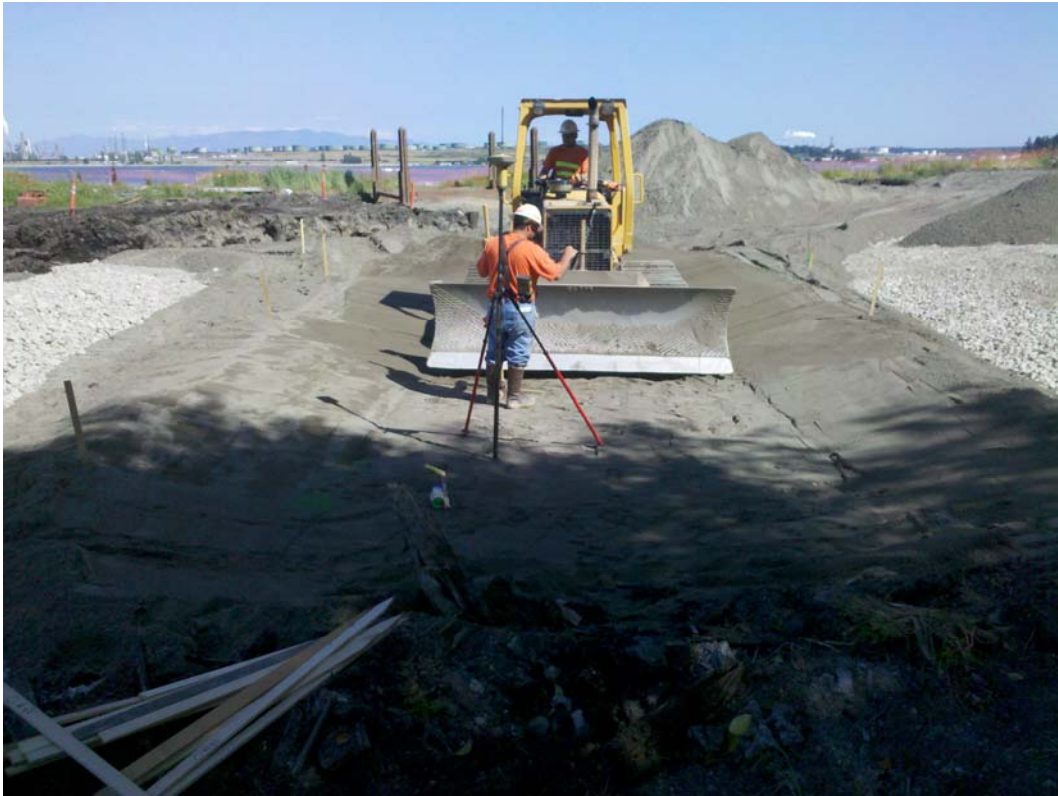
Photograph 21 – Grading beach sand in wetland mitigation area (July 28, 2011).

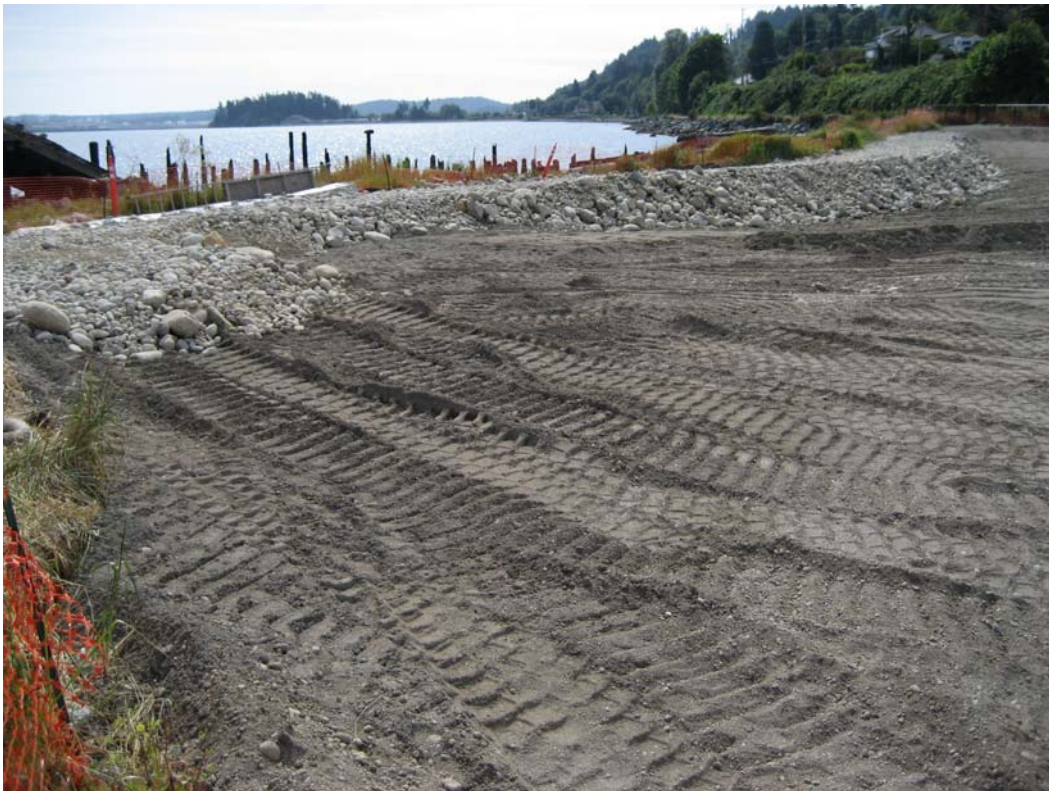
Photograph 22 – Temporary protective berm installed in wetland mitigation area (September 1, 2011).

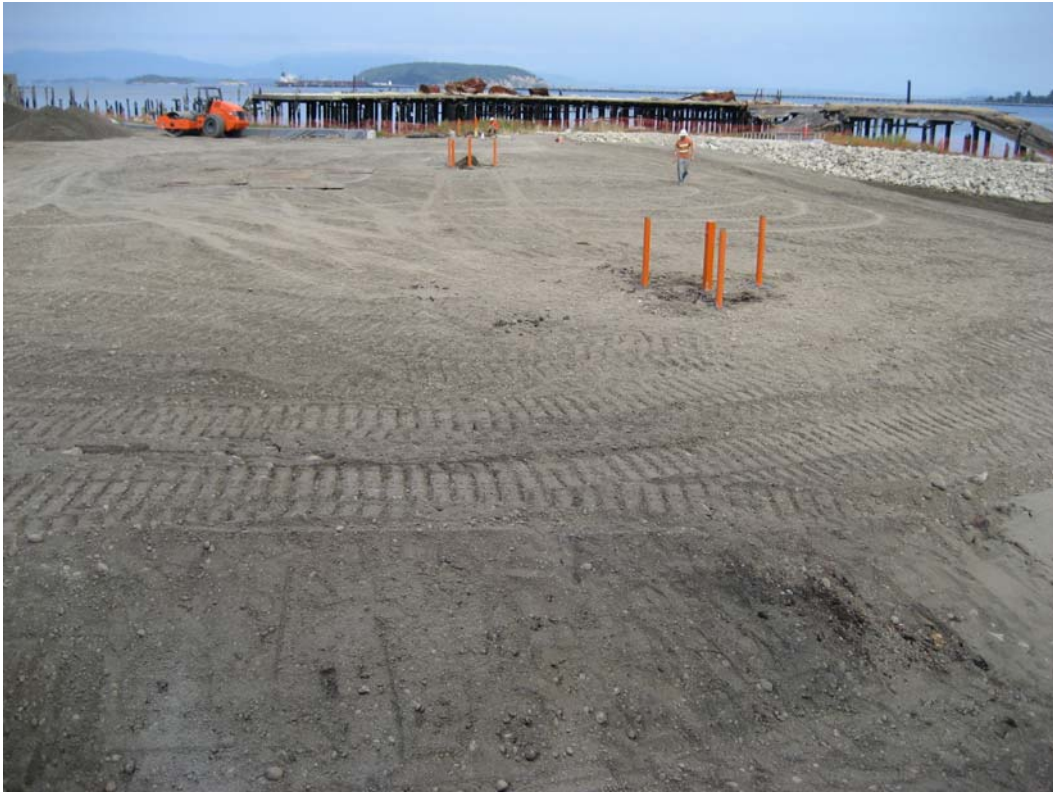
Photograph 23 – Groundwater monitoring wells MW-1 through MW-3 constructed in wetland buffer planting area (September 12, 2011).

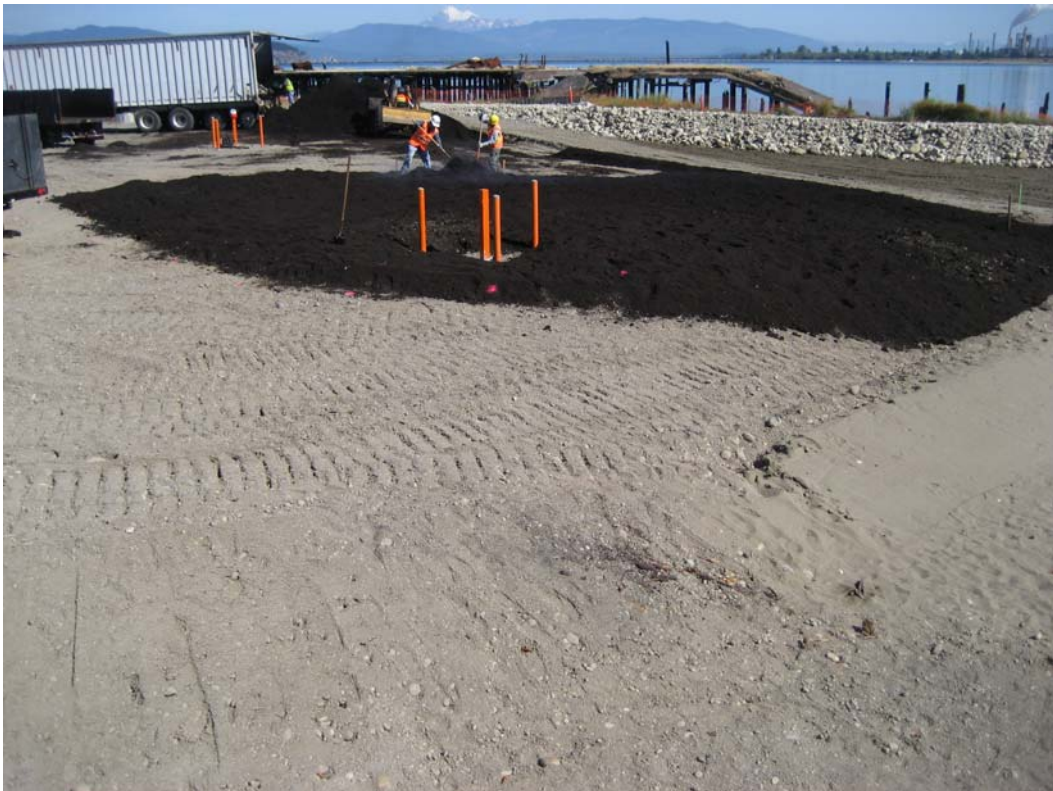
Photograph 24 – Delivery and placement of compost in wetland buffer planting area (September 20, 2011).

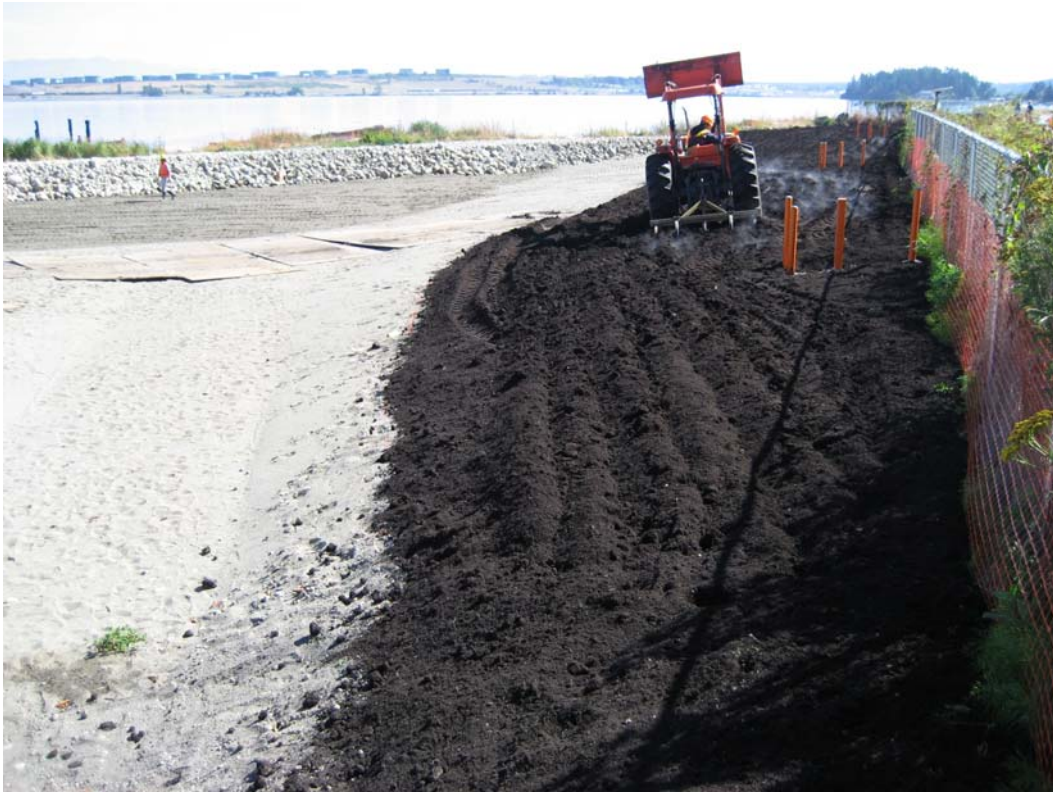
Photograph 25 – Tilling compost into clean backfill material in wetland buffer area. Note groundwater monitoring wells MW-4 through MW-6 along Site fence (September 20, 2011).
