***Final
Construction Completion Report
Phase I
Upland Interim Remedial Action
Custom Plywood Site
Anacortes, Washington***

***Prepared by Hart Crowser
under Direction and Contract with
the Washington State Department of
Ecology under Agreement with
GBH Investments, LLC***

***October 22, 2012
17800-04***

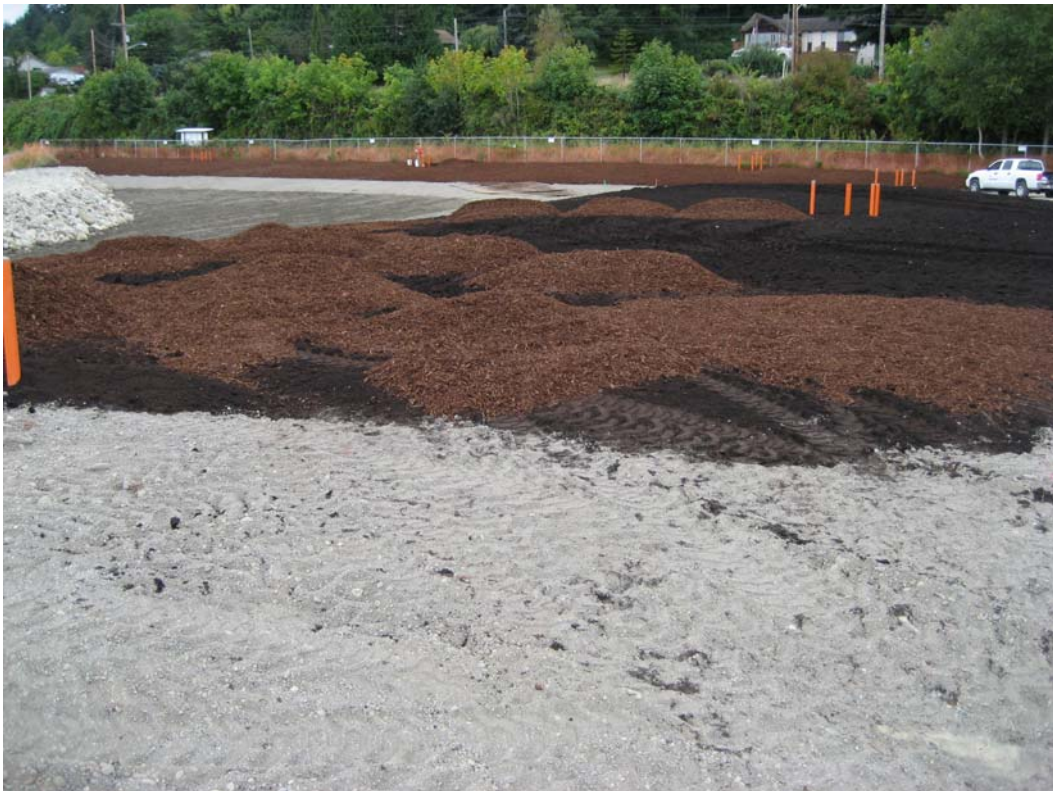
Photograph 26 – Mulch piles to be spread over compost-amended buffer planting area (September 21, 2011).

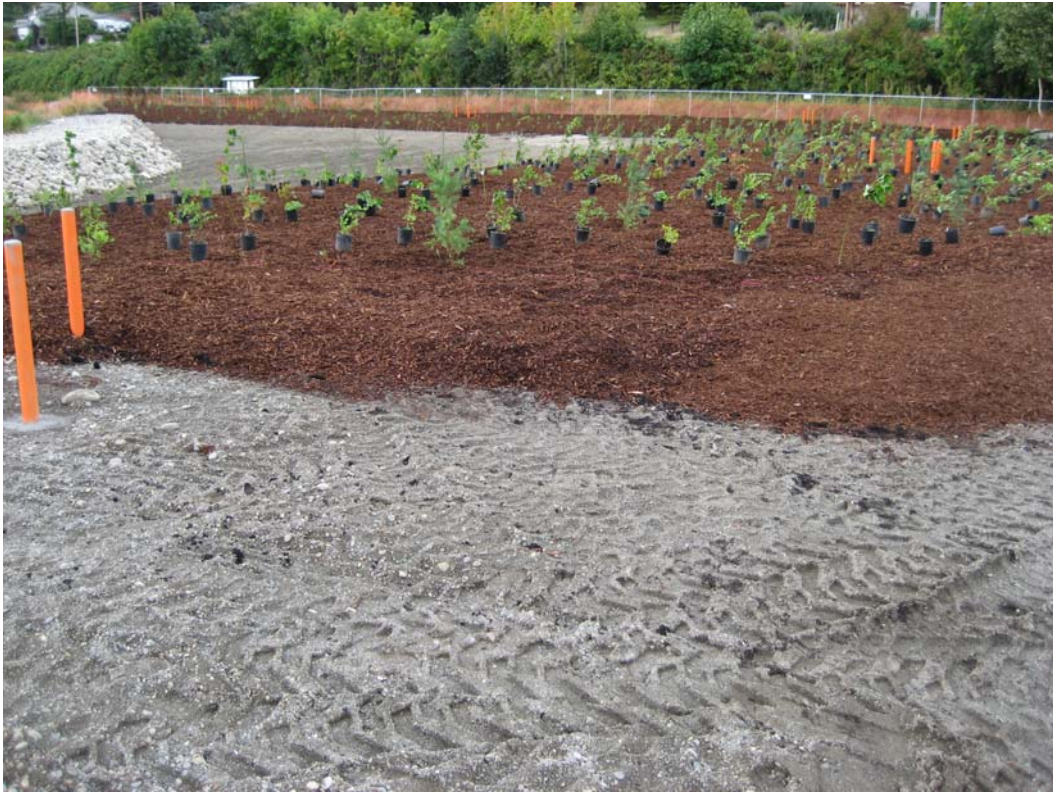
Photograph 27 – Placement of native trees, shrubs, and groundcover at planned spacing intervals before planting (September 22, 2011).

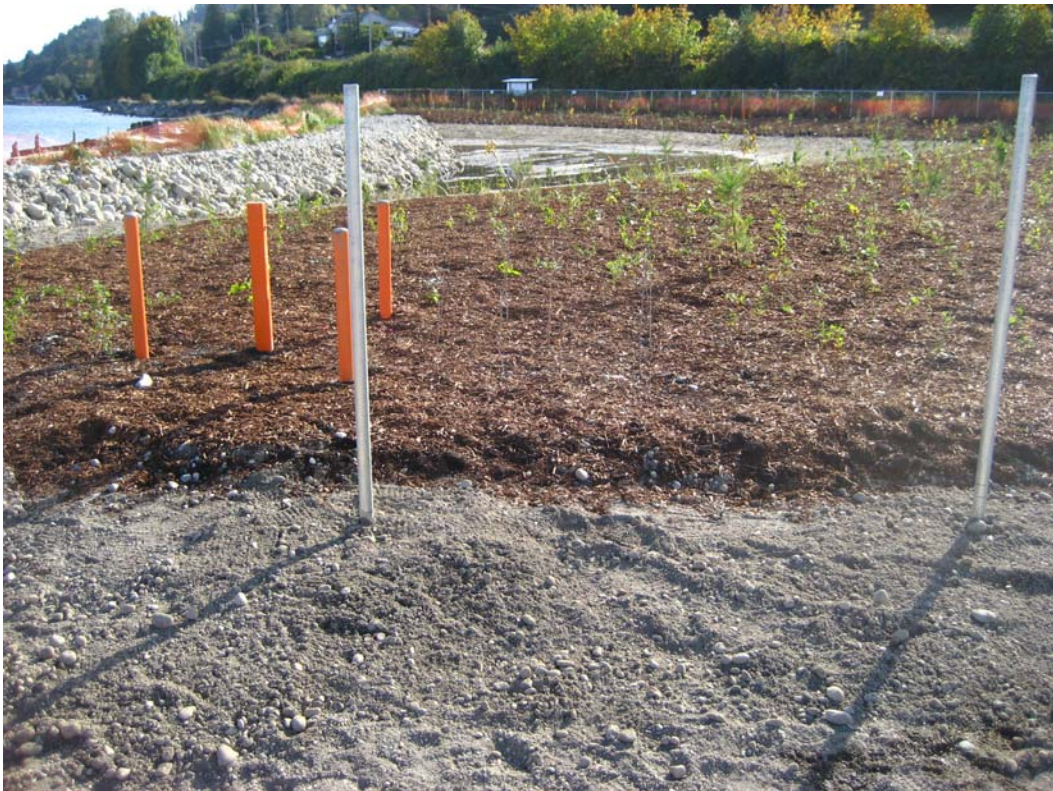
Photograph 28 – Native vegetation planted in wetland buffer area. Note posts installed for temporary fence at buffer area boundary (October 13, 2011).

Barrier plantings were densely planted in a strip 8 feet wide along the inside of the temporary fence to develop into a thicket that would replace the fence over time. The temporary fence will be removed once the barrier plantings become established.

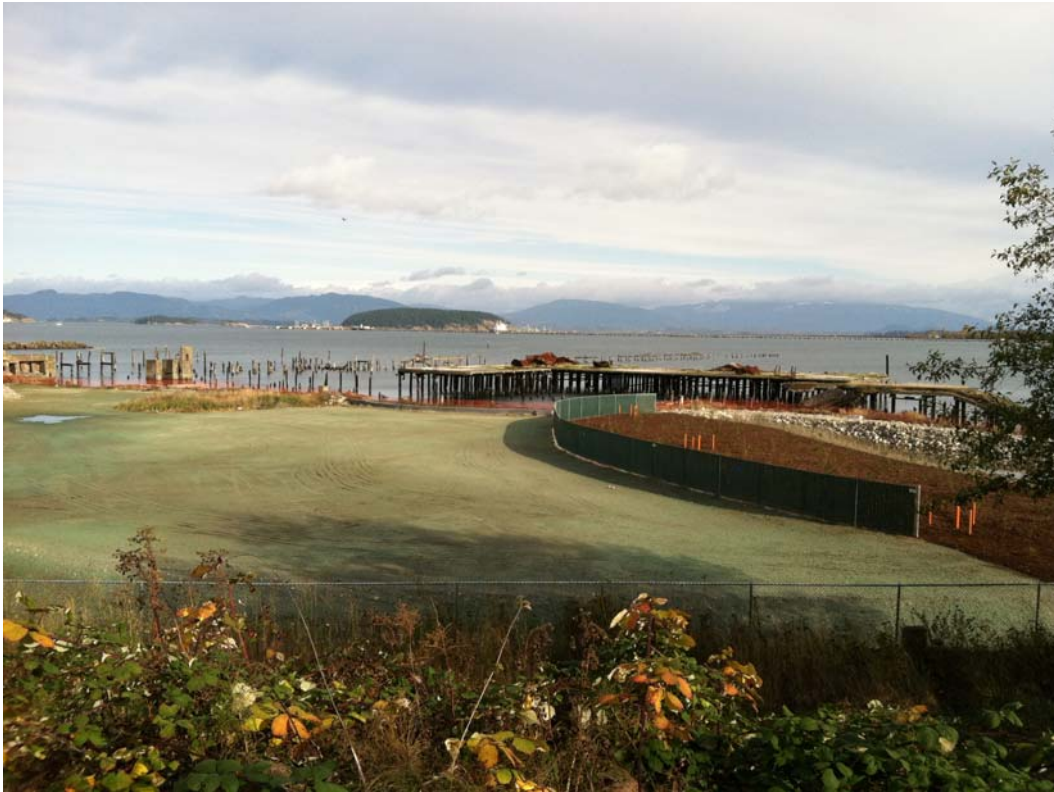
Photograph 29 – Graded and hydroseeded area north of wetland buffer area (November 14, 2011).

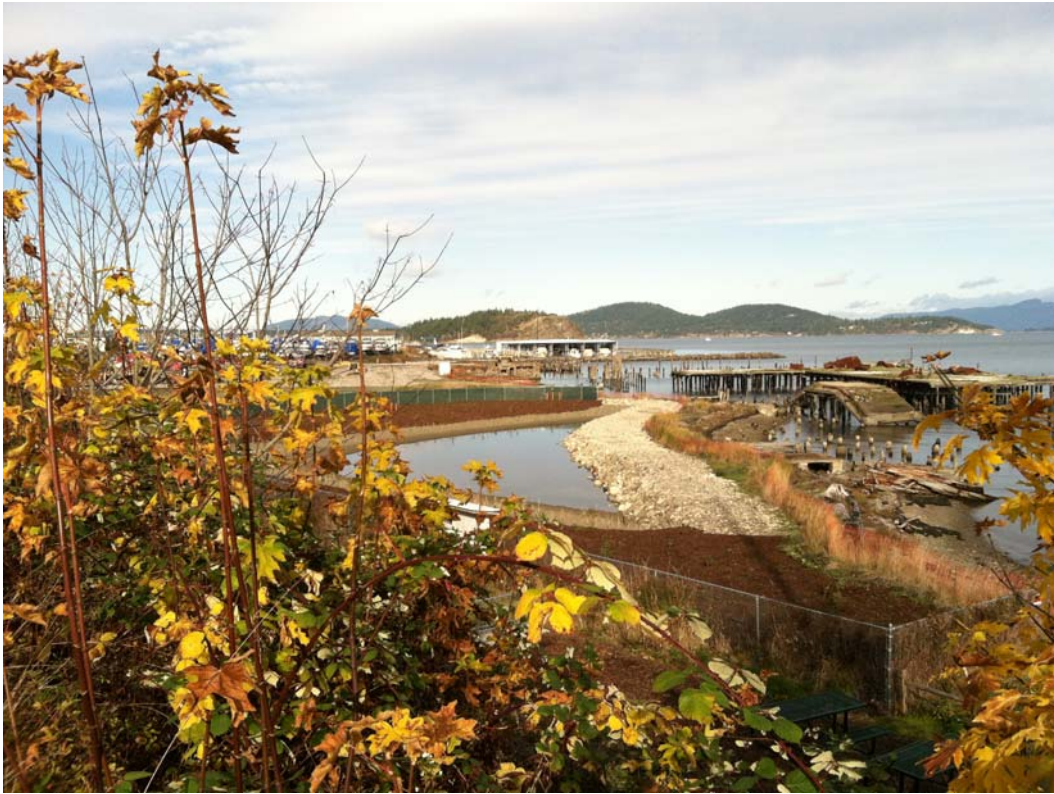
Photograph 31 – Completed wetland mitigation and buffer areas. Note temporary berm in place along OHW line (denoted by high-visibility fence) (November 14, 2011).

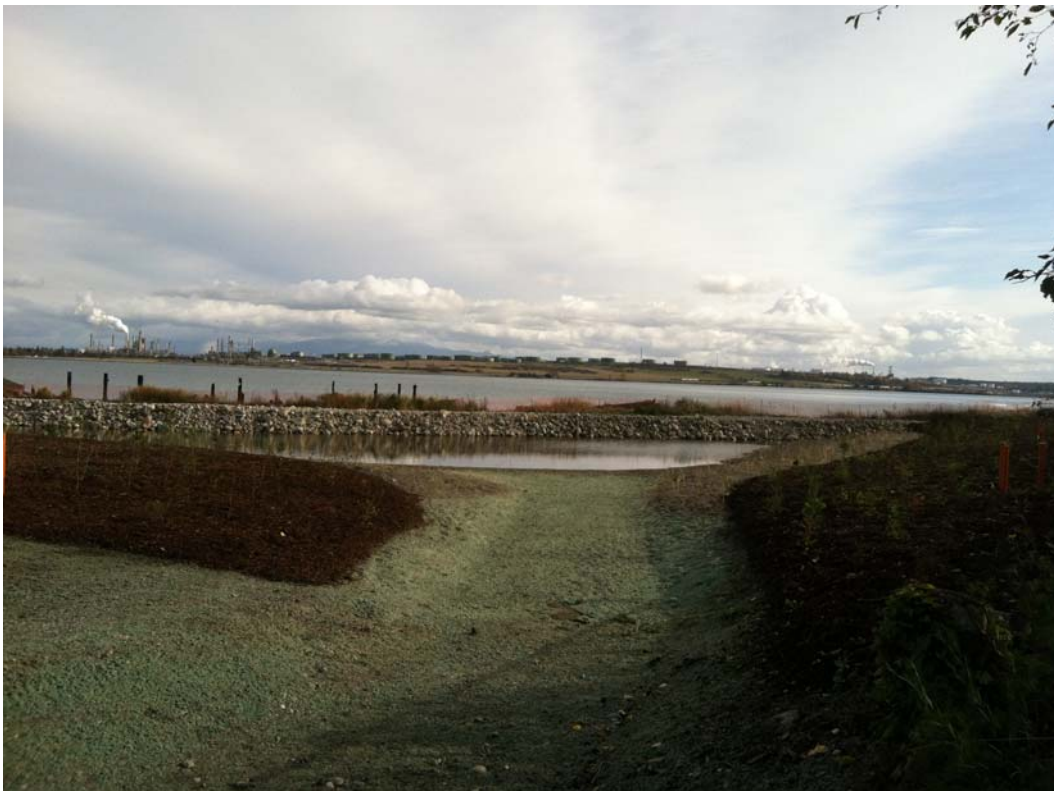
Photograph 32 – Completed stormwater swale conveyance into wetland mitigation area (November 14, 2011).

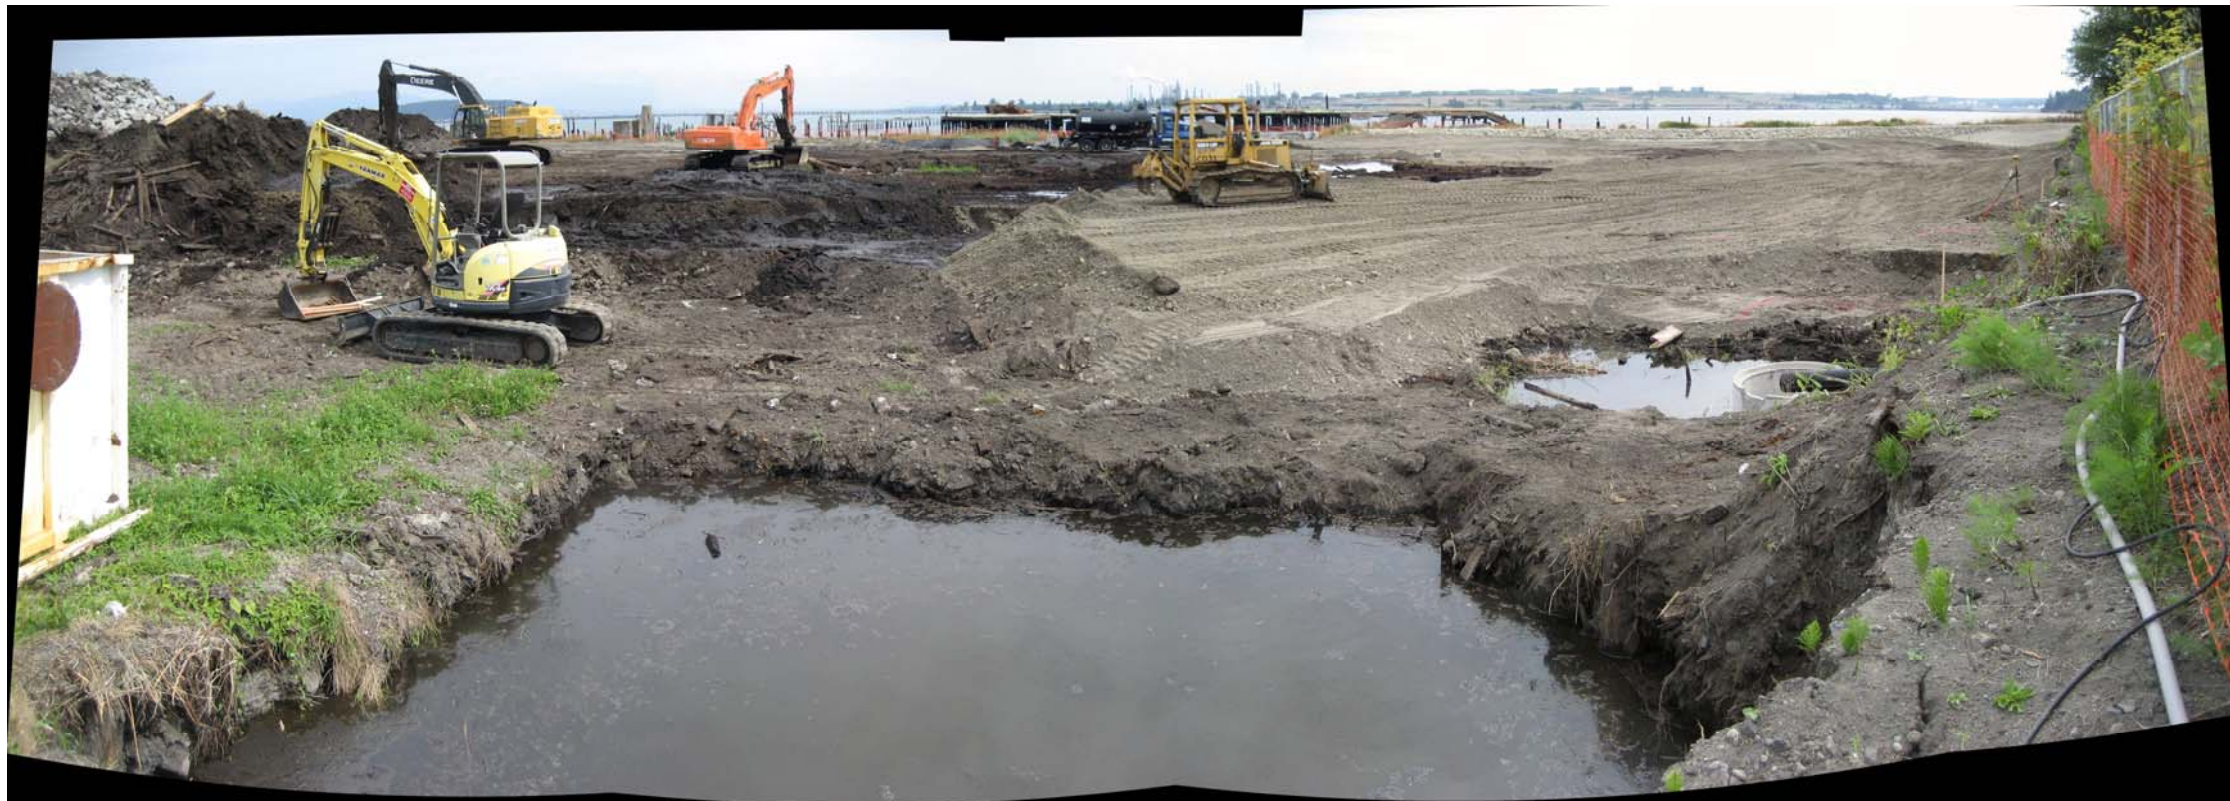
Photograph 44 – Progress of backfilling and grading northward from wetland mitigation and buffer areas. Note temporary sump and discharge line at City of Anacortes outfall discharge point on right (September 1, 2011).

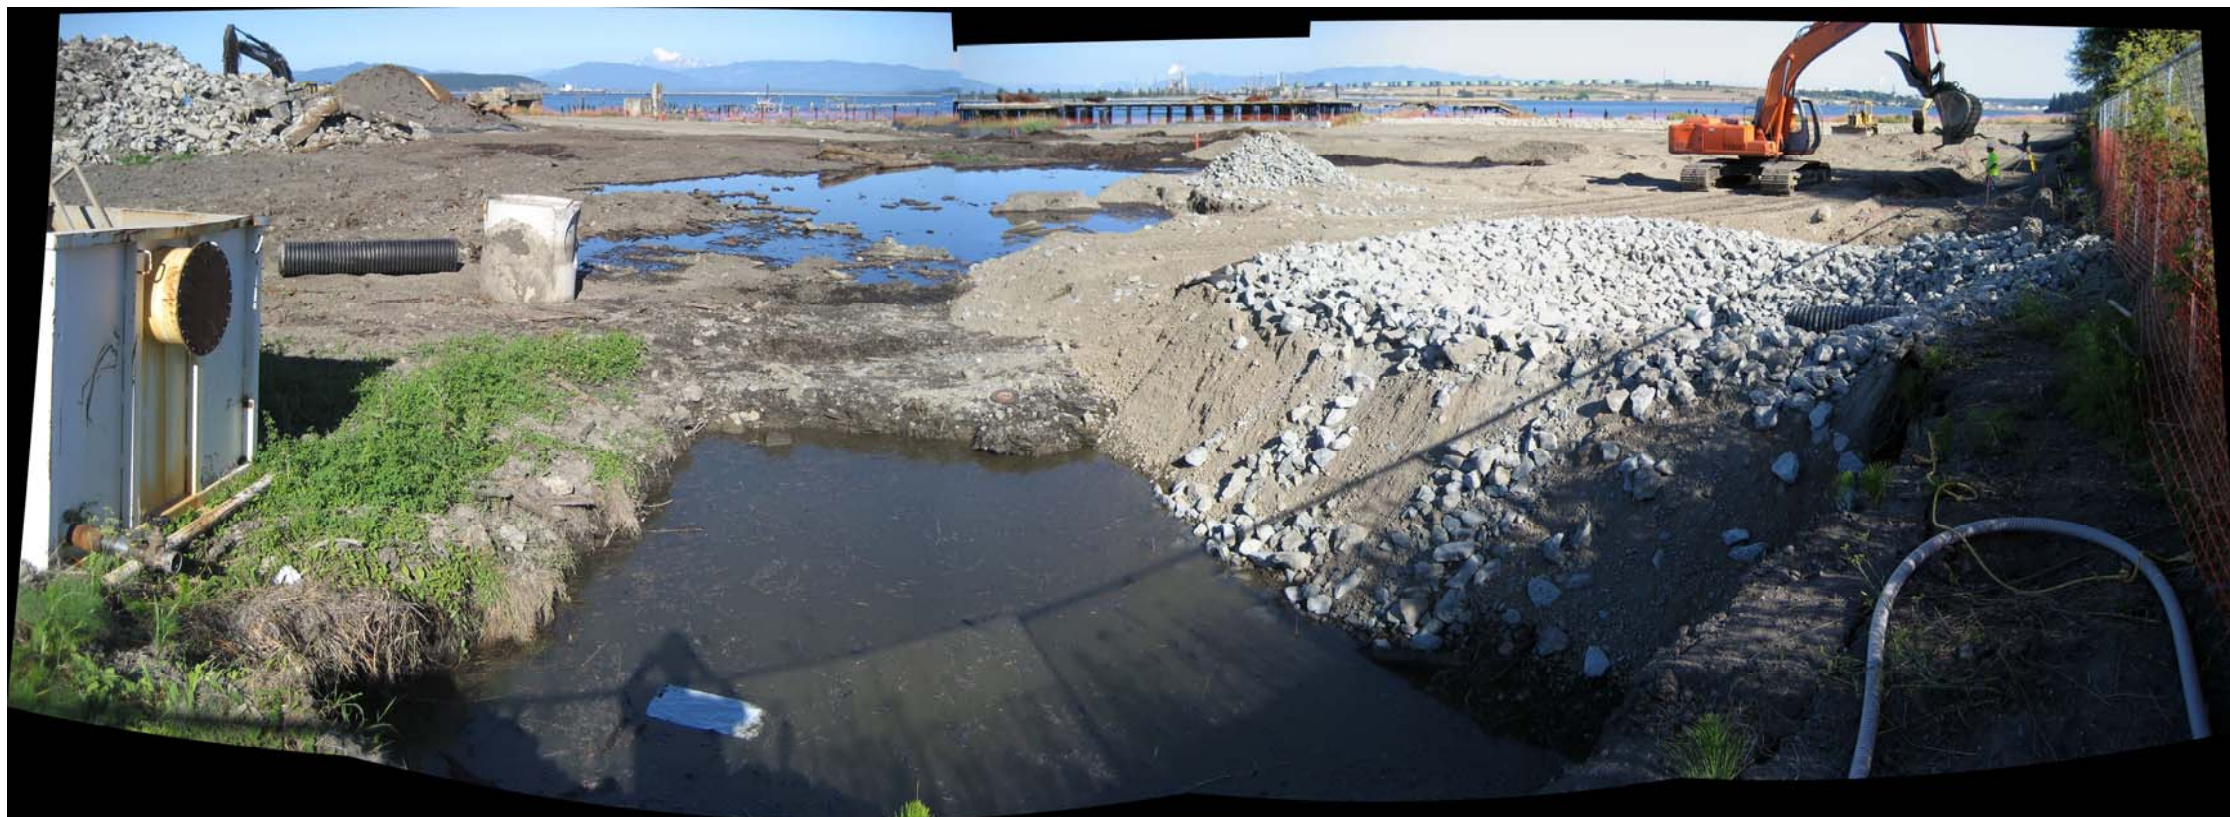
Photograph 45 – Former temporary sump and discharge line at City of Anacortes outfall discharge point replaced with quarry spall lined stormwater swale receiving basin (September 6, 2011).

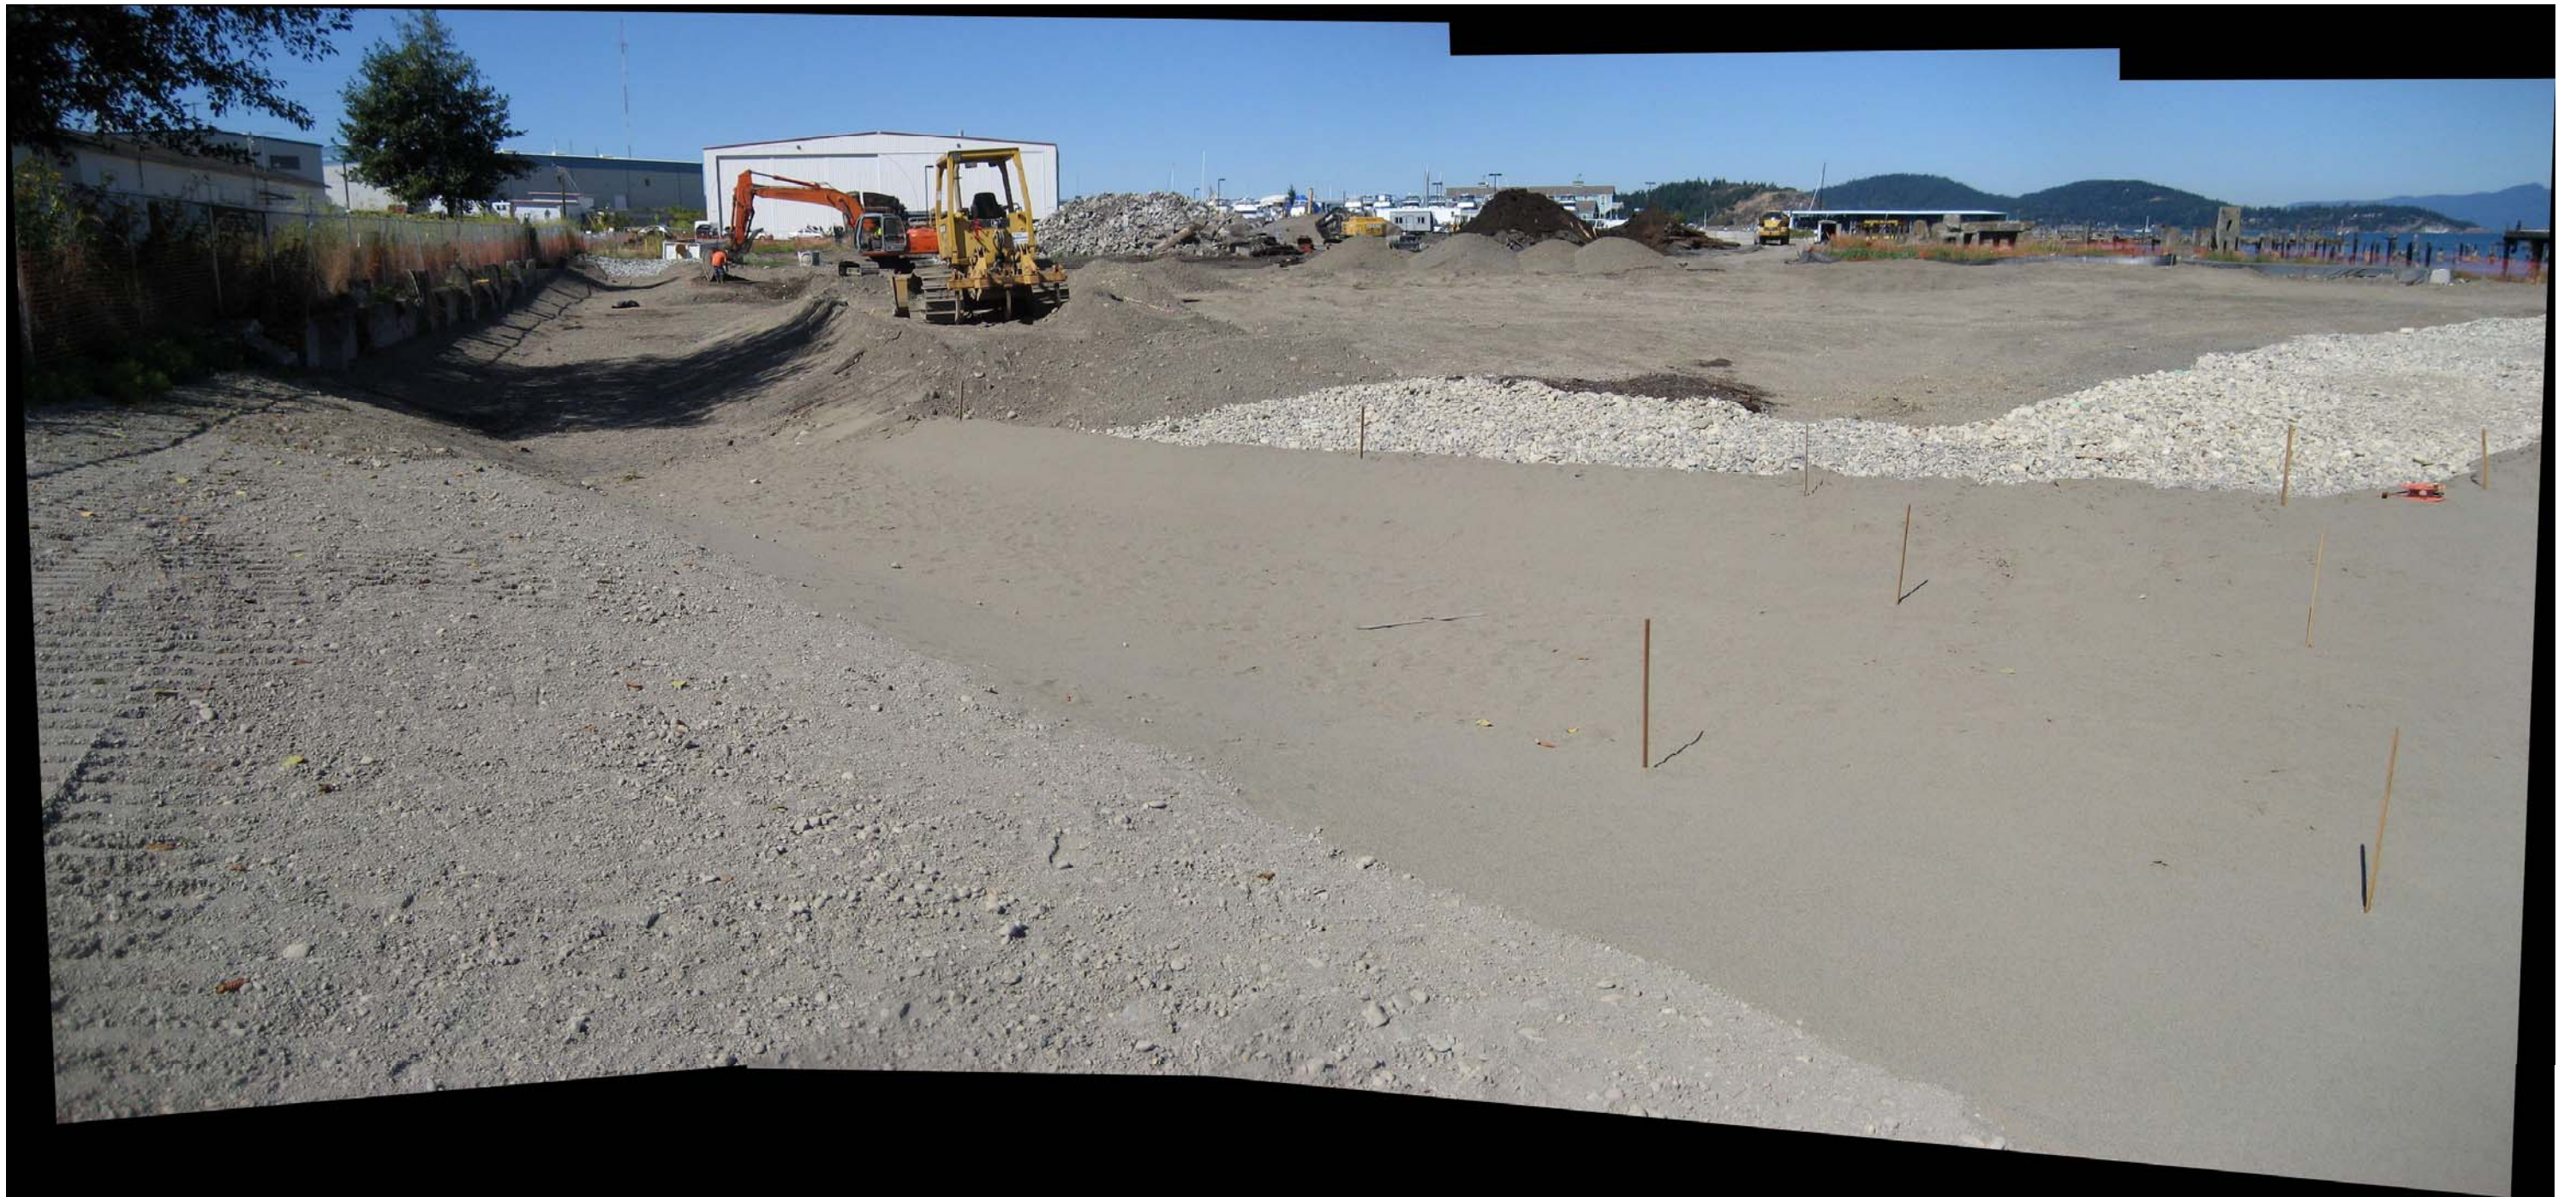
Photograph 46 – Construction of stormwater swale conveyance channel into wetland mitigation area (September 7, 2011).

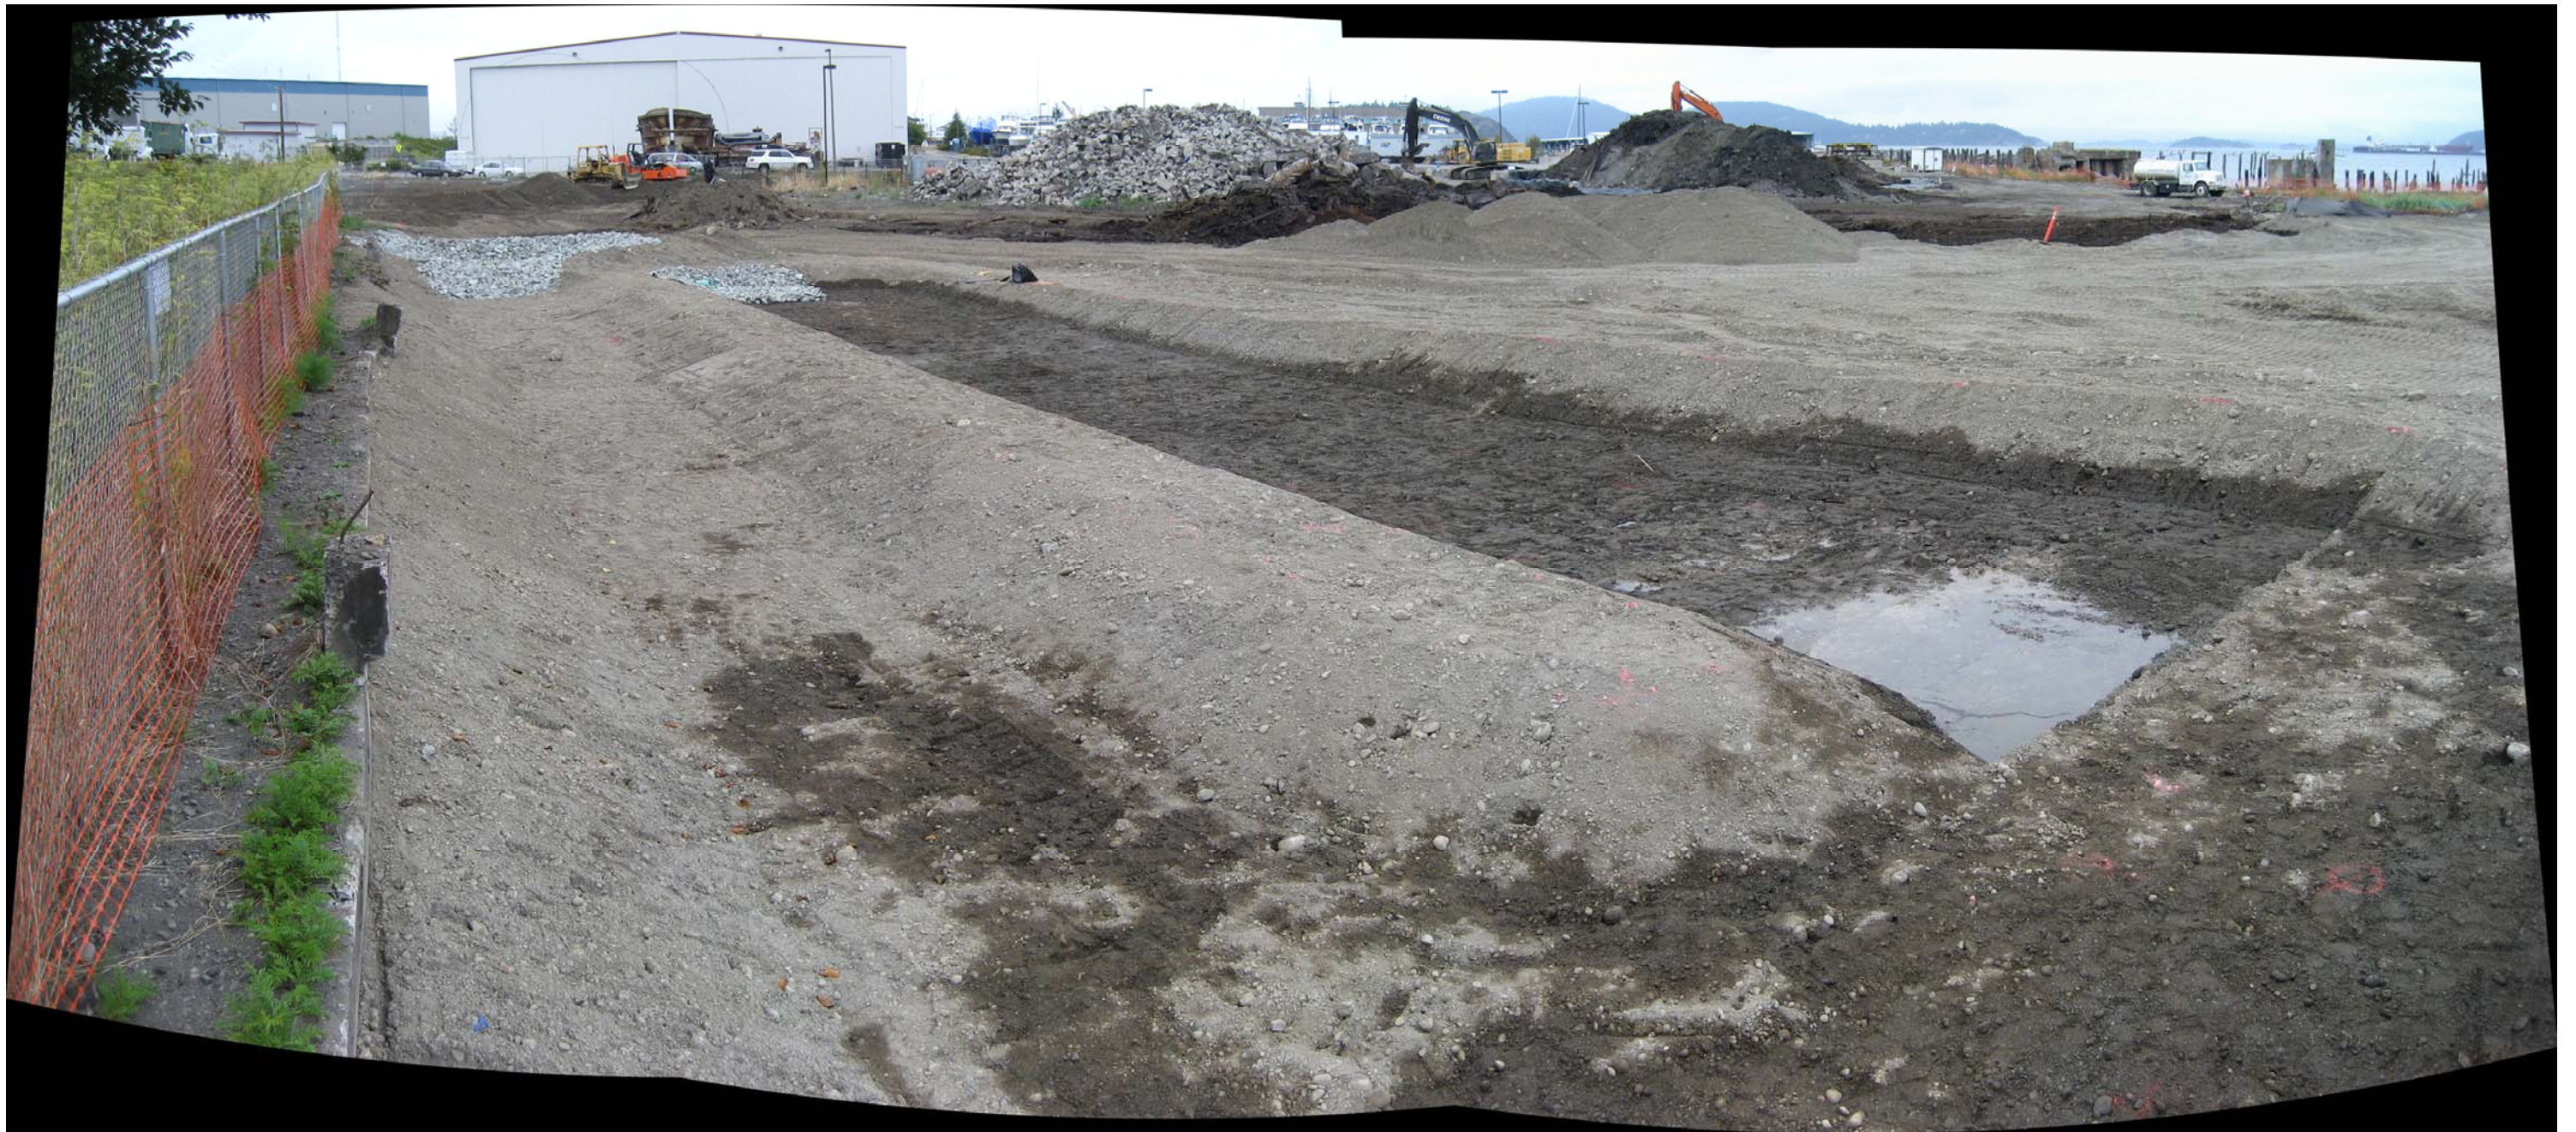
Photograph 47 – Stormwater swale overflow bypass channel shown on the left. Treatment swale footprint before topsoil and compost placement shown on the right. Note stormwater receiving basin visible in the background (September 15, 2011).

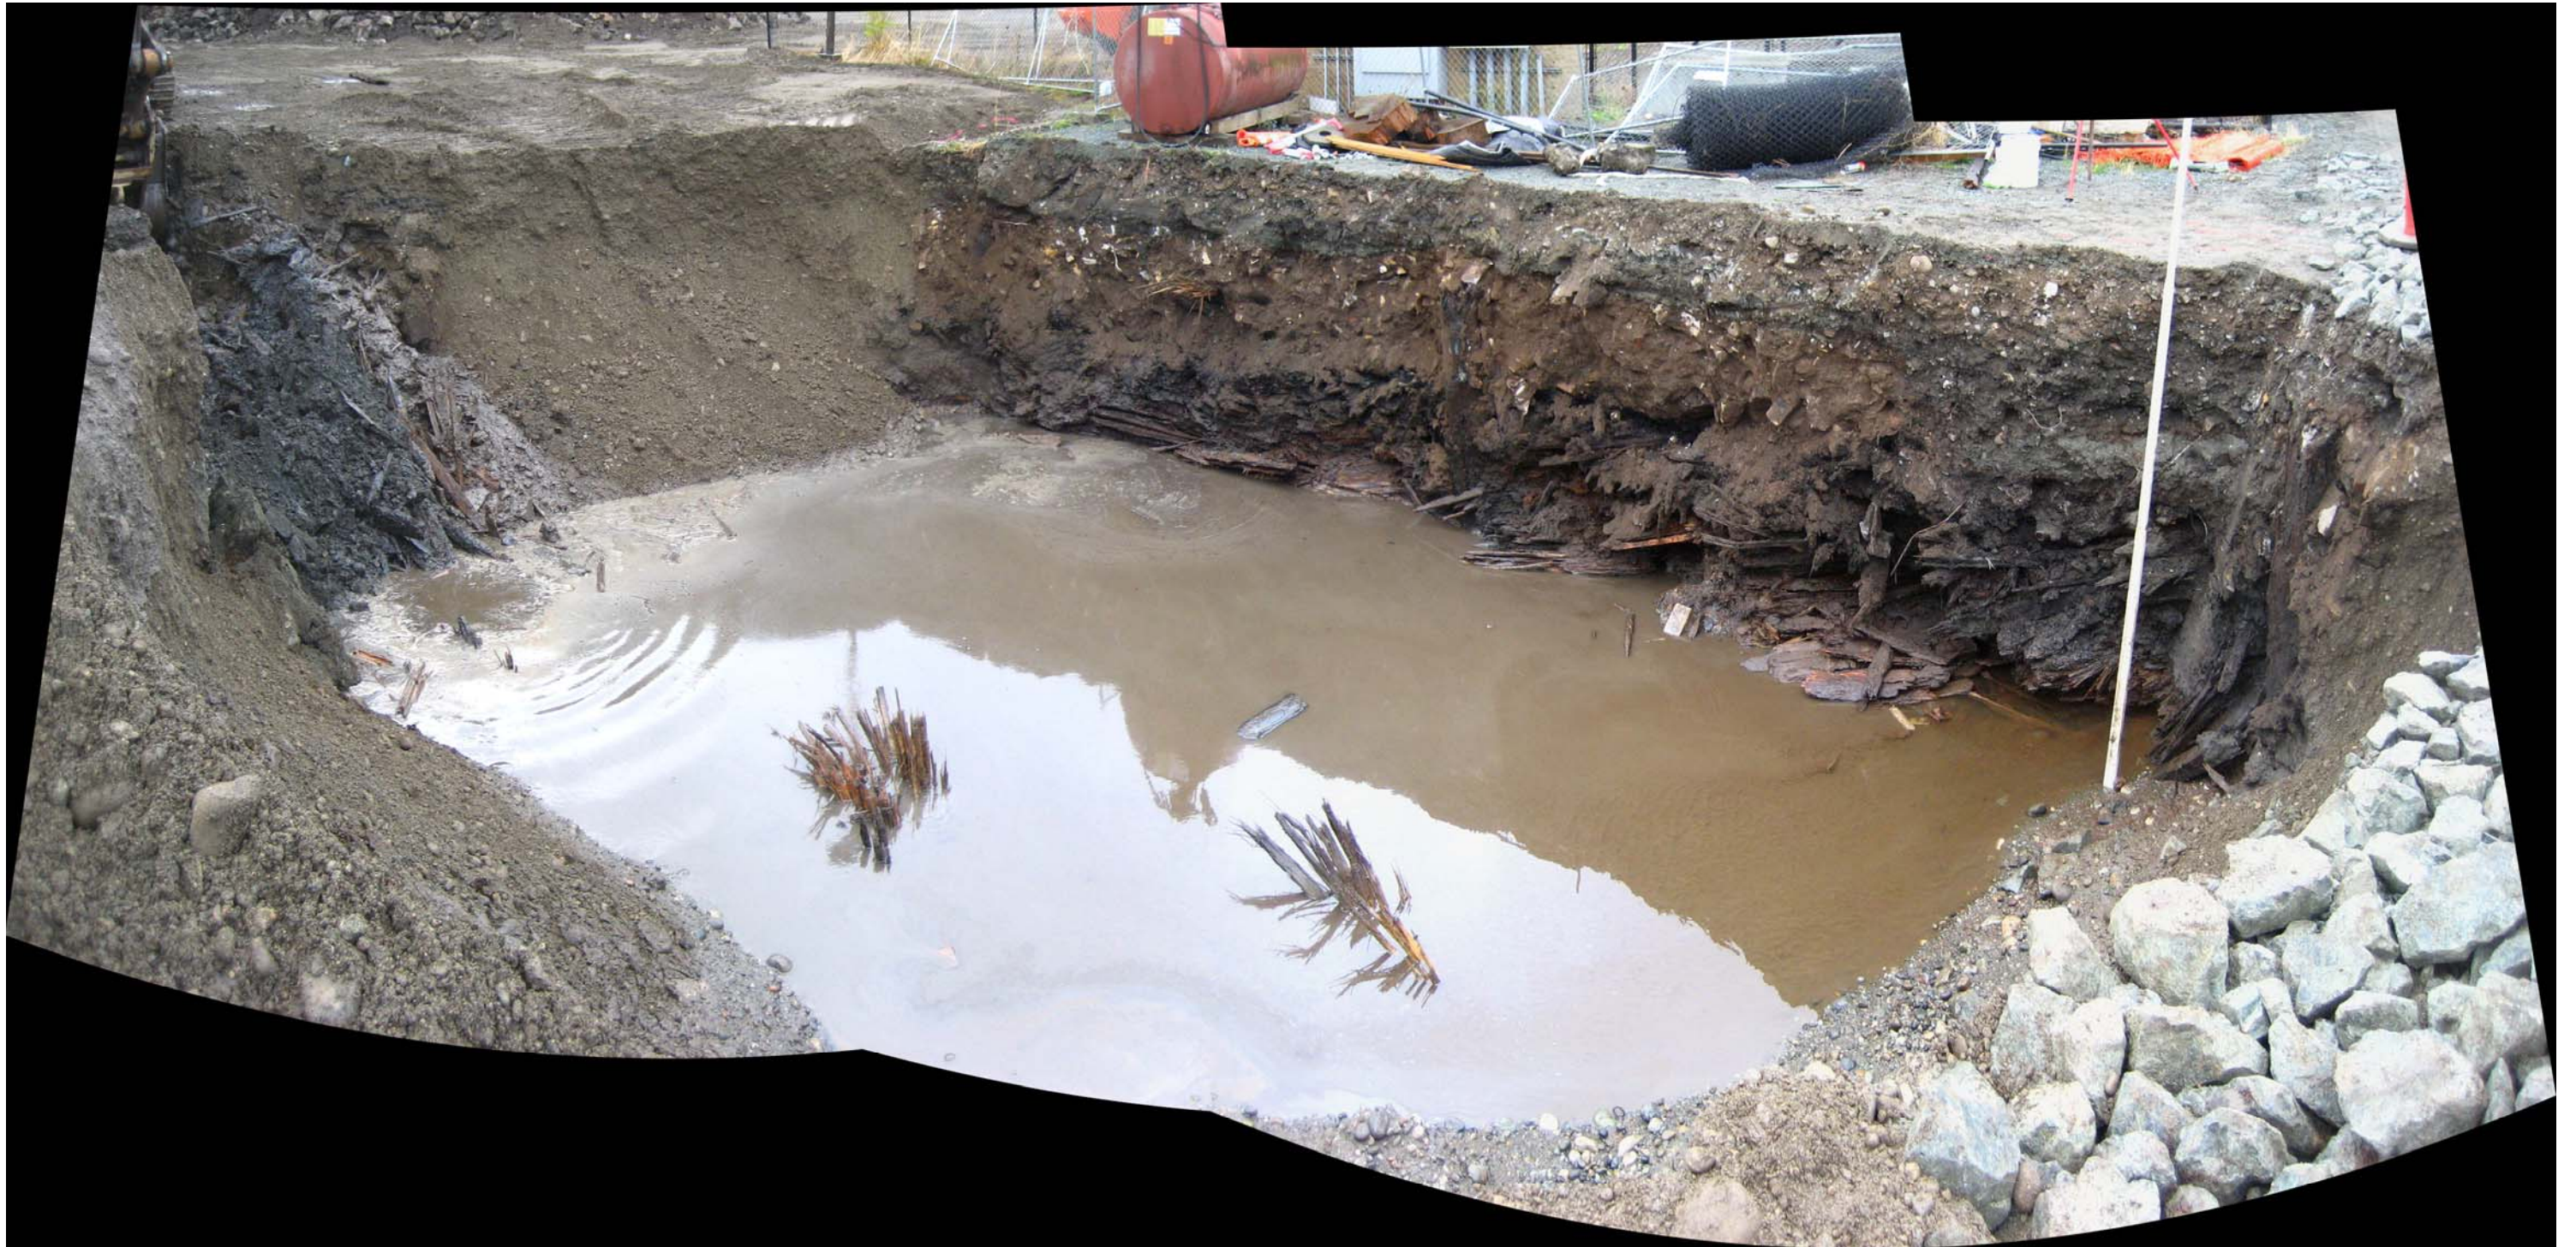
Photograph 48 – Example of stratigraphy observed during excavation. Note ponded groundwater and splintered piling remnants in excavation floor (GMX-S16 cell D and GMX-S43 cell J excavation areas, October 11, 2011).

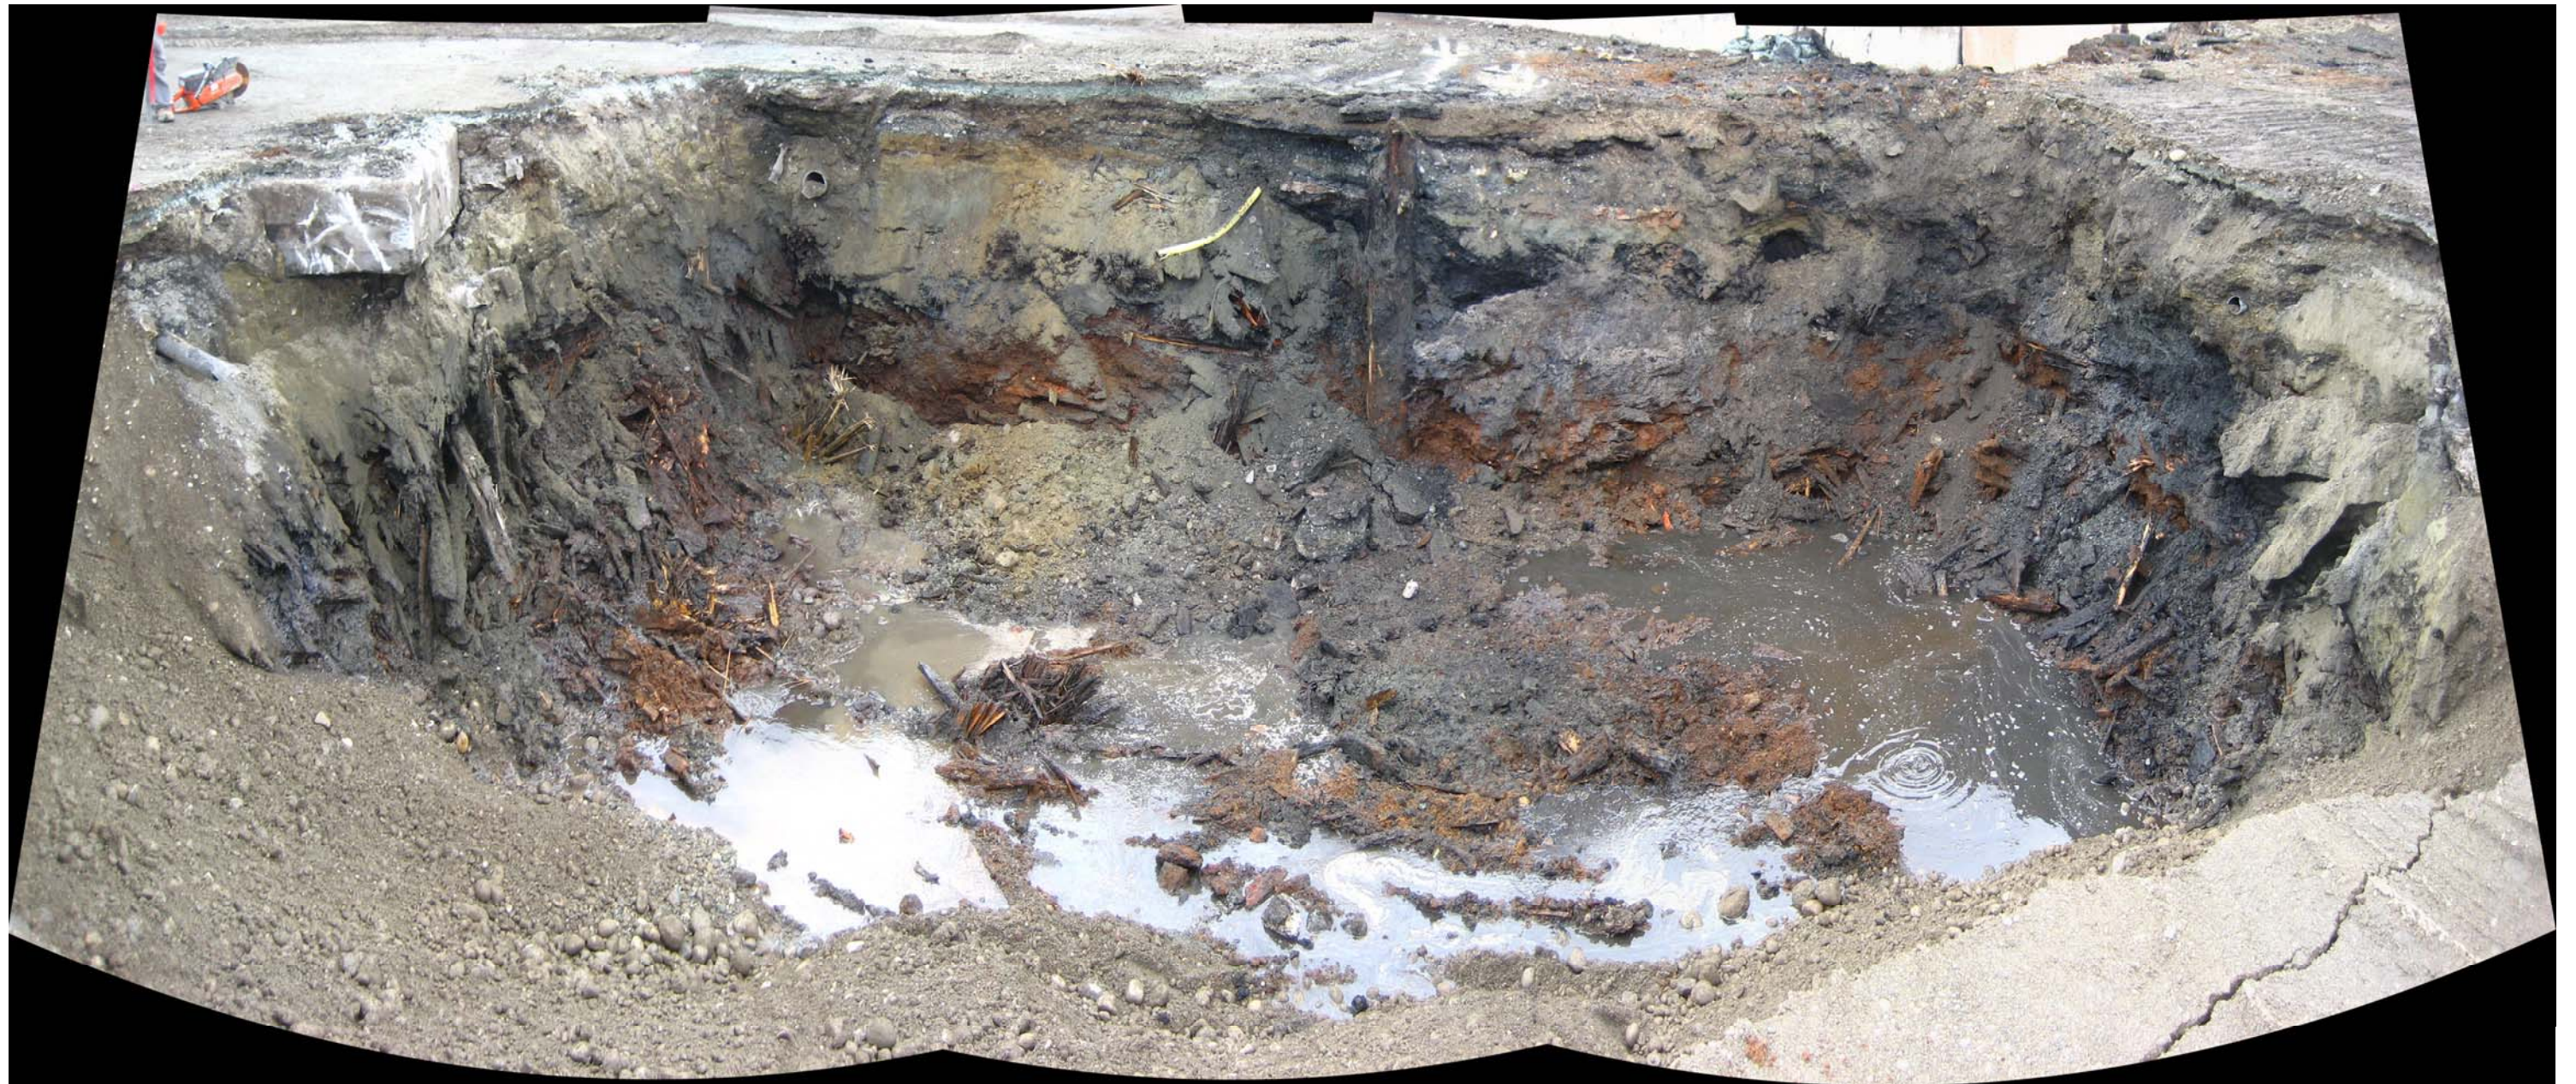
Photograph 49 – Example of stratigraphy and heterogeneity encountered during excavation (GMX-S43 cell K excavation area, October 11, 2011).
