## TECHNICAL MEMORANDUM

To: Mr. Joe Hunt, LHG  
From: Craig Hultgren, LHG  
Date: July 15, 2024  
Site: JJ Wood Energy – 90 Tenant Way, Longview, Washington  
VCP#: SW1648  
Subject: Remedial Excavations

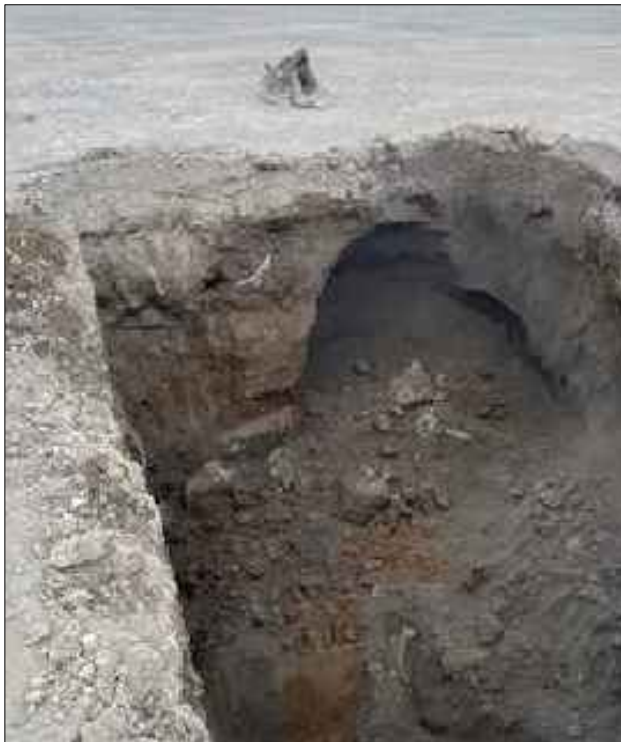
PHOTO 2  
Excavation near MW07 - contact of original soil vs. dredge sand fill from 2014 remedial excavation.

The gray dredge sand backfill soil used in the original remedial excavation was observed in both excavations. The excavation near MW07 removed approximately 6 feet of soil before the dredge sand was encountered. All of that soil was sent to the landfill. The excavation near sample EX-NCW-8.5' location had dredge sand present along the southwest sidewall and floor.

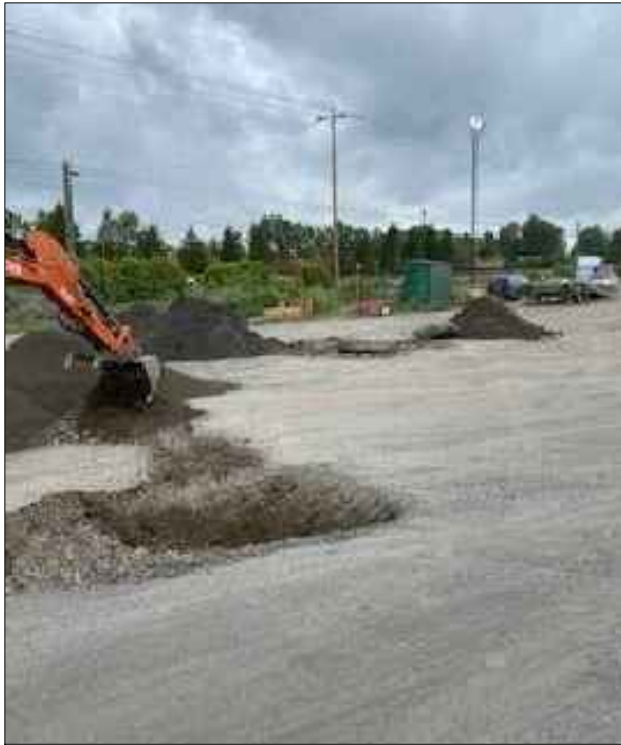
PHOTO 3  
2 remedial excavations.

The first excavation began immediately southeast of monitoring well MW07 and was advanced towards the original remedial excavation performed in 2014. The purpose of this excavation was to remove any remaining PCS that was left in place during the previous excavation. This excavation measured 15 feet wide by 12 feet long by 9 feet deep.

The second excavation was performed near sample EX-NCW-8.5' and was advanced approximately 10 feet north. The location of both excavations is shown on Figure 3. Groundwater was encountered in both excavations at a depth of approximately 8 feet bgs. Each excavation was advanced approximately 1 foot below the water table. Confirmation soil samples were collected from both excavations.

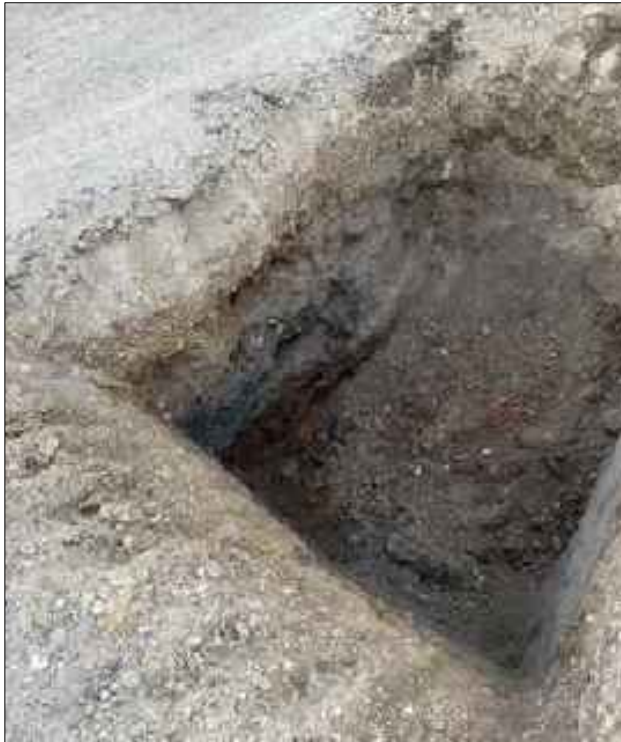
PHOTO 4  
Abundant bark and wood debris at 5' bgs in  
Excavation 2.

**DRPH** – One sample (EXC2-5 which had abundant bark and wood debris) had a detection of DRPH above the MRL at a concentration of 57.8 mg/kg. This concentration is below the CUL of 2,000 mg/kg. This soil was removed during the excavation process.

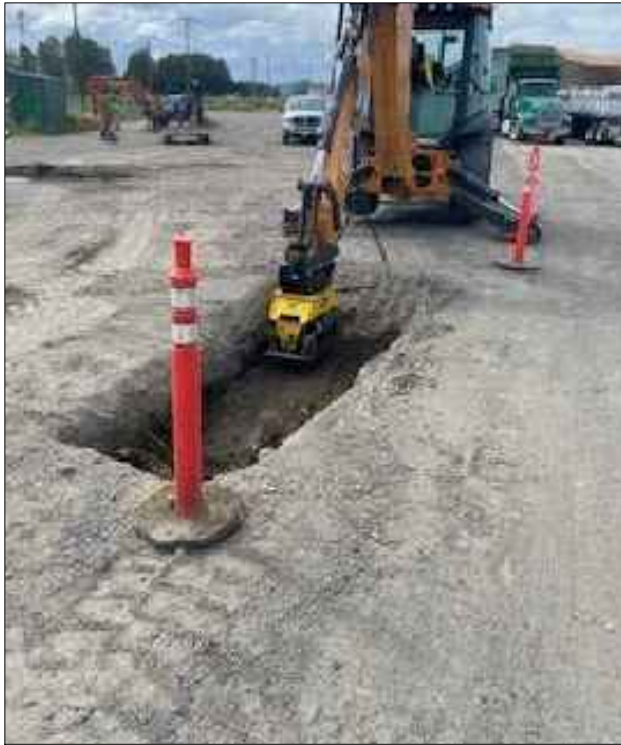
PHOTO 5  
Backfill and Compaction.

At the conclusion of sampling, each excavation was backfilled using clean imported granular fill and clean overburden stockpiled at the site. The backfill was compacted in 2-foot lifts using a plate compactor attachment. Approximately 2-feet of  $\frac{3}{4}$ -inch minus gravel was placed on the ground surface and compacted to match existing conditions.

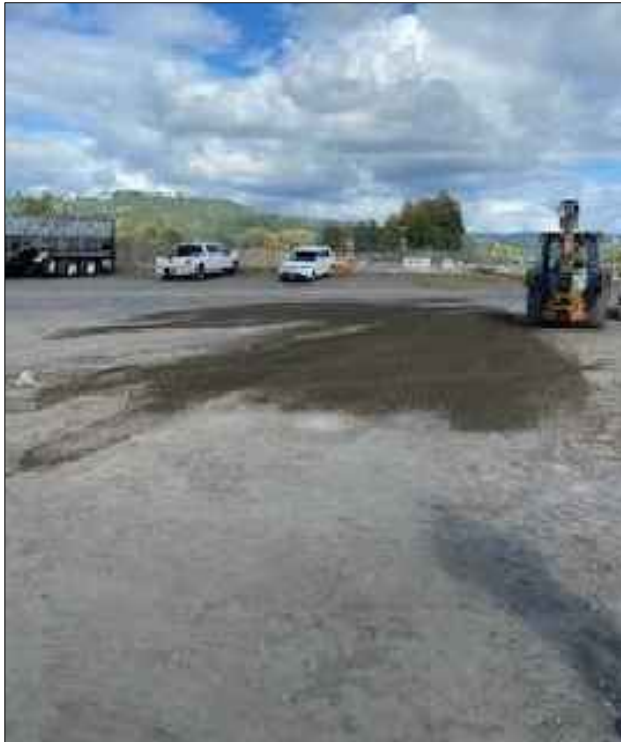
PHOTO 6  
Final surface restoration.
