**Draft**  
**Project Startup Summary Report**  
**Bellevue Airfield Park Development**  
**(Former Eastgate Landfill)**  
**Bellevue, Washington**

October 19, 2015

Walker Macy  
Portland, Oregon

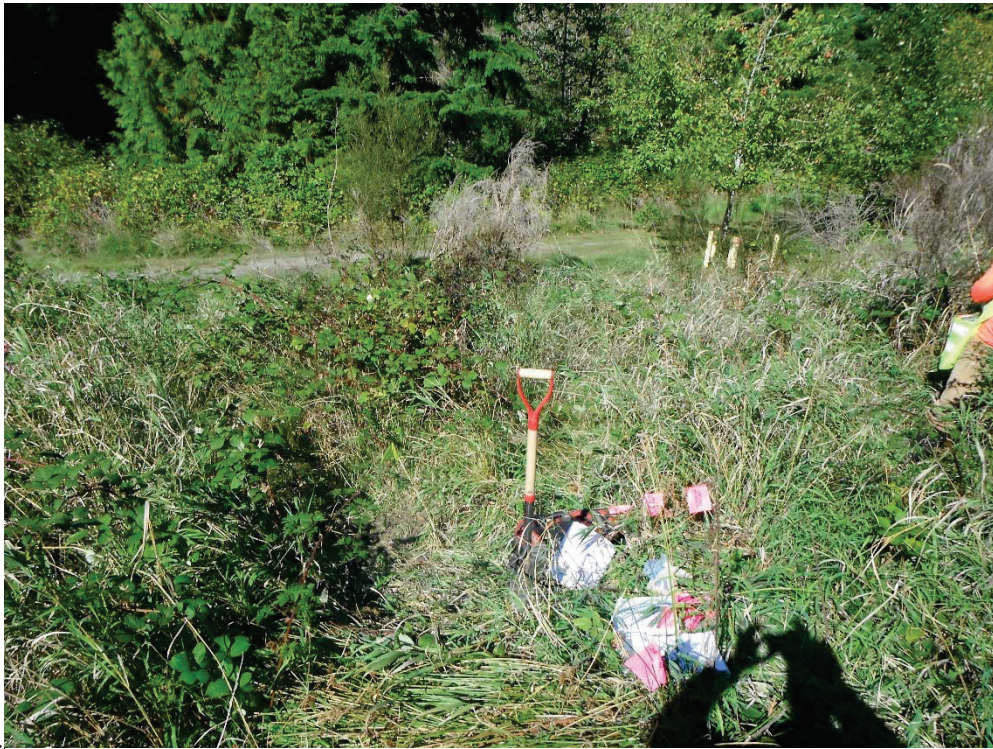
1. Sampling Point SP-A.

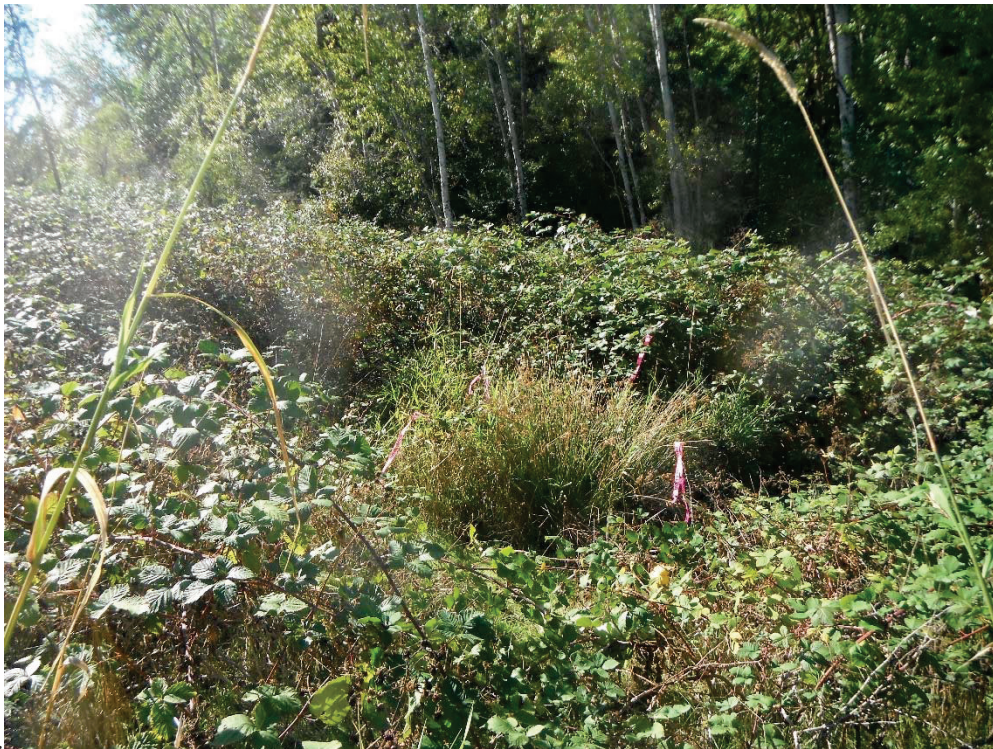
2. Component of Wetland A dominated by soft rush.

Additional species found in Wetland A/A1 include, but are not limited to, soft rush (*Juncus effusus*, FACW) and evergreen blackberry (*Rubus laciniatus*, FACU). Hydrophytic vegetation is considered present based on the prevalence index, as the wetland includes areas containing both reed canary grass and soft rush.

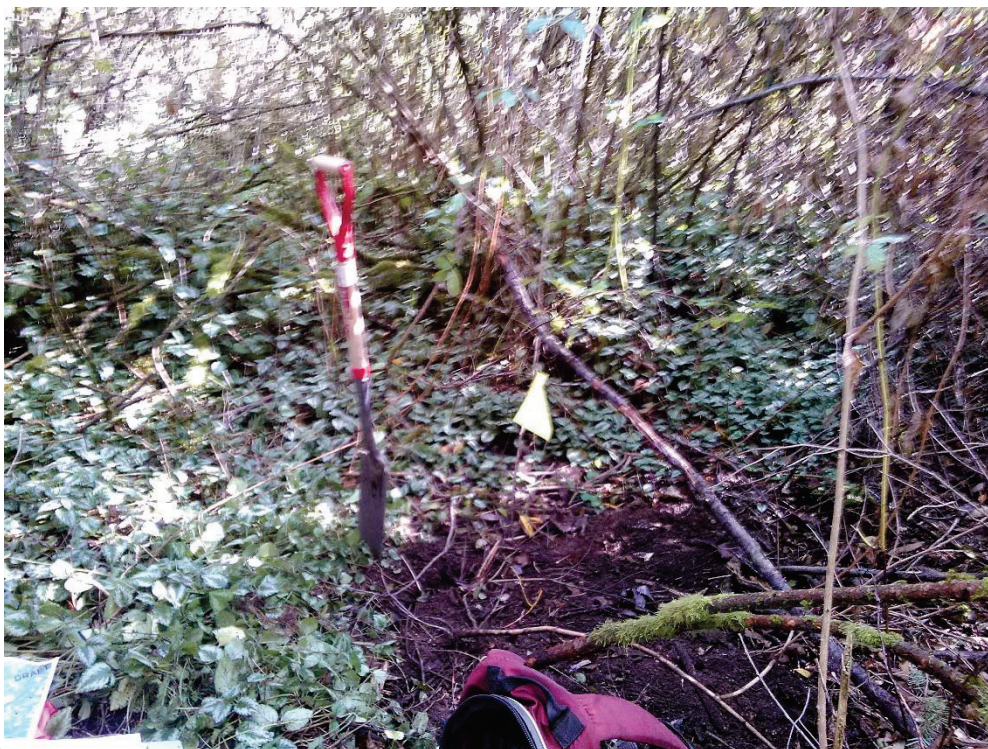
3. Sampling Point SP-01.

Areas upslope from Sampling Point SP-01 may contribute surface flow, but no hydrology indicators were observed. During the field investigation, the soil in Sampling Point SP-01 was dry. The soil from 0 to 4 ft BGS was a black fibrous sandy loam, underlain by a black (7.5YR 2.5/1) sandy loam with dark brown (7.5YR 3/4) and dark yellowish brown (10YR 3/6) features from 4 to 22 inches BGS. The features observed were hard nodules that appear to be relict features. Nodules and concretions that

Soil in the forested areas were generally similar to those seen in Sampling Point SP-01, but lacked nodules, and no hydrology indicators were observed.

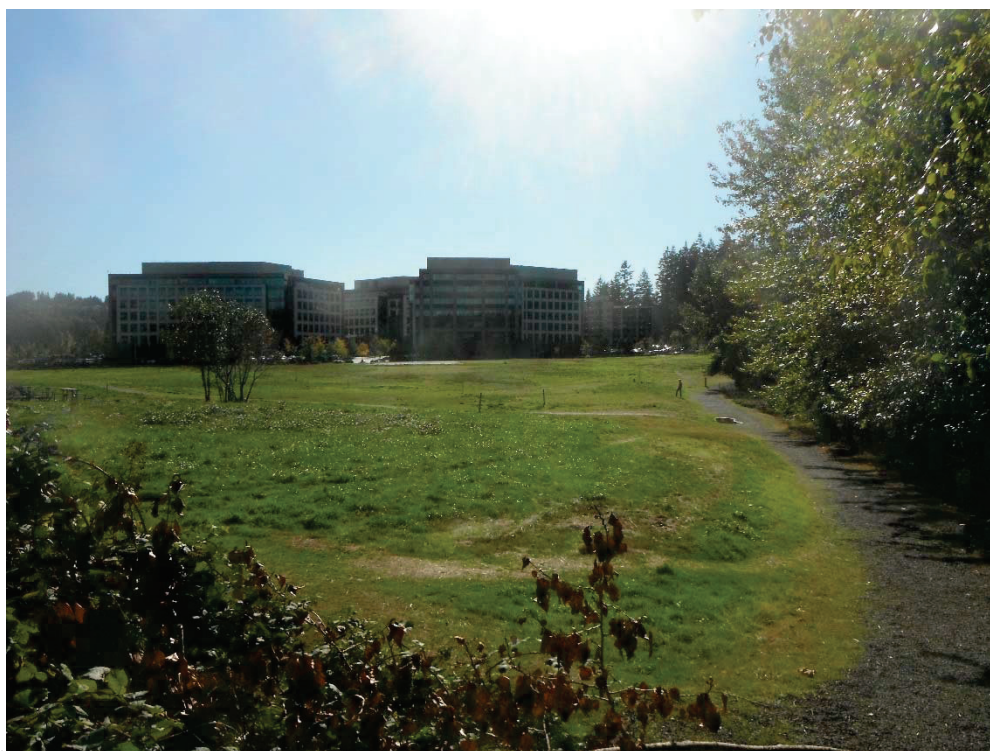
5. Former landfill area.

The former landfill area within the project area is dominated by unidentified grasses and herbaceous species. Grasses were unidentifiable at the time of the field investigation due to the lack of distinguishable features (as conditions were dry and the site is mowed); other herbaceous vegetation includes, but is not limited to, Queen Anne's lace (*Daucus carota*, FACU) and bird's-foot trefoil (*Lotus corniculatus*, FAC). A grass-lined swale was observed in this section of the study area, and vegetation in the swale was typical of the area.

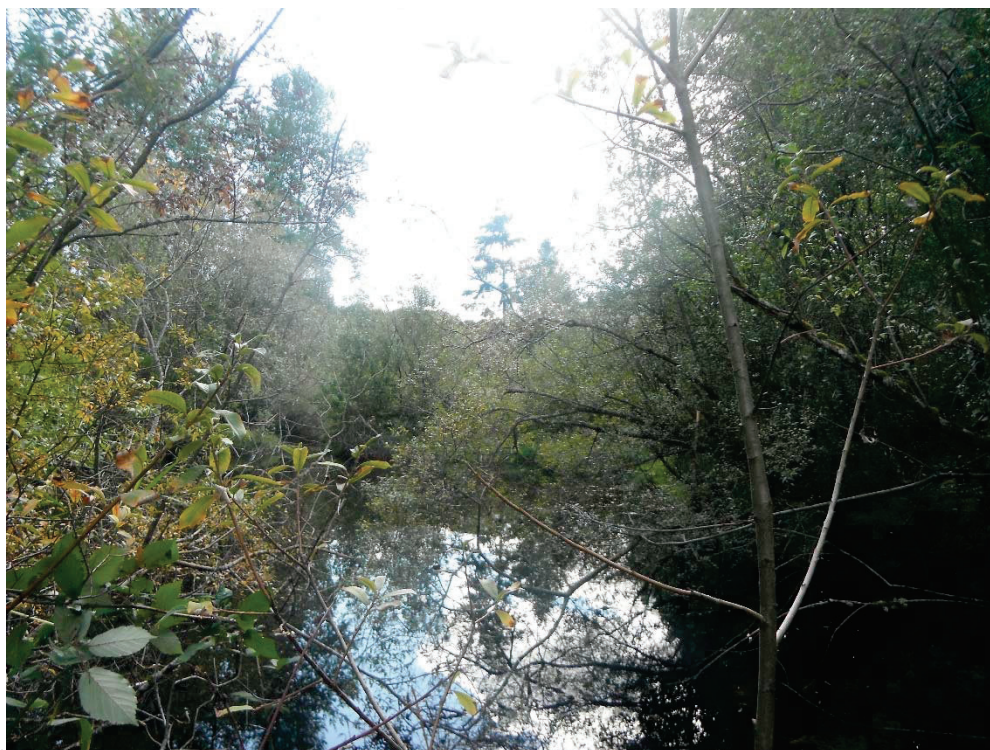
6. Stormwater detention pond.

A three-cell stormwater detention pond (Pond A) was observed within the north-central portion of the project area. Pond A is designed as a wet pond, and contained standing water in each cell at the time of the field investigation. Pond A was initially constructed in the early 1980s and was modified to a three-cell configuration in 1983 to improve its water quality treatment capability. Pond A is reportedly dredged every 5 to 10 years (city of Bellevue Staff personal communication 2015). Pond A is bordered by walking trails and drains via underground piping to Phantom Lake.
