Sediment Remedial Investigation Report

Ecology Site Name: BNSF Wishram Track Switching Facility
Ecology Facility/ Site ID: 1625461
Cleanup Site ID: 230

BNSF Railway Company
BNSF Wishram Railyard, Wishram, Washington

Wishram Sediment Remedial Investigation Report
June 10, 2024

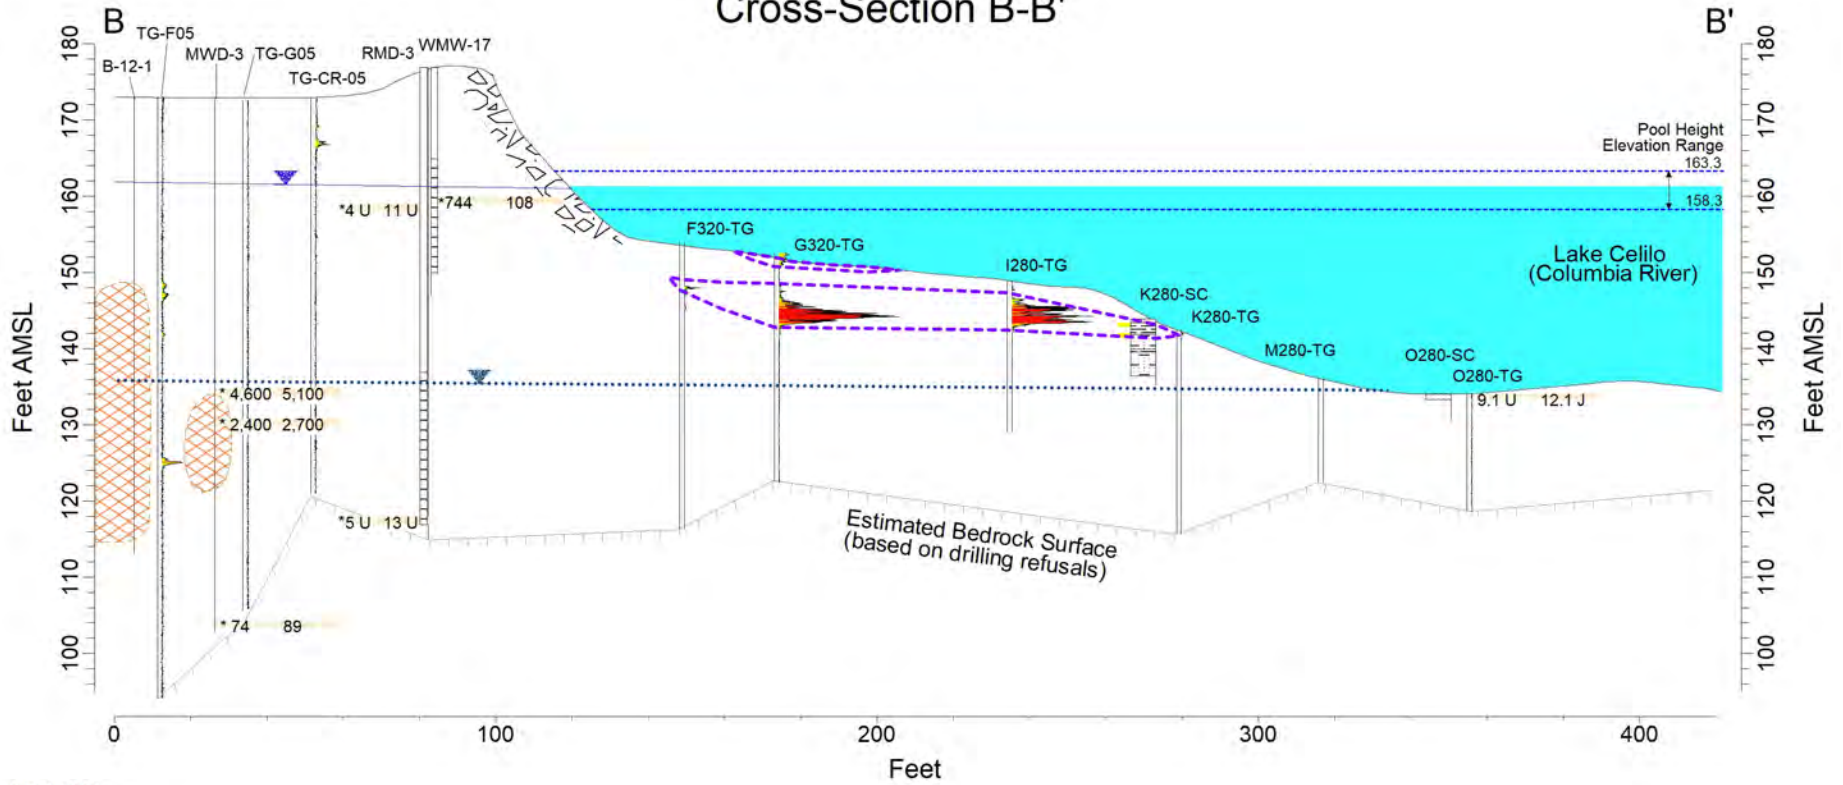
Cross-Section B-B'

- Approximate current water table
- Approximate pre-1957 water table
- Inferred Extent of NAPL based on Observations and TarGOST
- Inferred Upland Zone of Oil-like LNAPL from Upland RI
- Rip Rap

- ### Observed NAPL-Related Impacts
- Interval of heavy impacts (saturated or coated)
 - Interval with observed bleb(s)
 - Interval of sheen
 - Interval of odor or staining

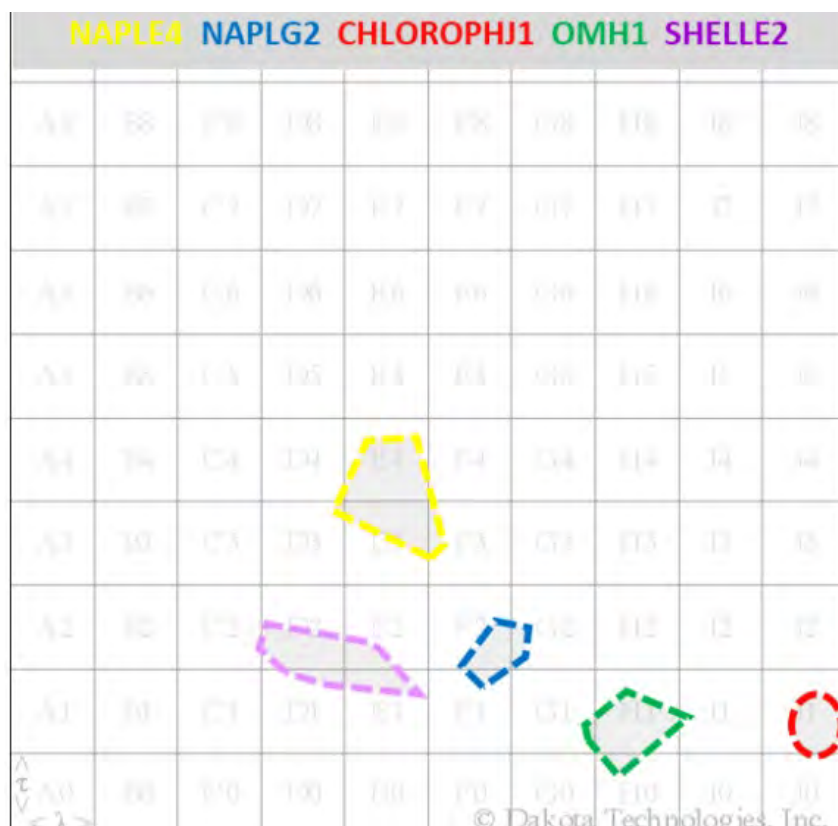
Cluster diagram of the Basis Set waveforms used in the NNLS processing

It should be noted that the NNLS process can result in low-level false-positive responses of any of the targeted waveforms. This is because the natural variability in the fluorescence associated with each of the materials cannot be accounted for in the basis set that is used to inform the NNLS categorization process. This requires determining a minimum threshold for NAPL-like signals if the resulting data set is to be used effectively assess NAPL extents. Locations and intervals where NAPL-like signals were observed are summarized in Table 3-7, and the signal associated with each location's peak response is included. Table 3-7 provides a point-by-point evaluation of the TarGOST profiling (both raw and NAPL-like TarGOST responses) and collocated confirmatory coring and relevant sampling results and includes key observations and notes. This evaluation indicates NAPL-like TarGOST responses of approximately 10 %RE and greater are indicative of NAPL-related impacts at the site. As summarized in Table 3-7 the data indicate NAPL was present at 18 TarGOST locations at various thicknesses ranging from 0.1 to 6 feet. The data also suggest that when NAPL-like TarGOST responses are closer to 10 %RE NAPL-related impacts may consist of concentrations of sorbed PAHs associated with NAPL or small discrete blebs of NAPL. Higher responses generally indicate NAPL saturated zones. The breakpoint between these two NAPL-related impact conditions cannot be established.

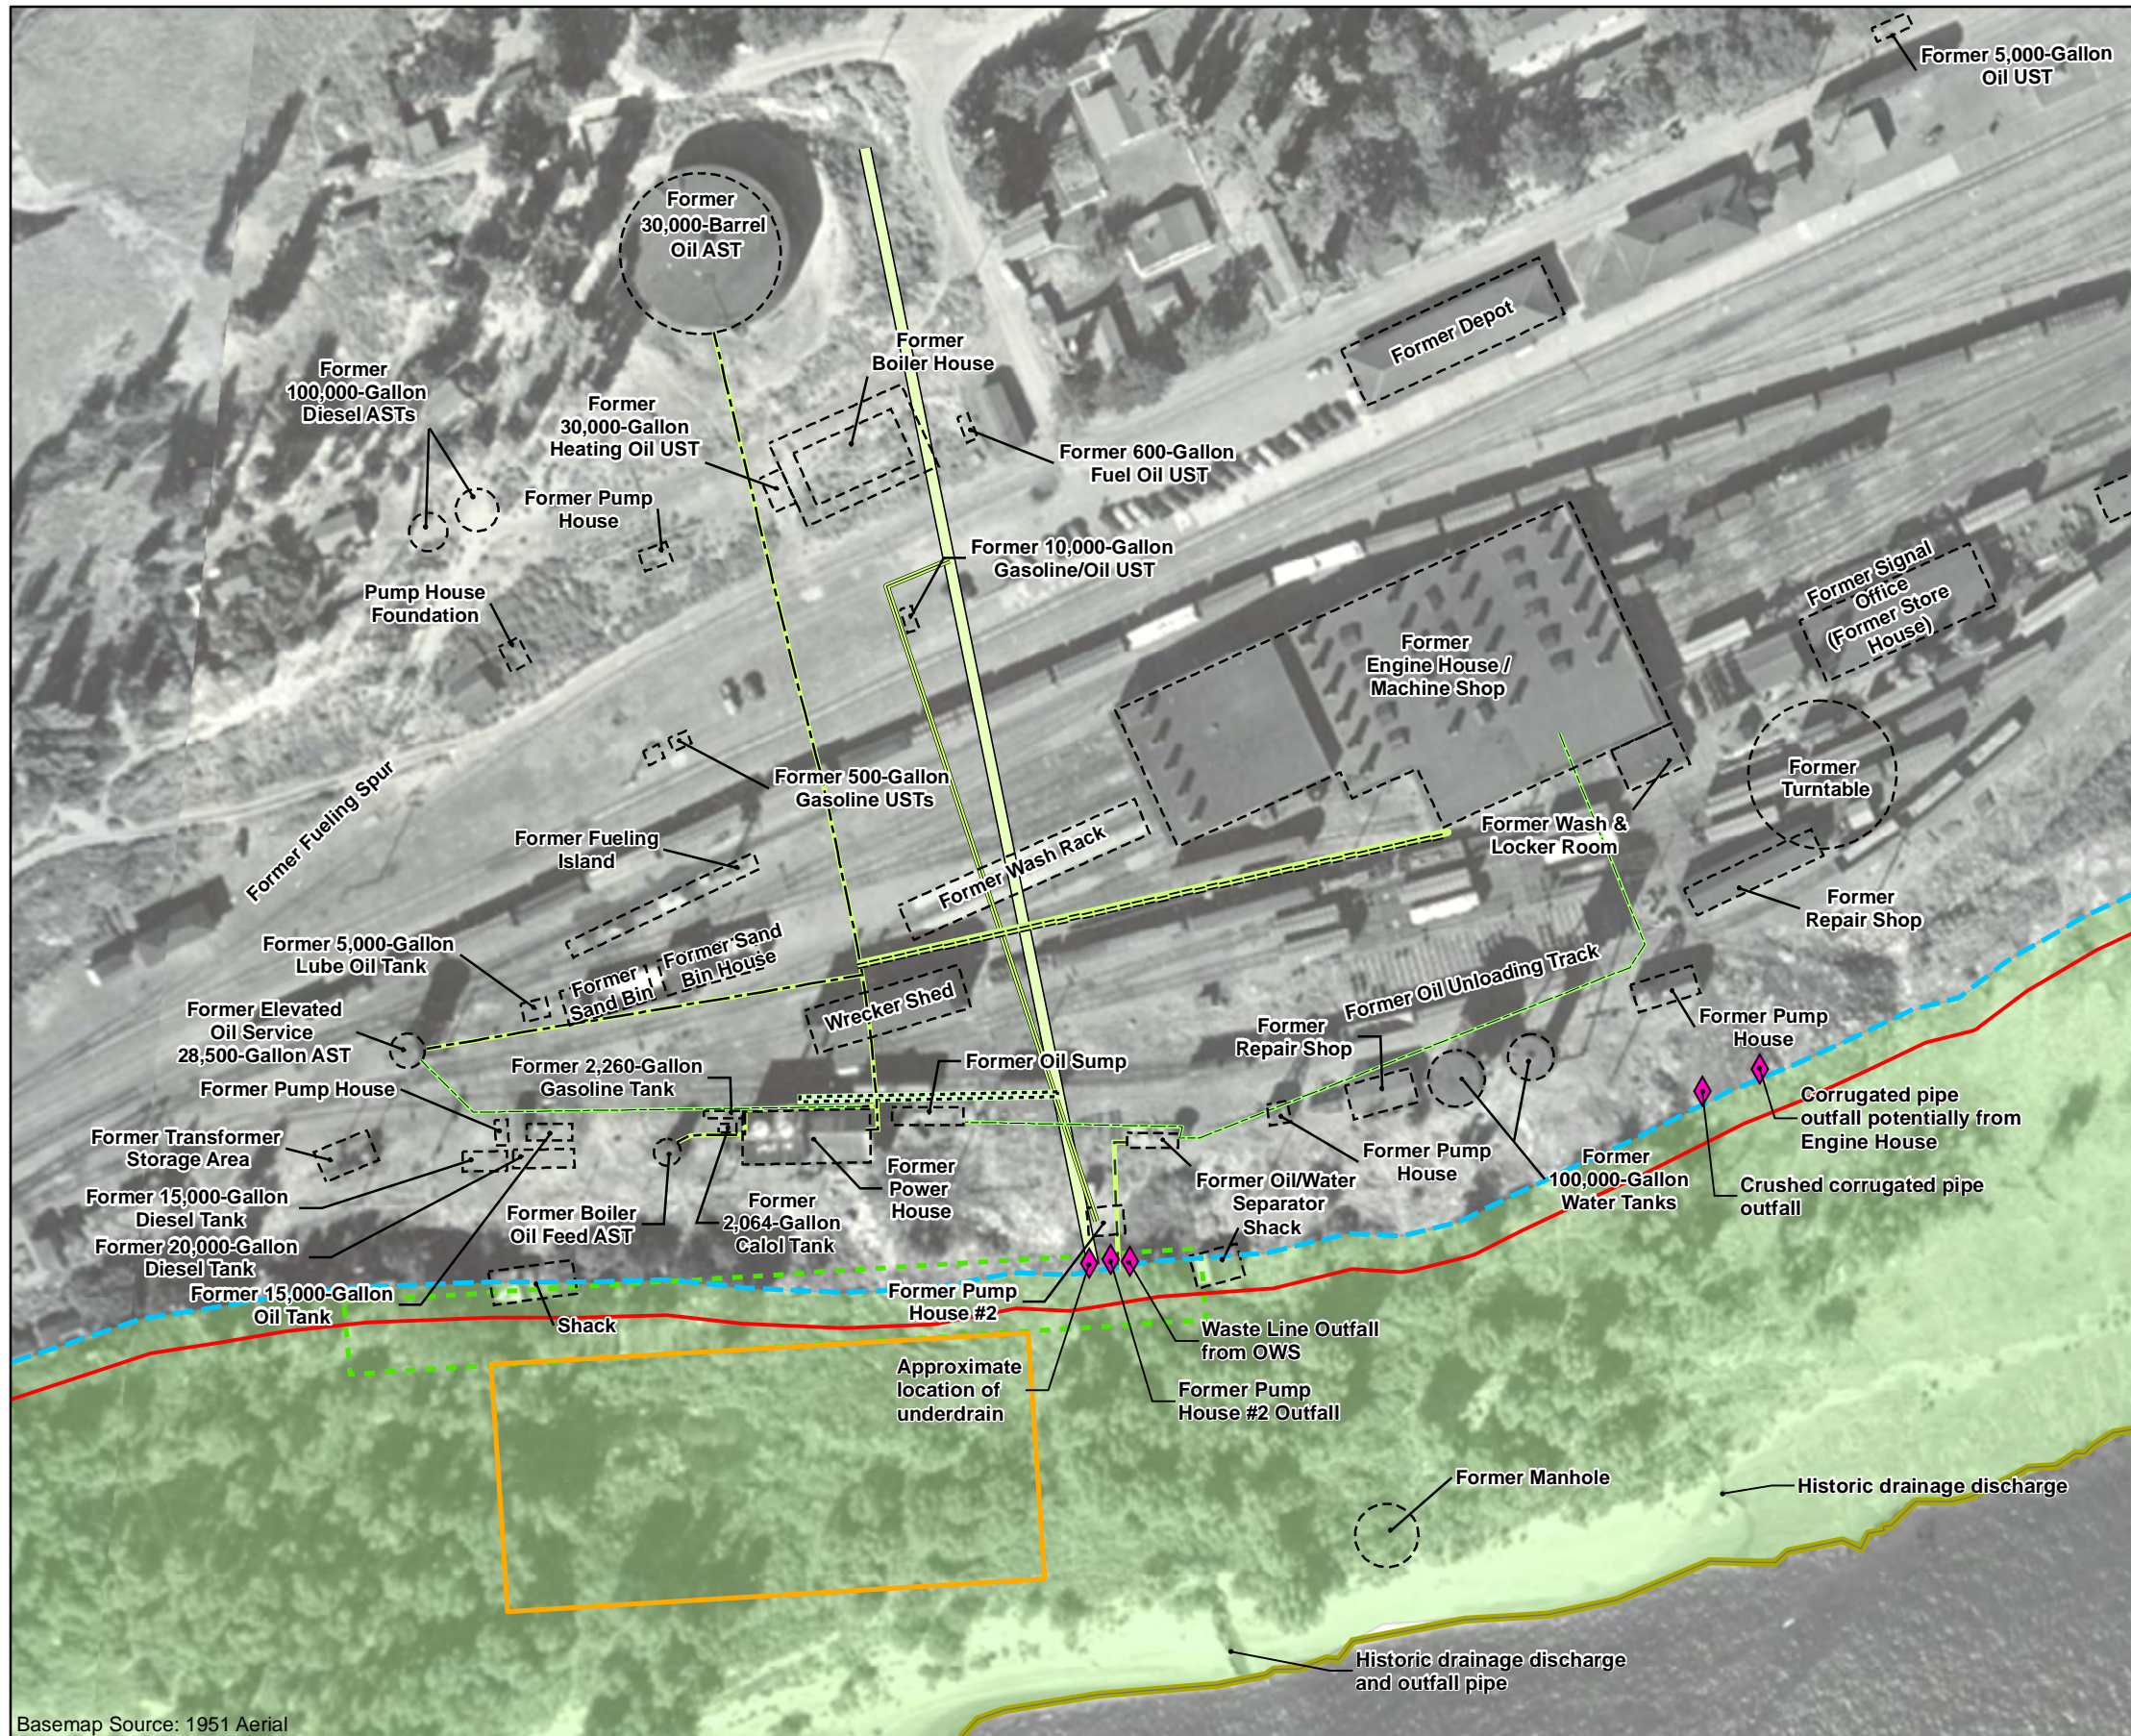
Figure 1-3. Current Site Features
BNSF Track Switching Facility
Wishram, Washington

- ◆ Former Outfall Location
- ▭ Remedial Investigation Area
- Current Shoreline
- Former Steam Line
- Former Bunker Fuel / Oil Pipeline
- Former Oil Drain
- Former Oil Trough
- Former Sewer Line (Potential)
- Stormwater Underdrain (A portion removed from service circa 1960)
- Stormwater Underdrain (Rerouted portion circa 1960)
- ▭ Former Site Feature
- ▭ WA Ecology Initial Investigation Area
- ▭ 2018 Initial Investigation Area
- Former Shoreline
- ▭ Inundated Lands

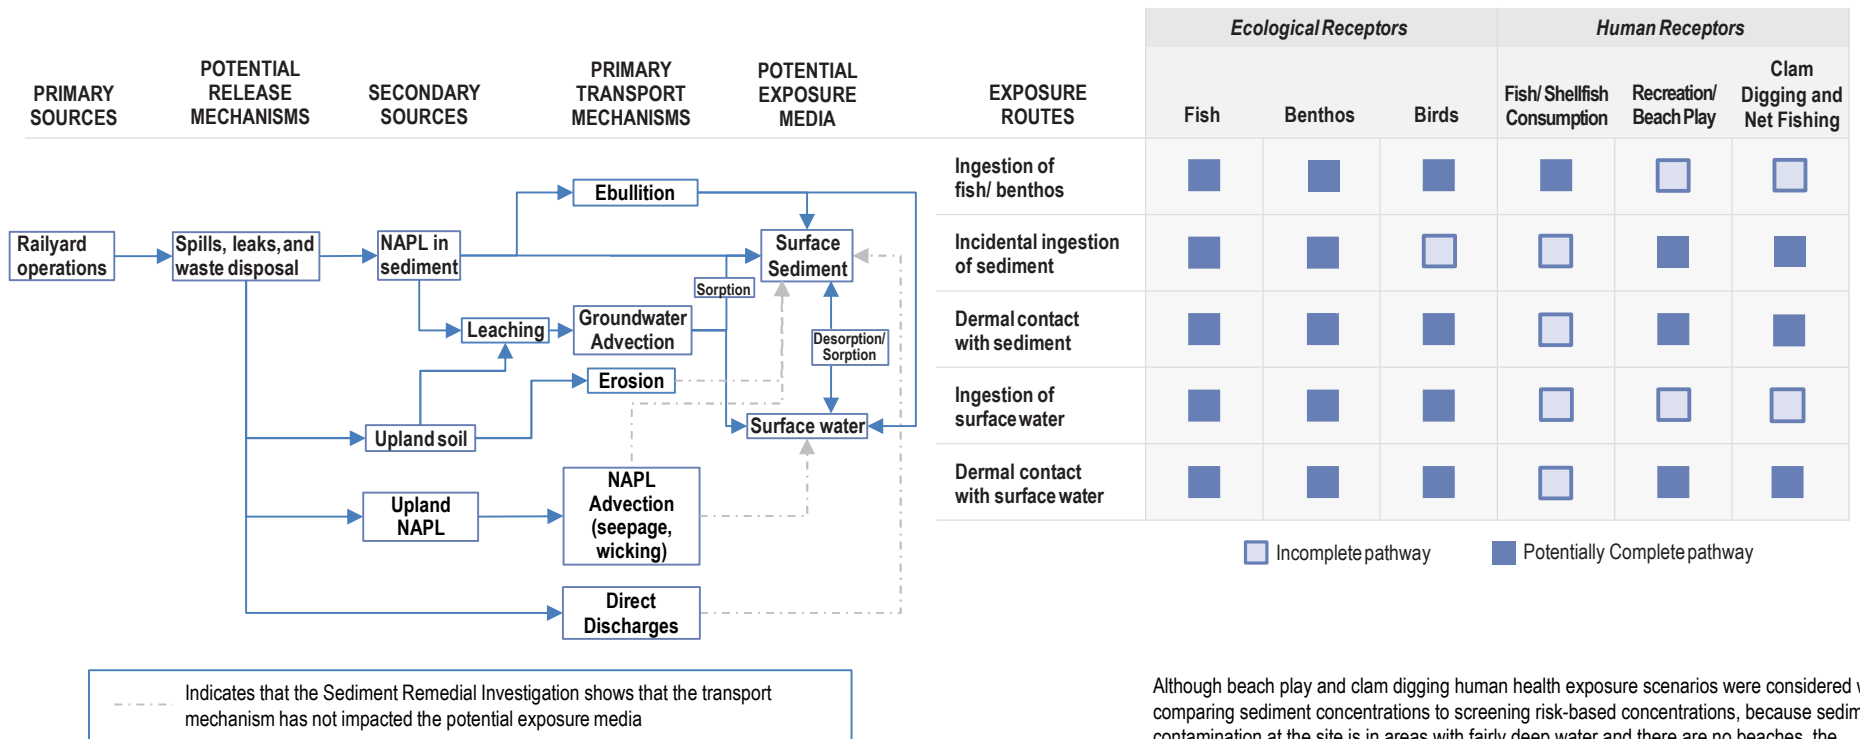
Figure 4-4. Conceptual Site Model for Sediment and Surface Water
 BNSF Track Switching Facility
 Wishram, Washington

Although beach play and clam digging human health exposure scenarios were considered when comparing sediment concentrations to screening risk-based concentrations, because sediment contamination at the site is in areas with fairly deep water and there are no beaches, the pathways are insignificant or incomplete.
