Draft Site Reconnaissance and Data Review Report

Raplee Property
Cleanup Site ID #5275

City of Stanwood

August 5, 2024

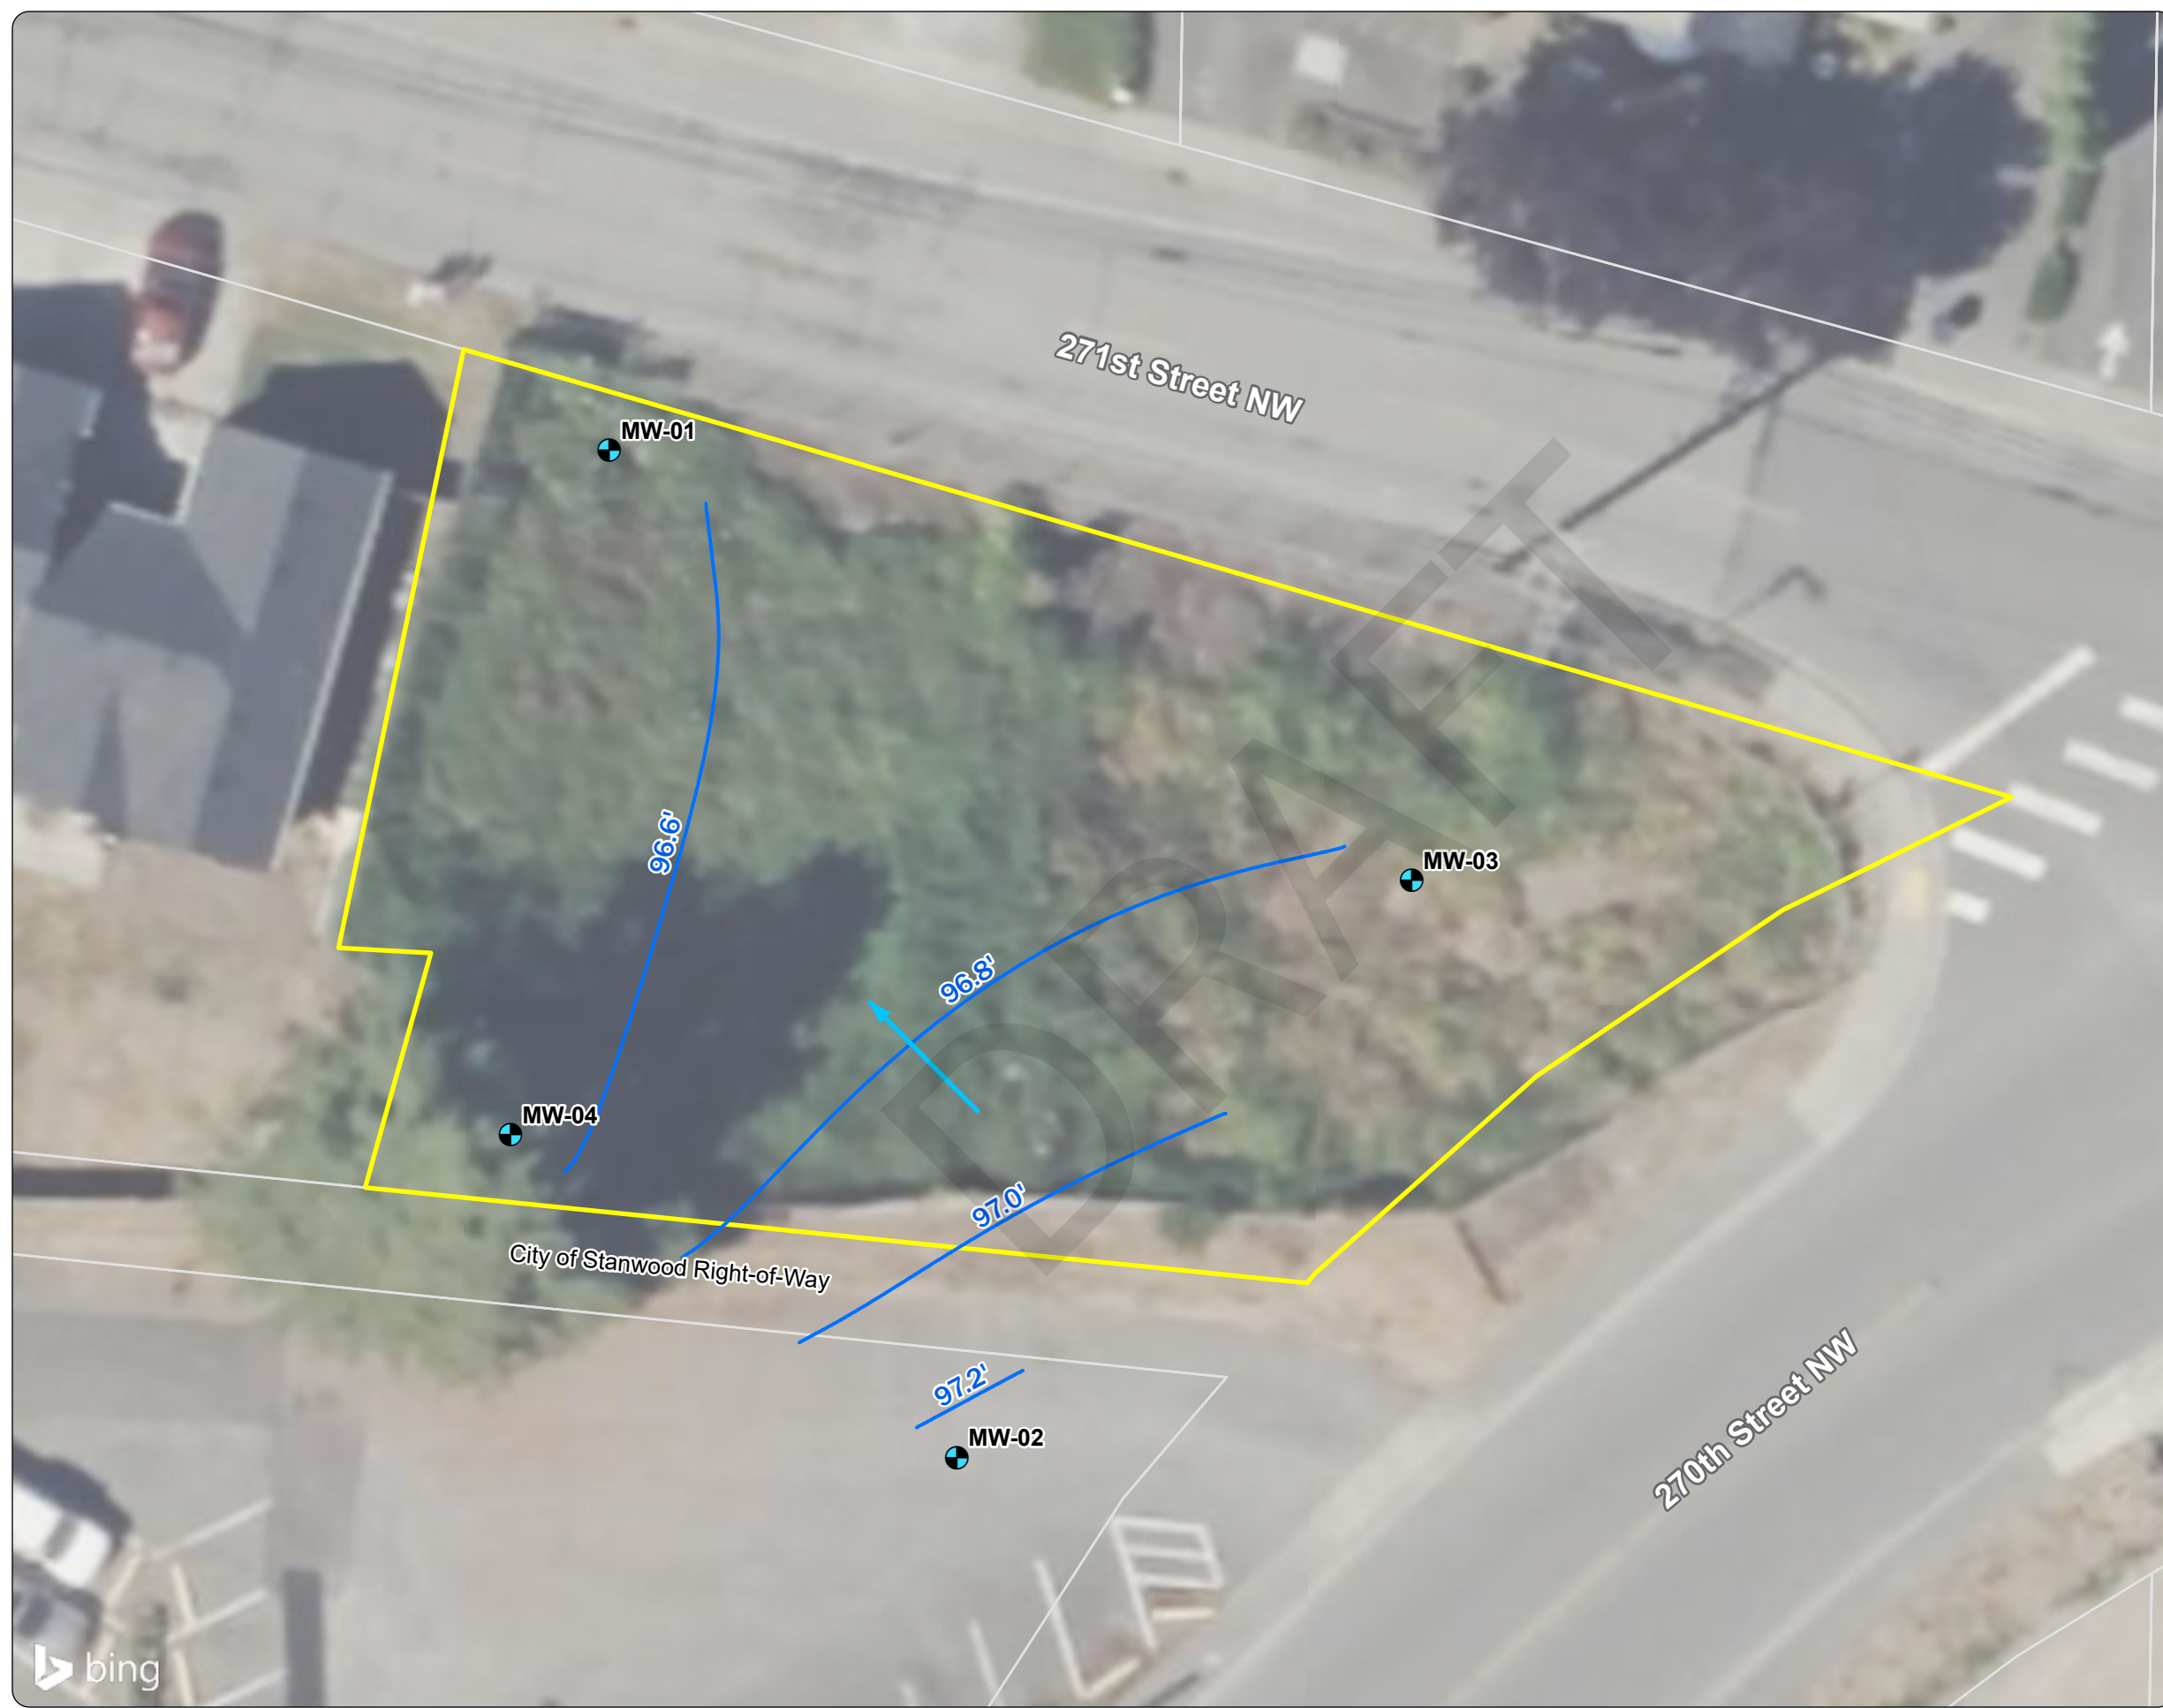
Notes:
 Depths to groundwater measured between 1:01 pm and 1:27 pm on July 12, 2024.
 All property feature locations are approximate.
 TOC elevations are expressed in feet relative to an arbitrary datum of 100.00 feet at MW-04 SAIC, 2006).
 TOC = top of casing.

The condition of the four present monitoring wells was also assessed. All wells were located, opened, and water levels measured. Groundwater was encountered at depths ranging from 1.75 to 3.49 feet bgs (see Table 2-3 and Figure 2-4). Petroleum hydrocarbon-like odors were observed at monitoring wells MW-02 and MW-04; however, no NAPL was encountered in any of the wells during water level measurement with an interface probe or observed on the surface of the probe after its removal from the well.

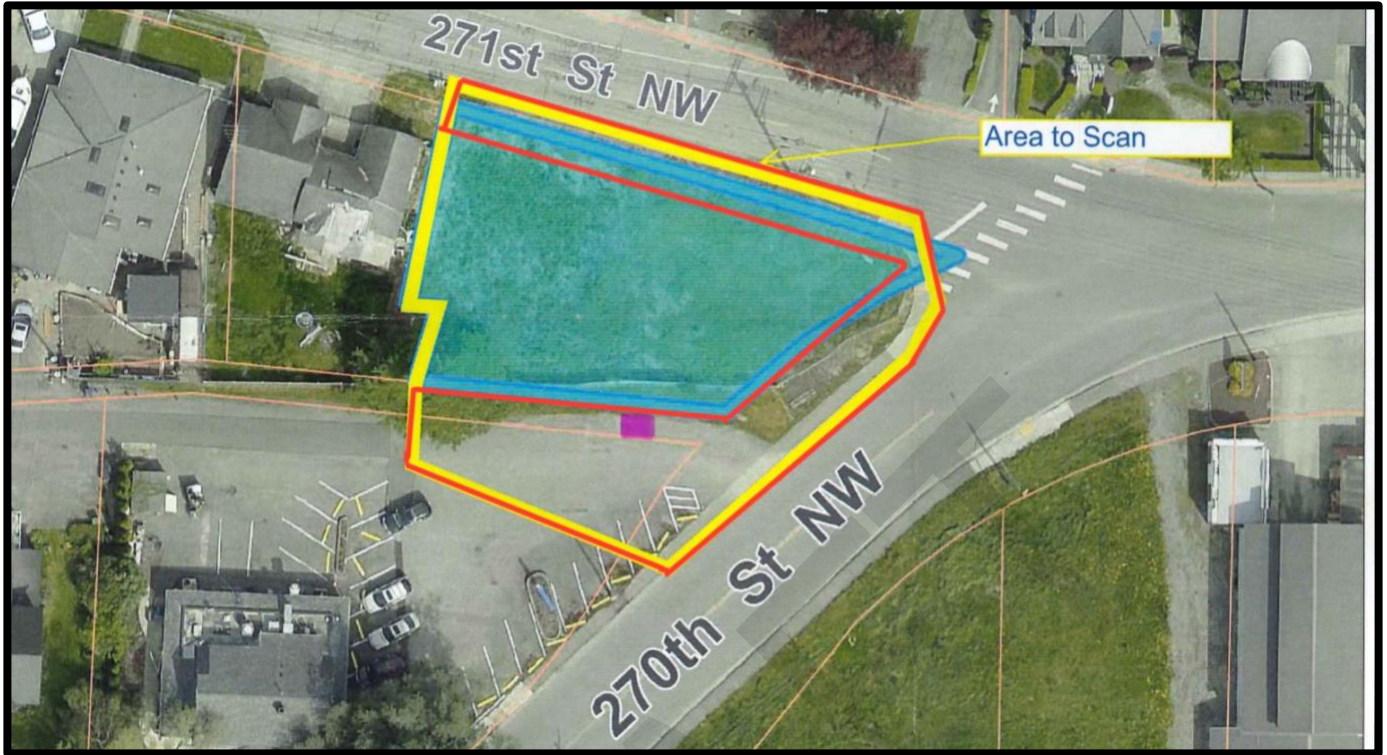
Image 1: Site map with the extent of the requested area bordered in yellow, and the approximate extent of the area scanned on this date bordered in red. The blue border indicates the approximate boundary of the fence line. The pink highlighted area indicates the approximate location of observed UST indications.

Indications of potential USTs were observed at a depth of approximately 3 feet bgs within a single 7-foot by 11-foot rectangular area near the southeast corner of the fence line. This area is located approximately 2 feet to the northeast of monitoring well MW-02. This area corresponds with the location of the USTs identified in the 2006 site investigation (SAIC 2006).

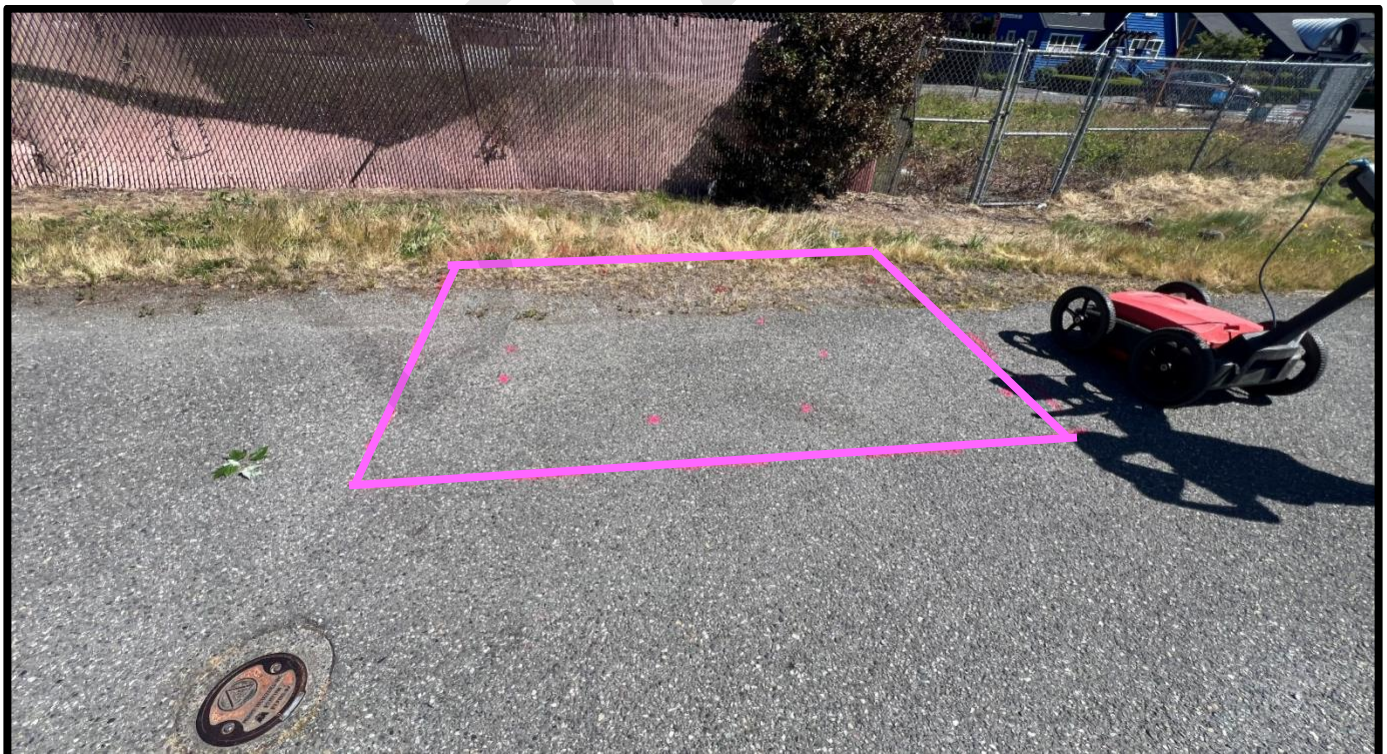
Image 2: Portion of the area scanned on this date, with pink lines indicating the approximate boundary of potential UST indications.

FINDINGS
<p>Upon arrival, GeoTest was directed to the requested area by the client. During the scan, indications of potential USTs were marked on the ground in pink spray paint. Areas obstructed by dense vegetation could not be scanned on this date. See Image 1 for the extent of the area that could be scanned. Findings are described below:</p> <ul style="list-style-type: none"> - Indications of potential USTs were observed within a single 7' x 11' rectangular area near the southeast corner of the site fence line. These indications were observed at a depth of approximately 3' below ground surface. The client was notified of these findings prior to departure.

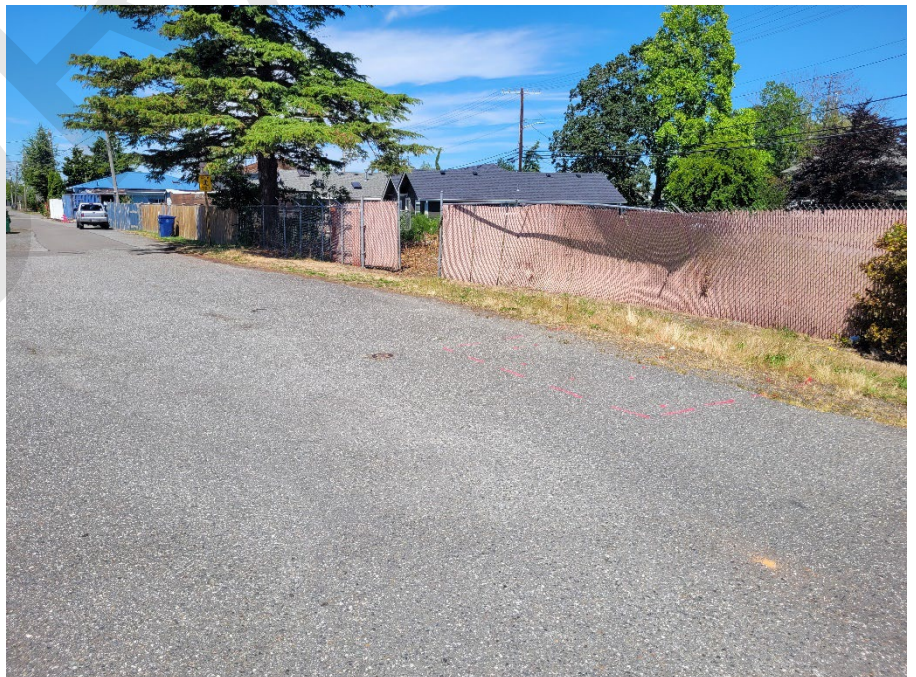
Photo No. 4.

Photo from the neighboring property to the south, looking northwest. Monitoring well MW-02 is in the center with the adjacent ground-penetrating radar (GPR) anomaly marked in pink paint.

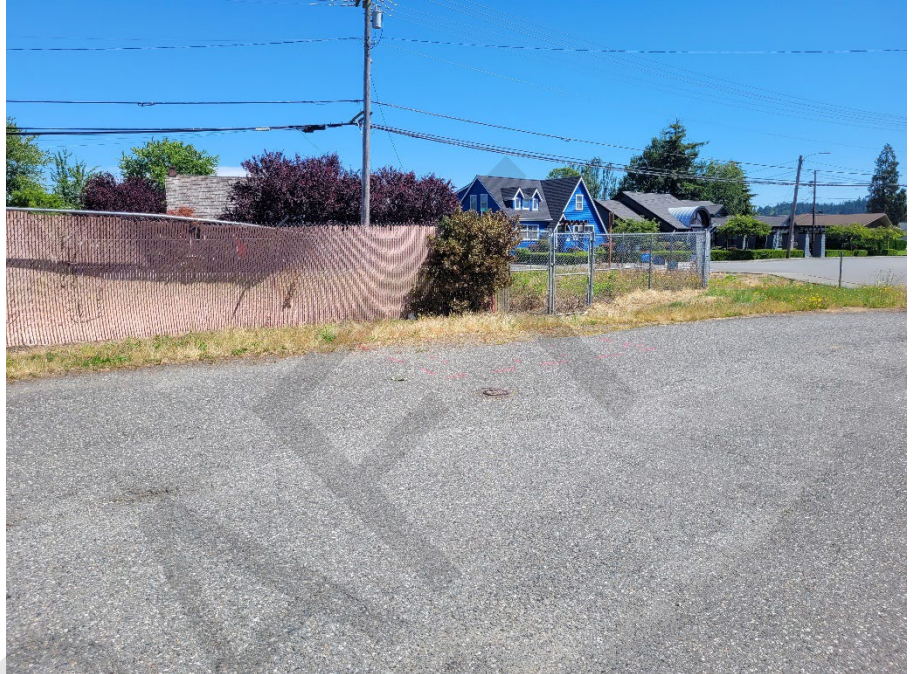
Photo from the neighboring property to the south, looking northeast towards MW-02 and the GPR anomaly.

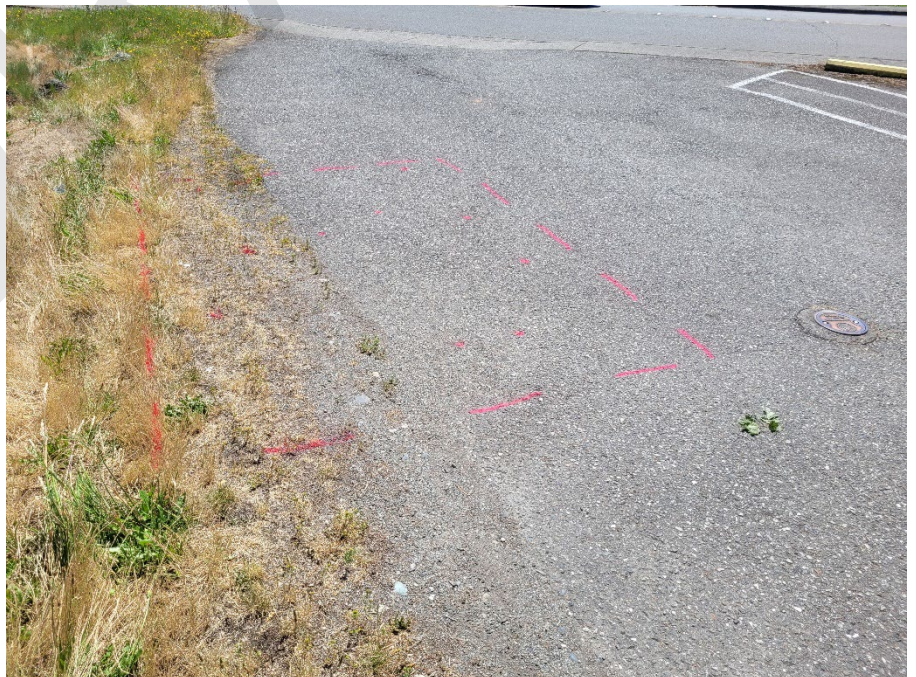
Photo No. 6.

Photo looking east toward the GPR anomaly marked in pink paint, with MW-02 to the right.

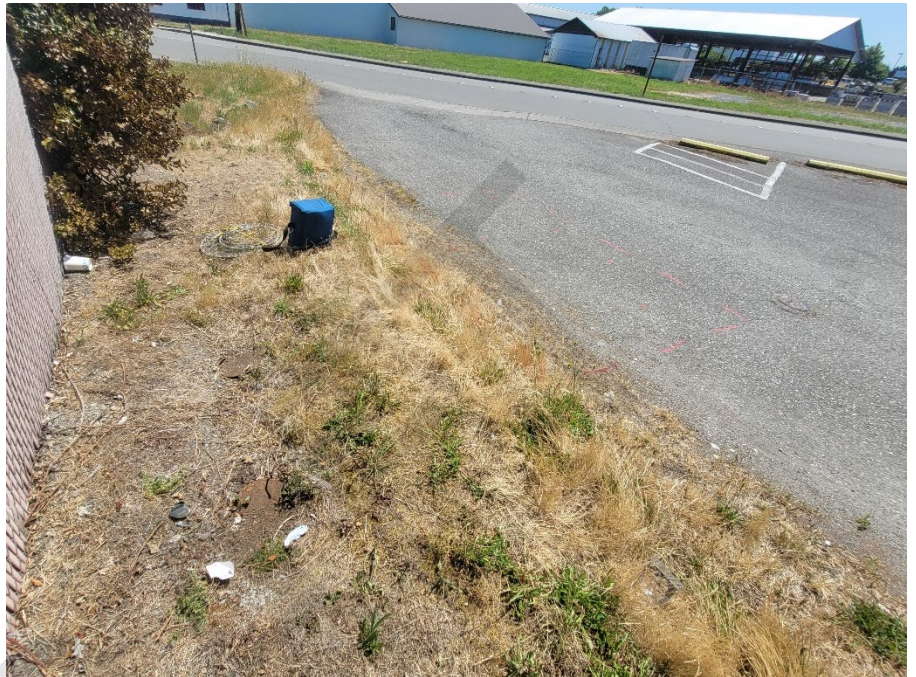
Photo on the south side of the Property looking east toward the two presumed fill ports (center left and bottom left), the GPR anomaly marked in pink paint (center) and monitoring well MW-02 (right).

As stated in the table above, two potential fill ports were observed in the grassy area between the south fence of the Property and the paved alley. The ports had iron caps situated in iron flush-mount vaults spaced approximately three feet apart. The caps were rusted in place and unable to be opened. The ports are located 5 feet immediately north of the area identified in the GPR survey and approximately 15 feet north of monitoring well MW-02. These are likely the two fill ports identified in the same area during the 2006 site investigation (SAIC 2006).

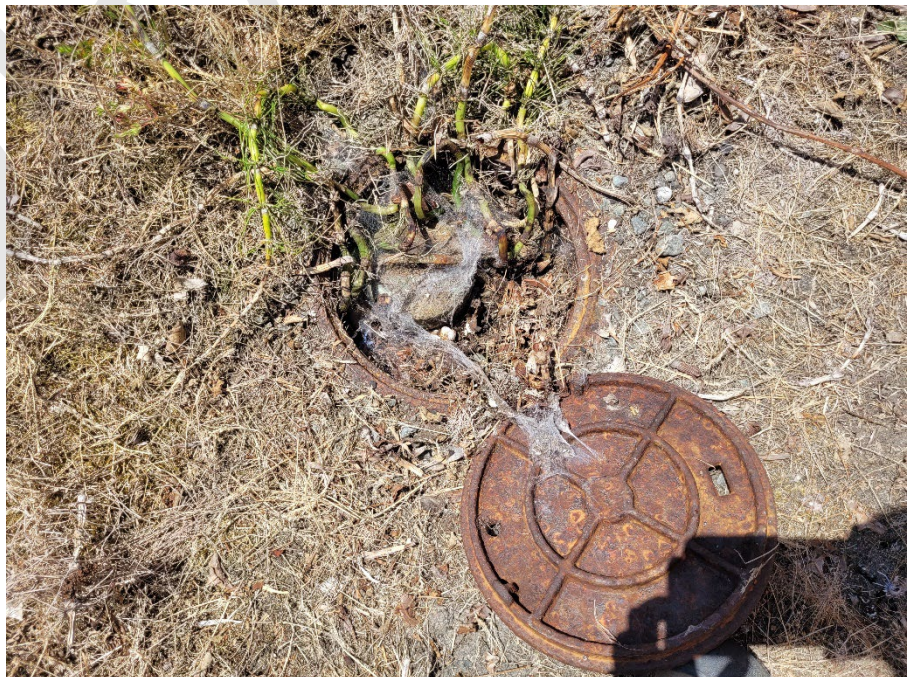
Photo No. 8.

Photo of the interior of the east presumed fill port showing the metal pipe and pipe cap within.

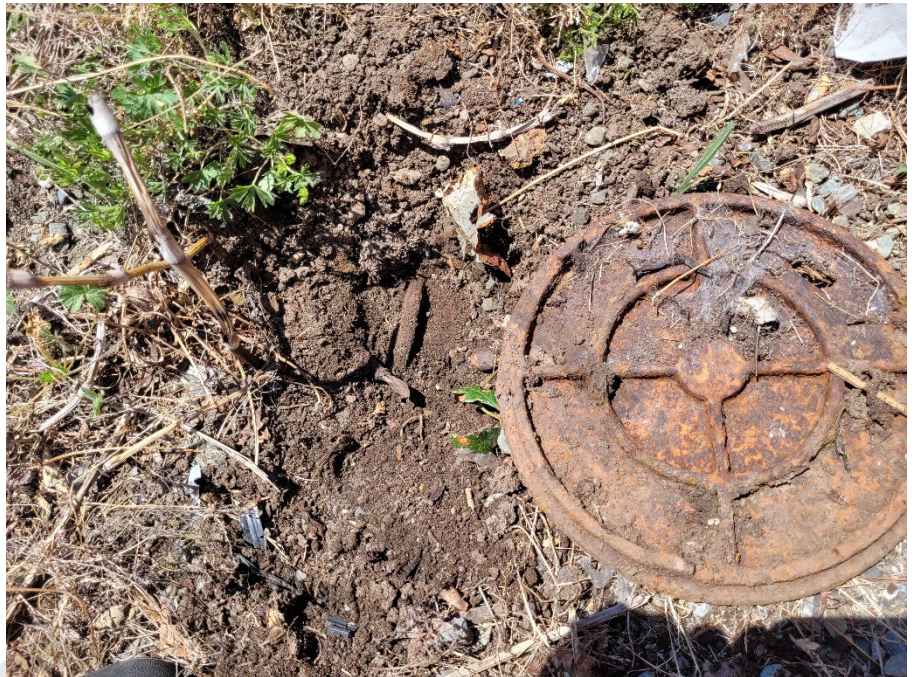
Photo of the interior of the west presumed fill port showing the metal pipe and pipe cap buried with soil inside.

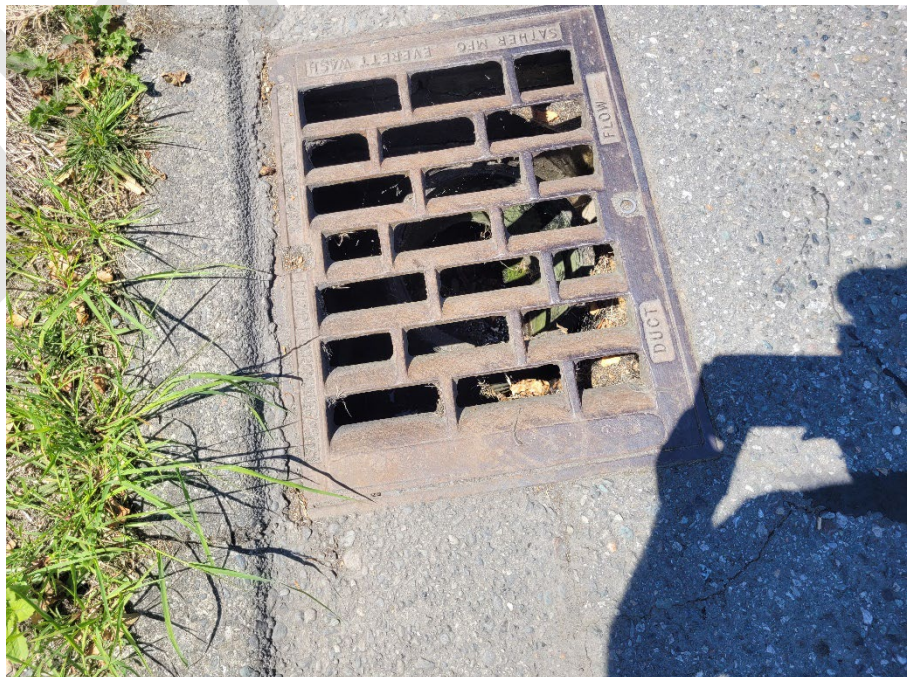
Photo No. 16.

Photo of the interior of the catch basin in 271st Street NW near the northwest corner of the Property. No sheen, odor, or staining was observed through the grate.

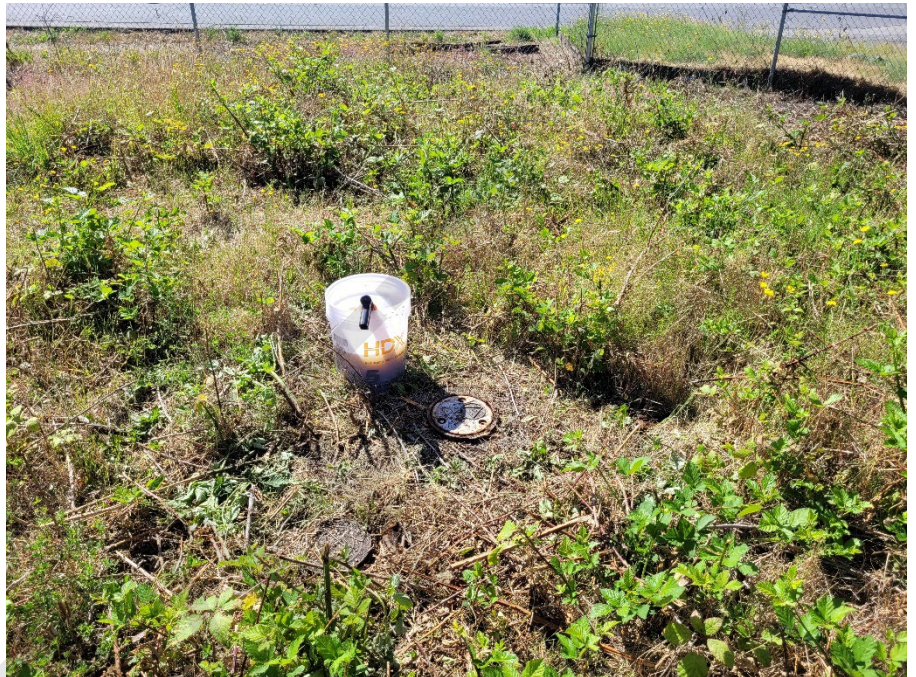
Photo looking southeast toward monitoring well MW-03. Down and to the left of MW-03 in the photo is an old iron monitoring well cover. The bucket contains surface water removed from the monitoring well monuments on the day of the site visit.
