Re: DTG Yakima – Agreed Order No. DE 21624 – Monthly Progress Letter – July

Re: Monthly Data Assessment Report DTG Yakima Landfill Fire Incident – July 2024

DTG LPL LANDFILL FIRE INVESTIGATIONS AND MITIGATION

Monthly Monitoring Data Review

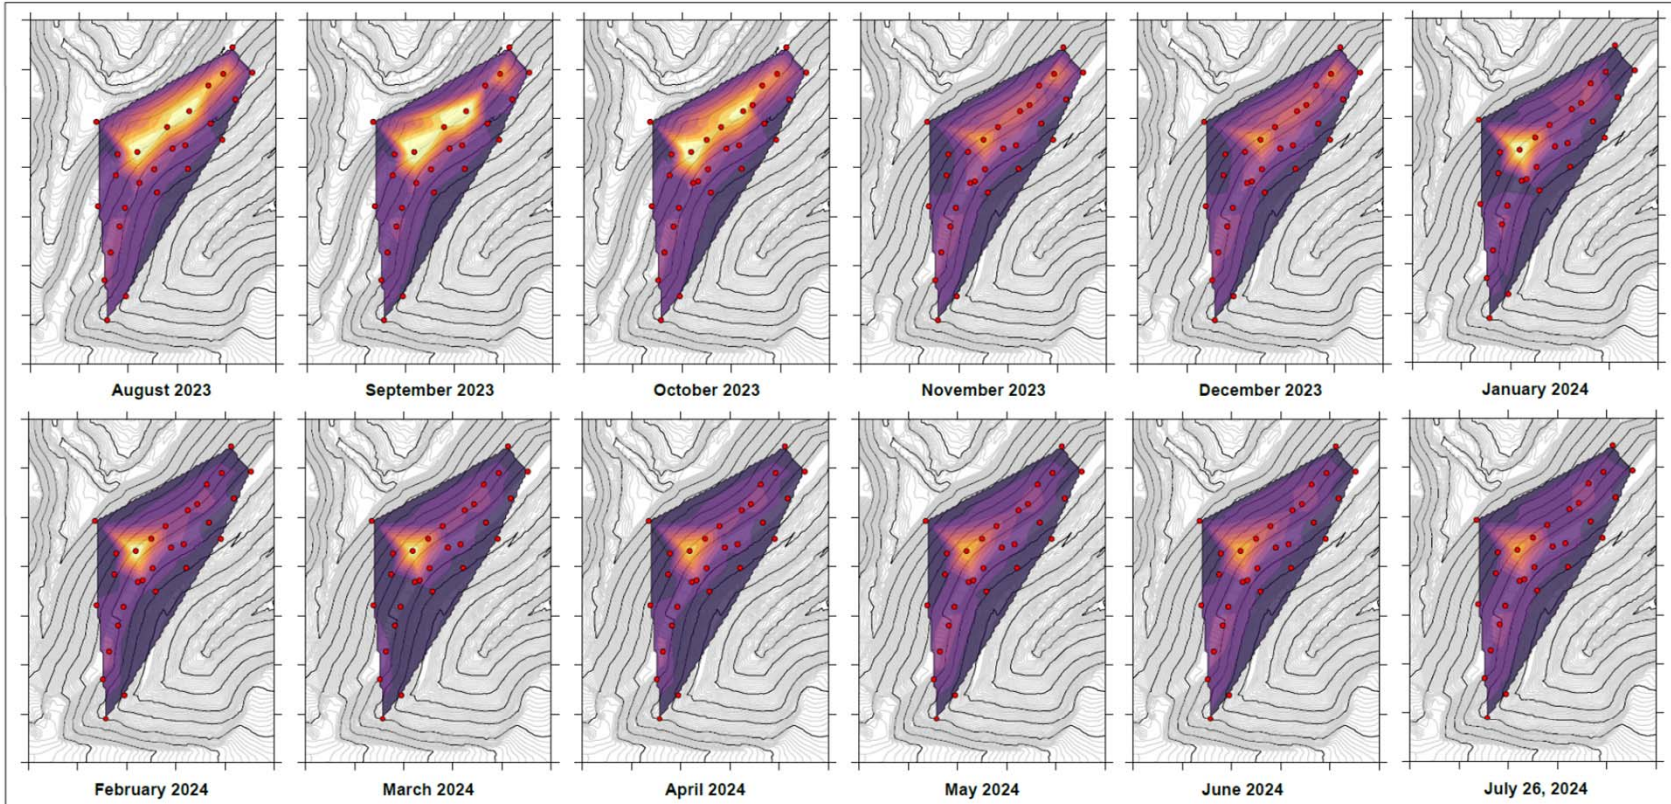
Plotting of the temperature data in plan view clearly shows that the area affected by fire has markedly decreased over time. Based on the available data, LFCI believes that a small smolder continues to be active in close proximity to GP-3, and that the rate of combustion of the smolder is steadily decreasing.

- Data taken from first monitoring event of each month
- Data was linearly interpolated between data points
- Datapoints (probe locations) represented in red
- Temperatures measured in Degrees Farenheit
- Contours are of existing ground at beginning of project, with design contours added for after addition of fill

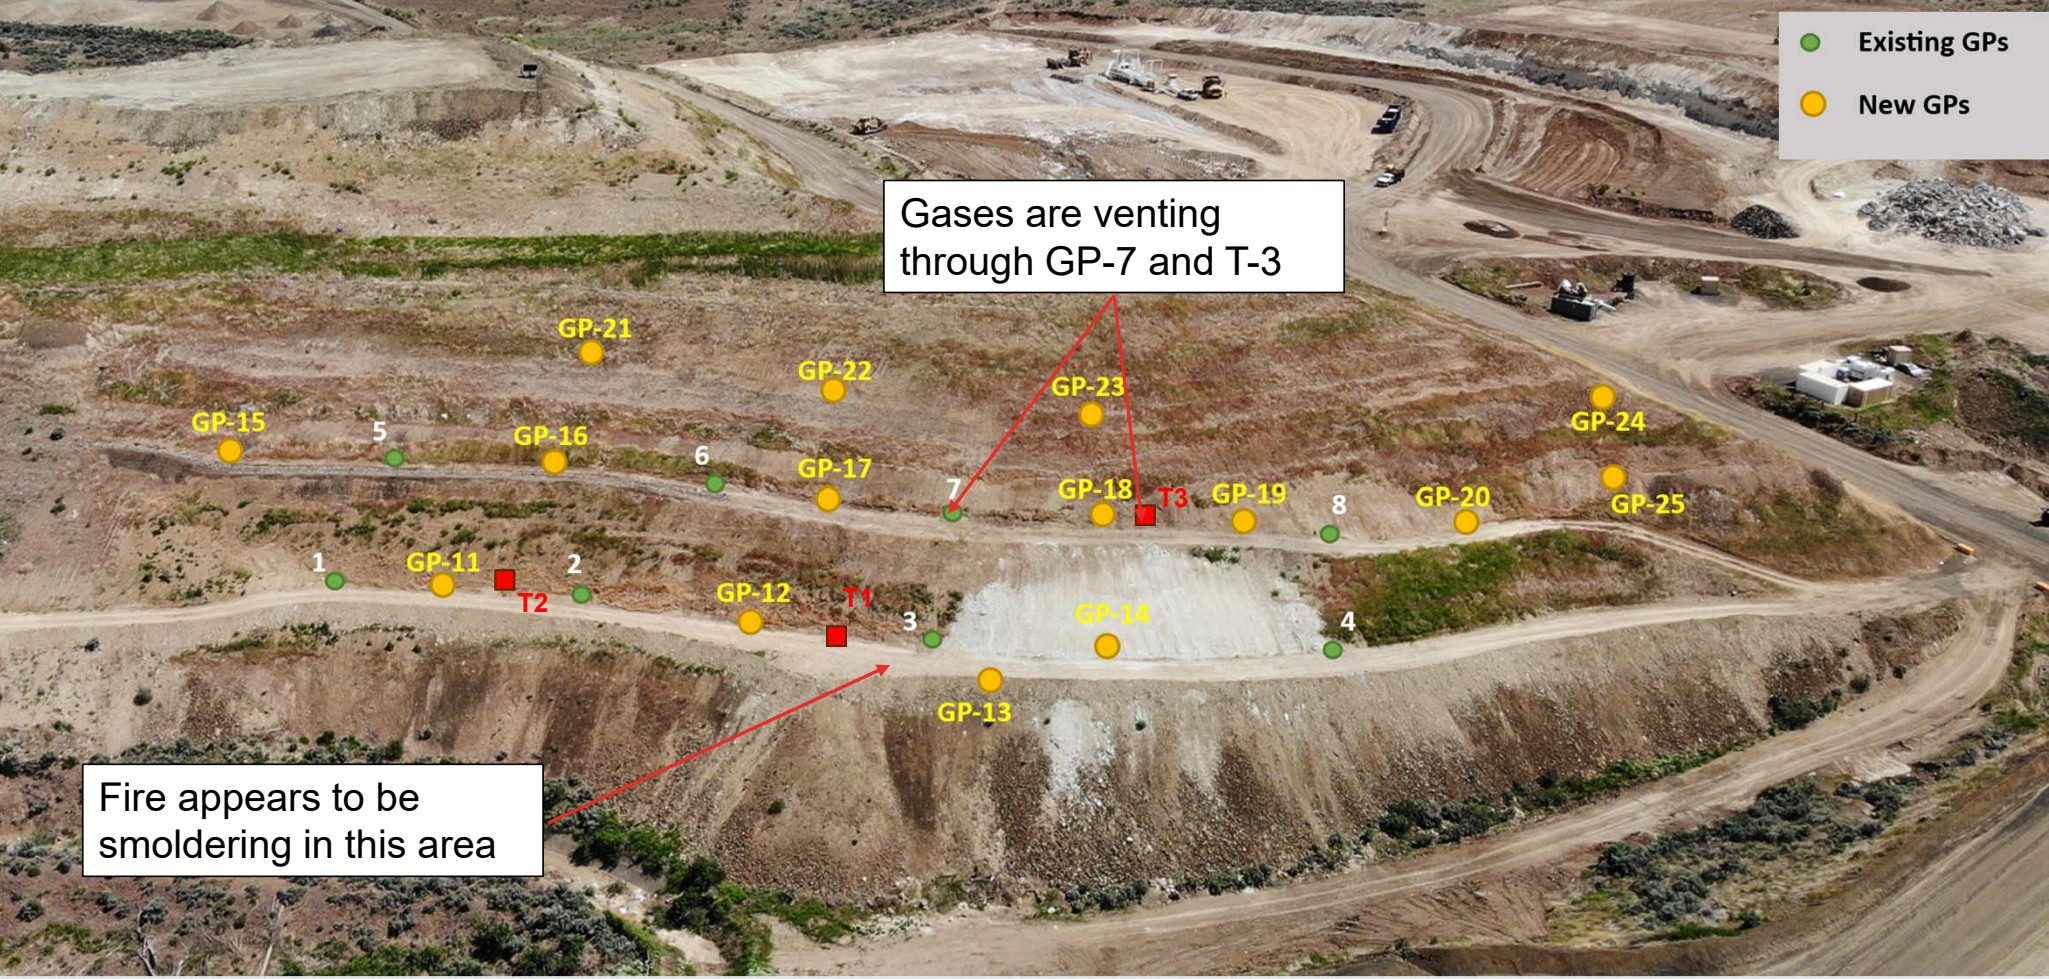
Fire Path

Overall, it appears that the waste is smoldering underneath GP-3 and T-1 (elevated temperature) and a 'chimney' effect is occurring, causing higher CO and VOC's in T-3 and GP-7.
