SITE ASSESSMENT REPORT

SPOKANE INTERNATIONAL AIRPORT

Facility Site ID: 6332493; Cleanup Site ID: 16774

Issued: 13 August 2024

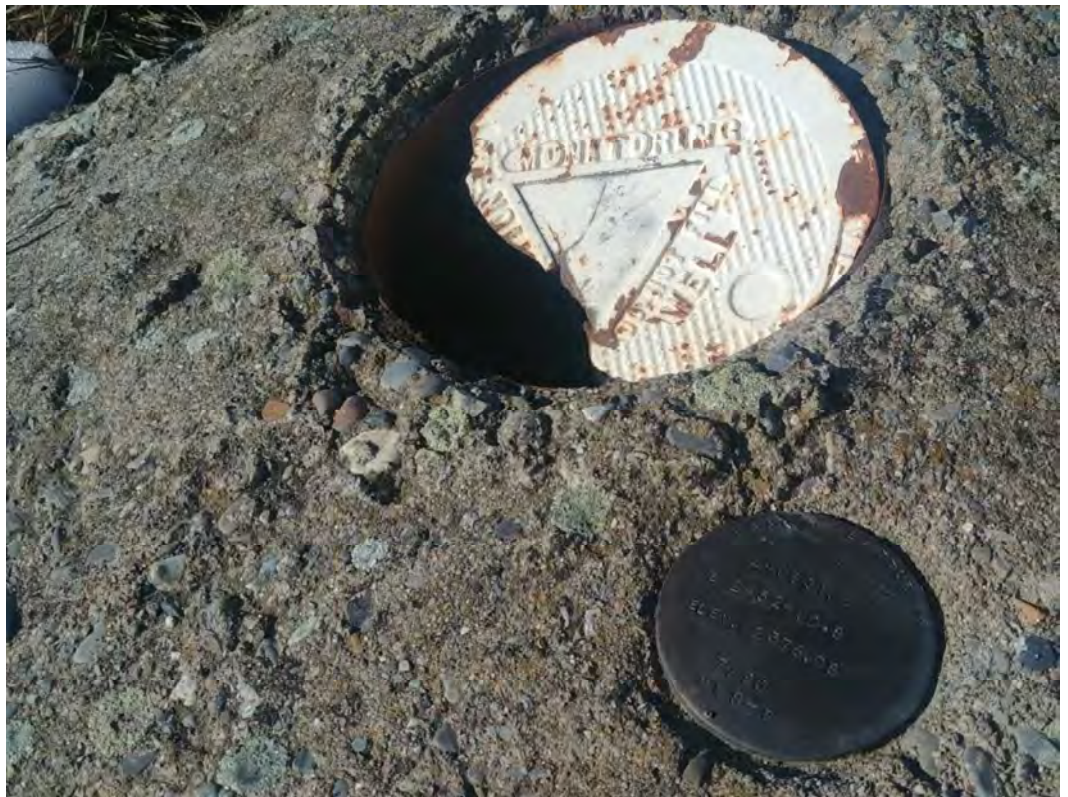
Photo No.
2

View of the broken monument lid on MW-8b. The entire monument should be replaced.
