## CONSTRUCTION COMPLETION REPORT

North Substation Property  
7500 8th Avenue Northeast  
Seattle, Washington

Seattle City Light  
700 5th Avenue, Suite 3200  
Seattle, Washington

Project No.: 1267-004

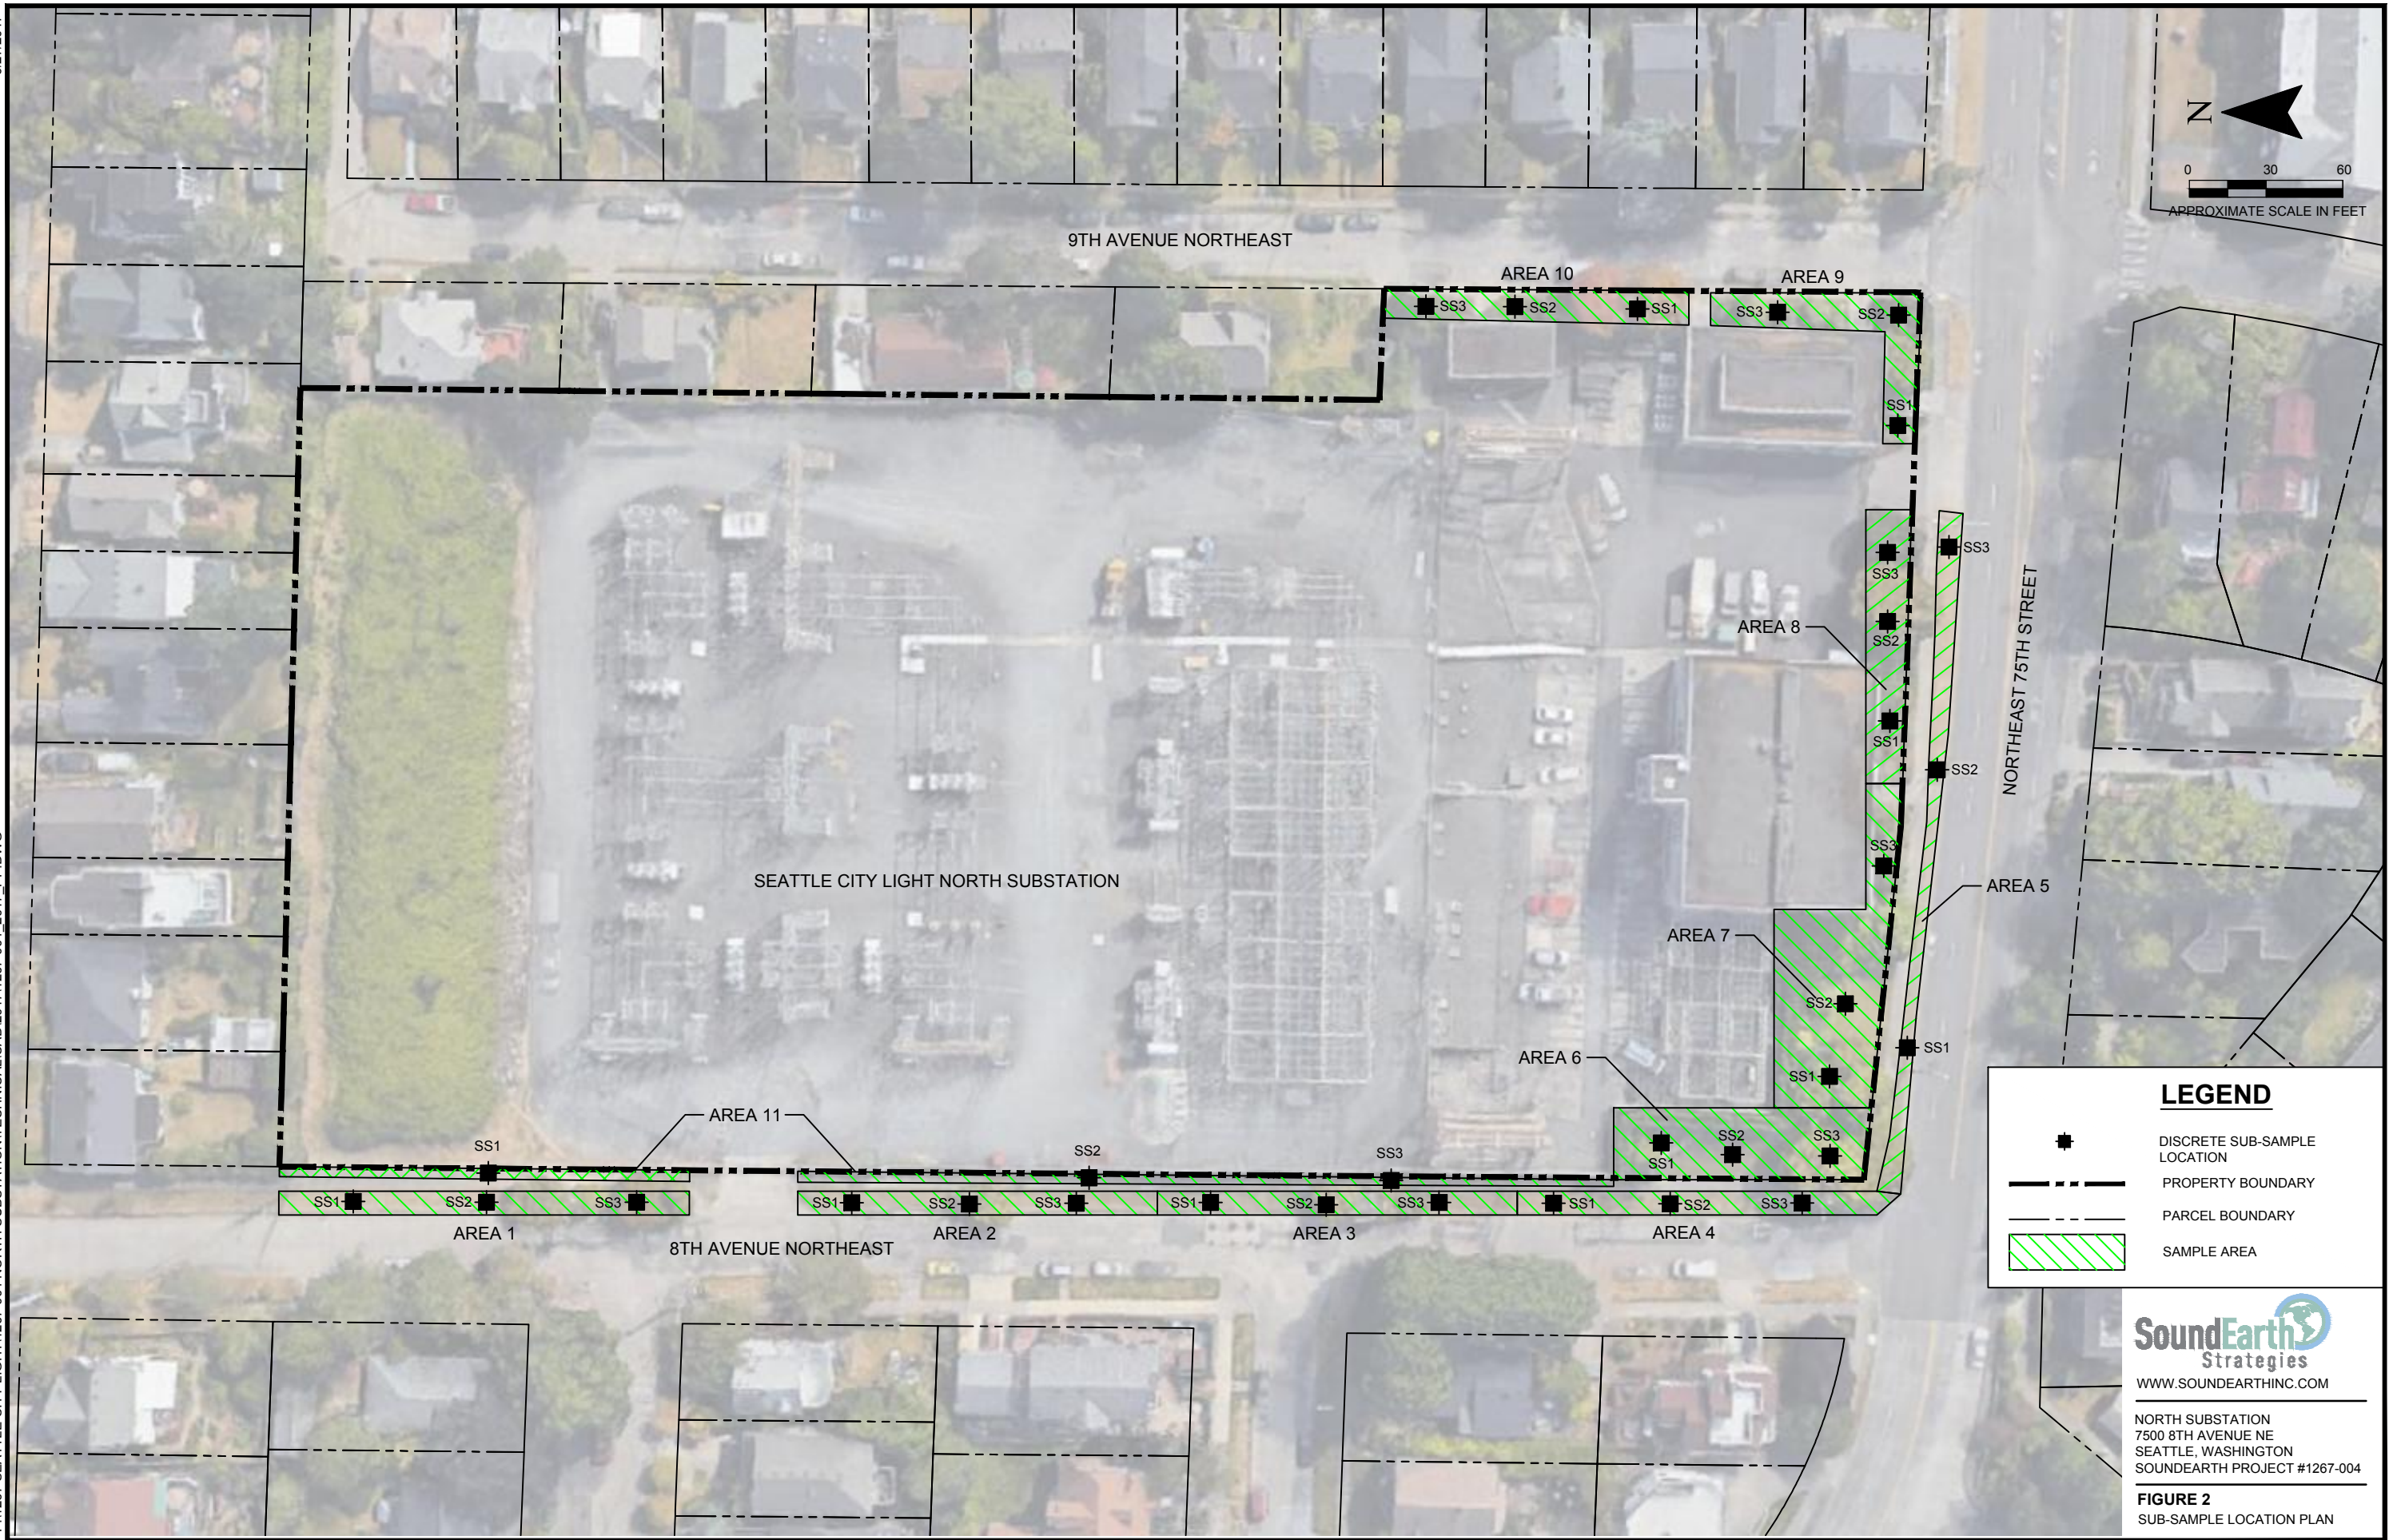
**FIGURE 2**  
SUB-SAMPLE LOCATION PLAN

The investigation consisted of collecting soil samples from 11 sampling areas (Areas 1 through 11) located along the western, southern, and southeastern Property boundaries, as shown on Figure 2. Three discrete soil samples were collected from each area at a depth of 0 to 0.5 foot below ground surface (bgs) using pre-cleaned, stainless steel tools. Prior to collecting each sample, ground cover, vegetation, and organic material were removed from the surface. Each sample was screened in the field for potential evidence of contamination using visual observations and notations of odor, and by

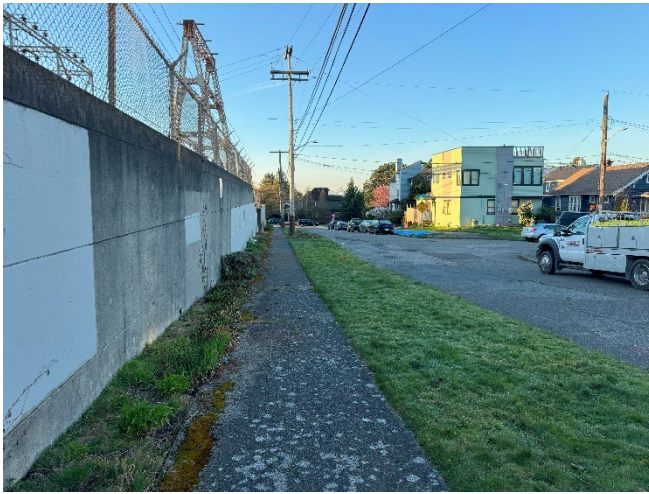
**Photograph 1.** View of Areas 2, 3, and 4 on 8th Avenue Northeast prior to excavation, looking south.

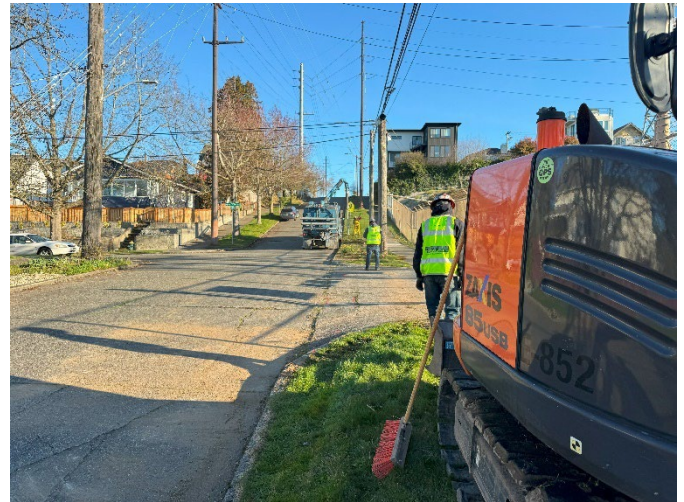
**Photograph 2.** View of Area 1 on 8th Avenue Northeast prior to excavation, looking north.

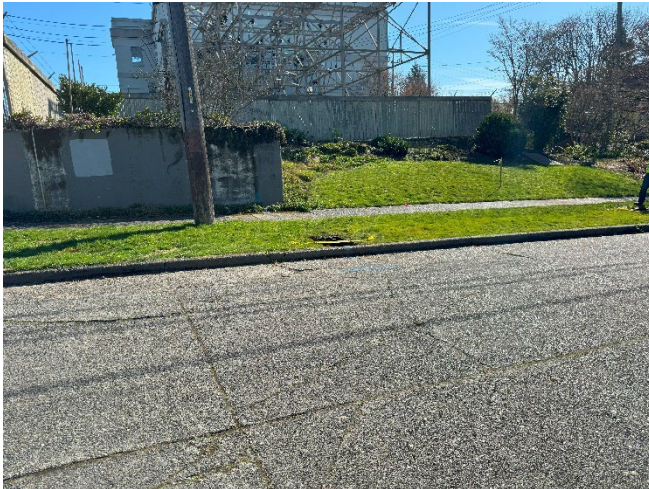
**Photograph 3.** View of Area 6B on 8th Avenue Northeast prior to excavation, looking east.

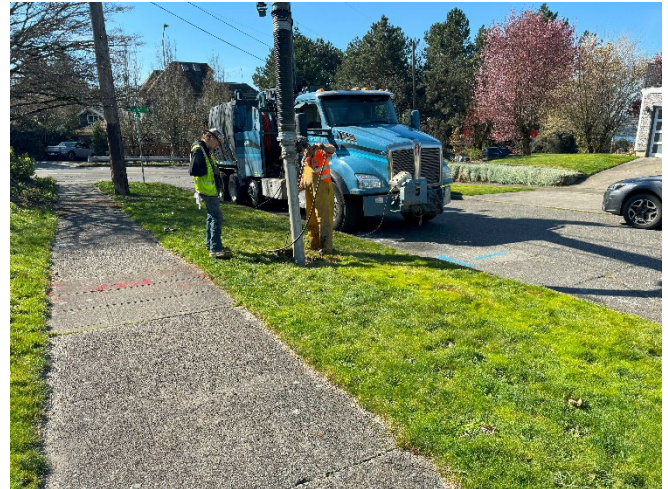
**Photograph 4.** Hydrovac potholing near subsurface electrical infrastructure in Area 4, looking southwest.

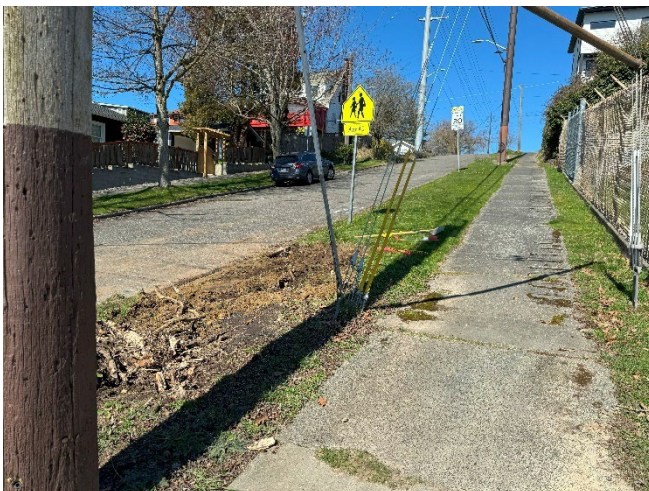
**Photograph 5.** Removal of tree stump debris in Area 1, looking north.

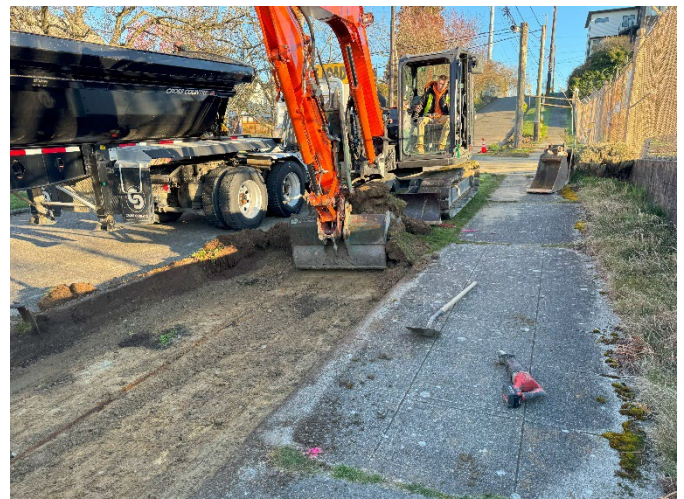
**Photograph 6.** Excavation of contaminated soil to a depth of 1 foot in Area 2, looking north.

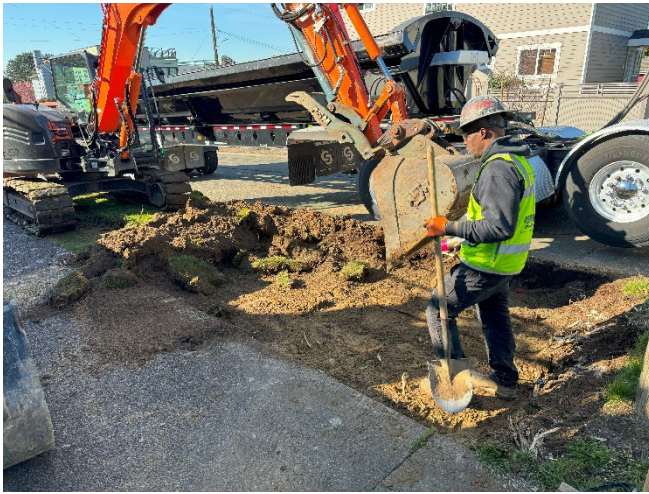
Photograph 7. Removal of contaminated soil to a depth of 1 to 1.5 feet in Area 3, looking southwest.

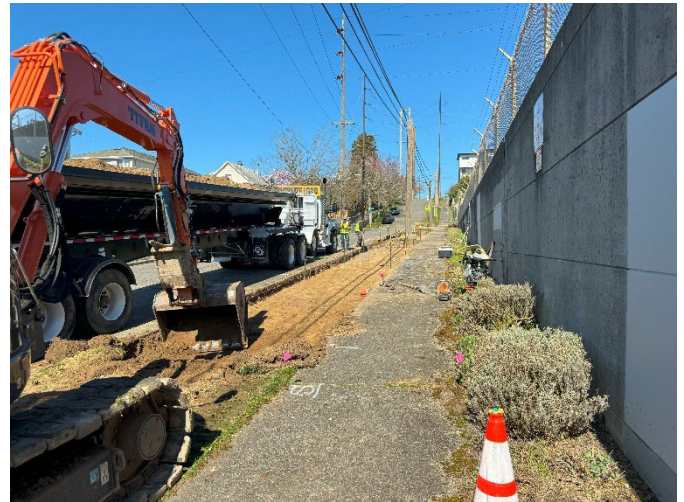
Photograph 8. View of Areas 2 and 3 after excavation to a depth of 1 foot, looking north.

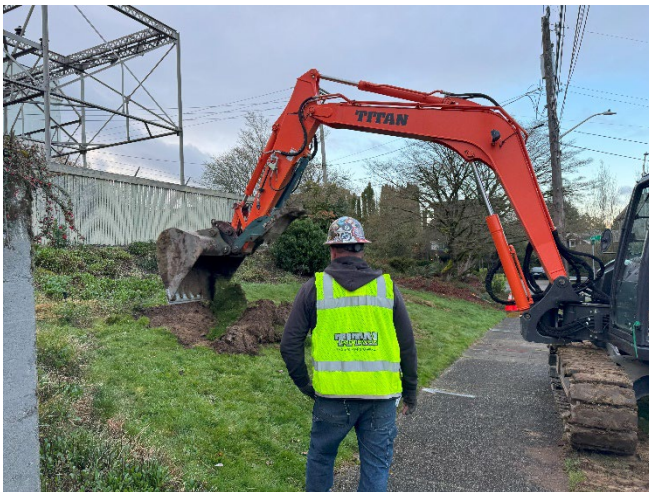
Photograph 9. Removal of contaminated soil in Area 6B to a depth of 1 foot, looking southeast.

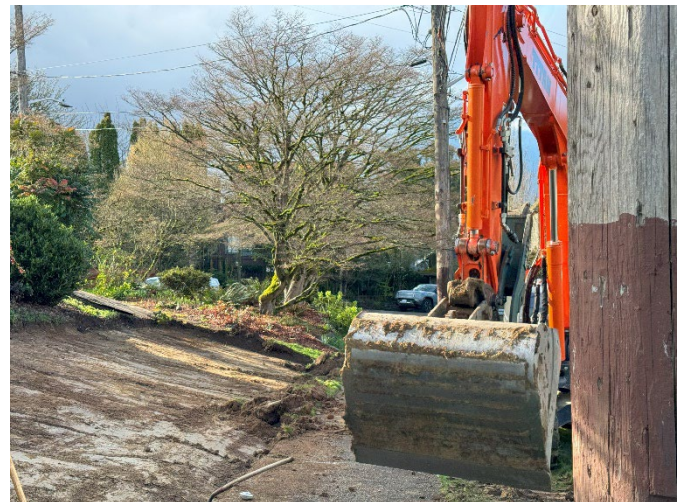
Photograph 10. View of Area 6B after excavation to a depth of 1 foot, looking southeast.

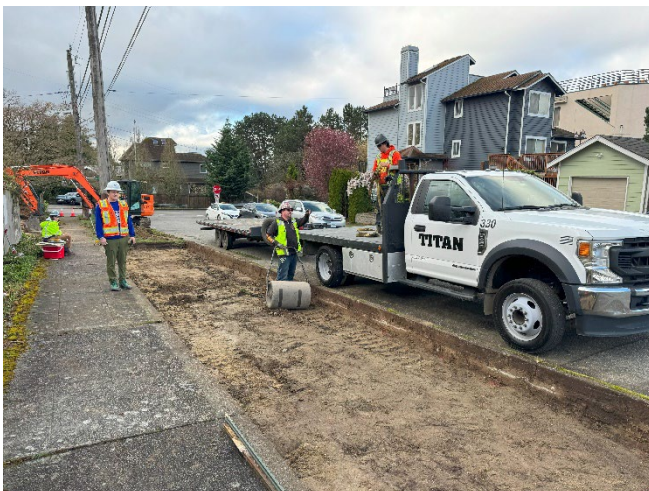
Photograph 11. View of Area 3 after excavation to a depth of 1 foot, looking south.

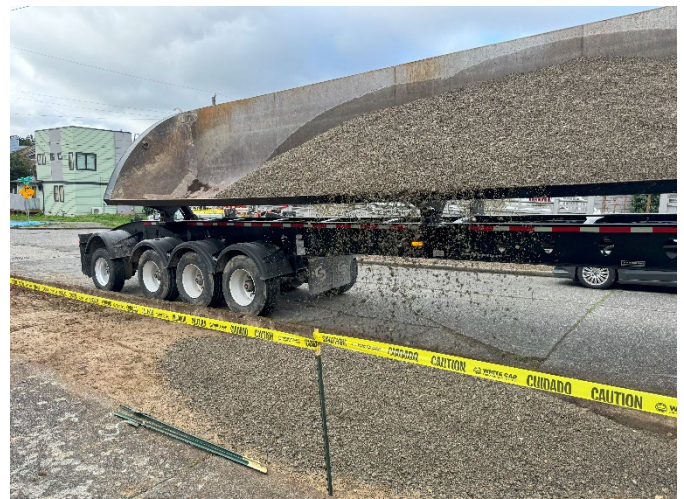
Photograph 12. Backfilling of Area 2 with Type 17 material, looking southwest.

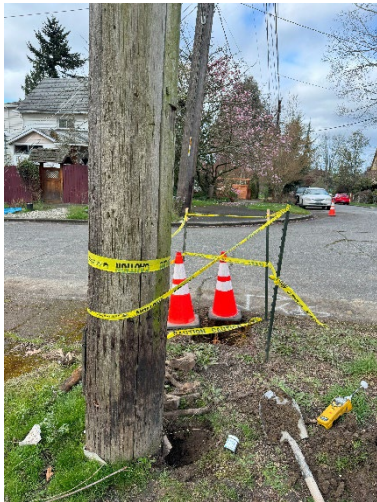
Photograph 13. Collection of soil sample at base of utility pole in Area 3, looking west.

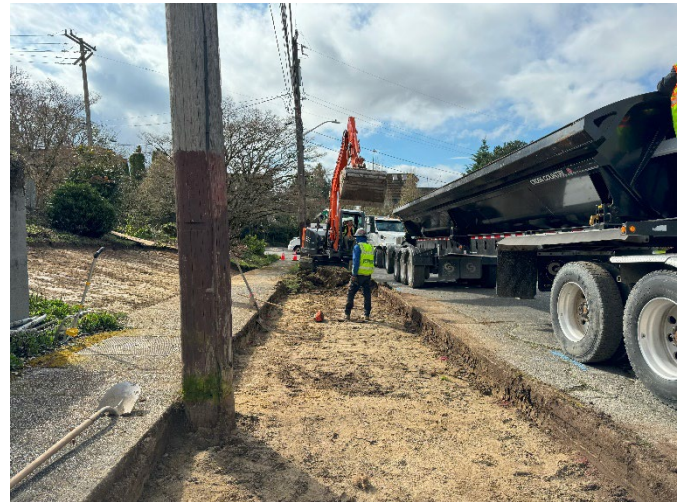
Photograph 14. Removal of contaminated soil to a depth of 1 foot in Area 4, looking south.

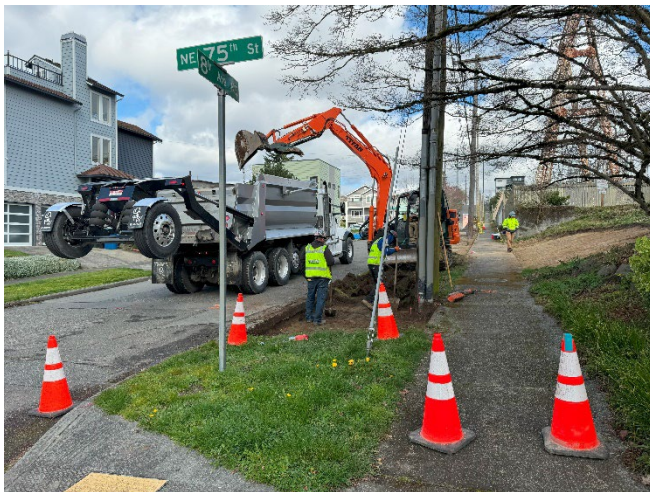
Photograph 15. Removal of contaminated soil in Area 4 outside of ADA ramp curb radius, looking north.

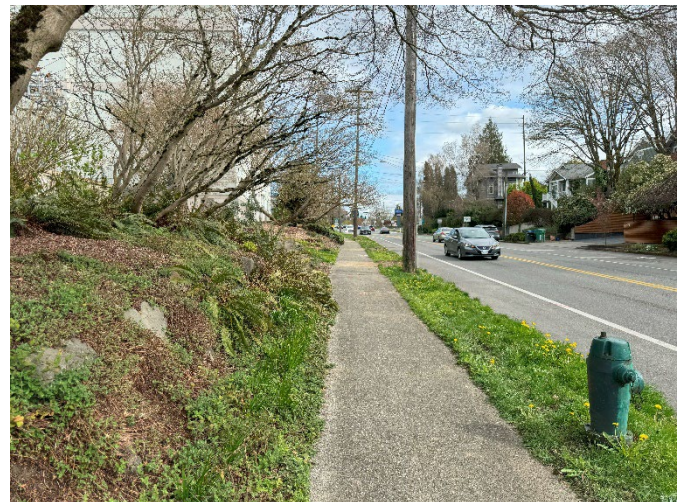
Photograph 16. View of Area 5 on Northeast 75th Street prior to excavation, looking east.

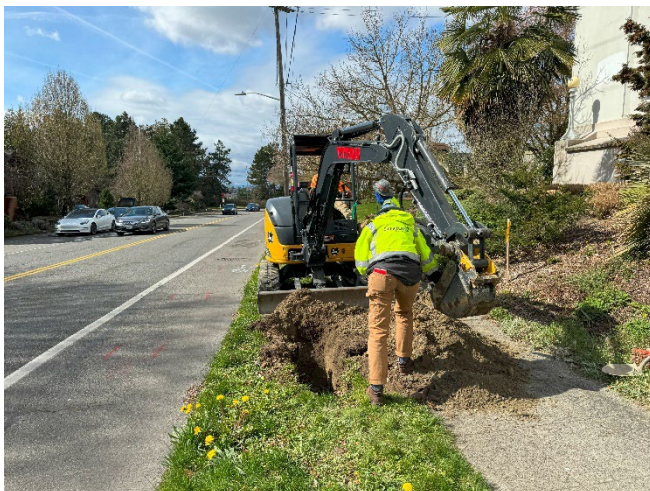
Photograph 17. Test pitting for confirmation soil sample collection in Area 5, looking west.

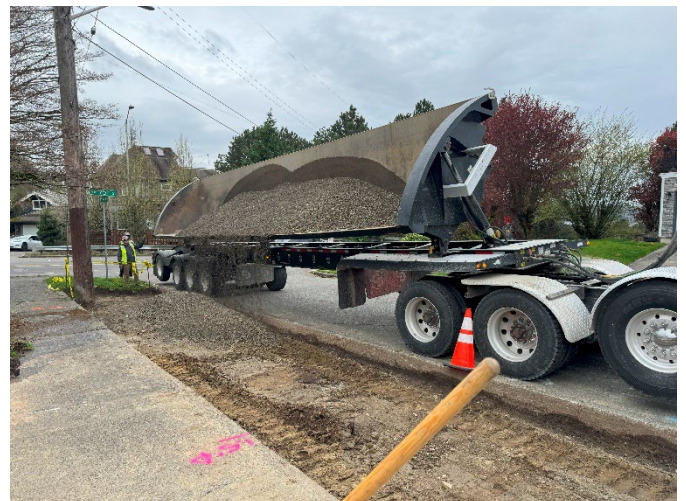
Photograph 18. Backfilling of southern portion of Area 4 with Type 17 material, looking southwest.

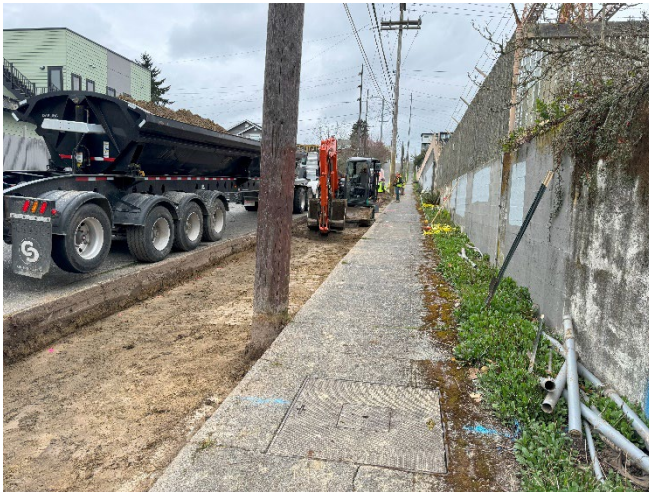
Photograph 19. Southern portion of Area 3 following excavation to a depth of 1.5 feet, looking north.

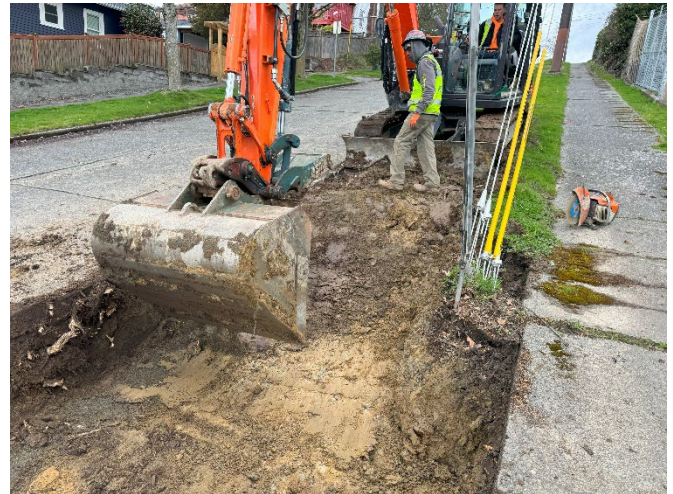
Photograph 20. Excavation of Area 1 to a depth of 2 feet, looking northwest.

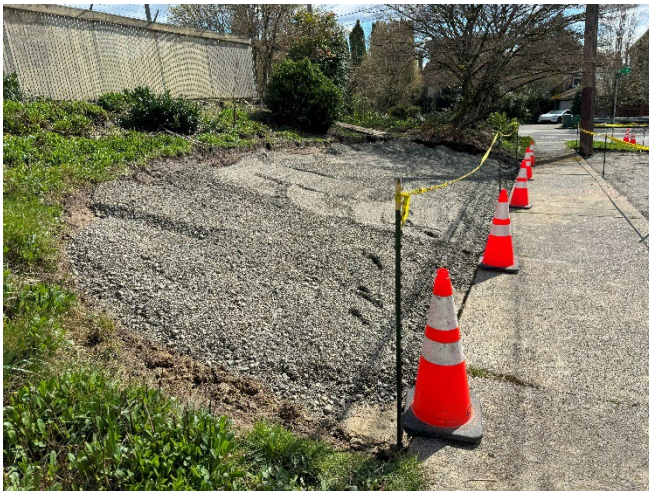
Photograph 21. Placement of Type 17 material in Area 6B, looking south.

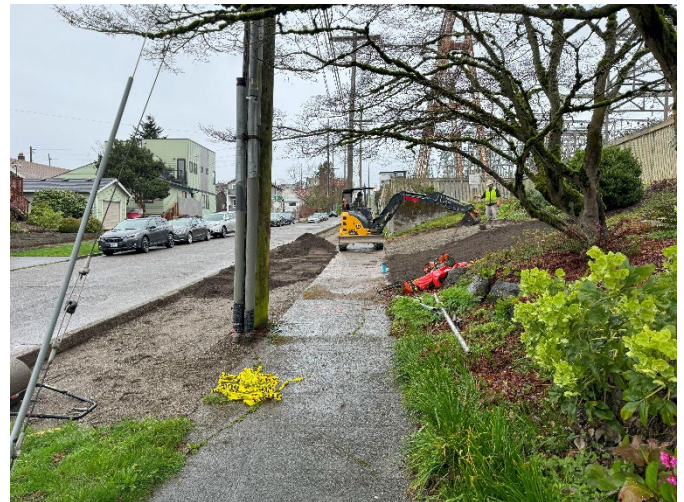
Photograph 22. Placement of topsoil in Areas 4 and 6B, looking north.

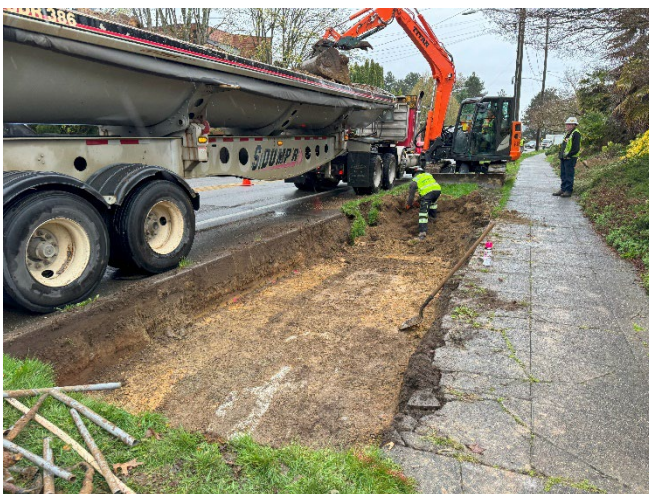
Photograph 23. Removal of contaminated soil to a depth of 2 feet in Area 5, looking west.

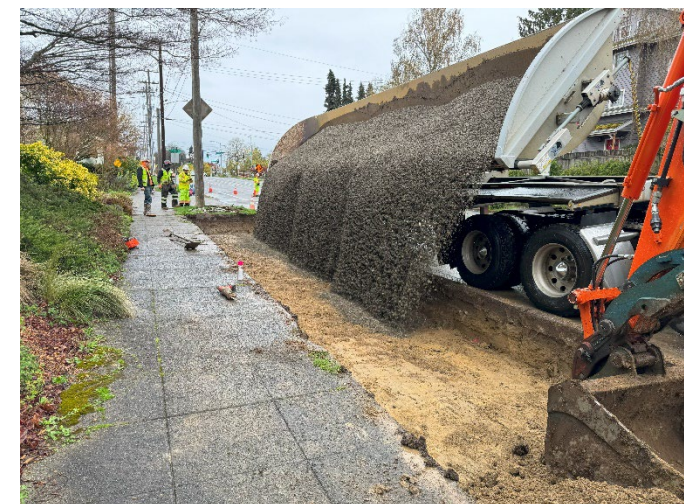
Photograph 24. Backfilling of eastern portion of Area 5 with Type 17 material, looking east.

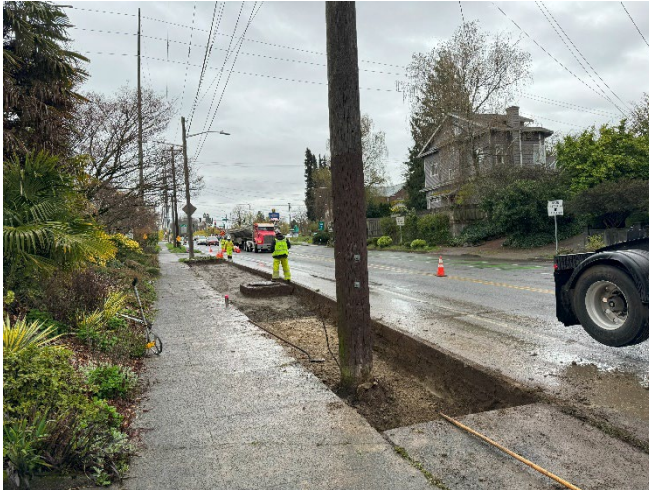
Photograph 25. Excavation and backfilling around utility pole vault in Area 5, looking east.

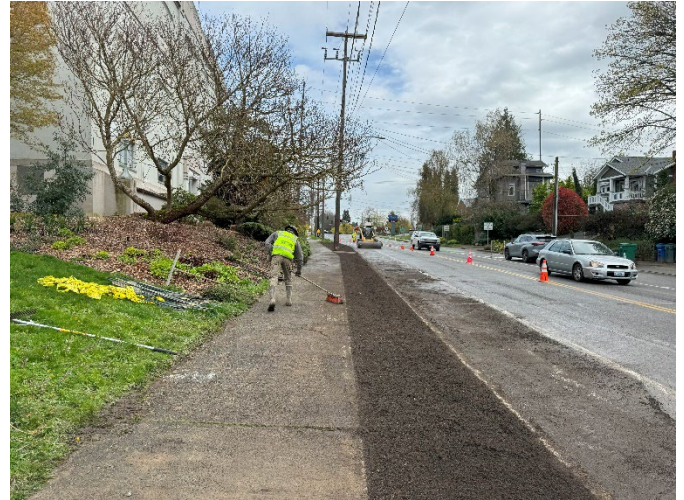
Photograph 26. Placement of topsoil in Area 5, looking east.

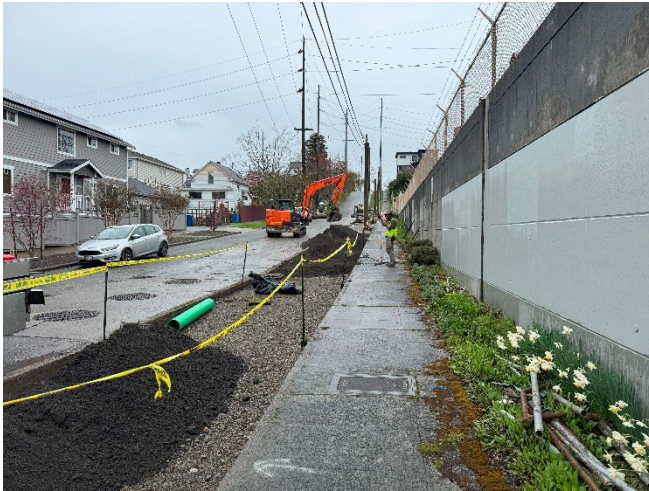
Photograph 27. Placement of topsoil in Areas 2 and 3, looking north.

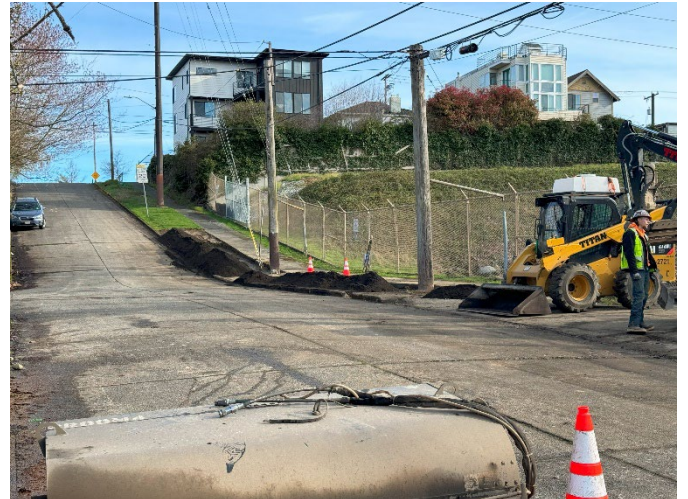
Photograph 28. Placement of topsoil in Area 1, looking northeast.

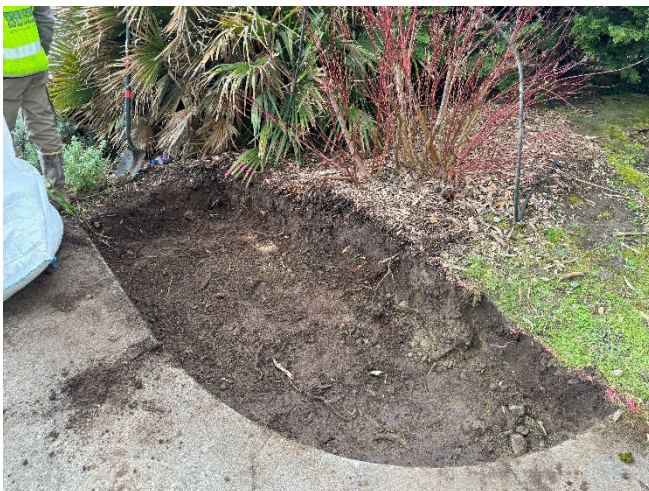
Photograph 29. Limited excavation of Area 7A to a depth of 1 foot, looking southwest.

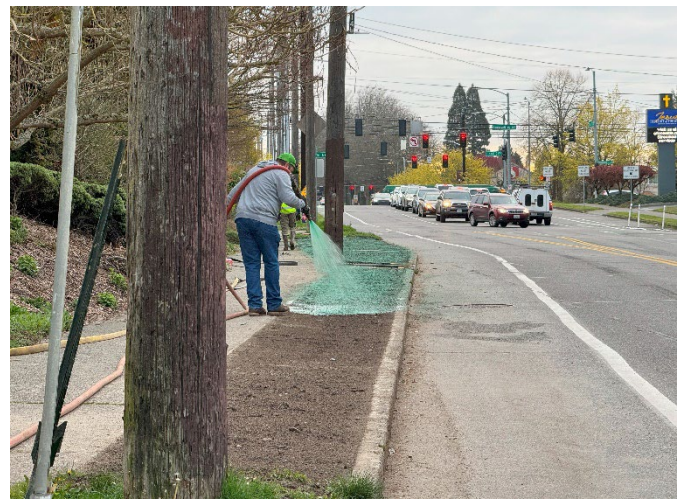
Photograph 30. Hydroseeding of Area 5, looking east.

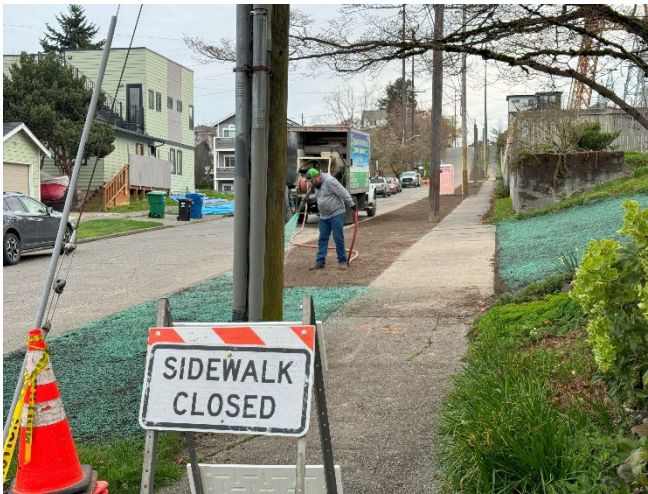
Photograph 31. Hydroseeding of Areas 4 and 6B, looking north.

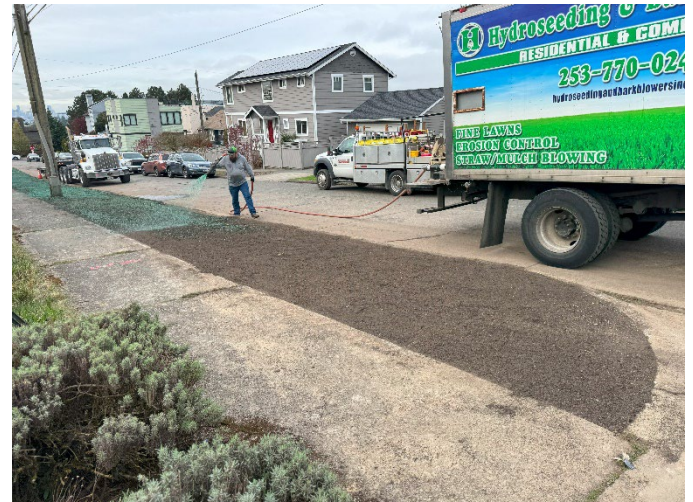
Photograph 32. Hydroseeding of Area 2, looking southwest.

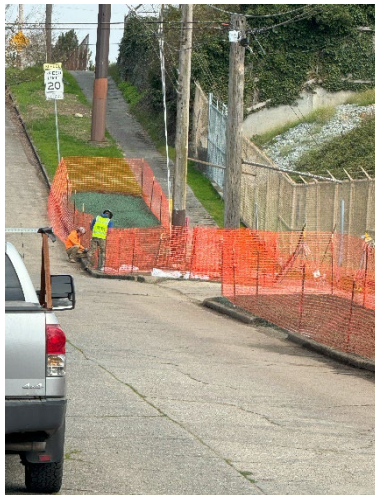
Photograph 33. Final condition of Area 1, looking north.

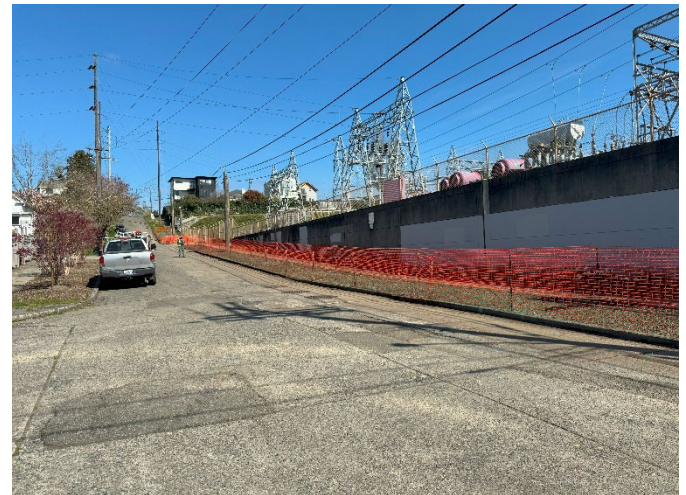
Photograph 34. Final condition of Areas 2 and 3, looking northeast.

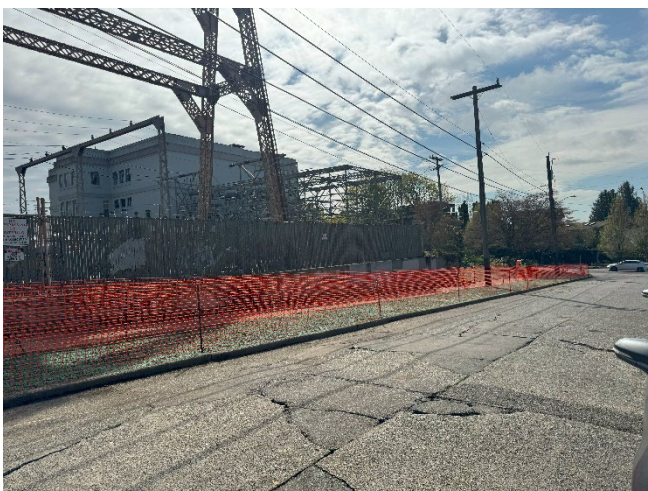
Photograph 35. Final condition of Areas 3, 4, and 6B, looking southeast.

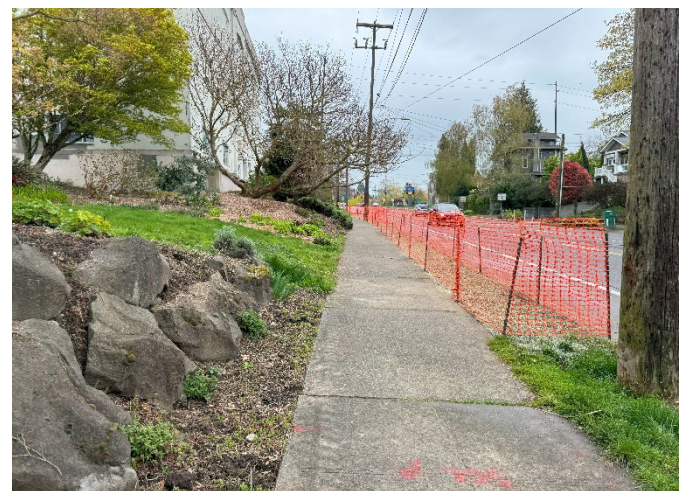
Photograph 36. Final condition of Area 5, looking east.
