**APPENDIX A  
HISTORICAL FEATURE  
DECOMMISSIONING AND REMOVAL REPORT**

## **HISTORICAL FEATURE DECOMMISSIONING AND REMOVAL SUMMARY REPORT**

**BLOCK 79 EAST PROPERTY  
701, 739, AND 753 9<sup>TH</sup> AVENUE NORTH  
SEATTLE, WASHINGTON**

May 17, 2021

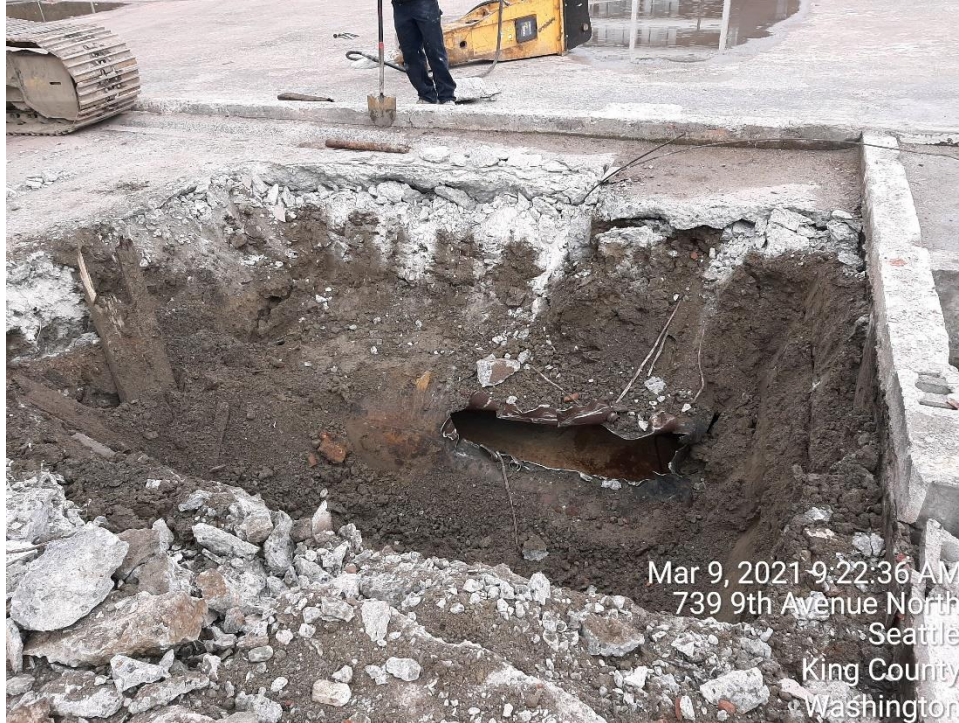
**Photograph 1:** UST-L excavation showing UST-L tank opened to inspect fill material.

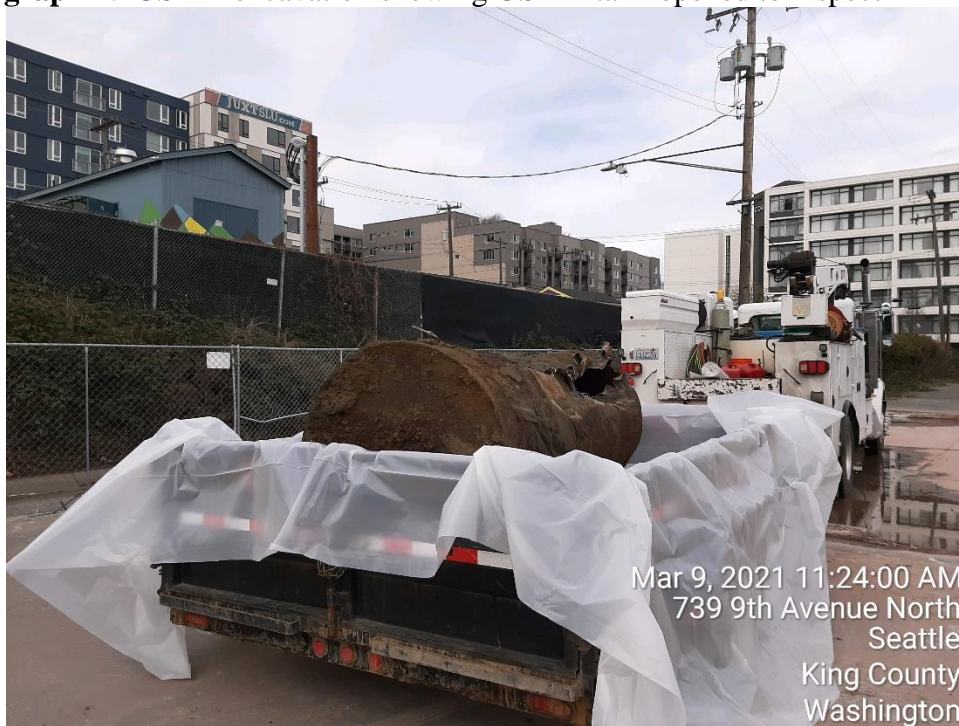
**Photograph 2:** UST-L removed from the excavation.

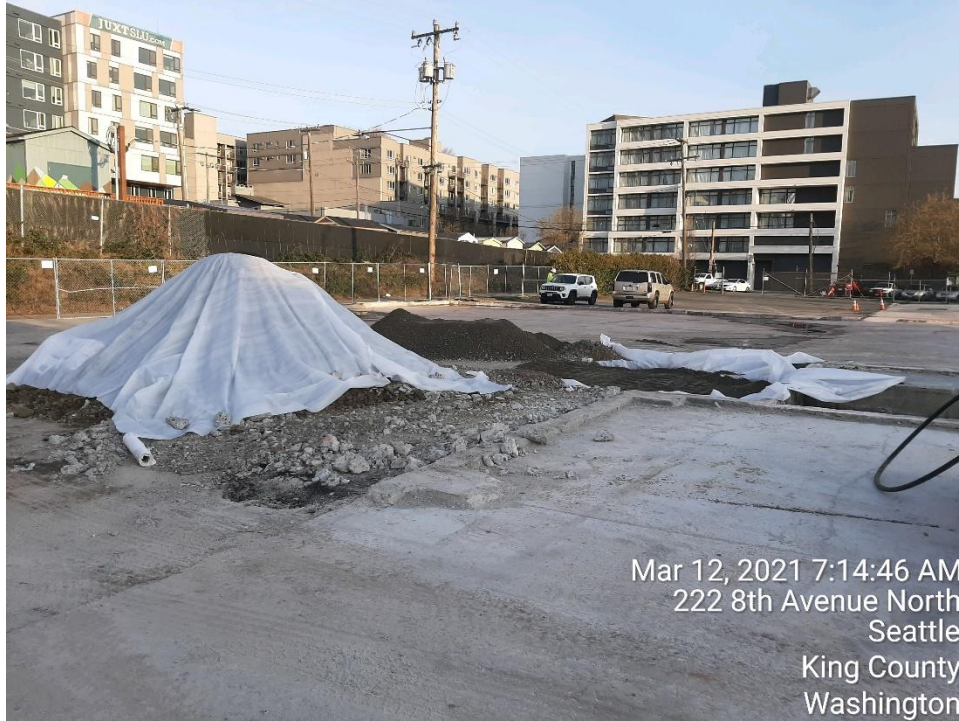
**Photograph 3:** UST-L lined and backfilled excavation and stockpile, viewed from the south.

Linescape performed an additional locate of the lines running from UST-L on March 10, 2021 using an energized trace. UST-L conveyance pipe locations were confirmed to extend to the west and north (Figure 2). Conveyance lines were cut, sealed, and capped at the edge of the excavation. No residual product was observed in the conveyance lines. Soil samples were collected from the limits of the UST-L excavation in accordance with the Work Plan. Approximately 55 cubic yards (93 tons) of soil was removed from the UST-L excavation and stockpiled immediately west of the excavation limits (Figure 2). Three soil samples were collected from the UST-L spoils stockpile in accordance with the Work Plan and Ecology Guidance to profile the soil for disposal. On March 11, CGI lined the UST-L excavation with plastic and backfilled it using imported clean gravel (Appendix C, Photograph 3). An asphalt cap was applied on March 22, 2021.

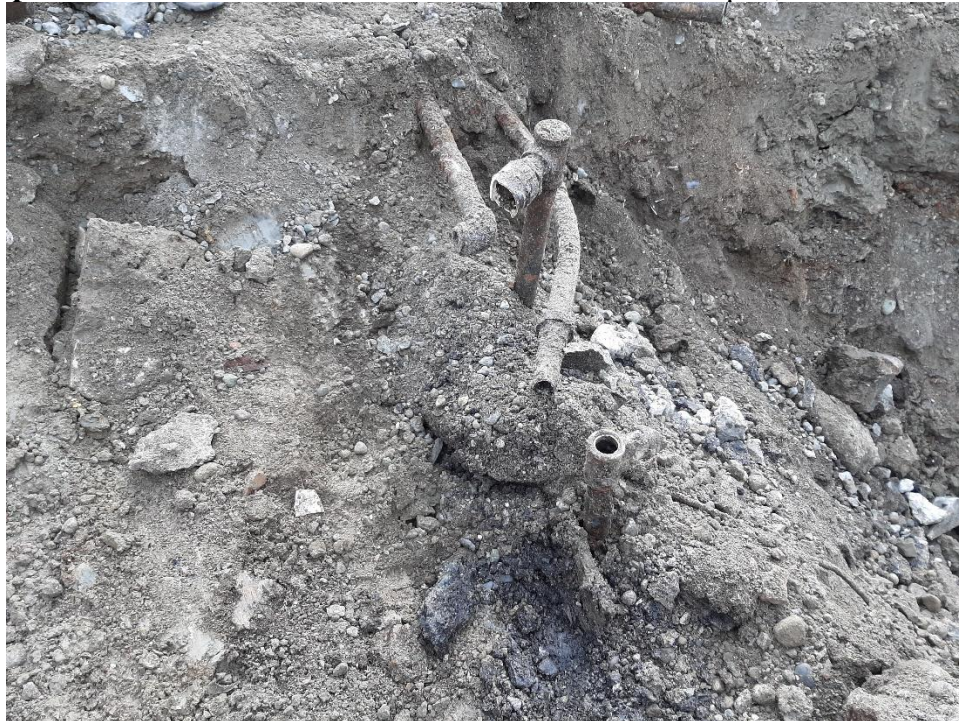
UST-A top-lines exhibited dark gray staining and Farallon observed a strong petroleum odor when the soil was excavated (Appendix C, Photograph 4). Farallon collected a residual product sample through the open fill port for waste characterization. Linescape performed an additional locate of the lines running from UST-A on March 10 using an energized trace. Conveyance pipe locations (based upon the magnetic trace performed by Linescape) are shown on Figure 2.

**Photograph 4:** Uncovering the top of UST-A and associated piping. Note, oil-soaked soil around lines at top of tank.

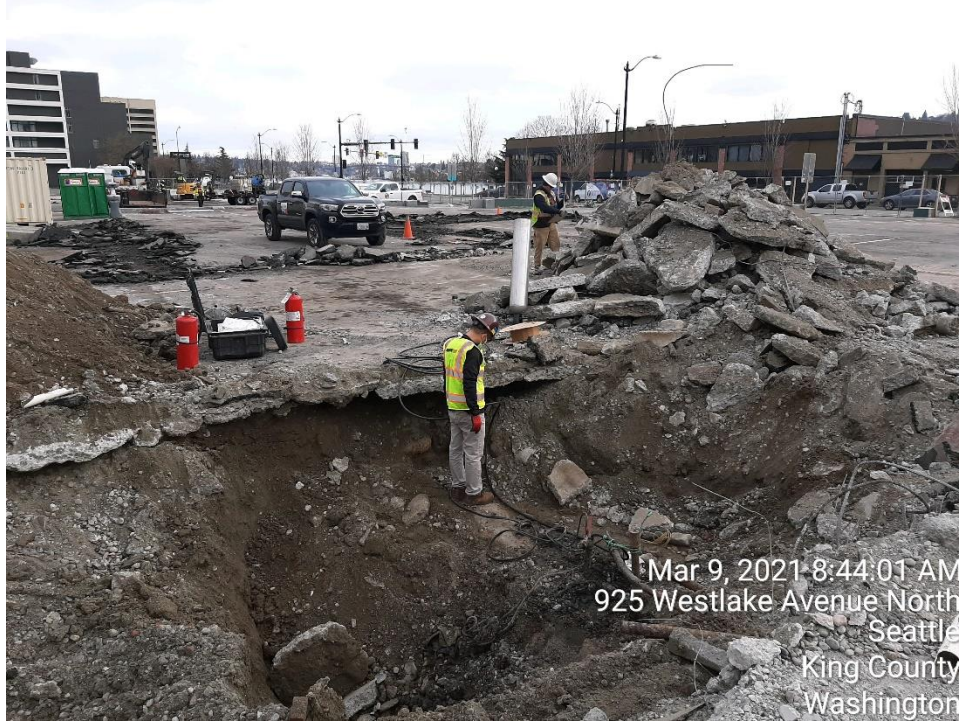
**Photograph 5: Marine Chemist inerting UST-A.**

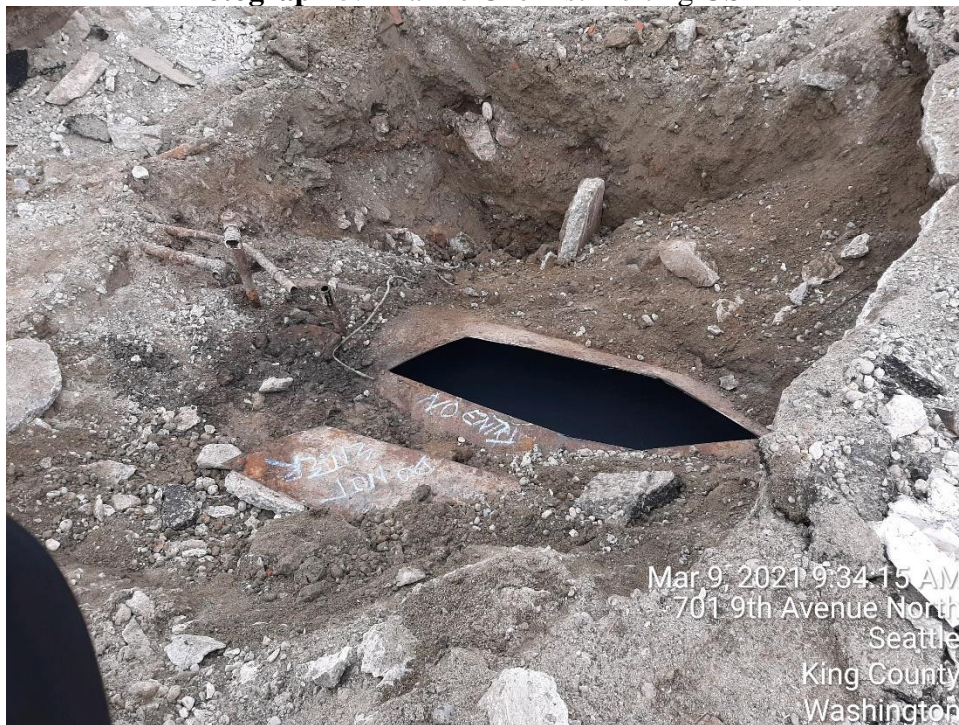
**Photograph 6: UST-A cut open for tank cleaning.**

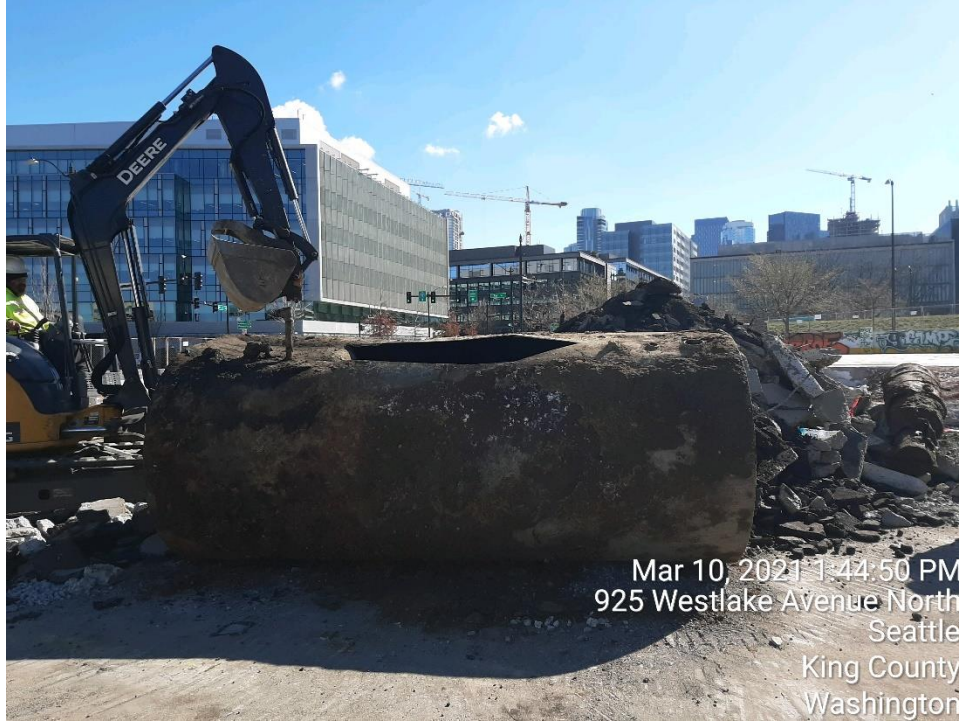
UST-A was removed on March 10, 2021 by CGI under Farallon and ECI supervision using an excavator with a "thumb" attachment to grasp the end of the tank and pull it from the ground (Appendix C, Photograph 7). Conveyance lines were cut, sealed, and capped at the edge of the excavation. At the time of removal, Farallon observed significant corrosion, including multiple holes ranging in diameter from 1 to 3 inches on the bottom of UST-A (Appendix C, Photograph 8). Following removal, Farallon observed heavily stained soil in the bottom of the UST-A excavation (Appendix C, Photograph 9). Based on the condition of the bottom of UST-A and the observed staining in the UST-A excavation, additional soil was removed from the bottom of the UST-A excavation on March 12, 2021 to a depth of approximately 13 feet bgs, at which depth petroleum product-saturated soil was observed. Ecology was notified of the product-saturated soil on March 13, 2021.

**Photograph 7:** UST-A removed from the ground.

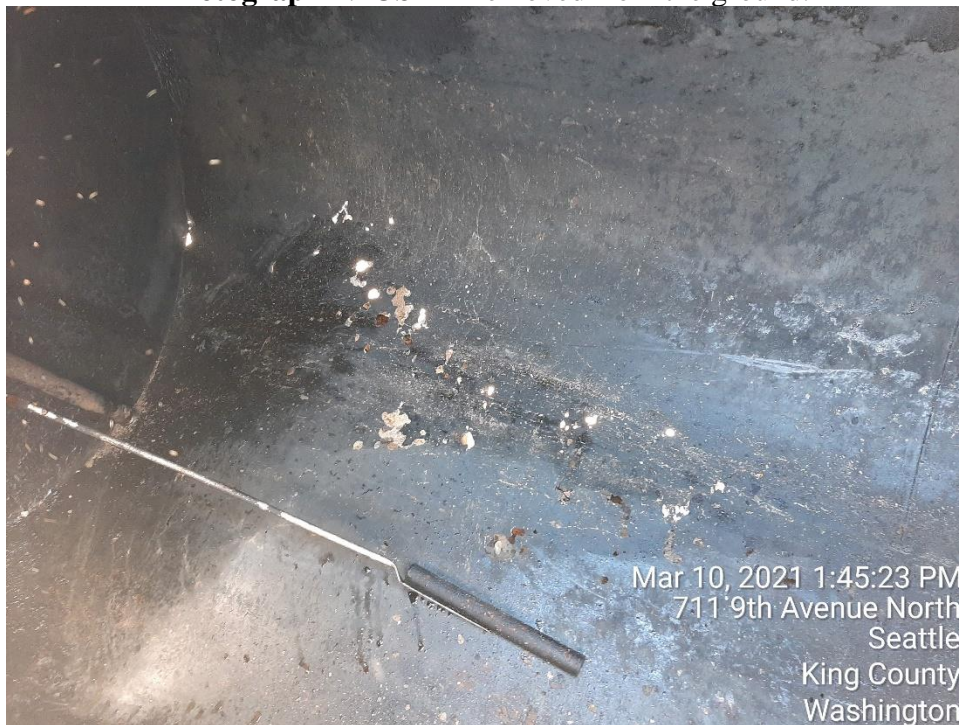
Permanent decommissioning and removal of UST-A was completed on March 10, 2021. UST-A was observed to be in poor condition at the time of removal and soil staining was observed in overburden and below the tank invert, which prompted removal of additional soil from the bottom of the UST-A excavation to a maximum depth of 15 feet below ground surface. Observations at the time of UST-A removal included stained and product-saturated soil, and soil sampling analytical results from the UST-A excavation confirmed a release of waste oil to soil and likely to groundwater below the UST.

**Photograph 8:** Holes in the bottom of UST-A.

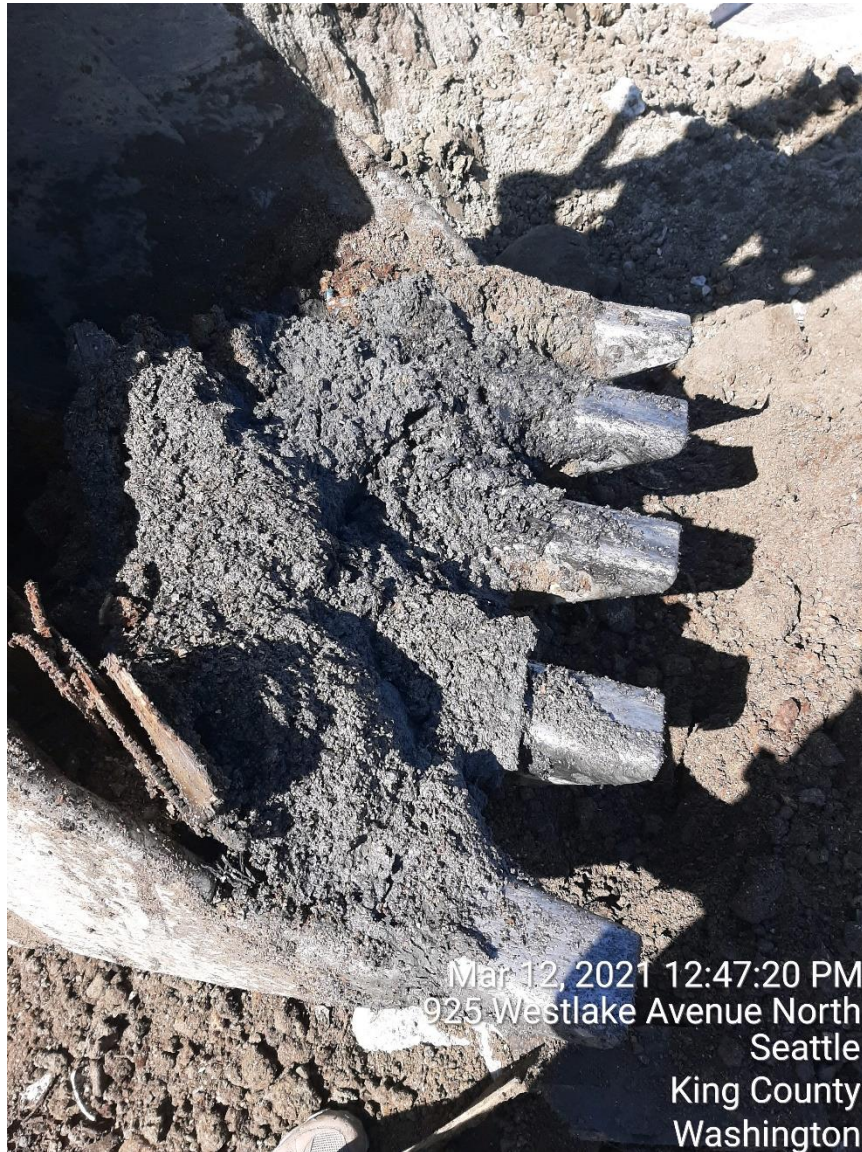
poor condition at the time of removal and soil staining was observed in both overburden and below the tank invert, which prompted removal of additional soil from the bottom of the UST-A excavation to a maximum depth of 15 feet bgs. Product-saturated soil was observed in the excavation on March 12, 2021 at depths between 13 and 15 feet bgs and was removed to the maximum extent practicable. Ecology was notified of the product-saturated soil on March 13, 2021, and of the confirmed release from UST-A on April 7, 2021. Analytical results from soil sampling in the UST-A excavation and visual observations confirmed a release of waste oil from UST-A that has contaminated soil and likely groundwater on the Ducati Property.

**Photograph 9:** Below left. Soil from UST-A below tank location, at a depth of 15 feet bgs.

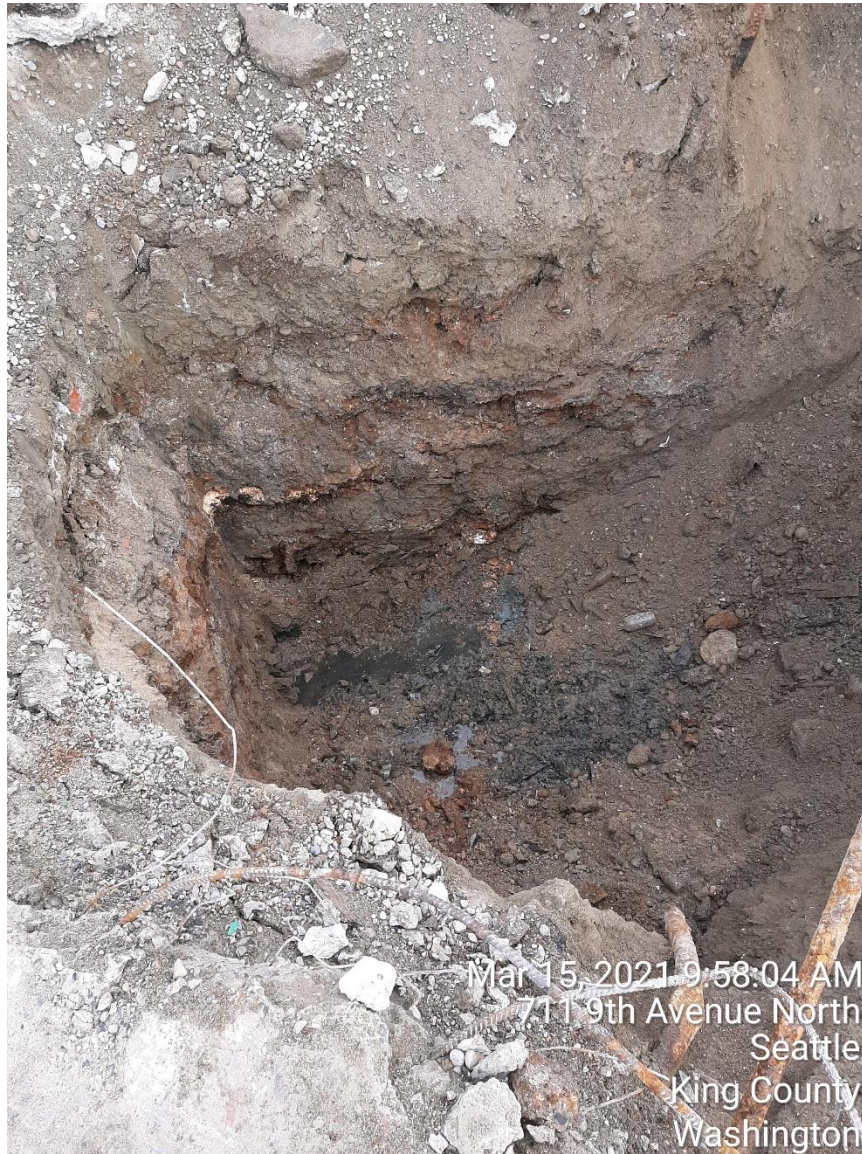
**Photograph 10:** Above right. Groundwater with sheen entering southwestern corner of UST-A excavation at a depth of 15 feet bgs.

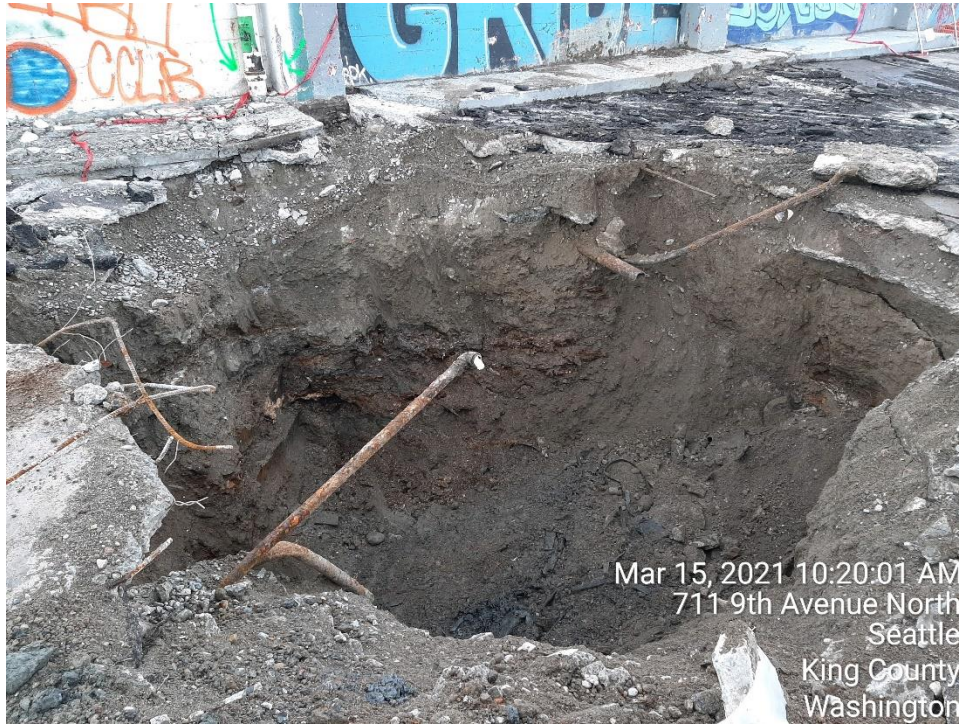
**Photograph 11:** Capped lines at the UST-A excavation.

Permanent decommissioning and removal of UST-A were performed March 8 through 10, 2021. UST-A was located directly underneath the previously identified waste oil sump on the Ducati Property and was observed to contain residual product that analytical results confirmed to be waste oil (Figure 2). UST-A was inerted, cleaned, and removed on March 10, 2021 in accordance with Ecology Guidance and applicable requirements. Conveyance lines to UST-A were cut, sealed, and capped at the edge of the excavation (Appendix C, Photograph 11). UST-A was observed to be in

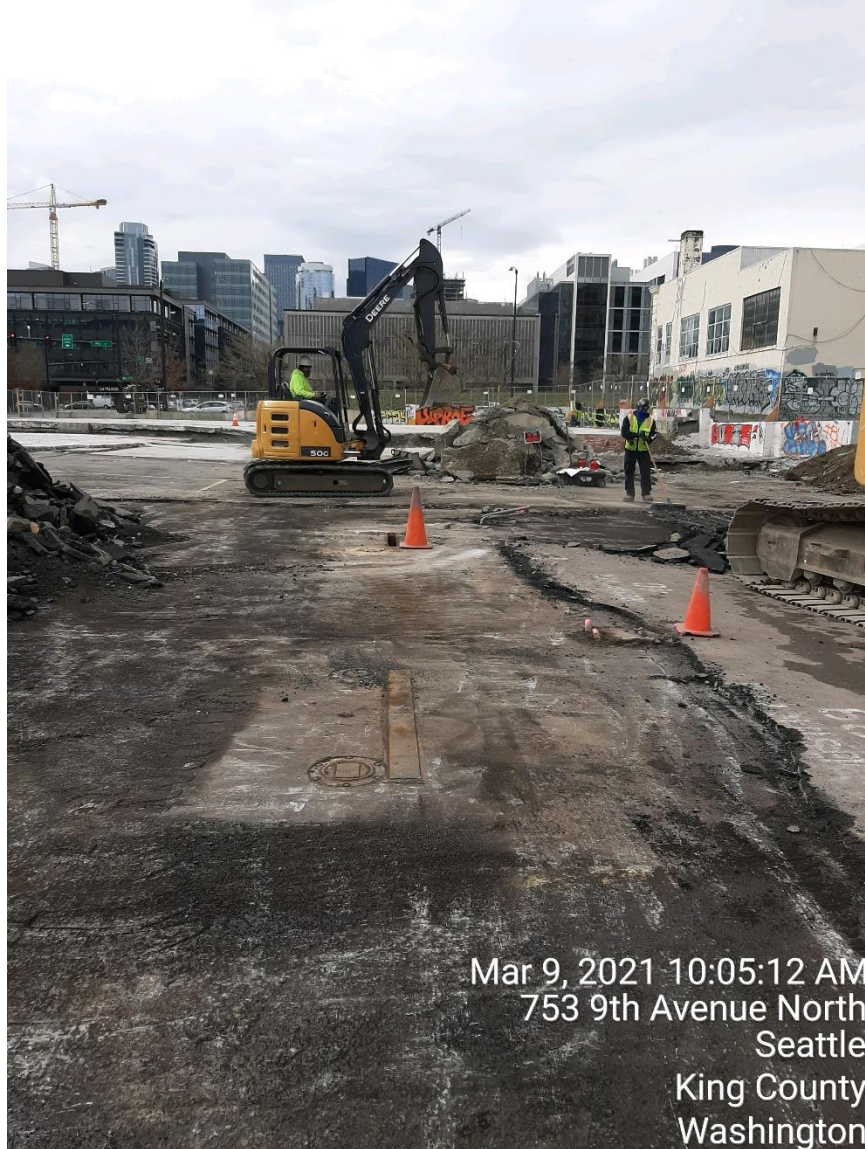
**Photograph 13:** Below left. Hoist-1 (background) and Hoist-2 (foreground) from the north before concrete demolition.

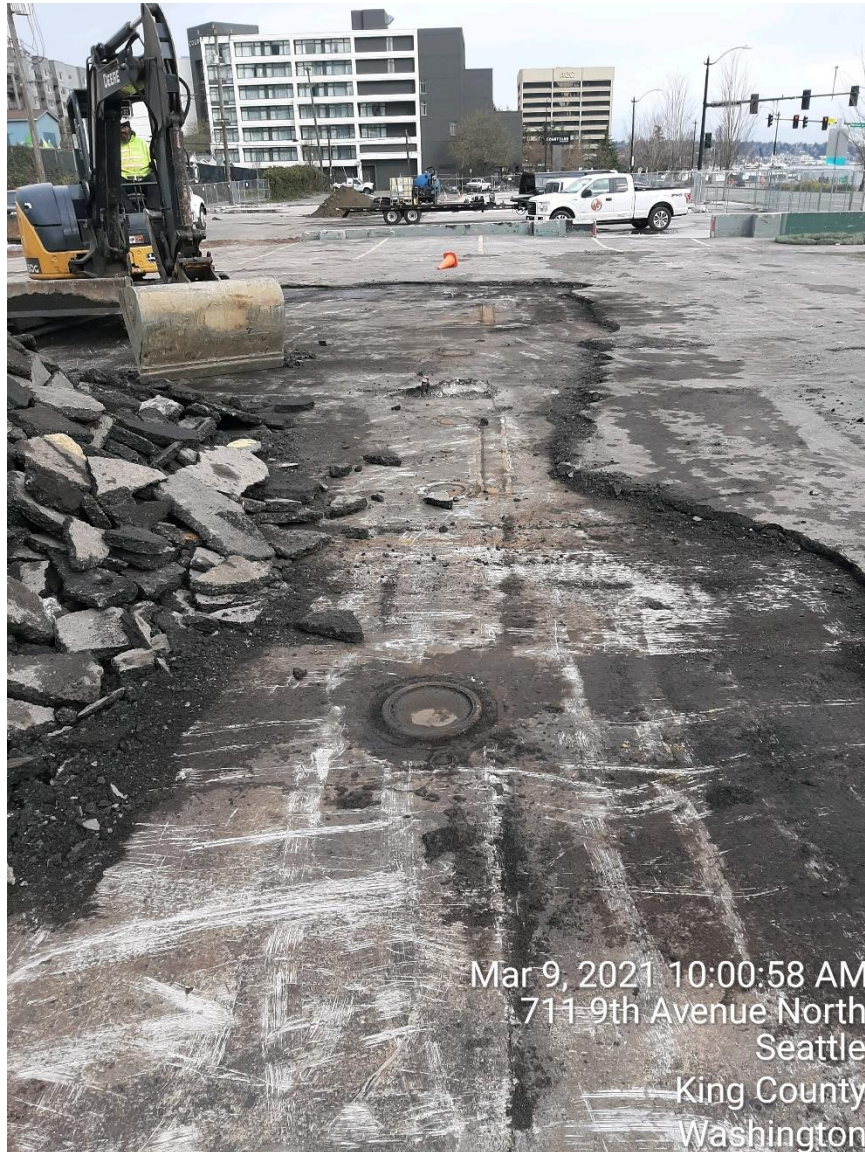
**Photograph 14:** Above right. Hoist-S2, Hoist-4, Hoist-S1, and Hoist-3 from the south before concrete demolition.

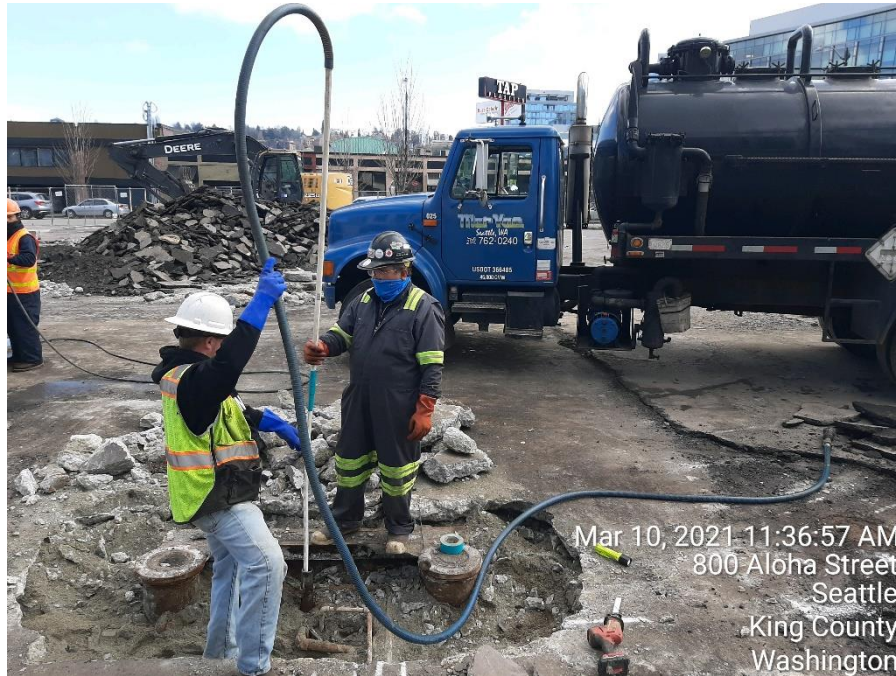
**Photograph 15:** Mar-Vac removing oil from accessible hoist reservoir fill lines.

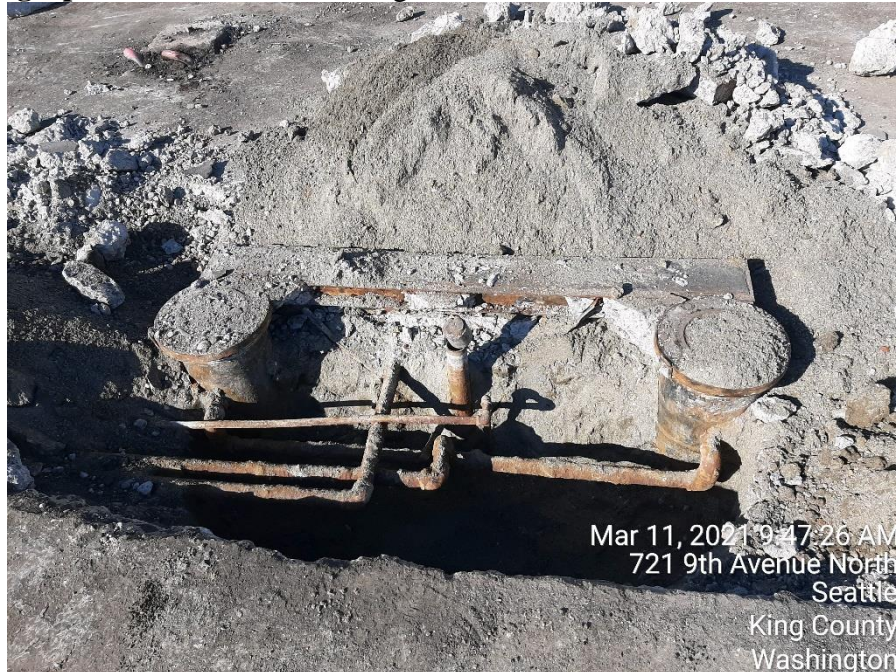
- Hoist-2, removed March 11, 2021: Stained soil was observed at the bottom of the excavation, and additional soil was excavated until no visual impacts were observed.

**Photograph 16:** Hoist-2 lines exposed.

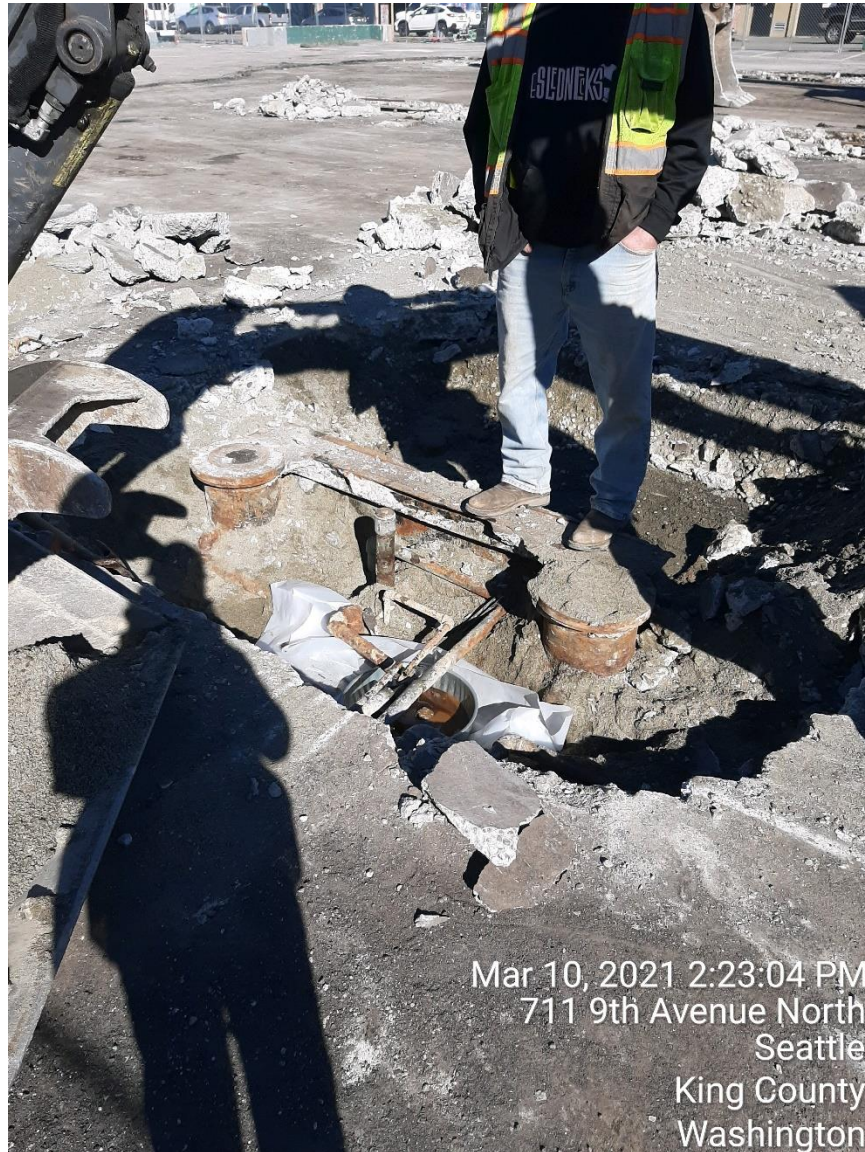
**Photograph 17:** Below left. ECI cutting lines at Hoist-5 and draining remaining oil.

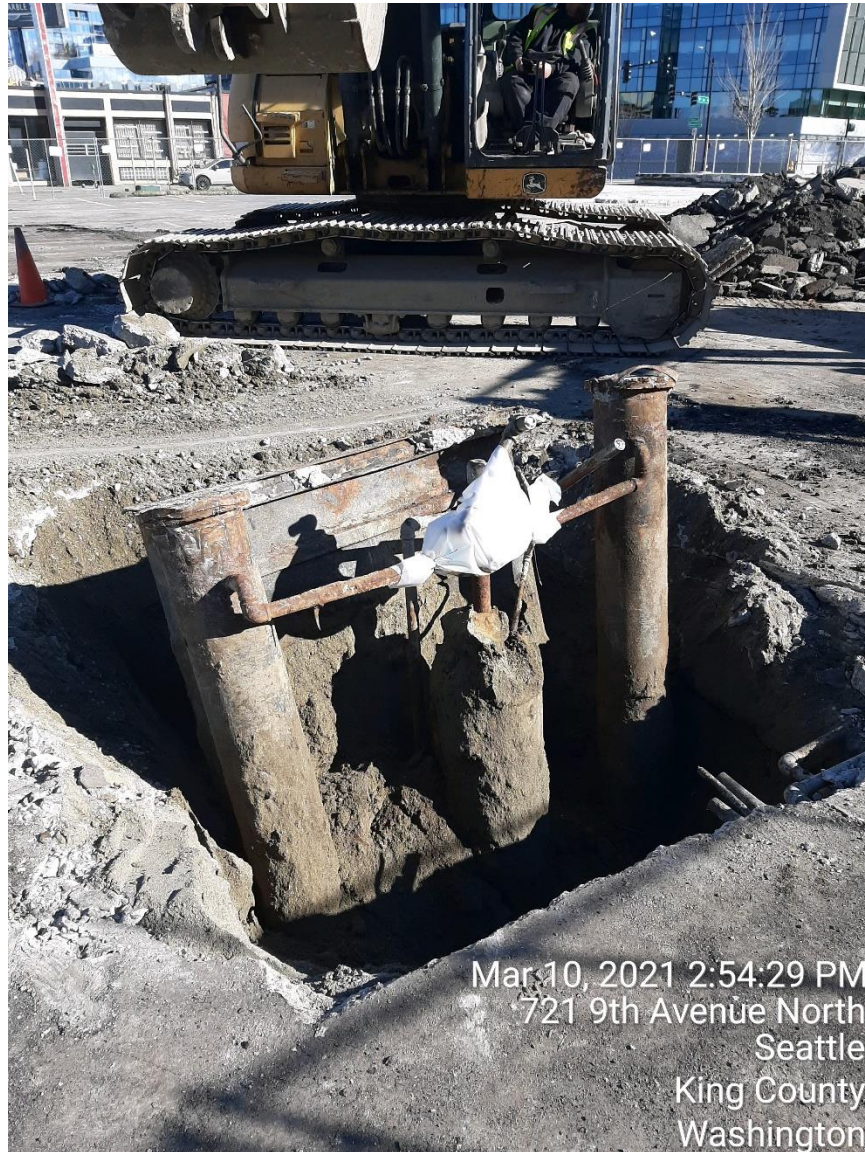
- Hoist-5, removed March 10, 2021: No soil staining or odor was observed.
- Hoist-6, removed March 12, 2021: Corrosion and holes were observed in the conveyance line to hoist cylinders, and additional product removal was performed.

**Photograph 18:** Above right. Hoist-5 being pulled from the ground.

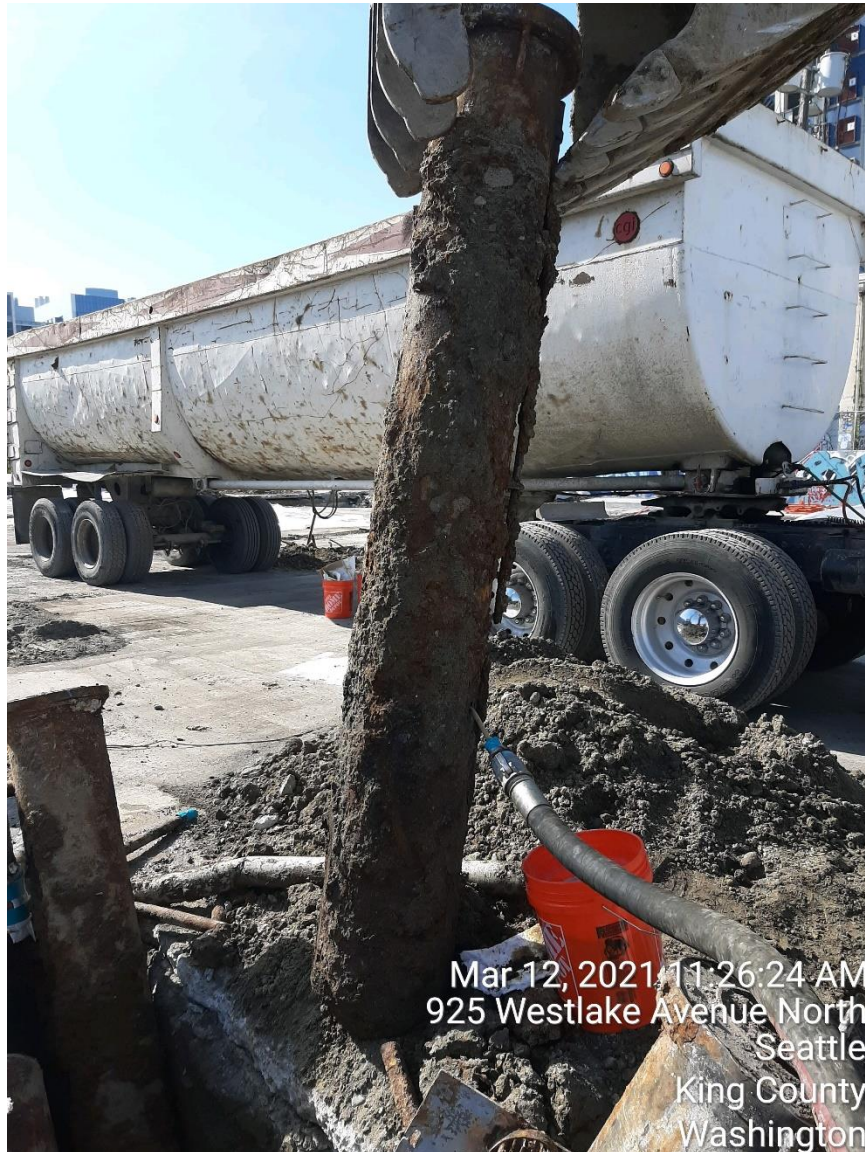
- Hoist-3, removed March 12, 2021: The hoist was observed to be leaking during removal, and additional product removal was performed.
- Hoist-4, removed March 11, 2021: No soil staining or odor was observed.

**Photograph 19:** ECI drains oil from leaking hole in Hoist-3 cylinder.

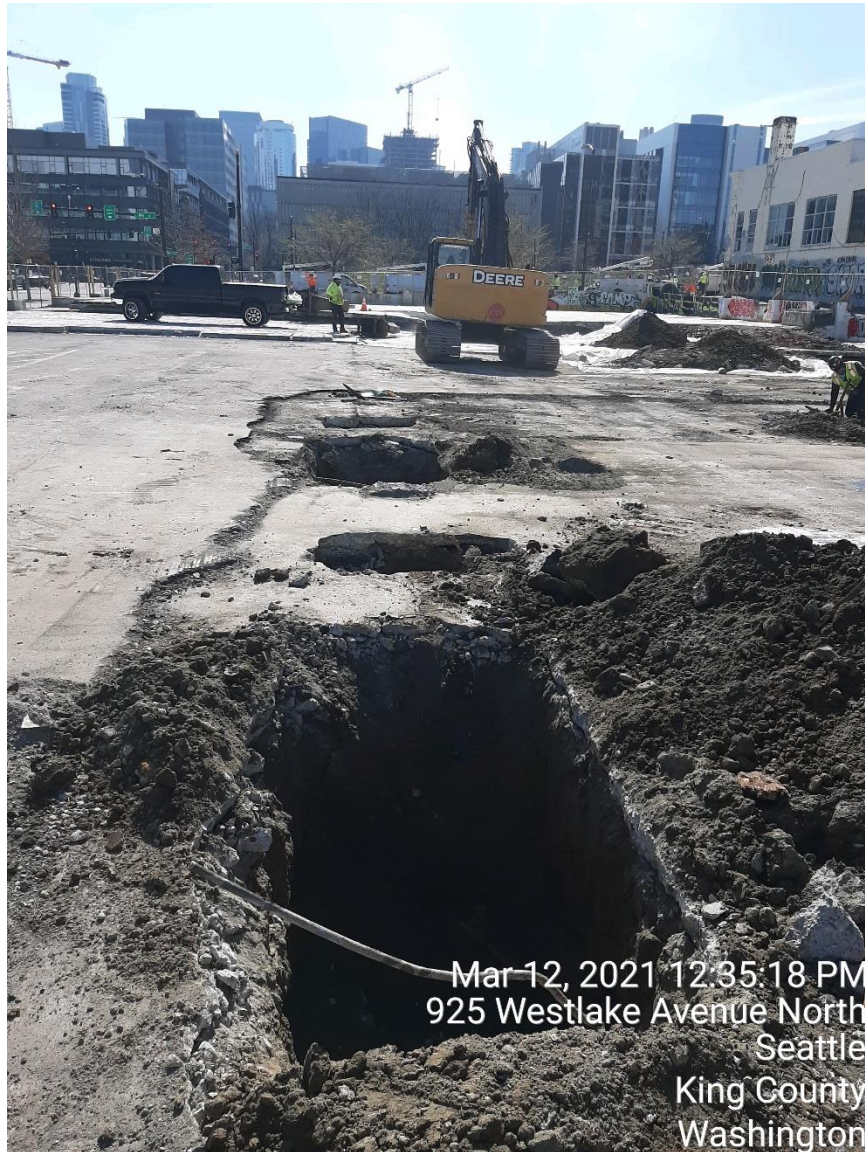
**Photograph 20:** Hoist-3 excavation in foreground viewed from the north. Hoist-S1, Hoist-4, and Hoist-S2 excavation visible behind it.

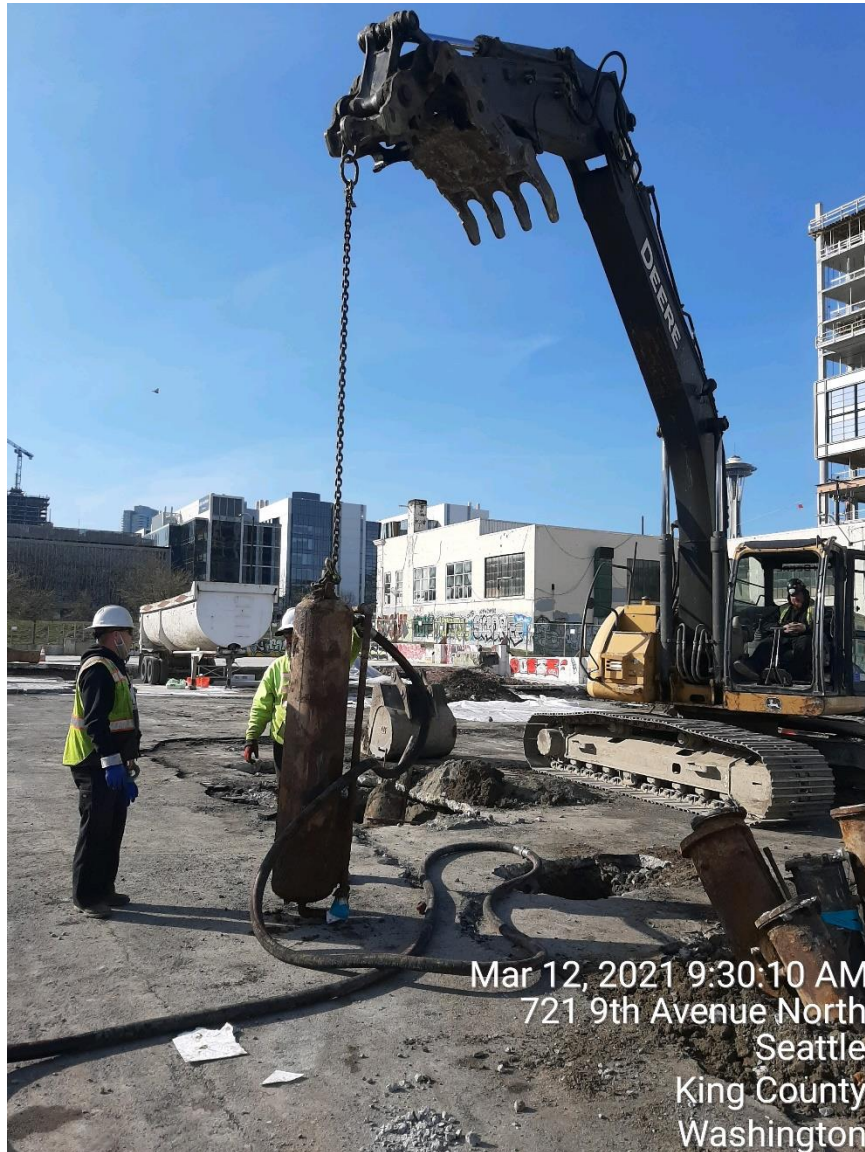
**Photograph 22:** ECI vacuums oil from Hoist-6 cylinder.

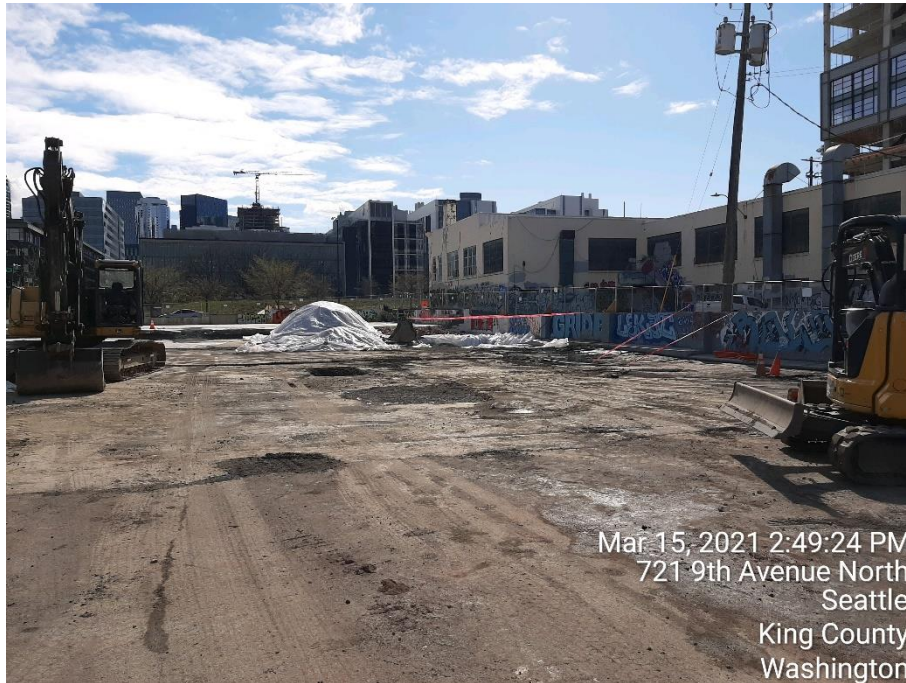
**Photograph 24:** Western hoists lined, backfilled, and compacted.
