APPENDIX C
BORING LOGS

REMEDIAL INVESTIGATION WORK PLAN

Block 79 East Site
701, 739, 753 9th Avenue North
Seattle, Washington

Farallon PN: 397-035

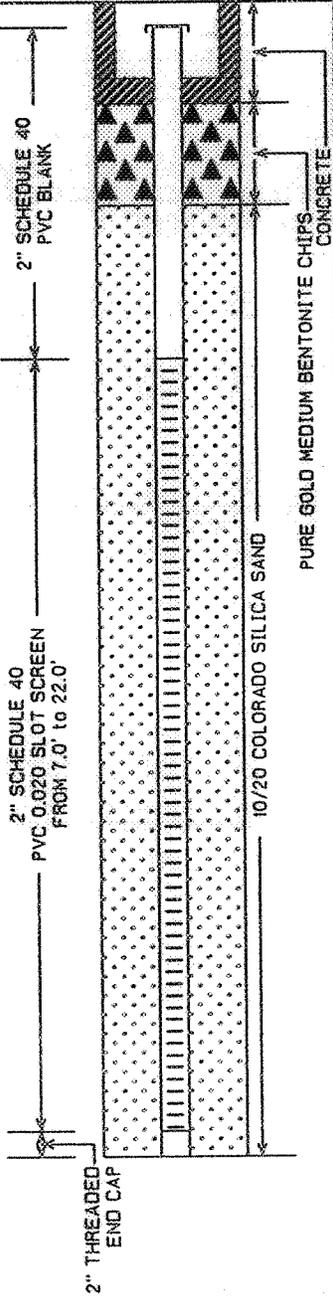
DEPTH (in feet)	WELL CONSTRUCTION		SOIL DESCRIPTION		SAMPLE DATA				
	U.S.C.S.	LITHOLOGY	TYPE	DEPTH	BLOWS /ft	%RECOVERY	PID (ppm)		
0 - 1.5		ASPHALT & GRAVEL							
1.5 - 3.5		FILL: Silty sand; dark gray-brown; fine to medium sand; little wood debris; soft; moist	SS	11 1 2	30				
3.5 - 7.5		FILL: Silty sand; gray-green; fine to medium sand; trace fine gravel; very soft; moist; no odor	SS	7 7 9	20				
7.5 - 11.5		FILL: Silty sand; gray-green; fine to medium sand; trace fine gravel; very soft; wet; no odor	SS	4 4 4	10				
11.5 - 15.5		FILL: Silty sand; gray-green; fine to medium sand; trace fine gravel; very soft	SS	5 6 9	10				
15.5 - 20.5	ML	SANDY SILT: Green-gray; very fine to fine sand; medium dense; wet; no odor							
20.5 - 22.5	SM	SILTY SAND: Green-gray; very fine to medium sand; stiff; moist; no odor	SS	12 13 19					
Total Depth = 24'

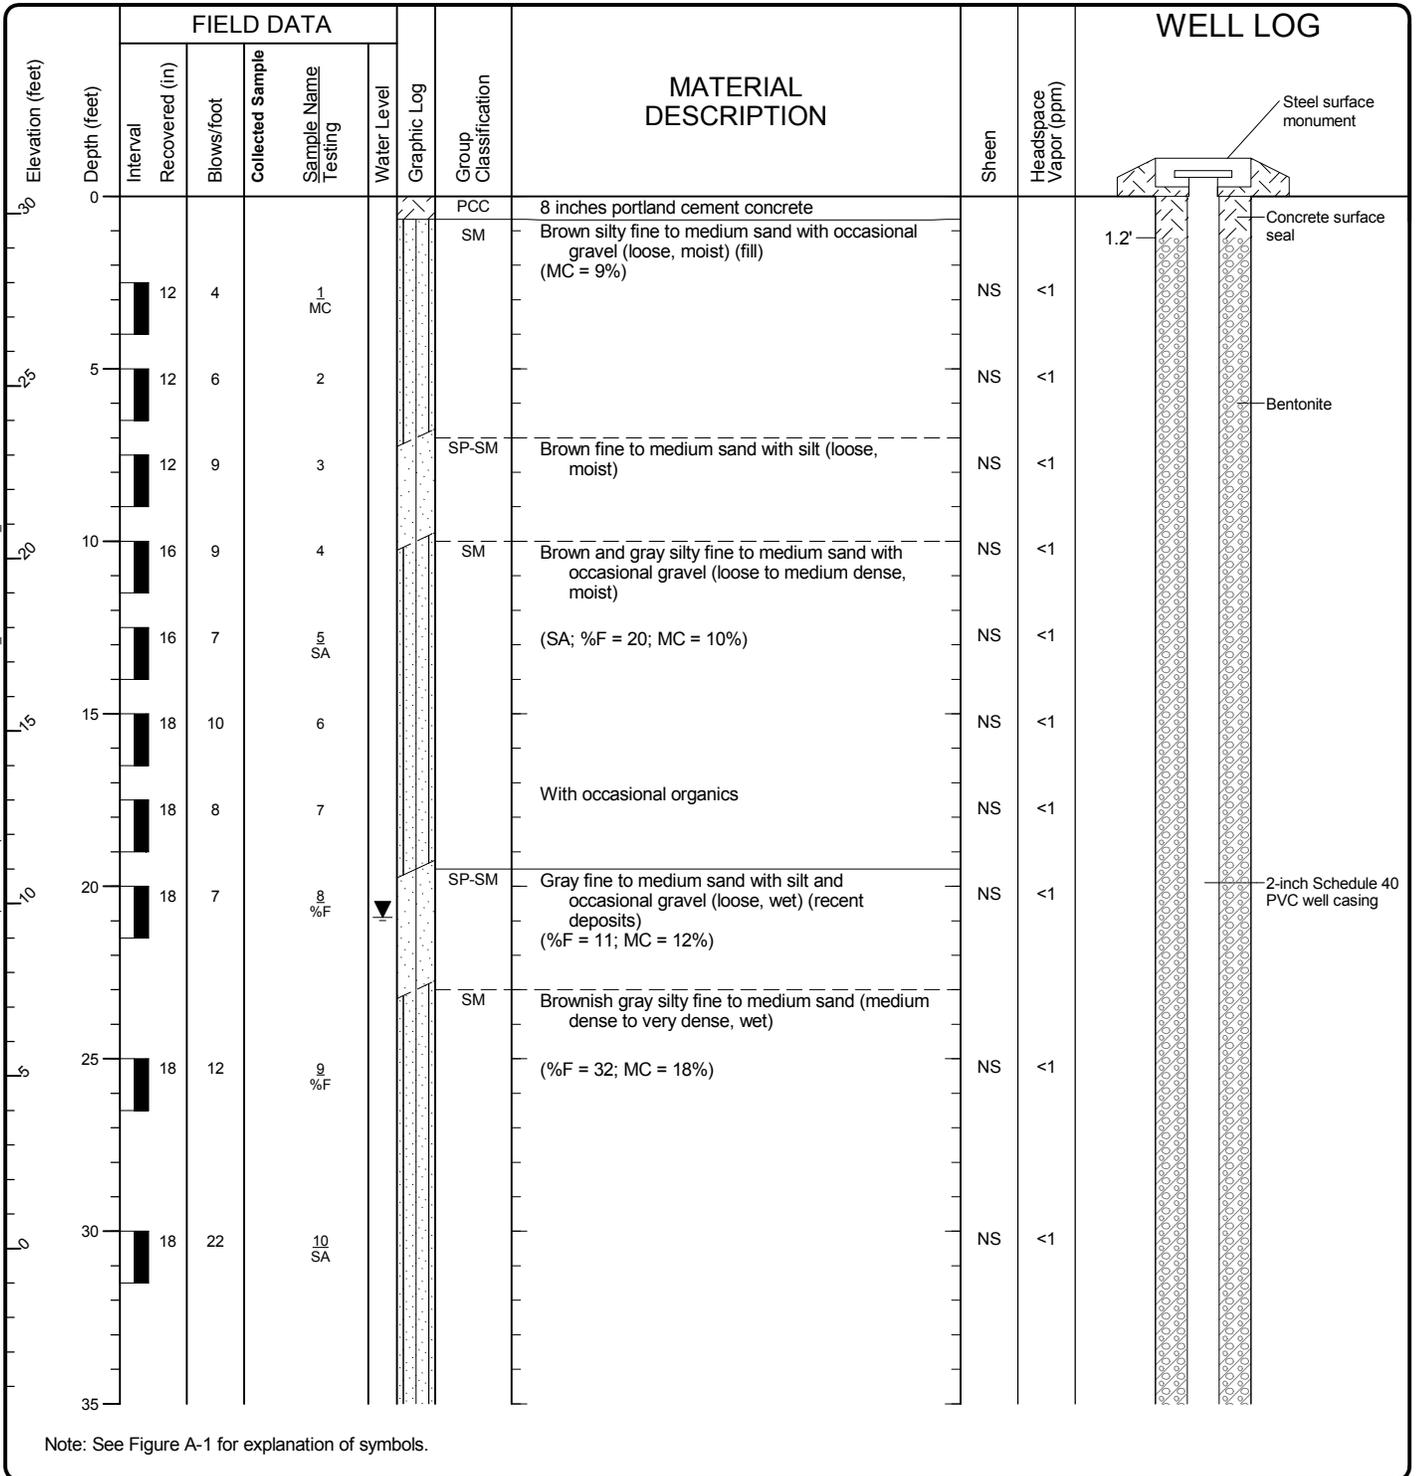
Log of Monitoring Well MW-1

Start Drilled 8/22/2014	End 8/22/2014	Total Depth (ft) 61.5	Logged By Checked By GP DPC	Driller Geologic Drill, Inc.	Drilling Method Hollow-Stem Auger
Hammer Data Autohammer 140 (lbs) / 30 (in) Drop	Drilling Equipment Diedrich D50 Turbo	DOE Well I.D.: BIJ 490 A 2 (in) well was installed on 8/22/2014 to a depth of 59.8 (ft).			
Surface Elevation (ft) Vertical Datum 30.5 NAVD88	Top of Casing Elevation (ft) 30.10	Groundwater Date Measured 9/6/2014	Depth to Water (ft) 20.9	Elevation (ft) 9.6	
Easting (X) Northing (Y)	Horizontal Datum	Notes:

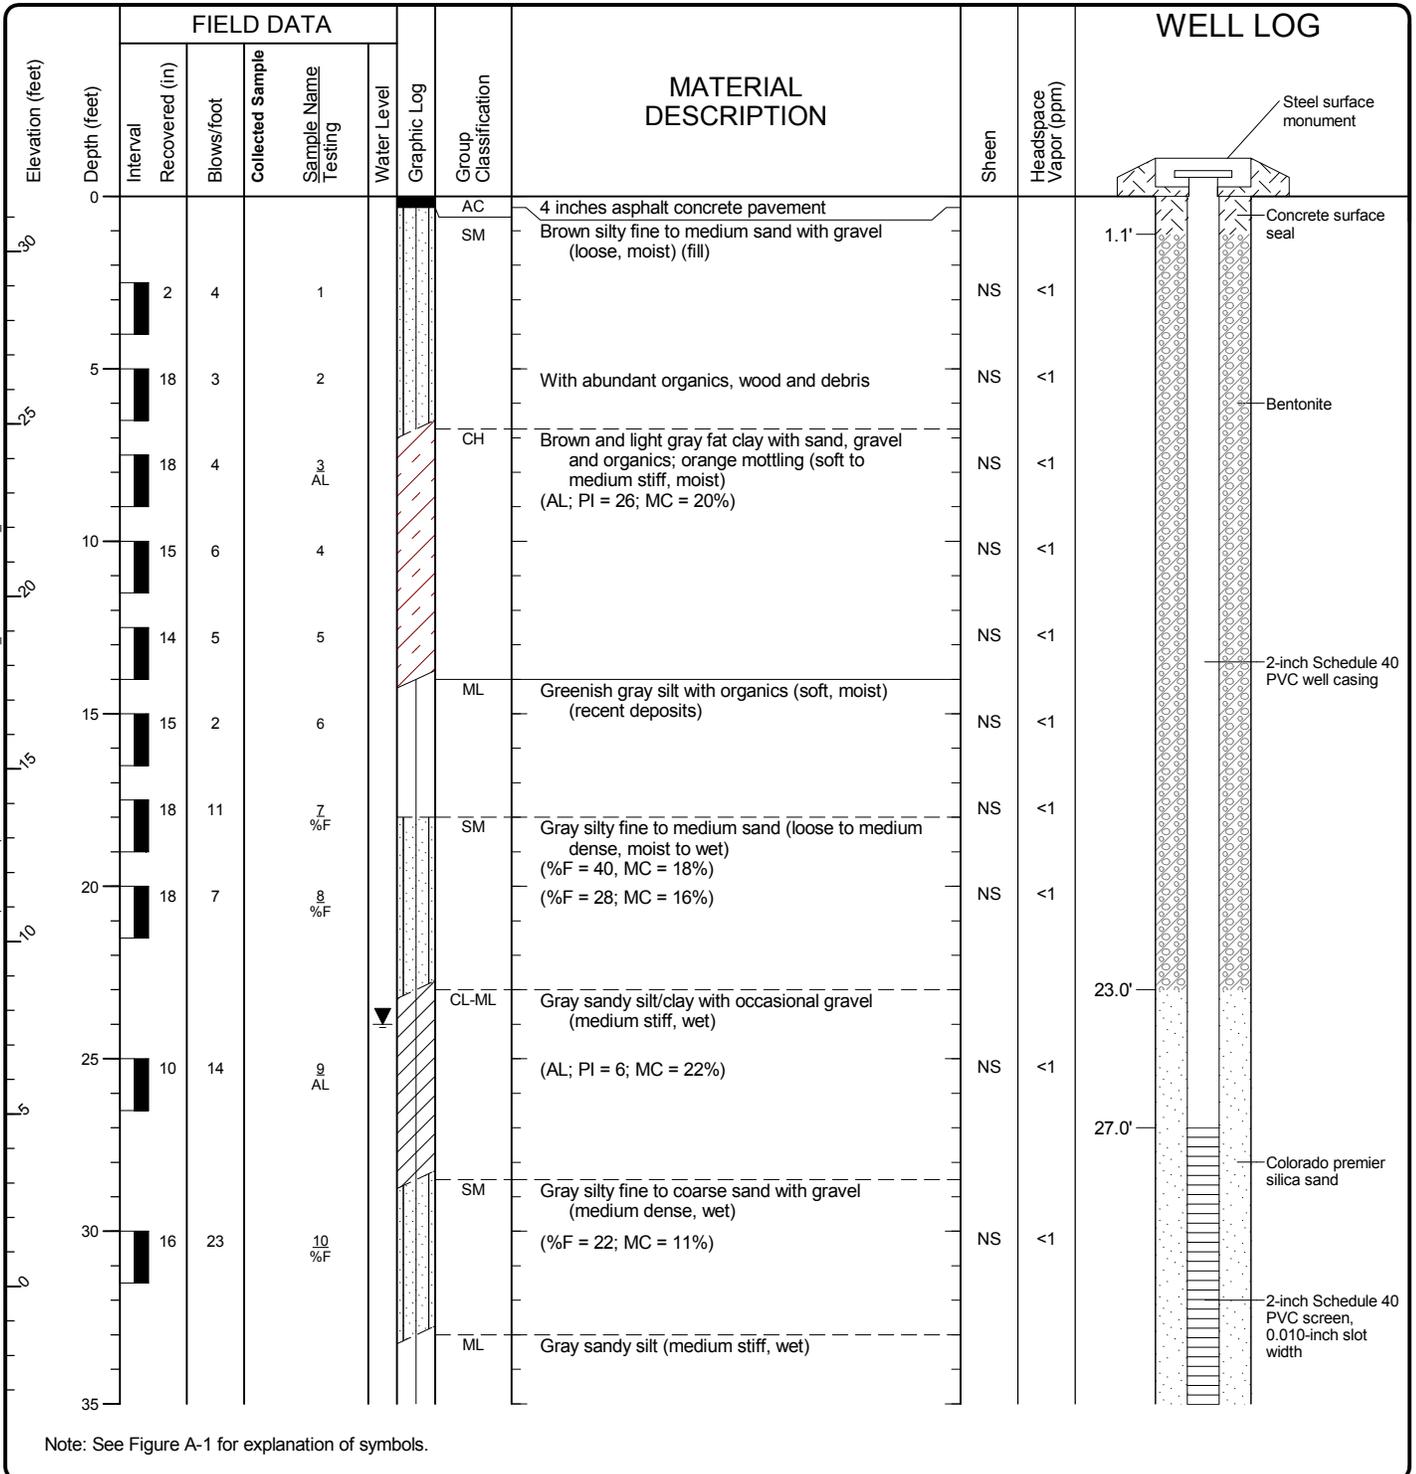
Log of Monitoring Well MW-2

Drilled	Start 8/23/2014	End 8/23/2014	Total Depth (ft)	60	Logged By Checked By	GP DPC	Driller	Geologic Drill, Inc.	Drilling Method	Hollow-Stem Auger
Hammer Data	Autohammer 140 (lbs) / 30 (in) Drop		Drilling Equipment		Diedrich D50 Turbo		DOE Well I.D.: BIJ 492 A 2 (in) well was installed on 8/23/2014 to a depth of 37 (ft).			
Surface Elevation (ft)		31.6		Top of Casing Elevation (ft)		31.00		Groundwater		
Vertical Datum		NAVD88		Date Measured		9/6/2014		Depth to Water (ft)		Elevation (ft)
Easting (X) Northing (Y)		Horizontal Datum		Date Measured		9/6/2014		Depth to Water (ft)		Elevation (ft)
								24.0		7.6
Notes:

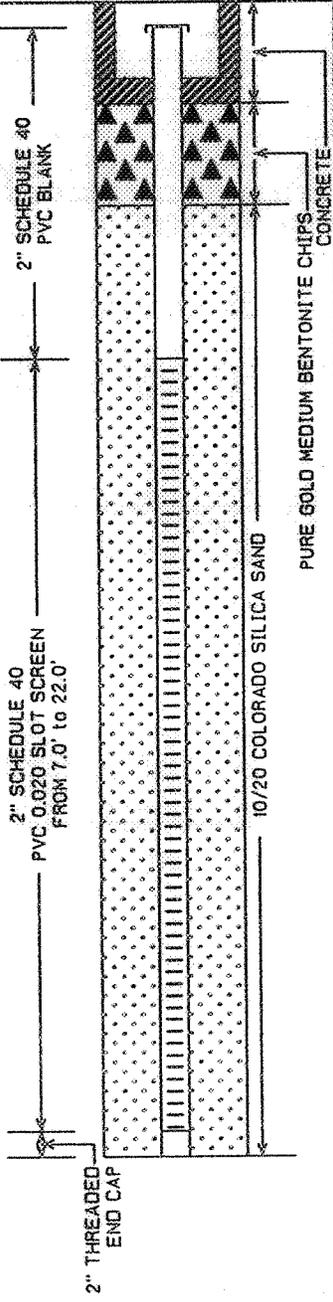
21.5 - 22.5	SM	SILTY SAND: Green-gray; very fine to medium sand; stiff; moist; no odor	SS	12 13 19					
Total Depth = 24'

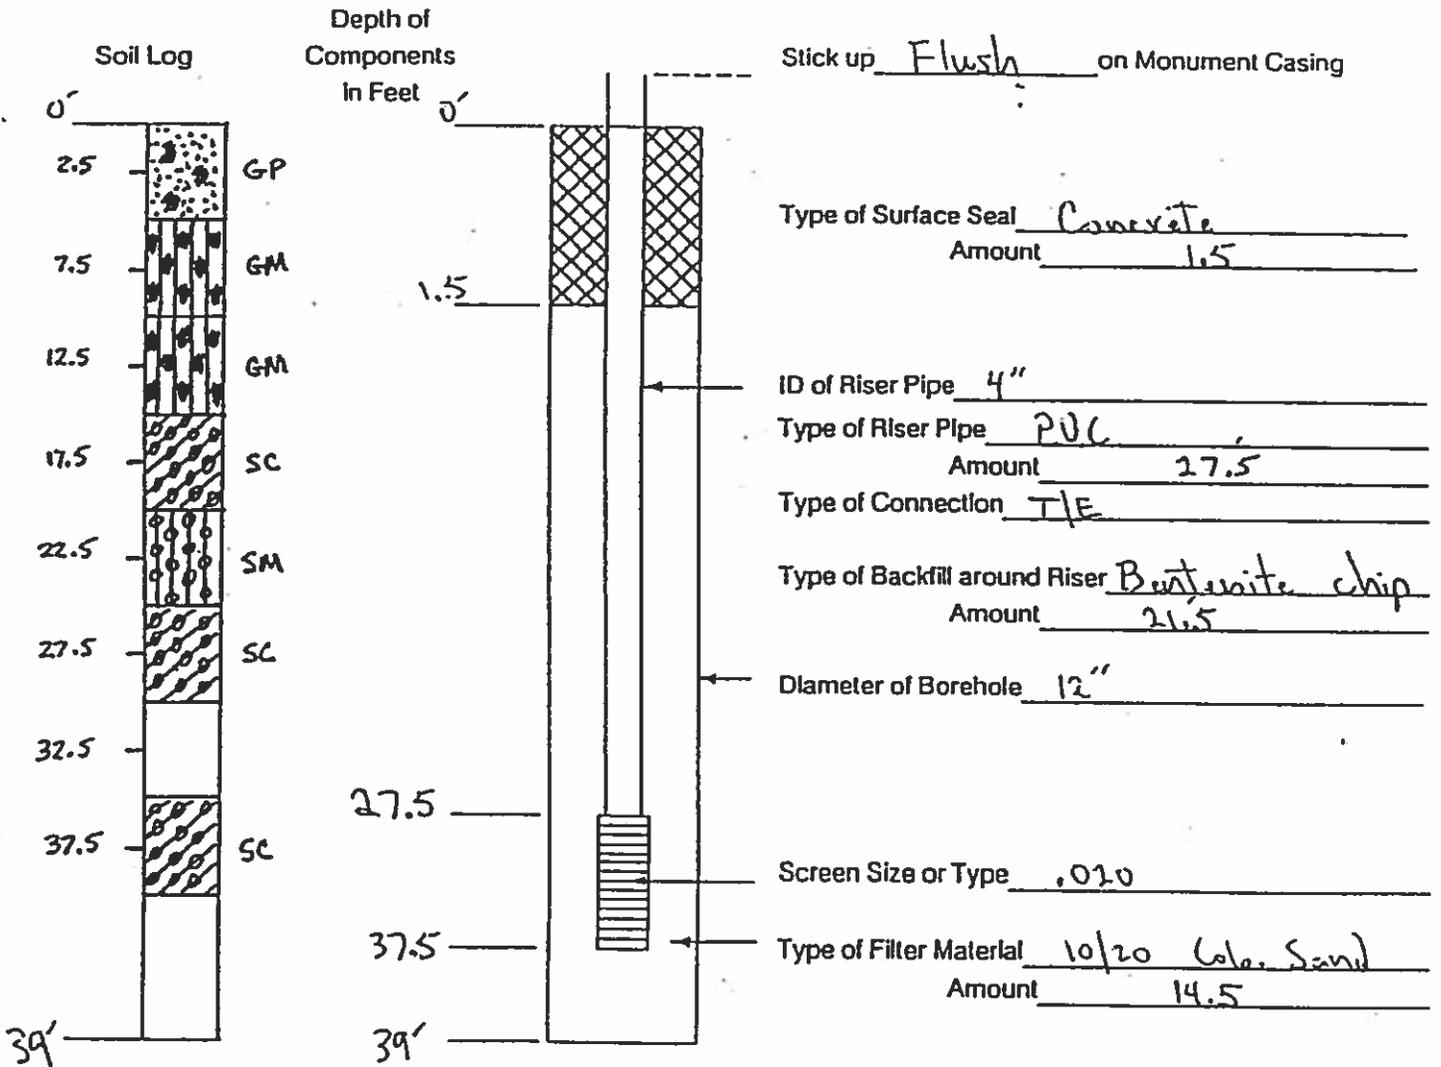
Remarks: Monitoring Well #2, Boring #4
Sample not available at 32.5 due to debris in hole.

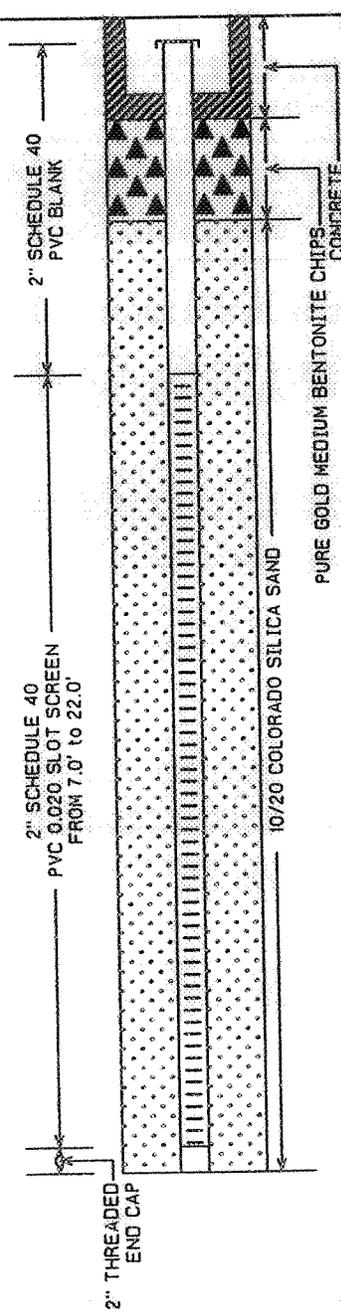
21.5 - 24.5		in addition to an apparent substantial silt layer, recovery consisted mainly of wood	SS	5 5 20	10				
24.5 - 25.5		Total Depth = 24'

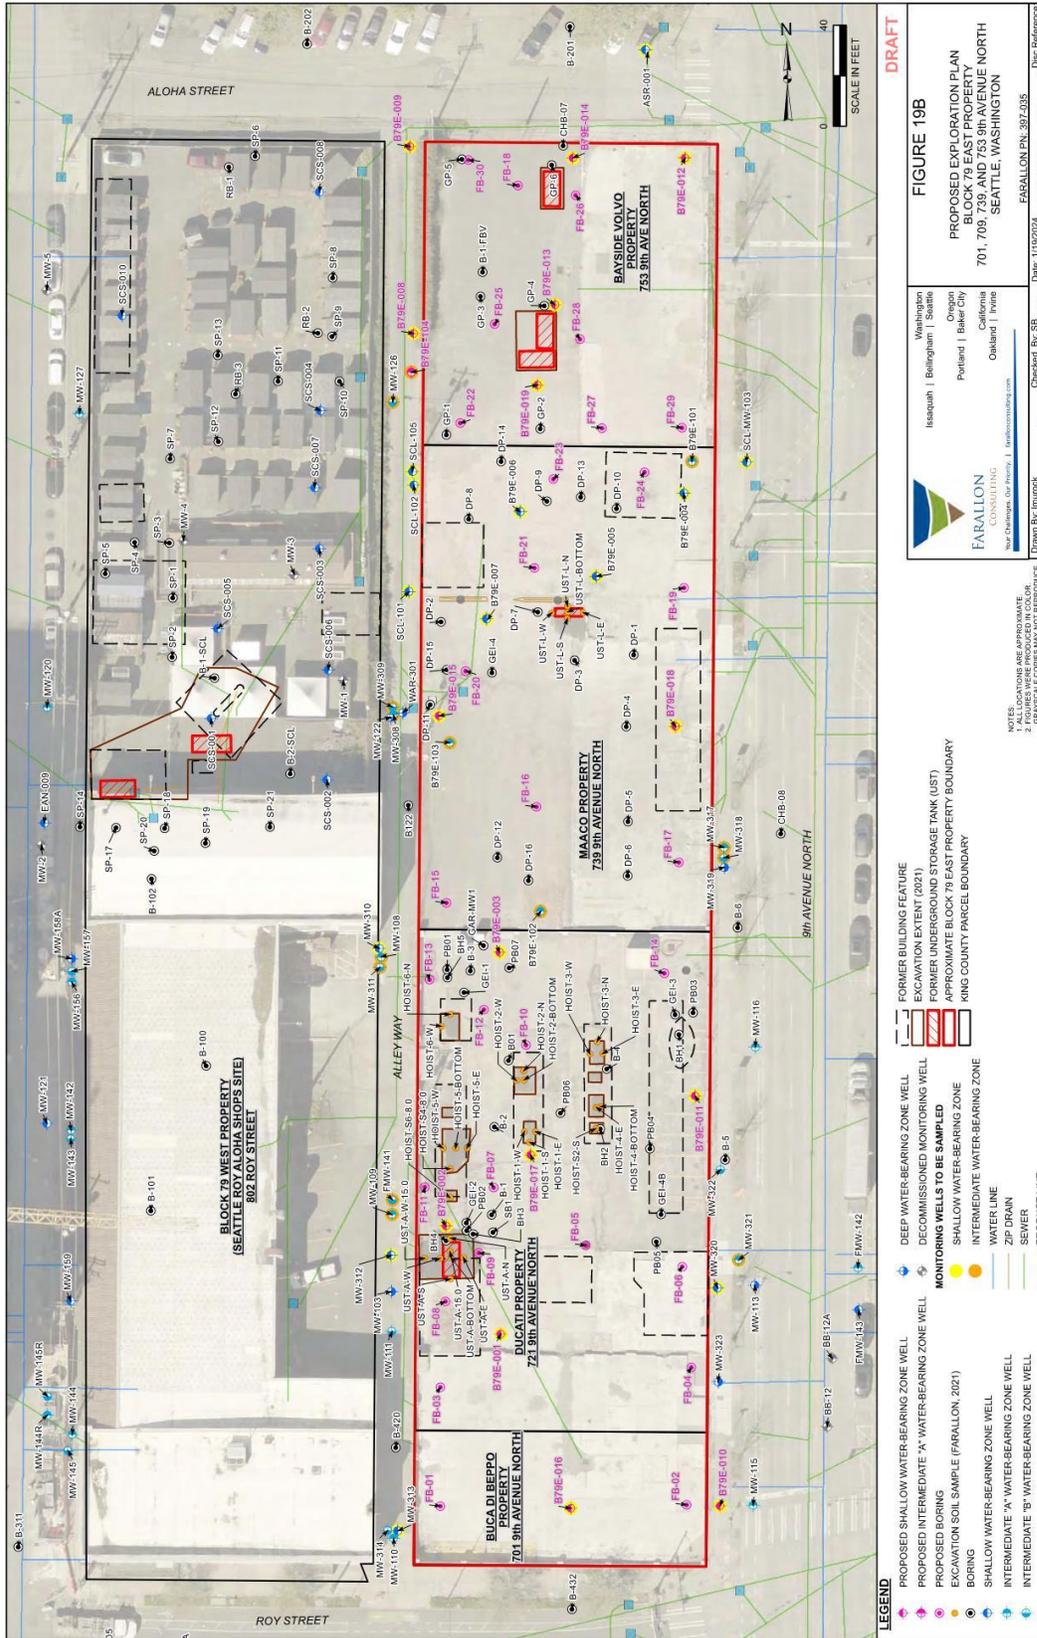
Figure 2. Proposed exploration plan showing existing and proposed boring locations.
