Independent Soil Remediation Diesel Fuel Spill

741 Urban Industrial Way East Wenatchee, Washington

Project Number: 244060.00

February 16, 2024 Revised: February 28, 2024

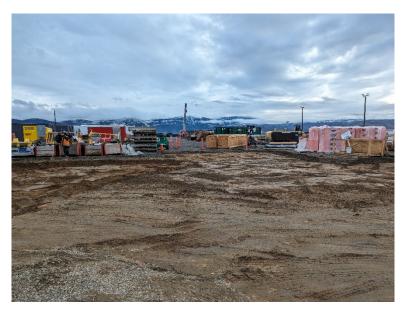
The diesel spill occurred in a construction laydown area. Gravel was removed and underlying soil was field screened for diesel impact.

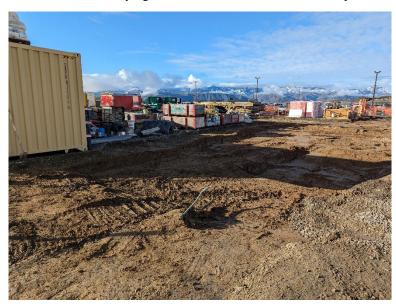
The spill occurred in a graveled area. About 1-foot of impacted gravel and soil was removed throughout the remedial excavation.

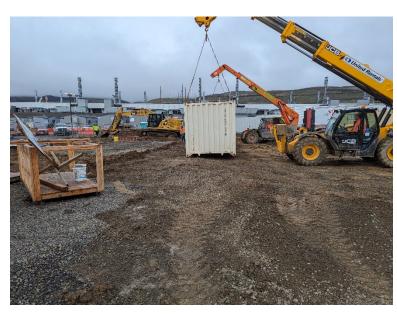
The spill occurred while fueling a portable fuel tank from a tanker truck. Storage containers were relocated to access soils.

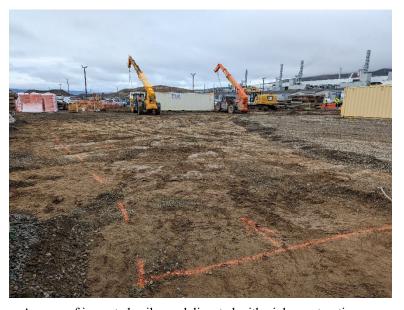
An area of impacted soil was delineated with pink construction paint prior to excavation.

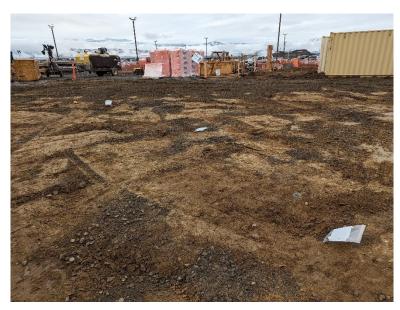
Field screening samples were collected in resealable plastic bags and evaluated for petroleum impact.

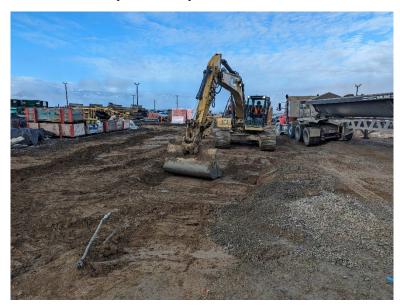
Petroleum impact was observed to extend to a maximum of 3-feet bgs in the east portion, in the vicinity of where the spill occurred.

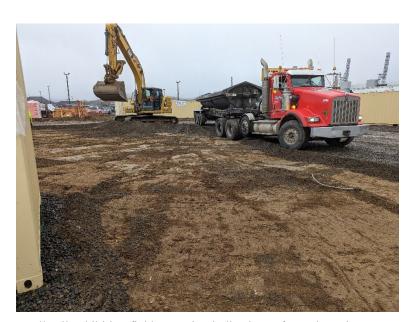
All soil exhibiting field screening indications of petroleum impact was excavated for disposal at Greater Wenatchee Landfill.

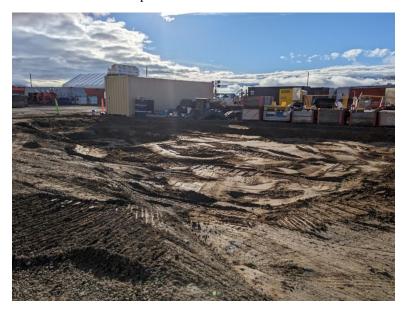
View of the final excavation looking southeast. Laboratory analytical determined all petroleum impacted soil was excavated.

In Fulcrum's opinion, no further remedial action is necessary to address the diesel spill. Fulcrum recommends that a copy of this remediation report be retained by all parties.
