**Re: No Further Action opinion for the following contaminated Site**

**Site name:** Monroe Auto Salvage  
**Site address:** 426 E Fremont St, Monroe, Snohomish County, WA 98272  
**Facility/Site ID:** 2753  
**Cleanup Site ID:** 4539  
**VCP Project No.:** NW3251

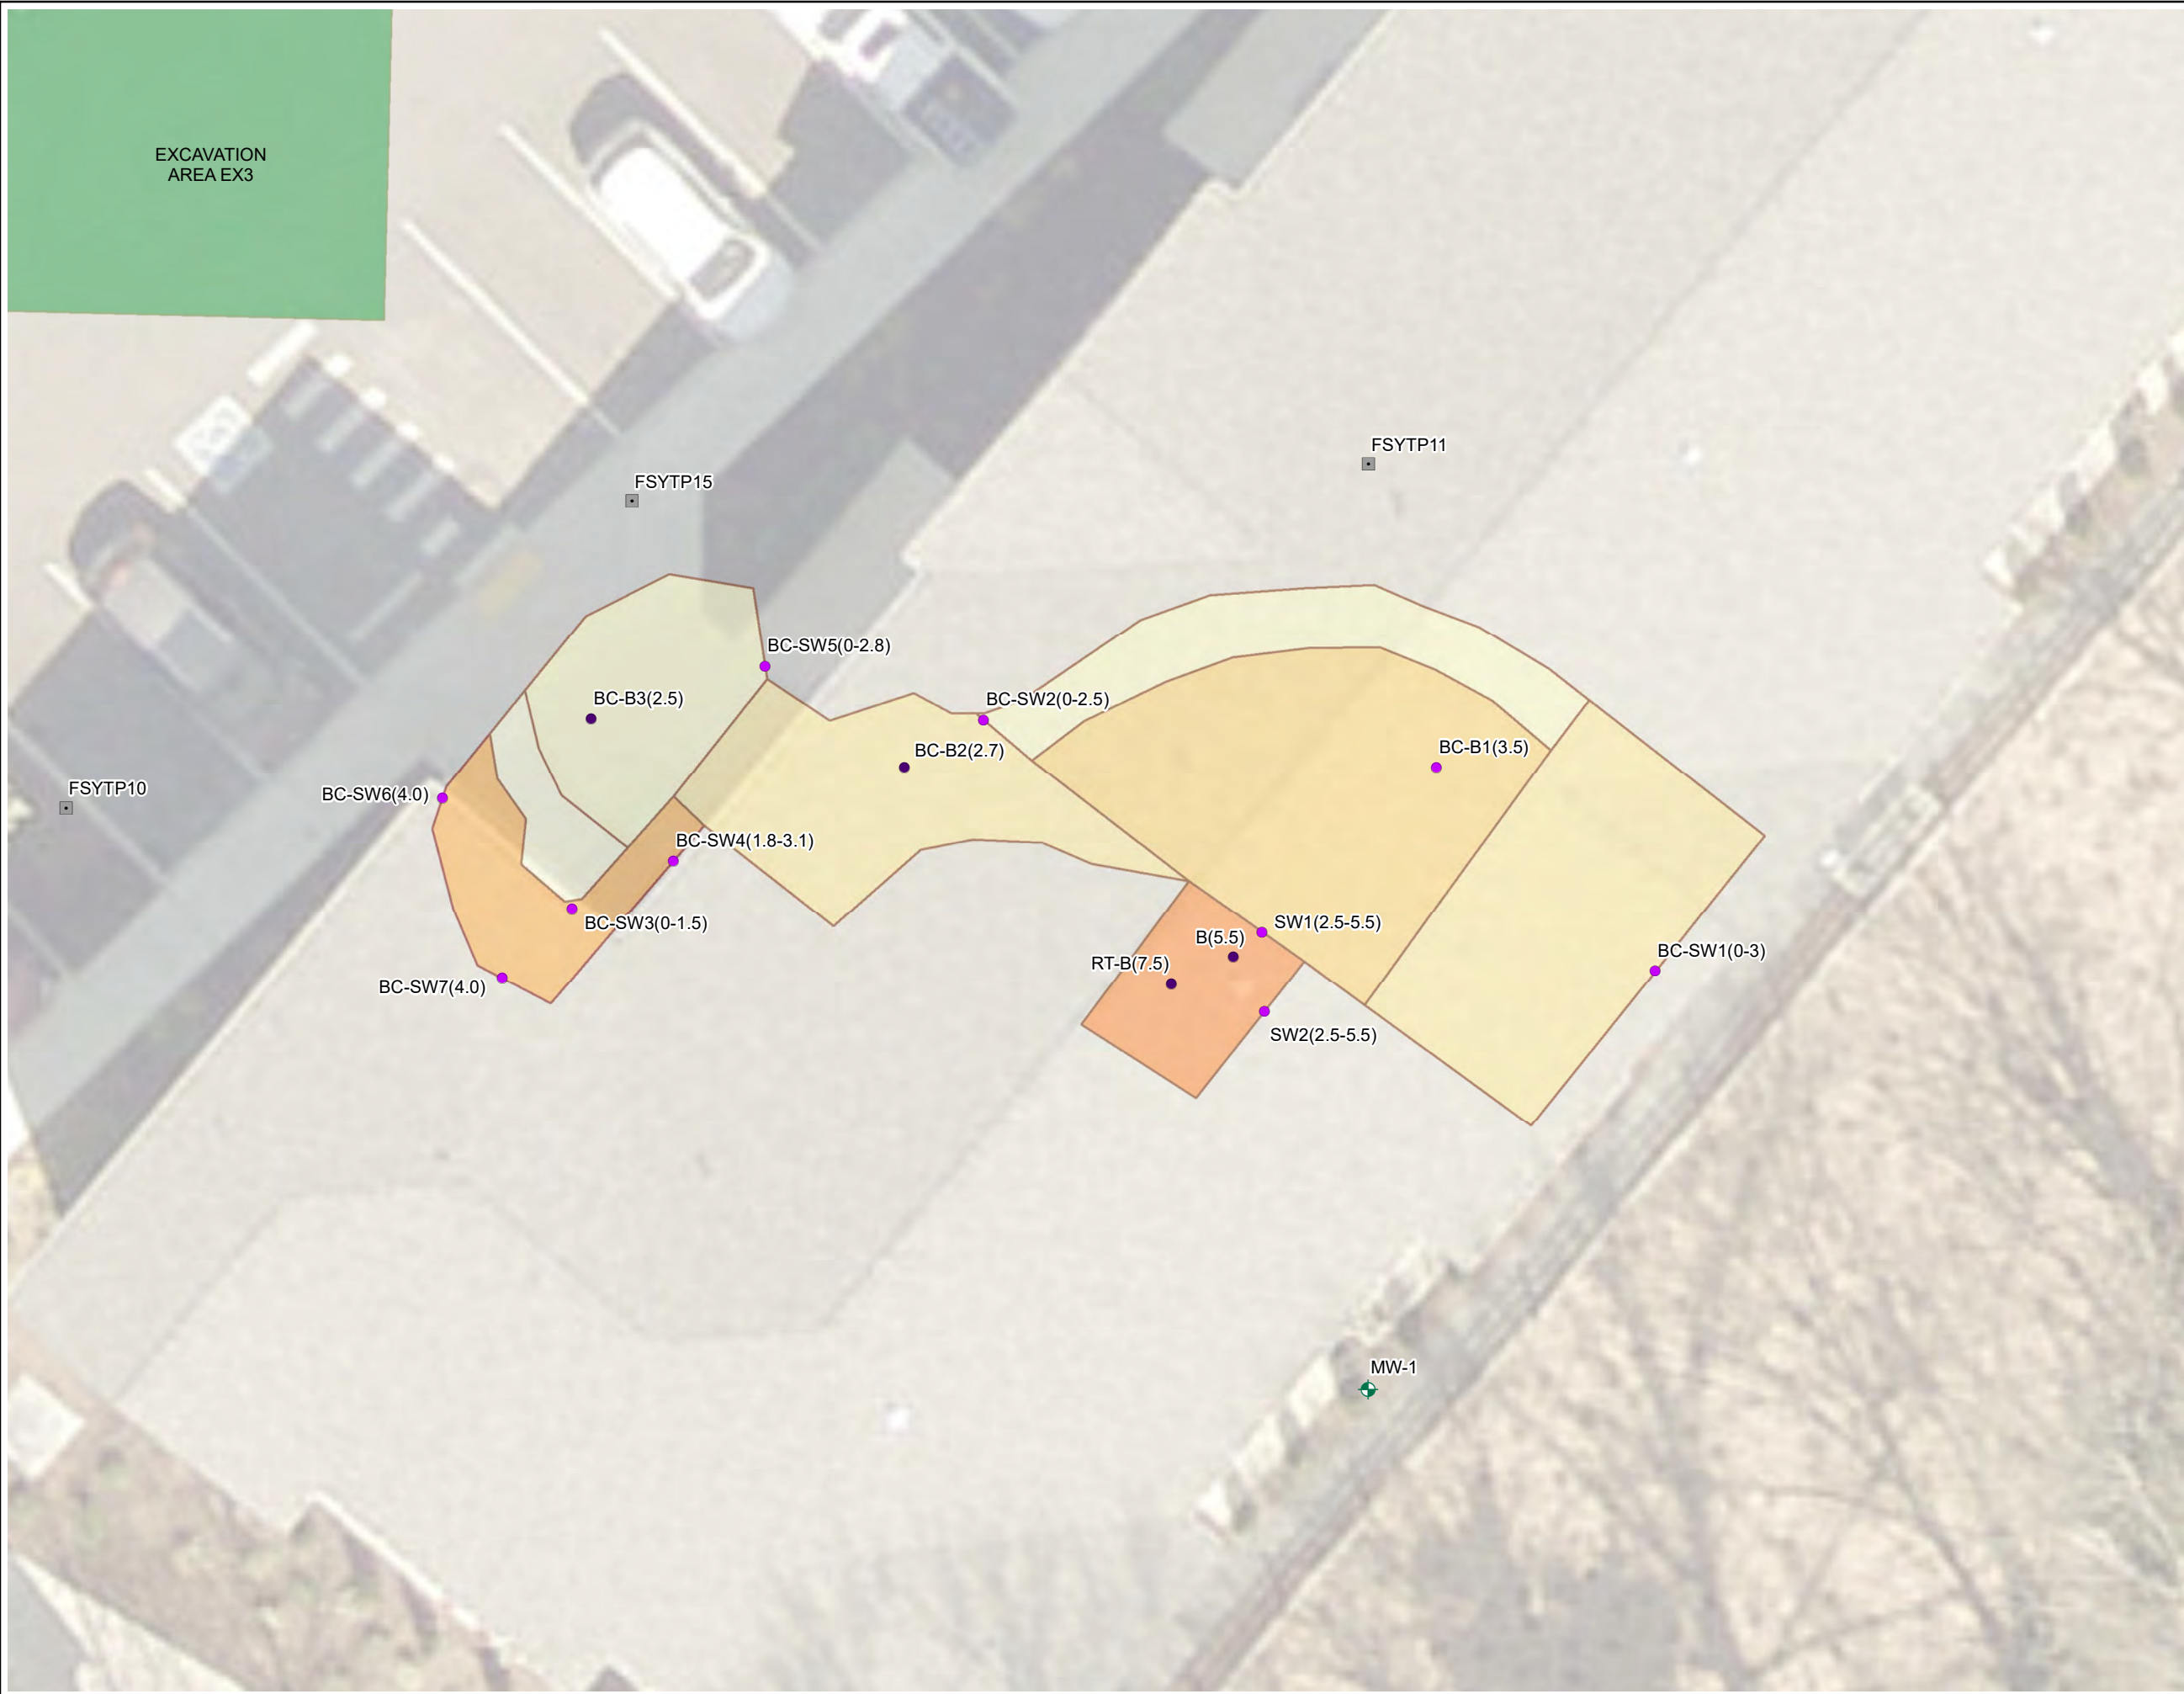
**FIGURE 11**  
 REMEDIAL EXCAVATION AREAS  
 (1997 - 2019)  
 526 SIMONS ROAD  
 MONROE, WASHINGTON  
 FARALLON PN: 2747-001

- MONITORING WELL (EMCON, 1996)
- TEST PIT LOCATION (FARALLON, 1999)
- BOTTOM CONFIRMATION SOIL SAMPLE (LANDAU, 2019)
- SIDEWALL CONFIRMATION SOIL SAMPLE (LANDAU, 2019)
