SUBSURFACE SURVEY GROUND PENETRATING RADAR (GPR) EVALUATION					
Project Name	Raplee Property - GPR	Project No.	24-2153	Date	9/12/2024
Project Address	9816 271st Street NW Stanwood, WA 98292				
Client Address	Maul Foster & Alongi, Inc. (MFA) 1329 North State Street, Suite 301 Bellingham, WA 98225				
Attention	Carolyn Wise, MFA Senior Hydrogeologist

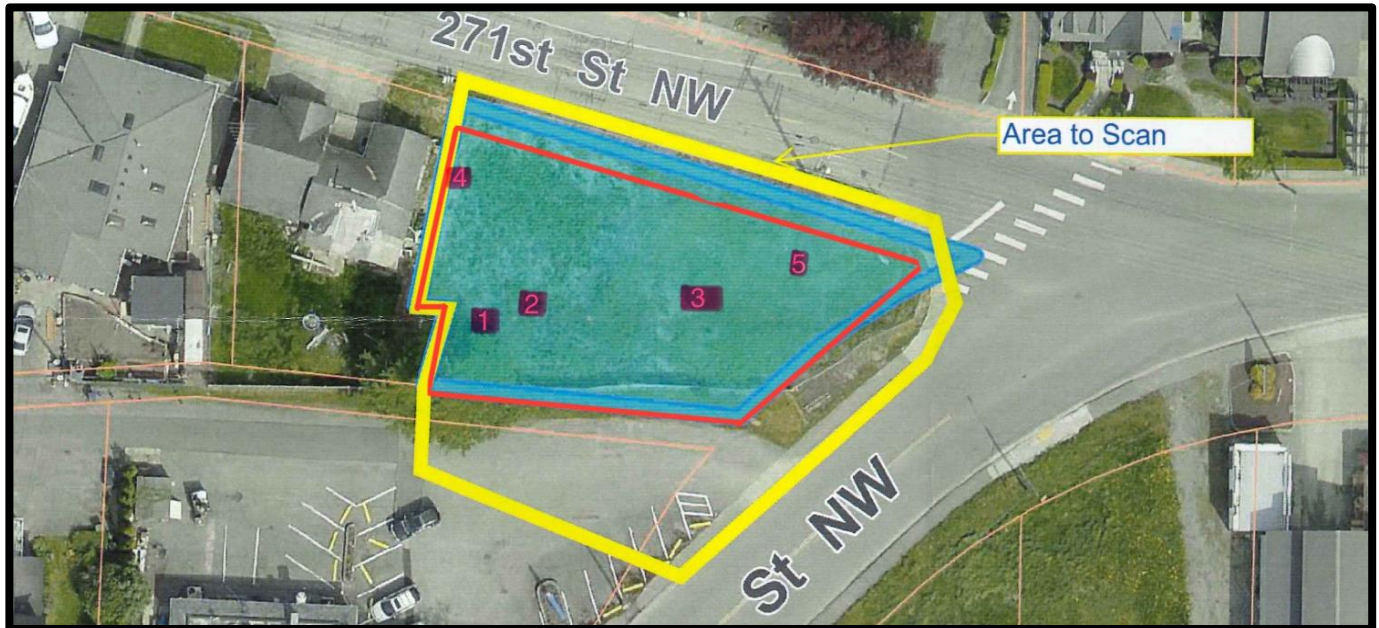
Image 1: Site map with the extent of the requested area bordered in yellow, and the approximate extent of the area scanned on this date bordered in red. The blue border indicates the approximate boundary of the fence line. The approximate location of subsurface anomalies identified on this date are marked and numbered in pink .

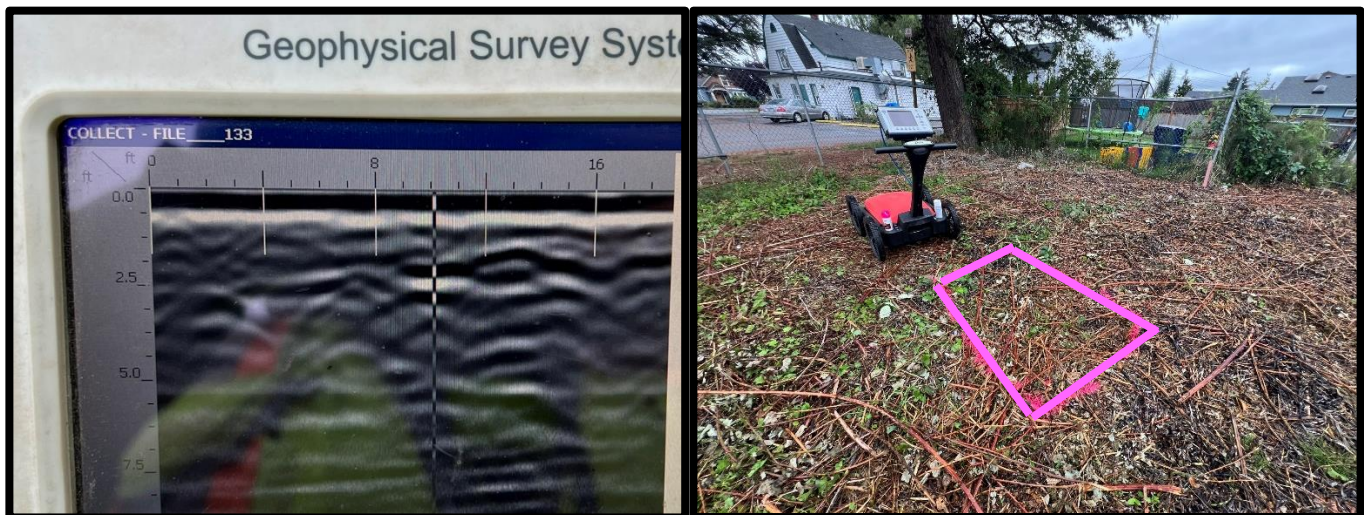
Image 2: GPR cross-section with vertical reference line centered on Anomaly 1 (left). Its observed extent is outlined in pink (right).

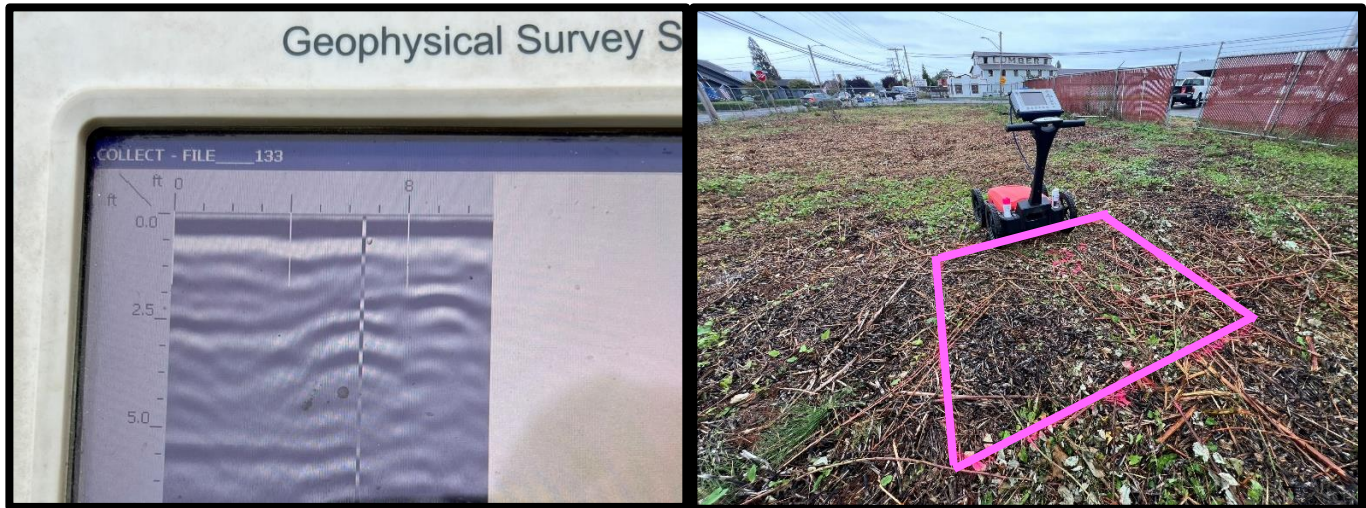
Image 3: GPR cross-section with vertical reference line centered on Anomaly 2 (left). Its observed extent is outlined in pink (right).

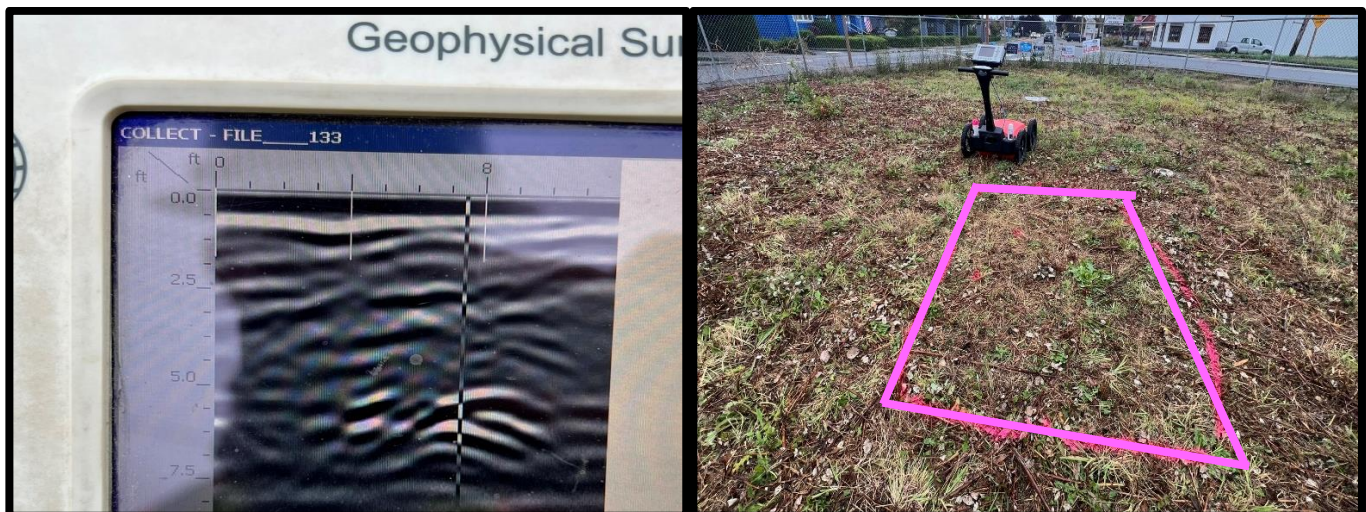
Image 4: GPR cross-section with vertical reference line centered on Anomaly 3 (left). Its observed extent is outlined in pink (right).

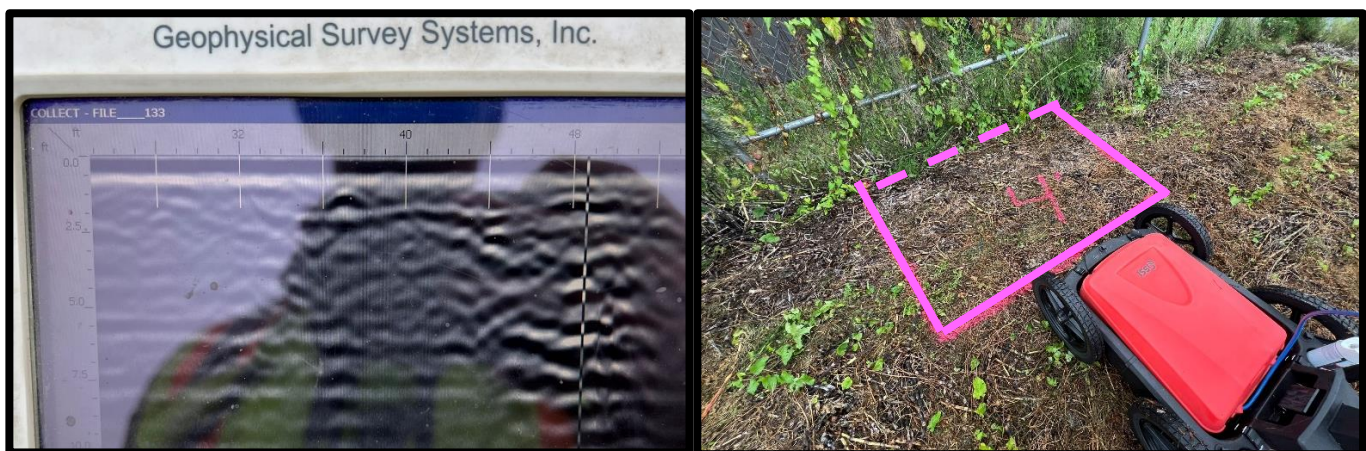
Image 5: GPR cross-section with vertical reference line centered on Anomaly 4 (left). Its observed extent is outlined in pink (right).
