AC Custom Metal Work

SHARP Report — Part 1 of 2

17063 AC Custom Metal Work 20240617

Conceptual site model

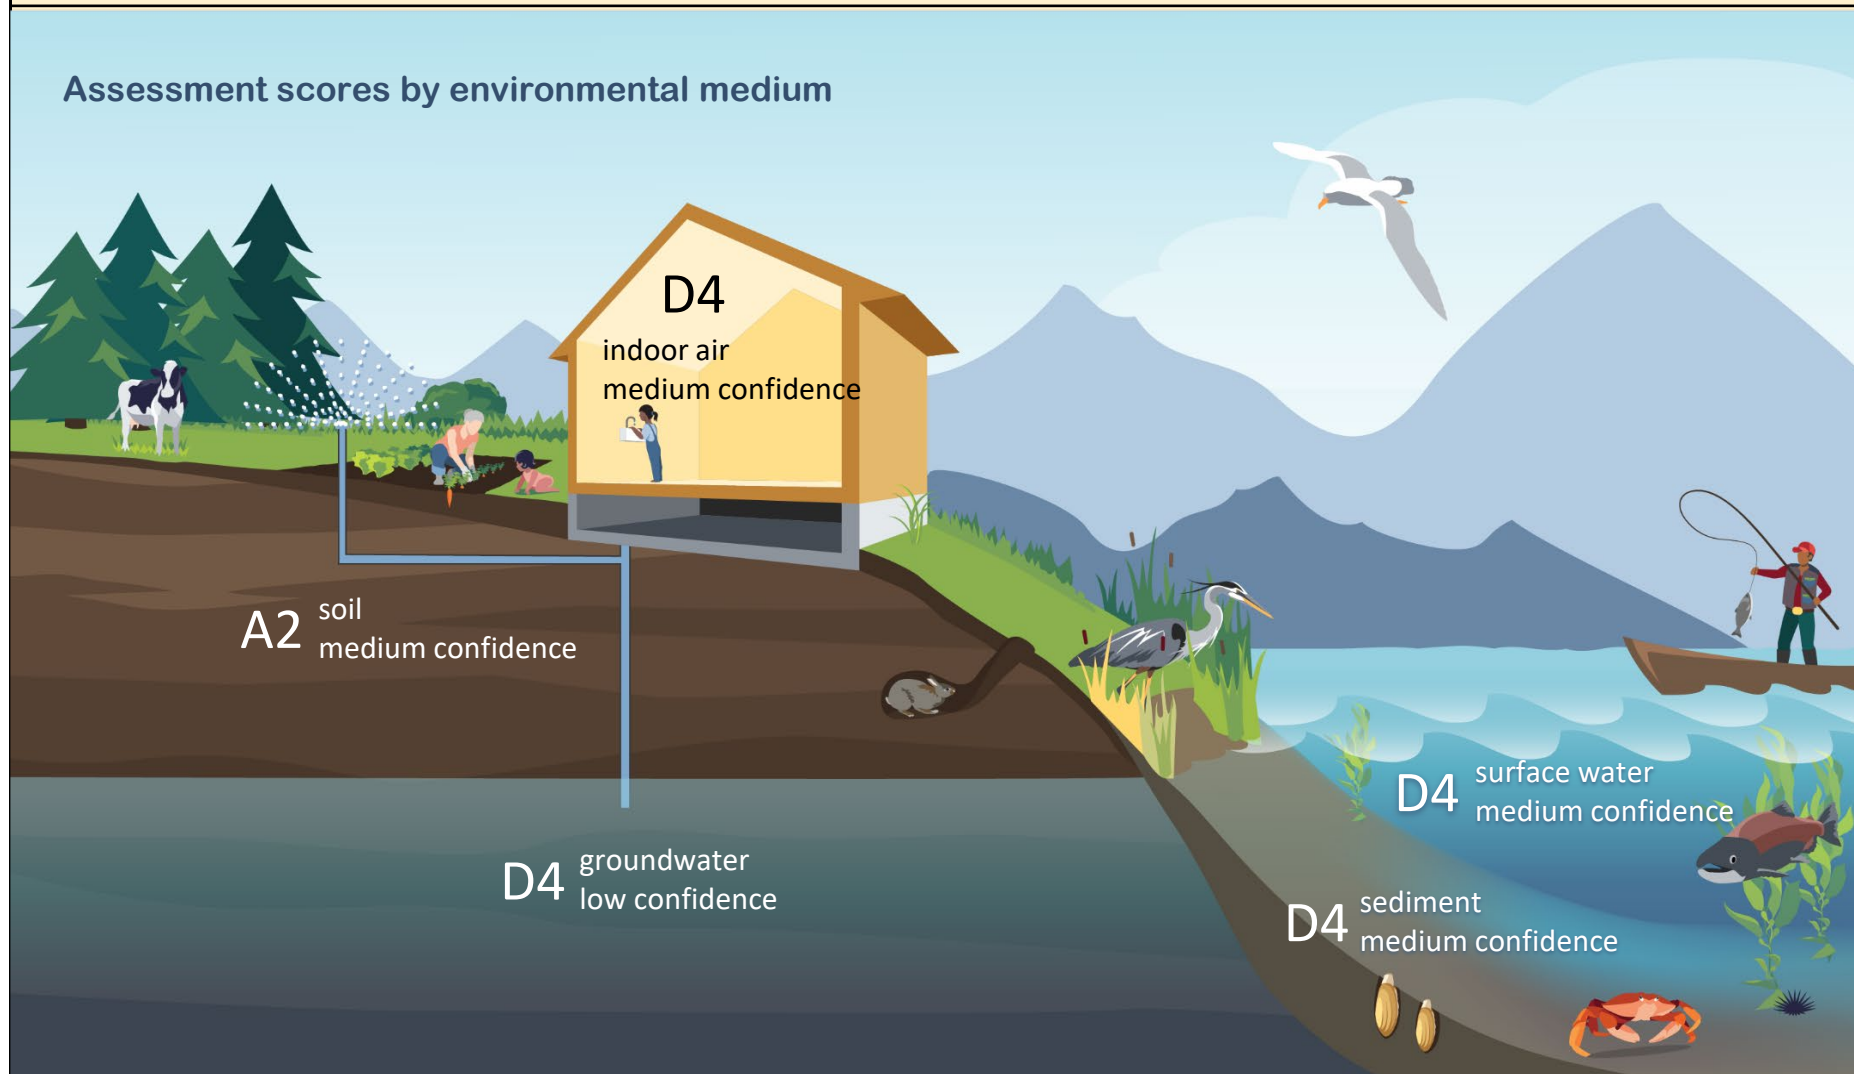
Assessment scores by environmental medium

SHARP Media	Scores	Confidence	Additional Factors	
Indoor air	D4	medium	multiple chemical types	⊘
Groundwater	D4	low	risk to off-site people	⊘
Surface water	D4	medium	climate change impacts	⊘
Sediment	D4	medium	plant/animal tissue data	⊘
Soil	A2	medium

Soil analytical results for oil-range petroleum hydrocarbons are above MTCA Method A.

One soil sample was taken, resulting in 12,000 mg/Kg (Method A cleanup level is 2,000).
