Soils and Hydrology Report

Pierce County, WA

SCJ ALLIANCE
CONSULTING SERVICES

Project Reference: SCJ # 2529.01

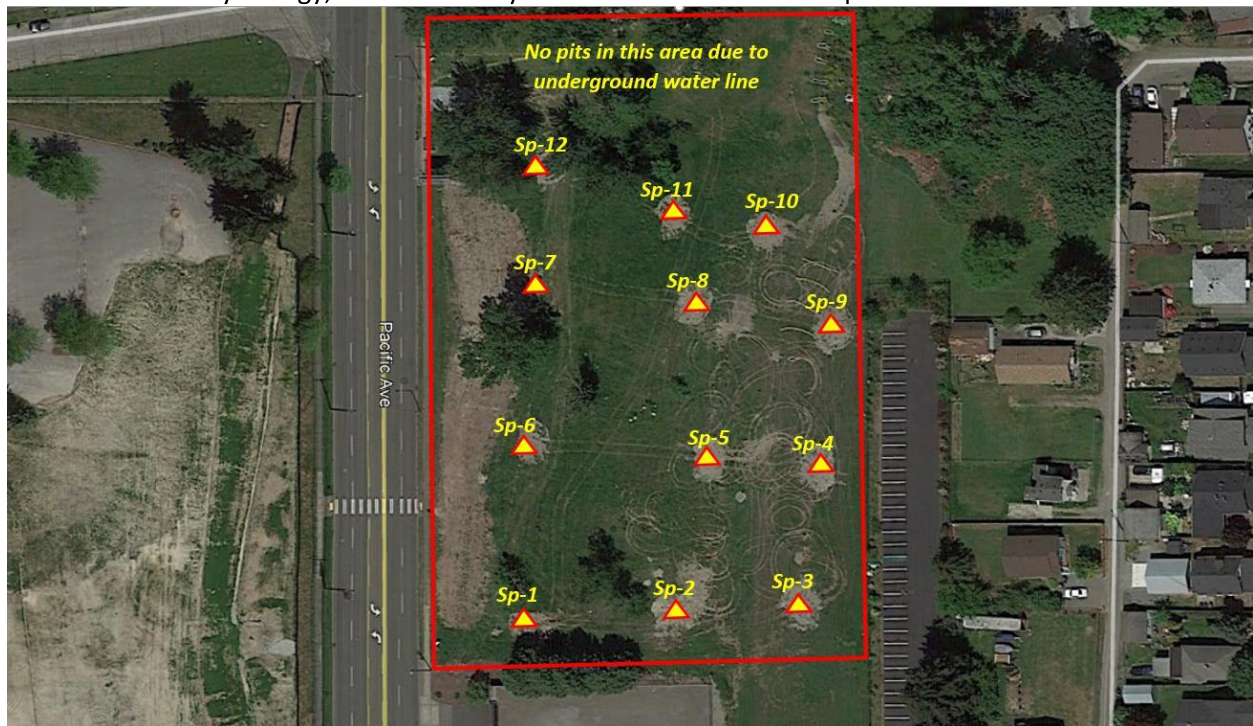
The purpose of this report is to assess potential soil contaminants that might impact development choices. Soil profile conditions in each of the 12 soil pits were documented and representative soil samples were collected from various layers in various pits to send to the lab to screen for potential hydrocarbon and heavy metal content, primarily to assess the type of fill present. Recent Google Earth images document the soil pit locations (Figure 6).

None of the 12 soil pits evaluated had undisturbed native soil profiles. However, some of the fill materials appeared to be displaced native soil – possibly from regrading onsite or imported mineral materials from nearby project areas. Therefore, some of the fill layers had textures similar to local glacial till sediments. Other fill layers included chunks of concrete mixed with the native sediments which appeared to come from either road or parking lot reconstruction projects. Some of the fill layers were mixed with woody debris.

Some of the fill layers trapped infiltrating stormwater, and therefore, were seeping during the onsite soil pit investigations. However, depth to the seeping zones was not consistent across the site and thus appears to be an artifact of soil layering from filling and compaction and was not a reflection of a shallow groundwater table across the site.

Near-surface compaction of fill materials in the low elevation swale base in the eastern portion of the site appears to cause water to pond over the surface in some areas during winter months. No surface ponding was present during the April site visit, but there was evidence of past ponding. That ponded water drains across the surface to the northeast, leaving the site via a swale feature (mentioned previously) that exits the site near the northeast parcel corner. None of these hydrologic features is a result of natural hydrology, but rather they are a result of surface compaction of fill materials.

Figure 6. Showing final soil pit locations.

Infiltration of onsite stormwater may not be possible due to limited infiltration potential in these compacted fill sediments.
