Inspection Report

Facility Name:	Inspector:	Inspection Date:
City Fill Closed Landfill	Quyen Keeton	February 17, 2022 Thursday a.m.
Address:	City:	ZIP Code:
35 th and Pacific Ave	Tacoma	98418
Facility Contact:	Phone:	Permit Number:
		Closed

City Fill Closed Landfill

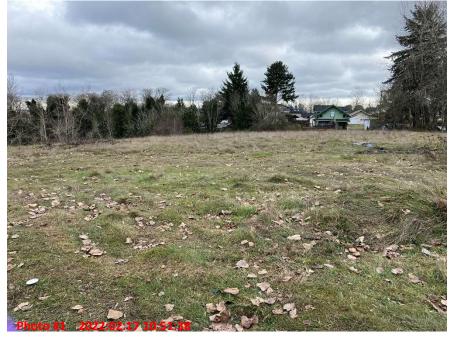
Closed landfill surface

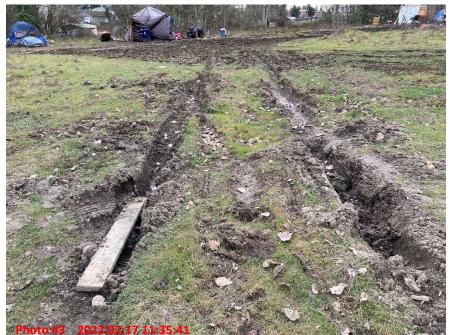
There was no noticeable differential settlement. We saw tire marks on the closed landfill (see photos on page 5). We did not inspect the face of the landfill for seepage.

Tire marks on the closed landfill

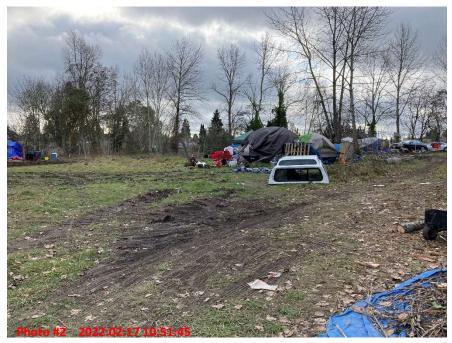
People living homeless moved from on top of the landfill to an area south but still on the property. There were couple tents on the closed landfill.

People live homeless on the closed lanfill

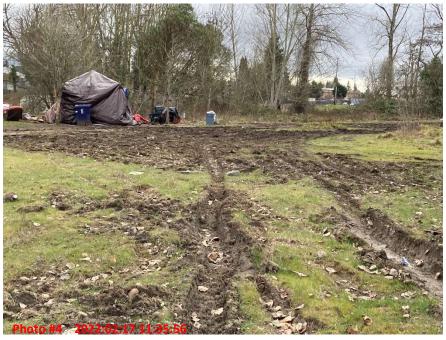
Tire marks on the closed landfill
